POLYTECHNIC OF TORINO  
FACULTY OF ARCHITECTURE  
Degree in Architecture  
**Honors theses**

**Innovative method patterns on static analysis and structural intervention  
project for the rehabilitation and functional recovery of Montalenghe's Castle**

by Davide Capra, Fabio Cavaglià, Fabio Violin

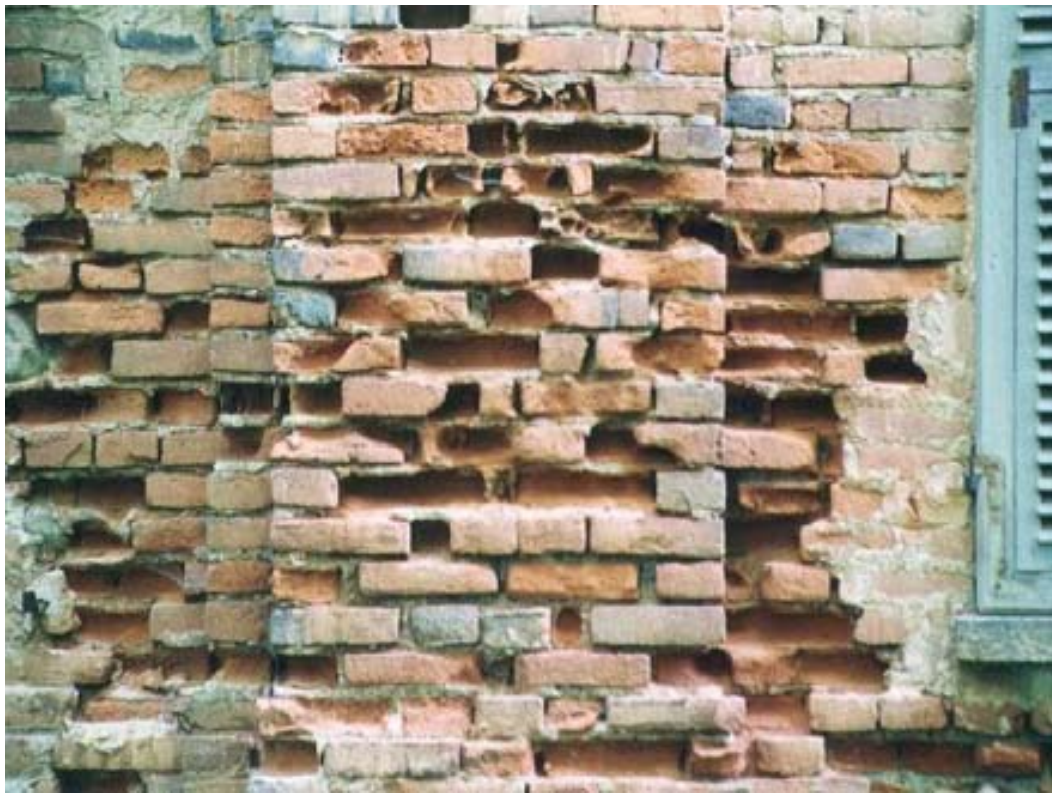
*Erosion of the brick*

The deterioration analysis, carried out following the *Normal Recommendations 1/88*, allowed to identify the different alterations to the building walls: disjointedness, detachment and efflorescence of the plaster, brick honeycombing, mortar erosion, rust stains, biological patina and evidence of vegetation.

The renovation of the external masonry walls included the restoration of bricks and original plaster, the reshaping of mortar joints and plaster made of finish mortar which allow, like in ancient times, to figure out the building texture.

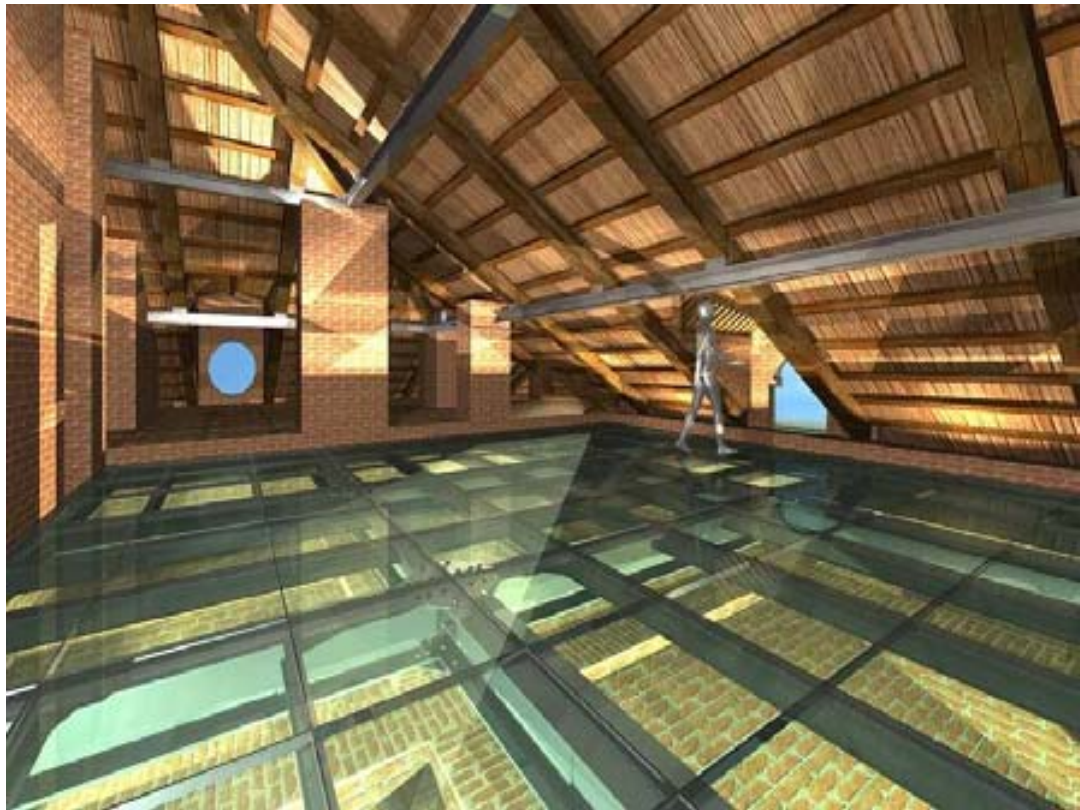
*The attic room after recovery*

Thus, the reconstruction of the covering was deemed necessary, keeping the original structure pattern and reusing again the still existing ligneous elements. As regards the wooden garret at the second floor, an intervention of conservative restoration was foreseen, whereas the increase in the overloads called for the realisation of newly-made steel garrets, placed above the mentioned ones.
