Analysis of the structural and architectural damages and hypothesis of reinforcement of the church S.Bernardino in Saluzzo, Italy

by Gianaria Chiara

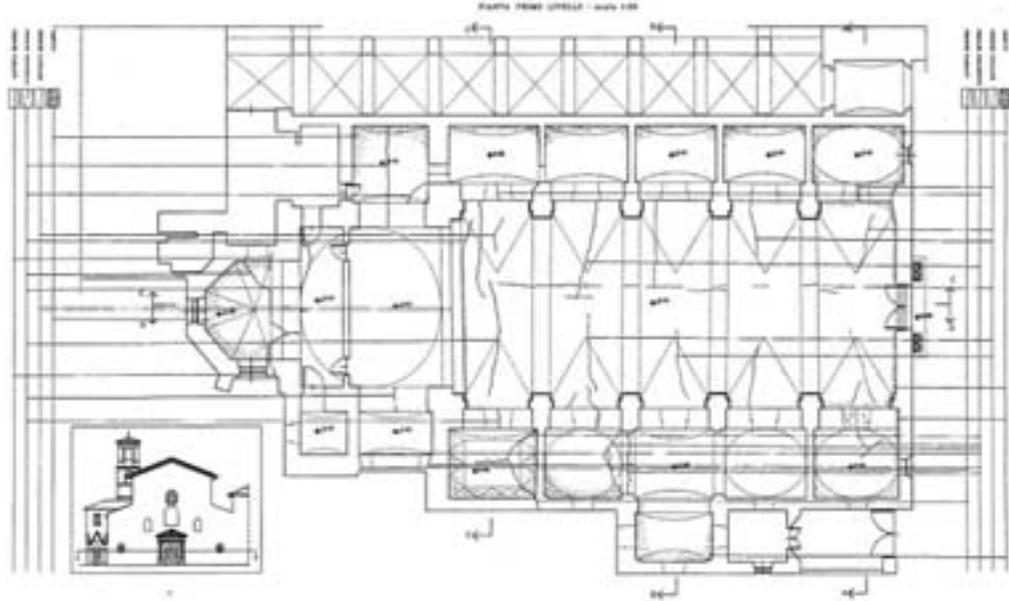
The barrel vaults of the five spans which make up the central nave and particularly the last two spans against the presbitero, have some advanced cracks in key, perpendicular to their directrix, whereas some capillary cracks are found parallel to the same directrix still corresponding to the keystone

The walls present advanced and capillary cracks having mostly vertical and 45° direction on both sides of the central nave.

The first two side chapels ,both on northern and on southern sides, present only some capillary cracks of small sizes; the third chapel on the northern side, besides having a wide humidity situation, presents advanced cracks, particularly corresponding to the key and the directrix of the arch which divides this chapel from the next one.

The presbitero chapels present advanced cracks corresponding to the keystone parallel to the directrix of the same.

The apse is damaged by passing-through and advanced cracks, which follow the direction of the ribs of the (umbrella) vault in the contacting side between the transept and the apse self.

The chink situation coming out shows clearly that the cause of the structural modifications is principally

- the repair of the passing-through cracks by means of reinforced concrete
- the reinforcement of the foundations by means of microsupports (micropoles), which overpassing the clayey strata on which the foundations selves are placed, may reach a depth suitable to secure the bulding stability.
