POLITECNICO DI TORINO
SECOND SCHOOL OF ARCHITECTURE
Master of Science in Architecture (Rehabilitation and Revaluation)
Honors theses

The yard for restauration and structural rehabilitation of the “Cappella della SS. Sindone” in Turin. Contribution for the restauration project of the external surfaces of the Guarini’s Chapel

by Monica Marelo

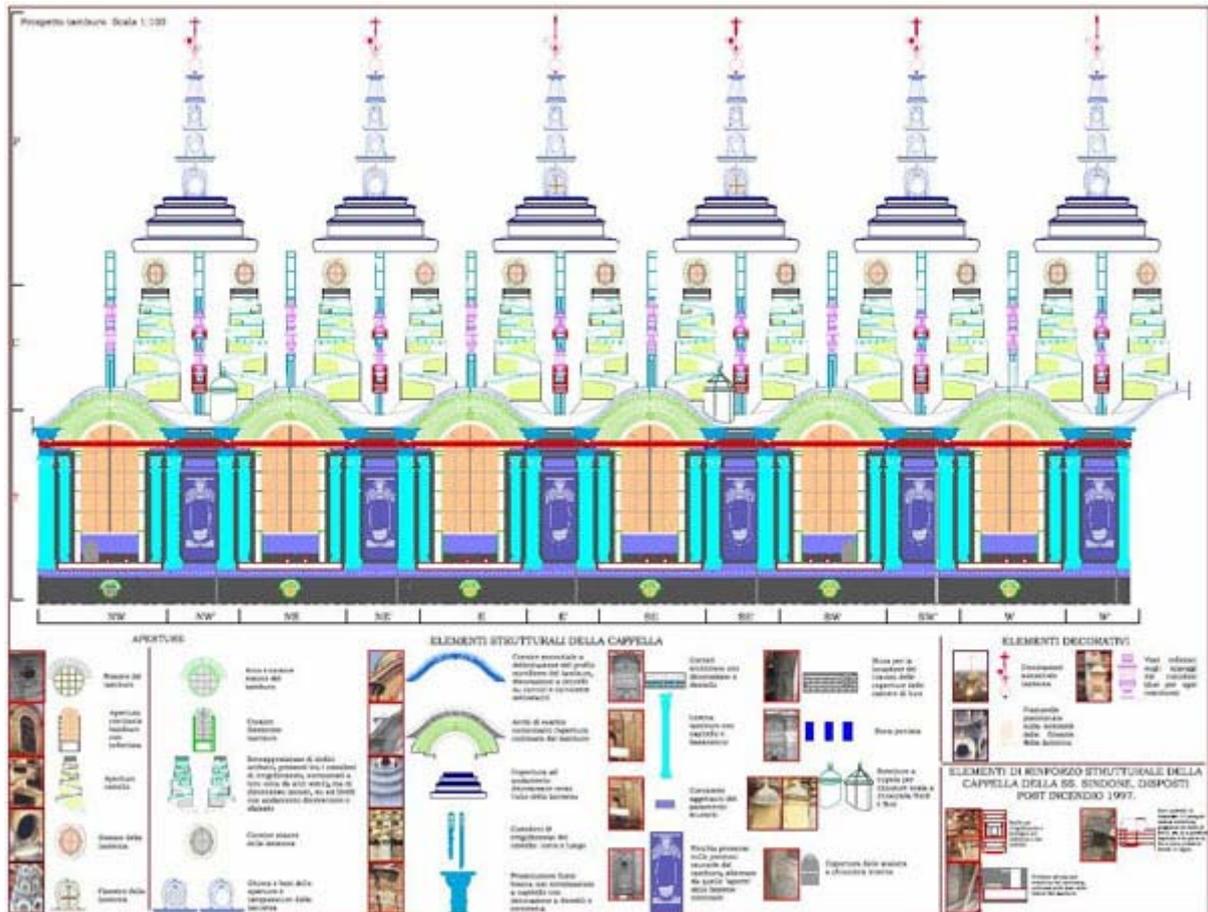
Table with identification of the structural elements making up the exterior of the Guarini's Chapel

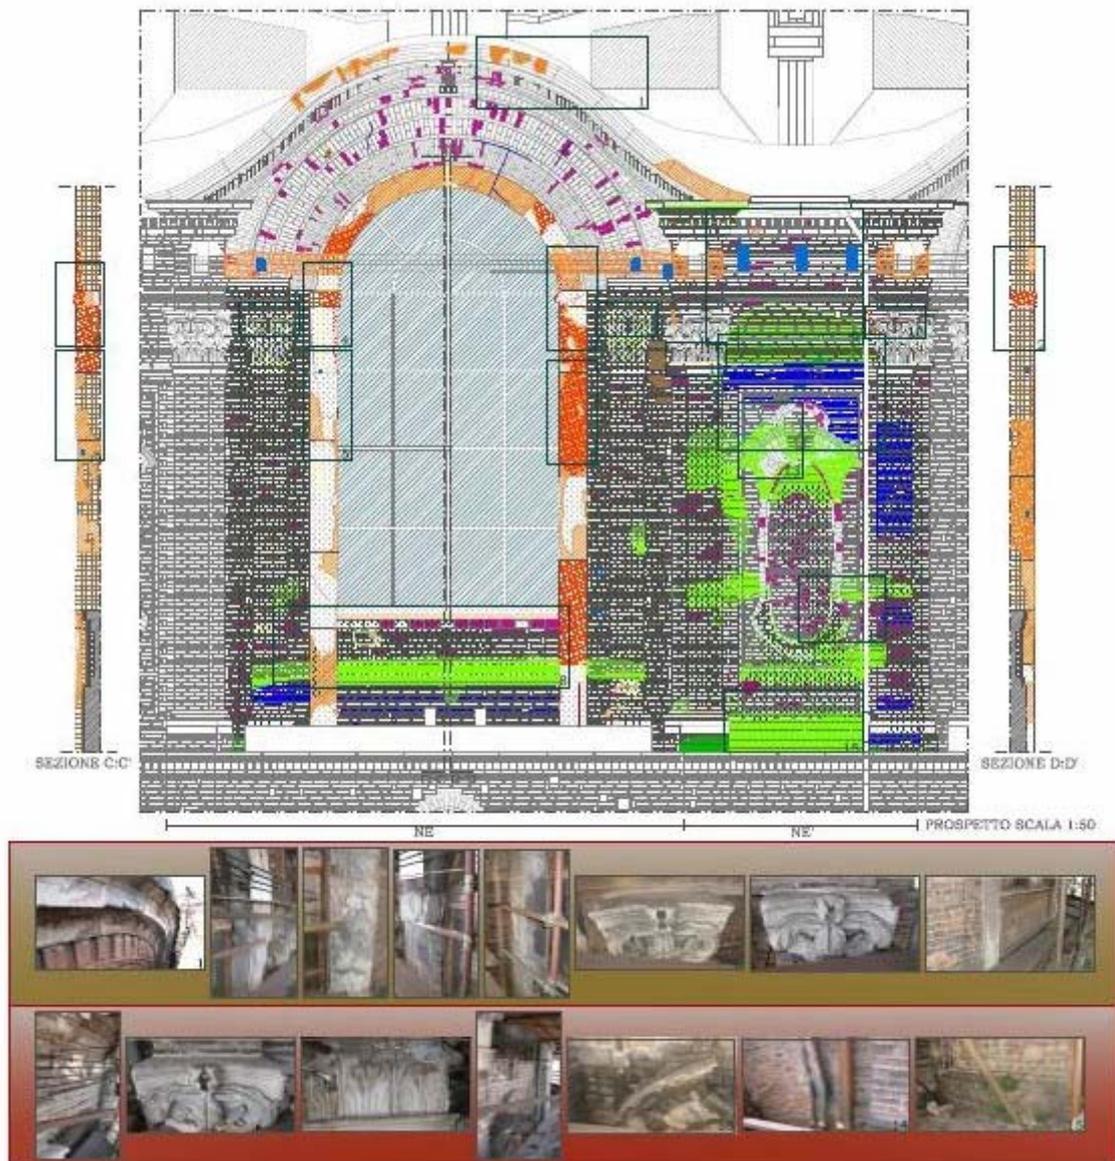
The drum is composed of six foreheads and it is affected of two types of degradation. The first one is related to the fire of the 1997 which is showed very pronounced but it is different among the six foreheads. In this case it finds the presence of: fessures determined both from the forehead materials contact to the heat of the flames and from the fusion of the chains situated inside the bottle-holder and the drum; exfoliations, erosions, chromatic alteration and gaps.

The second one degradation type results to be the consequence of the post fire condition surfaces: absence of maintenance, the presence of constants zones of shade produced by the external scaffolding... in this case there are a lot of degrades: stains, inferior and superior vegetation, plaser mining, efflorescences, degrade of metallic elements and encrustation.

Significant degradation of NE-NE' s forehead of the drum
