POLITECNICO DI TORINO
SECOND SCHOOL OF ARCHITECTURE
Master of Science in Architecture
Honors theses

Bra: Town Hall. Survey, chronology of the main building works and analysis of the most important cases of deterioration

by Luciana Rinaldi

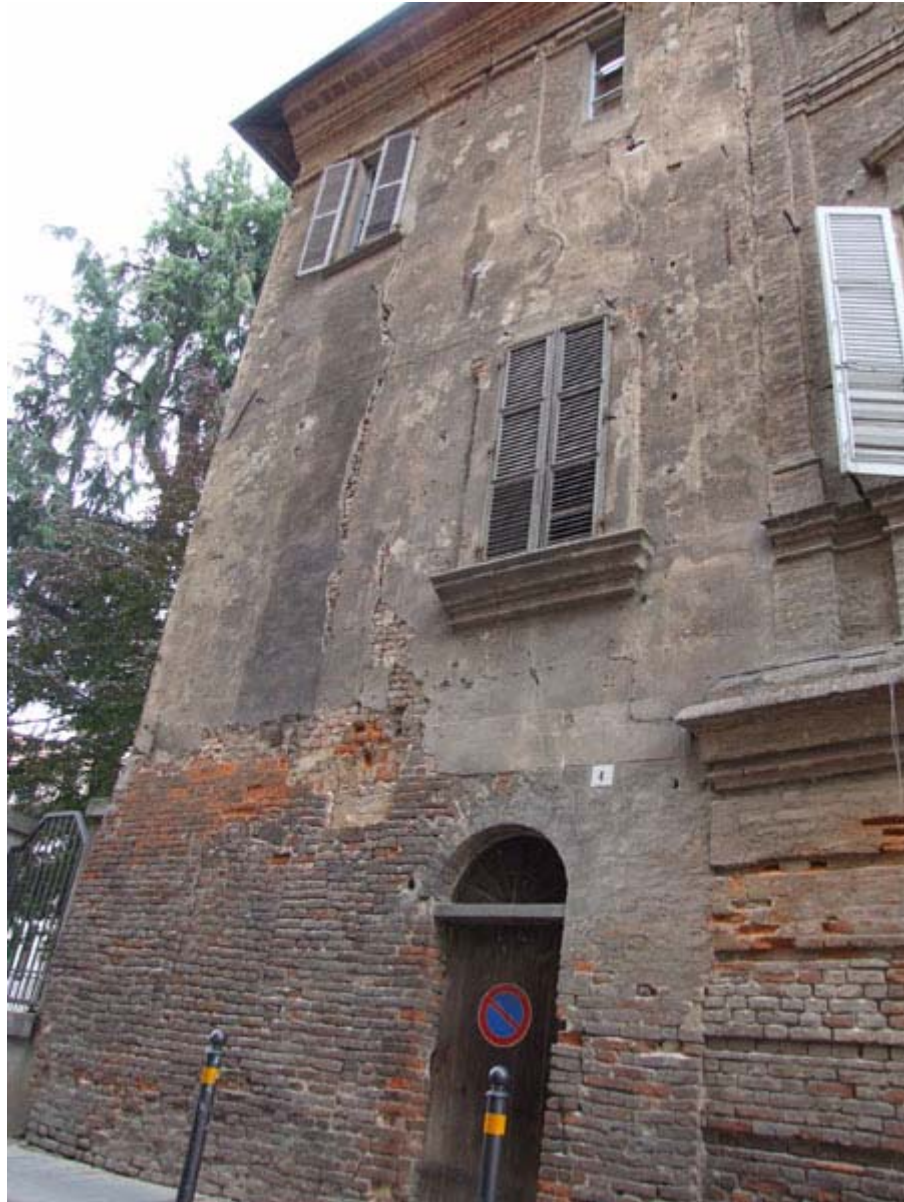
Photo of the oldest part of Town Hall overlooked via Barbacana

Some cracks, cutting the masonry from the cornice, are visible; their course, slimming down from top to bottom, indicates that the cracks are caused by the subsiding of the foundations. Since here the earth is not coherent, because it was brought on purpose to fill up the chasm of the “Rocca”, the above-mentioned lesions are due to settlement from filling material. Their vertical direction shows that the cause is imputable also to the rotation due to the push of the vaulted floors on the supporting walls. The cracks formed where the pushing found the weakest points in the walls, therefore less thick or empty inside, which hints at the presence of a small window in the space between the two greater fissures, as testified by Boetto's lithograph, and the results of the thermographic analysis would confirm it.

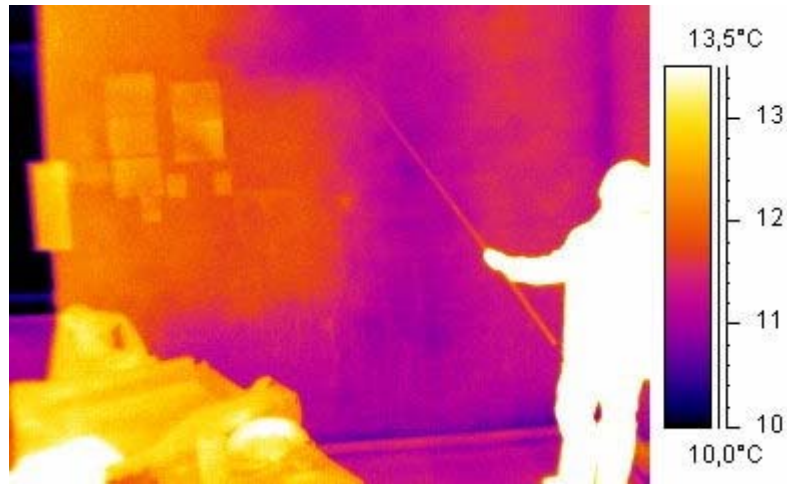
Thermographic image underlines a discontinuity due to unlike material and the form would make to hypothesize the tamponade of opening

Such flimsiness is due to the adoption of vaulted floors in substitution of wooden floors, which probably took place during the eighteenth-century extension works, though without increasing the masonry section. The thermographic analysis executed in the meeting points of the walls, where the extension works were carried out, shows obvious signs of constructive discontinuities related to bad scarfing. This could be attributable to the fact that such works, dated 1650 and 1730, were effected leaning on the pre-existing walls.
