2. Action on **the Egg**

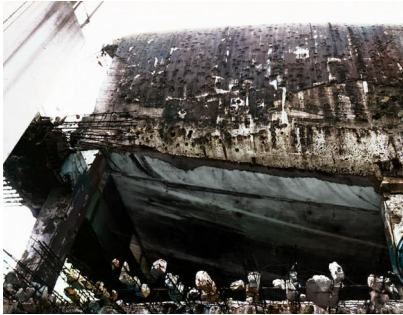
Decays	Discoloration
Hatch

Decay description	Color variation from what is expected or planned. Originally, the ceilings and the walls were white.
Visible effects at sight	The zones are not thick. Brownish areas seem to be shallow.
Possible causes	Sunlight, severe weather, and high temperatures, along with low quality paint, absence of water repellent layer.
Decay mechanism	The plaster is in poor condition; the surface is marked by a shift in color to dark brownish, which is the result of the building's neglect for more than thirty five years after it was partly destroyed by conflict.
Suggested intervention	Check the degree of discoloration to see whether the decay is only aesthetic or profound in order to avoid additional risky decays.

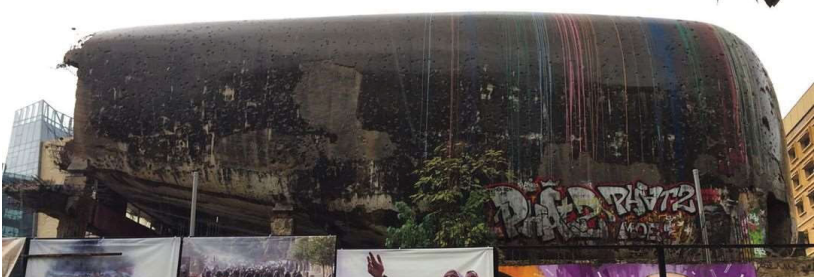
Decays	Spalling
Hatch

Decay description	A detachment of the coating from the base along its plane.
Visible effects at sight	Surface discontinuity: plaster Large portions of the plaster layer have come unstuck. The finishing layer is rough and 2 cm elevated from the concrete.
Possible causes	Thermal loops. Climate Impact, weathering.
Decay mechanism	The lack of adhesion between the concrete and the plaster caused the coating to separate from the substrate.
Suggested intervention	In order to avoid more harmful decays, check the degree of separation to see whether it is only superficial or severe. The investigation may be carried out on-site using macroscopic observation.

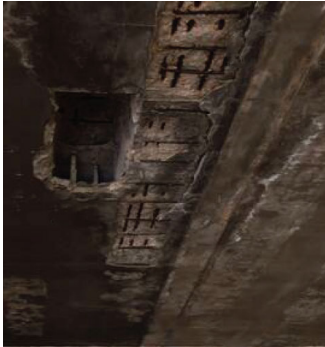
Decays	Corrosion
Hatch

Decay description	Some areas appear darker than the surface's normal tone. Mainly oxidation.
Visible effects at sight	Some zones have a deeper tint than others. Surface irregularity of the concrete, reinforcement metals are exposed. On the surface of the pilar, a few small circular holes of varying diameters.
Possible causes	Weather effect, and a gas or liquid chemically attacks an exposed surface
Decay mechanism	Progressive disintegration of a material caused by the mechanical or cavitation impact of moving gases, fluids, or solids.
Suggested intervention	Exposed reinforcement metal should be investigated. The investigation may be carried out on-site using macroscopic observation.

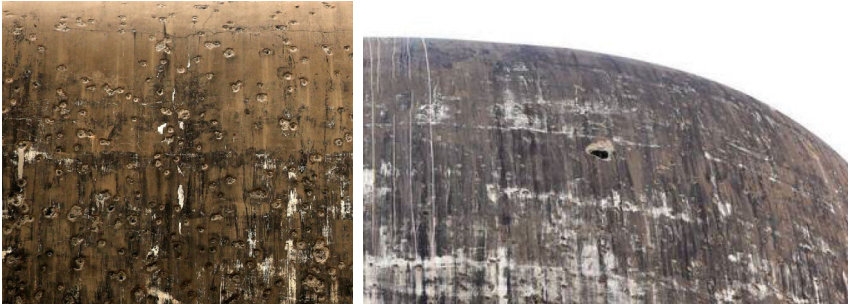
Decays	Human Action
Hatch

Decay description	Mechanical damage caused by human action
Visible effects at sight	Cavities
Possible causes	The structure was subjected to the impact of bullets during the conflict. Impact of a firearm; projectiles
Decay mechanism	Isolated impact of combat bullets, resulting in the loss of plaster and a piece of the concrete underneath. The degradation is concentrated in the building.
Suggested intervention	Check the detachment status to determine if the decay is problematic. If not, the decay may be kept to keep the memory of past events.
Notes & remarks	This decay is apparent on the structure's four façades as well as internally.

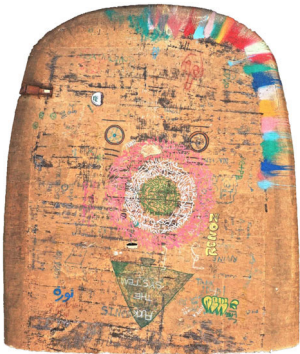
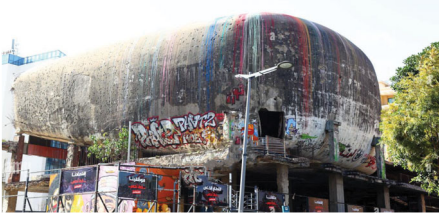
Decays	Graffiti
Hatch

Decay description	Biogeochemical paint, ink, or similar coating on the surface of building materials.
Visible effects at sight	Paint on the surface of the plaster. The majority of the texts include swearing.
Possible causes	Human intervention via the use of spray paint.
Decay mechanism	Human intervention through the use of many color spray cans. The decay is concentrated on the building's interior and exterior walls.
Suggested intervention	No intervention required, unless the painting/grafifiti releases toxic harmful chemicals.
Notes & remarks	This decay is apparent on every part of the shell.

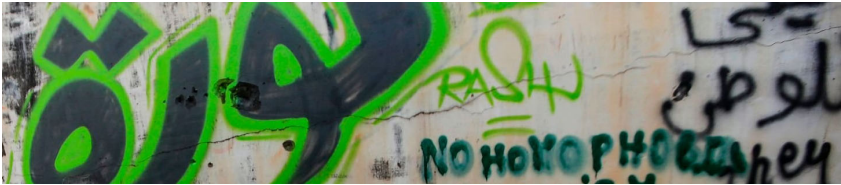
Decays	Diagonal Cracks
Hatch

Decay description	<p>A crack: is the total or partial separation of concrete into two or more portions caused by breaking or fracturing.</p> <p>Diagonal Crack: An angled crack that is generally 45 degrees to the dimension axis of 0.1mm.</p>
Visible effects at sight	<p>The surface discontinuity highlited in the photo (Long Diagonal crack).</p> <p>Small fractures around the large fissure.</p>
Possible causes	<p>The result of a spall, most likely generated by an impact.</p> <p>The material's characteristics (Dosage).</p>
Decay mechanism	<p>An angled fissure formed by shear stress in a flexural part, generally approximately 45° to the horizontal axis; or a fissure in a slab that is not parallel to either the lateral or longitudinal axes.</p>
Suggested intervention	<p>Determine if the decay is only superficial or significant in order to avoid future risk. The investigation may be carried out on-site using macroscopic observation & sonic and thermographic tests.</p>

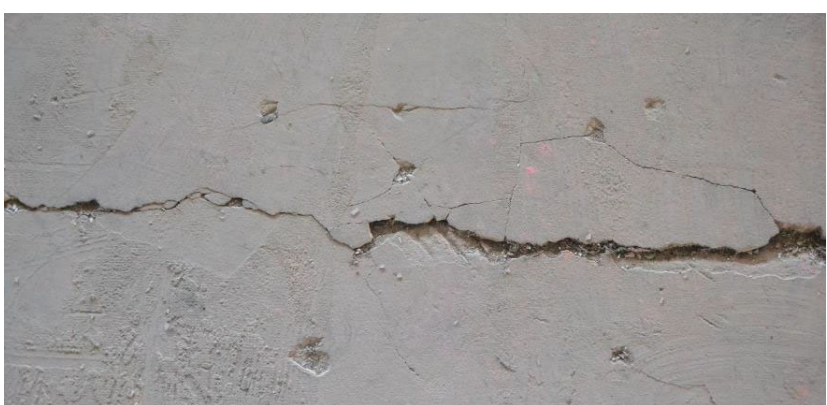
Decays	Shrinkage cracking
Hatch

Decay description	Shrinkage Cracks: Cracks in a structure or member caused by tension failure. dim: 1mm
Visible effects at sight	The Surface Discontinuity failure. Smaller fractures all around large crack.
Possible causes	The structure's morphology. The material's characteristics (Dosage).
Decay mechanism	It occurs as a result of tension failure induced by external or internal limitations when moisture content decreases, carbonation emerges, or even both.
Suggested intervention	Determine if the decay is only superficial or significant in order to avoid future risk. The investigation may be carried out on-site using macroscopic observation & sonic and thermographic tests.

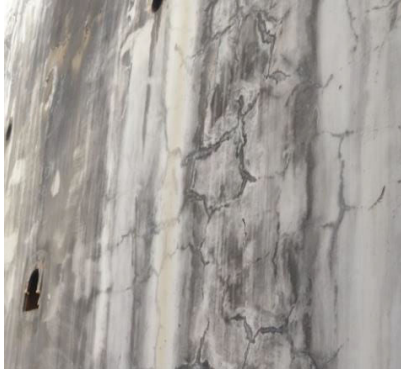
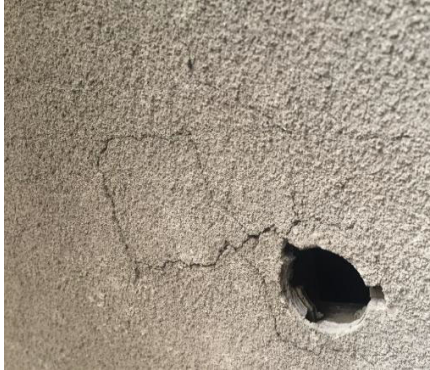
Decays	Thin Pattern Cracks
Hatch

Decay description	Pattern Cracks: fine cracks in concrete in the shape of a pattern with dimensions more between $0.5\text{mm} < 1\text{mm}$
Visible effects at sight	Numerous polygonal fractures with varying dimensions on the surface. The decay has spread onto the surface. Some zones have darker tints than others.
Possible causes	Thermal distinction between the several layers Mechanical processes. Concrete density variability. Material characteristics. Mode of operation: executive. Weather action.
Decay mechanism	It occurs due to a reduction in the volume of the substance near the surface.
Suggested intervention	Determine if the decay is only superficial or significant in order to avoid future risk. The investigation may be carried out on-site using macroscopic observation & sonic and thermographic tests. In the lab: Chemical analysis: alkali aggregates reaction to provide qualitative information on interior detachments and potential fracture expansion. (The phrase "alkali-aggregate reaction" refers to a reaction that happens in concrete over time between extremely alkaline cement paste and non-crystalline silicon dioxide, which is present in many common aggregates. This reaction may cause the changed aggregate to expand, resulting in spalling and a loss of concrete strength.)

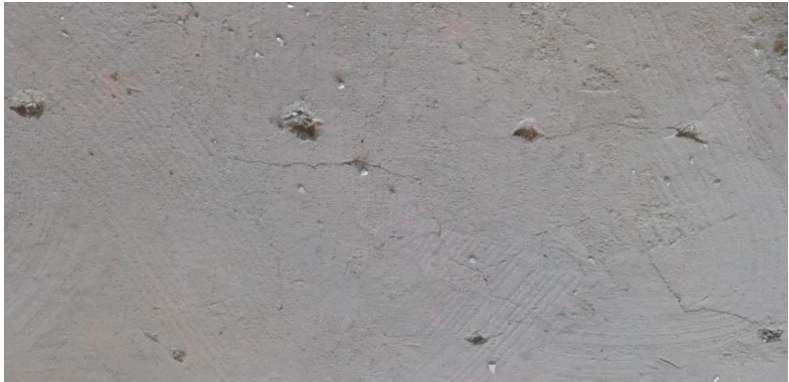
Decays	Hair line crack
Hatch

Decay description	Hairline cracks are cracks on an exposed concrete surface that are so light that they are hardly detectable (0.1mm).
Visible effects at sight	A thin fracture that breaks the surface's consistency without affecting the lower layers.
Possible causes	Moisture. Mortar shrinkage upon drying.
Decay mechanism	Hair cracks form on the surface owing to a variety of factors, including atmospheric pollutants, unequal shrinkage, and moisture. They do not entirely penetrate the plaster layer.
Suggested intervention	Take a sample to see whether the decay is only aesthetic or harmful in order to avoid risky decays. On-site: Examination of the nearby structure and details to determine if the hair fractures are caused by a lack of wall stability.

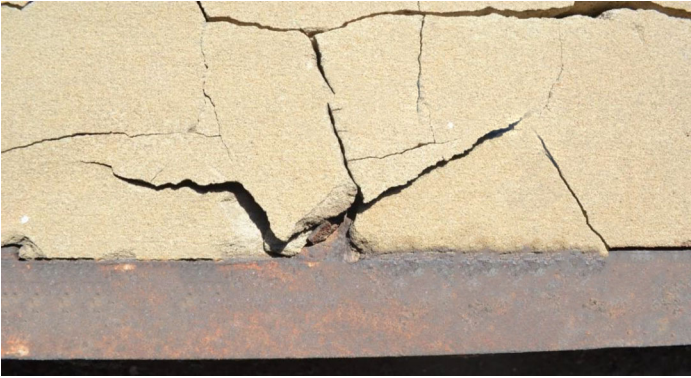
Decays	Serious Cracks
Hatch

Decay description	A full or partial separation of bars along a line caused by reinforcing corrosion.
Visible effects at sight	Surface discontinuity all the way along the ceiling and the stair step. Material loss because the fracture is substantial (>5mm).
Possible causes	Concrete carbonation. The reinforcing of the frame has corroded. Sedimentation of water.
Decay mechanism	Steel corrosion generally results in bolt rupture, resulting in a fracture.
Suggested intervention	Locate the reinforcing steel beams and chemically examine it to determine their degree of corrosion and the possibility of further deterioration. Consolidate the crack to prevent future movement between the 2 components; use substance that is compatible with the previous ones in terms of chemic elements, texture, and pigment. Development of alternative technical ways to prevent fracture growth.

Maintenance	Check twice a year if any further cracks appears to take action again.

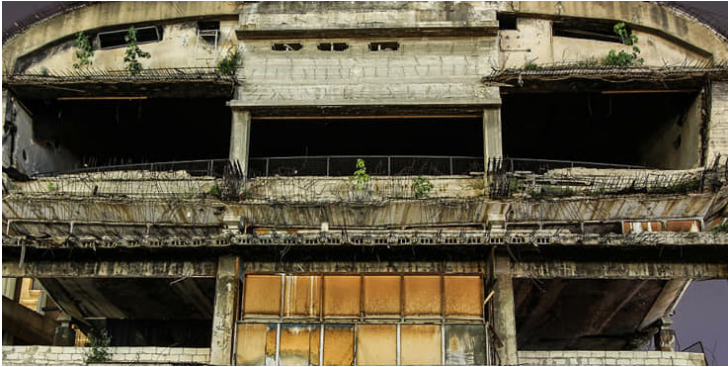
Decays	Biological Growth
Hatch

<p>https://blogbaledi.com/awesome-shots-from-the-egg-beirut/</p>
Decay description	<p>Surface organic growth (moos and grass) Moos are vegetative organisms that make little, soft, green cushions a few centimetres in size. They resemble thick micro-leaves (a few millimetres in size) that are firmly packed together. Mosses typically grow on stone surfaces, open spaces, cracks, and also medium lenght wild plants up to 10-15 cm.</p>
Visible effects at sight	<p>Moos: A thin, soft coating made of of thick, green and brown leaves with little adherence to the substrate. Grass is a form of vegetation that consists of small plants with long, thin leaves.</p>
Possible causes	Long exposure to outdoor areas, with the presence of moisture.
Decay mechanism	<p>The moisture present aided in the growth of micro-vegetation. The moss is localized in certain areas of the structure, particularly the outside, and is therefore visibly caused by precipitation.</p>

Suggested intervention	<p>The use of an ammonia-containing solution softens the moss. Moss removal using mechanical or hydro washing. Specific biocides are used. Low-pressure hydro washing with clean water of the surface to eliminate any residual residues of pesticide and biological bugs. The last preventative intervention against the development of vegetation and autotrophic bacteria by vaporization at low doses of biocide.</p>

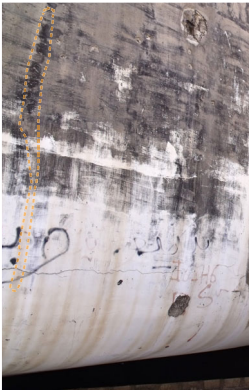
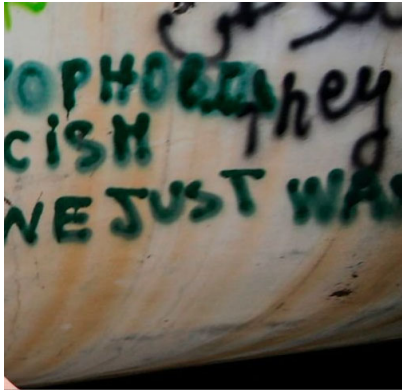
Decays	Trickling
Hatch

Decay description	Weathering causes unexpected differences in the outward appearance of the building. It is mostly an aesthetic issue.
Visible effects at sight	The flow path of rainfall causes grayish brown streaks that are parallel and vertical.
Possible causes	Exposed concrete without water repellent protective layer causes these dark lines.
Decay mechanism	This all originates with dust and debris in the atmosphere accumulating on the elevation. The stream of precipitation thus tends to wipe certain regions selectively, resulting in significant color contrasts among clean and dirty areas.
Suggested intervention	No intervention required.
