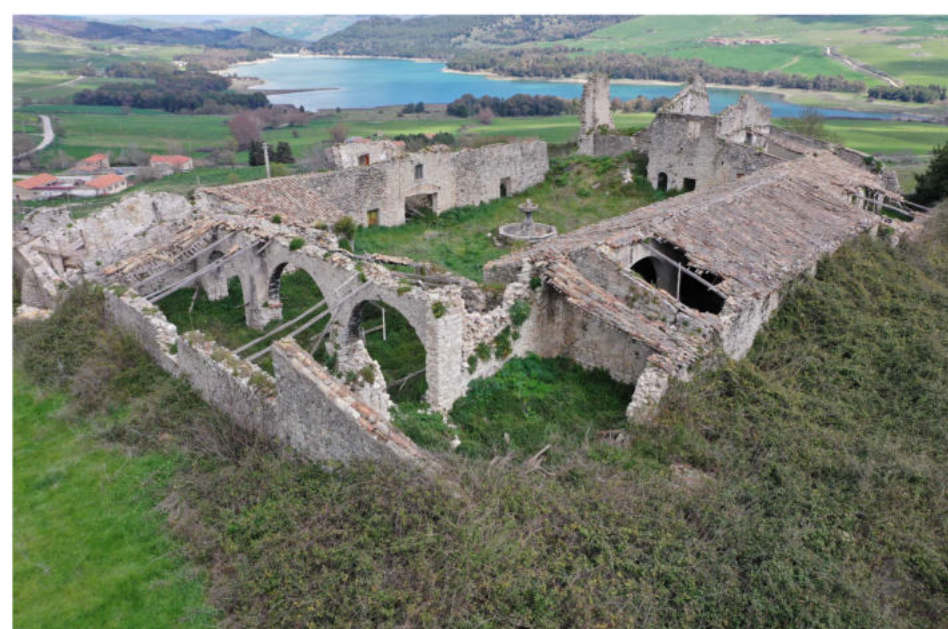
27. Particolare strutturale dello stato di degrado delle fessurazioni della muratura della Chiesa con pareti intonacate
