**Gardella's Lost Legacy:
The Church of Alessandria.**

Study, 3D documentation and
Analysis

Board No. 08

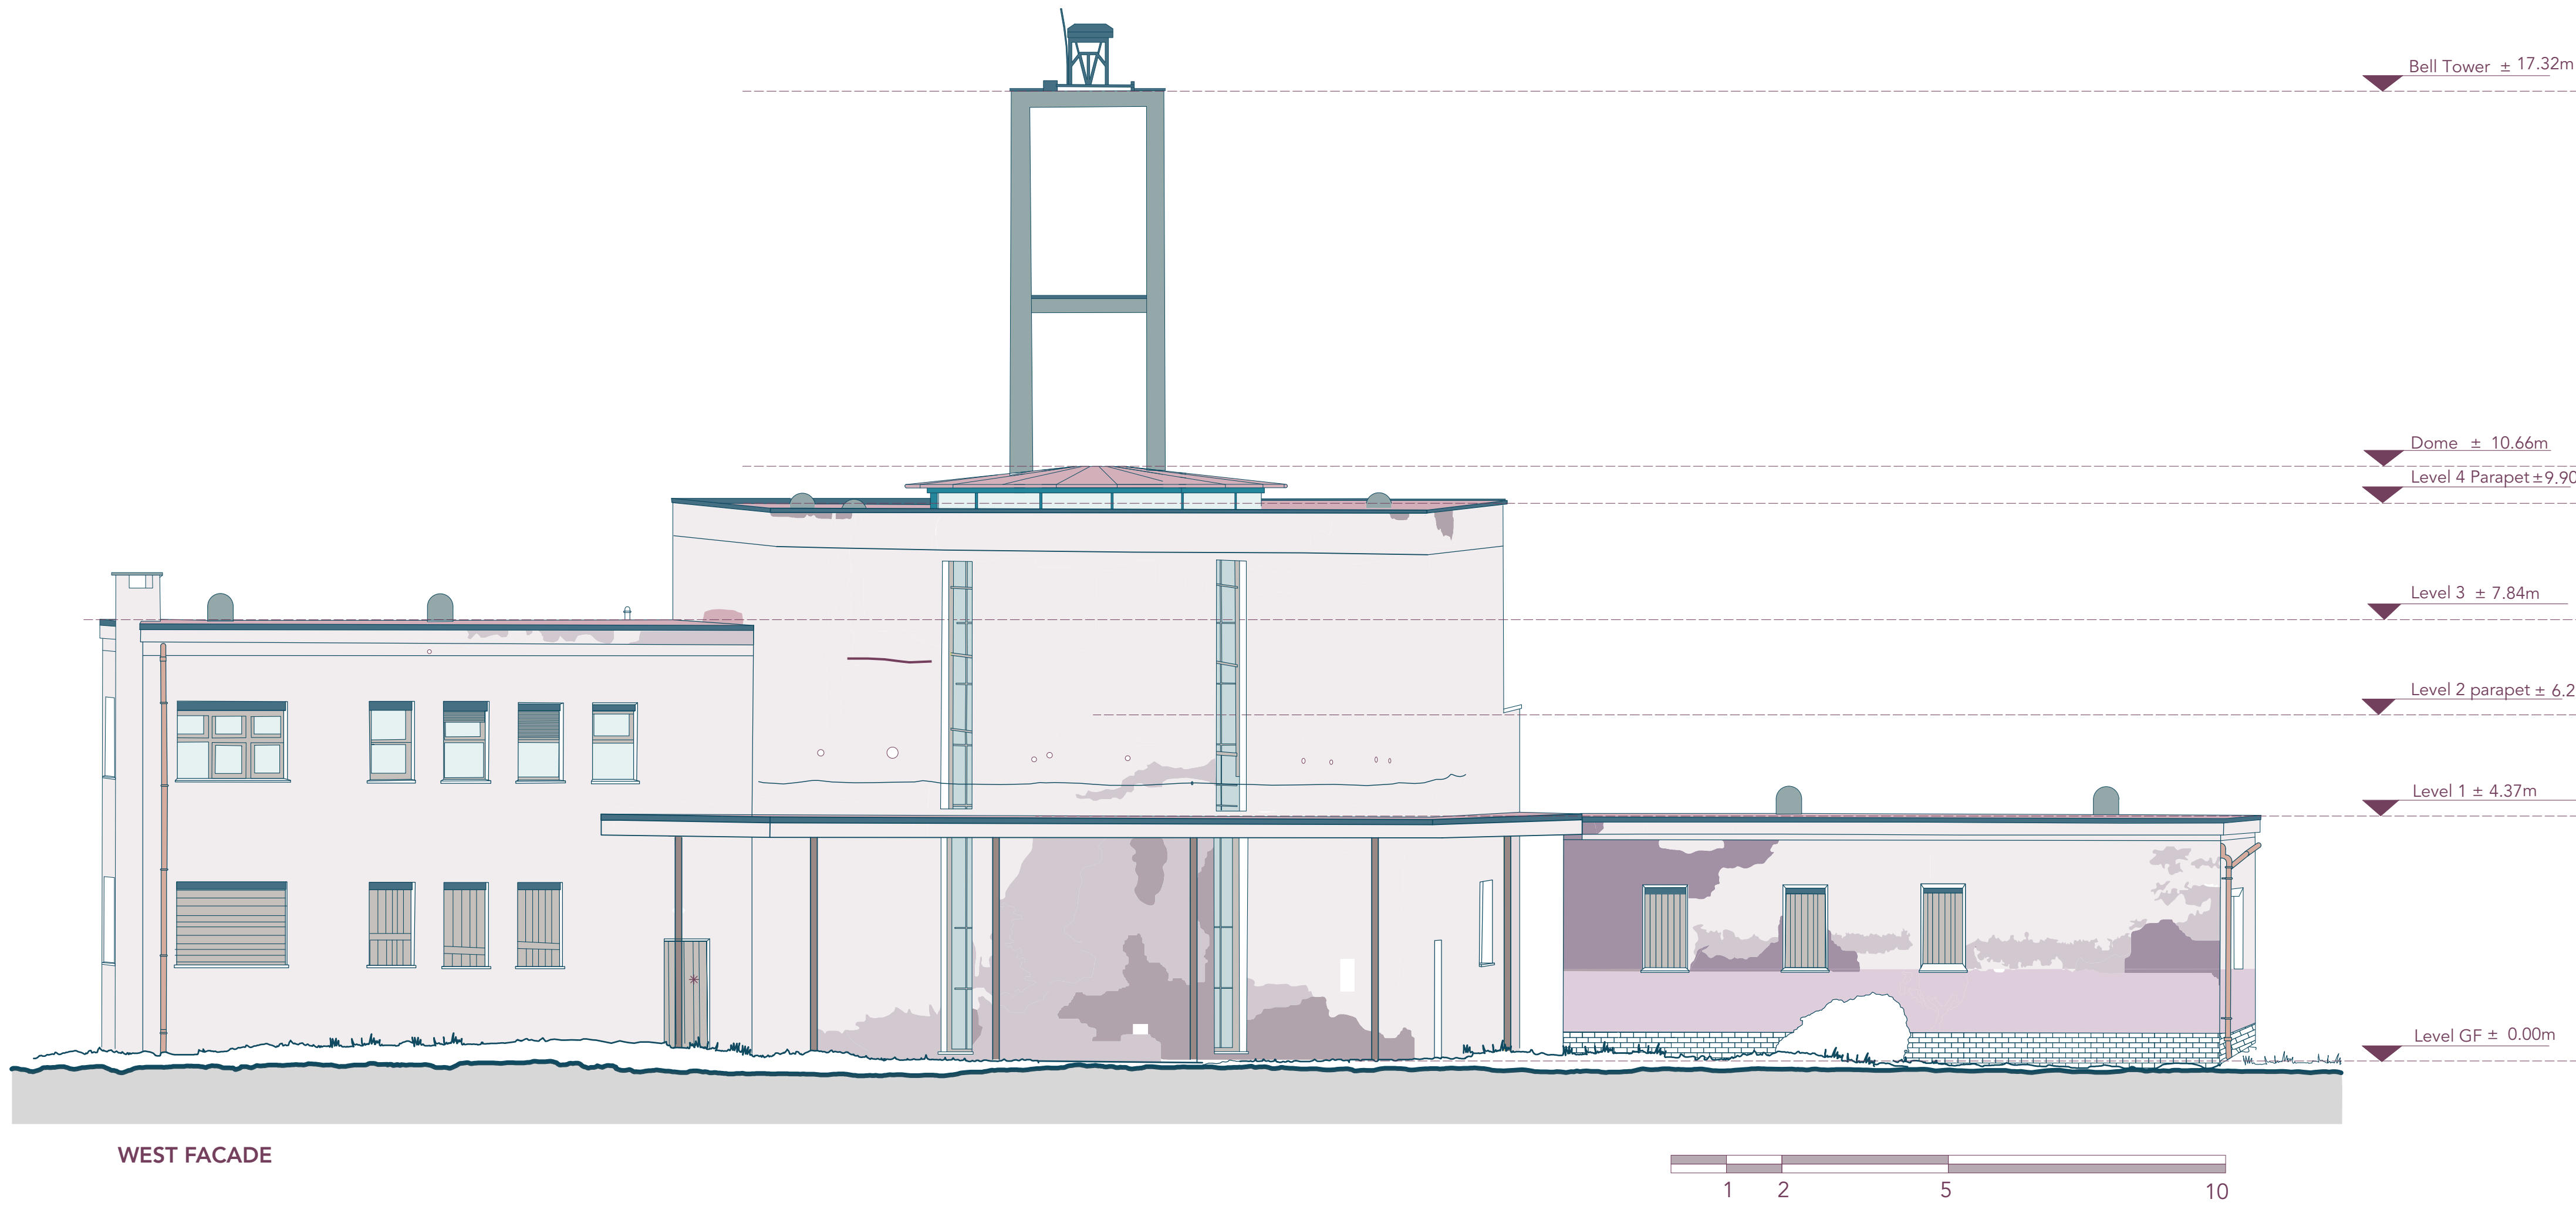
Load Bearing Elements	
Cross weave bond Four headed	Gothic bond Two headed
<p>This hypothesis is based on the thickness of these walls. The four headed cross weave bond is up to 50cm thick and these walls are from 50cm to 60cm thick. This synthesis proves that these are solid brick walls which support the large open space and ceiling of the altar.</p> <p>The bond however, seems a little irregular at certain places but the overall structure is intact.</p>	<p>The interior of this area was not surveyed but the exposed brick bond allowed to determine the thickness of these walls, which in design documentation is set to 30 cm. The Block weave bond gives a brick wall of 25 cm excluding finishes.</p> <p>Parts of the perimeter walls of this wing has cracks and fissures, indicating structure has been compromised.</p>

Steel & Concrete Elements	
Reinforced Concrete Elements	Steel Columns
<p>Found in Bell Tower, Chimney, and roof anchor elements</p>	<p>6 Steel columns of 5 cm radius supporting roof of Ambulatory</p>
Building Services	
Drainage Pipes	
<p>The drainage pipes on the facade seem to be in plastic, very similar to PVC. Comparing with old photos of the church, these pipes are seemingly original and have not been replaced.</p>

Wall Finishes			
Paint on Plaster Type 1	Paint on Plaster Type 2	Exposed Plaster Layer	Ceramic Tiles
<p>Typical Paint finish found on the facade. The texture of finish is different from that of Type 2 which is apparent in the photographs of how the paint layer has been detached.</p> <p>For this reason, a differentiation is highlighted which can be due to different types of plasters used.</p> <p>This texture suggests use of cement plaster for these surfaces.</p>	<p>The texture of surface suggests that a different kind of plaster has been used on this surface. The float and scratch coat in the degraded parts suggest a lime based or soft cement based plaster used in this area. The peeling paint layer suggests the issue of rising damp and the structure is in dire need of restoration.</p>	<p>All three layers, that is, the scratch coat, float coat and the finish coat are exposed. Flaking layers of paint can be seen in these areas. Overall the condition of finishes are severely deteriorated causing various forms of detachment and disintegration.</p> <p>From the photographic analysis, the plaster seems to be of Type 1, which is cement based (hypothesis).</p>	<p>At the base of South wing there are ceramic tiles, which seem to have been an addition to form a damp proof course. This addition does not seem to have a greater impact on the rising damp situation as can be seen from the condition of degradation.</p> <p>These tiles do not go with the rest of the design language of the building, hence can be removed with proper solution for damp proofing.</p>

Window Finishes		
Wood	Glass	Metal wire mesh
<p>Wood is used in almost all the windows of this building. All the windows on the ground floor are closed with wooden planks, probably during the restoration attempts from 2020 - 2023. These wooden planks are already showing signs of degradation. The window frames on the upper floors are still intact with great signs of decay and gaps.</p>	<p>Some of the windows in the upper floors still have glass intact, if not fully, parts of broken glass can be seen. Shutter boxes in metal can be seen above the window frames of the windows facing West and South facade. They do not appear in the East Facade. It may have been an intentional design move by the architect Gardella, for the purpose of allowing sunlight from the East.</p>	<p>Some of the windows on the ground floor, and especially the two narrow full height windows behind the naves are closed with the metal wire mesh for safety. In some photo documentations from 2020, the window glass seems to be intact, it may have been damaged and removed after this time during the restoration attempt.</p>

Roof and Other Finishes		
Metals	Metal Frame	Bitumen sheets on roof
<p>Metal has been utilized in various parts of the building, such as, the coping, the structure of bell in the bell tower, the covering of the dome etc.</p> <p>The coping, as shown in the picture, covers all the parapet walls, however, it seems to have been a much later addition. Even with the addition of coping, the parapets show serious forms of degradation linked to dripping water.</p>	<p>The studies of early 20th century architecture suggests that metal window frames began to be used in the first half of 20th century as window frames.</p> <p>With the amount of corrosion seen on these frames, it can be assumed that these frames are of metal and not aluminium.</p> <p>The structure of the dome is very innovative and light weight. The glass in some parts of the frame still seems intact.</p>	<p>Roofs of all three blocks of the church have recently been renovated with the addition of Bitumen layer at the top for water proofing. This addition could have been fruitful for stopping water penetration to the interior of the building, but for the facade, there appears to have been further degradation due to the addition of this layer, especially biological growth.</p>
