**Gardella's Lost Legacy:  
The Church of Alessandria.**  
Study, 3D documentation and  
Analysis

Board No. 09

The Church Building

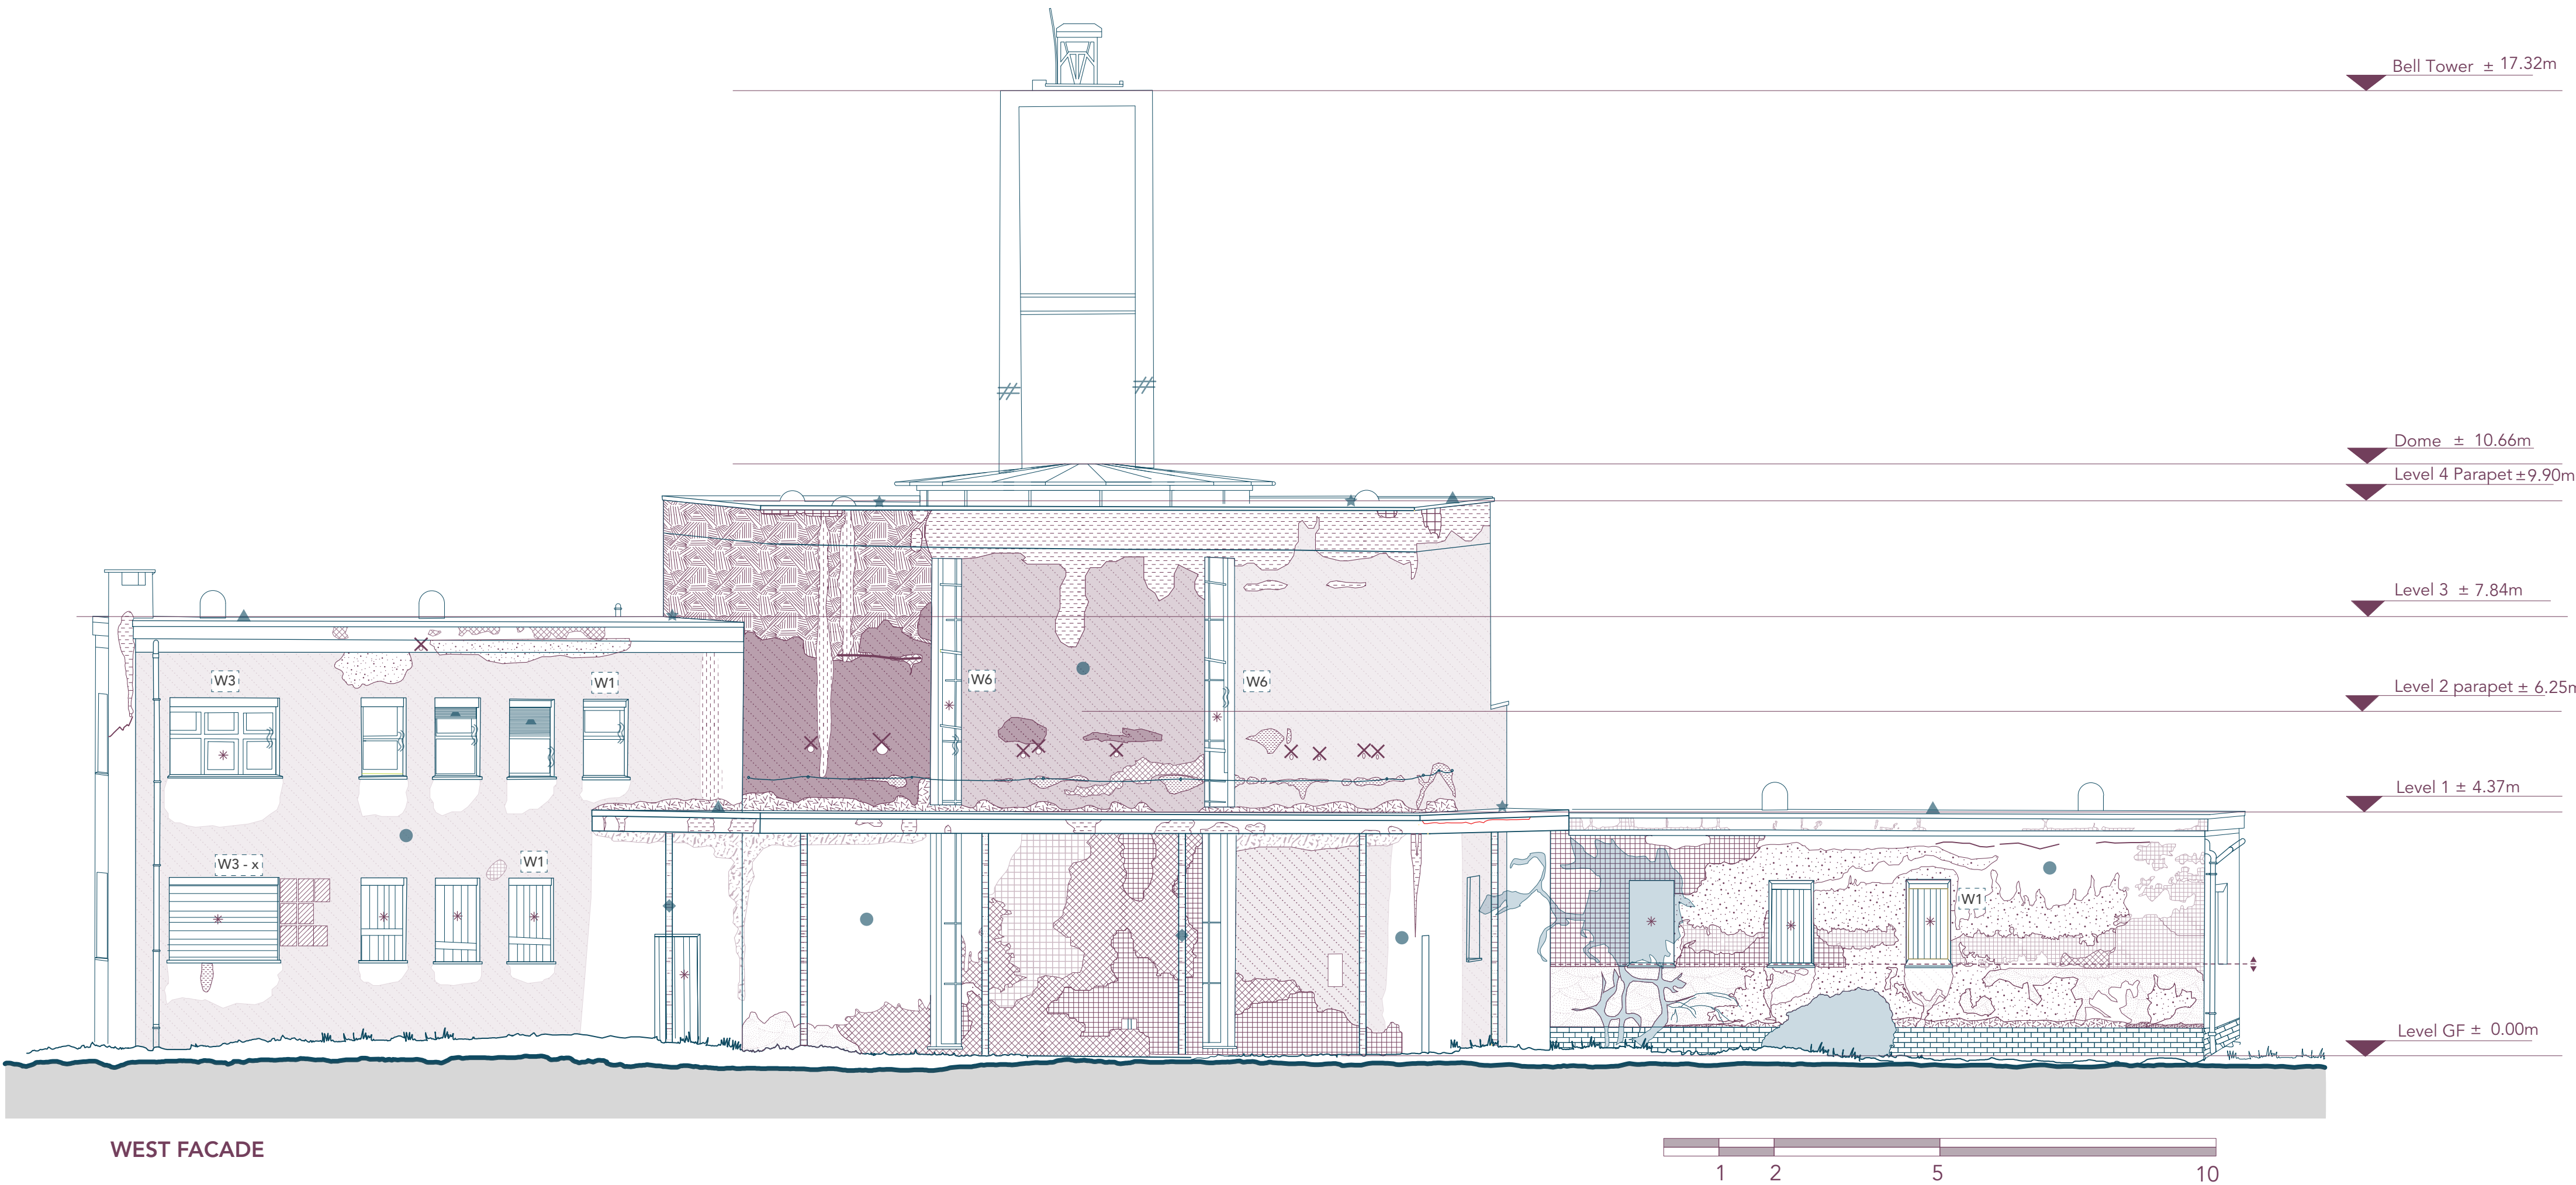
Degradation Analysis			
Pattern/Symbols	Photo	Degradation and Description	Causes
West Facade Degradation		<b>Missing Elements in Windows</b>  Window (58.9 x 882 cm), indicating material loss as the <i>glass is missing</i> and they are closed with wire mesh. The wooden frame has dark greenish and black spots along the grains indicating <i>moss, algae, or fungi growth</i> . Fine cracks, particularly in areas exposed to direct sunlight and moisture are visible. <i>Peeling or flaking paint</i> , exposing raw wood underneath. <i>Moisture stains</i> can also be seen on the frame.	Biological growth is due to constant exposure to moisture and rain infiltration, with weakening or unsealed joints / lack of protective coatings. Repeated wetting and drying cycles causing cracks. Detachment of finishing paint is also due to environmental condition and aging. Missing glazing component, causing water ingress to the interior.

Window (200 x 150 cm) are similar to other window sills in the building, the growth of algae, moss or mildew are apparent also here, as indicated by greenish and blackish spots. Extensive detachment of paint visible on the frame revealing raw wood. Hardware of the window seems to be broken leading to no proper closure of the shutter or the window casement fixtures.	Reasons of decay in W7 and W8 are similar to those mentioned for other windows.
		The size of the window is same as W7. This window is covered with wooden panels/planks, which are not part of the original design (similar to W1). The original window frame is either missing or degraded to an extent that it needs to be covered with panels to save it. The added planks are also weathered and show signs of biological growth, which is also visible in the window sill, suggesting neglect or inadequate maintenance.	
Surface Degradation		<b>Chromatic Sampling</b>  This is not considered as a degradation type, instead an intervention method used to test and match the original or intended paint layers for restoration purposes. If executed improperly, they may leave patches unprotected, which can expose the underlying plaster or masonry to weathering. However, in this case, the sampling is rightfully applied to the least degraded wall.	It often involves removing existing paint layers, leaving the plater or masonry temporarily unprotected. It is done because, as the analysis shows, almost all the building finishes have been degraded and have been exposed to chromatic alteration. However, to promptly address the issue, the final finishes must be decided sooner.

Moisture related Degradation		<b>Rising Damp Causing Detachment</b>  The degradation visible includes significant peeling and flaking of the wall's paint layer, exposing the underlying plaster. The deteriorated wall shows multiple types of detachment and growth of moss and algae.	The observed degradation can be attributed to rising damp, which causes moisture to ascend through the wall via capillary action. This phenomenon is often exacerbated by the absence or failure of a damp-proof course DPC, poorly drained soil near the structure, or a high groundwater level. If it is not treated, over time the absorbed moisture dissolves more salts within the wall materials causing further degradation.
		<b>Moisture stains Causing Detachment</b>  The moisture stain surrounding the central dark streak is lighter in color, with a grayish tone, spreading across a wider area on both sides. The irregular edges and discoloration suggest moisture has seeped into the wall's surface layers , likely saturating the plaster or paint. This area shows signs of surface deterioration, such as minor peeling or roughness.	Caused by the presence of water or moisture in the material, moisture stains are characterized by color changes, usually darker than the original material, and may be accompanied by phenomena such as efflorescence, surface cohesion loss, or biological growth. These stains indicate underlying issues like infiltration, condensation, or rising damp and usually appear irregular, depending on the source and path of the water.

<b>Moisture stains due to dripping water (Colatura)</b>  Dark moisture stains on the upper portion of the wall, particularly concentrated beneath the metal coping. The discoloration appears as streaks and patches, suggesting water dripping. The stains are darker in some areas, indicating prolonged exposure to water.	The moisture stains are due to water dripping water from the parapet causing stain under the metal coping. This could result from inadequate waterproofing or improper installation of the coping, allowing rainwater to seep beneath or flow over its edges. Repeated exposure to dripping water leads to moisture accumulation and stains on the wall surface, and the absence of proper drainage exacerbates the problem.

- Use biocidal solution or essential oil to clean the moss, algae or fungi (such as, quaternary ammonium compounds or natural thyme oil.
- Natural wood fillers can be used for superficial cracks and for structural cracks, low viscosity epoxy consolidant can be used. It is necessary to ensure structural integrity and replacing any broken or loss wooden sections.
- Removal of flaking paint with non-abrasive chemical stripper or scraper.
- Sand the surface of the frame to prepare for new coatings. It should be protected by application of linseed oil based primer followed by breathable micro-porous paint.
- Finally to replace the glass and re doing the seal between frame joints and masonry opening.

- Same solutions as above for treating the wood
- The existing glazing condition must be checked in order to decide if it needs replacement.
- The hardware of the window must be replaced in case the existing hardware are no longer workable.

- Ensuring that sampling areas are finalized by matching the appropriate paint or coating as determined by the testing process.
- Application of the chosen finish uniformly across the facade to restore aesthetic and functional integrity.

- Gently cleaning the wall using dry-brushing method. Water based cleaning must be avoided as it can dissolve salts and push them further into masonry.
- A temporary superficial layer of lime based plaster maybe applied to absorb the salts and protect underlying masonry.
- Drainage around the base of the building should be improved by sloping the ground away from the structure and installing channels to divert water away. This is feasible also in case of flooding.
- It is necessary to introduce a chemical damp proof course by injecting hydrophobic silicone resins or lime compatible injection mortars into masonry to create a barrier against rising water.
- Finally, removing degraded plaster and using salt resistant and breathable plaster. Paint finish should be mineral based.

- After resolving the main source of moisture in the wall, in this case, rising damp, the surface should be cleaned using mild detergent solution or pH neutral cleaning agent. For this building, since the walls are structurally compromised, manual brushes should be used to avoid further damage.
- After the wall completely dries, a hydrophobic, breathable treatment like silane or siloxane-based water repellents can be applied to prevent further water penetration.
- Breathable plaster should be used, such as lime based systems to allow trapped moisture to evaporate- Lime wash or mineral based paints for finishing will allow vapor permeability.

- Replacing the existing coping with a design that includes a minimum overhang of 3-5 cm beyond the wall surface. A drip groove underneath the coping is necessary to break the surface tension and redirect water. Materials should be weather resistant, such as terracotta, zinc or stone with proper sealing. Coping should have a slope of 5-10 degrees to direct rainwater away from the parapet. Drip edge can be designed along the underside of the parapet (while keeping the integrity of the original design) to avoid direct water contact with the walls.
- The surface should be cleaned and protected with hydrophobic coating (after testing its compatibility with plaster) as explained in the steps earlier and finally the plaster and paint finishes should be applied as explained.
