**Gardella's Lost Legacy:
The Church of Alessandria.**

Study, 3D documentation and
Analysis

Board No. 10

South Facade

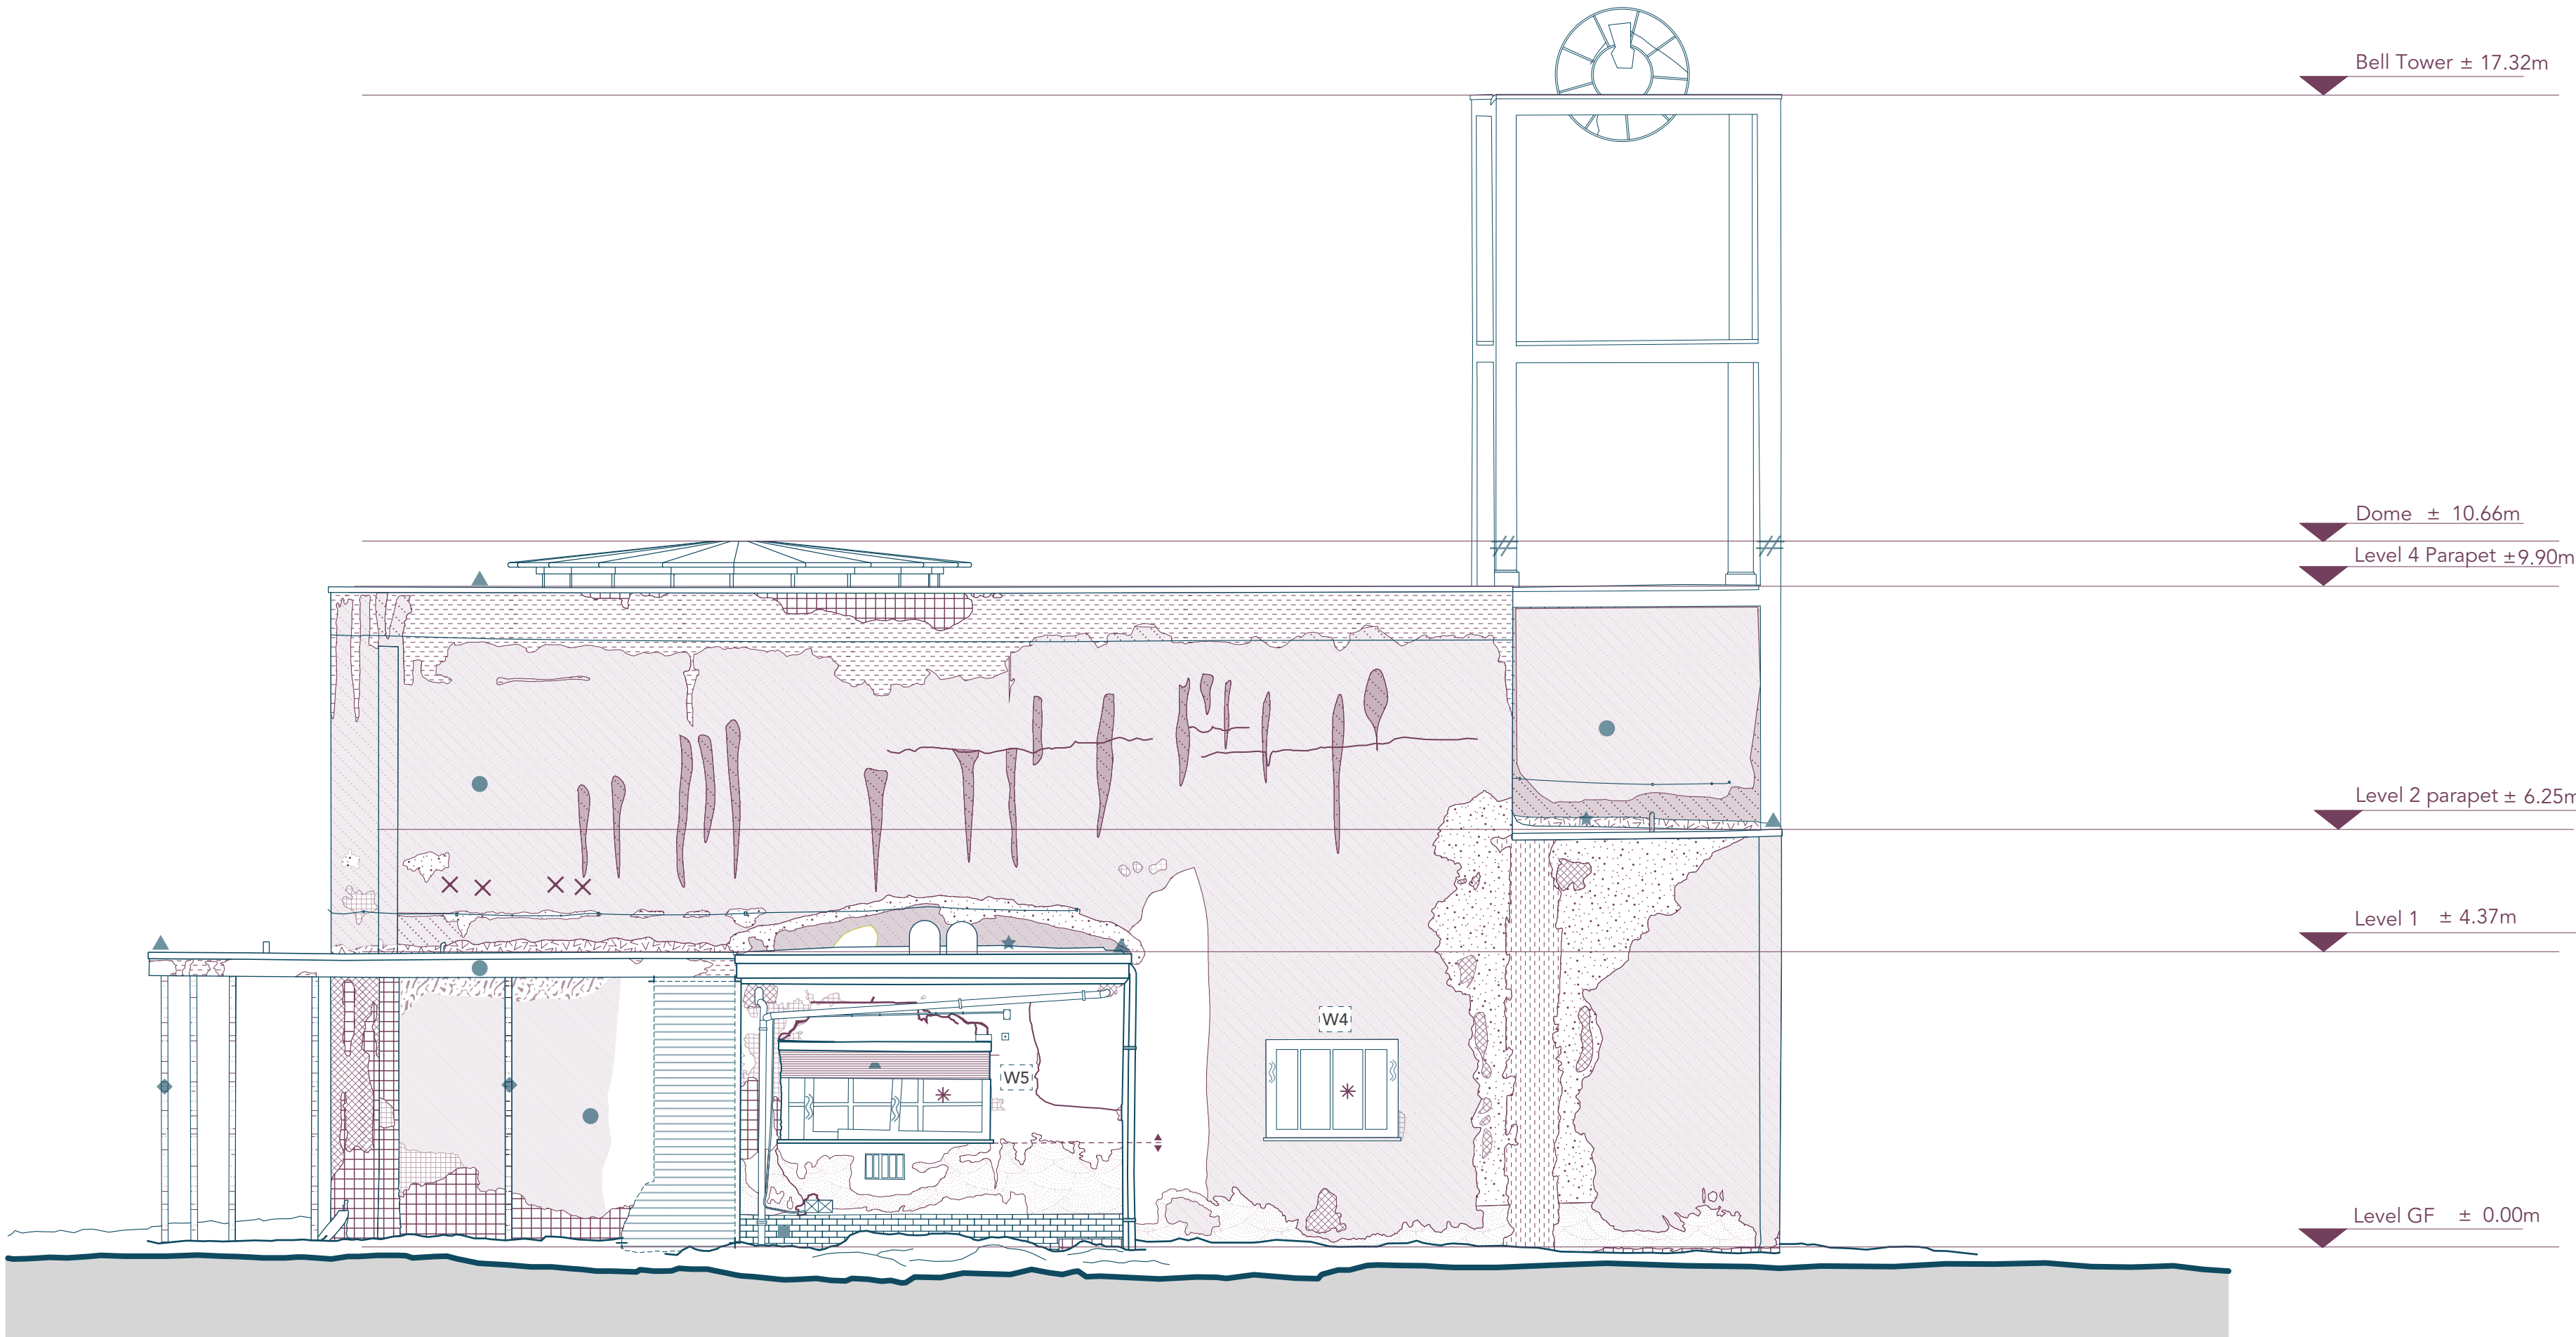
Degradation Analysis			
Pattern/Symbols	Photo	Degradation and Description	Causes
South facade Windows		Missing Elements in Windows The window (size 218 x 150 cm) consists of an inner frame, likely the original, and a larger wooden frame with a mesh installed in front of it to provide protection. The inner frame shows signs of wear but appears to have been preserved. The outer one exhibits discoloration. The metal mesh is intact but dirty, while the sill shows biological growth. The glass panes are missing, leaving the structure vulnerable.	The windows are in constant exposure to environmental factors, and when combined with a lack of maintenance, these elements accelerate the deterioration of the frames and facilitate the growth of moss or algae on the sill due to persistent moisture accumulation. The absence of glass may be due to vandalism, structural movement, or environmental factors.
		This window (size 320 x 155) is lacking of pane glasses but posses an inner wooden frame, an outer wooden frame holding a metal mesh, and a wooden rolling shutter above the opening. The white frame shows peeling paint and gaps, while the wooden frame and shutter are weathered, with discoloration and cracks. The sill shows biological growth and there are significant structural cracks above this window showing problems with lintel beam.	Caused by long-term exposure to environmental elements such as rain, sunlight, humidity, and fluctuating temperatures. The absence of glass increases its vulnerability to these factors. The wooden elements have likely suffered due to the lack of protective coatings and regular maintenance. The biological growth on the sill indicates the presence of persistent moisture, which likely accumulates due to exposure to rainwater.

Disintegration & Detachment		D1 Minor Detachment - Peeling paint The paint layer exhibits detachment from the plaster surface, with sections curling, flaking, or completely missing. Edges of the detached paint are jagged, and the surface underneath often shows signs of discoloration, dampness, or roughness. The remaining paint appears brittle and uneven, indicating a loss of adhesion to the underlying surface.	Levels of moisture in the wall, due to rising damp, and inadequate waterproofing. The type of paint used may not be compatible with the plaster or previous paint layers (e.g., oil-based paint over a water-based primer or vice versa). These reasons leads to weak bonding and eventual peeling over time.
		D2 Moderate Detachment - Exposed plaster The paint layer has completely detached in some areas, exposing the underlying plaster. The exposed plaster shows, rough texture, and potential signs of minor degradation or cracking. The boundary between the detached paint and the intact surface is irregular, with adjacent paint peeling or curling at the edges.	Prolonged exposure to water through rising damp, leaking structures, or condensation can weaken both the paint and plaster. Moisture is penetrating the plaster, causing crumbling, disrupting the paint's adhesion, leading to detachment. Over time, the plaster layer may develop cracks, crumble, or weaken due to natural aging, freeze-thaw cycles, or exposure to moisture.

Lacuna (Gap) - Exposed bricks due to loss of continuity of mortar and paint The plaster layer is entirely missing in certain areas, exposing the underlying brick substrate. The exposed brickwork shows surface weathering, discoloration, and slight mortar degradation between bricks. Adjacent to the lacuna, the plaster exhibits flaking and cracking, suggesting ongoing deterioration.	Exposed brickwork is the advanced stage of degradation. It seems to be due to the rising damp and prolonged exposure to the moisture. Environmental conditions, such as exposure to freeze-thaw cycles, harsh winds, & UV radiation, could have degraded the exposed plaster layer and mortar joints for it to fully detach from the surface exposing bricks.
Surface Degradation		Chromatic Alteration - C1 Minor Subtle discoloration or variation in tone compared to the surrounding facade. appears as slightly darker patches, with no sharp boundaries or significant textural change. These alterations are more evident in areas of the facade likely subjected to slightly different environmental conditions, such as UV light or water retention.	Water absorption due to inadequate waterproofing or retention in porous materials. Deposition of airborne pollutants and dirt, which adhere to damp surfaces. Incomplete drainage from rainwater runoff, leaving behind dirt and moisture residues. It can also be due to UV radiation breaking down the pigments in the paint. It has led to Aesthetic disruption and indication of moisture retention, which can lead to deeper material damage over time.

Chromatic Alteration - C2 Moderate The facade shows more pronounced discoloration compared to C1 alterations, characterized by vertical streaks, darker patches, and uneven shading. The streaks can either be water runoff or the superficial scratches. The background surface shows widespread subtle darkening, indicating general weathering or pollutant accumulation.	Same as above. In addition, The scuff-like marks may result from incidental contact with objects (e.g., tools, ladders, or maintenance activities) or superficial dirt streaks from nearby activity.
		Chromatic Alteration - C3 Severe decolorization This type displays severe discoloration, characterized by dark streaks, diffuse stains, and localized spots of intense discoloration.	Persistent water infiltration and runoff causing saturated materials darken in color, and water runoff causes streaking and staining. Loss of cohesion in the plaster or concrete due to freeze-thaw cycles, chemical reactions, or sustained exposure to environmental stressors.

- Removal of moss, algae, and dust with a solution of water and mild detergent. A biocidal treatment is needed for preventing regrowth of moss.
- The original and the added wooden frames need to be examined for structural soundness and checking insect infestation or rot. The temporary metal mesh maybe removed for further restoration treatment of the window.
- Epoxy wood consolidant can be applied to a mild decay of wood for consolidation. Crack and gaps in wood to be filled with wood fillers. Then any existing surface finish must be removed and the primer should be applied for moisture and weather resistance. Paint the surface using oil based paint and then glass maybe added according to the requirement.

- Determining the purpose of planks, either it is structural or protective? Then the inspection of added planks for rot, and insect damage must be done. The planks already look damaged and degraded, hence, upon inspection, if they do not serve a structural purpose, they must be removed to avoid further damage to the original frame. If necessary for structural reasons, they must be replaced.
- The original frame needs to be adequately repaired and reinforced as mentioned for other windows. If the planks are necessary, the replacing planks should follow the aesthetics.
- The rest of the process follows the same procedure as already explained for other wooden window frames.

- Mechanical scraping with a soft blade can be used to remove peeling paint . For stubborn areas, natural paint stripper can be used but it must ensure to not affect the underlying plaster.
- Underlying plaster must be inspected for cracks, detachment, or salt efflorescence using visual inspection and moisture mapping. Weak areas must be consolidated with lime grout injection and reapplying missing sections of plaster using hydraulic lime mortar (match the original).
- The surface must be clean and dry before applying the primer and the final paint must be selected as per original aesthetic achievement requirement.

- Through cleaning using soft brushes (since the structure of this wing is compromised).
- re-pointing of eroded mortar joints and stabilizing edges with lime based consolidant. Hydraulic lime mortar with natural pozzolans should be used to fill the gaps. Natural pozzolanas helps in areas exposed to higher mechanical stress or water infiltration, which is the case of this wall.
- Paint to match the original one (preferably lime based)
- For long term moisture management, improve drainage, seal cracks and apply siloxane-based water repellent on the masonry by brushing or spraying.

- First step involved conducting a chromatic investigation using NDT spectrophotometric analysis to assess the extent and nature of color variations across the facade. This will ensure a precise understanding of the degradation mechanisms and original color values identification.
- Careful removal of the degraded layers of paint with soft brushing or mechanical dry cleaning with low pressure air jets. This process should ensure no damage to the substrate.
- Preparation of the substrate (if needed)
- Repainting the whole surface, since the chromatic alteration is visible everywhere.

- The degraded layer should be removed following methods given above, in addition, a poultice-based cleaning paste can be applied to absorb deeper stains without introducing excess moisture.
- Biological growth to be treated using biocidal treatment with natural ingredients.
- Plaster consolidation
- Repainting the facade

- In this scenario, the rest of the process remains the same. However, a poultice-based cleaning solution seems more relevant to draw out deep yellow stains caused by moisture, mineral deposits or pollutants.
- The whole surface must be repainted.
