**Gardella's Lost Legacy:
The Church of Alessandria.**
Study, 3D documentation and
Analysis

Board No. 11

EAST FACADE

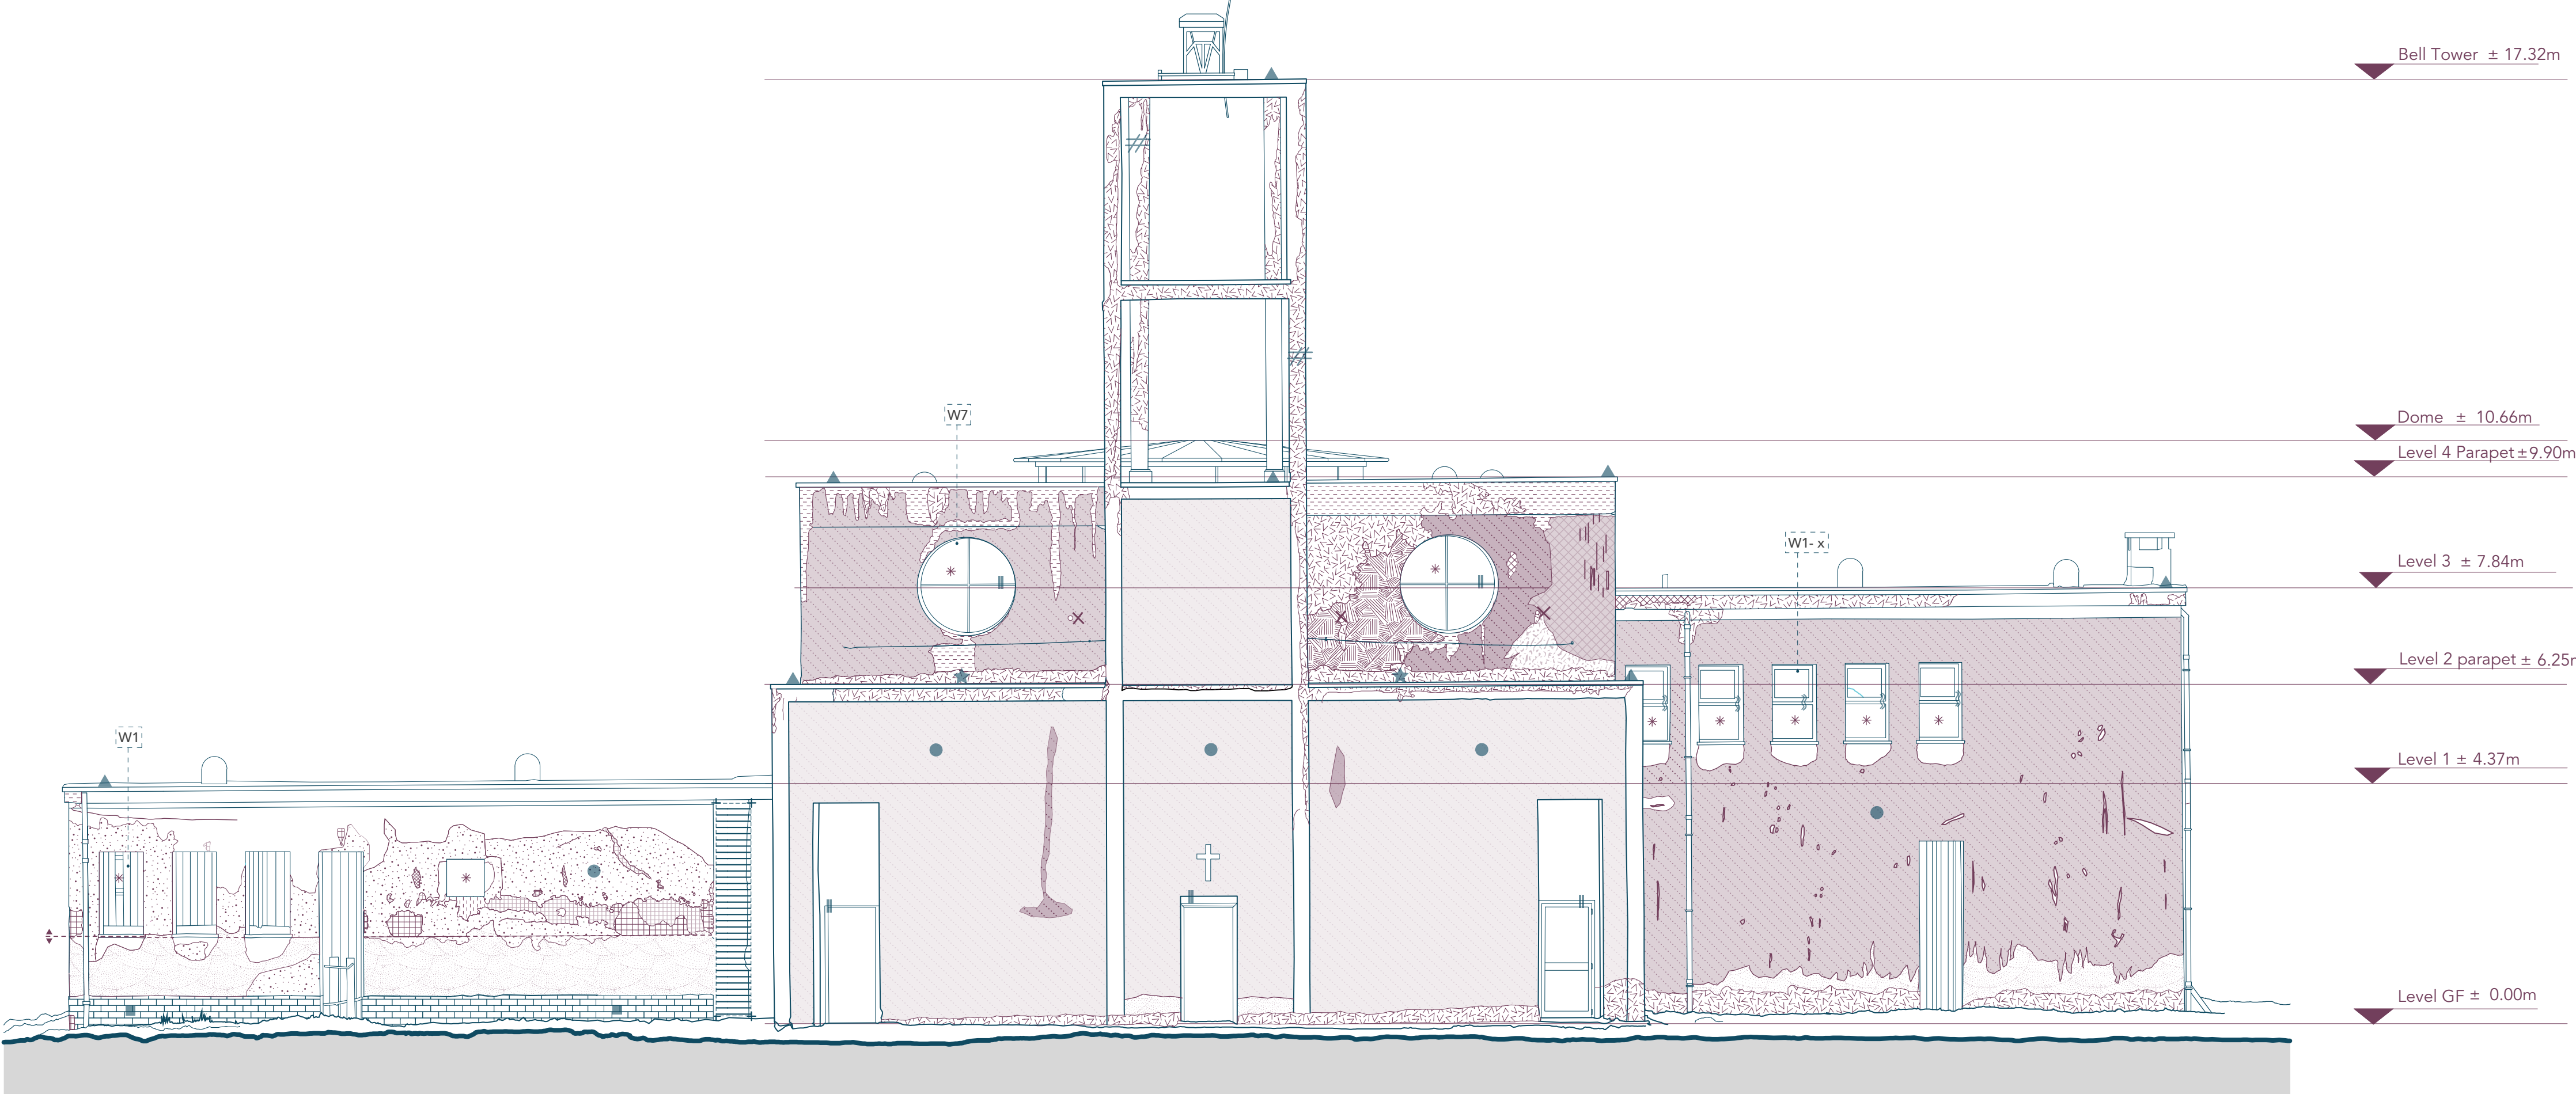
Degradation Analysis			
Pattern / Symbols	Photo	Degradation and Description	Causes
East Facade Windows	W1*	Missing Elements in Windows These windows of size 80 x 150 cm of the south wing are covered with wooden planks. The planks were installed during 2020-2023 restoration probably as a temporary measure to prevent further damage or intrusion while awaiting permanent restoration or replacement of the original frames and glass. The window is a circular opening (90 cm diameter) with remnants of an original metal grid and wooden planks installed inside, likely for temporary closure. The metal grid is intact but exhibits potential <i>corrosion, visible as dark discoloration and possibly rust</i> . The boards show signs of weathering, with uneven coloration and potential warping or deterioration due to exposure to moisture. The edges of the circular opening display <i>staining, moss/algae growth, and surface erosion</i> , particularly along the bottom edge.	The windows were likely left open for an extended period due to vandalism, structural decay, or deferred maintenance, leaving the church vulnerable to weather and environmental damage. The <i>absence of glass and frames</i> over time allowed water and moisture to penetrate the interior and exterior surfaces, leading to, peeling plaster, and biological colonization (<i>visible staining below the windows</i>).

W7*	The windows are missing the glass and lack of protective coating on the metal grid causing exposure to environmental moisture leading to rust and corrosion, which is evident from the discoloration. The accumulation of rainwater at the base of the circular frame (<i>visible from the dark, damp area and moss growth</i>) has caused moisture-related damage to the concrete and surrounding materials.	
	W1-x*	W1-X windows of size 80 x 150 cm are most likely similar to W1 (original design). The frames are deteriorated, with visible cracking, uneven surfaces, and discoloration likely caused by weathering and lack of maintenance. Some panes appear intact but dirty, while others seem <i>broken or missing</i> . The sill, likely made of stone or concrete, show dark discoloration and <i>moss/algae growth</i> , indicating prolonged moisture exposure.	The missing or broken glass is likely due to either <i>vandalism, structural movement, or environmental impact</i> (e.g., <i>strong winds or falling debris</i>). The discoloration and moss growth on the sills suggest pooling or absorption of water, causing moss and algae growth and leading to plaster degradation

Material Incompatibility		Plaster change demarcation line This part of the facade shows two types of plaster applications. The upper part of the mortar appears smoother and more uniform in texture (likely a cement based mixture). There are visible patches of plaster detachment but overall holds better integrity. The lower part exhibits more pronounced degradation and moisture related damage (likely a lime-based or weaker cement lime mixture). There is also discoloration or possible erosion of plaster in lower part and worse material cohesion.	The two mortars reflect two different times of application, with material quality or composition varying due to factors such as local availability or cost. The lower line of mortar may indicate a repair or restoration phase, where a different, potentially less durable or more porous mortar was used, possibly to address earlier degradation due to rising damp issues.

Structural Degradation	×	Wall Perforations The holes appear small and localized, with dark discoloration or staining around them. The staining suggests potential water ingress, or material seepage from within the wall. They are relatively uniform in spacing and alignment, suggesting an <i>intentional or structural purpose</i> . The discoloration below the holes hints at potential water seepage, mold, or biological growth , indicating moisture-related issues	These holes may have been created to anchor structural elements (e.g., scaffolding, signage, or bracing) during construction or previous repair work that began in 2020. Over time, the absence of proper sealing allowed moisture ingress, leading to staining and potential internal degradation.
		Scratches/abrasions on paint The black marks are irregular and vertical to slightly diagonal. Some are thin and linear, while others are broader or smudged. They appear scattered across the wall surface, with a higher density in certain areas, suggesting external forces or contact with objects. The wall has an uneven finish, and the scratches are superficial, likely not penetrating deeply into the plaster or render.	The marks could result from physical contact with sharp or abrasive objects, such as scaffolding, ladders, or tools scraping against the wall during construction, maintenance, or repair activities. The irregularity and variety in depth/width of the scratches suggest accidental or unintentional abrasion.

~	Crack - Medium Intensity The crack appears as a horizontal fissure that extends below the parapet-wall junction but does not exhibit significant displacement or crumbling. The formation of these cracks can be linear or rectilinear and their proper intensity can be tested through a series of structural analysis performed by experts.	Major causes can be Thermal expansion and contraction - Daily and seasonal temperature fluctuations can cause materials to expand and contract at different rates. This cyclic movement creates tensile stresses at rigid connections, such as the parapet-wall junction. Water Ingress and Freeze-Thaw Cycles can be another reason. Since there is an obvious rising damp from the ground, this can be due to Settlement or Structural Movement of the foundations as they cause horizontal cracking.
	~	Fissures - Severe Intensity Diagonal Cracks: Typically caused by differential settlement or structural movement, Horizontal Crack: Likely due to thermal stress or weakened structural elements, especially near load concentrations. The cracks show advanced propagation and connect multiple points, indicating compromised structural integrity. Some areas show detachment of plaster, which exposes the underlying masonry to environmental damage.	Foundation movements leading to differential settlement may have caused tensile stresses in the upper masonry layers, leading to diagonal cracks. The alignment of diagonal cracks suggests stress redistribution due to an unstable load-bearing element. It can also be due to the inadequate structural reinforcement in areas like window lintels or slab-wall junctions leading to shear or tensile failures. Other reasons are same as above aggravated to a worse condition

Solutions / Interventions	
<ul style="list-style-type: none">- In these windows, apparently, the whole frame of the windows are missing, hence they need to be replaced with new ones, keeping in mind their thermal properties. The design of the frames and window aesthetics must match the original design. Careful procedure must be taken in order to remove temporary closure with planks and structural durability of the lintel of openings must be tested and fixed before intervention of new windows. A permanent solution for window sills must be planned to avoid water accumulation.	
<ul style="list-style-type: none">- Removing debris and dirt from the metal frame and plaster in the opening using soft brushes and a low-pressure water spray.- Cleaning the metal bars with a wire brush or rust-removal tools to eliminate surface corrosion. Then treating the metal bars to stabilize corrosion and applying corrosion resistant primer to protect from future rusting.- Finally, the desired size of glass can be added to the frame based on the required thermal properties.

<ul style="list-style-type: none">- First, wood must be inspected for rot and insect intensification and areas of high moisture content must be identified. The frame's structural integrity must also be tested to detect any weak spots.- After removing dust and debris, wood must be repaired for any damages identified (for example, applying wood consolidation agent) and parts of frames beyond repair must be replaced.- The old paint must be removed with help of chemical paint stripper and a suitable primer must be applied to the surface to protect against UV damage. In addition, existing hardware of the windows must also be examined.- Broken or damages glass to be removed, and new glass (ensuring thickness of the frame) must be added.	
<ul style="list-style-type: none">- Conducting laboratory tests to confirm the composition of both plasters and performing moisture mapping to identify areas of trapped water or capillary rise in lower section.- Cement based plasters are not compatible with lime based materials and are less permeable, hence in case it is used in the upper section, it is necessary to remove it carefully without damaging the masonry.- After cleaning the surface, a lime based plaster can be used for both upper and lower section for better compatibility and for enhanced durability, aggregates and pozzolanic additives can be added.

<ul style="list-style-type: none">- Cleaning the stained surface using Biocidal cleaner to remove Biological growth and discoloration around the perforations.- For rust and other salty deposits, a neutral pH rust remover or poultice with clay and distilled water can be used. There is no apparent efflorescence around the holes, but it is still a good solution to extract salts, just in case.- Holes can then be filled with a suitable lime based mortar, with fine aggregates for structural voids. For smaller perforations, lime putty filler can be used for a finer finish.- final steps are using suitable lime based surface plaster and final paint finish as per aesthetic requirement.	
<ul style="list-style-type: none">- Cleaning of the surface using low pressure water washing and soft natural-bristle brush to remove surface dirt and loose particles without damaging plaster. For persistent grime in scratches areas, mild, non-ionic detergent can be used by diluting in water.- For filling and repair, lime-based filler mortar can be used which is compatible with the original plaster. For example, Hydraulic lime mixed with fine sand. The areas of scratches must be filled with small trowel or palette knife, ensuring smooth texture. To fill shallow abrasions, lime slurry can be filled in abraded areas.- Final surface finishing as per original aesthetics.

<ul style="list-style-type: none">- Performing structural assessment using Non-destructive techniques such as; Thermograohy or ground penetrating radar to detect moisture or voids. Crack monitors to be used to assess the crack's behaviors over time.- To repair the crack, first cleaning and removal of dirt and debris is required. To fill the crack, it needs grout injection, preferably Hydraulic lime based for material compatibility. It should be injected under low pressure to stabilize internal masonry voids without creating rigid zones.- After this, the surface needs to be re done with polymer-modified lime mortar, which provides flexibility to withstand further thermal stresses. For finishing, breathable lime based plaster is suggested with paint finish to match the original aesthetics.- Conduct a structural analysis using non-invasive techniques as mentioned above.- Install carbon fiber mesh or steel helical bars across the diagonal and horizontal cracks to stabilize the masonry and restore tensile strength.- Secondly, the cleanliness of the cracks and injection of Hydraulic Lime based grout which will allow to consolidate the masonry without compromising breath-ability. In addition, Pozzolan-Enhanced Lime Grouts provides additional strength while maintaining the material compatibility of pure lime, it is a better option for filling larger voids.- For long term solution, discreet expansion joints near structural weak points may be added.
