POLITECNICO
DI TORINO

Master in Architecture for
Sustainability
A.Y. 2024 - 2025

Gardella's Lost Legacy: The Church of Alessandria.

Study, 3D documentation and
Analysis

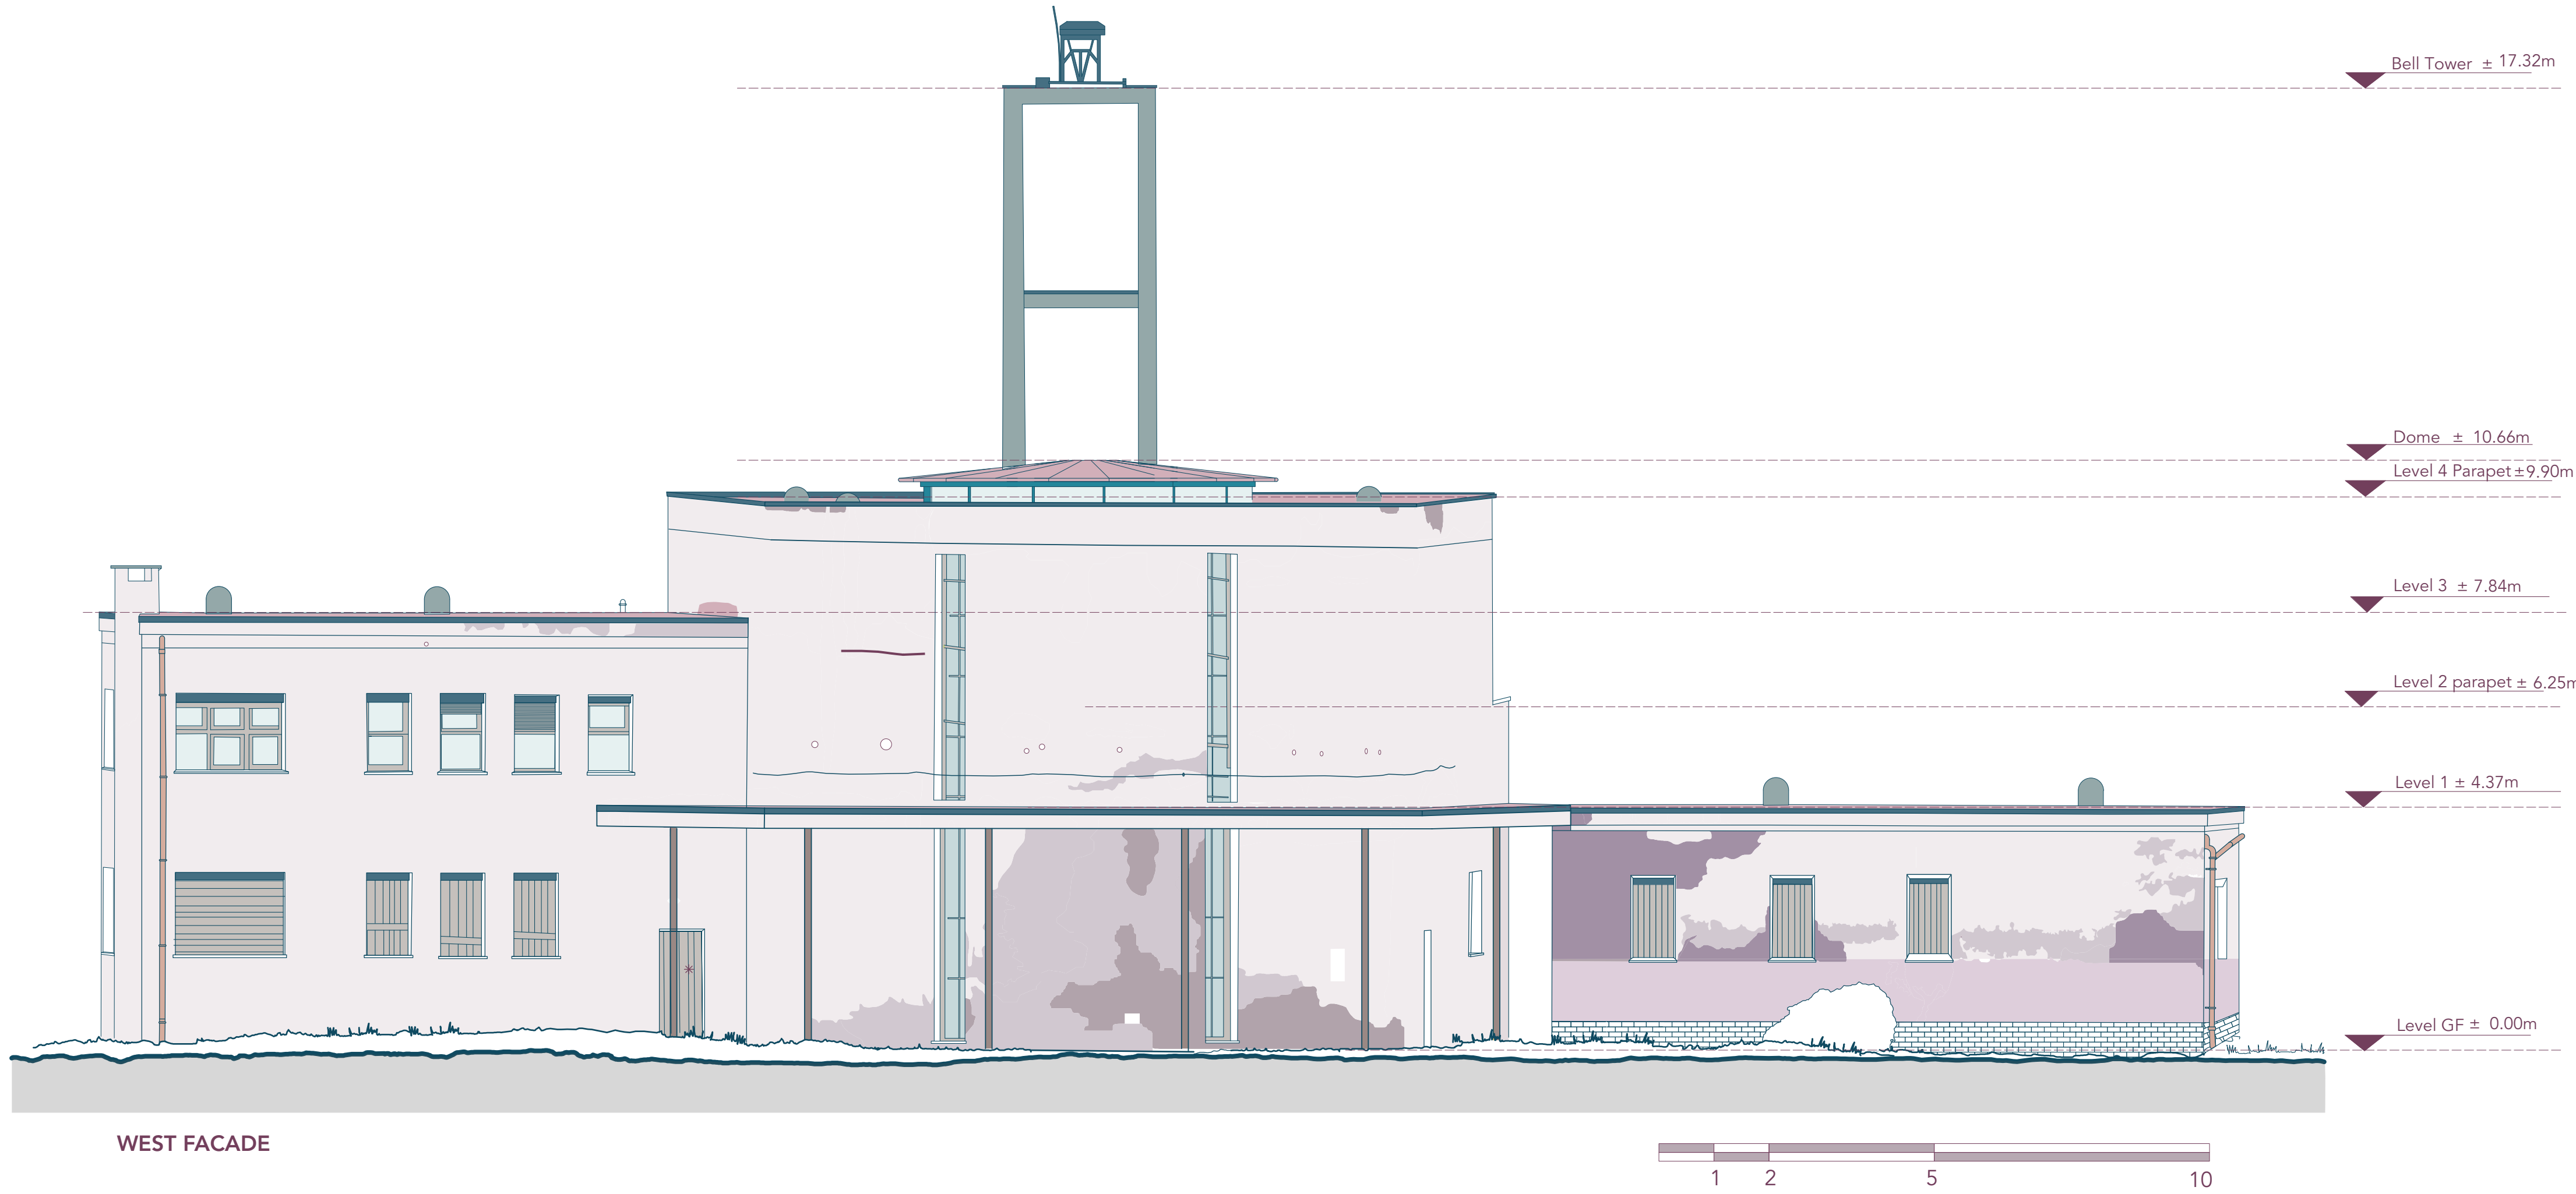
Load Bearing Elements	
Cross weave bond Four headed	Gothic bond Two headed
<p>This hypothesis is based on the thickness of these walls. The four headed cross weave bond is up to 50cm thick and these walls are from 50cm to 60cm thick. This synthesis proves that these are solid brick walls which support the large open space and ceiling of the altar.</p> <p>The bond however, seems a little irregular at certain places but the overall structure is intact.</p>	<p>The interior of this area was not surveyed but the exposed brick bond allowed to determine the thickness of these walls, which in design documentation is set to 30 cm. The Block weave bond gives a brick wall of 25 cm excluding finishes.</p> <p>Parts of the perimeter walls of this wing has cracks and fissures, indicating structure has been compromised.</p>

Steel & Concrete Elements	
Reinforced Concrete Elements	Steel Columns
<p>Found in Bell Tower, Chimney, and roof anchor elements</p>	<p>6 Steel columns of 5 cm radius supporting roof of Ambulatory</p>
Building Services	
Drainage Pipes	
<p>The drainage pipes on the facade seem to be in plastic, very similar to PVC. Comparing with old photos of the church, these pipes are seemingly original and have not been replaced.</p>

Wall Finishes			
Paint on Plaster Type 1	Paint on Plaster Type 2	Exposed Plaster Layer	Ceramic Tiles
<p>Typical Paint finish found on the facade. The texture of finish is different from that of Type 2 which is apparent in the photographs of how the paint layer has been detached.</p> <p>For this reason, a differentiation is highlighted which can be due to different types of plasters used.</p> <p>This texture suggests use of cement plaster for these surfaces.</p>	<p>The texture of surface suggests that a different kind of plaster has been used on this surface. The float and scratch coat in the degraded parts suggest a lime based or soft cement based plaster used in this area. The peeling paint layer suggests the issue of rising damp and the structure is in dire need of restoration.</p>	<p>All three layers, that is, the scratch coat, float coat and the finish coat are exposed. Flaking layers of paint can be seen in these areas. Overall the condition of finishes are severely deteriorated causing various forms of detachment and disintegration.</p> <p>From the photographic analysis, the plaster seems to be of Type 1, which is cement based (hypothesis).</p>	<p>At the base of South wing there are ceramic tiles, which seem to have been an addition to form a damp proof course. This addition does not seem to have a greater impact on the rising damp situation as can be seen from the condition of degradation.</p> <p>These tiles do not go with the rest of the design language of the building, hence can be removed with proper solution for damp proofing.</p>

Window Finishes		
Wood	Glass	Metal wire mesh
<p>Wood is used in almost all the windows of this building. All the windows on the ground floor are closed with wooden planks, probably during the restoration attempts from 2020 - 2023. These wooden planks are already showing signs of degradation. The window frames on the upper floors are still intact with great signs of decay and gaps.</p>	<p>Some of the windows in the upper floors still have glass intact, if not fully, parts of broken glass can be seen. Shutter boxes in metal can be seen above the window frames of the windows facing West and South facade. They do not appear in the East Facade. It may have been an intentional design move by the architect Gardella, for the purpose of allowing sunlight from the East.</p>	<p>Some of the windows on the ground floor, and especially the two narrow full height windows behind the naves are closed with the metal wire mesh for safety. In some photo documentations from 2020, the window glass seems to be intact, it may have been damaged and removed after this time during the restoration attempt.</p>

Roof and Other Finishes		
Metals	Metal Frame	Bitumen sheets on roof
<p>Metal has been utilized in various parts of the building, such as, the coping, the structure of bell in the bell tower, the covering of the dome etc.</p> <p>The coping, as shown in the picture, covers all the parapet walls, however, it seems to have been a much later addition. Even with the addition of coping, the parapets show serious forms of degradation linked to dripping water.</p>	<p>The studies of early 20th century architecture suggests that metal window frames began to be used in the first half of 20th century as window frames.</p> <p>With the amount of corrosion seen on these frames, it can be assumed that these frames are of metal and not aluminium.</p> <p>The structure of the dome is very innovative and light weight. The glass in some parts of the frame still seems intact.</p>	<p>Roofs of all three blocks of the church have recently been renovated with the addition of Bitumen layer at the top for water proofing. This addition could have been fruitful for stopping water penetration to the interior of the building, but for the facade, there appears to have been further degradation due to the addition of this layer, especially biological growth.</p>

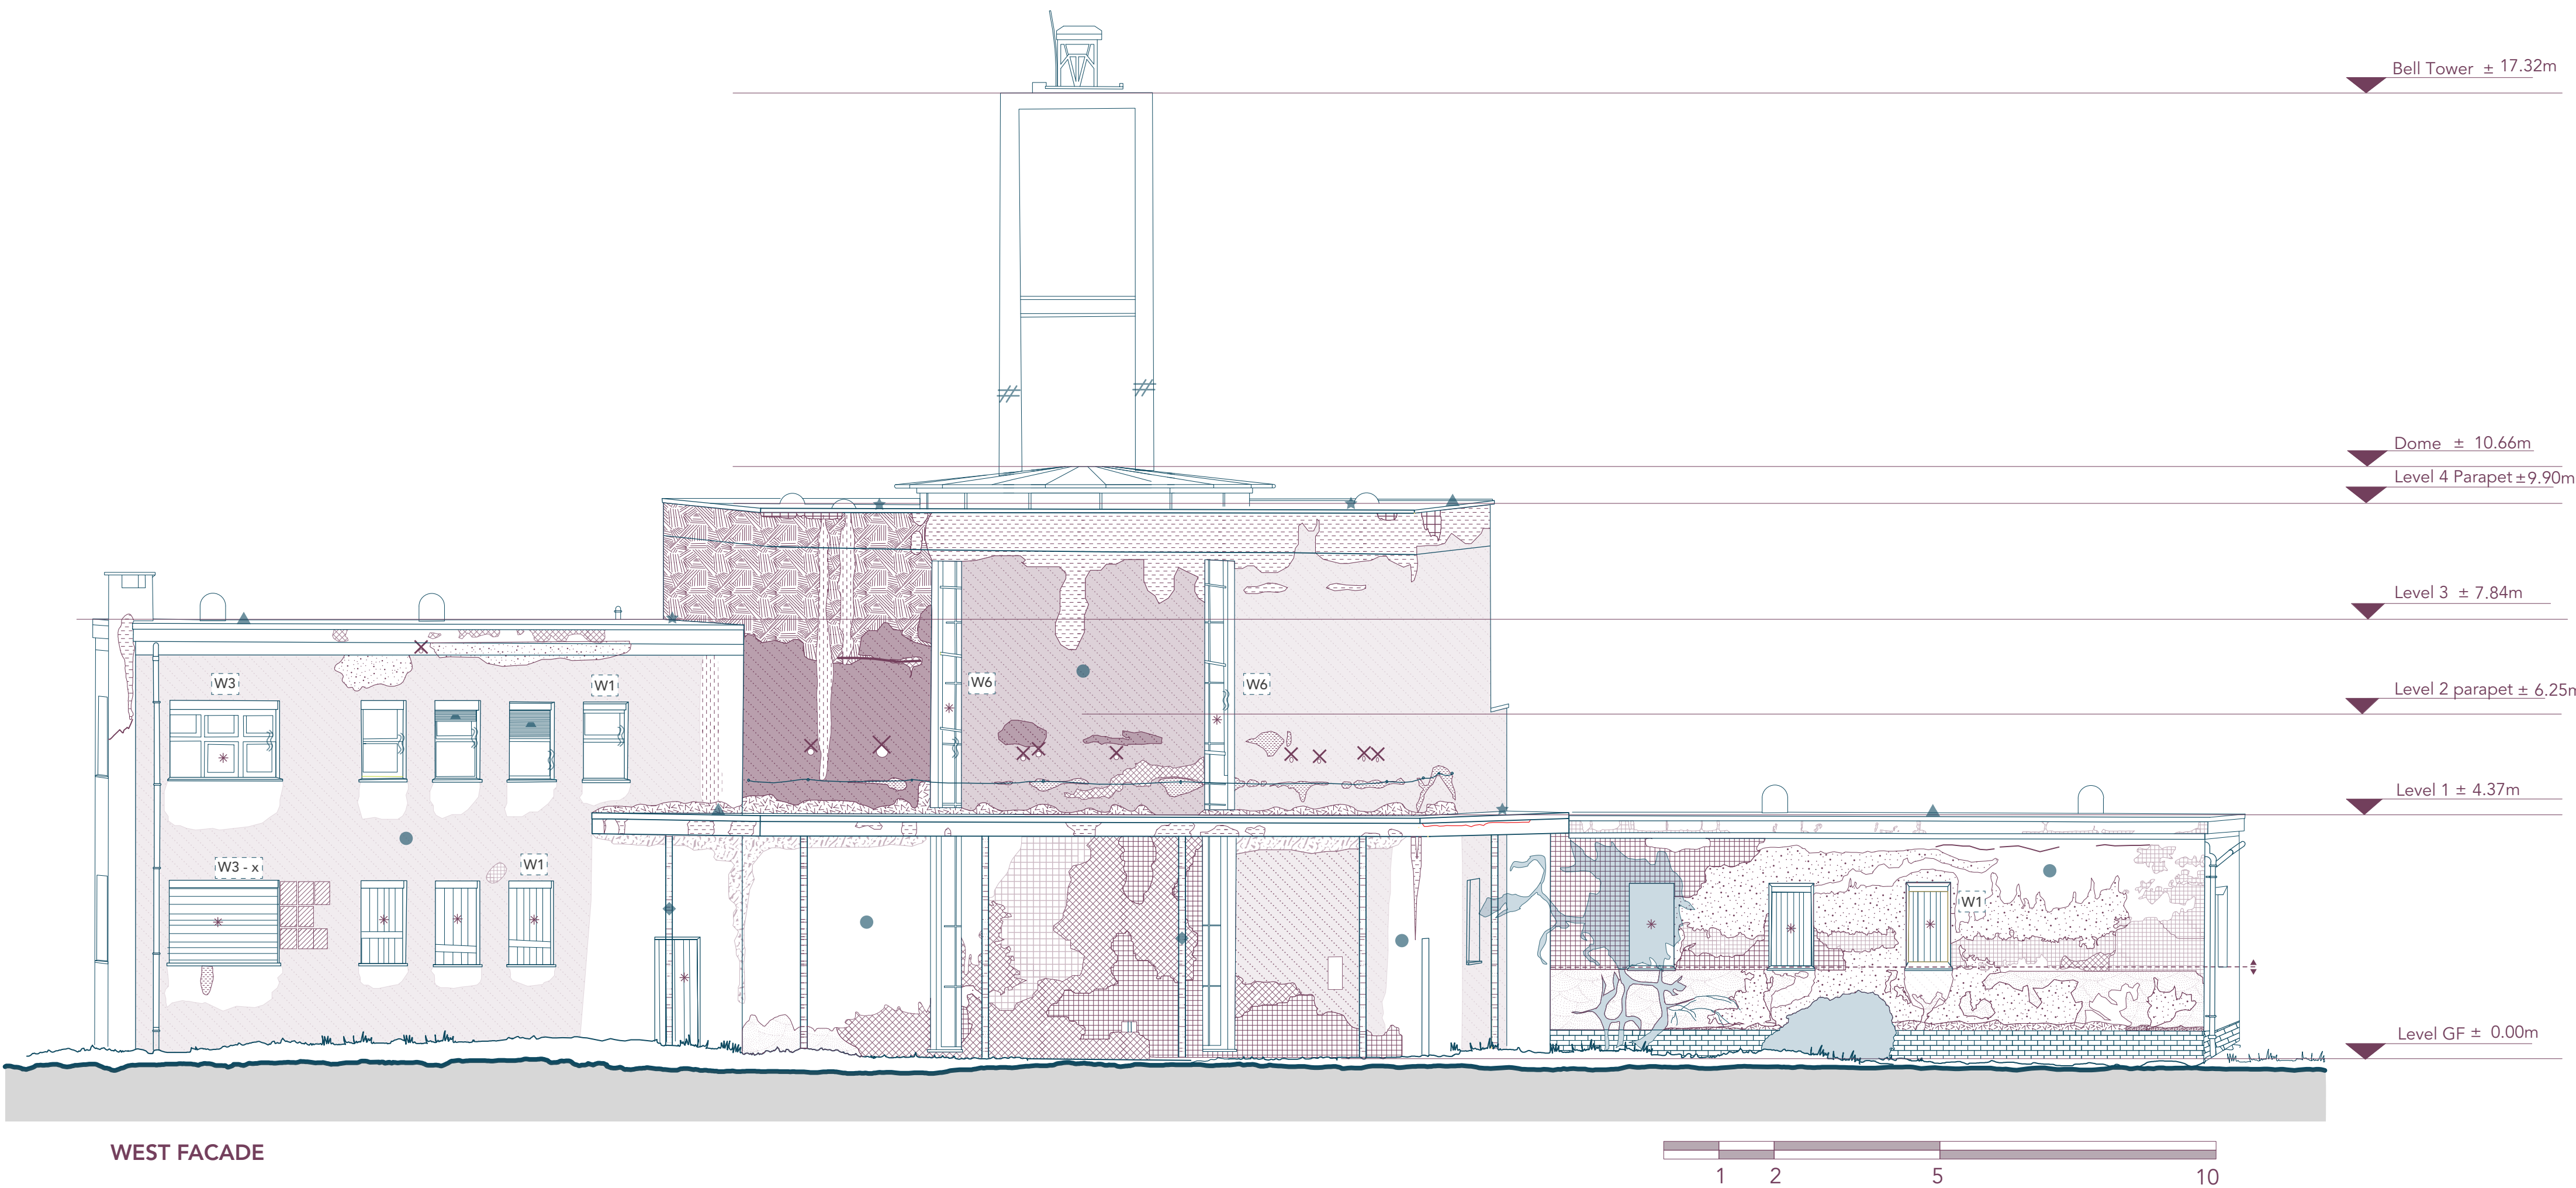
Degradation Analysis			
Pattern/Symbols	Photo	Degradation and Description	Causes
West Facade Degradation		Missing Elements in Windows Window (58.9 x 882 cm), indicating material loss as the <i>glass is missing</i> and they are closed with wire mesh. The wooden frame has dark greenish and black spots along the grains indicating <i>moss, algae, or fungi growth</i> . Fine cracks, particularly in areas exposed to direct sunlight and moisture are visible. <i>Peeling or flaking paint</i> , exposing raw wood underneath. <i>Moisture stains</i> can also be seen on the frame.	Biological growth is due to constant exposure to moisture and rain infiltration, with weakening or unsealed joints / lack of protective coatings. Repeated wetting and drying cycles causing cracks. Detachment of finishing paint is also due to environmental condition and aging. Missing glazing component, causing water ingress to the interior.

Window (200 x 150 cm) are similar to other window sills in the building, the growth of algae, moss or mildew are apparent also here, as indicated by greenish and blackish spots. Extensive detachment of paint visible on the frame revealing raw wood. Hardware of the window seems to be broken leading to no proper closure of the shutter or the window casement fixtures.	Reasons of decay in W7 and W8 are similar to those mentioned for other windows.
		The size of the window is same as W7. This window is covered with wooden panels/planks, which are not part of the original design (similar to W1). The original window frame is either missing or degraded to an extent that it needs to be covered with panels to save it. The added planks are also weathered and show signs of biological growth, which is also visible in the window sill, suggesting neglect or inadequate maintenance.	
Surface Degradation		Chromatic Sampling This is not considered as a degradation type, instead an intervention method used to test and match the original or intended paint layers for restoration purposes. If executed improperly, they may leave patches unprotected, which can expose the underlying plaster or masonry to weathering. However, in this case, the sampling is rightfully applied to the least degraded wall.	It often involves removing existing paint layers, leaving the plater or masonry temporarily unprotected. It is done because, as the analysis shows, almost all the building finishes have been degraded and have been exposed to chromatic alteration. However, to promptly address the issue, the final finishes must be decided sooner.

Moisture related Degradation		Rising Damp Causing Detachment The degradation visible includes significant peeling and flaking of the wall's paint layer, exposing the underlying plaster. The deteriorated wall shows multiple types of detachment and growth of moss and algae.	The observed degradation can be attributed to rising damp, which causes moisture to ascend through the wall via capillary action. This phenomenon is often exacerbated by the absence or failure of a damp-proof course DPC, poorly drained soil near the structure, or a high groundwater level. If it is not treated, over time the absorbed moisture dissolves more salts within the wall materials causing further degradation.
		Moisture stains Causing Detachment The moisture stain surrounding the central dark streak is lighter in color, with a grayish tone, spreading across a wider area on both sides. The irregular edges and discoloration suggest moisture has seeped into the wall's surface layers, likely saturating the plaster or paint. This area shows signs of surface deterioration, such as minor peeling or roughness.	Caused by the presence of water or moisture in the material, moisture stains are characterized by color changes, usually darker than the original material, and may be accompanied by phenomena such as efflorescence, surface cohesion loss, or biological growth. These stains indicate underlying issues like infiltration, condensation, or rising damp and usually appear irregular, depending on the source and path of the water.

Moisture stains due to dripping water (Colatura) Dark moisture stains on the upper portion of the wall, particularly concentrated beneath the metal coping. The discoloration appears as streaks and patches, suggesting water dripping. The stains are darker in some areas, indicating prolonged exposure to water.	The moisture stains are due to water dripping water from the parapet causing stain under the metal coping. This could result from inadequate waterproofing or improper installation of the coping, allowing rainwater to seep beneath or flow over its edges. Repeated exposure to dripping water leads to moisture accumulation and stains on the wall surface, and the absence of proper drainage exacerbates the problem.

- Use biocidal solution or essential oil to clean the moss, algae or fungi (such as, quaternary ammonium compounds or natural thyme oil).
- Natural wood fillers can be used for superficial cracks and for structural cracks, low viscosity epoxy consolidant can be used. It is necessary to ensure structural integrity and replacing any broken or loss wooden sections.
- Removal of flaking paint with non-abrasive chemical stripper or scraper.
- Sand the surface of the frame to prepare for new coatings. It should be protected by application of linseed oil based primer followed by breathable micro-porous paint.
- Finally to replace the glass and re doing the seal between frame joints and masonry opening.

- Same solutions as above for treating the wood
- The existing glazing condition must be checked in order to decide if it needs replacement.
- The hardware of the window must be replaced in case the existing hardware are no longer workable.

- After resolving the main source of moisture in the wall, in this case, rising damp, the surface should be cleaned using mild detergent solution or pH neutral cleaning agent. For this building, since the walls are structurally compromised, manual brushes should be used to avoid further damage.
- After the wall completely dries, a hydrophobic, breathable treatment like silane or siloxane-based water repellents can be applied to prevent further water penetration.
- Breathable plaster should be used, such as lime based systems to allow trapped moisture to evaporate- Lime wash or mineral based paints for finishing will allow vapor permeability.

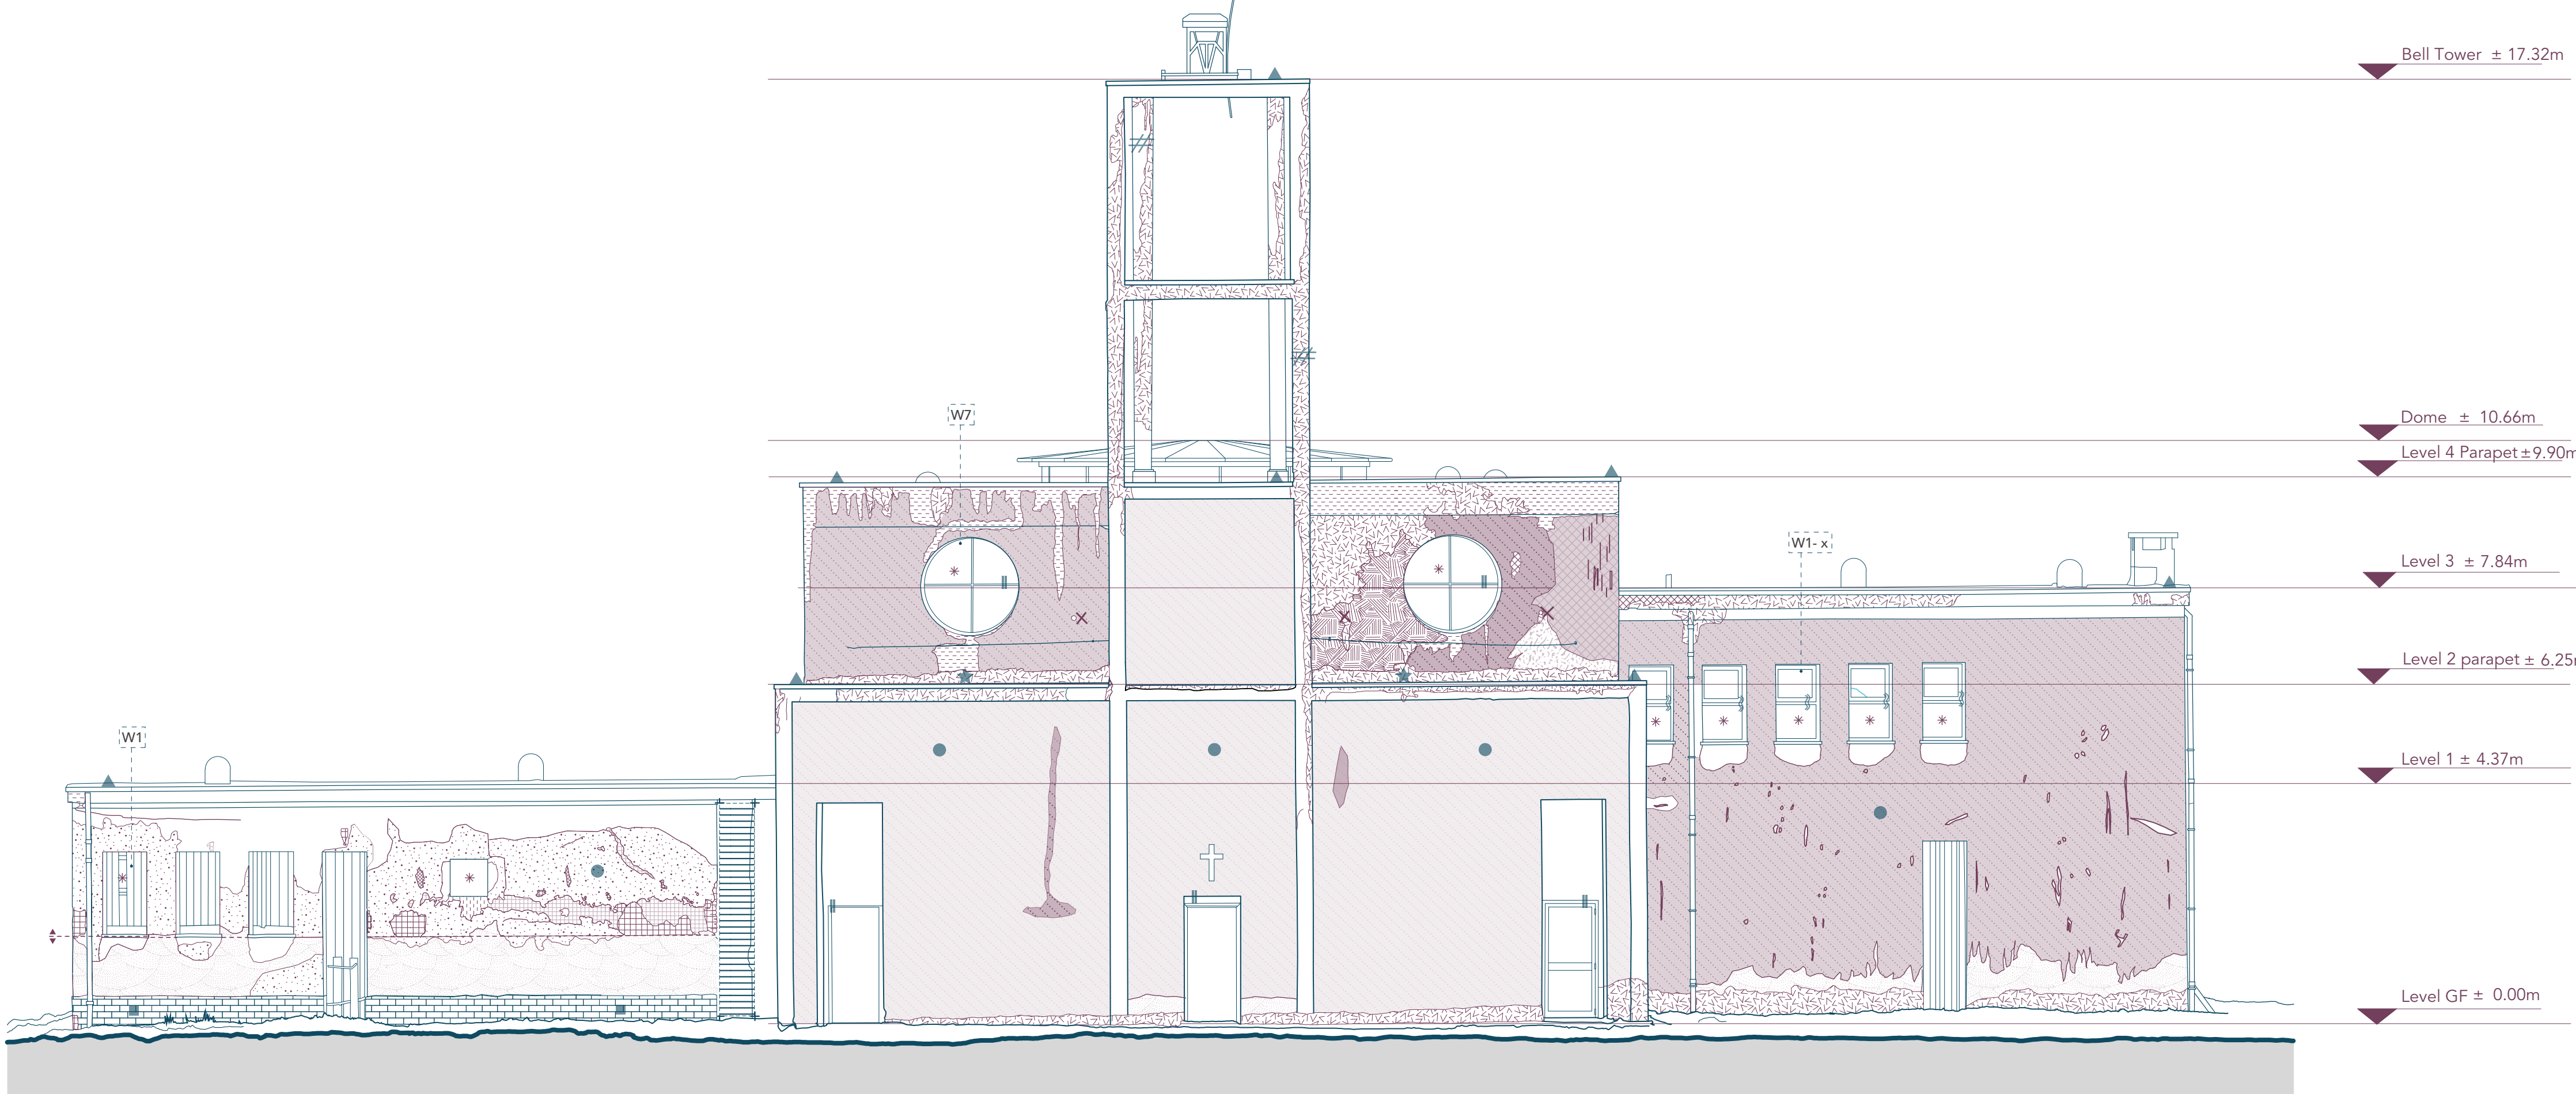
EAST FACADE

Degradation Analysis			
Pattern / Symbols	Photo	Degradation and Description	Causes
East Facade Windows	W1*	Missing Elements in Windows These windows of size 80 x 150 cm of the south wing are covered with wooden planks. The planks were installed during 2020-2023 restoration probably as a temporary measure to prevent further damage or intrusion while awaiting permanent restoration or replacement of the original frames and glass. The window is a circular opening (90 cm diameter) with remnants of an original metal grid and wooden planks installed inside, likely for temporary closure. The metal grid is intact but exhibits potential <i>corrosion, visible as dark discoloration and possibly rust</i> . The boards show signs of weathering, with uneven coloration and potential warping or deterioration due to exposure to moisture. The edges of the circular opening display staining, moss/algae growth, and surface erosion, particularly along the bottom edge.	The windows were likely left open for an extended period due to vandalism, structural decay, or deferred maintenance, leaving the church vulnerable to weather and environmental damage. The <i>absence of glass and frames</i> over time allowed water and moisture to penetrate the interior and exterior surfaces, leading to, peeling plaster, and biological colonization (<i>visible staining below the windows</i>).
