Analysis of the instability, institutions of provisional support and intervention of reinforcement in the San Giuseppe church of Fossano

by Tommaso D'Amico

This study concerns the provisional safety procedure for the San Giuseppe Church of Fossano, Cuneo, Italy carried out by means of an adequate temporary protective framework to tackle the static shortcomings of the structure.

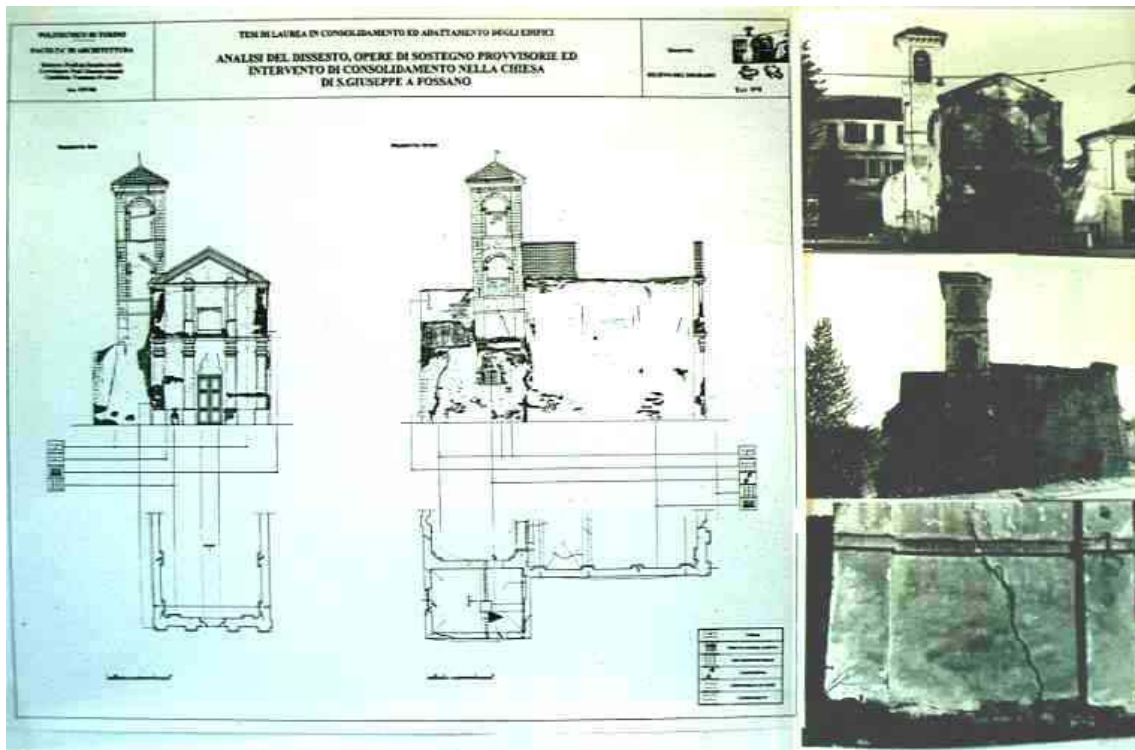
As was stated above, structural modifications can have different causes, vary with time and influence each other, such as the degradation of the structural components due to their old age (I refer in particular to those degradation evidences modifying the original static layout), such as the breaking or tension loss of the iron tie rods of the Welsh vault, the "unthreading" of the wooden tie beams of the trusses, or causes inherent in the structural lay-out due to errors or faults in the original static plan such as the incorrect use of the thrusting members at the base of the bell tower, in particular on its CD side, where a discharging arch is located which today, due to the serious degradation affecting the whole structure, shows three bearing points: the two wing walls and the angle pier of the bell tower corresponding to the crown section of the arch.
