W I N D O W S C H E D U L E

D O O R S C H E D U L E

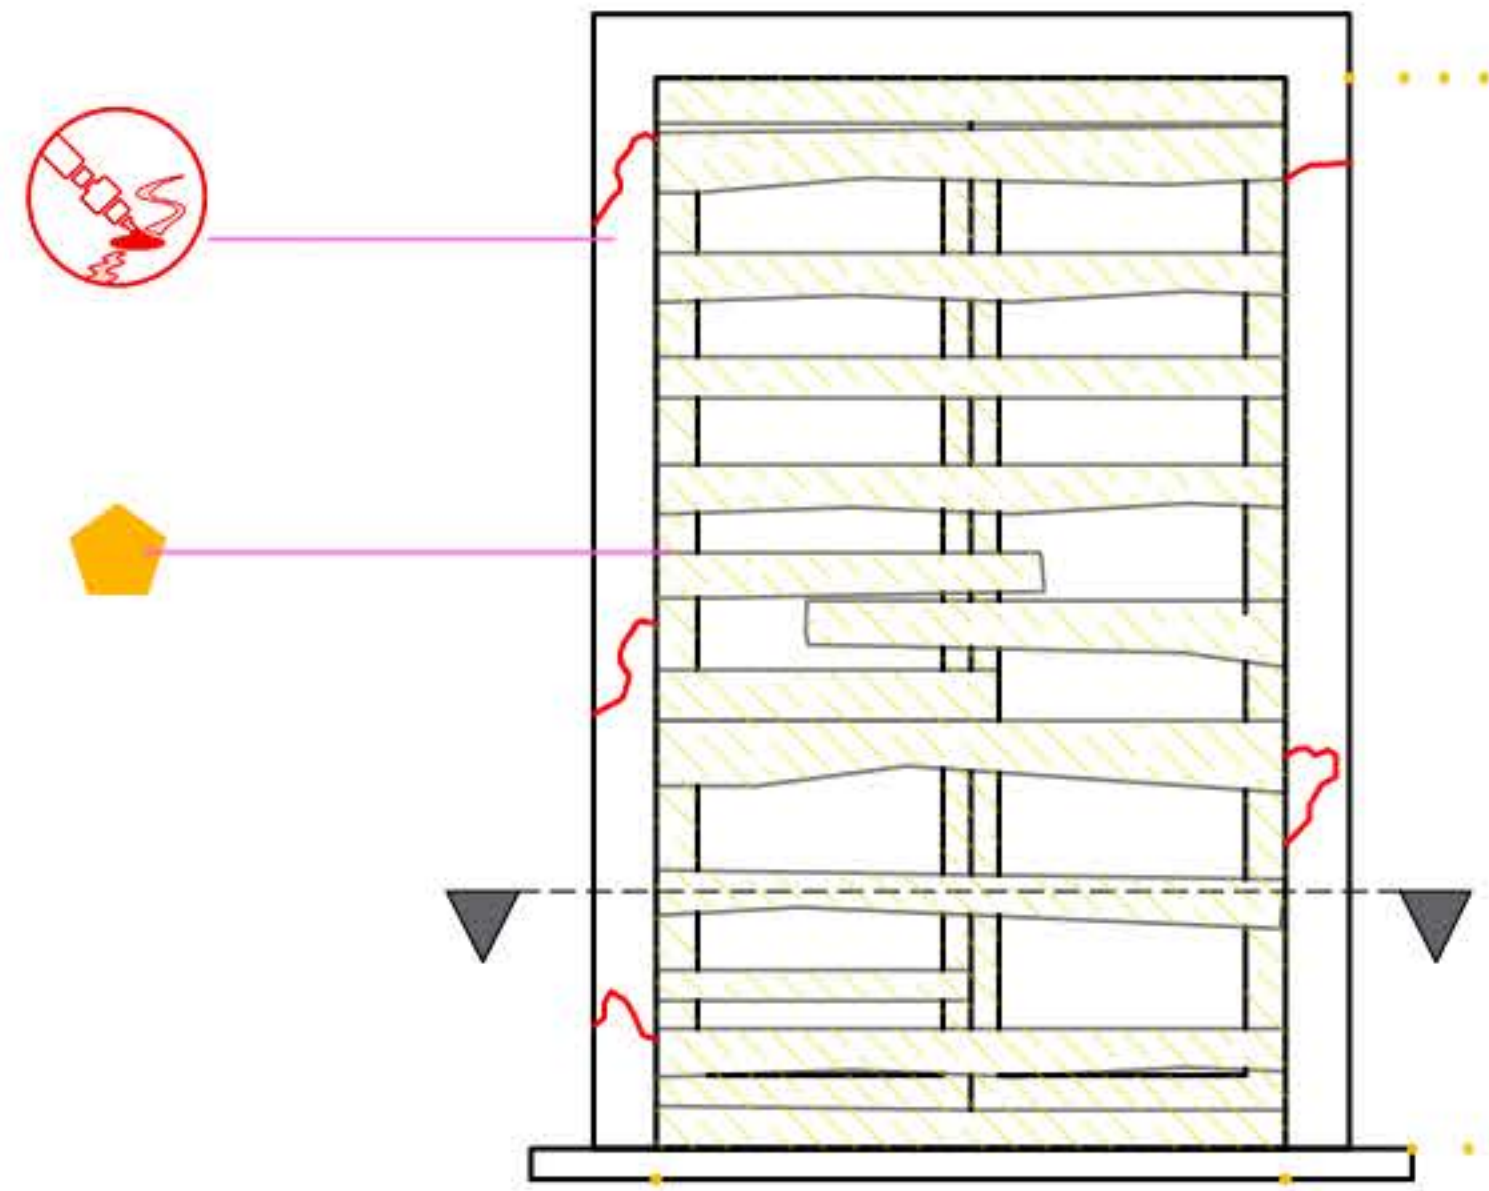
NO. - W1 LOCATION - ROOM 2

BEFORE

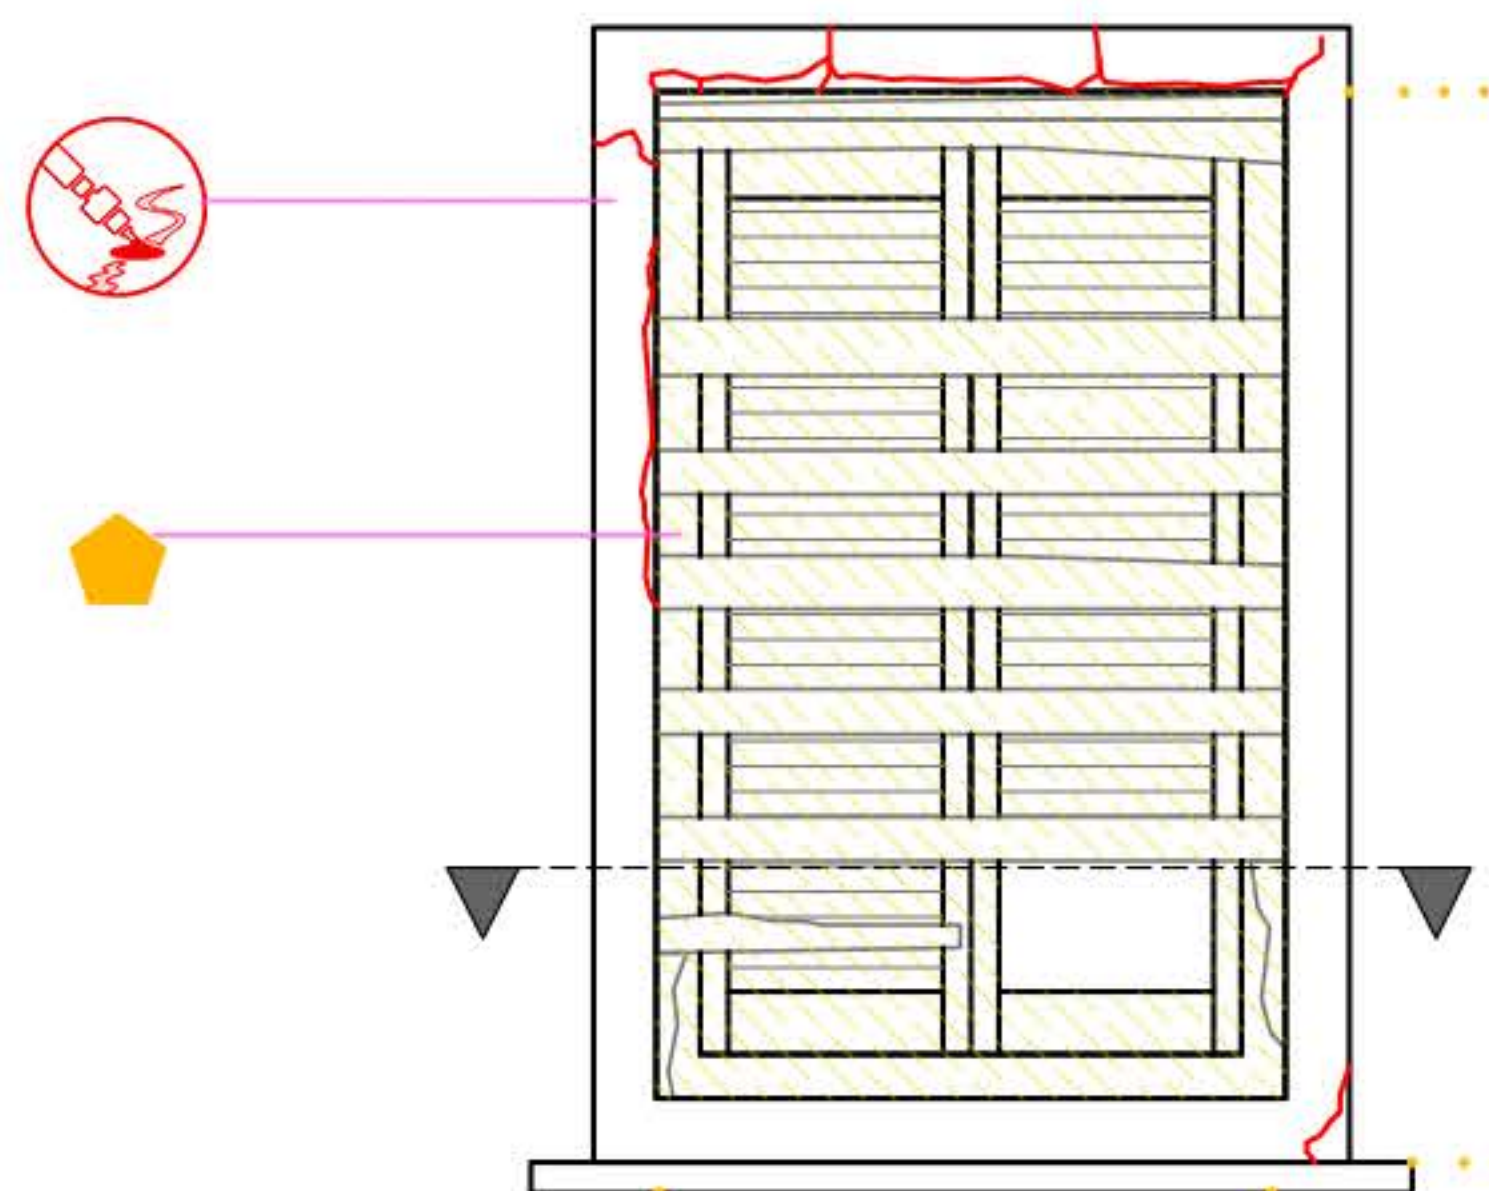
NO. - W1 LOCATION - ROOM BELOW STAIRCASE

BEFORE

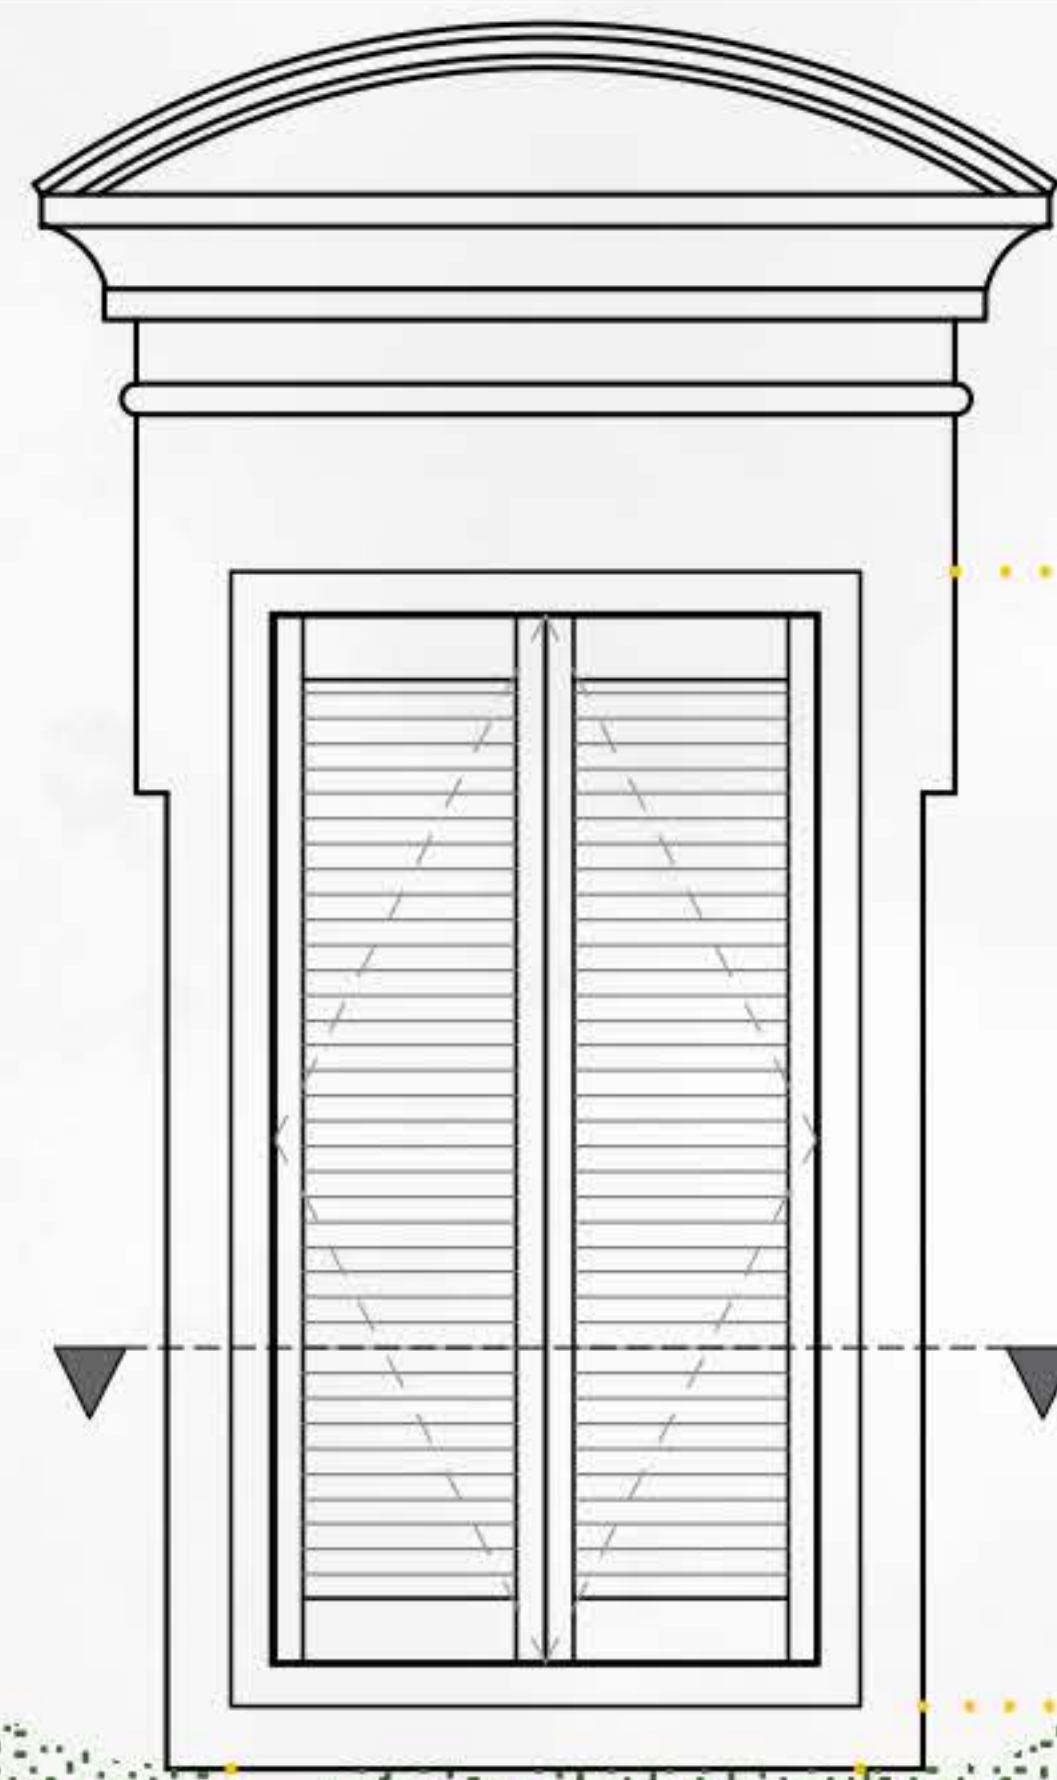
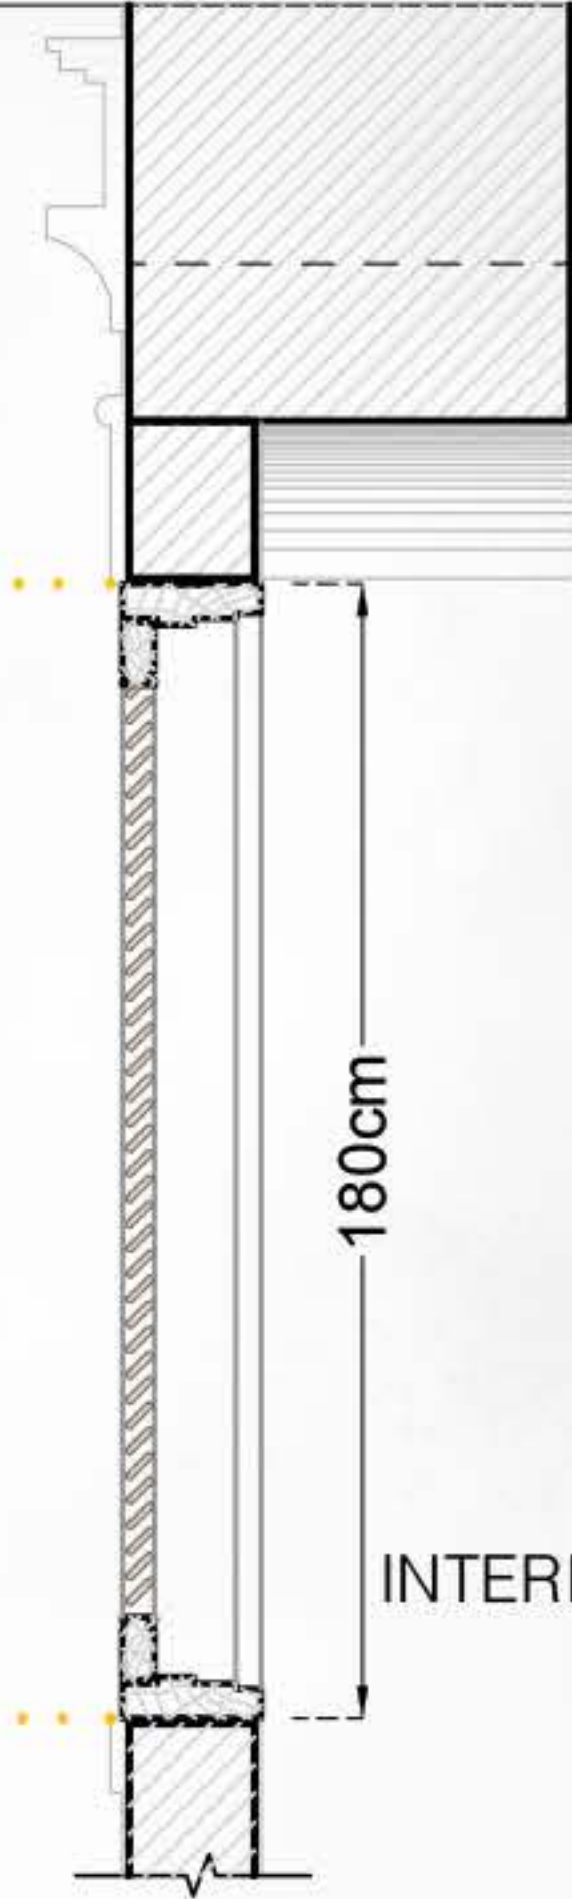
NO. - W2 LOCATION - ROOM 9

BEFORE

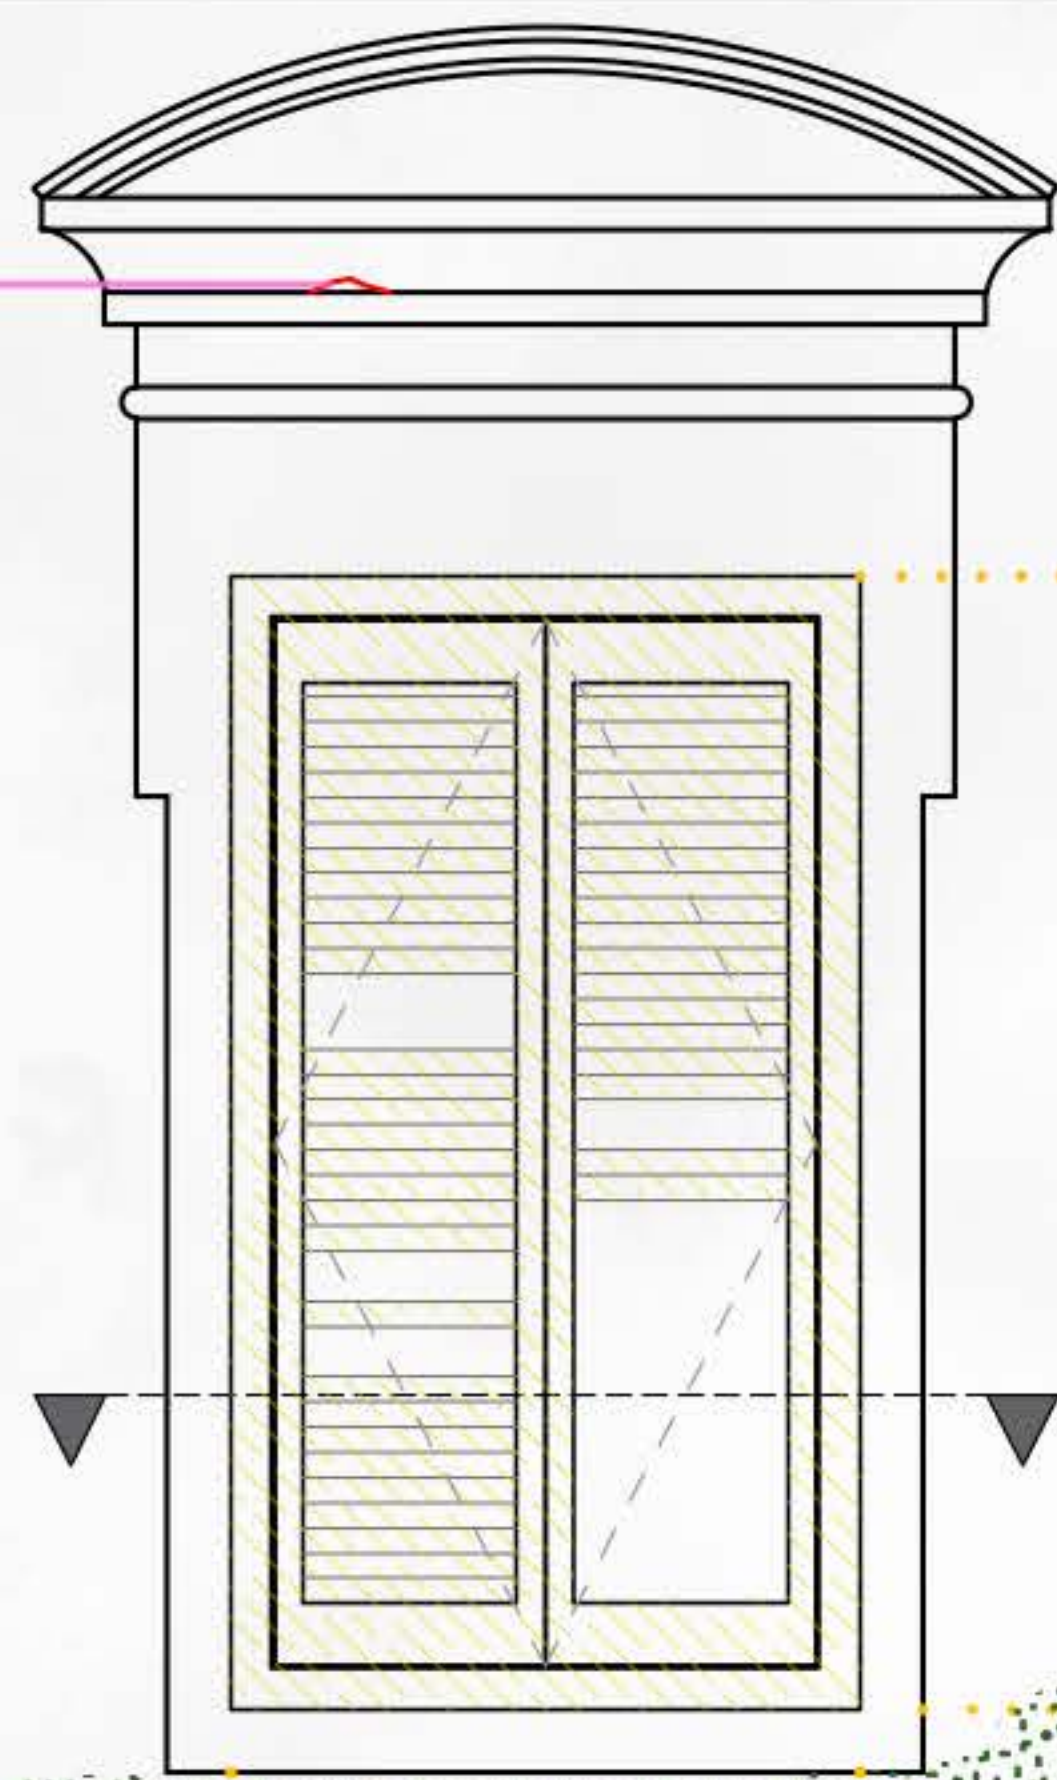
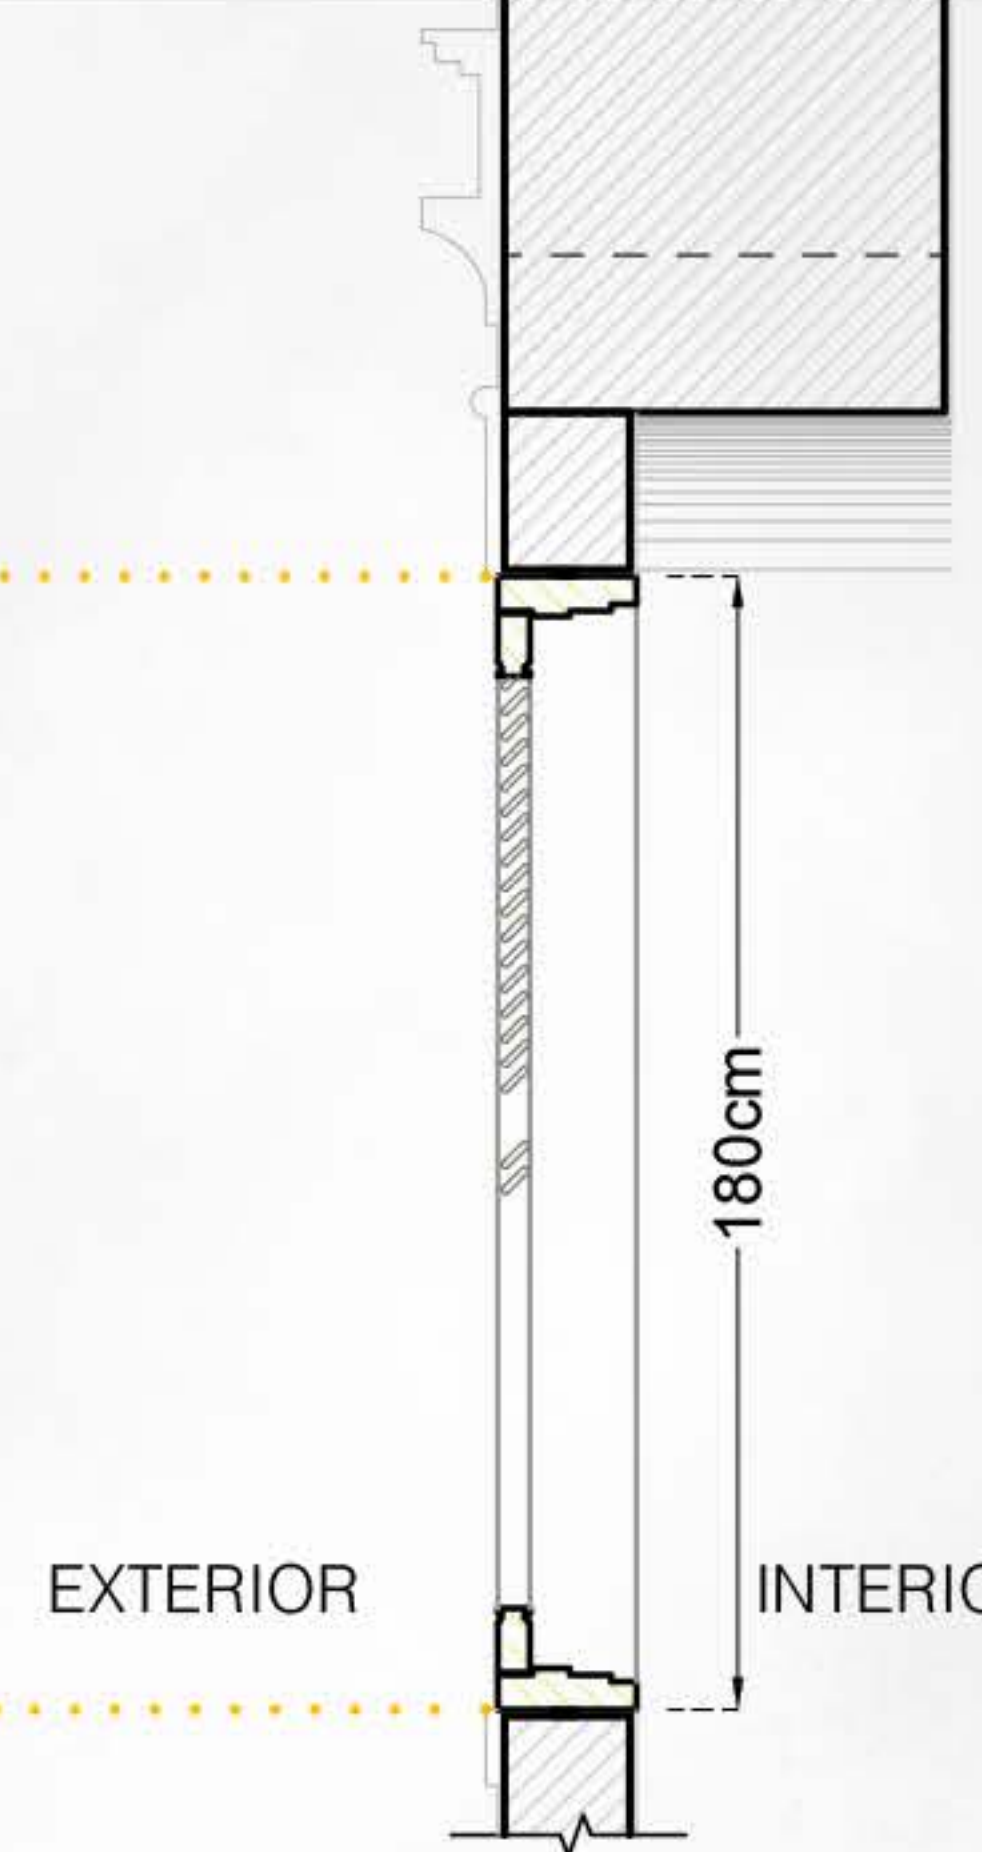
NO. - W2 LOCATION - ROOM 8

BEFORE

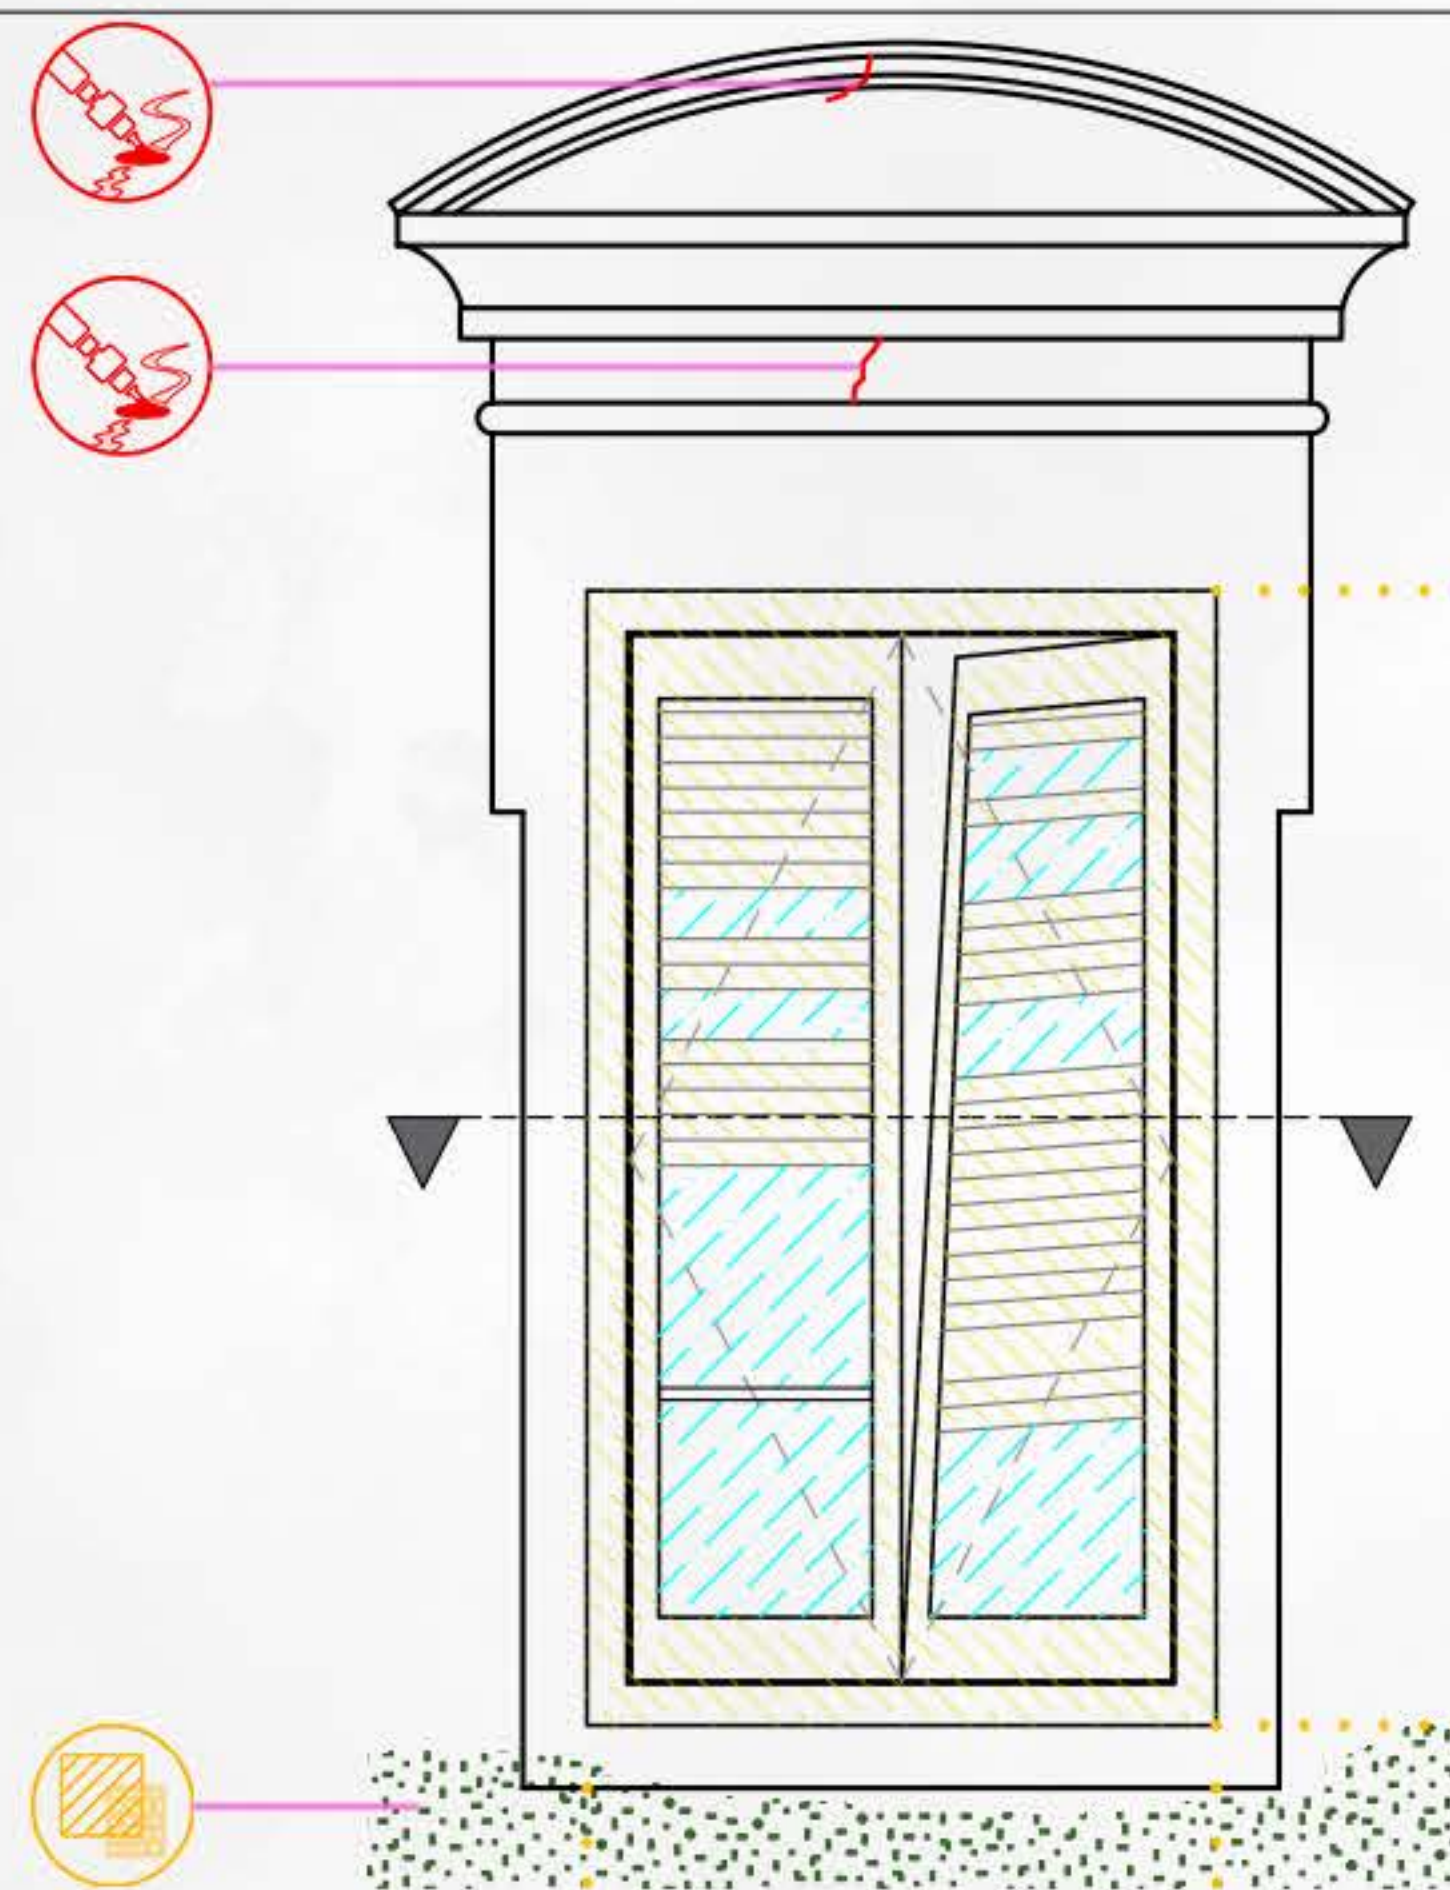
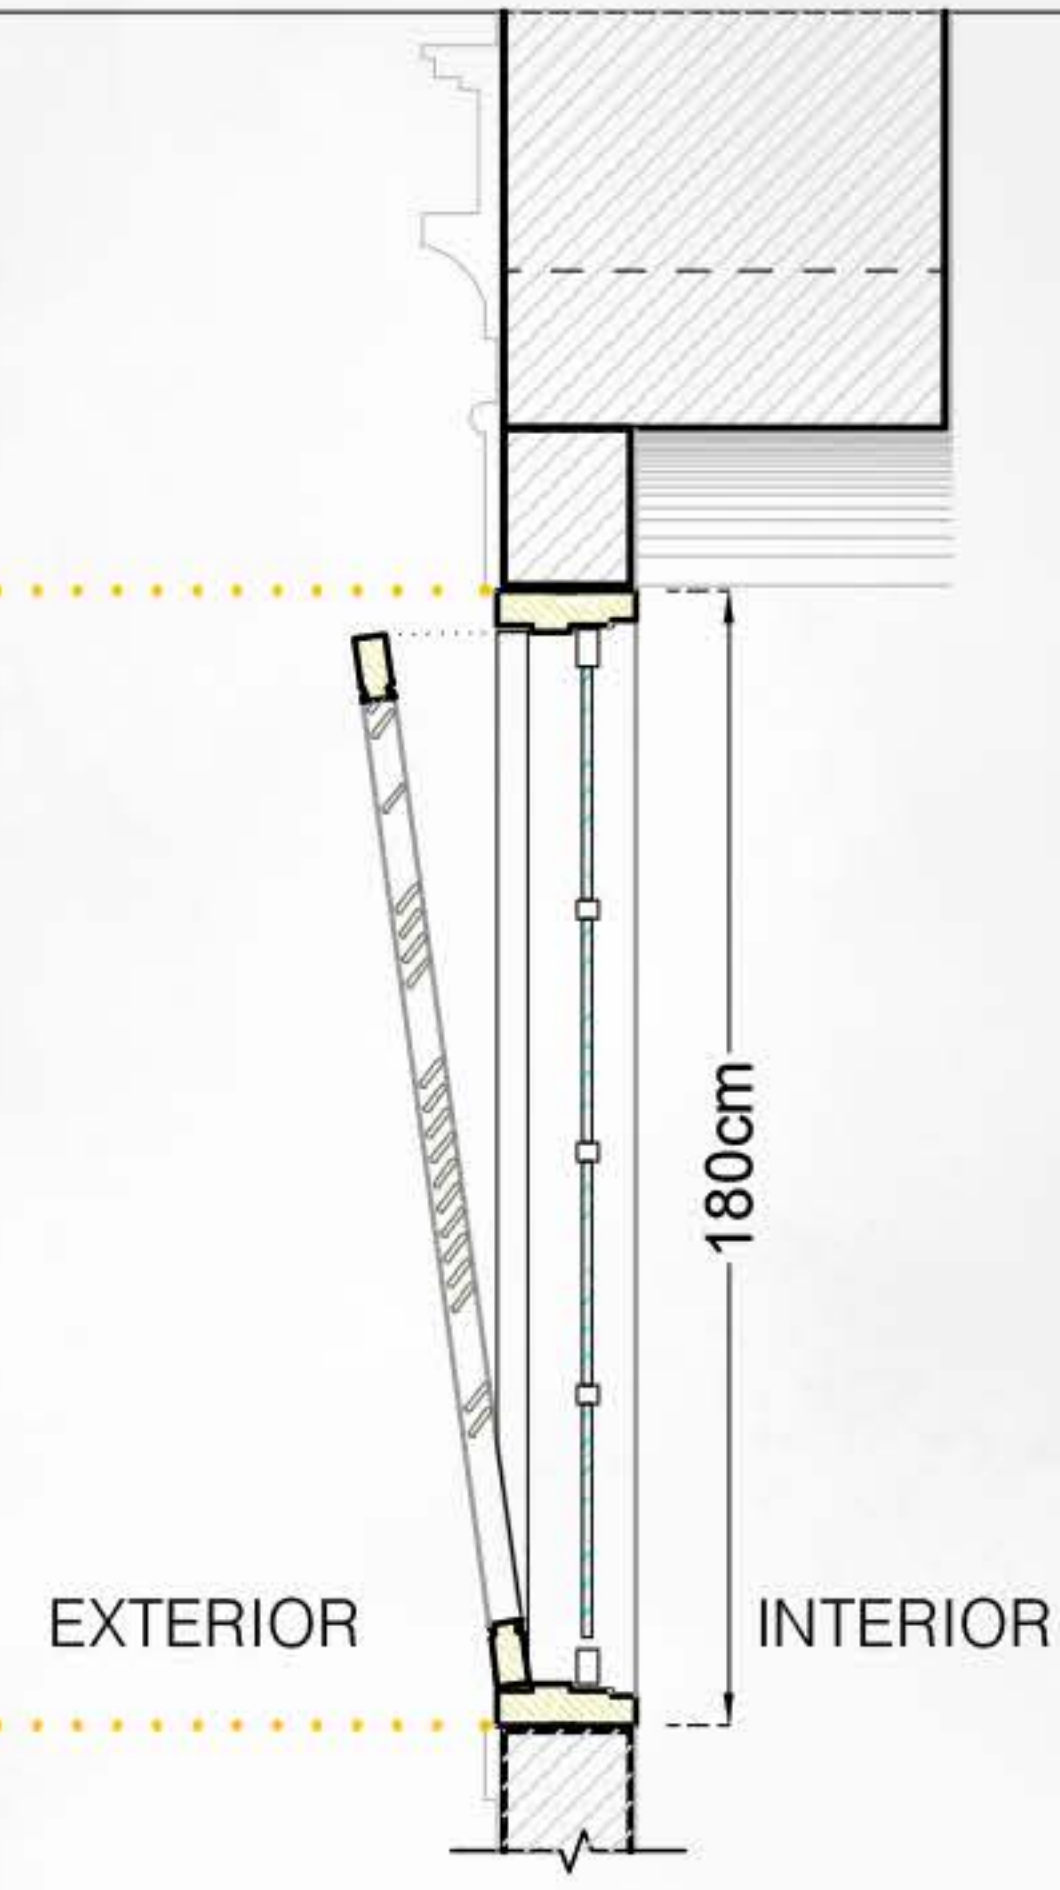
NO. - W2 LOCATION - STAIRCASE FACING ELEVATION E1

BEFORE

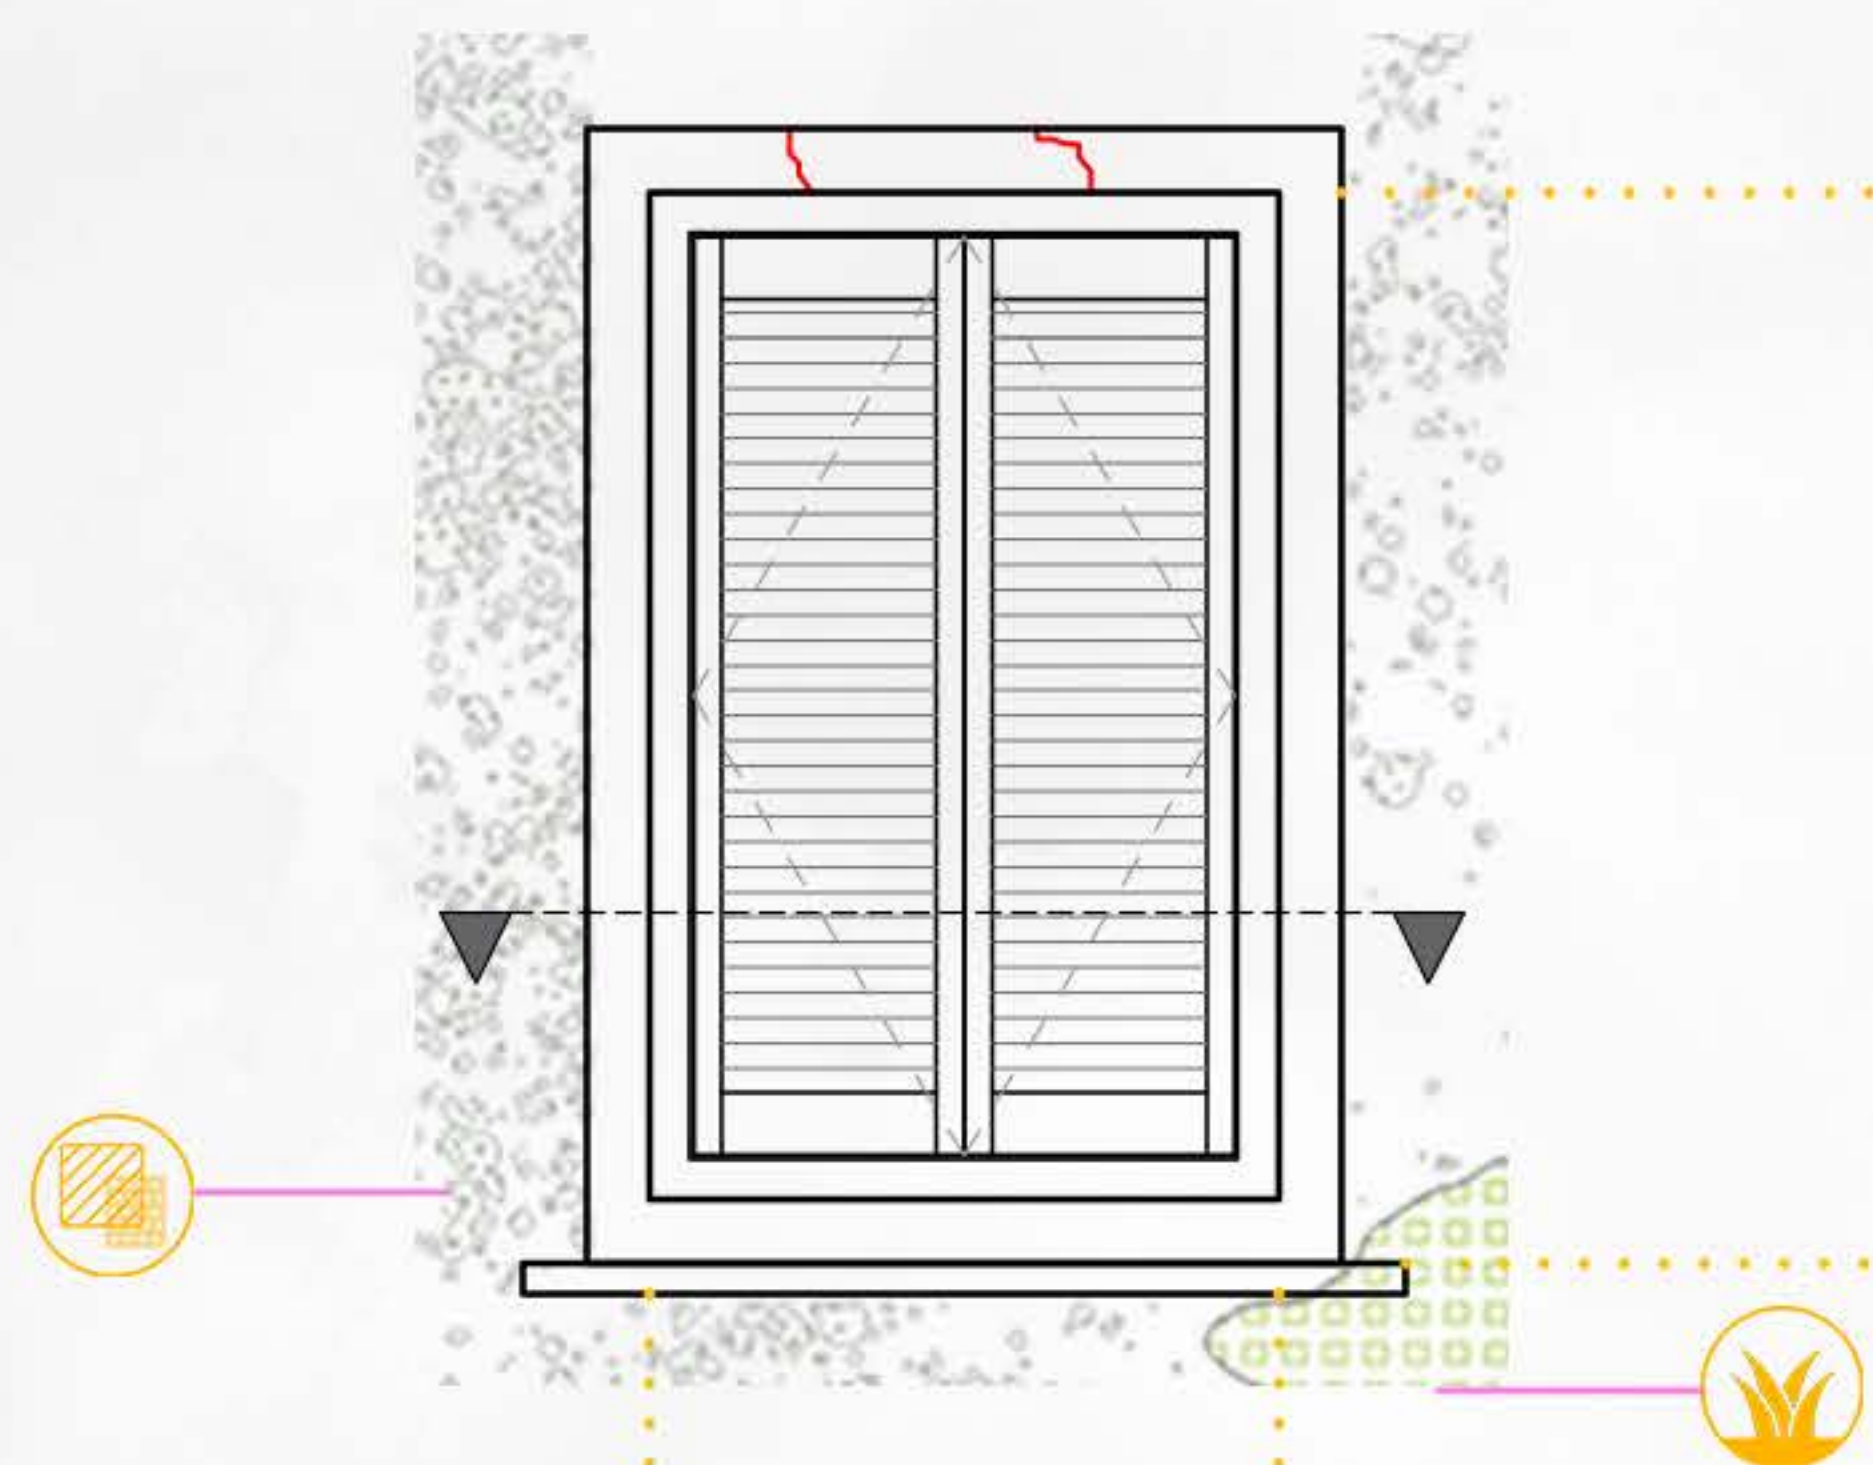
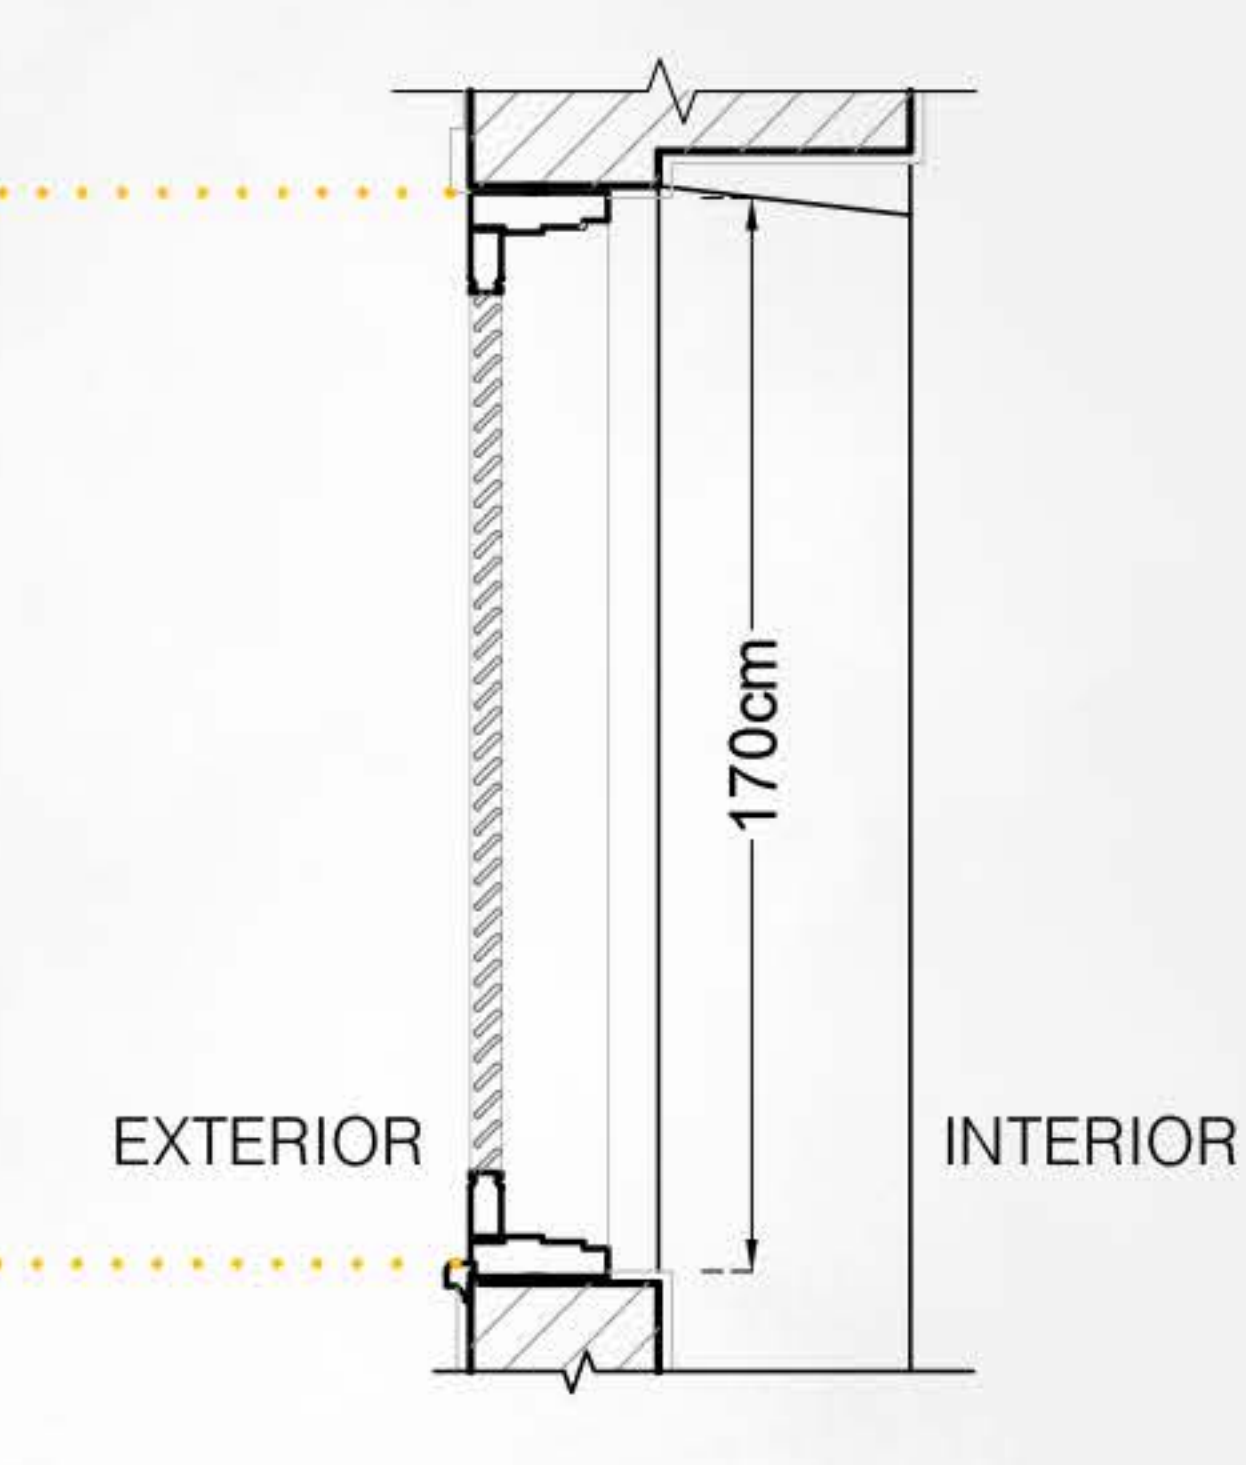
NO. - W2 LOCATION - STAIRCASE FACING ELEVATION E4

BEFORE
