W I N D O W S C H E D U L E

D O O R S C H E D U L E

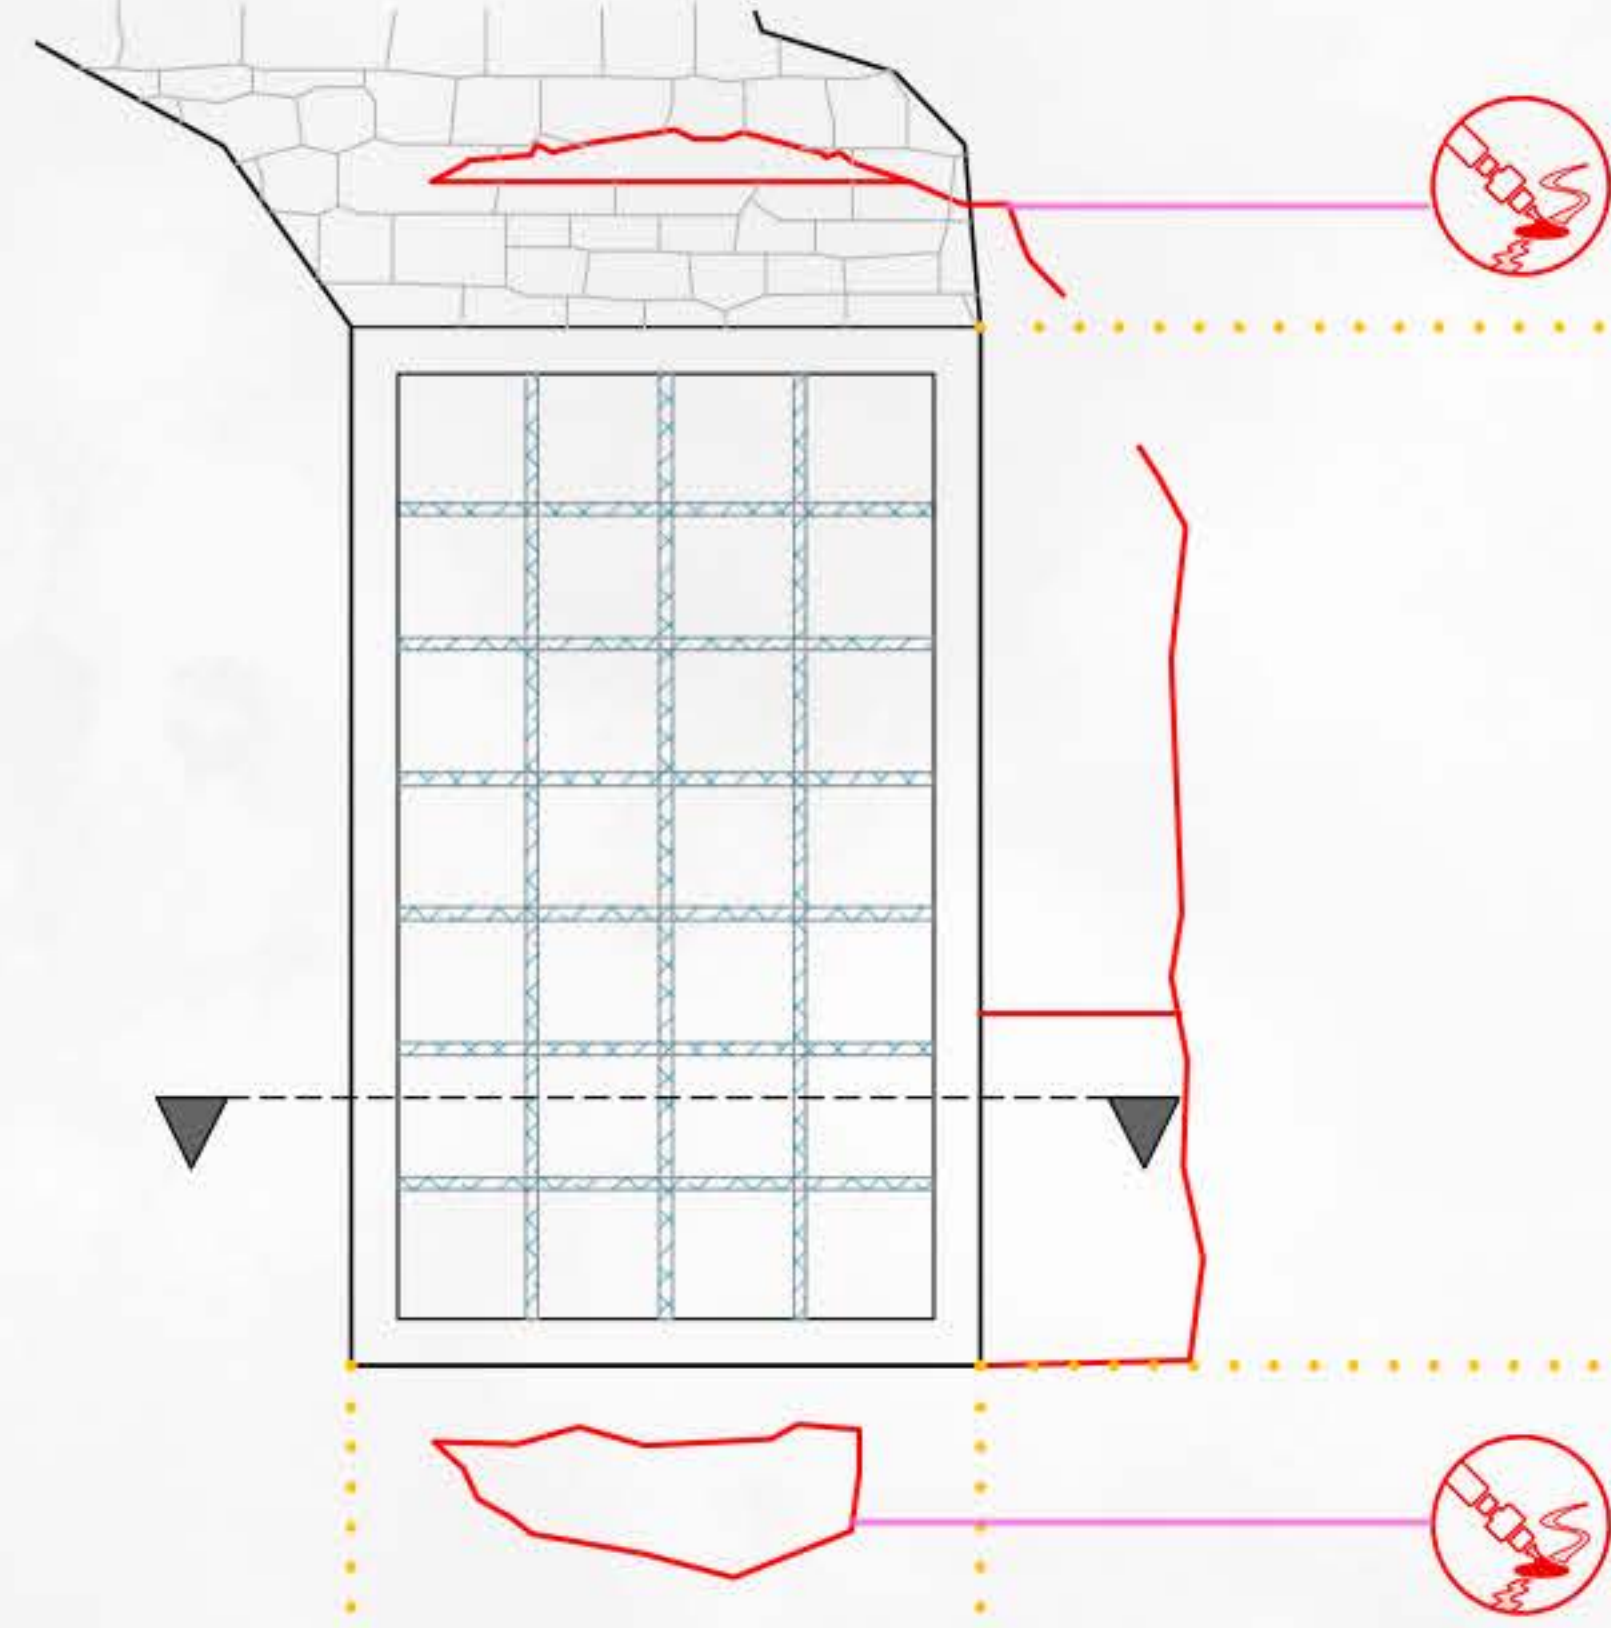
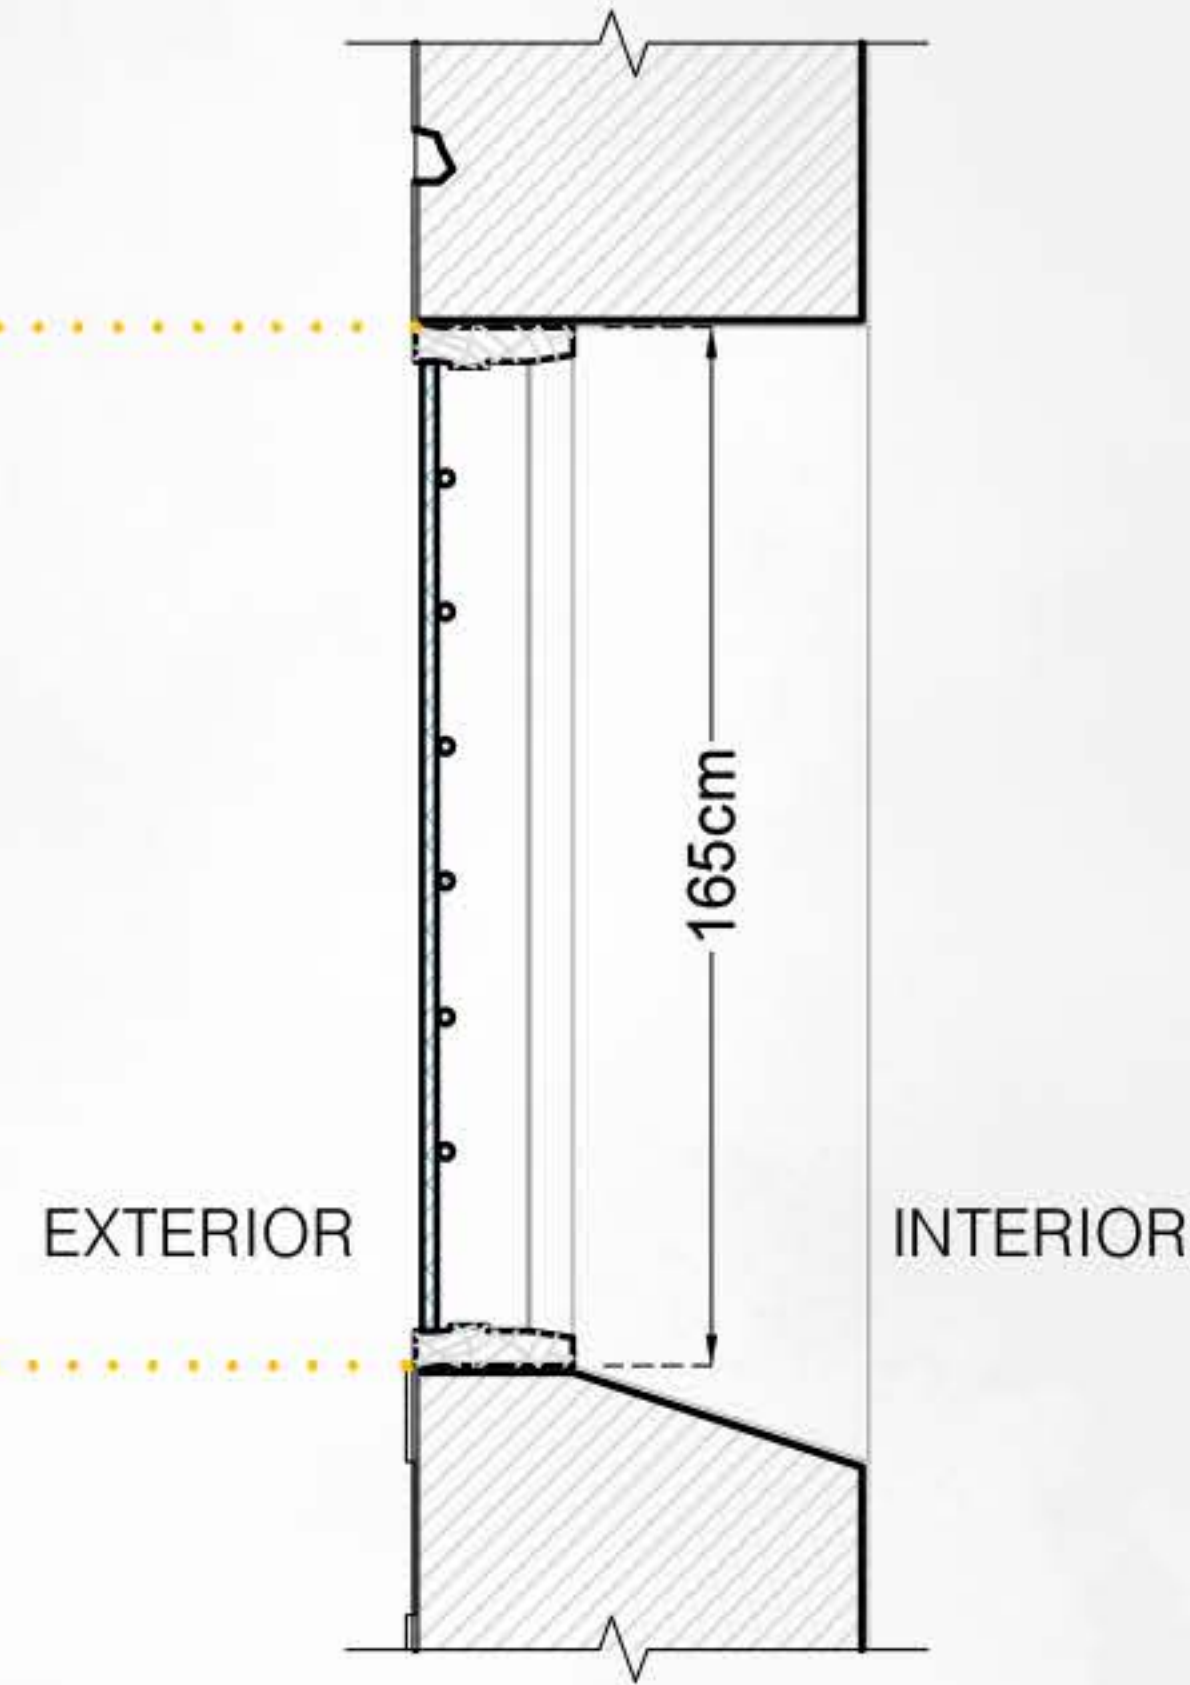
NO. - W3 LOCATION - ROOM 6

BEFORE

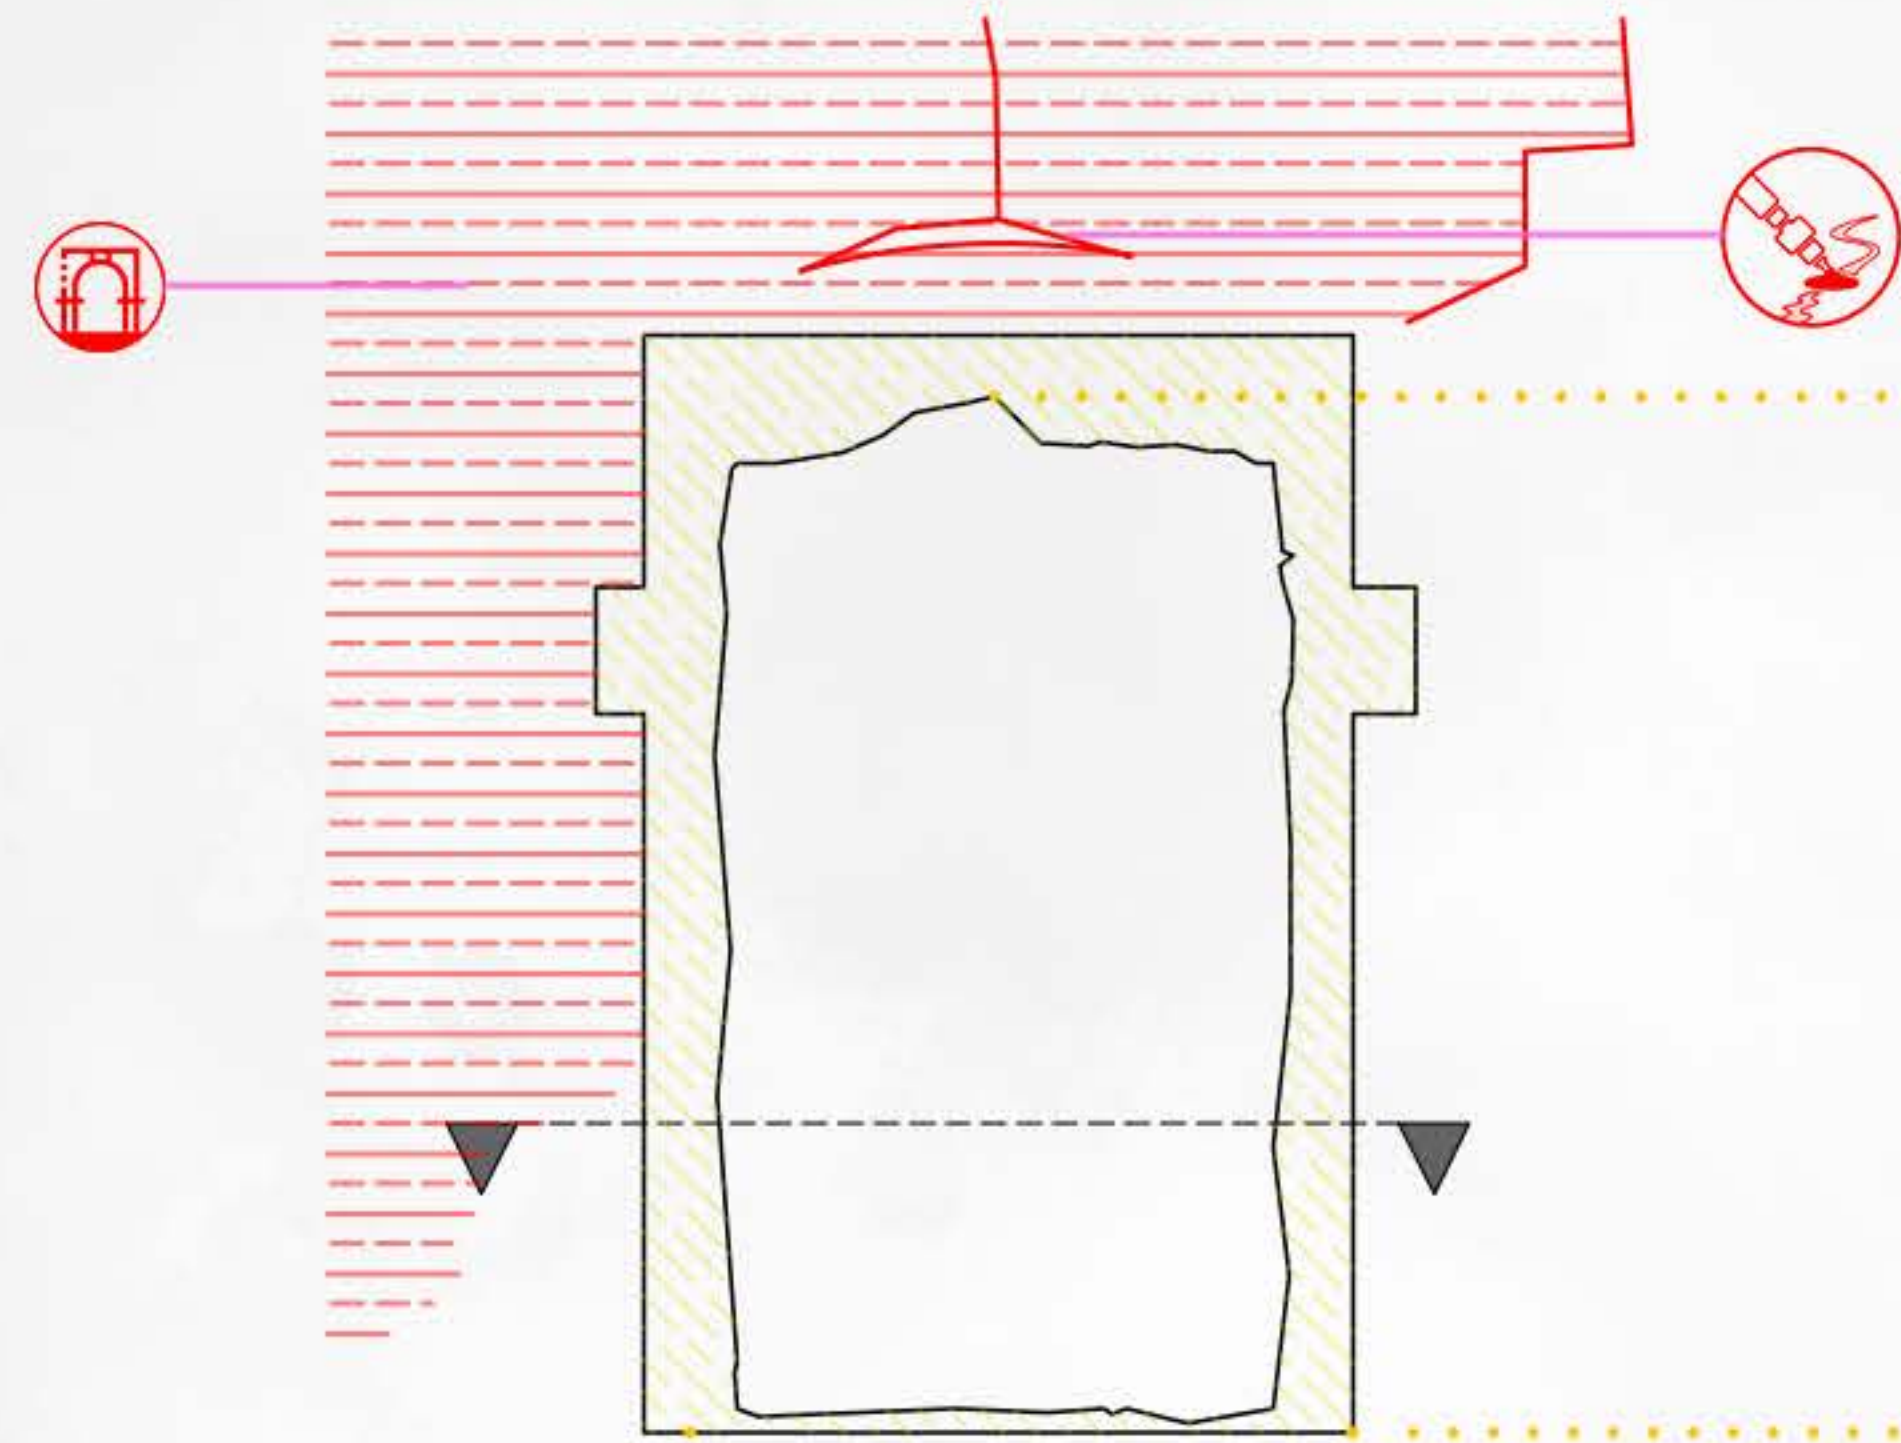
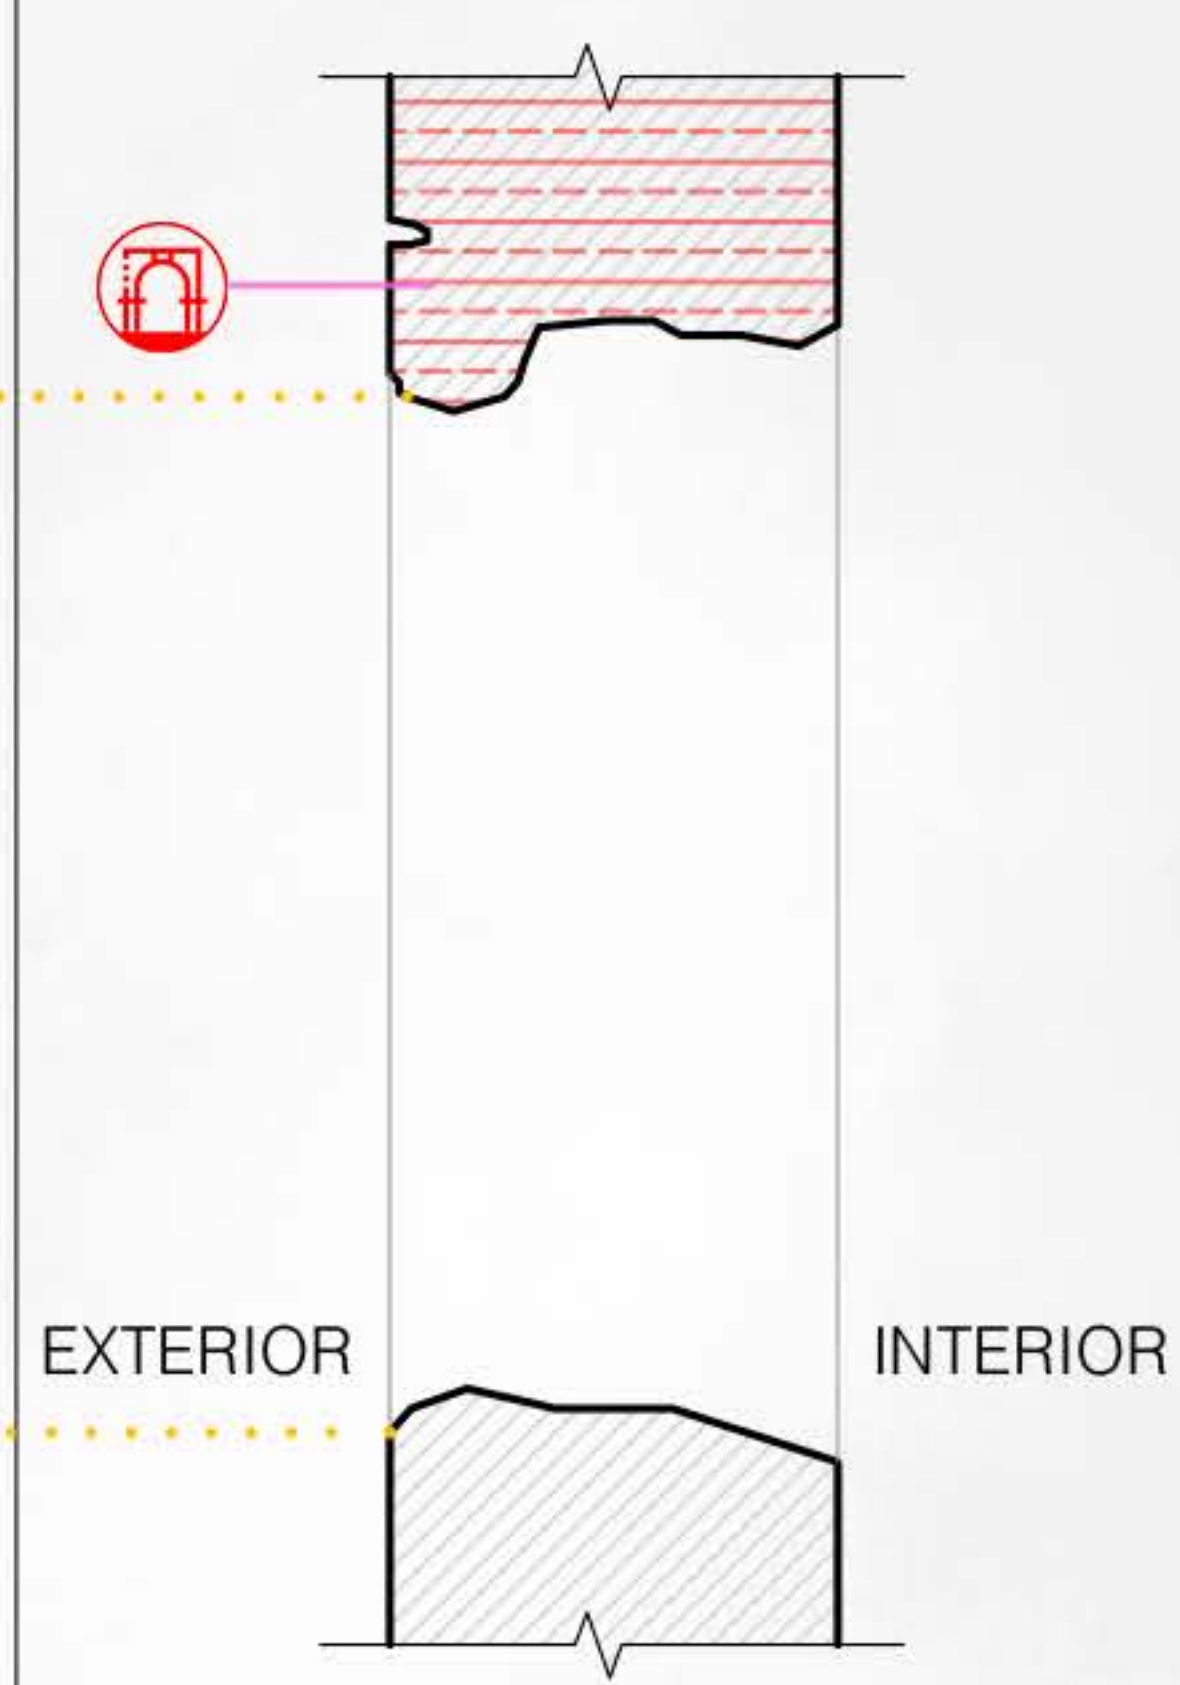
NO. - W3 LOCATION - ROOM 3

BEFORE

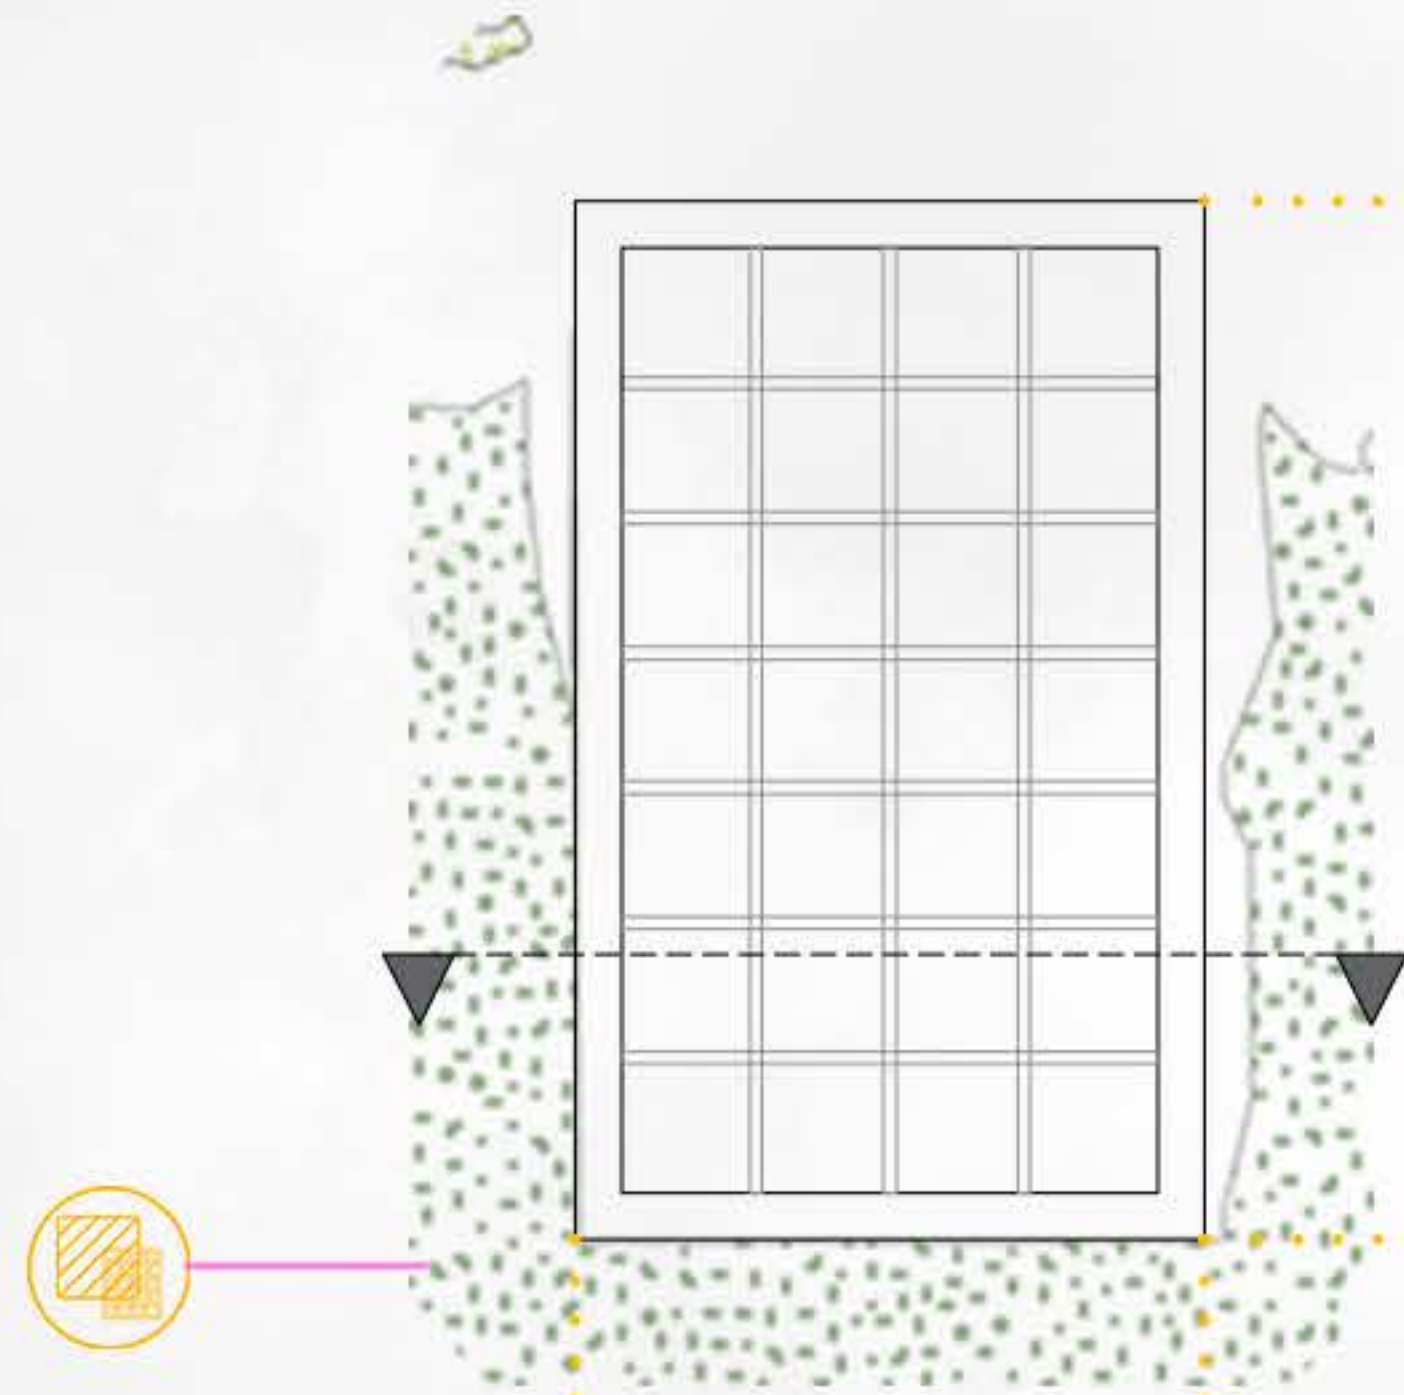
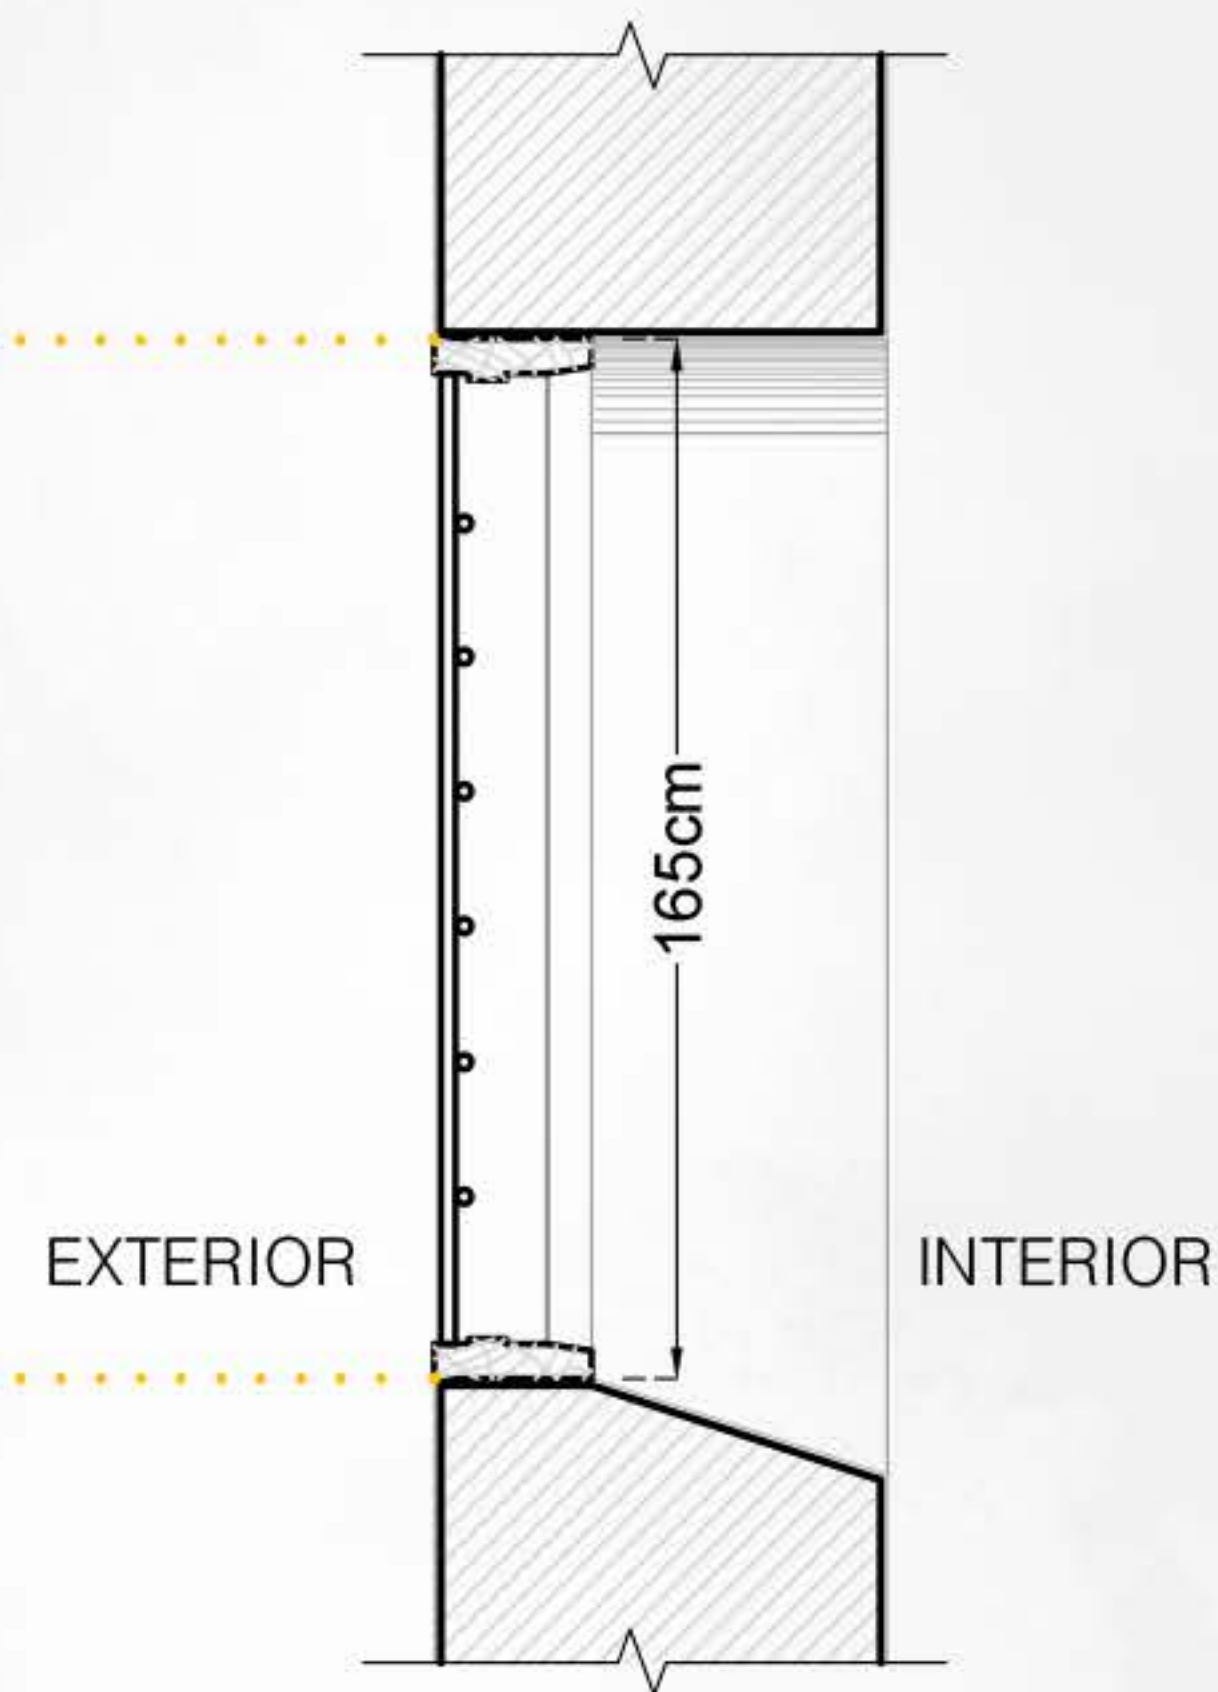
NO. - W3 LOCATION - ROOM 4

BEFORE

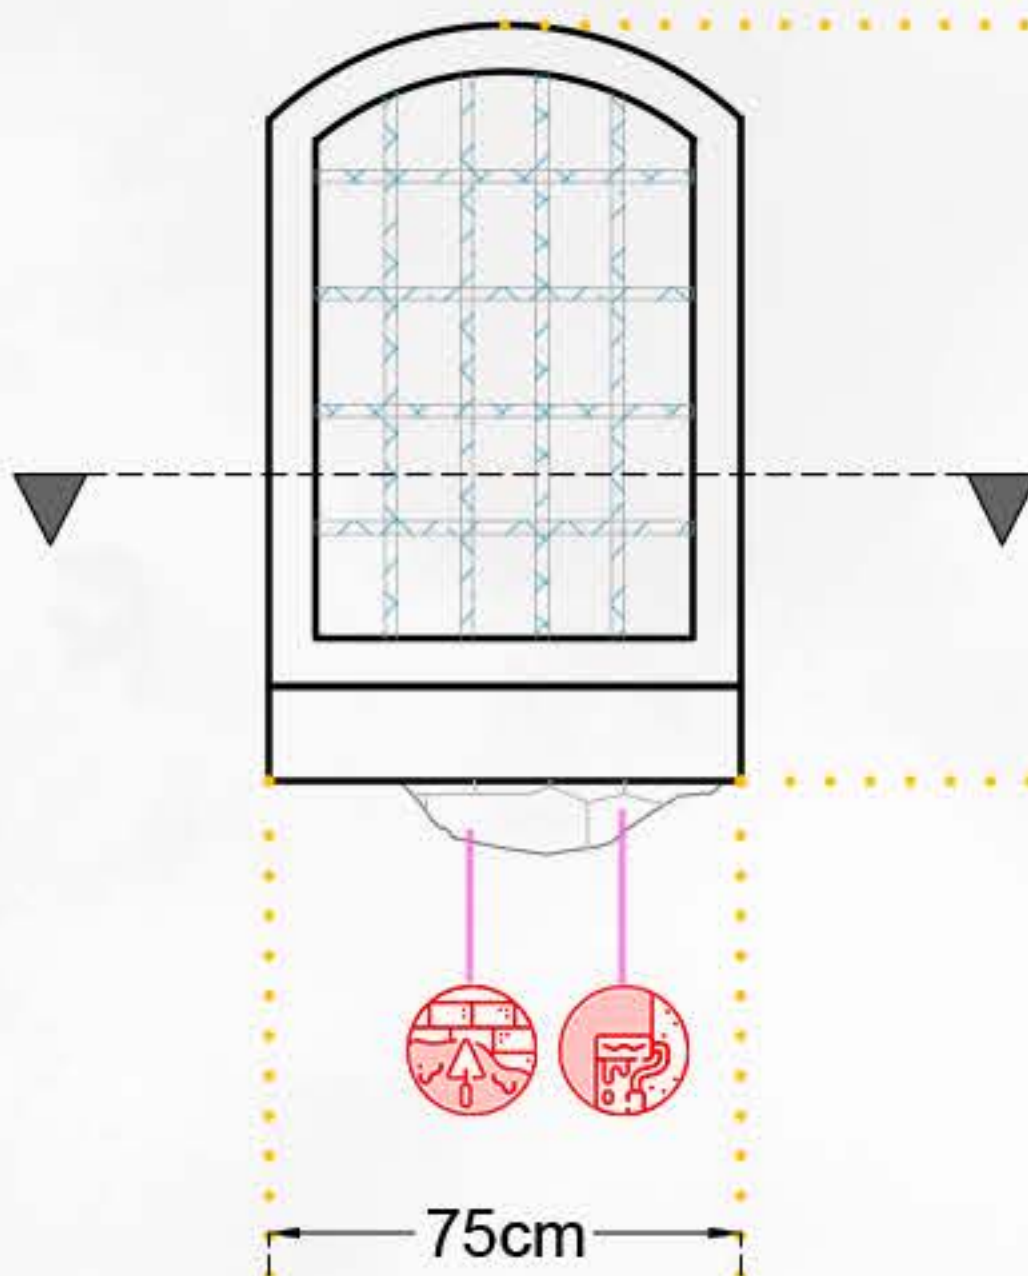
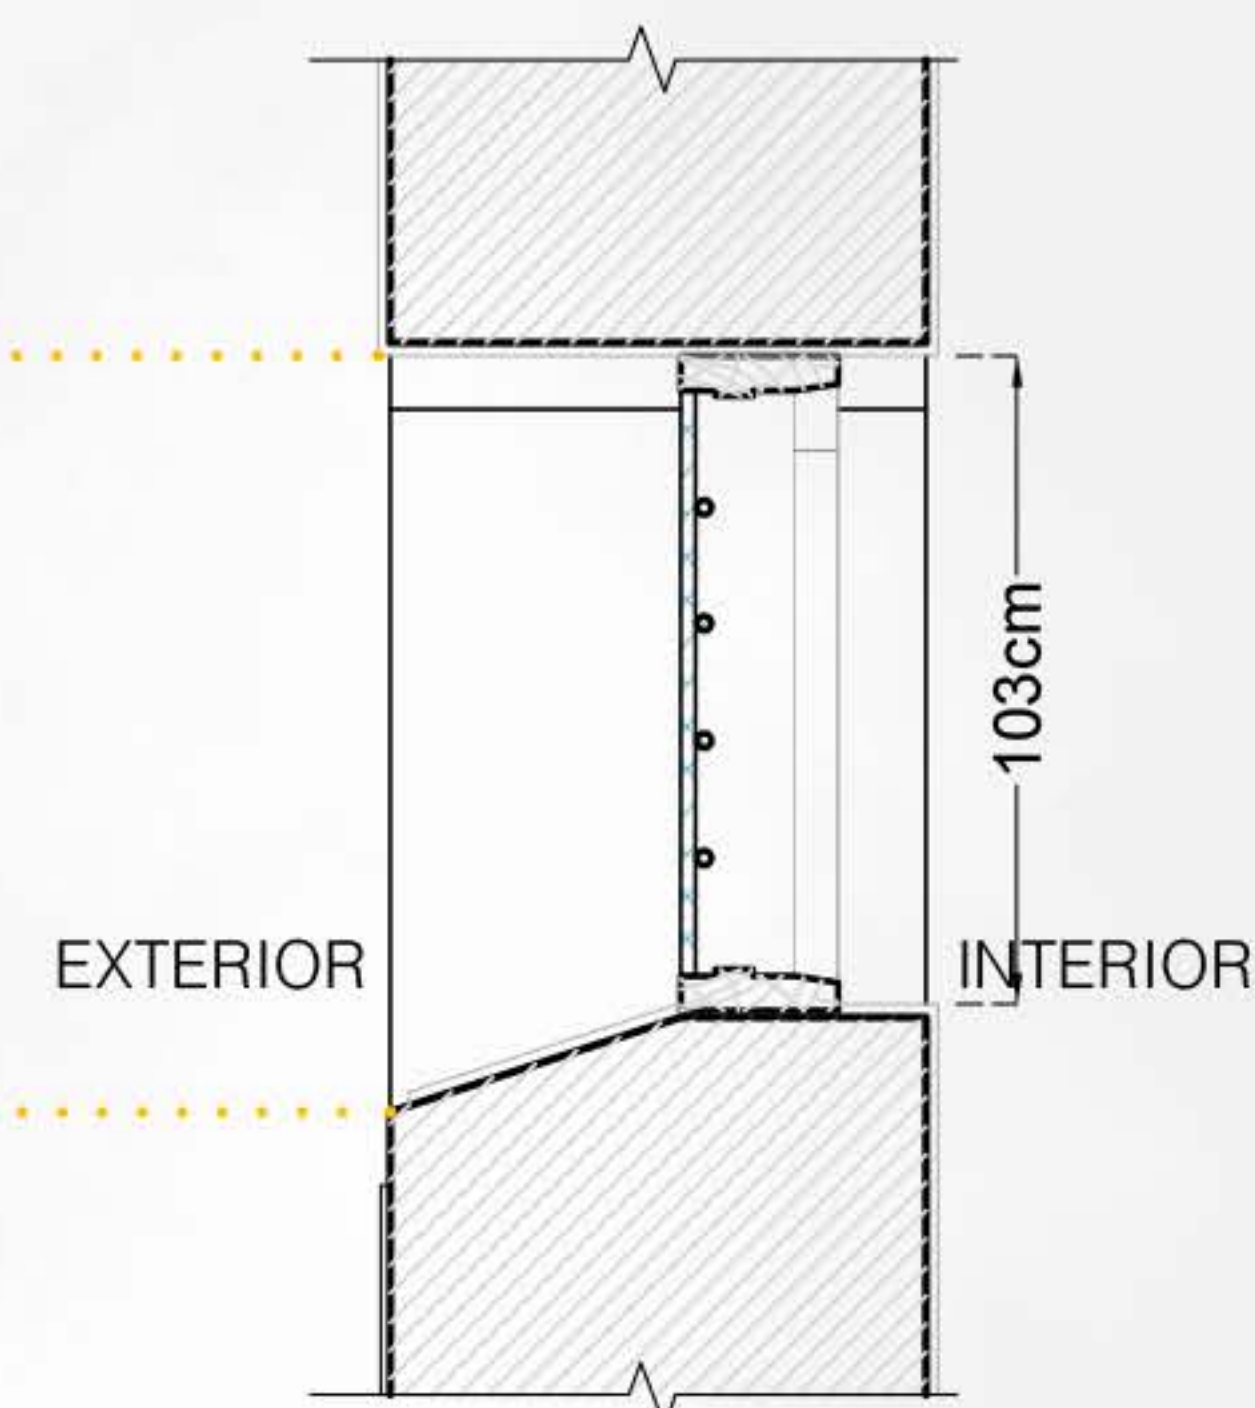
NO. - W4 LOCATION - CHAPEL

BEFORE

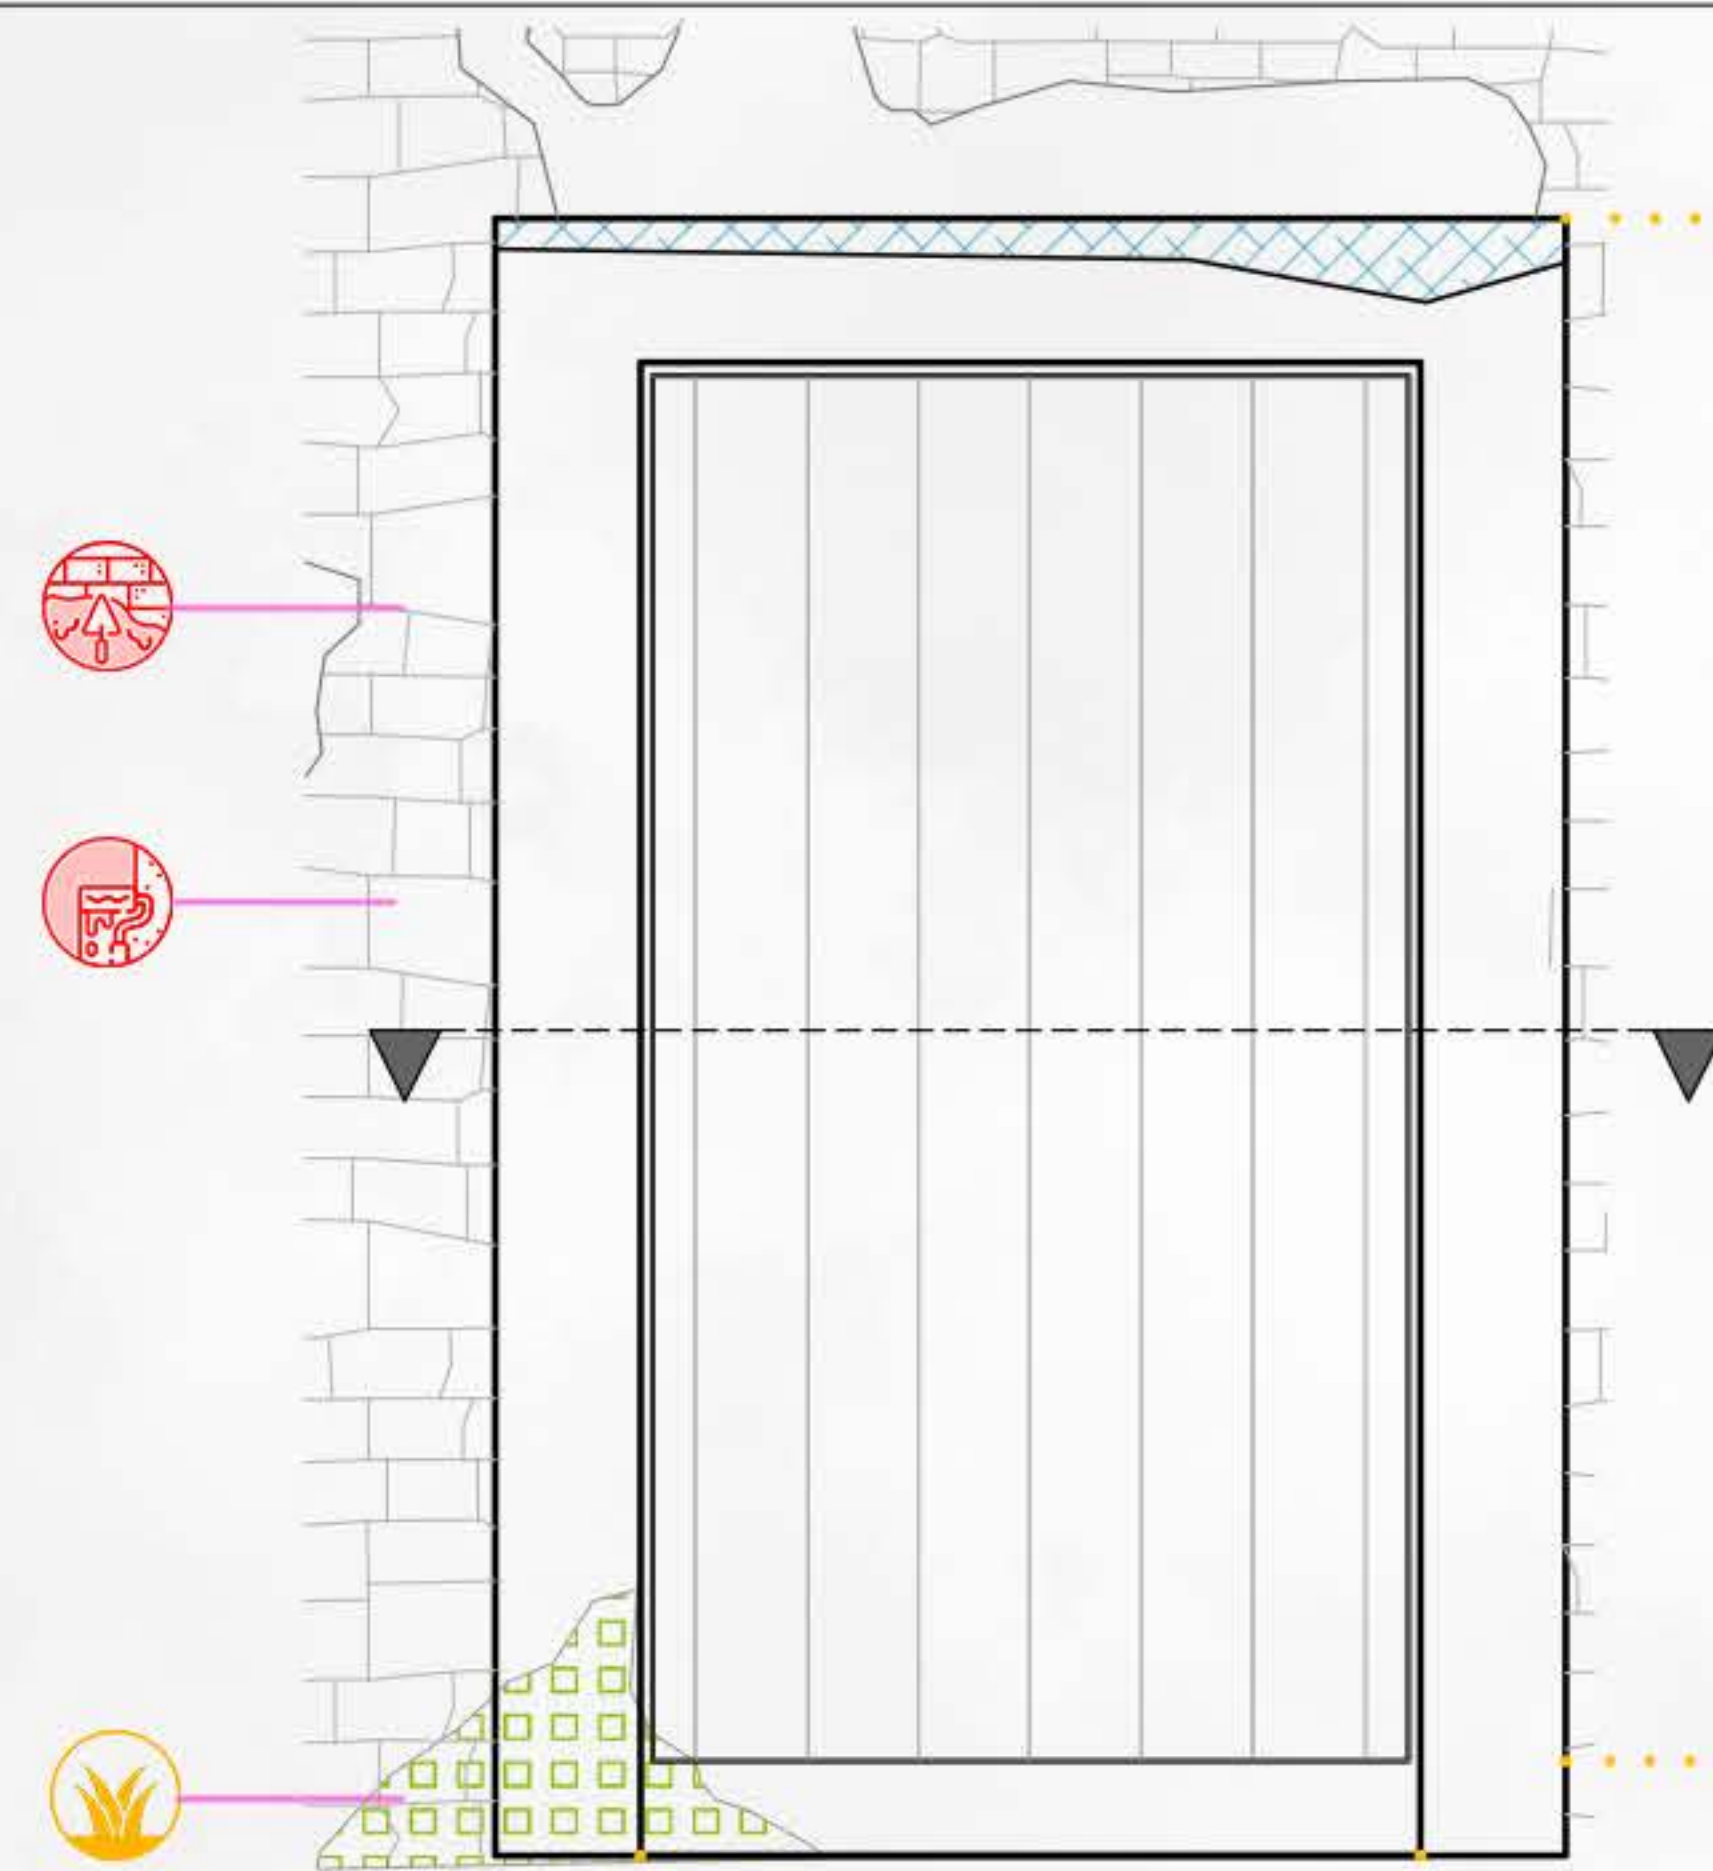
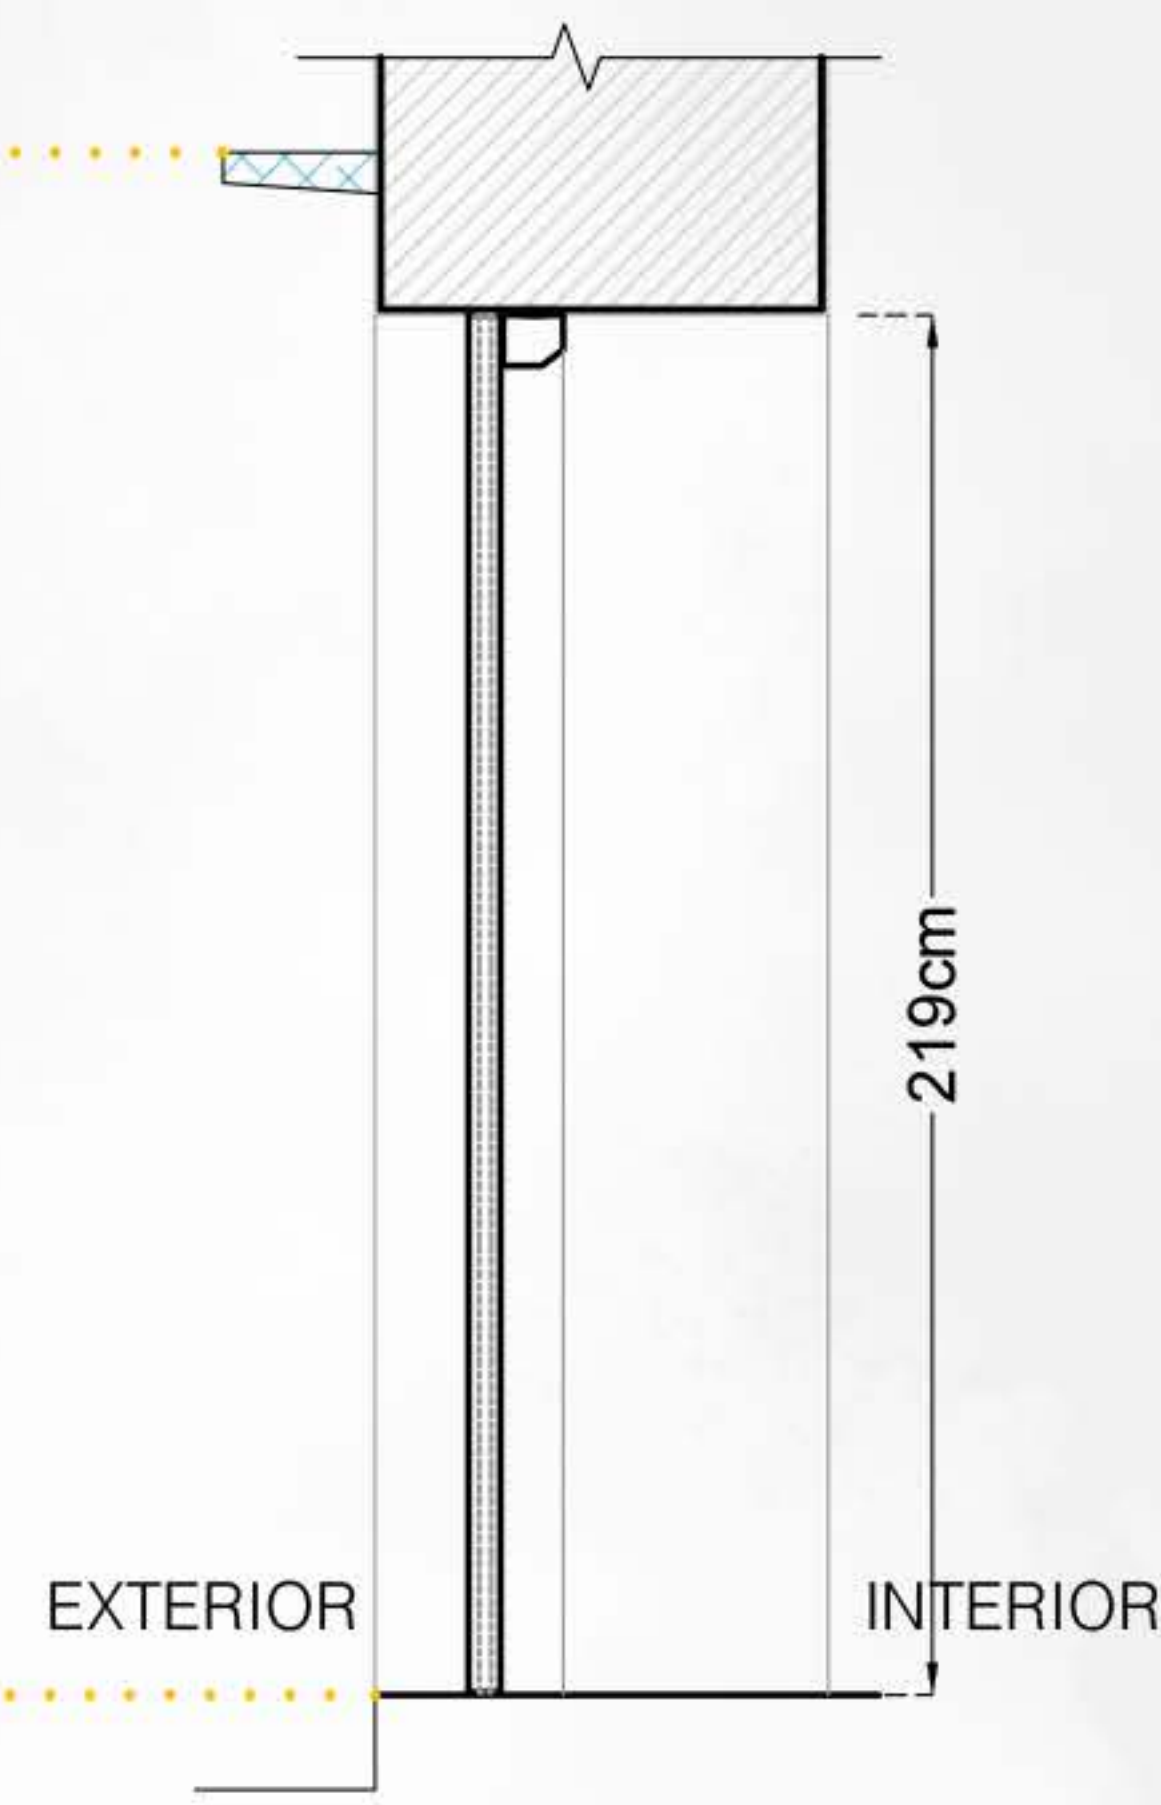
NO. - D3 LOCATION - ROOM 7

BEFORE
