W I N D O W S C H E D U L E

D O O R S C H E D U L E

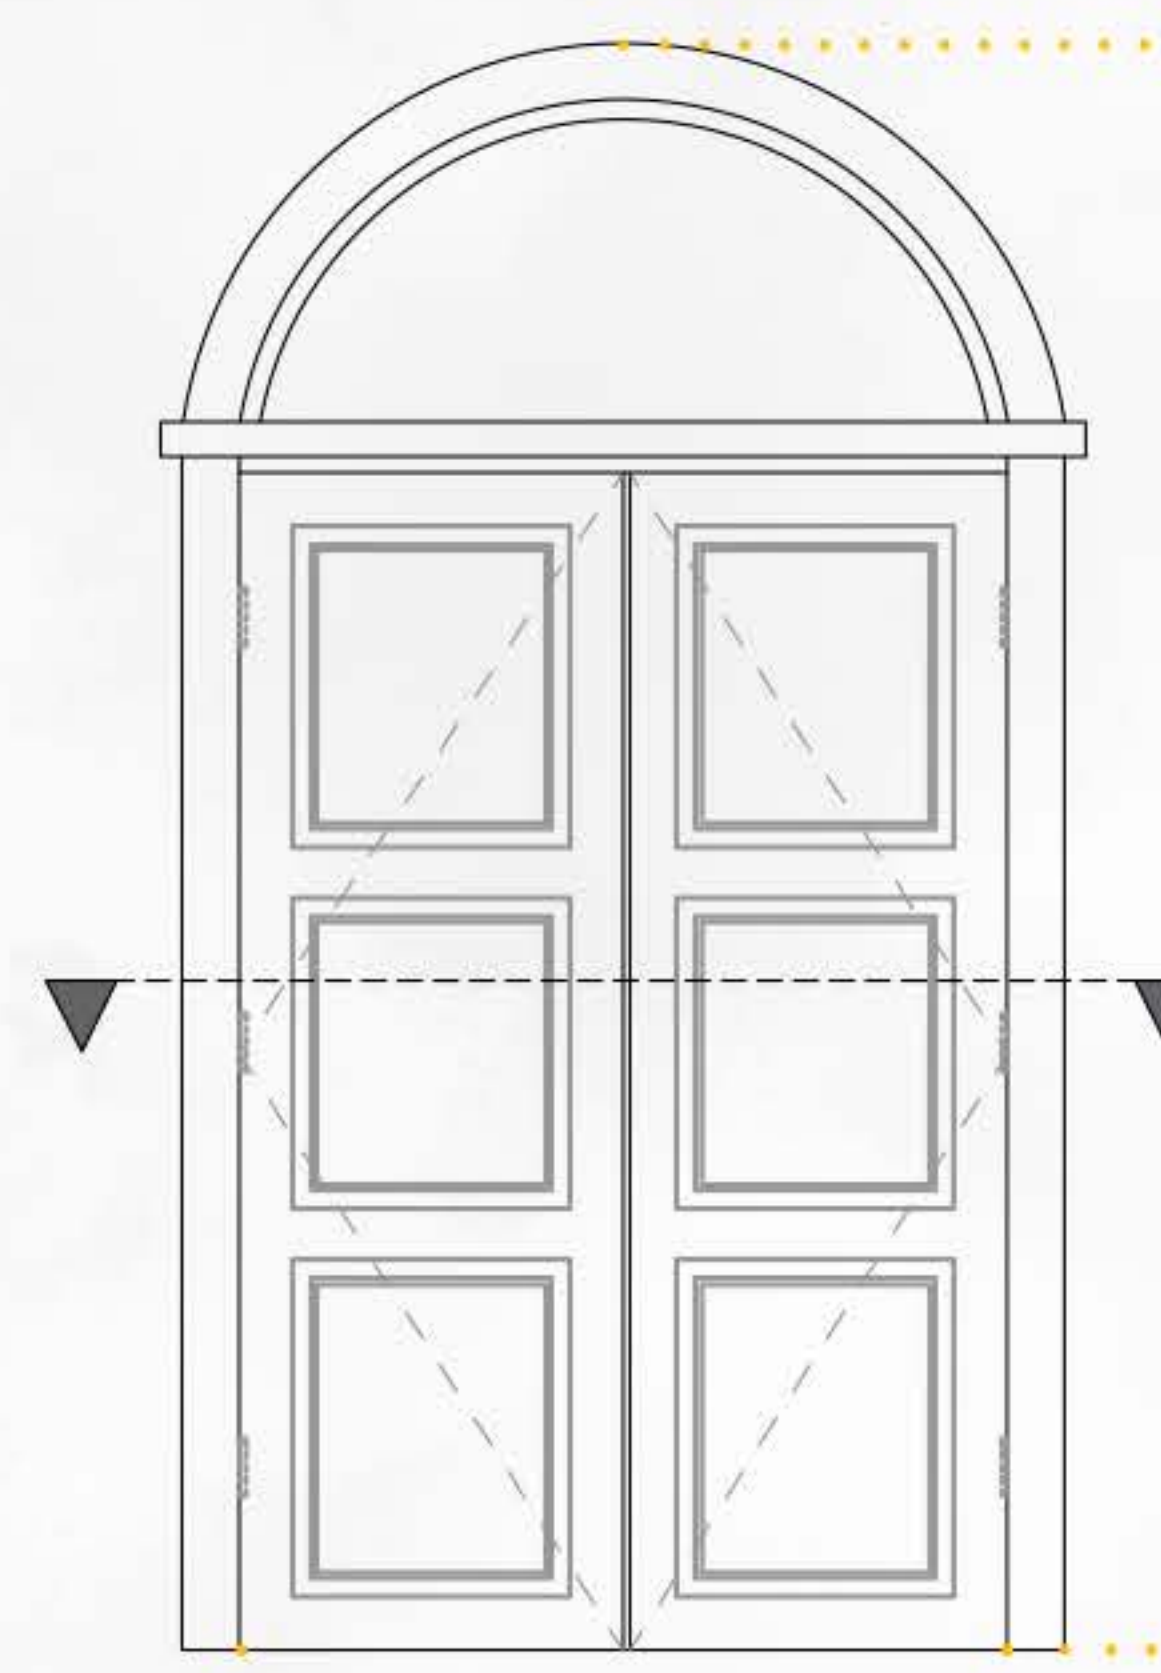
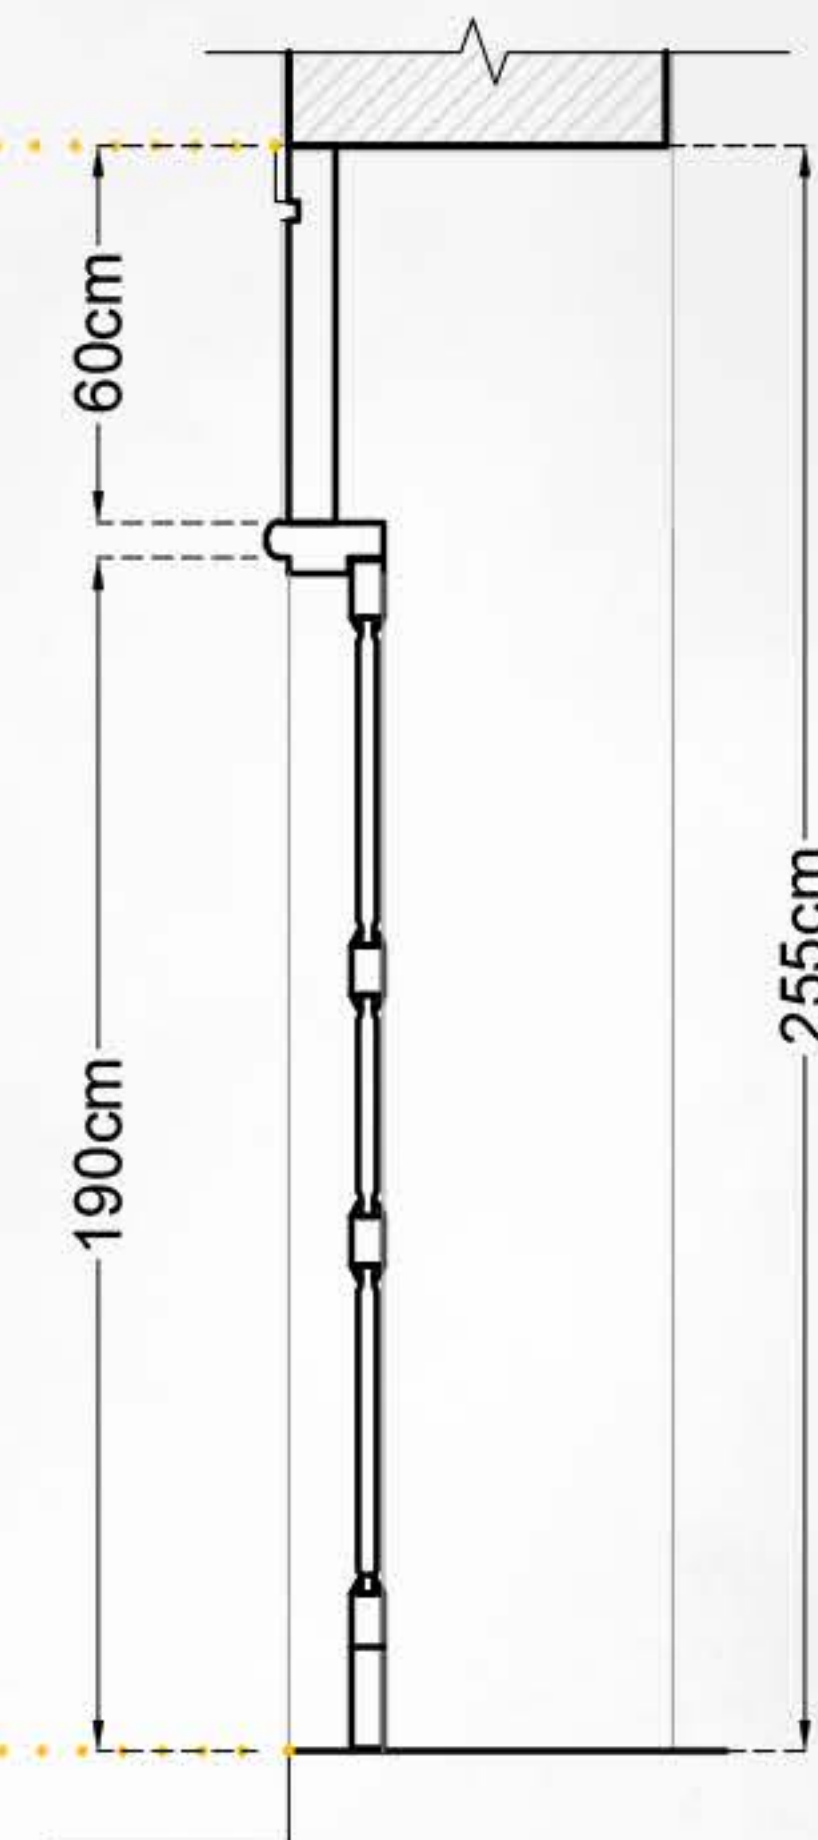
NO. - D5 LOCATION - ROOM 1

BEFORE

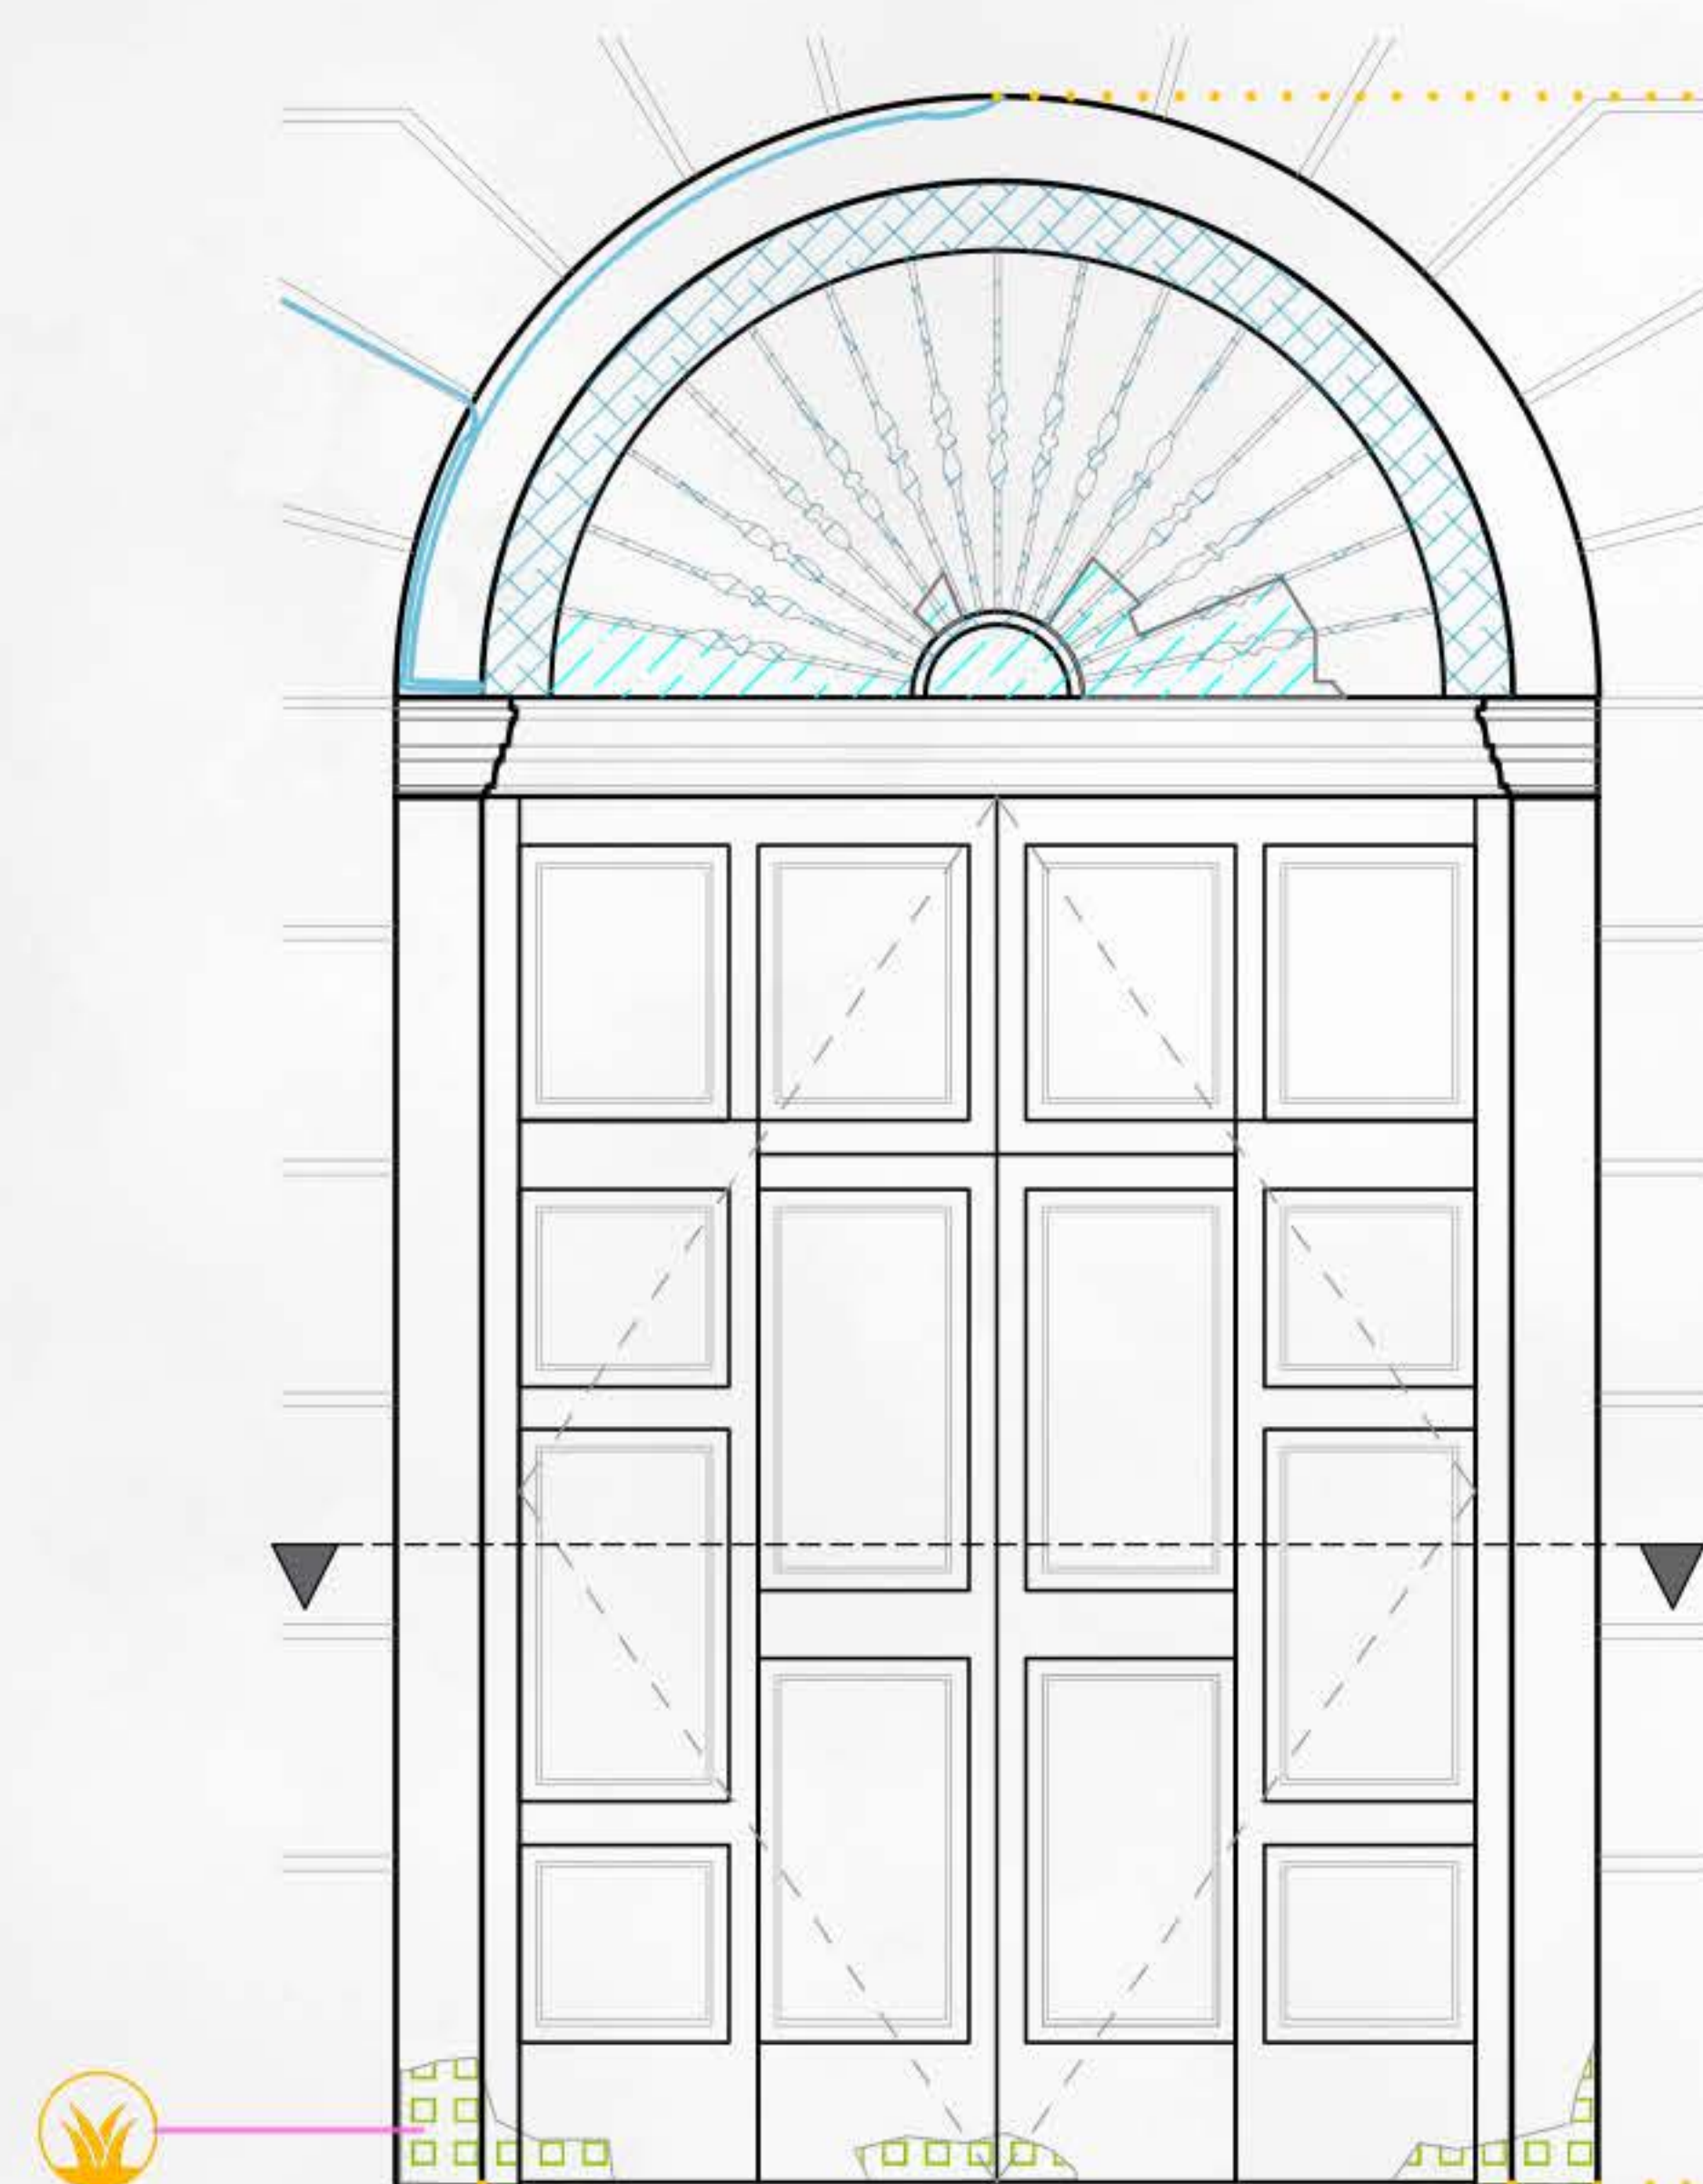
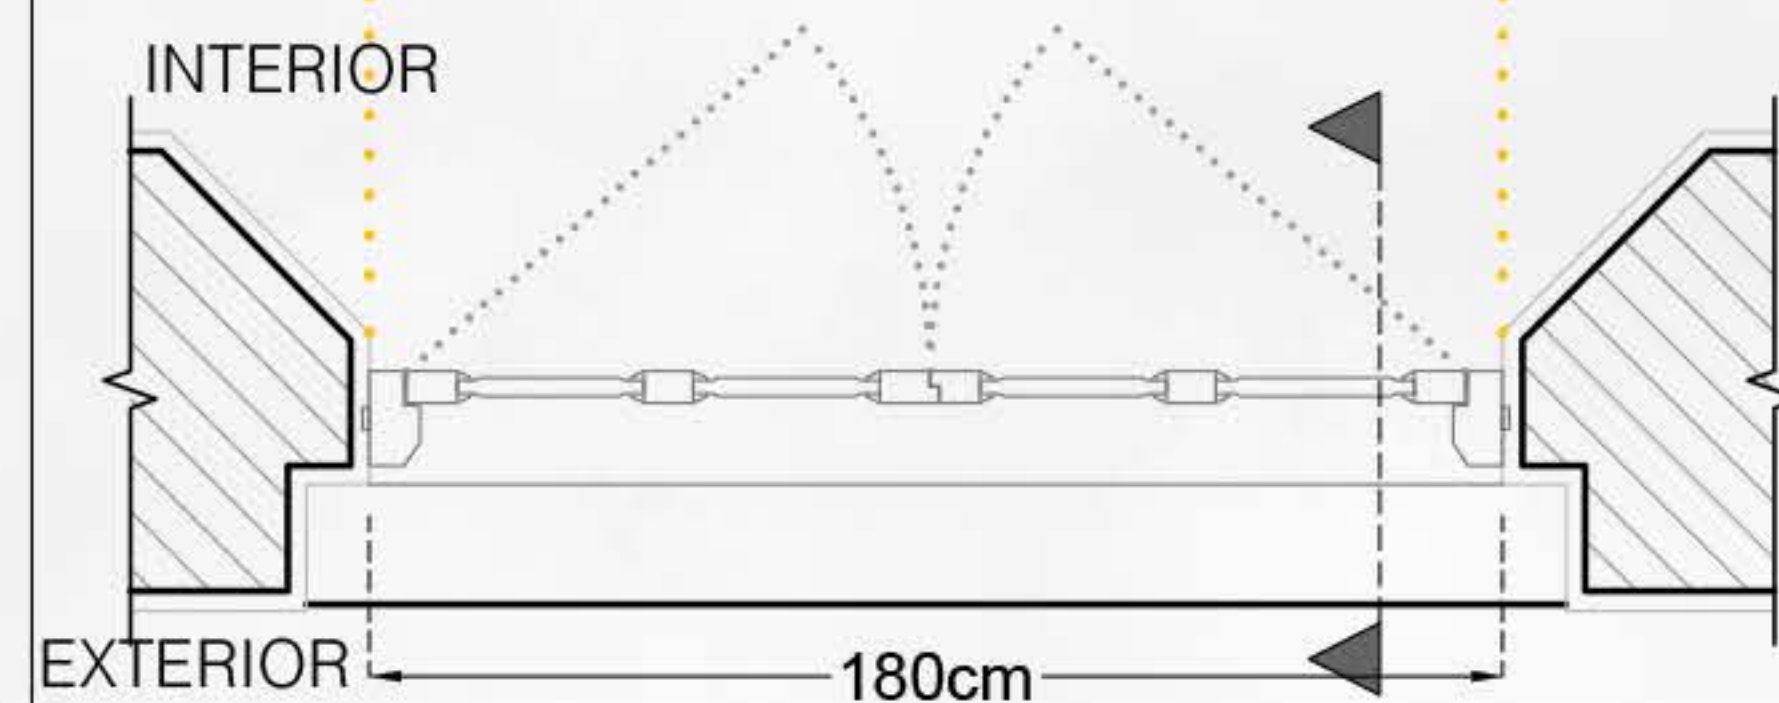
NO. - D1 LOCATION - ROOM 1

BEFORE

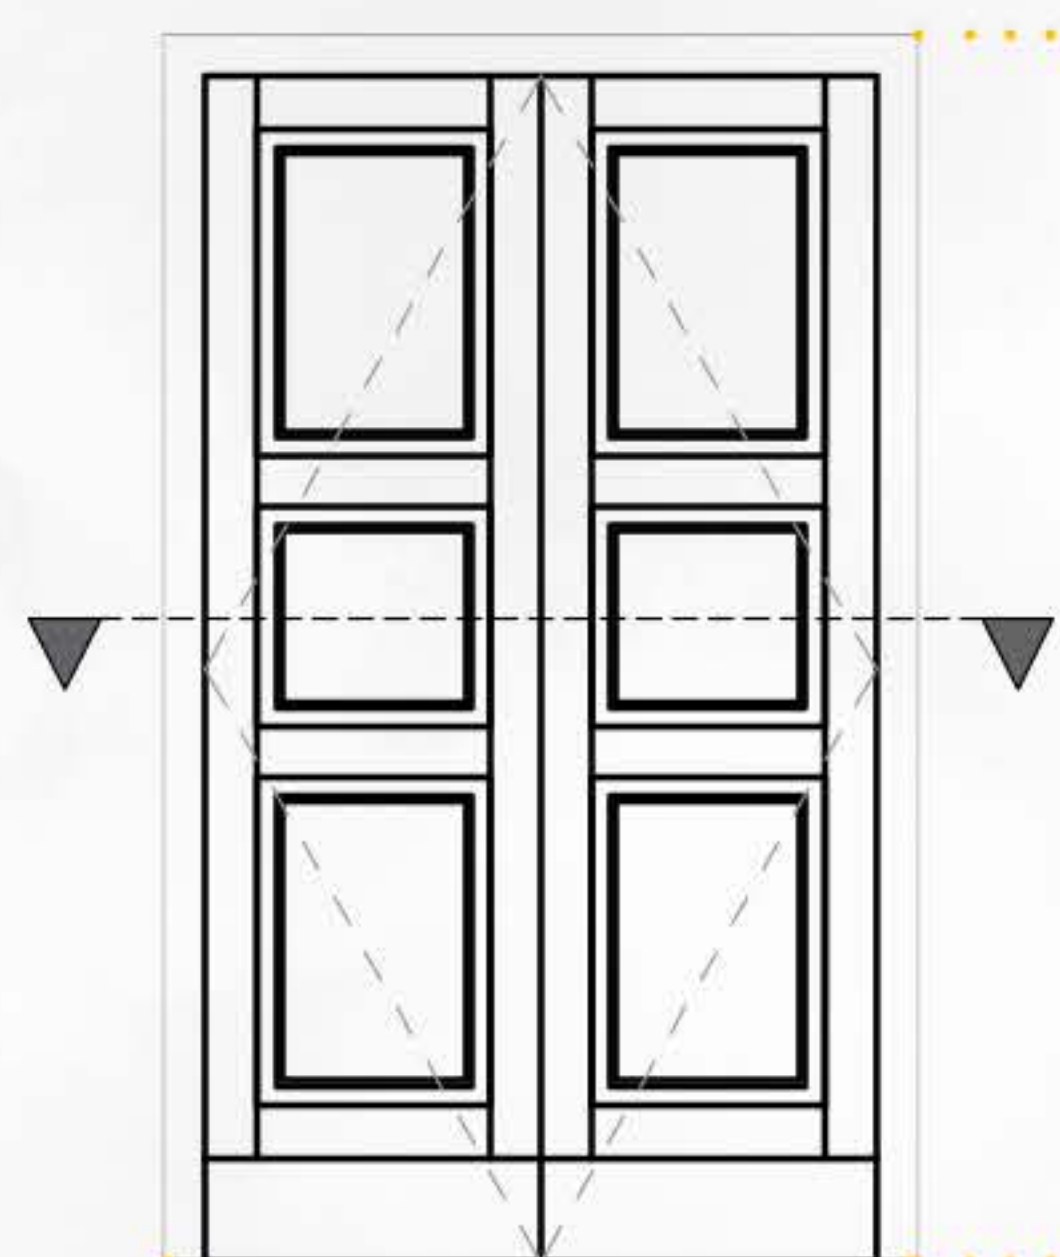
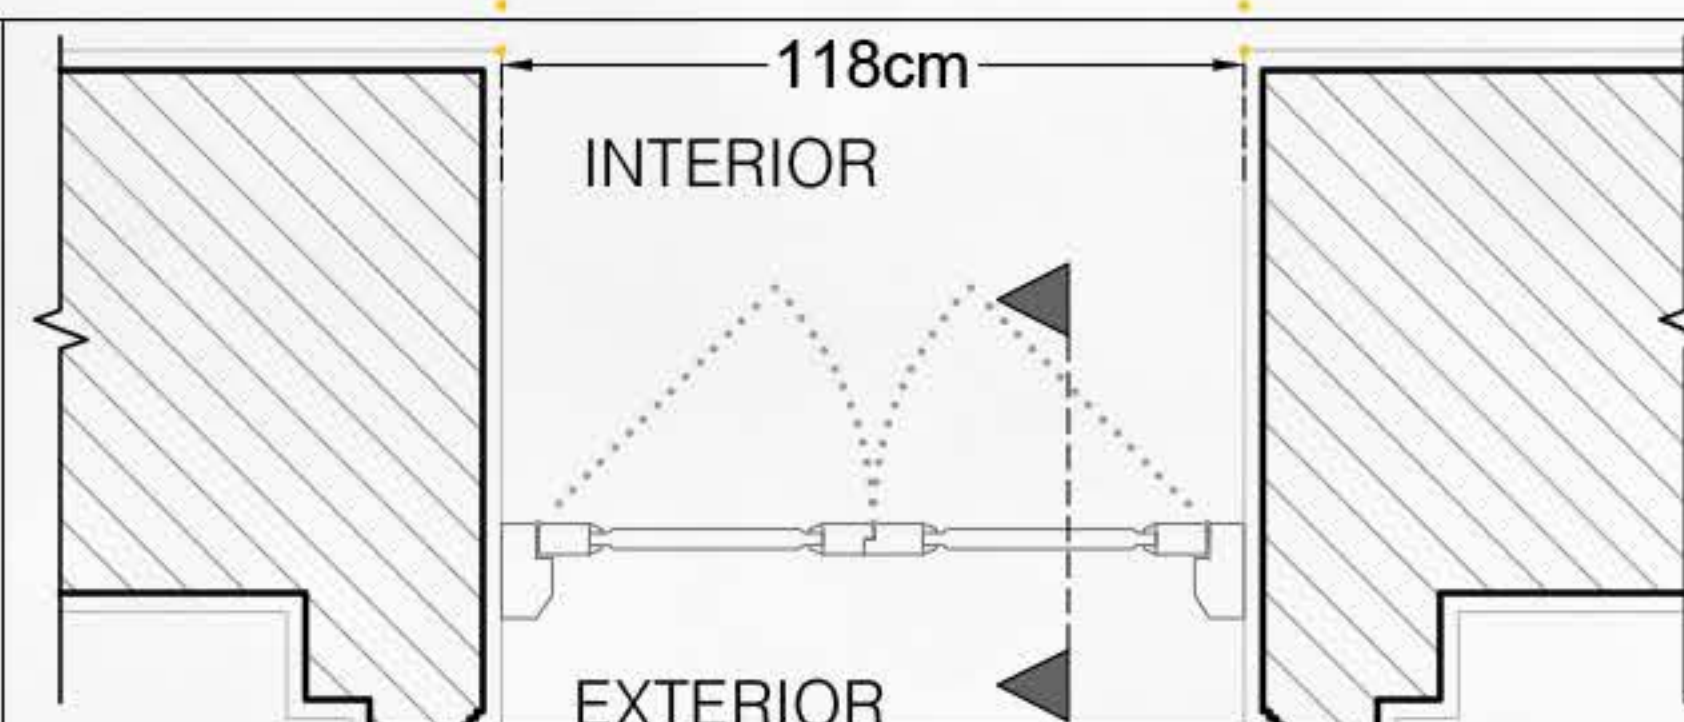
NO. - D2 LOCATION - CHAPEL

*Chapel door not verified

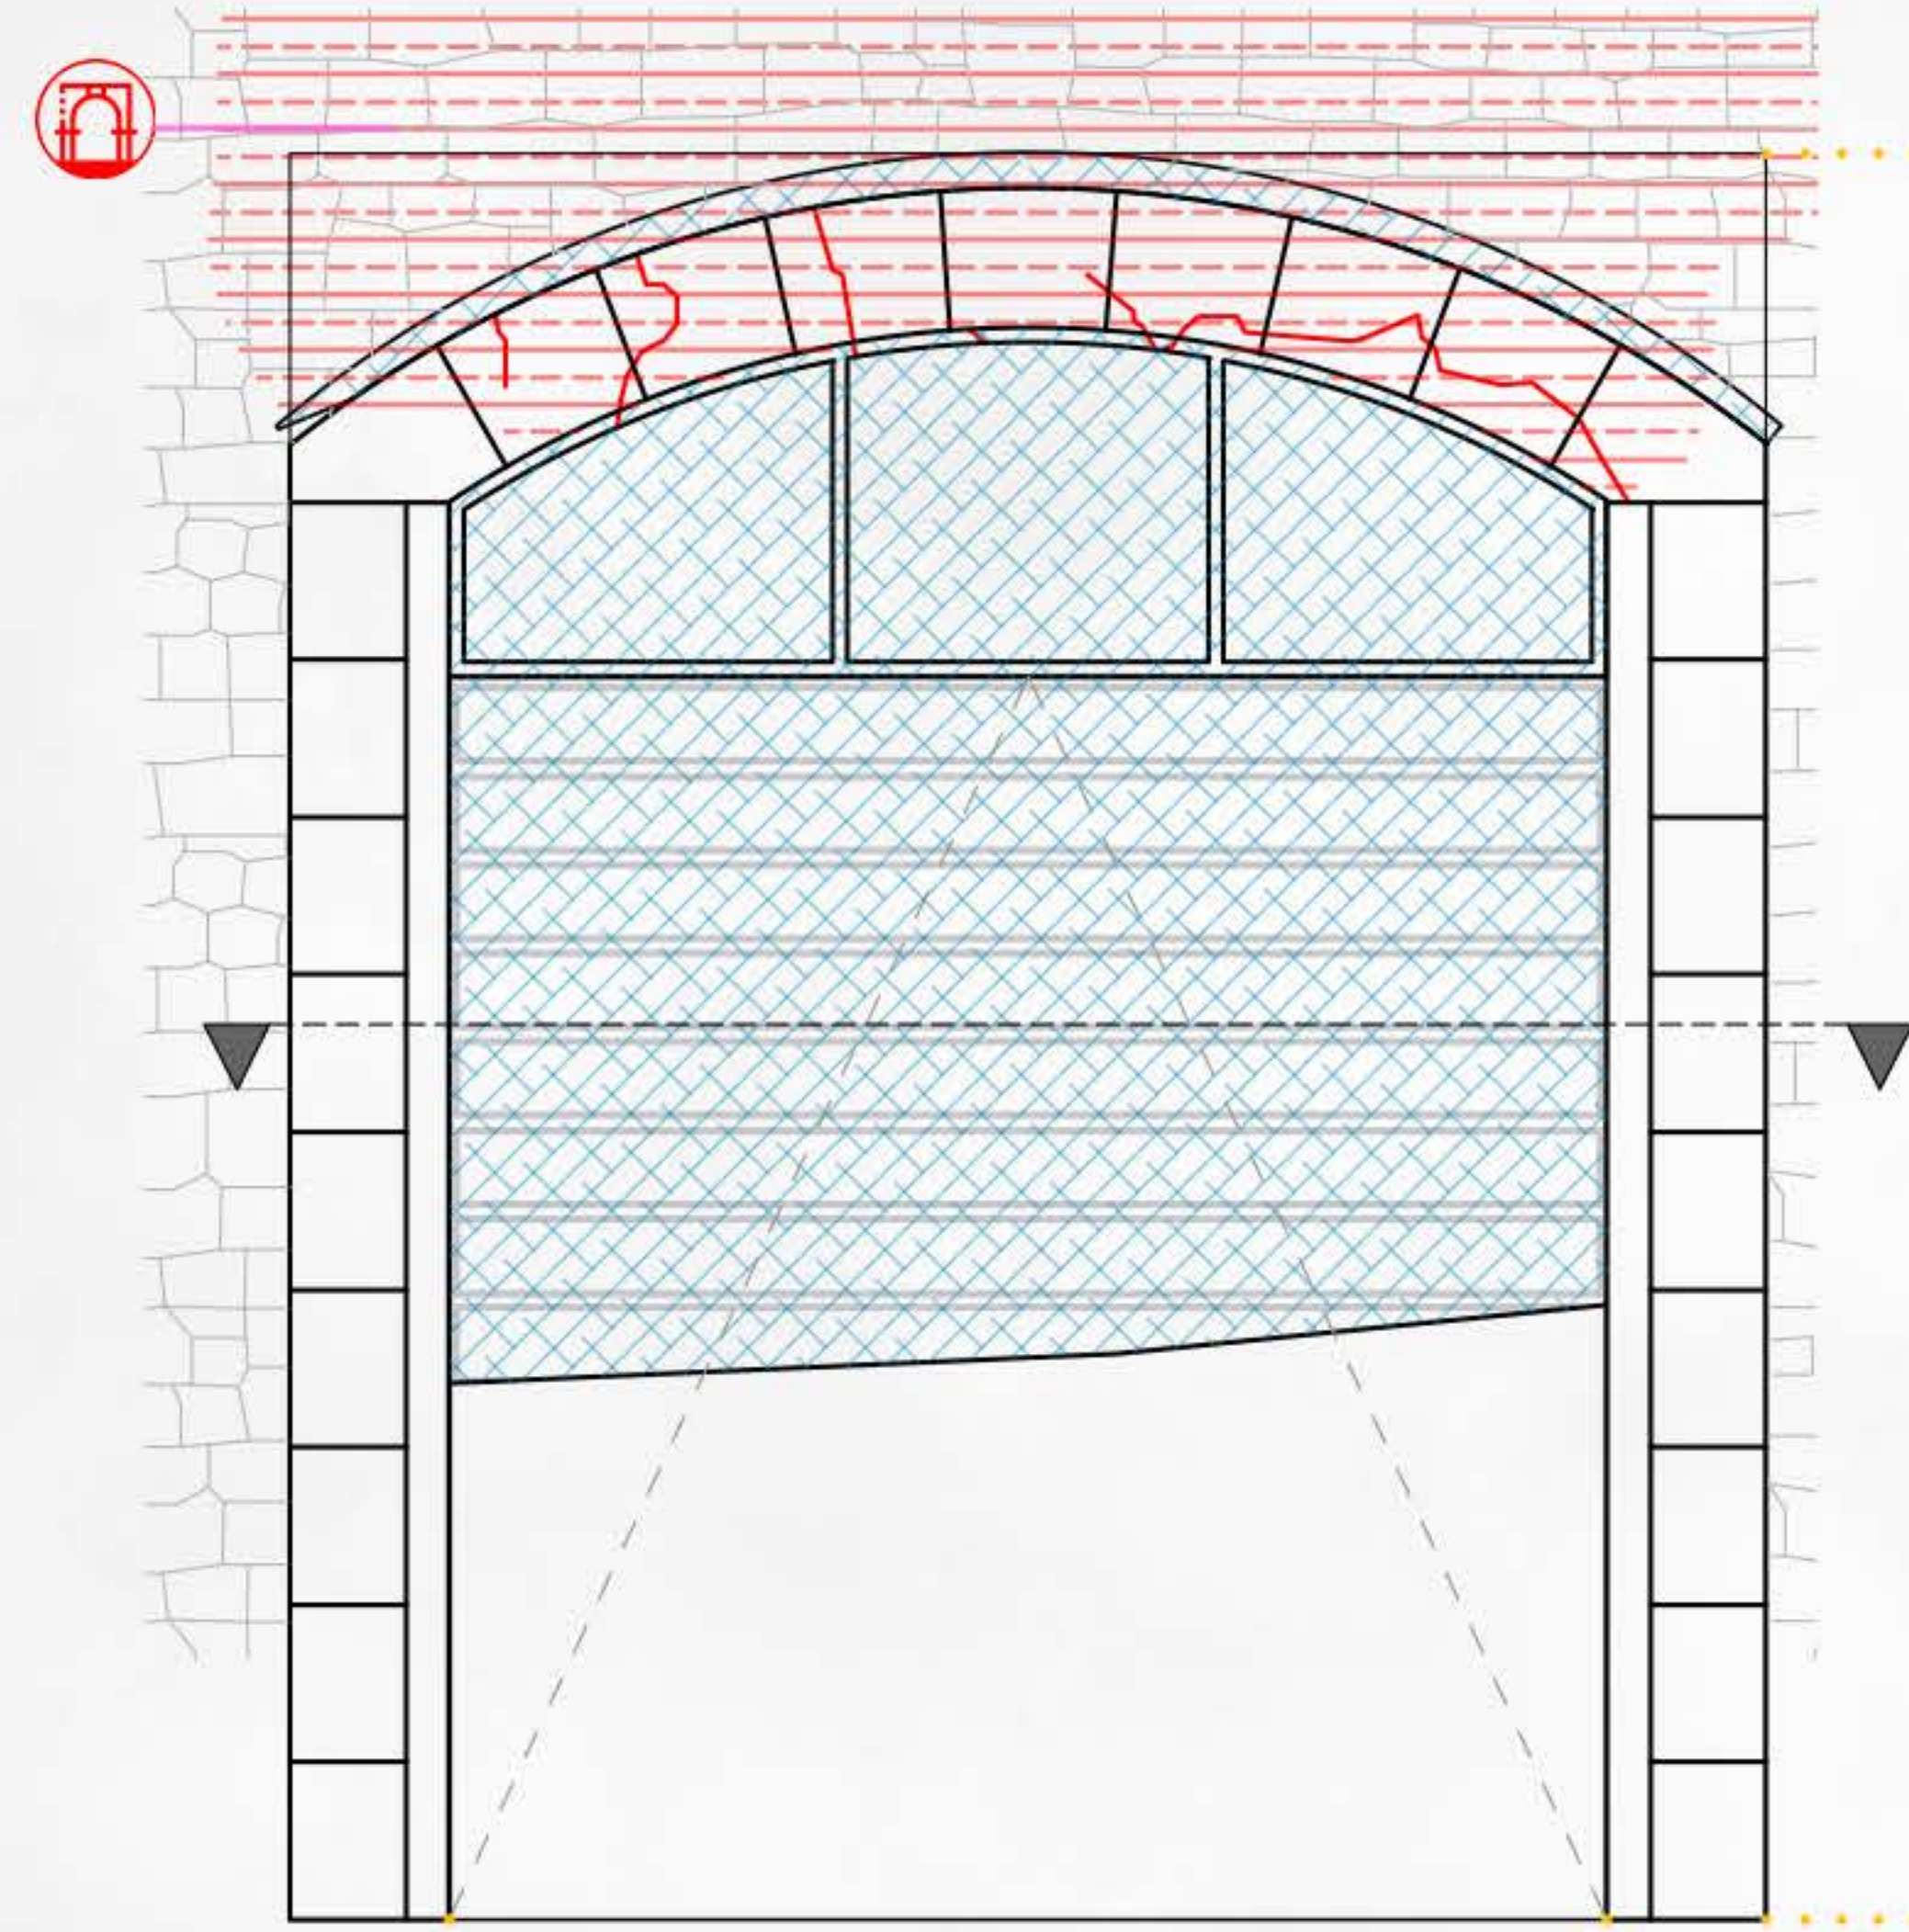
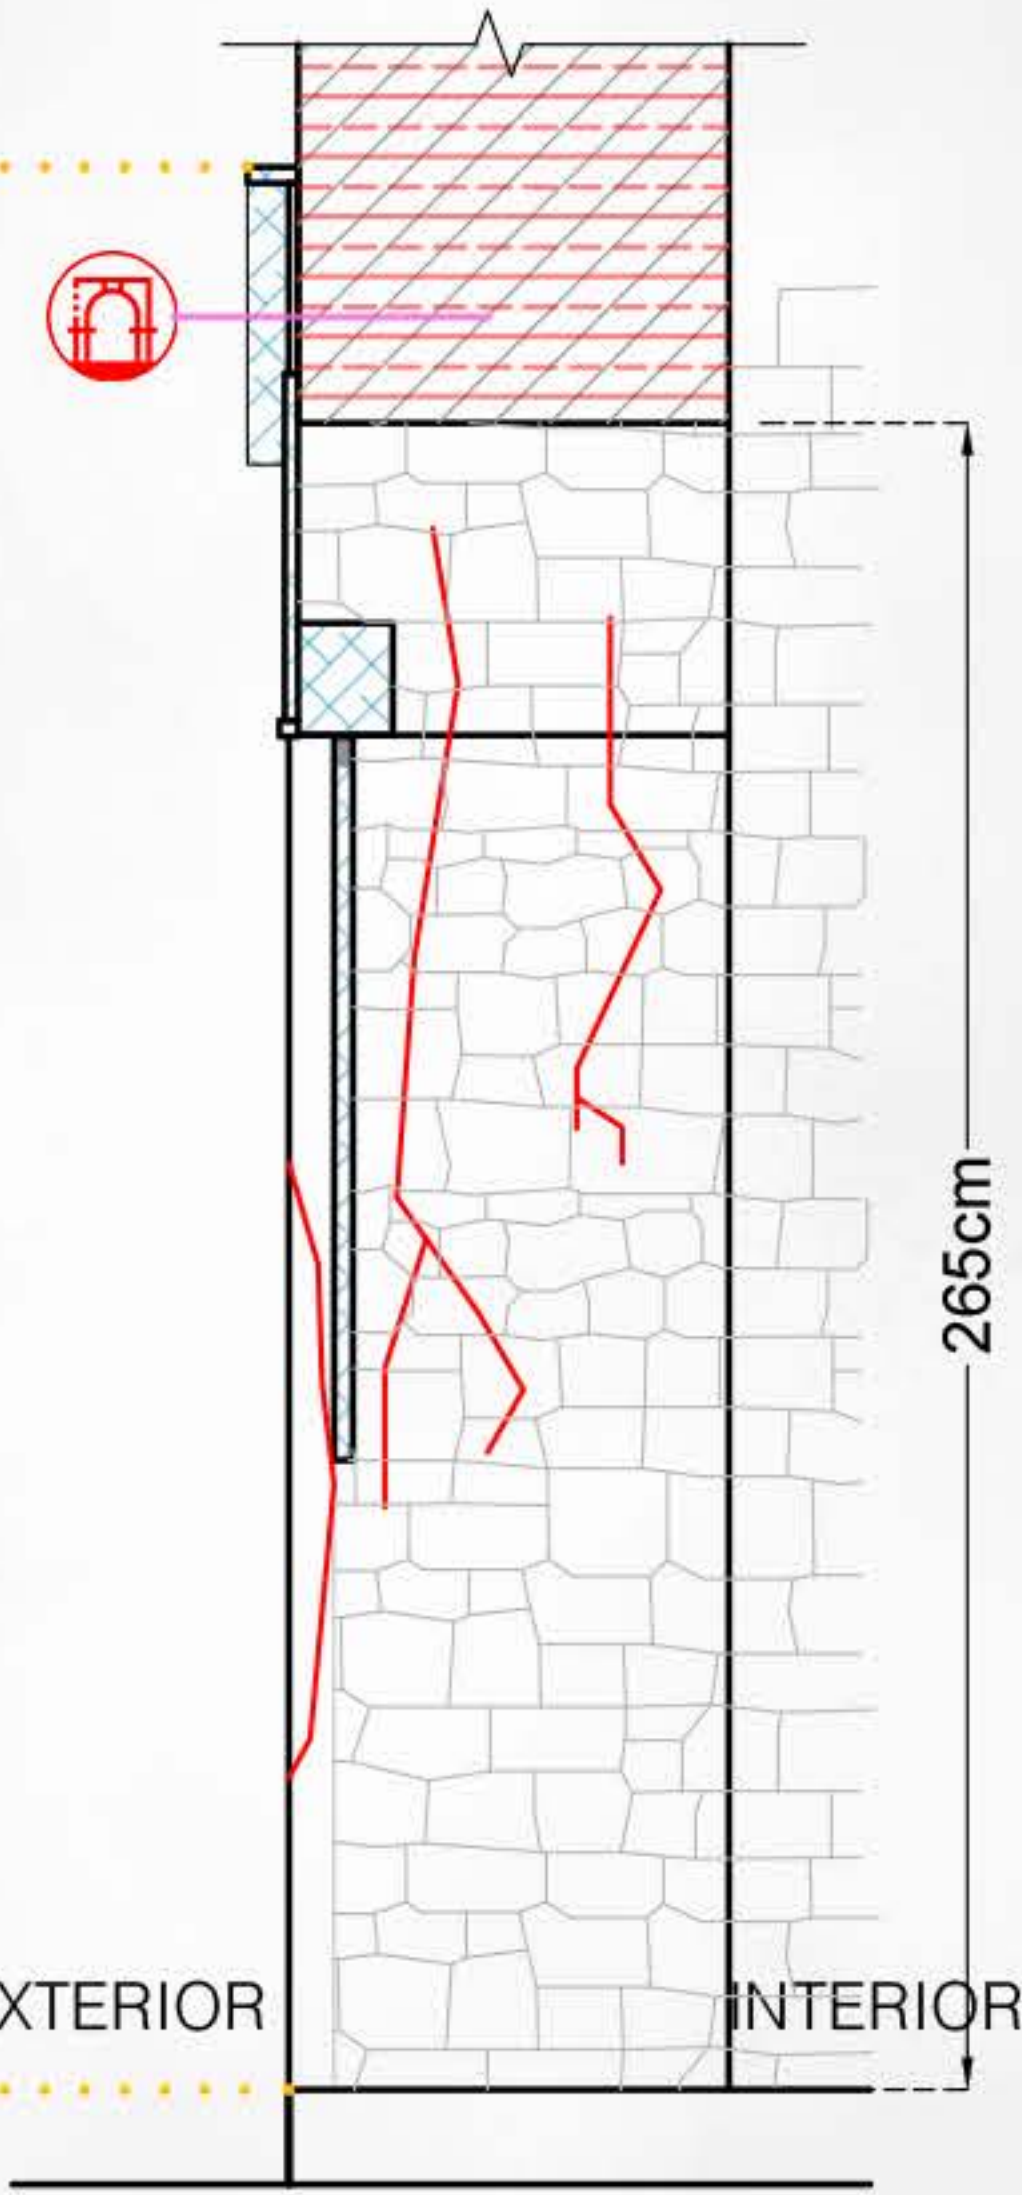
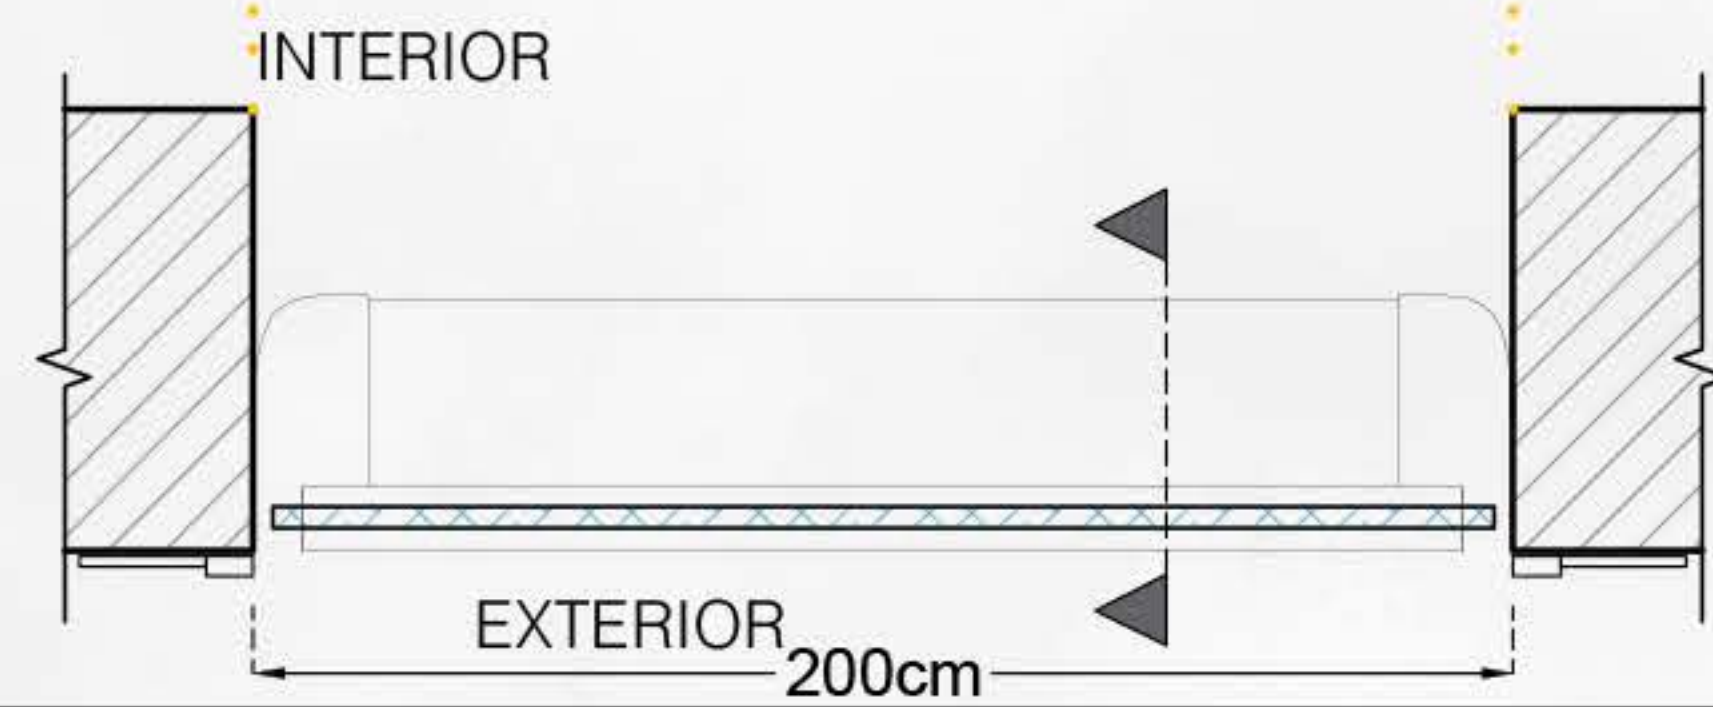
NO. - D4 LOCATION - ROOM 3

BEFORE
