# VERNACULAR RESIDENTIAL ARCHITECTURE FROM THE GOLDEN CYCLE IN THE BRAZILIAN MIDWEST

BEST PRACTICES FOR THE RESTORATION

POLITECNICO DI TORINO  
DEPARTMENT OF ARCHITECTURE AND DESIGN  
MASTER THESIS IN ARCHITECTURE FOR HERITAGE

Débora Carneiro Ávila  
*Student*

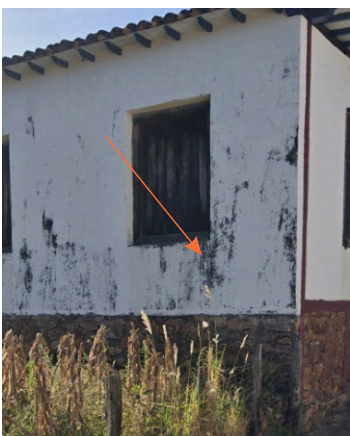
*Decay: Moisture darkening  
Possible Causes: Water infiltration from rain or leaks; Rising damp from the ground; Lack of protective overhangs or drainage; Use of non-breathable surface coatings; Hair cracks allowing moisture ingress  
Location: exterior wall painting*

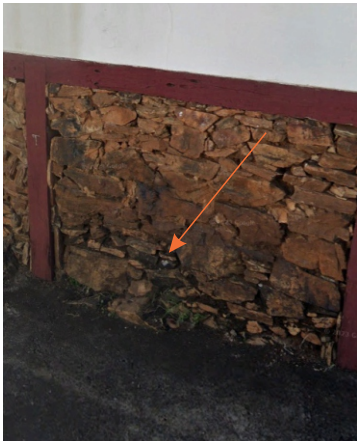
*Location: Stone Foundation (Cangicado)*

*Decay: Black crust*

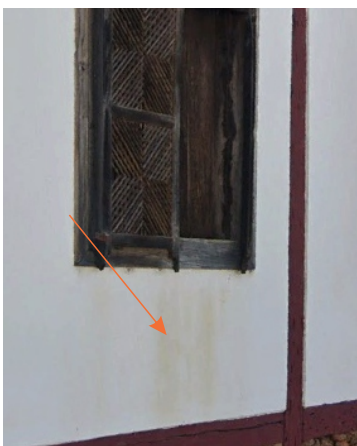
*Decay: Stains*

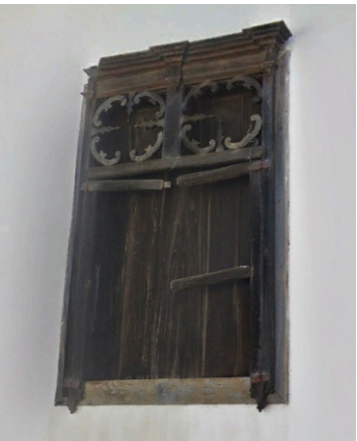
*Decay: Wood-decaying fungi*

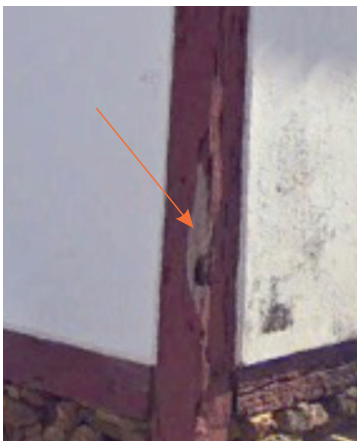
*Decay: Wood-boring insects*

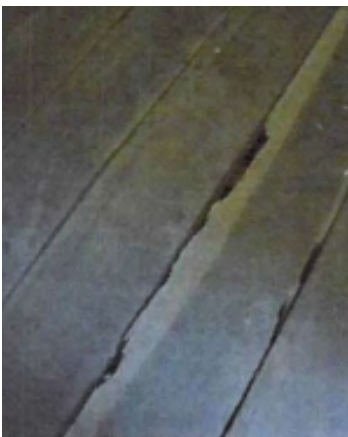
*Decay: Impact damage*

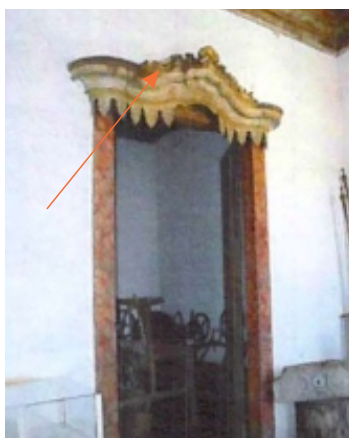
*Decay: Soiling*  
*Possible Causes: Airflow patterns carrying dust and pollutants toward*  
*the top of the door; Poor indoor air quality or ventilation; Smoke from*  
*candles, cooking, or heaters; Condensation attracting dust in humid*  
*areas; Previous water infiltration leaving dirty marks;*  
*Improper or infrequent cleaning in hard-to-reach areas*  
*Location: Safena*

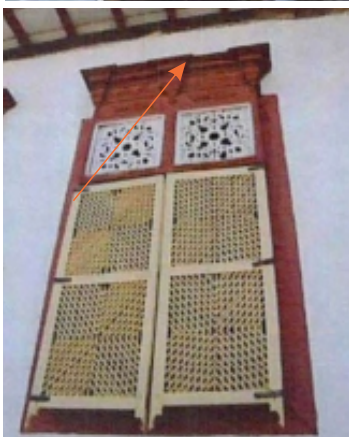
*Decay: Soiling*  
*Possible Causes: Dirt from the ground or wall surfaces; Air pollution*  
*and vehicle emissions; Condensation attracting airborne particles;*  
*Bird droppings or insect activity; Accumulation in textured or rough*  
*window frames*  
*Location: Gelosia window*

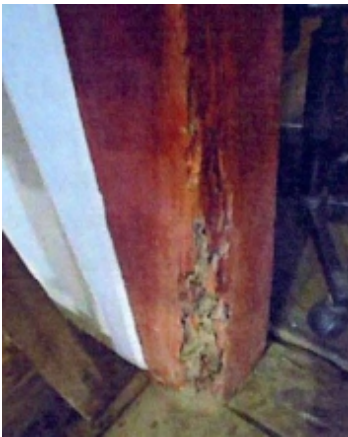
*Decay: Wood-boring insects*  
*Possible Causes: Use of untreated or unprotected wood;*  
*Lack of preventive chemical treatment; Wood in direct contact*  
*with soil or damp masonry; High wood moisture content;*  
*Cracks or openings allowing insect entry;*  
*Warm and humid environments favorable to insect activity*  
*Location: Door jamb*

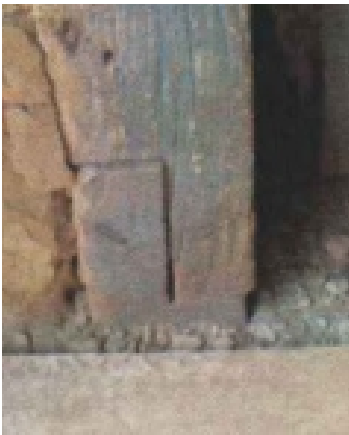
*Decay: Incision*

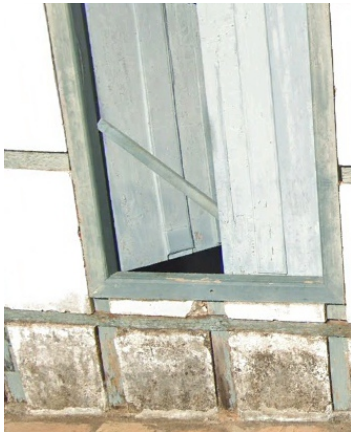
*Decay: Rising damp*

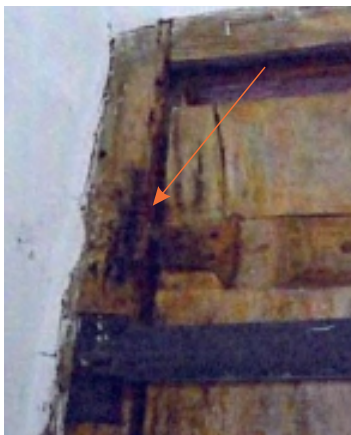
*Decay: Stains*

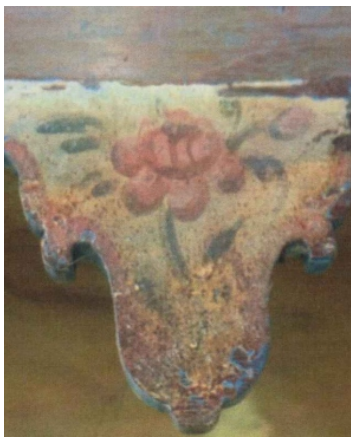
*Decay: Bleaching*

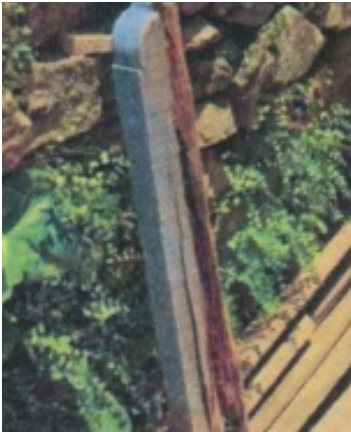
*Decay: Wood-decaying fungi*

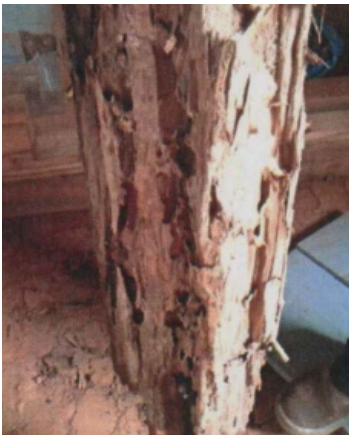
*Decay: Wood-boring insects*  
*Possible Causes: Use of untreated or unprotected wood;*  
*Lack of preventive chemical treatment; Wood in direct contact*  
*with soil or damp masonry; High wood moisture content;*  
*Cracks or openings allowing insect entry; Warm and humid*  
*environments favorable to insect activity*  
*Location: Pillar*

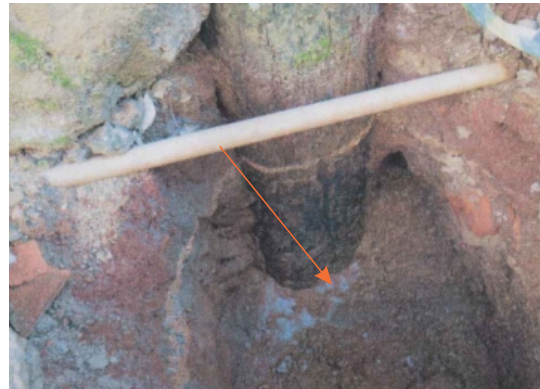
A survey was conducted on the house's foundations
