# *Appendix*

## *Appendix A: Building Analysis*

# *Appendix A:* Building Analysis

# *Appendix B:* Design Proposal

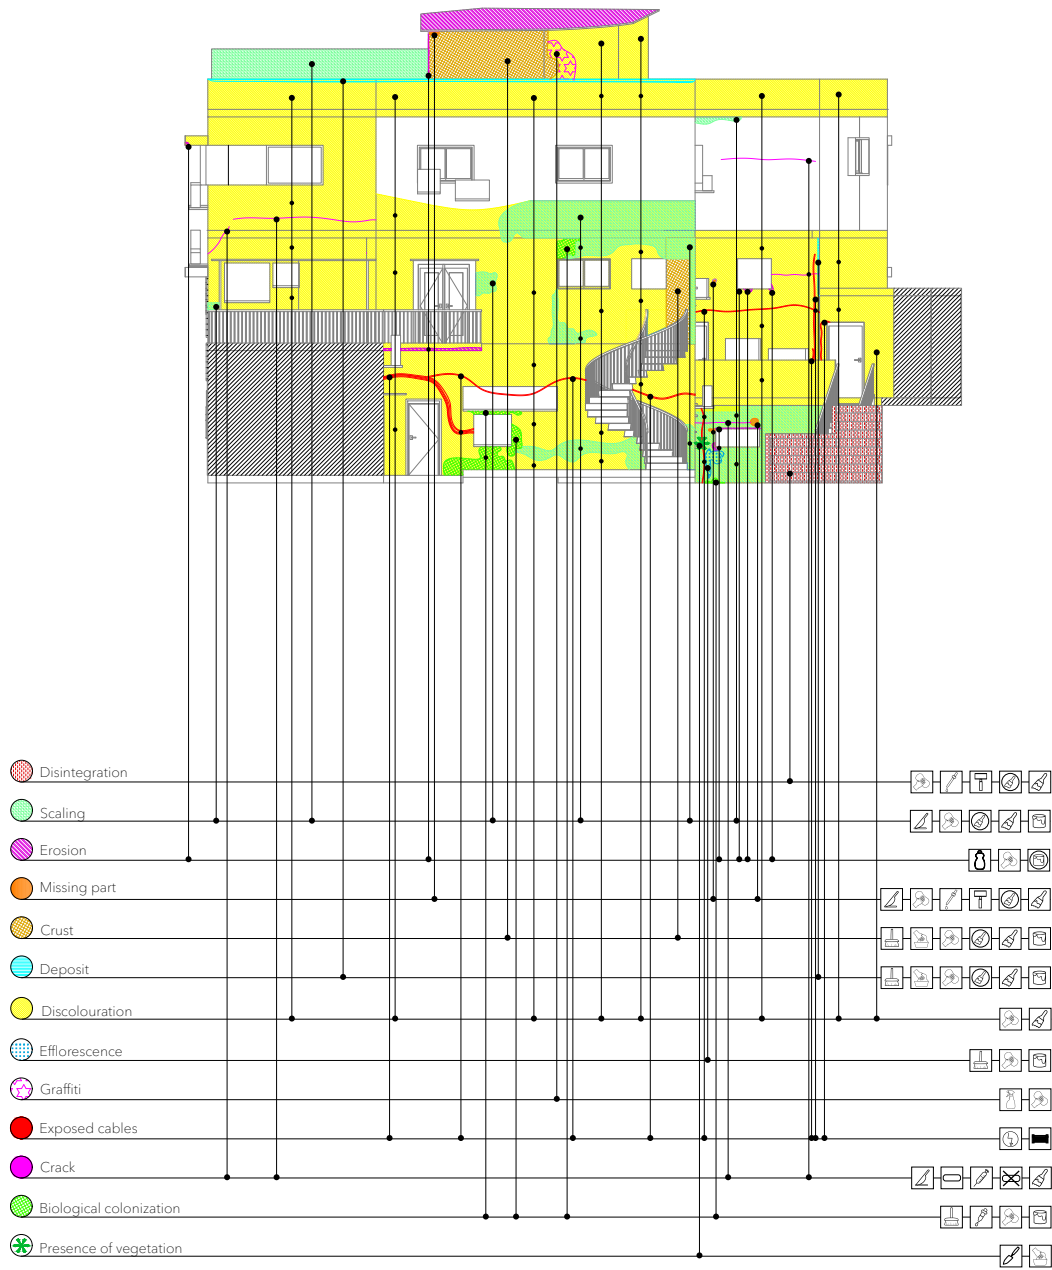
Fig.A.34 - Degradation analysis, east façade

DETACHMENT	<div>1</div> <div>Disintegration</div> <p>"Detachment of single grains or aggregates of grains." - ICOMOS-ISCS: Illustrated glossary on stone deterioration patterns, p.20.</p> <p>gradual disintegration of the mortar joints between the masonry bricks due to weathering, moisture, and pollutants, which can weaken the structural integrity of the masonry and allow increased water penetration.</p>

<div>2</div> <div>Scaling</div> <p>"Detachment of stone as a scale or a stack of scales, not following any stone structure and detaching like fish scales or parallel to the stone surface..." - ICOMOS-ISCS: Illustrated glossary on stone deterioration patterns, p.26.</p> <p>crumbling of the plaster into loose fragments, due to exposure to moisture, thermal activity or structural movements from the modifications in the building.</p>

<div>3</div> <div>Erosion</div> <p>"Loss of original surface, leading to smoothed shapes." - ICOMOS-ISCS: Illustrated glossary on stone deterioration patterns, p.30.</p> <p>exposure of moisture and passage of time causes the metal to begin to rust, resulting also in cracking and spalling of surrounding materials.</p>

<div>4</div> <div>Missing part</div> <p>"Empty space, obviously located in the place of some formerly existing stone part." - ICOMOS-ISCS: Illustrated glossary on stone deterioration patterns, p.36.</p> <p>holes in the wall caused by a poor installation of bars or non poor openings for insertion of tubeswater penetration.</p>

<div>5</div> <div>Crust</div> <p>"Generally coherent accumulation of materials on the surface. A crust may include exogenic deposits in combination with materials derived from the stone. A crust is frequently dark coloured (black crust)" - ICOMOS-ISCS: Illustrated glossary on stone deterioration patterns, p.42.</p> <p>Change in the surface in forms of dark stains caused by presence of liquids or pollution, without a loss of material (such as crumbling).</p>  	<div>6</div> <div>Deposit</div> <p>"Accumulation of exogenic material of variable thickness. ...Some examples of deposits : atmospheric particles such as soot or dust..." - ICOMOS-ISCS: Illustrated glossary on stone deterioration patterns, p.44.</p> <p>gray-black soot stains on the plaster, which are concentration of carbon particles of fuel caught on the surface due to pollution activity.</p>

<div>7</div> <div>Discoloration</div> <p>"Change of the stone colour in one to three of the colour parameters : hue, value and chroma." - ICOMOS-ISCS: Illustrated glossary on stone deterioration patterns, p.46.</p> <p>gradual degradation of the plaster due to increased amount of sunlight and hot temperatures, leading to color fading (giving the shade of yellow), surface crumbling and loss of cohesion to the under layer.</p>  	<div>8</div> <div>Efflorescence</div> <p>"Generally whitish, powdery or whisker-like crystals on the surface. Efflorescences are generally poorly cohesive and commonly made of soluble salt crystals." - ICOMOS-ISCS: Illustrated glossary on stone deterioration patterns, p.48.</p> <p>White stains on the surface of the plaster coming from the end of a tube which is depositing water from the air-conditioner engine. The color white may be also due to the gathering of salts on the wet surface.</p>

DISCOLORATION & DEPOSIT	<div>9</div> <div>Graffiti</div> <p>"Engraving, scratching, cutting or application of paint, ink or similar matter on the stone surface." - ICOMOS-ISCS: Illustrated glossary on stone deterioration patterns, p.56.</p> <p>spray paint on the plaster finishing that may harm in terms of further degradation, aesthetics and authenticity.</p>

<div>10</div> <div>Exposed cables</div> <p>Not a degradation type defined in ICOMOS glossary</p> <p>concentration of passage of numerous cables and tubes on the external part of the facade, mainly on the backyard, making a risk of electrifying and outbreaks.</p>

<div>11</div> <div>Crack</div> <p>"Individual fissure, clearly visible by the naked eye, resulting from separation of one part from another." - ICOMOS-ISCS: Illustrated glossary on stone deterioration patterns, p.10.</p> <p>horizontal cracks, resulted probably from interventions inside the wall, expansion of the material due to temperature change and humidity, as well as earthquakes.</p>

<div>12</div> <div>Biological colonization</div> <p>"Colonization of the stone by plants and micro-organisms such as bacteria, cyanobacteria, algae, fungi and lichen (symbioses of the latter three)." - ICOMOS-ISCS: Illustrated glossary on stone deterioration patterns, p.64.</p> <p>fungus growth created where there is moisture, characterized by the strong green color, and can lead to health hazards due to the release of airborne spores.</p>

- Clean
- Apply bonding agent
- Fill with mortar
- Apply bonding primer
- Apply plaster
- Remove loose pieces
- Apply siloxane hydrophobic coating
- Apply acid-based rust remover
- Apply epoxy coating
- Dry brush
- Wash
- Spray graffiti remover
- Unify cables routes
- Enclose in PVC conduit
- Seal with tape
- Inject epoxy resin
- Remove tape
- Apply biocide gel
- Remove root
