**Static analysis of the disarrangement of a building for the cult:  
San Lorenzo in Traverses of Pragelato**

di Enrico Montanaro  
Tutor: Roberto Roccati

In the fraction of Traverses it is situated the church of San Lorenzo, already existing in four hundred, then reconstructed in 1688.

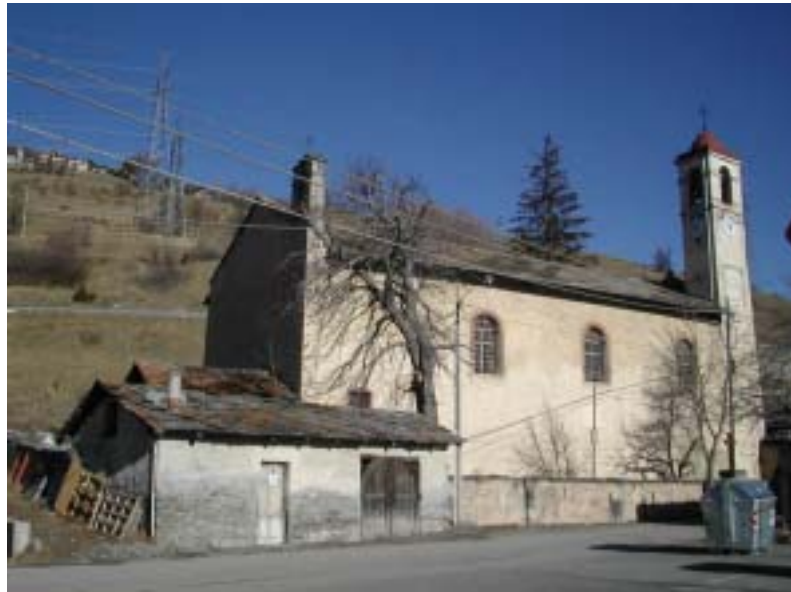
The church introduces particular lesions on the east front and on the times to the inside. to analyze the behavior of the structure and the cause of these fessurazionis I have had to verify the ground on which San Lorenzo has been built. I have reached the conclusion that the whole slope is unstable and therefore there is a yielding of the ground toward valley that determines the I degrade of the church.

The church of San Lorenzo in Travereses

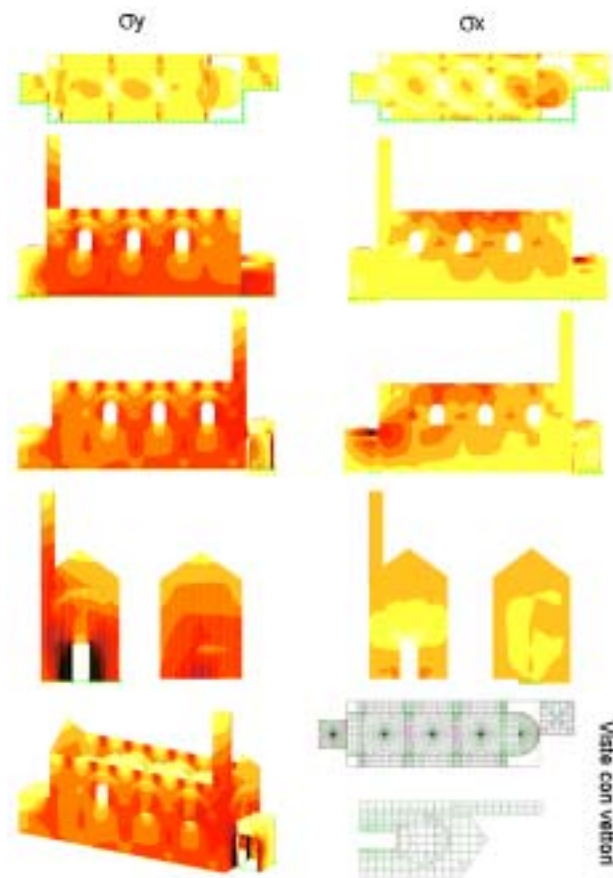
I have departed from the study of the model FEM of the church without lesions and I have observed the behavior of the structure. With the insertion of the yeldings of foundation I have begun to see interesting results.

Study of the normal tensions in direction x and y

Continuing with the study of the model I have reached a situation very similar to the reality, which she has confirmed the fact that the whole slope is unstable and more particularly that the ground on which the church has been built is surrendering toward valley.

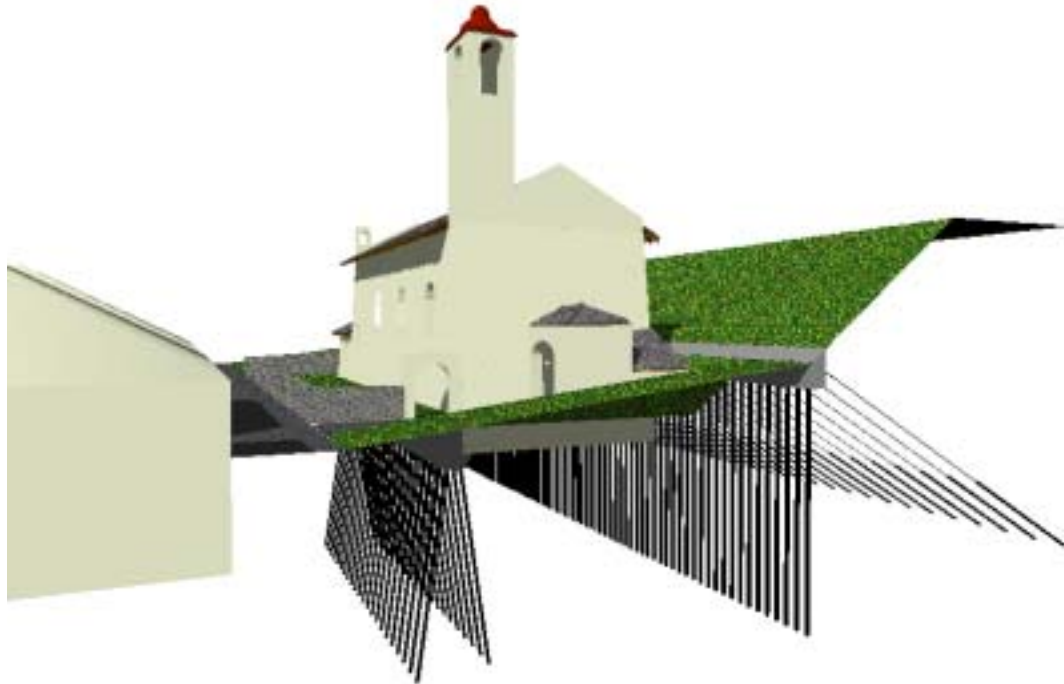
Three-dimensional vision of the section of the ground with the insertion of the micropalis.

In this geologic situation and geomorfologica it is necessary to absorb the due horizontal and oblique strengths to the glide of the ground toward valley, a good solution it is that of the tilted micropalis. The pushes of the ground can entirely be annulled by a system of "submerged elementary reticolari" compotes every from an oblique connecting rod and from a vertical strut. Studying the section of the ground is chosen to position awry immediately the micropalis of the church and at the base of the underlying building the church.

To assure a greater stability to the church they will be realized some micropalis under the foundation of the wall perimetrale that has suffered the lowering.
