POLYTECHNIC OF TORINO FACULTY OF ARCHITECTURE 2 Degree in Architecture <u>Honors theses</u>

Evaluation of the Structural Integrity of Brick Towers: The Sineo Tower-house in Alba (CN)

by Graziano Cau and Cosimo Perrone Tutor: Giuseppe Ferro Co-tutor: Giuseppe Lacidogna

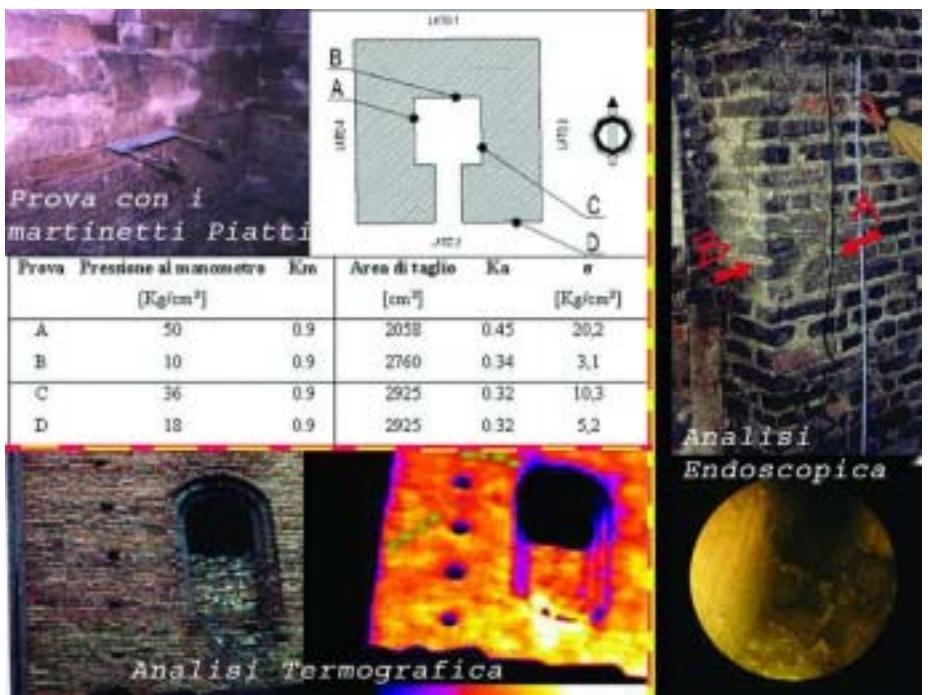
The analyses made it possible to locate certain phenomenons like the damage of the building due to infiltration of rain-water; the presence of sub-superficial damage; the mortar joints deterioration; ect.

The endoscopic images were analysed one by one, comparing a visual observation with the data collected on the spot. Conclusions were drawn from the endoscopic analysis: the cracks found were due mostly to poor original manufacturing of the wall; the wall texture proved not to be homogeneous between the inner and the outer surfaces.

With the flat-jack test it was possible to measure the wall's tensional state. The tests were applied, where possible, in four points of the tower's underground floors and the values of the push-back pressures due to shear tresses were measured. The tension values measured do not result in line with the tension values calculated with the analytic testing. The slant of the tower and the empty spaces in the upper portion are the main causes of these deviances.

Thermograpy, endoscopy and flat-jacks

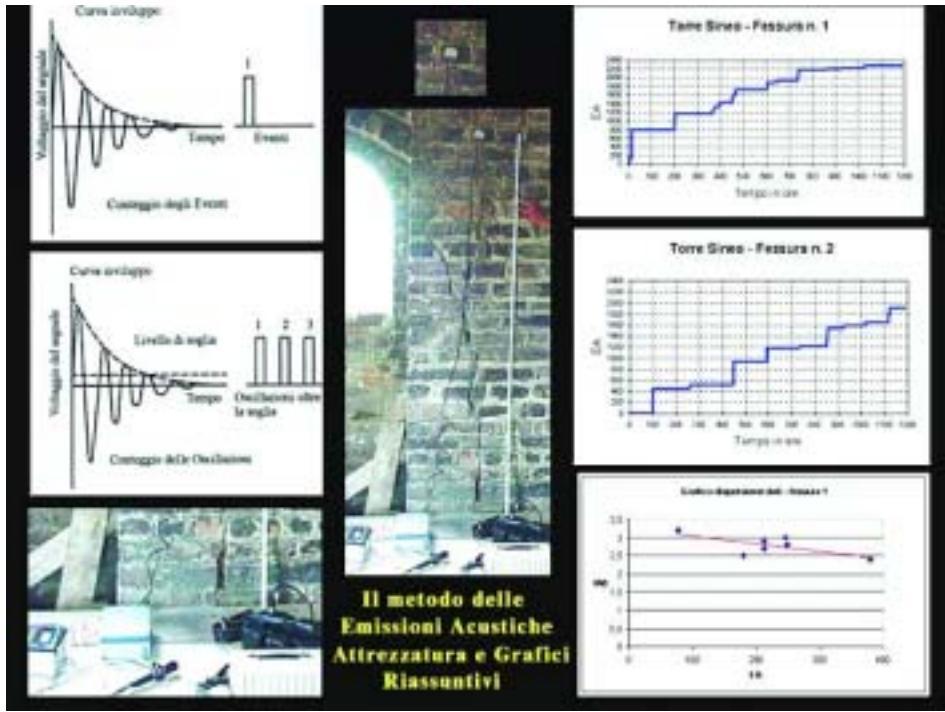
The monitoring of two of the towers flaws has been carried out using the acoustic emission (EA) method. The two gaps have been observed for a total of about 1194 hours. It was so possible to draw cumulative diagrams showing the oscillations in time. From the analysis of these graphs, it was possible to evaluate the evolution of the gapping process, which seems to diminish, even though the cracks can't be seen on the surface.

Acoustic Emission, equipment and graphs

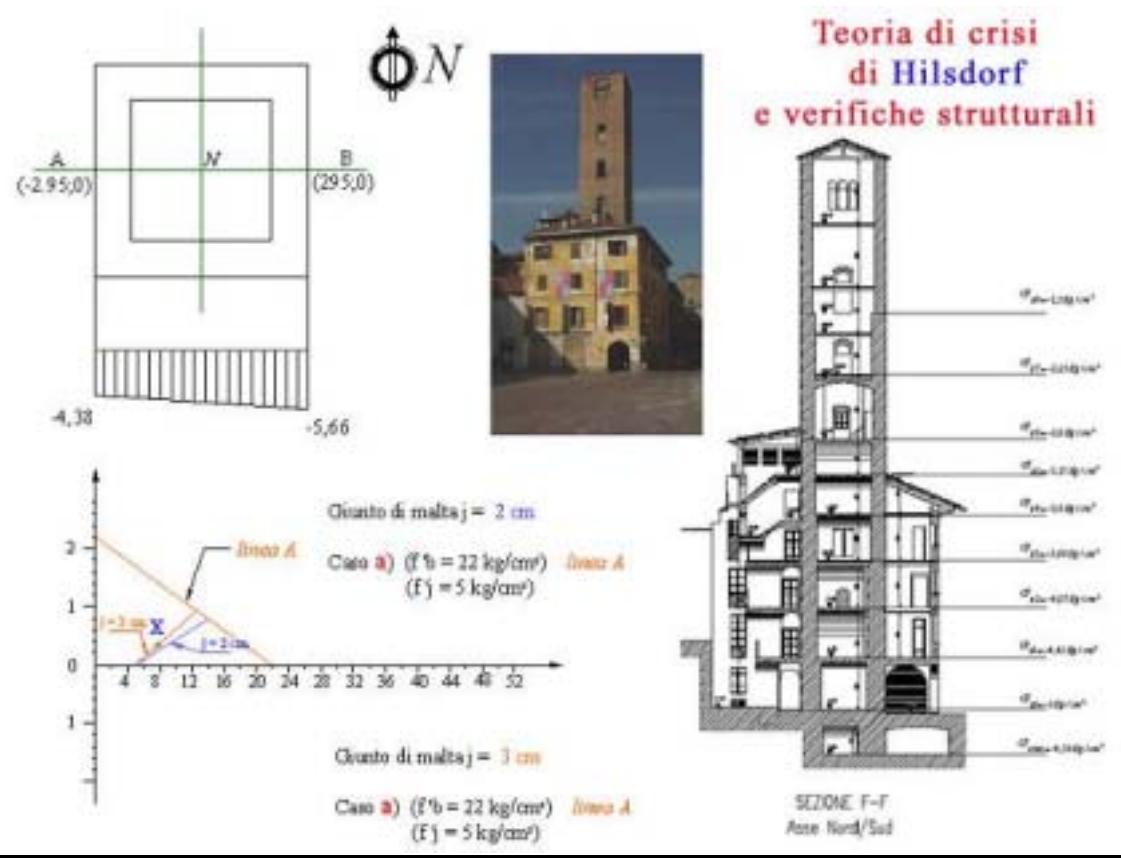
The dispersion diagram resulting from this comparison show how the gapping events monitored result as stabilizing for static loads rather than for dynamic loads. Finally, in regards to the structural verifications, we surveyed the load capacity of the structure by means of the analysis of the loads, the critical load test, the checking in combined bending & axial load and the Hisdorf crisis criteria; therefore the structure has to be analysed by a static approach.

Hilsdorf crisis criteria and structural checking
