POLITECNICO DI TORINO

**Corso di Laurea Magistrale
in Ingegneria Civile**

Tesi di Laurea Magistrale

Structural Health Monitoring of the Forth Road Bridge

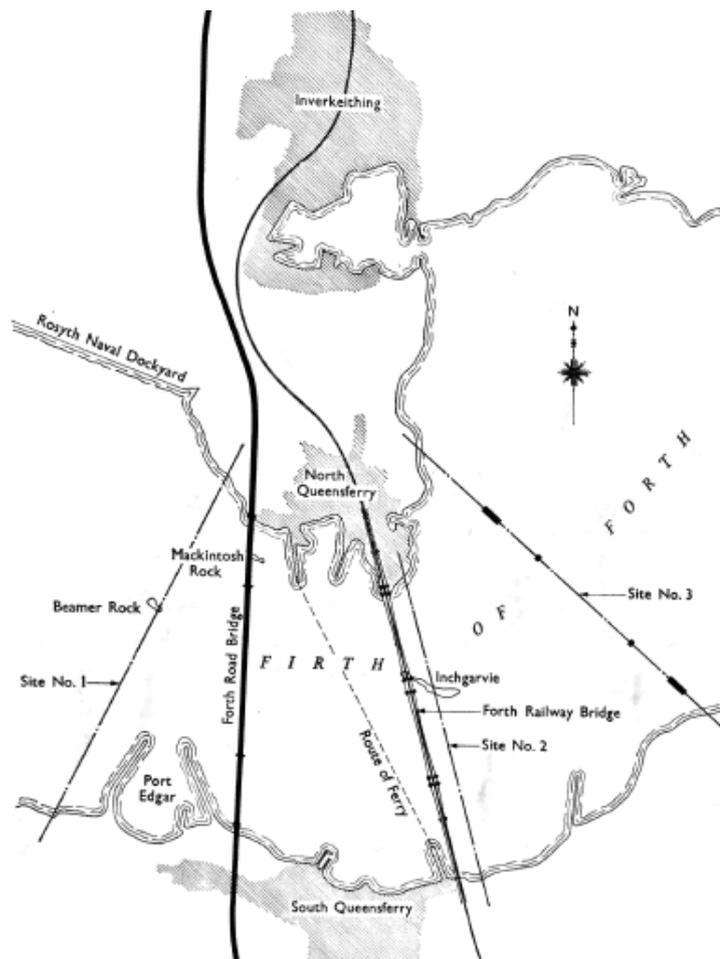
Figure 2.1: FRB proposed site locations (ICE, 1967)

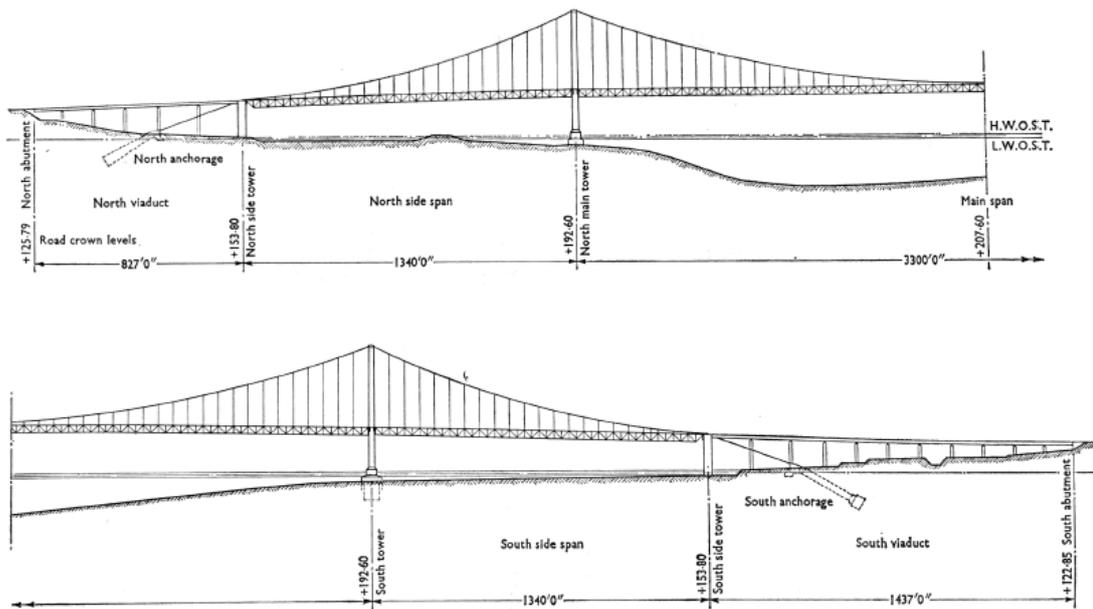
Figure 2.2: FRB detailed design (ICE, 1967)

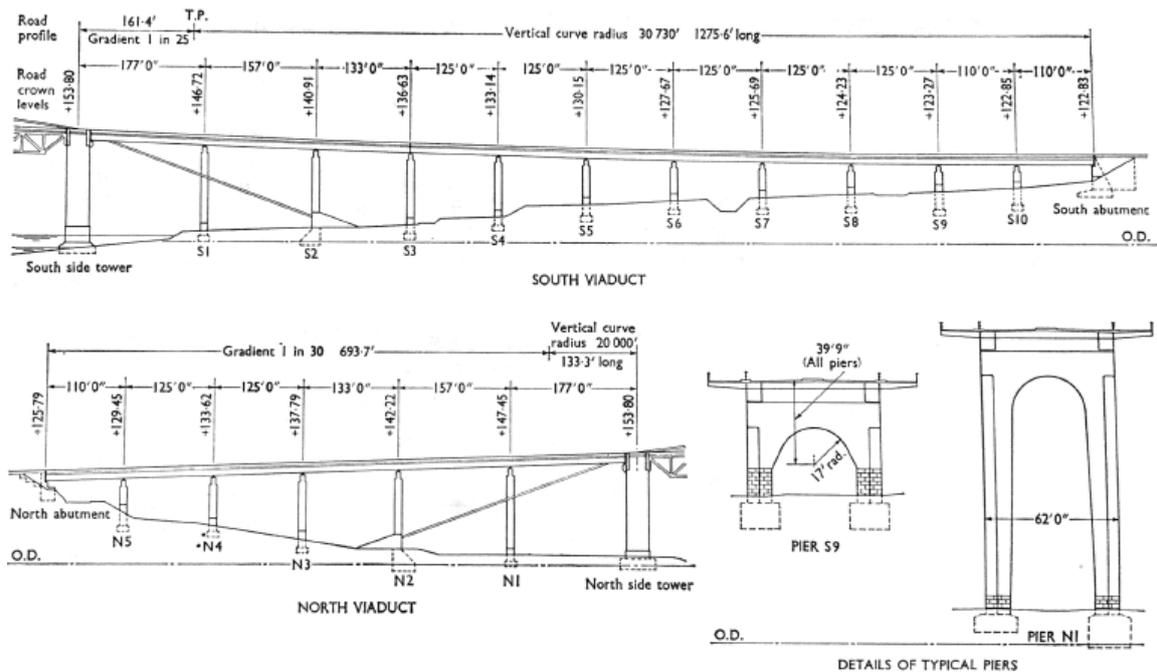
Figure 2.3: General elevation of viaducts and piers (ICE, 1967)

The north and the south viaducts support the carriageways, footpaths, and cycle tracks between the ends of the approach road embankments and the side towers. The south viaduct is longer and has eleven spans, while the north one has six spans. Figure 2.3 shows a detail of the viaducts. On both sides reinforced concrete piers support the deck structure in spans varying from 34 metres to 50 metres.

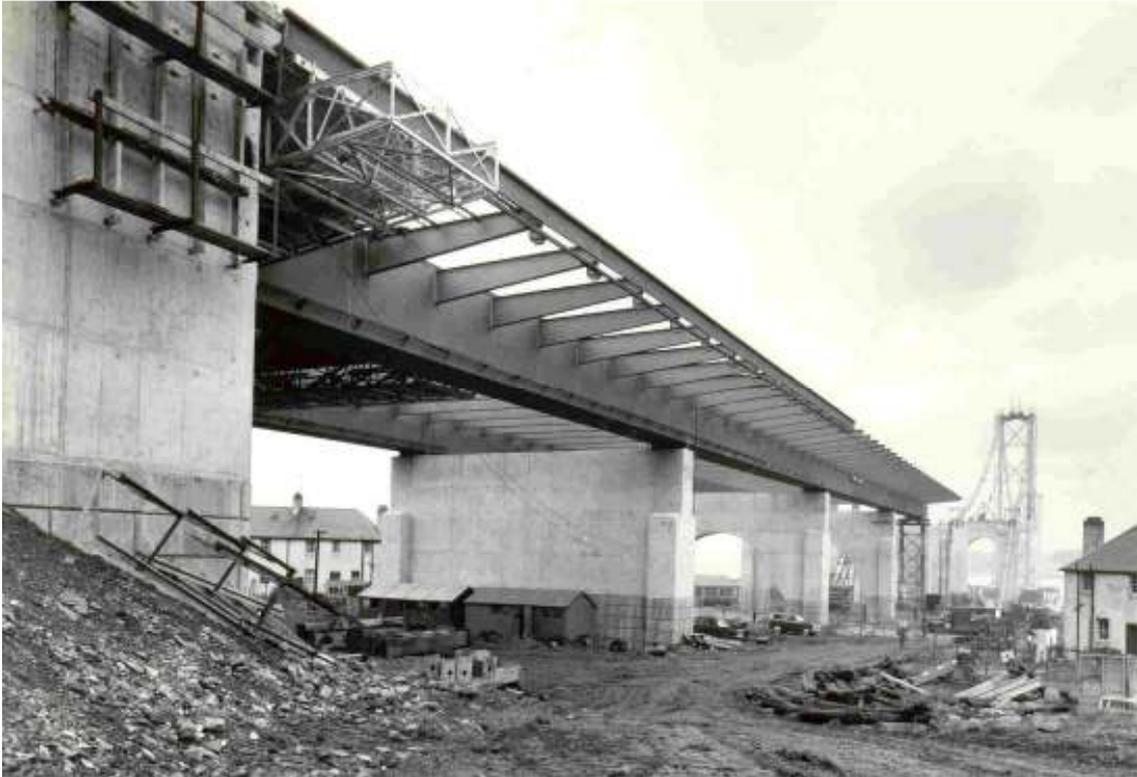
Figure 2.4: Construction of the deck on the south viaduct (Transport of Scotland, 1964)

The suspended structure on the viaducts is a prefabricated box girder made of welded high tensile steel. The cross girders, which occur at 3 metres centres, are made continuous trough the box beams to the outriggers where an edge beam provide end restraint.

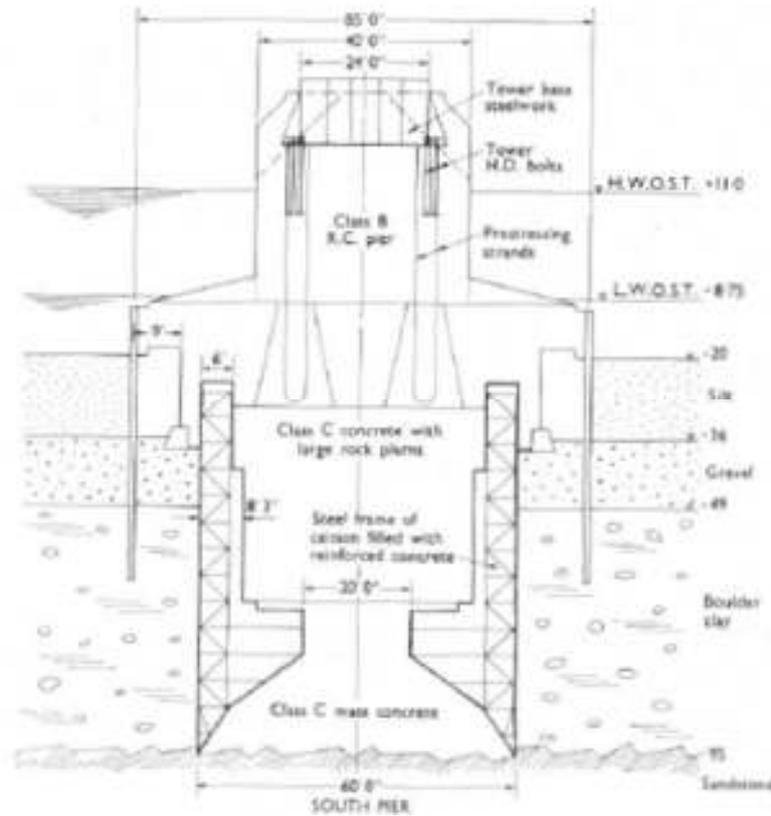
Figure 2.5: Cross section of south pier (ICE, 1967)

The geological conditions varied greatly across the river and required quite different construction methods to be used for each pier. The realization of the south pier proved much more difficult as the bedrock was much deeper on this side. The construction started with the building of a large figure of eight frames at the suitable side on the north shore, which consisted of twin circular welded steel box members. Then it was floated across the river to the position of the south pier. Sheet piles were driven around the frame to form a cofferdam. Inside these two 18 metres diameter caissons were built, which were sunk through gravel and boulder clay until they reached rock about 30 metres below the surface. The caissons were then filled with concrete to form the foundation for the tower.

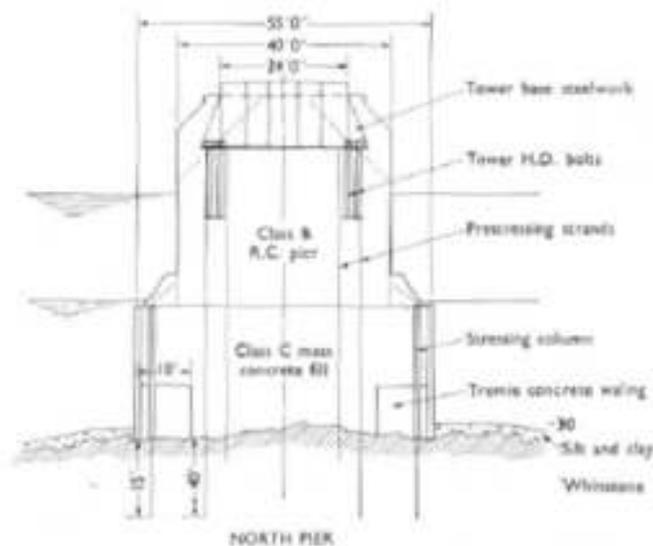
Figure 2.6: Cross section of north pier (ICE, 1967)

The north main pier is found on the mackintosh rock. First level was took off by underwater blasting, then the broken rock was grab out and piles forming the base of the pier were driven straight into the bedrock. Prefabricated waling unit was built, floated out to the site and landed on the small piers where it was secured. Side walls shutters were erected and the struts positioned, then erected stressing columns and concreted sidewalls. Then strands were inserted and stressed, and at the end dewatered cofferdam to enable the pier to be completed in the dry.

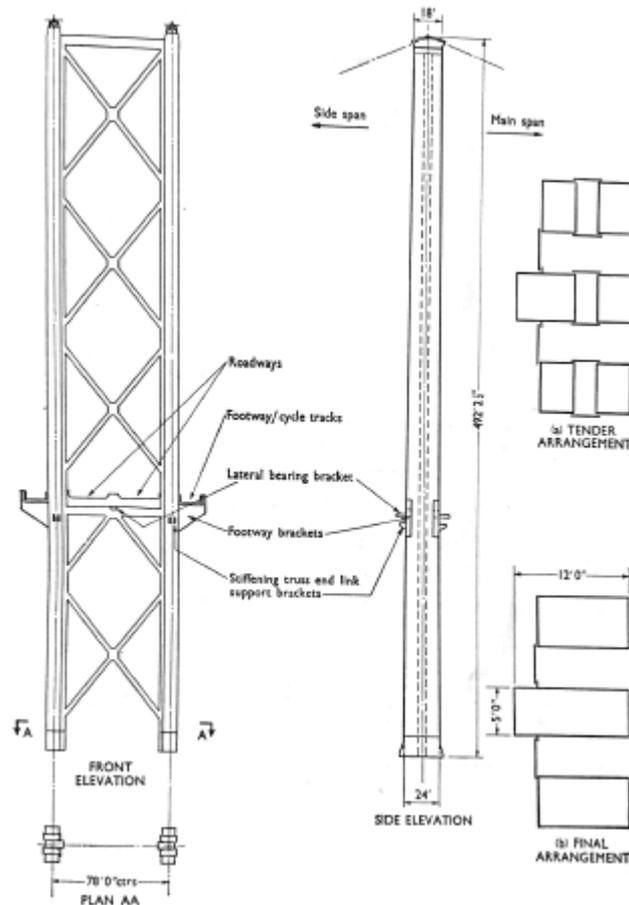
Figure 2.7: General arrangement of the main towers (ICE, 1967)

It can be noted that the tower base has been sized accordingly to ensure both bending resistance and that they can support themselves in the free standing orientation when subjected to high winds. With reference to Figure 2.7, it can be seen that the base size changed from tender to detailed design to accommodate this.

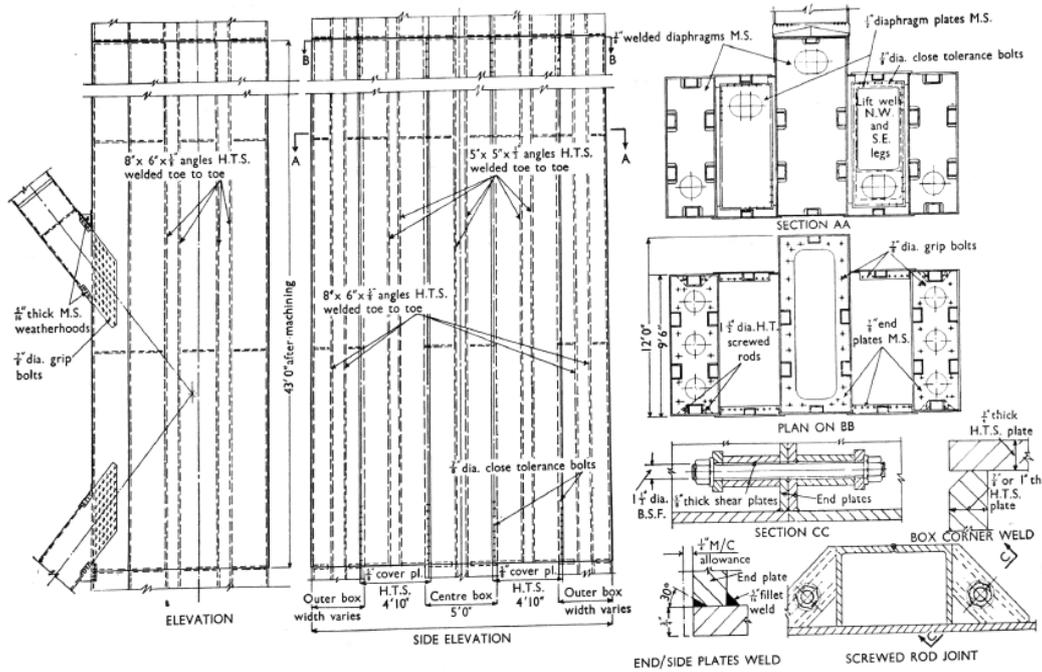
Figure 2.8: Main tower leg details (ICE, 1967)

Both towers measure 150 by 24 metres in terms of height and width (centres to centres) (ICE, 1967). Figure 2.6 shows how the tower legs are strengthened throughout their length by the addition of welded angles (ICE, 1967). It should also be noted that the maximum steel thickness was 25 millimetres (ICE, 1967) in order to assist the welding processes adopted for construction. Furthermore, Figure 2.8 highlights the design for the main tower leg base.

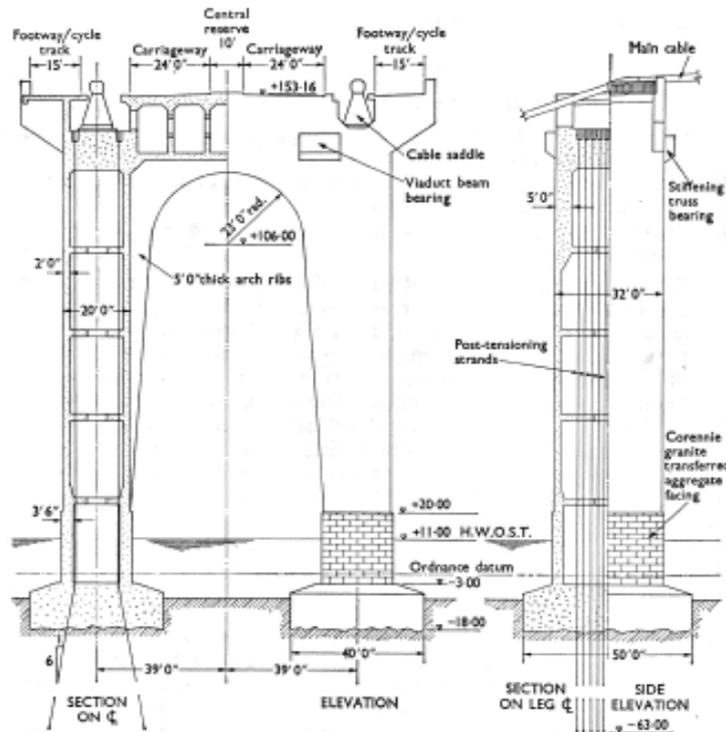
Figure 2.9: Elevation and sections of side towers (ICE, 1967)

Figure 2.8 illustrates the detailed design of both side towers, made of two reinforced concrete legs and a cross beam all of box section. The cable saddles are located at the tops of each leg. It can be noted from the figure that the reinforcement is provided with post-tensioned strands which extend from the summit of the tower to the tower base, then a further 13.7 metres into the foundation rock (ICE, 1967).

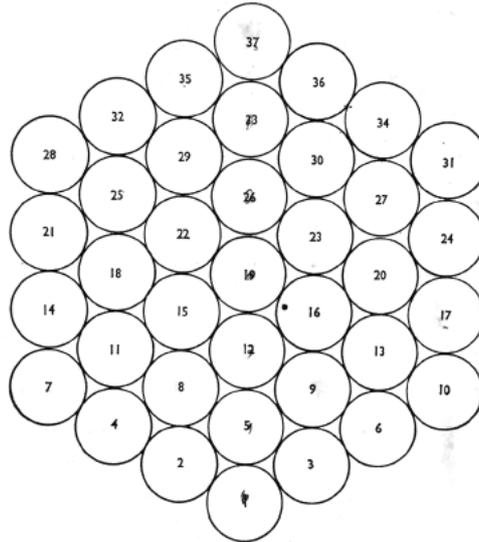
Figure 2.10: Pattern of strands in cable before compacting (ICE, 1967)

According to (ICE, 1967) each cable required a cross sectional area of 0.22 m^2 to cope with the stresses caused by loading. Therefore, it was decided to use 37 strands of 314 wires each as shown in figure 2.10. Every wire has a diameter of 4.98 millimetres. The cables are spun in a series of strands that are arranged in the form of a hexagon, in order to reach a circular form after been compacting.

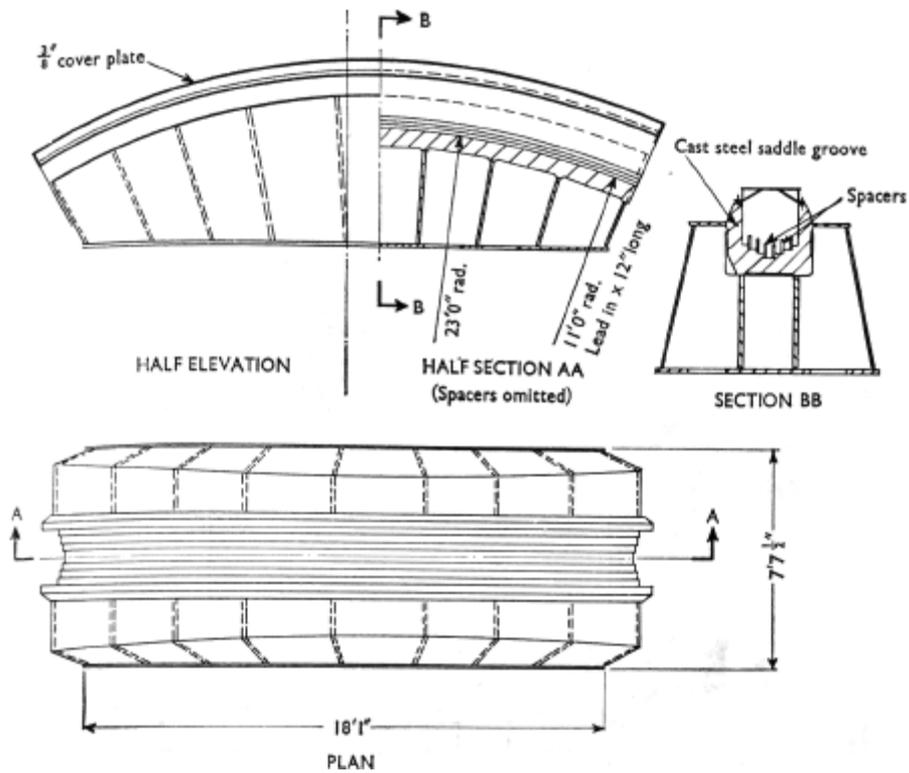
Figure 2.11: Main tower saddle details (ICE, 1967)

The saddles on the main and side towers support the FRB's main cable. The difference between the two is based on their support. The saddles located on the main tower are fixed. Whereas the saddles located on the side towers are on rocker bearings. The reasoning for this is to accommodate for changes in longitudinal displacement which are caused by load and temperature variations (ICE, 1967). Figure 2.11 and figure 2.12 illustrate the details for both the main and side tower saddles. It can be noted that both saddles feature spacers. These were incorporated into the design to assist the spinning process and ensure the hexagon shape was maintained.

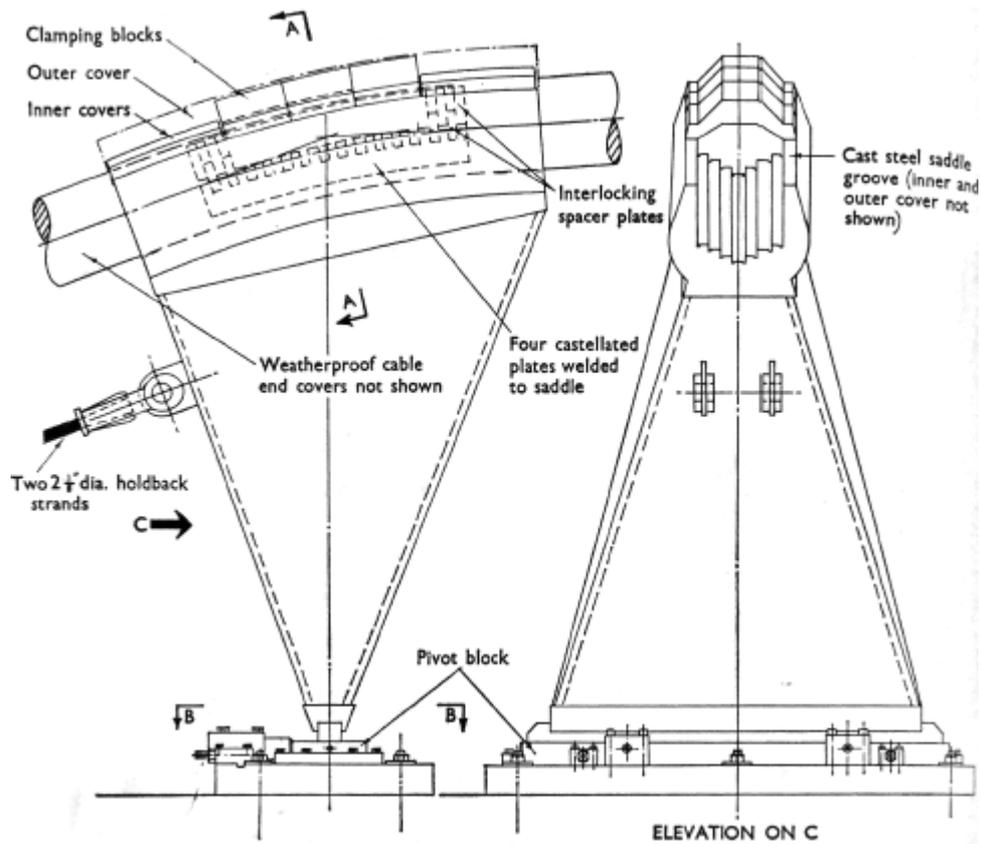
Figure 2.12: Side tower saddles (ICE, 1967)

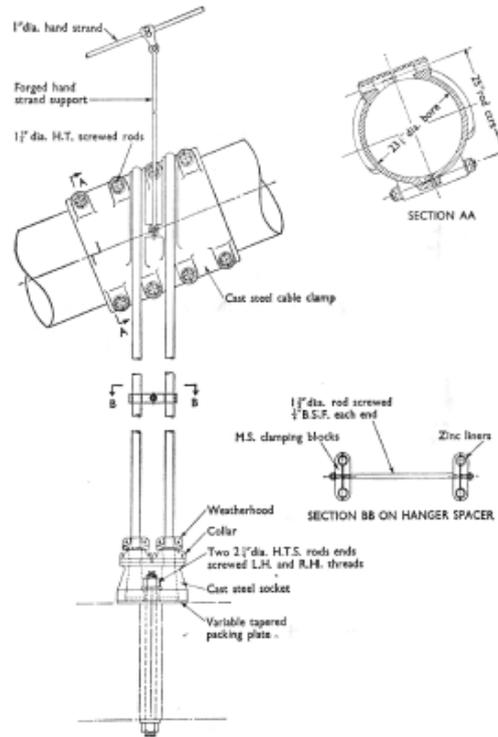
Figure 2.13: Cable band and hanger assembly (ICE, 1967)

Main cables support also the hanger ropes which are connected to the cable trough high tensile steel cable bands. The hanger rope varies dependent on its location. At the main span the rope has a diameter of 44.5 millimetres. By comparison the diameter at the side span is 54 millimetres (ICE, 1967). The difference in diameter results in varied breaking loads: 218 and 300 tons respectively (ICE, 1967).

The connexion to the top chord of the stiffening truss is realized with a common socket that takes the two rope ends and a pair of high tensile bolts. Where the rope enters the socket, which is the point most vulnerable to corrosion, a split cap and rubber gasket where fitted to exclude moisture. Figure 2.13 shows cable band and hanger assembly.

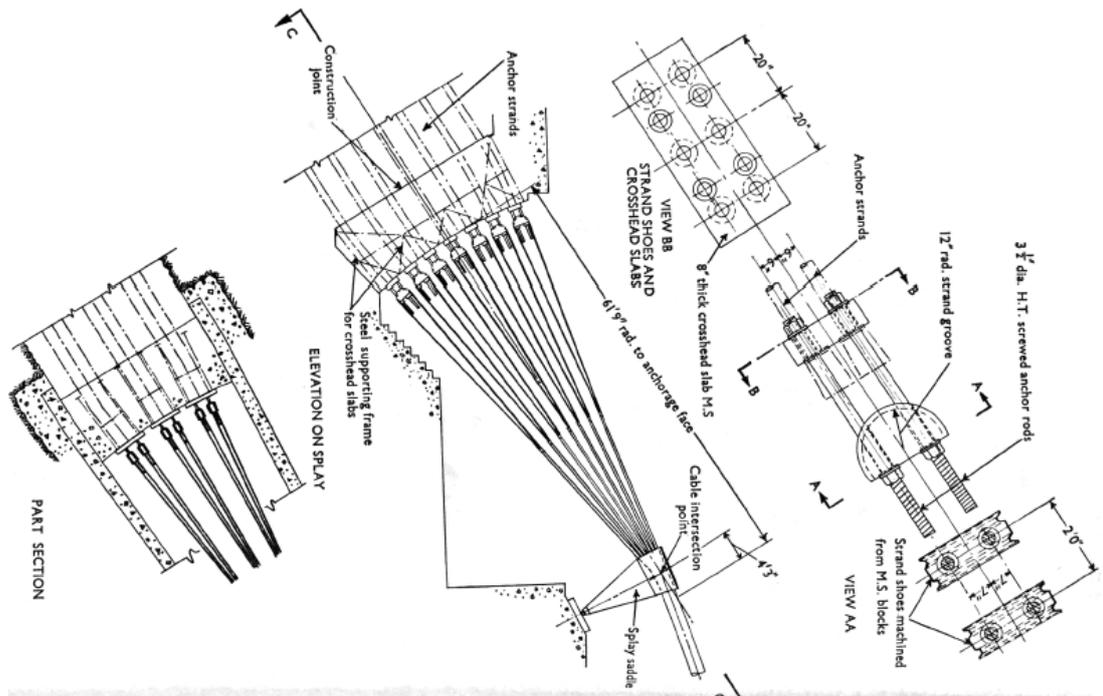
Figure 2.14: FRB main cable anchorage detailed design (ICE, 1967)

The load from the cable is transferred to the concrete block via anchorage strands, connected to 19 crosshead steel slabs 203 millimetres thick (ICE, 1967). This was achieved by pairing the main cable strands to 6 anchorage strands per slab, which ensured the load (375 tons per main cable strand) was distributed equally (ICE, 1967). Figure 2.14 illustrates the detailed design for the FRB main cable anchorages.

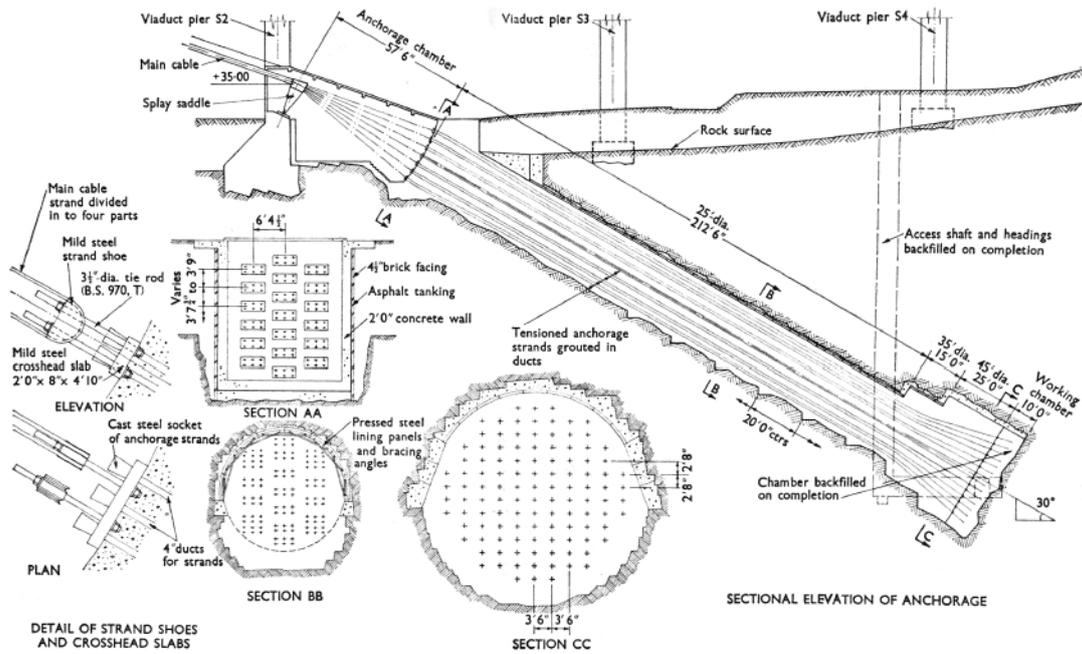
Figure 2.15: General sections of south anchorage tunnel (ICE, 1967)

When the ducting for the cables was finished concrete fill started from the surface. Threading of the cables in to the ducts was carried out from the top. The four strands in each cable were stressed simultaneously by four separate jacks. After all stressing works had been finished, the strands were grouted.

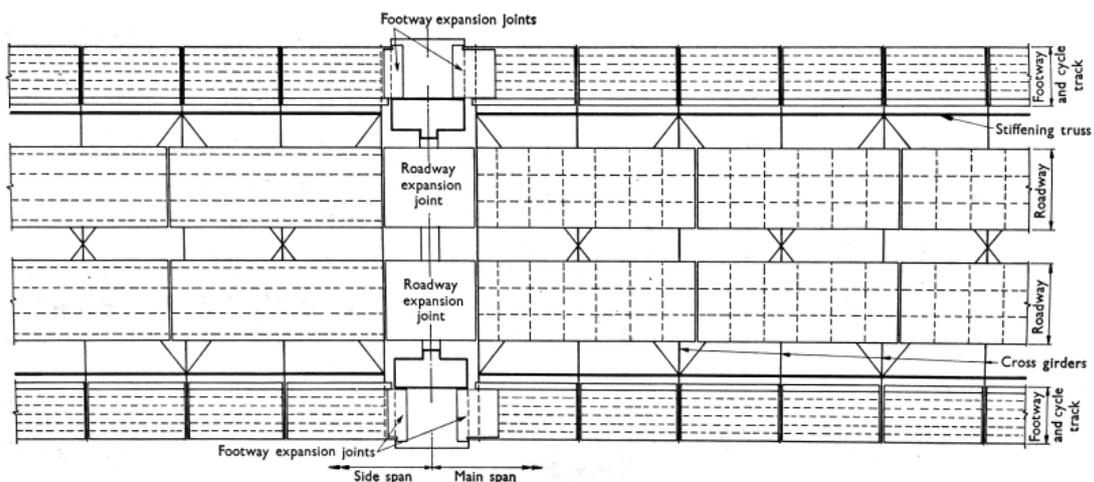
Figure 2.18: FRB deck arrangement (ICE, 1967)

The trusses are 24 metres wide and 8.4 metres deep. The main span has an orthotropic deck made up of a 12.7 mm stiffened steel plate overlaid with 38mm thick mastic asphalt, on a waterproofing layer. The side span decks are 203mm thick reinforced concrete slab with a similar surfacing to the main span. The decks on both the main and side spans are supported on steel stringer beams that span between large steel cross girders spaced at 9.144 metre centres. These cross girders are supported by two longitudinal stiffening trusses, which are in turn attached to the main cables by rope hangers. Deck's panels are 18.29 metres long with expansion joint that were offset from the cross girders to obtain the continuity of the panel over the support.

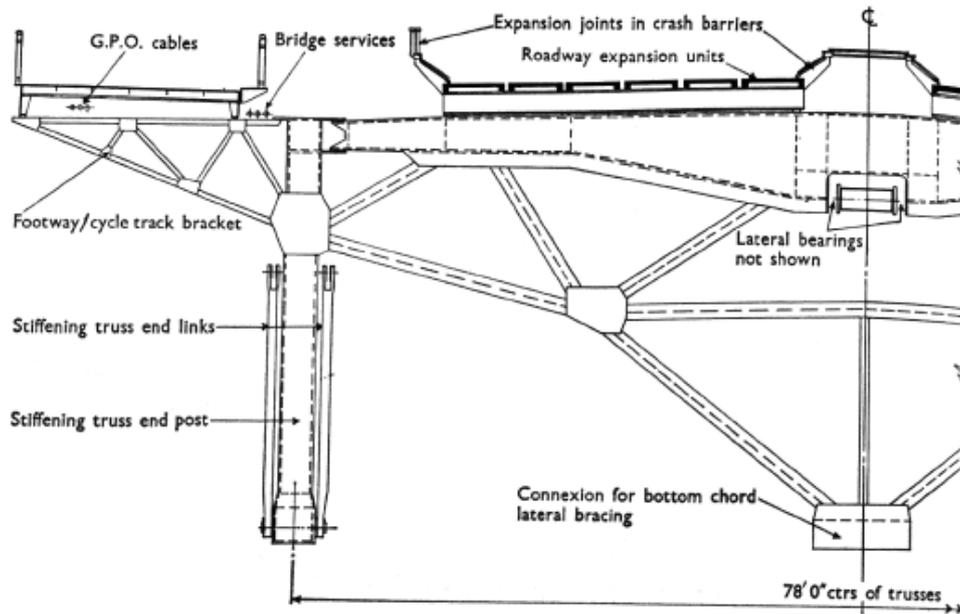
Figure 2.19: Cross girder of main span at main tower (ICE, 1967)

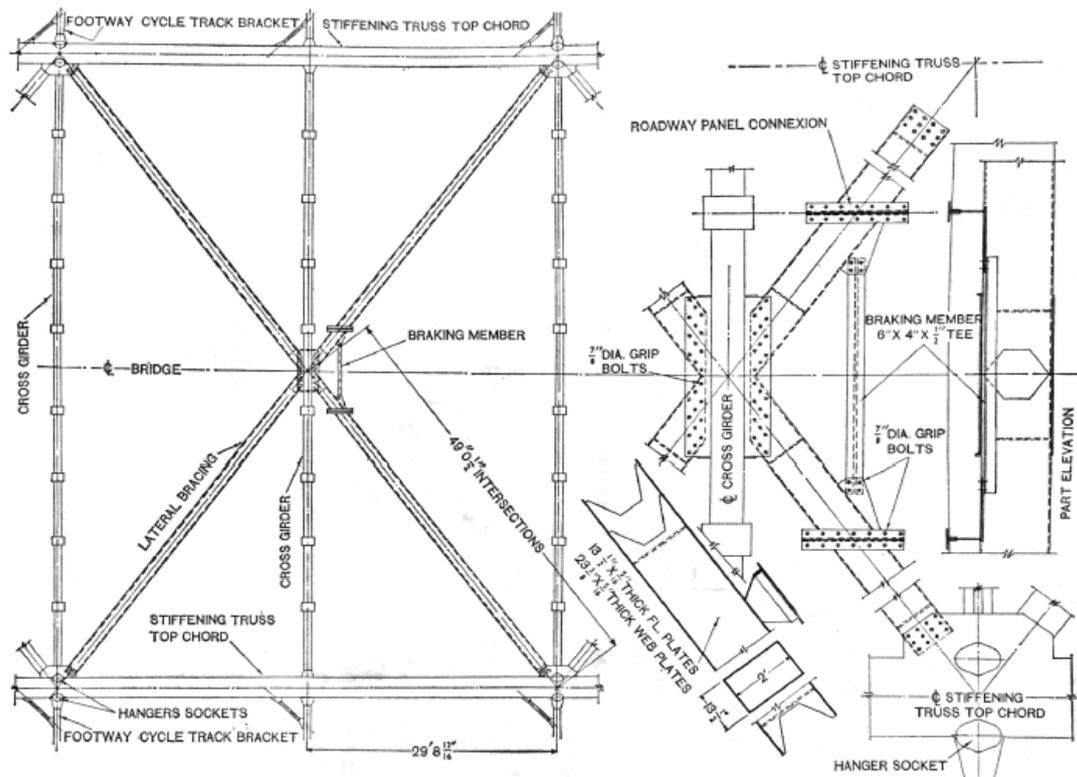
Figure 2.20: Top chord lateral bracing (ICE, 1967)

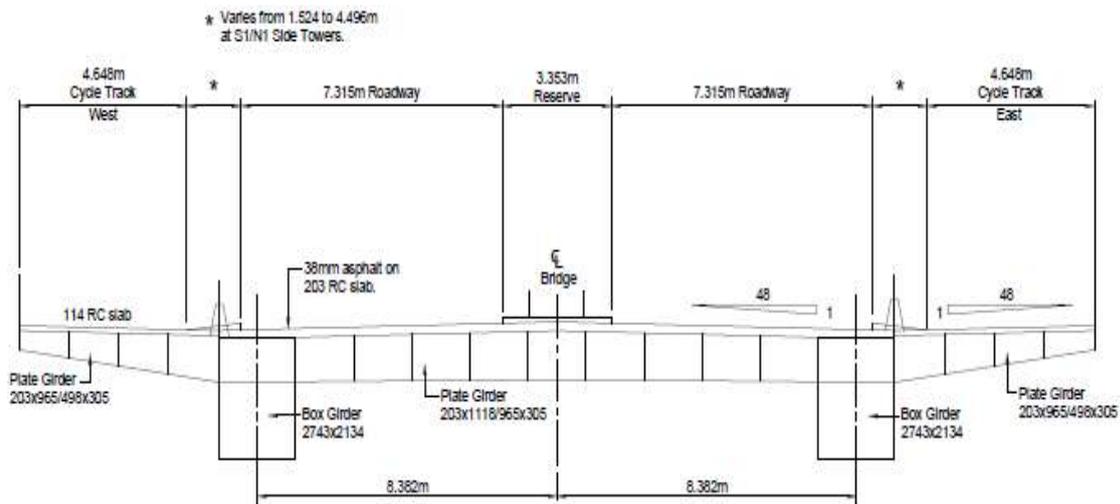
Figure 2.21: Typical viaduct section (facing North) (Jack, 2003)

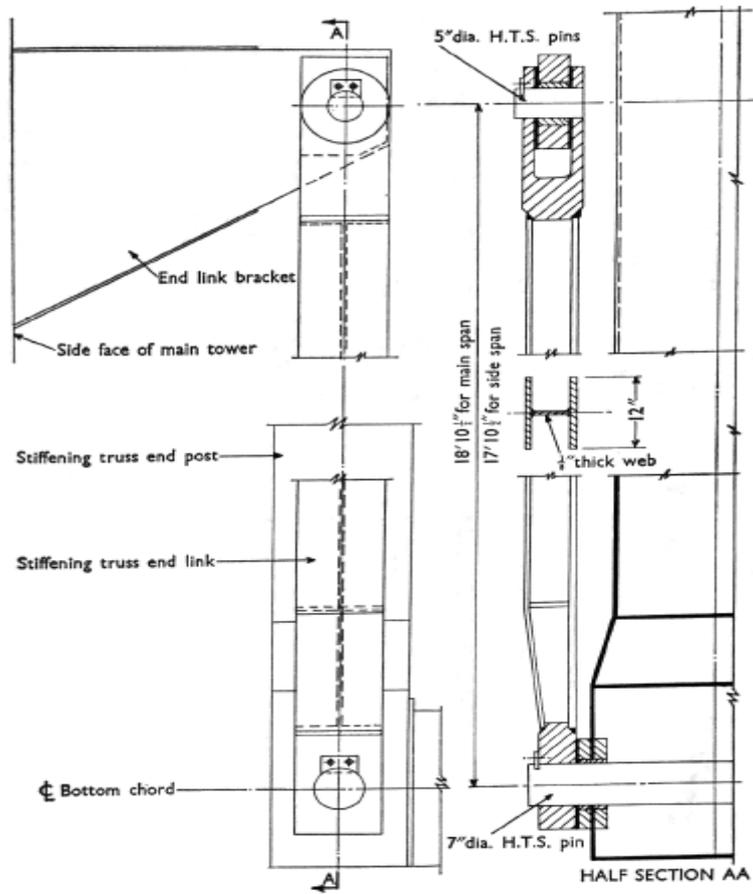
Figure 2.22: Stiffening truss end link (ICE, 1967)

The links connecting the main towers to the ends of the stiffening trusses are formed from mild steel H sections. The link members are connected to the bottom chord of the truss and to a pair of cantilevered support brackets from the main towers. These connections are formed with pins made from high tensile steel (Forth Estuary Transport Authority, 2008). Details of the links are shown in Figure 2.22.

Figure 2.22 highlights the end truss link and detailed design. The end link of the FRB provides the load path for the vertical loading, caused by the movement of vehicles and weather effects (temperature and wind), as well as, the dead load of the deck, and transfers this to the bridge tower via a bracket (Arndt M., 2017). In addition, the end link allows the deck to accommodate for longitudinal movement of up to 800 millimetres (Arndt M., 2017)

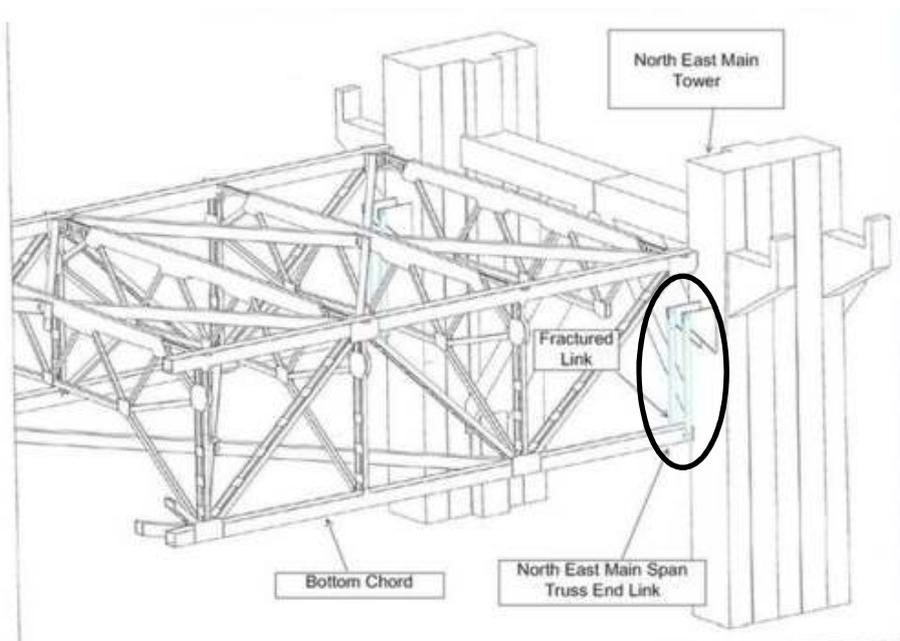
Figure 3.2: Location of the defective steel component (BBC, 2015)

On the 1st of December 2015 a fracture was discovered at the truss end link at the north east main span during a routine inspection. On the 3rd of December the bridge was closed to all traffic. The closure of the forth bridge was an event of national significance, since it caused an economic impact of around 1£ million per day.

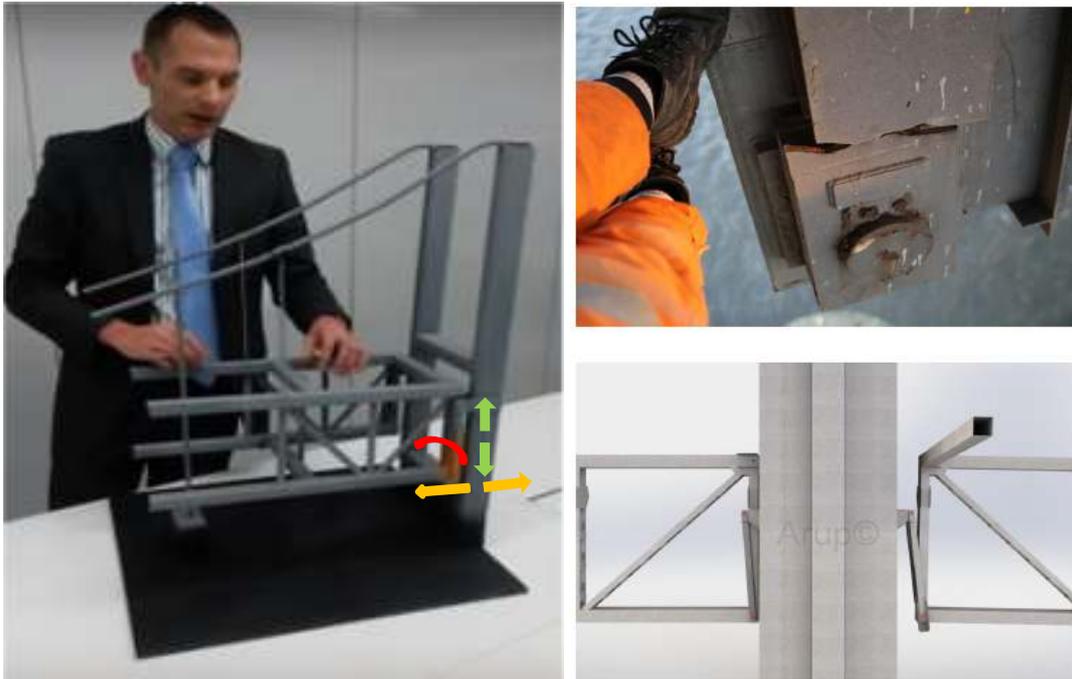
Figure 3.4: End truss link movement diagram and fracture photos (Arndt,2015)

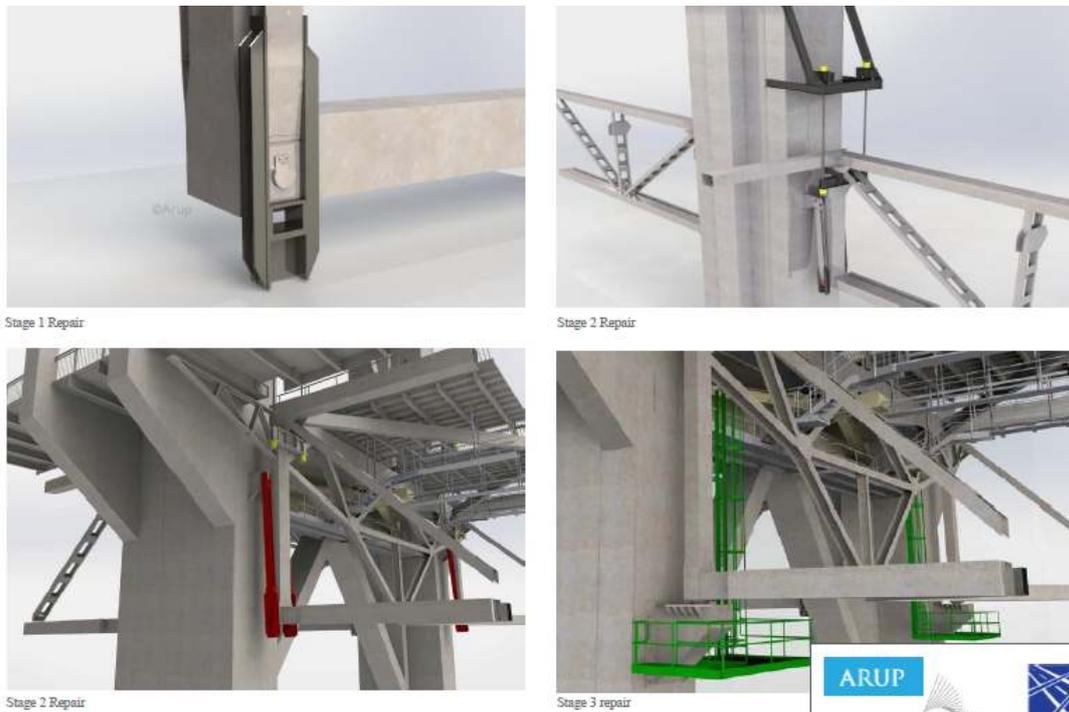
Figure 3.3: End link repair stages (Arndt M., 2017)

The repair work carried out on the truss end link was split into three phases, shown in the figures below.

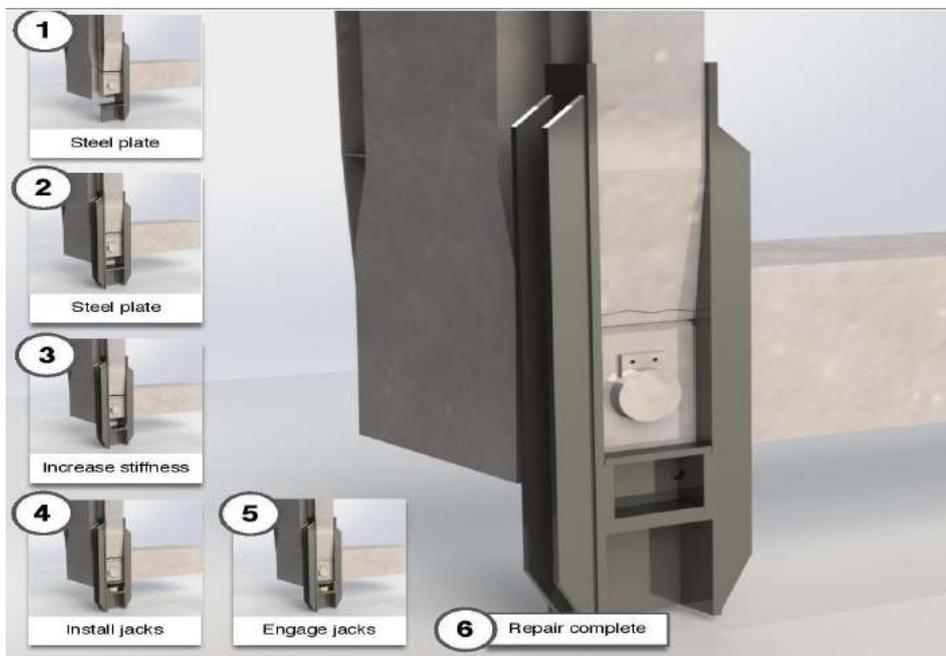
Figure 3.5: Truss end link repair: Phase one (Arndt M., 2017)

At the same time during this phase a SHM system was commenced and installed to provide temperature, strain, stress and displacement at all eight end link positions. In addition, incremental load tests were conducted to observe real-time structural behaviour. (Transport Scotland, 2017). After twenty days following the successful completion of the load tests, the FRB was reopened to approximately 91 percent of traffic. HGVs and abnormal loads were still not allowed to cross the bridge because it was discovered that lower pin joints of the other links were partially seized, inducing high stresses (Transport Scotland, 2017). On the 23rd of December phase one was completed.

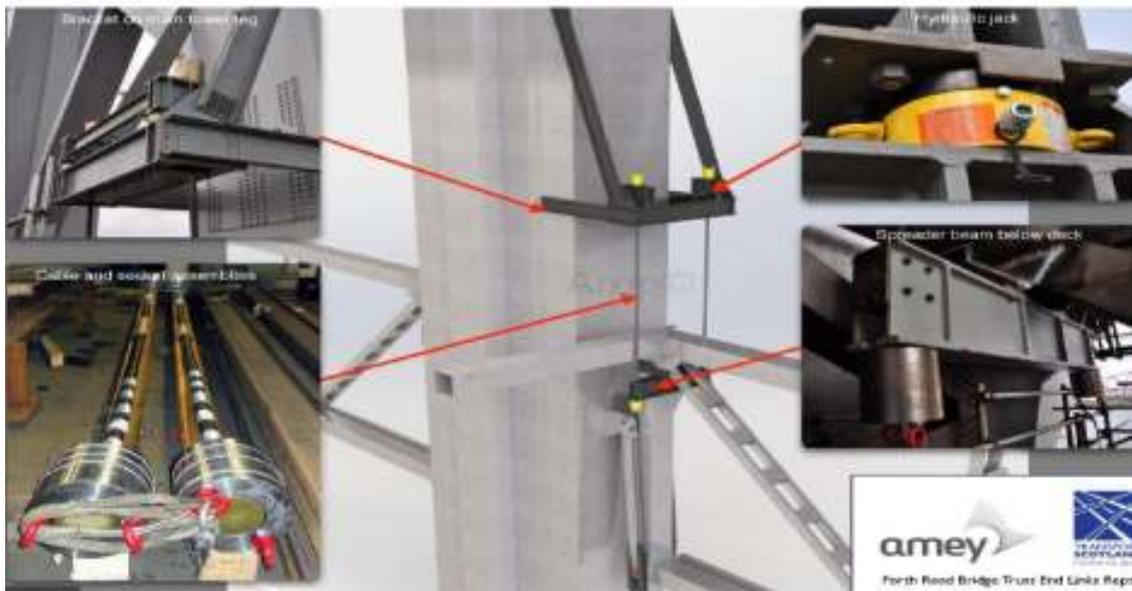
Figure 3.6: Truss end link repair: phase two (Arndt M., 2017)

Phase two design was completed on the 13th of January and by this time the SHM was in place at all eight links. Stage two involved constructing new steel brackets attached to the tower legs, from which the deck would be jacked and supported via steel cables. On the 20th of February 2016, phase two was completed and the bridge was fully reopened to all vehicles upon completion of load testing. The phased reintroduction of HGVs was trialled for safety during overnight load tests, with lorries merged into general traffic using a temporary ramp-metering system and the structural impact monitored in real-time using the SHM system.

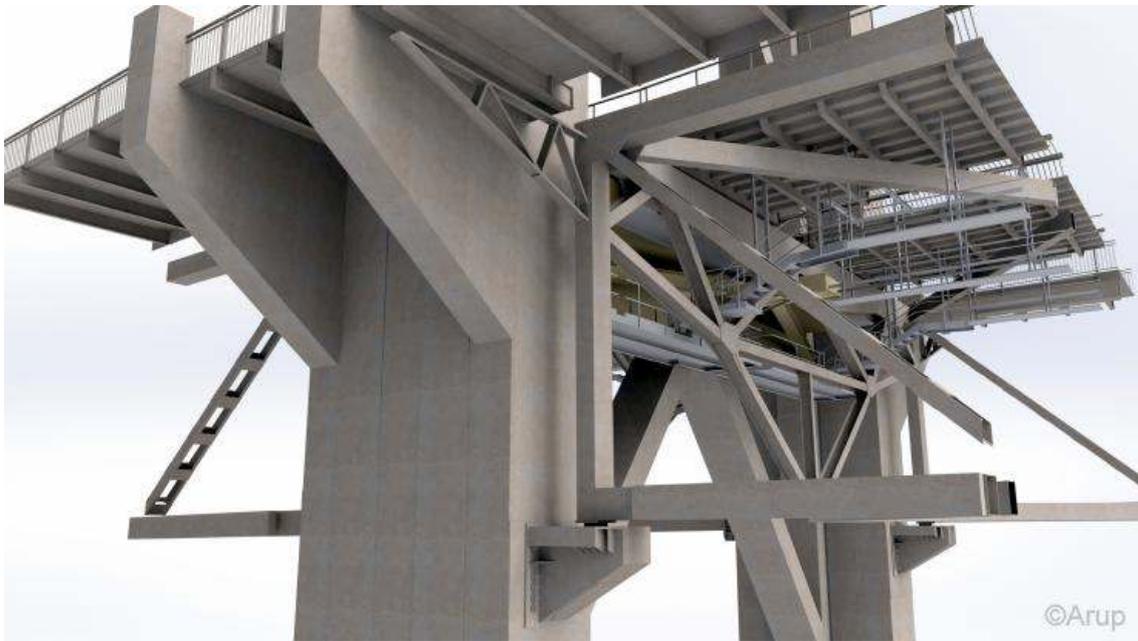
Figure 3.7: New sliding bearing (Arndt M., 2017)

The final stage of the work programme involved installing a new sliding bearing design to replace the fractured end link (Transport Scotland, 2017). In springtime 2017, the new bearing was installed and supported on a new bracket below the bridge deck (Transport Scotland, 2017). The replacement work was carried out successfully without causing bridge closure. By springtime 2018 the remaining end links were replaced with the new design. Structural health monitoring was then incorporated to complete that installed during the initial emergency works.

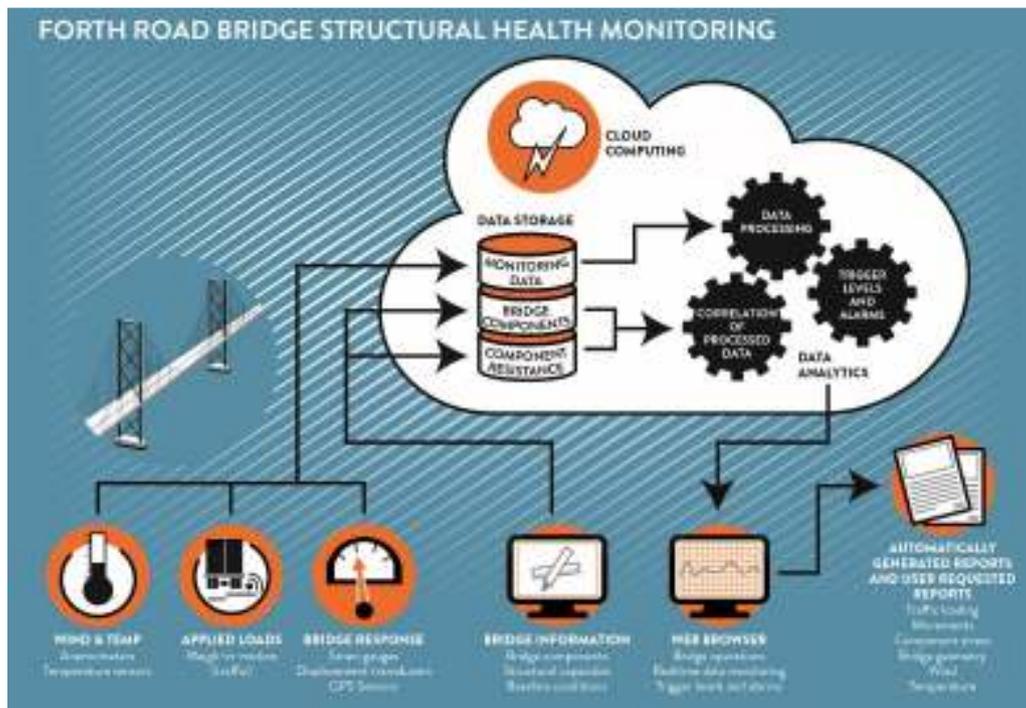
Figure 4.1: FRB structural health monitoring (Kitching, 2017)

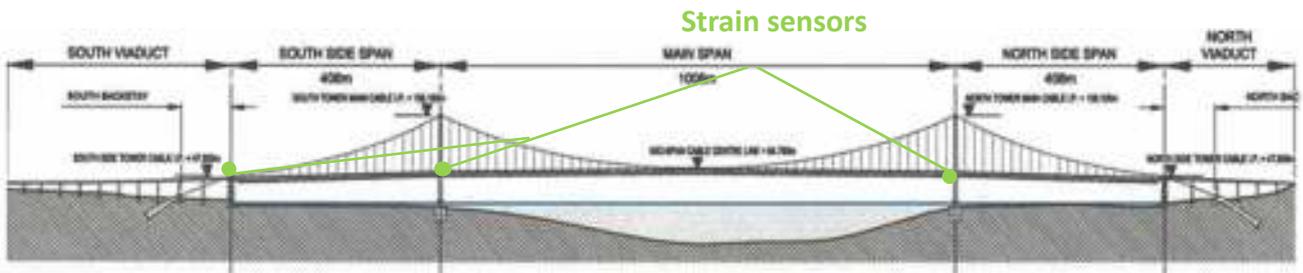
Figure 4.2: Sensors location (Angus,2017)

During the process of replacement of the links, 150 strain gauges and displacement sensors together with four data acquisition units (DAU) were installed first on the bridge (Angus E. , 2017). **Errore. L'origine riferimento non è stata trovata.**1 illustrates the first sensor arrangement utilised for the initial truss end link repair. This system was utilised to monitor the strains and displacements once the bridge was reopened to vehicles (excluding HGVs).

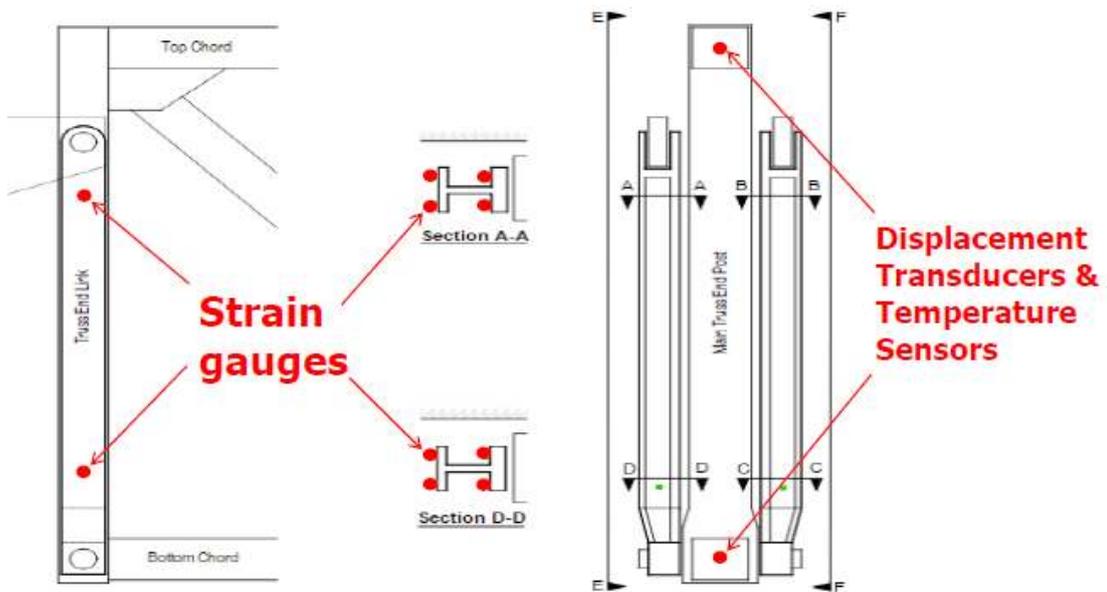
Figure 4.3: FRB truss end link original SHM system arrangement (Angus, 2018)

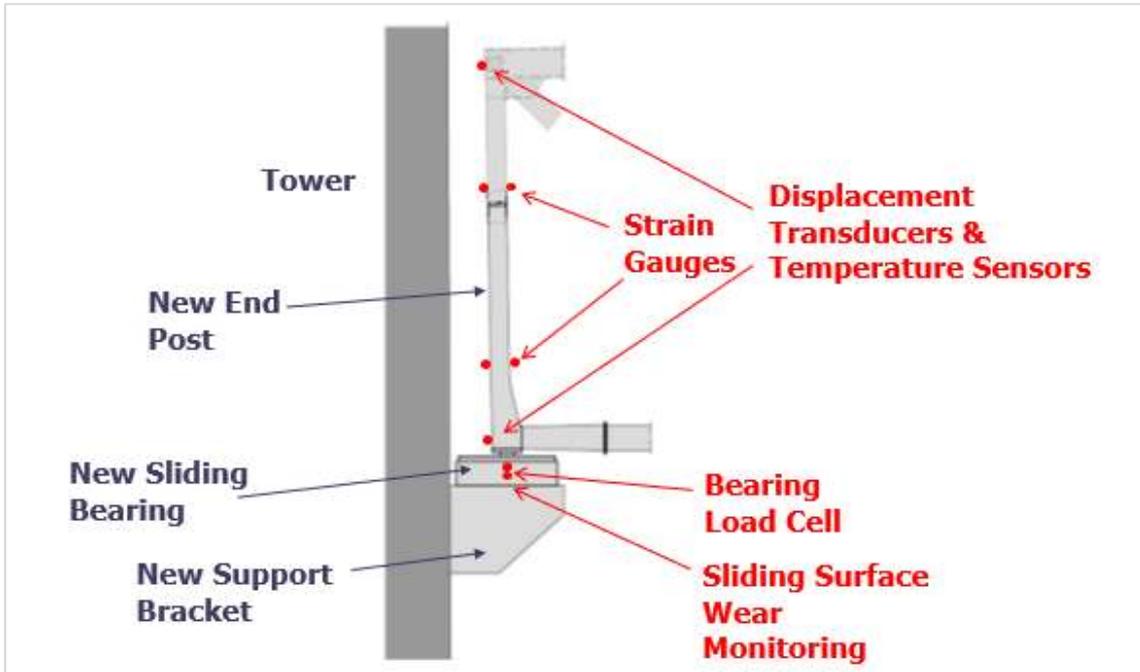
Figure 4.4: FRB new SHM system arrangement: main towers (Angus, 2018)

Figure 4.4 and Figure 4.5 highlight the updated SHM system utilised when the temporary end link repair work was replaced with the current sliding bearing design. It should be noted that the bearing types differ for the truss end links at the side towers from the main towers, with the side towers utilising a rocker bearing configuration. It should be noted that in Figure 4.4 a change in the load acting on the bearing sensor indicates a potential failure in the end truss link.
