POLITECNICO DI TORINO

**Corso di Laurea Magistrale
in Ingegneria Civile**

Tesi di Laurea Magistrale

Structural Health Monitoring of the Forth Road Bridge

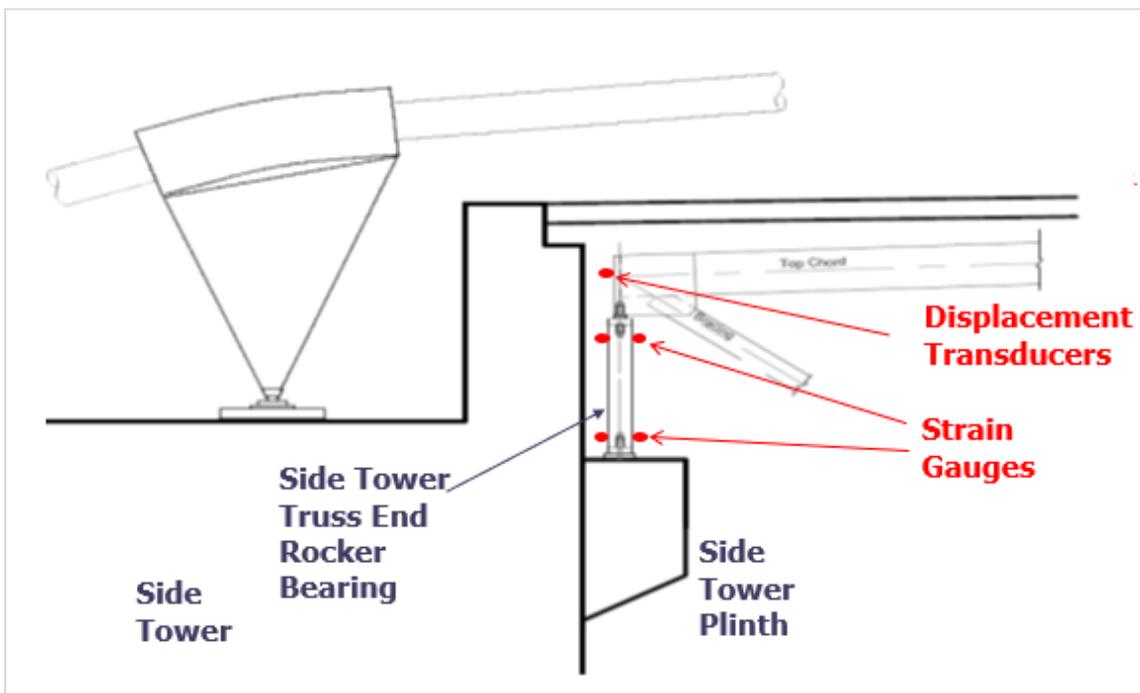
Figure 4.5: FRB new SHM system arrangement: side towers (Angus, 2018)

Figure 4.4 and Figure 4.5 highlight the updated SHM system utilised when the temporary end link repair work was replaced with the current sliding bearing design. It should be noted that the bearing types differ for the truss end links at the side towers from the main towers, with the side towers utilising a rocker bearing configuration. It should be noted that in Figure 4.4 a change in the load acting on the bearing sensor indicates a potential failure in the end truss link.

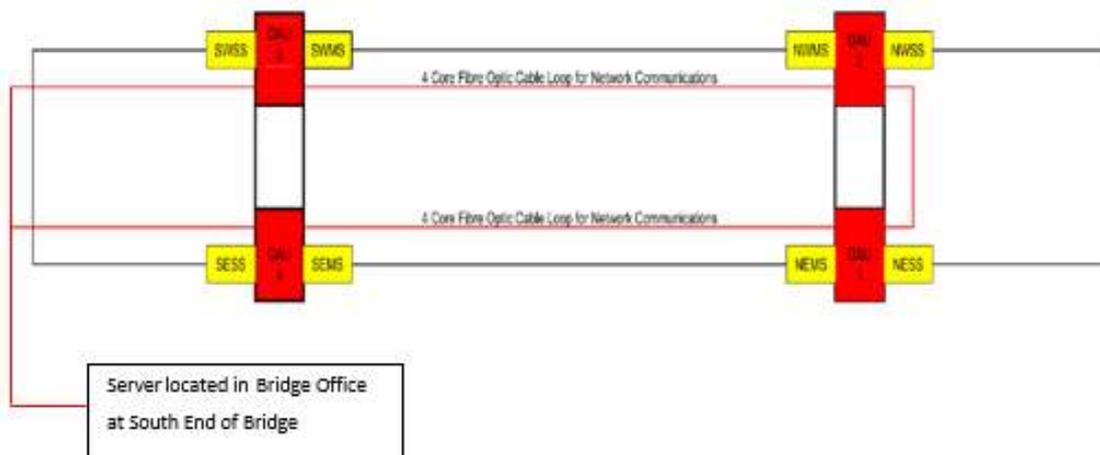
Figure 4.6: System overview (Strainstall, 2016)

Currently the SHM system on the Forth Road Bridge consists of a network of DAU's distributed over the bridge structure. The SHM main system is made up of (Data Software) DS-DAU's, connected by a fibre-optic network to one server, which is located at the bridge office (Strainstall, 2016).

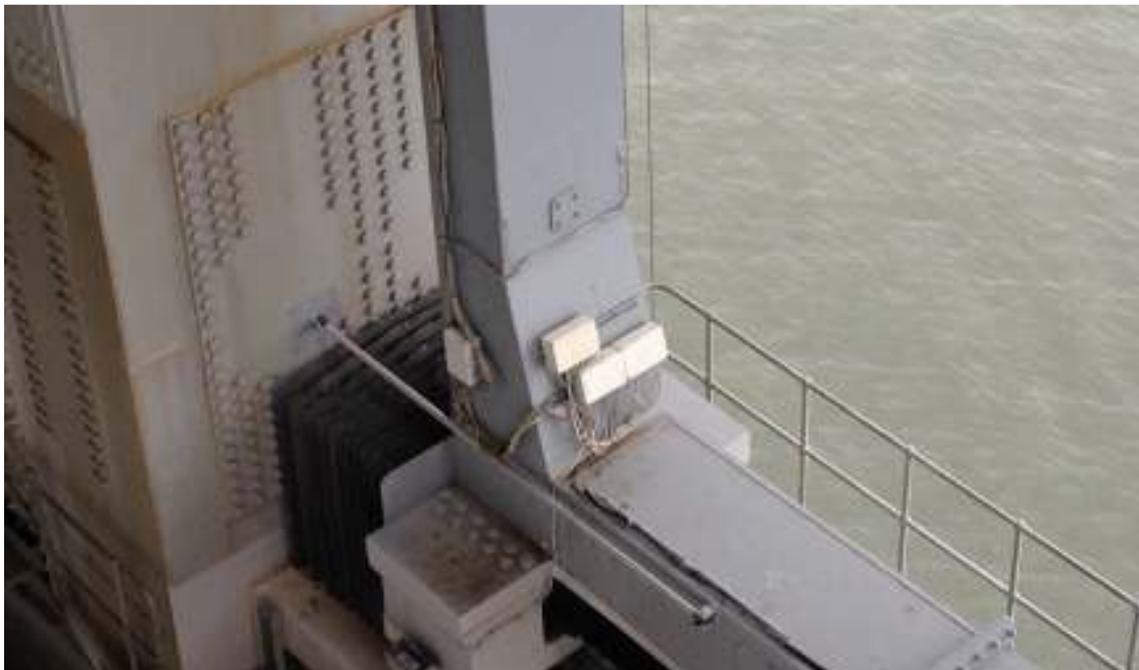
Figure 4.9: Displacement transducer at the bottom of the end post at NEMS

The deployments in the main towers are at the bottom of the end post next to the sliding bearings and at the top. The deployment in one of this section at the North Tower is shown in Figure 4.7. These areas have been selected as the design of the structure dictates that movement will be allowed at these locations. These movements should however be closely monitored to ensure there are within expected ranges and there is no unexpected structural behaviour, which may indicate damage.

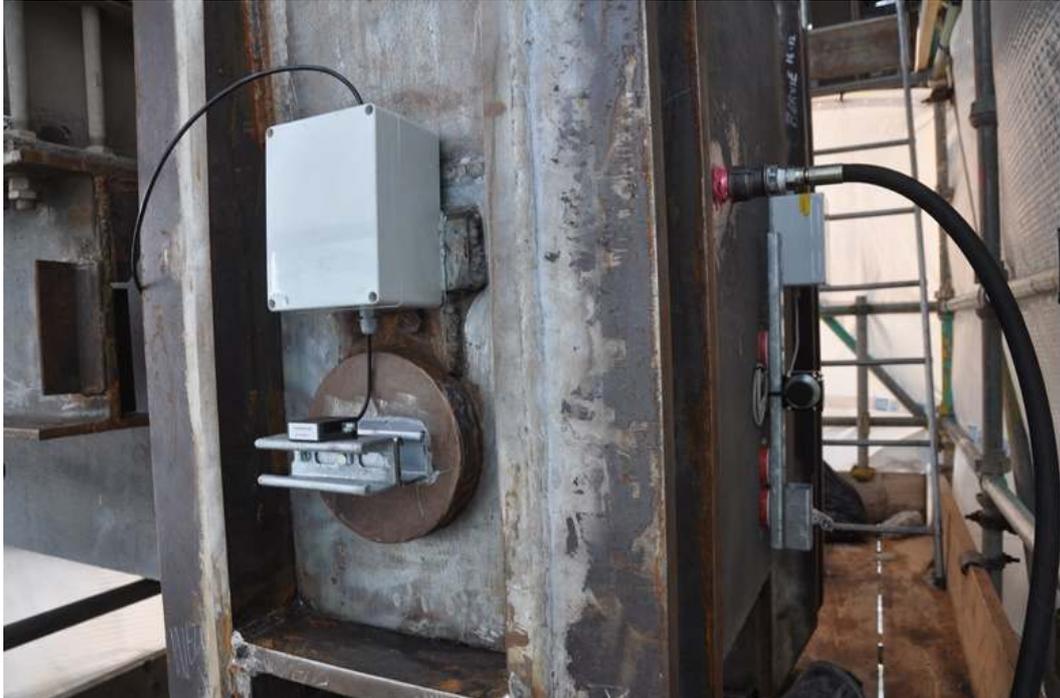
Figure 4.10: Tiltmeter on truss end link NEMS (Kitching, 2017)

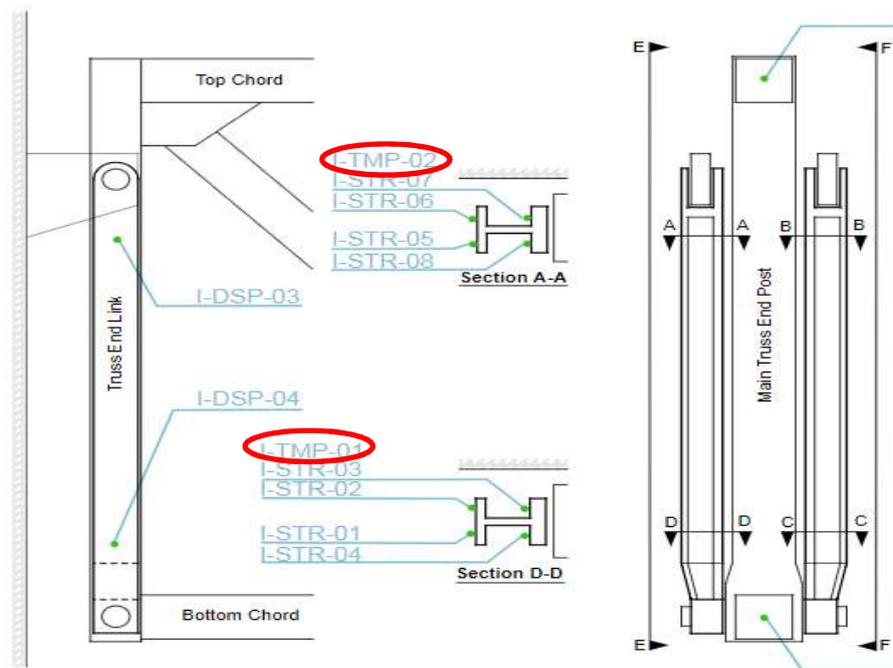
Figure 4.12: Strain gauge temperature sensor at NEMS truss (Arndt M., 2017)

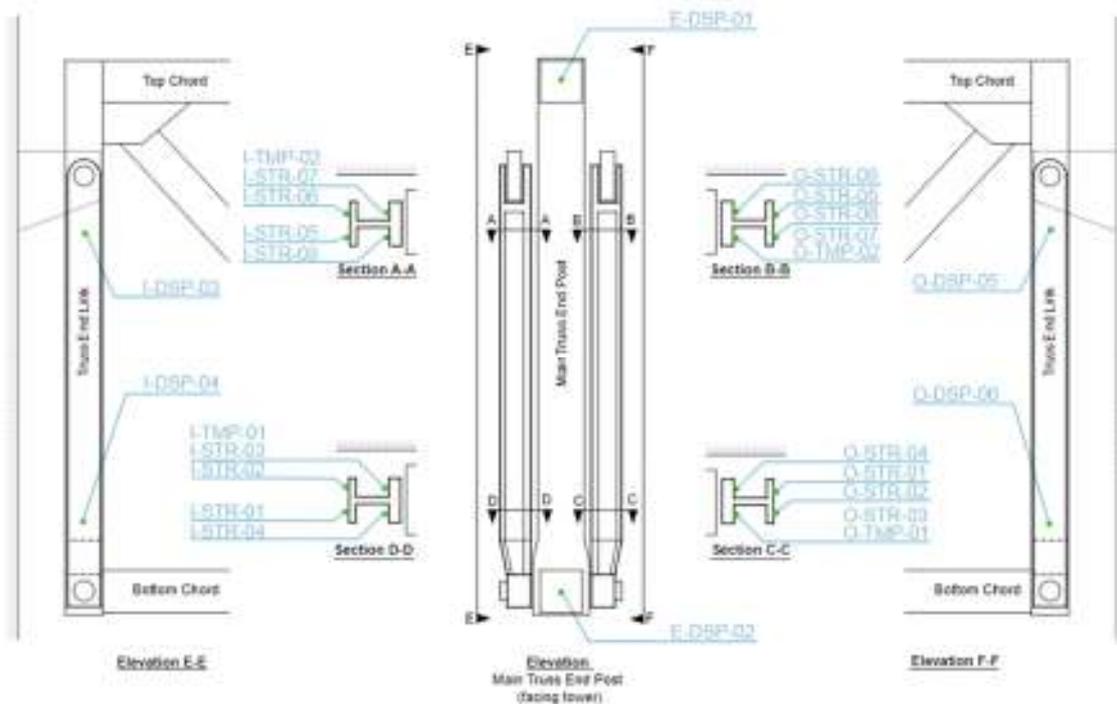
Figure 5.1: Strain gauges positions (Arndt M., 2017)

There is a total of eight strain sensors per link located at each side of the towers, see Figure 5.1. Strain sensors 01,02,03 and 04 together with displacement transducers 02 have been analysed in this thesis.

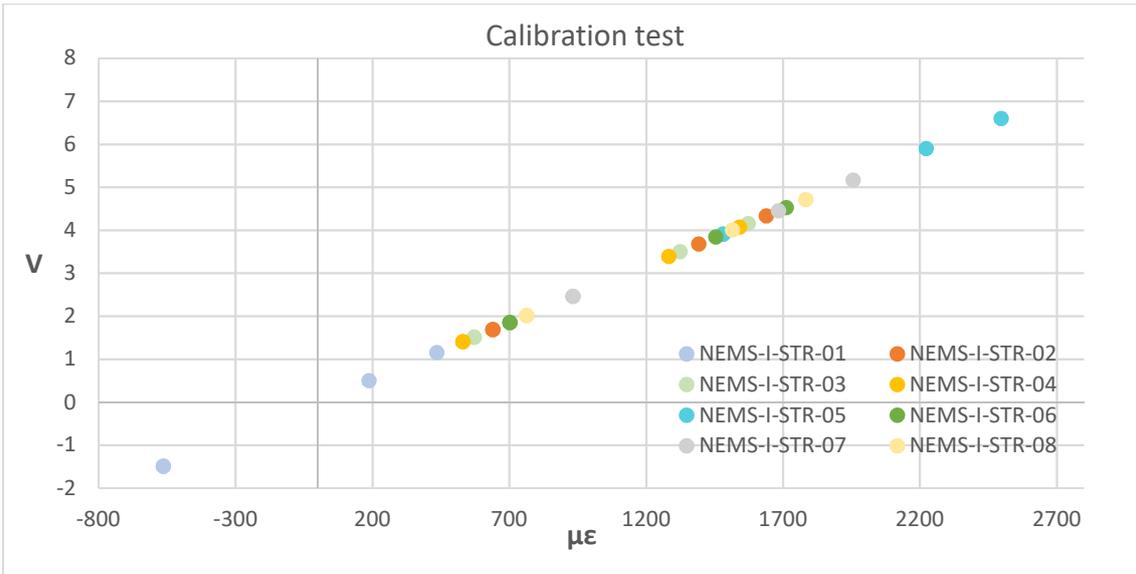
Figure 5.2: V- $\mu\epsilon$ correlation

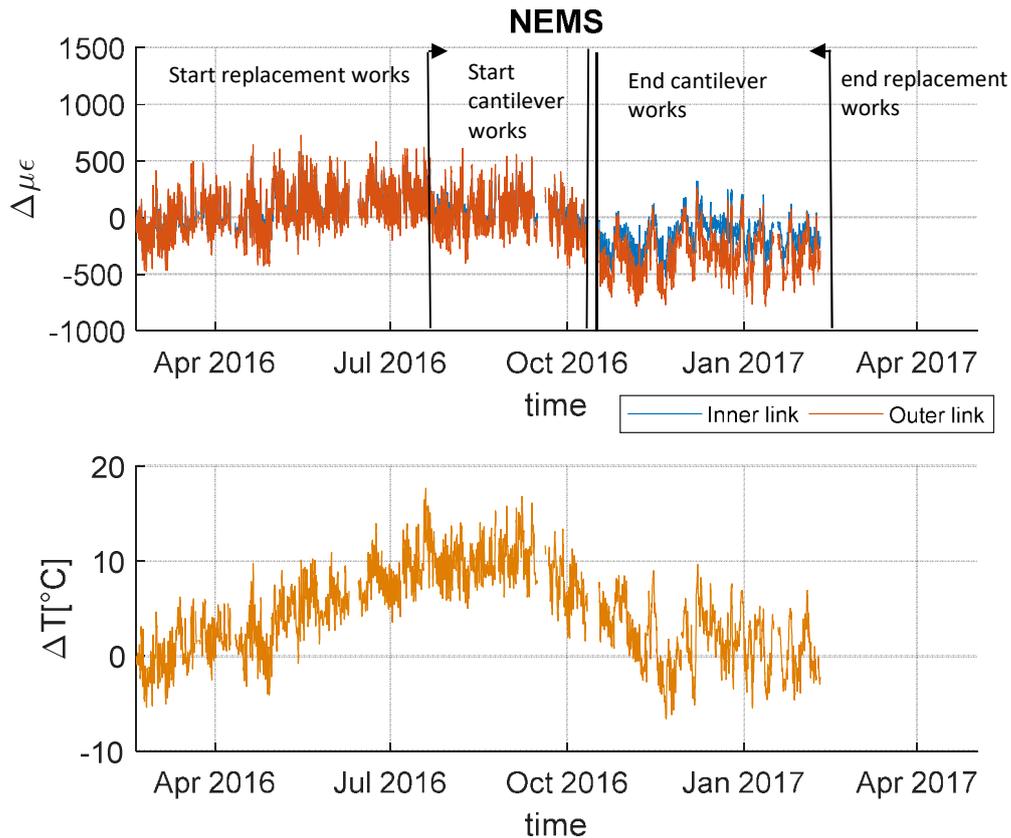
Figure 6.1: NEMS full-time history uncompensated strain and temperature

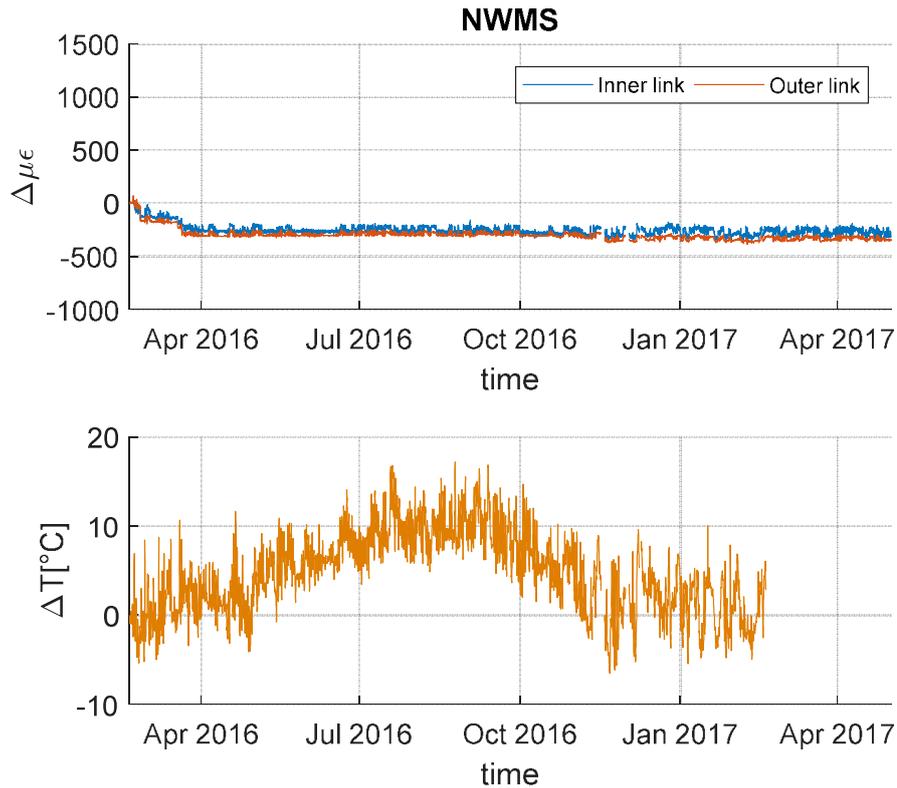
Figure 6.2: NWMS full-time history uncompensated strain and temperature

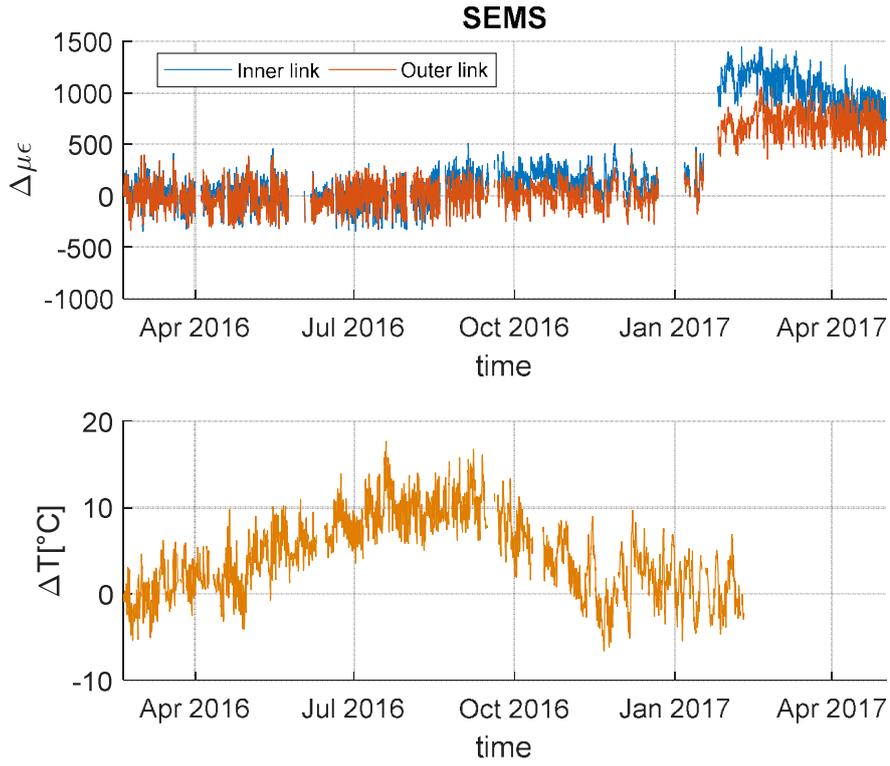
Figure 6.3: SEMS full-time history uncompensated strain and temperature

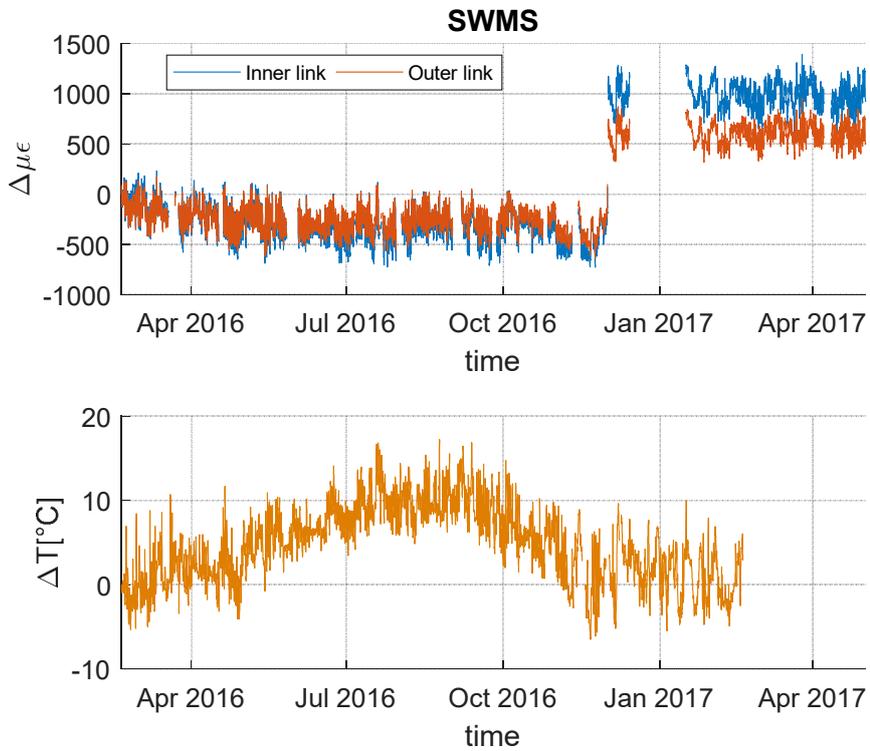
Figure 6.4: SWMS full-time history uncompensated strain and temperature

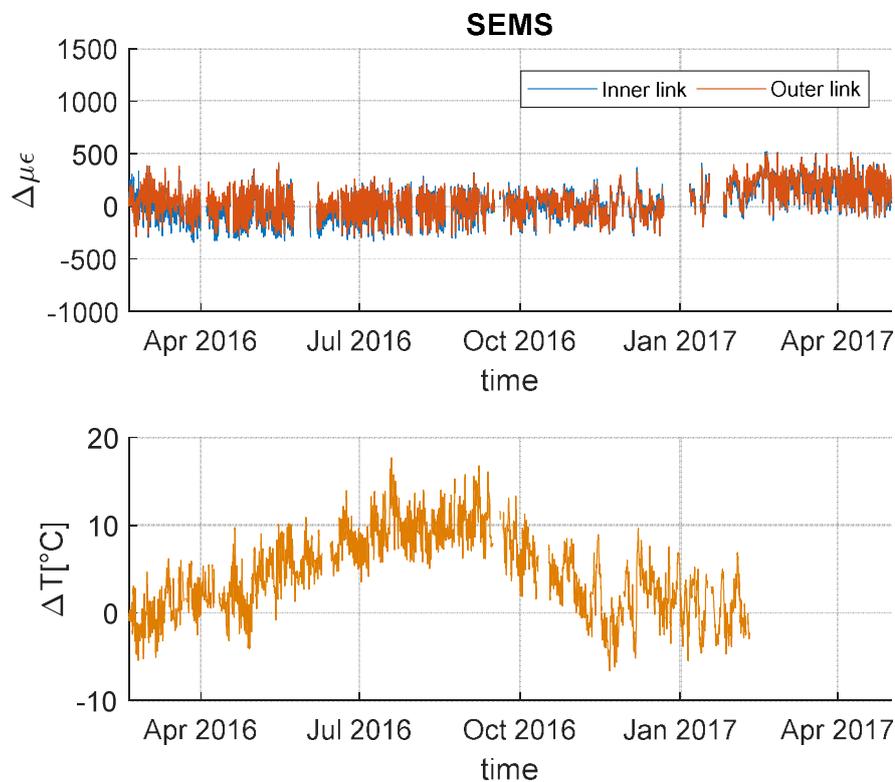
Figure 6.5: SEMS full-time history shifted data

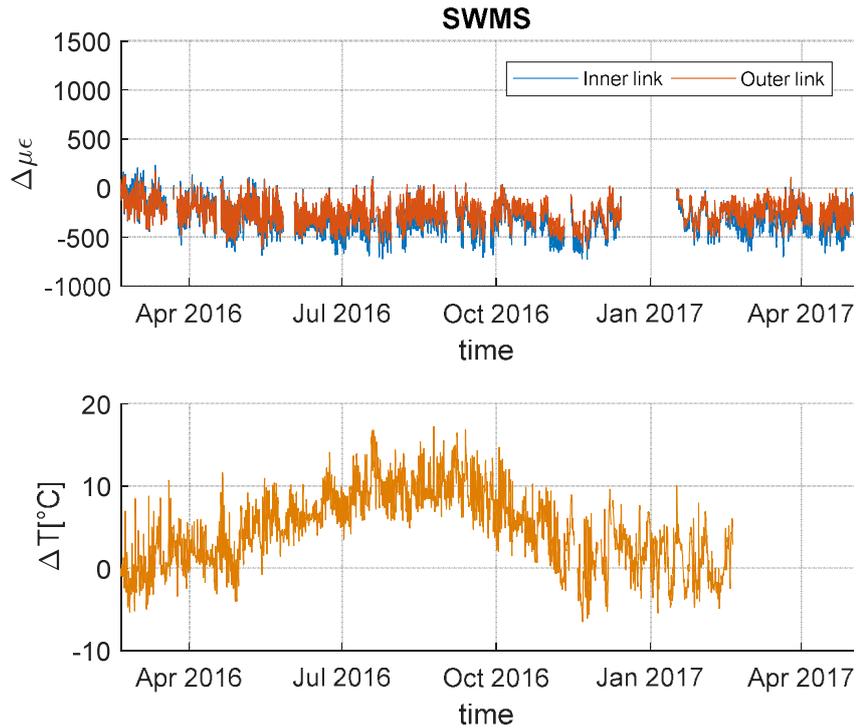
Figure 6.6: SWMS full-time history shifted data

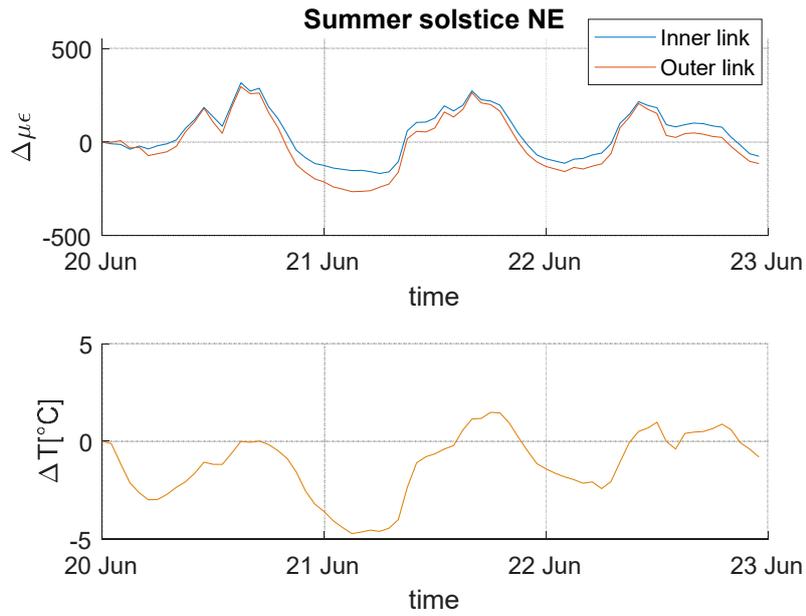
Figure 6.7: NEMS Summer solstice uncompensated strain and temperature

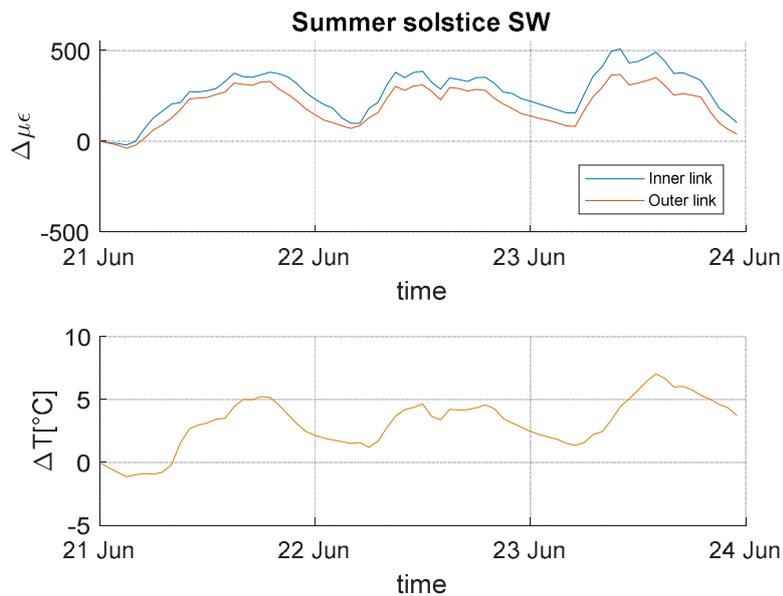
Figure 6.10: SWMS Summer solstice uncompensated strain and temperature

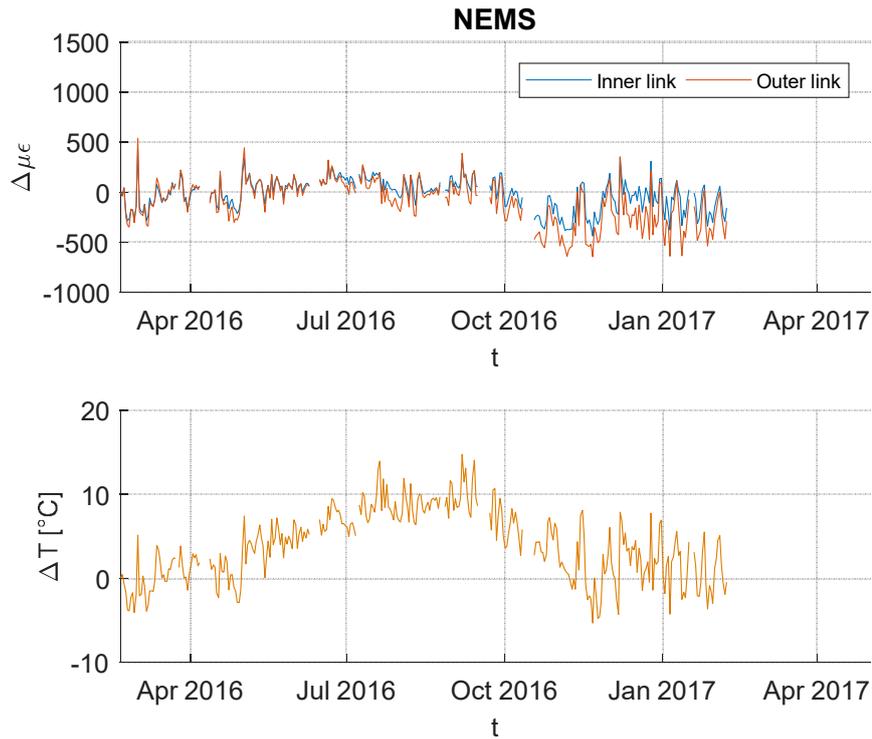
Figure 6.15: NEMS full-time history of reduced strain and temperature

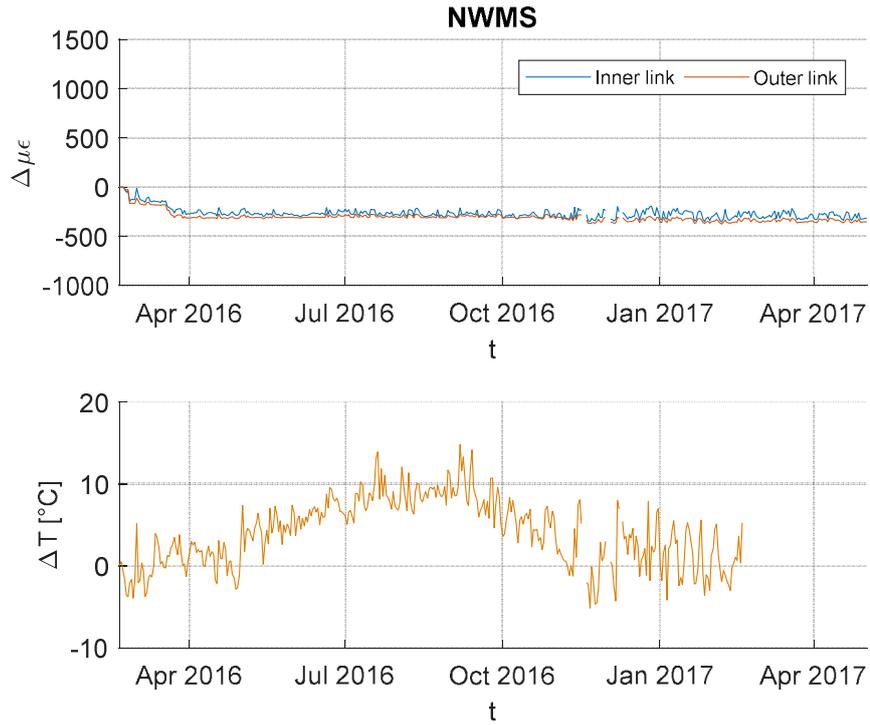
Figure 6.16: NWMS full time history of reduced strain and temperature

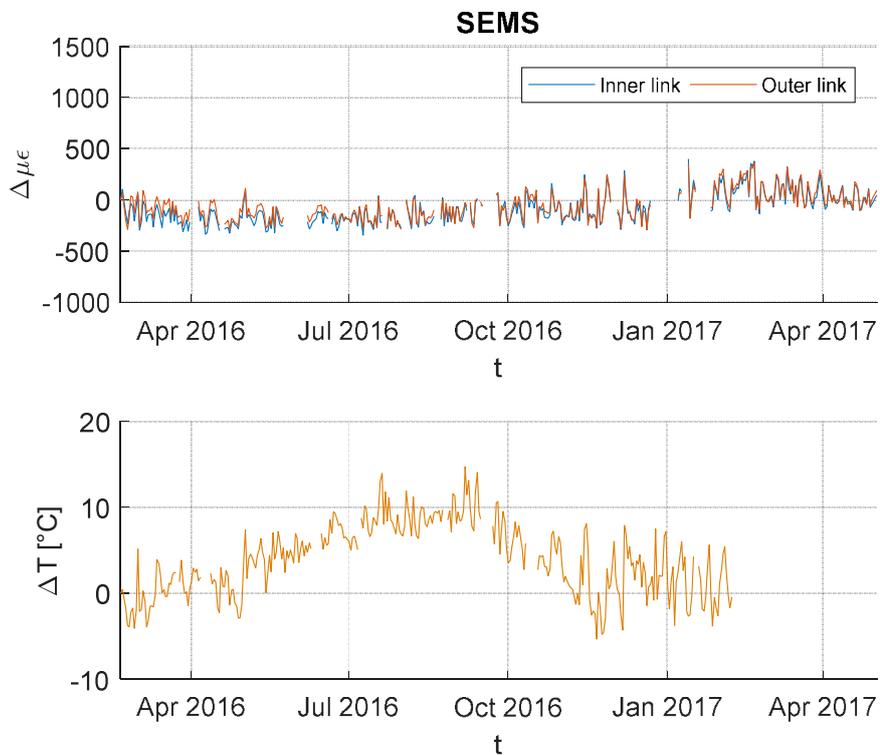
Figure 6.17: SEMS full-time history of reduced strain and temperature

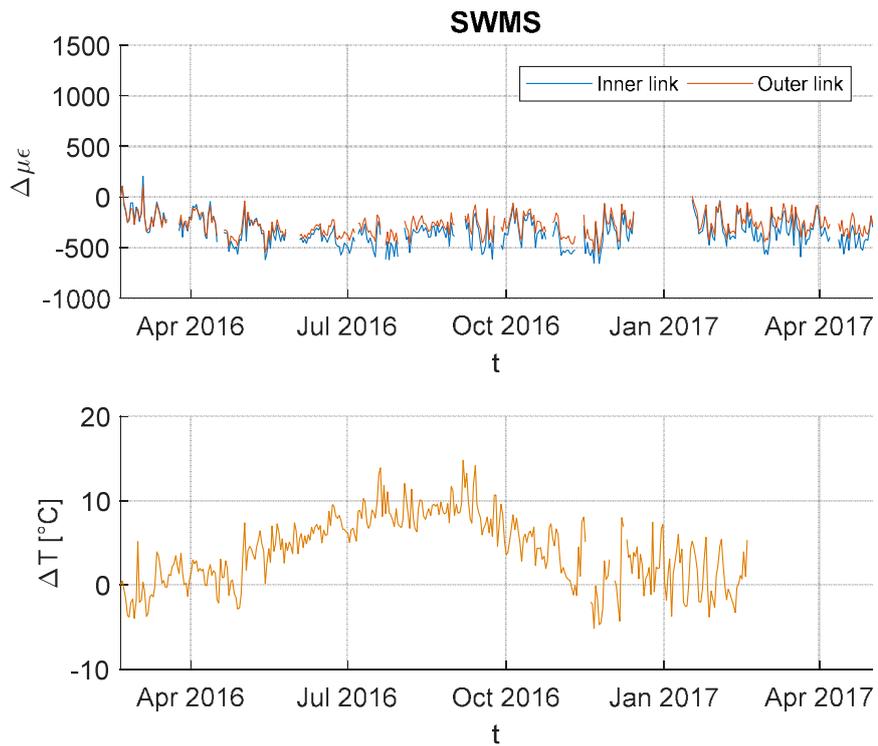
Figure 6.18: SWMS full-time history of reduced strain and temperature

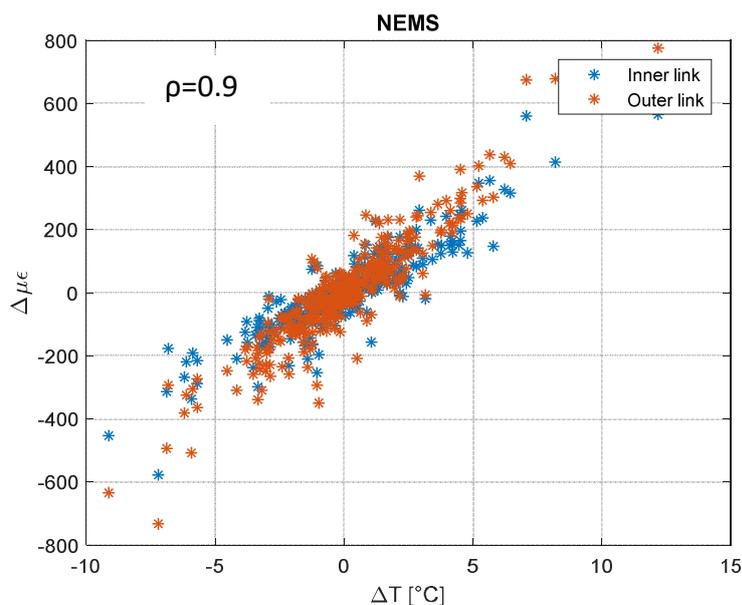
Figure 6.20: NEMS strain temperature correlation

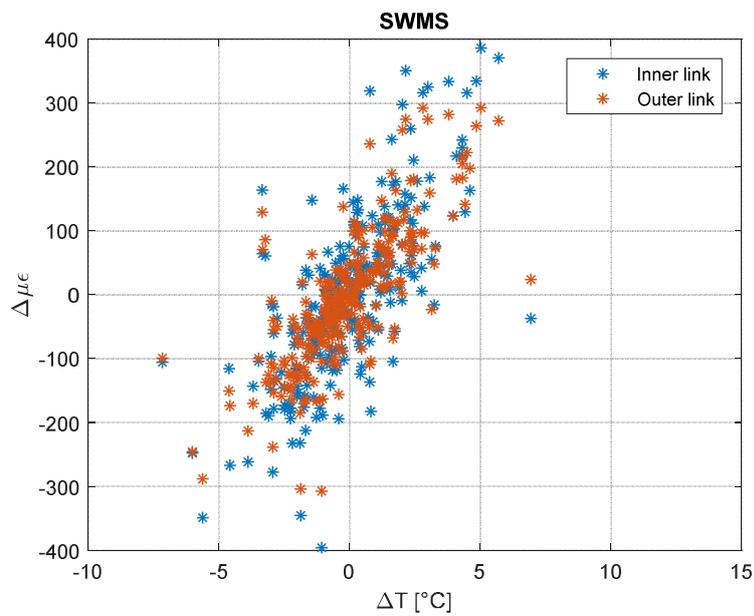
Figure 6.23: SWMS strain temperature correlation

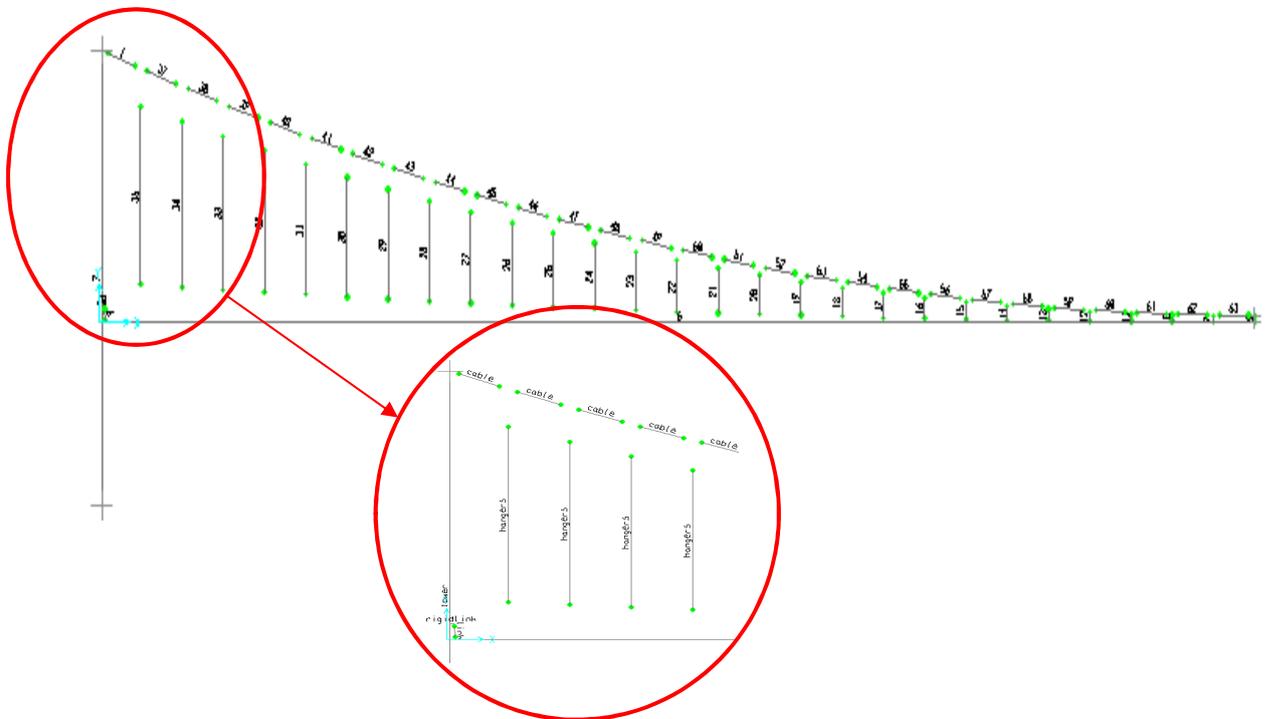
Figure 6.24: Finite element model

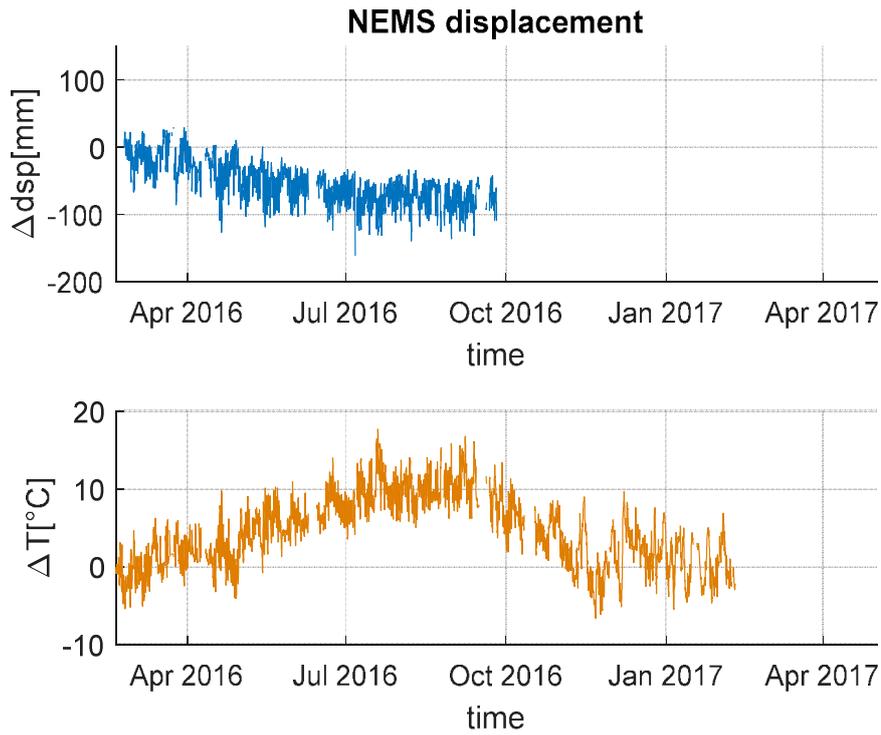
Figure 6.27: NEMS full-time history uncompensated displacement

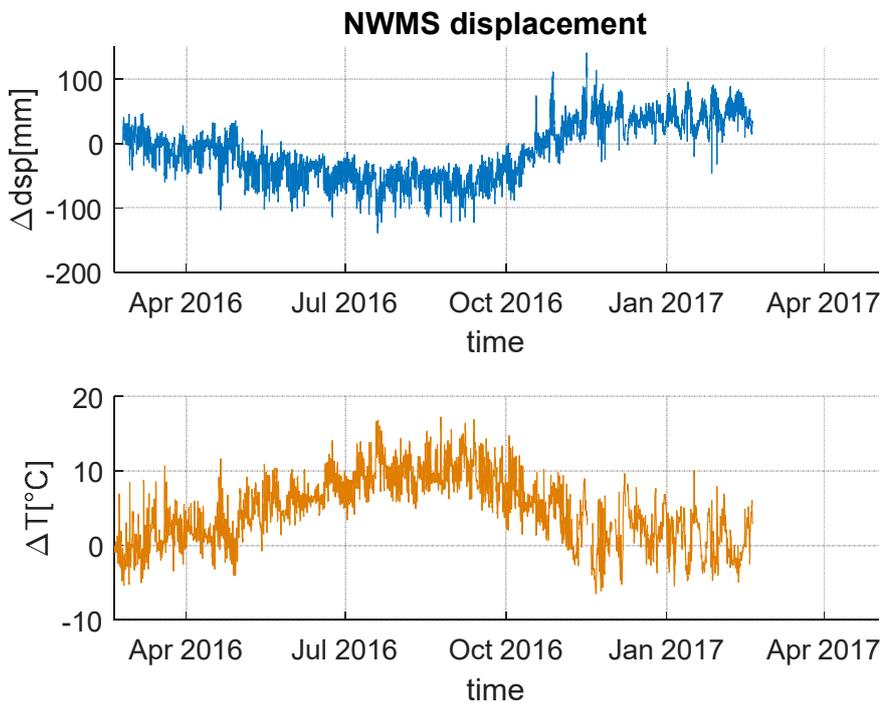
Figure 6.28: NWMS full-time history uncompensated displacement

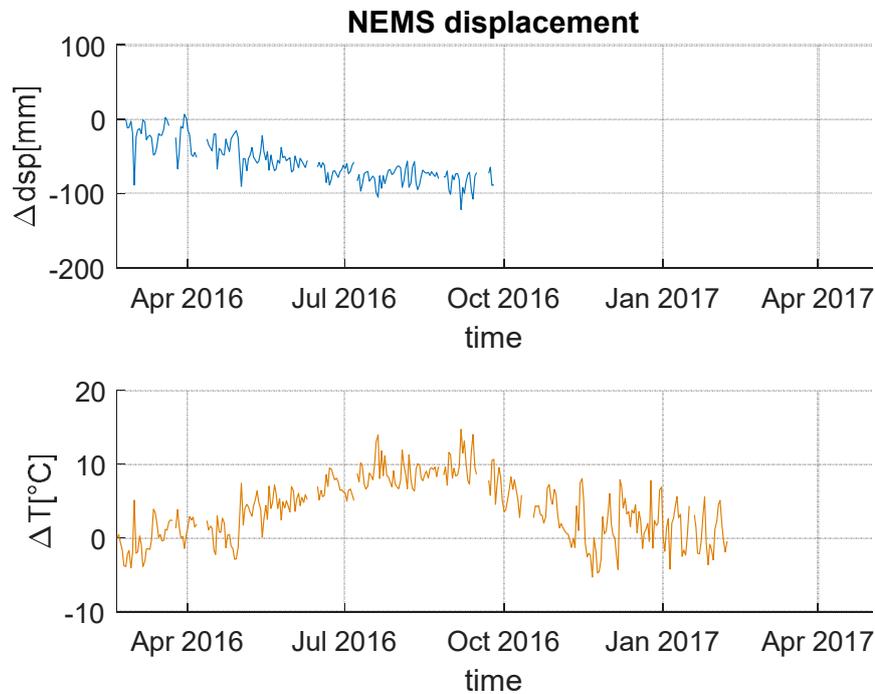
Figure 6.29: NEMS full-time history reduced displacement

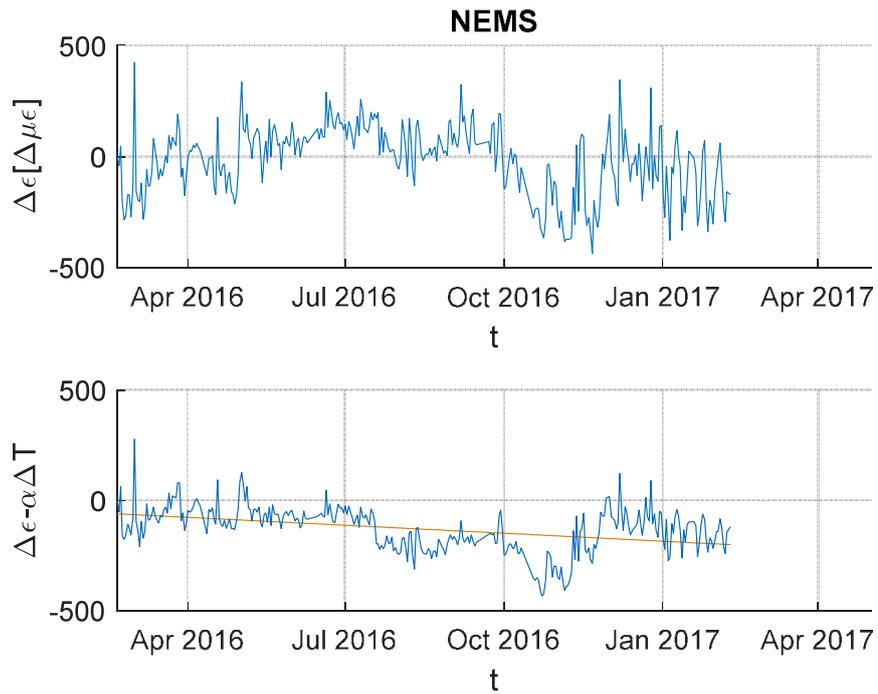
Figure 6.31: NEMS compensated data

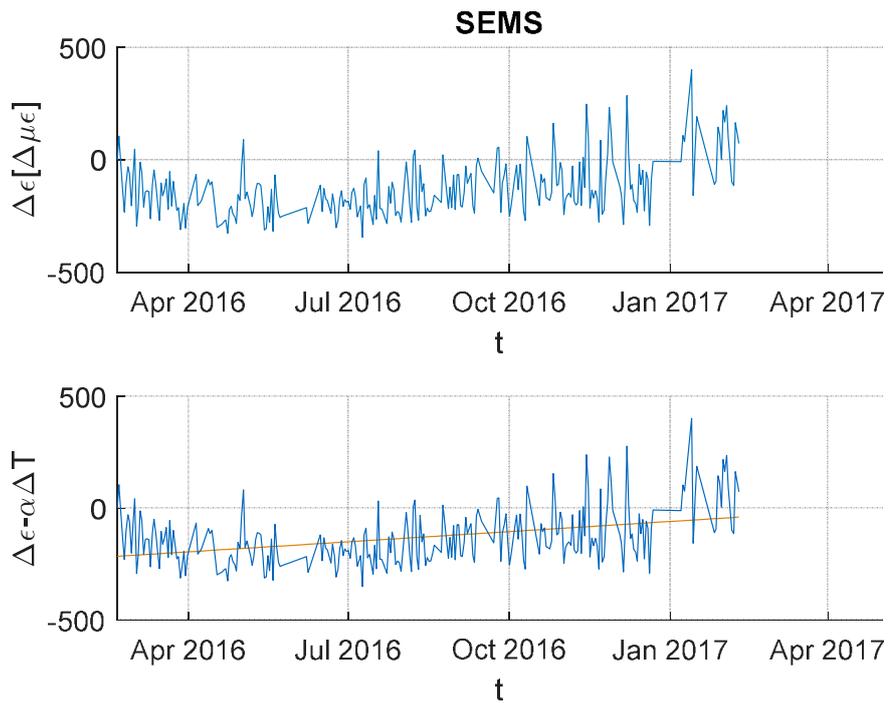
Figure 6.32: SEMS compensated data

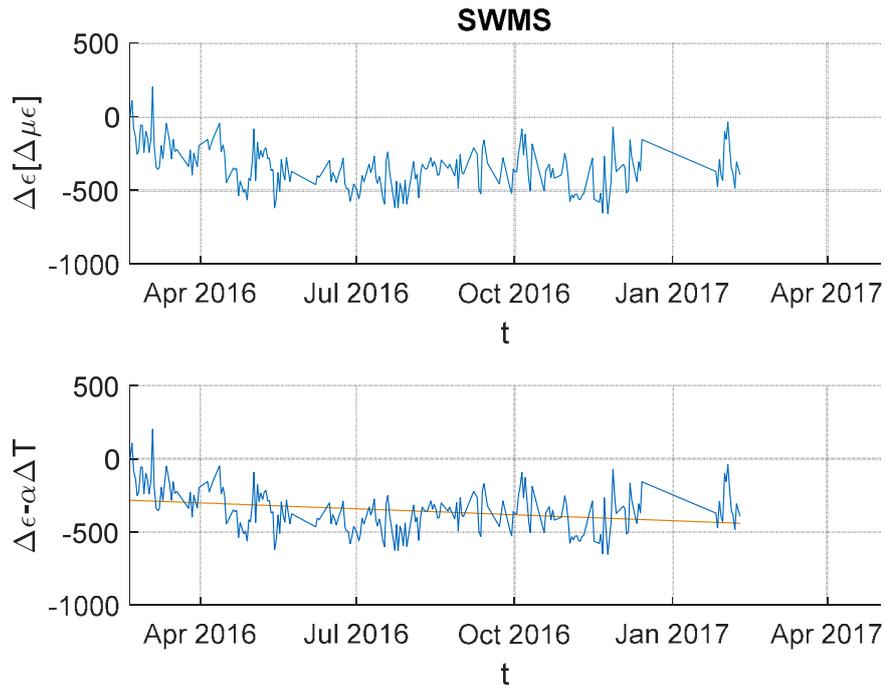
Figure 6.33: SWMS compensated data

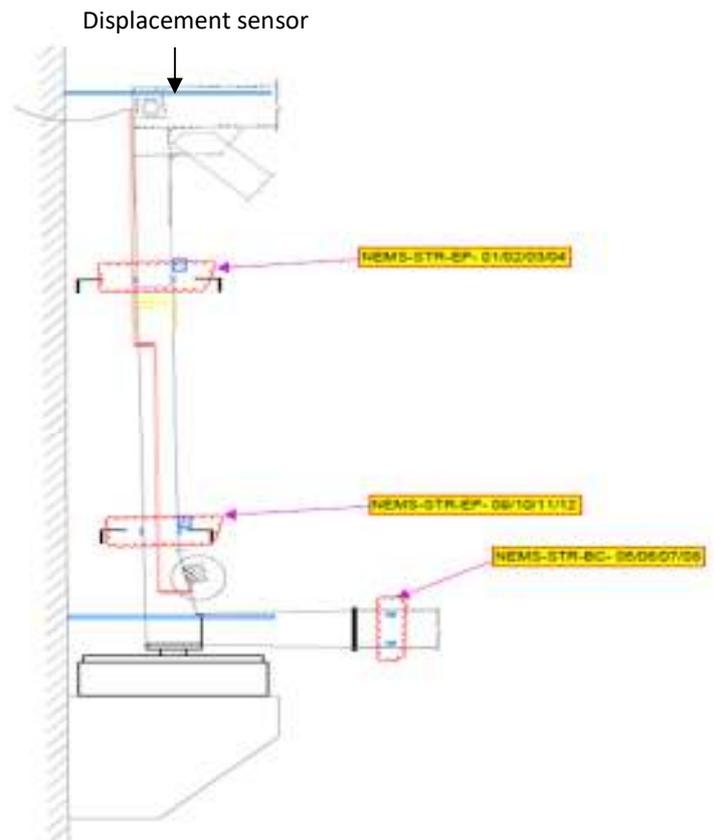
Figure 7.1: New bearing sensors arrangement

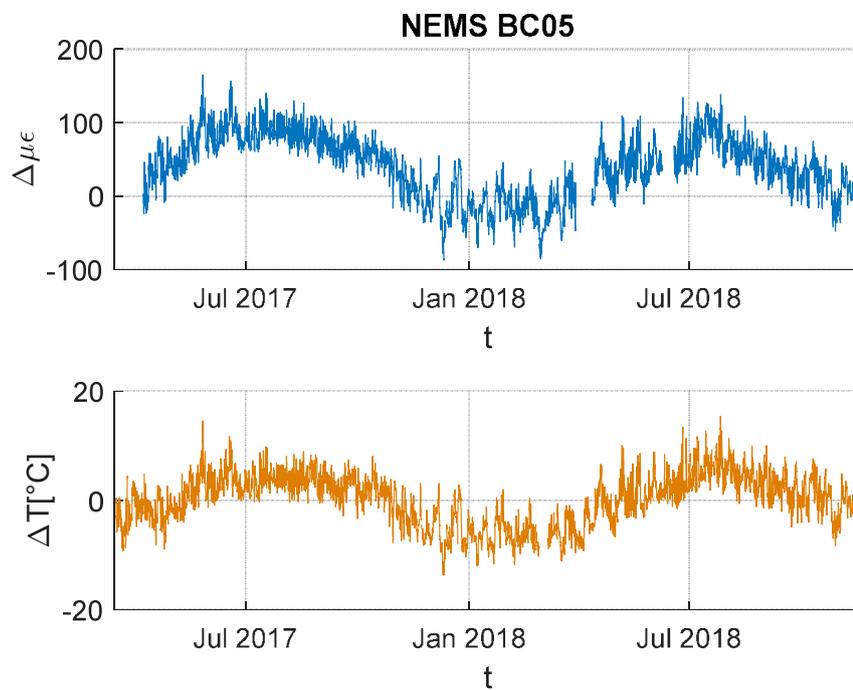
Figure 7.2: BC full time history uncompensated strain and temperature

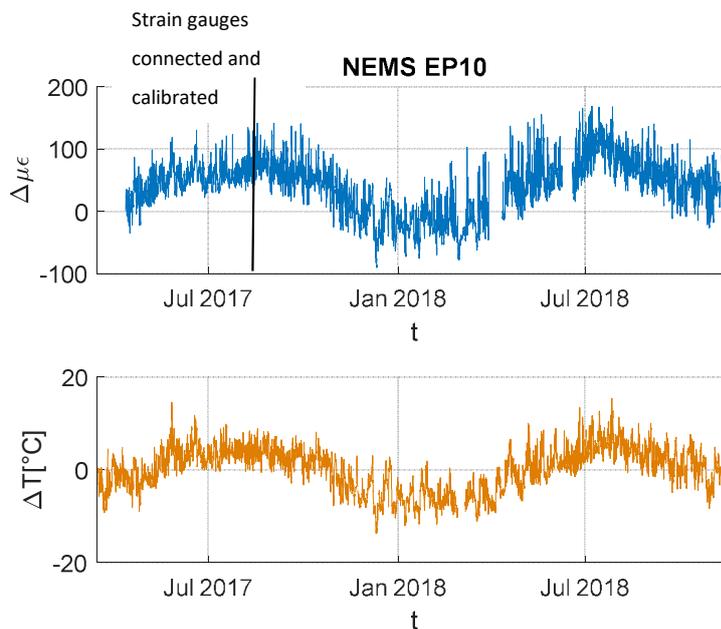
Figure 7.3: EP full time history uncompensated strain and temperature

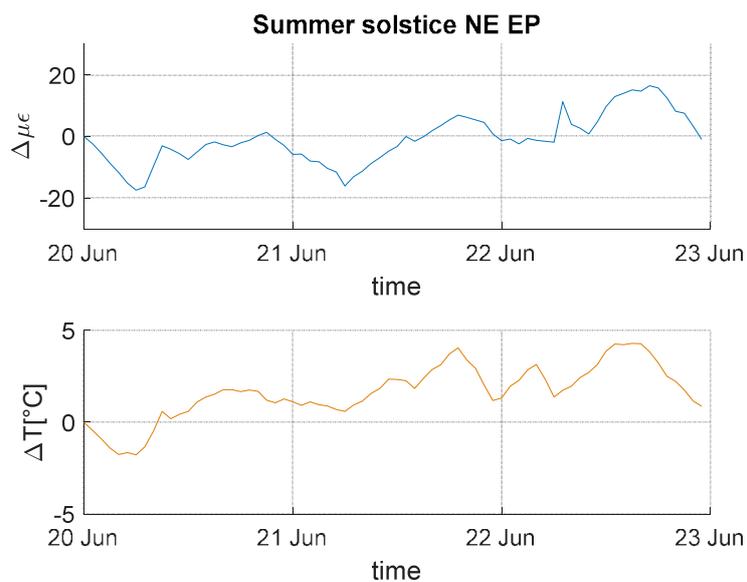
Figure 7.5: EP Summer solstice uncompensated strain and temperature

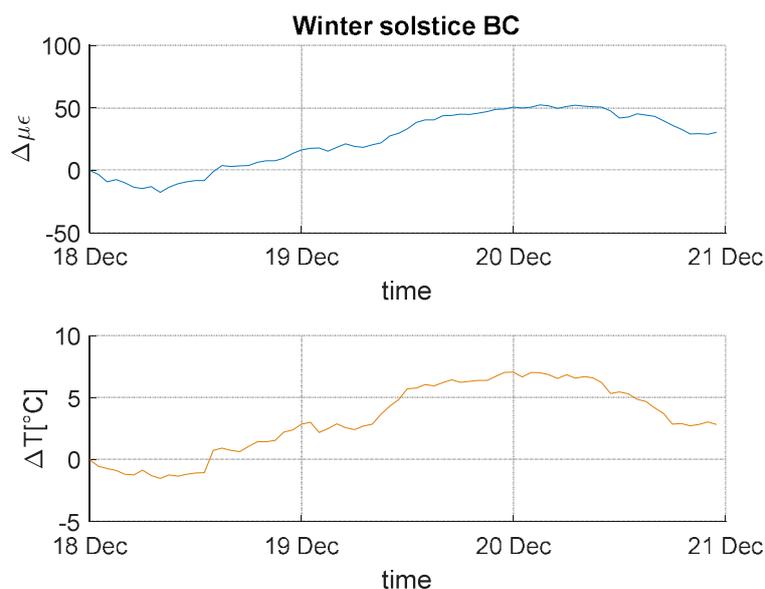
Figure 7.6: BC Winter time uncompensated strain and temperature

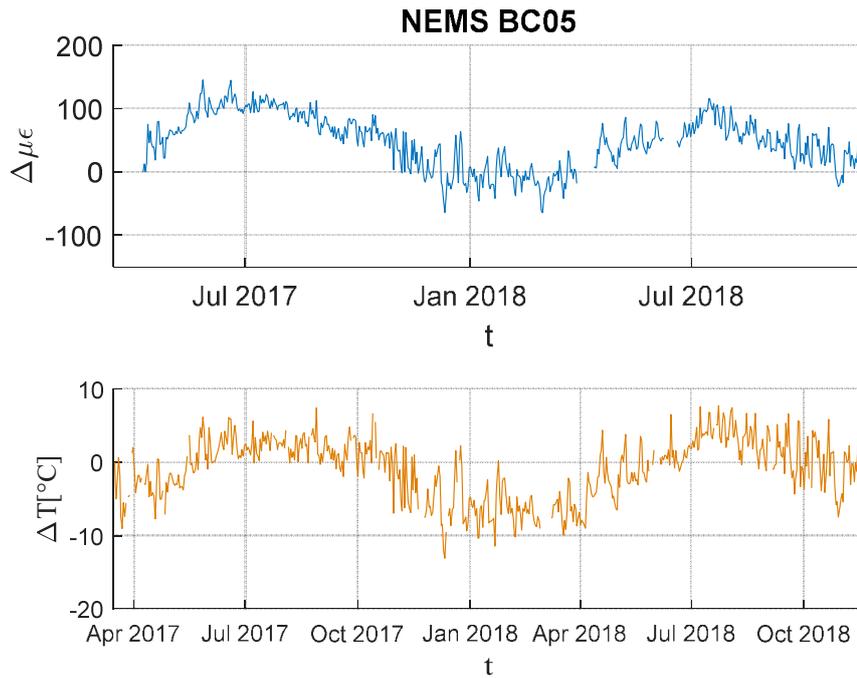
Figure 7.8: BC full-time history of reduced strain and temperature

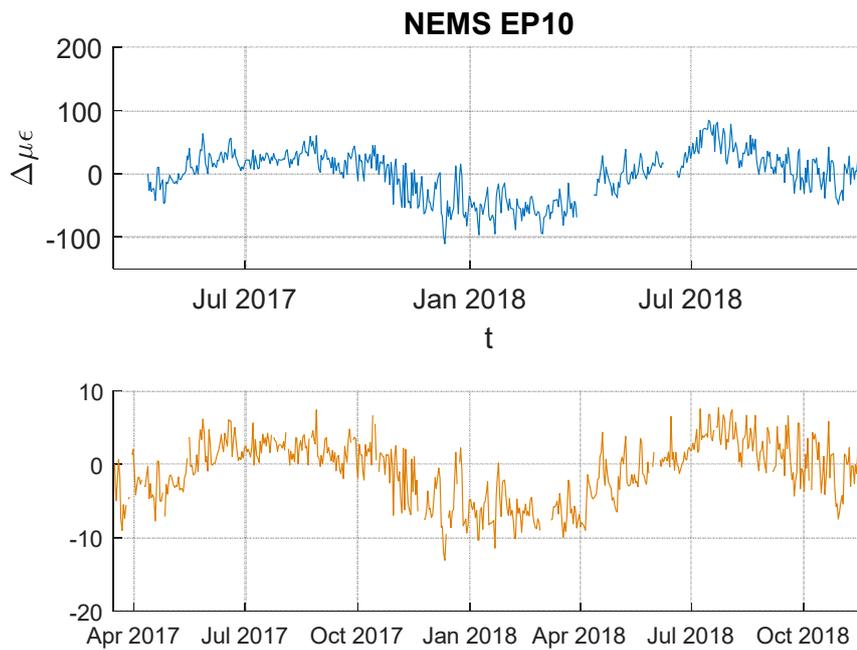
Figure 7.9: EP full-time history of reduced strain and temperature
