POLITECNICO DI TORINO

**Corso di Laurea Magistrale
in Ingegneria Civile**

Tesi di Laurea Magistrale

Structural Health Monitoring of the Forth Road Bridge

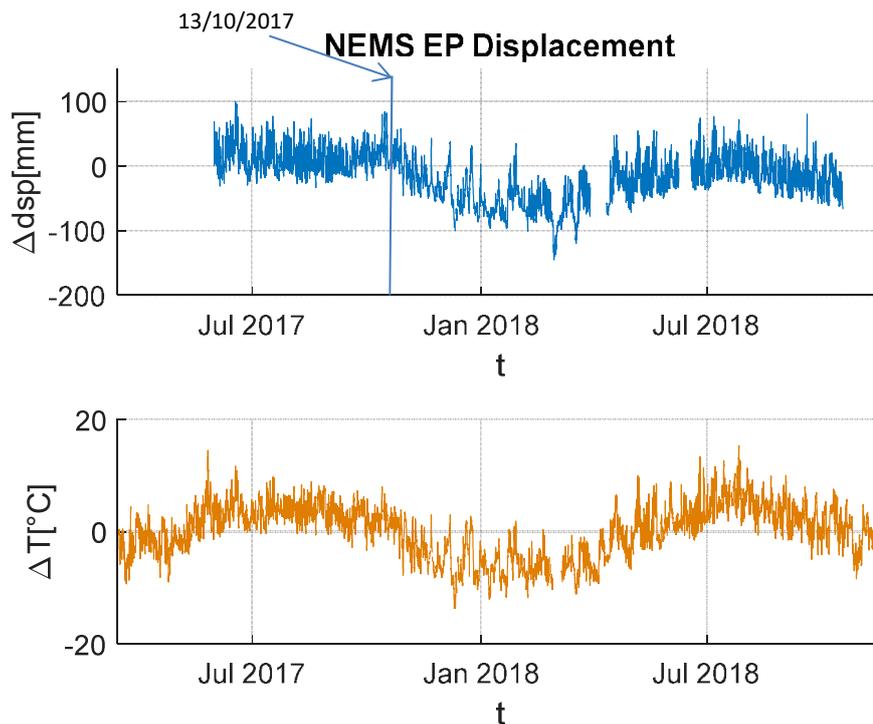
Figure 7.12: EP full-time history uncompensated displacement

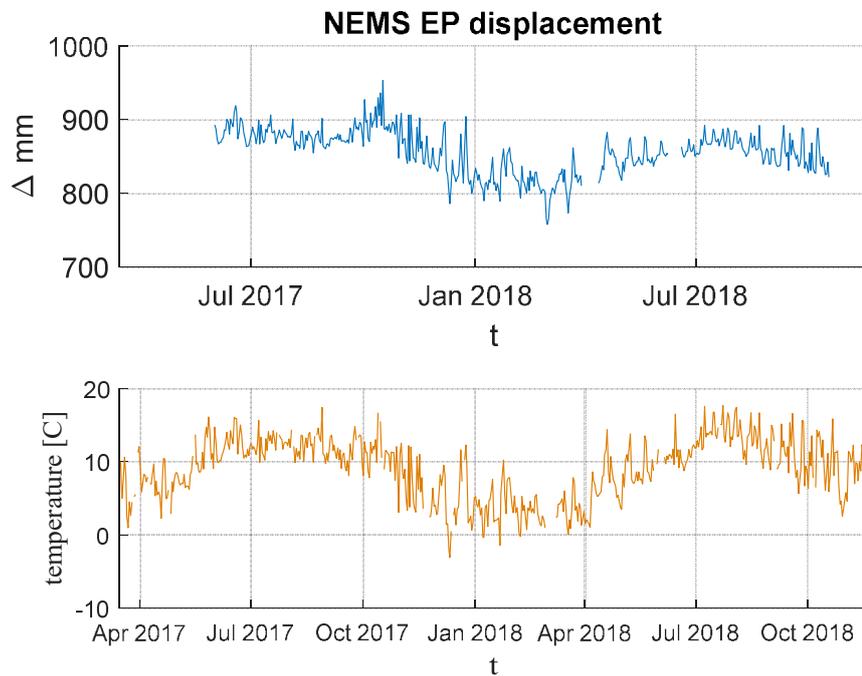
Figure 7.13: EP full-time history of reduced strain and temperature

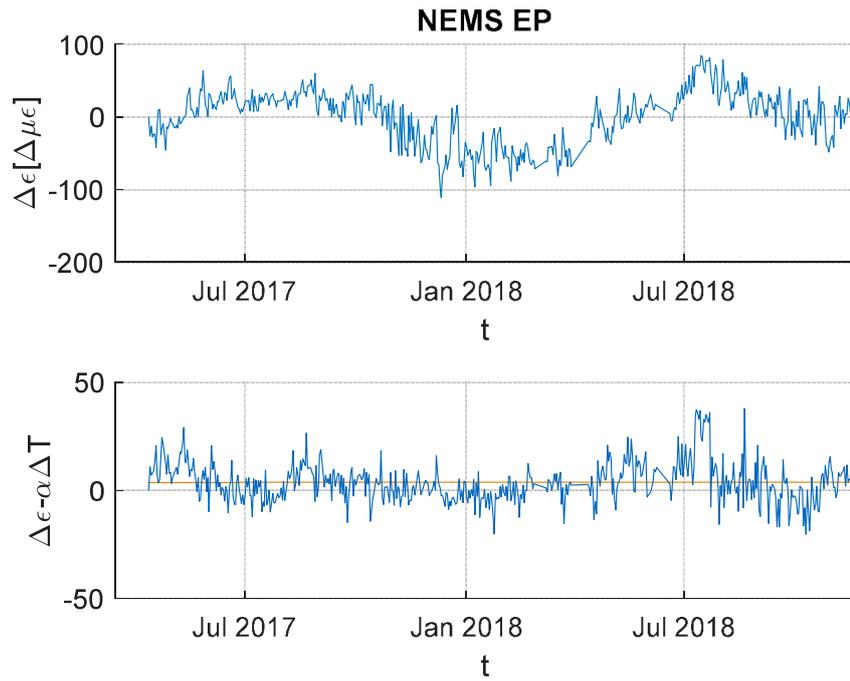
Figure 7.15: EP compensated data

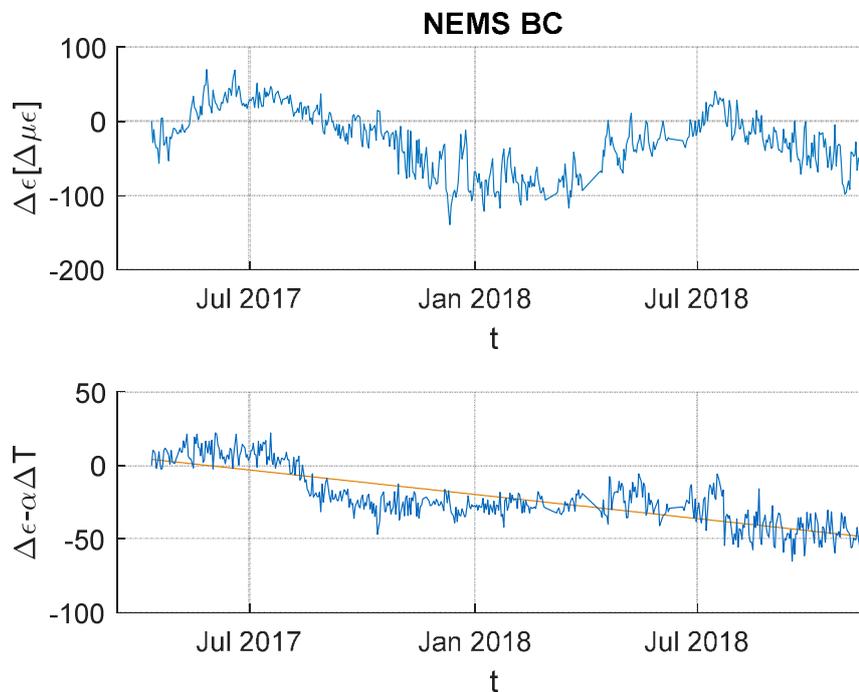
Figure 7.16: BC compensated data
