POLITECNICO DI TORINO

Master's Degree in Civil Engineering

Master's Degree Thesis

**Tailings Dam Collapse and Propagation Modelling: A Study Case
in Brazil**

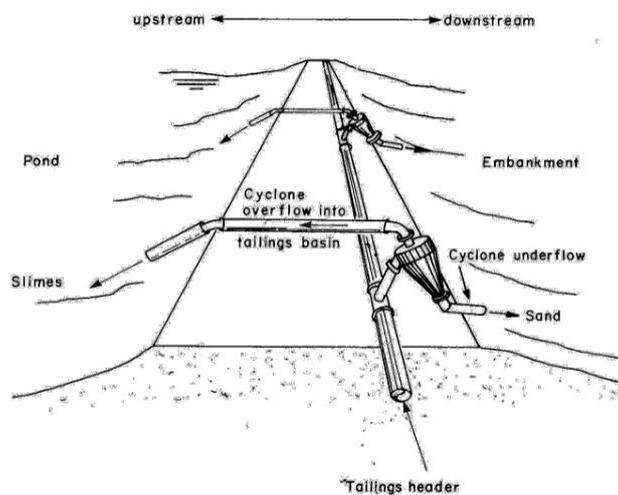
The hydraulic separation can be done using hydrocyclones, which also enables the division of the tailings into fine and coarse particles (more commonly sand). The excess water and the coarse particles are launched downstream and the fine material with remaining water is launched upstream the dyke (Figure 1) (Thomé & Passini, 2018).

Figure 1 - Hydraulic separation through hydrocyclones (Fleurisson & Cojean, 2016).

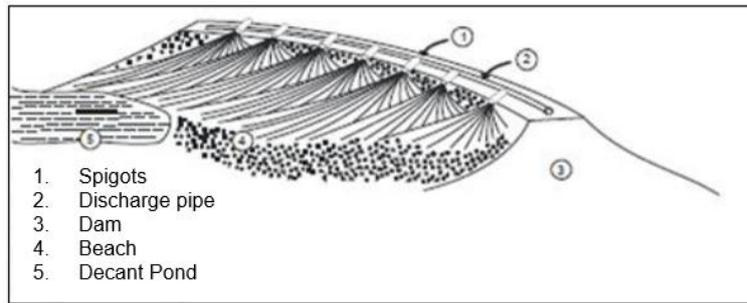
Another technique is the spigotting, where all the material is disposed upstream the dyke (Figure 2). Due to different settling velocities, the coarse particles accumulate near the discharge points, forming beaches that work as a retention shell (Martin, 2002), meanwhile, the fines are carried by the water flow and deposit on the ponds (Thomé & Passini, 2018).

Figure 2 - Spigotting technique (Adapted from Thomé & Passini, 2018).

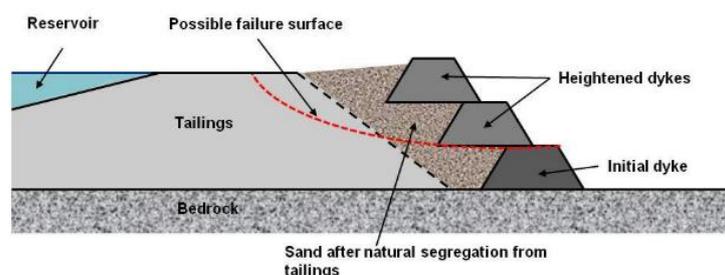
Initially, only the starter dyke is constructed, and when the need for more volume capacity takes place, the so-called heightening dykes are built (Figure 4). Different procedures can be used for this process, according to the shift of the axis of the dam. Among them, there is the upstream method that consists of the construction of the new dykes over the beaches formed in the decantation after discharge, moving the crest of the dam upstream (Thomé & Passini, 2018).

Figure 4 - Upstream Heightening dam (Fleurisson & Cojean, 2016).

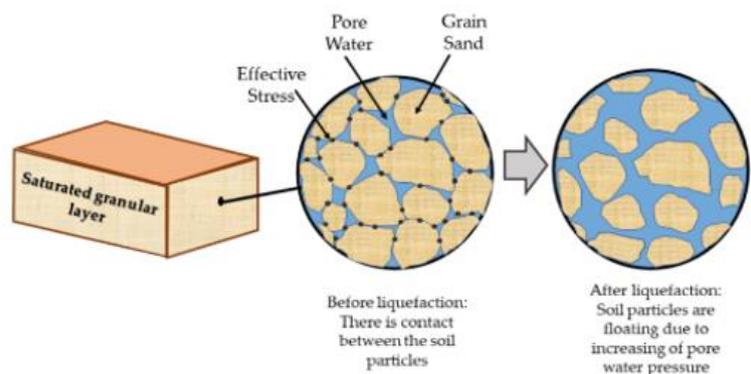
Due to the low permeability of tailings and at undrained conditions, the water is not able to percolate, so this compressive stress is also transmitted to the fluid, and, consequently, the pore pressures increase (Lima Bevilaqua, 2019) (Rodríguez Pacheco, 2019). When the pore pressure reaches a critical level and the intergranular stresses are annulled (reduction of effective stresses), the soil behavior becomes viscous liquid (**Erro! Fonte de referência não encontrada.**) (Araujo & Ledezma, 2020).

Figure 5 - Liquefaction and the loss of adhesion among the particles due to the excessive water pore-pressure (adapted from Araujo & Ledezma, 2020).

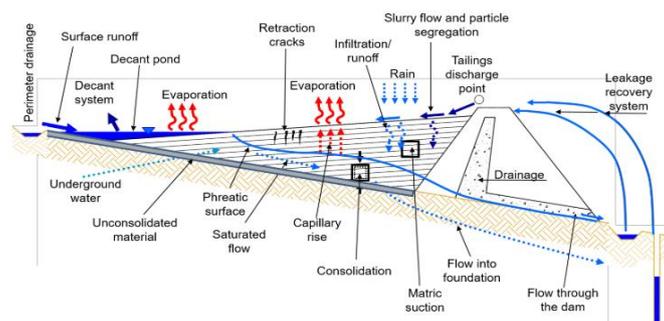
As mentioned above, some problems related to water may affect the stability of the system, therefore, water control during the construction is fundamental. It is necessary to assess and reduce as much as possible the water flow inside the dam and in the foundation. Water can originate from the slurry and the environment, through rainfalls, run-offs coming from the upper catchment (Fleurisson & Cojean, 2016), the underground, or from a capillary rise. The water coming from rainfall partly infiltrates the beach and the rest flows as a surface run-off until reaching the ponds. Also, evaporation occurs and induces the capillary rise coming from the phreatic surface (Rodríguez Pacheco, 2019). Figure 6 summarizes the phenomena related to water that affect the operation of tailings dam.

Figure 6 - Water control in tailing dams (Rodríguez Pacheco, 2019).

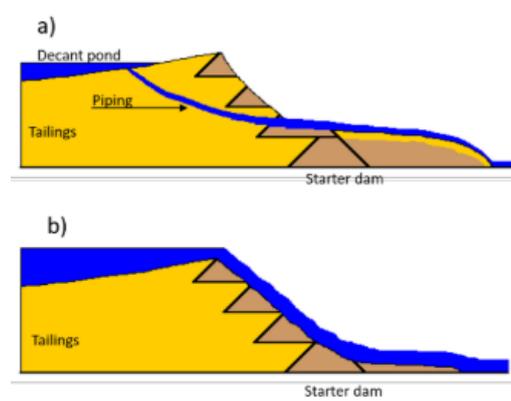
Moreover, it is required to assess and control the water level in the settling pond to prevent the occurrence of water overtopping, which may cause crest erosion and dam breaching. To avoid seepage, the level of the water table must be as low as possible from the top of the impoundment, which is often formed by coarser material with higher permeability (Fleurisson & Cojean, 2016). Additionally, the level of the phreatic line is an important factor for the dam stability since the pore-pressure increases with higher levels of the water table. Failure can occur if the width of the beach is too short and the ponds are close to the dam crest, which increases the hydraulic gradient (Rodríguez Pacheco, 2019). Figure 7 describes the phenomena mentioned above.

Figure 7 - a) Piping, b) Overtopping (Rodríguez Pacheco, 2019).

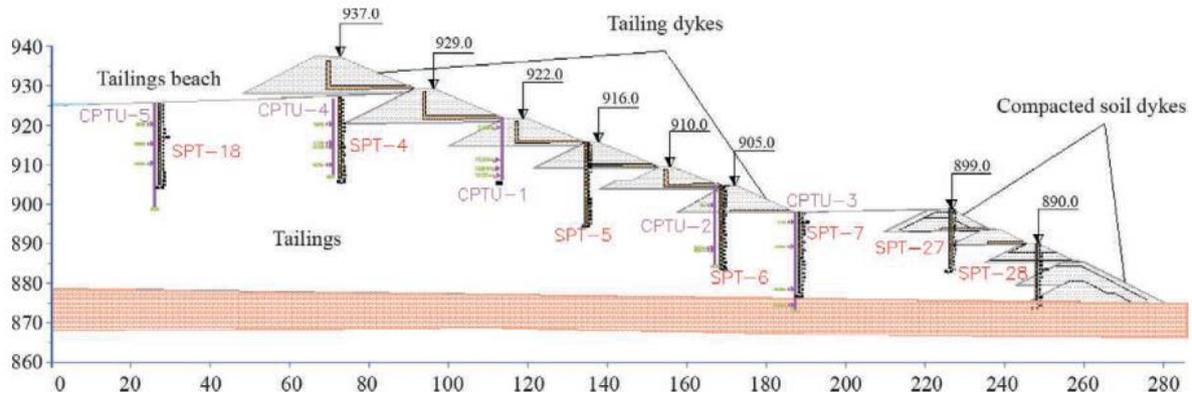
As the volume of production and, consequently, of tailings increased, the upstream method was the main choice to enhance the capacity of the dam, and nine more raising lifts were added to the structure in 14 stages, built using compacted soils or compacted tailings (Figure 9). Finally, the last dike was constructed in 2013 and the total height of the dam reached 86 m (Lima Bevilaqua, 2019).

Figure 9 - Cross-section of Dam I (Schnaid et al., 2013).

Regarding the internal drainage of the system, there is not much information concerning the first dykes, but the executive projects indicate the construction of blanket drains, made of sinter feed, and longitudinal tubes, for the second and fourth heightening. For the remaining ones, As-Built projects were consulted and, according to it, blanket drains and chimney drains were used for the fifth to ninth heightening, constituted by sinter feed or sand, and for the last one, only a blanket drain made of sand was installed (Vale & TUV SUD, 2018). This drainage system can be observed in Figure 9.

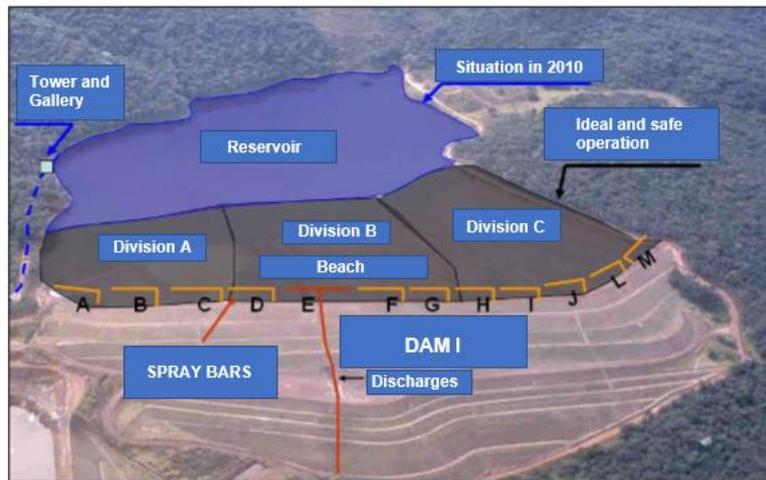
Figure 10 - Tailings Disposal System (adapted from Silva, 2010).

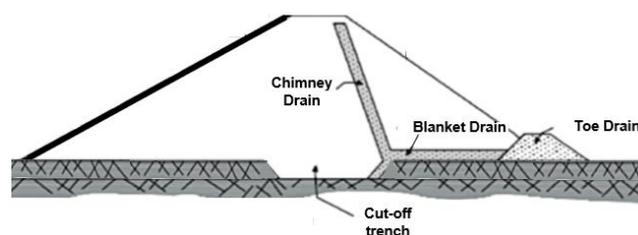
For the outlet of the draining system, perforated PVC tubes were designed (raises 5, 6,7, and 8), toe drains covered by geosynthetic material (raises 9 and 10), and a cut-off trench of 2 m (raise 8) (Vale & TUV SUD, 2018). Some of the structures mentioned above, which constituted the drainage system, are illustrated in Figure 11. Furthermore, the superficial drainage is made of concrete channels on the berms that direct the flow downstream.

Figure 11 - Internal drainage system (adapted from ANA - Agência Nacional das Águas, 2016).

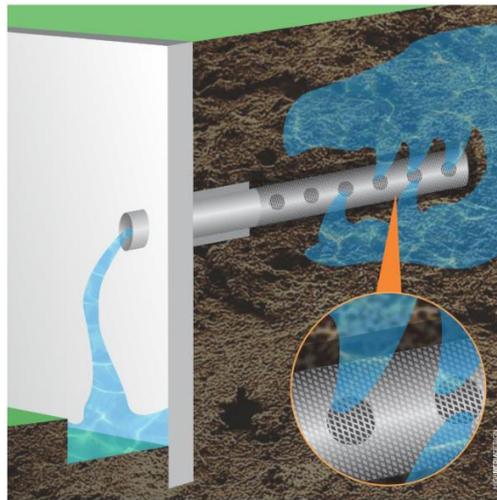
From the year 2017, the company owning the complex decided to install deep horizontal drains (Figure 12), after a reunion of international specialists, where it was alerted that the factor of safety was 1.06 (*CPI: Rompimento da Barragem de Brumadinho*, 2019), and it was necessary to drawdown the water table to achieve stability (Jornal Estado de Minas Gerais & Parreiras, 2019). These drains are installed in boreholes with a horizontal axis and small inclination to allow the water flow by gravity; they are constituted by tubes and filters, which retain the particles during the water movement. They reduce the water pore-pressure by collecting the water from the infiltration of the water table (*CPI: Rompimento da Barragem de Brumadinho*, 2019).

Figure 12 - Deep Horizontal Drain (*Dreno Horizontal Profundo - Drilling*, n.d.).

The procedure to install the drains was, nevertheless, poorly executed and did not enhance the safety factor of the impoundment. On the contrary, an incident occurred on June 2018, during the installation of drain 15 (in a planned total amount of 30), when an excess of water pressure during the drilling caused hydraulic fracturing and, consequently, pipping, when solid material was dragged to the downstream side of the dam (*CPI: Rompimento da Barragem de Brumadinho*, 2019).

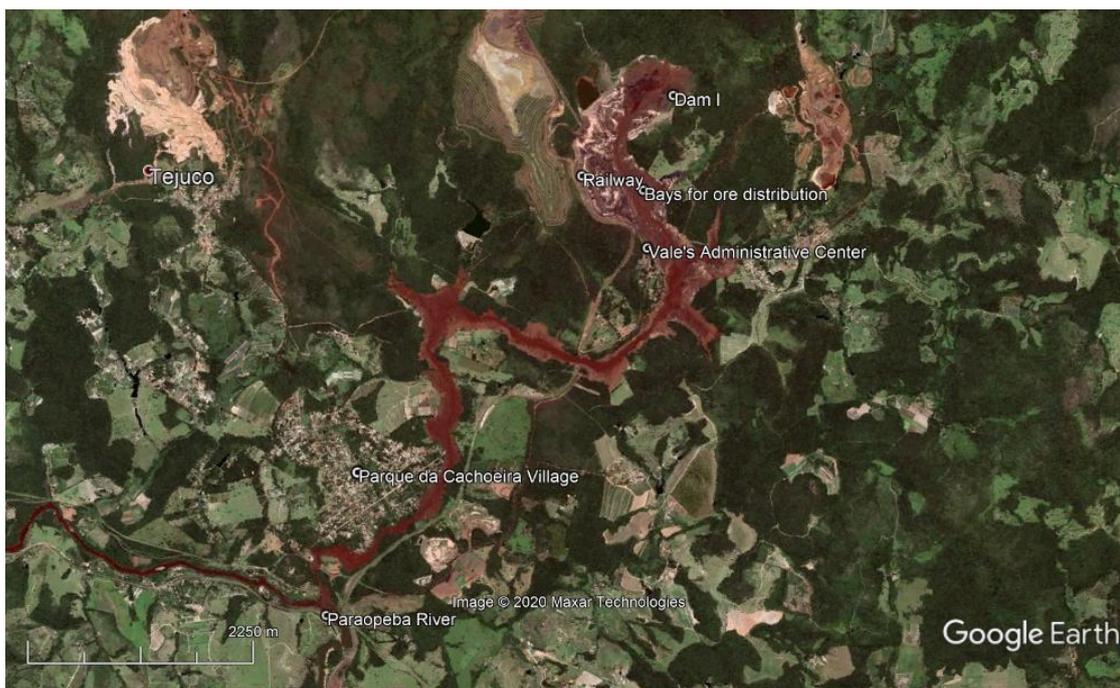
Figure 13 - Damage extension of dam breaching (Google Earth, 2019).

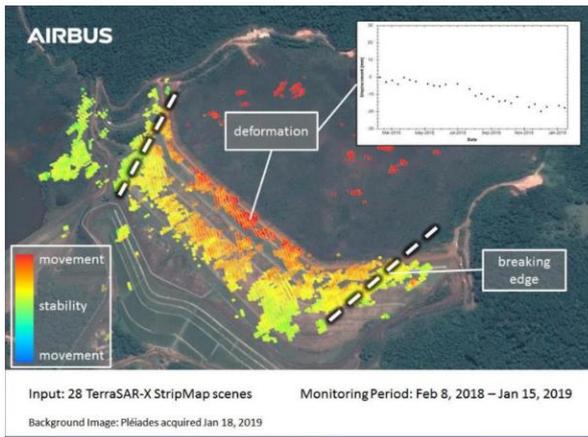
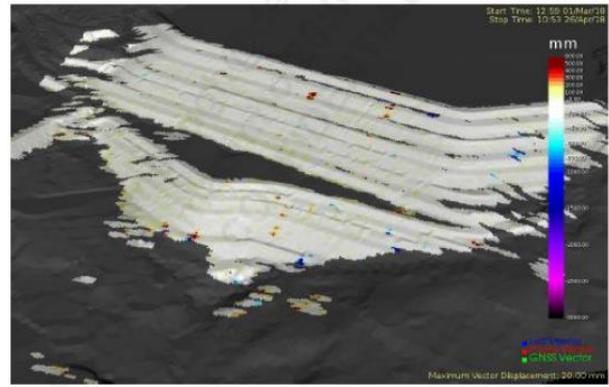
Data from satellite monitoring indicated movement and deformation of the downstream side of the dam in the analysis right before the collapse (Figure 14). These results matched with deformations detected from a ground-based radar interferometry, located near the railway, which pointed to a reduction of the amplitude of the reflected wave in a certain area. This could be related to the variation of humidity or level of compaction (*CPI: Rompimento da Barragem de Brumadinho*, 2019).

Figure 14 - Satellite monitoring of the dam movement and real-time result from the ground-based radar interferometry (CPI: *Rompimento da Barragem de Brumadinho*, 2019).

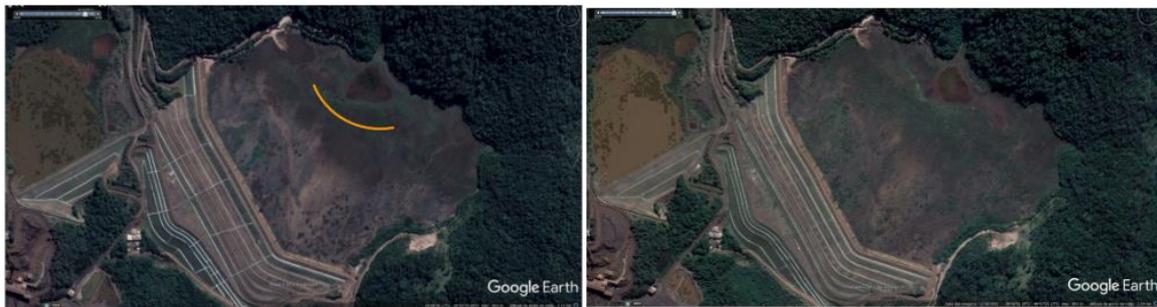
Some hypotheses about problems in the drainage system can be raised while observing satellite images of the dam months before the collapse (Figure 15). The existence of superficial water on the backside of the dam (after inactivation) can be observed, which is very close to the rupture crest (Figure 16) (D. M. Pereira et al., 2019).

Figure 15 - Satellite images showing superficial water in the reservoir, in June of 2017 and 2018, respectively (D. M. Pereira et al., 2019).

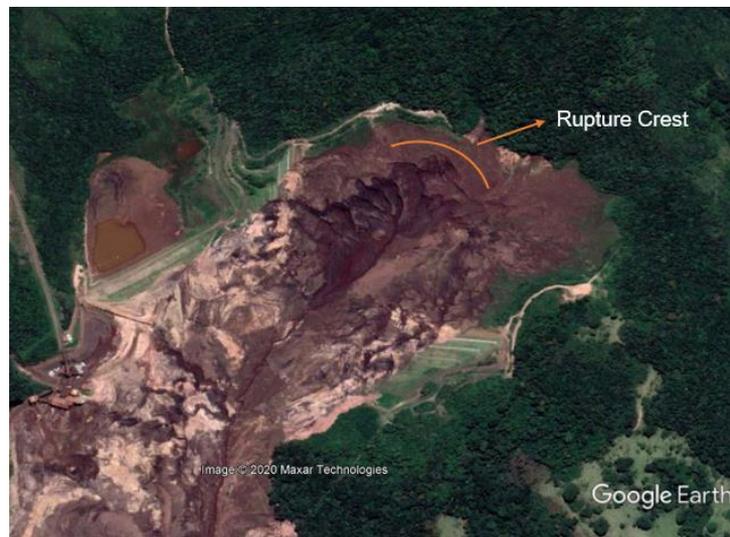
Figure 16 - Satellite image showing the rupture crest in March of 2019 (adapted from Google Earth, 2019).

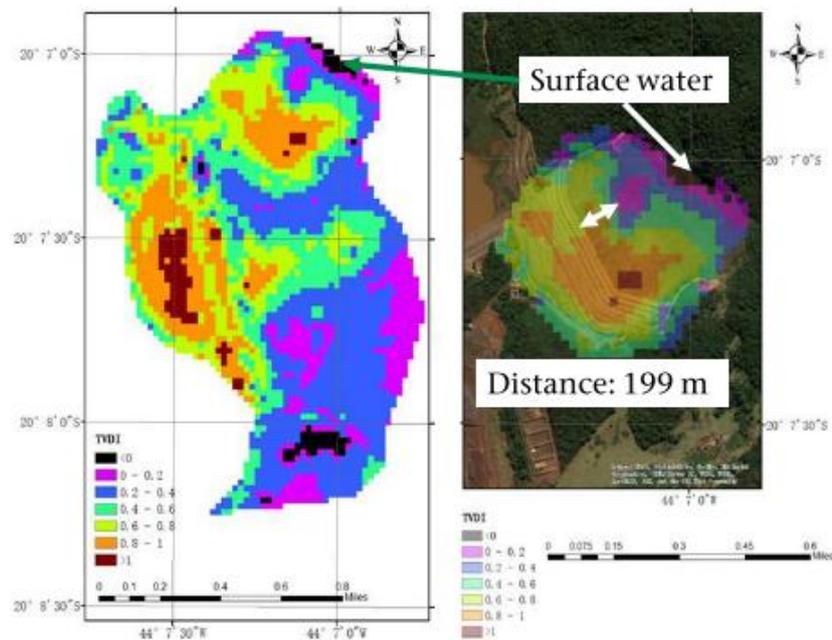
Another study evaluated the Temperature Vegetation Dryness Index (TVDI) before and after the collapse, using Landsat-8 data. This parameter is correlated to the soil moisture, in the way that the lower the value of TVDI, the higher is the soil moisture, and consequently, the soil is more likely to suffer from liquefaction. According to the analysis, the TVDI at the dam body was relatively high, but the region close to the vegetation boundary and another about 199 m from the dam crest had TVDI either negative or between 0 and 0.2, indicating high soil moisture (Figure 17) (Lan et al., 2019).

Figure 17 - TVDI distribution on January 14, 2019 (Lan et al., 2019).

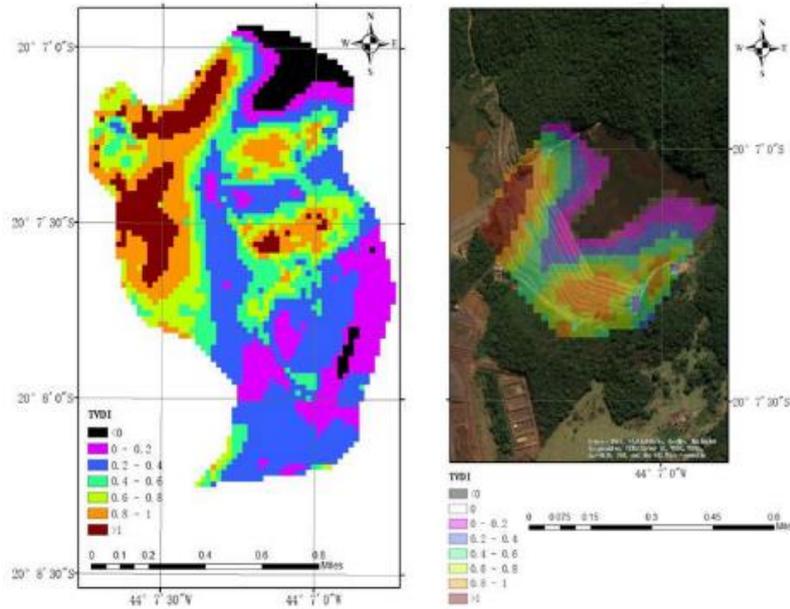
The same analysis was performed after the collapse, and it showed the surface, the sub-soil, and the water in the tailings dam exposed, with a large area of negative values, confirming the high level of soil moisture (Figure 18). Moreover, this area had no precipitation in January, directing the attention to the insufficient drainage and the possibility of water accumulation (Lan et al., 2019).

Figure 18 - TVDI distribution on January 30, 2019 (Lan et al., 2019).

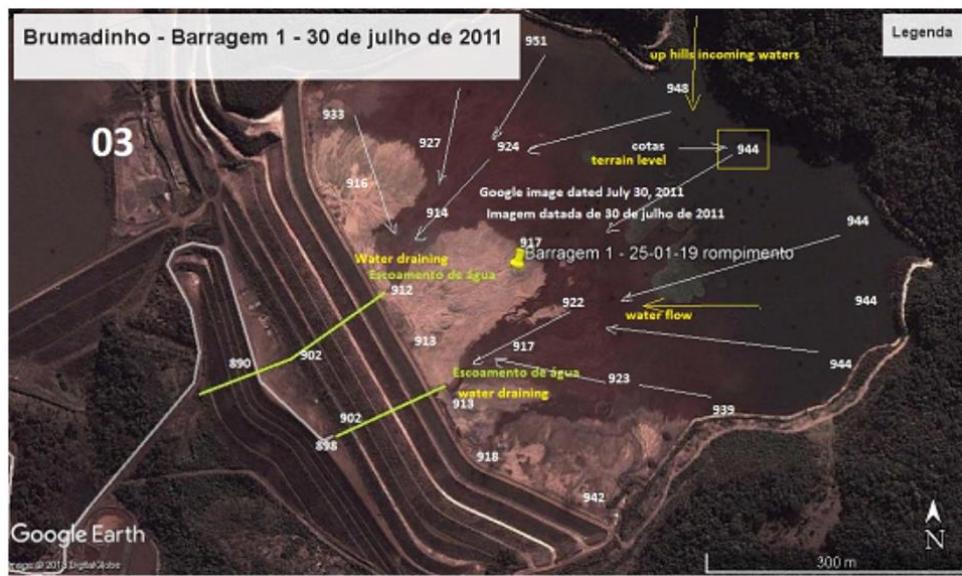
A study about the dam I stability was carried out by Frederico Lopes Freire, who analyzed aerial images of the structure. He pointed out the saturation increase due to constant natural drainage within the impoundment, whose origin probably derives from higher elevation points and the dense forest behind it. In Figure 19, it is possible to visualize the tailings pond, and the arrows indicate the flow of water, drained outside the dam at the elevations 912 m and 913 m (*BRUMADINHO ENGINEERING HISTORY – World Mine Tailings Failures - from 1915, n.d.*).

Figure 19 - Aerial images of the analysis of water influence, in July 2011 (*BRUMADINHO ENGINEERING HISTORY – World Mine Tailings Failures - from 1915, n.d.*).

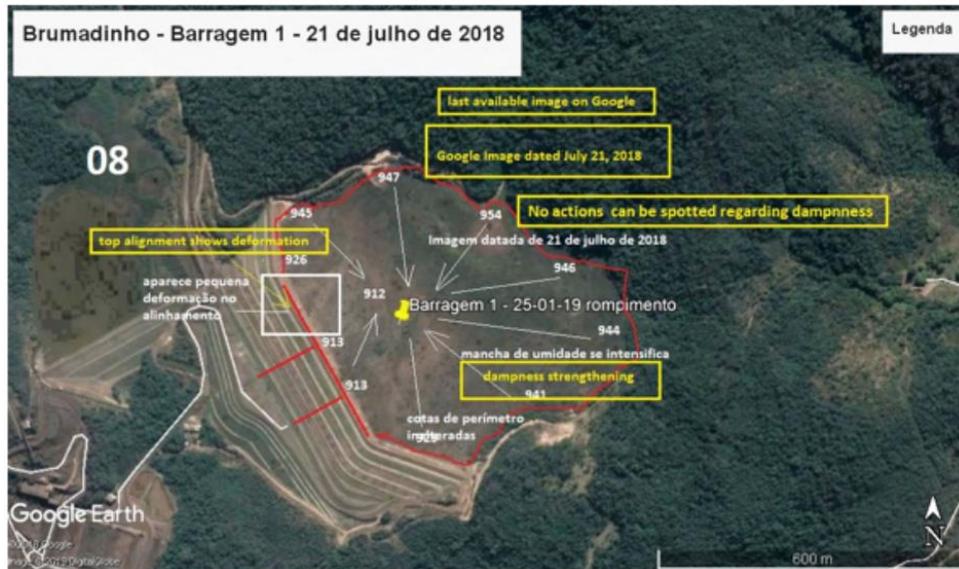
Figure 20 shows the same image after some years, when the dam was already inactive. In this context, the arrows point to the middle of the reservoir, and the water is not more collected by the drains, causing an increase of the humidity stain. Moreover, it was noted a top alignment deformation on the left side of the dam (indicated by the white square) (*BRUMADINHO ENGINEERING HISTORY – World Mine Tailings Failures - from 1915, n.d.*).

Figure 20 - Aerial images of the analysis of water influence, in July 2018 (*BRUMADINHO ENGINEERING HISTORY – World Mine Tailings Failures - from 1915, n.d.*).

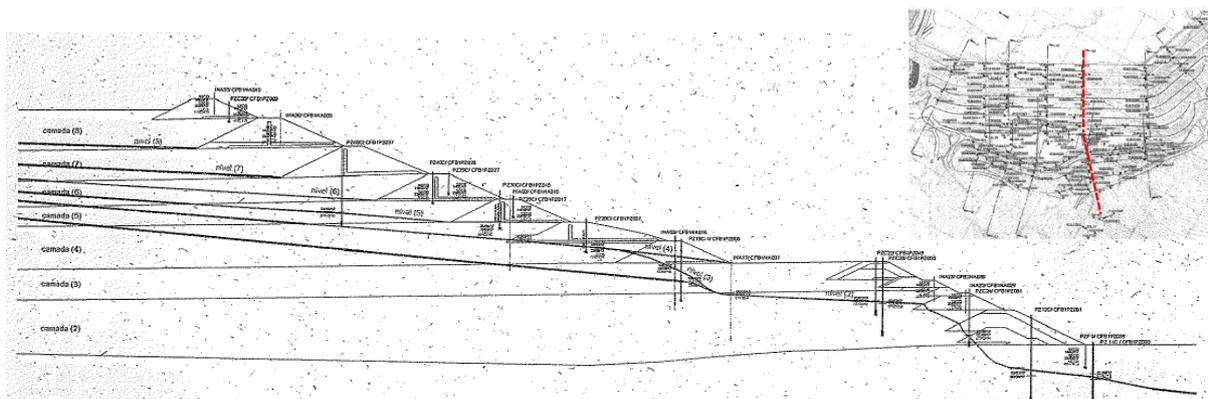
Another study was performed, in 2018, by a company hired by Vale to monitor dam I. It was done the stability analysis of the system, and it was computed the factor of safety and the circular slip surface, using the Limit Equilibrium Method. They analyzed some sections of the dam, and they considered the drained and undrained conditions for the calculation. The most critical cross-section is illustrated in Figure 21, with a red dashed line indicating its position in the aerial image (Vale & TUV SUD, 2018).

Figure 21 – The most critical cross-section of the dam, according to the LEM analysis (Vale & TUV SUD, 2018).

The piezometric condition adopted was interpreted considering not only piezometers but also the results of Piezocone Penetration Tests (CPTU) since they identified the presence of perched water tables below lenses of fine material. Then, layers of tailings were defined, through the verification of CPTU studies, which are illustrated in Figure 21, and each of these layers is assigned to a different piezometric level (Vale & TUV SUD, 2018) (Bonatto, 2019).

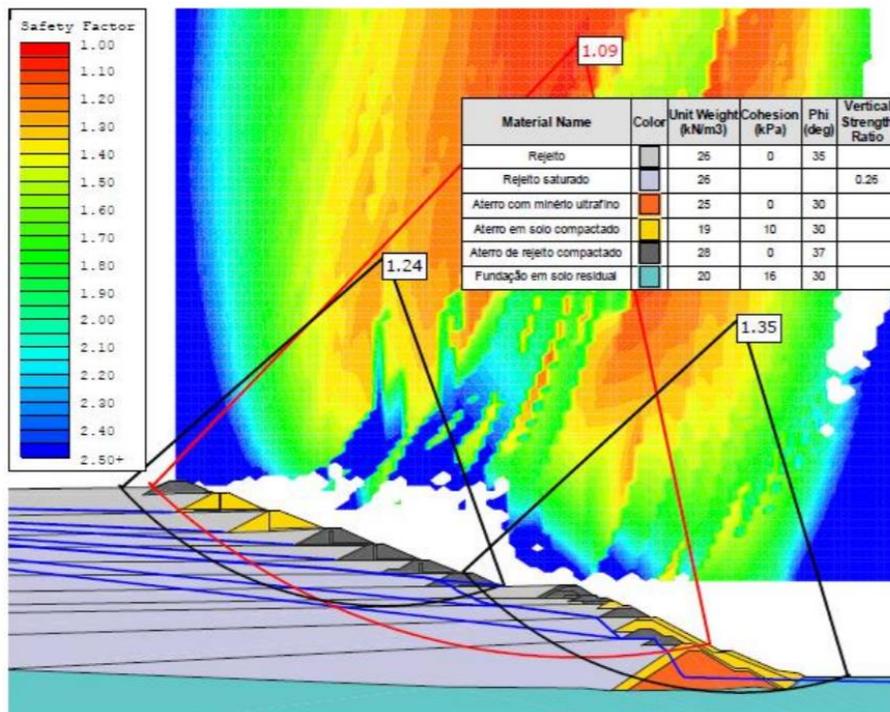
In the drained condition, the lower value of the factor of safety was $FS=1.60$, which is greater than the minimum established by the Brazilian codes as $FS=1.50$. In this case, the critical slip surface develops in the lower part of the dam (first to third raises), showing that those dykes control the stability. Nonetheless, for the undrained situation, the critical factor of safety was $FS=1.09$, the critical surface develops along the saturated tailings, involving their maximum possible volume, and the analysis shows that the upper part of the dam is more critical (Figure 22) (Vale & TUV SUD, 2018).

Figure 22 - Analysis of stability by LEM under undrained conditions (Vale & TUV SUD, 2018).

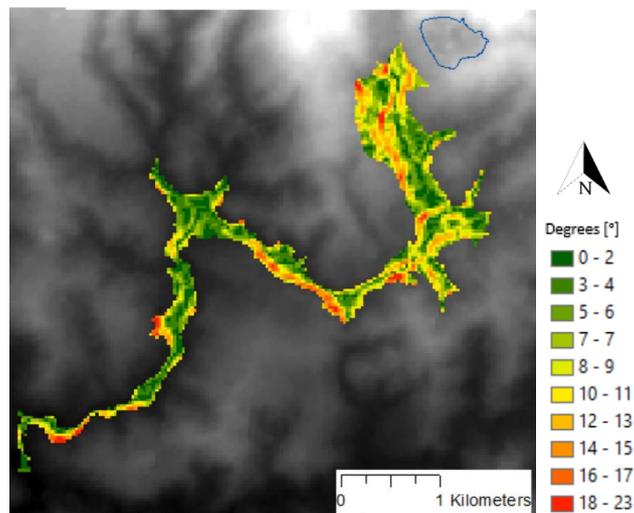
Figure 32 - Slope map of the area that covers the runout.

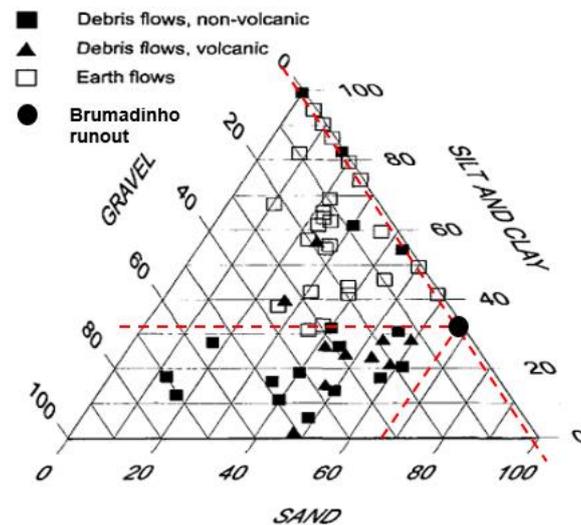
Figure 33 - Textural composition of the runout.

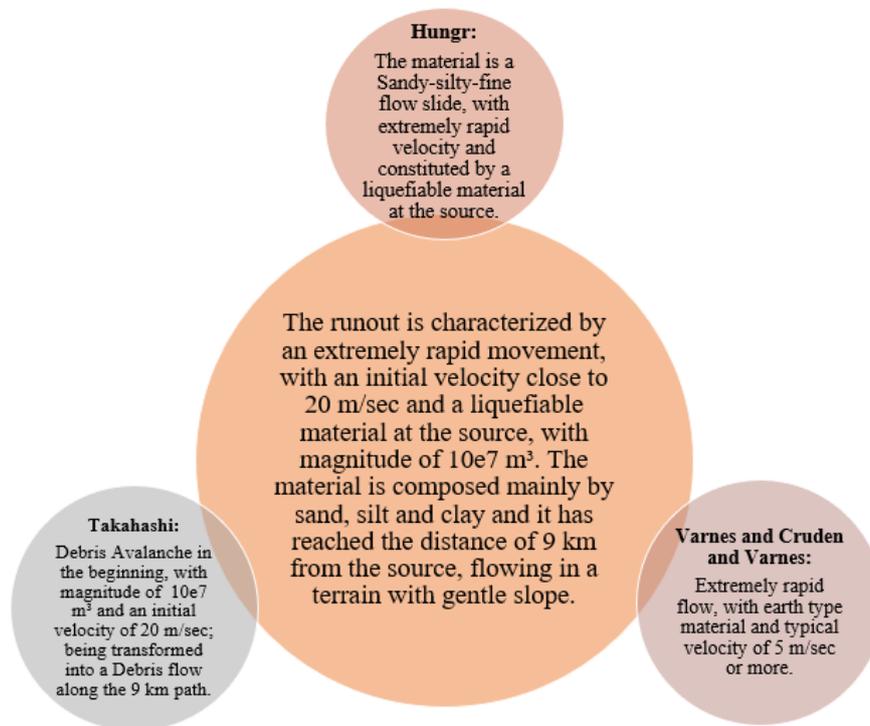
Figure 34 - Final Classification of the runout in Brumadinho.

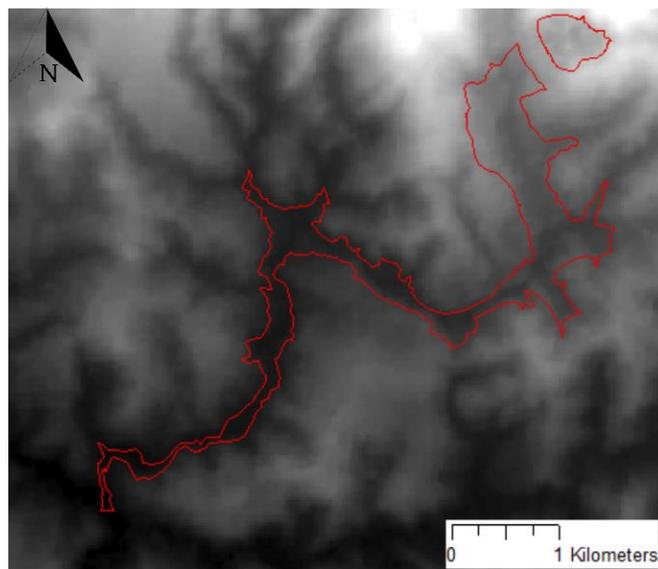
Figure 35 - Digital Elevation Model of the terrain and the contour of the damage extent.

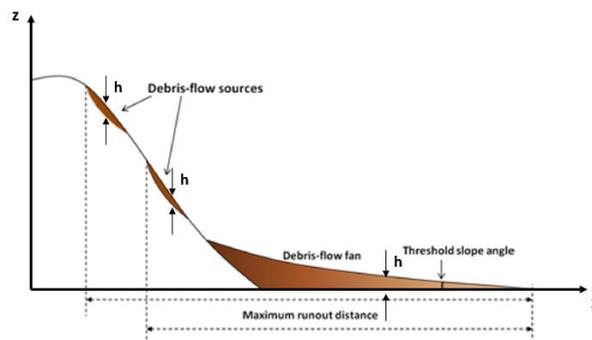
Figure 37 - Scheme of the coordinates and height h of the flow (adapted from Kritikos & Davies, 2015).

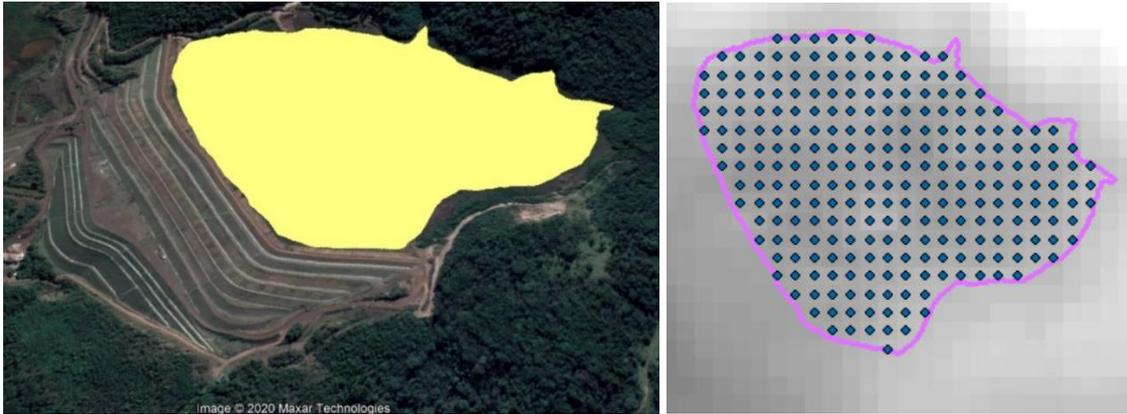
Figure 38 - a. Area of the detachment obtained using Google Earth; b. points in the detachment are for which the value of height was assigned.

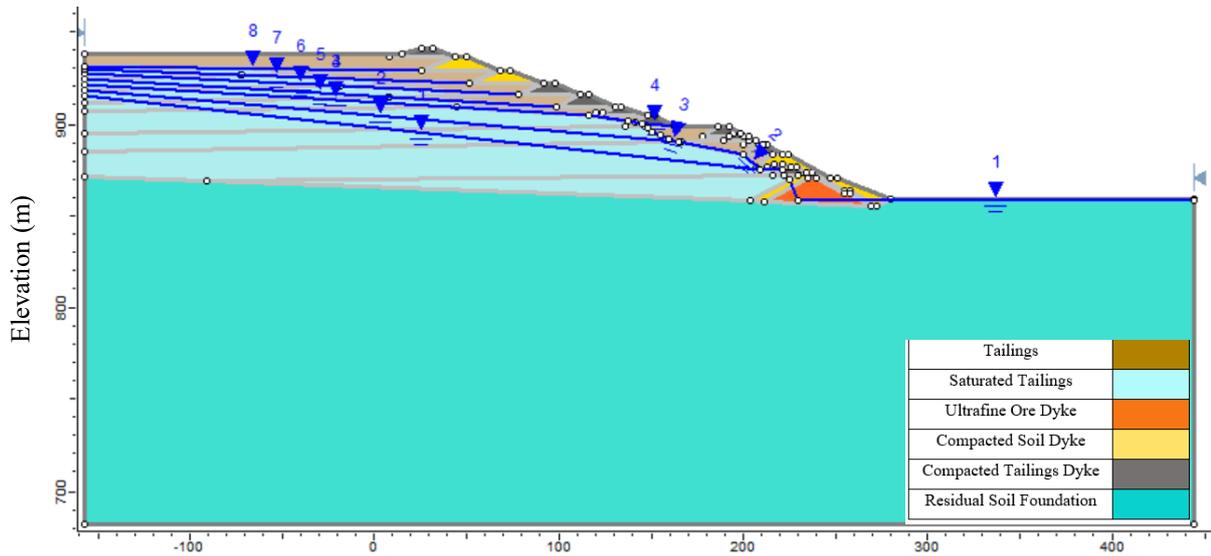
Figure 39 - Model for LEM analysis on Slide.

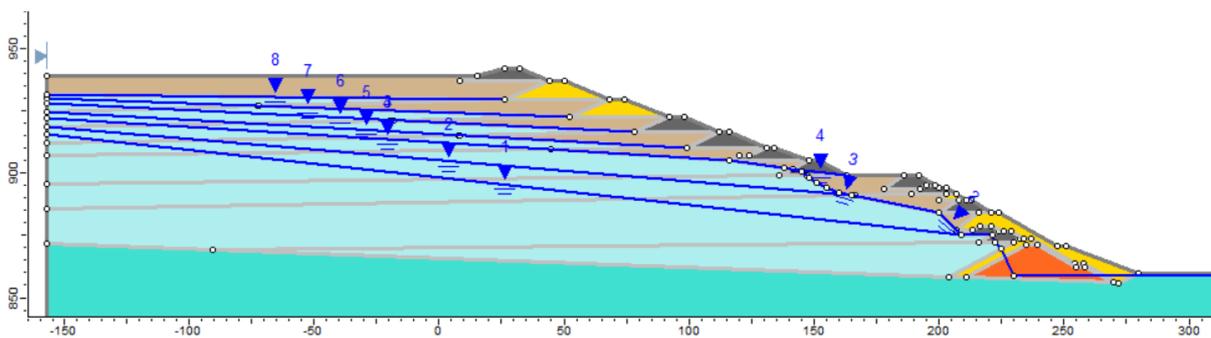
Figure 40 - Model for LEM analysis on Slide in detail.

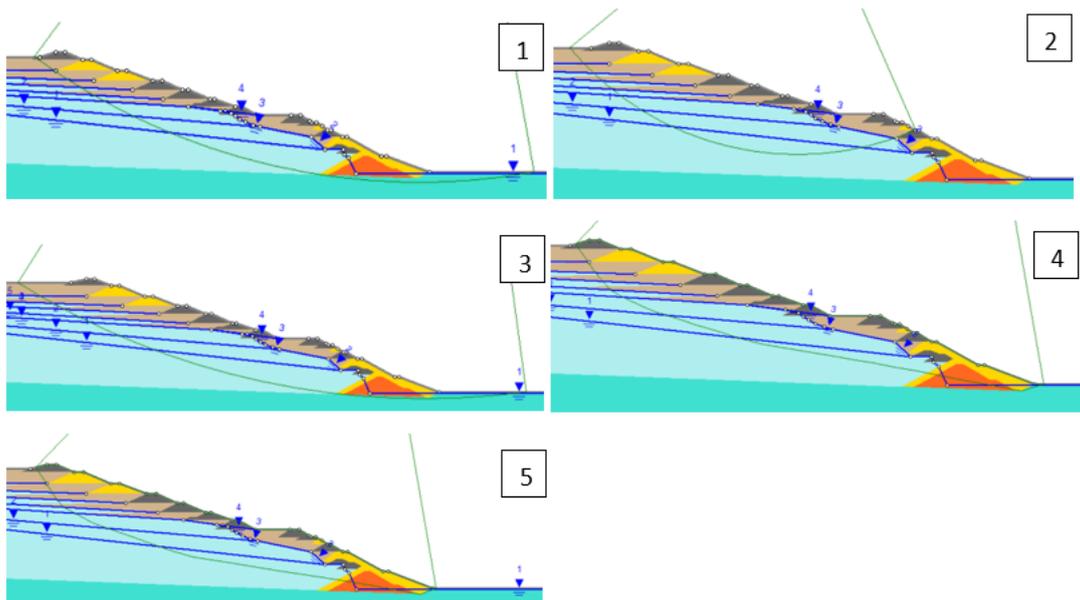
Figure 41 - Slip surfaces obtained from the Slide analysis.

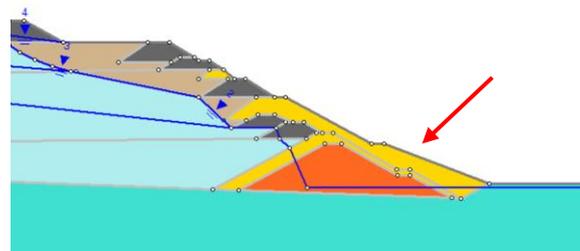
Figure 43 - Indication of the place of rupture at the bottom of the dam in the model.

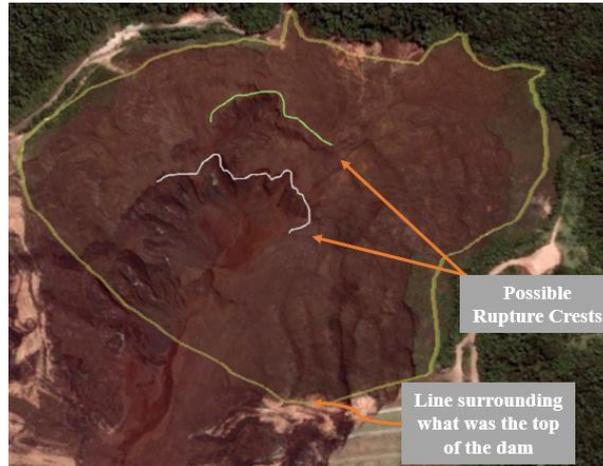
Figure 44 - Verification of possible rupture crests.

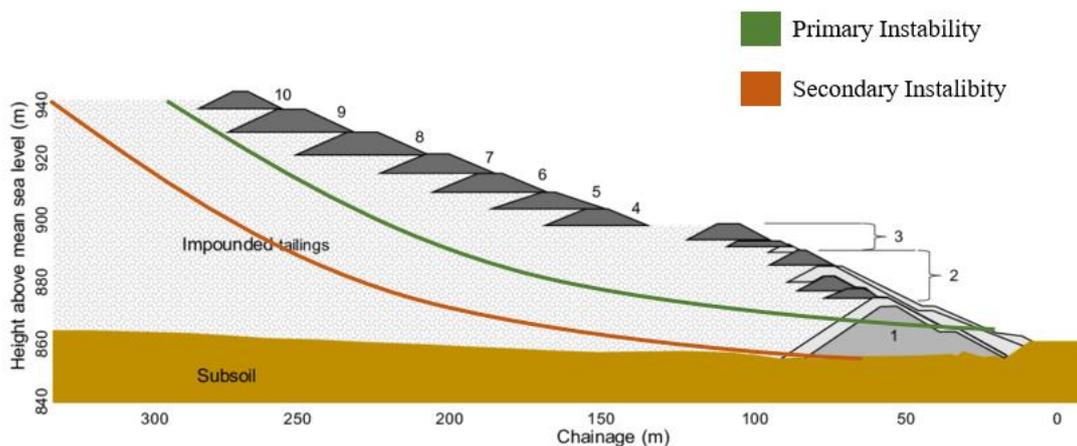
Figure 45 - Primary and secondary instabilities of tailings dam (adapted from Lumbroso et al., 2020).

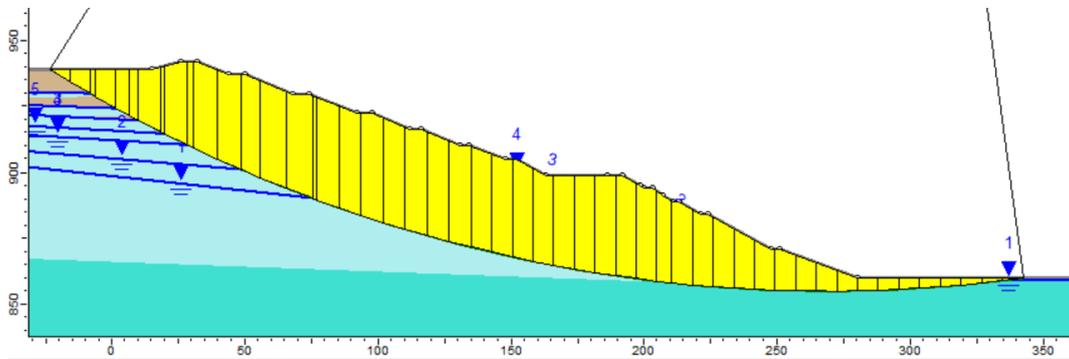
Figure 47 - Vertical Slices from LEM analysis.

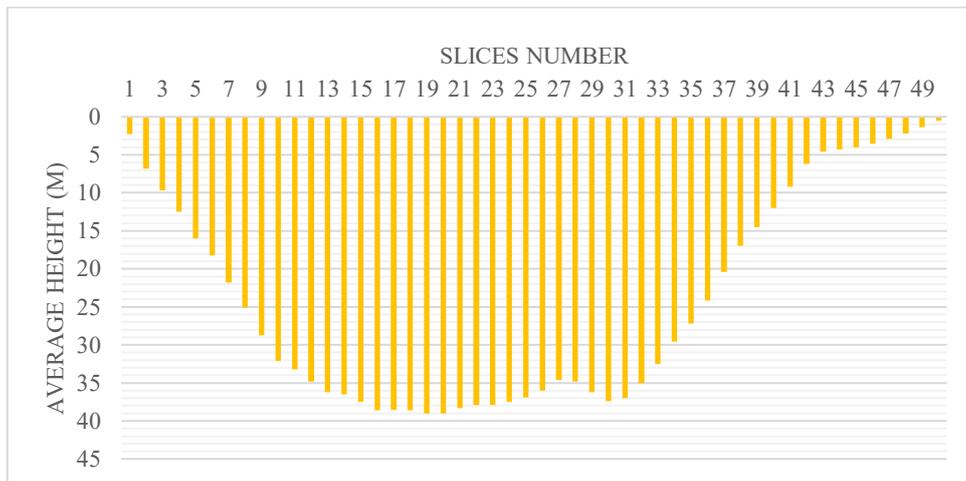
Graphic 1 - Values of height derived from the vertical slices of LEM on Slide.

The correspondent released volume is obtained by taking the area between the slip surface and the surface of the dam and multiplying it by an average width, giving a value of, approximately, 4 million m³ (almost 60% of reduction in volume). Therefore, even if this approach is more robust since it considers a numerical analysis to obtain the slip surface, it is not possible to reproduce the occurrence of a secondary instability as discussed previously. Then, for this specific problem, it is observed a significative underestimation of the released volume, being less reliable in comparison to the previous method.

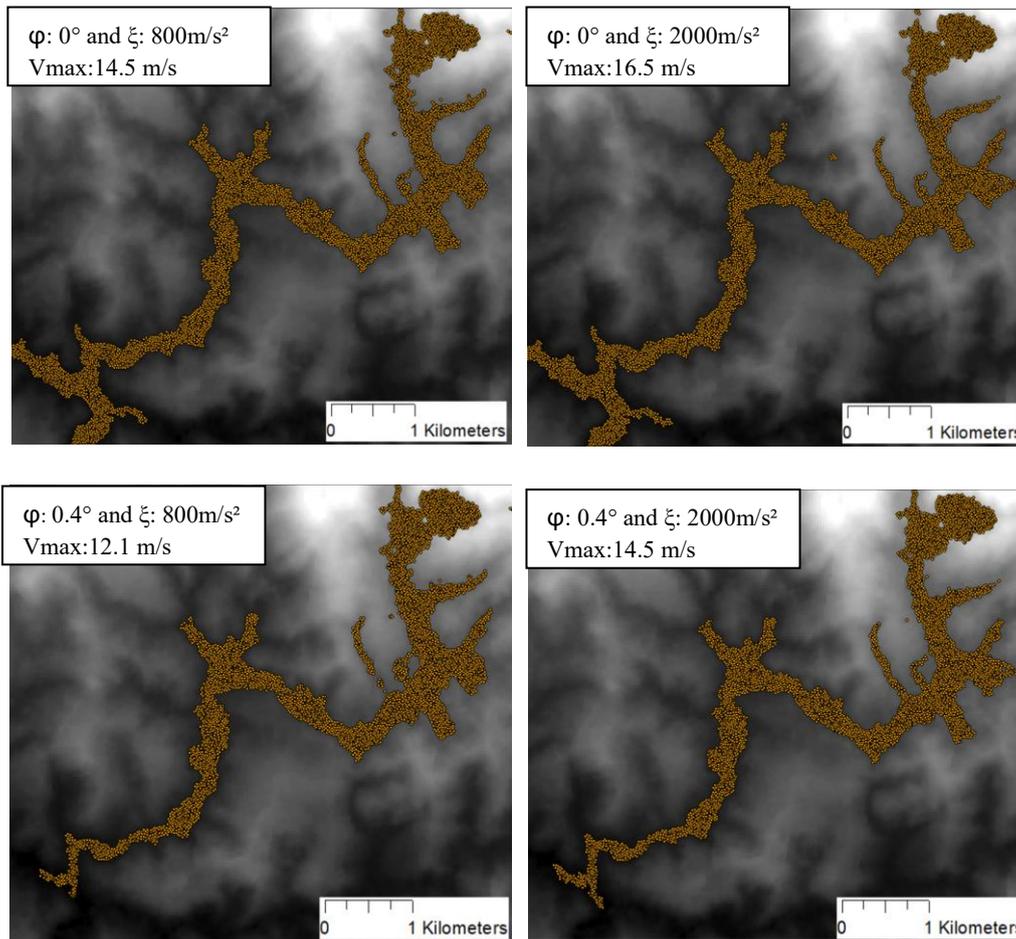
Figure 50 - Results of Voellmy Calibration (method I).

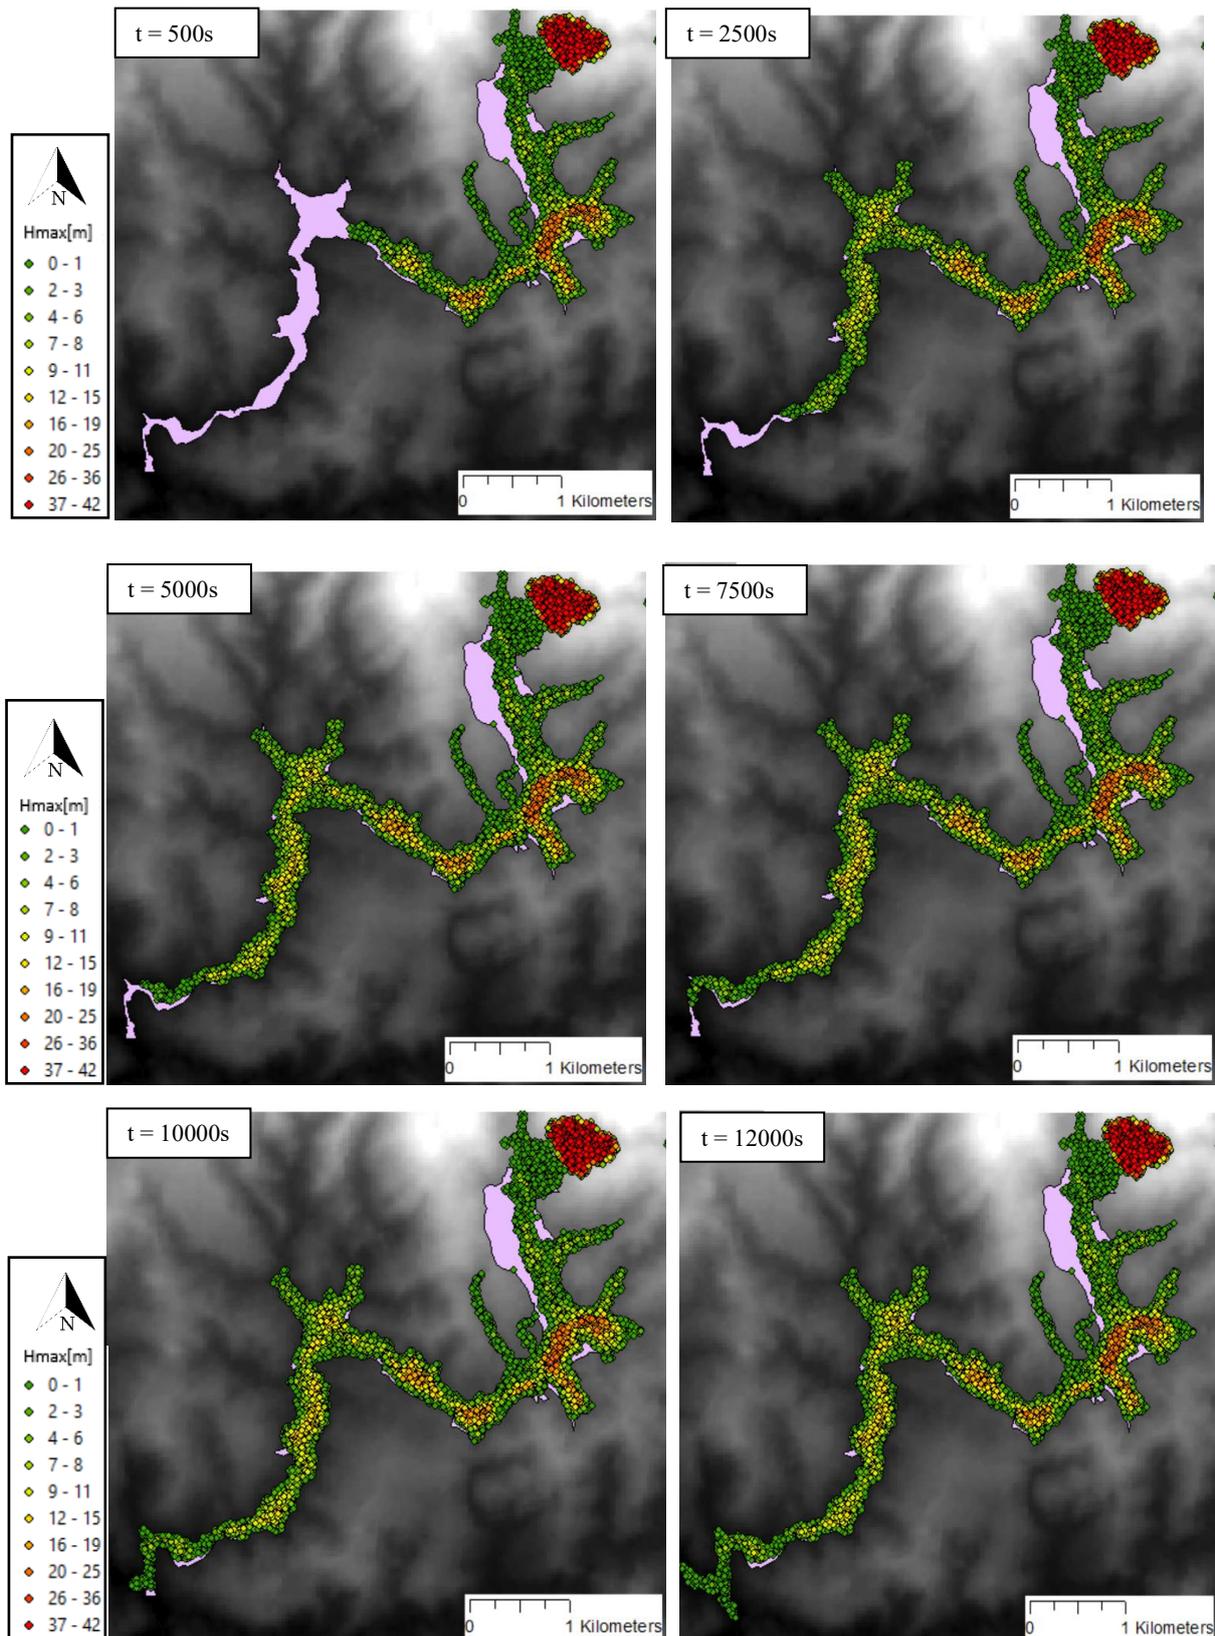
Figure 51 - Results of simulation with Voellmy Rheology (method I), $\varphi = 0.4^\circ$ and $\xi = 2000 \text{ m/s}^2$.

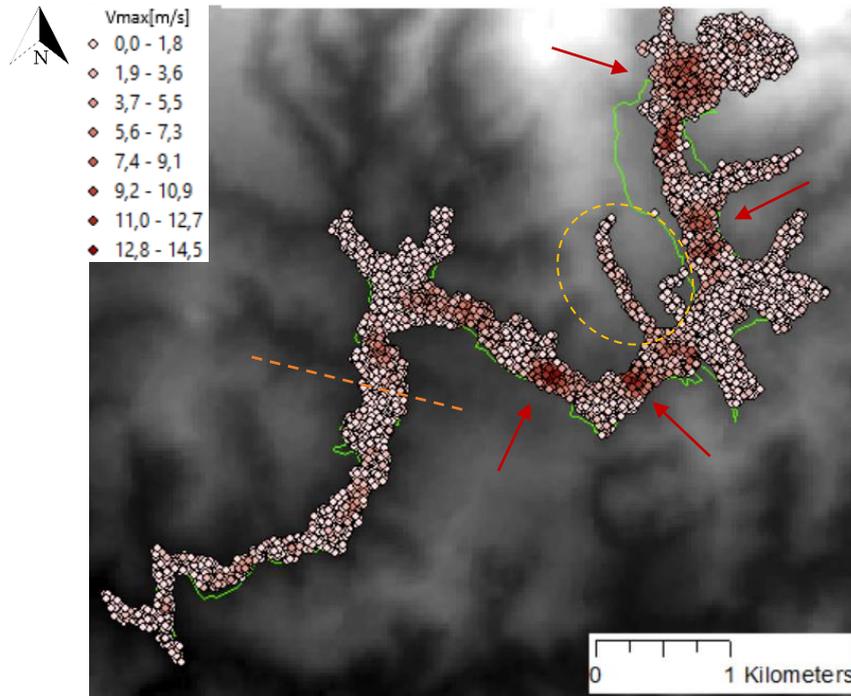
Figure 53 - Map of velocities with Voellmy Rheology (method I), $\varphi = 0.4^\circ$ and $\xi = 2000 \text{ m/s}^2$, $t=12000\text{s}$.

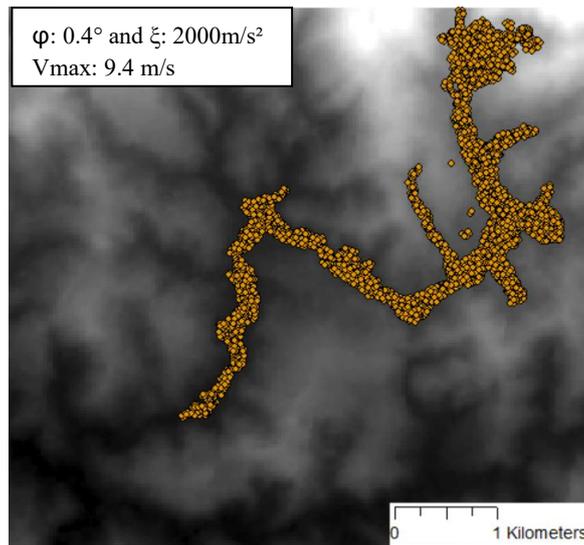
Figure 54 - Results of Voellmy calibration (method II).
