POLITECNICO DI TORINO

Master's Degree in Civil Engineering

Master's Degree Thesis

**Tailings Dam Collapse and Propagation Modelling: A Study Case
in Brazil**

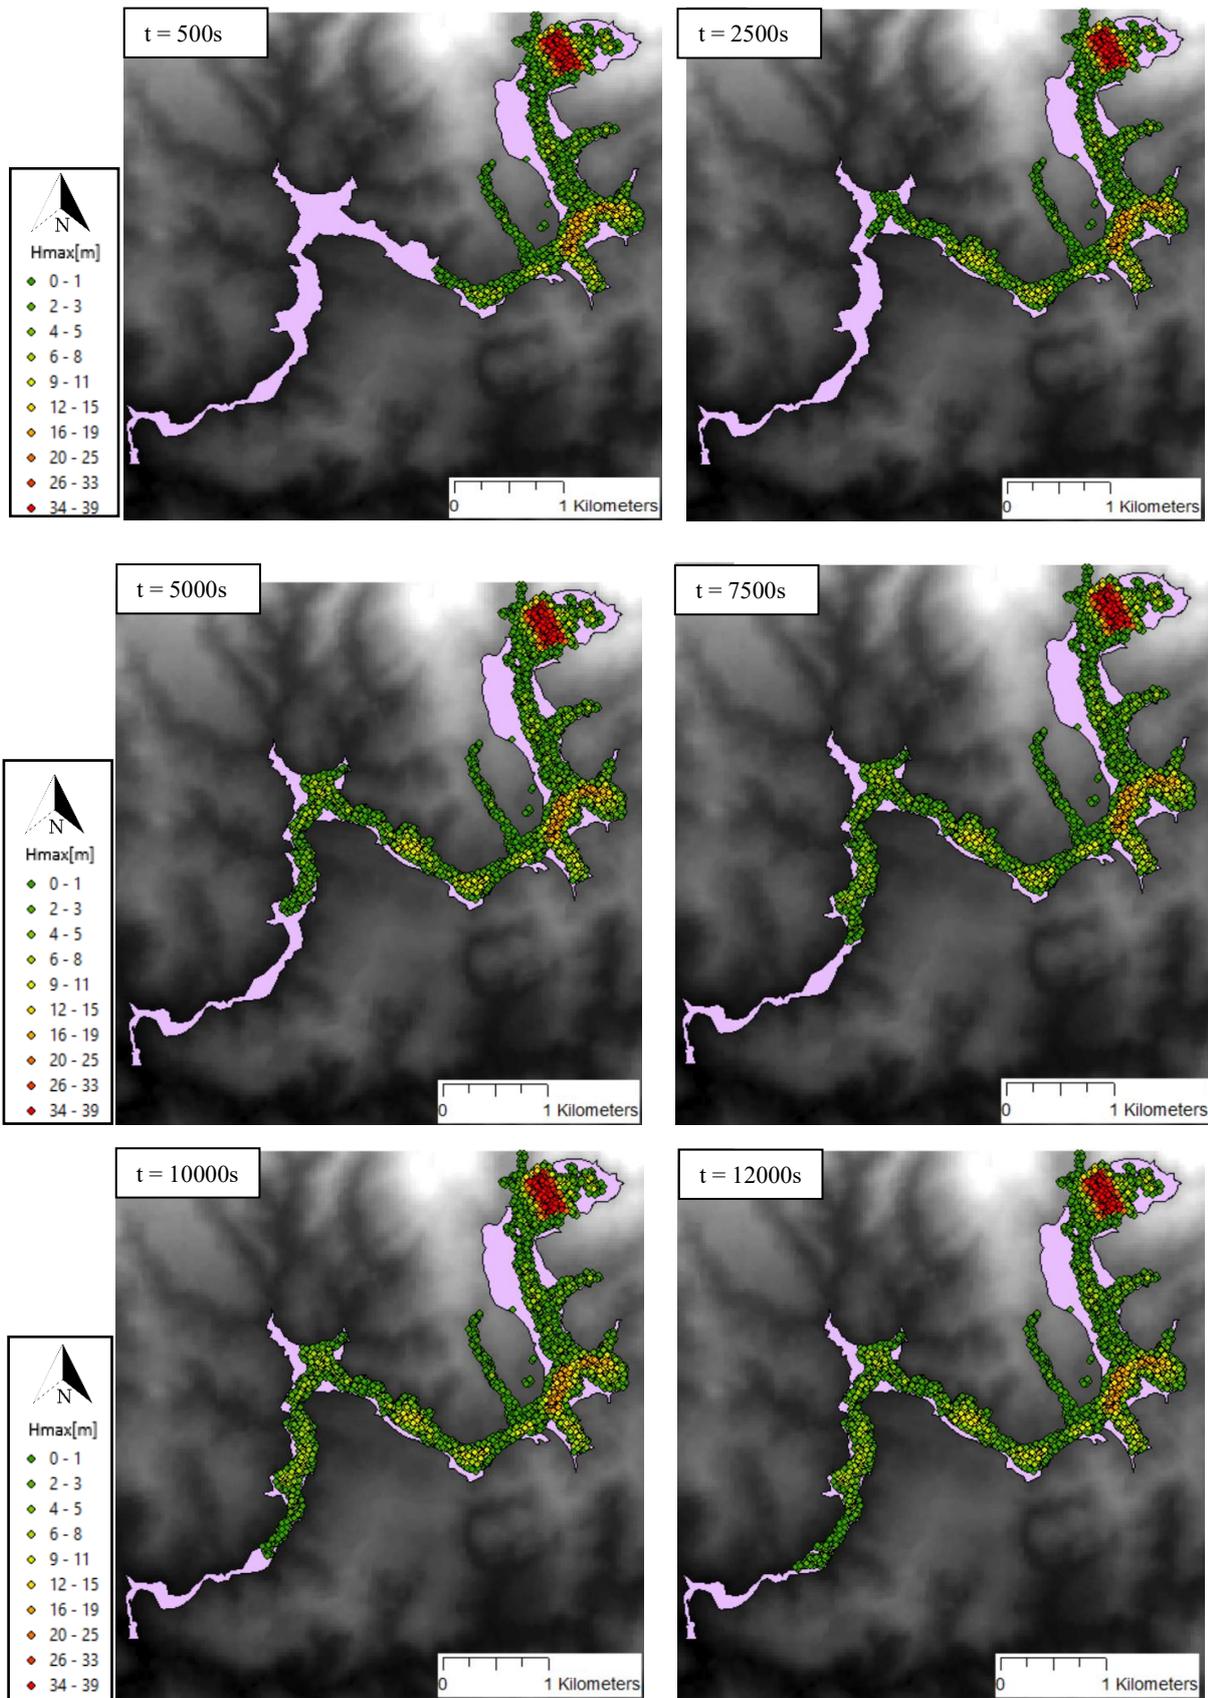
Figure 55 - Results of simulation with Voellmy Rheology (method II), $\varphi = 0.4^\circ$ and $\xi = 2000 \text{ m/s}^2$.

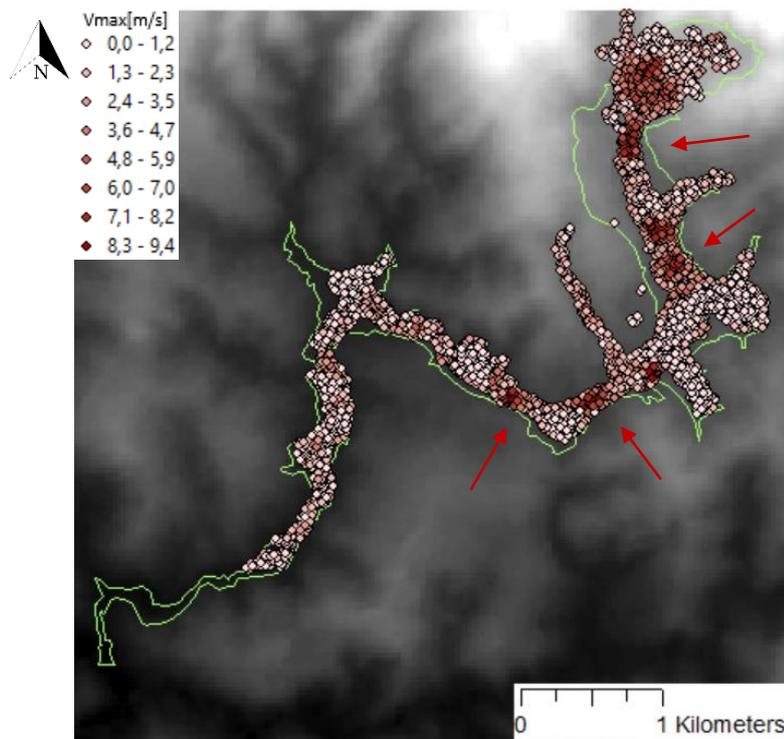
Figure 56 - Map of velocities with Voellmy Rheology (method II), $\varphi = 0.18^\circ$ and $\xi = 2000 \text{ m/s}^2$, $t=12000\text{s}$.

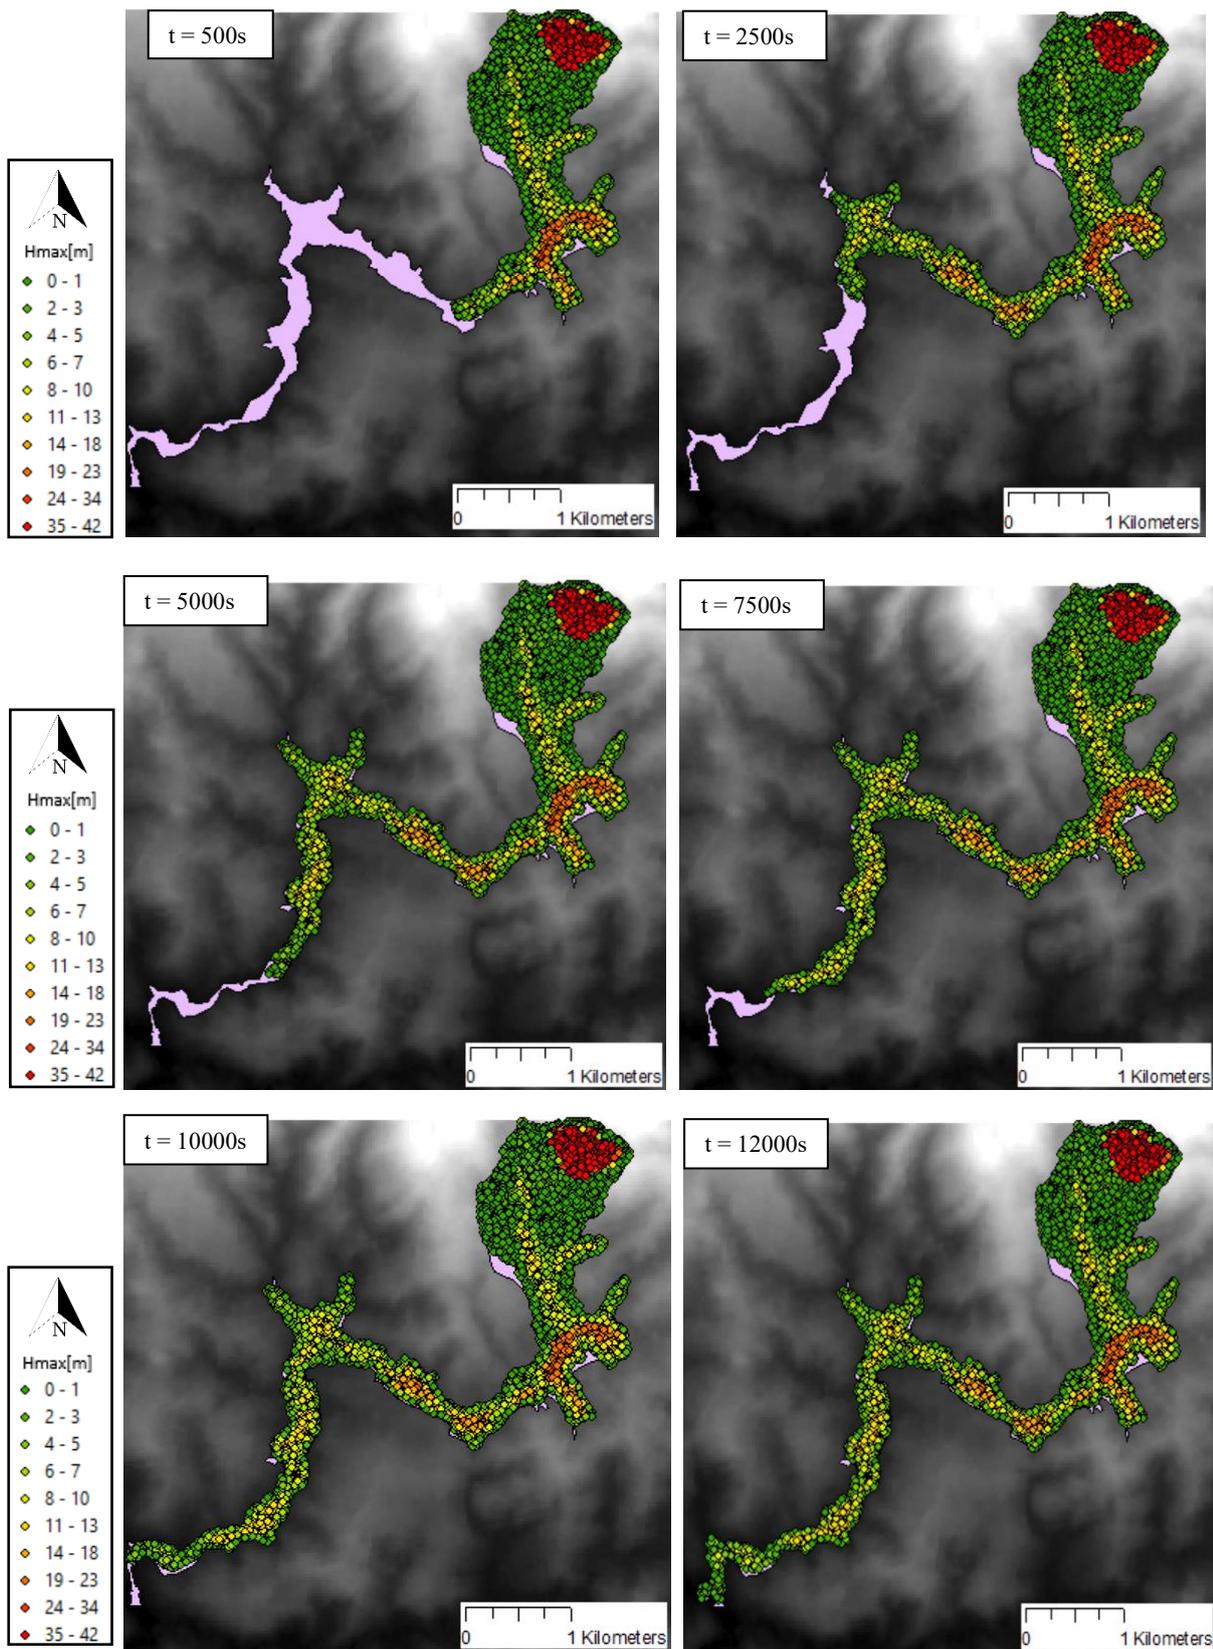
Figure 57 - Results of simulation with Bingham Rheology (method I), $\tau_y=50$ Pa and $\mu_0=250$ Pas.

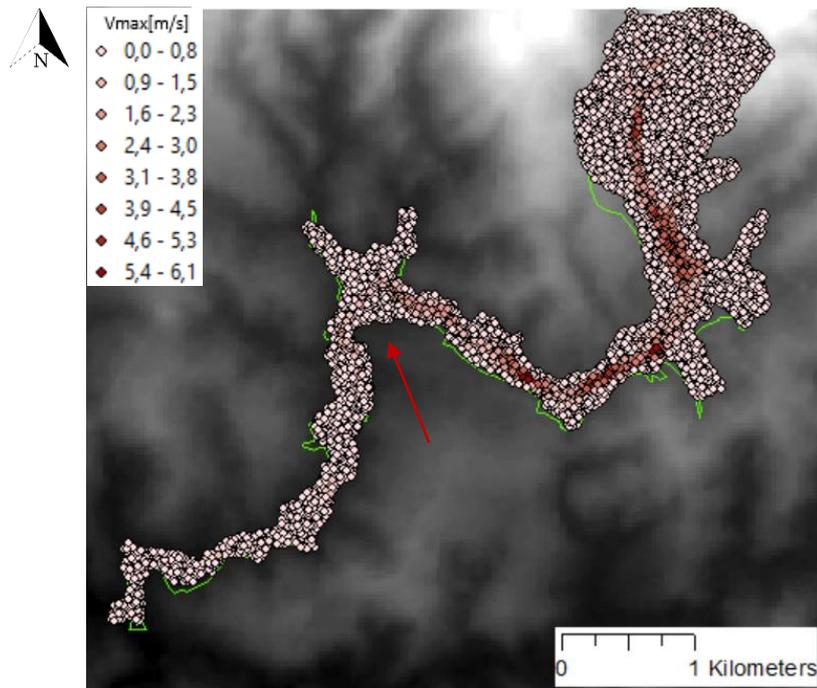
Figure 58 - Map of velocities with Bingham Rheology (method I), $\tau_y=50$ Pa and $\mu_0=250$ Pas, $t=12000s$.

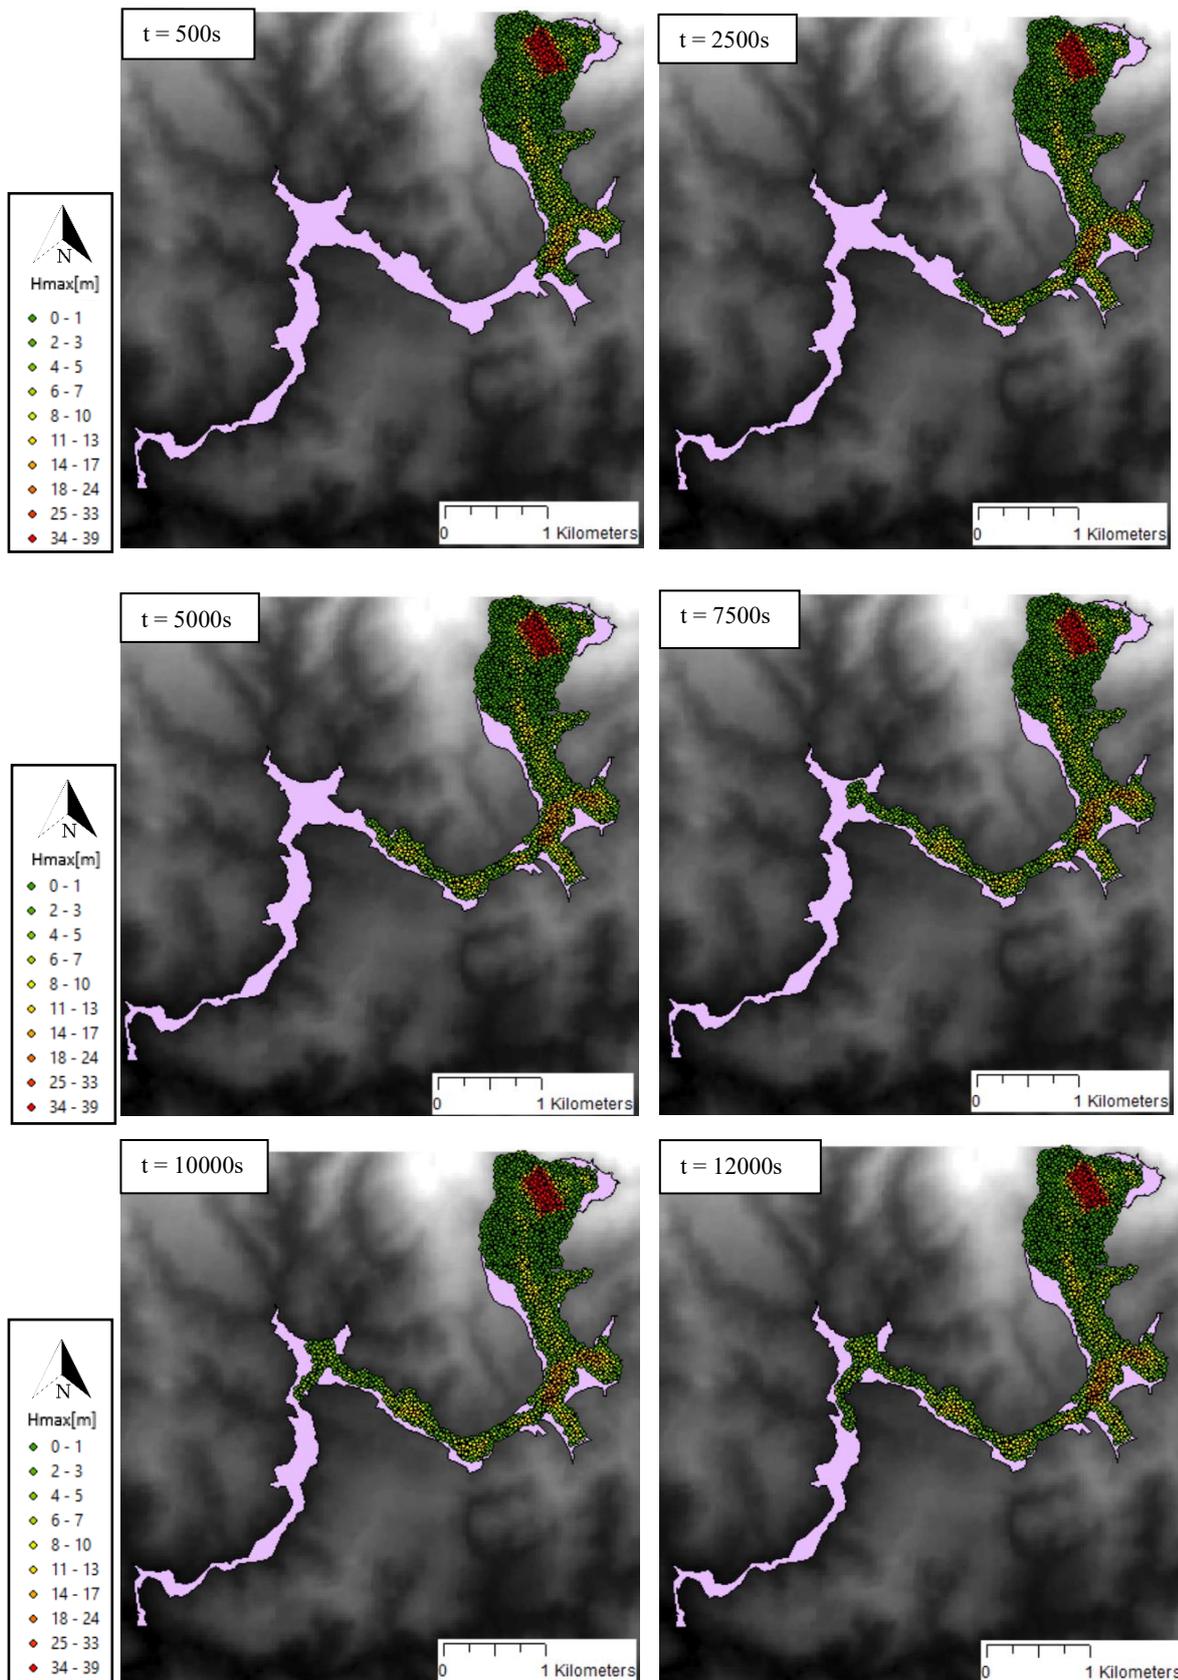
Figure 59 - Results of simulation with Bingham Rheology (method II), $\tau_y=50$ Pa and $\mu_0=250$ Pas.

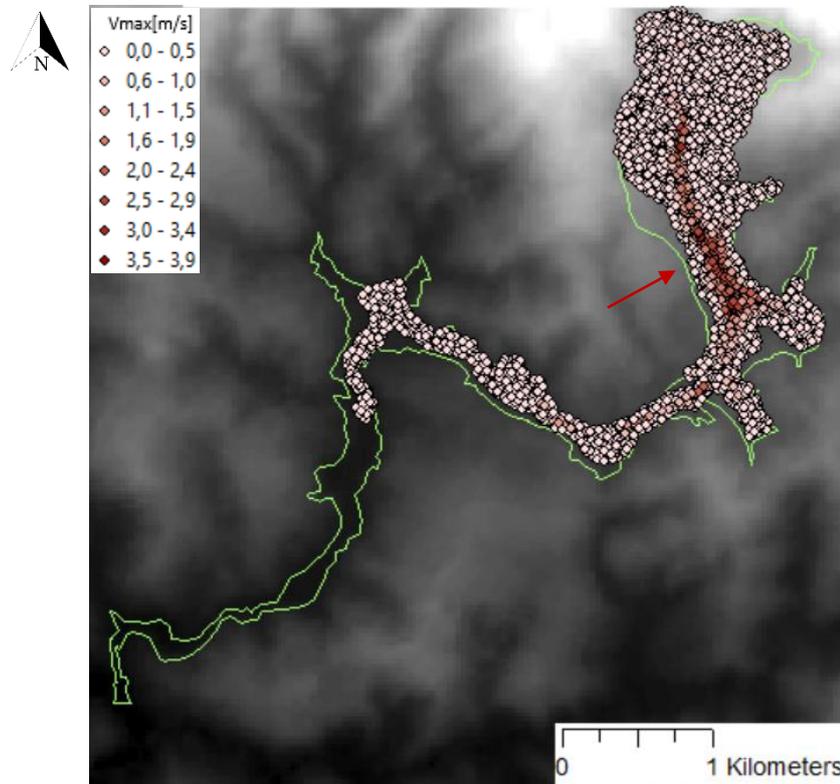
Figure 60 - Map of velocities with Bingham Rheology (method II), $\tau_y=50$ Pa and $\mu_0=250$ Pas, $t=12000s$.

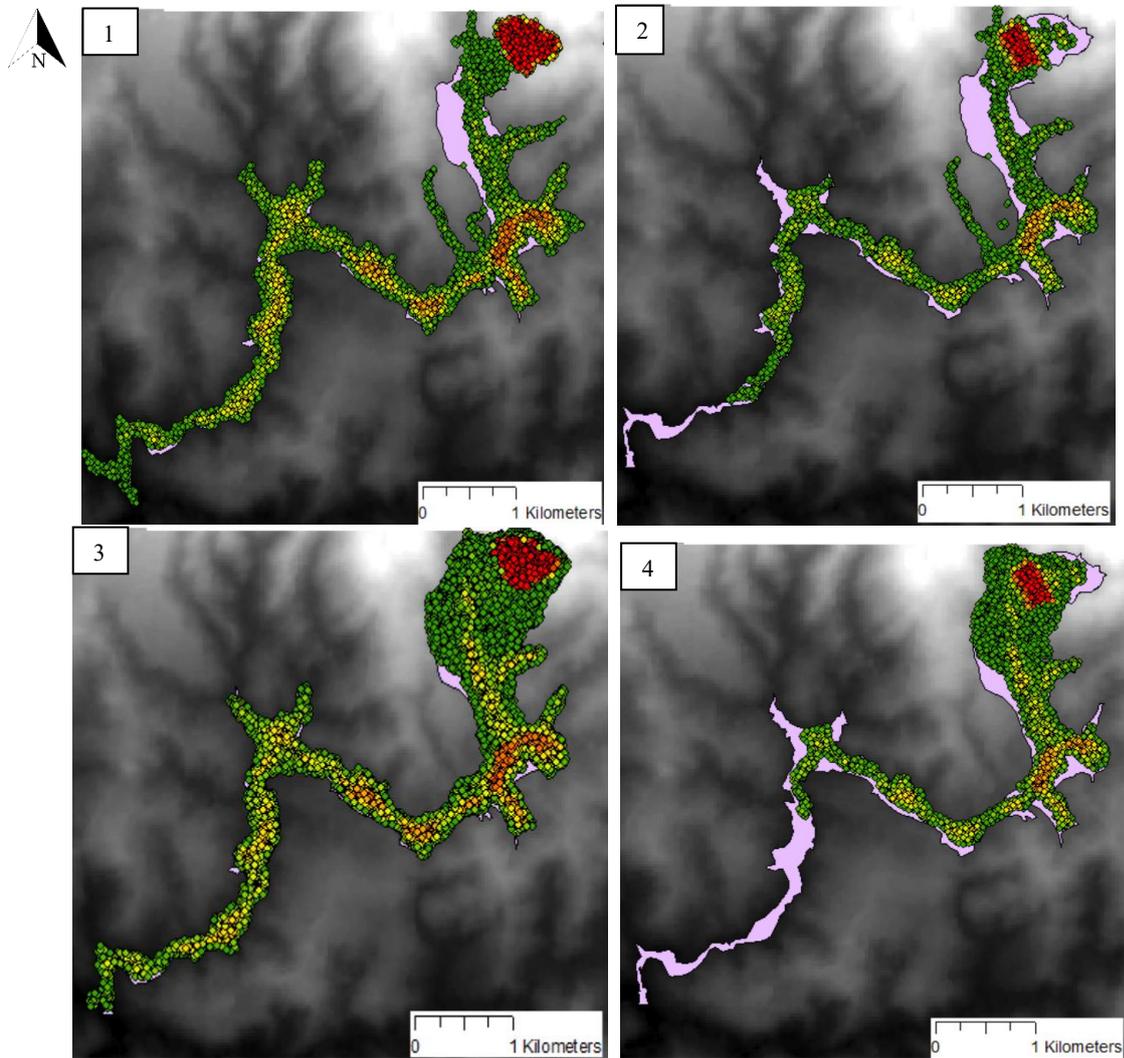
Figure 61 - Comparison between the different simulations in terms of shape and maximum height (m), 1- Voellmy (method I), 2 – Voellmy (method II), 3 – Bingham (method I), 4 – Bingham (method II).

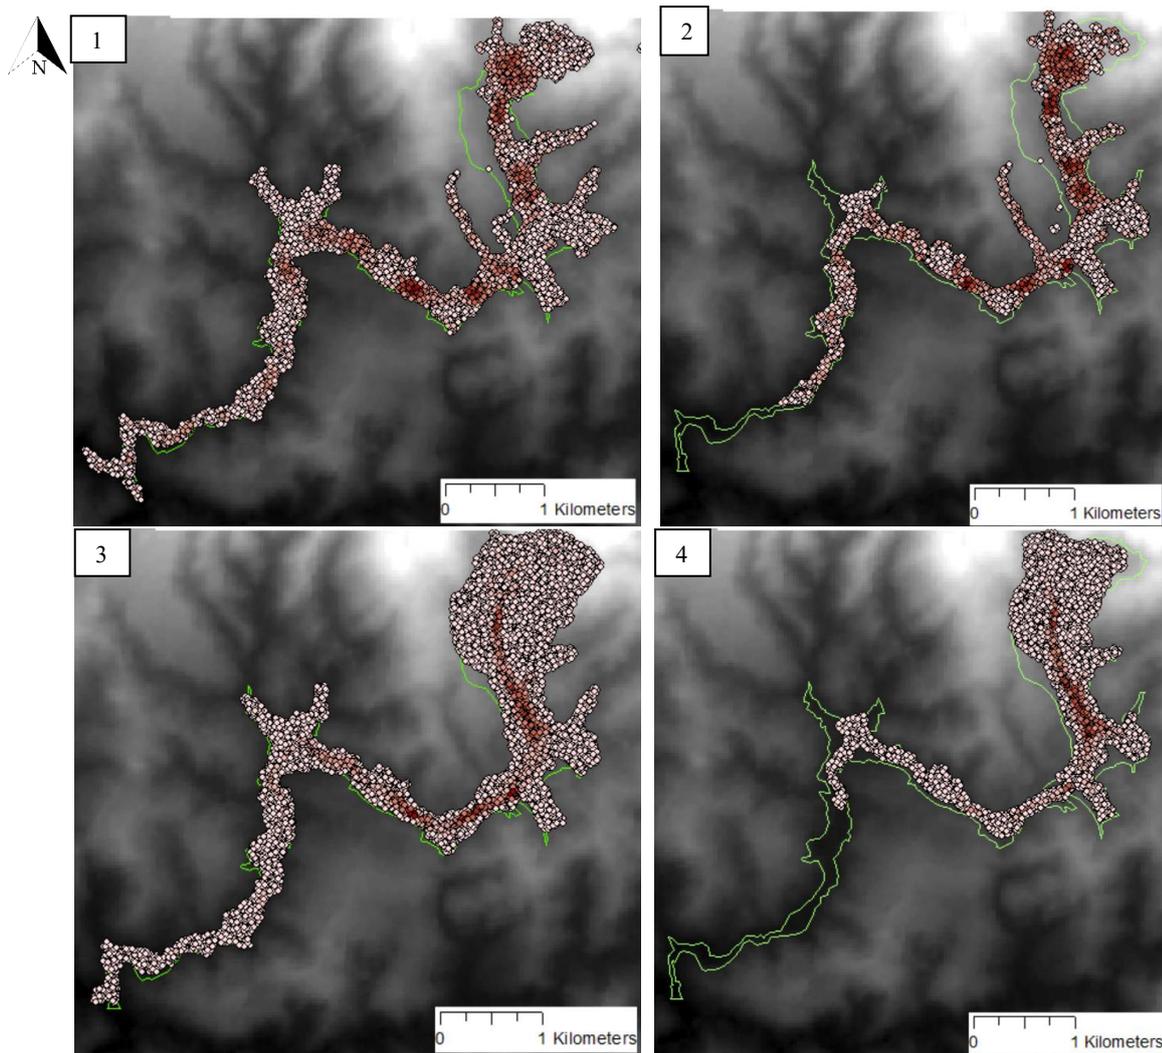
Figure 62 - Comparison between the different simulations in terms of velocity (m/s), 1- Voellmy (method I), 2 – Voellmy (method II), 3 – Bingham (method I), 4 – Bingham (method II).

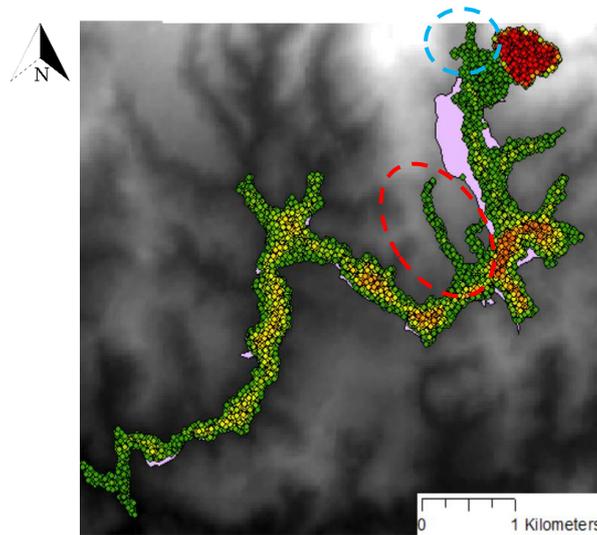
The mentioned branches are highlighted in Figure 63.

Figure 63 - Voellmy branches.

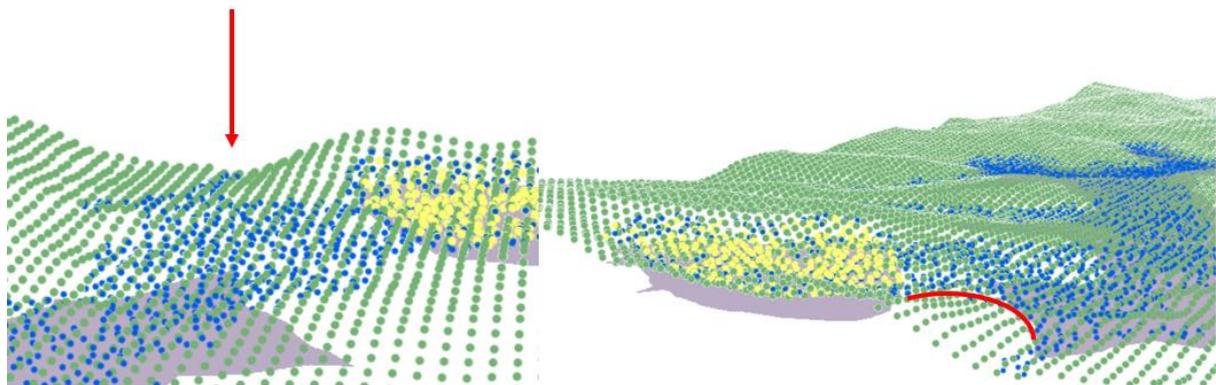
Figure 64 - Analysis of Voellmy branch I.

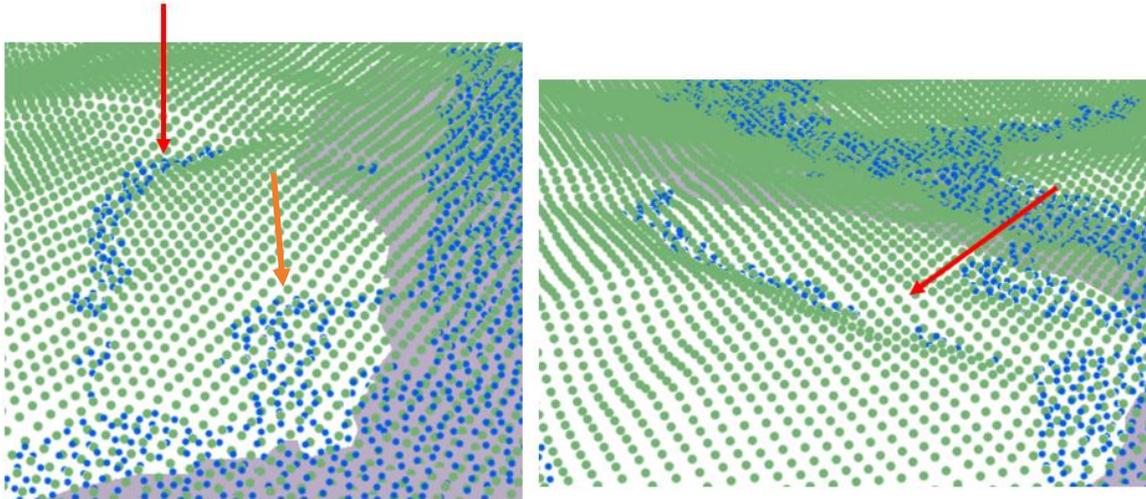
Figure 65 – Analysis of Voellmy branch II.

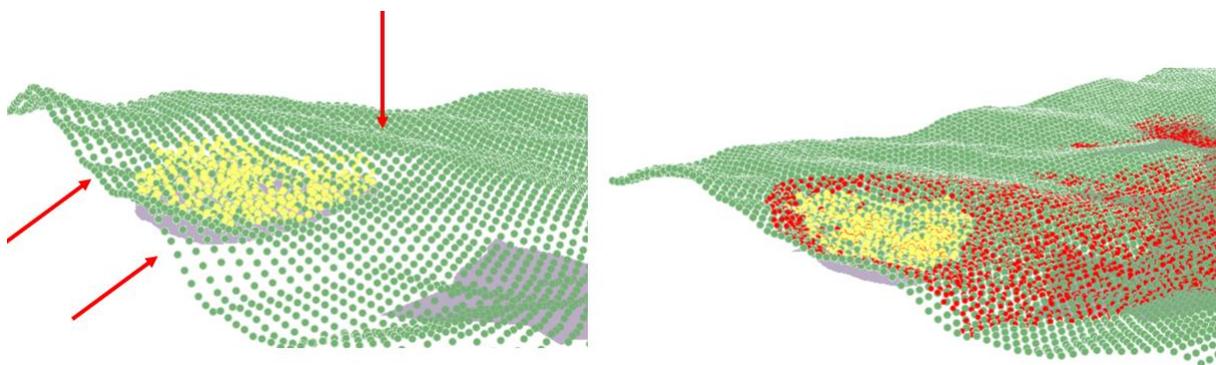
Figure 69 - Analysis of Bingham overflow.

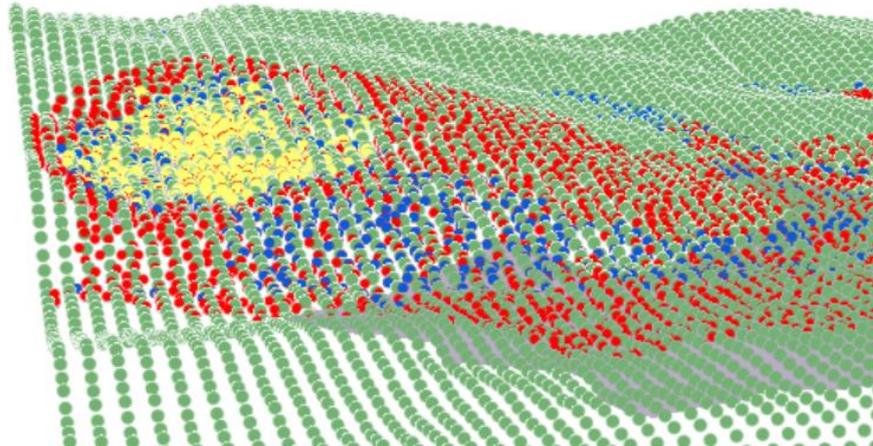
Figure 70 - Comparison between Voellmy and Bingham flows in 3D, for the first method.

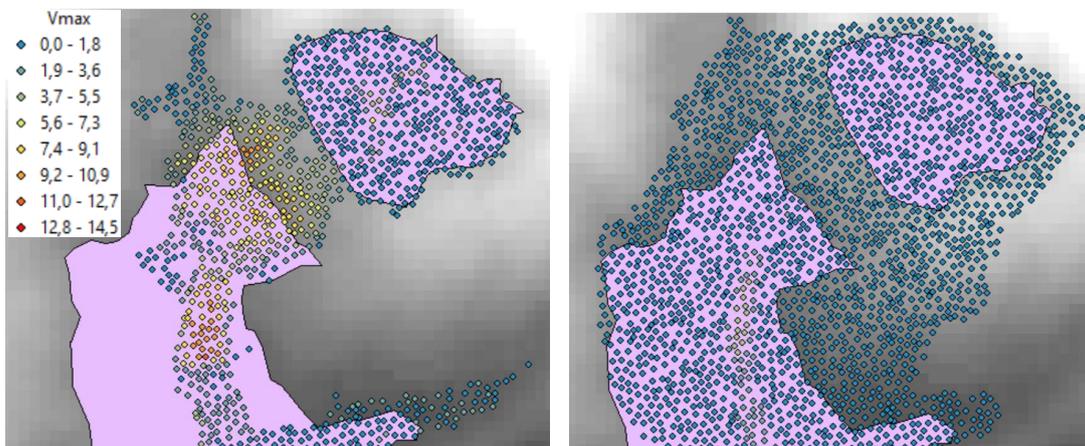
Figure 71 - Comparison between Voellmy and Bingham velocities, for the first method.

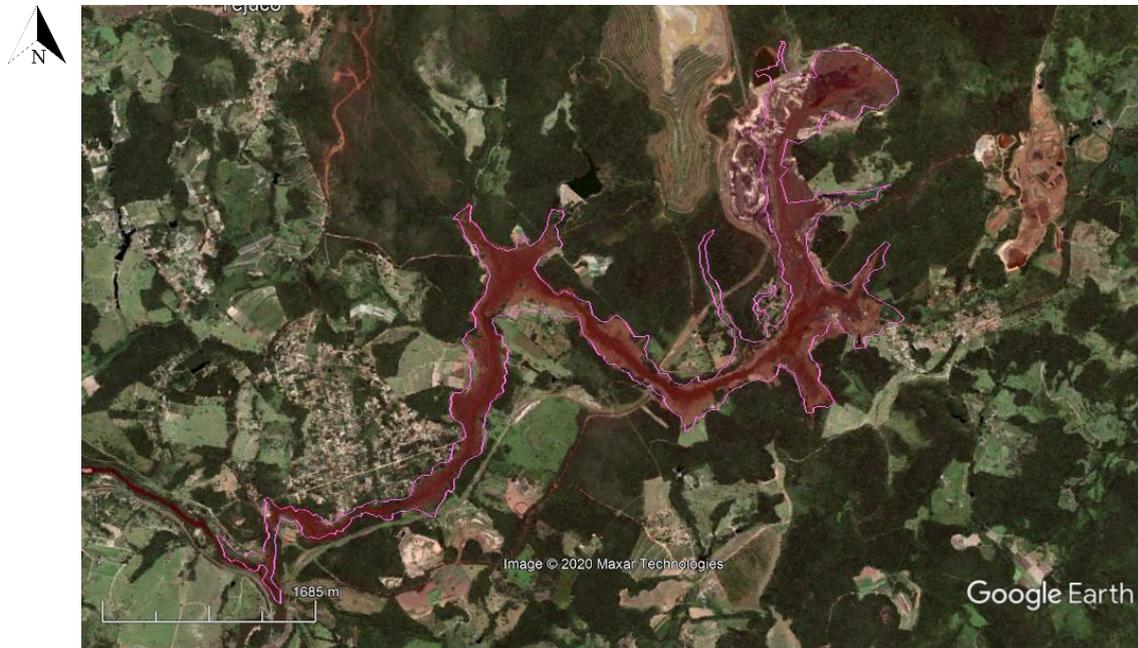
Figure 75 - Final shape of Voellmy (method I) simulation plotted on Google Earth.

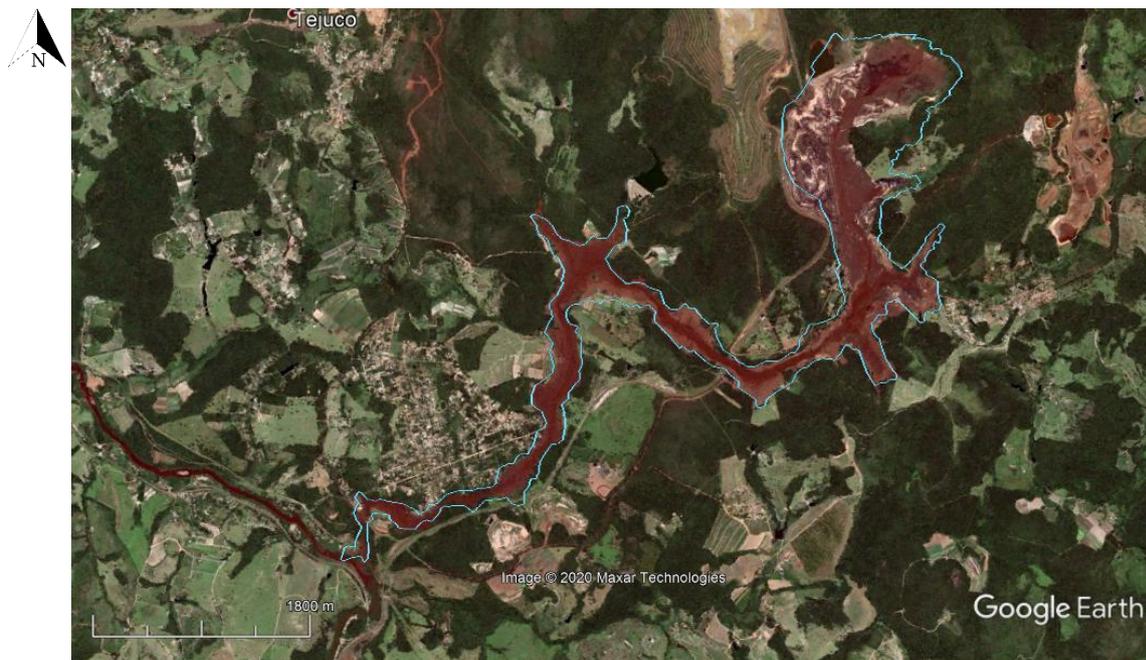
Figure 76 - Final shape of Bingham (method I) simulation plotted on Google Earth.

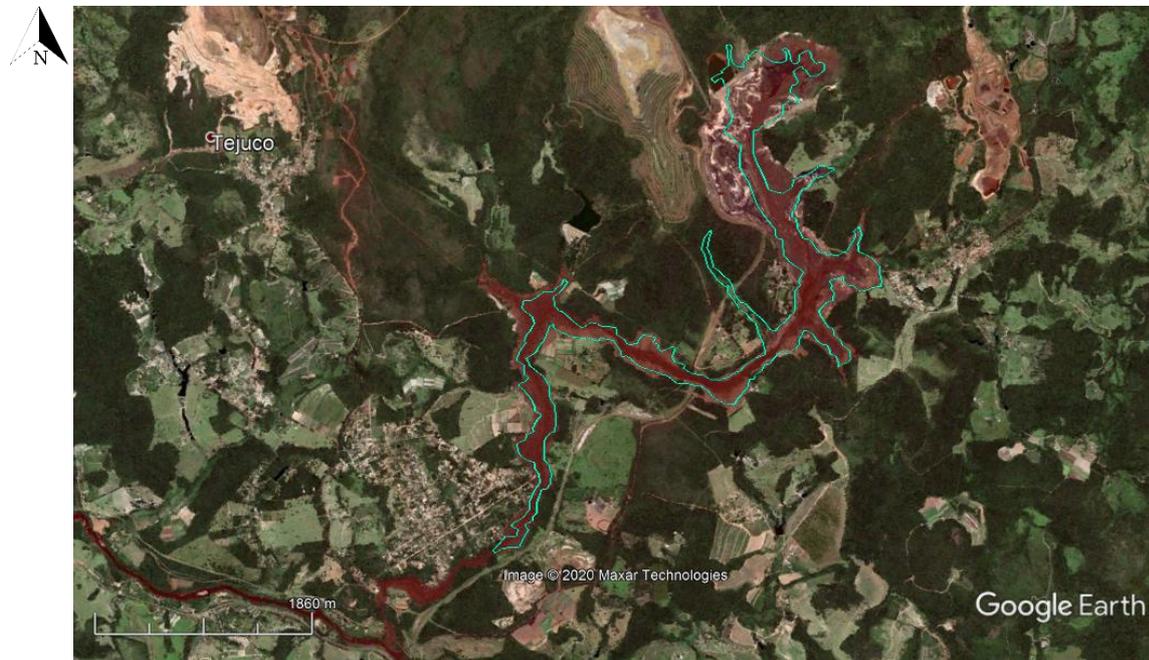
Figure 77 - Final shape of Voellmy (method II) simulation plotted on Google Earth.

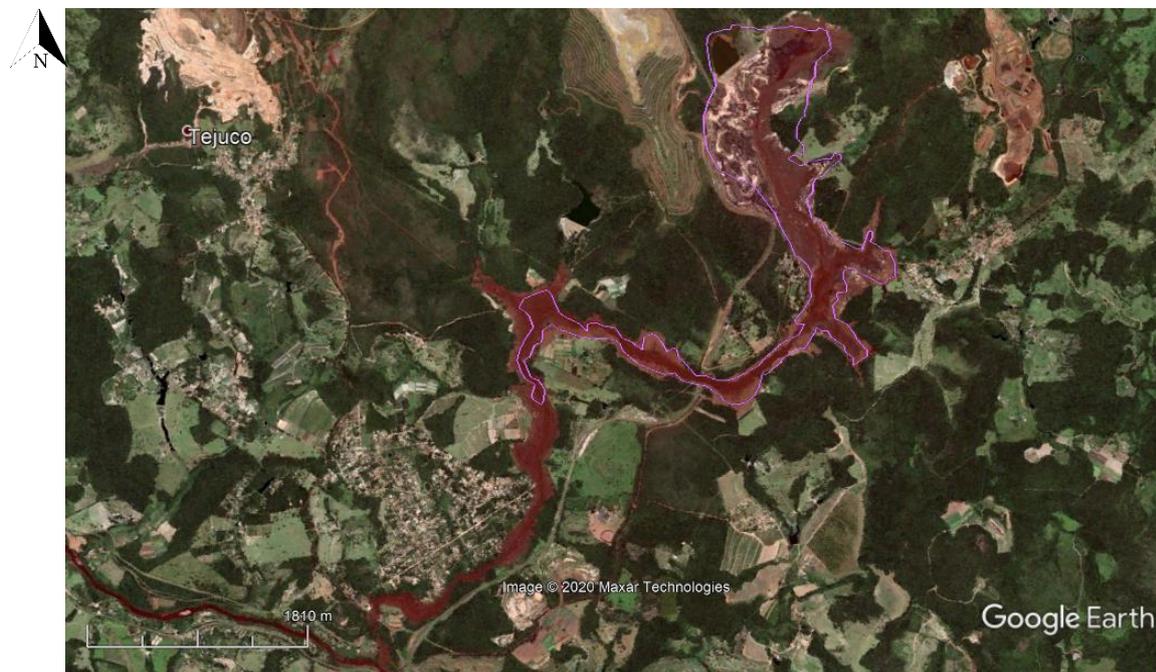
Figure 78 - Final shape of Bingham (method II) simulation plotted on Google Earth.

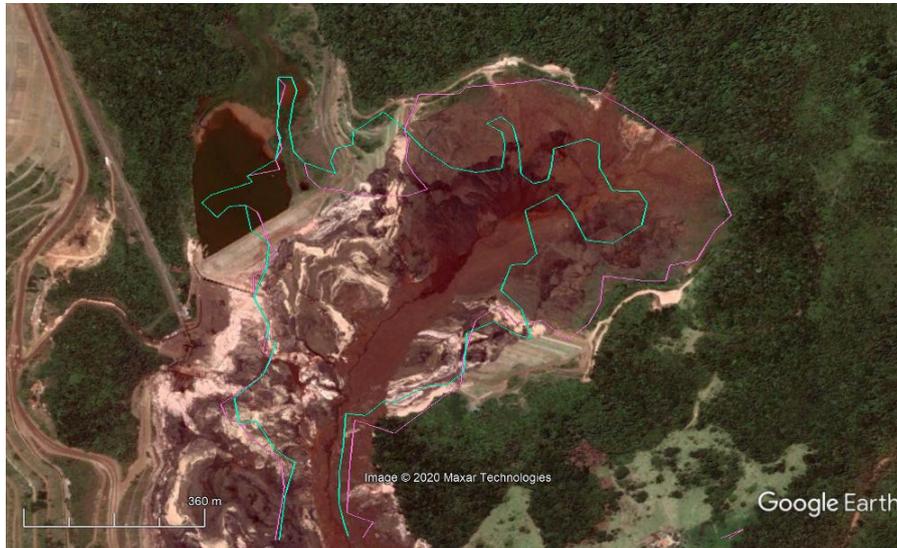
Figure 79 - Comparison between the detachment area and the Voellmy simulations.
