Technical Paper

Deformation of the foundation and structure of Tomioka Silk Mill's East Cocoon Warehouse

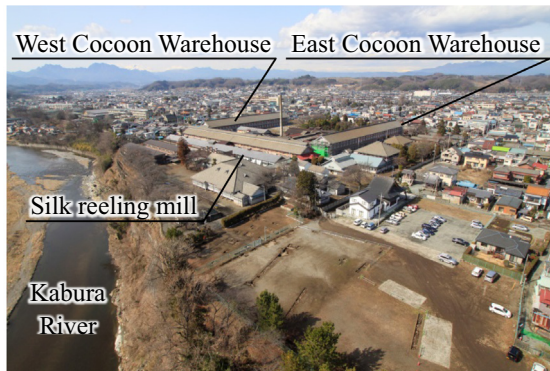
Photograph 1. Perspective view of the Tomioka Silk Mill. Reproduced from Tomioka City, 2013.

Photograph 1 shows a perspective view of the Tomioka Silk Mill. The Kabura River flows along the southern side of the property. The silk reeling mill is located at the southern end of the complex. The major axes of the East and West Cocoon Warehouses run north–south. The Tomioka Silk Mill is located on a terrace by the Kabura River at an elevation of approximately 167 m. An elevation view of the southern side of the East Cocoon Warehouse is shown in Fig. 1 (Tomioka City Board of Education, 2006). The building is 14.01 m wide, 14.80 m high, and 107.71 m long. It has a total of 92 pillars; 30 each are located along the eastern and western walls, 28 are in the center, and two each are located along the northern and southern walls. Cedar pillars approximately 10 m long support the second floor and the roof. These features are similar to those of the West Cocoon Warehouse (Shogaki et al., 2015).

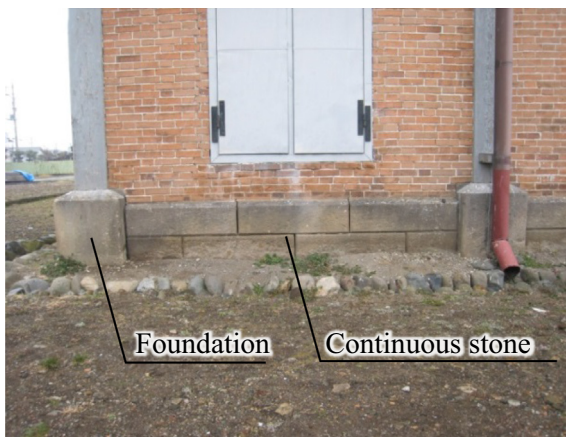
Photograph 2. Foundation and continuous stones.

brick construction (approximately 81 kN/m^2). The ratio of the ultimate bearing capacity (226.3 kN/m^2) to the weight (81 kN/m^2) of the stored cocoons and the timber-framed brick construction is 2.8. This ratio is considered as the safety factor for similar current construction method. The northern half of the West Cocoon Warehouse was used for coal storage for the first 24 years of the building's life. The first floor of the building was constructed in 1896 (Tomioka, 2013), and concrete was placed in the spaces between the foundation stones in 1981, as shown in Photograph 2.

The foundation stones are Miocene sandstone with a height of 1 m and square cross sections with 60 cm sides. Approximately 60 cm of the height of the stones is exposed at the East Cocoon Warehouse, as shown in Photograph 2. The elevation E of the tops of the foundation stones was measured using the TS, which has a precision of 1 mm for distance measurements and 5" for rotation measurements. Continuous rows of stones are present between the foundation stones. These rows are 90 cm long and 30 cm high and are composed of the same stone material as the foundation stones. There is no connecting material between the continuous stones, and they are in direct contact with each other. The width G of each of the gaps between the continuous stones was measured to within 0.01 mm using a vernier caliper, as shown in Photograph 4. The inclination of the pillars and the settlement of the foundation stones were measured in December 2014, and the gap widths G were measured in February 2015. The elevations of the foundation stones on the western side of the East Cocoon Warehouse could not be measured because the adjoining Cocoon Drying Facility had fallen down as a result of a snowstorm in 2015. Therefore, the elevations of the foundation stones on the East Cocoon Warehouse were newly measured in March 2017. However, except for those on the western side of the East Cocoon Warehouse, the elevations of the foundation stones obtained in March 2017 were similar to those in February 2015.

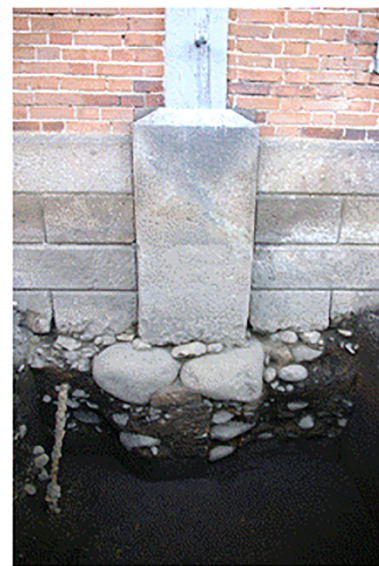
Photograph 3. Foundation structures. Reproduced from Tomioka City, 2013.

Photograph 3 shows the foundation and brick wall. Two stones with a diameter of approximately 50 cm were placed

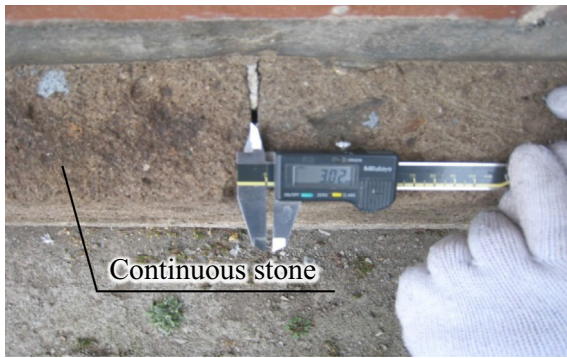
Photograph 4. Gap between continuous stones measured using a vernier caliper.
