**The XVII century Hacienda Perodias
in south-western Colombia and its
contested memory. New functions and
transformation processes**

Daniel Lozano | S276685
MSc Architecture Construction City

Master's Thesis

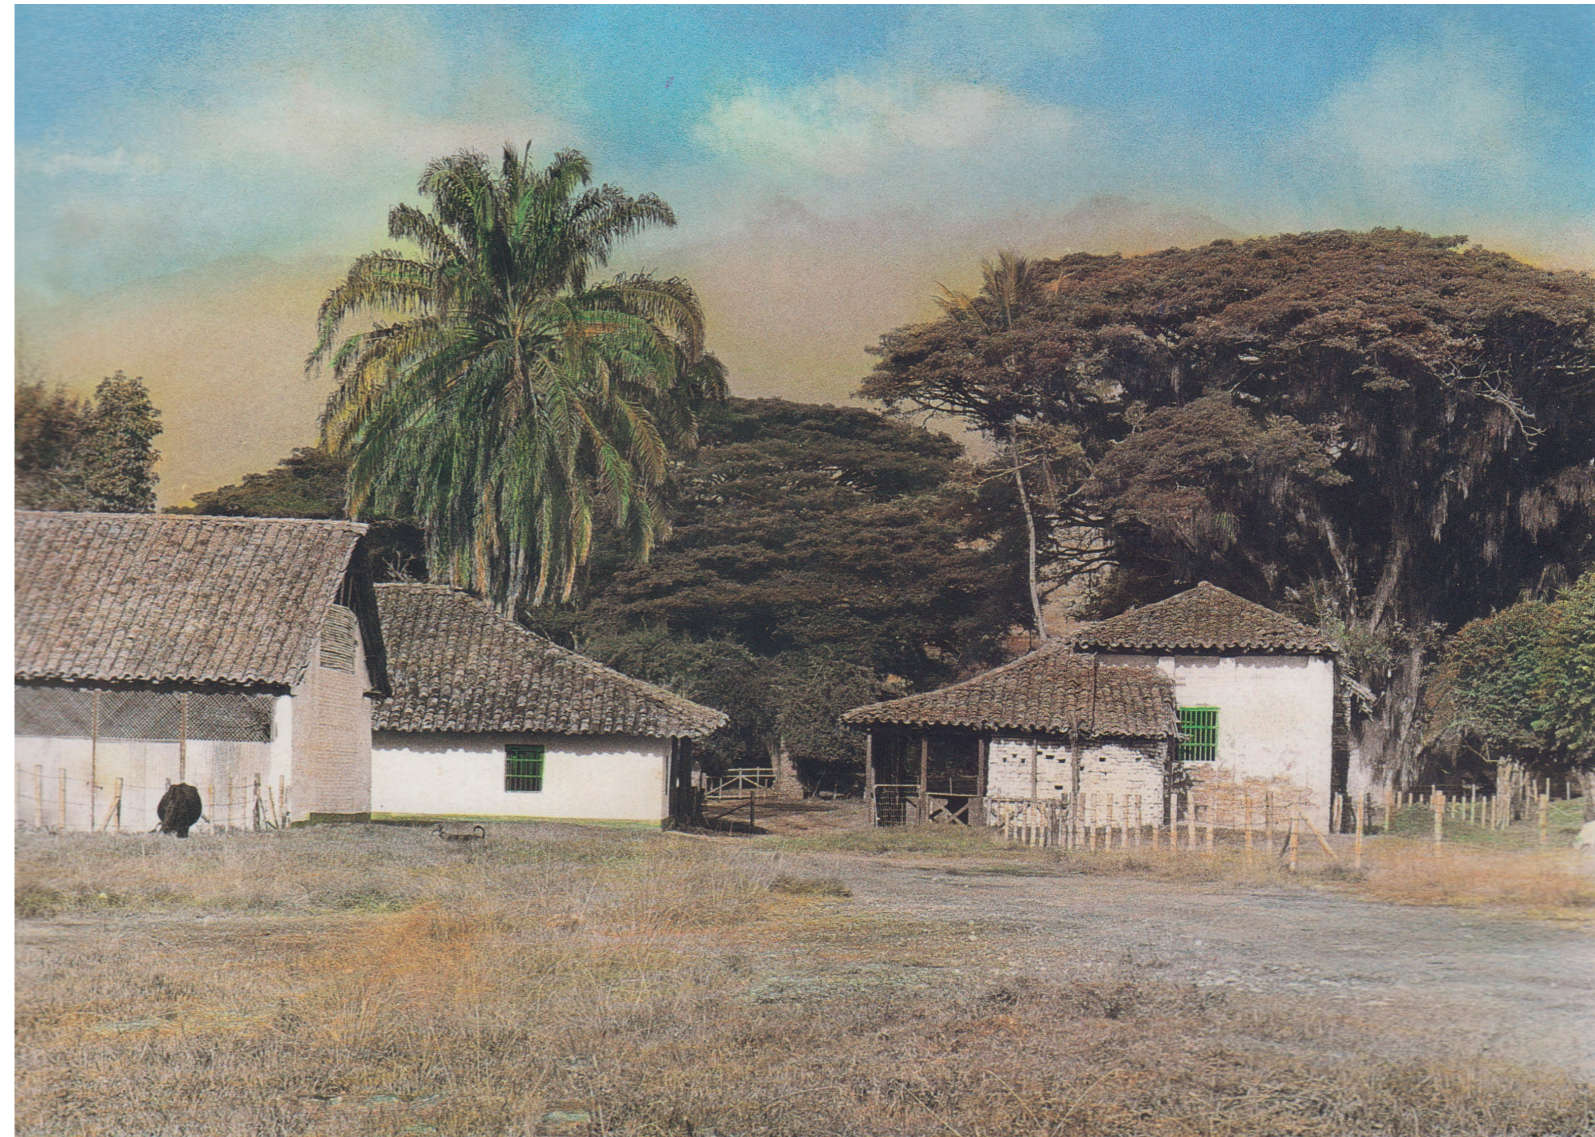
Below, [Figure 9] the building complex of the Hacienda 'Perodías,' 1987. The indoctrination chapel was capture here from its rear façade.

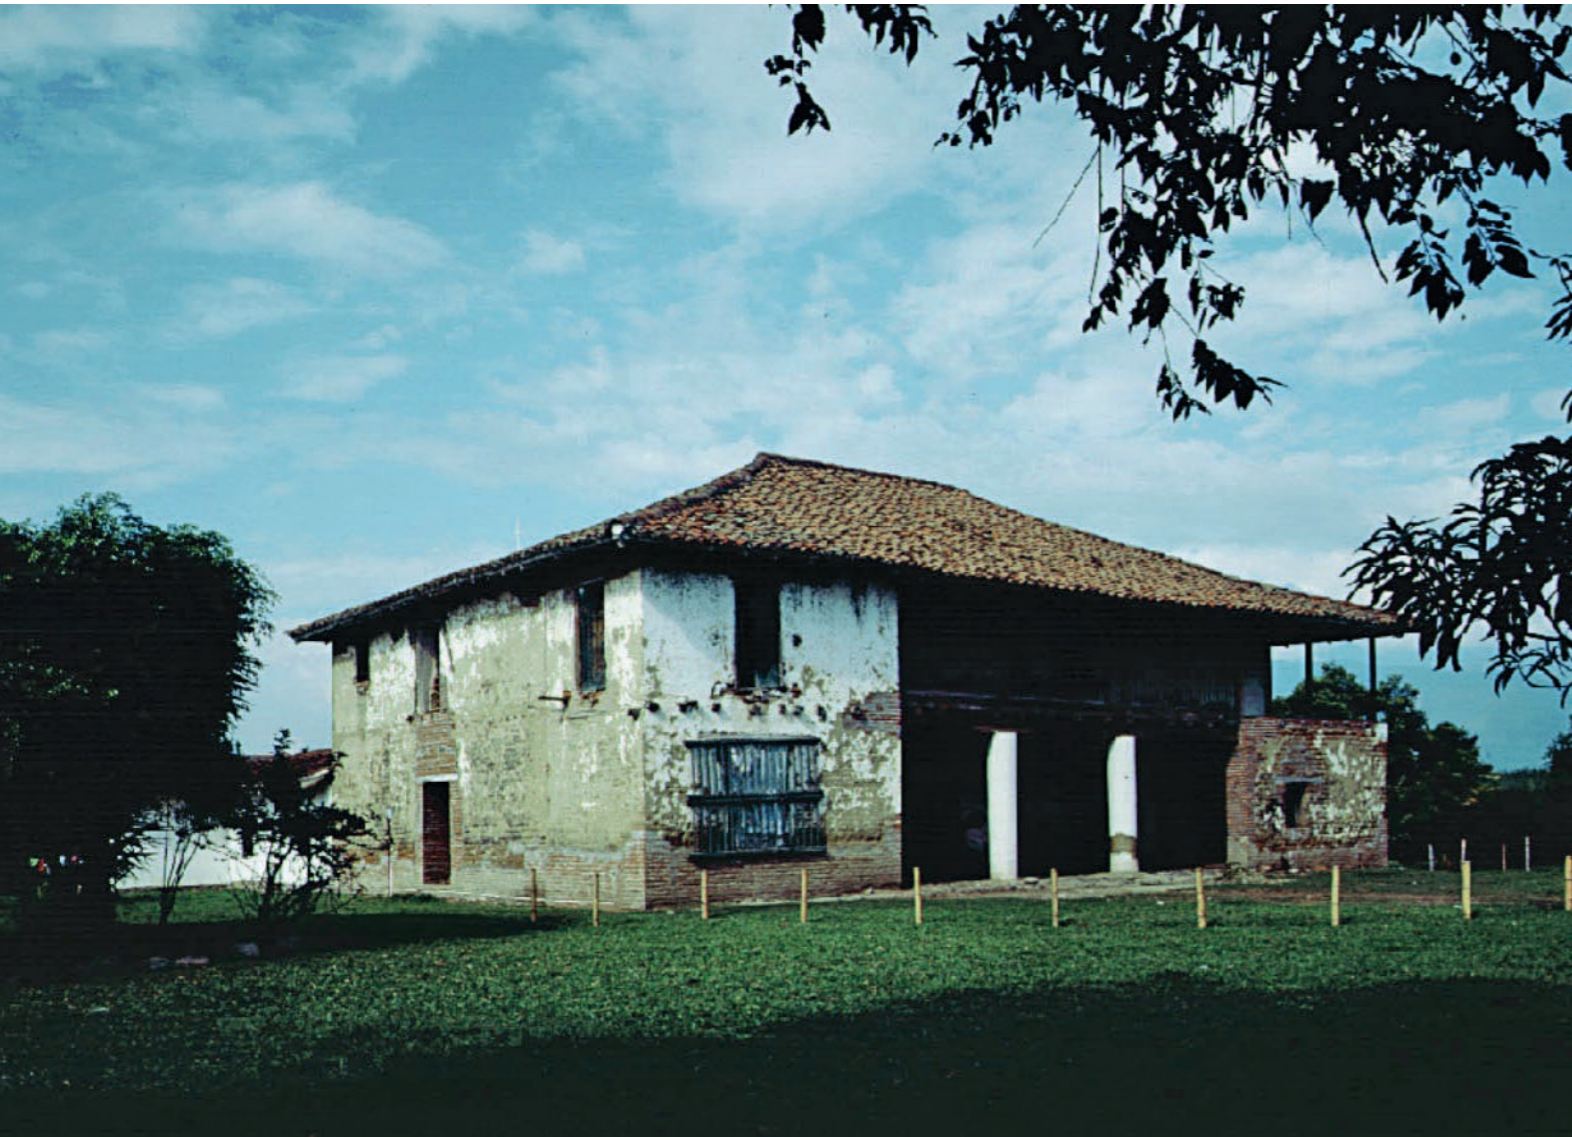
Below, [Figure 10] Hacienda El Hato
(Pradera).
Photo by Antonio Castañeda (1997)
in Villegas, *Arquitectura campo
colombiano*, 214

were also listed as National Monuments in 1996 along with other 13 building complexes in the region,¹⁴ have been in a state of abandonment for more than two decades. The current condition of the haciendas *El Hato*, *La Industria* (see **fig. 5 and 6**) *El Alisal*, and *Perodías* is critical, to the point that they are all at risk of total collapse. Moreover, *El Alisal*, established in the second half of the XVI century, and *Perodías*, from the first decades of the XVII century, are two of the oldest existing representatives of *Casas de Hacienda* in the Cauca River Valley and constitute, together with the haciendas *García Abajo* and *Hatoviejo*, the group of heritage complexes that still retain their respective indoctrination chapels, albeit the state of conservation of those standing in *El Alisal* and *Perodías* is truly distressing. The indoctrination chapels in the haciendas *Arroyohondo*, *Japio*, *Cuprecia*, *Cañasgordas* and *El Paraíso*, together with many others unregistered, were demolished due to the abandonment of these spaces after the abolition of slavery in the country. Likewise, other examples were also dismantled as a sign of rejection by some radical landowners of the Catholic Church right after the country's Independence. More recently, their disappearance is due to the looting and destruction perpetrated by individuals

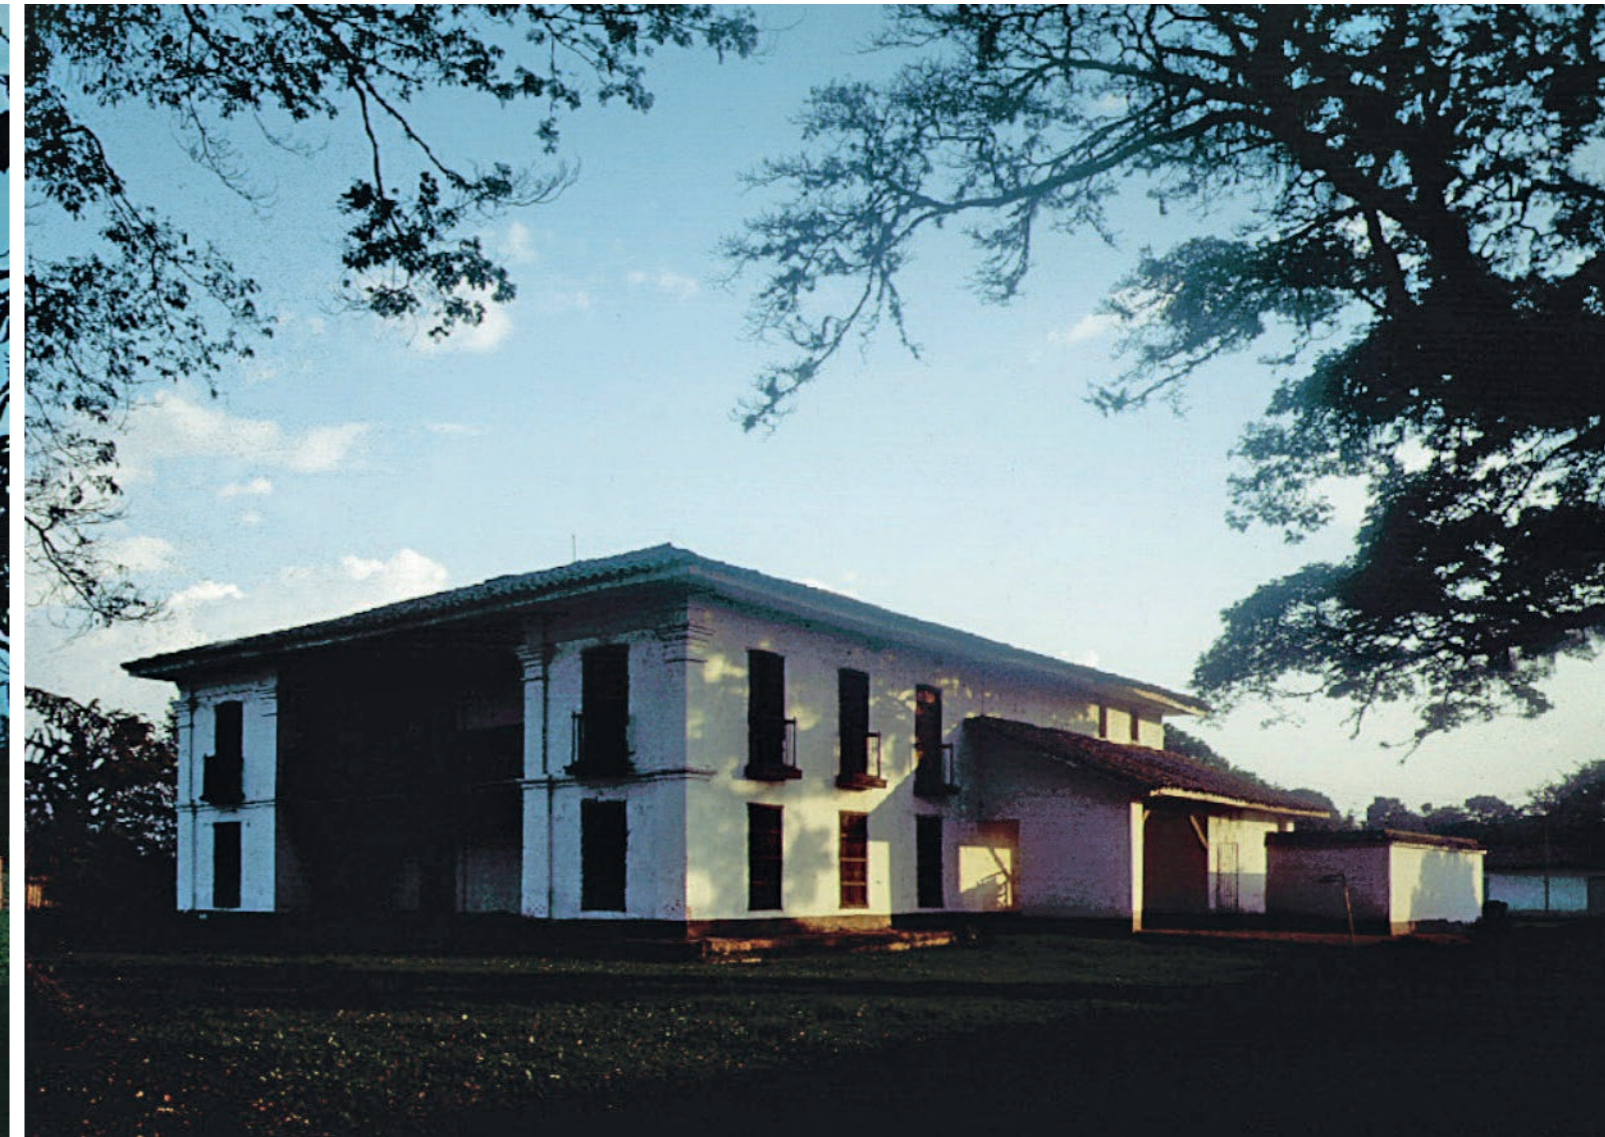
Below, [Figure 11] Hacienda La
Industria (Florida).
Photos by Antonio Castañeda (1997)
in Villegas, *Arquitectura campo
colombiano*, 220-221.

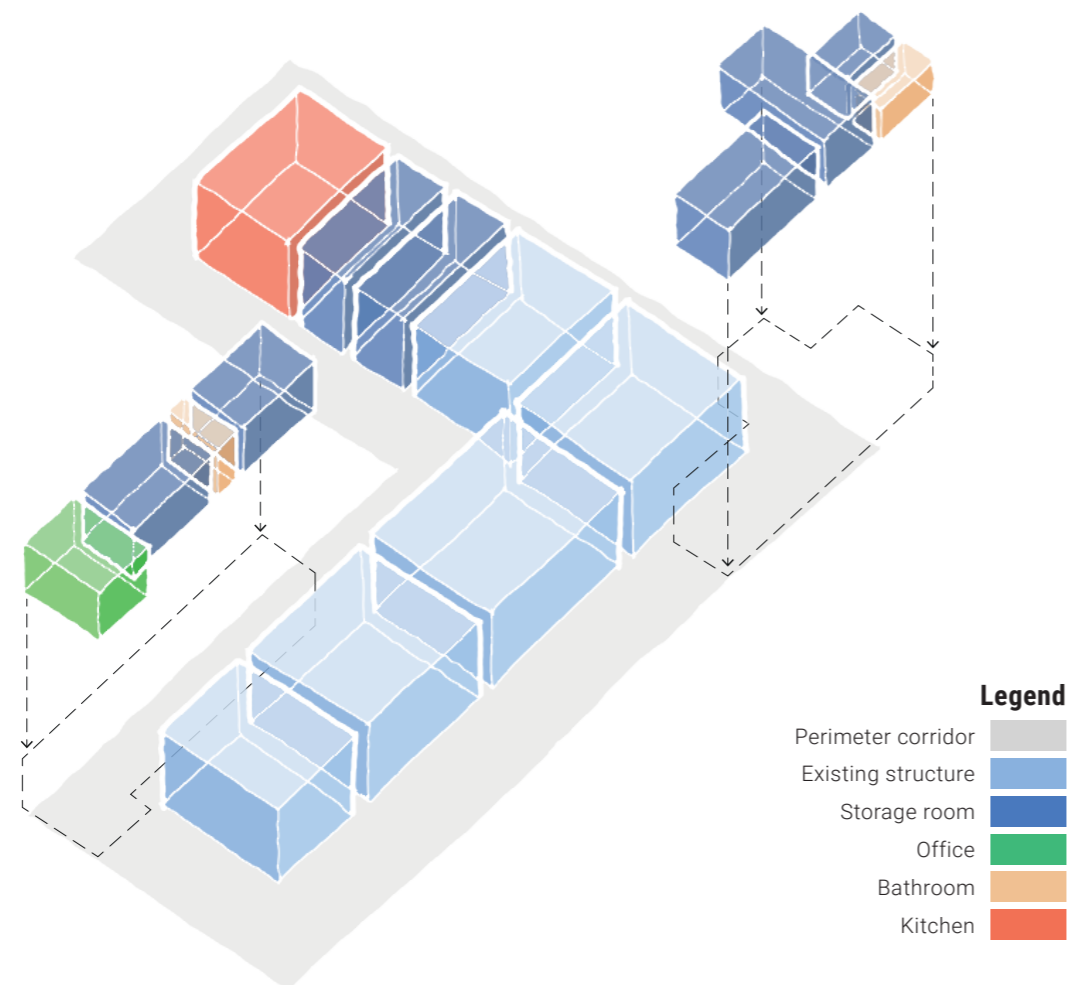
[Figure 23] The spatial distribution of the Family House.
Drawing by the author, 2022.

In constructive terms, the family house is composed of four clearly distinguishable construction systems: a punctual foundation for its load-bearing elements, structural walls in bahareque and minor divisions in fired clay masonry, punctual elements in wood that receive the roof while framing the façades, and a roof system in fired clay roof tiles supported by a “collar tie framing” structure. In general terms, all these construction systems incorporate the use of materials obtained from the surroundings of the house, i.e. they are construction techniques based on the use of earth, solid timber, bamboo and various vegetal fibres abundant in the surrounding landscape, with the only exception being the nails made in forge or smithy, which ensure the scissor tie of the rafters on which the ridge beam rests.¹⁶

The foundations defined for the wooden pillars and the *bahareque* walls consist of the superimposition of two layers, one in boulders and the other in handmade baked clay masonry. The structural walls in bahareque, of considerable thickness (60-70 cm),¹⁷ are made up of various elements with different functions: as the main core, there are solid timber columns of 30 cm in diameter, which initially work as punctual elements that receive the loads transmitted by the roof, and between which a horizontal laying of bamboo strips is arranged. Due to

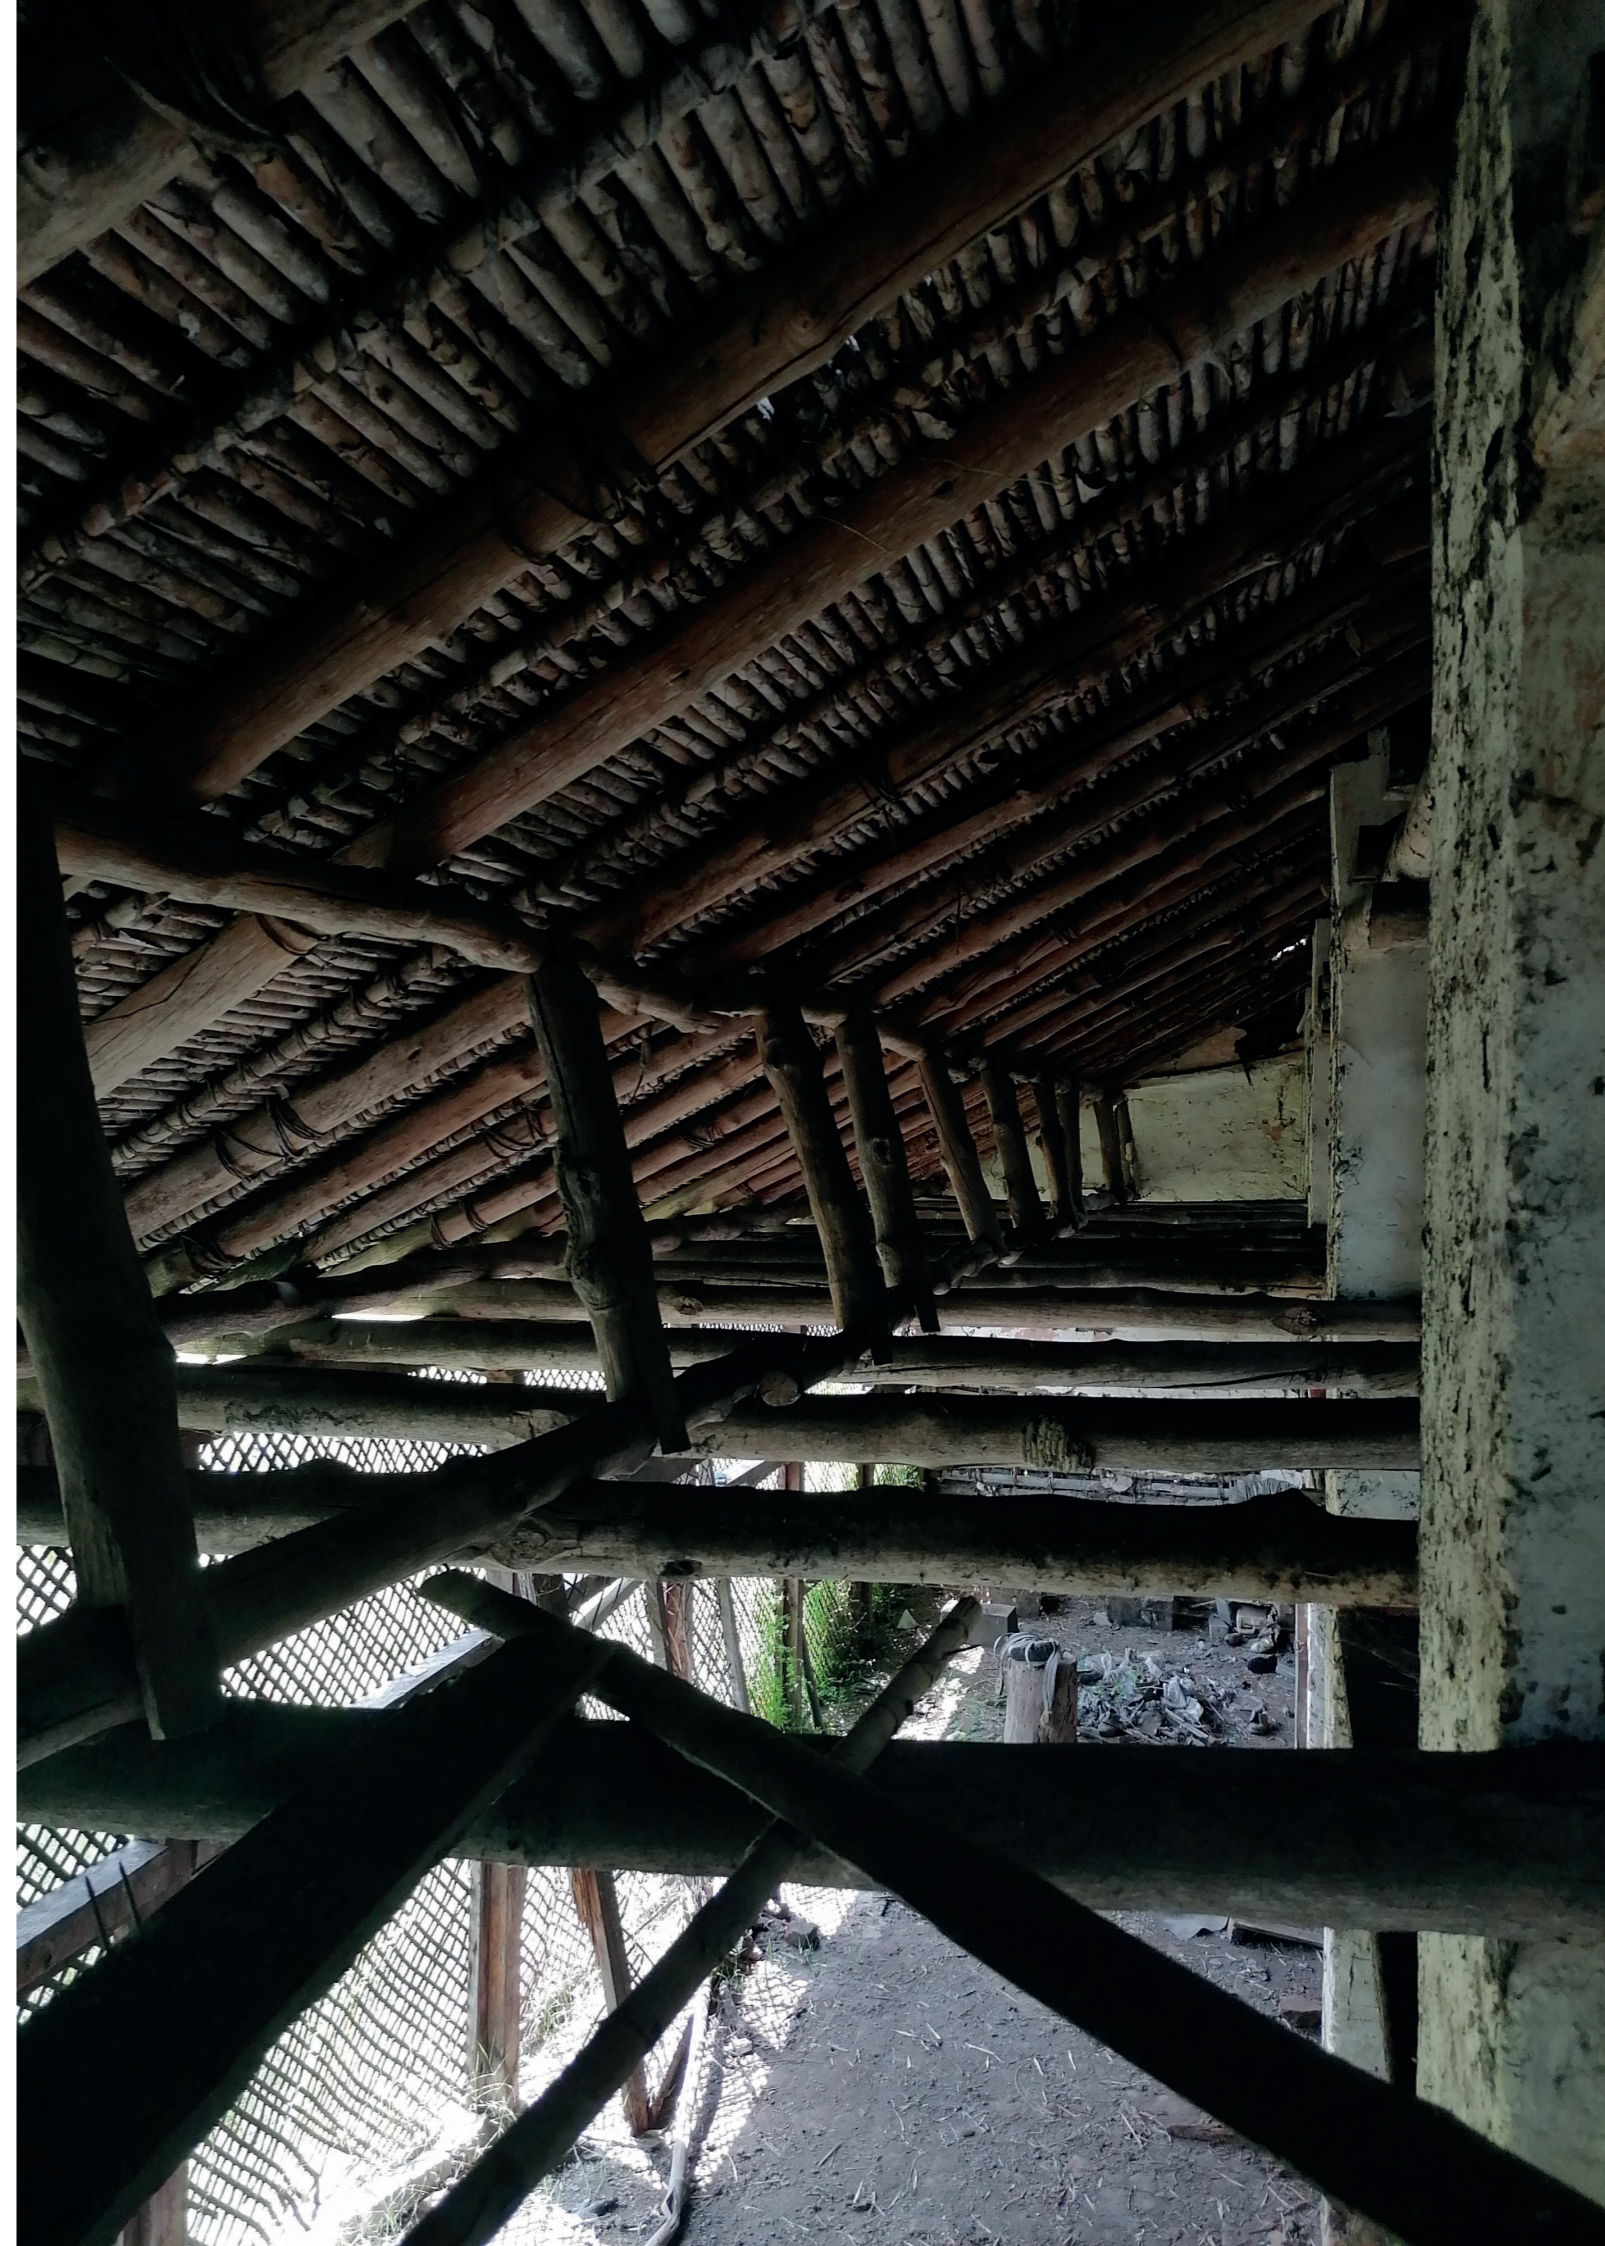
[Figure 26] The rhythm discernible in the roofing system of the warehouse.

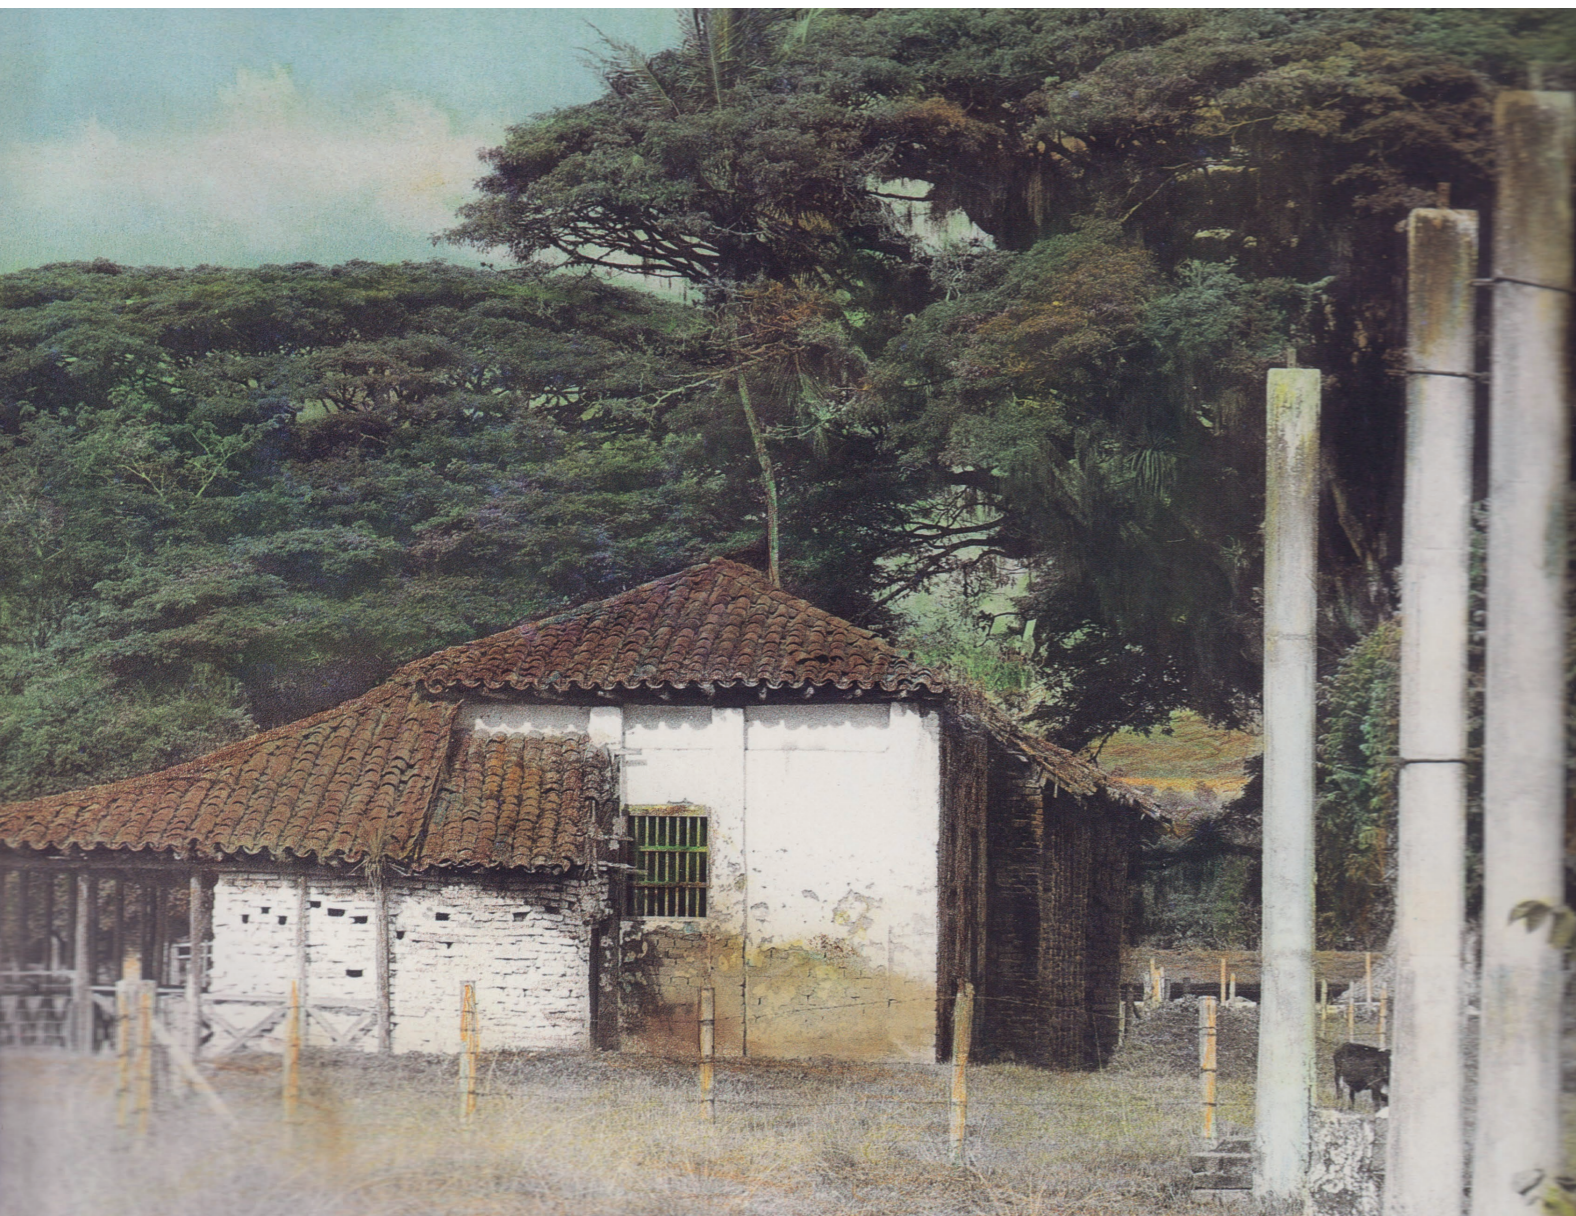
[Figure 29] The Chapel of the Hacienda Perodías, observed from the west. It is possible to distinguish the volumes of the shed and the store room juxtaposed to the presbytery walls.

Photo by Fernell Franco, 1965.

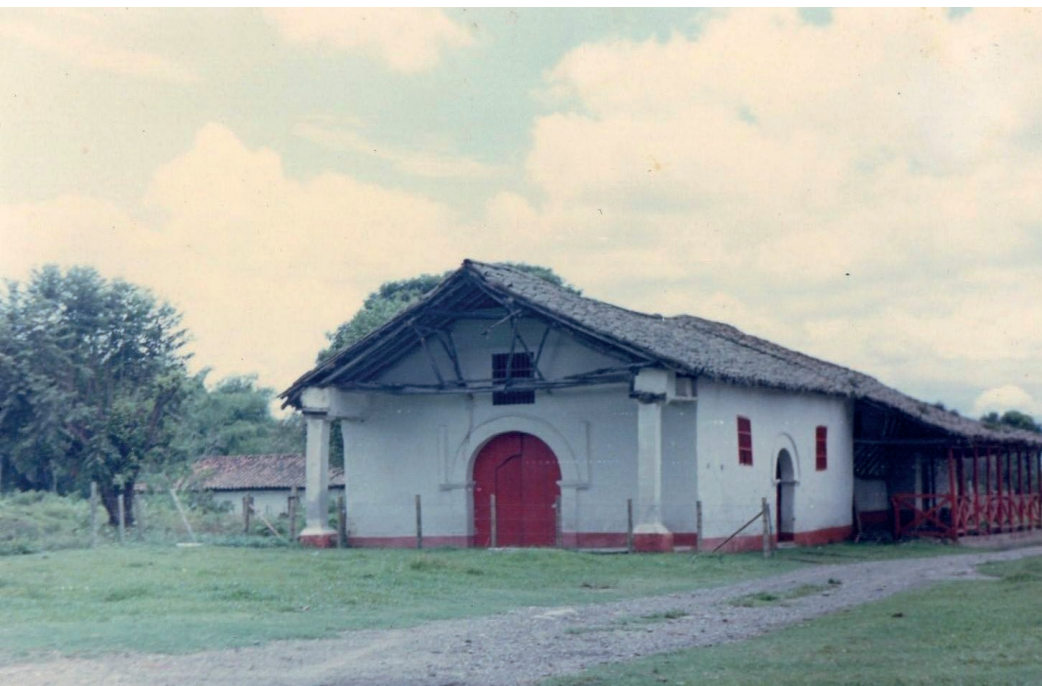
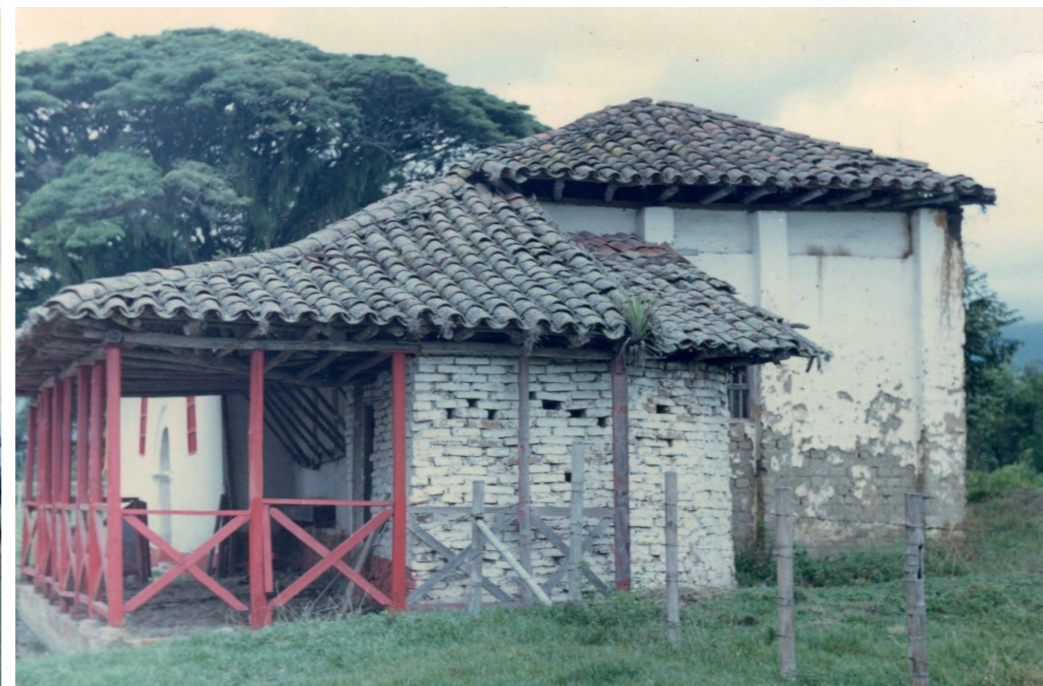
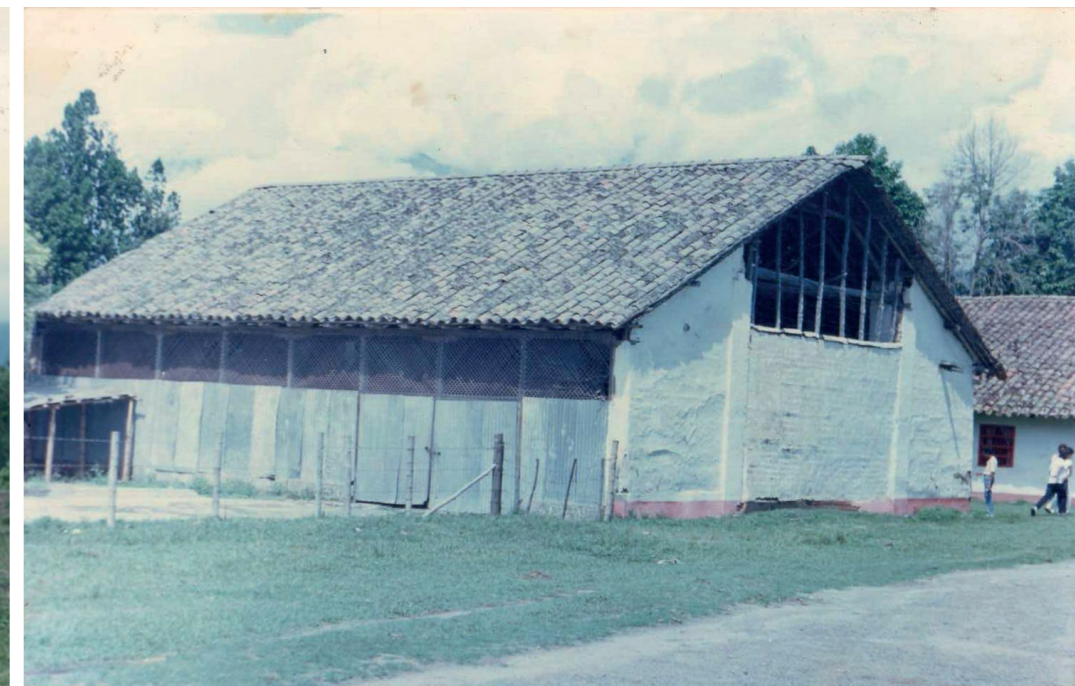
[Figure 37] The complementary buildings of the hacienda.

From left to right: the Chapel, captured from the Forecourt, its West façade, as well as the Warehouse, observed from the south-west. Photos property of Oscar Ibague Sanchez, personal digital archive, 1987.

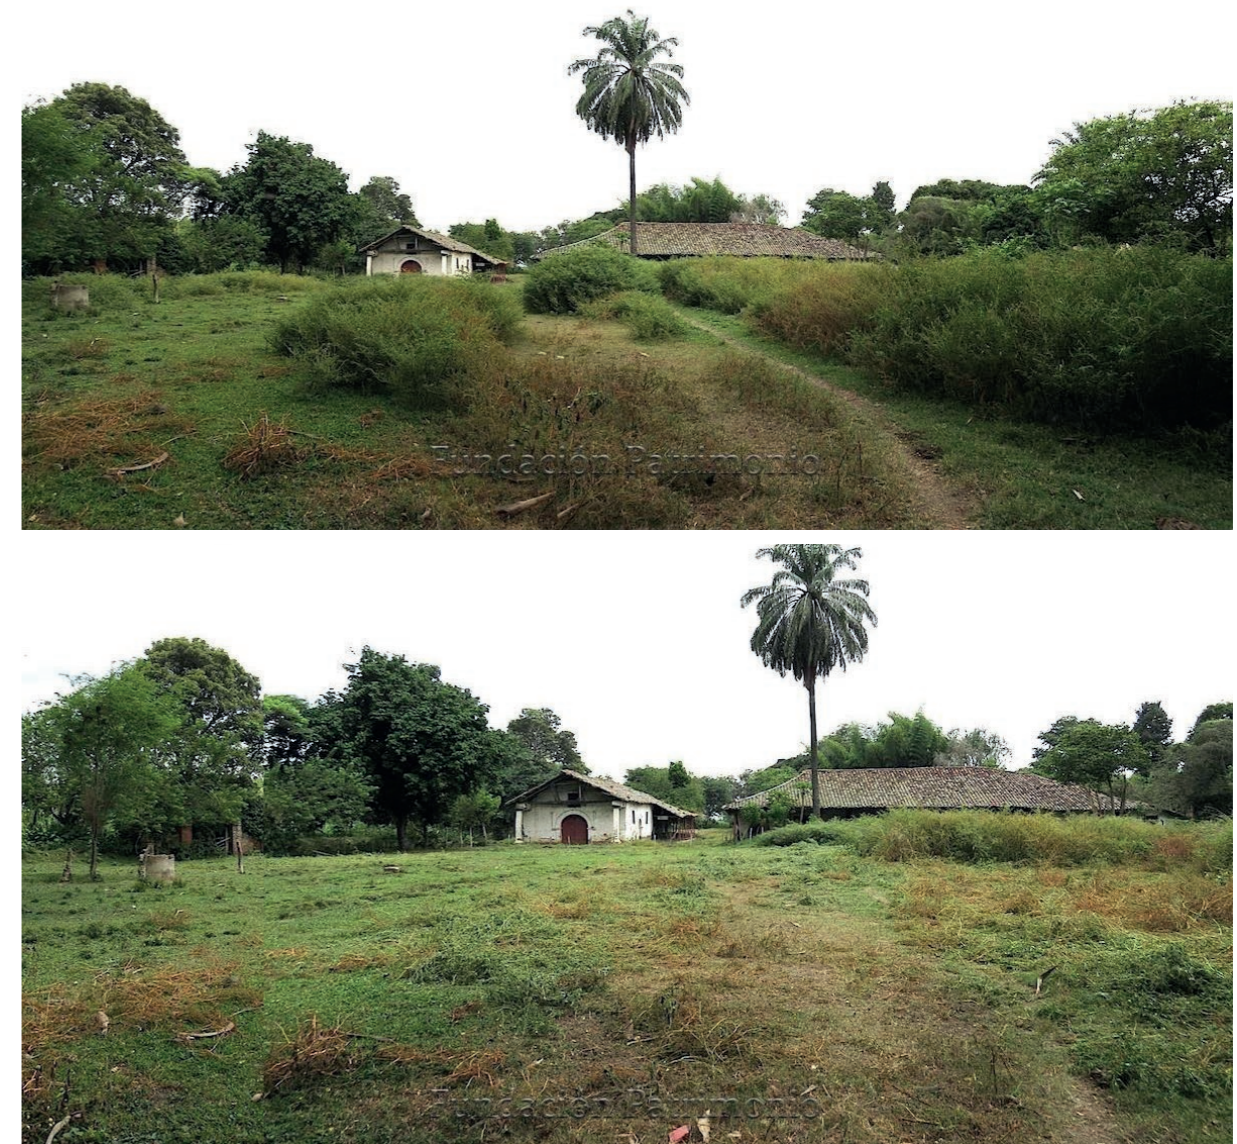
[Figure 40] The state of conservation of the architectural complex of the Hacienda Perodias at the beginning of 2014. The lack of proper maintenance and attention by the public authorities was already reflected harshly in the buildings, which, at this point, had not been properly used for more than a decade.

them. With the loss of just over 15% of its construction, the family house would be the most affected building by weather-related events up to that point.⁶

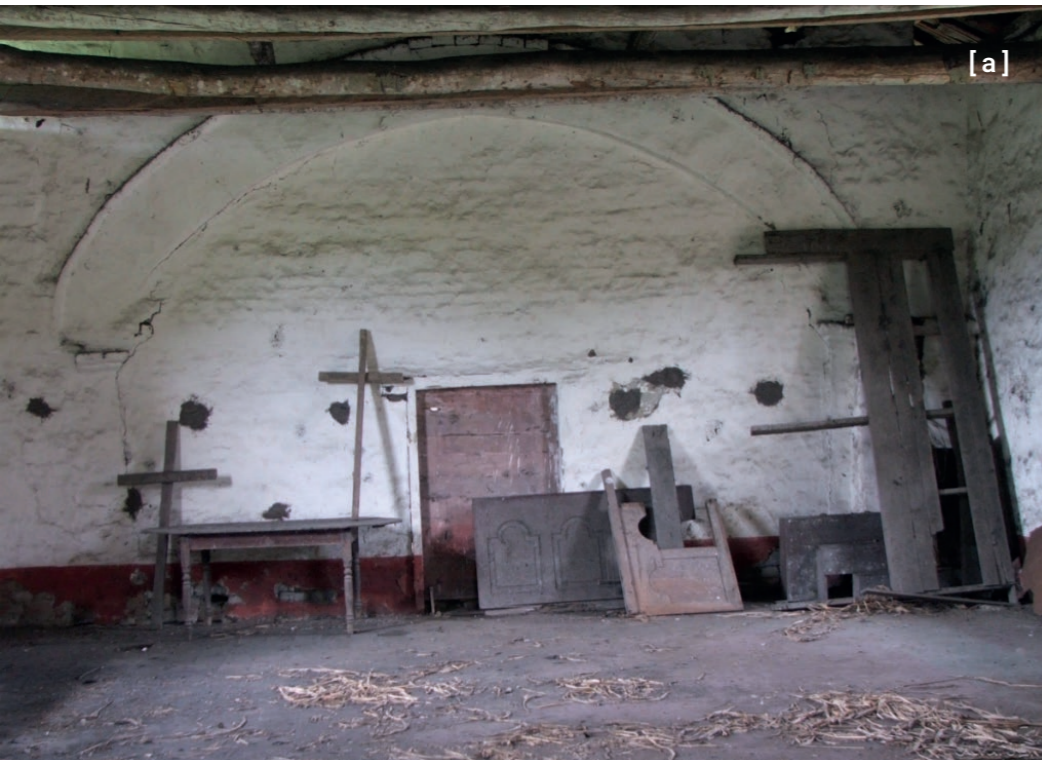
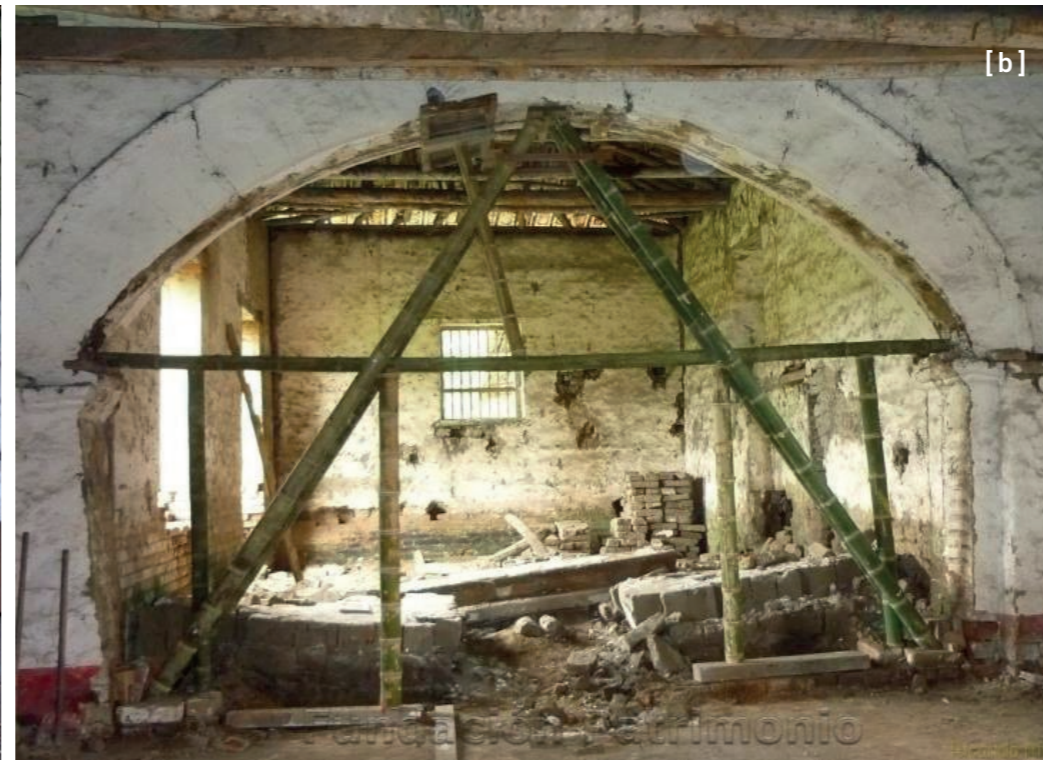
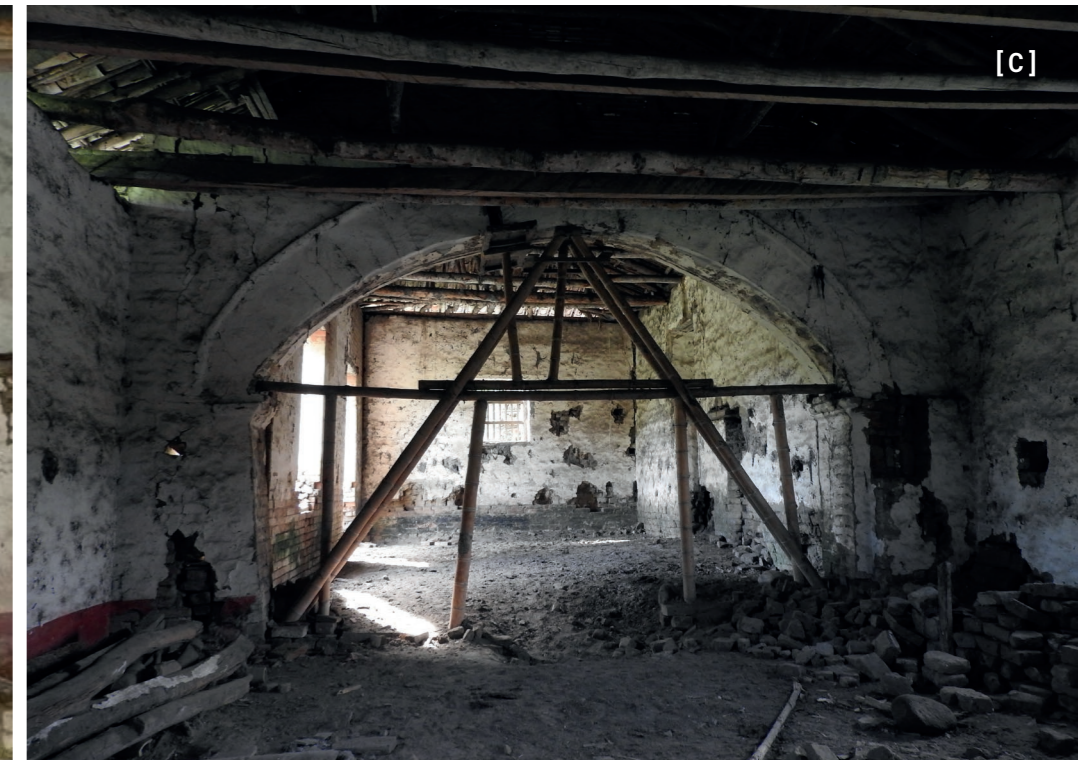
[Figure 41] The condition of the interior of the chapel throughout the last two decades: **a)** prior to the collapse of the dividing wall in 2011, **b)** the montage of a provisional centering in bamboo for the arch that same year, and **c)** the same structure after 9 years of abandonment. It is even possible to notice in here the impact treasure hunting had in the walls, an issue that represents a bigger threat for the preservation of this building than climatic conditions themselves.

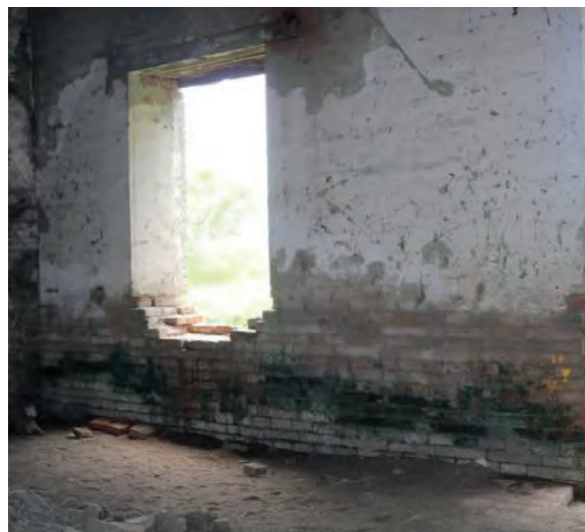
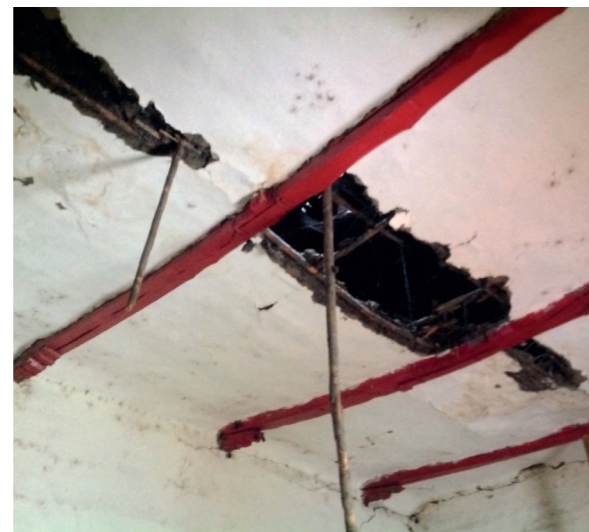
[Figure 46] Affectations due to dampness in the south wall of the presbytery (left), in the chapel, and the ceilings above the main hall, in the family house (right).
Photos by CITCE, 2018.

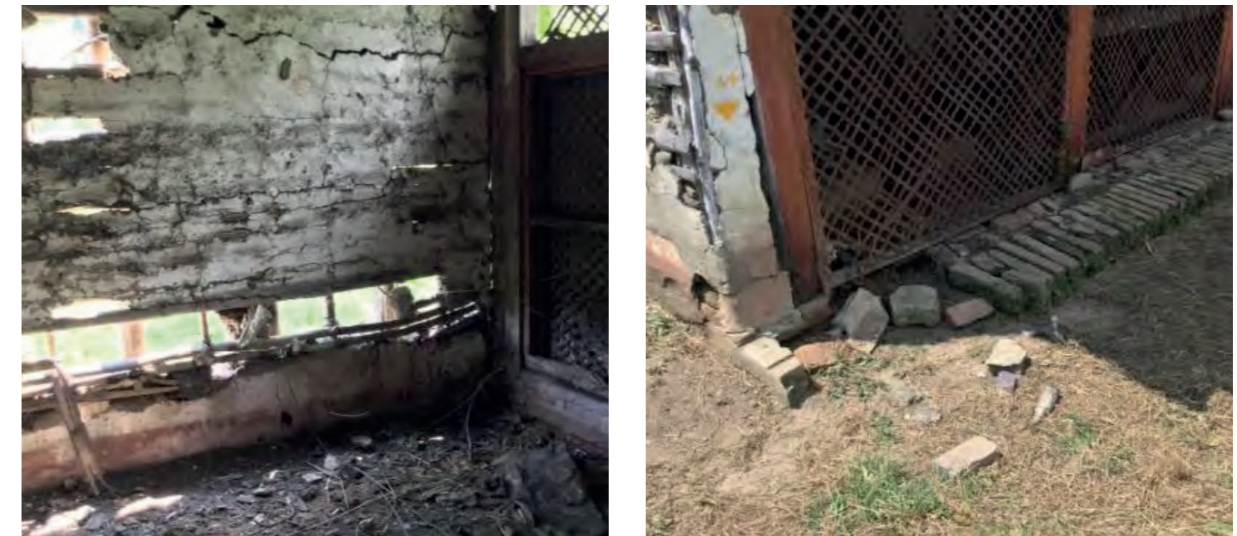
[Figure 47] Missing earth filling and disintegration of plasters of *bahareque* walls (left), and missing elements of the paver flooring outside the warehouse (right).

As a possible consequence of the process of detachment of the wall claddings, there is evidence of disintegration of fired clay bricks at the base of the south façade wall of the nave, due to the presence of minor plant species growing on them. The same phenomenon occurs on the handmade fired bricks that integrate the headwalls and their respective calicanto plasters, in the Warehouse, this time due to their exposition to weathering.^[19] Likewise, due to the prolonged exposure to weather conditions (wind and rain) that some of these fired clay brick walls have undergone, it is possible to detect processes of mechanical erosion and erosion by abrasion on the exposed surfaces. It is also feasible to find areas with evidence of erosion by wear and tear in the adobe walls of the chapel and in the abutments of the kitchen area in the Family House, a process that is due to the action of animals, in this case, the “licking” of the cows that tend to invade the land near the buildings. In addition, there are missing elements around the door and window hollows of the handmade fired clay bricks wall located in the south façade of the presbytery and pretty much all the adobe walls present missing components due to

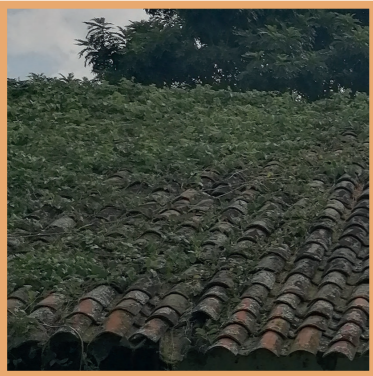
Biological Colonisation (Plants)

Description Colonization of the material by plants and microorganisms such as bacteria, cyanobacteria, algae, fungi and lichen. The presence of these organisms does not necessarily imply deterioration such that the preservation of the material is at risk

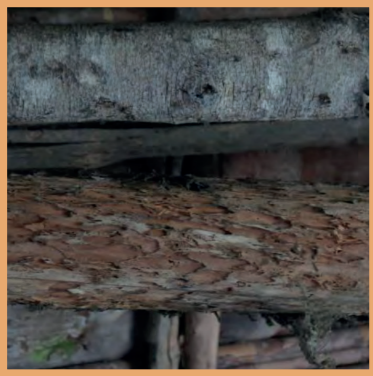
Biological Colonisation (Termites)

Description Affection of wooden components by termite nesting (*Cryptotermes brevis* species) inside. Depending on the time and extent of the attack, the strength of the wooden parts can be severely affected

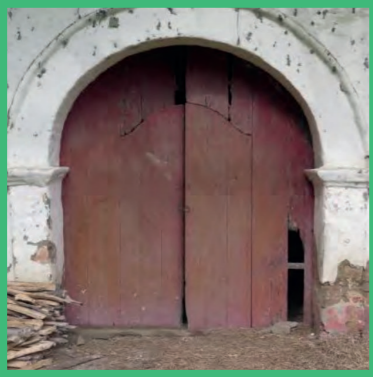
Chromatic Alteration

Description Variations in the parameters that define its colour due to material components. It generally involves the whole material.

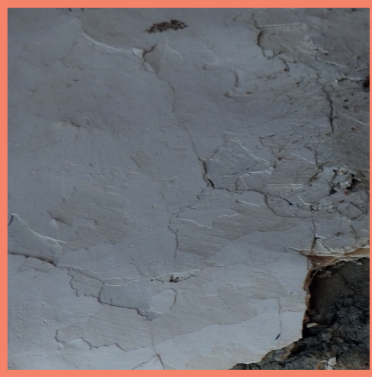
Peeling

Description Shedding, coming off, or partial detachment of a superficial layer (submillimeter to millimeter thickness) of coatings that have been applied on stone surfaces. It is a first sign of the subsequent complete detachment of the affected area

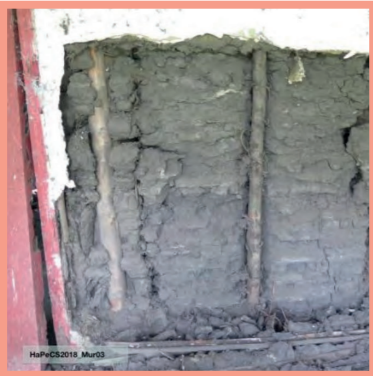
Detachment

Description Disruption in the continuity between the surface layers of the material, both with respect to each other and to the substrate: usually precedes its fall.

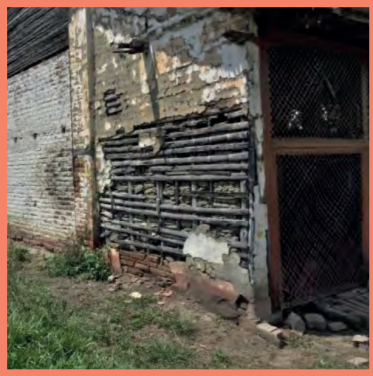
Disintegration

Description Crumbling with falling material in the form of dust or minute fragments.

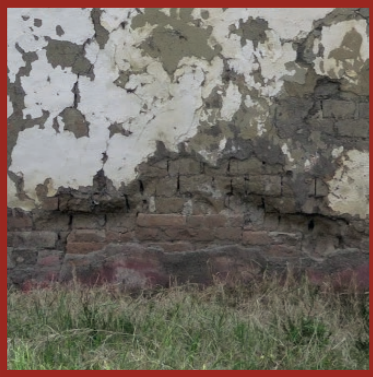
Erosion

Description Loss of original surface, leading to smoothed shapes.

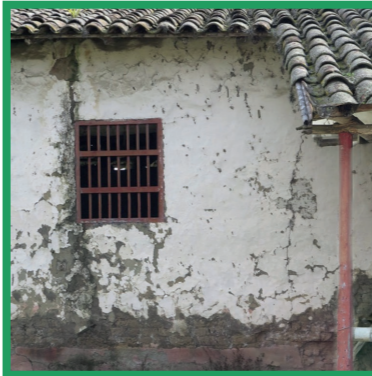
Fissure

Description Degradation manifested by discontinuity of the material, resulting from separation of one part from another. It is caused by thermal changes, telluric movements, and incompatibility of materials.

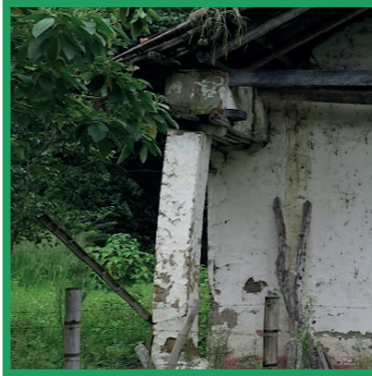
Slump

Description Slight displacement and loss of verticality of building components
