**The XVII century Hacienda Perodias
in south-western Colombia and its
contested memory. New functions and
transformation processes**

Daniel Lozano | S276685
MSc Architecture Construction City

Master's Thesis

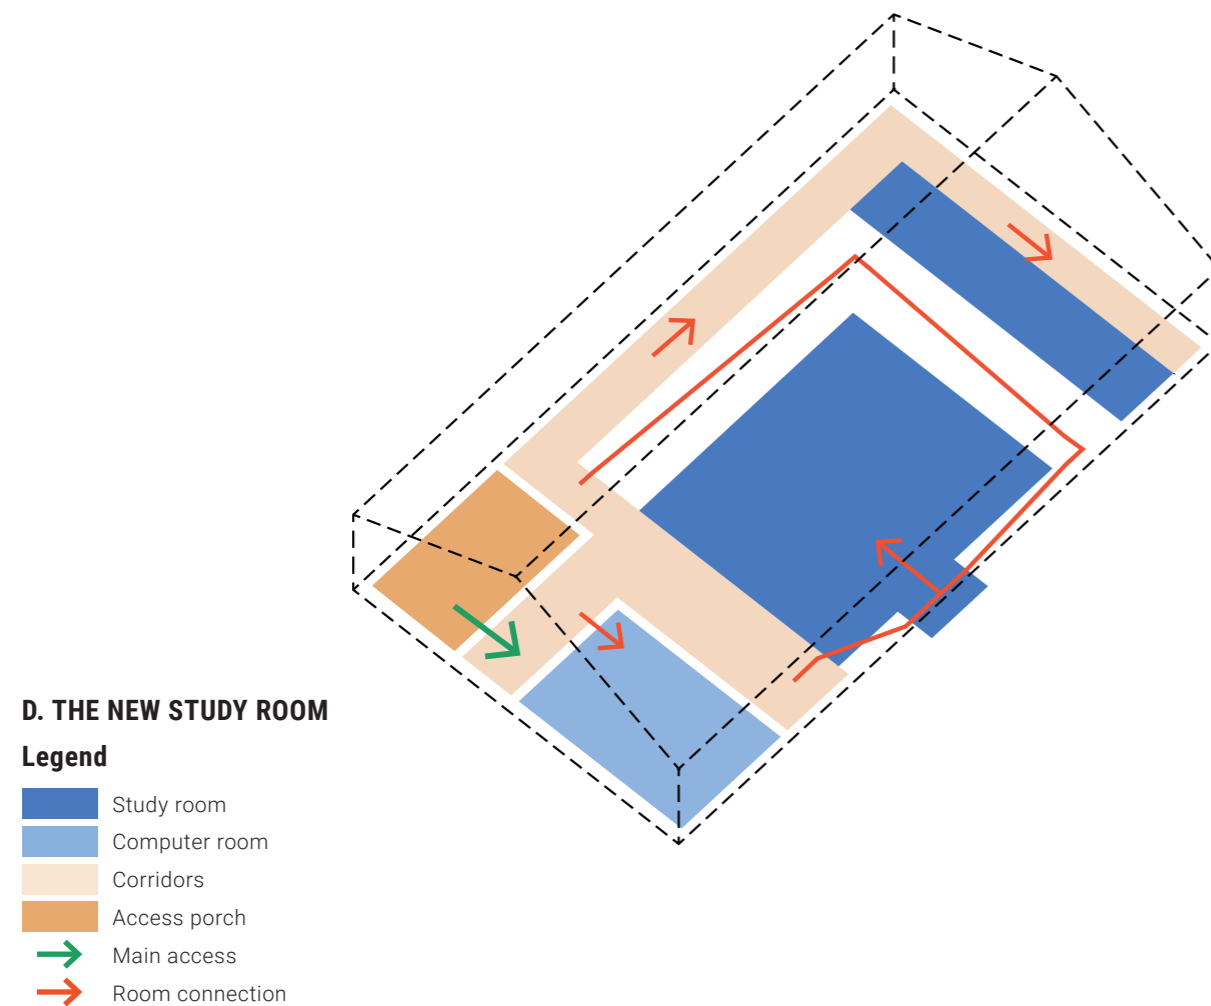
[Figure 60] The new buildings: from abandoned swimming pool to study and consultation room. Graphics by the author, 2022

The old swimming pool, adjacent to the house, was reused by considering its condition as a built element that provides

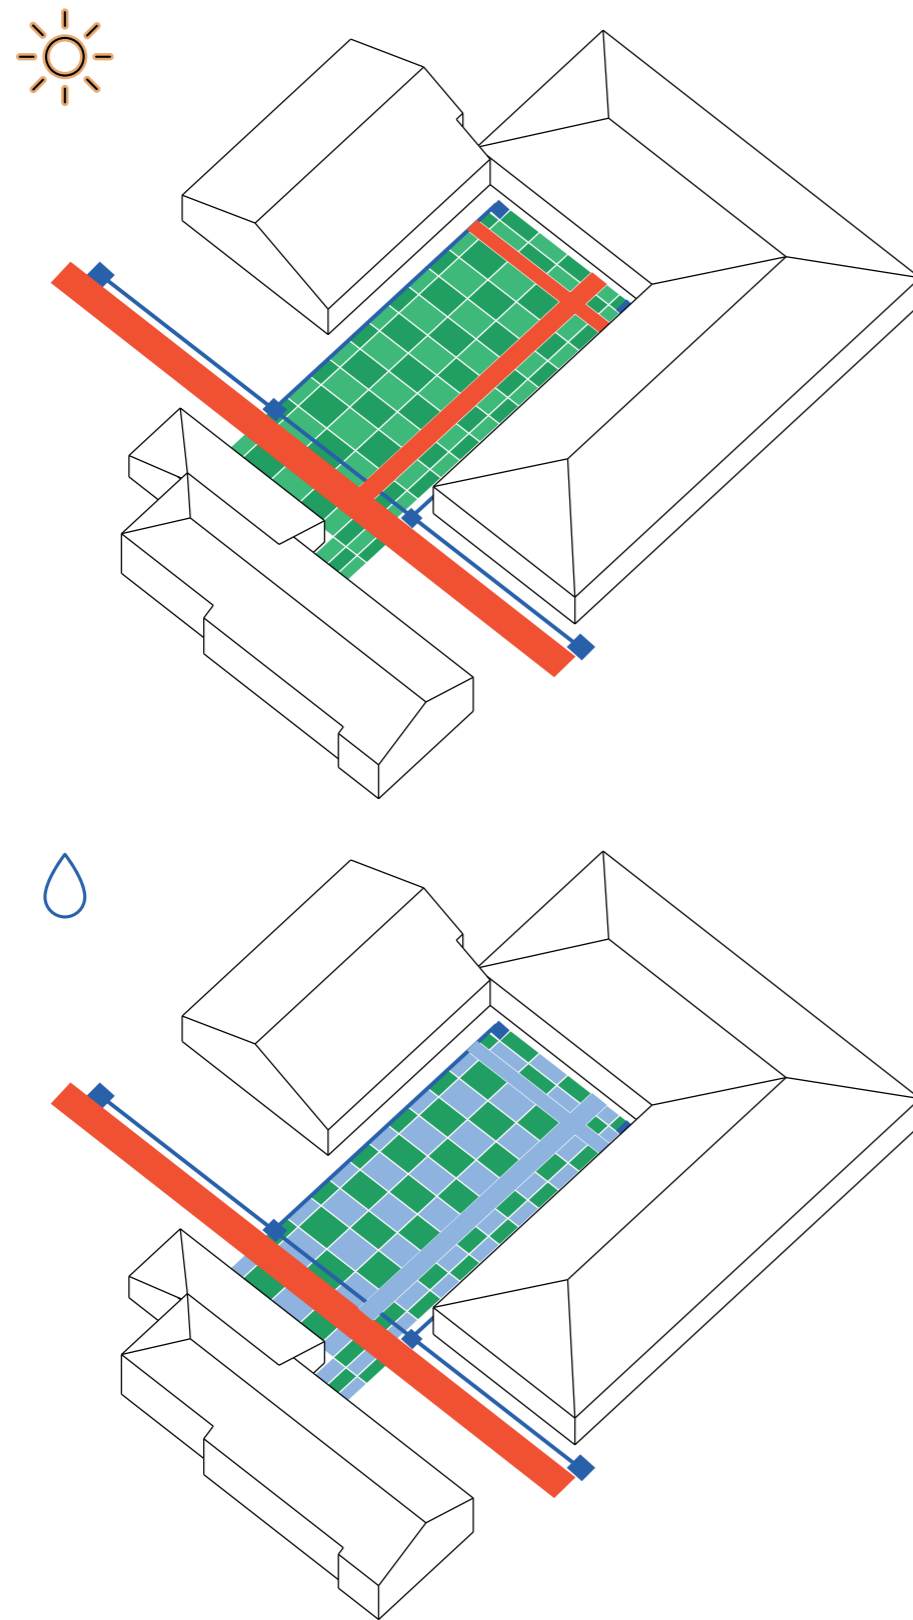
[Figure 63] The runoff water containment system: the flooding of the courtyard as an alleviation possibility. Graphic by the author, 2022

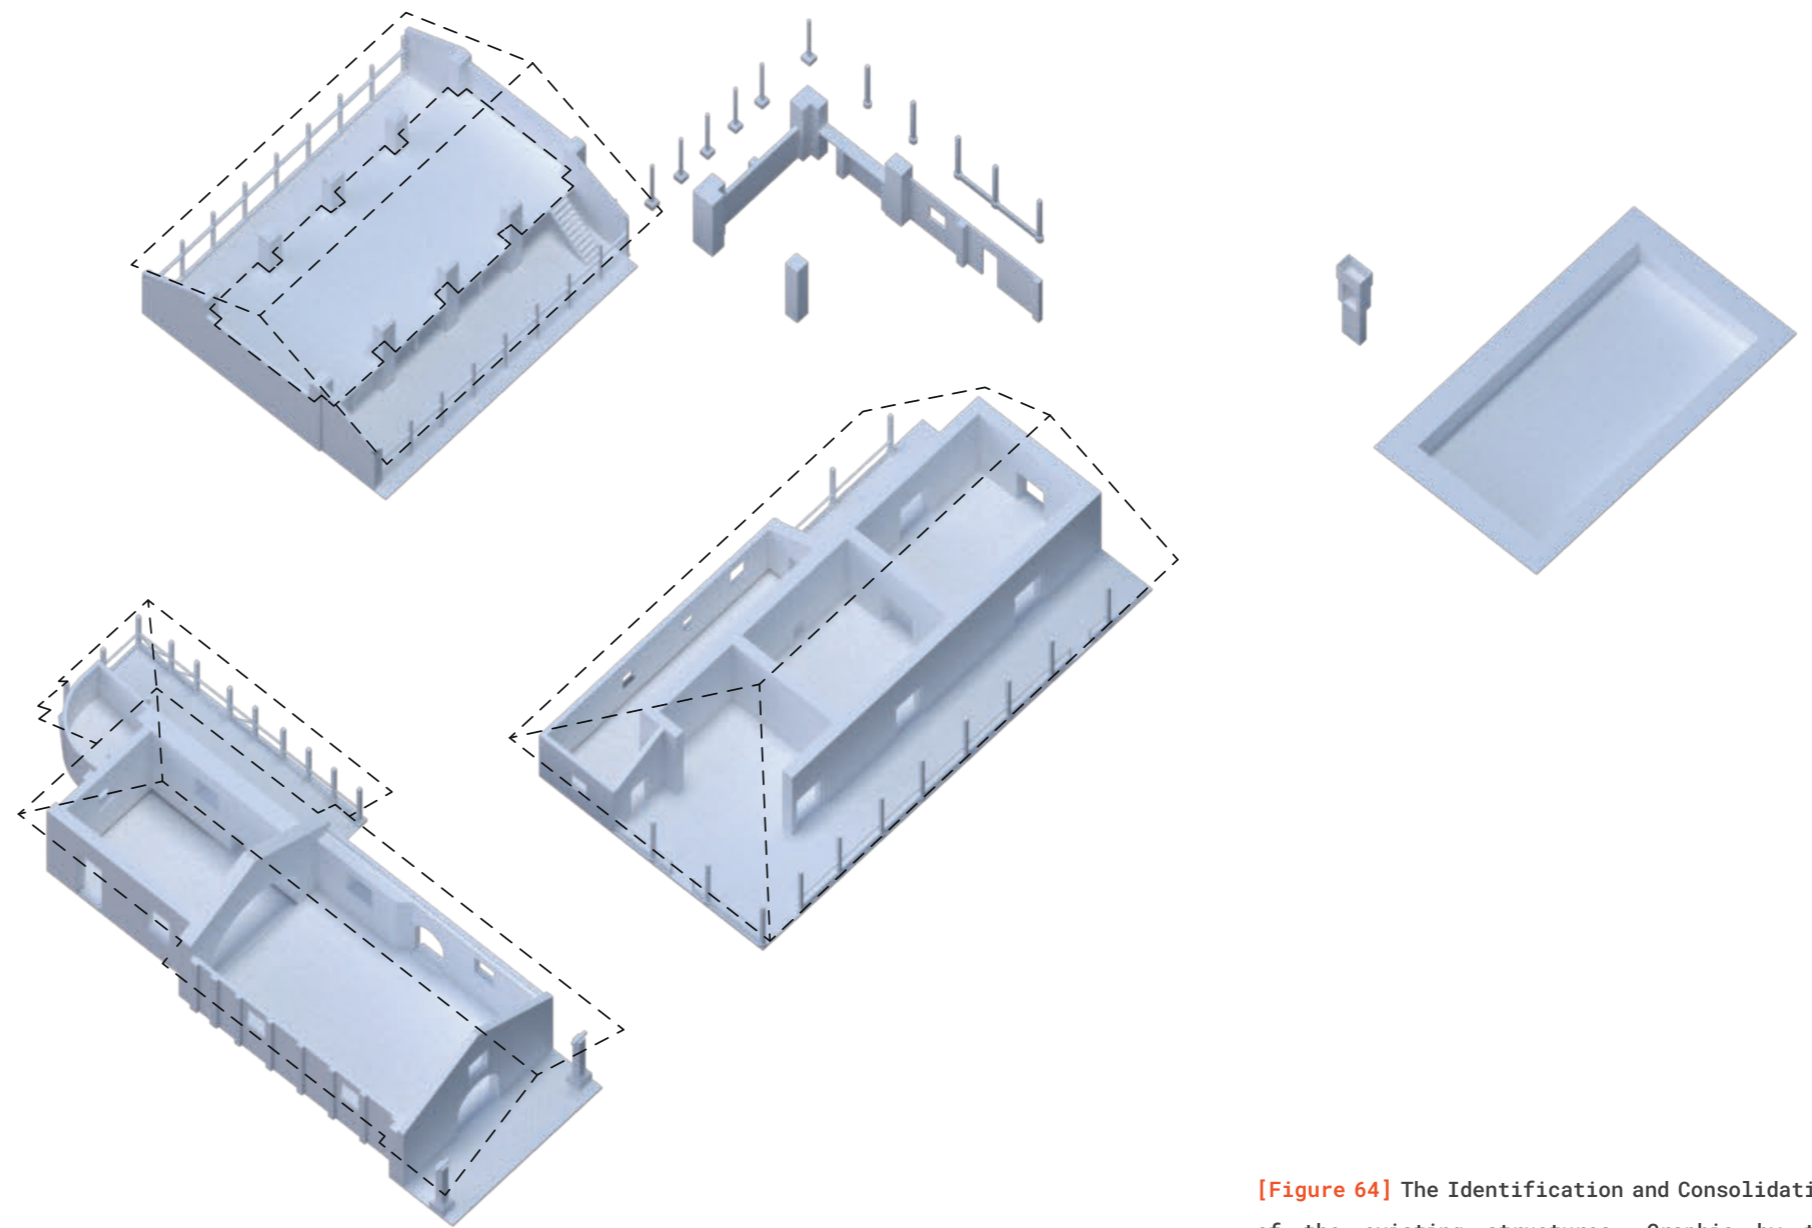
[Figure 64] The Identification and Consolidation of the existing structures. Graphic by the author, 2022

Likewise, in this same phase, the roofing systems of the Family House and the Warehouse were considered for intervention, with the aim of guaranteeing their waterproofing. As part of this set of actions, the roof of the chapel, dismantled in the previous phase, would be rebuilt and the wooden components found in most of the existing buildings would be adapted, i.e. the wooden pillars of both the side porch attached to the north wall of the presbytery and the perimeter corridor of the House and the east and west façades of the Warehouse. The same procedure
