**Politecnico
di Torino**

Master's degree course in Environmental and Land Engineering, specialist
pathway in Natural Hazards and Civil Protection

Master's Thesis

Vulnerability assessment of buildings to landslide

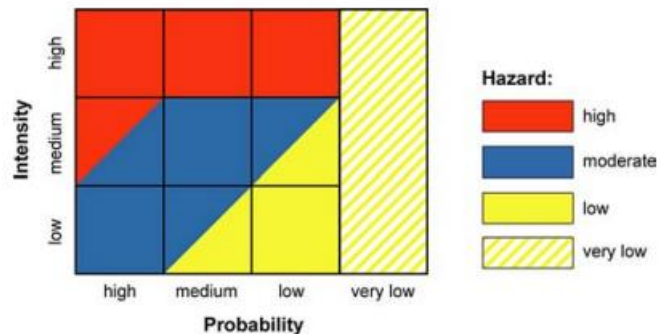
Figure 2: Diagram of hazard levels as a function of probability and intensity, BAFU 2015

3. Yellow → low danger: almost no danger to people, little damage to buildings
4. Yellow and white → residual danger: same as yellow zone
5. White → no known danger or negligible danger

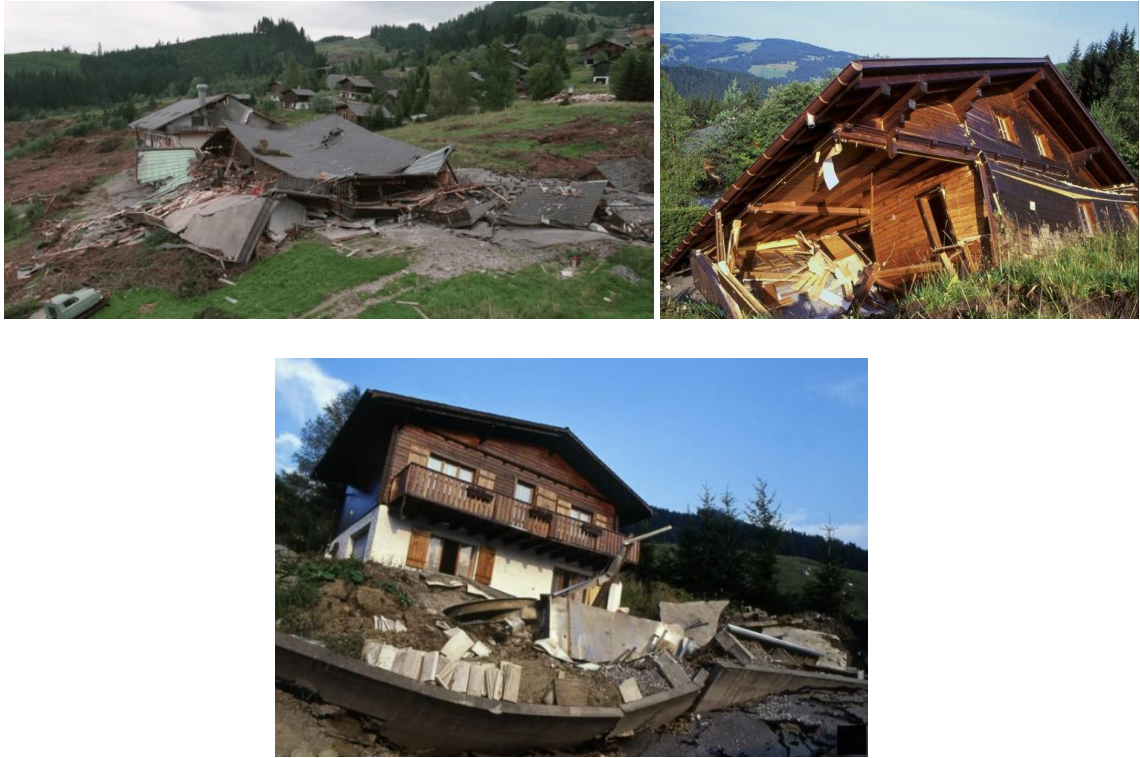
Figure 4: Both pictures, in the upper part, show wooden chalets, while the picture in the lower part shows wooden chalets with concrete foundation, destroyed by the landslide, source: La Liberté

destroyed (shown in *Figure 4*), as well as the hotel, the Falli-Hölili restaurant with a ski lift, campsites and military camps. There were no casualties because the village was evacuated the month before; the first signs appeared in March with several problems with the water pipes; then in April the owners' noticed cracks in their chalets and in June the area was evacuated.

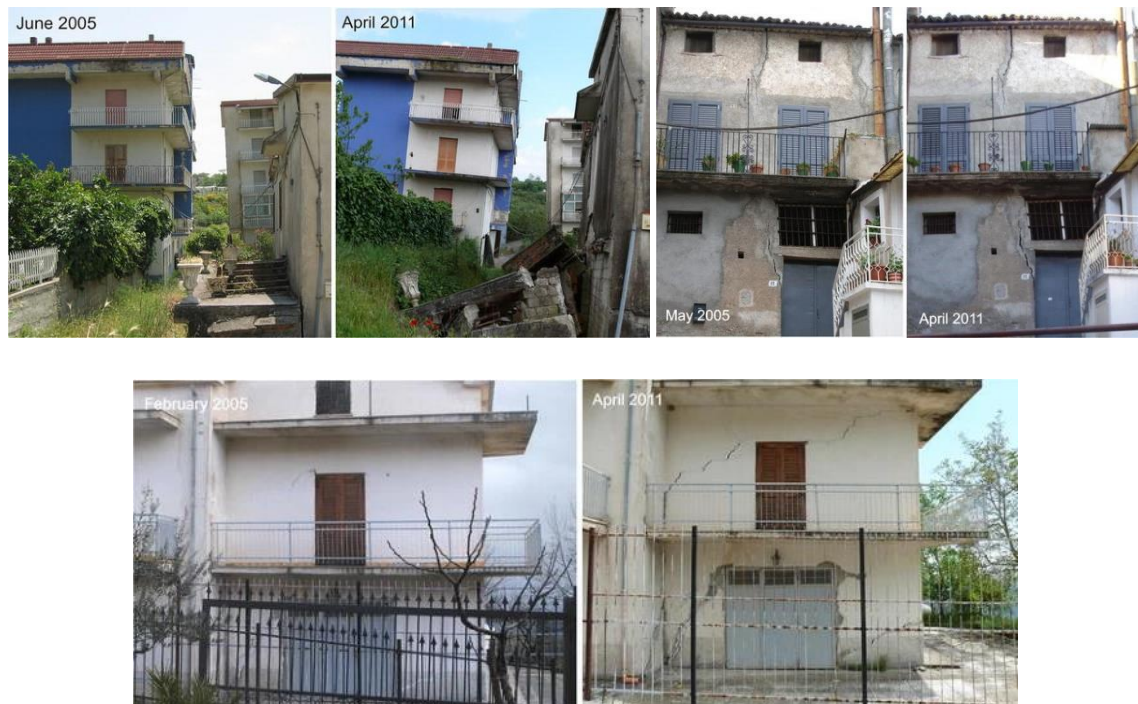
Figure 7: Masonry buildings affected by cracks and deformations, in 2005 compared to 2011

As a result of slow-moving landslide which affected the built-up area for several years, many structures in Lungro's centre are characterized by cracks and deformations, seen in *Figure 7*. This landslide is classified as slide with uncertain boundary, including some minor sliding and flow phenomena. The majority of buildings falling within this area are made of masonry.

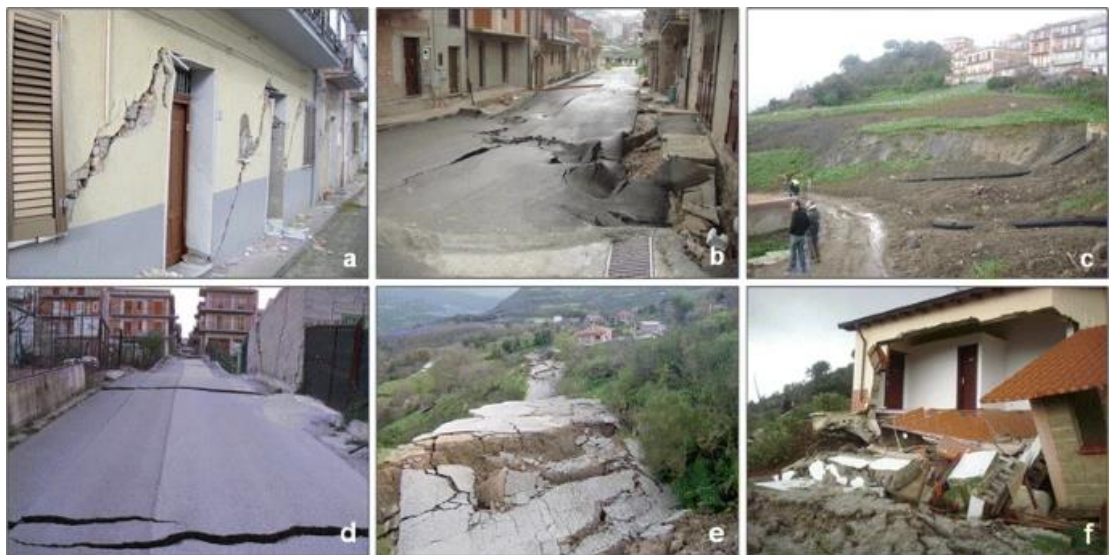
Figure 8: Severe damage to buildings, roadways, and infrastructure caused by large landslide in Stazzzone quarter (a,b), in Riana quarter (c,d) e in san Benedetto porcaro quarters (e,f)

On February 14 in 2010, a large landslide affected the urban centre of San Fratello town (Sicily Island, Southern Italy), causing severe damage to buildings, roadways, and infrastructure (shown in *Figure 8*), as well as about 2000 evacuees (out of a total population of 4500 inhabitants). This large complex landslide, with an area of more than 1,2 km², represents one of the largest phenomena in Sicily, (*Frodella, et al. 2017*).

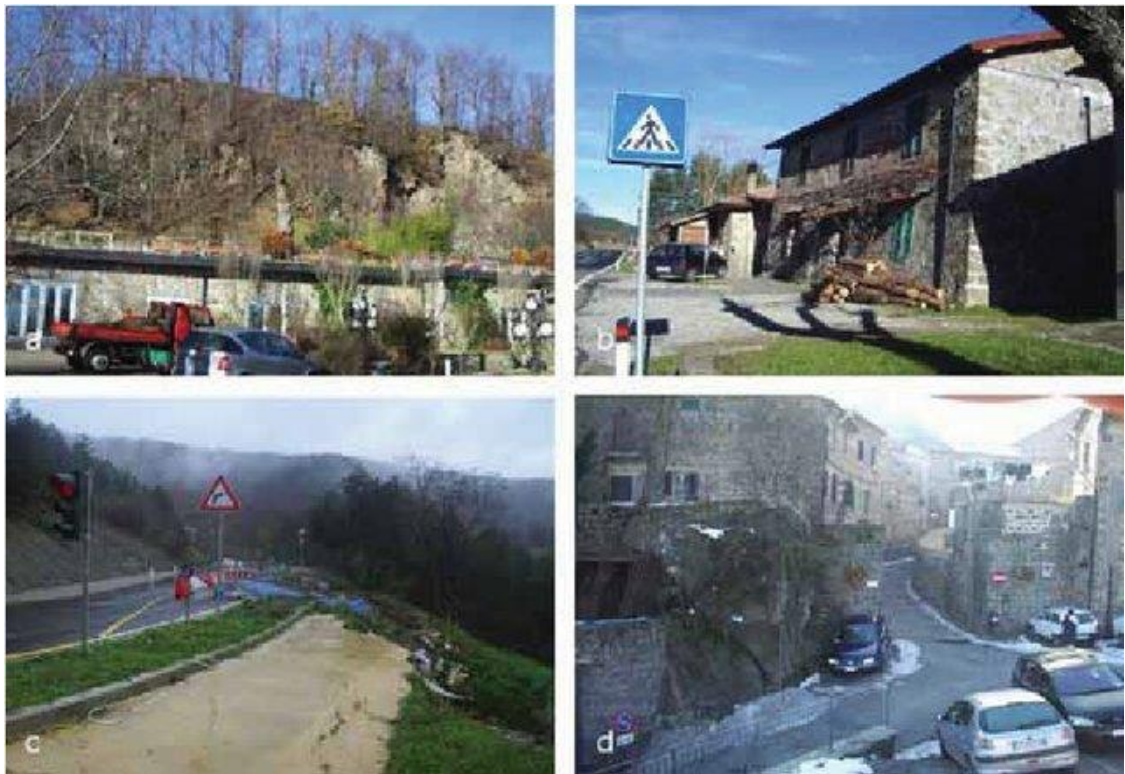
Figure 9: Buildings (a,b,c) and roads (d) affected by deformations due to landslide movement

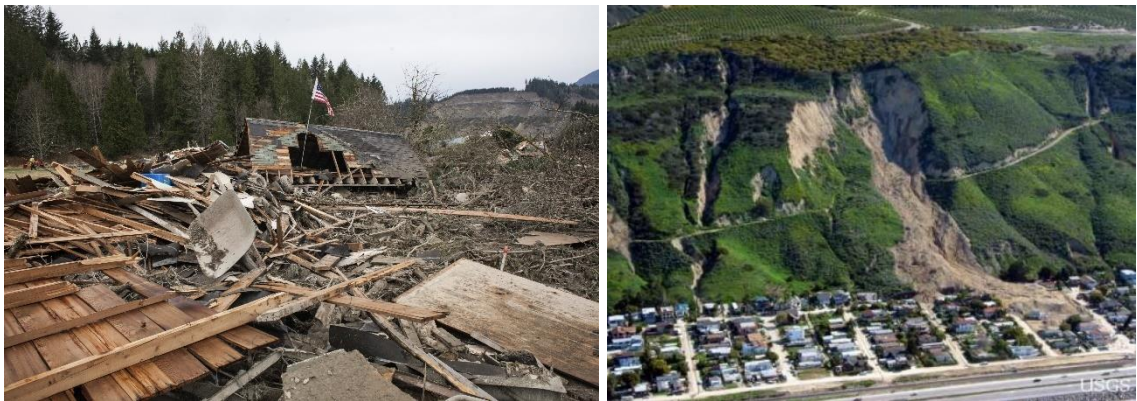
Figure 12: The left-hand image shows a wooden house destroyed by the landslide, the right one representing Oso landslide volume

43 people were killed and 49 houses destroyed. *Figure 12* shows: on the left wooden houses destroyed by the landslide, on the right a picture representing Oso landslide. This landslide completely destroyed the Steelhead Haven neighbourhood, as well as several homes located on nearby State Highway 530. Approximately 600 metres of highway were buried from a height of up to 6 m of debris, closing this important east-west communication route for more than 2 months.

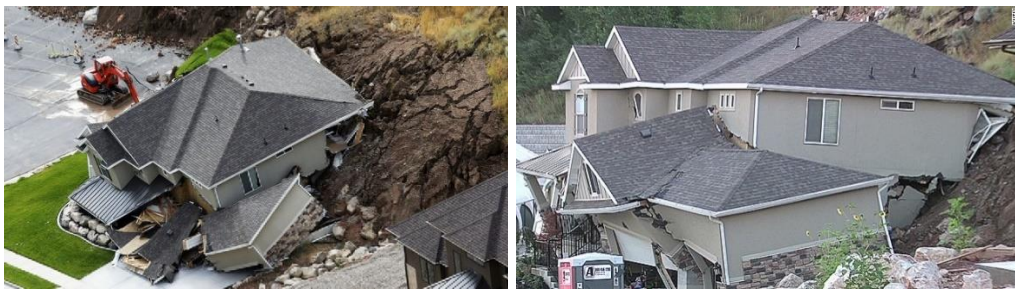
Figure 13: There are houses, made of stone and masonry, visibly damaged by landslide body

On August 5th, 2014, a 32 m-tall and 24° inclined hillslope failed behind a North Salt Lake City, Utah neighbourhood, moving 97000 m³ of material down slope and threatening several homes, visible in *Figure 13*. The landslide left an 18-metre-high head slope on the rotational landslide. Twenty-seven families were evacuated immediately, and seven families were warned to stay away from their homes overnight, waiting for the ground to stabilise.

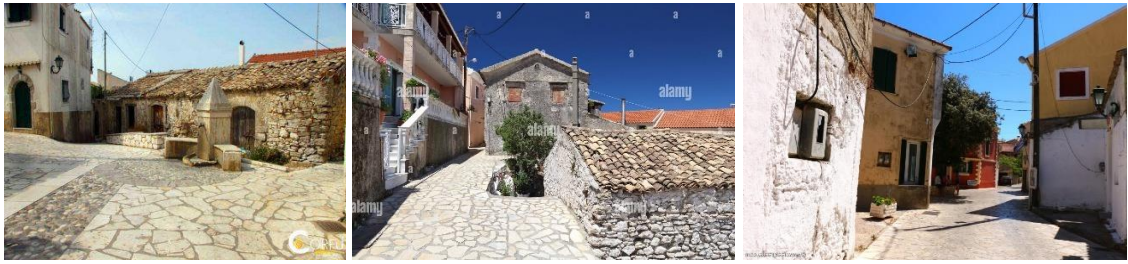
Figure 14: Examples of stone and masonry buildings in the Krini village

The monitoring data refer to the period 2016-2021; the average velocity of the Krini landslide was found to be 6 mm/year downwards (0.6 cm/year) and 28.7 mm/year (3 cm/year) eastwards. The average speed of the Pititsa landslide was 1.8 mm/year (0.2 cm/year) downwards and 7.7 mm/year (0.8 cm/year) eastwards. The area affected by the Krini landslide is 4080000 m² while the surface of active portion around the village of Pititsa is 800000 m². Examples of buildings that could be affected by the Krini landslide are shown in the *Figure 14*.

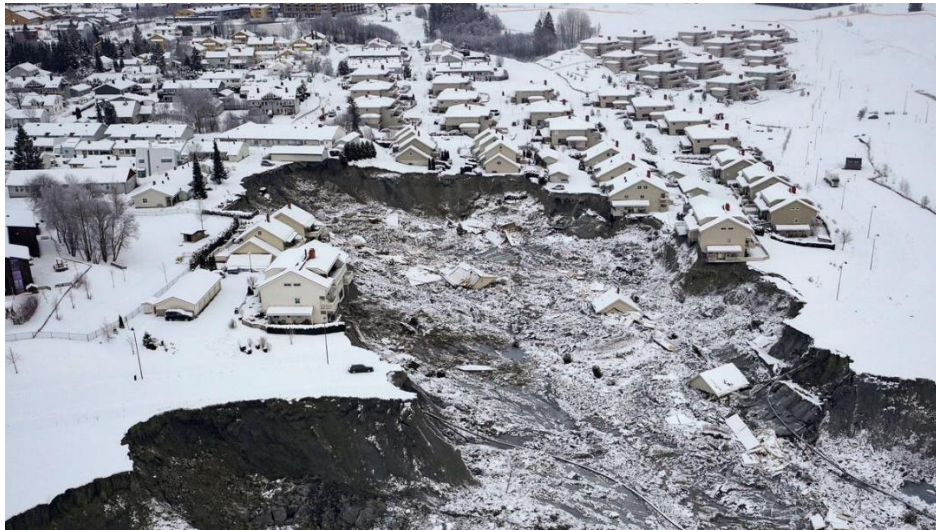
Gjedrum landslide, shown in *Figure 15*, was a quick clay landslide that occurred in the early hours of 30 December 2020 in Ask village, Norway. The latter was triggered by heavy rainfall in the days before the accident, which caused soil movement in this area. Gjedrum landslide involved an area of 300 by 700 metres; heavy rainfall also caused a debris flow affecting an area of 90000 m².

Figure 15: Gjedrum landslide, Norway, 30 December 2020, source: BBC news

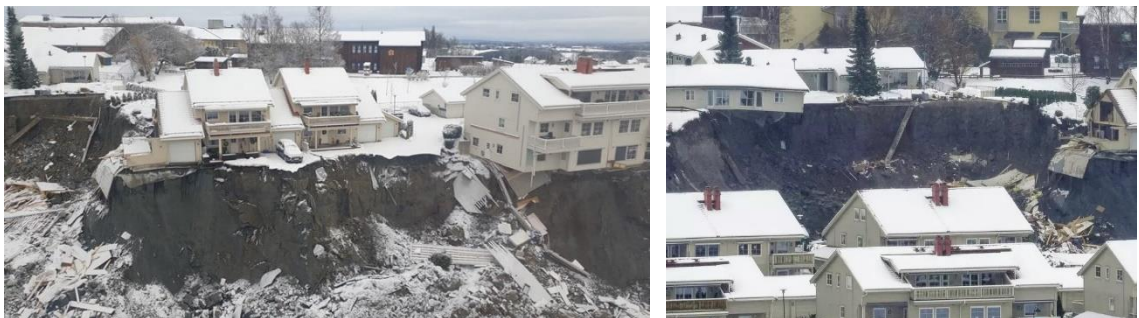
Figure 16: Houses and flats damaged by the Gjedrum landslide, source: BBC news

More than 30 buildings were destroyed, in particular residential buildings (houses and apartment blocks, visible in *Figure 16*), more than 1000 people were evacuated, 10 killed and 10 injured.

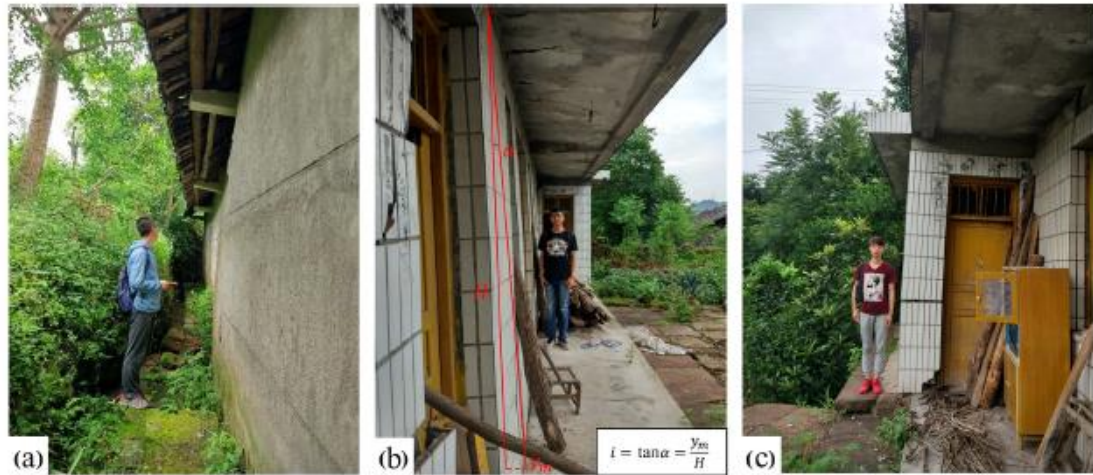
Figure 20: Integral decline state of the case study building: (a) the back wall of the building with an inclination of 1.0 %, (b) the front wall of the building with an inclination of 0.8 %, (c) the front wall of room) with an inclination of 0.7 %, (source: (Chen, et al. 2020))

Given these threshold values, if we assume 10 m as hypothetical building height, the critical horizontal distance between the top and building bottom is approximately 10 cm, assuming that i_m is equal to 1%. In the subsequent methodology parameter definition regarding inclination will be analysed in more detail.

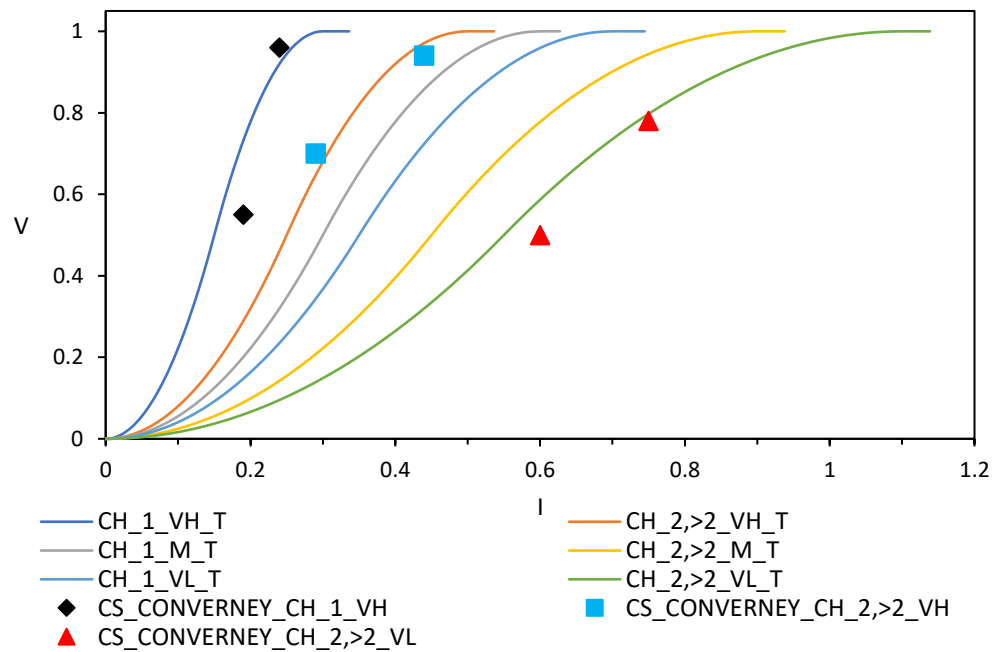
Figure 36: Chalet vulnerability curves and indicators obtained for case B

The graph concerning case **B** (chalet vulnerability assessment), with indicators implemented on the basis of the obtained data from the analysis of this case study, is shown in *Figure 36*. It is complicated to have precise information about the buildings that lie on the boundary between the landslide body and the stable slope; therefore, using an assumed intensity the presence of Chalets, Villas and Residential Buildings is considered in order to assess their vulnerability. Below is shown the graph concerning chalets, the others can be viewed in *Appendix 1*.

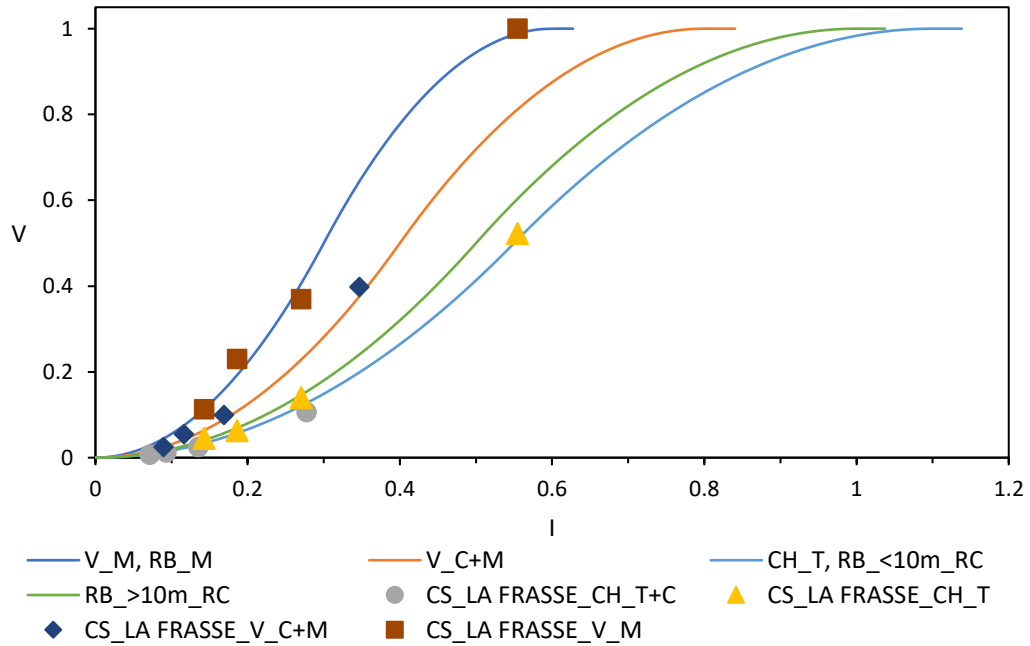
Figure 38: Vulnerability curves and indicators obtained for case C when the depth of the sliding surface is assumed to be higher than 30 metres

The graph concerning case **C**, with indicators implemented on the basis of the obtained data from the analysis of this case study, is shown in *Figure 38*.

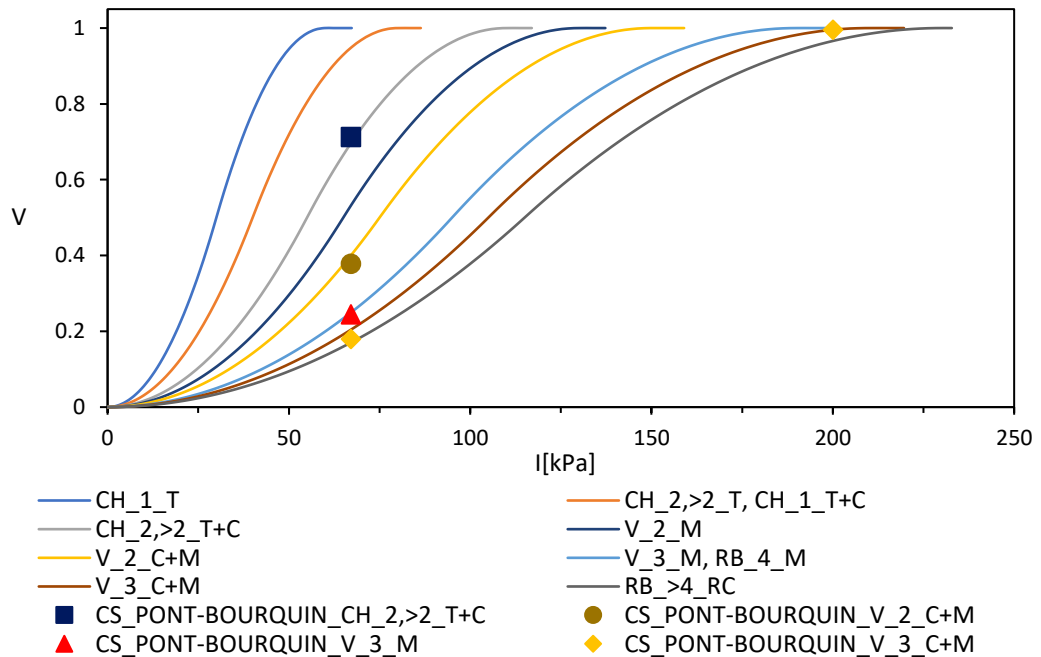
Figure 42: Vulnerability curves and indicators obtained for case **D** when the maintenance state is very high

indicators representing buildings progressively decreases; the yellow rhombus indicates the buildings' vulnerability to an earth flow impact that reached a velocity of 12 m/s. All buildings considered at earthflow impact have vulnerability equal to 1 and are therefore all represented by a single indicator.

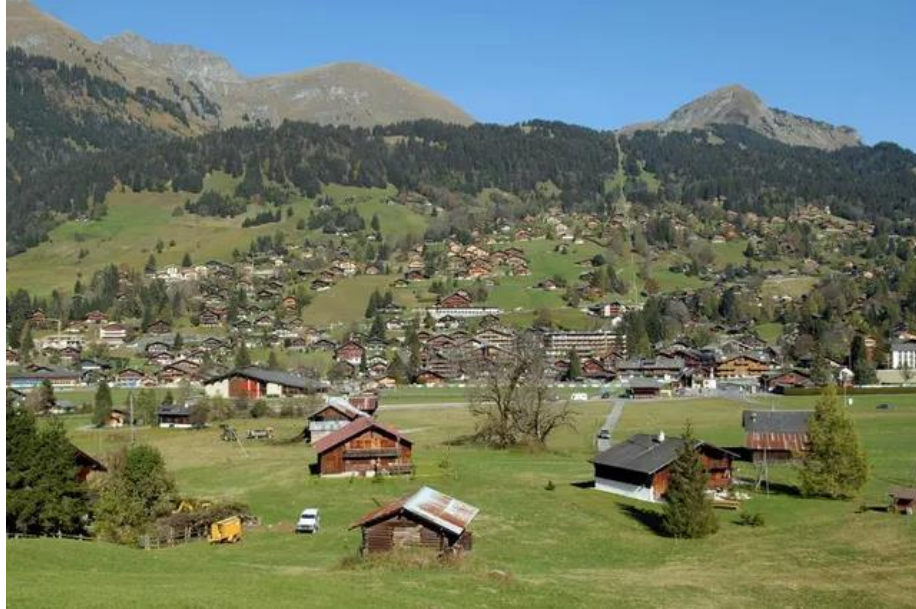
The landslide toe is located in the area around Les Diableres, a mountain village and ski resort at an altitude of 1200 metres. The buildings considered, as shown in *Figure 43*, are timber and timber-concrete chalets, masonry and masonry-concrete villas and residential buildings with up to four storeys. In the third plots, it can be observed how, going from a low to a high state of maintenance, the vulnerability of

Figure 43: Les Diableres village, located in the municipality of Ormont-Dessus, Canton of Vaud, Switzerland
