Politecnico di Torino

Master of Science Program in Civil Engineering

**Preliminary analysis for the structural
retrofitting of the Church of Santo
Stefano in Frassinò**

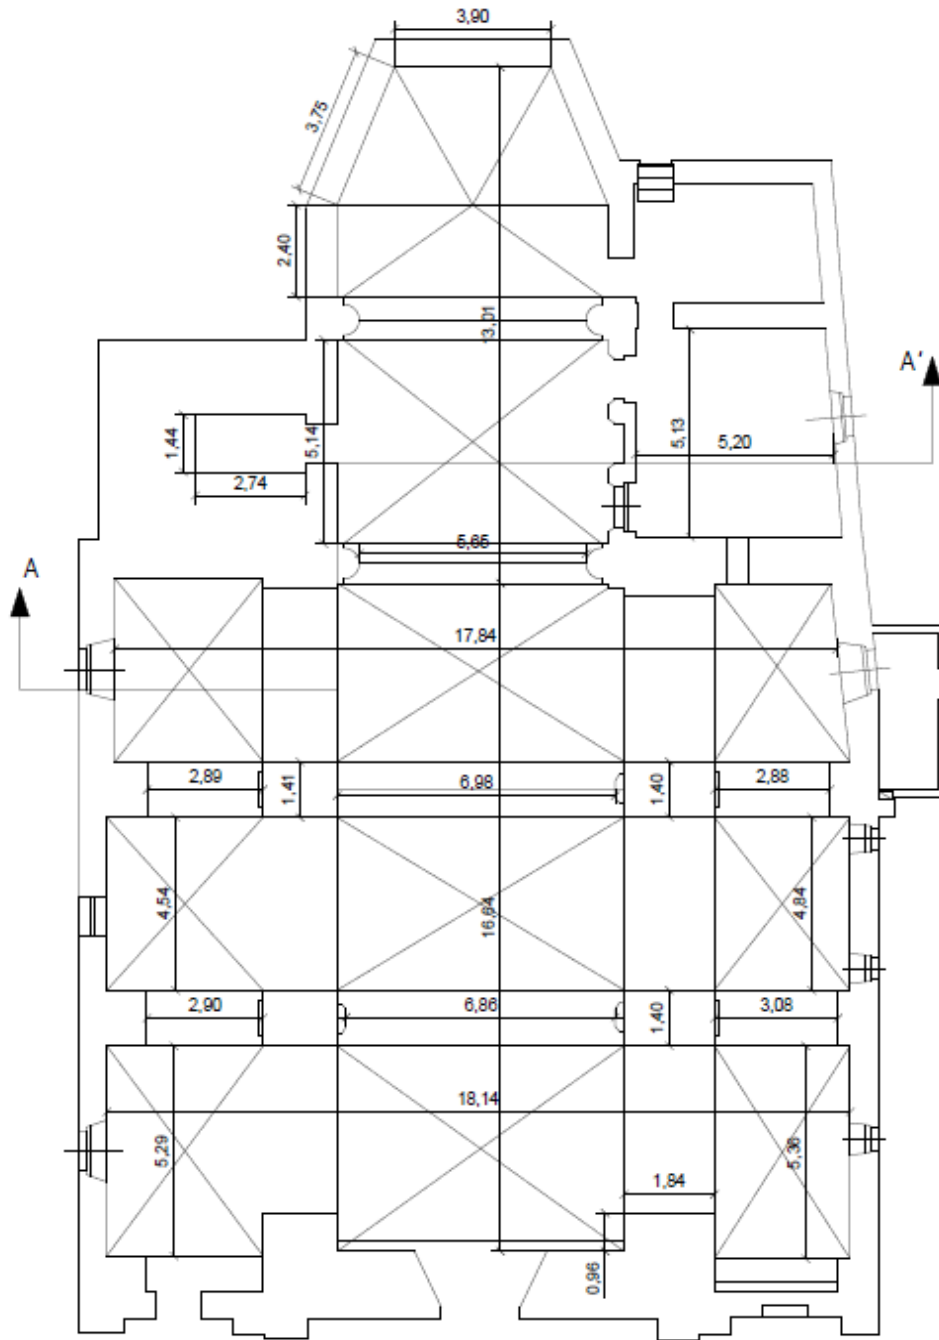
Figure 1-2. Planimetric diagram of Santo Stefano Church

In the case of the church under analysis, in the Figure 1-2, can be seen that the projections of the vaults are rectangular, so in line with the above mentioned the arches are pointed. In addition, the green lines represent the chains introduced as a structural intervention in order to give it strength to the vaults.

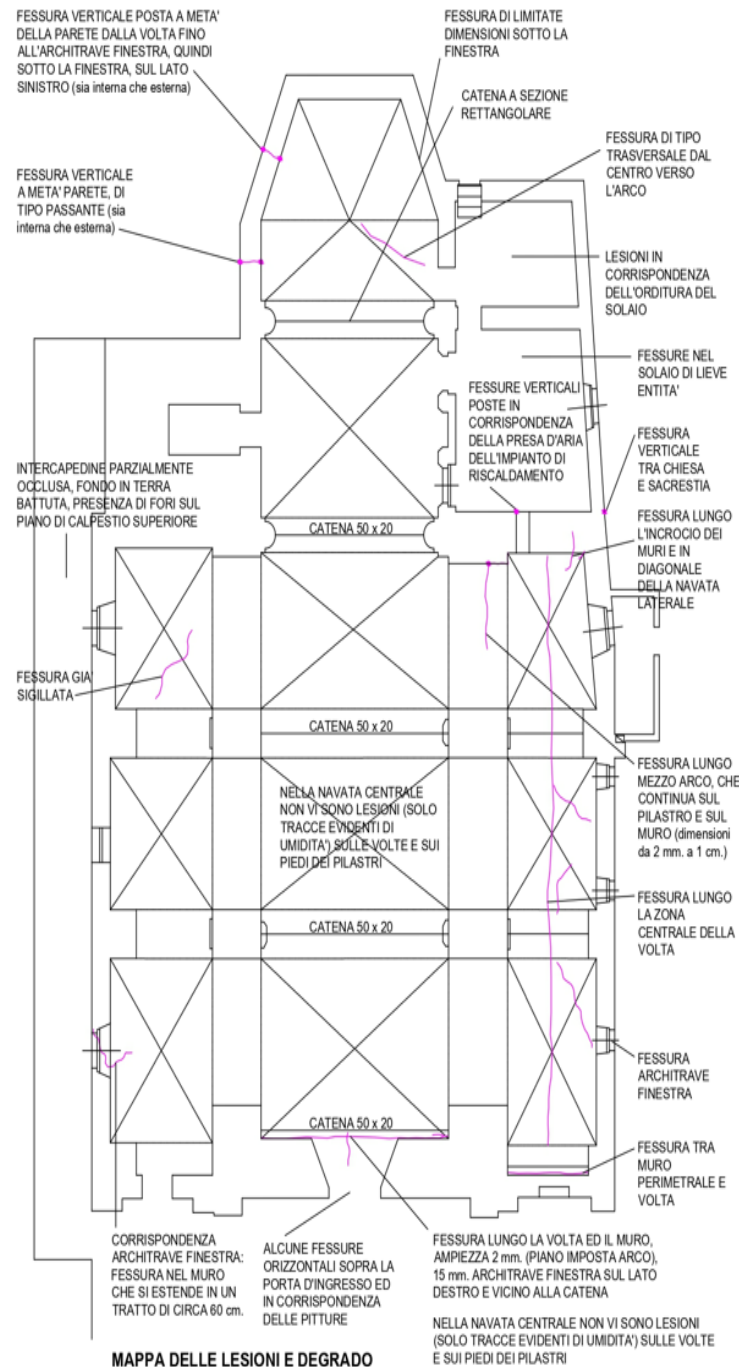
Figure 1-14. Map of lesions and degradation.

According to the design drawings, that are represented by the Figure 1-14, there were cracks in the side aisles and apse as well as moisture problems on the walls. However, the original 14th century core appears to be less damaged. Particularly, the central vaulting area of the right nave is cracked. For the aforementioned reason, the central nave was reinforced in remote times with three chains, of which two were inserted at the external supporting counter- forts, while a fourth chain crosses the sacristy. The tension of these chains was also controlled and two more of the same dimensions were added inside the left aisle. In addition to the above-mentioned procedures, the plaster on the walls was also removed up to one meter above the level of moisture found. These plasters were redone. [2]

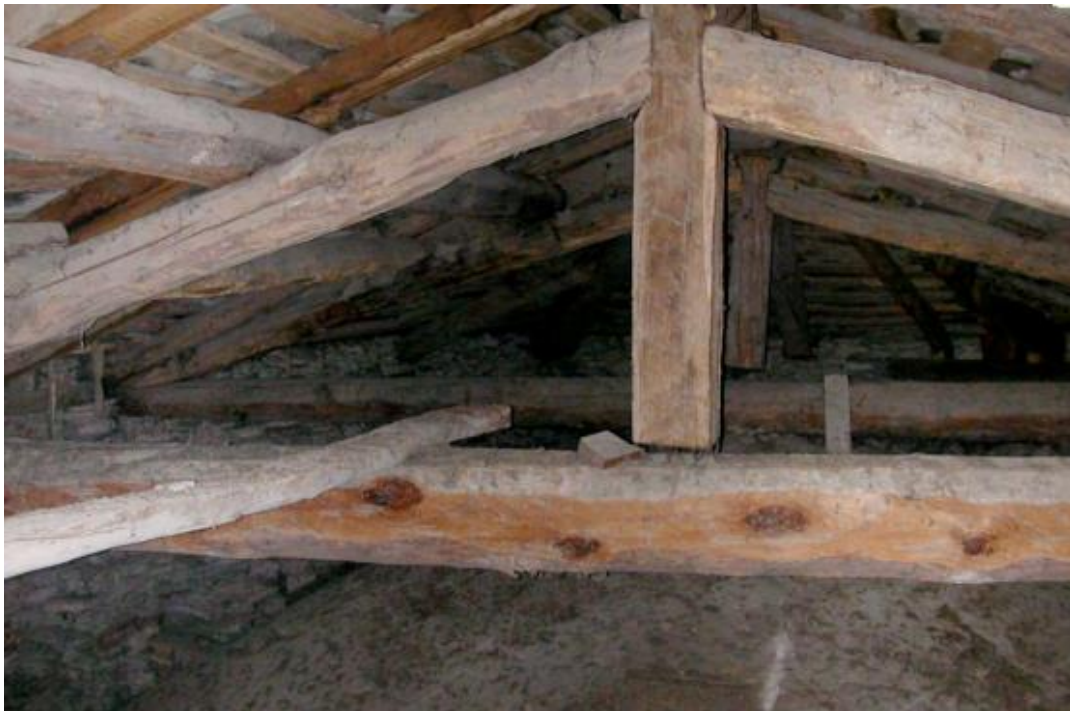
Figure 1-15. Condition of the roof.

Regarding the roof replacement project, an inspection was carried out that year in order to determine the condition of the existing ceiling. The Figure 1-15 represents the state of the roof in 2003. The structure is made of wooden trusses, still in good condition, while “*le terzere*” and the floorboard were not in optimal condition. The former can be defined as a half-beam supporting the main structure of the pitched roofs, its task is to carry the warp of the beams and to determine the slope of the roof.

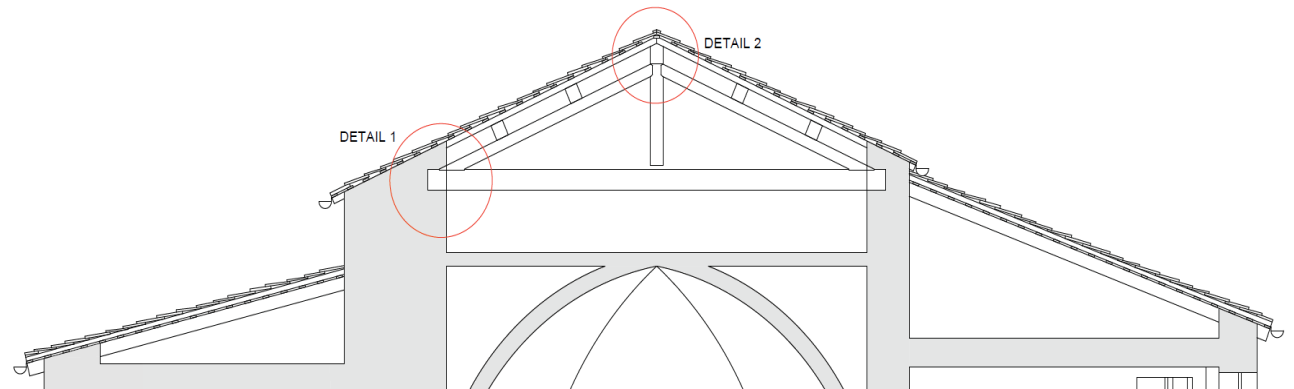
Figure 1-16. Cross section of roofing.

The Figure 1-16 provides a general understanding of how the roof of the structure under analysis was built. The red circles represent different details that were individuated in the construction, these were mentioned with the name Detail 1 and Detail 2. In the figures that are related to detail 1 it is possible to understand how the trussing elements were inserted into the masonry. On the other hand, in the figure Figure 1-19 that corresponds with the detail 2, the center of the truss element was shown.

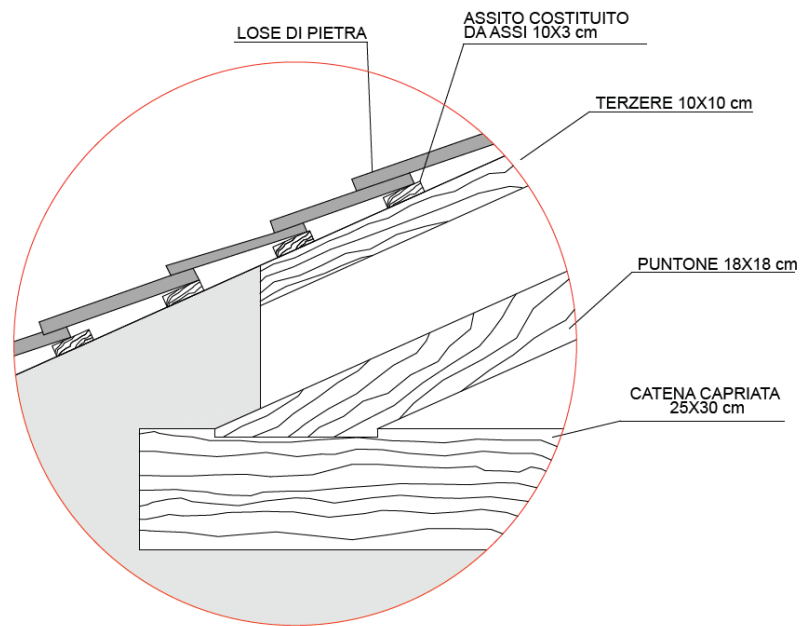
Figure 1-17. Insertion of the truss into the masonry before the intervention.

In the case of the detail 1 it is possible to analyze two states, the Figure 1-17 represents the state before the intervention, while the Figure 1-18 represents the state after the intervention, where the replacement of the elements mentioned before can be seen.

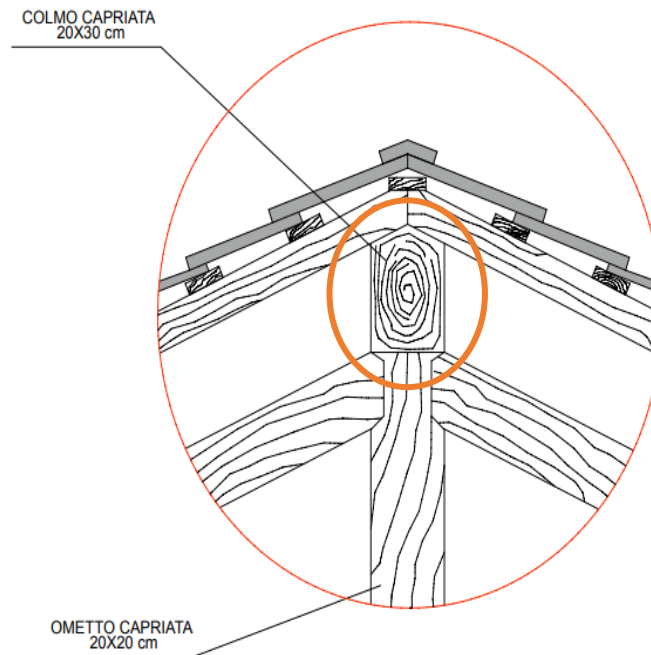
Figure 1-19. Centre of the truss element.

In the Figure 1-19, it is evidence with an orange circle the “colmo”, that means the upper part of the truss system that was changed.

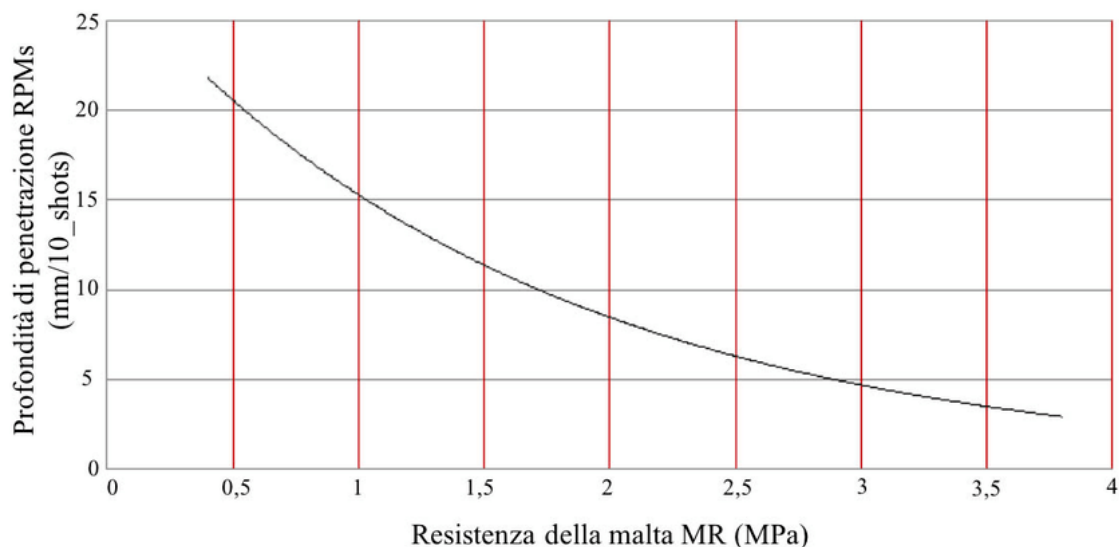
Figure 1-26. Correlation graph for estimating the strength of mortars.

The procedure was as follows, once a measuring section has been identified, three separate points are operated with a distance between them generally not exceeding 10 cm. Each survey point is followed by 10 beats, a specific micrometre is then used to measure the depth of penetration of the needle. With the help of a specific experimental correlation curve, the compressive strength can be estimated.

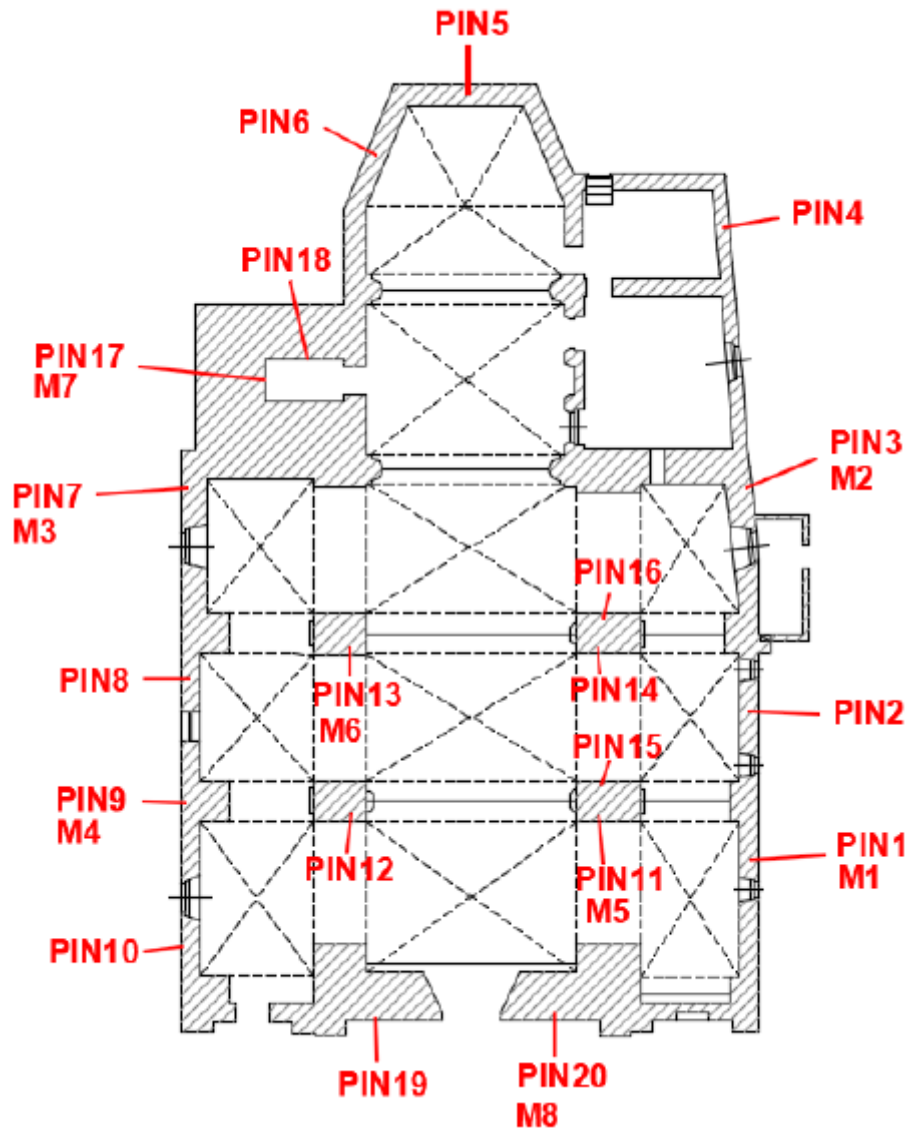
Figure 1-27. Locations of the tests.

The church was investigated in 20 areas as outlined in the Figure 1-27, 8 samples inside the church and 12 outsides were taken. The subindex PIN is correlated to the penetrometer tests that were performed, while the subindex M is related to the laboratory tests that consisted in the collection of mortar samples. The latter will be explained in the following paragraphs.

A mortar with very low resistance is found in zones 17 and 18 based on the distribution of the tests. These zones are located to the right of the presbyterium. Then, the zone 20 also individuates a low average strength, this zone is related with the entrance to the church.

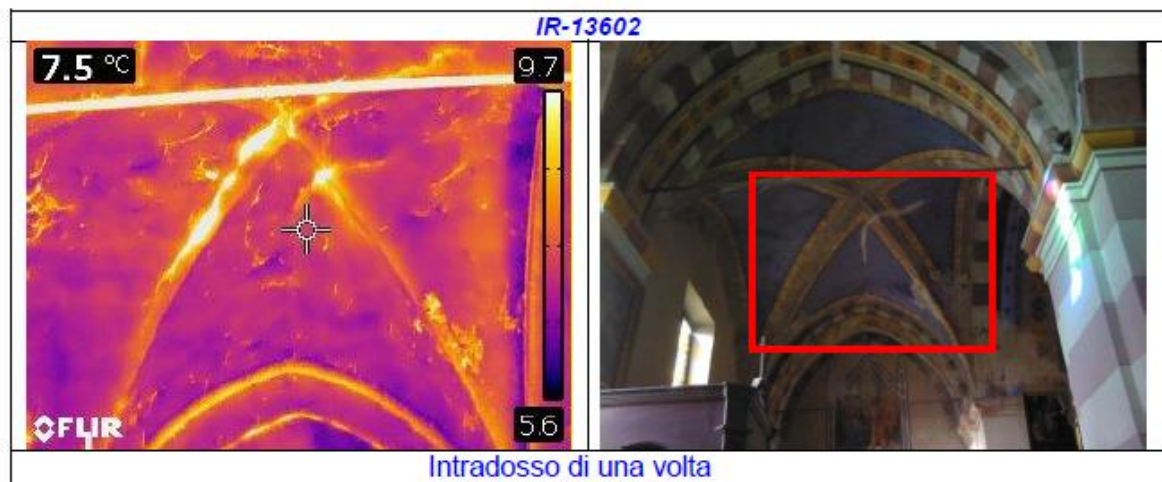
Figure 1-36.

The Figure 1-36 was taken in the intrados of a vault. From it is possible to notice that there is fracture of considerable size in the middle part, and so many little fractures around.

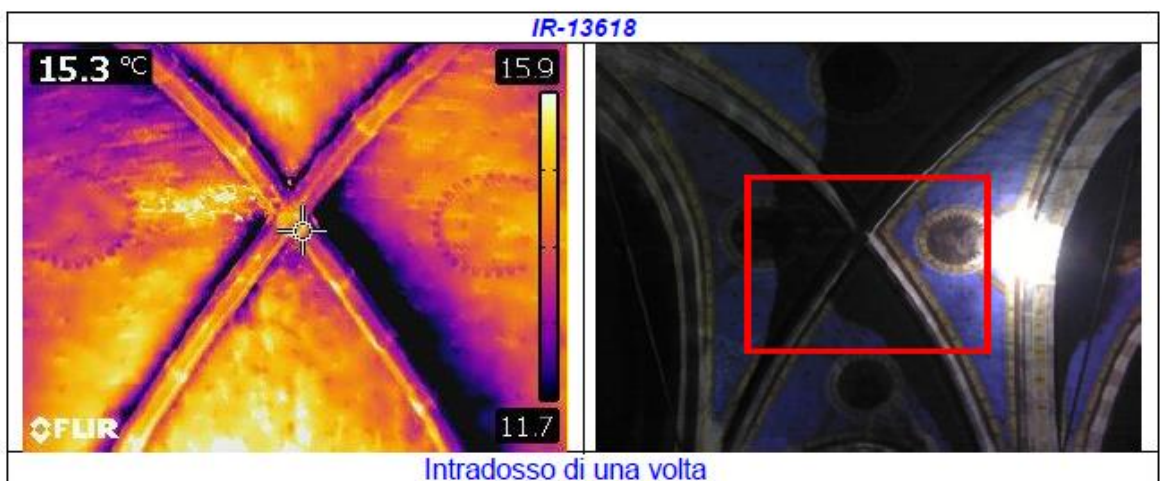
Another representation of the intrados of a vault is given by the Figure 1-37. From this image is possible to notice the moisture infiltration which is represented with a darker colour in next to the rib.

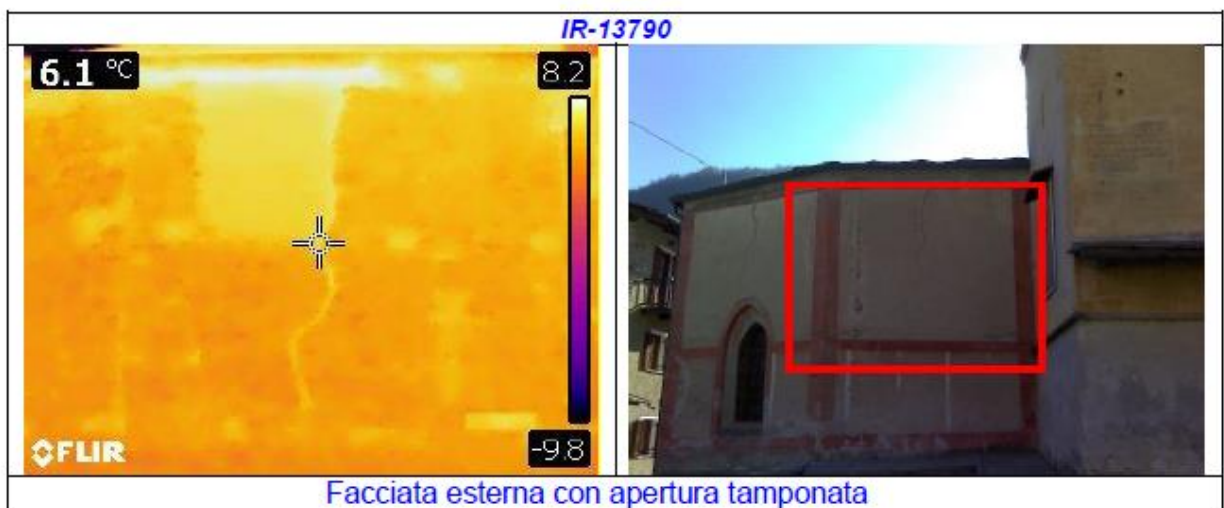
Figure 1-39.

The Figure 1-39 represents the external face with buffered opening, from the image is possible to understand the presence of a crack in the middle part of the wall.

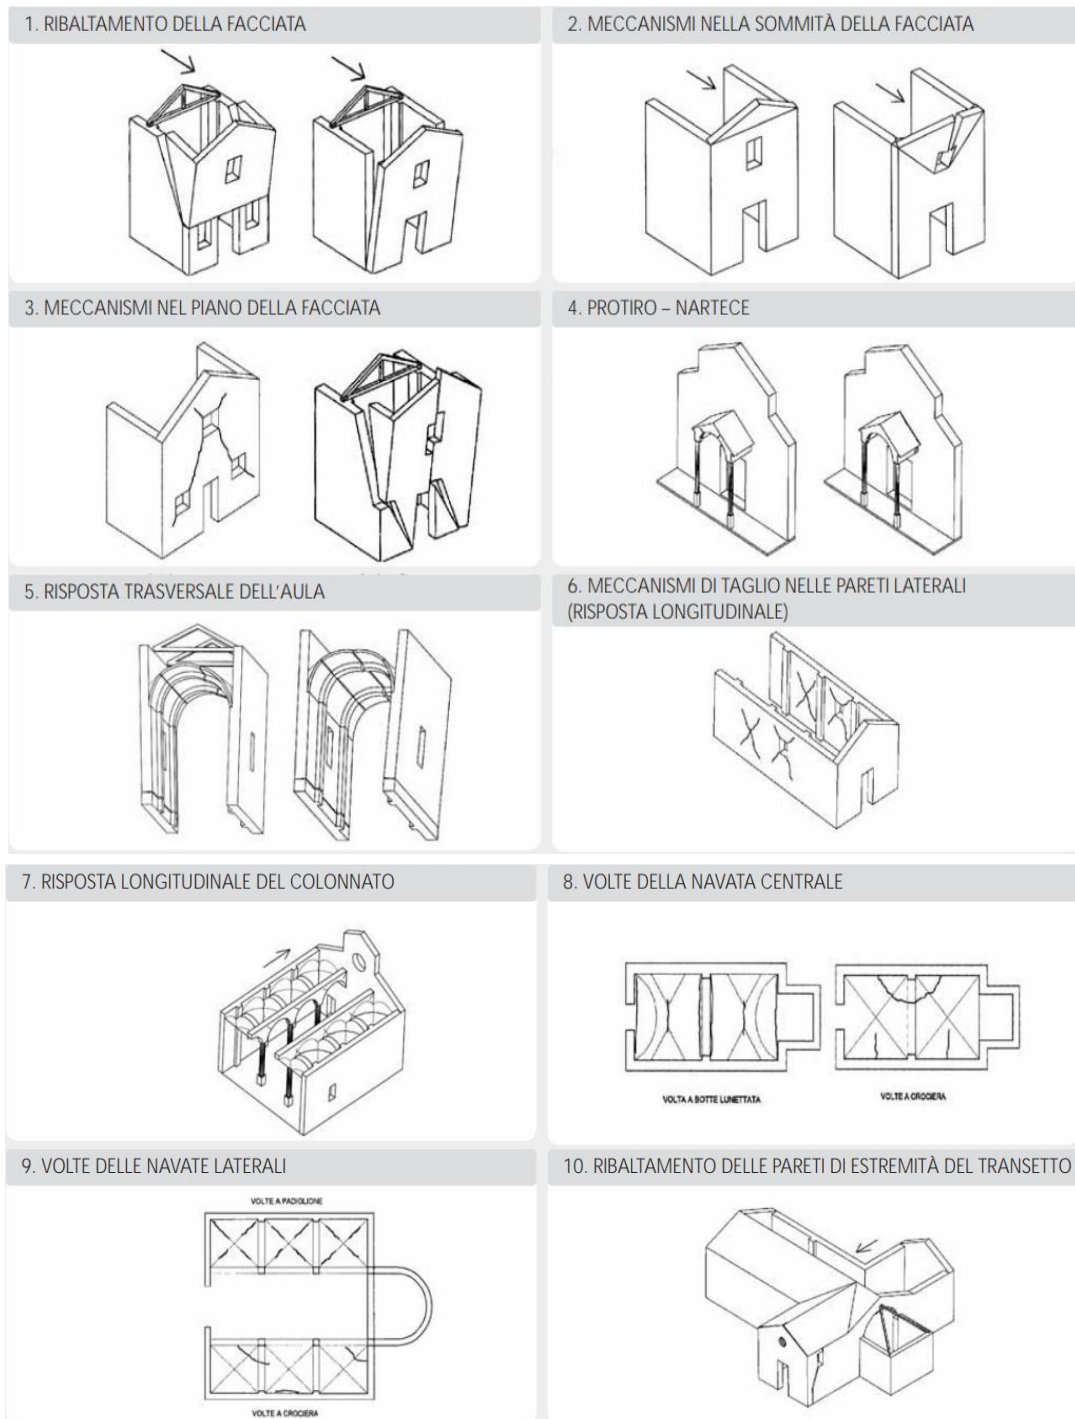
Figure 2-2. Collapse mechanisms extracted from the Annex C of the “Guidelines for evaluation and reduction of seismic risk of cultural heritage”.

The following figures, Figure 2-2, Figure 2-3 and Figure 2-4 extracted from the “Guidelines for evaluation and reduction of seismic risk of cultural heritage” give a more exhaustive understanding of the above-mentioned mechanisms.

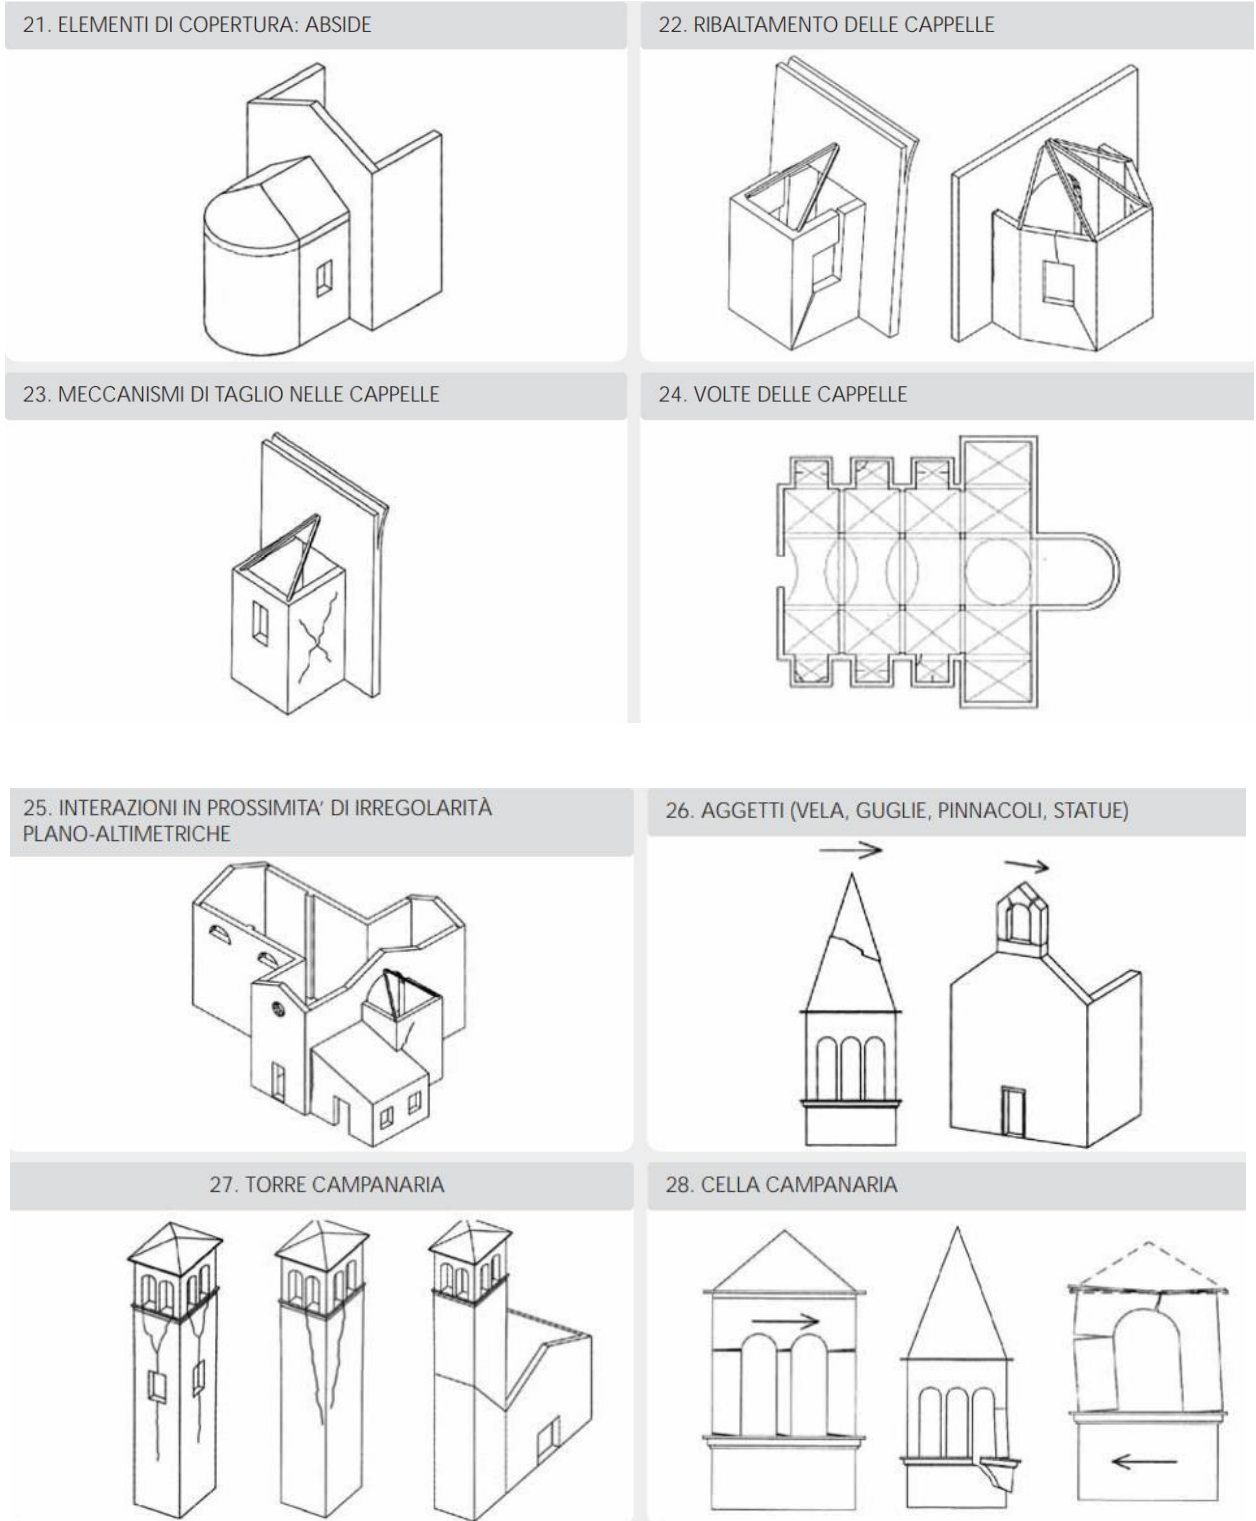
Figure 2-4. Collapse mechanisms extracted from the Annex C of the “Guidelines for evaluation and reduction of seismic risk of cultural heritage”.

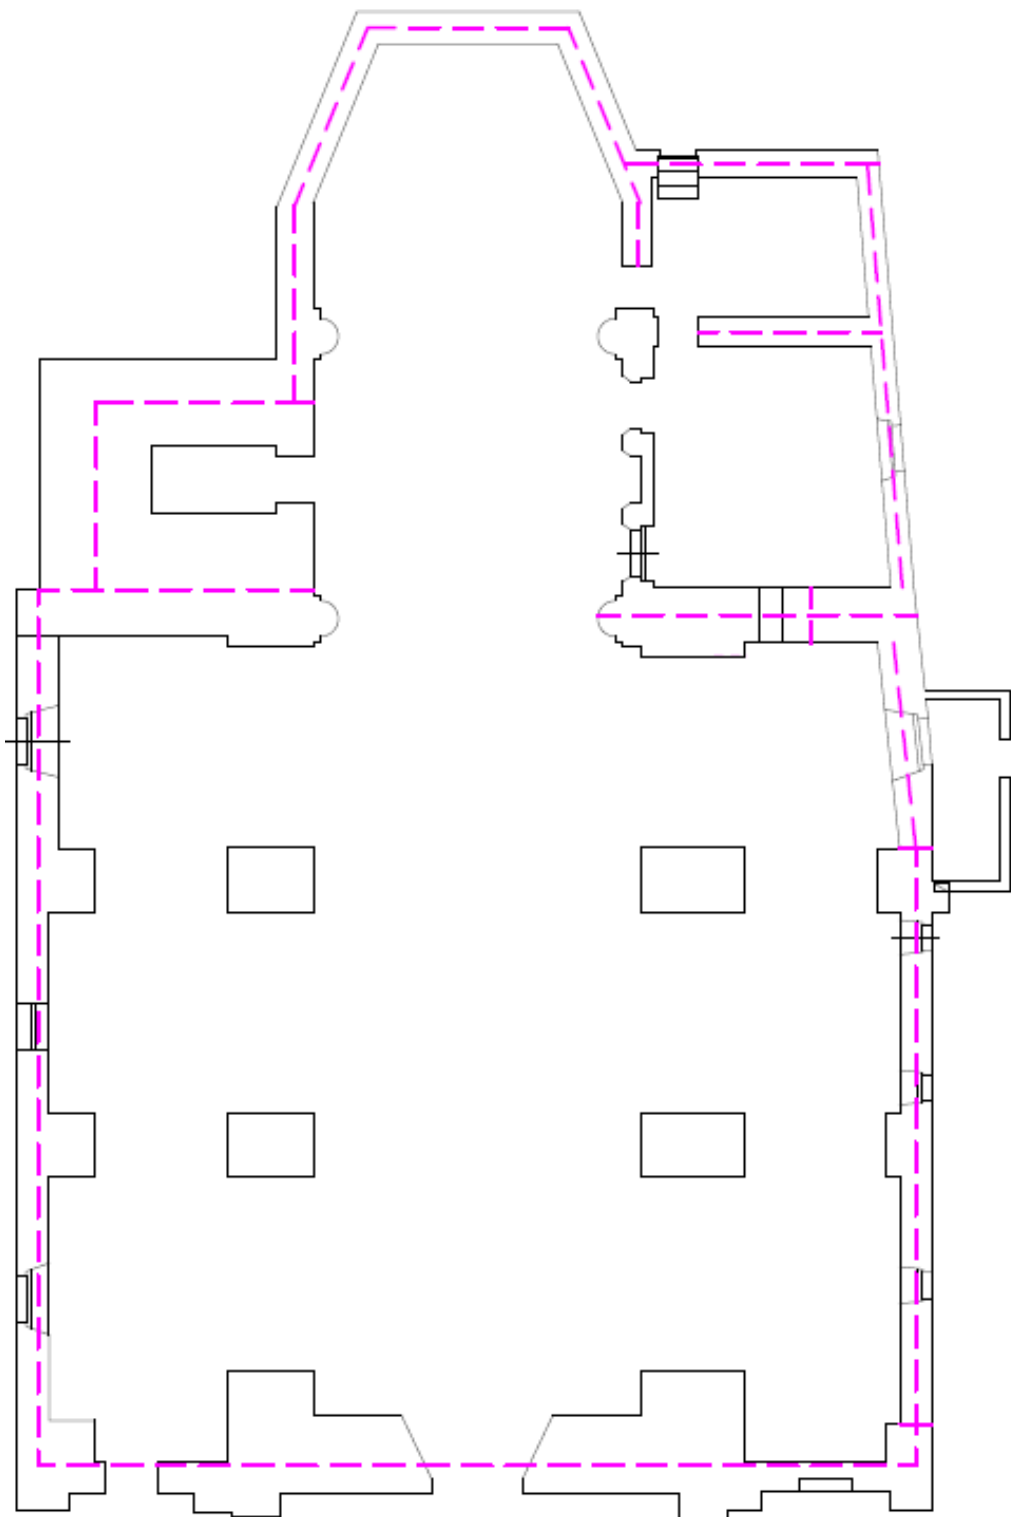
Figure 3-1. Structural plan with midline identification.

It is important to mention that this model is made up exclusively of lines, which interconnected with each other form a geometry, but these lines do not contain relevant information of the structure, it is only a geometric representation.

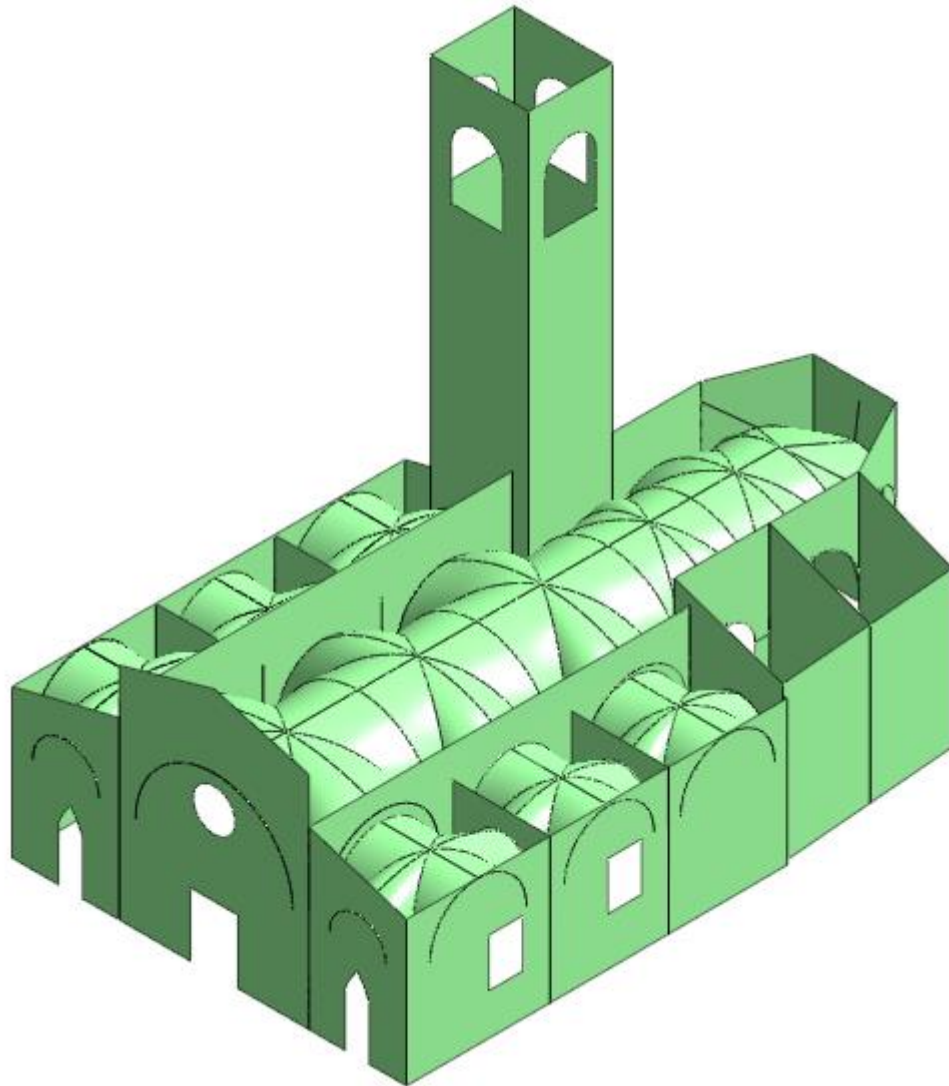
Figure 3-10. Complete model of the church.

Then, after having made the vaults, the model obtained is represented by the Figure 3-10.

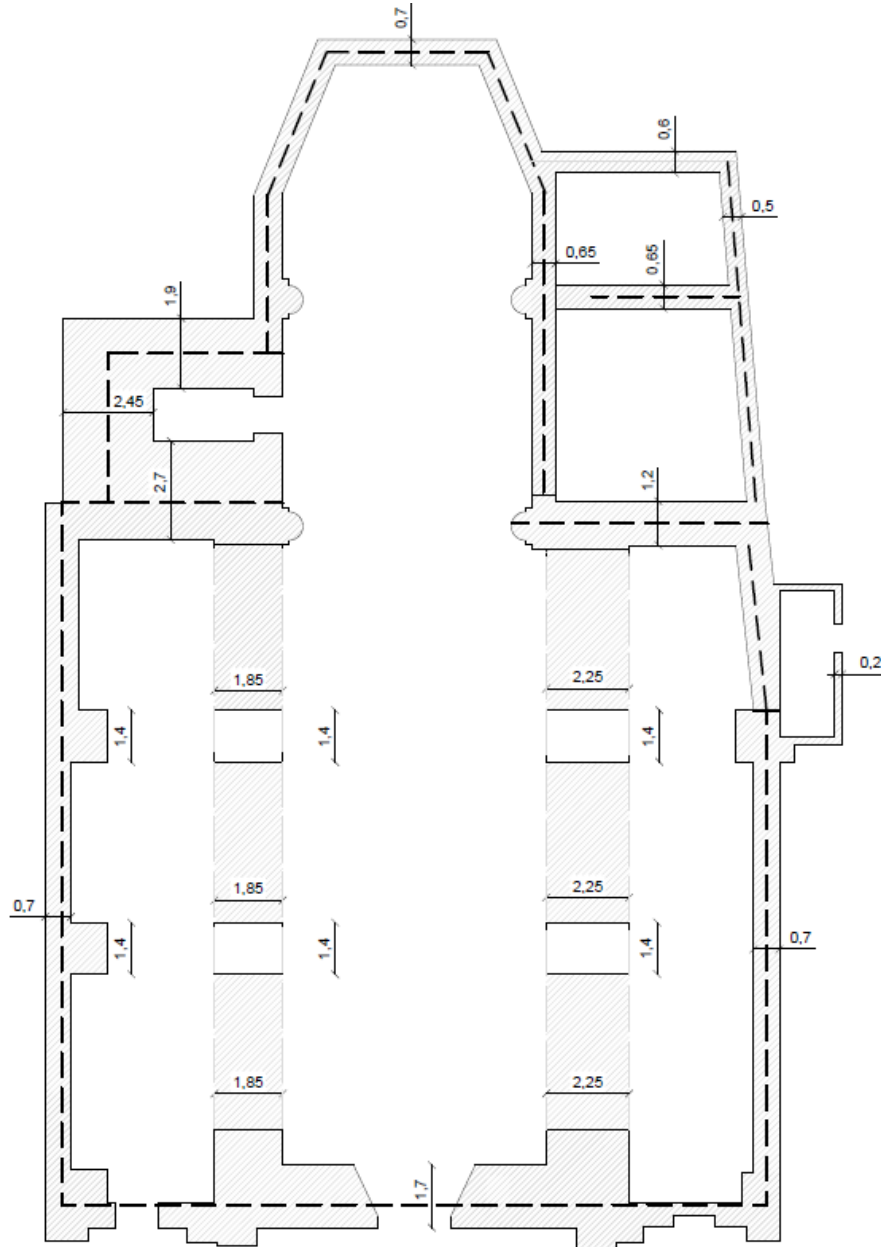
Figure 3-13. Thickness of the walls.

Considering the plan of the midline of the various walls, the different wall thicknesses were determined. The Figure 3-13 shows a dimensioned plan which allows the different thicknesses to be visualized.

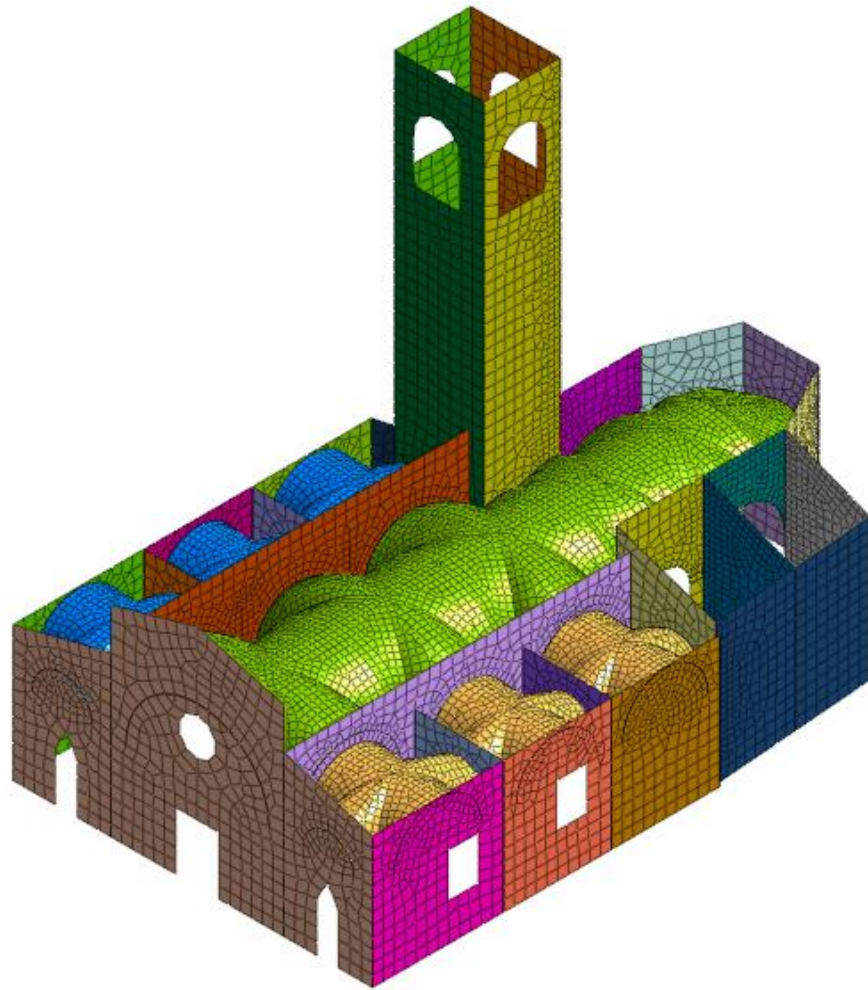
Figure 3-14. Structure's mesh.

the walls, the mesh size was between 50 - 70 cm., this choice is justified by the fact of providing an aspect ratio" closest to 1.0. Therefore, great attention was given to the congruency of the mesh to ensure accurate analysis. Overall, the use of size-based meshing method with a set size of 30 cm and 50-70 cm allowed for an efficient and uniform meshing process to be carried out, providing a foundation for reliable structural analysis. The shows the final arrangement of the meshes in the structure.

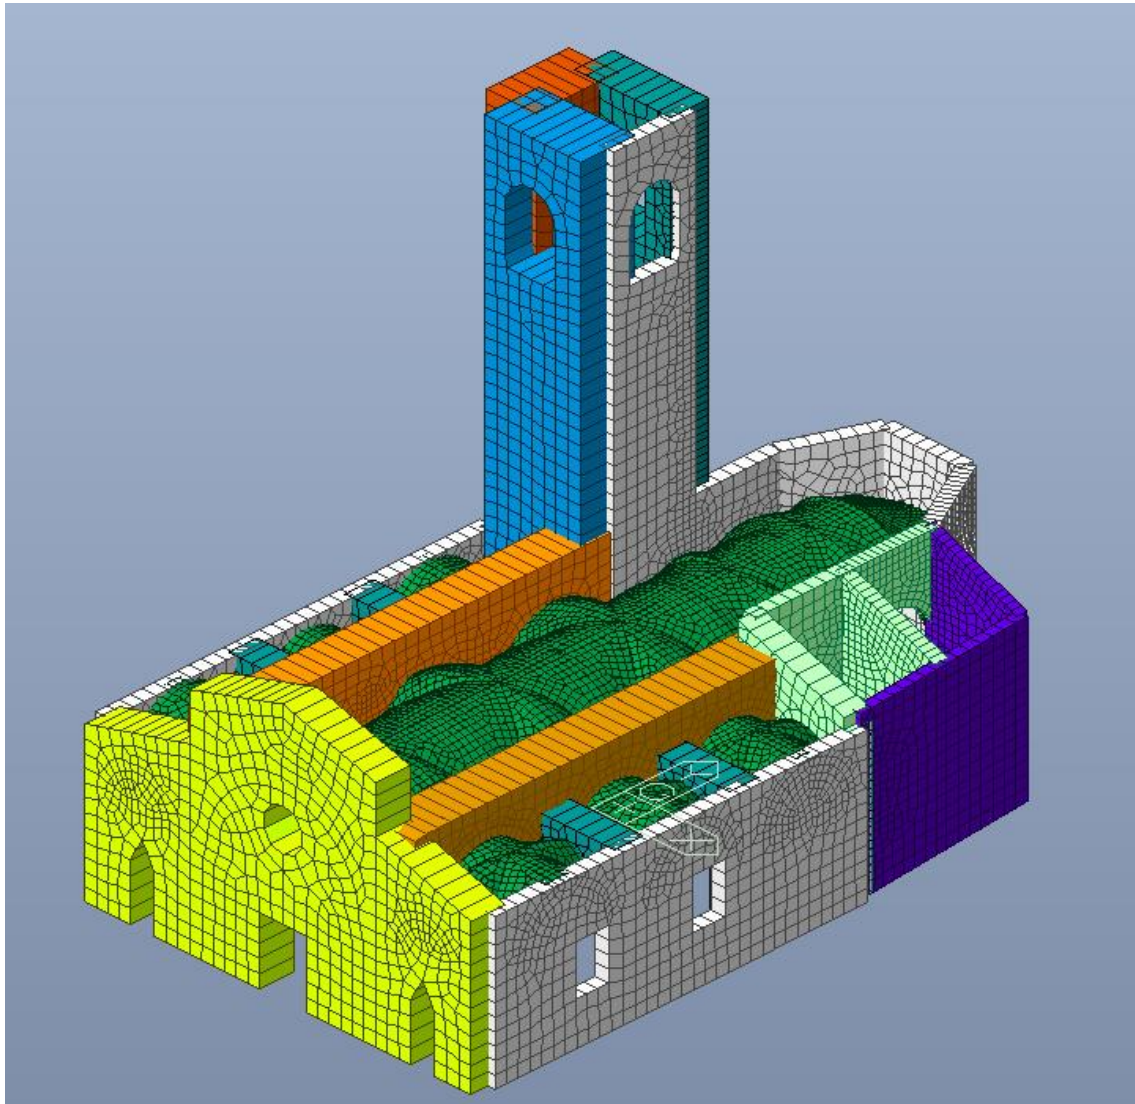
Figure 3-17. Result of the imported model in Midas Gen.

After defining the mesh, the subsequent step was to export the generated FEA NX model to Midas Gen using an *.mgt file. Initially, the Midas software could not recognize this model due to poorly defined mesh elements with overlapping. These errors were quickly identified in the 'Analysis message window' of Midas Gen. Then, the errors were resolved, resulting in the final model being successfully imported into the software.

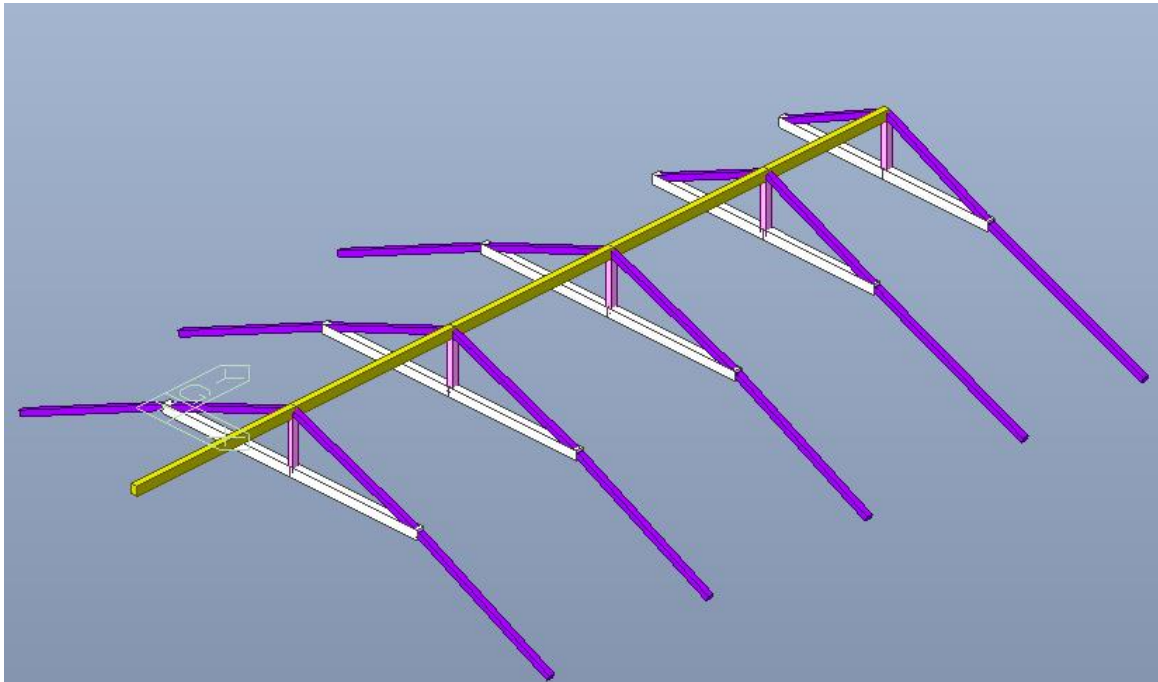
Figure 3-19. Calculation model of the roof -Midas gen.

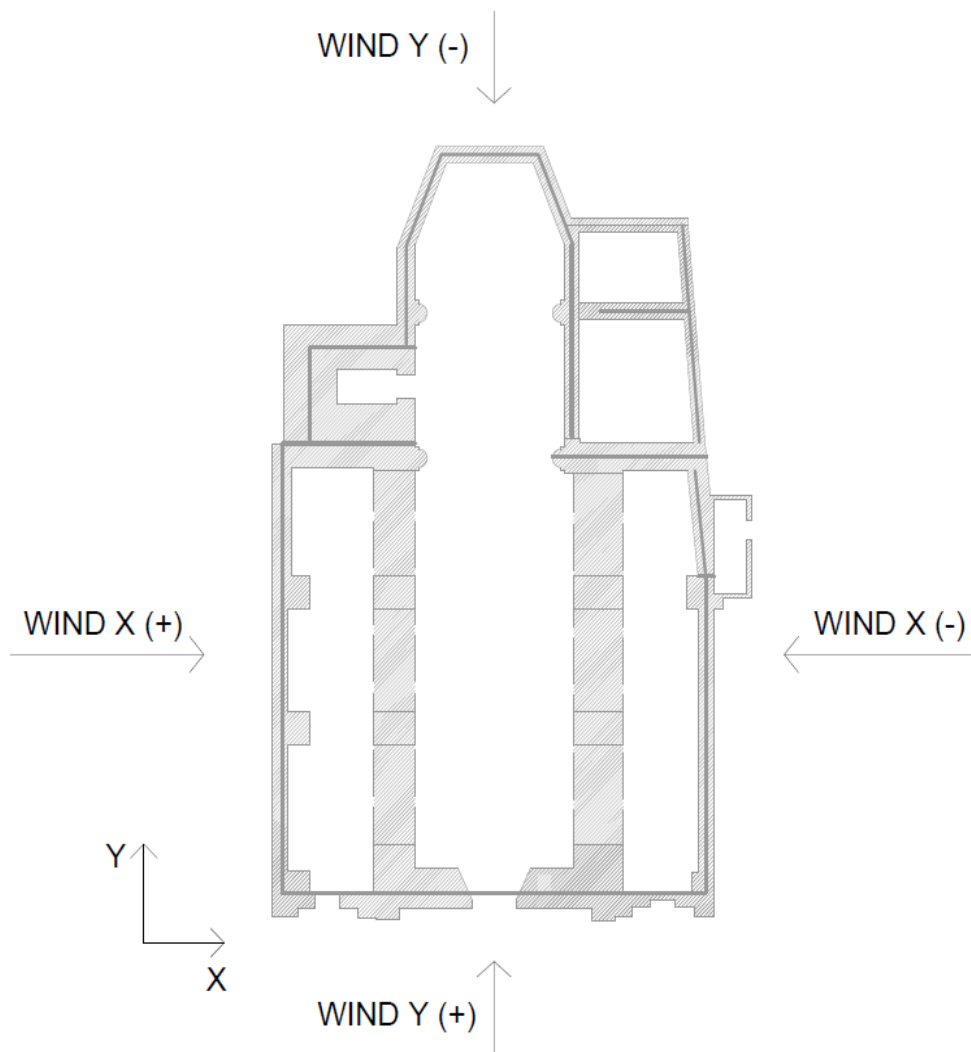
Figure 3-29. Wind scheme.

Before proceeding to the determination of the pressure coefficient, it is necessary to specify that the action of the wind must be considered in both directions, that is to say that the same surface can be subjected to upwind or downwind. The Figure 3-29 depicts the aforementioned.

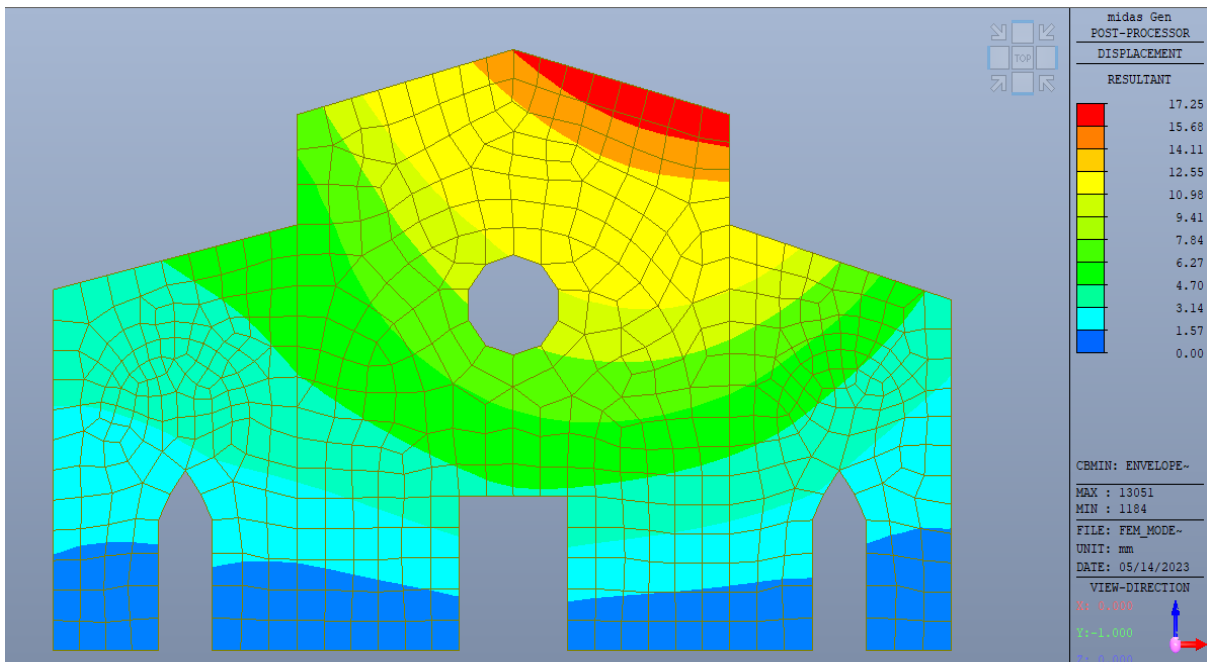
Figure 4-22. Resultant of the displacements Ultimate Limit State (SLU). Picture from Midas Gen.

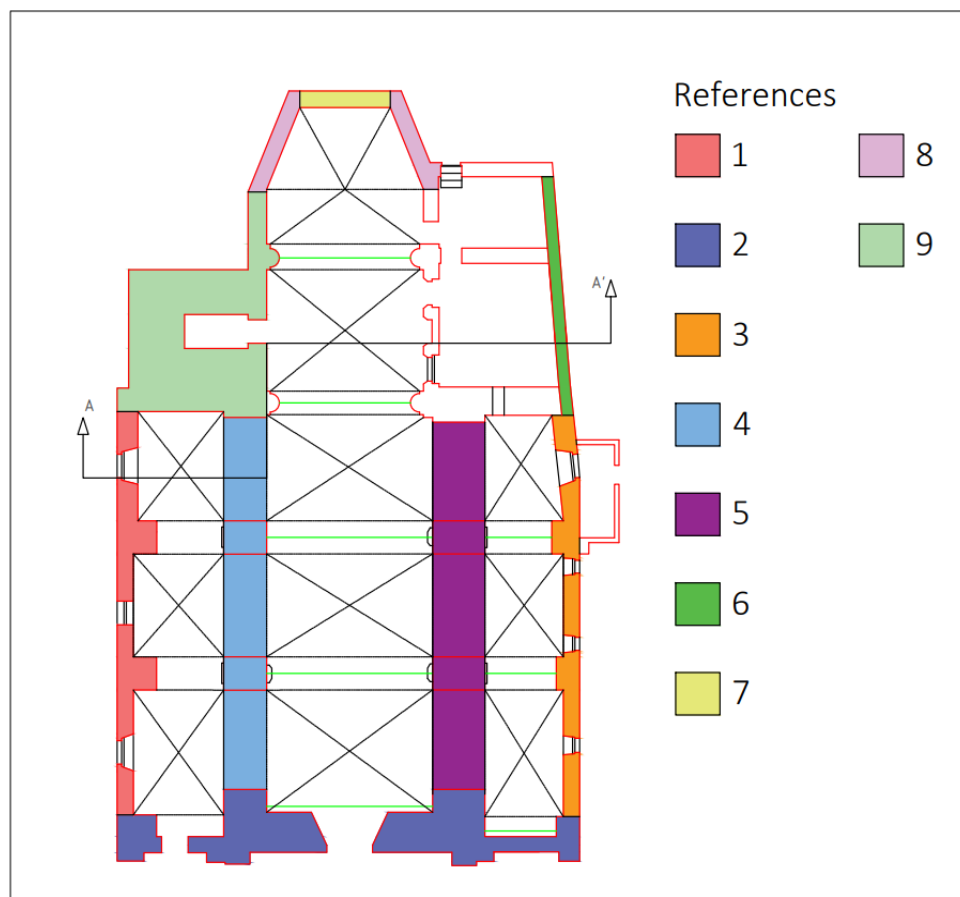
Figure 4-23. Walls under verification.

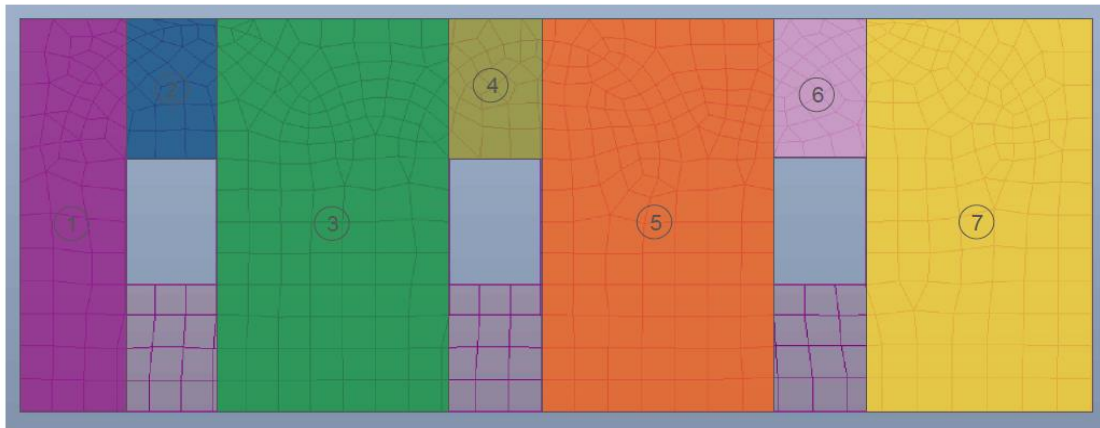
Figure 4-25. Wall N°1 - division. Image from Midas Gen.
