Politecnico di Torino

Master of Science Program in Civil Engineering

**Preliminary analysis for the structural
retrofitting of the Church of Santo
Stefano in Frassinò**

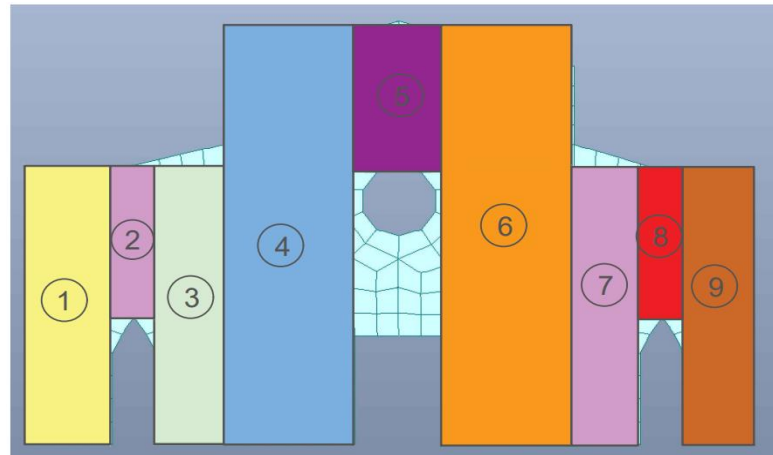
Figure 4-26. Wall N°2 - division. Image from Midas Gen.

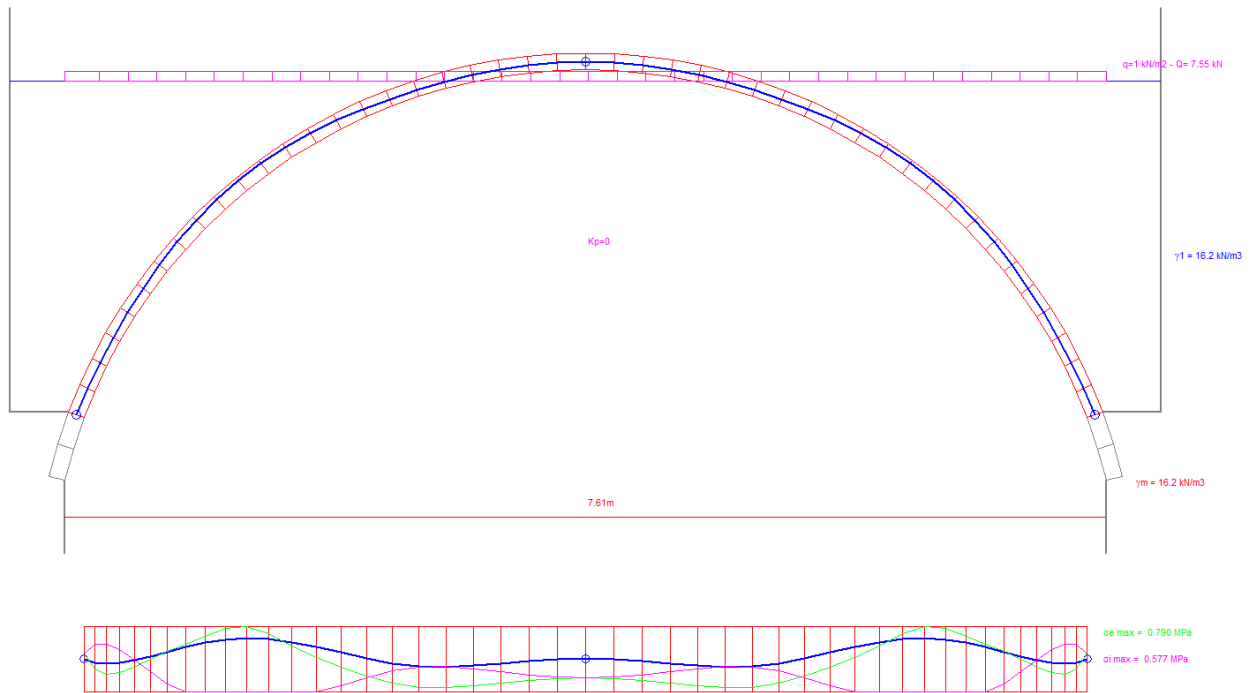
Figure 4-43. Pressure line of the Central Vault- Centred distributed load - Section 1.

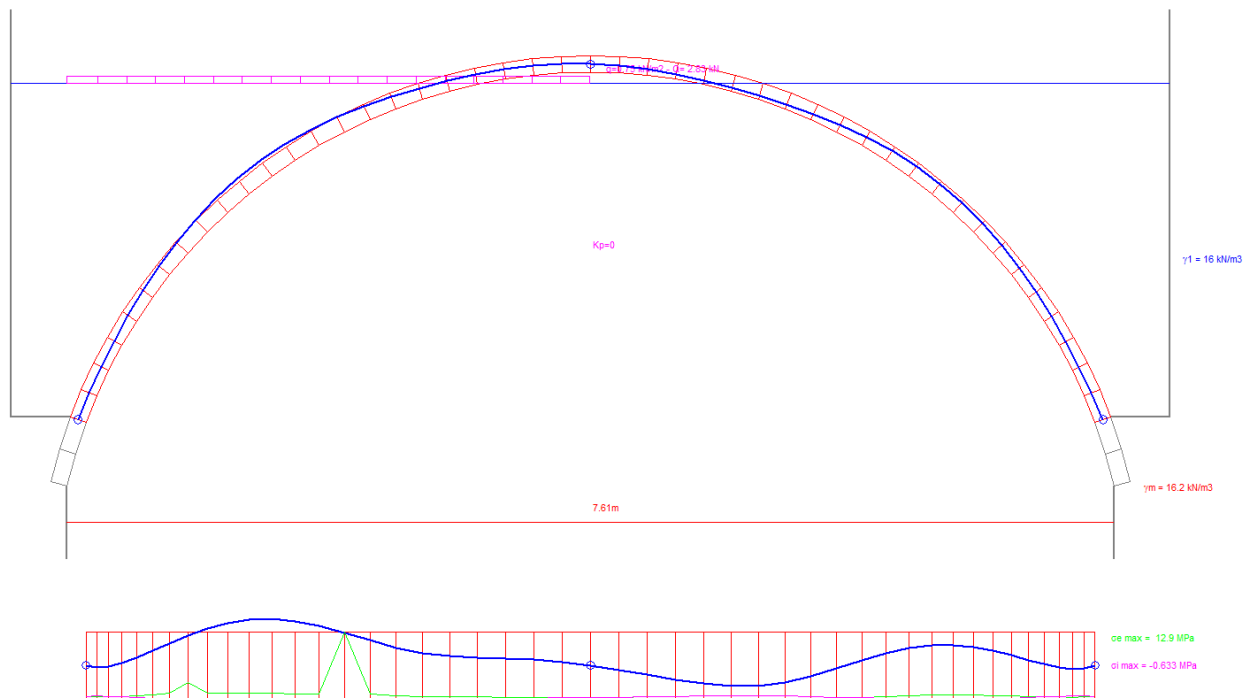
Figure 4-45 - Pressure line of the Central Vault- Asymmetrical Lateral distributed load - Section 1.

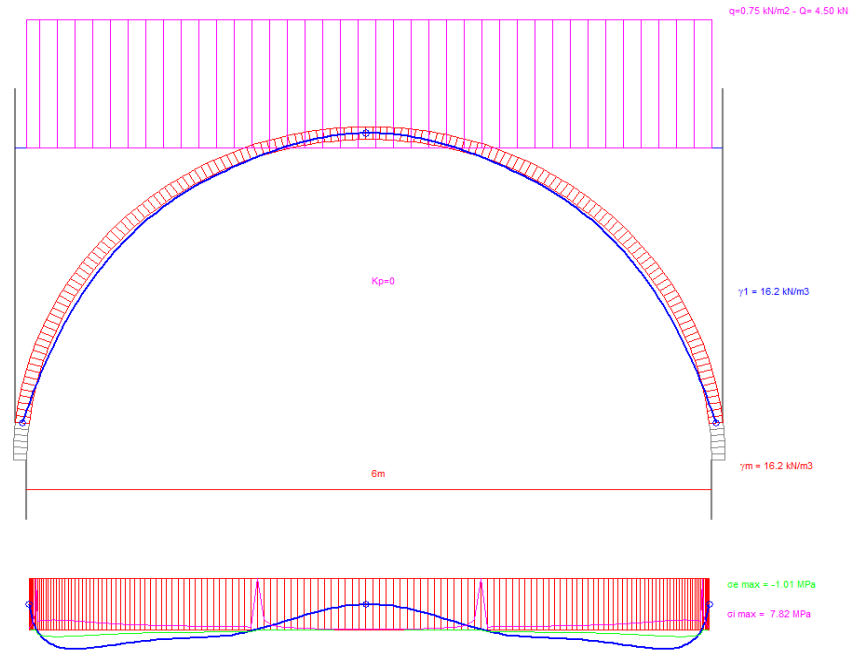
Figure 4-46. Pressure line of the Left Lateral Vault- Centred distributed load - Section 2.

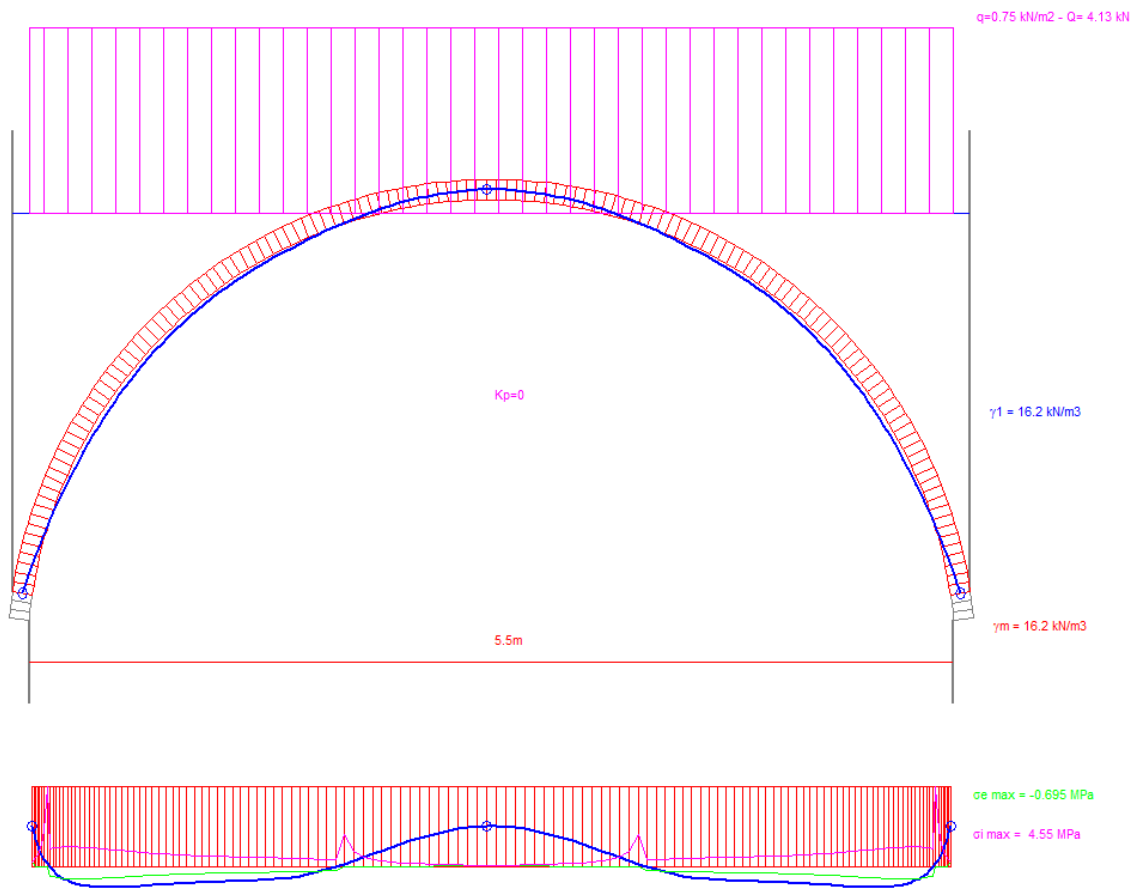
Figure 4-48. Pressure line of the Lateral Right Vault – Condition of centred distributed load - Section 2.

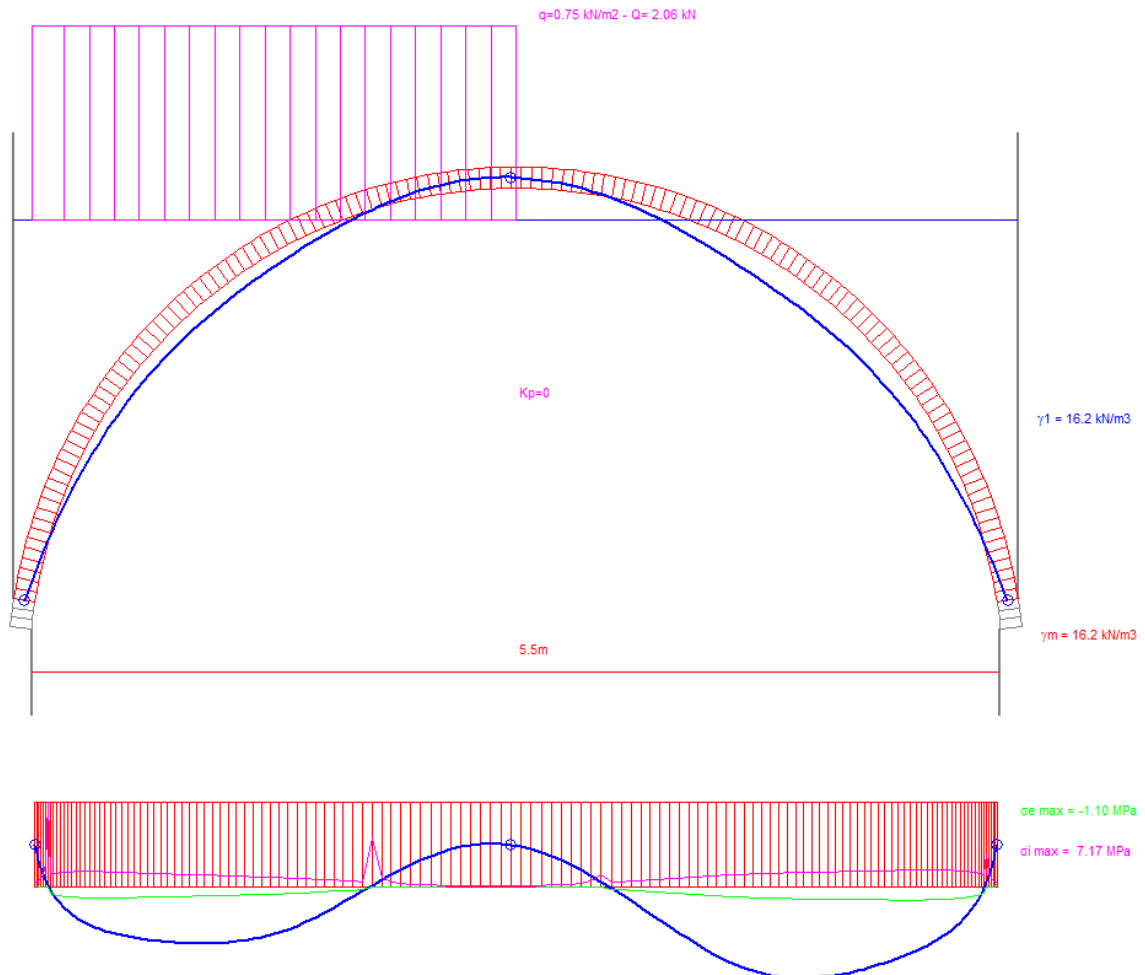
Figure 4-49. Pressure line of the Lateral Right Vault – Condition of asymmetrical load - Section 2.

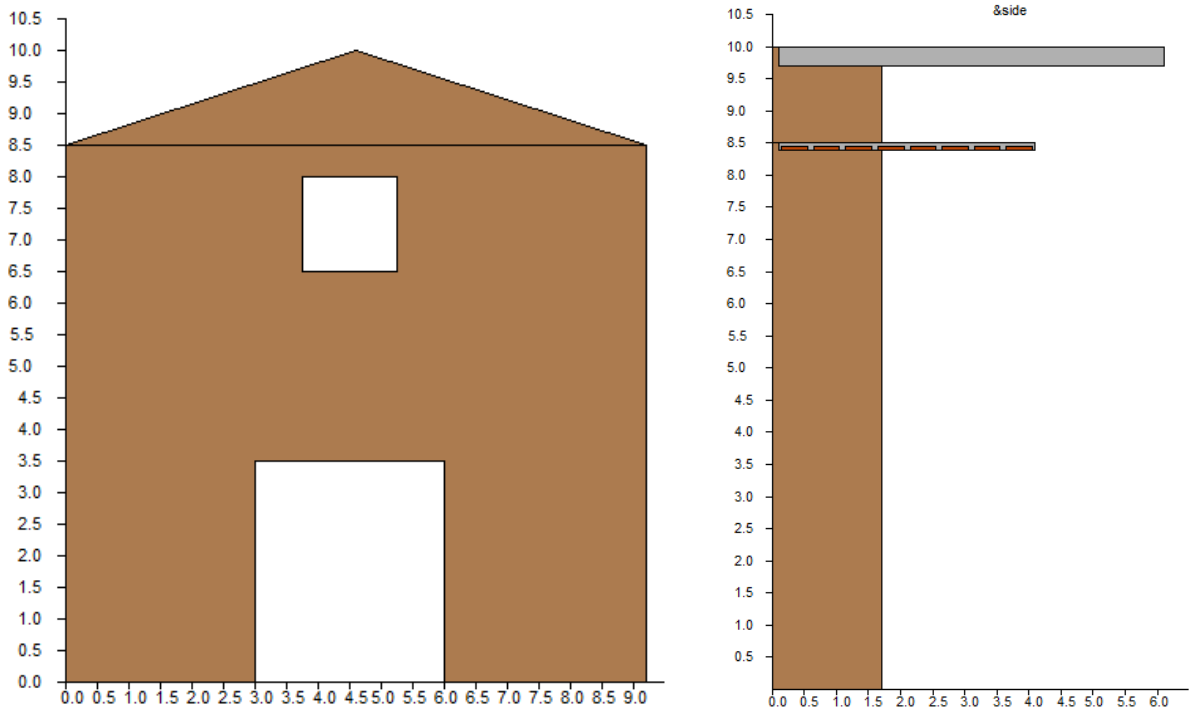
Figure 5-2. Front view and a section of the wall obtained from PRO_CINEm.

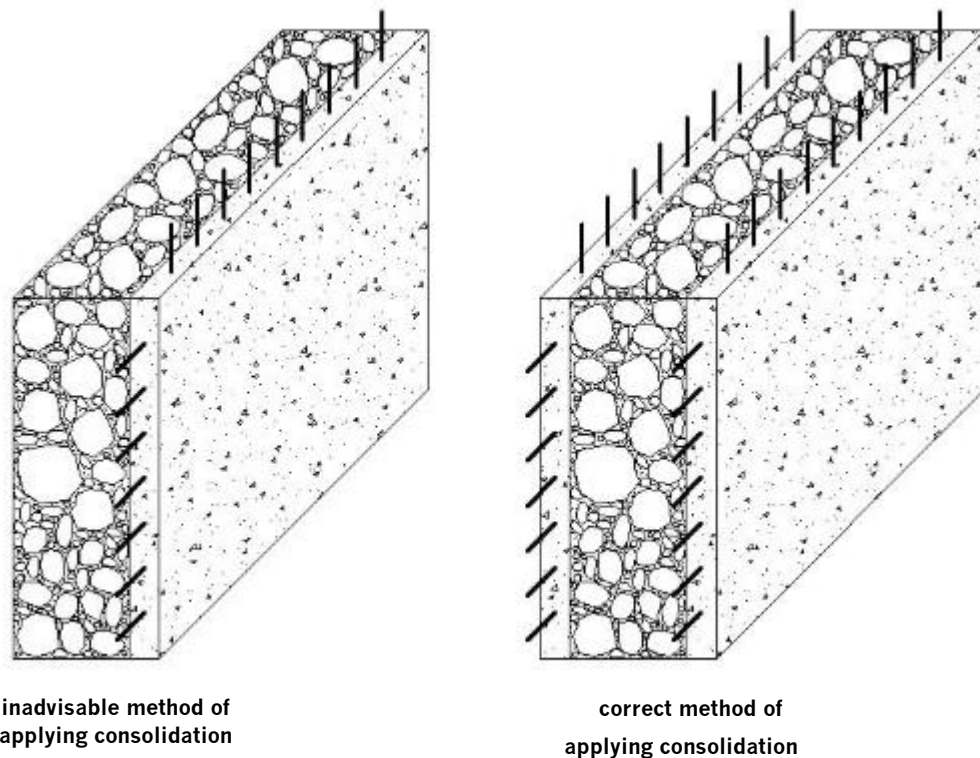
Figure 6-1. Correct and incorrect way to apply the reinforcement, image extracted from internet.

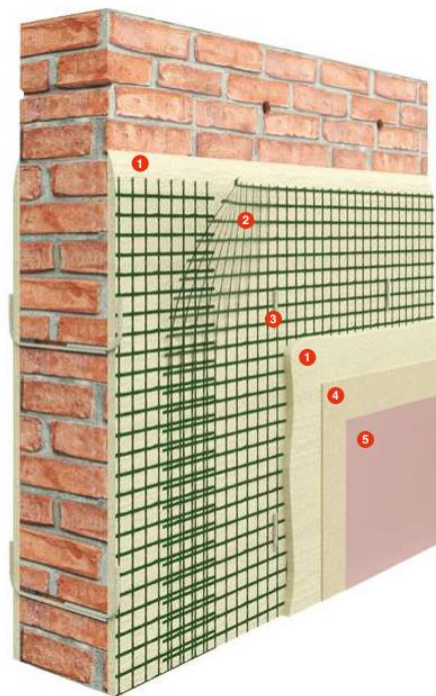
Figure 6-2. Composite reinforced mortar, image extracted from internet.

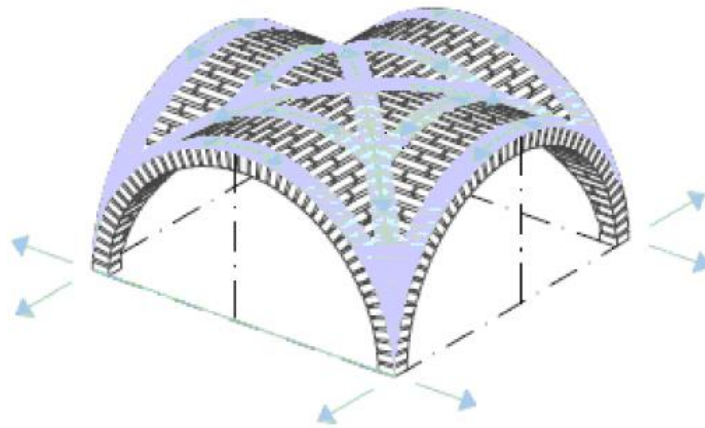
Figure 6-4. Scheme of how the reinforcement is applied.

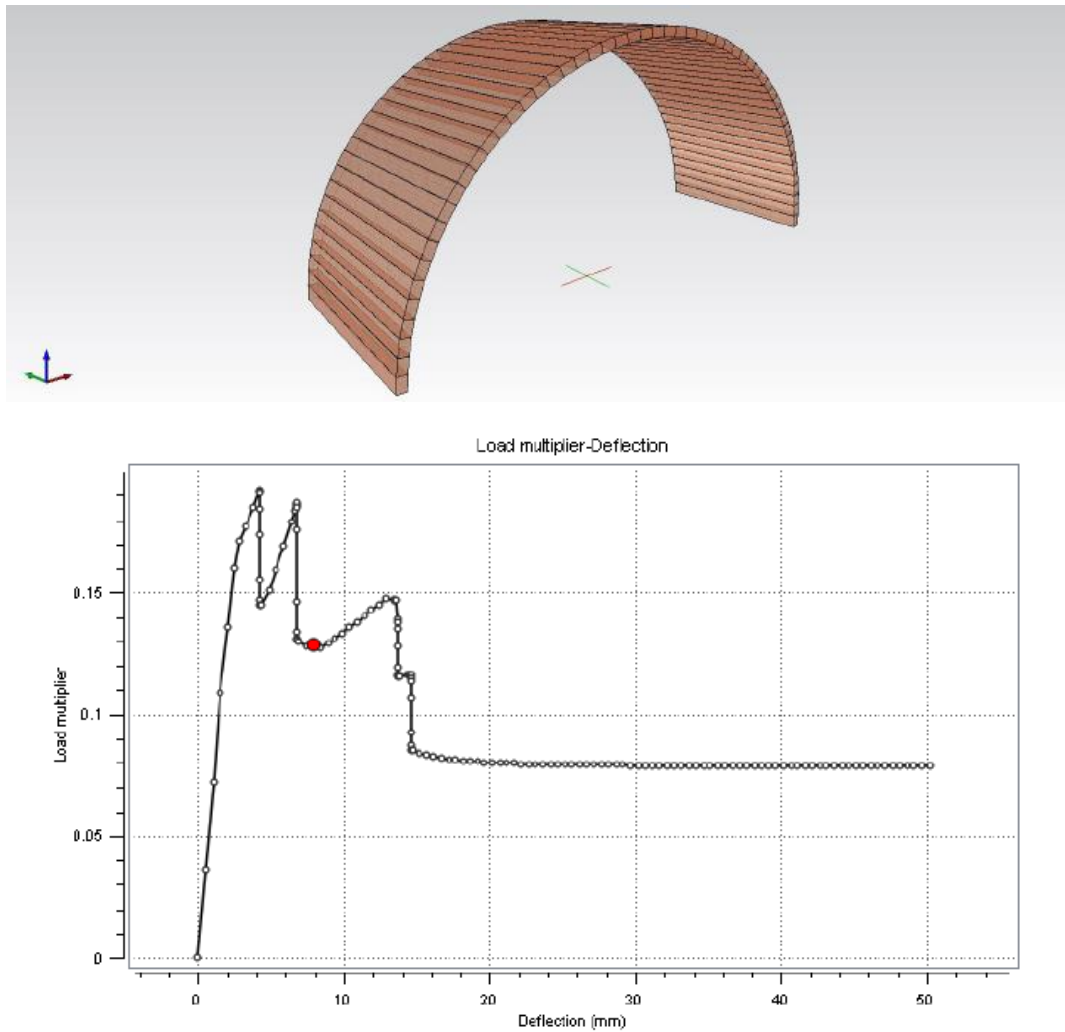
Figure 6-6. Pre opera of the central vault- Section 1. Image extracted from the GeoForce One.

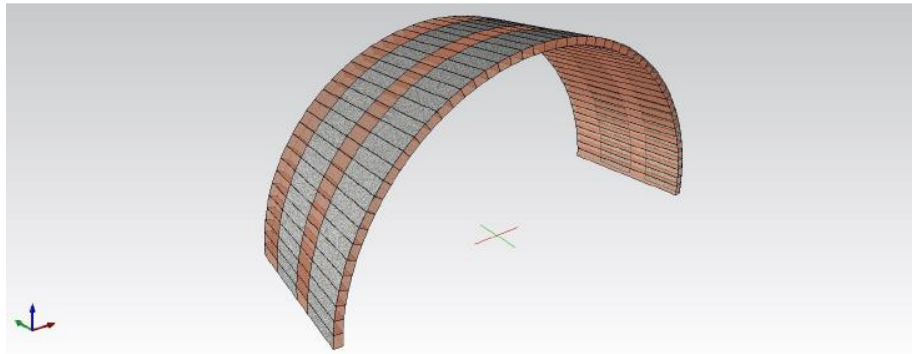
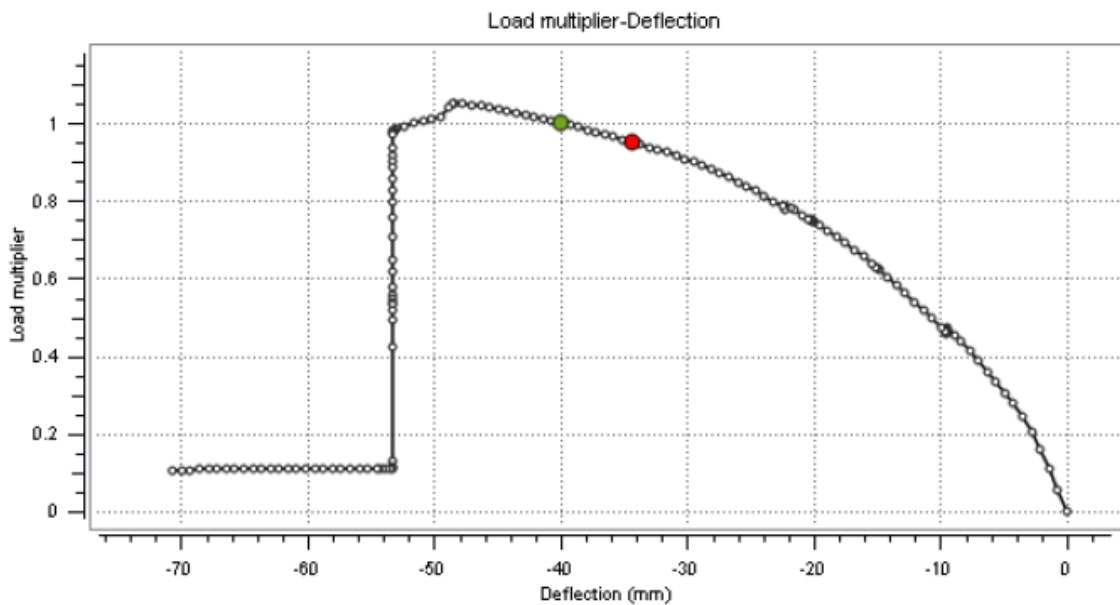
Figure 6-7. Post opera of the central vault – Section 1.

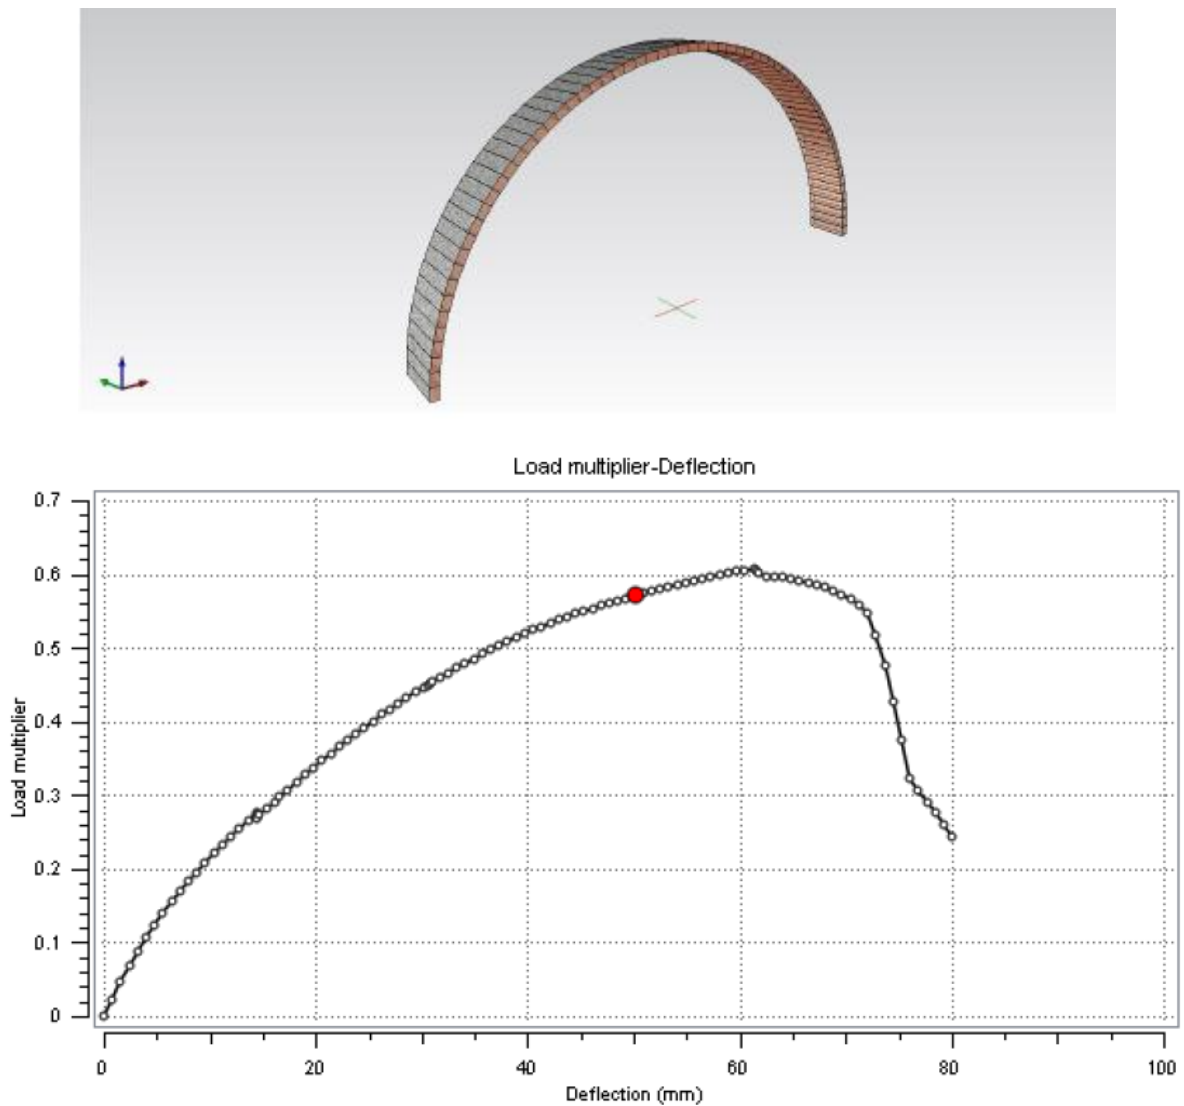
Figure 6-11. Post opera of the central vault – Section 3.

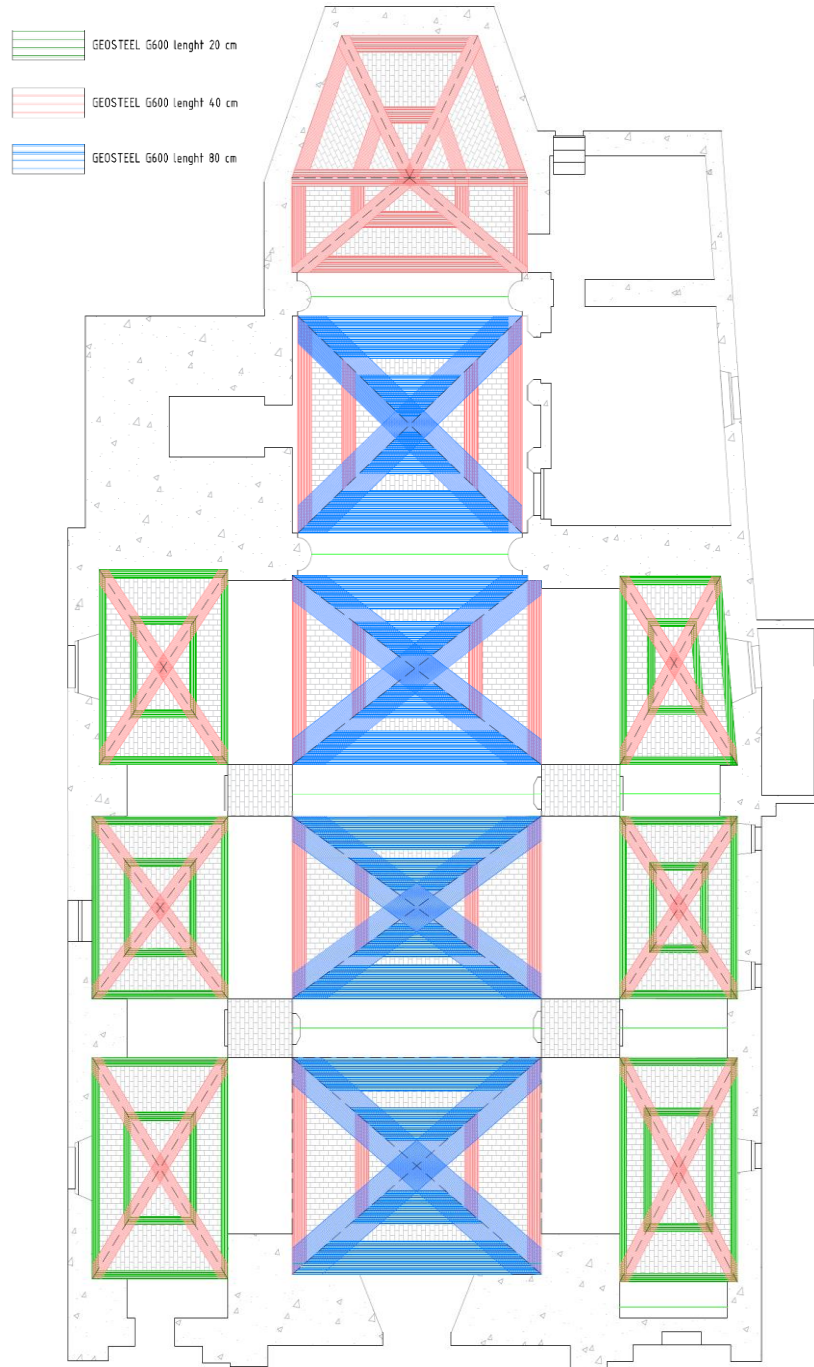
Figure 6-12. Vault's reinforcement.
