POLITECNICO DI TORINO

MASTER'S DEGREE THESIS

**Investigation Of Post-Construction Stress Distribution
and Influence of Deficiencies in Post-Tension System.**

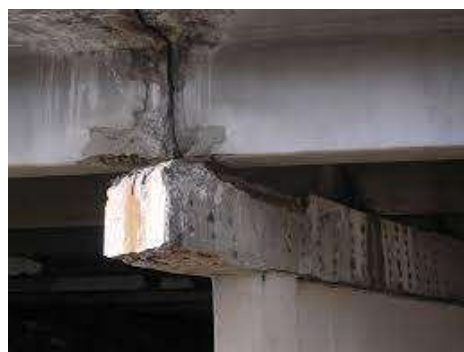
Figure 18 Joint damage

- **Cracked diaphragms:** The diaphragms, which provide structural support and distribute loads, exhibited cracks.
- **Deteriorated concrete:** The concrete in the superstructure showed signs of deterioration, indicating a decrease in its overall strength and integrity.
- **Surface corrosion on anchorages and bearing plates:** Corrosion marks were observed on the anchorages and bearing plates, suggesting the presence of corrosive elements and potential weakening of the structural components.
- **Opening of joints:** Joints, intended to allow movement and accommodate structural changes, showed signs of opening or separation.
- **Severe concrete cracking:** Extensive cracking in the concrete was identified, indicating significant stress and potential structural instability.

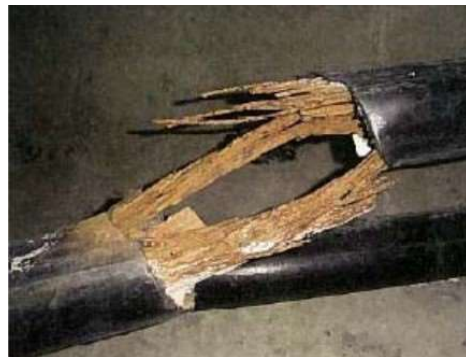
Figure 19 Tendon corrosion

Notably, tendon anchorages and deviation points are particularly susceptible to corrosion attacks as they represent critical points where the continuity of the structural element is compromised. These vulnerable areas emphasize the need to address corrosion-related issues to ensure the long-term integrity and safety of post-tensioned bridges (Menga, Kanstad, and Cantero 2022).

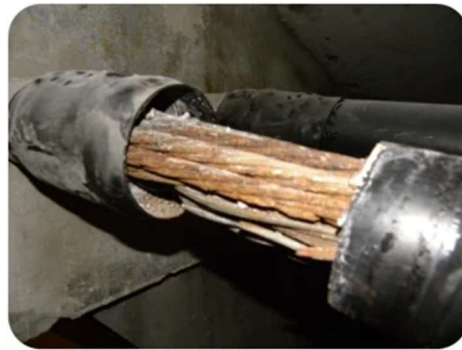
Figure 20 Corrosion in Tendons

Corrosion causes creates the conditions for corrosion to occur, while failure causes contribute to the overall failure of the structure. Among the corrosion causes, the presence of external chlorides is the most frequent cause. It is important to note that problems in the grout, is the second most frequent cause. The majority of structures in (Menga et al. 2023) report experienced corrosion-induced failure due to external chloride penetration and grouting issues.

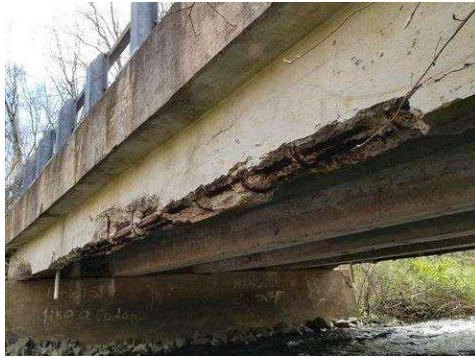
Figure 21 Concrete spalling due to corrosion

- Mild general or severe localized corrosion
- Reduction in prestress and/or tendon cross-section
- Presence of cracks and efflorescence
- Concrete spalling and/or delamination

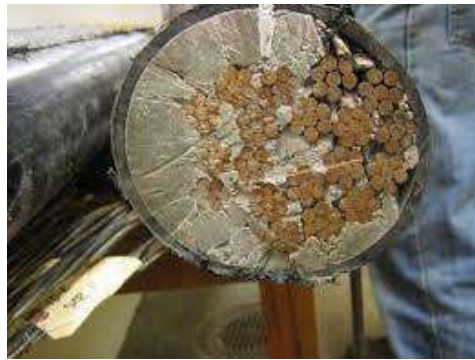
Figure 22 Voids in Ducts

When voids exist in the ducts, tendons are surrounded by air instead of grout, creating a favorable environment for corrosion initiation. Once chlorides penetrate the duct, they react with the air and trigger corrosion of the tendons. Notably, even if voids are subsequently filled with grout, actively corroding tendons can continue to corrode. It is essential to recognize that the penetration of chlorides into the concrete takes time. Therefore, in short-term failures, particularly in structures less than 10 years old, where external chlorides are the major corrosion cause, the combination of other failure causes may contribute to the overall failure.

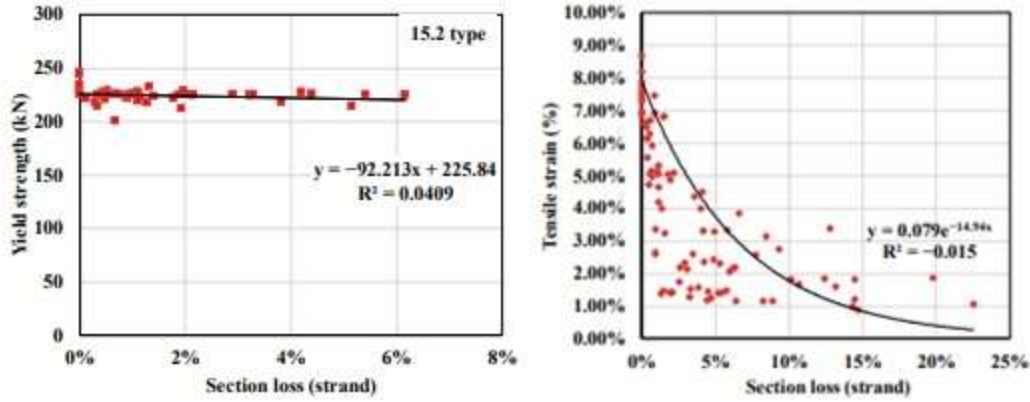
Figure 25 Yielding & Ultimate Strength with Respect to Cross-sectional Area

The study conducted investigated the tensile strength and ductility of corroded strands, revealing intriguing findings. Despite a significant section loss of 22.52% in the most corroded specimen, there was no substantial difference in the observed yield strength. However, the ultimate strain of the wire was more severely impacted, with a mere 5% section loss resulting in an 85% maximum reduction in deformation capacity.

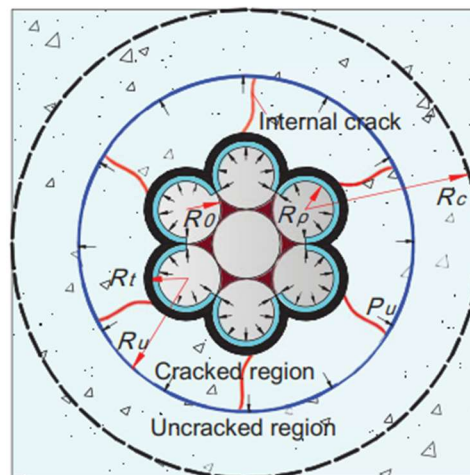
Figure 26 concrete cracking due to strand corrosion. (Wang et al. 2019)

Where $\Delta V_r = n\Delta V_w$, n is the strand rust-expansion ratio; ΔV_w is the volume change of wires; ΔV_c is the volume change of concrete induced by expansive pressure; ΔV_p is the volume of corrosion products that fill cracks and pores.

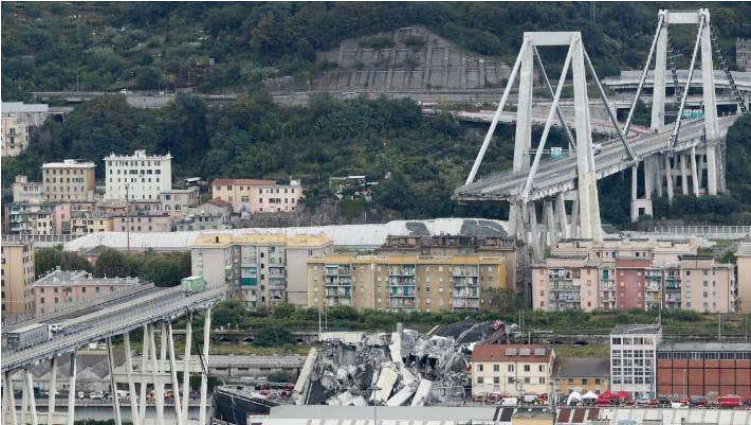
Figure 31 Polcevera bridge after collapse

During phase 4 of the operations, the original plan to inject grout into the ducts was unsuccessful, leaving many segments incompletely filled with grout materials. Subsequently, in the official investigation conducted by the ministry of infrastructure and transportation in 2018, the deficiency of grout in the tendon ducts was identified as the primary cause of pitting corrosion in the steel tendons. Pitting corrosion, discovered during the post-collapse inspection of the cables of Polcevera Bridge, manifests as localized holes and cavities in the steel tendons, posing a more destructive force than uniform corrosion and resulting in reduced load-bearing capacity, particularly under repeated loads. Its local occurrence makes pitting corrosion challenging to detect, exposing the cables to high levels of stress concentration.

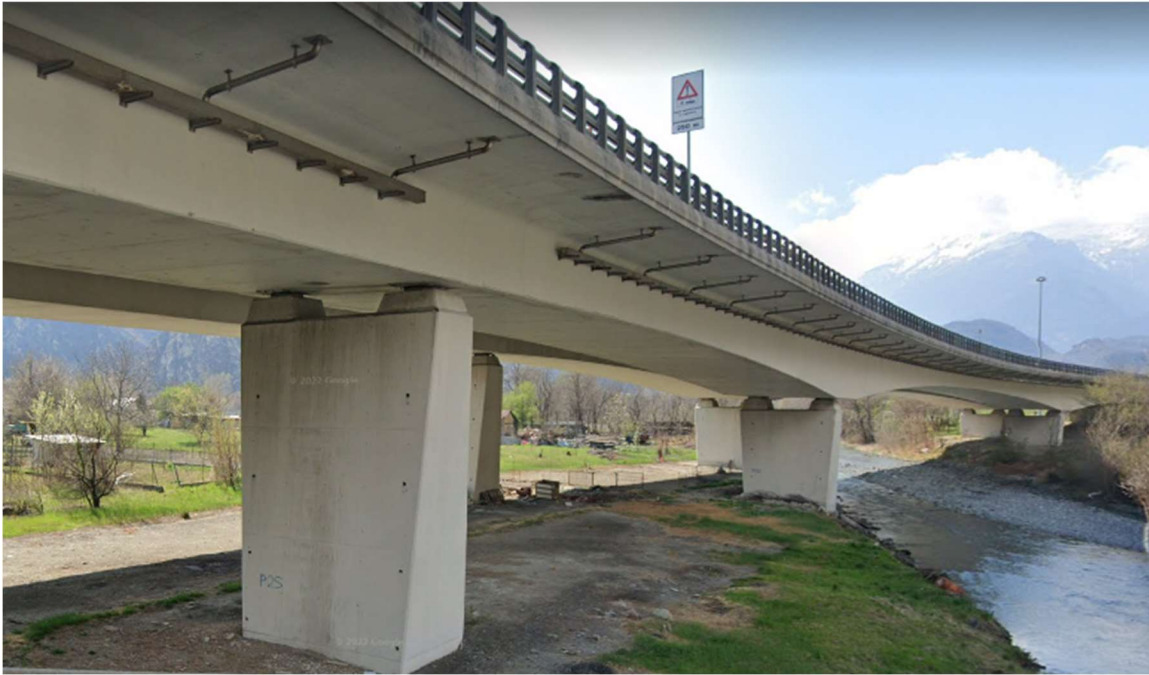
Figure 32 case study Bridge

The case study bridge, completed in November 1992, is located in northern Italy. This road viaduct is a vital link connecting Italy, with France. Moreover, it forms an integral part of the European route E70, a major corridor running from La Coruna in Spain to Trabzon in Turkey, crossing from west to east. The completion of the bridge represented a remarkable feat in modern engineering and transportation advancement, facilitating enhanced connectivity between Italy and France.

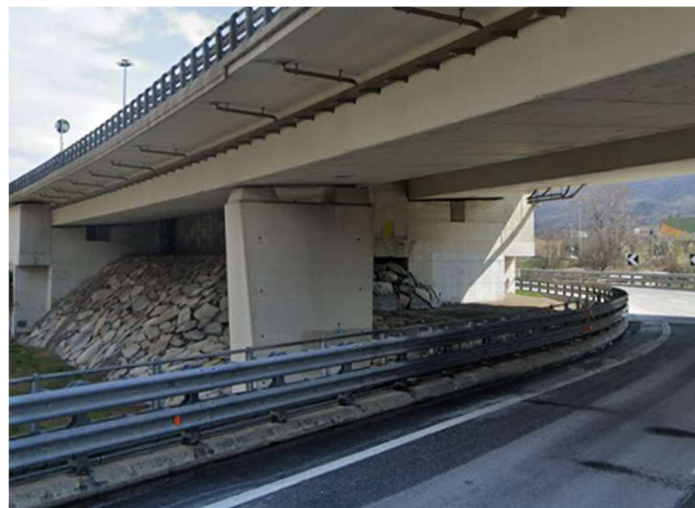
Figure 51 Bridge-Column Connection

The vertical load on the structure is initially distributed onto two pads situated directly above the columns, as depicted in Figure 51 Bridge-Column Connection. From there, the load is efficiently transferred to each column, enabling them to effectively bear the vertical loads. A detailed discussion regarding the load bearing pads will be presented at the conclusion of this section.
