# **GEORGIAN DARBAZI**

**Politecnico  
di Torino**

Department of Architecture and Design  
Master Thesis in Architecture Construction City  
AY 2023-2024

**Georgian Darbazi:  
Inspecting the fibers of the  
past, present & future**

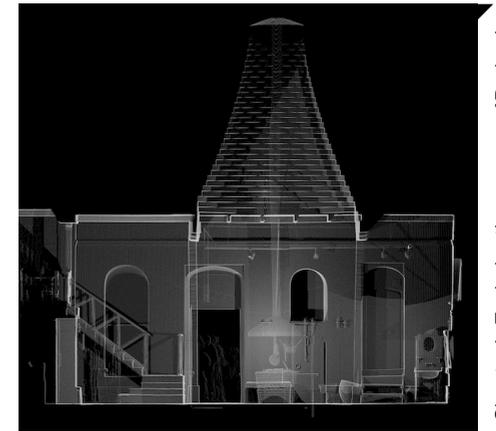
The territorial differences within the construction of different types of crowned structures can also be explained by the distribution of dendrological resources. In eastern Georgia we meet deciduous forestry such as **Oak** and **Beech** species up to 50 meters in height, which have miscellaneous body parts useful for various structural elements; Meanwhile, in the West and south of the country people were using **Fir** and **Spruce** trees with regular trunks and gradually shrinking crowns – suited for every element within the construction of *Gvirgvini* roof. As we can see, craftsmen tried to be economically and environmentally sustainable by utilising every part of a tree. (Fig. 24 ) (Sumbadze, 239)

▼ **Fig. 24/** Longinoz Sumbadze, *The use of wood for Darbazi covering in Eastern and Southern Georgia*, “The Architecture of the Georgian Folk Dwelling Darbazi”, 1984

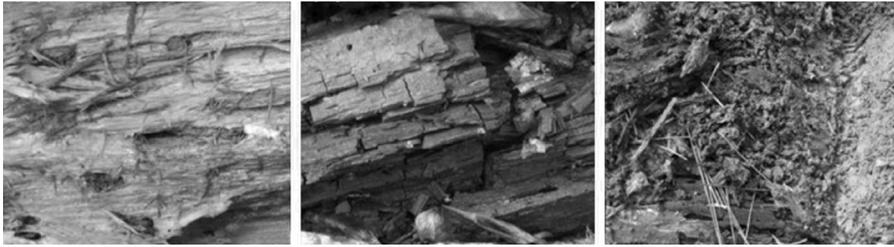
▲ **Fig. 42/** Historical wood biodegradation types: (A) white-rot, (B) brown-rot and (C) soft-rot (Fukasawa 2021).

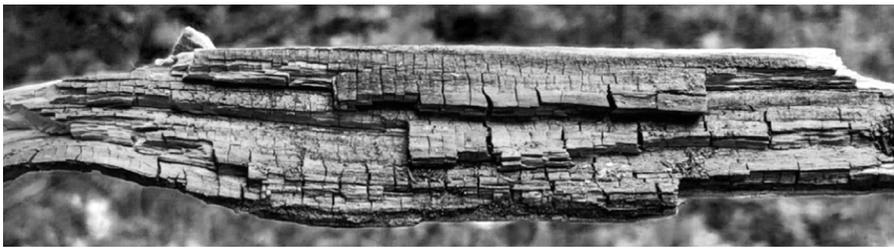
According to Shupe<sup>7</sup>, wood-decaying fungi are grouped into three categories: **brown rot, white rot and soft rot**. (Fig. 42) They attack various chemical components within wood material: cellulose, hemicellulose and lignin, and generate metabolic chain, thus compromising structural integrity of timber. The results of strength deprivation may vary depending on the fungi type, wood species and lumber dimensions.

**Brown rot** (“Dry” rot) (Fig. 43) is a type of fungi commonly attacking softwoods but potentially is harmful for hardwood as well, while **white-rot** fungi attack is mostly observed on hardwoods. “White-rotted hardwood undergoes little surface alteration, develops a white or bleached appearance, displays near-normal shrinkage and in the early stages of decay is solid to the touch rather than friable.” (Shupe, 2008, 6)

▼ **Fig. 43/** Classic advanced brown rot fungal decay in a softwood. Source: Goodell, Barry, Jerrold E. Winandy, and Jeffrey J. Morrell. 2020. "Fungal Degradation of Wood: Emerging Data, New Insights and Changing Perceptions" *Coatings* 10, no. 12: 1210.

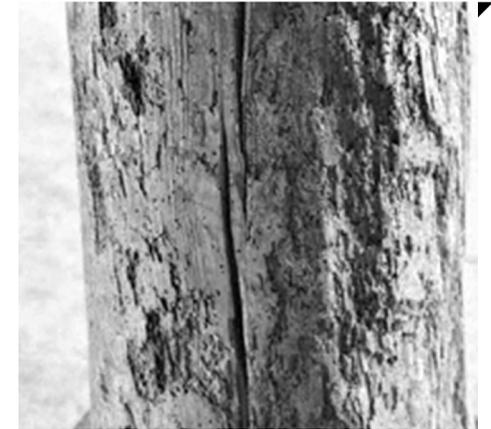
▲ **Fig. 44/** Column attacked by beetles. Source: Wang, s.: damage classification to historical wooden structures: a preliminary survey and recommendation for Dong minority drum towers, *int. Arch. Photogramm. Remote sens. Spatial inf. Sci.*, xlv-m-1-2021, 821–827, 2021 <https://doi.org/10.5194/isprs-archives-XLVI-M-1-2021-821-2021>

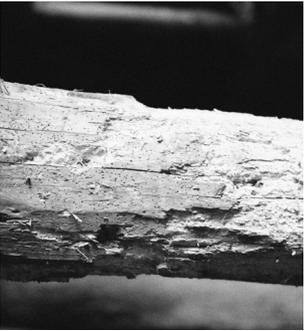
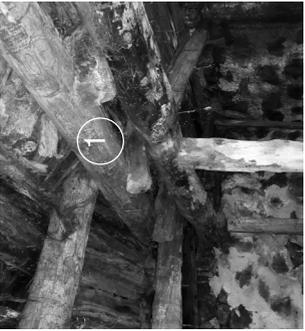
Mold; Severe Insect attack; (Galleries, exit holes & dust excrements);	Moderate Fungi attack (white rot); Mold; Moderate/severe Insect attack;	Severe Fungi attack (soft rot); Moderate Insect attack;	16-20 cm
Natural weathering; Alteration (Dust deposition);	Natural weathering; Alteration (Dust/smoke deposition); stains;	Fractures; Transversal rupture of multiple elements; Sagging soil; Lacuna in rear wing; Alteration (Dust/smoke deposition);				1. 16-20 cm 2. 3x20 cm
Knots; Stains; Longitudinal fractures;	Longitudinal fractures; Knots;	Knots; fractures;

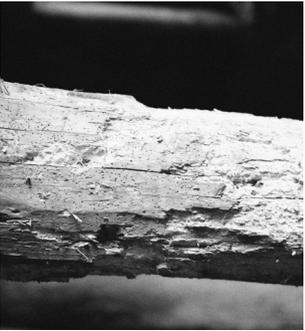
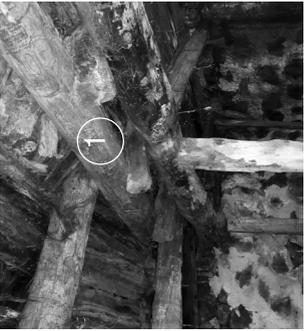
Mold; Severe Insect attack; (Galleries, exit holes & dust excrements);	Moderate Fungi attack (white rot); Mold; Moderate/severe Insect attack;	Severe Fungi attack (soft rot); Moderate Insect attack;	16-20 cm
Natural weathering; Alteration (Dust deposition);	Natural weathering; Alteration (Dust/smoke deposition); stains;	Fractures; Transversal rupture of multiple elements; Sagging soil; Lacuna in rear wing; Alteration (Dust/smoke deposition);				1. 16-20 cm 2. 3x20 cm
Knots; Stains; Longitudinal fractures;	Longitudinal fractures; Knots;	Knots; fractures;

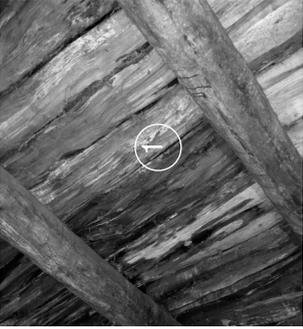
Mold/mildew; Moderate-Severe fungi attack (soft rot);	Multiple fractures;	Knots; stains; Cracking;	4x24 cm

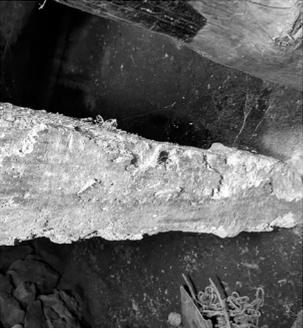
Severe Insect attack (Galleries, exit holes & dust excrements);	Alteration (Dust deposition); Weathering;	Knots; crookedness;	20-24 cm

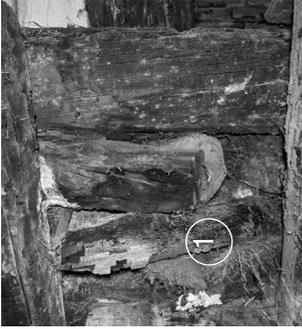
Moderate/severe Fungi attack (soft rot); Moderate insect attack;	Transversal rupture of elements; Longitudinal fractures; Alteration (Dust and smoke deposition);	Knots; Stains;	16-18 cm

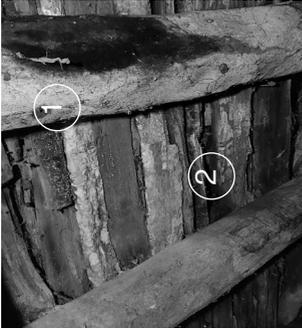
Severe Fungi attack (white rot);	Alteration (Dust and smoke deposition); Weathering	Knots; Stains;	1. 24-28 cm 2. 4x20 cm

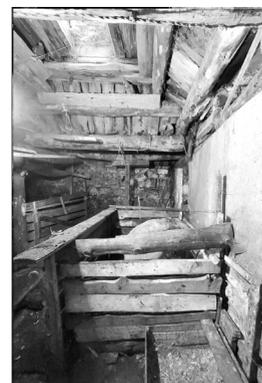
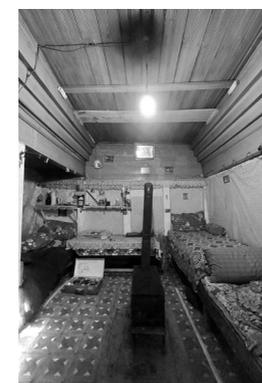
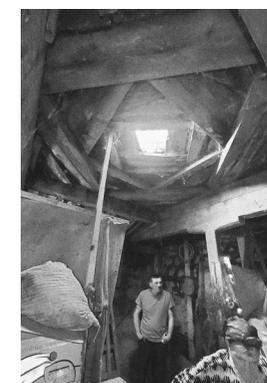
From the visual survey, we can detect substantial damage within wooden frameworks, such as severe infection by fungi and mould deposition on horizontal bearing elements, moderate to severe insect attacks within the vertical bearing structure, rotting and rupturing of secondary wooden elements, resulting in sagging soil and partial absence of the roof. Alongside with biological deterioration of timber components, it's worth noting their mechanical state – absence, dislocation, cracking and rupturing of separate structural or non-structural members, followed by manual attempts of replacement and strengthening by the owners themselves.

Fig. 53/ Maghradze dwelling, Akhori chamber

Fig. 54/ Maghradze dwelling, Oda chamber

Fig. 55/ Maghradze dwelling, Darbazi space

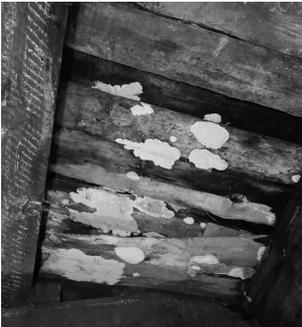
Fungal attack (white rot); Minor Insect attack;	Multiple fractures; Alteration (Dust and smoke deposition);	Knots; stains;	16x18 cm

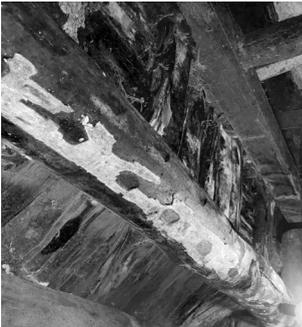
Severe Fungal attack (white rot); Moderate-severe Insect attack;	Alteration (Dust and smoke deposition); Weathering;	Knots; stains; Longitudinal Fractures;	16x20 cm

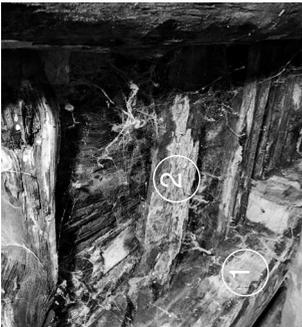
Severe Fungi attack (white rot; soft rot); Insect attack (Galleries, exit holes & dust excrements)	Transversal rupture of multiple elements; Water leakage; Lacuna; Alteration (Dust and smoke deposition);	Knots; crookedness;	1. 20-26 cm 2. 15-18 cm

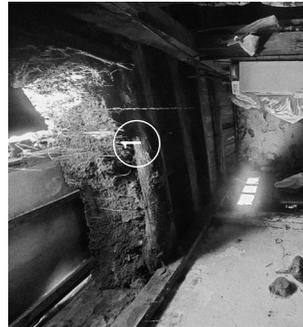
Fungi attack (soft rot);	Longitudinal fractures; Water leakage and Sagging soil; Lacuna in the roof;	Knots;	18-20 cm

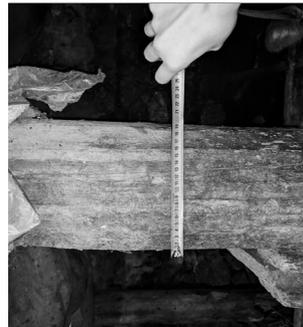
Mold/mildew; Moderate-Severe Insect attack (Galleries, exit holes);	Minor fractures; Alteration (Dust deposition); Weathering;	Knots;	19 cm

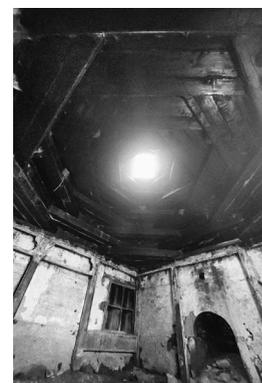
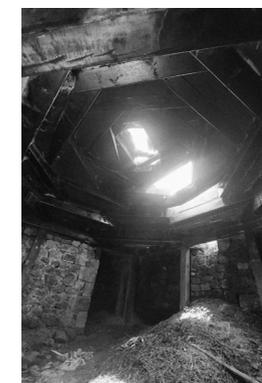
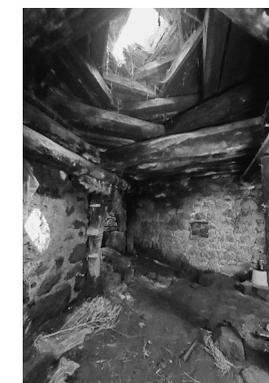
To appraise the dwellings through the structural scope, both *Darbazi* halls seem to have retained overall structural integrity, but ruptures of several roofing elements in the big hall (shown in the table below) and biological harm within a few joints might be compromising for retaining it.

As for biological hazards, we can observe mild to moderate fungal attacks on multiple roofing elements in both halls, especially on crude logs and baulk boards within the lateral wing of the main *Darbazi* space and neighbouring chamber. Moreover, we clearly see the pest infestation mainly on vertical structural components. The dwellings are damaged by the humidity and/or water leak, and sagging soil from the roof.

Fig. 56/ Melikidze house, view on Gvirgvini (smaller hall).

Fig. 57/ Melikidze house, view on Gvirgvini (primary hall).

Fig. 58/ Melikidze house (view on second Gvirgvini in Primary hall).

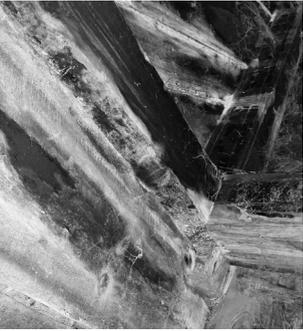
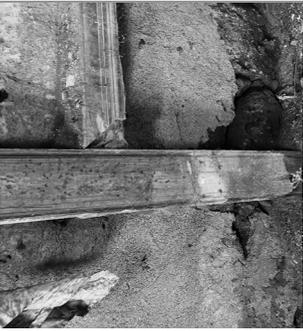
Mild/moderate; Mild Insect attack;	Damp column base; Weathering;	Partial fractures due to nails/spikes; Traces of removed decorations; Stains	16x18 cm
Mild-moderate fungi attack; (soft rot) Mild-moderate Insect attack; (galleries, exit holes);	Severe fungi attack (white rot);	Mold/mildew; Mild Insect attack;	Biological decay	Mechanical failure; Other	Defects	Av. Dimensions of timb. element
Transversal rupture of multiple elements; Water leakage; Lacuna; Alteration (Dust and smoke deposition);	Partial Fractures; Alteration (Dust and smoke deposition);	Damp column base; Weathering;	Mechanical failure; Other	Mechanical failure; Other	Defects	Av. Dimensions of timb. element
Knots; crookedness; Partial fractures due to nails/spikes;	stains;	Partial fractures due to nails/spikes; Traces of removed decorations; Stains	Biological decay	Mechanical failure; Other	Defects	Av. Dimensions of timb. element

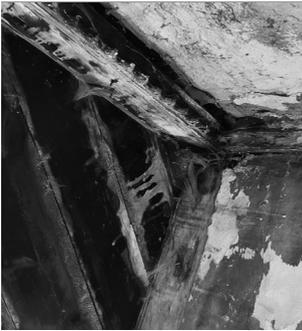
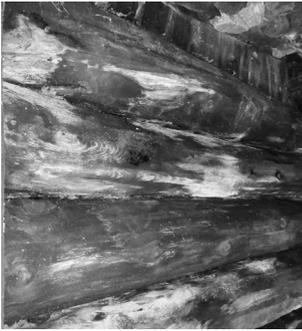
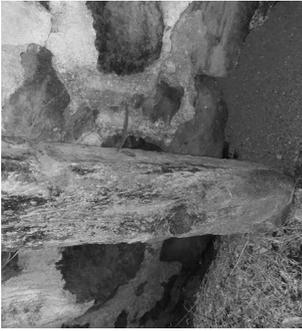
Moderate-severe Fungi attack (white rot); Mold/mildew; Mild insect attack;	Partial longitudinal fractures; Water leakage; Alteration (dust and smoke deposition); Weathering;	Stains;	20x24 cm
Moderate/severe Fungi attack (white rot); Mold/mildew; Mild insect attack;	Moderate-severe fungi attack (soft rot); Mild insect attack;	Moderate-Severe Insect attack (Galleries, exit holes);	Biological decay	Mechanical failure; Other	Defects	Av. Dimensions of timb. element
Partial longitudinal fractures; Water leakage; Alteration (dust and smoke deposition); Weathering;	Minor longitudinal fractures; Alteration (smoke deposition);	Alteration (Dust deposition); Weathering; Damp base;	Biological decay	Mechanical failure; Other	Defects	Av. Dimensions of timb. element
Stains;	Stains; knots;	Stains; knots; Partial fractures due to nails/spikes;	Biological decay	Mechanical failure; Other	Defects	Av. Dimensions of timb. element

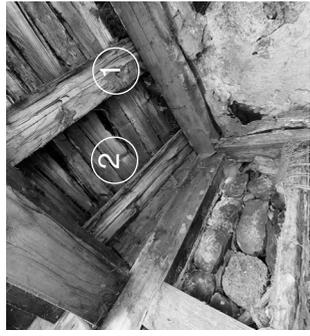
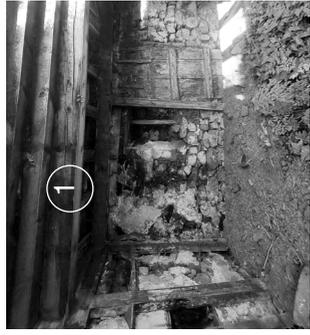
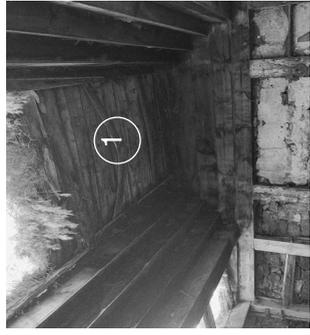
<p>Moderate/severe fungi attack (soft rot); Mild/mildew;</p> <p>Natural weathering; Alteration (Dust deposition);</p> <p>Knots; Stains; Longitudinal fractures;</p> <p>1. 20-24 cm; 2. 4x18 cm</p>	<p>Mold/mildew; Moderate Insect attack;</p> <p>Natural weathering; Alteration (Dust deposition);</p> <p>Longitudinal fractures; Knots; stains;</p> <p>16x20 cm</p>	<p>Mild- moderate Fungi attack; (soft rot); Mild -moderate insect attack;</p> <p>Lacuna in the roof; Sagging soil; Longitudinal fractures of wooden beams and planks;</p> <p>Knots; fractures; rupture of elements;</p> <p>3x16 cm</p>
<b>Image N</b>	<b>Biological decay</b>	<b>Mechanical failure; Other</b>	<b>Defects</b>	<b>Av. Dimensions of timb. element</b>

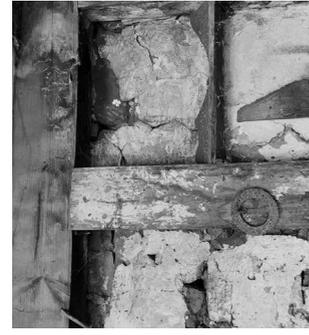
<p>Mold/mildew; mild-moderate Insect attack;</p>	<p>Paint decay; Minor longitudinal fractures; Weathering;</p>	<p>Knots; Partial fractures due to nails/spikes;</p>	<p>16-20cm</p>	<b>Image N</b>
<b>Biological decay</b>	<b>Mechanical failure; Other</b>	<b>Defects</b>	<b>Av. Dimensions of timb. element</b>

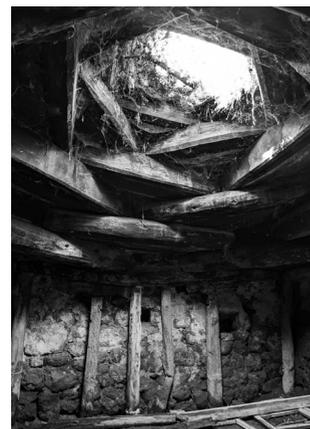
Fig. 64/ Datashvili dwelling (Darbazi hall).

Habitat is assembled by two primary spatial units – the main hall with *Gvirgvini* roofing and the Akhori room for cattle. We enter the dwelling from the south-eastern side through a short hallway, descending halfway underground, we encounter a myriad of columns and mixed wooden roofing structures assembled with wooden logs and lumber. The geometrical difference within the wooden framework, more

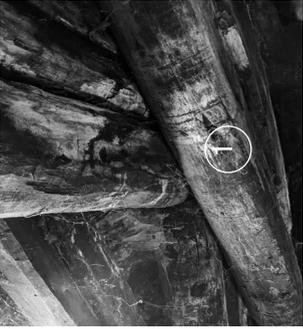
Mediocre fungi attack (white rot); Mild-mediocre insect attack; Mold/mildew;	Sagging soil on roof top levels; Transversal fractures of several elements; Alteration (Dust and smoke deposition);	Knots; Stains; Minor longitudinal fractures;	30-32 cm

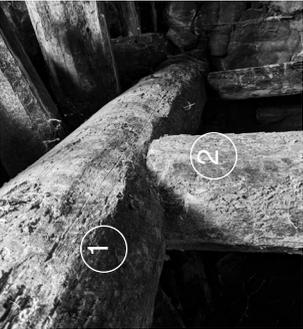
Severe Insect Attack (Galleries, exit holes; dust excrements); Mold/mildew;	Weathering; Alteration (Dust and smoke deposition);	Knots; stains;	1. 34-38 cm 2. 28-32 cm

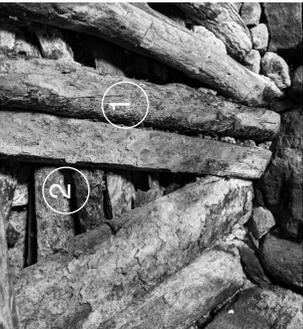
Moderate fungi attack (white rot); Severe Insect attack (Galleries, exit holes & dust excrements);	Deflecting elements; Alteration (Dust and smoke deposition); Weathering;	Stains; Multiple knots; Longitudinal fractures;	1. 10-14 cm 2. 6-8 cm

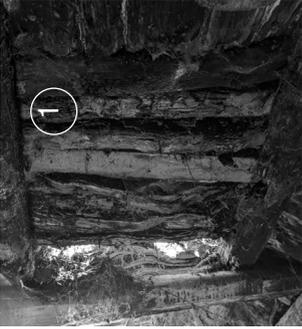
Severe fungi attack (soft rot); Insect attack (Galleries, exit holes & dust excrements);	Weathering; Alteration (Dust and smoke deposition); Fracture and Rupture of elements;	Knots; Stains;	4x20 cm

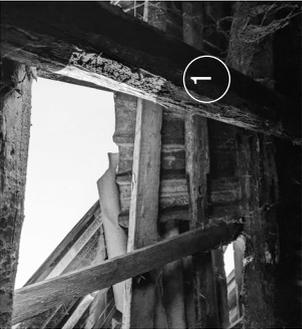
Mediocre fungi attack (soft rot); Severe Insect attack;	Minor longitudinal fractures; High moisture content; Lacuna in the roof;	Longitudinal fractures; Knots; stains;	28-32 cm

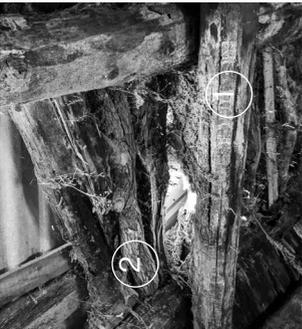
Moderate/severe fungi attack (soft rot); Mold/mildew;	Water leakage from defected roof; Fracture and rupture of elements; Alteration (Dust and smoke deposition);	Knots; Stains; Longitudinal fractures; Crookedness;	1. 28-32 cm; 2. 8-12 cm

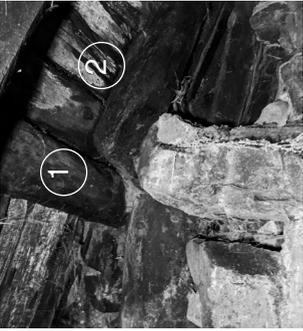
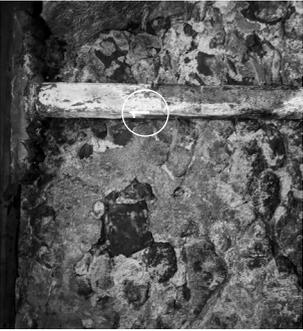
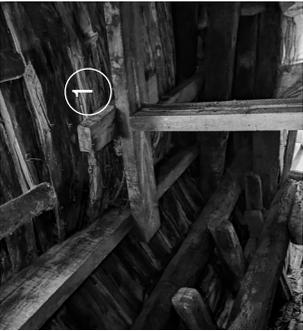
Mediocre-severe fungi attack (white rot);	Mediocre - severe insect attack; Mold/mildew;
<b>Biological decay</b>	<b>Biological decay</b>	<b>Biological decay</b>	High moisture content; Longitudinal fractures; Alteration (Dust/smoke deposition);	Weathering; Paint decay; Dust/smoke deposition;
<b>Mechanical failure; Other</b>	<b>Mechanical failure; Other</b>	<b>Mechanical failure; Other</b>	Knots; Stains;	Longitudinal fractures; Knots; stains;
<b>Defects</b>	<b>Defects</b>	<b>Defects</b>		
<b>Av. Dimensions of timb. element</b>	<b>Av. Dimensions of timb. element</b>	<b>Av. Dimensions of timb. element</b>	1. 24-28 cm 2. 14-16 cm	20-24 cm
				4x20 cm

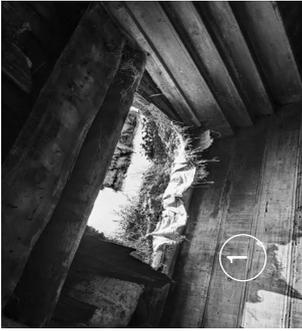
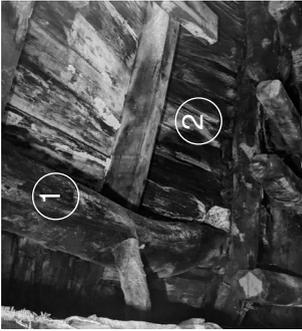
Mold/mildew; Moderate-severe insect attack;	Severe fungi attack (soft rot); Mild- moderate insect attack (exit holes);
<b>Biological decay</b>	<b>Biological decay</b>	<b>Biological decay</b>	Weathering; Sagging soil; Lacuna in rear wing; Alteration (Paint delamination)	Sagging of baulk boards and secondary beams; Weathering; Alteration (dust and smoke deposition);
<b>Mechanical failure; Other</b>	<b>Mechanical failure; Other</b>	<b>Mechanical failure; Other</b>	ractures due to nails/spikes;	Longitudinal fractures; Deflection;
<b>Defects</b>	<b>Defects</b>	<b>Defects</b>		
<b>Av. Dimensions of timb. element</b>	<b>Av. Dimensions of timb. element</b>	<b>Av. Dimensions of timb. element</b>	18x22 cm	1. 28-32 cm; 2. 4x24 cm
				1. 30-34 cm; 2. 4x24 cm

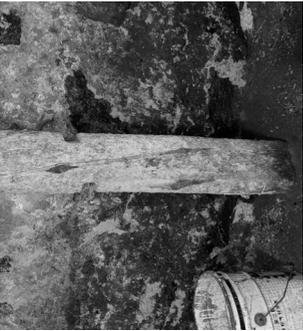
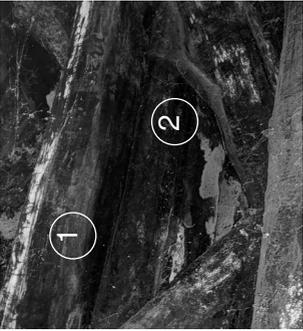
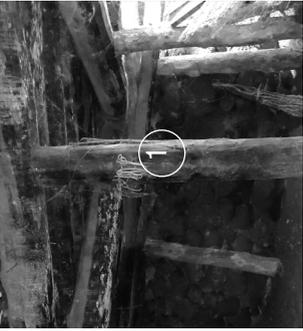
Severe insect attack (Galleries, exit holes & dust excrements);	Moderate fungi attack (white rot); Mold; Mild /moderate Insect attack (exit holes);	Weathering; Dust/smoke deposition; damp base;	20x24 cm
			Moderate fungi attack (white rot); Mold; Mild /moderate Insect attack (exit holes);	Weathering; Dust/smoke deposition;	Longitudinal fractures;	1. 30-34 cm 2. 4x24cm
			Moderate fungi attack (white rot); Mold; Mild /moderate Insect attack (exit holes);	Lacuna in the rear wing; Buckling and rupture of pillars;	Longitudinal fractures; Knots;	28-32 cm

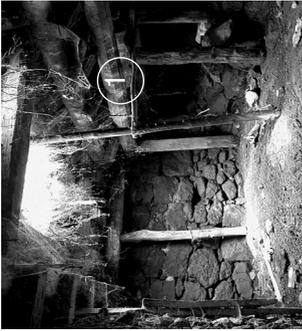
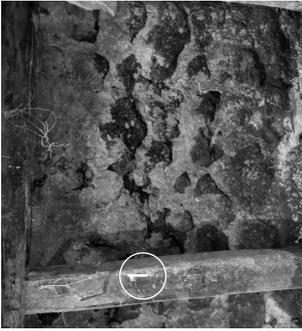
Severe fungi attack (white rot); Mold/mildew; Moderate insect attack (exit holes);	Weathering; Dust/smoke deposition;	Longitudinal fractures;	1. 30-32 cm; 2. 4x24 cm
				Mild fungi attack (white rot); Mild /moderate Insect attack (exit holes);	Lacuna in the frontal and central part; Sagging soil; Dust/smoke deposition;	Longitudinal fractures;	30-32 cm;
				Moderate Insect attack (galleries; exit holes);	Weathering; Dust/smoke deposition; Damp base;	ractures due to nails/spikes;	22-24 cm

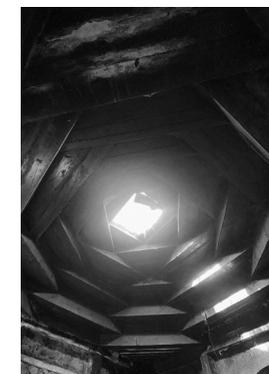
Fig. 75/ Aspanidze dwelling. View on main Gvirgvini crown

From a structural point of view, the overall integrity of the dwelling complex is compromised, but separately the remaining frameworks of some chambers meet the basic requirements. The space we encounter first, which supposedly used to be the main entrance, currently lays in masonry ruins. (Fig. 75) Otherwise, the main hall, in contrast to the adjacent Takarebiani *Oda* chamber, remains mostly intact considering the wooden framework, but lacks thermal integrity due to partially collapsed stone masonry walls and cover within tandoor section.

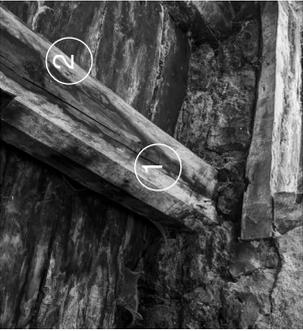
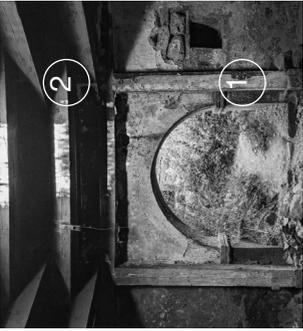
Moderate fungi attack (white rot); Mold; Mild/moderate insect attack (exit holes);	Weathering; Dust/smoke deposition;	Longitudinal fractures;	1. 20x24 cm 2. 20x20 cm
			Mold; Mild Insect attack (exit holes);	Weathering; Dust/smoke deposition;	Longitudinal fractures;	1. 20x20 cm 2. 20x24 cm
			Moderate/severe fungi attack (white rot, soft rot); Mold; Mild Insect attack (exit holes);	Weathering; Dust/smoke deposition; Sagging elements;	Knots; Longitudinal fractures;	1. 30-34 cm 2. 4x24cm

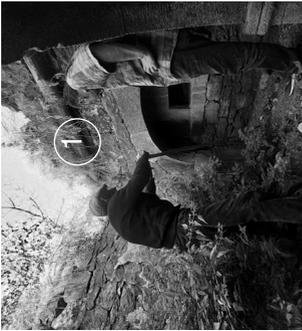
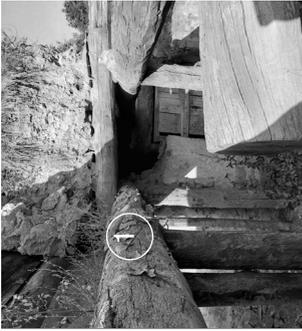
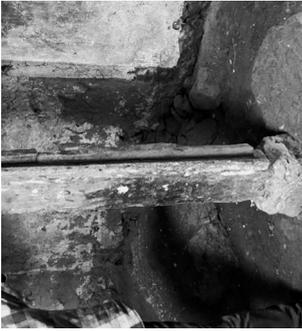
Mild Insect attack (exit holes);	Absence of the roof; Sagging soil; Dust/smoke deposition;	Knots; longitudinal fractures;	24-30 cm
			Mold; Mild Insect attack (exit holes);	Weathering; Dust/smoke deposition;	Knots; fractures due to nails/spikes;	20x24 cm
			Severe Insect attack (galleries; exit holes);	Lacuna in the roof; sagging soil; Weathering;	Knots; longitudinal fractures;	28-34 cm

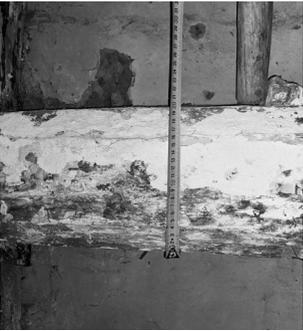
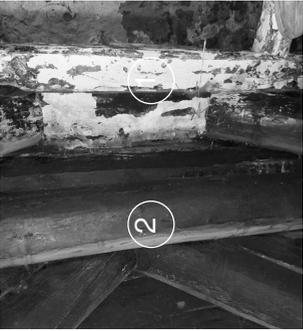
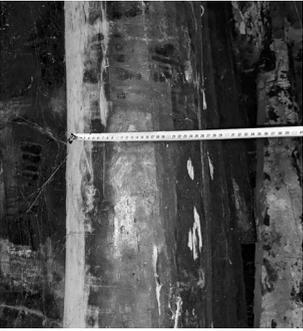
Image N	Image N	Image N	Biological decay	Mechanical failure; Other	Defects	Av. Dimensions of timb. element

Mild fungi attack (white rot); Mold; Mild/moderate Insect attack (exit holes);	Weathering; Paint decay; Dust/ smoke deposition;	Knots; fractures due to nails/ spikes;	20 cm
	Mild Insect attack (exit holes); Mold;	Mild Insect attack (exit holes);	Weathering; Paint decay; Dust/ smoke deposition;	Knots;	1. 30-34 cm 2. 22x24cm	
	Mild Insect attack (exit holes);		Weathering; Dust/smoke deposition;		34 cm

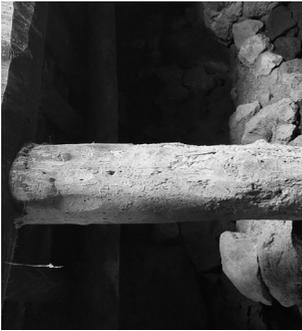
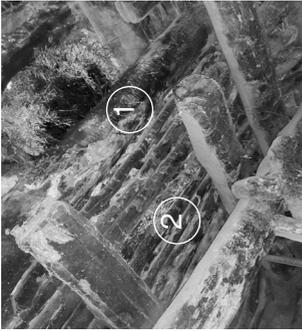
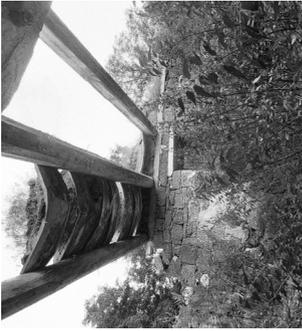
Image N	Image N	Image N	Biological decay	Mechanical failure; Other	Defects	Av. Dimensions of timb. element

Severe Insect attack (galleries, exit holes);	Weathering; Rupture of elements;	Knots; fractures due to nails/ spikes;	28-32 cm
	Severe Insect attack (galleries, exit holes & dust excrements);	Severe Insect attack (galleries, exit holes & dust excrements);	Weathering; Lacuna in roof; Dust/ smoke deposition		1. 28-30 cm; 2. 4-8 cm	
			Absence of roofing elements; Sagging soil;			
			Beam deflection; Transversal fractures; Rupture;

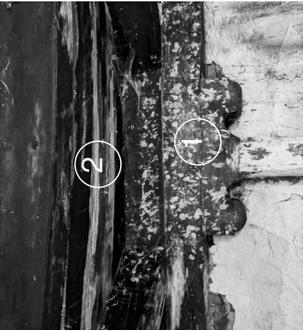
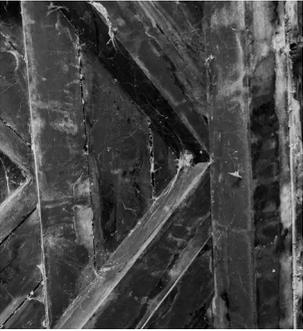
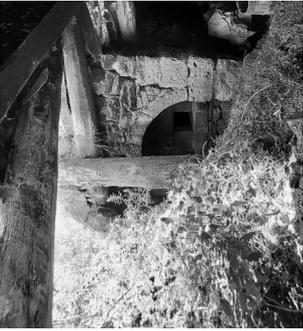
Image N	Image N	Image N	Biological decay	Mechanical failure; Other	Defects	Av. Dimensions of timb. element

Moderate/severe fungi attack (white rot); Mold; Moderate/severe Insect attack;	Weathering; Dust/smoke deposition;	Multiple fractures due to nails/spikes;	1. 20x18 cm; 2. 20x24 cm
			Moderate Fungi attack (white rot); Mold; Moderate/severe Insect attack;	Weathering; Dust/smoke deposition;		18-22 cm
			Moderate/severe fungi attack (white rot); Mild Insect attack (exit holes);	Weathering; Dust/smoke deposition;		
				Sagging soil and Water leakage from defected roof; lacuna in rear wing

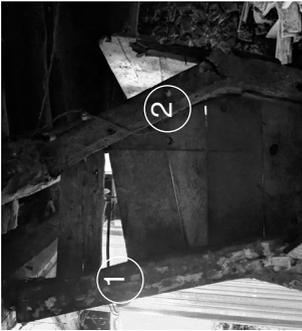
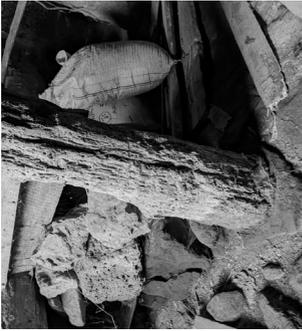
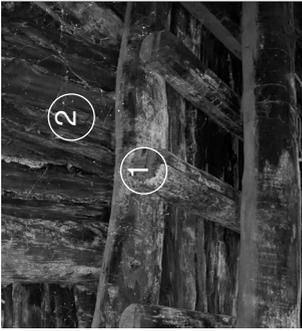
Image N	Image N	Image N	Biological decay	Mechanical failure; Other	Defects	Av. Dimensions of timb. element

Moderate fungi attack (white rot); Mild Insect attack (exit holes);	Weathering; Rupture of elements;	fractures due to nails/spikes;	1. 20x22 cm; 2. 20x20 cm
			Severe Insect attack (galleries, exit holes & dust excrements);	Damp base; Weathering; Buckling;	Knots;	24-28 cm
			Moderate/severe fungi attack (white rot); Mold; Mild/moderate Insect attack (exit holes);	beam deflection; Weathering; Dust/smoke deposition; Sagging soil;	Knots; Crookedness;	1. 28-30 cm; 2. 4x20 cm

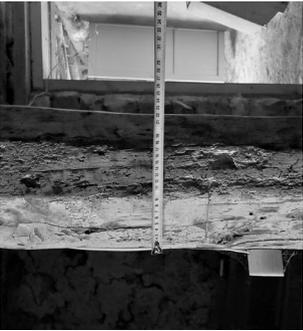
Image N	Biological decay	Mechanical failure; Other	Defects	Av. Dimensions of timb. element

Severe Insect attack; (Galleries, exit holes);	Weathering; Dust/smoke deposition;	Knots; Partial fractures due to nails/spikes;	22 cm

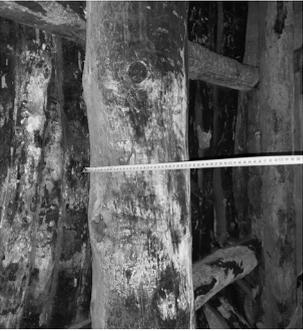
Mild Fungi attack (white rot); Mold; Mild Insect attack (exit holes);	Weathering; Dust/smoke deposition;	Knots;	28-30 cm

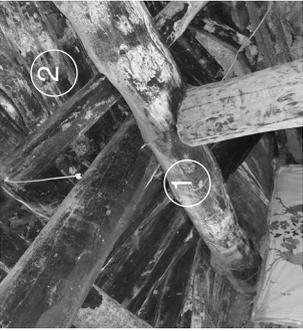
Moderate/severe Fungal attack (white rot); Moderate-severe Insect attack (Galleries, exit holes);	Weathering; Dust/smoke deposition;	Knots; Crookedness;	1. 28-34 cm; 2. 24-28 cm

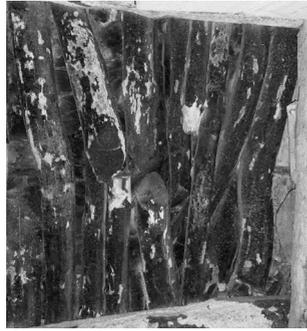
Severe Fungal attack (white rot); Moderate-severe Insect attack;	Multiple fractures; Transversal rupture of multiple roof elements; Cracking; Sagging soil and Water leakage from defected roof; lacuna in Eastern wing	Knots; Crookedness;	16-20cm

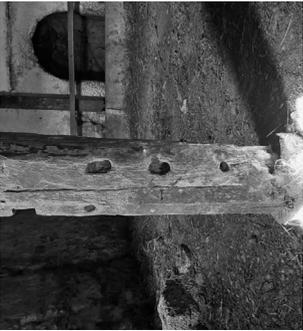
Image N	Biological decay	Mechanical failure; Other	Defects	Av. Dimensions of timb. element

Mild fungi attack (white rot); Mold; Moderate/severe Insect attack; (exit holes);	Transversal fractures ; total rupture; Dust/smoke deposition;	Crookedness; Knots; Partial fractures due to nails/spikes;	24-28 cm

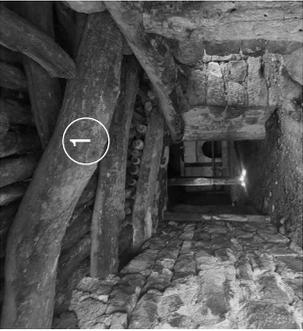
Severe Insect attack (Galleries, exit holes & dust excrements);	Longitudinal fractures; Cracking;	Crookedness; Knots; Partial fractures due to nails/spikes;	28-36 cm

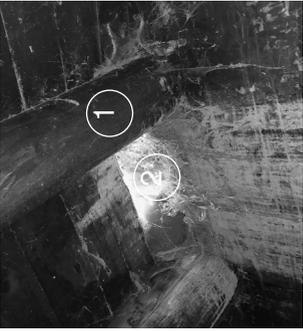
Mild Fungal attack (soft rot); Moderate-severe Insect attack;	Dust/smoke and guano deposition;	Knots;	1. 30-32 cm; 2. 4x24cm;

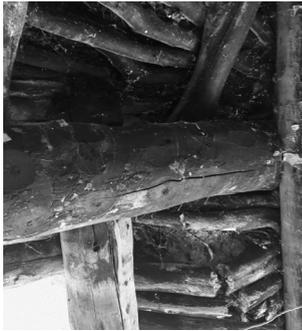
Image N	Biological decay	Mechanical failure; Other	Defects	Av. Dimensions of timb. element

Mild fungi attack (white rot); Mold; Moderate/severe Insect attack; (exit holes);	Transversal fractures ; total rupture; Dust/smoke deposition;	Crookedness; Knots;	6-10 cm

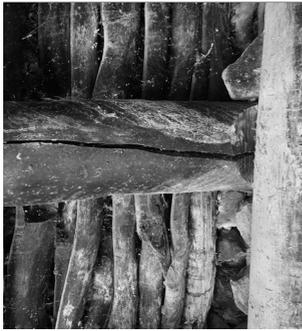
Mold; Moderate/severe Insect attack (exit holes);	Longitudinal fractures; Cracking; Dust/smoke deposition;		32-36 cm

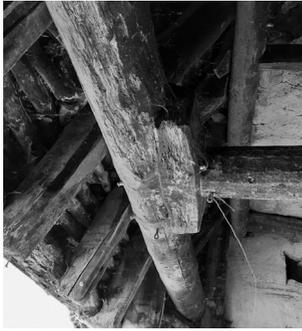
Mild Fungal attack (soft rot); Moderate-severe Insect attack;	Multiple fractures; Cracking; Dust/smoke deposition;	Knots; Partial fractures due to nails/spikes; Traces of removed decorations;	30-32 cm

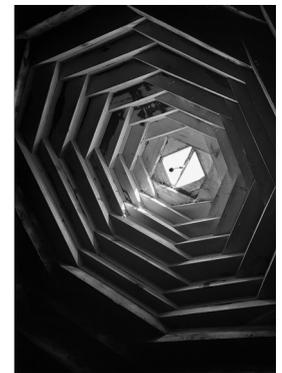
Fig. 92/ Darbazi hall, view on Gvirgvini structure

We can start the journey through the Maisuradze dwelling through the North-East facet, walking past the hallway and living room with historic fireplace (Fig. 91), we are presented with a central part of the dwelling – *Darbazi* hall with multilayered *Gvirgvini* ceiling (Fig. 92), the upper half of

Another local case of maintenance was found in Ude village (case study N16) conducted by Maisuradze brothers, who restored the whole dwelling, including the intricate wooden ceiling system with their hands (Fig. 102). Despite the lack of details about wooden species and techniques used, this *Gvirgvini* seems like a fine representation of the local restoration abilities.

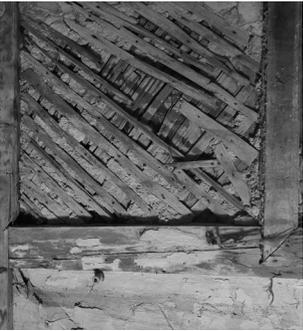
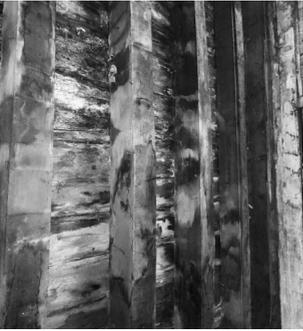
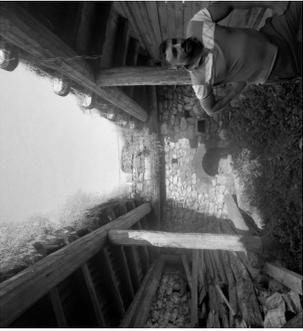
Image N	Image N	Image N	Biological decay	Mechanical failure; Other	Defects	Av. Dimensions of timb. element

White Mold;	Mild fungi attack (white rot); Mold/mildew; ild Insect attack;	lacuna in Central wing	
Fractures of woven fabric; Decay of mortar; Weathering;	Sagging of primary beams;				Stains; Knots;	20-24 cm
Stains;

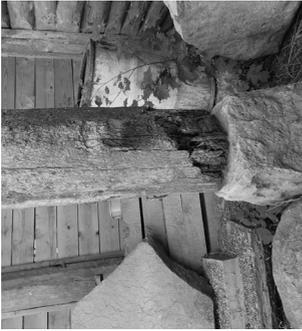
Image N	Image N	Image N	Biological decay	Mechanical failure; Other	Defects	Av. Dimensions of timb. element

Mild fungi attack; Mild – moderate Insect attack (Galleries, exit holes;);	White Mold; (Galleries, exit holes);	Weathering; Transversal fractures; Rupture of some elements;	
Weathering; Longitudinal fractures;					Knots;	1. 18-22cm; 2. 12-15cm;
fractures due to nails/spikes;						
30-32cm

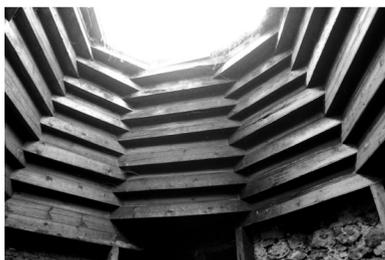
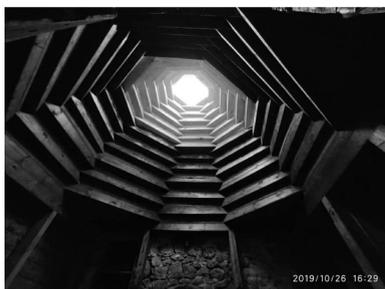
▼ Fig. 102/ Gvirgvini in Maisuradze dwelling, before and after restoration. Photos provided by Pavle Maisuradze

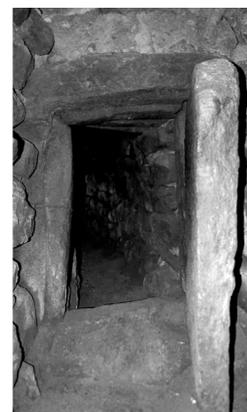
**Fig. 115/** **Darani** in Lebisi, Georgia. Source: <https://memkvudreoba.gov.ge/objects/immovable/immovableObject?id=16459>

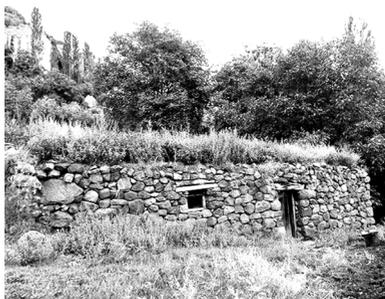
**Fig. 116/** Darbazi dwelling showing the top part of **Erdo**. Source: <https://kvirispalitra.ge/article/57941-erdogvirginiani-darbazuli-sakhlebi/>
