Thesis Report

Master of Architecture in Sustainability

Revitalisation of the Industrial Heritage

Transforming Historic Sites Honoring Historical Functions
with Sustainable Design Concepts for Adaptive Reuse.

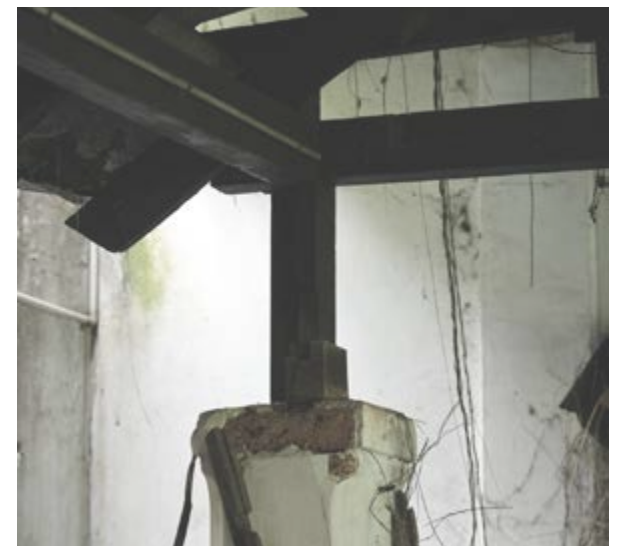
Figure 23: Image depicting the vernacular architecture details.
[Source Image: photographs taken by the author]

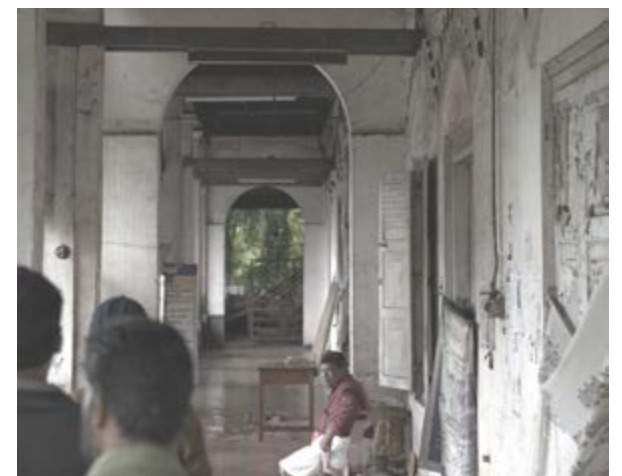
Figure 24: Image highlighting colonial-influenced architectural details.
[Source Image: photographs taken by the author]

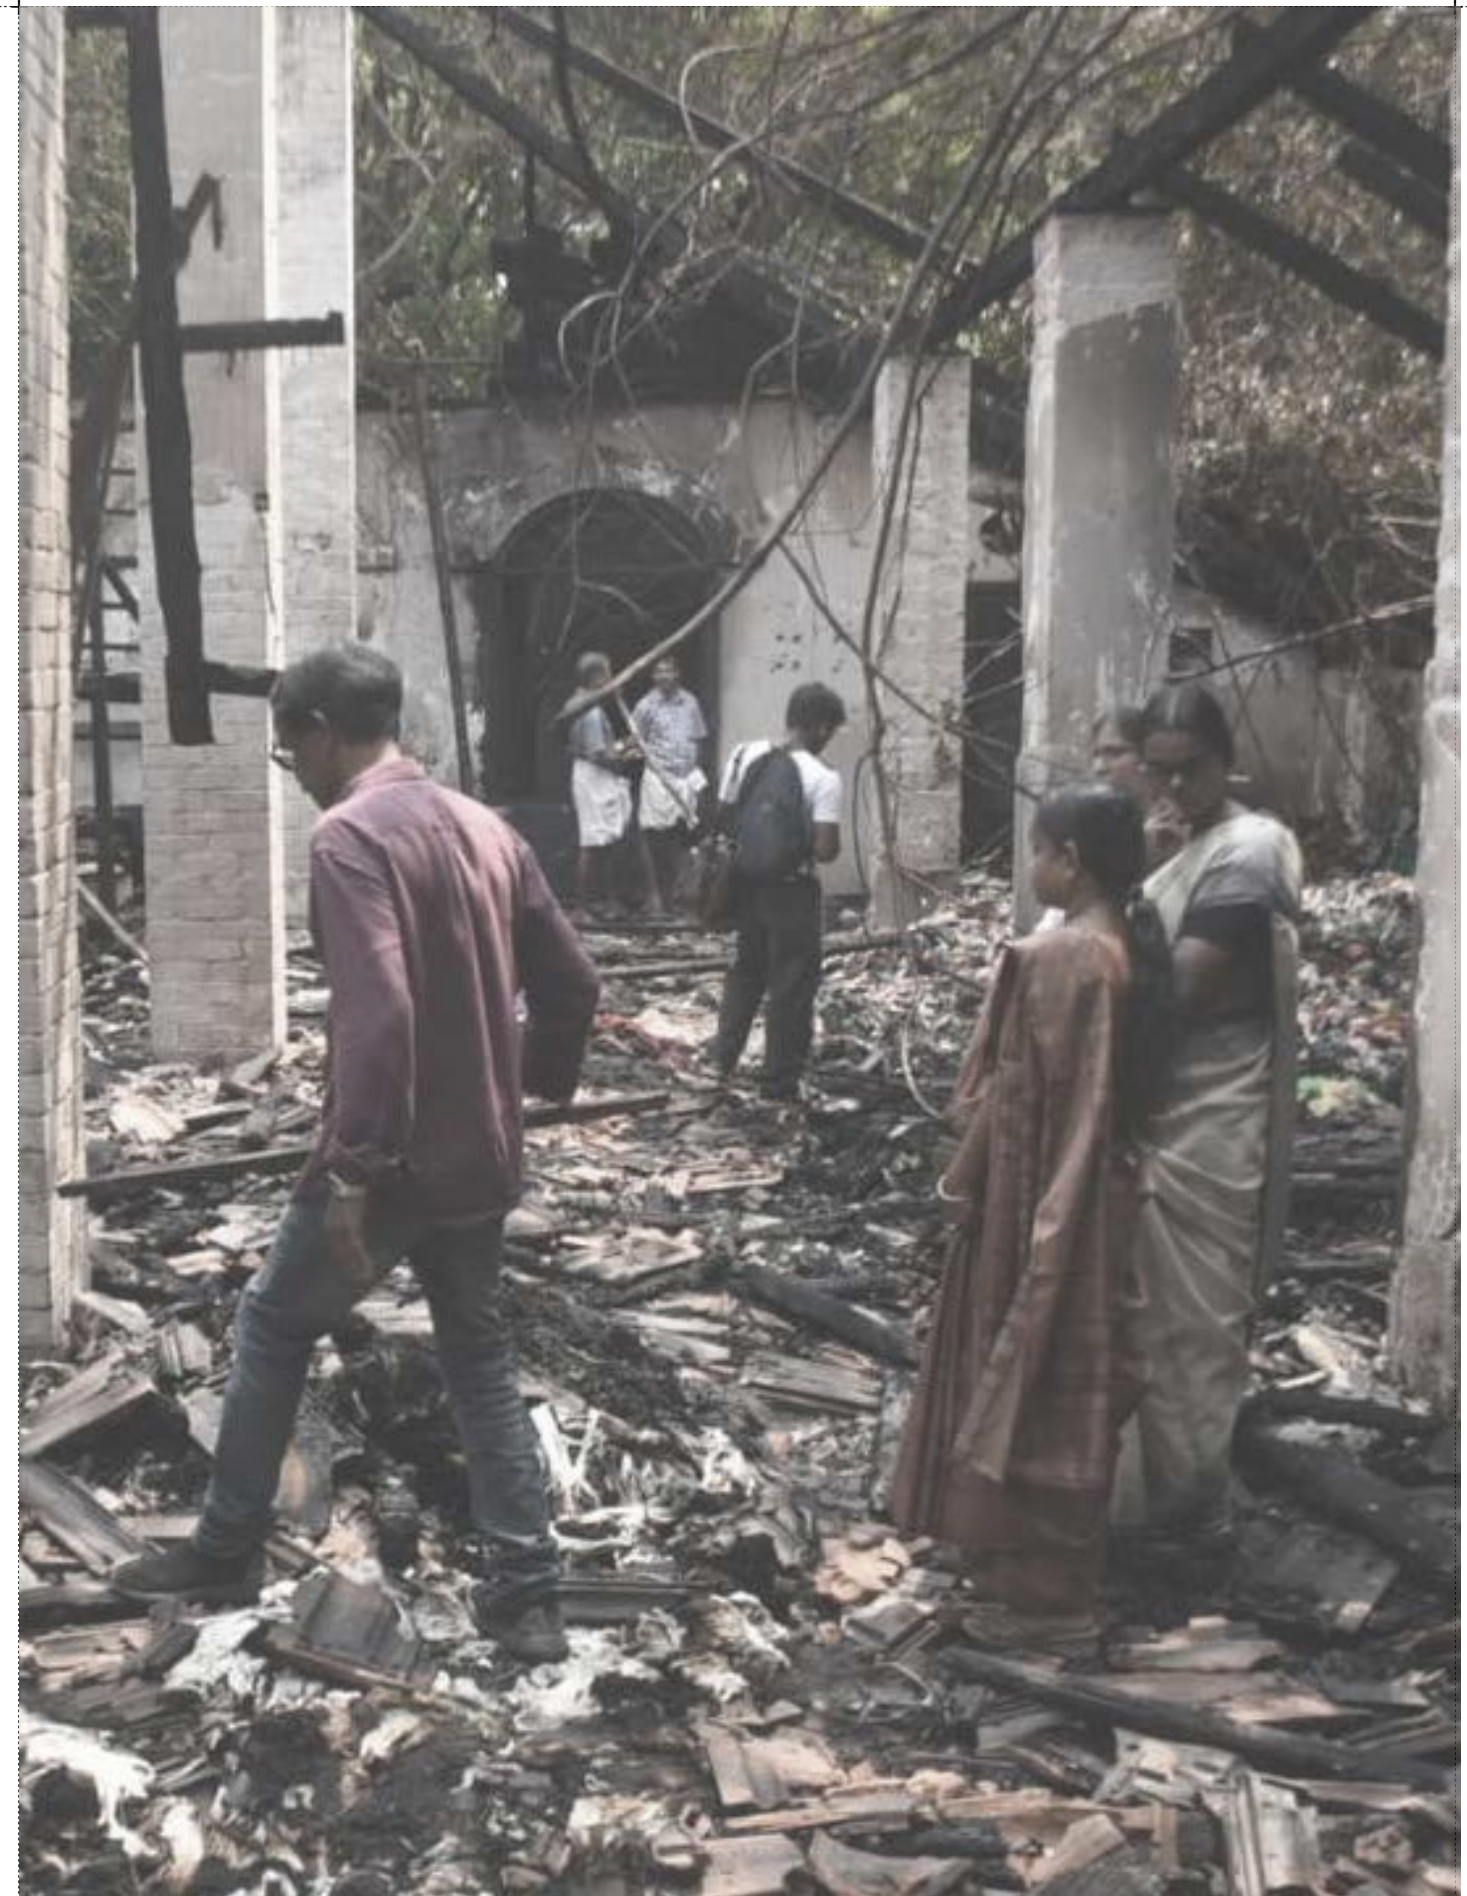
Figure 25: Image depicting the destruction caused by a fire outbreak.

On March 14, 2024, a significant fire broke out at the abandoned Comtrust Weaving Factory in Kozhikode. The fire began around 9 p.m., causing extensive damage, including the collapse of the roof. Firefighters extinguished the blaze by 11:30 p.m., but their efforts were initially delayed due to mud blocking the factory's main gate, which hindered vehicle access (The News Minute, 2020). As a precautionary measure, power to nearby buildings was cut off. The factory, which has been closed since 2009 because of financial difficulties, had become a site for anti-social activities such as drug use and theft (Upper Crust India, 2024).

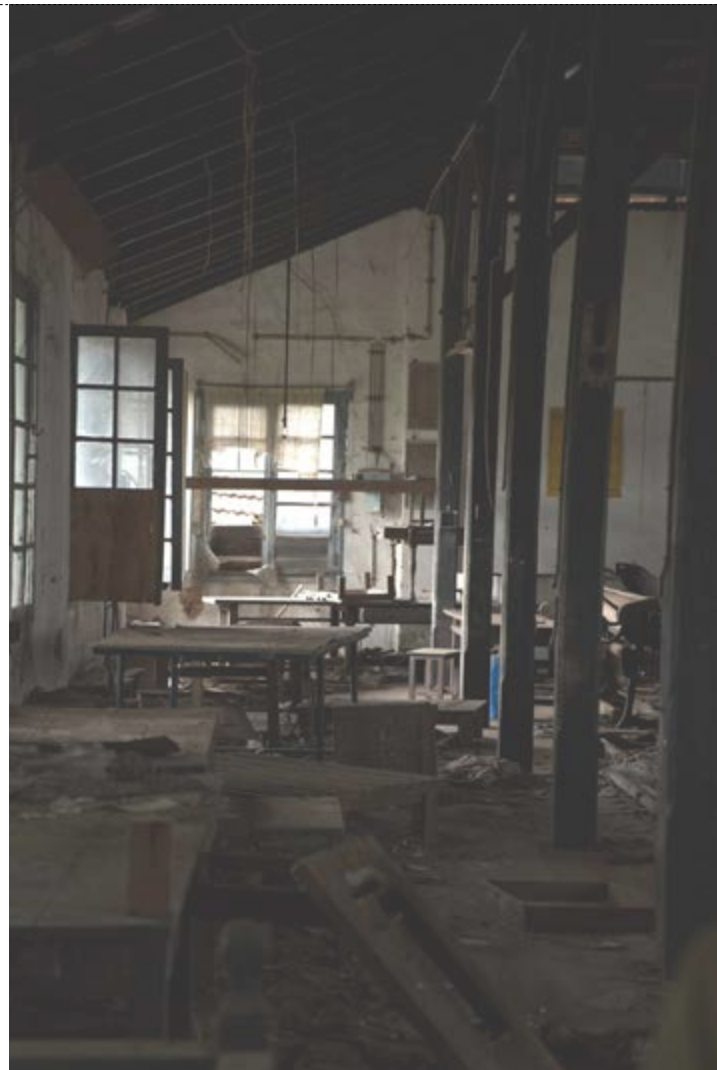
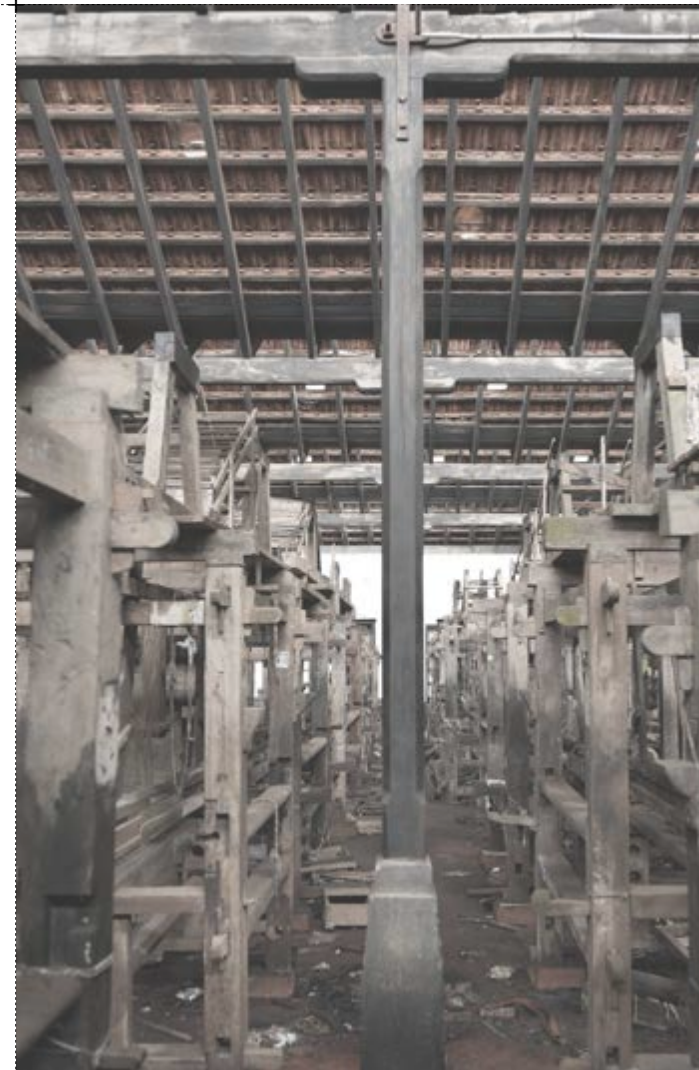
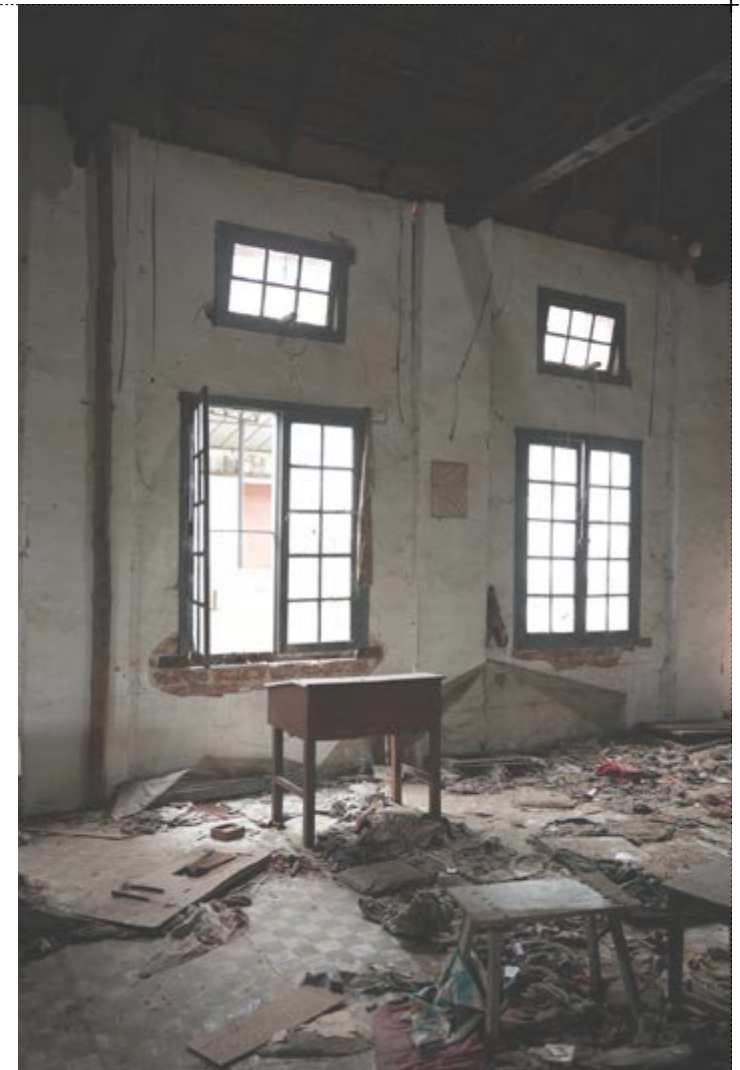
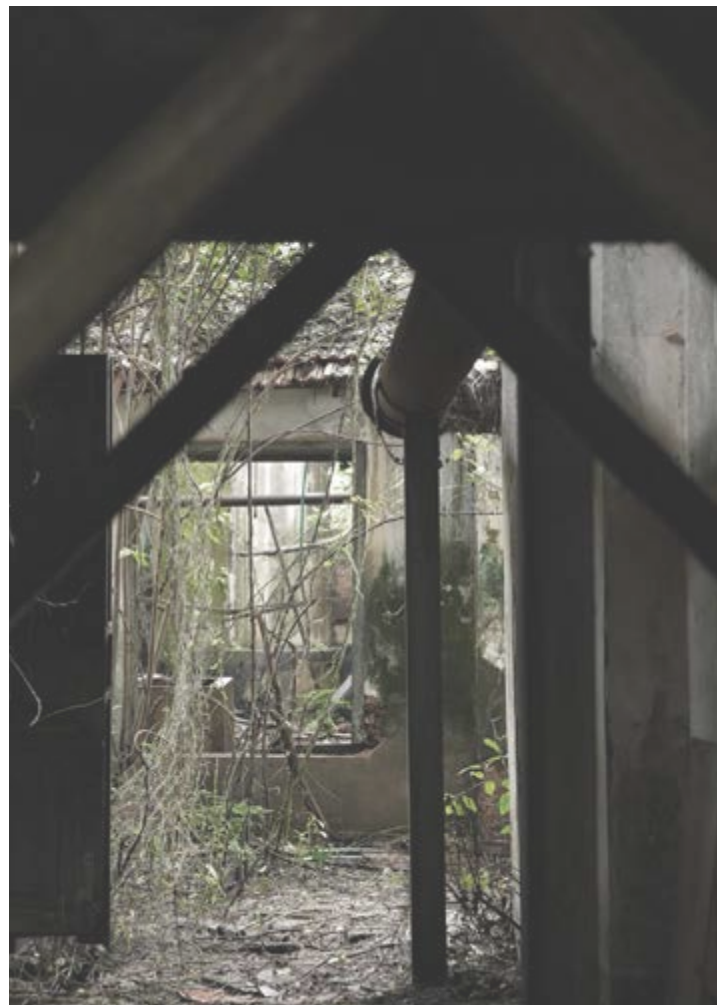
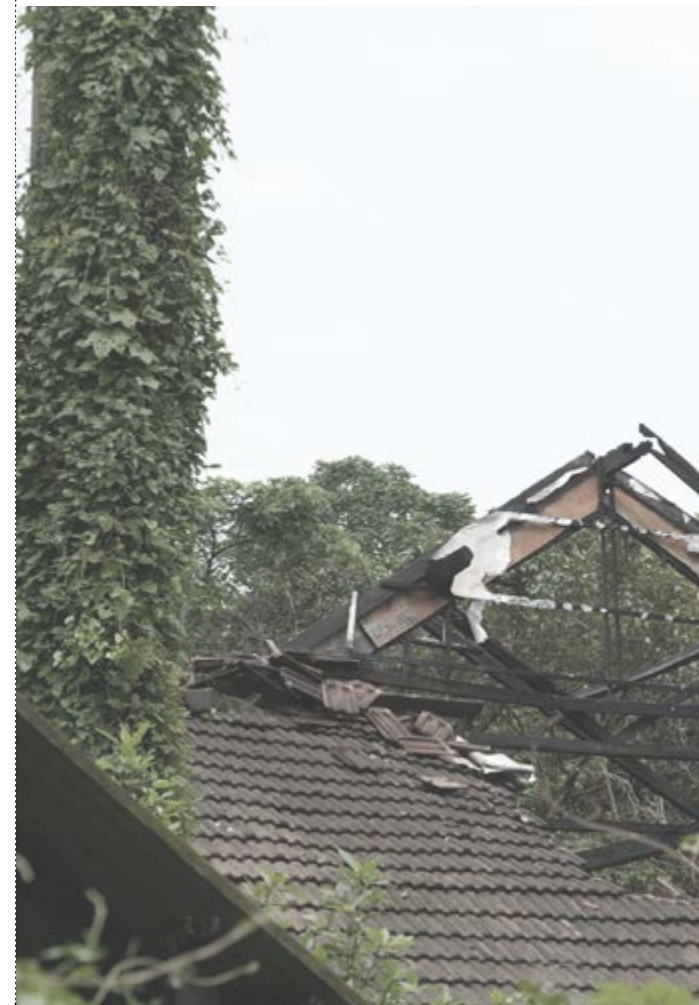
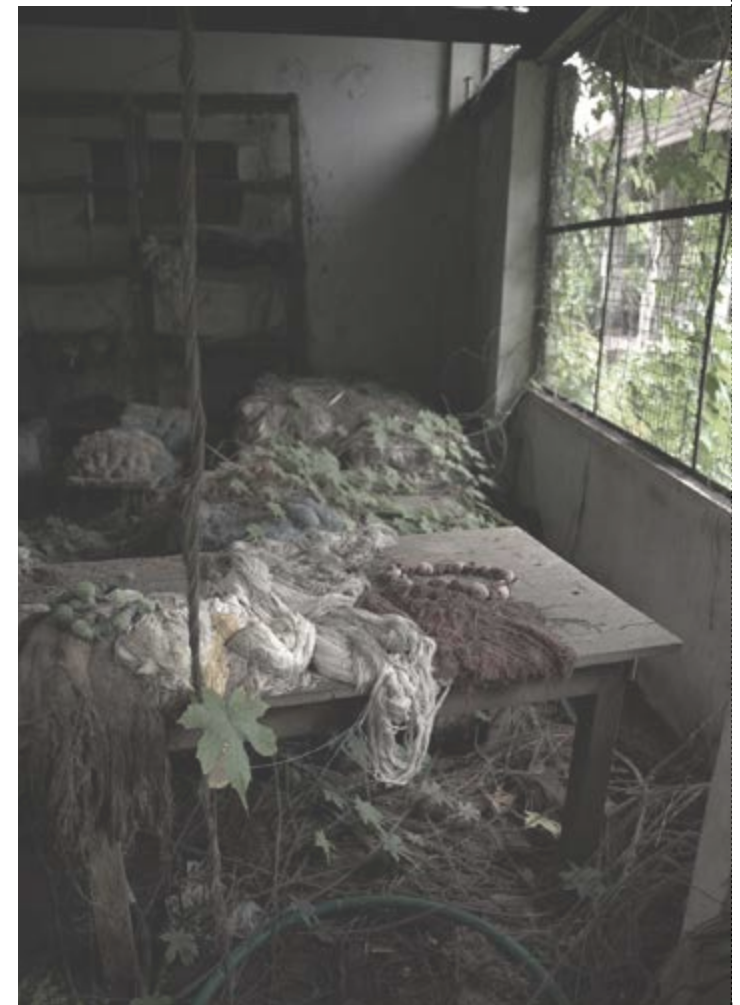
Figure 26: Image depicting the current condition of the comtrust mill.
[Source Image:photographs taken by the author]

Figure 27: Image depicting the current condition of the comtrust mill.
[Source Image:photographs taken by the author]

Figure 28: Image depicting the current condition of the comtrust mill.
[Source Image:photographs taken by the author]

Figure 29: Image depicting the current condition of the comtrust mill.
[Source Image:photographs taken by the author]

Figure 30: Image depicting the current condition of the comtrust mill.
[Source Image:photographs taken by the author]

Figure 31: Image depicting the current condition of the comtrust mill.
[Source Image:photographs taken by the author]

Comtrust Mill in Calicut, once an architectural and historical landmark, played a crucial role in shaping the local community by breaking caste barriers and offering hope and livelihood to many. Its social, material, and architectural significance made it a valuable asset to the region. However, the mill has fallen into neglect, with severe damage to its structure, parts completely destroyed, and valuable materials like wood and copper stolen over time. The abandoned site has also become a hub for illegal activities at night. Any efforts to restore or repurpose the mill now involve a conflict between three key groups: the Commonwealth Trust, which owns the high-value land and seeks to sell it for real estate development; the former factory workers, who have long demanded that the government take over and revive the factory; and the government itself, which has proposed turning the mill into a museum to create employment opportunities for the displaced workers.

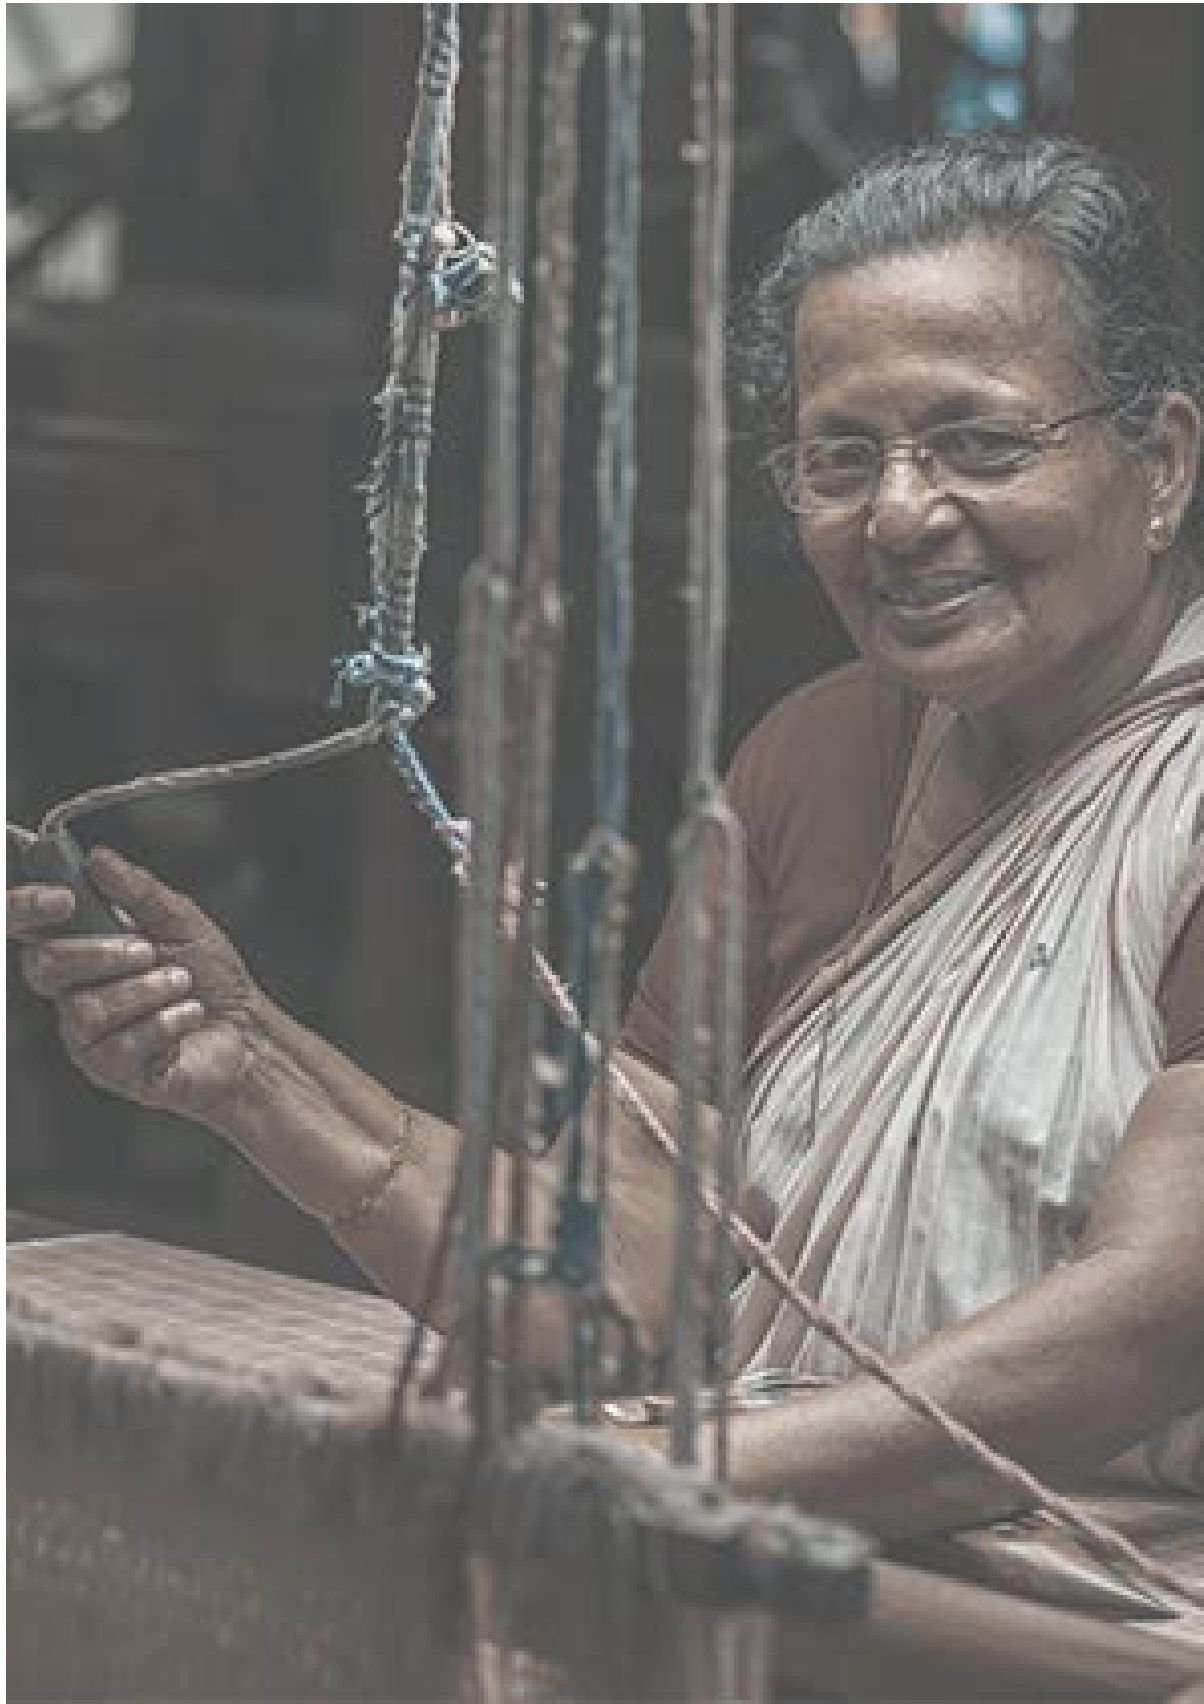
Figure 32: Image of a worker demonstrating the loom weaving method.
[Source Image:photographs taken from google]

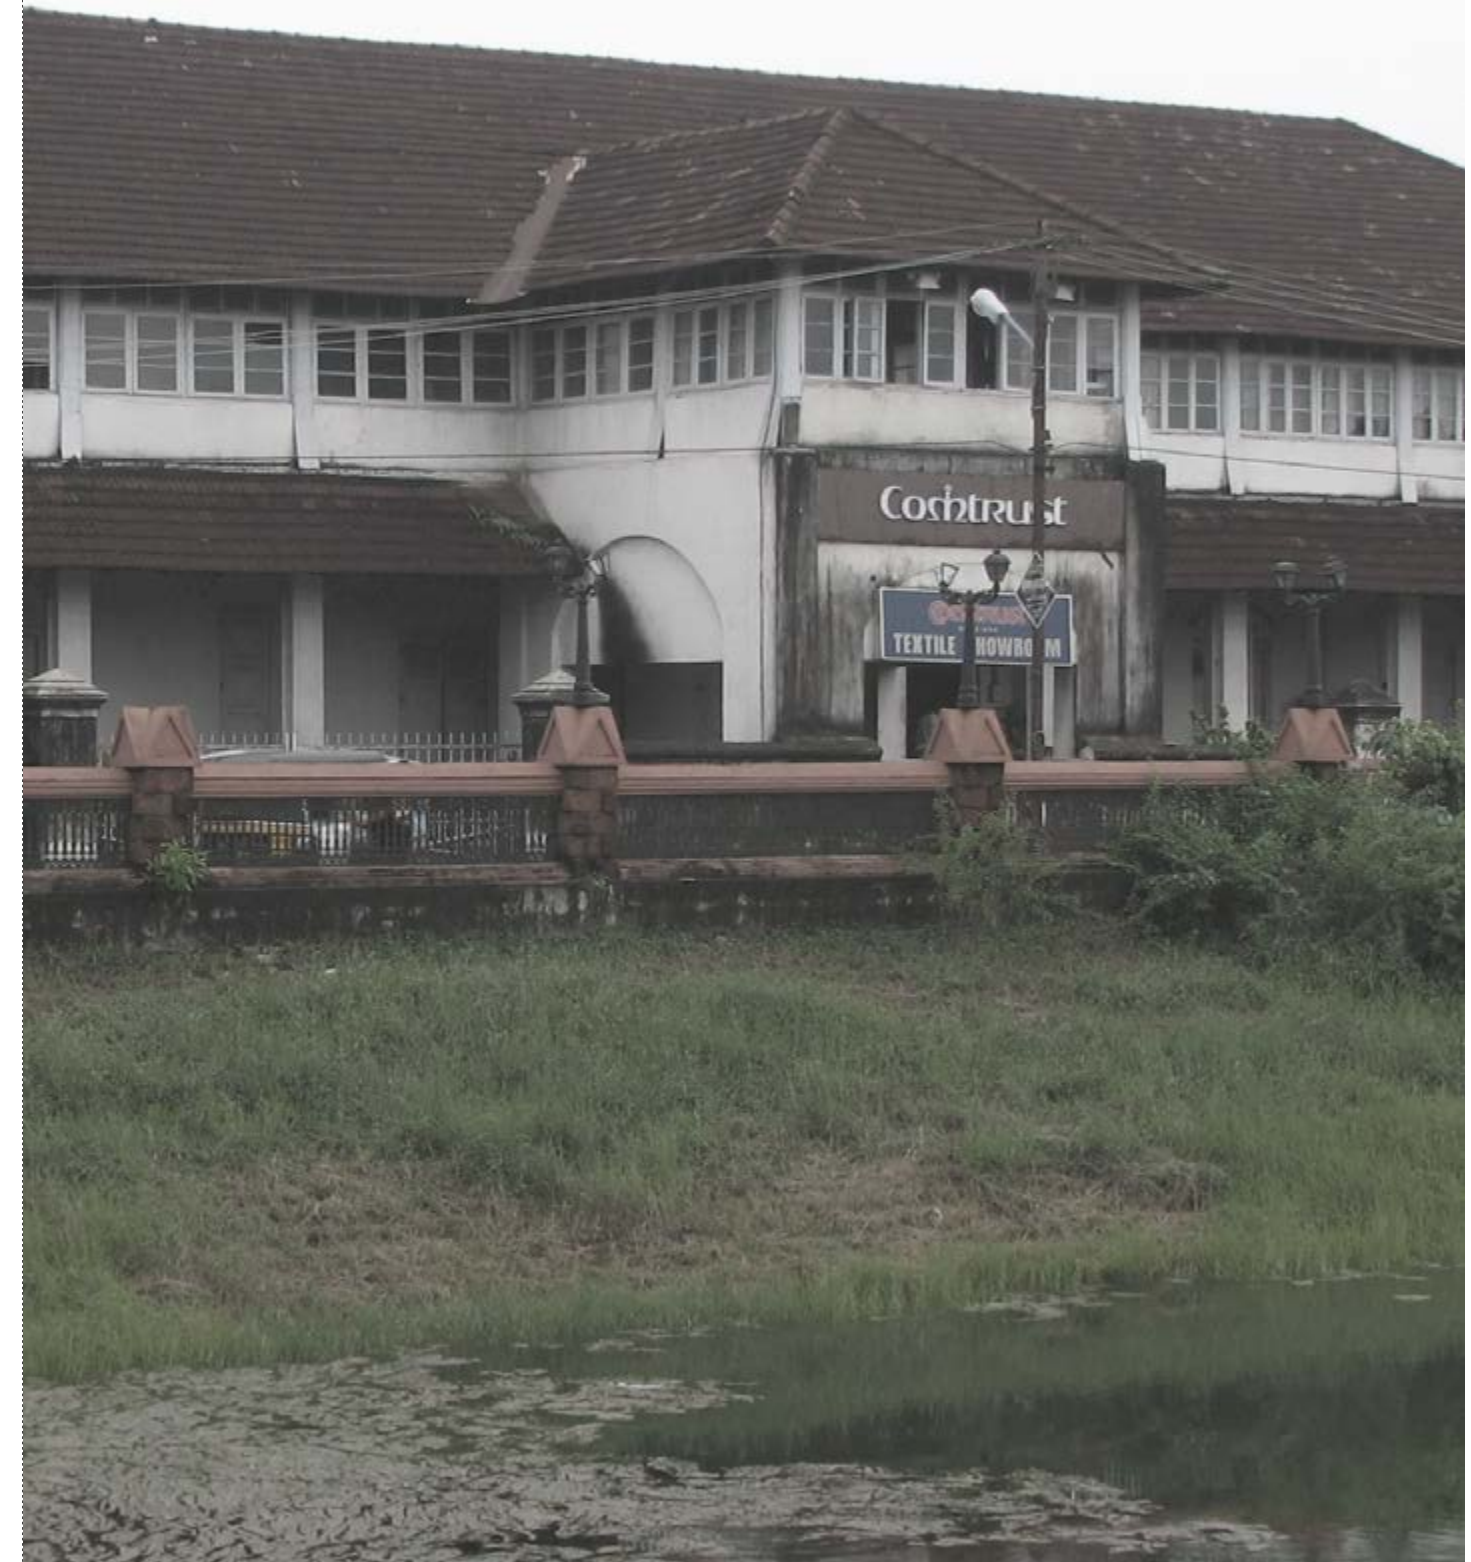
Figure 61: Front image of the Comtrust building
main block entrance
[Source: <http://kallivalli.blogspot.com/2013/01/?m=1>]

Once a thriving industrial facility, the mill's structure now stands largely abandoned since its closure in the late 20th century. Many of the original buildings, which date back to the late 1800s, exhibit wear and tear, with crumbling walls, broken windows, and overgrown vegetation.

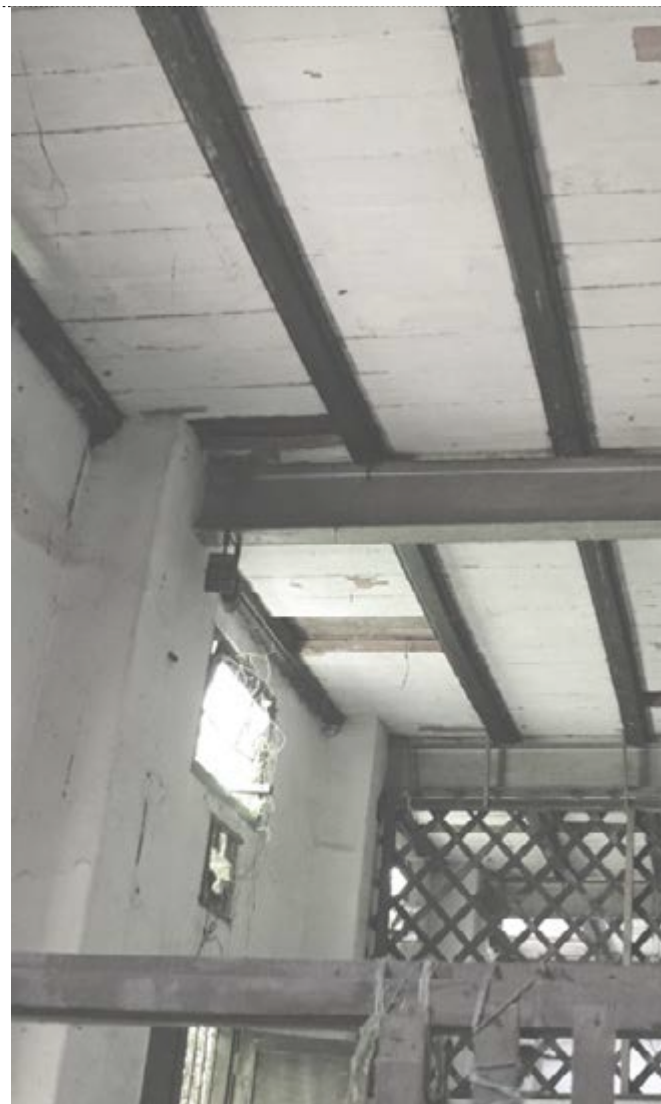
Figure 68: Ceiling constructed with Kurudi Blocks
[Source: Taken By Author]

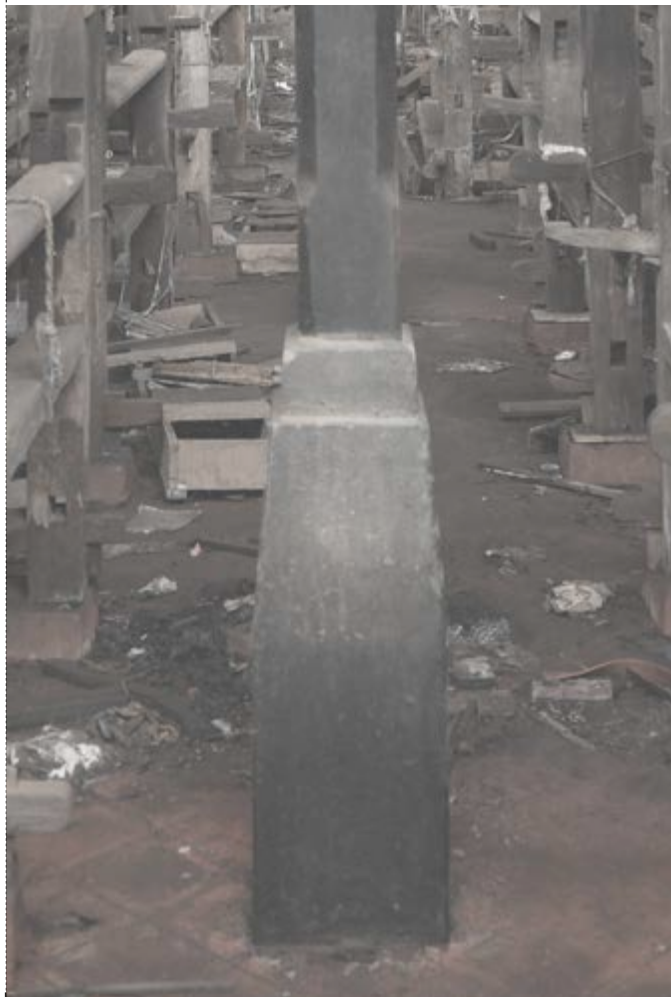
Figure 69: Natural stones are used for pillar base foundation
[Source: Taken By Author]

Stone is a vital material in the foundations and basement walls of the Comtrust Building, chosen for its durability and resistance to ground moisture. The use of locally sourced stone enhances the building's connection to the regional architectural language while providing a robust and stable foundation for the structure. Stone's natural resistance to water helps prevent moisture penetration into the masonry, ensuring long-term structural integrity. Additionally, the weight and strength of stone contribute to the overall stability of the building, supporting the brick masonry walls above. This use of stone underscores the building's commitment to both traditional craftsmanship and lasting functionality.

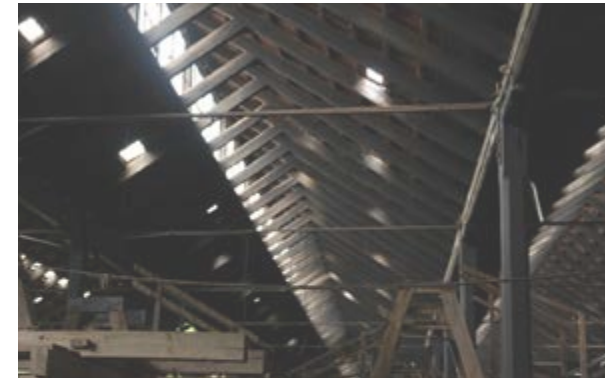
Figure 70: Colonial style roofing system used in the looming area
[Source: Taken By Author]

The factory buildings feature an industrial colonial style, with long, rectangular structures typical of the functional requirements of textile production facilities.

The architecture prioritizes large open spaces for machinery and processing, with high ceilings and wide spans supported by steel beams.

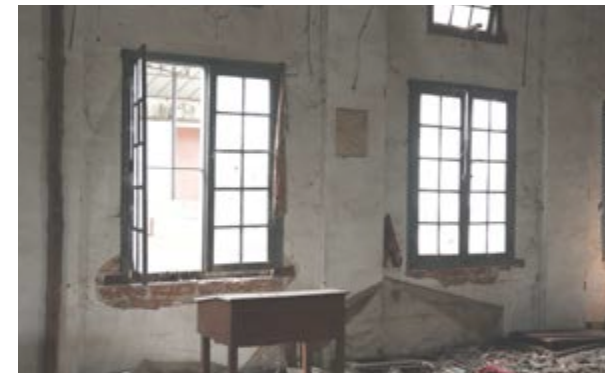
Figure 71: Brick and lime mortar is used for the basic wall construction
[Source: Taken By Author]

The use of red brick and lime mortar is characteristic of early 20th-century industrial buildings. This material choice provided durability, essential for factory environments. Exposed brickwork, a common feature in colonial industrial architecture, is visible in much of the original structure.

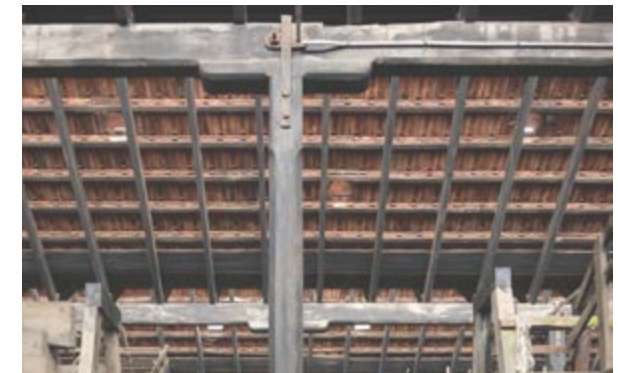
Figure 73: Wooden trusses are used for the whole roofing system
[Source: Taken By Author]

The factory's roofs are often pitched, supported by wooden trusses, and covered with tiles. This was a practical solution to deal with Kerala's heavy monsoon rains. The roof design also helps maintain a cooler internal environment, essential for maintaining the quality of textiles and comfort for workers.

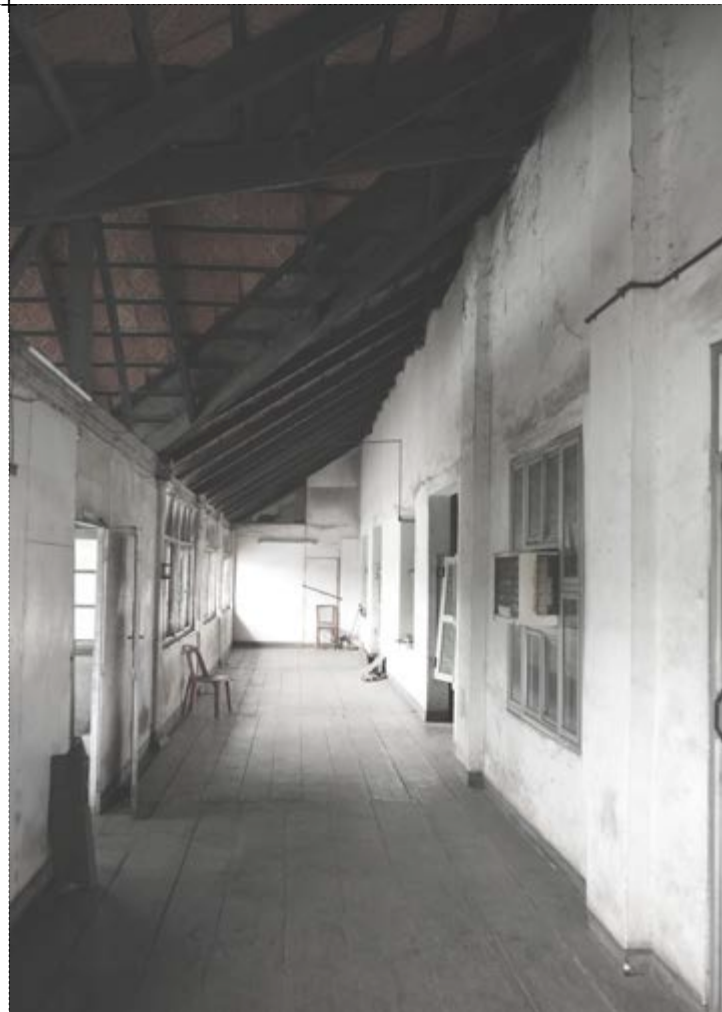
Figure 74: Image of a corridor in the Comtrust building office block
[Source: Taken By Author]

In addition to production units, the compound included administrative offices, designed with colonial-era elegance, featuring verandahs, colonnades, and high ceilings. The administrative buildings tend to have more detailed architectural elements compared to the utilitarian factory spaces, often incorporating colonial architectural flourishes such as ornamental arches and cornices.

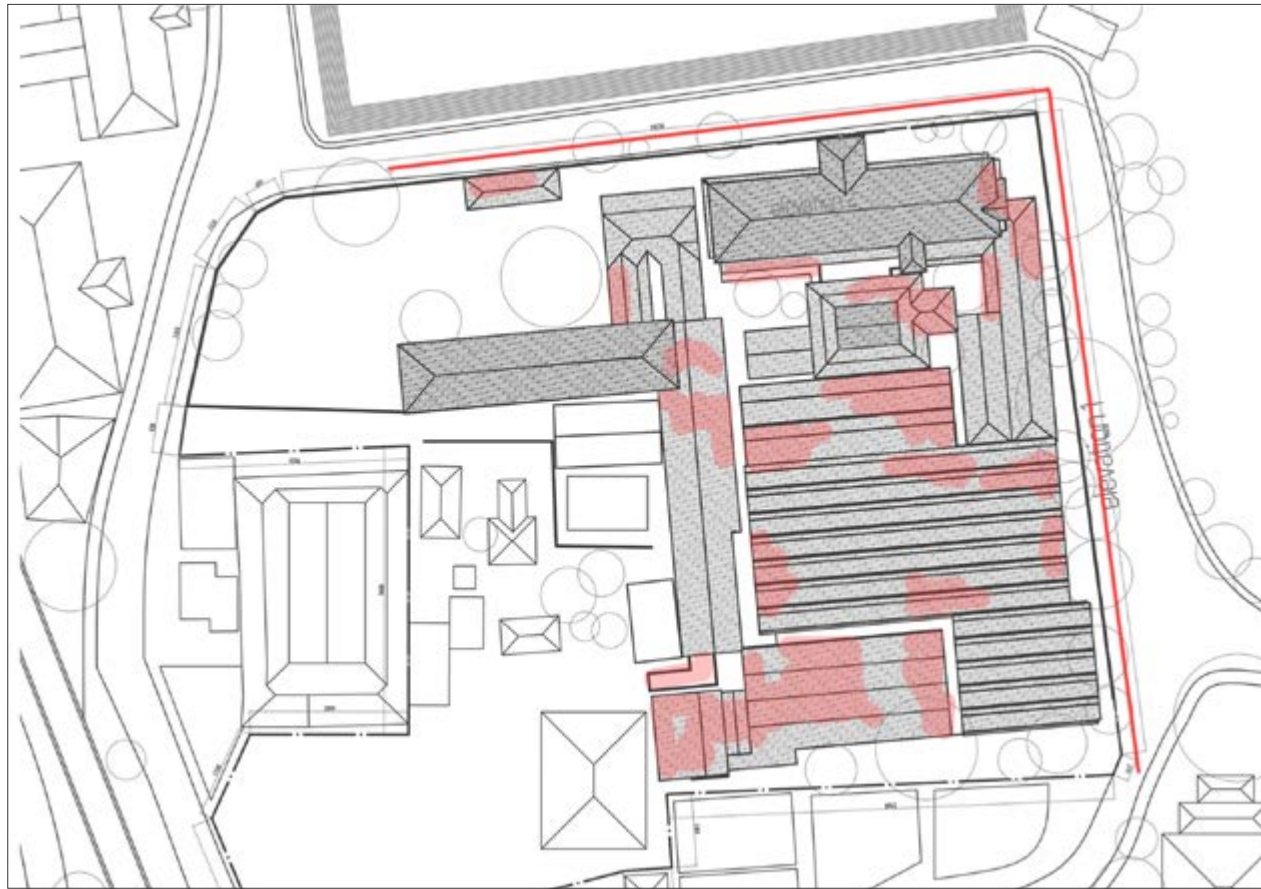
Figure 78: Plan of comtrust building showing the exterior damages
[Source: Created By Author]

The exterior defects and decay of the Comtrust building in Mananchira have likely developed due to environmental factors, aging, and moisture exposure. Over time, exterior plaster and paint can begin to crack and peel, particularly in areas exposed to rain, humidity, and temperature fluctuations.

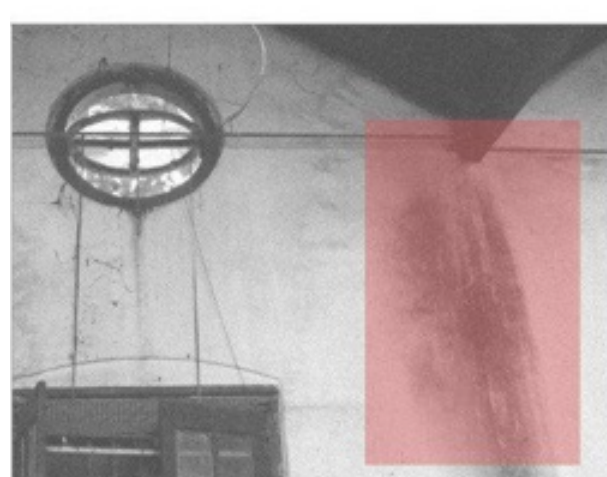
Figure 81: Image showing the tile damages

Tiles have accumulated soil and vegetation due to debris and moisture, creating conditions for plant growth. This can lead to cracked tiles, water infiltration, and added weight. Regular cleaning, protective coatings, and improved drainage are essential for preventing damage.

Replace or fix the tiles and remove the soil and growth of vegetation.

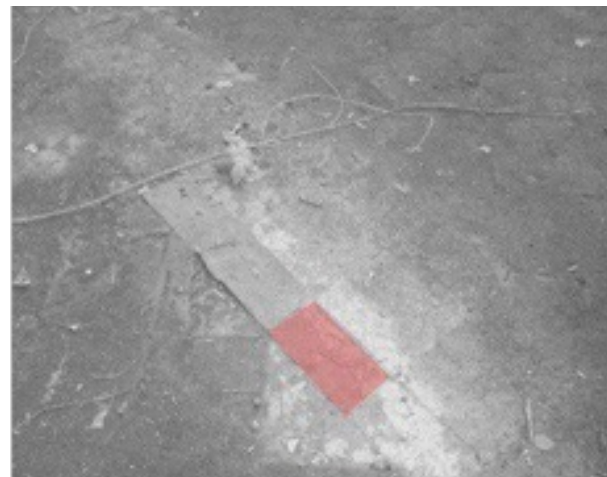
Figure 82: Image of the damage on the wooden flooring

The wooden flooring shows termite damage and gaps, compromising its integrity and appearance. Termites hollow the wood, while gaps result from pest activity or wear. Immediate extermination, repairs, and protective treatments are essential to prevent further damage and deterioration.

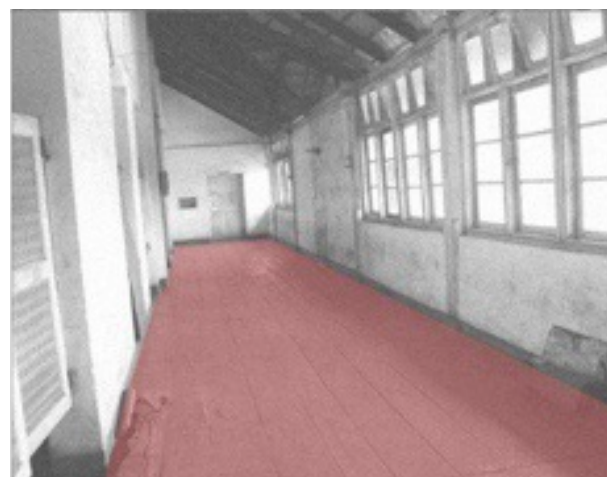
Figure 83: Image of structural damages

Building shows structural damages, including cracked walls, weakened foundations, decayed wooden elements, and rusted metal parts. These issues stem from aging, moisture infiltration, and lack of maintenance, requiring urgent restoration to preserve the building's structural integrity.

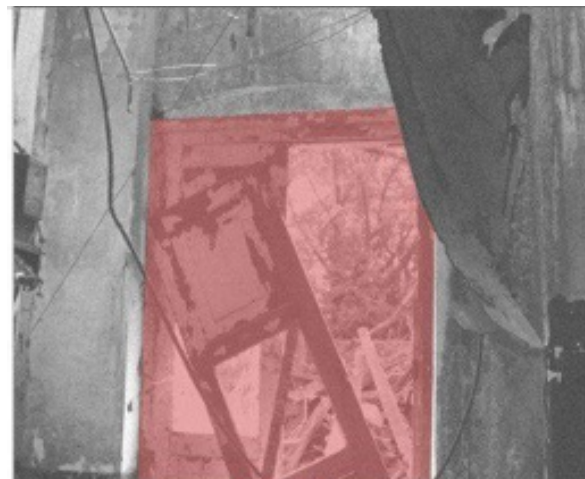
5.0.8. Broken Doors

Figure 87: Image showing damages on the doors
[Source: Created By Author]

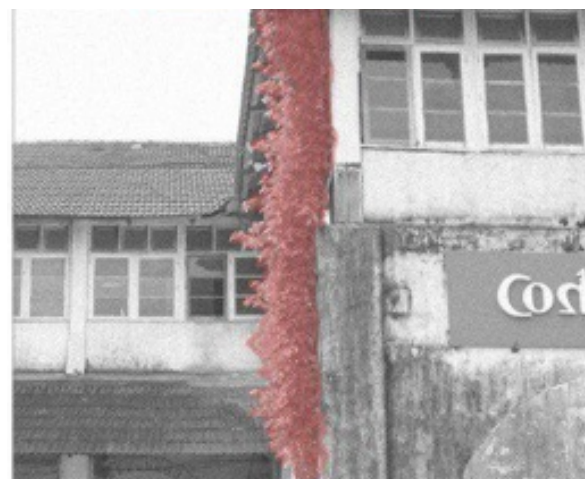
5.0.9. Climbers

Figure 88: Image showing the growth of climber plants over the exterior wall
[Source: Created By Author]

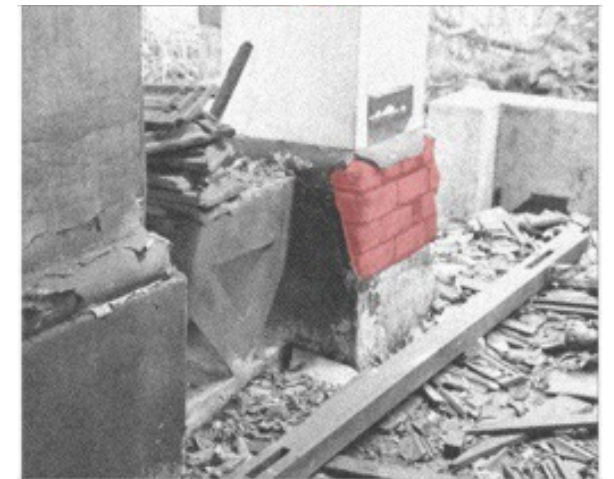
5.0.10. Wall Damage

Figure 89: Image showing the damages on the wall
[Source: Created By Author]

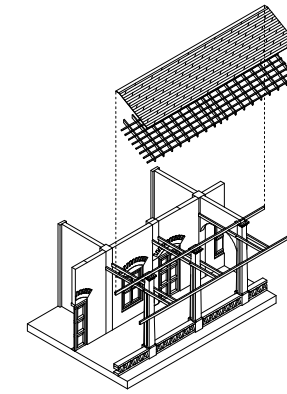
The structure's foundation and walls are built from thick laterite stone, a locally sourced material known for its strength and thermal insulation properties. This ensures the building can support the heavy loads associated with industrial use while maintaining a comfortable indoor environment in Kerala's tropical climate. The use of lime mortar enhances flexibility, reducing the risk of cracks and ensuring the building's longevity.

Figure 106: Exploded structural schematics of block 1
[Source: Created By Author]

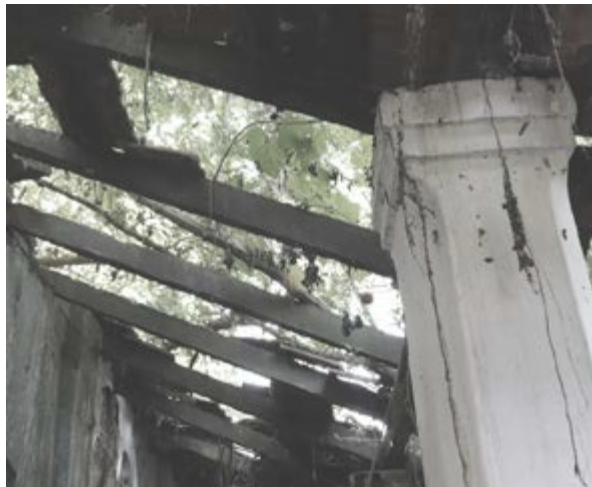
Figure 116: Image showing roof damages of block 2
[Source: Taken By Author]

Damaged roof

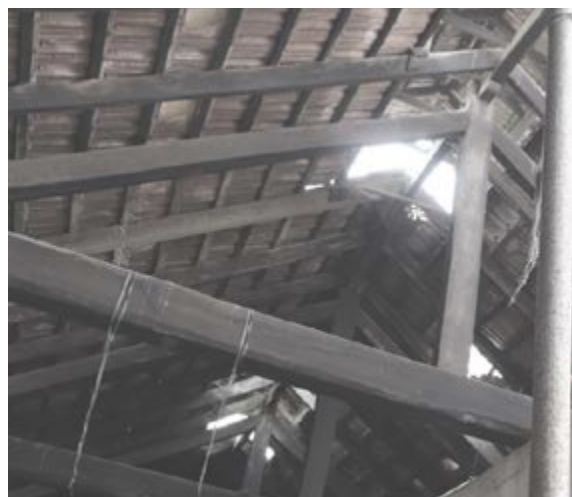
Figure 134: Image of king post truss roof frame
[Source: Taken By Author]

King post truss

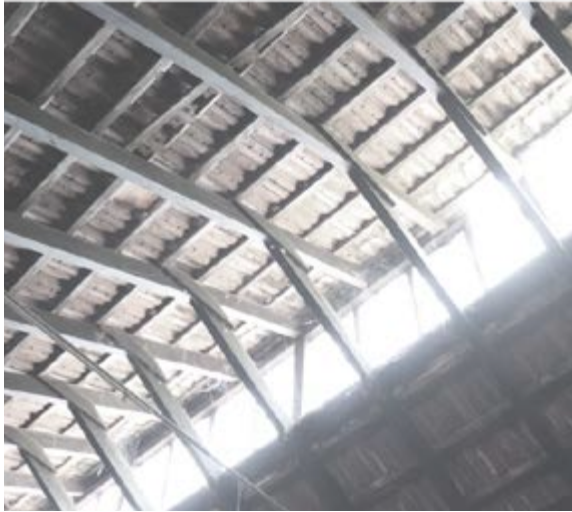
Figure 149: Image of the saw tooth roof
[Source: Taken By Author]

Saw Tooth Roof detail
