Thesis Report

Master of Architecture in Sustainability

Revitalisation of the Industrial Heritage

Transforming Historic Sites Honoring Historical Functions
with Sustainable Design Concepts for Adaptive Reuse.

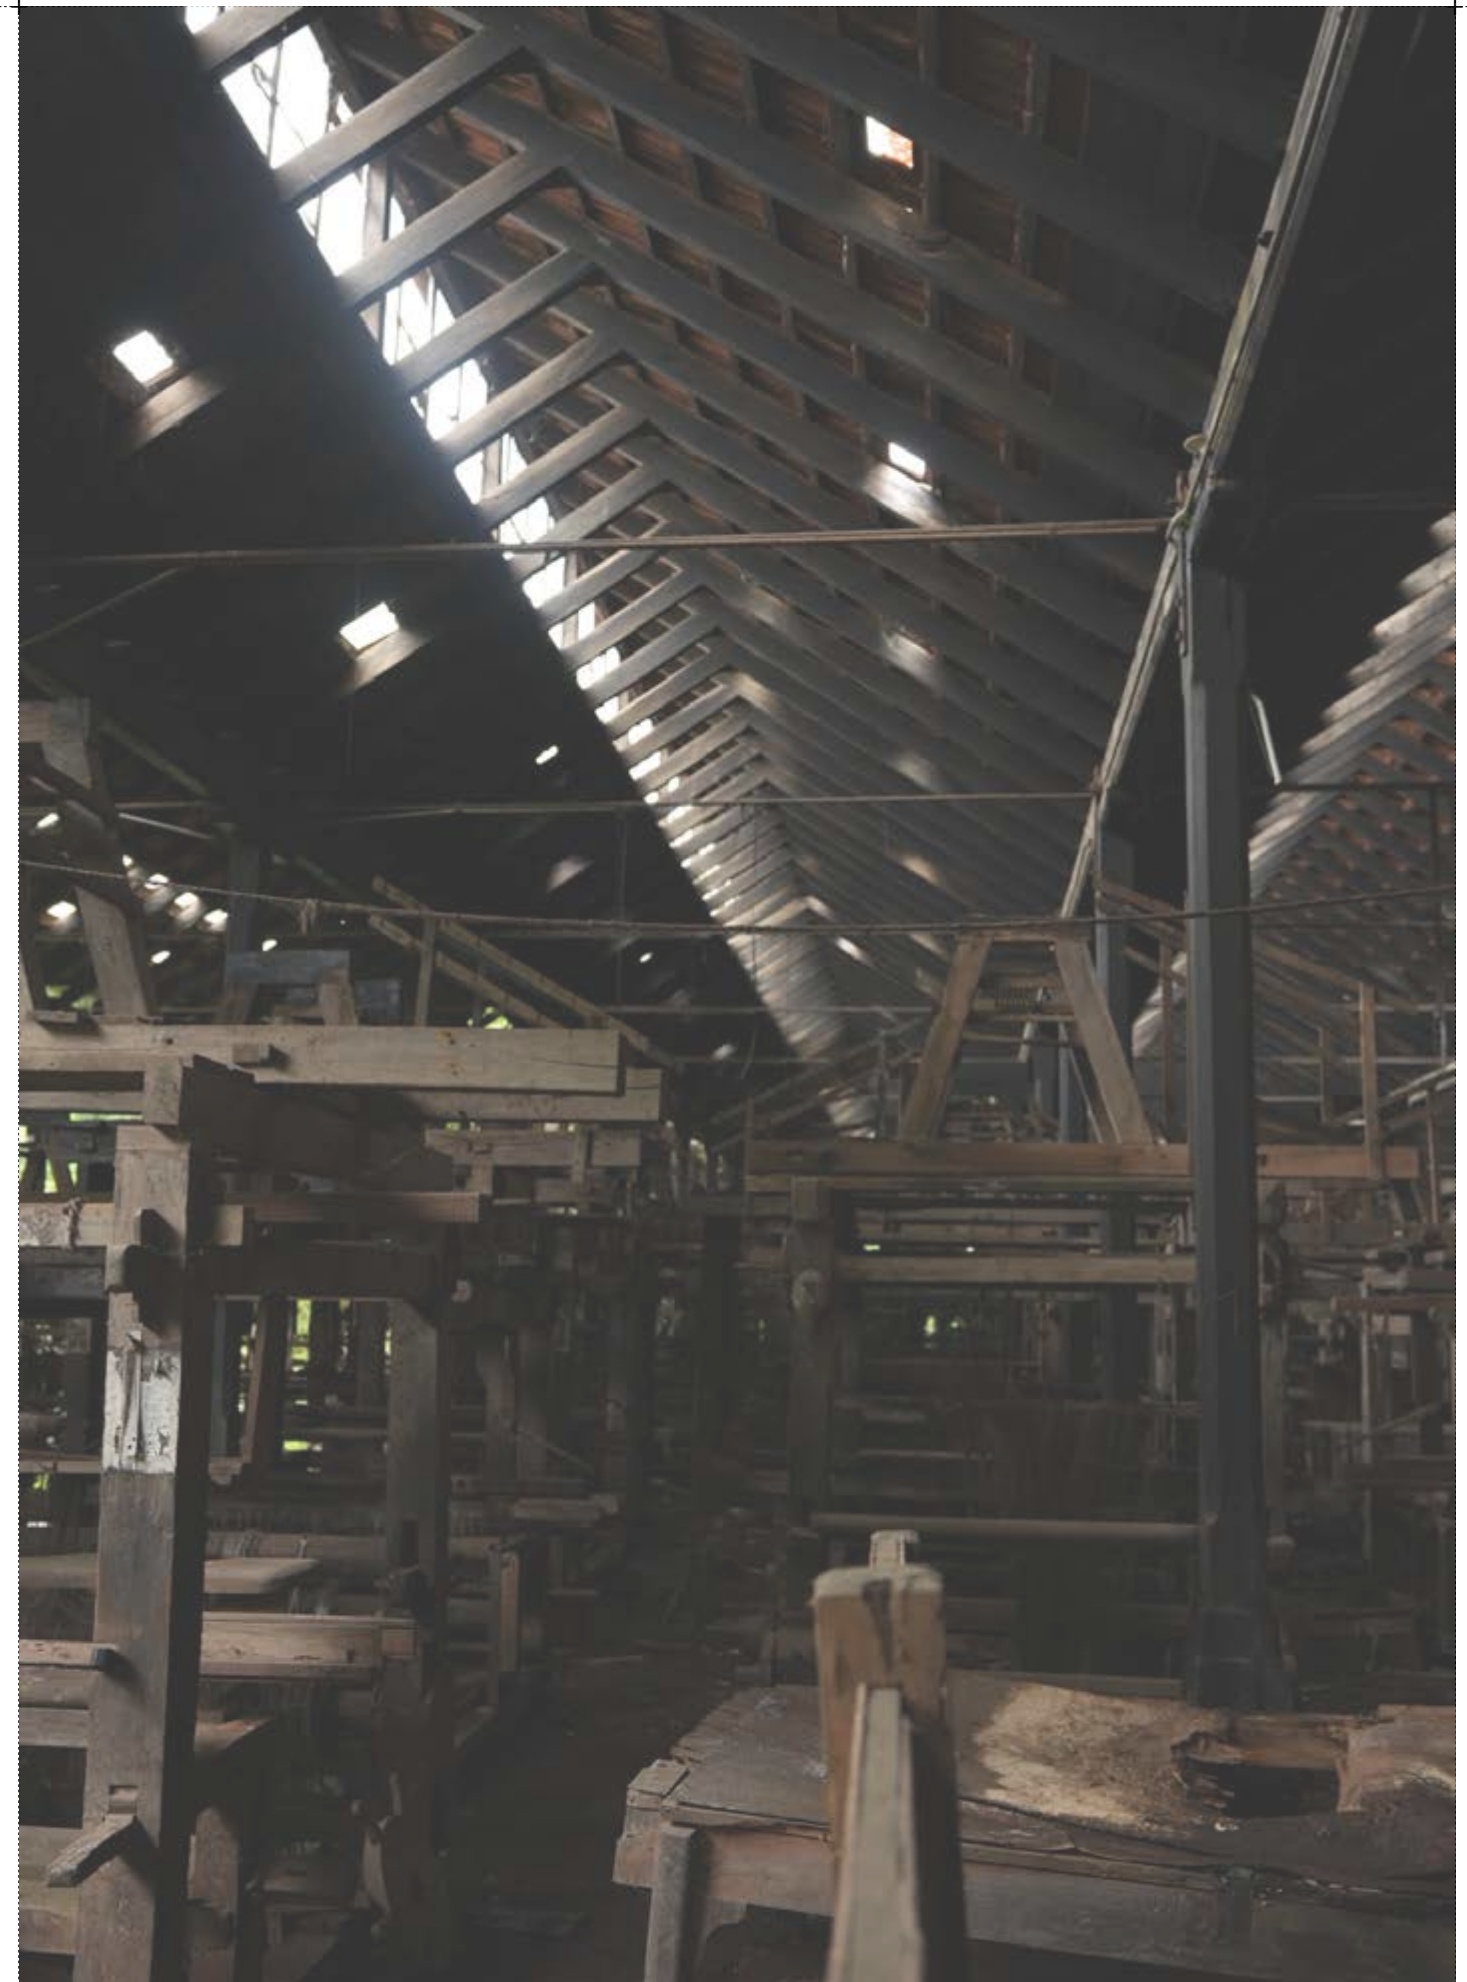
Detail C - The building features composite columns, which combine wood and a brick base to create a strong, efficient support system for the structure. These columns are designed to carry significant loads, particularly for the long spans of wooden beams that form the framework of the roof and upper floors. The brick base provides a sturdy, stable foundation, ensuring the column's ability to withstand vertical and lateral loads. The use of wood in the upper portion of the columns complements the traditional aesthetic of the building while maintaining the necessary strength for the beam supports. The wooden columns are carefully engineered to interact with the brick base, creating a balanced structure that integrates both materials. This combination of wood and brick not only enhances the building's structural integrity but also ties

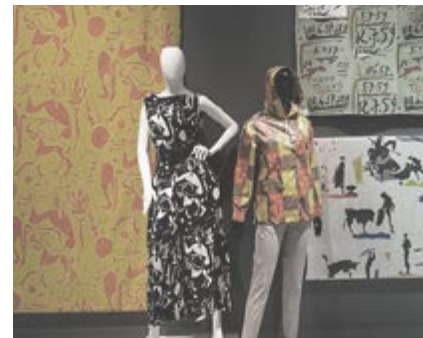
<p>Figure 165: Clothing on market [Source: https://tinyurl.com/5585fec8]</p><p>These products can be supplied to retail and international markets, promoting sustainable fashion globally.</p></div>

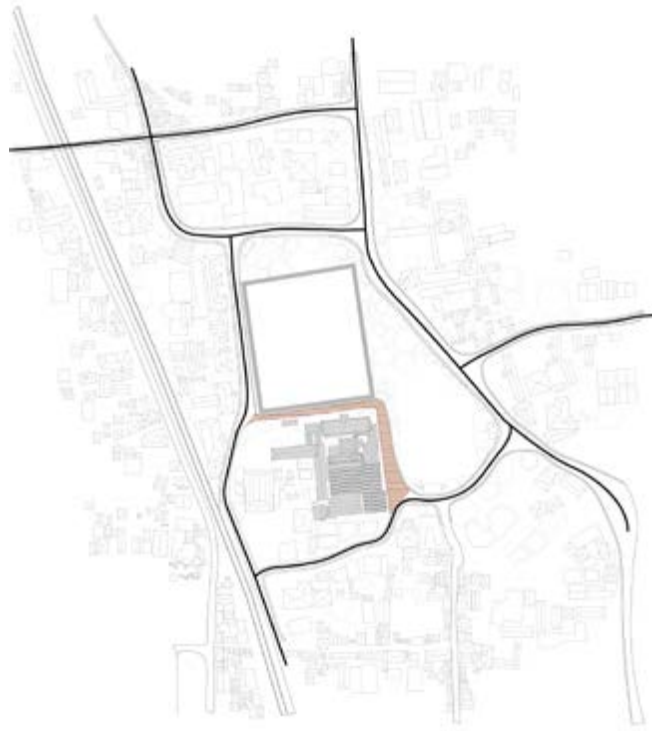
Figure 167: Figure showing the transformation of a road to a completely pedestrian walkway
[Source: Created by Author]

To accommodate the existing traffic conditions, modifications have been implemented to enhance accessibility and aesthetics. The road in front of the Comtrust Mananchira building has been transformed into a pedestrian-only zone, designed as a landscaped front yard. This change prioritizes pedestrian movement, creating a safe and inviting environment for visitors while reducing vehicle congestion in the area. The newly designed space integrates greenery, pathways, and seating areas, promoting a sense of community and connection with the historical architecture of the building. By converting the road into a pedestrian-friendly landscape, the area encourages foot traffic, fosters social interaction, and highlights the building's cultural and architectural significance.

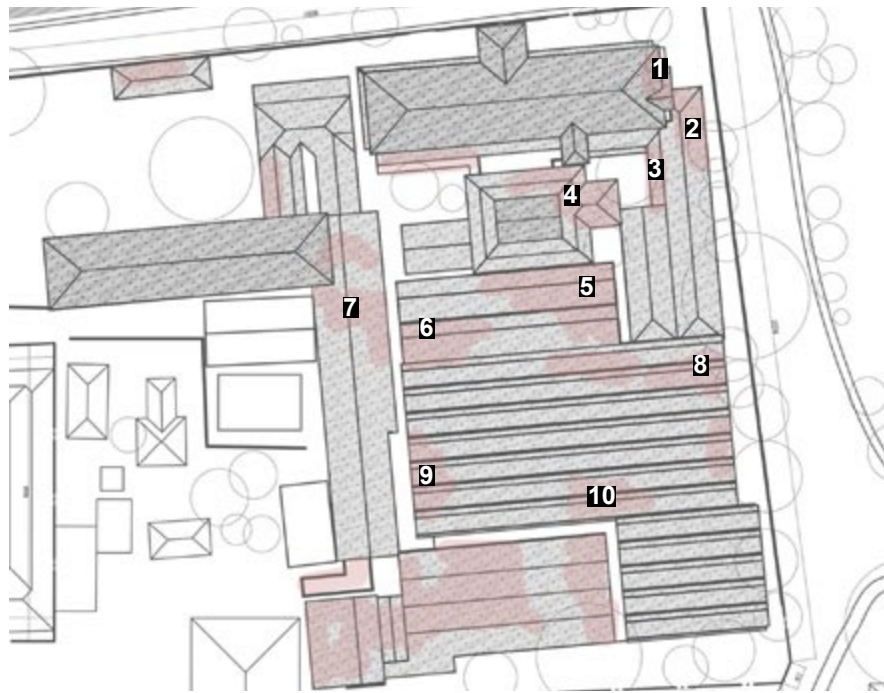
The deterioration of the building's structural integrity, particularly the roof area, resulting from prolonged neglect.

Figure 171: Figure showing the structural damages on the comtrust building
[Source: Created by Author]

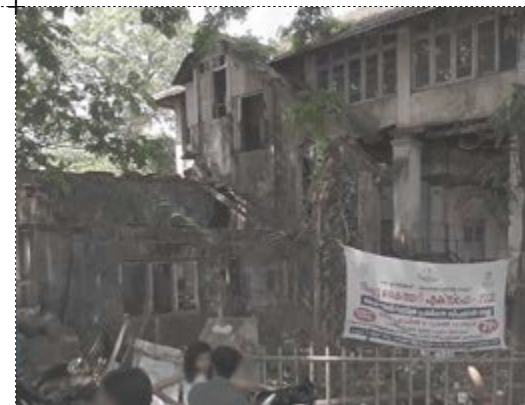
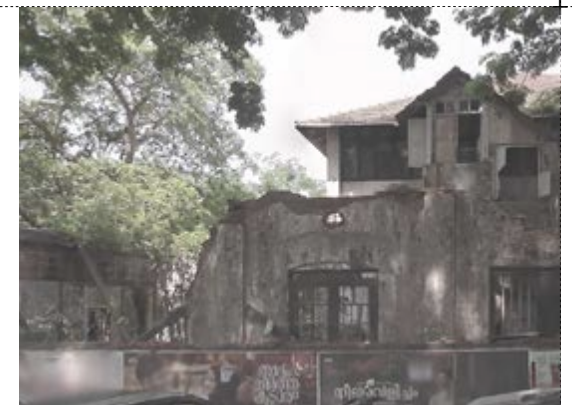
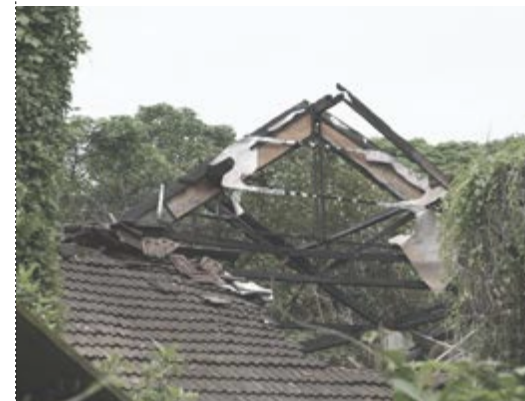
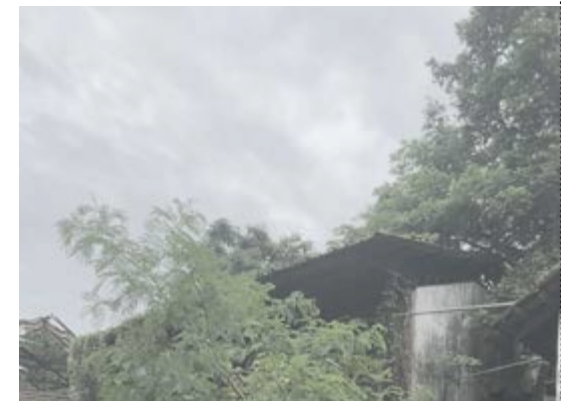
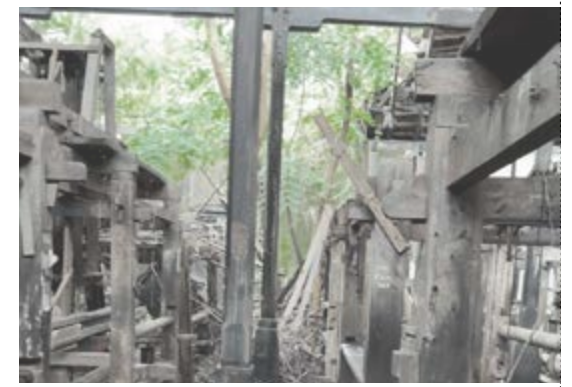
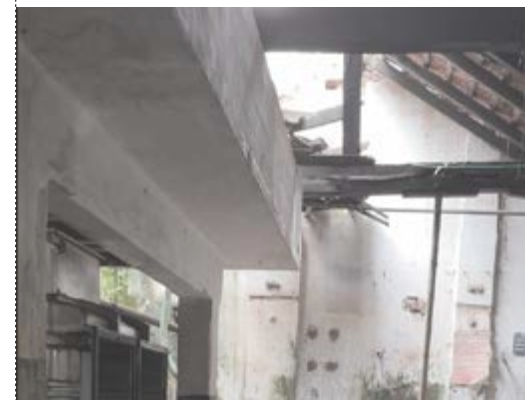
Figure 173: Images showing the identified spaces for potential renovation
[Source: Taken by Author]

Photographs showing the material degradation and destruction caused to the structure

Area where permanent damage has compromised the integrity of the main structure.

Severely damaged spaces are revitalized into flourishing green areas through the integration of plants, trees, and landscaped features to enhance environmental health and visual appeal. These green transformations can include outdoor gardens, indoor vertical greenery, and biophilic interior designs. The objective is to restore these areas to support biodiversity, improve air quality, and create functional, attractive spaces for communities, promoting sustainability and environmental well-being.

Efforts have been made to preserve the building’s natural character wherever possible. In areas that were extensively damaged, new interventions have been introduced. These new elements are designed to align with the architectural heritage of the original structure, maintaining visual coherence while offering a refreshed and functional appearance.

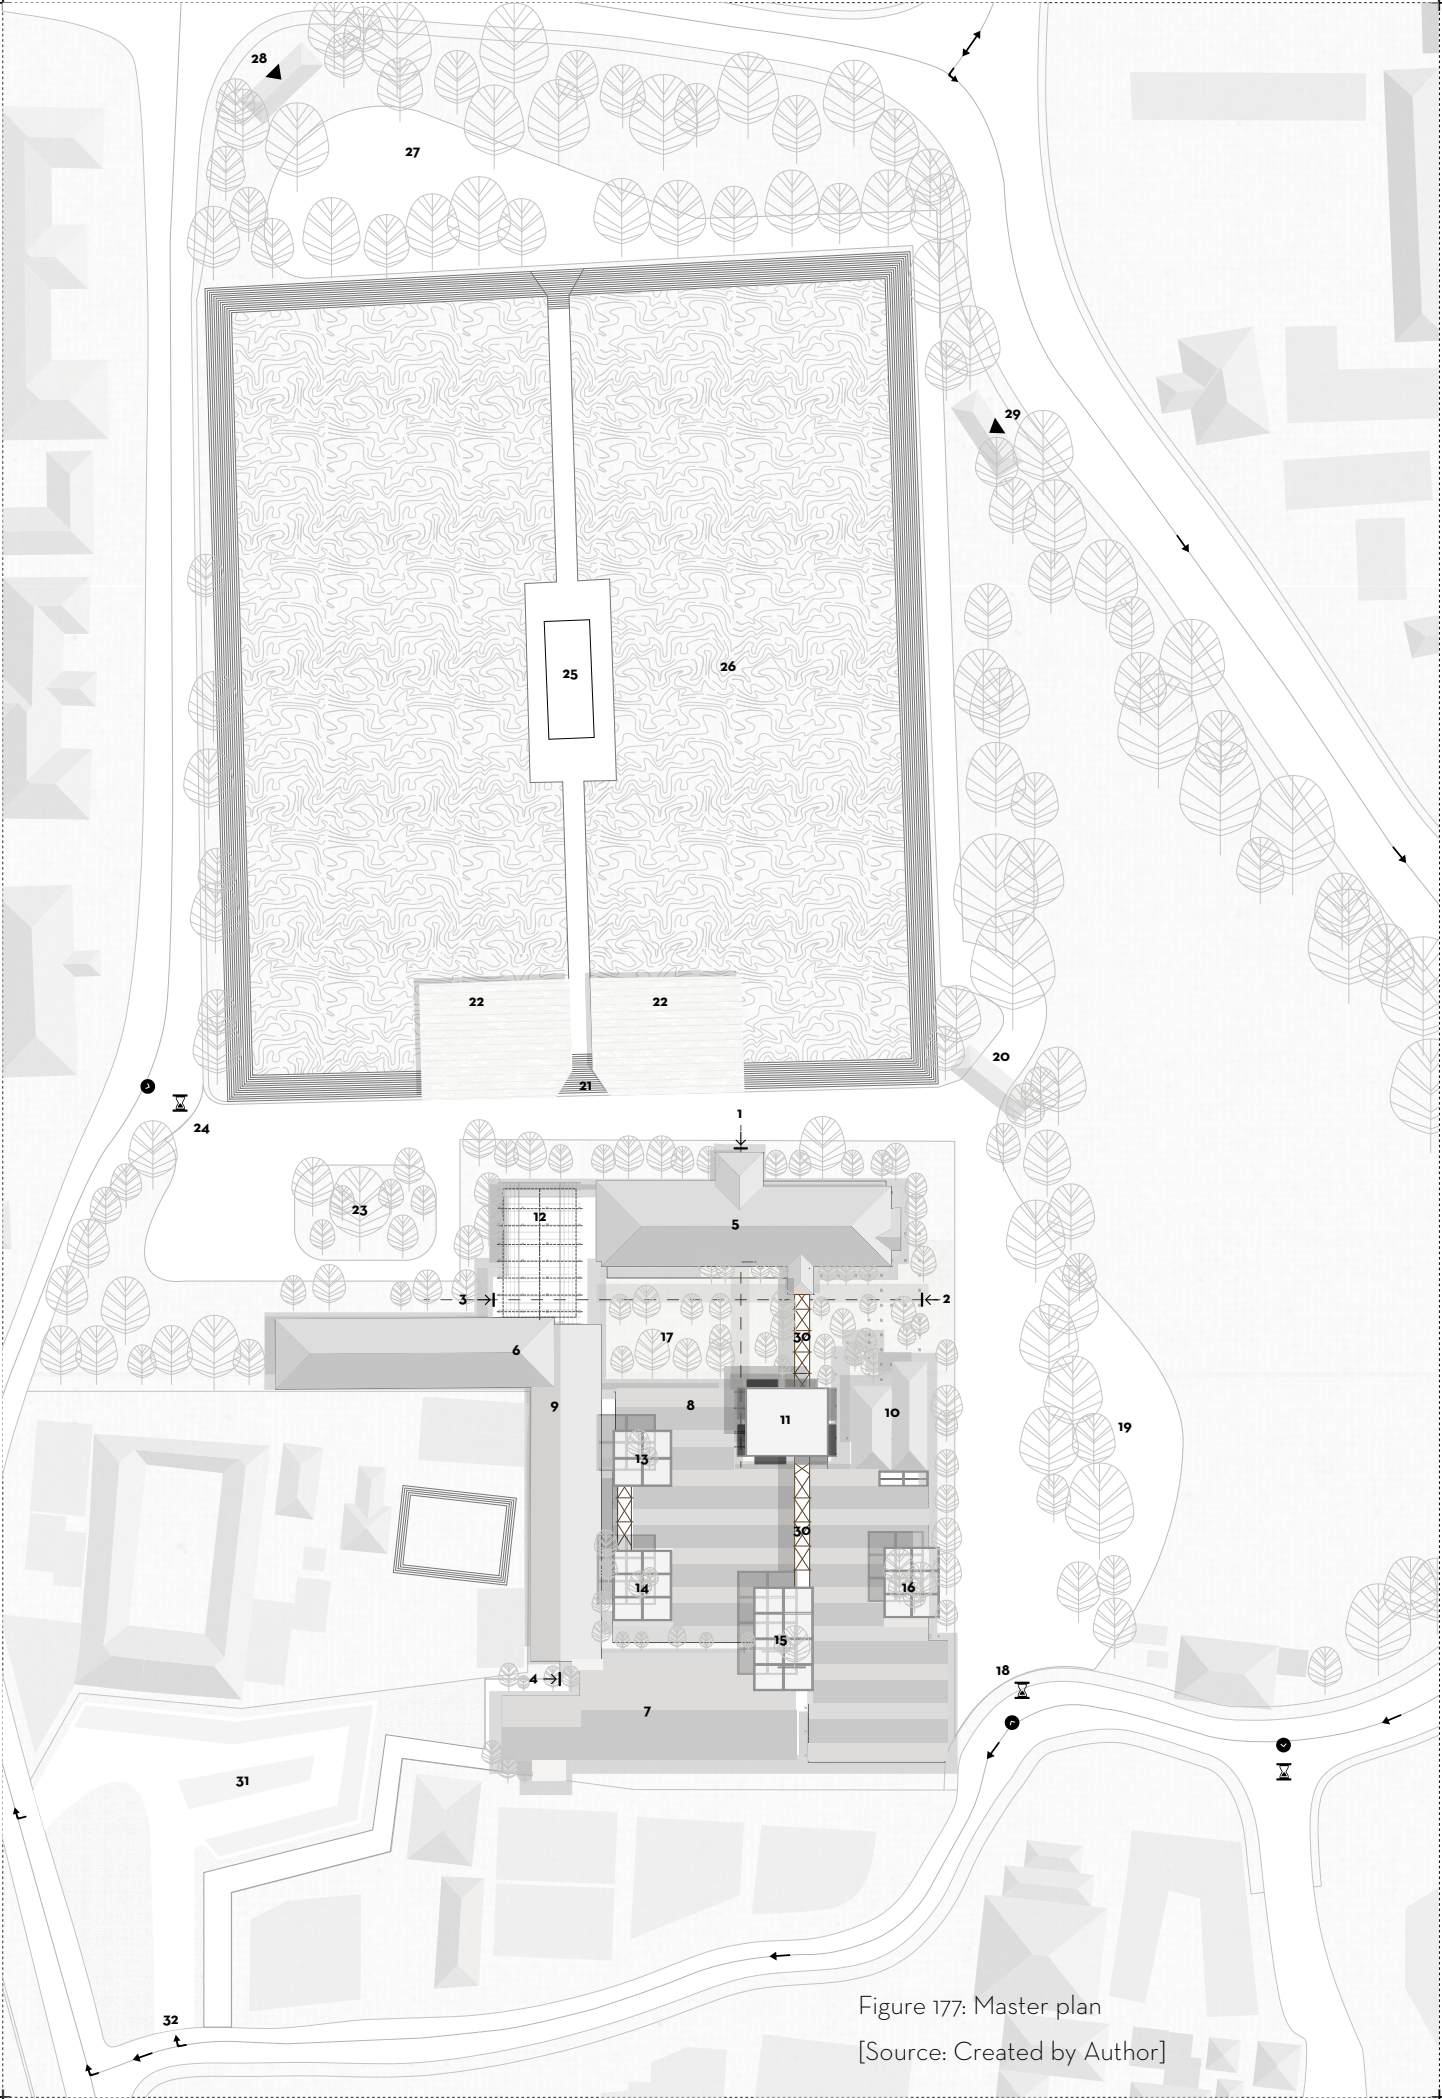
- 1. Entrance 1 (Main Block)
- 2. Garden Entrance
- 3. Museum Entrance
- 4. Service Entrance
- 5. Main Block
- 6. Exhibition / Museum Block
- 7. Recycling Block
- 8. Workshops
- 9. Service Block
- 10. Administration Block
- 11. Watch Tower
- 12. Exhibition Pavillion
- 13. Green Spillout Interactive Zones 1
- 14. Green Spillout Interactive Zones 2
- 15. Green Spillout Interactive Zones 3
- 16. Observatory Tower
- 17. Courtyard
- 18. Square Entrance 1 (Proposed)
- 19. Square Garden (Main)
- 20. Pond Walkway
- 21. Bridge Entrance
- 22. Decks
- 23. Garden
- 24. Site Entrance
- 25. Bridge
- 26. Pond
- 27. Garden
- 28. Garden Entrance 1 (Existing)
- 29. Garden Entrance 2 (Existing)
- 30. Building Bridges
- 31. Service Parking
- 32. Service Site Entrance

Figure 177: Master plan
[Source: Created by Author]
