MASTERPLAN

The design encompasses a complete revitalisation of the old textile mills to accomodate a museum for the showcasing of the history of the prior mill district. It has spaces for art galleries, permanent exhibitions, craft workshops, travelling exhibitions, archives, library, NTC offices, boutiques, restaurant, amenities, visitor's centre, textile centre and heritage gardens with plaza spaces and pond. The main idea of the design was to retain the existing integrity of the building while replacing the dilapidated with contrasting elements. The indigenous vegetation has been retained and the paths have been created along it. The ruins are emphasised and the gardens provide for open spaces which is otherwise lacking in this part of Mumbai. The main part which is detailed is the restaurant, pavilion, art gallery and amenities part of the entire site in order to depict how the prototype of a heritage revitalisation would work in the indian context. The pavilion is a new addition to the existing structure so as to provide more definition and access within the site whereas the restaurant is a retained existing block with a replaced roof. The art gallery on the other hand is ret

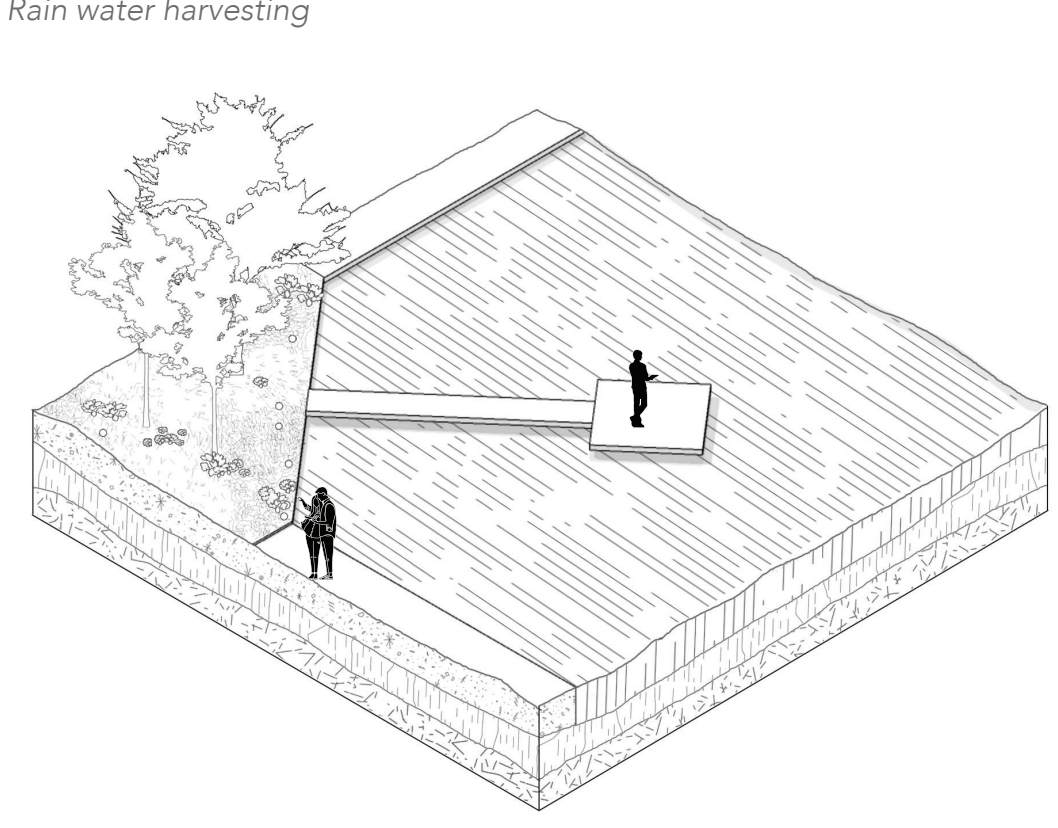
Rain water harvesting

The site has a variety of indigenous vegetation such as Ficus/ Banyan, Amla, Ashoka, Mango, Coconut palms, Neem, Ficus, Butea and Cassia among others. Path is created as per the position of ruins and the position of the trees. In order to make a natural look with lesser site intervention. The site has ruins of old buildings in various parts which has been emphasised through its urban footprint. The outline of the building shape is highlighted using pavements and trees. The addition of trees in the new open areas. The open spaces are created along the natural spaces where vegetation is scarce and also central to the site. Water bodies are introduced at the lowest contour as well as a subtank to the central pond.

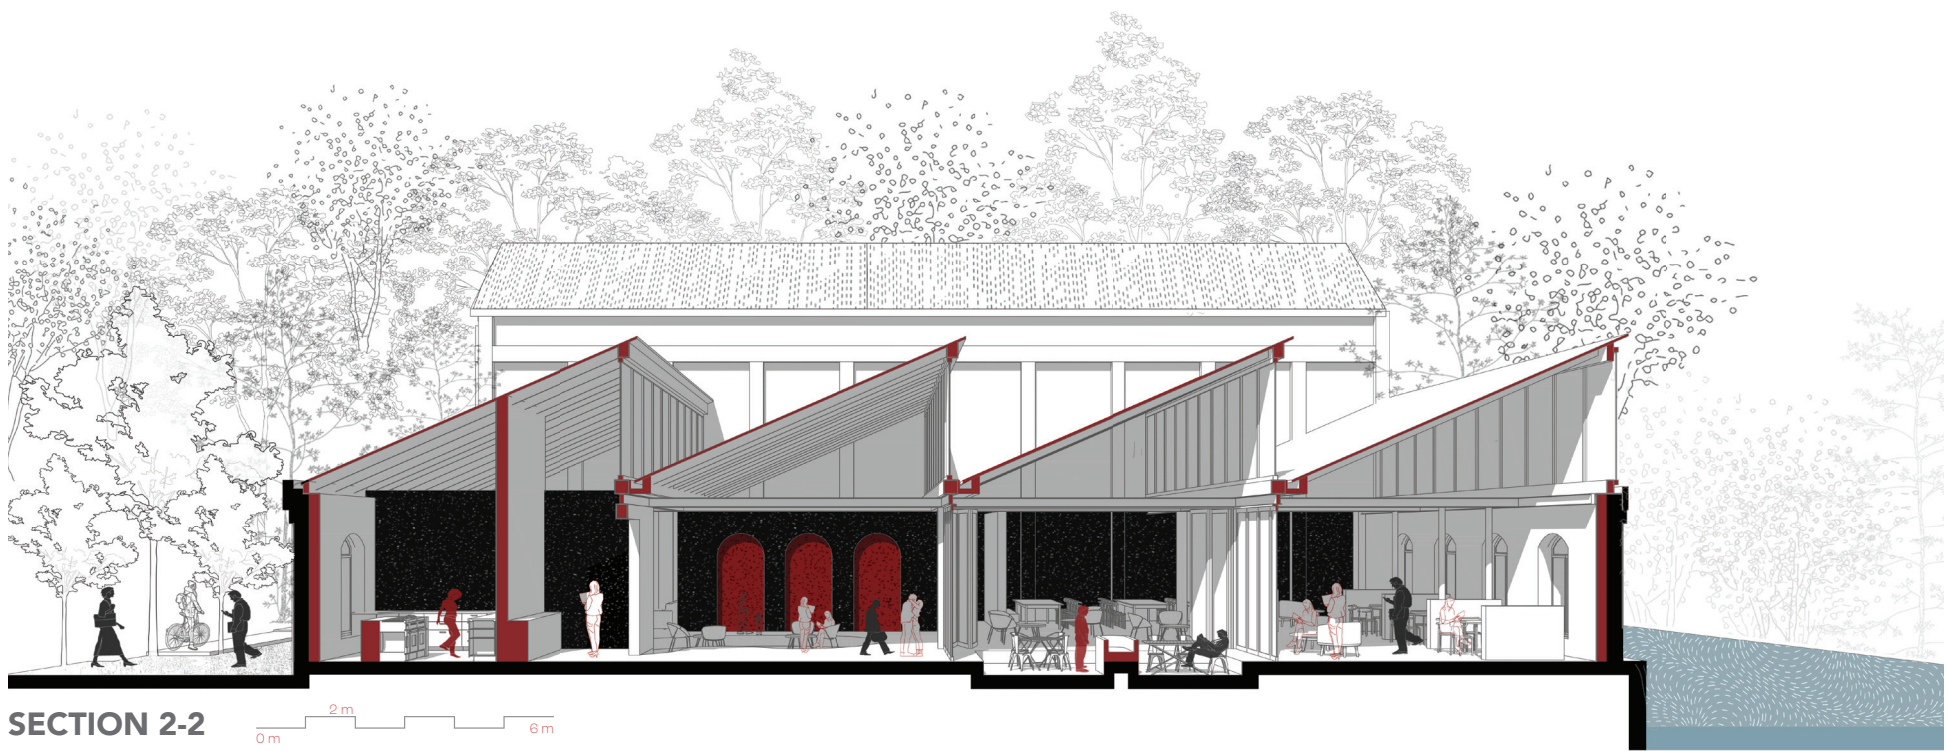
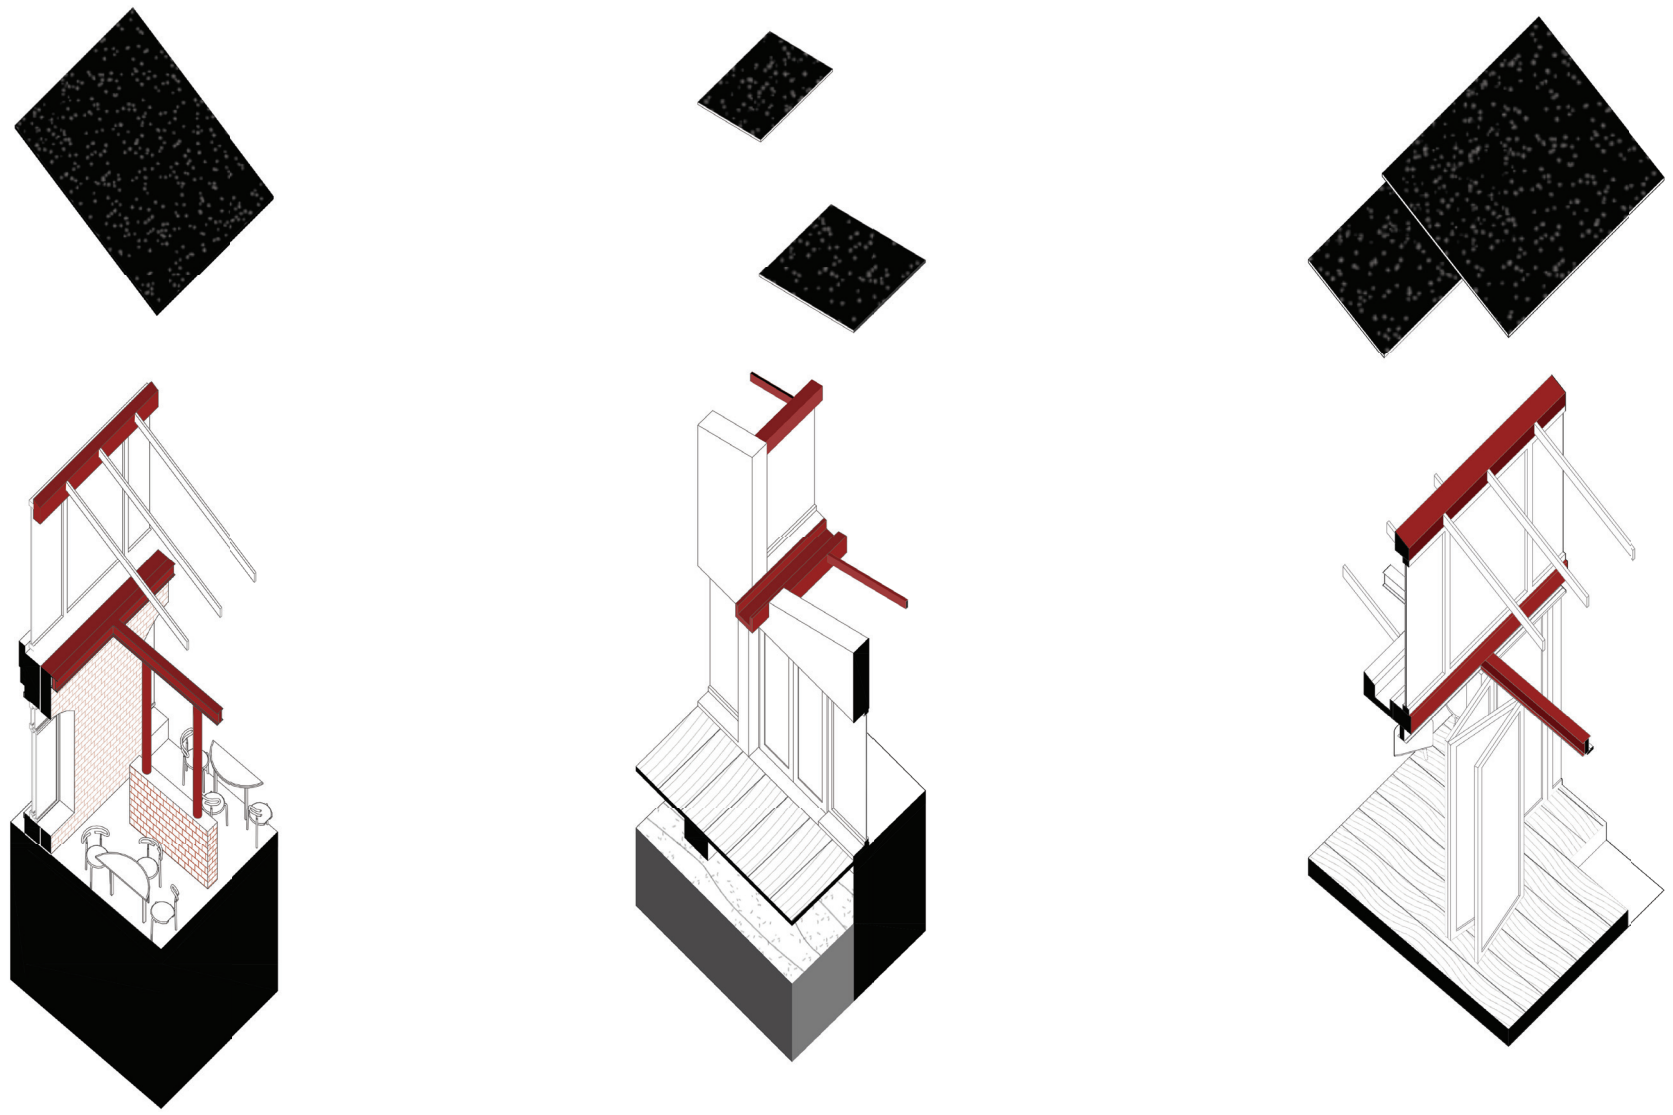
DETAIL 1: Connection to wall
JOINERY DETAILS

DETAIL 2: Door and roof

DETAIL 3: Roof and window

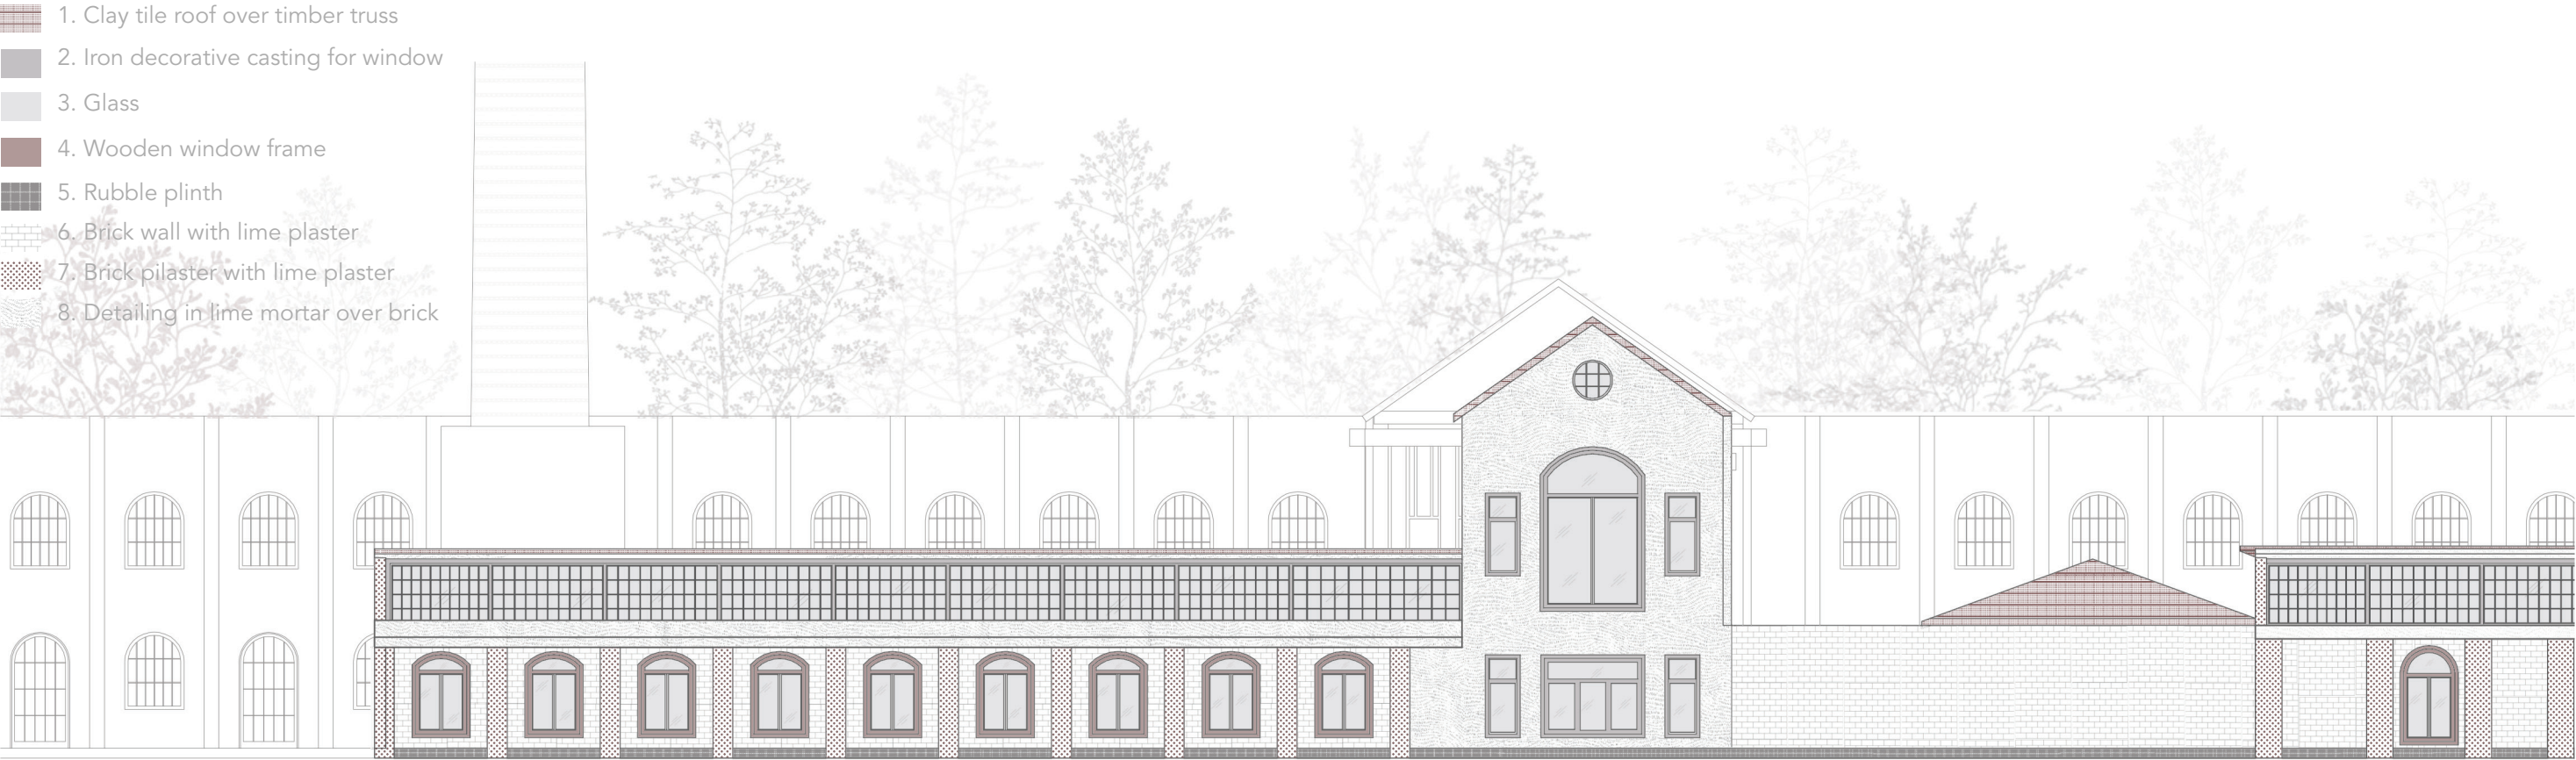
Building materials in the South elevation of the area in focus © Author

- 1. Clay tile roof over timber truss
- 2. Iron decorative casting for window
- 3. Glass
- 4. Wooden window frame
- 5. Stone plinth
- 6. Brick wall with lime plaster
- 7. Brick pilaster with lime plaster
- 8. Detailing in lime mortar over brick

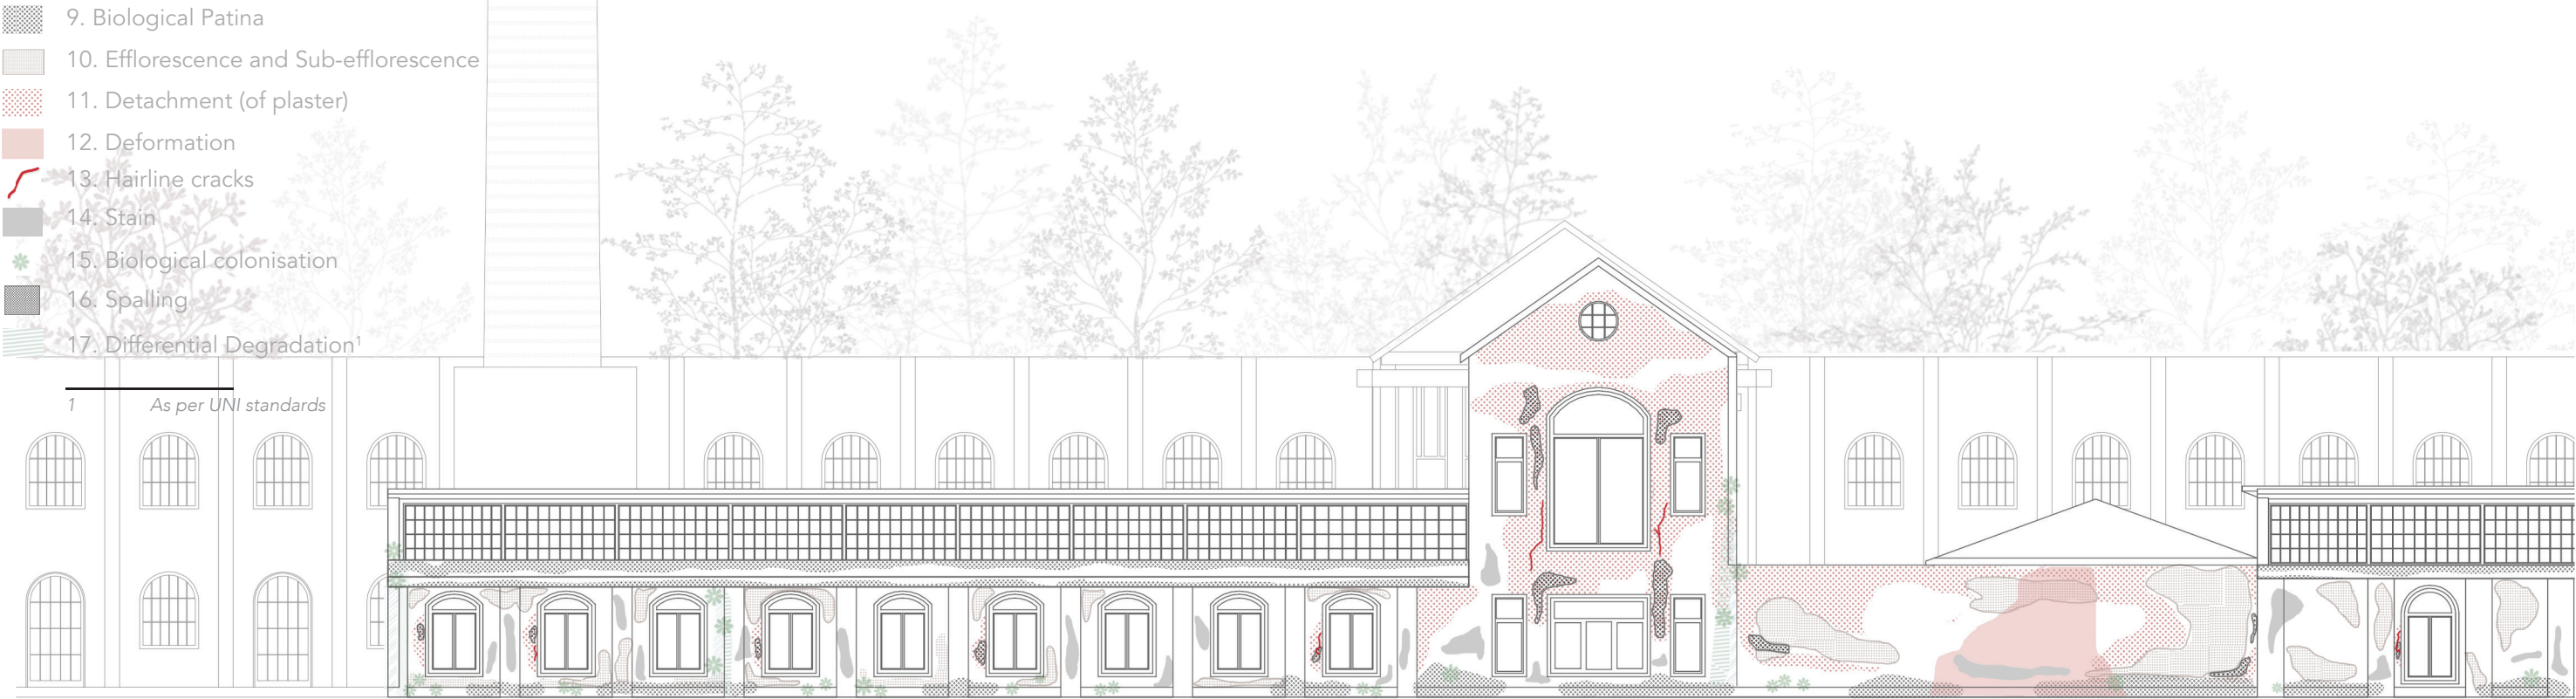
Decays on the South elevation of the area in focus © Author

- 9. Biological Patina
- 10. Efflorescence and Sub-efflorescence
- 11. Detachment (of plaster)
- 12. Deformation
- 13. Hairline cracks
- 14. Stain
- 15. Biological colonisation
- 16. Spalling
- 17. Differential Degradation¹

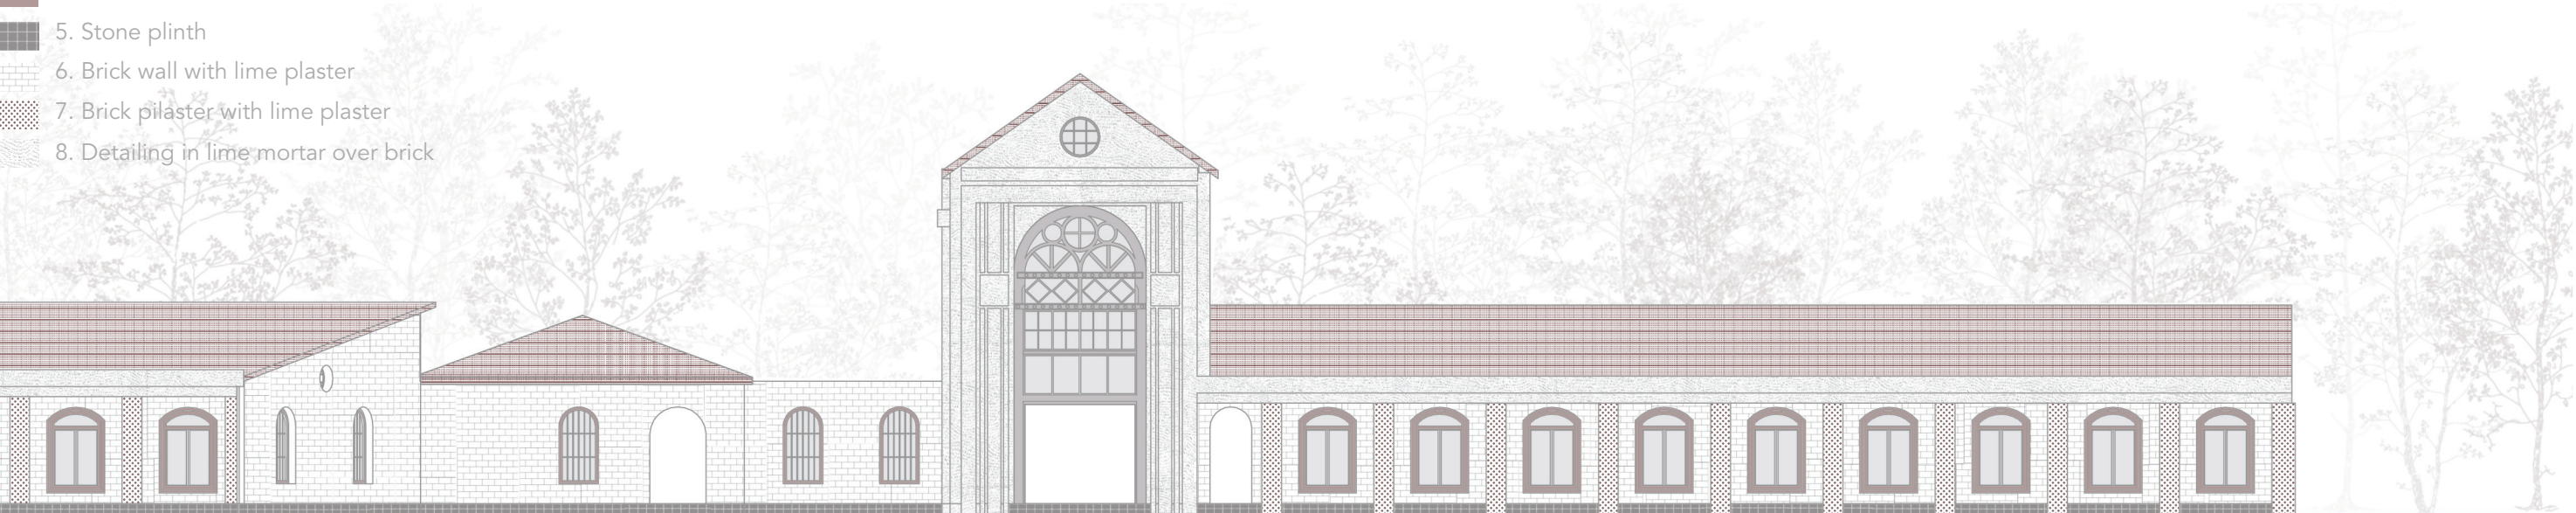
Fig. 279 Building materials in the North elevation of the area in focus © Author

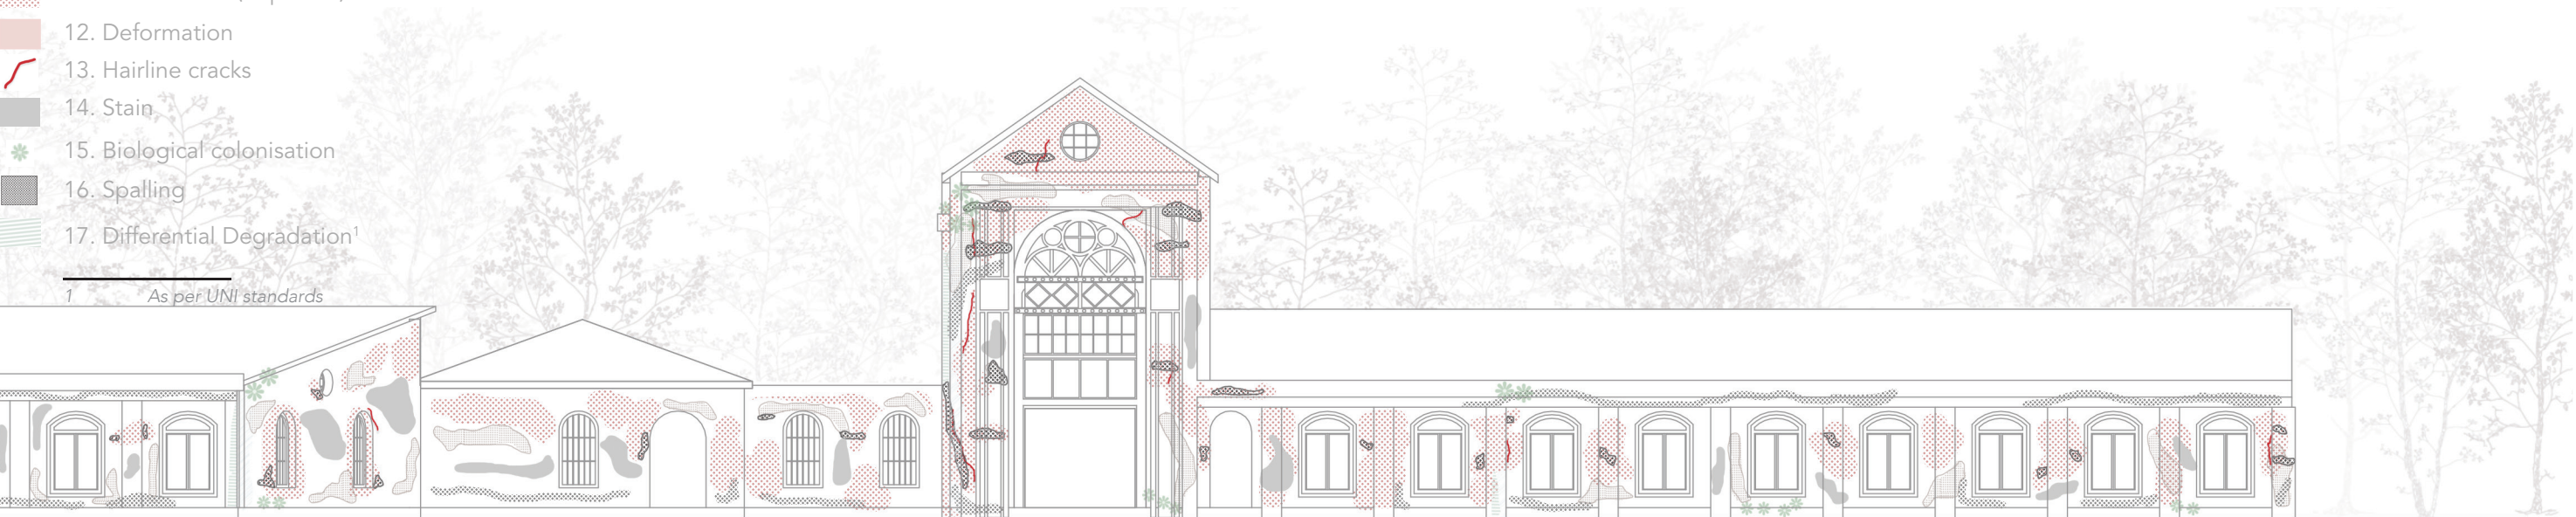
Fig. 279 Decays on the North elevation of the area in focus © Author

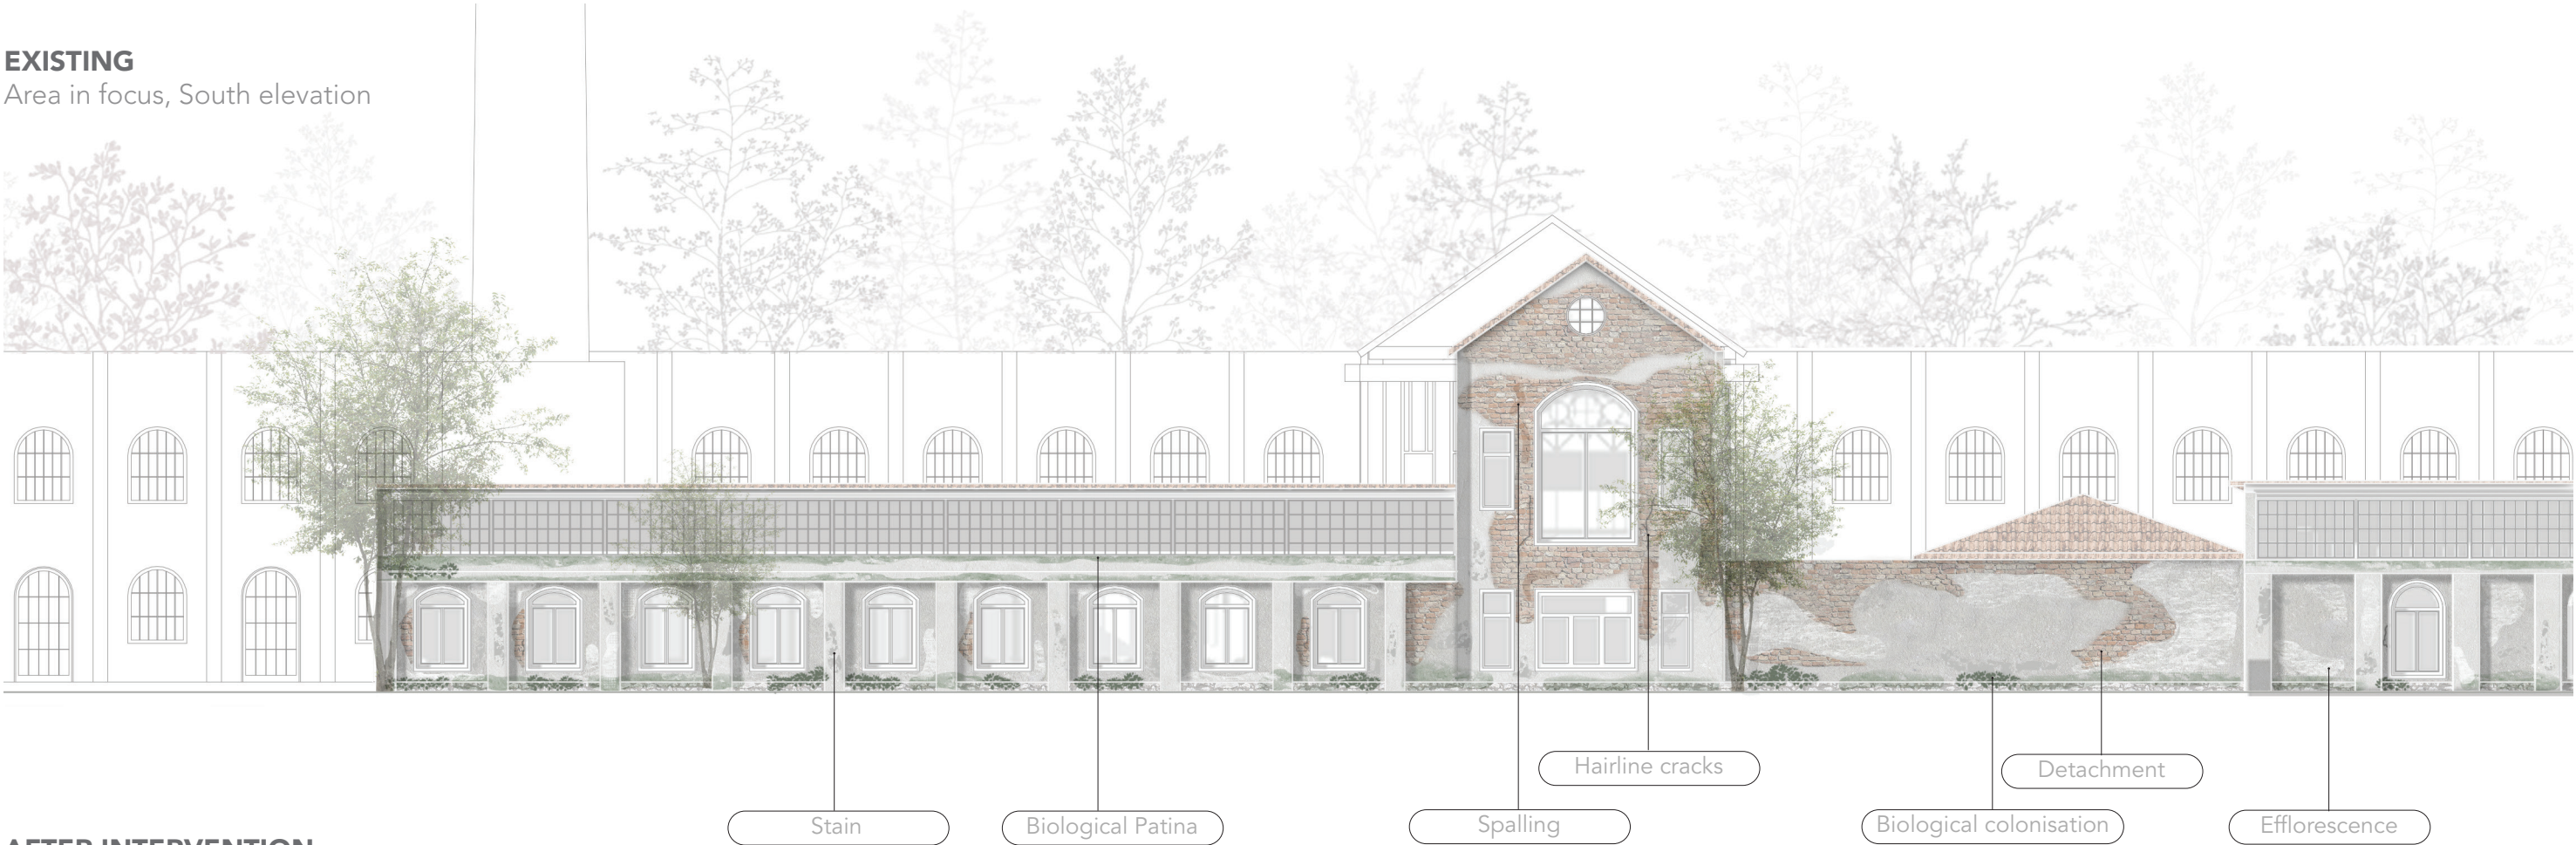
EXISTING
Area in focus, South elevation

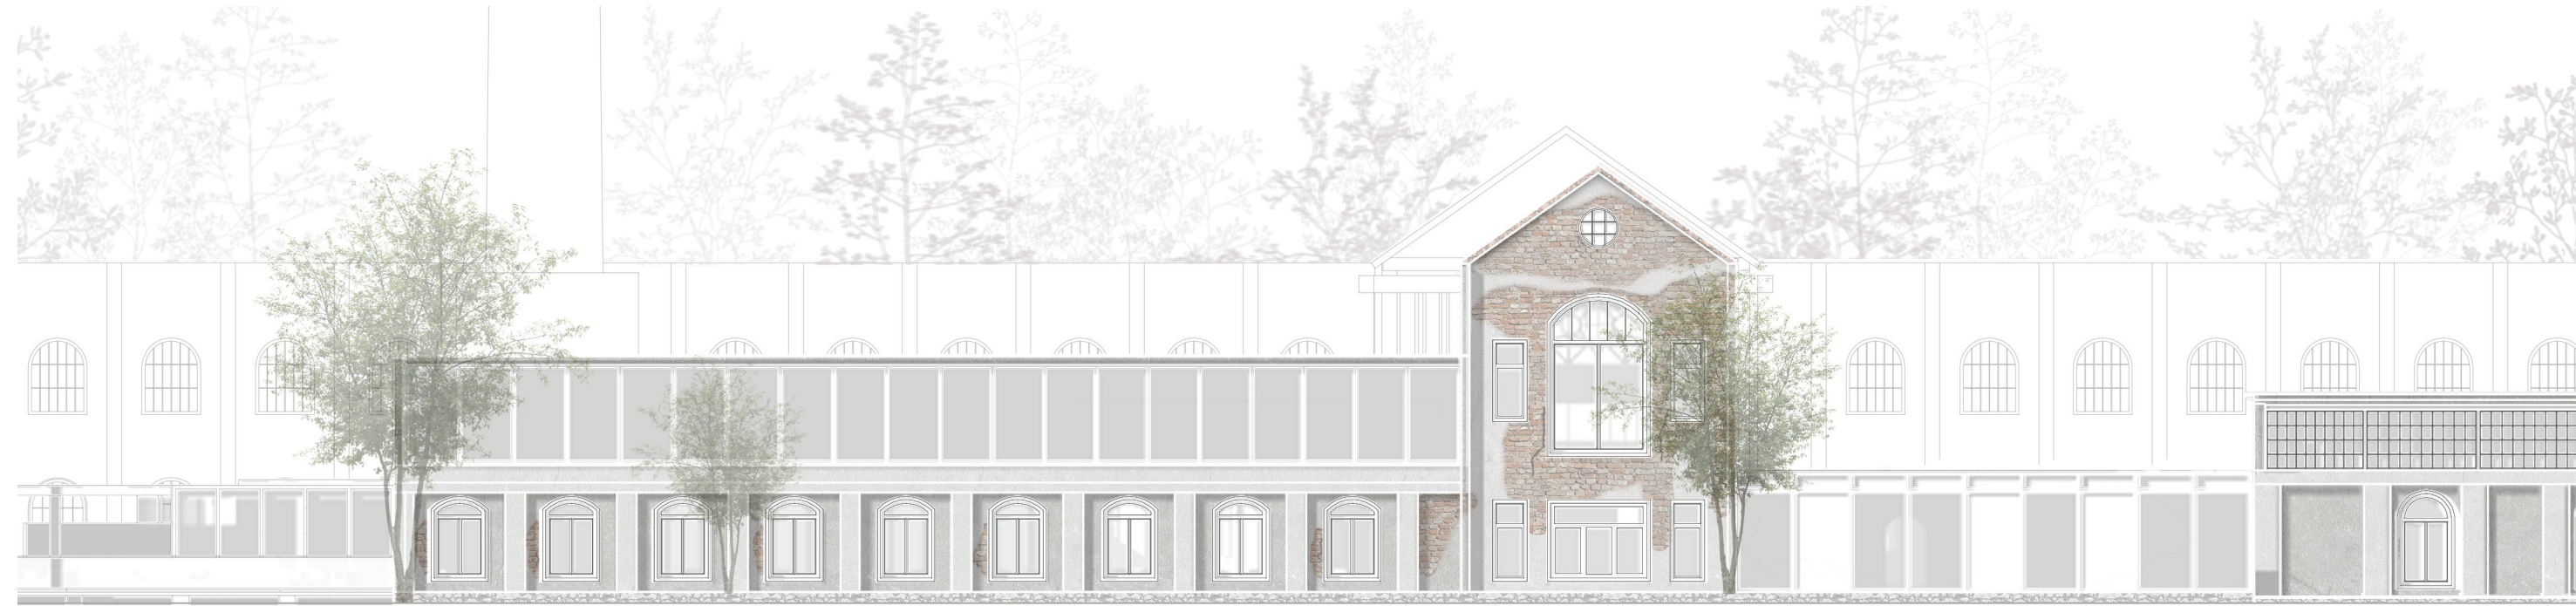
AFTER INTERVENTION
Area in focus, South elevation

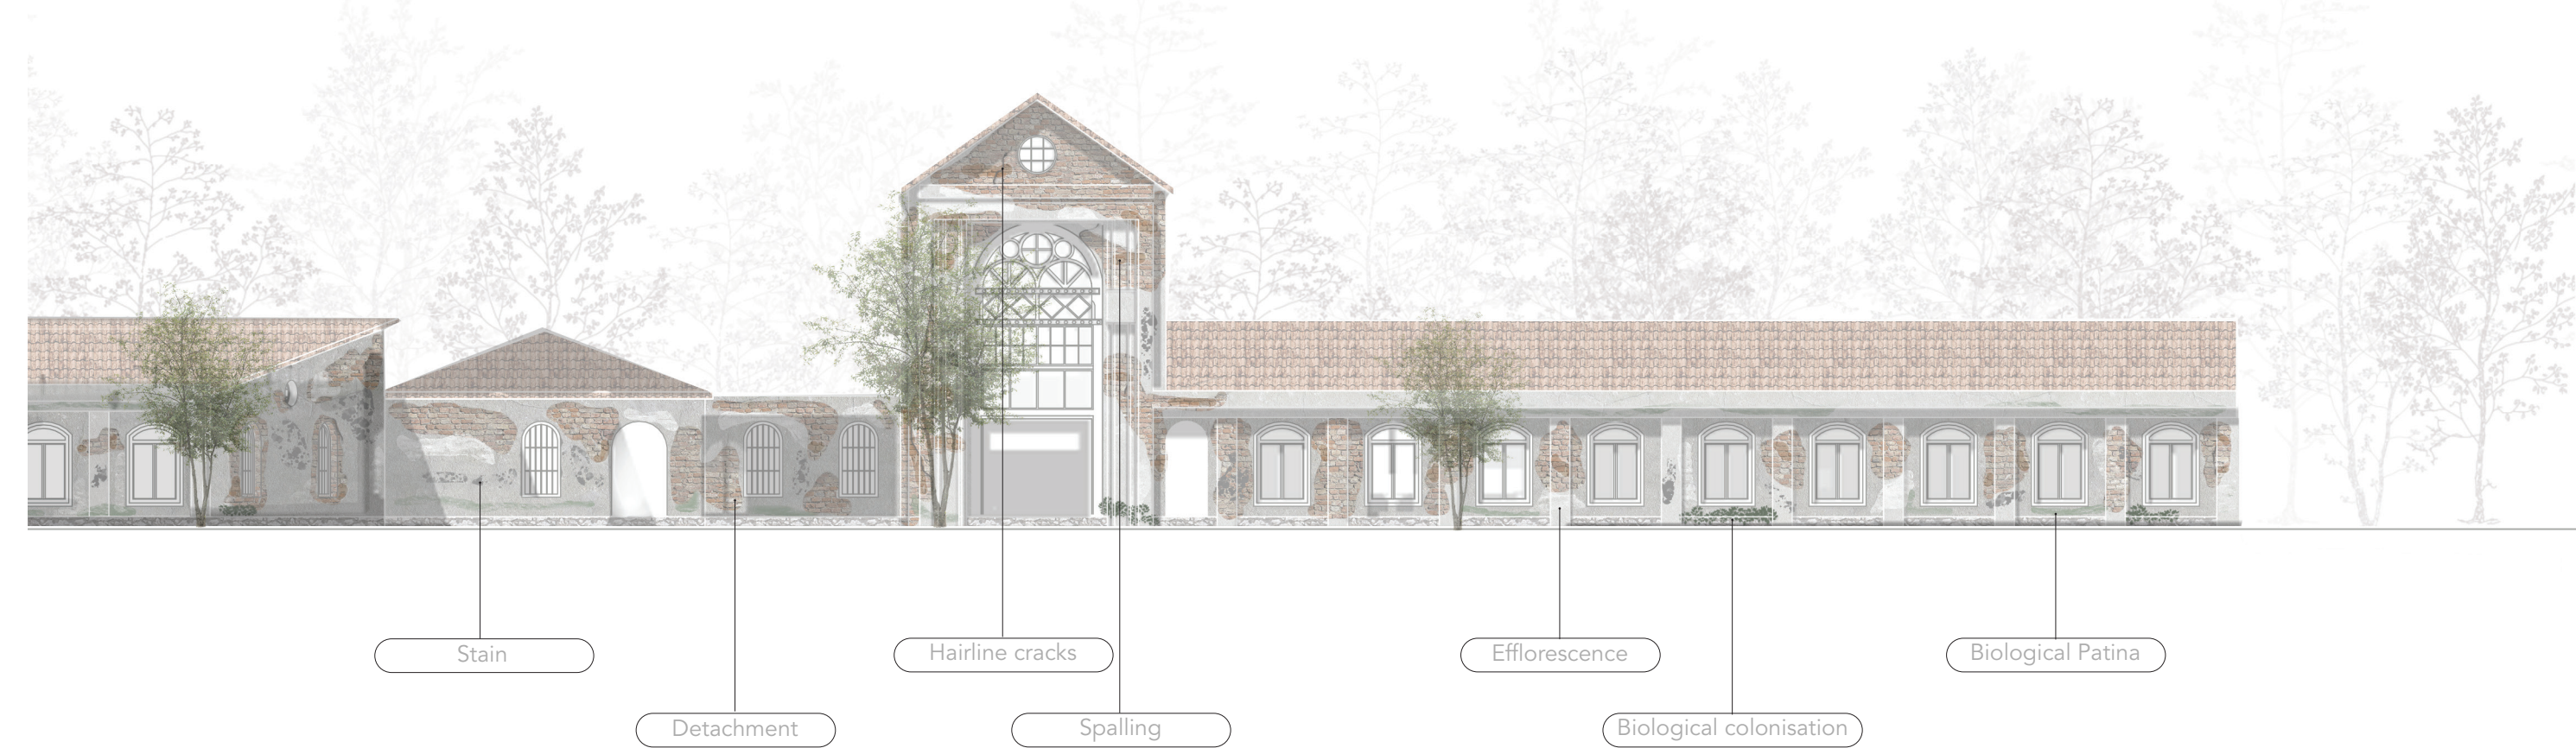
EXISTING

Area in focus, North elevation

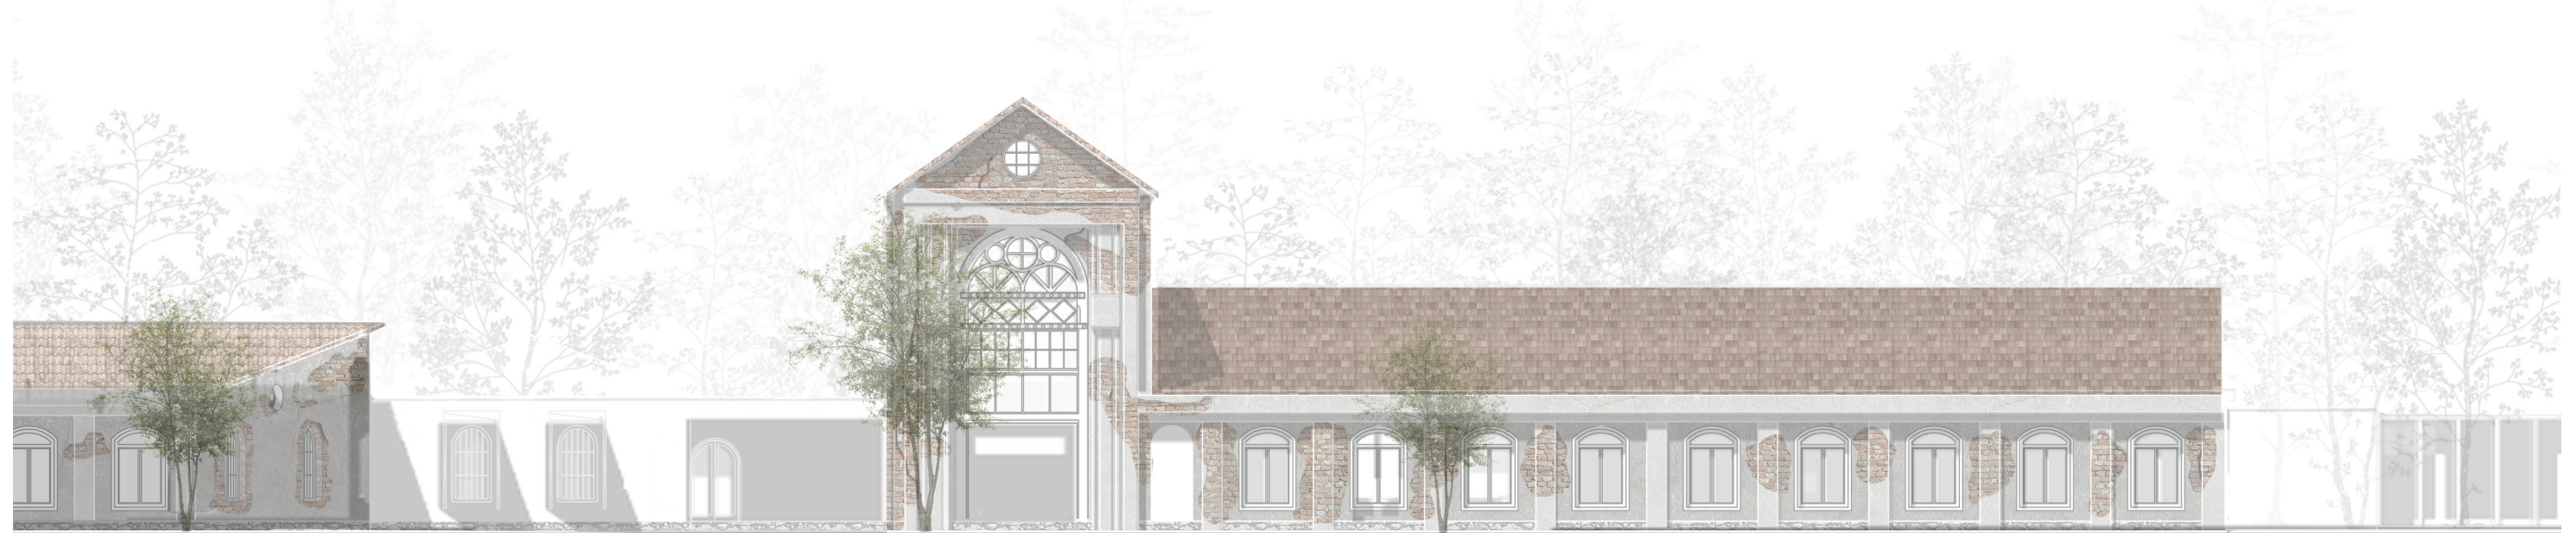
AFTER INTERVENTION

Area in focus, North elevation
