POLITECNICO DI TORINO

Master's Degree in Building Engineering

NUMERICAL ANALYSIS OF SEA CLIFF: THE CASE STUDY OF CERVO (IM)

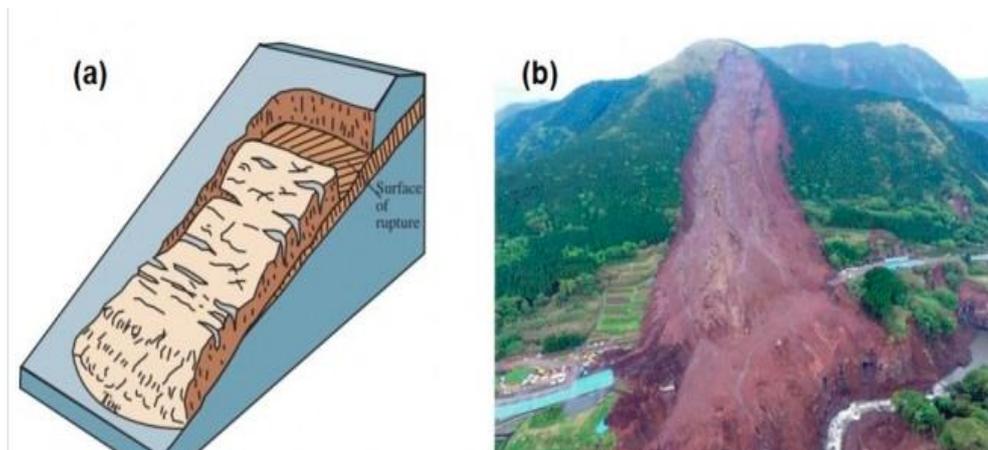
Figure 1.2.1.1 a) Illustration of a translational landslide (USGS, 2004) and b) Co-seismic translational landslide triggered in Japan in 2016 (Highland and Bobrowsky, 2018 by Khang Dang and Kyoji Sassa)

It takes place along a predefined flat surface with minimal or no ground rotation. Translational slides are primarily controlled by weak surfaces such as joints, bedding planes, or interaction of materials with different shear strength. Translational failures are frequently quick and can affect wide regions, posing considerable threats to infrastructure and safety.

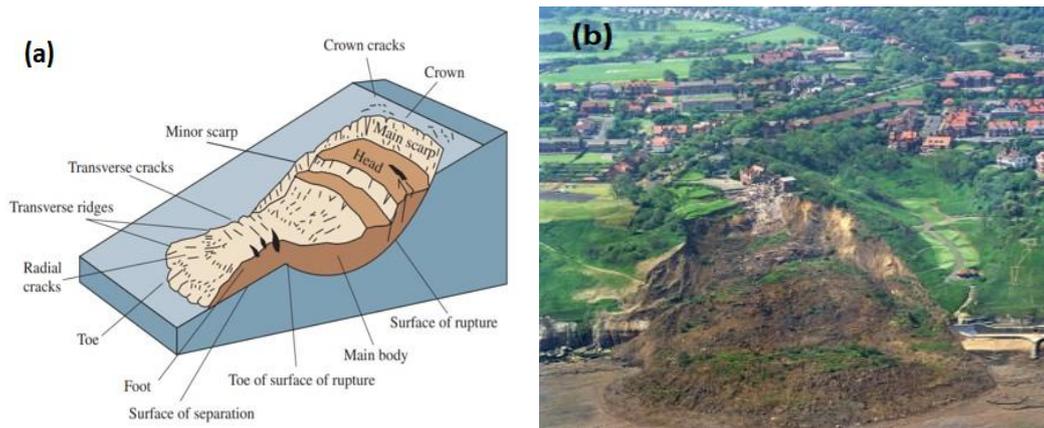
Figure 1.2.2.1 a) Illustration of a rotational landslide (USGS, 2004) and b) The rotational Holbeck Hall landslide in Scarborough North Yorkshire, England (June 1993)

Rotational failures are characterized by movement over a curved slip surface and are most common in homogenous, cohesive soils. This sort of failure produces a backward-rotating masses and is commonly found in soft clays and cohesive materials. The movement is frequently connected with ground shear failure, and its three-dimensional geometry is "spoon-shaped". (Refer Figure 1.2.2.1)

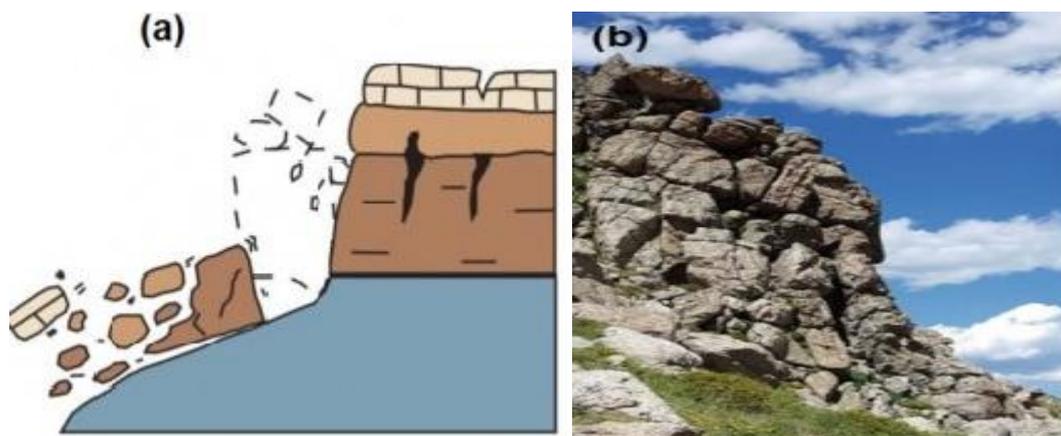
Figure 1.2.3.1 a) Illustration of a topple failure (USGS, 2004), b) Topple failures in granite boulders, Mount Evans, Arapaho National Forest, Colorado, U.S.A. (Highland and Bobrowsky, 2018)

This type of collapse occurs when rock columns rotate forward around a pivot point. It typically occurs on steep, jointed rock slopes with vertical or near-vertical discontinuities. Toppling failures are typical on coastal cliffs caused by undercutting by wave activity.

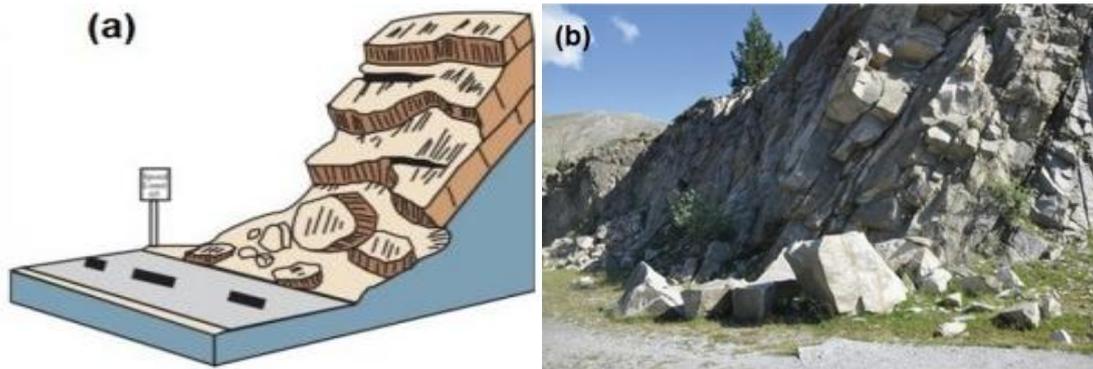
Figure 1.2.5.1 a) Illustration of a rockfall (USGS, 2004), b) Rockfall in Central Pyrenees, Spain (Corominas, 2017)

Rock falls happen when individual rock fragments separate from steep slope faces and fall or bounce downslope. This sort of breakdown is prevalent on coastal cliffs as a result of constant wave erosion and weathering, posing serious risks to those below. Falls are determined by the breaking strength of the discontinuous plane, which decreases with weathering from mechanical propagation and the existence of water. Once dislodged, a rock boulder will follow a certain trajectory determined by its size, shape, and the coverage material onto the slope. The movement type might be free-fall, bouncing, rolling, or a mix of those components.

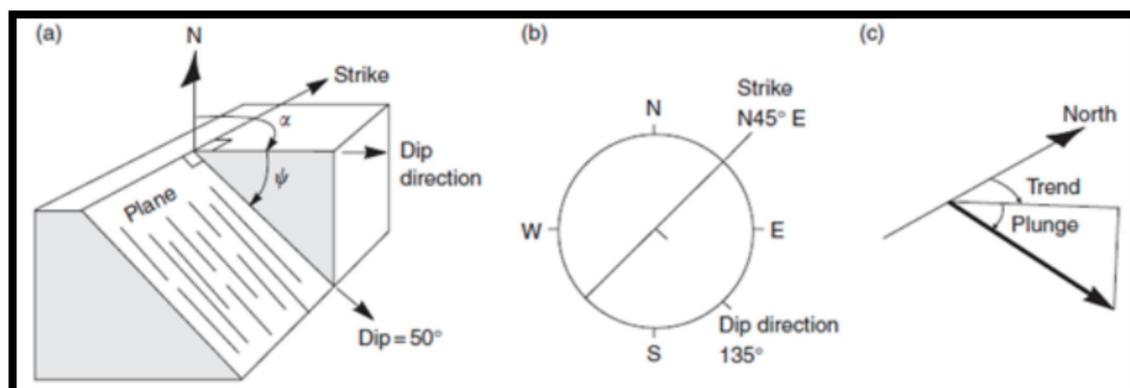
Figure 1.3.1.1 Terminology defining discontinuity orientation (a) isometric view of plane (dip and dip direction), (b) plan view of plane (c) isometric view of line (plunge and trend)

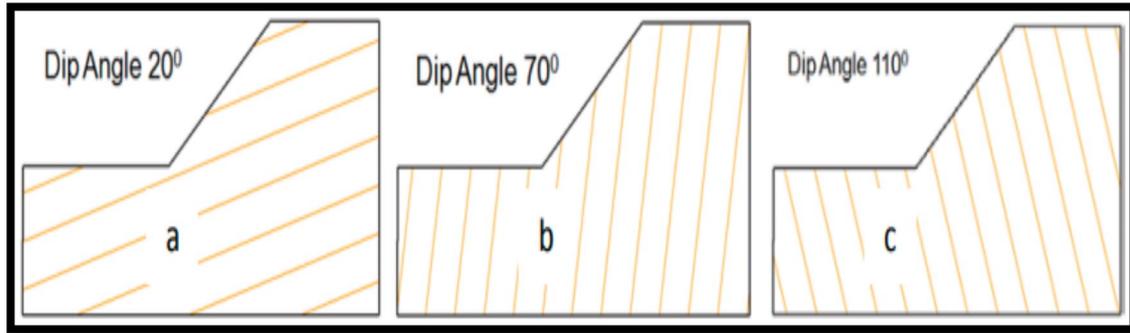
Figure 1.3.1.2 illustrates the effect of discontinuity orientation on the types of slope failure
<https://seismicconsolidation.com/wp-content/uploads/2020/03/factors-affecting-slope-failure-1.pdf>

The alignment of a large geological discontinuity in relation to an engineering component also influences the likelihood of unstable situations. The individual blocks' shapes are determined by the mutual orientation of discontinuities. A discontinuity's orientation is determined by its dip (highest incline to the horizontal) and dip direction (angle of discontinuity face with respect to North). The strike is at right angles to the dip direction, as shown in (Figure 1.3.1.1). Figure 1.3.1.2a Explain the likelihood of planar failure along a rock discontinuity, as the dip angle of discontinuity increases and becomes subparallel to the slope angle, the slope becomes rather stable (figure 1.3.2b). However, increasing the dip angle of the discontinuity makes it more prone to toppling failure. (figure 1.3.1.3c).

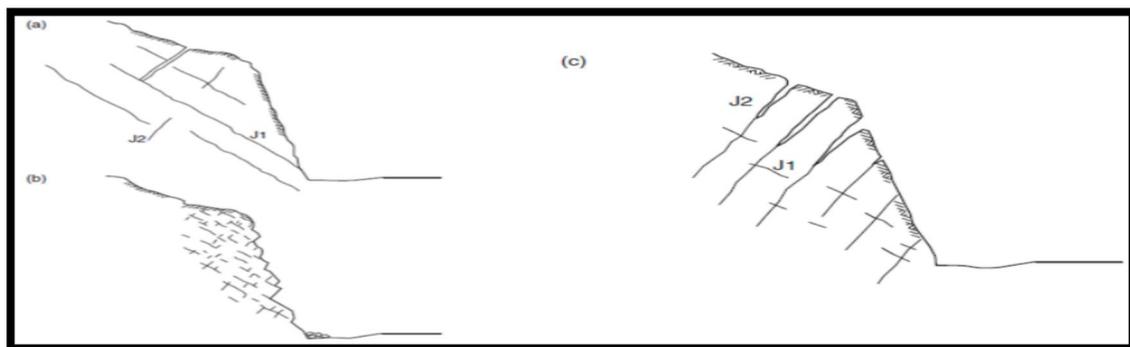
Figure 1.3.1.3 Effects of persistence on slope stability
<https://seismicconsolidation.com/wp-content/uploads/2020/03/factors-affecting-slope-failure-1.pdf>

The size of blocks able to slide from the face is determined by the persistence of discontinuities as well as the spacing. Furthermore, a tiny region of undamaged rock between low persistence discontinuities can have a favorable impact on stability since the strength of the rock is significantly increased.

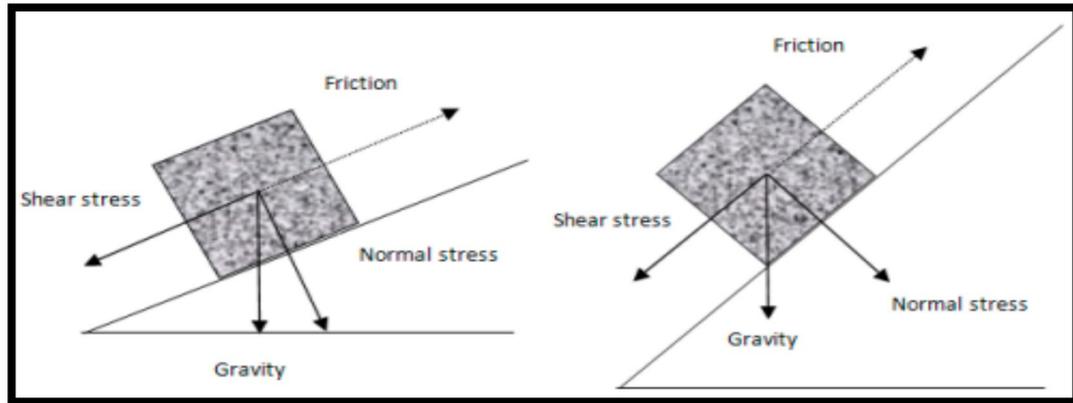
Figure 1.3.2.1 Effect of slope angle on slope stability

The height and inclination of the slope are important parameters in slope geometry that influence stability. The essential slope height is defined by the material's shear strength, density, and foundation bearing capacity. In general, slope stability decreases as slope height increases because the additional weight raises shear stress near the slope's toe. As the slope angle becomes steeper, tangential stress increases, resulting in stability.

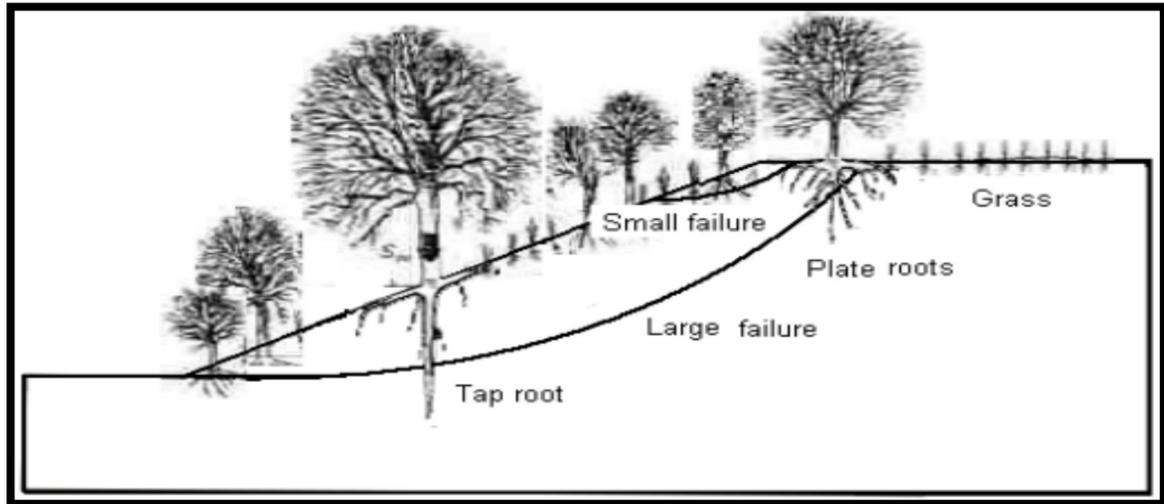
Figure 1.3.4.1 Mechanisms of root reinforcement of grass plants and tree
<https://seismicconsolidation.com/wp-content/uploads/2020/03/factors-affecting-slope-failure-1.pdf>

Plant roots provide a robust network that stabilizes unconsolidated soil, prevents erosion, and removes water, increasing shear strength. Although the weight of vegetation can marginally destabilize slopes with weak roots, vegetation generally improves slope stability. (Coppin and Richards, 1990) Grasses develop rapidly but possess shallow roots; herbs (a leafy green parts of plant) possess deeper roots but are more difficult to maintain; shrubs have deep roots and require little maintenance; and trees have strong roots but grow slowly. The efficiency of vegetation is determined by local circumstances such as slope, hydrology, and type of ground (soil or rock). Removing vegetation can cause higher erosion and slope instability.

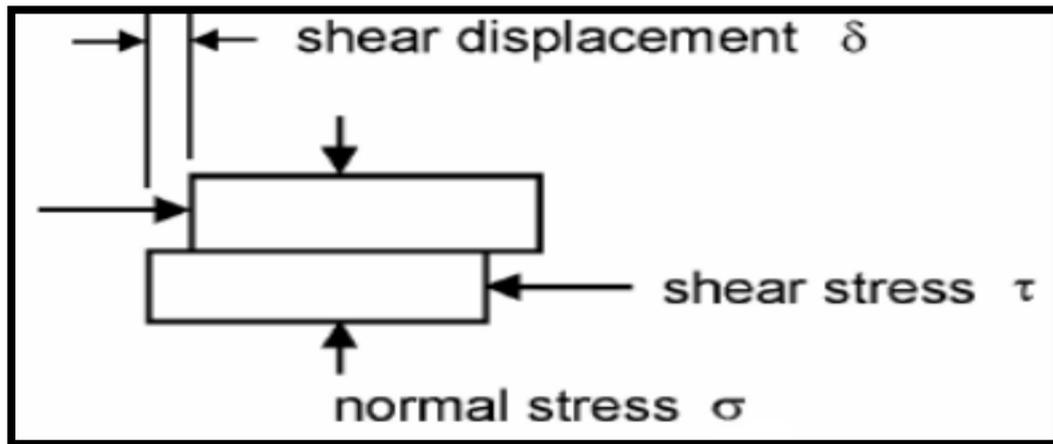
Figure 1.3.5.1 Shear testing of discontinuities or between two plane
<https://seismicconsolidation.com/wp-content/uploads/2020/03/factors-affecting-slope-failure-1.pdf>

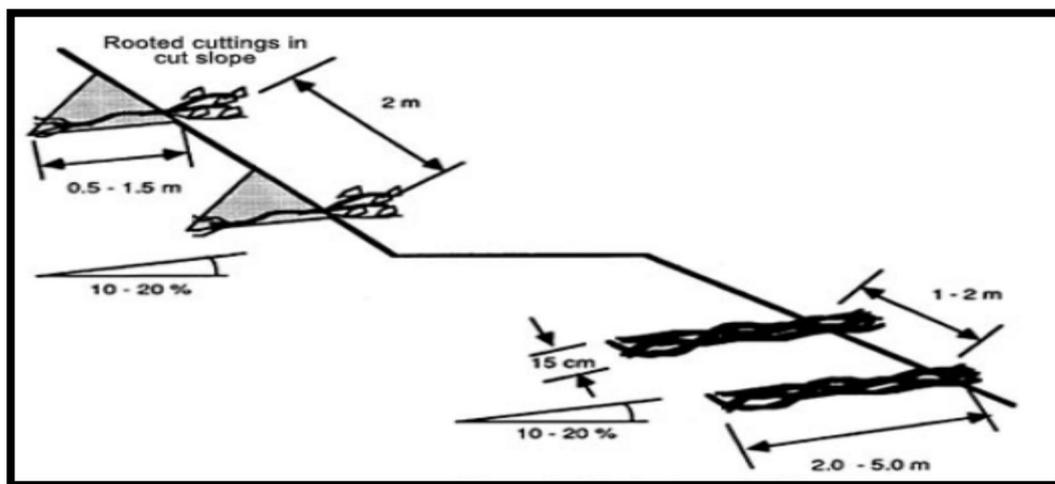
Figure 1.4.1.1 Compacted Bush Layers in Fills
<https://www.fao.org/4/t0099e/T0099e05.htm>

Contour brush stacking (Figure:1.4.1.1) is the process of placing live shrub or tree branches in successive horizontal rows along a slope. It can be observed that:

1. Installing branches perpendicular to the slope contour, rather than parallel, improves the resistance to shallow shear failures.
2. Staking is unnecessary.

3. The brush's layers and surfaces can be reinforced using wire mesh or other materials.
4. Brush layers are able to use throughout the fill building process. In this technique, brush layers are deposited, which is followed by a layer of dirt that is distributed and compacted. The cycle is repeated as needed.

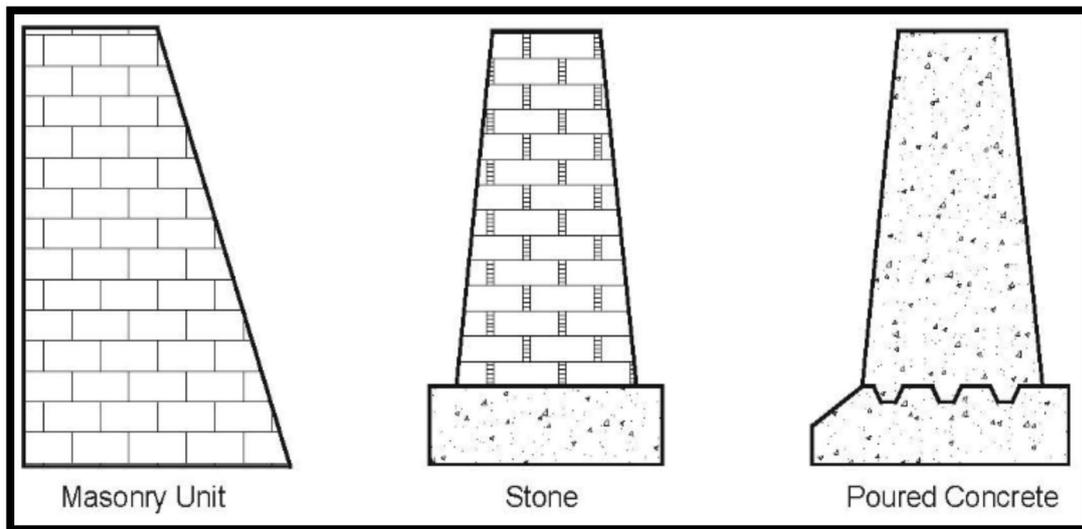
Figure 1.4.2.1 Types of retaining walls
<https://www.fao.org/4/t0099e/T0099e05.htm>

- Support structures include retaining walls, piles, buttresses, counterweight fills, crib walls, bin barriers, reinforced soil, and soil or rock anchors that are pre-stressed or post-tensioned (Figure 1.4.2.1).

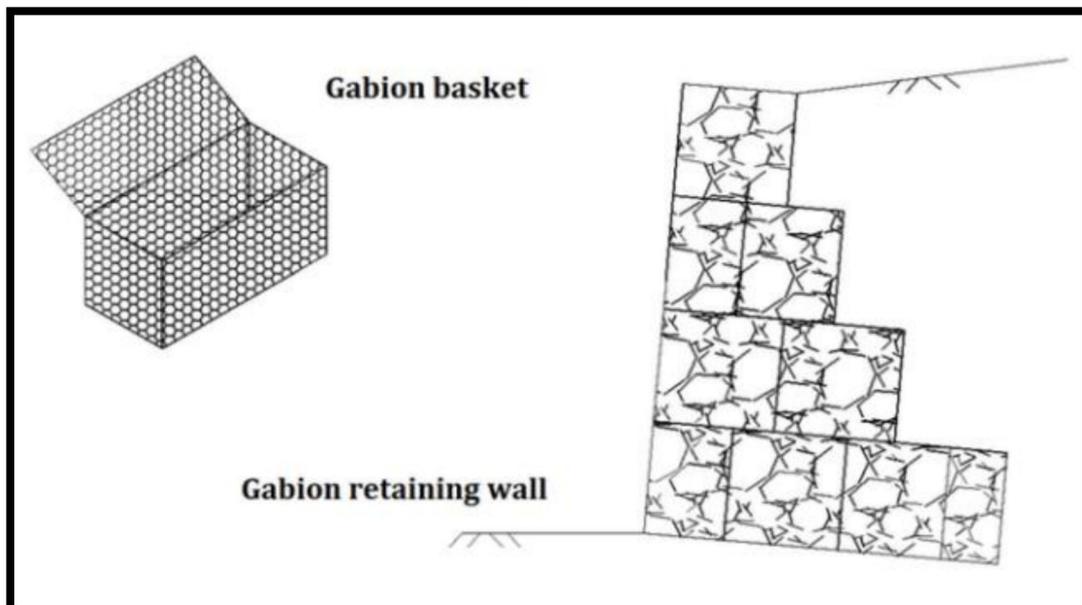
Figure 1.4.2.2 Gabion wall
<https://www.fao.org/4/t0099e/T0099e05.htm>

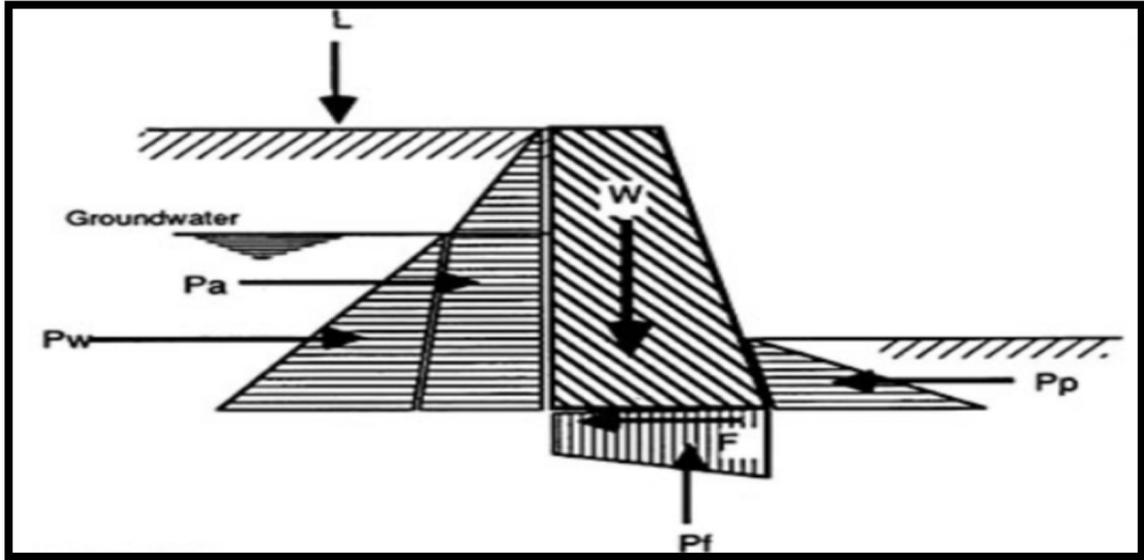
Figure 1.4.2.3 Forces on retain wall structures,
<https://www.fao.org/4/t0099e/T0099e05.htm>

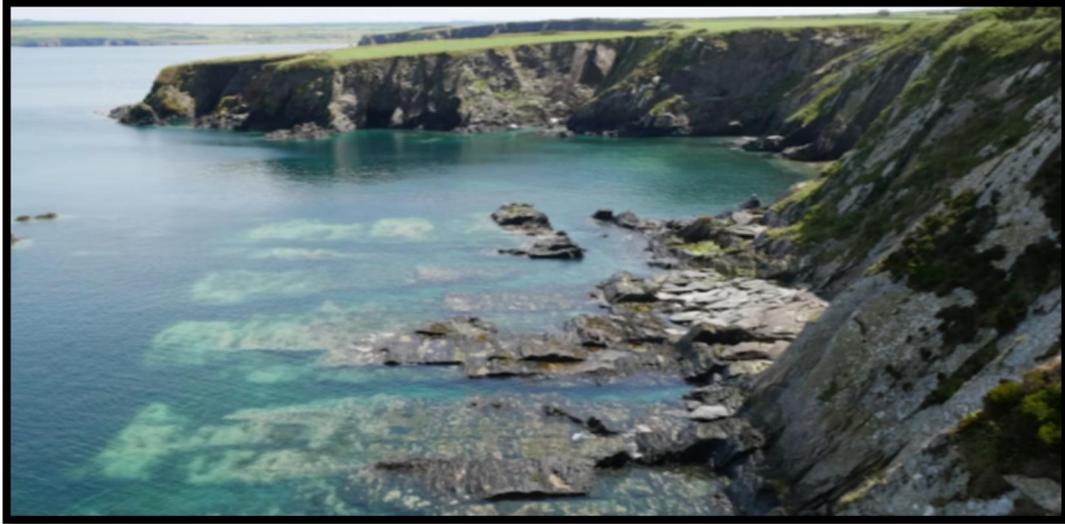
Figure 2.1 Erosion undercuts the foundation of the cliff(Alan,2016)

Coastal erosion causes the formation of cliffs. Weathering degrades the rock, erosion undercuts the foundation of the cliff, and mass movement transports debris down to the shore. (Refer Figure 2.1)

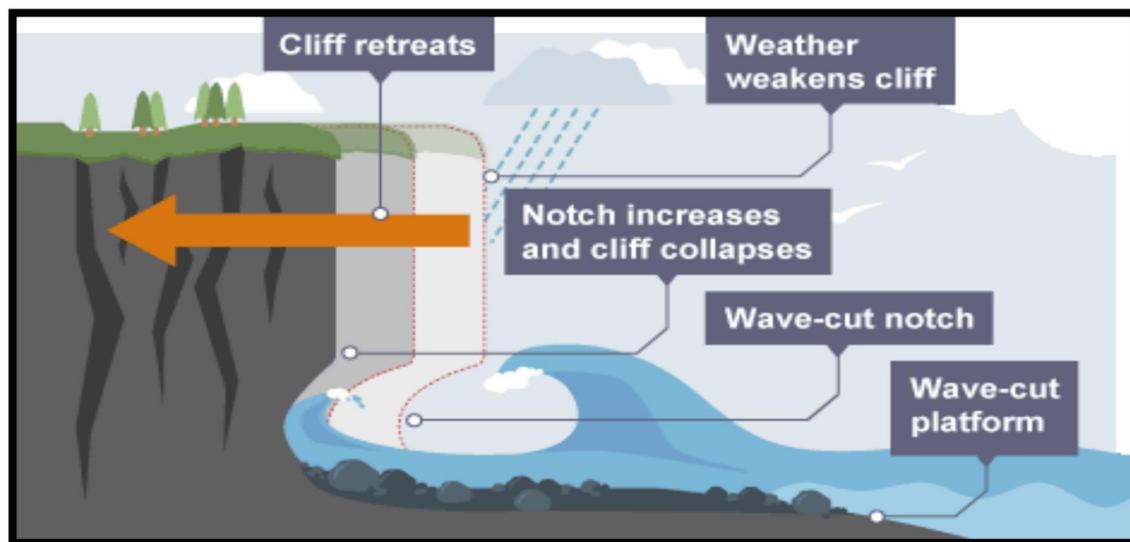
Figure 2.1 Degradation of Coastal Cliff
<https://quizlet.com/gb/219421903/formation-of-wave-cut-platforms-diagram/>

As the cliff recede, it creates a wave-cut platform that is frequently submerged at high tide. This is the cliff's old base. Areas of the wave-cut platform will be relatively smooth owing to abrasion from the waves that enter, while other areas will be considerably more rough and maybe coated in algae with barnacles.

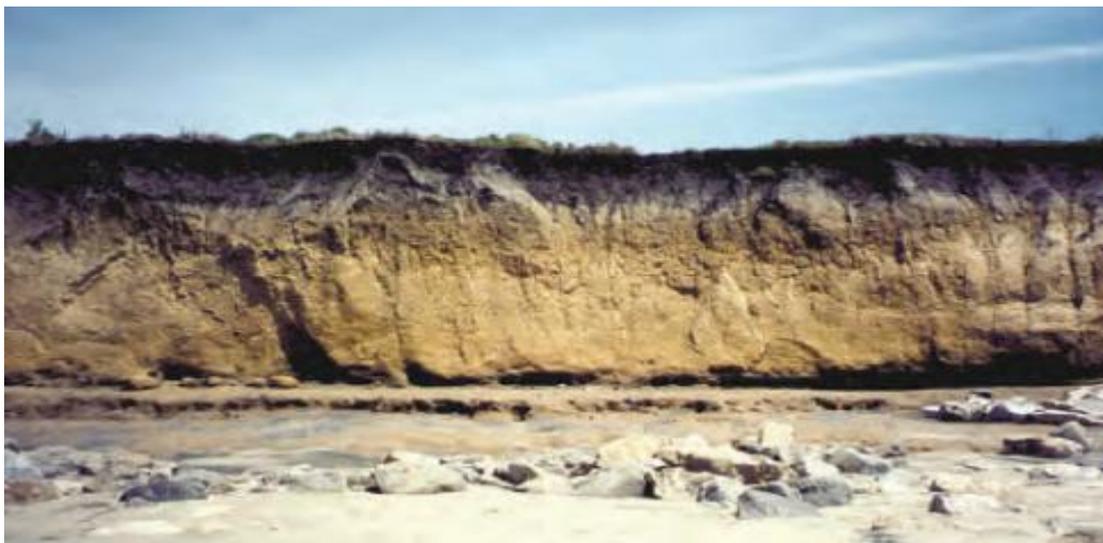
Figure 2.3.2.1 Ground-water discharge at the base of a coastal cliff that is underlain by impermeable rock has eroded a low notch, which undercuts and potentially destabilizes the cliff. Cliff is about 3 m high.
<https://pubs.usgs.gov/pp/pp1693/pp1693.pdf>

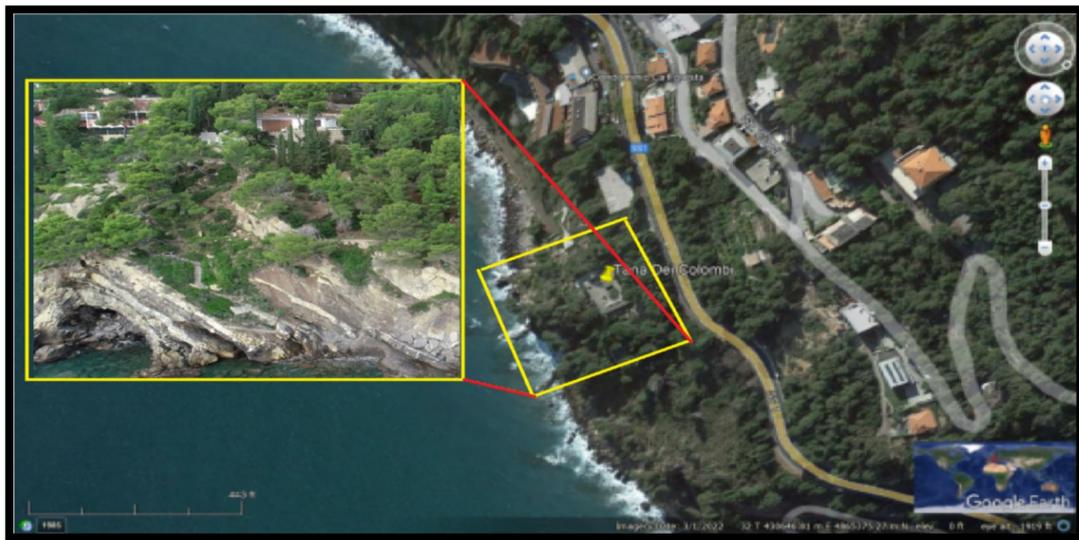
Figure 3.1.1.1 Site view of Case Study affected area(Scarpati,2023)

Due to the high erosion and decaying of notch depth, the risk of landslides in this area posed a serious threat to human life. Therefore, it was necessary to investigate the slope stability and forecast the upcoming landslide in order to ensure the safety of those traveling through this route.

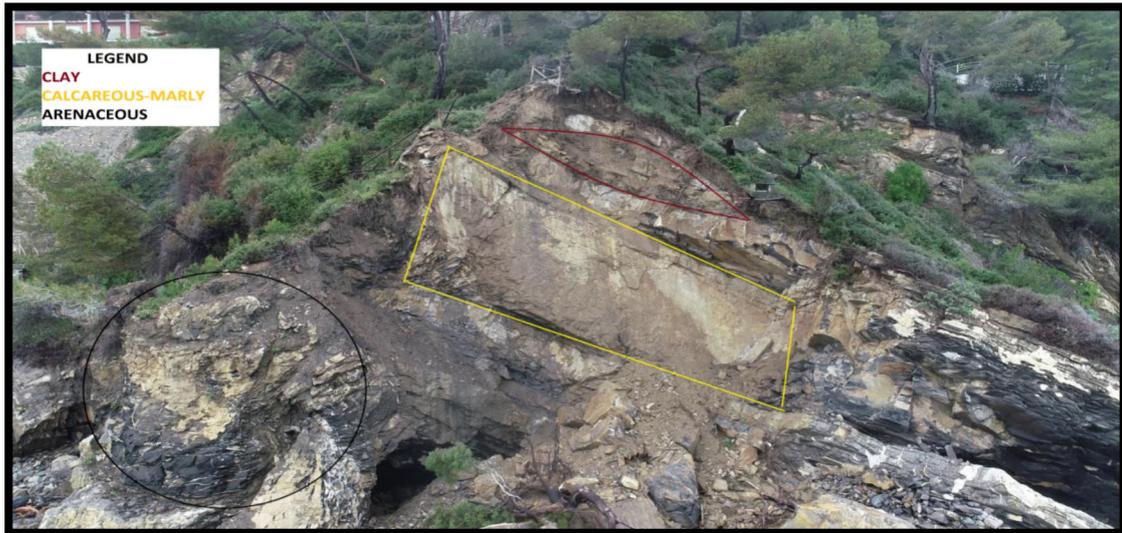
Figure 3.1.3.1 Layer formation (Scarpati,2024)

The lithological nature of the rock mass (flysch), consisting of an alternation of calcareous-marly (tough), arenaceous (tough) and clayey layers (tender), creates erratic erosion, with the formation of cavities and inlets (refer Figure: 3.1.3.1), where the softer clay lithotypes are removed from the wave motion), and overhanging rocky banks where the most tenacious lithotypes resist greater resistance to wave energy.

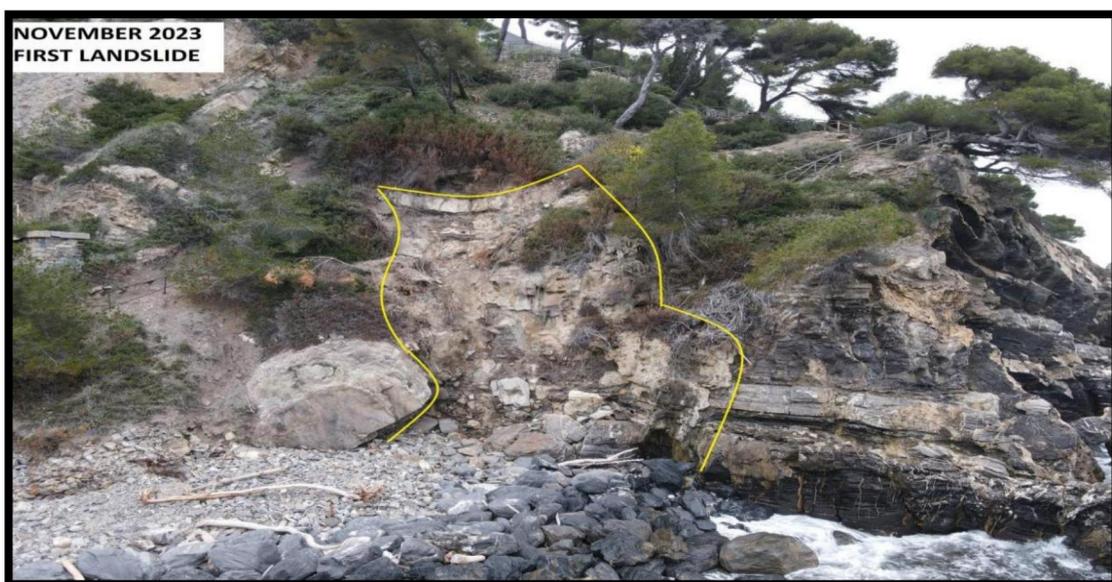
Figure 3.1.3.2 Marked first landslide occurred in November 2023 (Scarpati,2023)

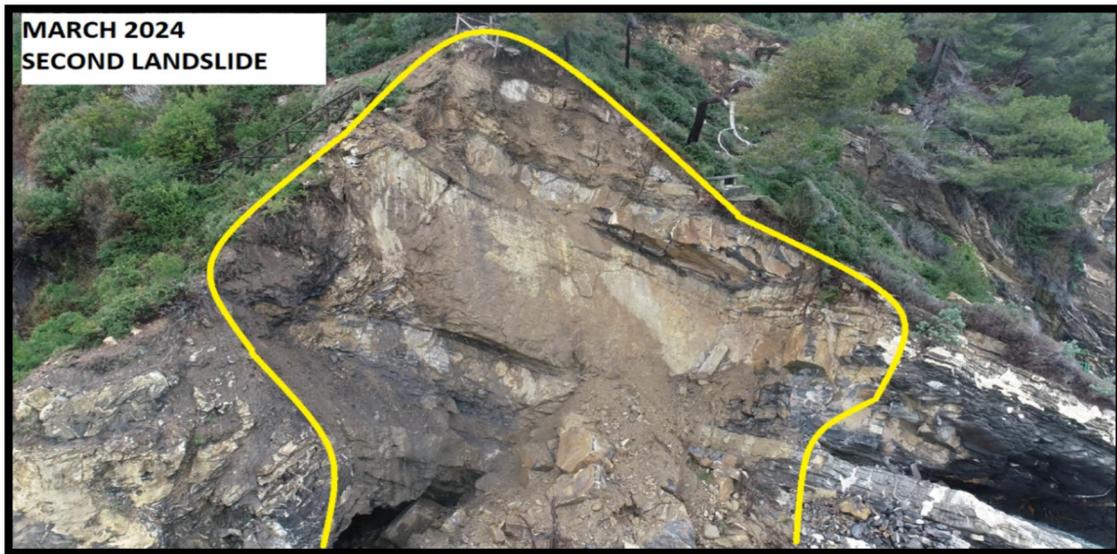
Figure 3.1.3.3 Marked second landslide occurred in March 2024 (Scarpati,2024)

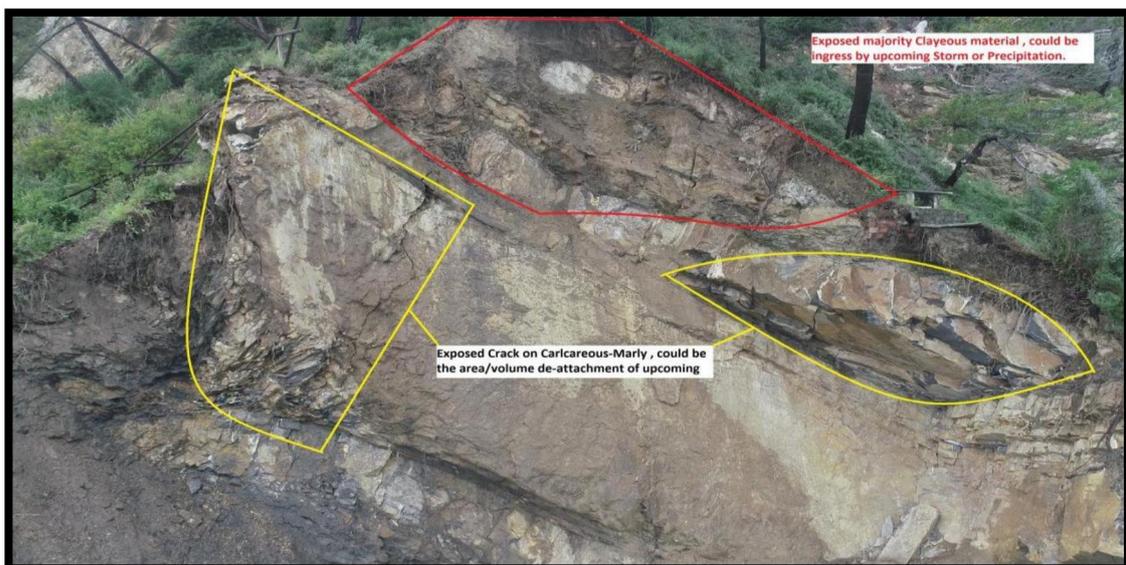
Figure 3.1.3.4 Causes for Upcoming Landslide.(Scarpati,2024)

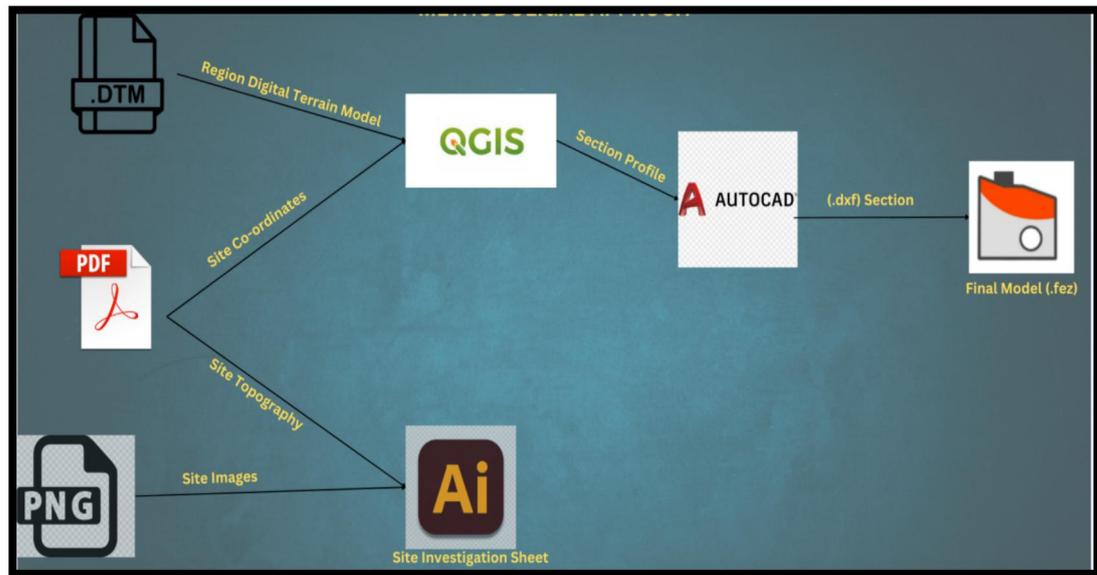
Figure 3.1.3.1 Methodological Approach for Numerical Analysis

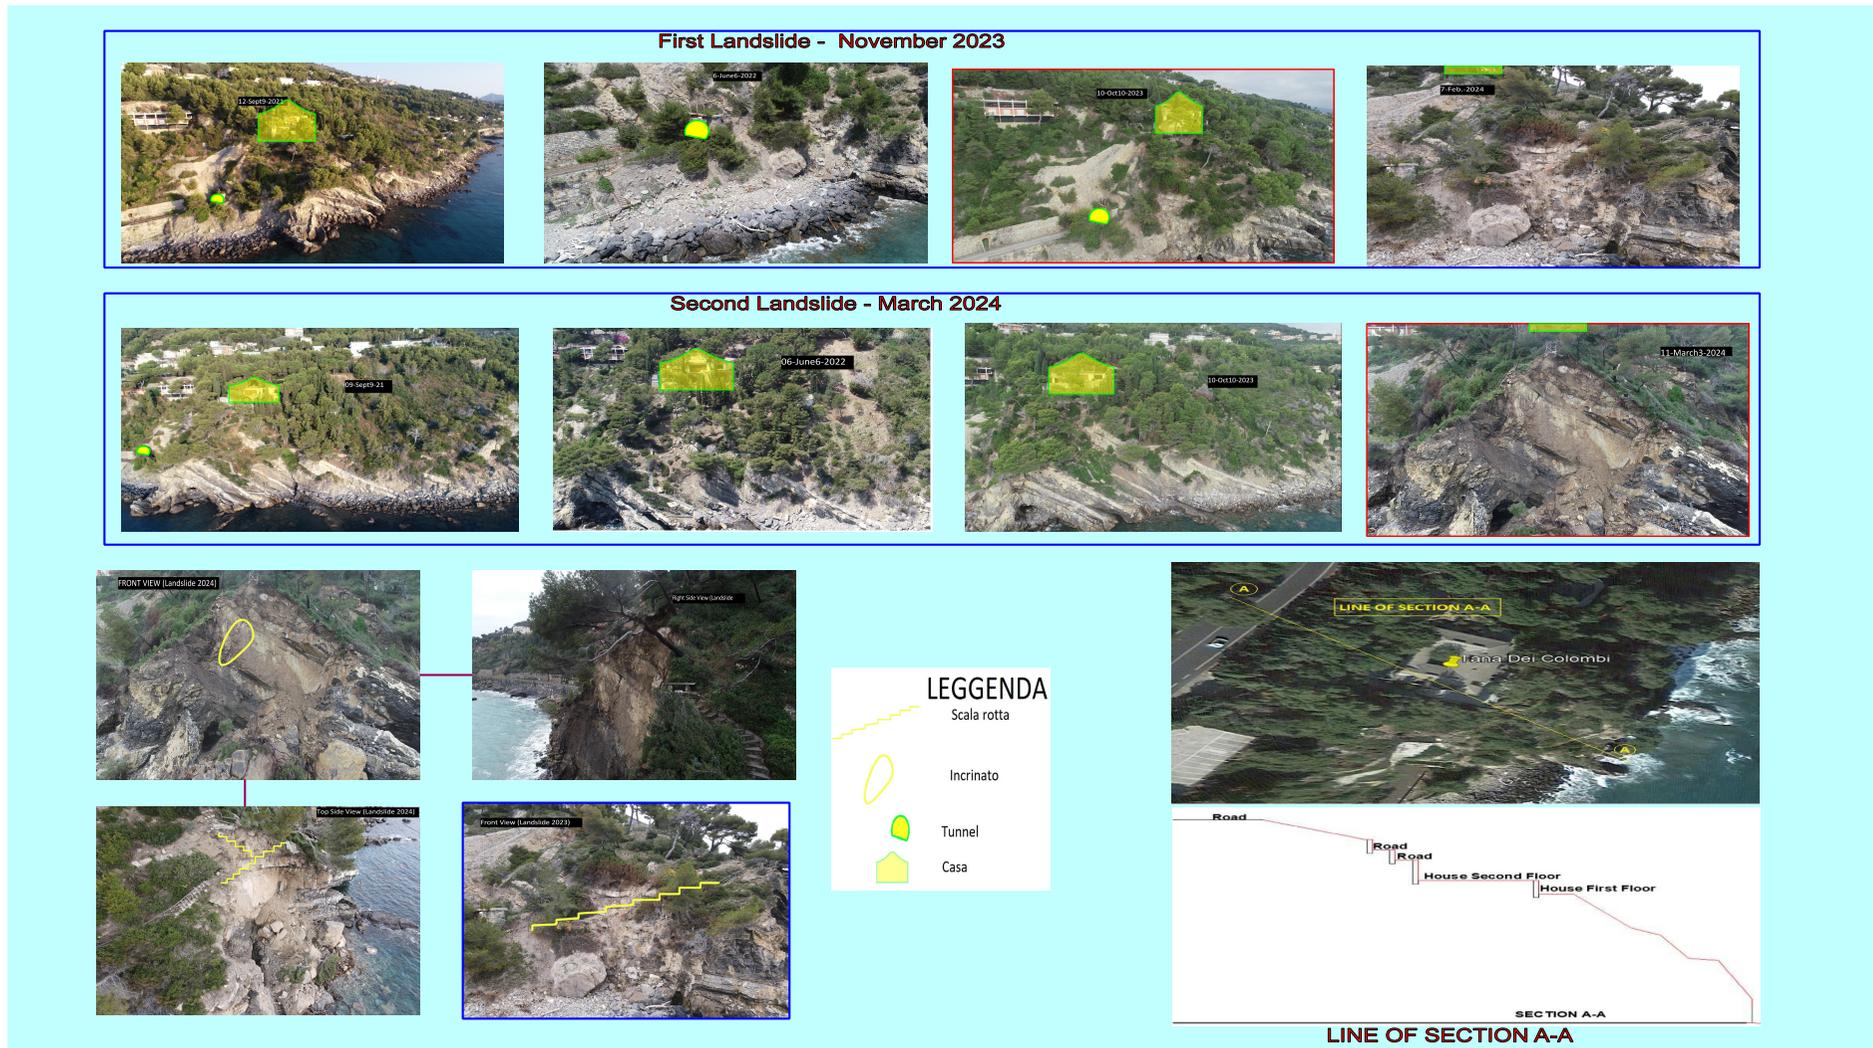
Figure 3.1.3.2 Site Landslide Tracking for over 4 years' time frame w-e-f 2021

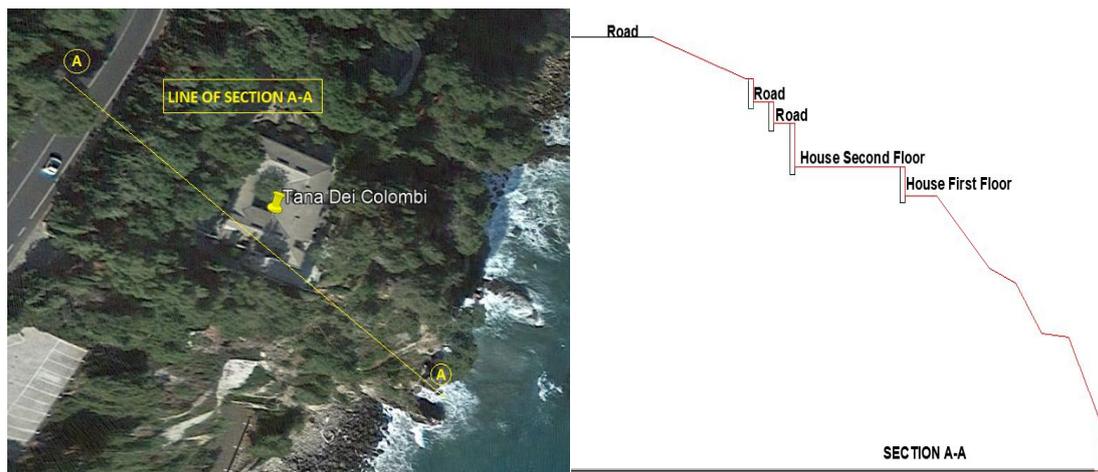
Figure 3.2.2.1 Line of Section & Section A-A considered for analysis

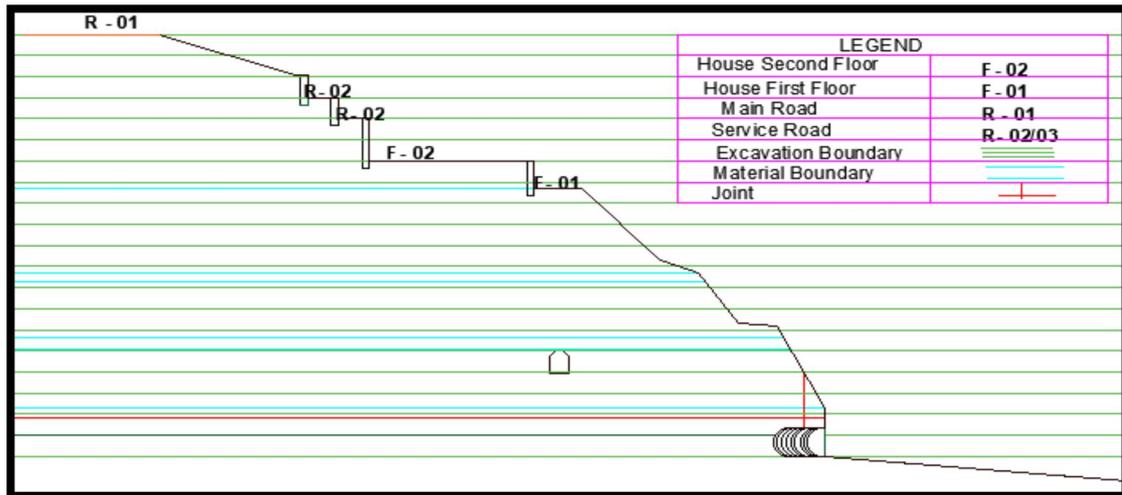
Figure 3.2.2.2 Updated section with multiple layers

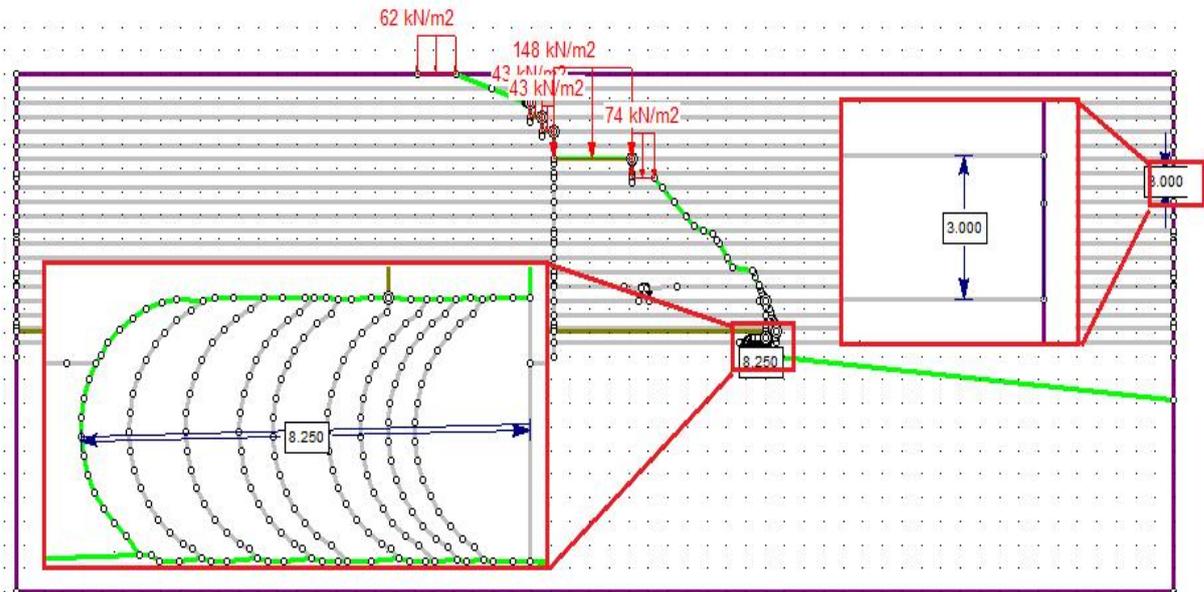
Figure 3.3.3.1 Stage boundary width for Notch-depth & Excavation

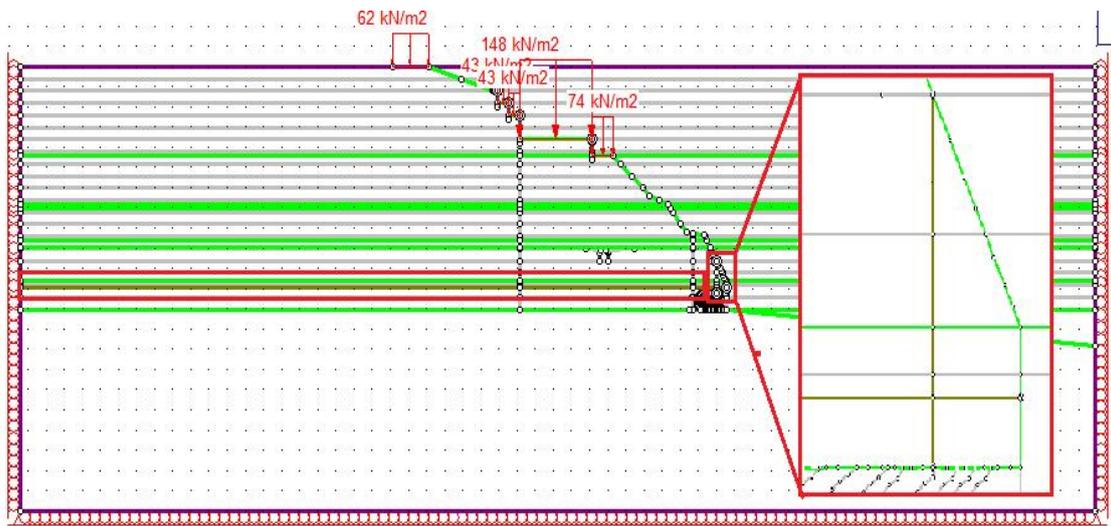
Figure 3.3.4.1 Highlights Joints & magnify the vertical joint along with dimensions

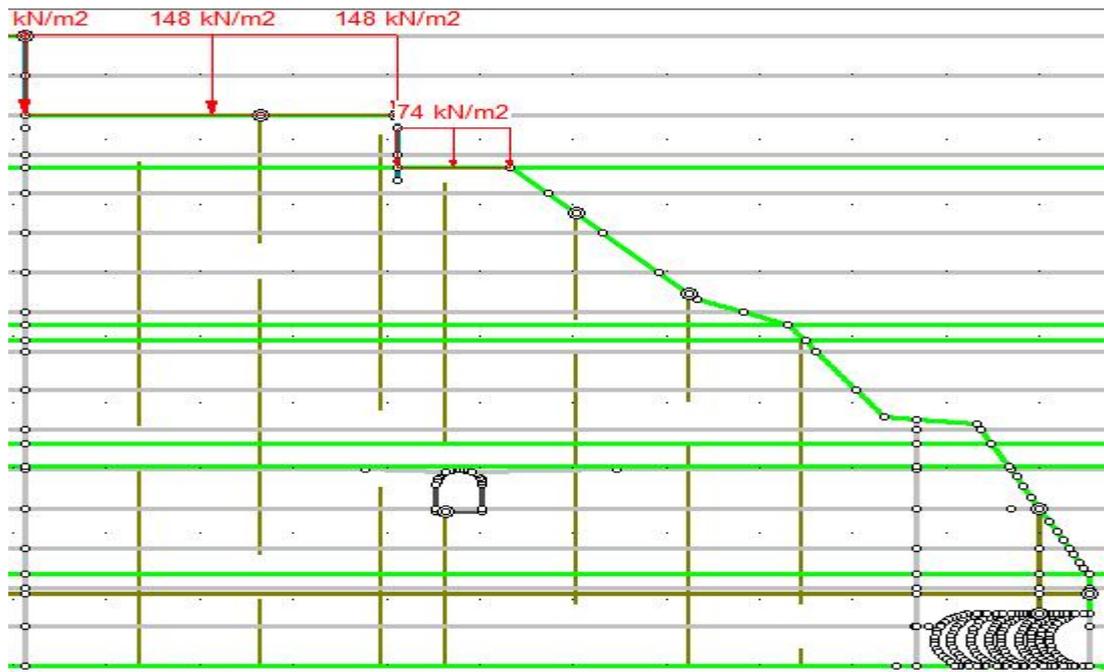
Figure 3.3.4.2 Desired Area b/w house & notch end for Joints Network

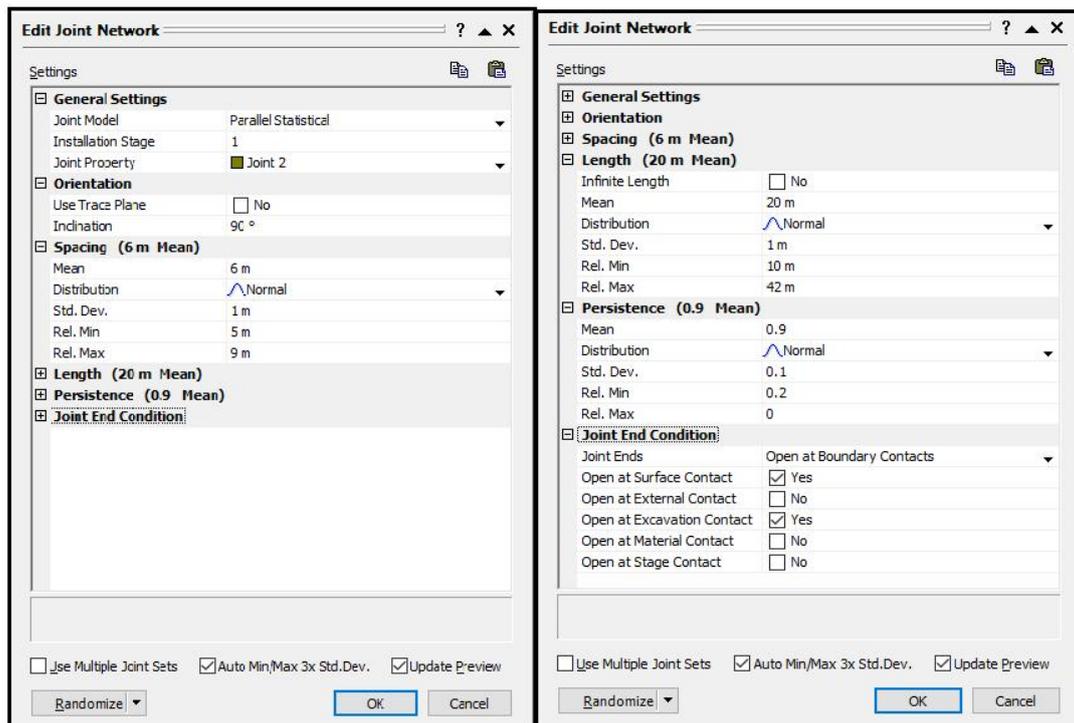
Figure 3.3.4.3 Selected properties of Joint Network

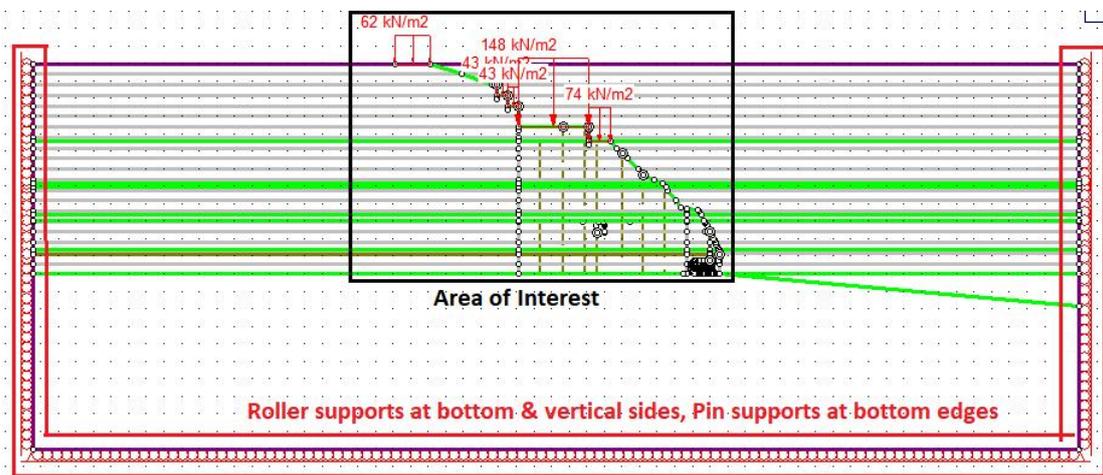
Figure 3.3.5.1 Highlighted the Area of Interest and the boundary constrains

(Refer Figure 3.3.5.1)

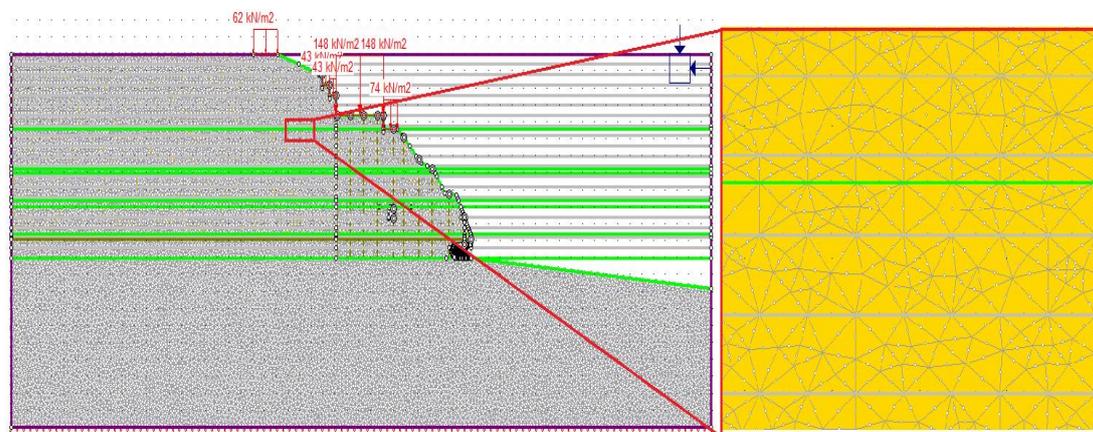
Figure 3.3.7.1 Mesh applied on section & magnify view of 6-Noded Triangle

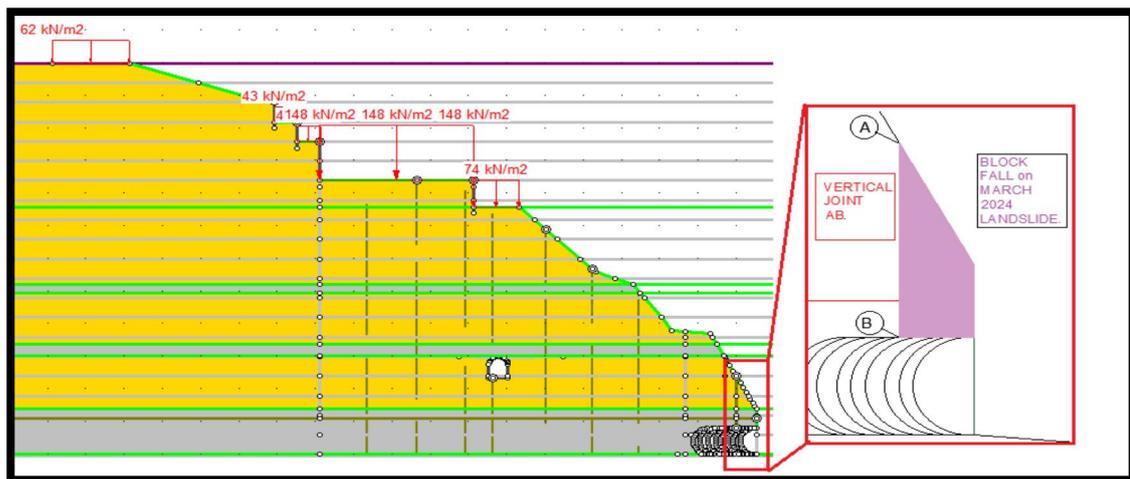
Figure 4.1.1.1 Pre-Failure Section extracted from QGIS via Digital Terrain Model of (2017).

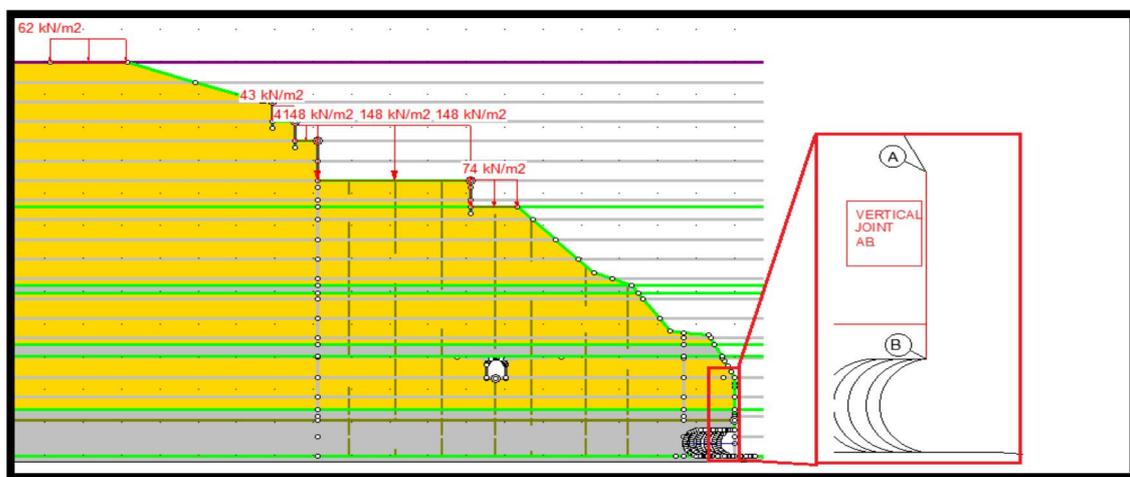
Figure 4.1.1.2 Post-Failure Section after observing photographs and pre-failure section.
