POLITECNICO DI TORINO

Master's Degree in Building Engineering

NUMERICAL ANALYSIS OF SEA CLIFF: THE CASE STUDY OF CERVO (IM)

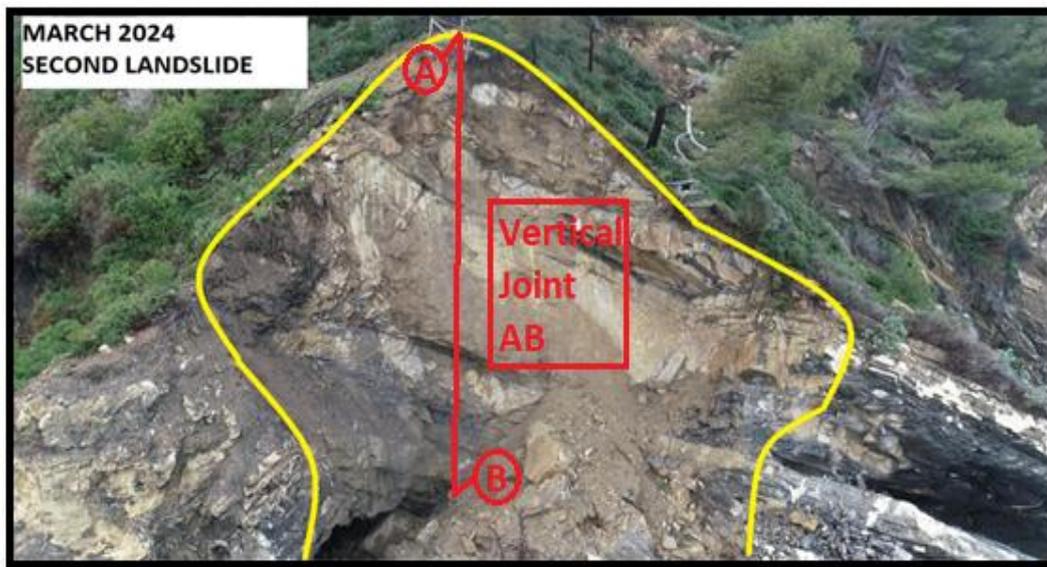
Figure 4.1.1.3 Photo of 2024 Landslide Block (Scarpati,2024)

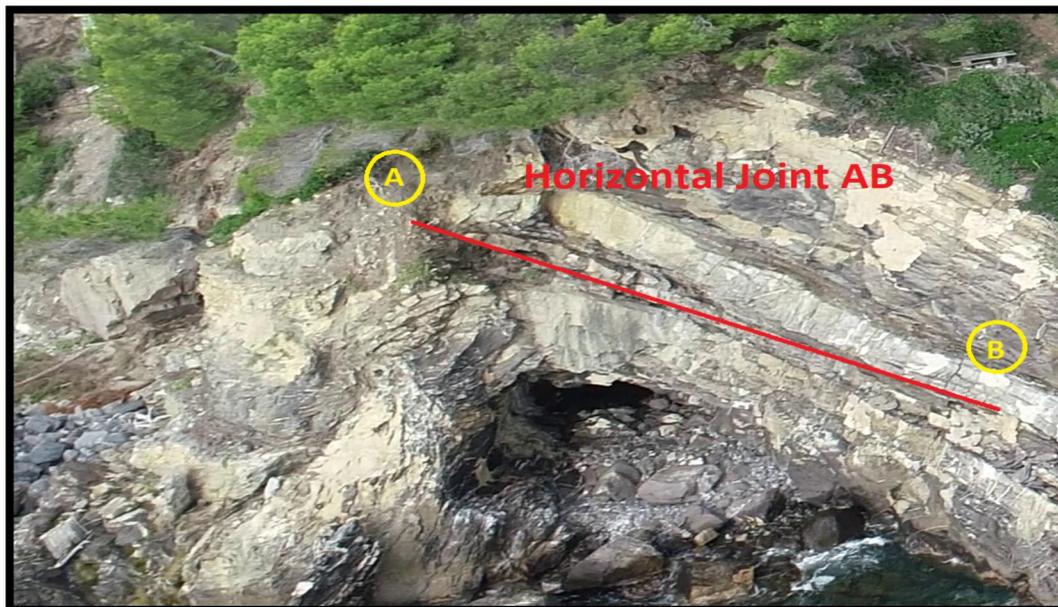
Figure 4.1.1.4 Photo before March 2024 landslide (Scarpati ,2024)

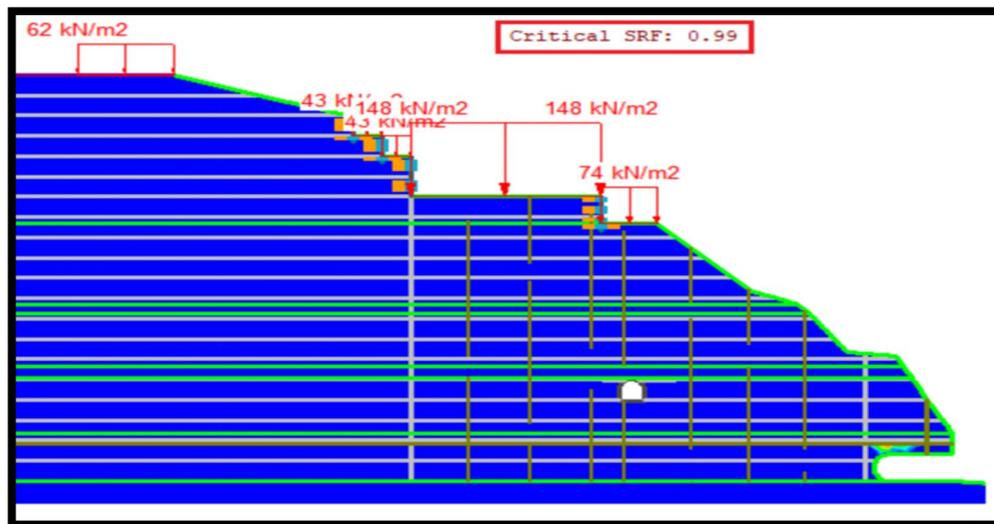
Figure 4.1.4.1 Critical S.R.F for Back Analysis

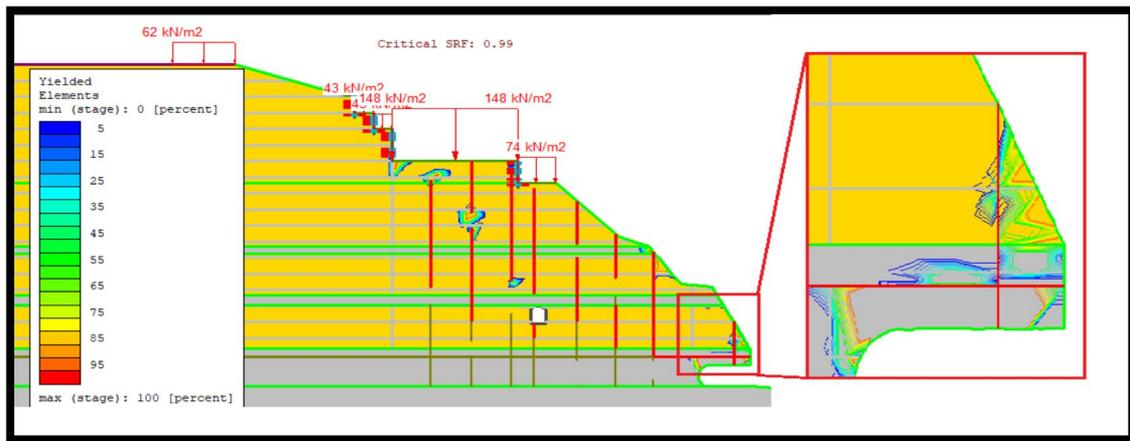
Figure 4.1.4.2 Appearance of Yield Element near the March 2024 Landslide

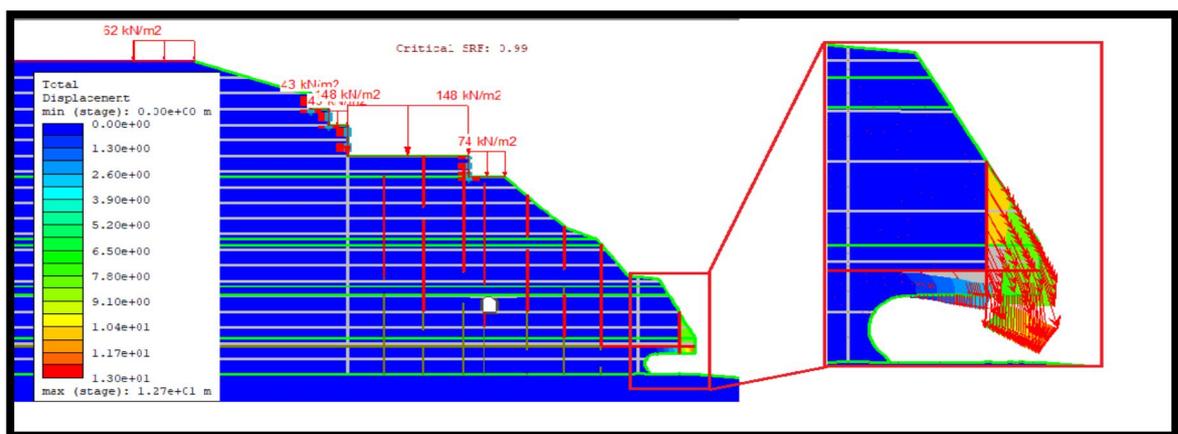
Figure 4.1.4.3 Total Displacement and Detachment of Block

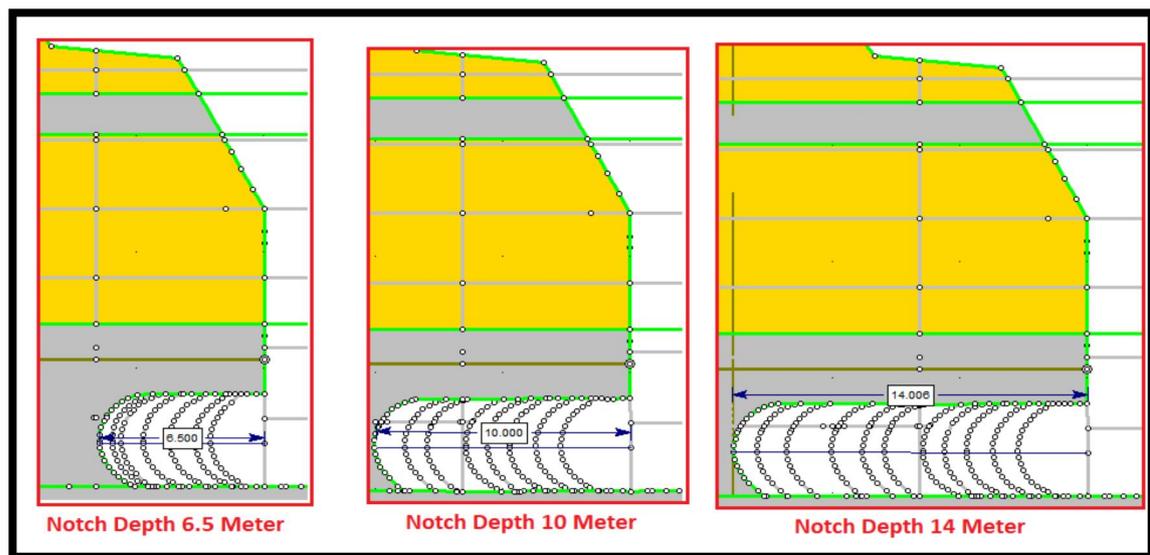
Figure 4.1.4.1 Three model with 3 different notch depth , with a persistent horizontal joint.

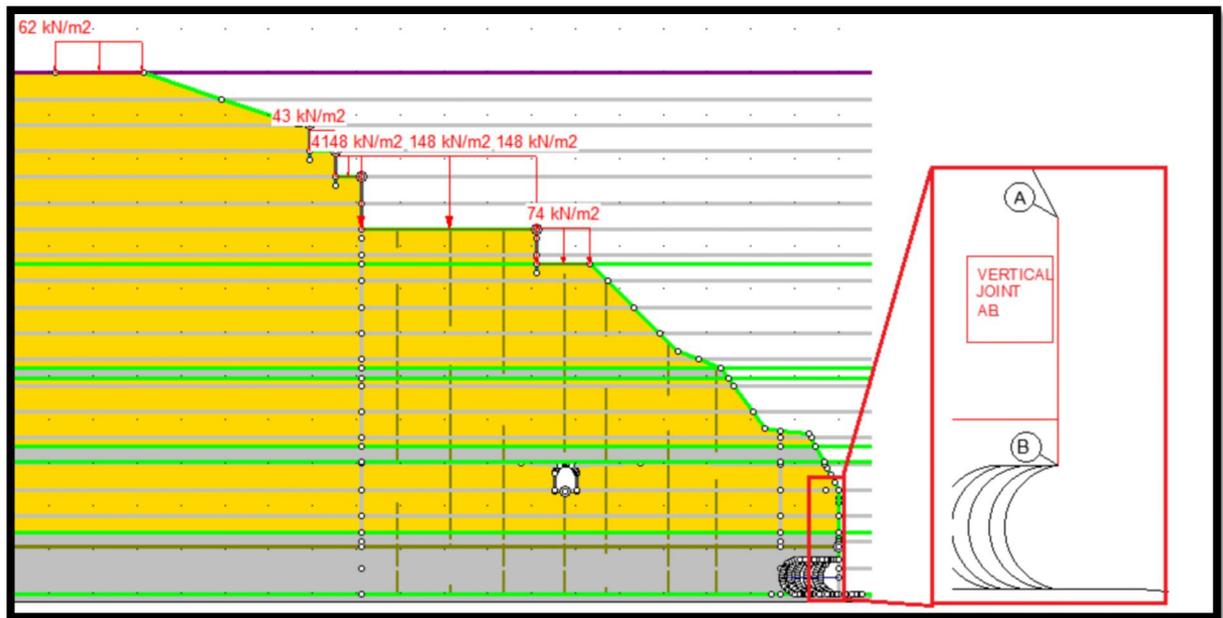
Figure 4.2.1.1 Baseline Model for Forecasting analysis

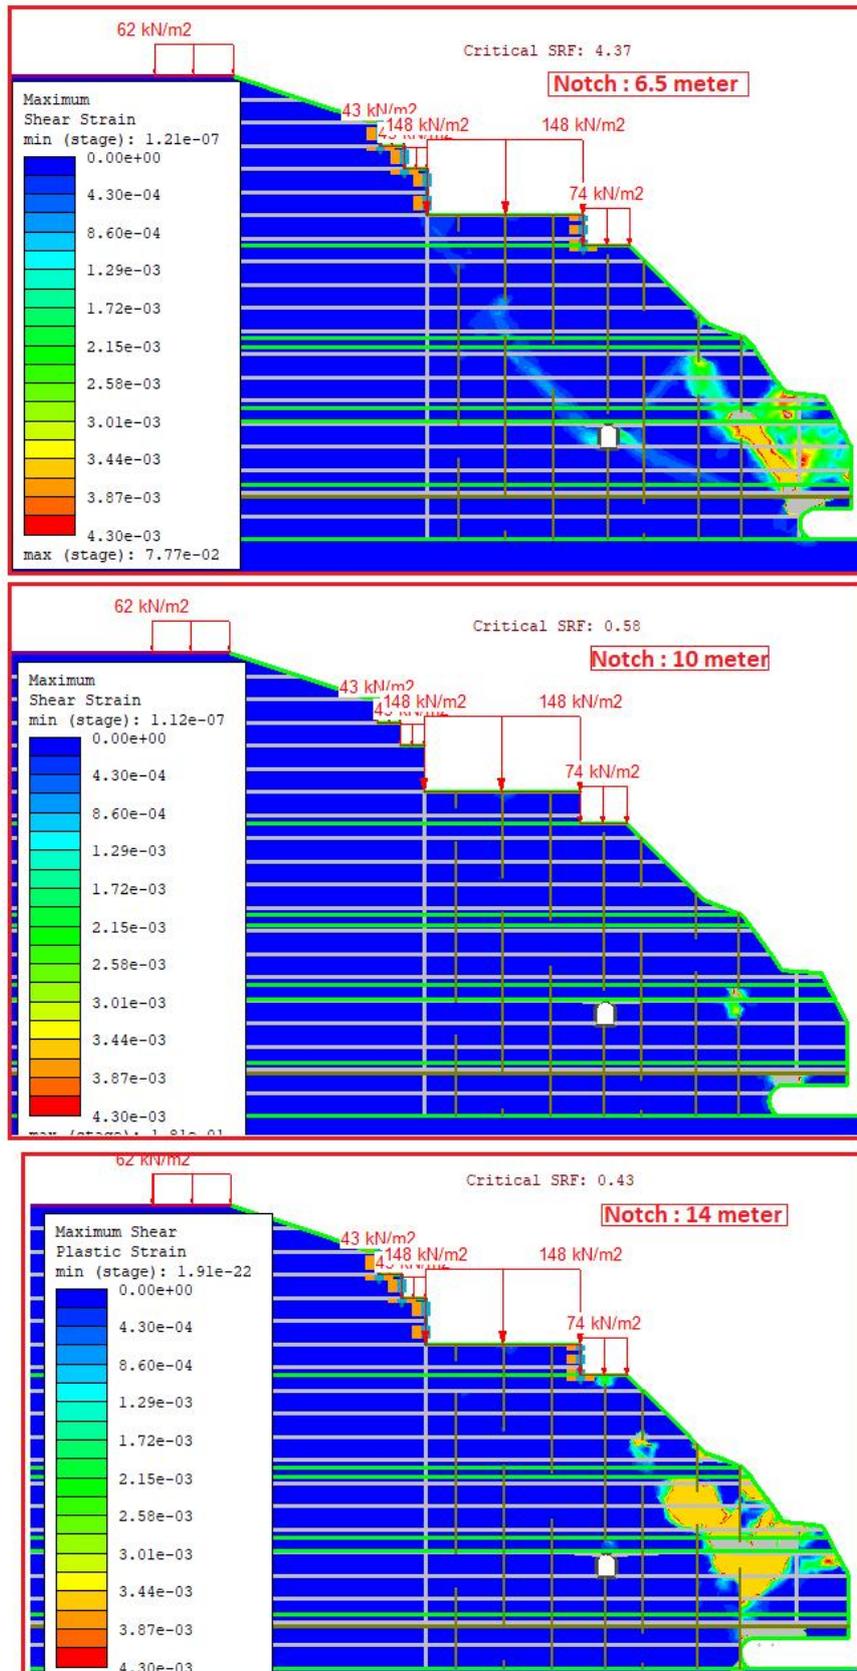
Figure 4.2.2.1 At S.R.F = 1 , Maximum Plastic Shear Strain

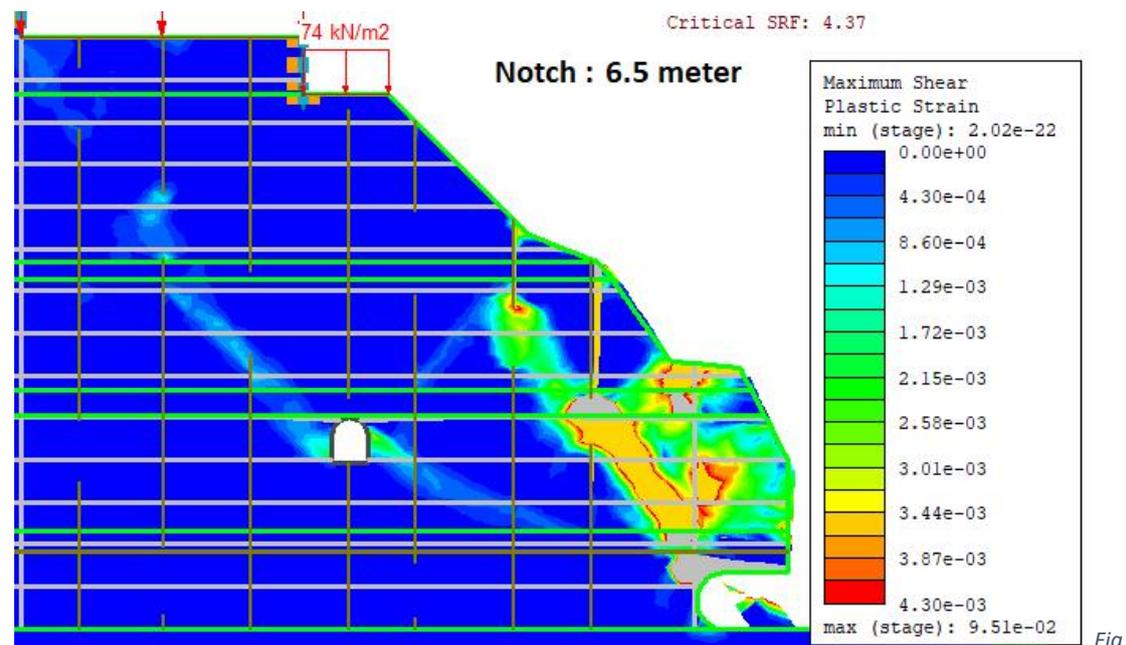
Figure 4.2.2.2 Limit Equilibrium of 6.5 notch depth model in terms of Maximum Plastic Shear Strain

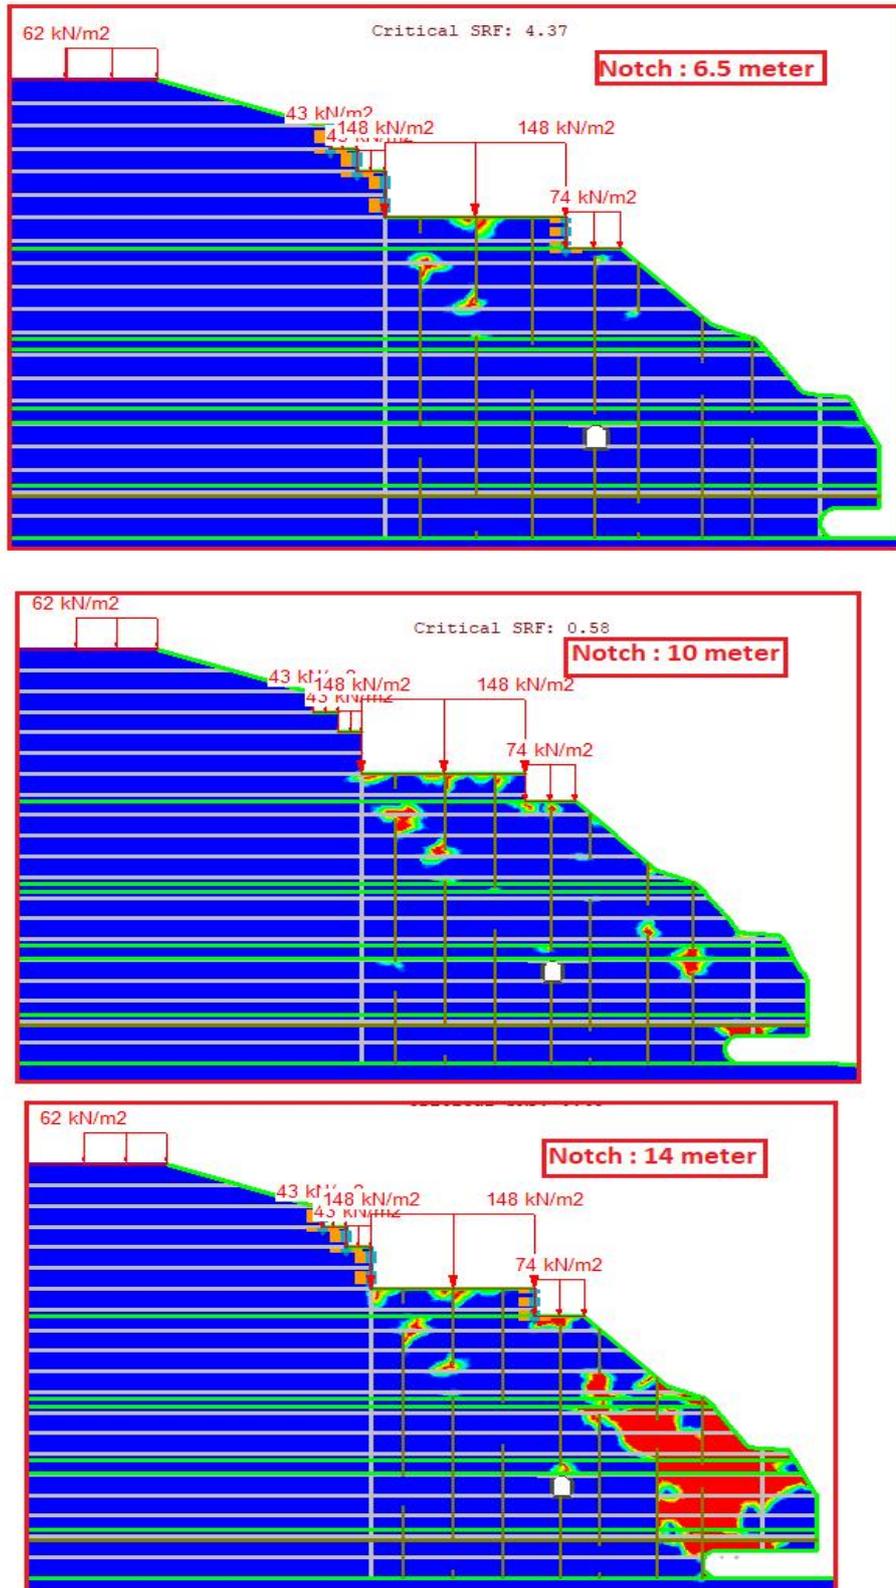
Figure 4.2.2.3 At S.R.F = 1 , Yield Element of 3 different notch model

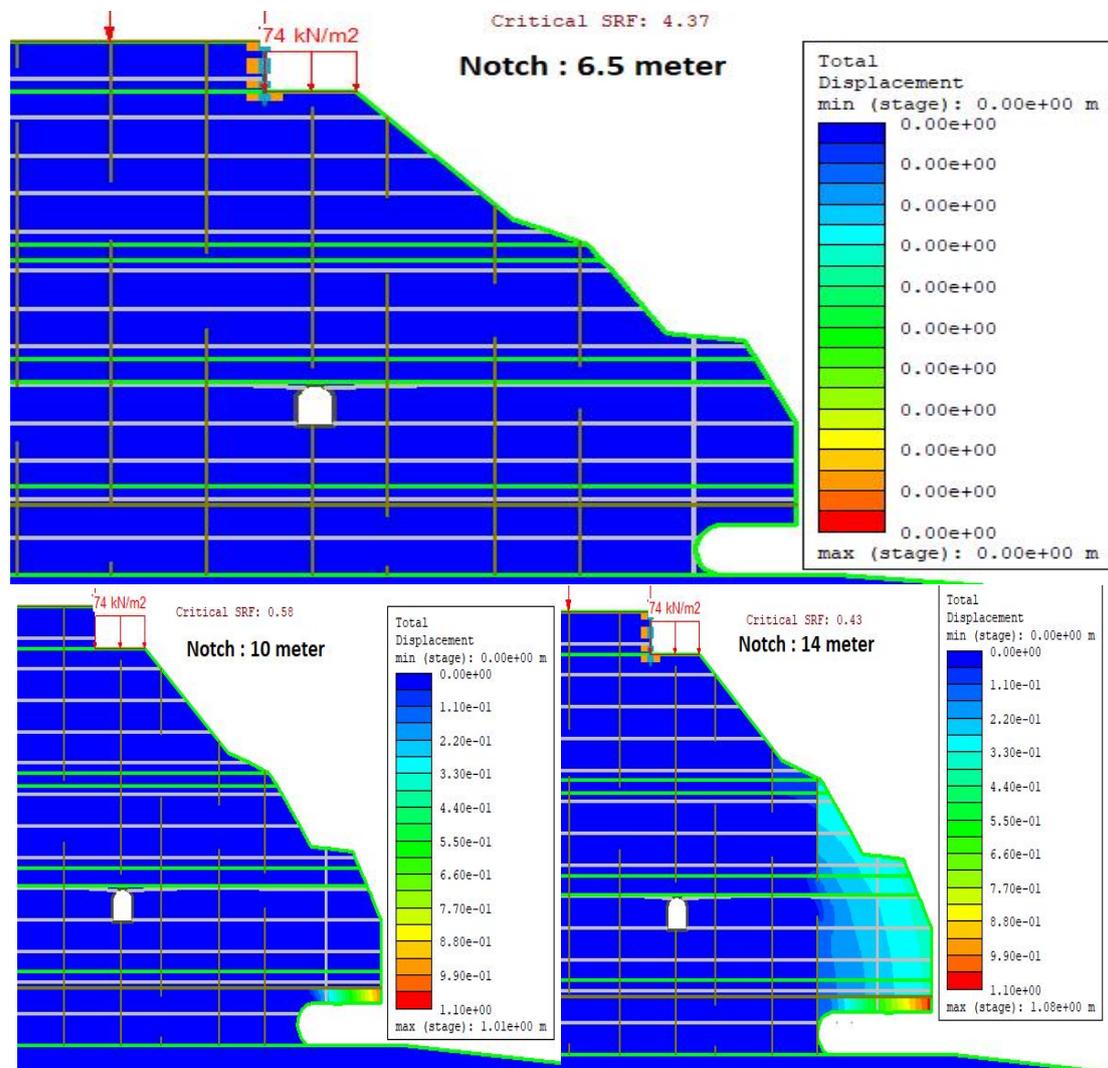
Figure qwr4.2.2.5 At S.R.F = 1 , Total Displacement of 3 different notch model

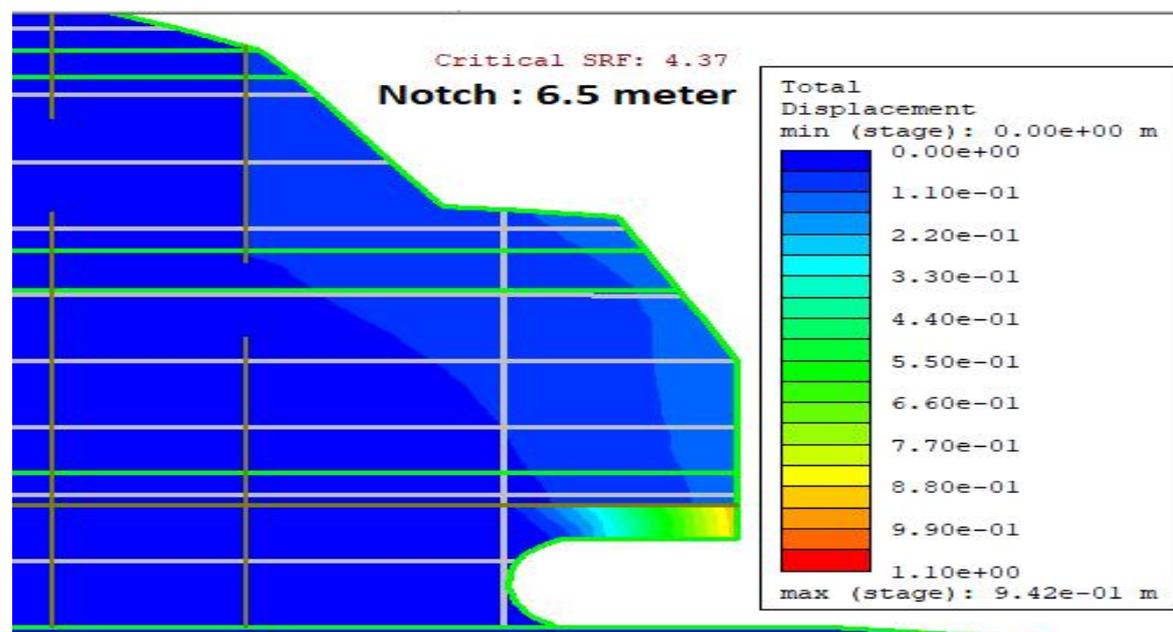
Figure 4.2.2.6 Limit equilibrium condition for 6.5 m depth model in terms of Total Displacement

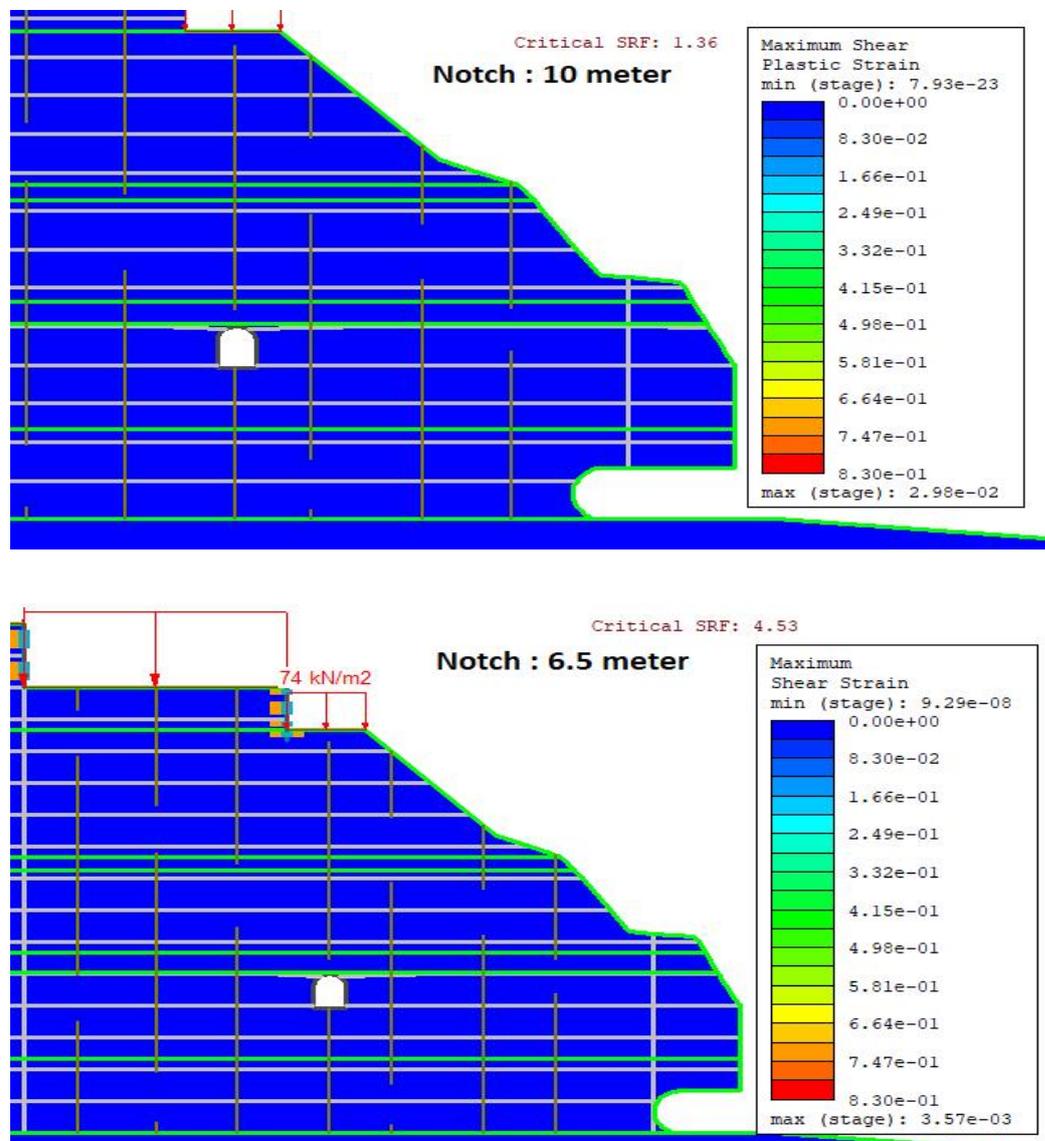
Figure 4.2.3.1 At S.R.F = 1 , Maximum Plastic Shear Strain of 10 and 6.5 meter notch model

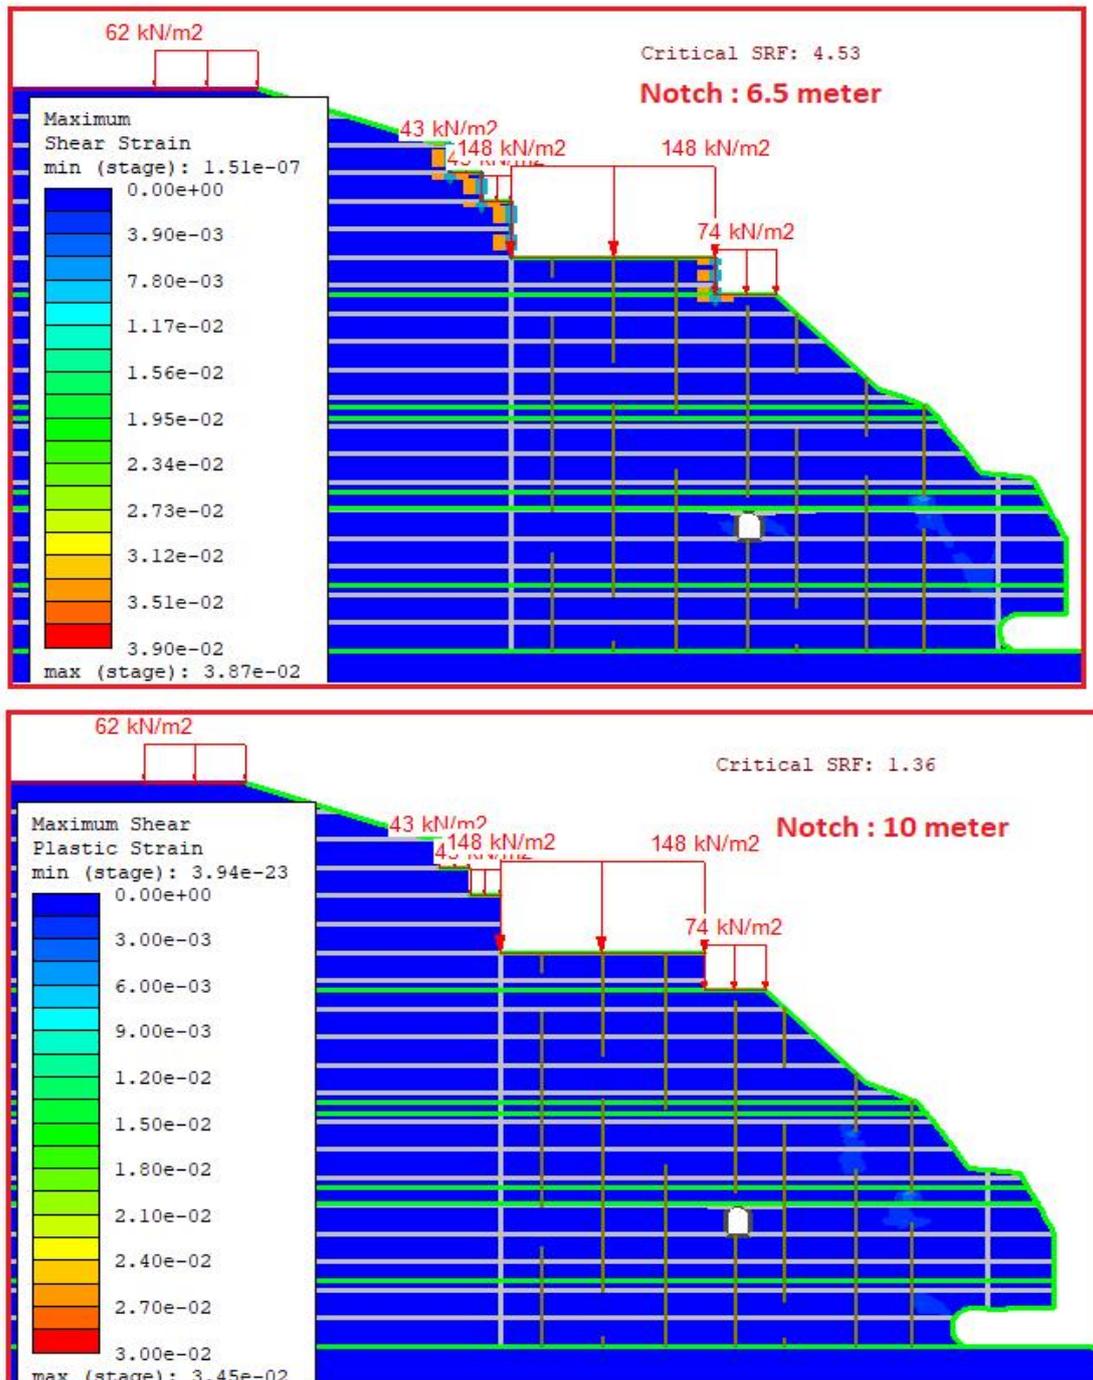
Figure 4.2.3.2 Limit equilibrium condition for 6.5 and 10 m notch depths model in term of Maximum Plastic Shear Strain

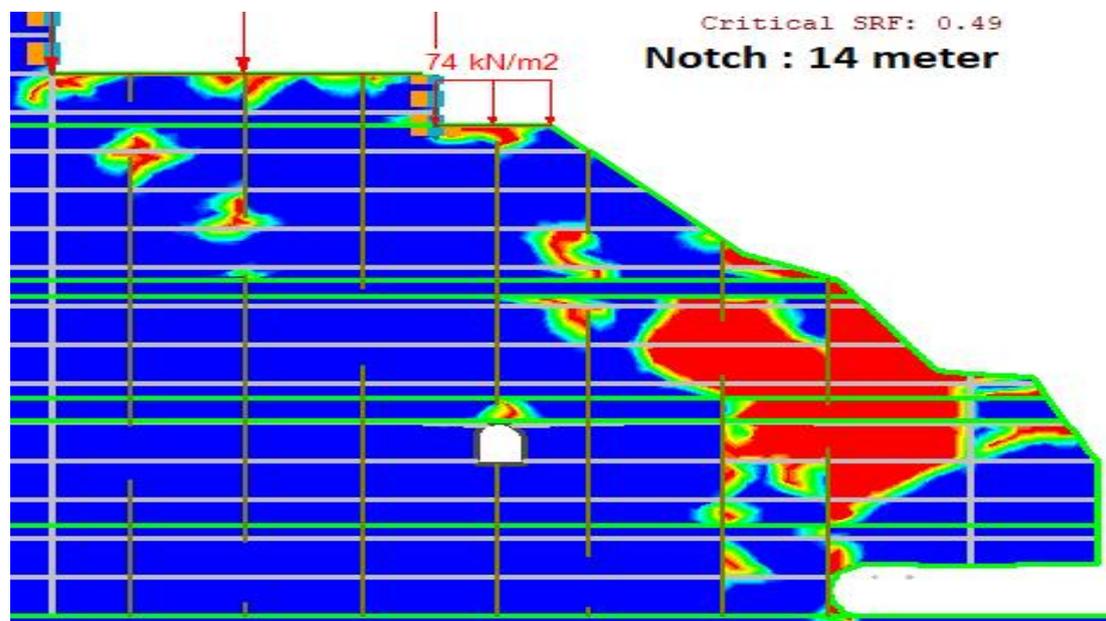
Figure 4.2.3.3 At S.R.F = 1 , Yielded Element of 14 meter notch model

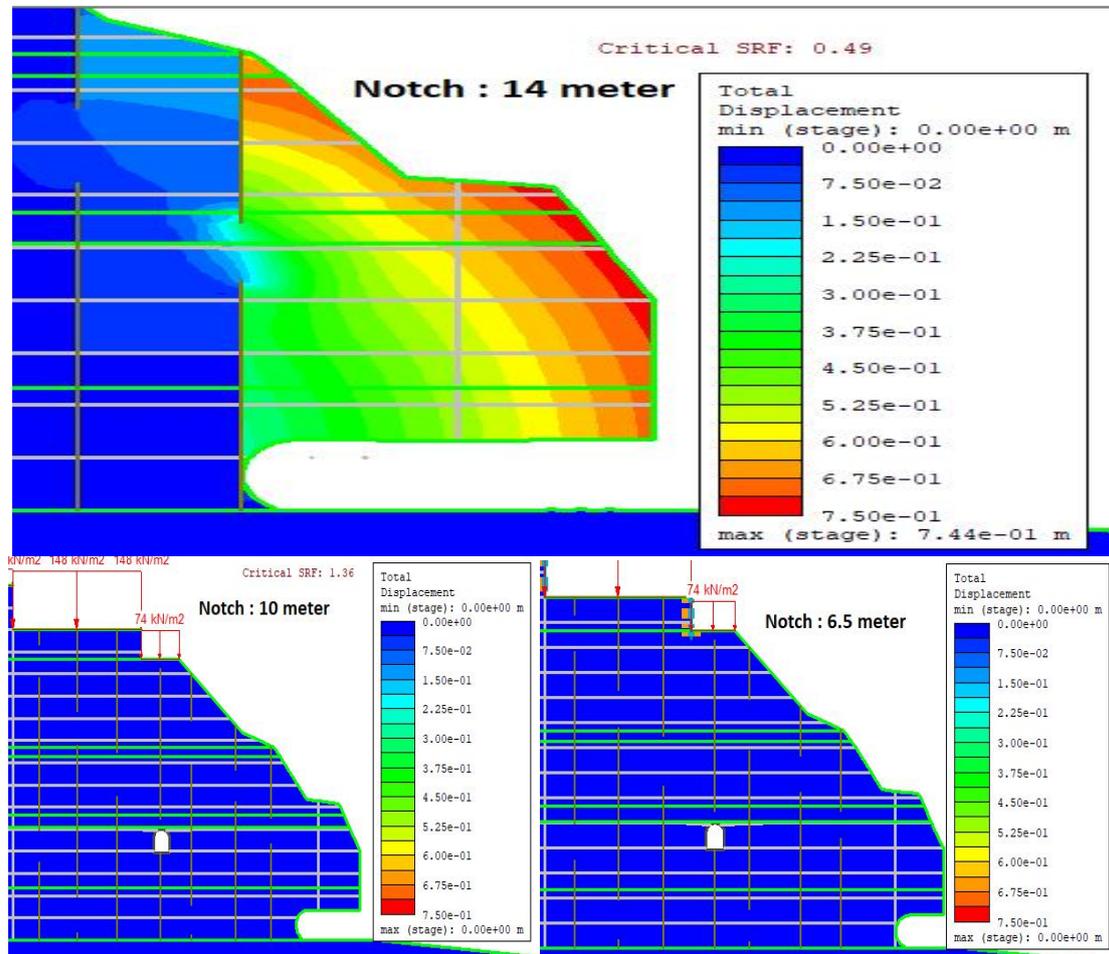
Figure 4.2.3.4 At S.R.F = 1 , Total Displacement of 3 different notch model

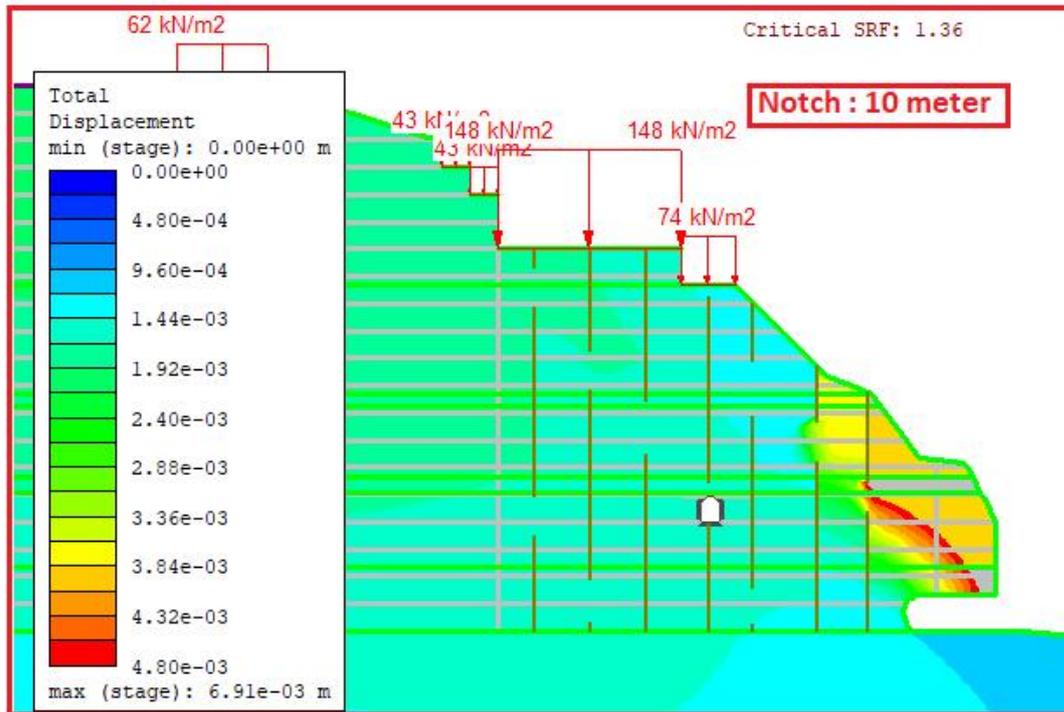
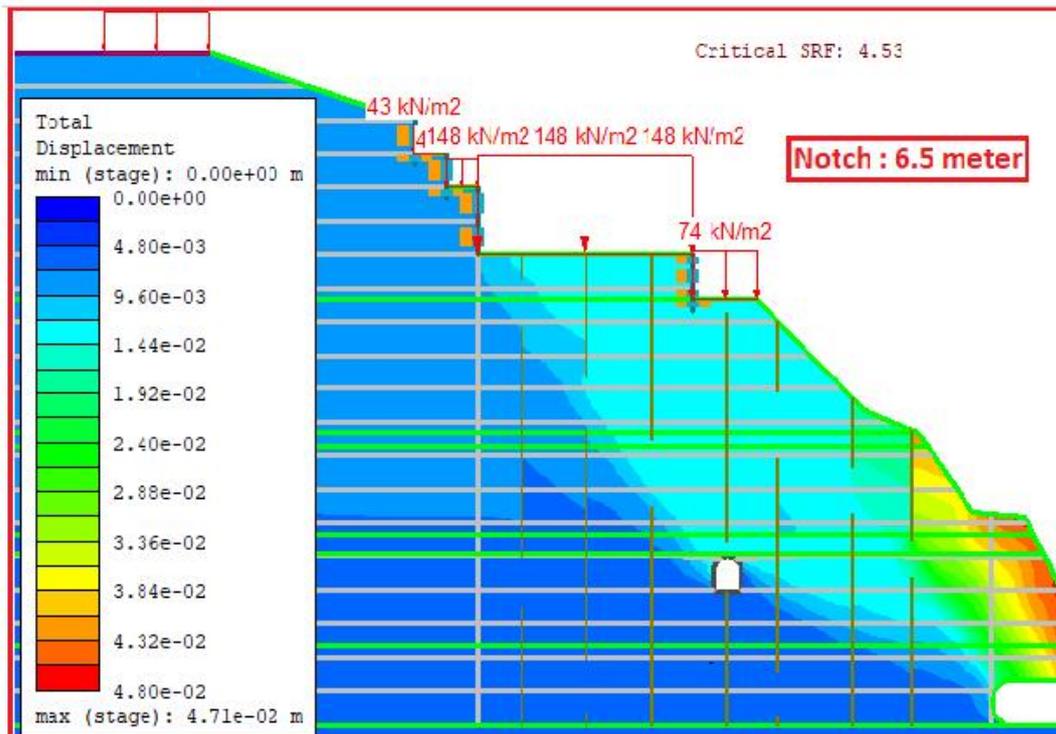
Figure 4.2.3.5 Vary S.R.F of 6.5 and 10 meter notch depth model in term of Total Displacement

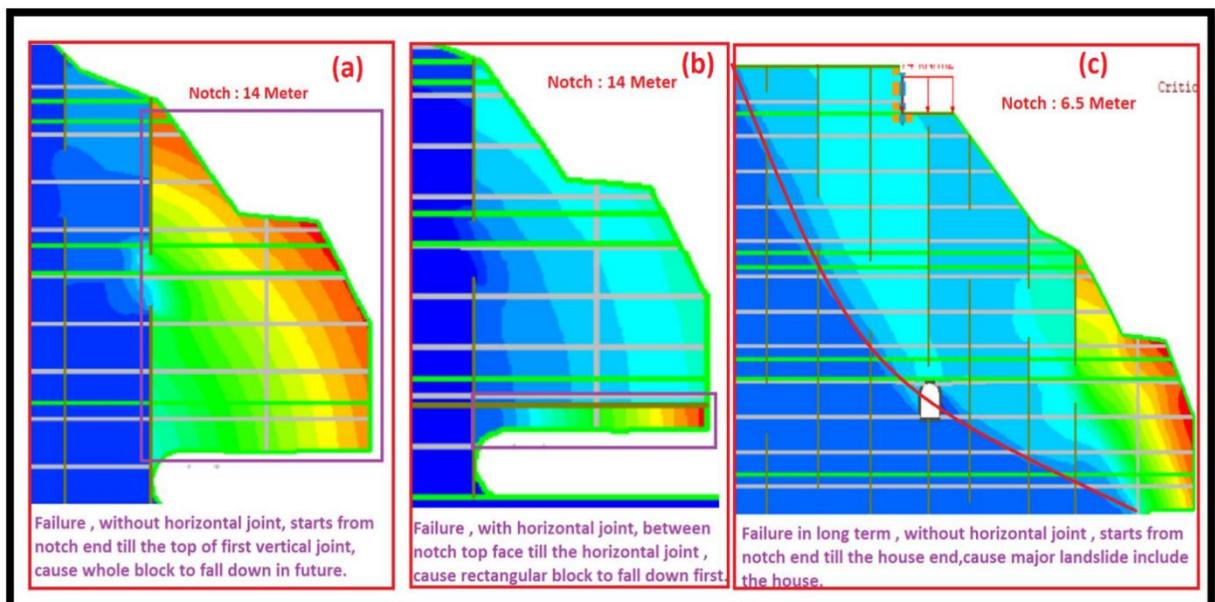
Figure 4.2.3.1 Predicted Failures
