CONSTRUCTIONAL FEATURES OF HARRAN DOMED HOUSES.
ON-SITE ASSESSMENT OF EARTHQUAKE-INDUCED DAMAGE.

MASTER'S DEGREE IN ARCHITECTURE FOR HERITAGE

July, 2025

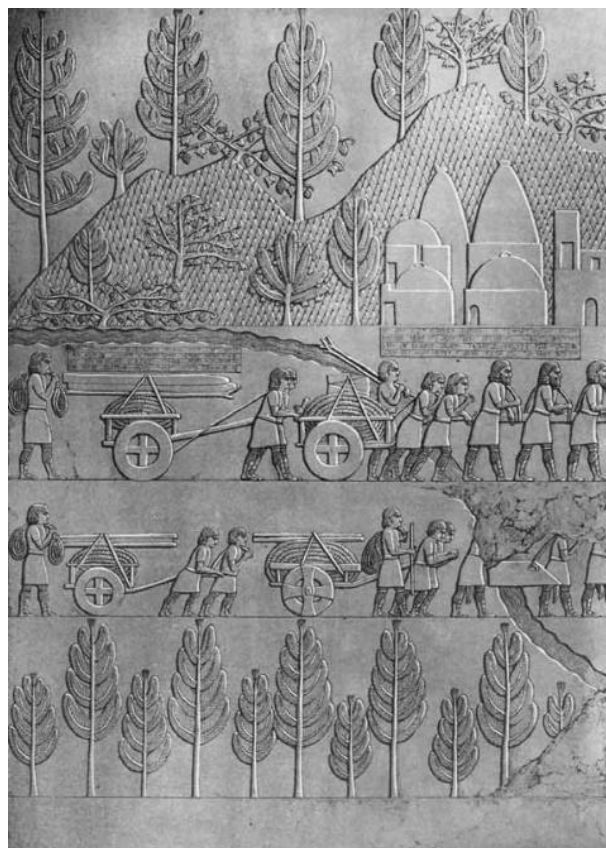
Figure 3 : This relief, found in Sennacherib's palace at Nineveh, depicts houses with domes (Patterson, 1915).

The dome's usage as a roofing technique in at least some regions of the ancient Near East can be almost certainly confirmed. One instance of iconographic evidence can actually be mentioned in this regard. The Neo-Assyrian relief that was found at Nineveh shows a scene of wood transport and dates back to the Assyrian king Sennacherib's reign (704-681 BC.). There are multiple domed buildings in the background (Figure 3), all of which have shapes that are strikingly similar to today's recognized ones (Tunca & Rutten, 2009).

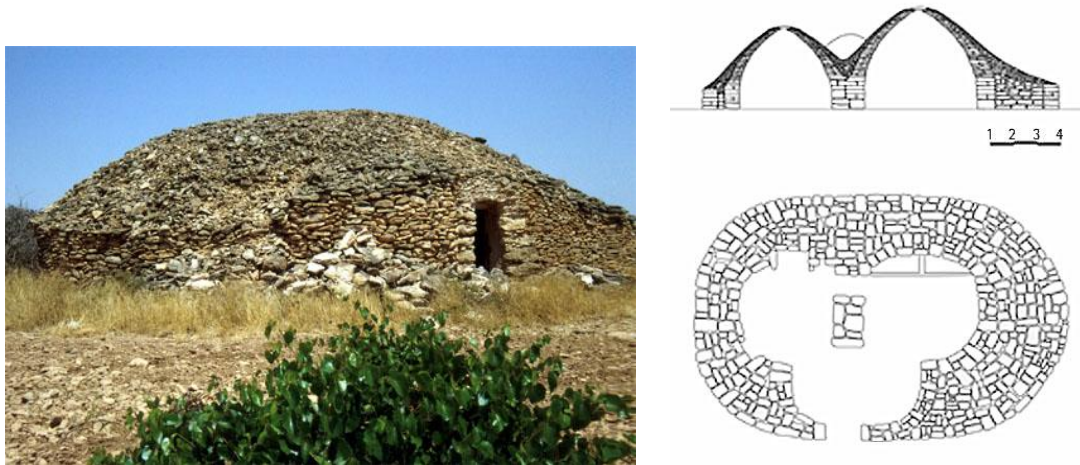
Figure 6 : *El bombo* located in Tomelloso, La Mancha, Spain in 2002.
(<https://www.stoneshelter.org/stone/objects/bombo/6.htm>)

In **Spain**, *El Bombo* near Tomelloso in La Mancha is a stone-built shelter for people and livestock. The structure resembles a stone mound, standing apart from frame (Figure 6). These shelters typically have one to four celled building. The living area features an open hearth with a low chimney and small niches on either side (Figure 7). The livestock section includes a manger running along the rear wall. The floors are made of compacted clay, while the walls are lime-washed in the living space and coated with brown clay in the livestock area, up to a height of 2.20–2.40 meters. Entrances are usually positioned on the southern side, and there are no windows (Juvanec, 2004).

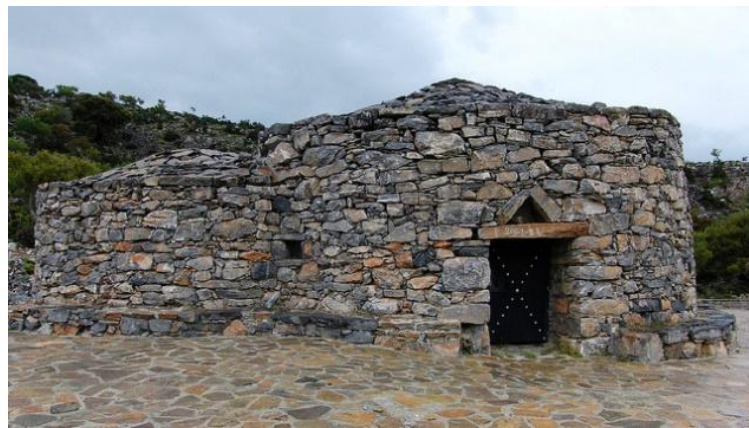
Figure 12 : A *mitata* structure including 2 domes in the island of Crete, Greece.
(http://www.wondergreece.gr/v1/en/Articles/Architecture/8721-Mitata_in_Crete)

Mitata structures located in the eastern part of the island of Crete, **Greece**, are rectangular and terraced. They are small and modest, built on mountain slopes at lower altitudes along pathways and winter grazing areas. The term *mitato* refers to a grouped structure composed of 2-3 corbelled domes (Figure 12). It has some specific areas : a coumos which is people's main living space, a space for cheese producing, a *tyrokelli* or *kleidospito* serving for the preservation of dairy products. Spacious courtyard featuring a dry-stone enclosure (mandra) for the daily task of milking ewes, as well as an outdoor dining area (Figure 13). The narrow entrance is the only opening; occasionally, there is a central opening for air circulation at the top of the dome. A platform made of stone for seating, a cheese-making fireplace, and a smaller one for cooking are all located inside. A mitato complex was typically inhabited from May to November by a clan of shepherds, who could be brothers or cousins. Shepherds' lives underwent a significant transformation in the 1980s when roads for cars were built up to the mountains and this change caused to ending usage of mitata (Arakadaki, 2009).

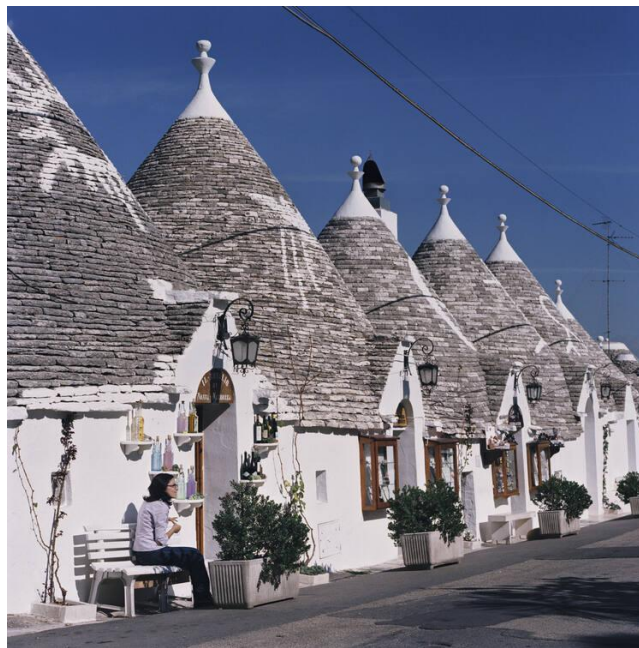
Figure 14 : *Trulli* structures in Alberobello, Italy.
(<https://whc.unesco.org/en/list/787/>)

Trulli of Alberobello, situated in the heart of Apulia's Valle d'Itria, stand out as remarkable examples of rural architecture. These stone masonry structures hold significant value, serving not only as storage spaces for agricultural tools and shelters for animals but also as a vital form of housing, both historically and in modern times (Todisco & Sanitate, 2016). Alberobello is a town in the Bari province, located near the Murgia hills and the Itria Valley. The town's historic center, home to around 2,000 *trulli*, was recognized as a UNESCO World Heritage Site in 1996 (Figure 14), (Corbi et al., 2023).

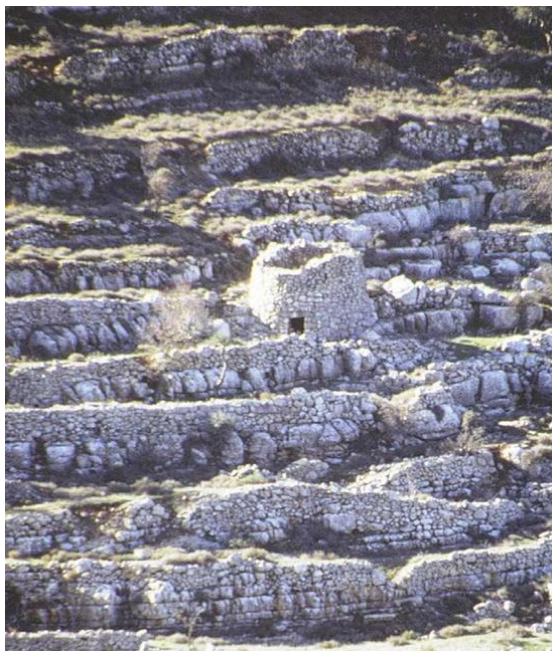
Figure 20 : *Al-mantarah* found in Silwad village near Ramallah, Palestine, seeming entirely natural and blending seamlessly with the surrounding landscape (Shadi, 2012).

The **Palestinian** *al-mantarah* is a traditional dry-stone hut, adapted for farmers through the years (Figure 20). Found across Palestine, it reflects Mediterranean architecture shaped by historical displacement and cultural exchange. It was built using the corbelling method, without any materials used to hold the stones together. There are three types of these huts as shown in figure 21. Type A was the most basic version, built using spheroidal dolerite or rough sandstone blocks, arranged in offset courses that slanted inward, leaving a small opening at the top, typically closed by a large stone slab or several stacked slabs. Type B was developed to provide more interior space. By employing an enhanced building method, the builders raised its height to 150 cm and diameter to 200 cm. In Type C, the hut's axis was lengthened to create an oval shape, expanding the interior space even more (Shadi, 2012).

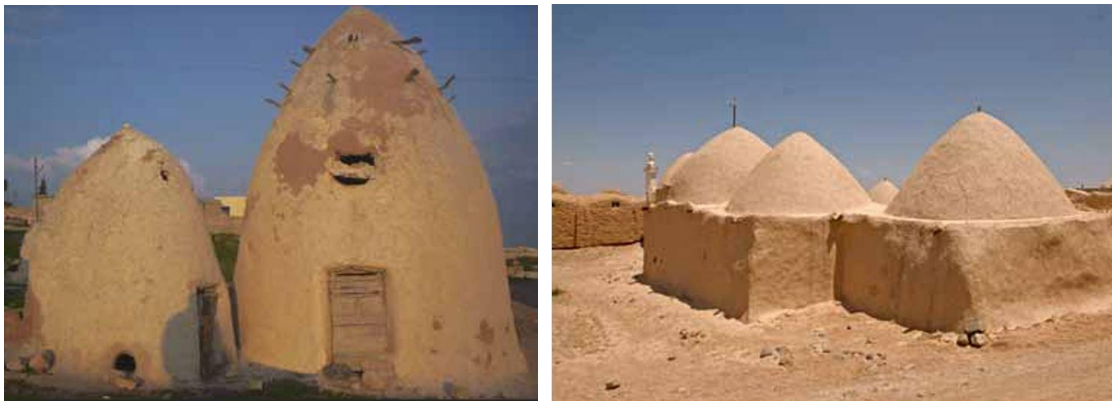
Figure 25 : Circular domes in Idlib, Syria (Dello & Mecca, 2009).

Figure 26 : Sultan domes in South Aleppo, Syria (Dello & Mecca, 2009).

1. Circular domed rooms which the dome originates directly from the ground level (Figure 25).
2. Quadrate domed rooms, known as 'normal dome' and 'Sultan dome' (*Qubba Sultanya*), are distinguished by the varying heights at which their domes rest on walls (normal dome: 10-90 cm; Sultan dome: 1-2.5 meters). Due to their more complex construction, Sultan domes were typically built by wealthier individuals (Figure 26).

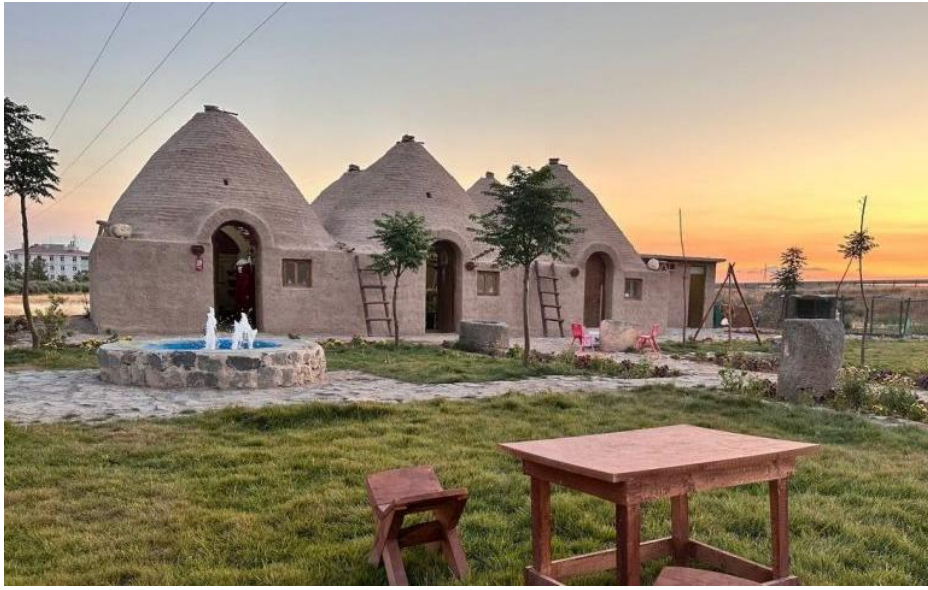
Figure 27 : Suruç domed houses in Turkey.
(<https://www.yenimesaj.com.tr/suruc-kumbet-evleri-ilgi-odagi-oldu-H1489964.htm>)

In **Turkey**, the domed houses that are geographically closest to Harran are the beehive houses of Suruç, located in the same city, Şanlıurfa (Figure 27). Key difference between Harran and Suruç domed houses is construction material. While stones and bricks recovered from ancient building remains were used in Harran domed houses. As indicated by Şahinalp (2012), main construction material of Suruç domed houses is adobe. Moreover, two types of domes in Suruç domed houses can be seen: conical and flat-topped. While conical domes reach a height of 1.5-2 meters, flat-topped domes are lower due to the end of adobe layers after 1-1.5 meters and the covering of the upper gap with wooden planks, followed by layers of straw or cotton stalks and mud (Figure 28).

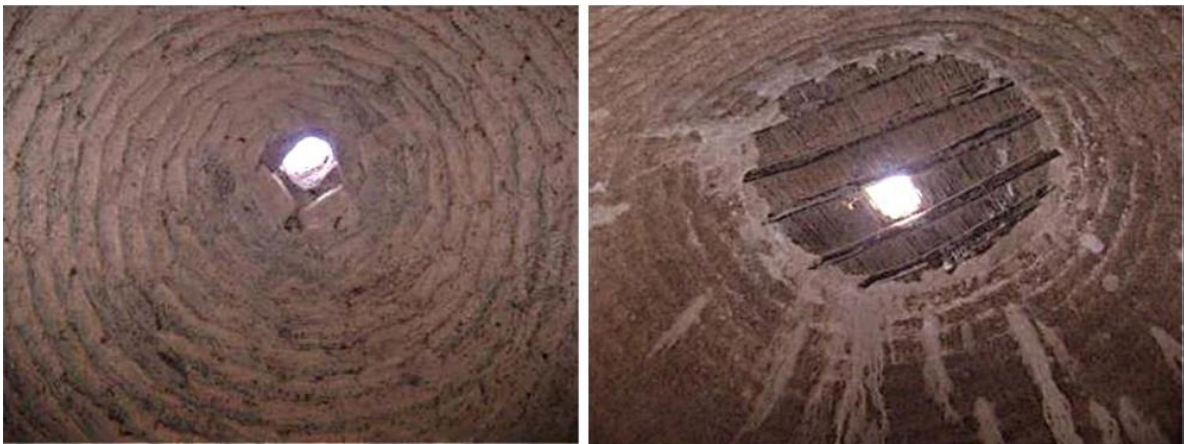
Figure 28 : Dome types of Suruç houses: conical dome (on the left) and flat-topped or truncated dome with wooden material used (on the right), (Şahinalp, 2012).

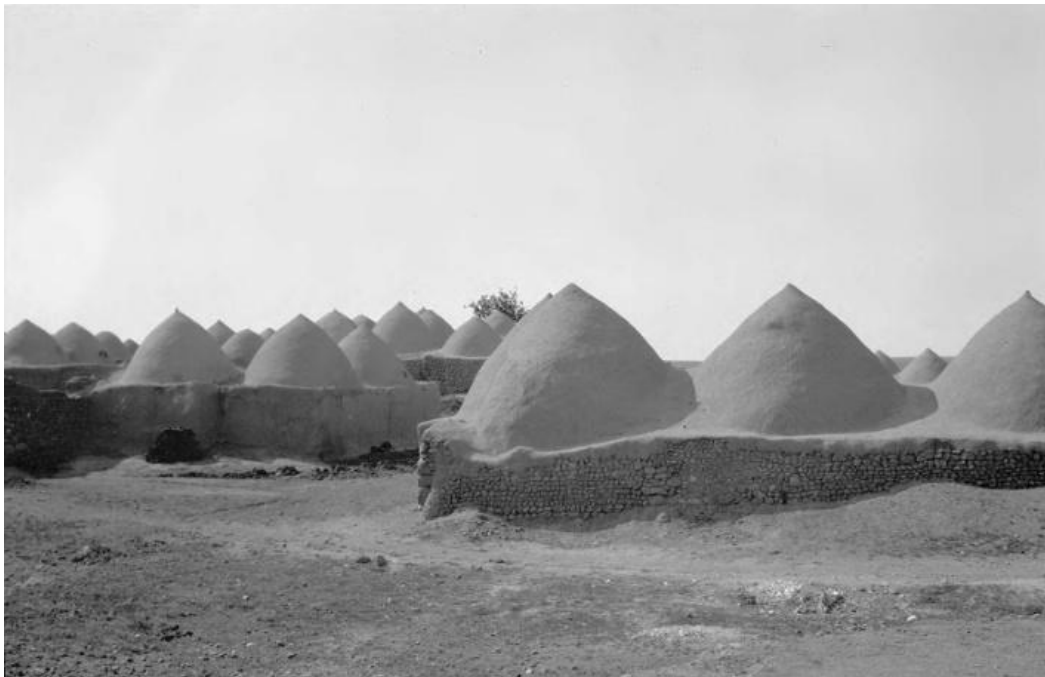
Figure 32 : Domed houses in Harran, in 1911.
(<https://gertrudebell.ncl.ac.uk/p/gb-3-1-21-1-12>)

It is reasonable to estimate that the current domed houses are no older than 70–150 years. These homes may have been destroyed, forgotten, and rebuilt numerous times throughout history. Over time, there had also been modifications to their form. Conical domes were constructed on the ground like tents, as depicted in a 19th-century image of Harran (Figure 31), but in the 20th century, all conical domes were constructed on square, pre-planned cubical bases (Figure 32), (Özdeniz et al., 1998).

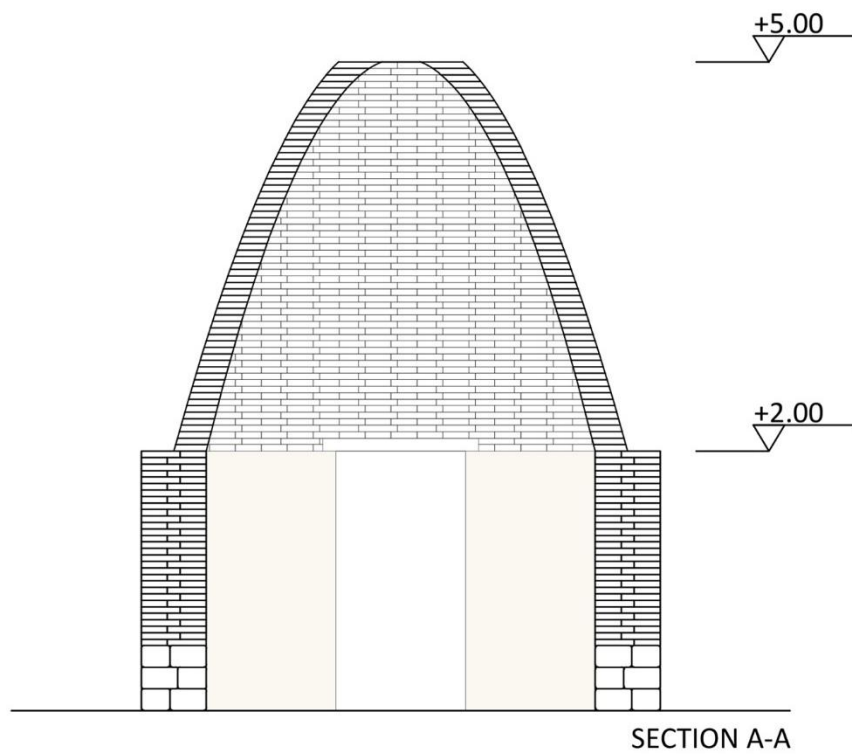
The dimensions of square-planned units can vary, sometimes being 3x3 meters and sometimes 2.5x2.5 meters from inner wall to inner wall. The wall thickness is at least 50 cm. The height of the walls, on which the dome will rest, also shows slight variations, ranging from a minimum of 150 cm to a maximum of 200 cm (Figure 35).

Figure 35 : Plan and section of a standard 3x3 meter 'unit' (2025).

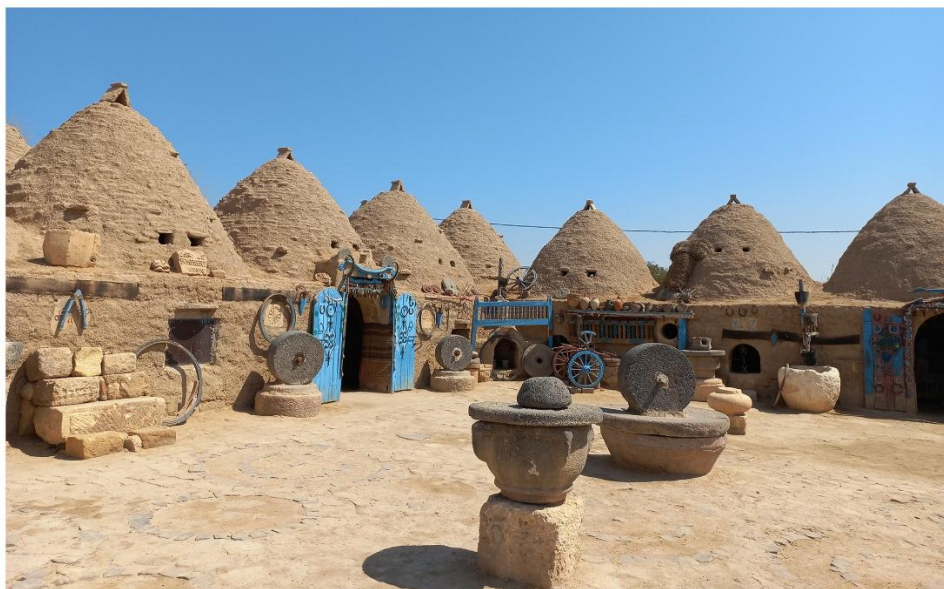
Figure 36 : 3D model of spatial organization of a domed house with courtyard and its photo (2025).

The plan of the houses in the region can be categorized into two types: either domed units arranged around a courtyard, enclosed by walls with access to the courtyard from the outside (Figure 36), or open to the exterior and not enclosed (Figure 37). Units that are enclosed are generally arranged in an L or U shape around a courtyard, with access to the exterior provided through the courtyard gate. The boundaries of these organized units are perceived more clearly. The spatial organizations are better designed for living, sleeping, dining, sheltering, etc. In such arranged domed houses, the concept of privacy is at a higher level (Yıldırım, 2015).

The tent made of goat hair, located within the courtyard, serves as a shaded area for animals and a space for making dairy products, while also functioning as a semi-open space where family members gather, sit and rest. Additionally, wooden platforms called *taht*, raised from the ground, are equipped with mattresses, allowing for sleeping outdoors on hot summer days. In the center of the courtyard, there is a well that meets the water needs (Figure 36), (Yıldırım, 2015).

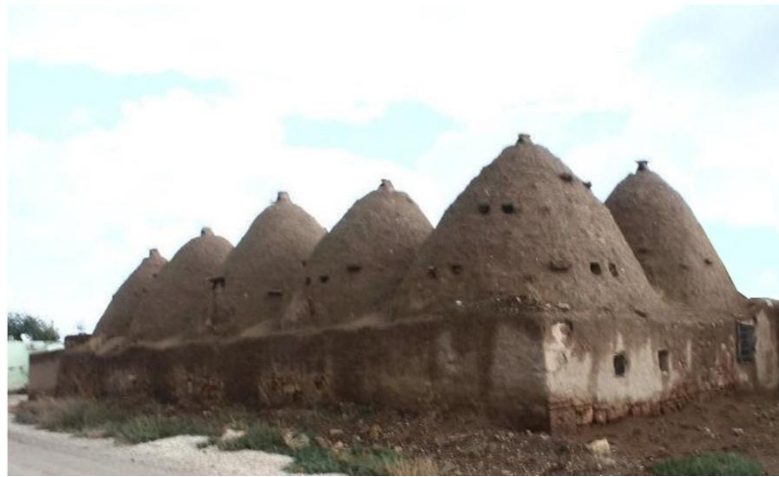
Figure 37 : 3D model and photo of a domed house with direct access to exterior (2025).
(Source of photo: Gülmüş, 2023).

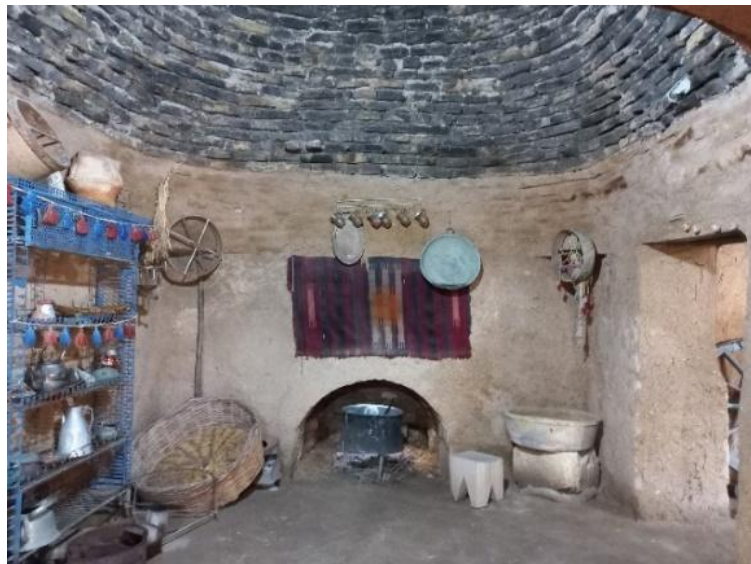
Figure 40 : Stove in the kitchen (Harran, 2024).

Domed units serve as living room, bedroom, kitchen, storage and barn (Figure 38). Furthermore, rooms can serve multiple functions. For example, a unit used as a living room during the day can turn into a sleeping area at night by laying mattresses on the floor. Similarly, the kitchen can also function as a sitting area during the winter. In the interior spaces, household items are hung, placed on shelves or put in niches on the walls (Figure 39). Additionally, a gap was created at the bottom of the wall for the stove, where food is cooked in the kitchen (Figure 40).

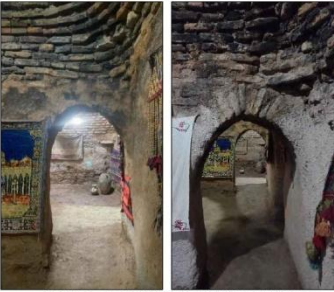
<p>ARCHED - 90 CM WIDTH - IN THE CORNER</p>

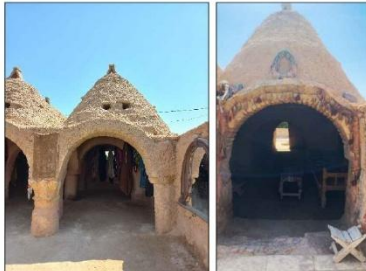
<p>ARCHED - 250 CM WIDTH - OPENING TO THE COURTYARD</p>

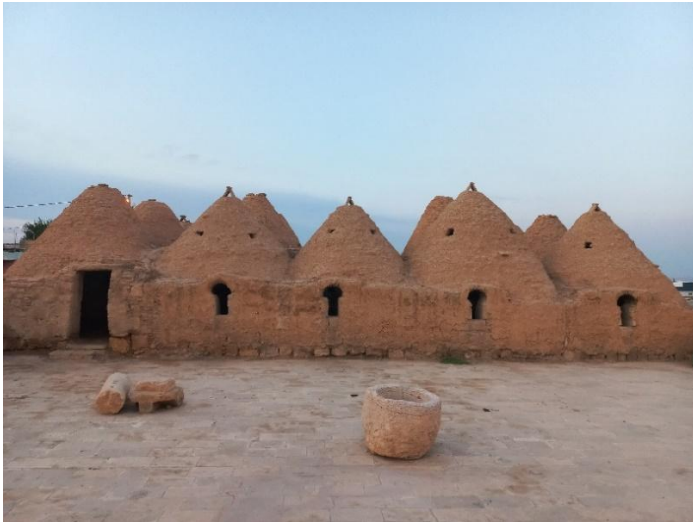
Figure 41 : A Harran domed house which have windows facing the courtyard (Harran, 2024).

The openings on the walls of cubical base may be considered as windows and visual contact between courtyard or street and interior space is achieved through the small window openings (Figure 41). Their shapes are almost a square and sizes are 30x30 centimeters (Figure 42). Window openings can be closed especially in winter to prevent the cold air go inside (Figure 43).

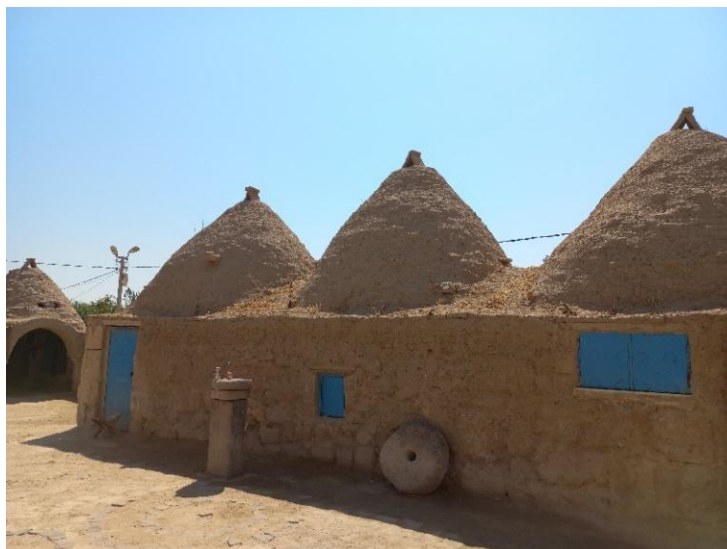
Figure 43 : Closed windows of a Harran domed house (Harran, 2024).

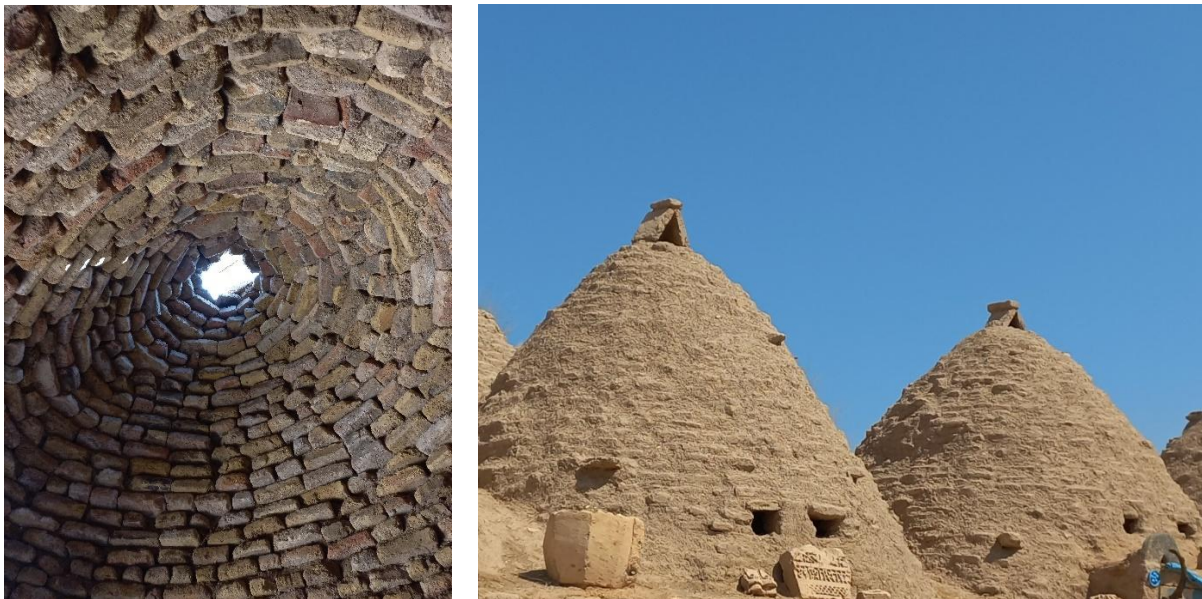
Figure 45 : Hole at the top of the dome in Harran houses (Harran, 2024).

The holes on the domes are positioned on opposite surfaces, facing each other. The number of holes on a single surface can sometimes be two or sometimes three (Figure 44). The hole at the top of the dome, approximately 30 centimeters in diameter, is of crucial importance for ventilation, allowing airflow from doors and windows to circulate naturally within the space (Figure 45). As noted by Mamir (2016), in order to prevent rain leaks, some top holes are covered with 3 small stones as a roof (Figure 46).

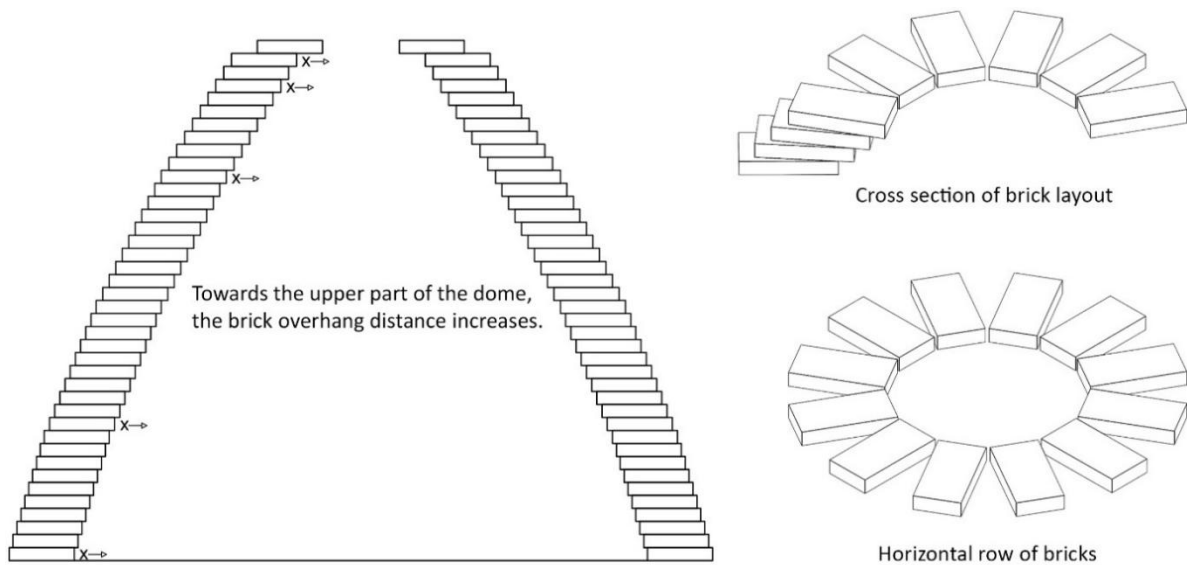
In this structural system, also referred to in the literature as a "corbelled dome" or "pseudo-dome," the dome can be built using adobe, stone, or brick. In the Harran domed houses, brick was used as a primary material. Each brick course is slightly projected inward compared to the one below, gradually reducing the span of the space and forming the dome. By stacking the bricks layer by layer in this manner, a parabolic-shaped dome with a thickness of 20–30 centimeters is achieved, leaving an opening at the top until the space is fully covered (Figure 47), (Gülmüş, 2023). The domes were built by stacking 30-40 rows of bricks on top of each other, using 700-1200 bricks in total (Önal, 2022).

Figure 47 : Construction method of domes in Harran houses (2025).

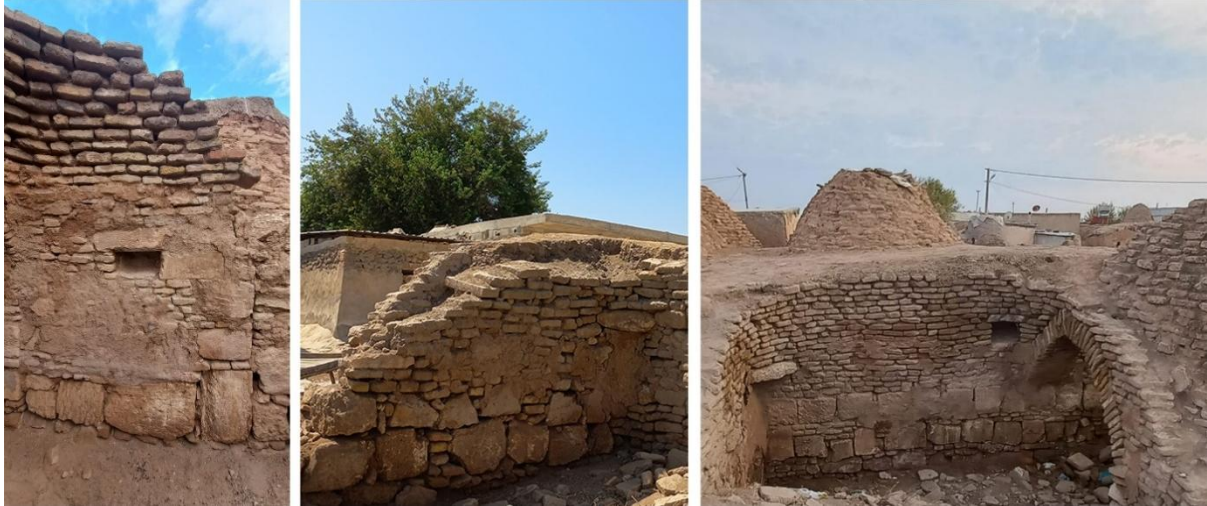
Figure 48 : Limestones used in the base of Harran domed houses (2024).

Large, flat, and rigid limestone blocks were used in the base of the structure (Figure 48), and these large stone blocks were brought from the Bazda Caves, historical quarries located very close to the area where the Harran domed houses were built (Figure 49).

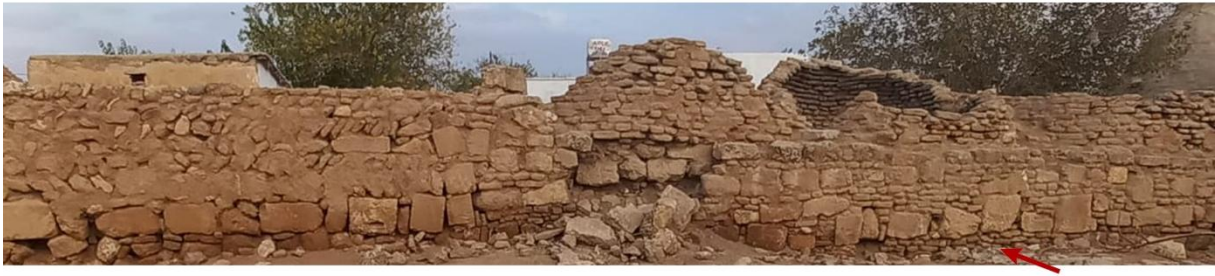
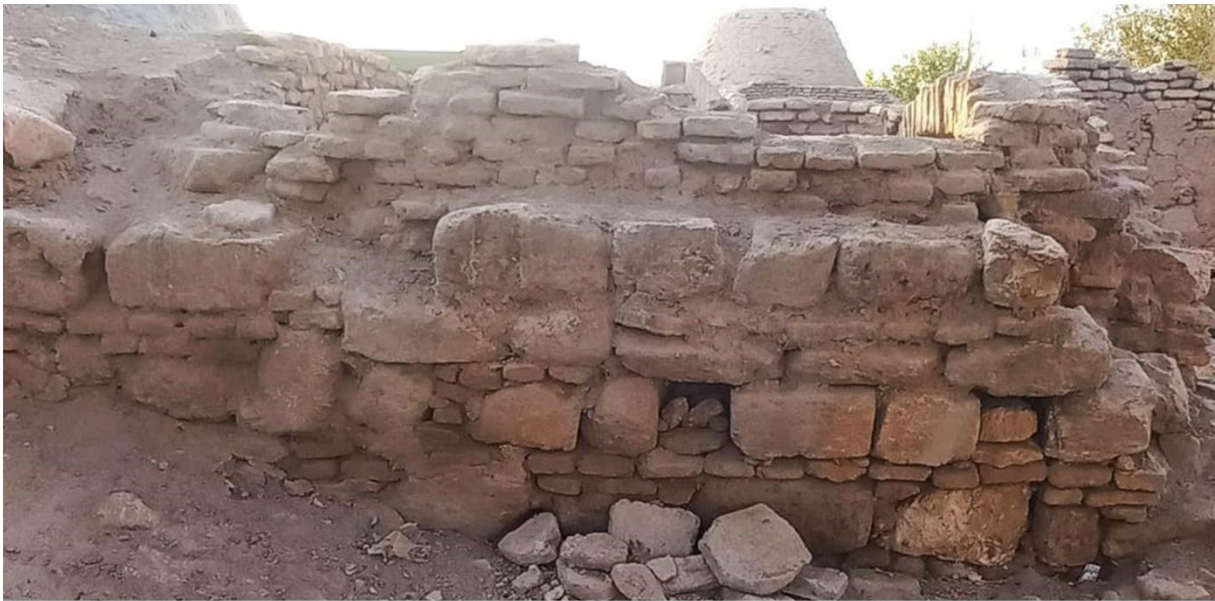
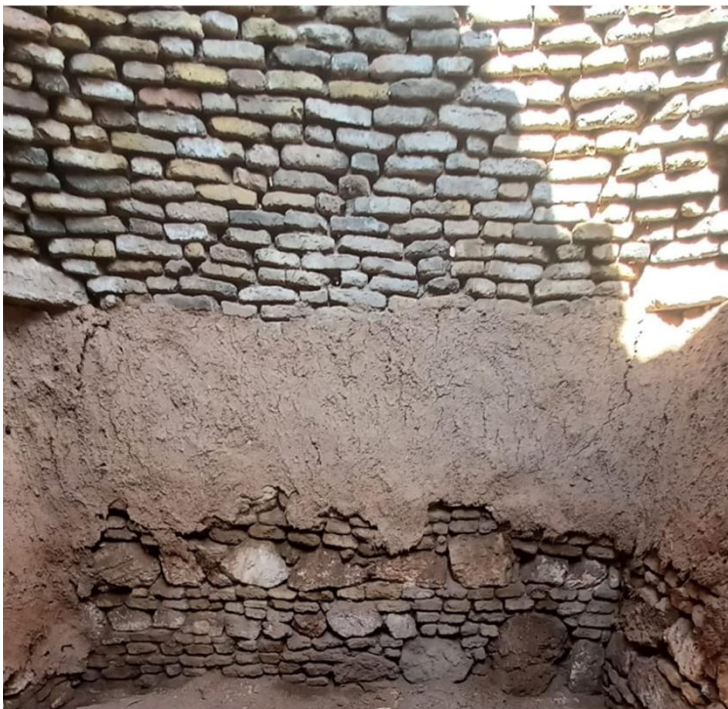
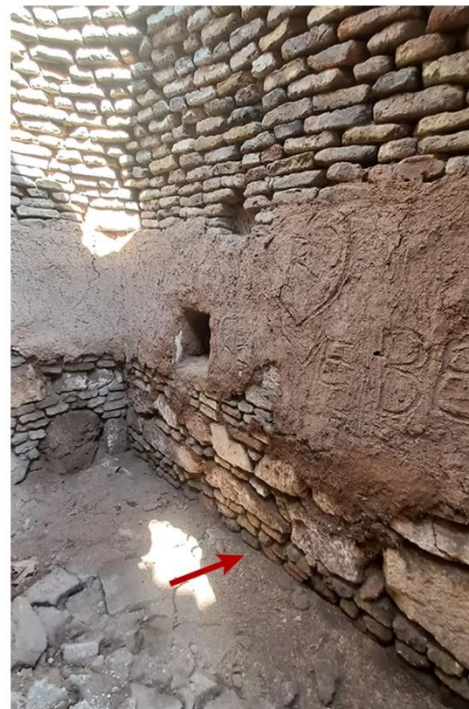
Figure 50 : Examples of combined use of different materials in the base. The red arrows indicate that the base begins with rows of bricks (2024).

There are some different scenarios in the use of materials for the base: sometimes limestone and brick were used together and in such cases, the base may sometimes start with layers of bricks instead of limestone, with limestone placed on top. (Figure 50).

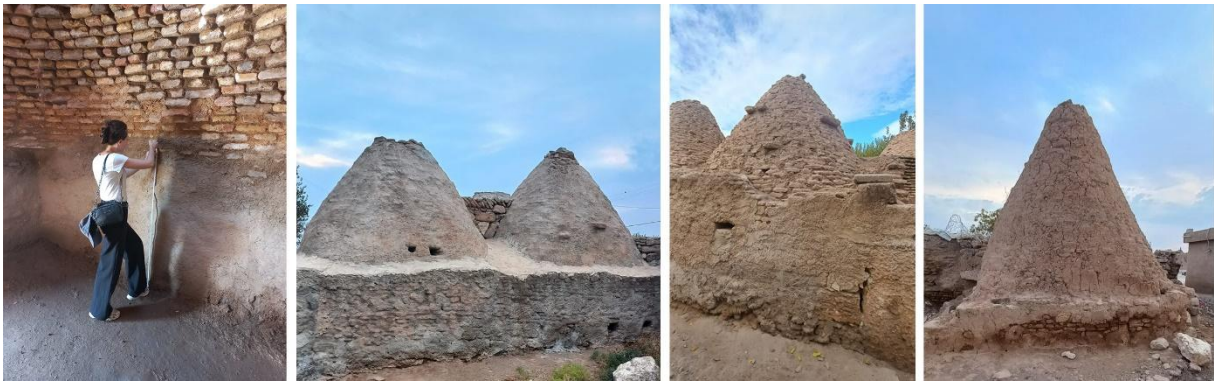
Figure 51 : From left to right: first three photos are the examples of the wall with nearly 1.50-2 meters height and the last one is an exception where the wall height is 50-60 cm (2024).

After the base is built to a height of approximately 50 cm, the load-bearing walls are constructed on top, reaching a total height of about 1.5–2 meters. Alternatively, there are a few exceptions where the transition from the base directly to the dome occurs, resulting in a wall length of approximately 50-60 cm in total (Figure 51). Bricks brought from nearby ancient building remnants and ruins, like limestones, have been used as the primary material for the walls. These bricks were made of clay and were processed by either sun drying or burning. Although their dimensions are not standardized, they are approximately 20×30×5 cm in size (Figure 52). The wall thickness is about 50 cm. Just like the bases, there are cases where different materials were used in the walls as well: while limestone and brick were used together, there are also a few exceptions where the wall was made entirely of stone (Figure 53). Additionally, in some cases, a cross arrangement of bricks has been observed in the walls (Figure 54).

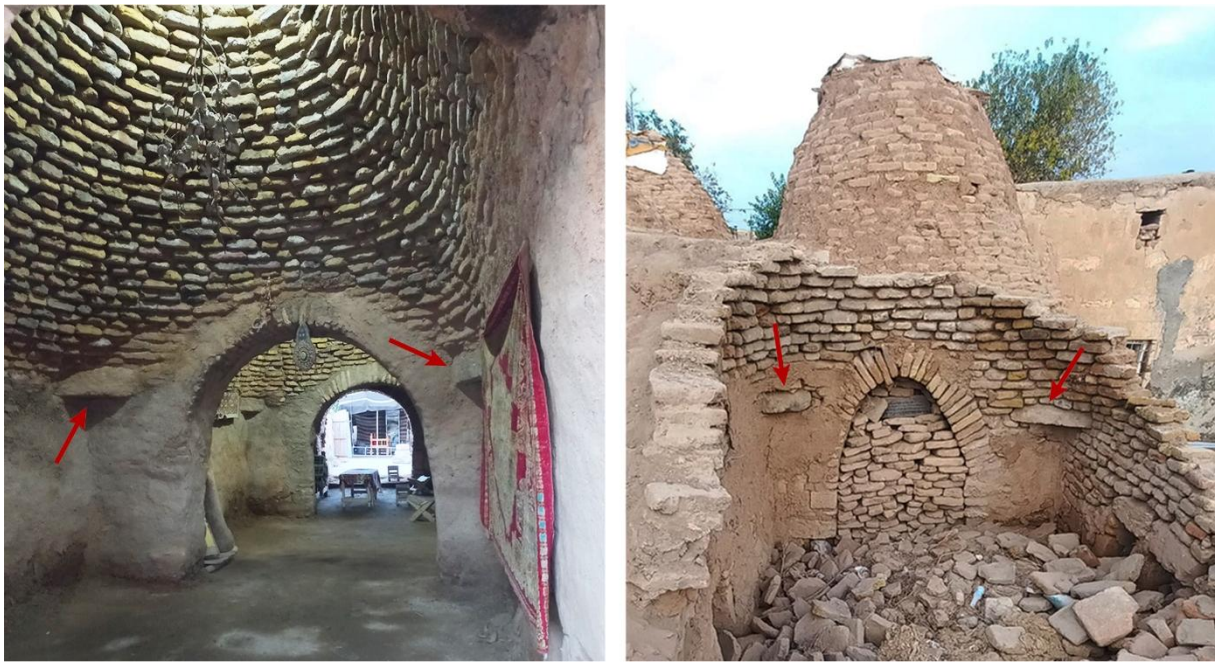
Figure 55 : Pendentives in Harran domed houses (2024).

Before starting the construction of the dome, a transition element is required after completing the wall construction. For this reason, stone blocks placed diagonally at a 45° angle in the wall corners serve as pendentives. Their dimensions are approximately 60x30x20 cm (Figures 55, 60 and 61). Although in most Harran houses the pendentive is a structural element that is only visible from the inside, there are a few houses, as shown in the figure 56, where it is also visible from the outside. The dome, which is about 5 meters above the ground, is also made of bricks, just as most of the walls (Figures 57, 60 and 61). At the junction between the wall and the dome, the wall extend outward, forming a protrusion (Figure 58). To securely bind the bricks in both the walls and the dome, the soil found in the Harran Plain, which is suitable for adobe production, is used to prepare adobe mud as mortar (Figure 58), (Gülmüş, 2023).

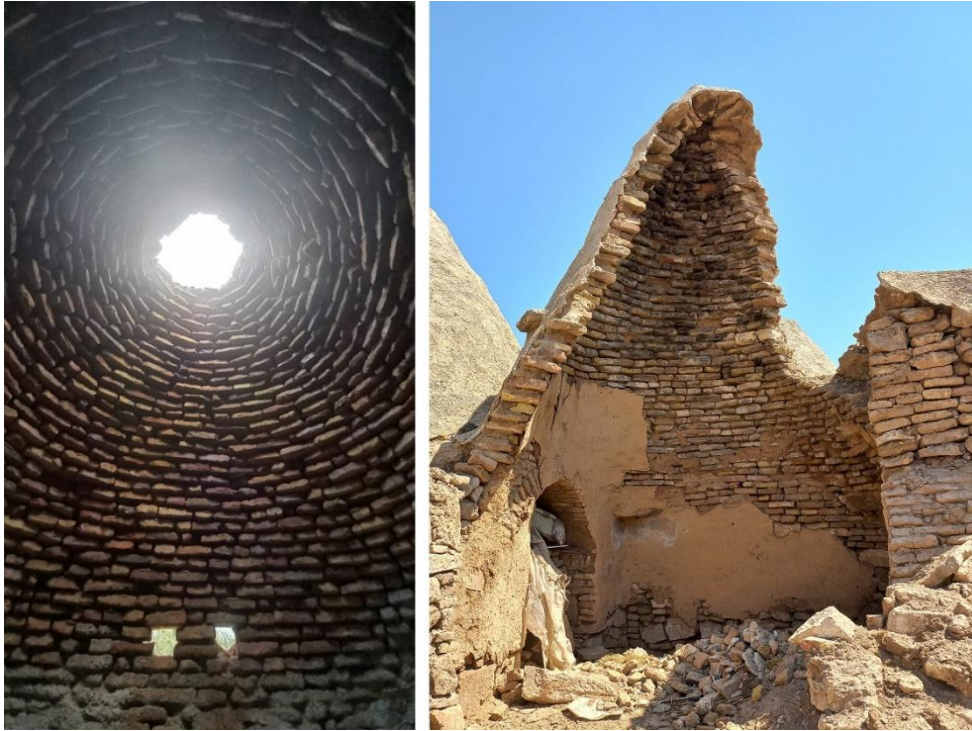
Figure 57 : The domes made of bricks of Harran houses, from left to right : bottom view of the dome, sectional view of corbelled dome of a collapsed house (2024).

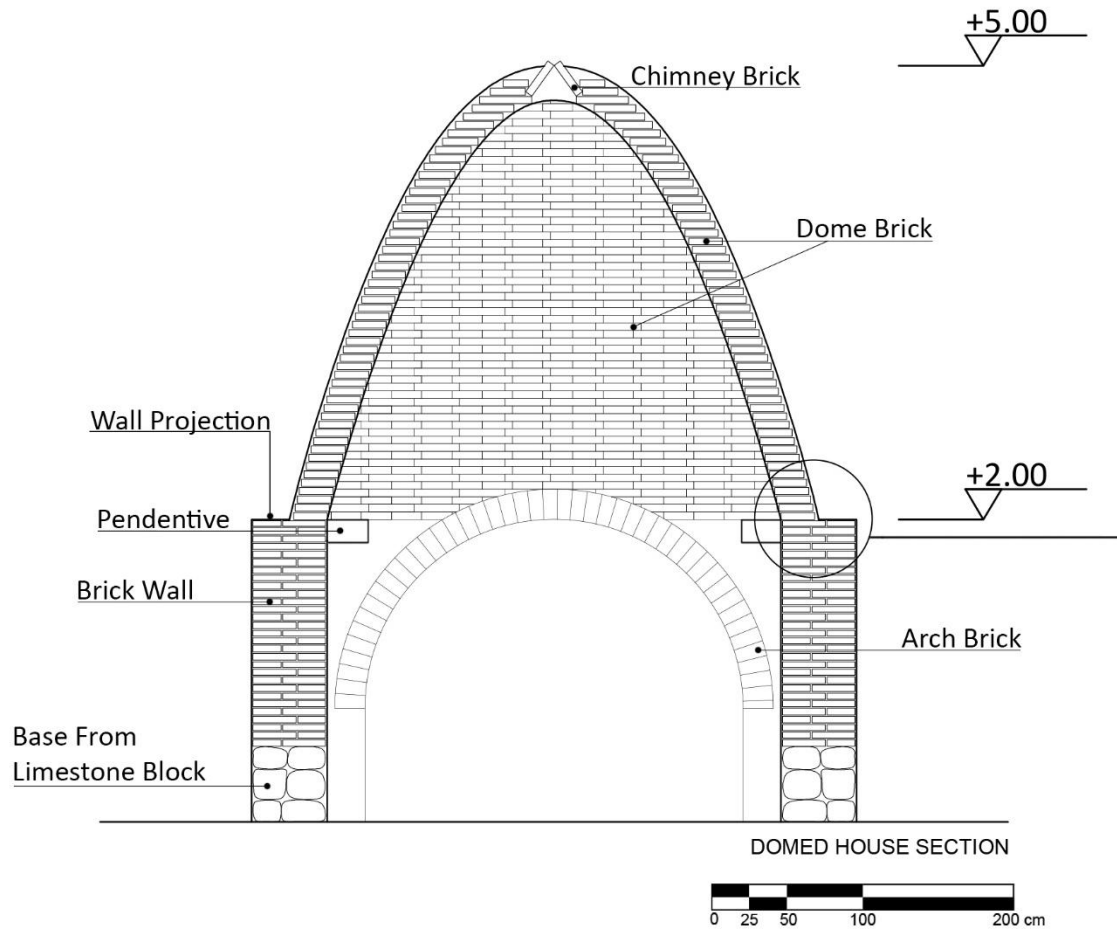
Figure 58 : Section of a typical Harran domed house showing the structural elements and detail showing the mortar between the bricks and plaster of the exterior structure (2025).

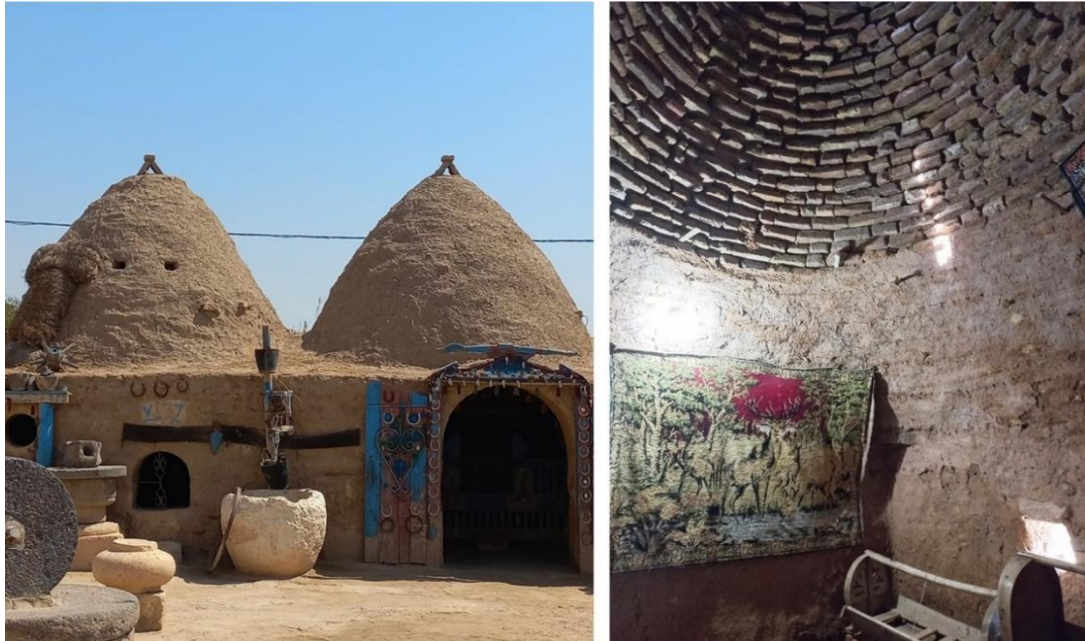
Figure 59 : From left to right : Completely plastered exterior surface, plastered interior walls and a partially exposed interior dome (2024).

The entire exterior of a completed domed house (both the walls and the outer surface of the dome) is covered with plaster. On the interior, only the walls are plastered, while the bricks of the dome are left exposed (Figures 58, 59 and 61). As stated by Yildirim (2015), the plaster material consists of clay-based soil mixed with straw or plant residues (Figure 58).

The plaster of domed houses needs to be renewed every two years. Otherwise, the dome may collapse due to neglect. When it rains, the soil on top of the plaster falls off, and as the rainwater seeps between the bricks, it erodes the mortar, which can cause the dome to collapse. For this reason, it is important to regularly renew the plaster.

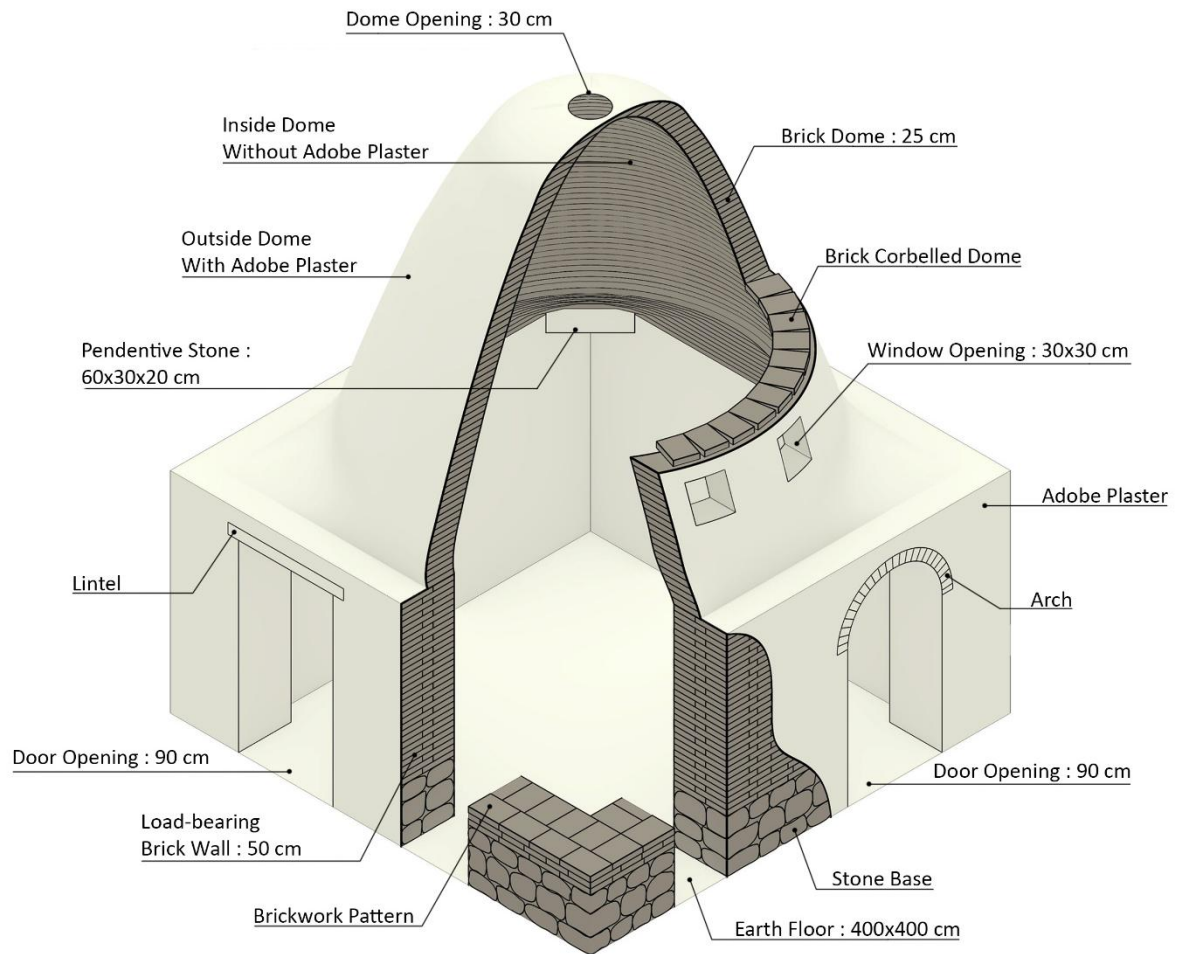
Figure 61 : 3D Axonometric section showing the structural elements of a typical Harran domed house (2025).

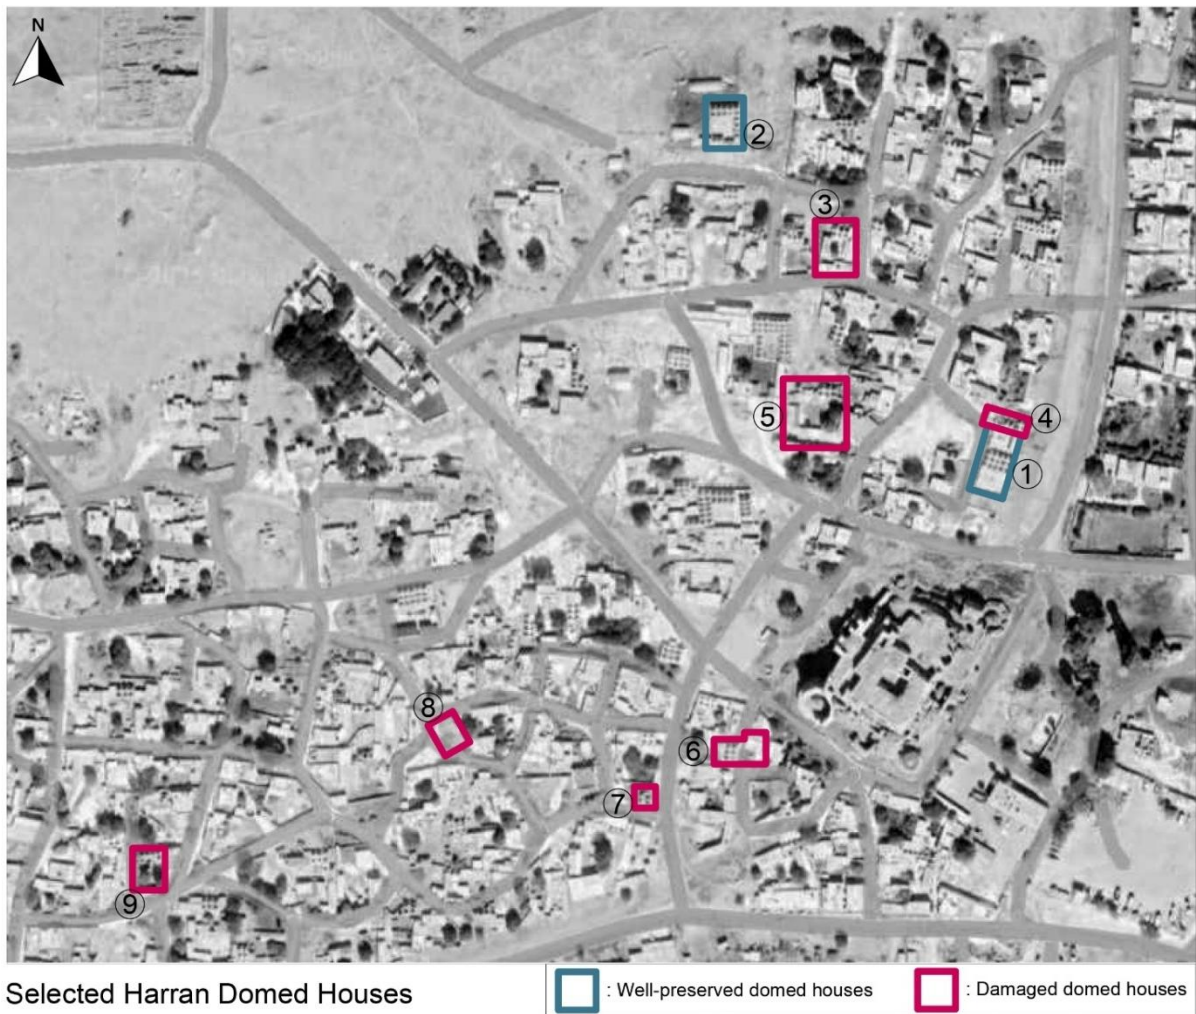
In this chapter, some of the houses detected during the site visit that were damaged by the earthquake will be examined. In figure 64 and figure 65, the map and the Autocad drawing from before the February 6th, 2023 earthquake shows a total of nine houses seen during the site visit, seven of which were ruined and two of which are well preserved. The architectural and constructional analysis of a typical Harran domed house has already been conducted in previous chapters based on the two houses that remain in good condition.

Figure 64 : Map and photos showing the selected seven damaged and two well-preserved domed houses (2025).
