CONSTRUCTIONAL FEATURES OF HARRAN DOMED HOUSES.
ON-SITE ASSESSMENT OF EARTHQUAKE-INDUCED DAMAGE.

MASTER'S DEGREE IN ARCHITECTURE FOR HERITAGE

July, 2025

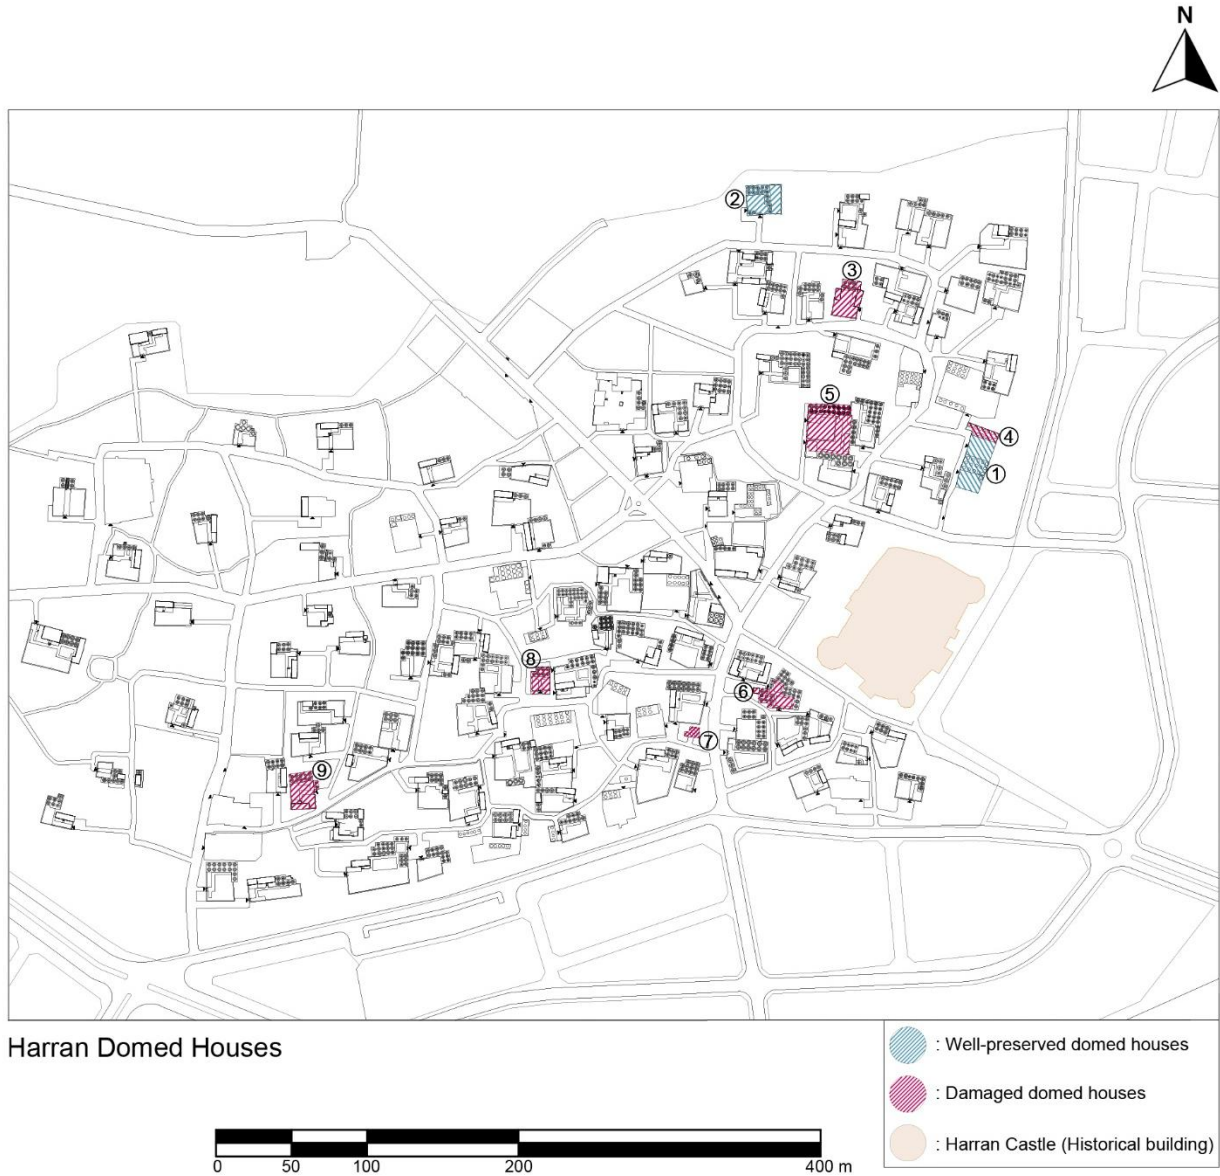
Figure 65 : Drawing showing the selected seven damaged and two well-preserved domed houses (2025).

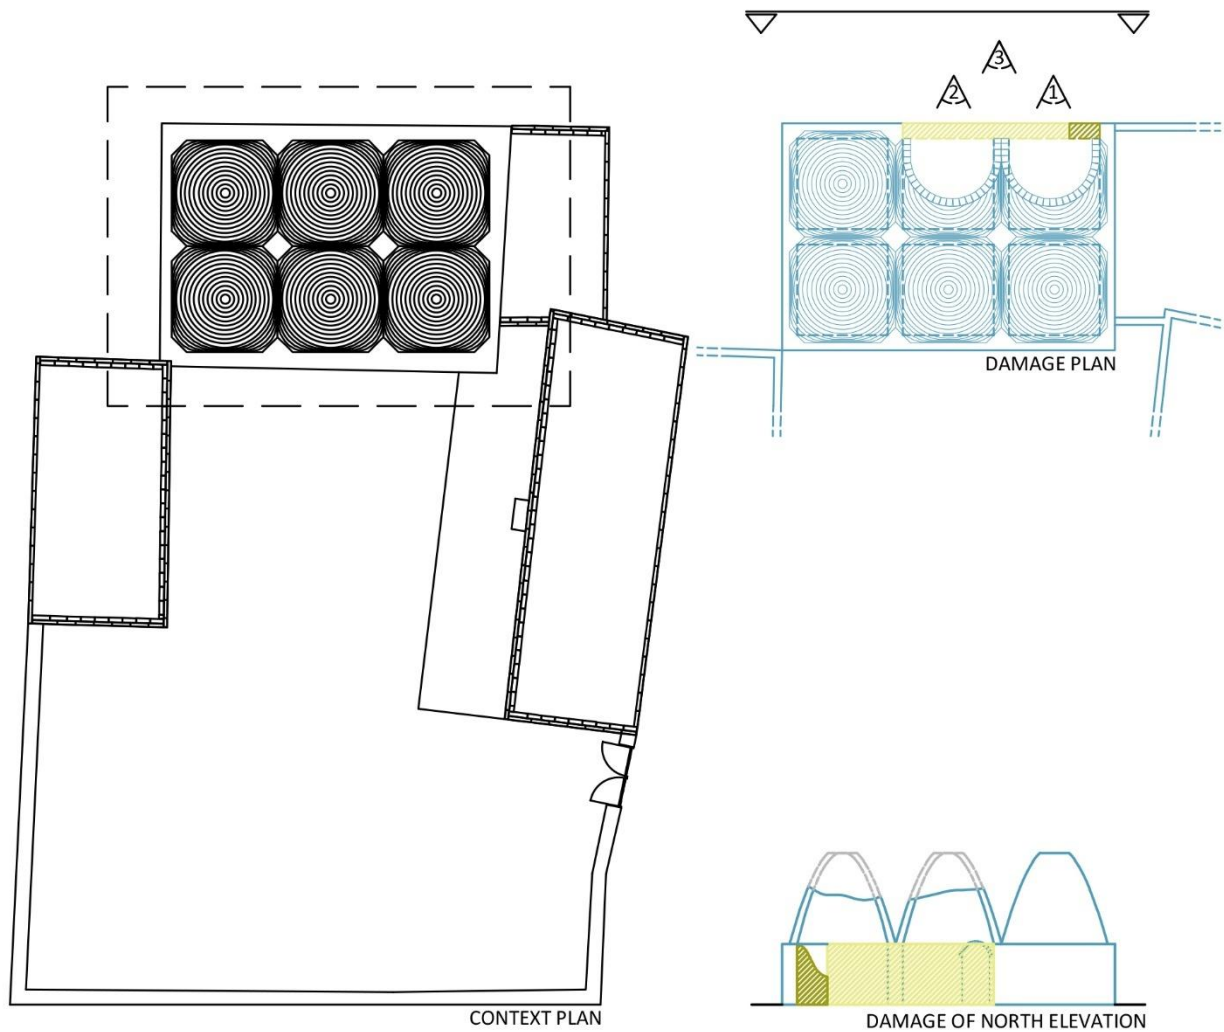
Figure 66 : Damage Drawings of House 3 (2025).

For each of the seven houses, the surviving portions are indicated with blue lines in both plans and elevations, while the collapsed portions are shown with grey dashed lines in the elevations. Wall damage is represented using different shades of yellow according to the remaining wall height:

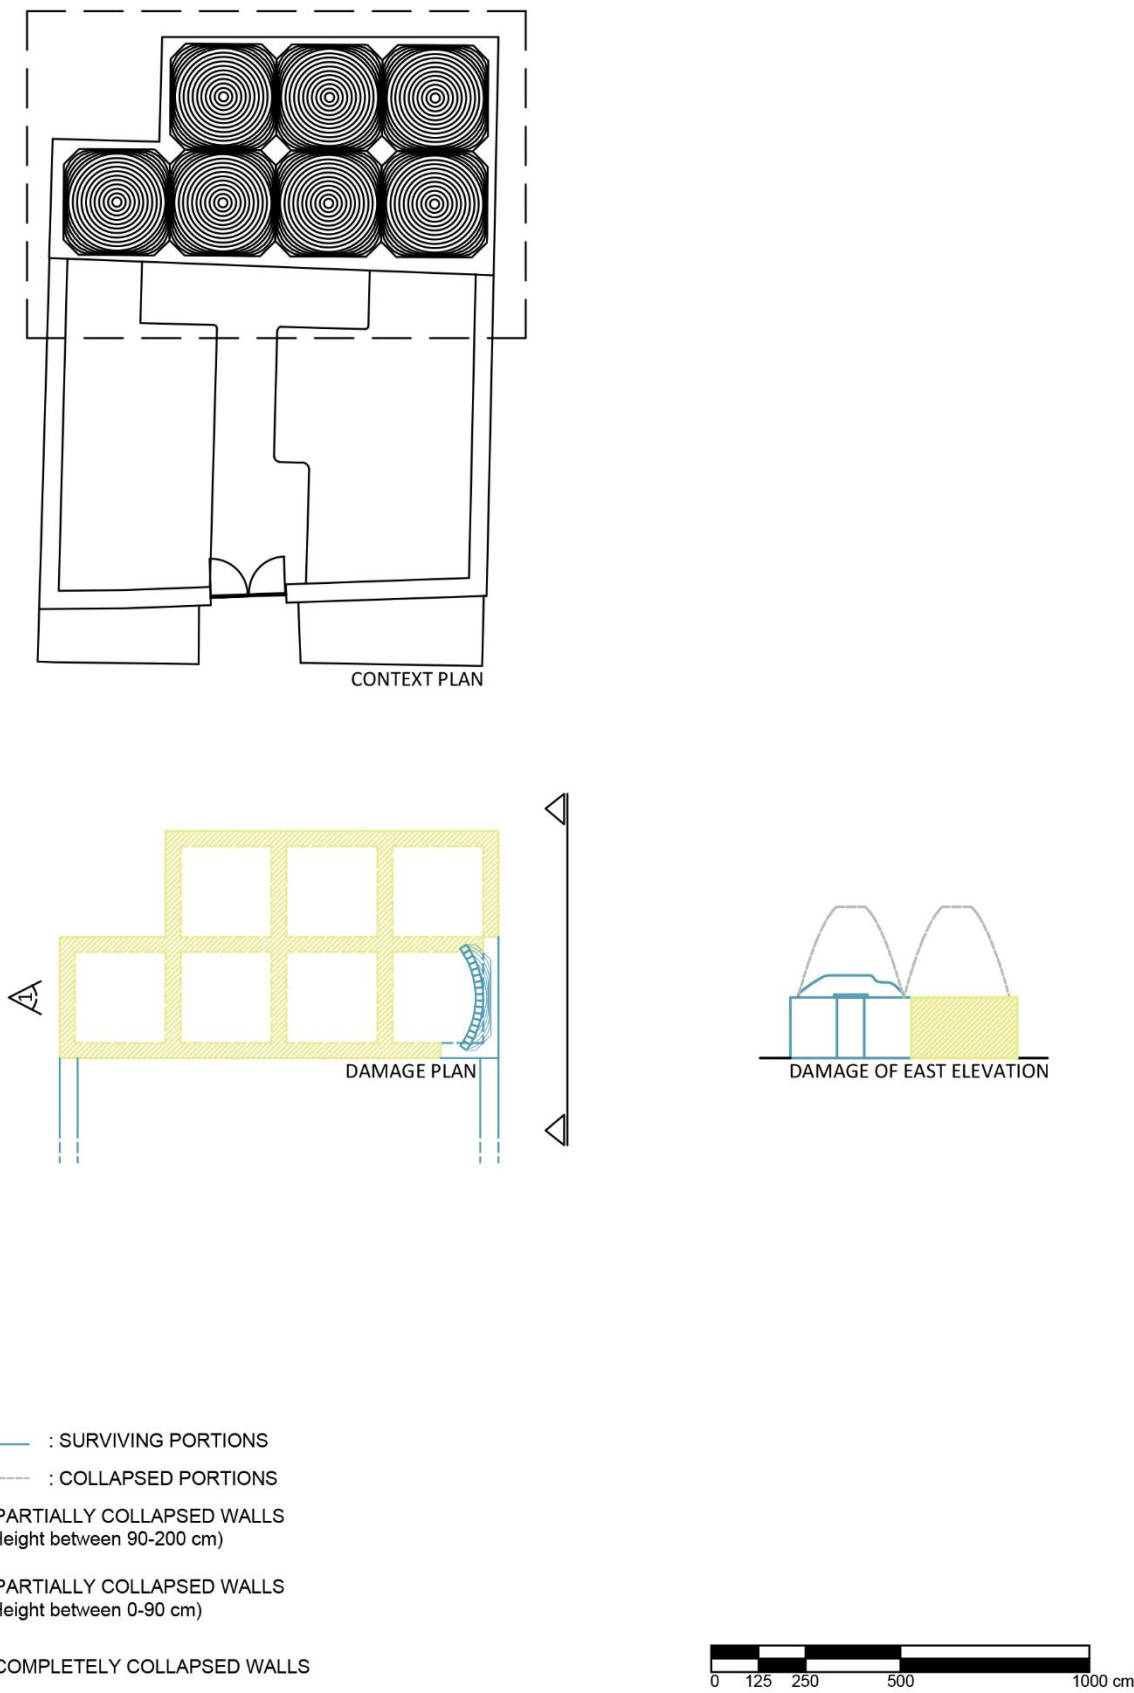
Figure 77 : : Damage Drawings of House 8 (2025).

House 8	The house is almost completely collapsed, and none of the domed units are in usable condition.

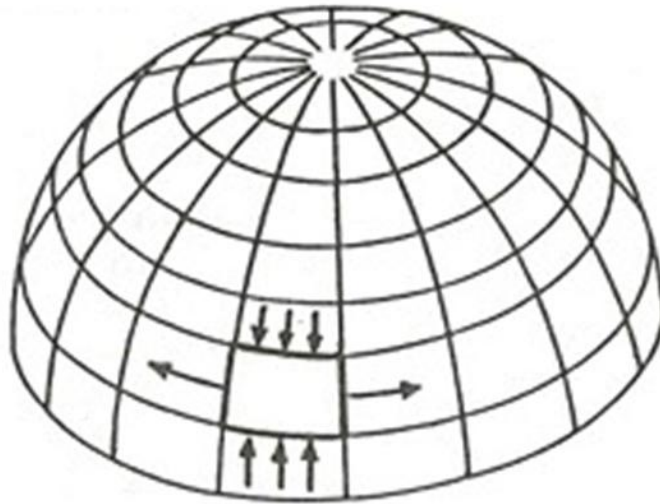
Figure 82 : Parallels in the domes require tensile strenght (Giuffrè, 1989).

Friction enables masonry to resist some horizontal tensile forces, especially near supports in domes (Figure 82). This pseudo-tensile strength depends on the vertical load because stones are pressed between those above and below. Sliding requires horizontal stress proportional to vertical pressure, friction, and overlap length. Longer overlaps increase tensile capacity. This principle allows squared stone masonry to act like a chain, a fact well understood by ancient builders (Giuffrè, 1989).

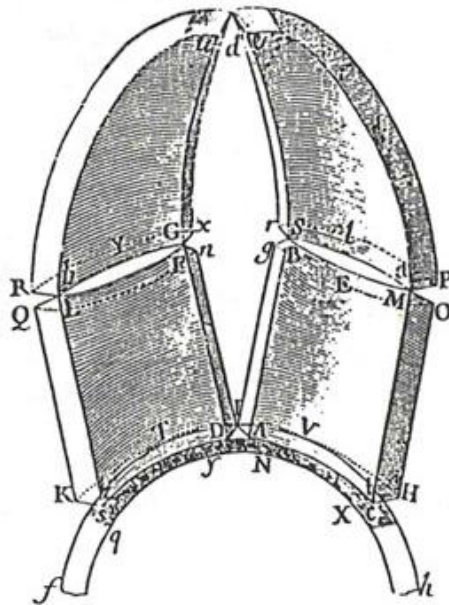
Figure 83 : Kinematic mechanism of domes (Giuffrè, 1989).

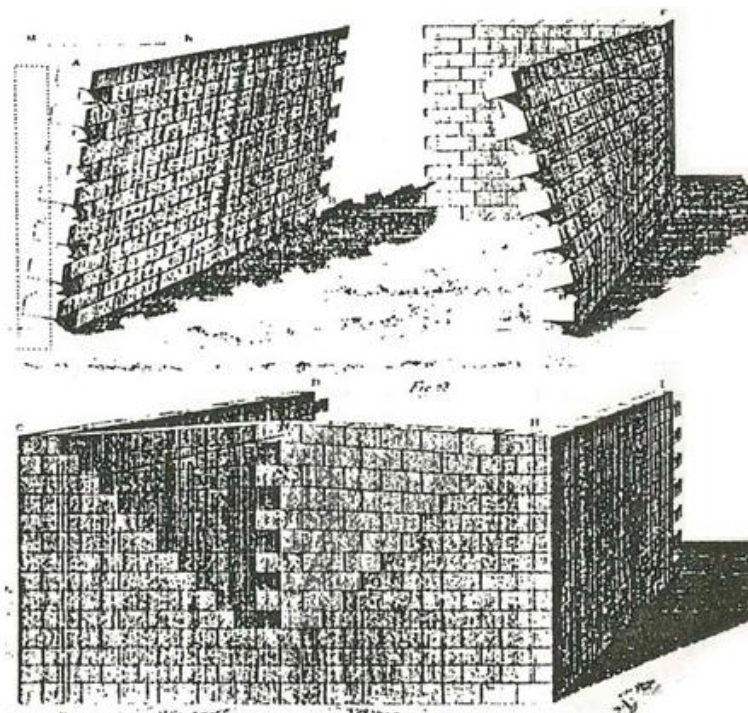
Damage typically occurs where the structure is weakest, and identifying the geometrical mechanism makes it possible to determine this vulnerable part and how it might move. The discontinuous nature of ancient masonry makes it particularly fragile. As a result, the most likely and hazardous effect of an earthquake is the out-of-plane collapse since masonry walls are least resistant in that direction when subjected to horizontal loads. (Figure 84), (Giuffrè, 1989).

Figure 84 : Collapse mechanisms (Giuffrè, 1989).

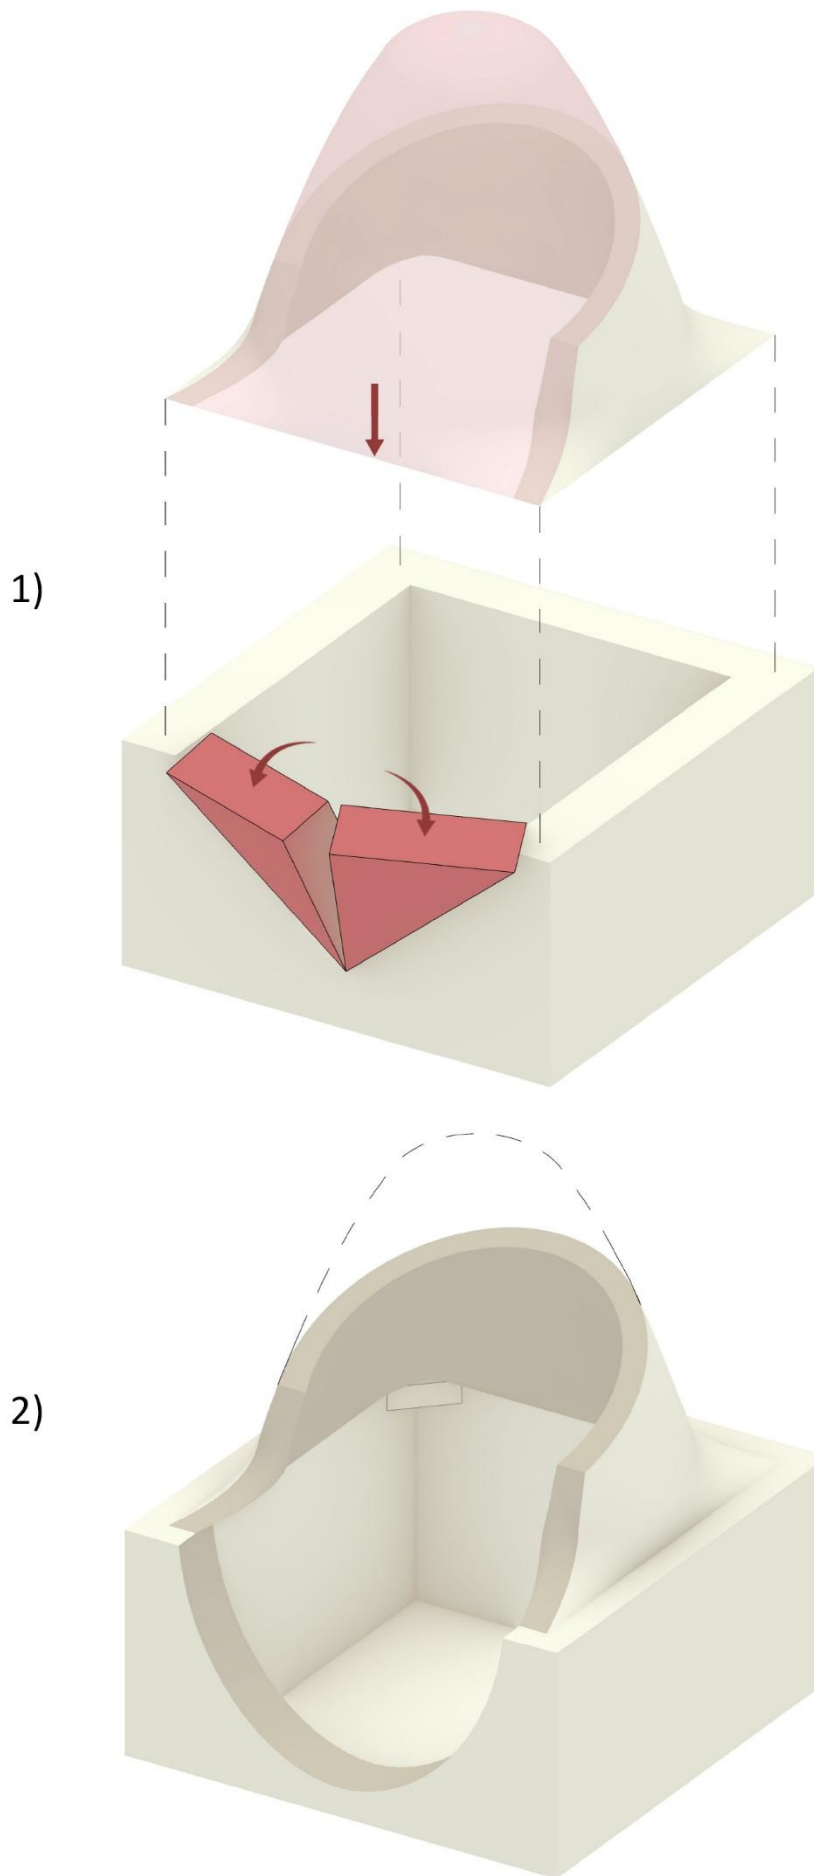
Figure 85 : Models of collapse mechanism of partially collapsed dome :
1) Movement of the walls – 2) Remaining portions (2025).

Figure 85 and 86 shows that the loss of supports on the collapsed wall side of the dome causes the portion of the dome on that side to collapse, but the remaining portion still stands.

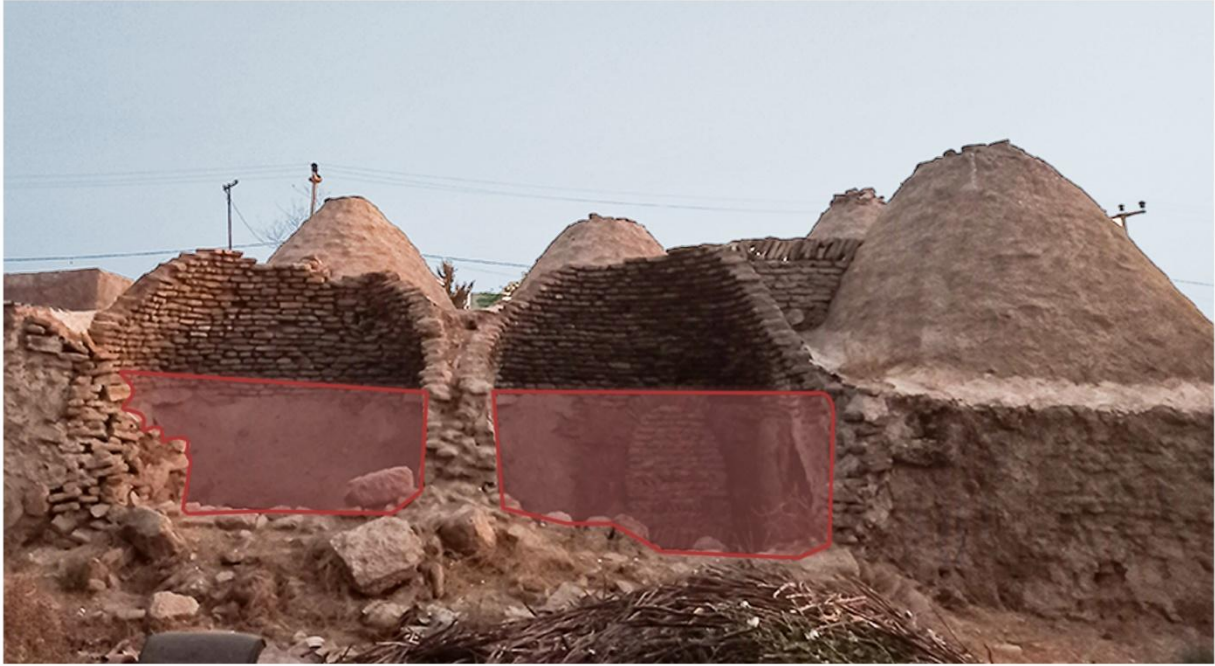
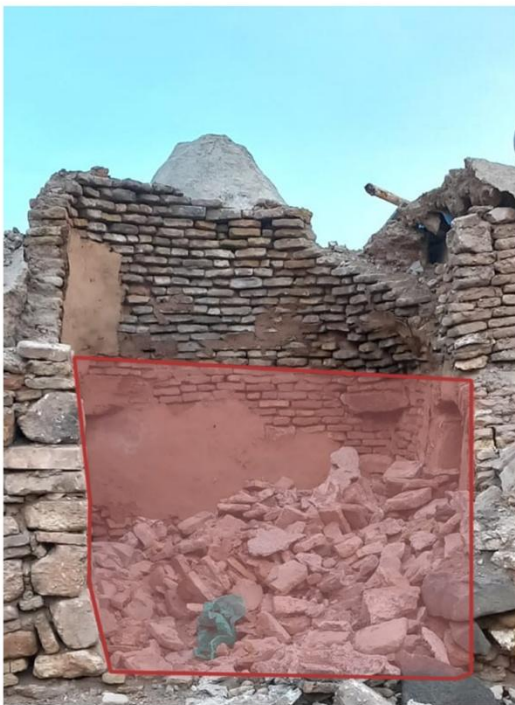
House 3

House 6

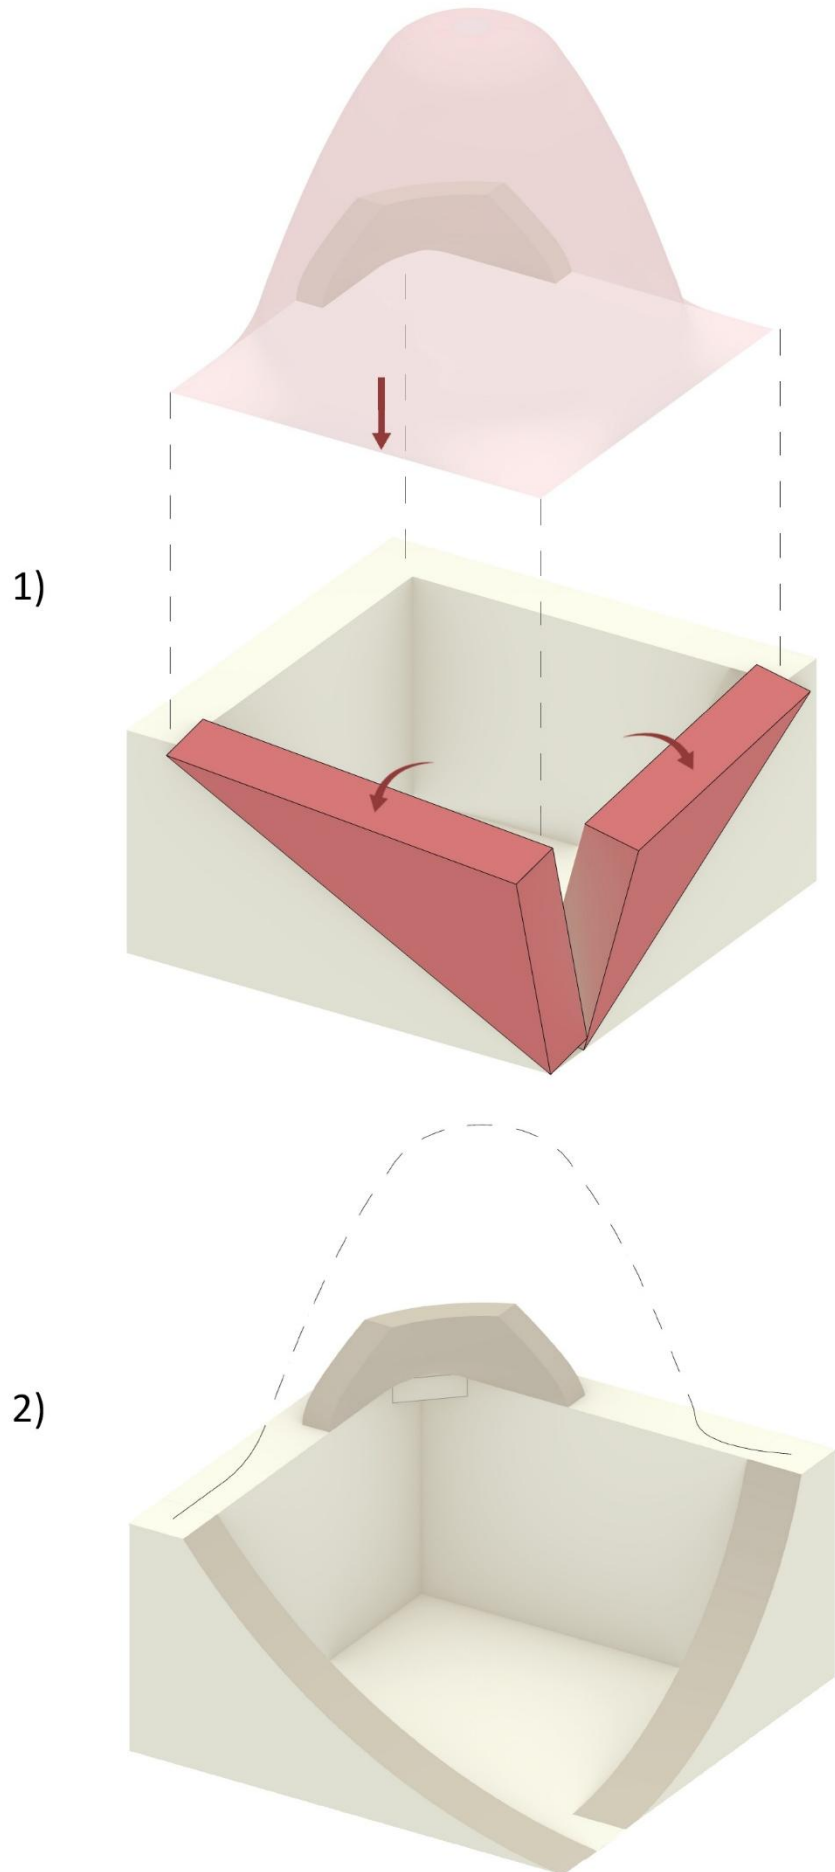
Figure 87 : Models of collapse mechanism of completely collapsed dome :
 1) Movement of the walls – 2) Remaining portions (2025).

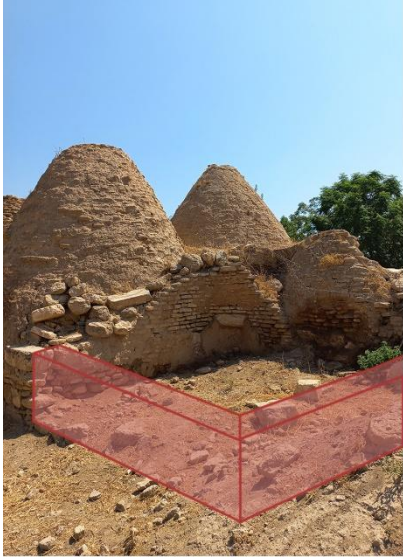
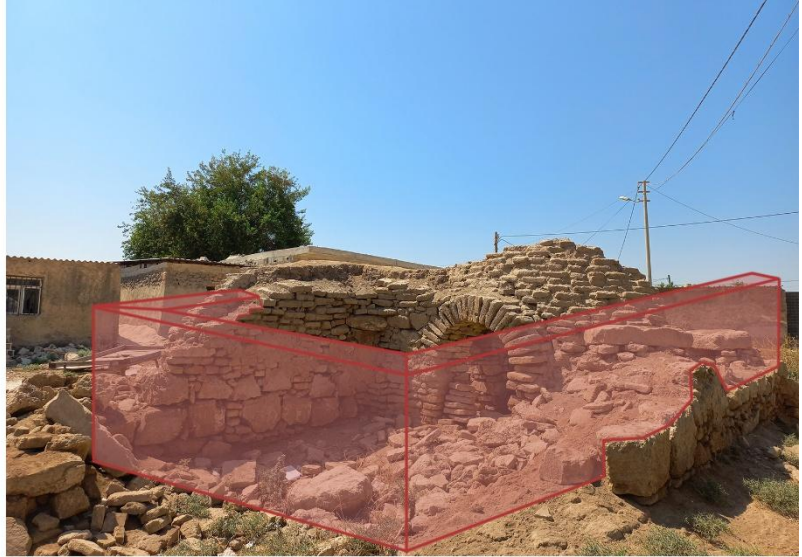
Figure 88 : Examples of houses with completely collapsed dome (2025).

House 5

House 7

Figure 87 and 88 shows that when two or three walls collapse, the dome will also completely collapse as it will have no remaining supports.
