POLITECNICO DI TORINO

**Master's Degree in
ARCHITECTURE FOR HERITAGE**
Master's Degree Thesis

**Karaköy Square Through Changes:
Urban Modernization and Heritagization in Istanbul from
1910 to 1960**

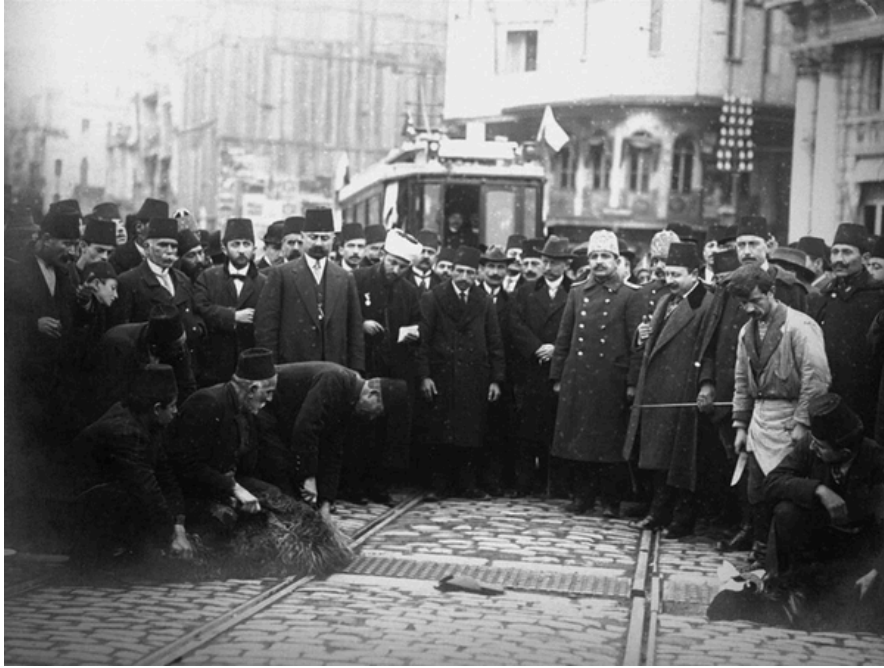
Figure 5. Karaköy - Eminönü Tram Line Opening, 1914
(<https://www.eskiistanbul.net/tag/karak%C3%B6y/>, accessed December 25, 2024)

In 1912, the necessary space was opened for the construction of the tram line, and some structures were demolished or moved back in the process. In this context, an important example in the study area is the Borsa (Commission and Consolidated) Inn. This inn was demolished and rebuilt as a single storey. Such structural interventions not only changed the urban texture of Istanbul, but also reshaped the city's commercial, transportation and social structures.

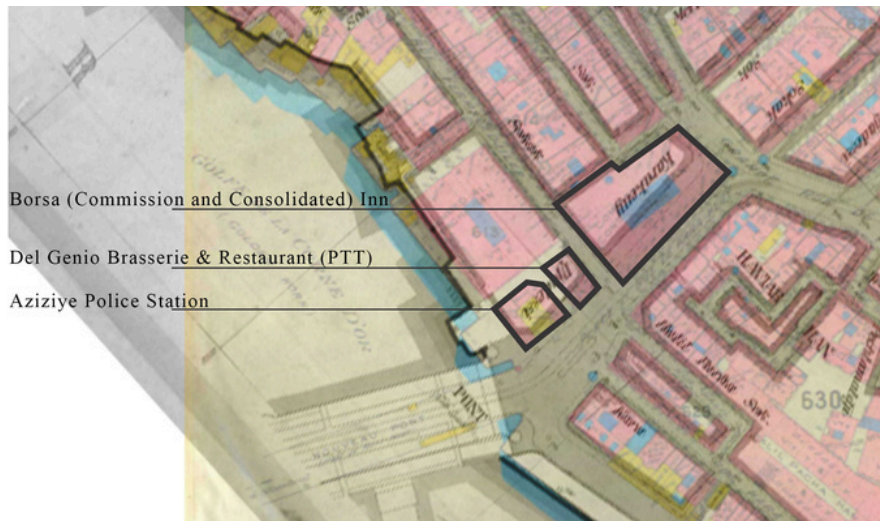
Figure 8. Marking the differences by overlaying the 1913 German Blueprints map onto the 1905 Goad map. (created by author),

The decisions taken regarding the newly constructed Galata Bridge also had significant effects on Karaköy Square. Especially the widening of the bridge and the advancement of its location caused architectural changes in the square. The effects on the buildings in the square, which started with the passage of the tram line, also led to the demolition of some buildings with the connection of the new bridge.

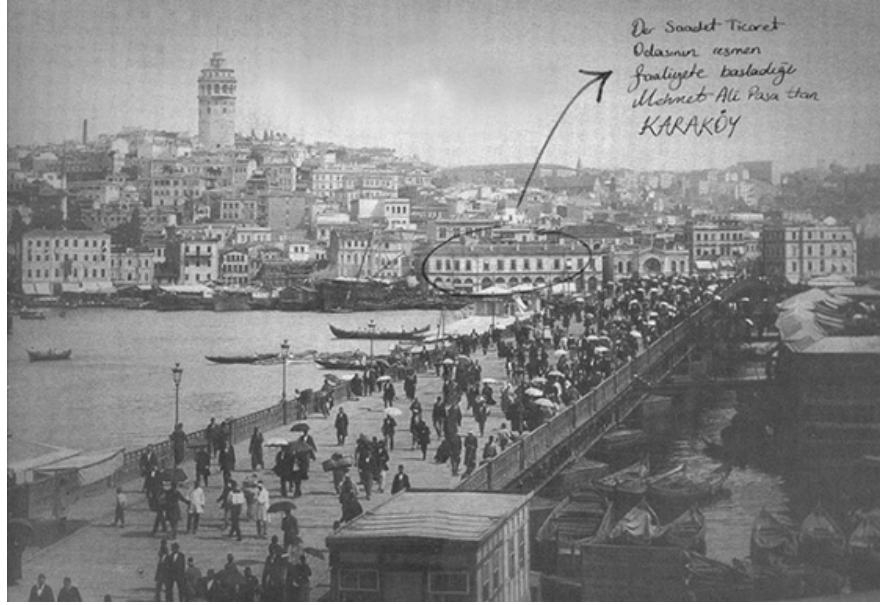
*Figure 10. Mehmet Ali Pasha Inn Marked As Dersaadet Chamber of Commerce
(unknown date, Istanbul Chamber of Commerce,
<https://istanbulticaretgazetesi.com/galeri/mehmet-ali-pasa-han>, accessed 27
January, 2025)*

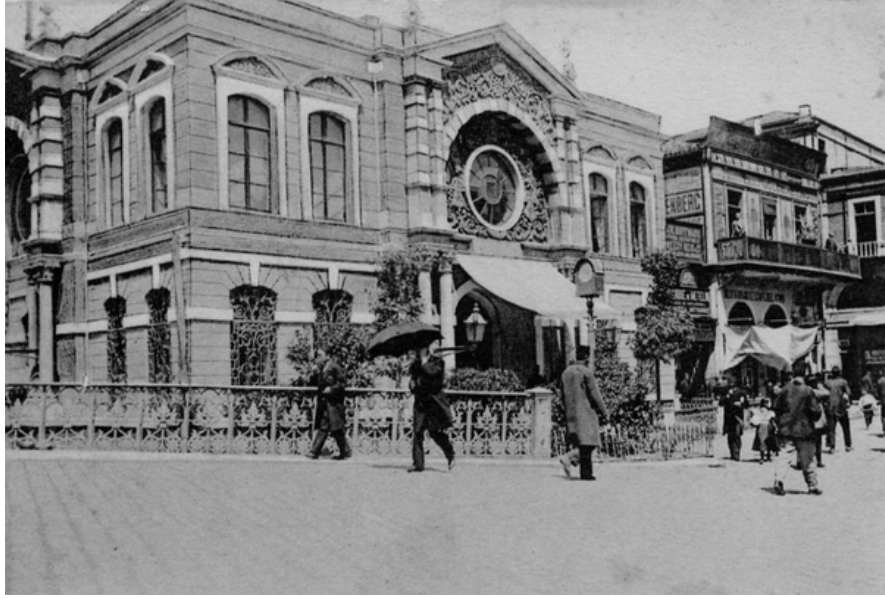
Figure 11. Aziziye Police Station, Max Fruchtermann, 1855
(<https://saltonline.org/en/2762/photography-collections-at-salt-research>,
accessed 5 May 2025)

On the 1905 Goad Map, the building on the left, close to the sea, at the beginning of the bridge is named Aziziye Police Station. Aziziye Police Station was built in 1866 when pedestrian traffic on the Galata Bridge increased significantly and the need for security became an increasingly important issue. It is one of the 232 police stations built by the Ottoman Sultan Sultan Abdulaziz. The building was known among the public as the “Ornate Police Station” due to its aesthetic architecture and eye-catching decorations. With its elegant and detailed stonework, facade and decorations, Aziziye Police Station became one of the most striking structures of the period. Beyond being just a security point, it became one of the symbol structures of Karaköy. However, it was seriously damaged in the great earthquake that occurred in 1893 and lost much of its structural integrity. (Çağlayan, 2016, 147) Thereupon, it was repaired by the famous Italian architect Raimondo Tommaso D’Aronco.

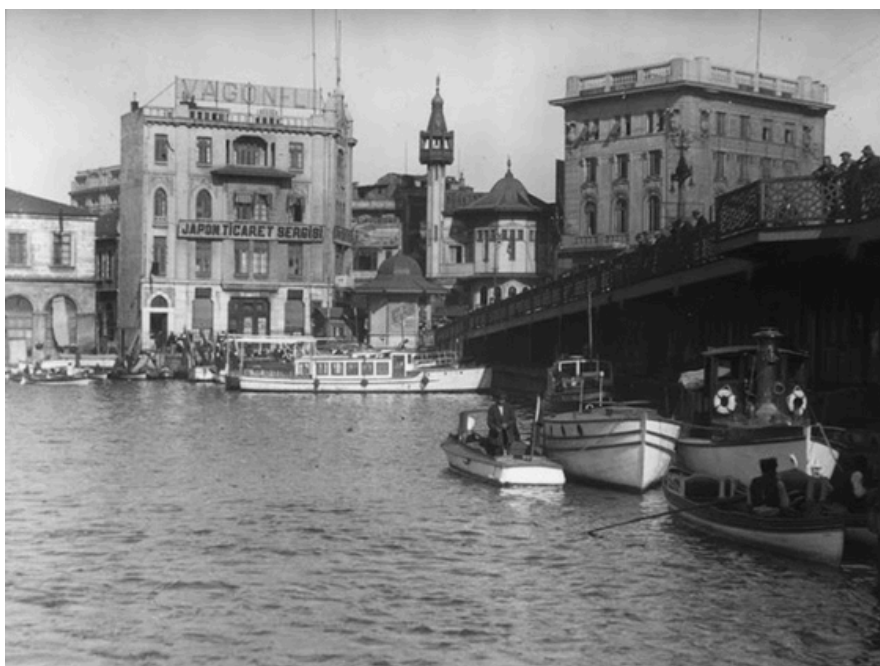
Figure 13. Wagon-Li, Wolfenstein: Karaköy, İstanbul, 1950
(<https://www.eskiistanbul.net/4543/wolfenstein-karakoy-istanbul-1950>,
accessed 6 May 2025)

After the demolition of the Aziziye Police Station, as seen on the Suat Nirven Map dated 1947 (Figure 12), a new structure was built in this area in 1910: the Wagon-Li (Wagons Lits Cook) building. This building belonged to the Wagon-Li company, a French

railway company famous especially for its sleeping and dining cars. (Asar, 2023) Wagon-Li played an important role in railway transportation in Europe since the end of the 19th century. This building, as a part of this multicultural structure of Karaköy, symbolized the presence of the French company in the region amidst the shops and trading points belonging to foreigners in the region. This situation further reinforced both the cultural and commercial diversity of Karaköy.

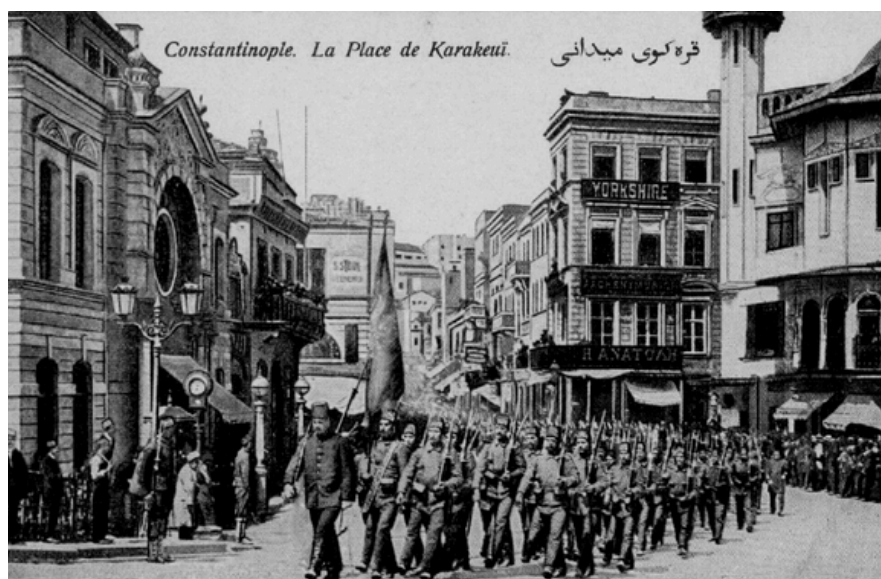
Figure 14. Aziziye Police Station on the left, Merzifonlu Kara Mustafa Pasha Mosque on the right; and Military Parade, Salt Research, before 1910)

Raimondo D'Aronco is a famous Italian architect who gained fame with his Art Nouveau style. He built a new mosque in 1903 in place of the old Merzifonlu Kara Mustafa Pasha Mosque in Karaköy Square. (Esmer, 2013) There was a small church here during the Byzantine period. With the conquest of Istanbul, the church was converted into a mosque. During the reign of Fatih Sultan Mehmet, it began to be used as a lodge. The lodge, which was ruined over time, was demolished by the Grand Vizier of the period. His name is Merzifonlu Kara Mustafa Pasha, and was rebuilt in 1670 as a fevkani² mosque. On the lower floor of the mosque, shops and warehouses were added in order to provide income for the place of worship and to meet the expenses of the mosque.

The name of the mosque became synonymous with its founder, Kara Mustafa Pasha, over time. However, in 1902, Sultan Abdulhamid decided to build a new mosque for this mosque, which was destroyed over time. Following this decision, it was decided that the cafeteria named Cafe d'Orient, which was operating in the area where the mosque would be built, should not be demolished. (Esmer, 2013) Therefore, it was decided to build the new mosque on top of the existing shops. The leading architects of the period, Gotzo, Patrokles, Kampanakis and Raimondo D'Aronco, submitted projects for this new mosque. Sultan Abdulhamid found the project proposed by D'Aronco more interesting and accepted this project and construction began. While the new mosque was being built, the shops and cafeteria on the lower floor were connected to the foundations of the old mosque by means of steel girders in order to be compatible. The main mass of the structure and its minaret were designed in an octagonal shape. Thus, the mosque was given a unique form. It has an octagonal structure, a marble exterior decorated with floral reliefs and a carved wooden minaret. It was also known as the wooden mosque. The new mosque stands out as the smallest structure in D'Aronco's career, especially with its elegant design and small scale. The details of this building are one of the examples of the architect's aesthetic understanding reflecting the Art Nouveau style.

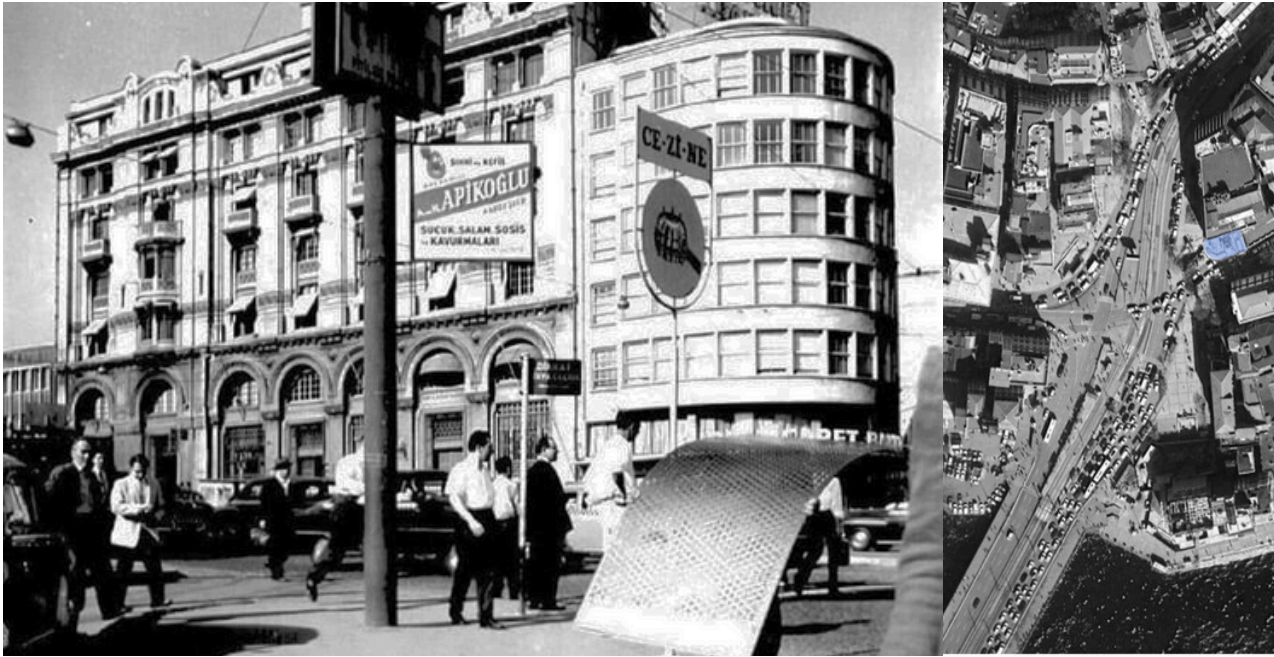
*Figure 20. Alemdar Kardeşler Building Next to Karaköy Palace
(<https://www.herumutortakarar.com/alemdar-kardesler-buro-binasi-seref-hani/#uael-gallery-6> , accessed 6 May 2025)*

The Alemdar Kardeşler Building is also controversial in terms of its functionality in the transformation process of Karaköy Square. During the period when the building was built, Karaköy was a region with intense trade and financial activity. In this context, the new

building should not only adapt to the physical environment but also support urban circulation and commercial structure. However, the views that Nezih Eldem's project, which was not implemented, was more successful in terms of architectural integrity are still debated today. Eldem had an approach that saw urban space as an interior and evaluated it on a human scale. He aimed to strengthen the interaction between the building and the city as a part of the square. In contrast, the Safa-Aru project is disconnected from the existing environmental factors. Today, the building design could not fully integrate with the urban texture of Karaköy.

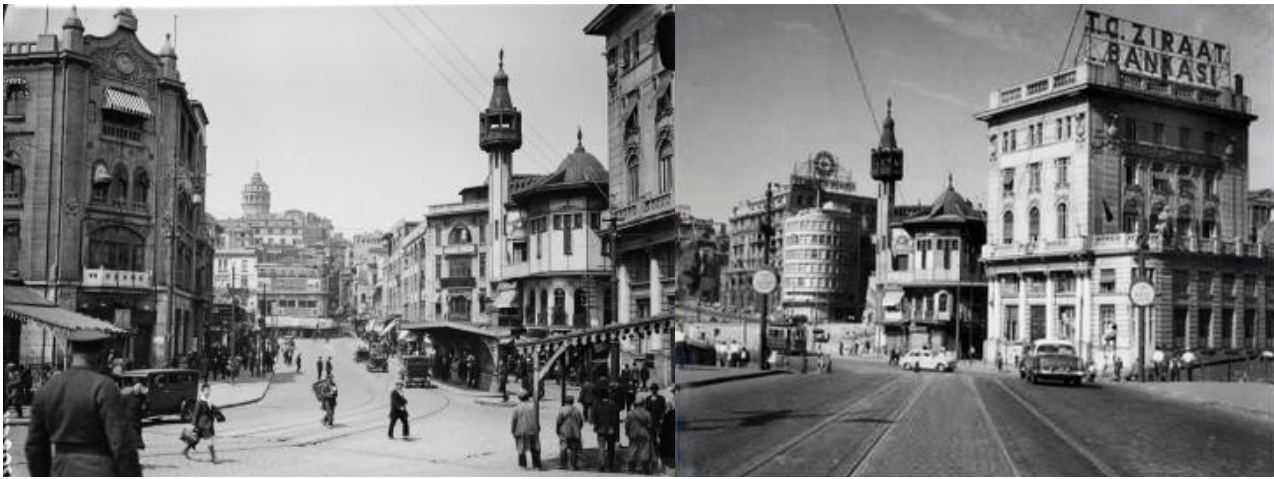
Figure 21. Before Alemdar Kardeşler Building before 1947

Figure 22. After Alemdar Kardeşler Building after 1947

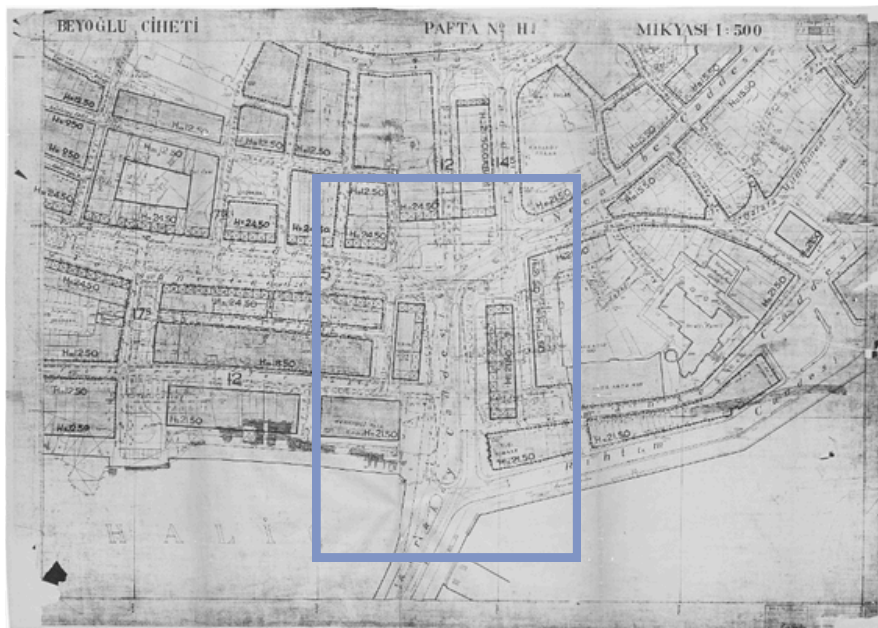
Figure 23. Beyoğlu District Zoning Plan, Sheet 9/4 (Scale 1:500), Salt Research, 1953

When the 1:500 scale zoning plan covering Karaköy is examined, it is seen that the building blocks surrounding Karaköy Square are largely defined by new high-rise building arrangements. There are especially building blocks determined with heights of 12.50, 18.50, 21.50 and 24.50 meters. This may indicate that the region was shaped as a dense trade center. This new order is somewhat parallel to the drafts presented by Prost in the late 1930s. However, with the Menderes period, there were more comprehensive transformations in practice. Most of the roads proposed in Prost's plans were preserved. However, after 1954, these axes may have begun to be arranged as wider boulevards in order to accommodate the increasing traffic density. The aim was to replace the old structures that determined the character of Karaköy with higher and more functional commercial structures within the framework of this new order. In the following section, the traditional texture of the region will be irreversibly changed and will lead to discussions.

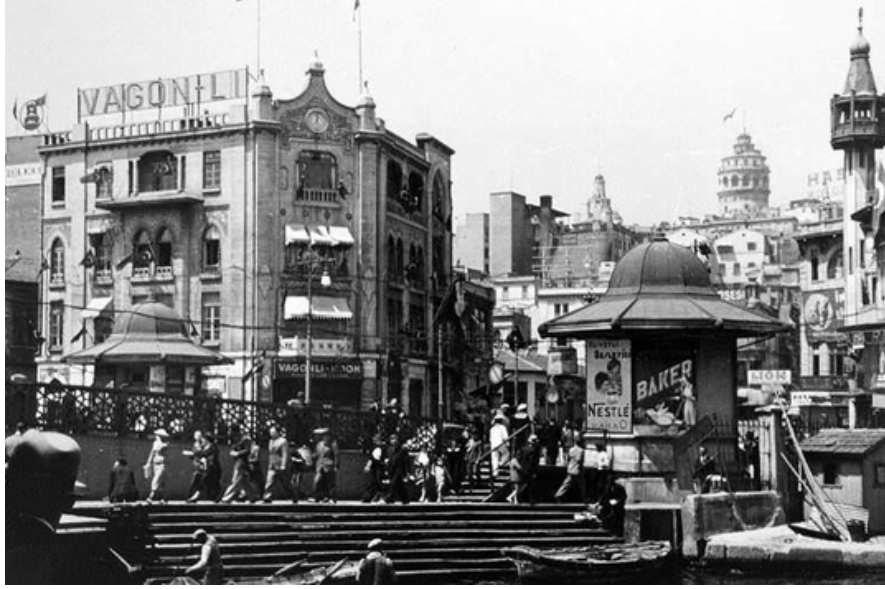
Figure 25. Wagon-Li Building Before Demolition, before 1956
(<https://www.eskiistanbul.net/tag/karak%C3%B6y/>, accessed 7 May 2025)

One of the first buildings affected by the demolition process was the Wagon Li building. This building was built as a smaller but as a multi-story building instead of the Aziziye Police Station, which was demolished due to the narrowness of the point where the bridge reached. It was used as the headquarters of the French Compagnie Internationale des Wagons-Li in Istanbul. It was an administrative and commercial building connected to the sleeping wagon services during the Ottoman and early Republican periods.

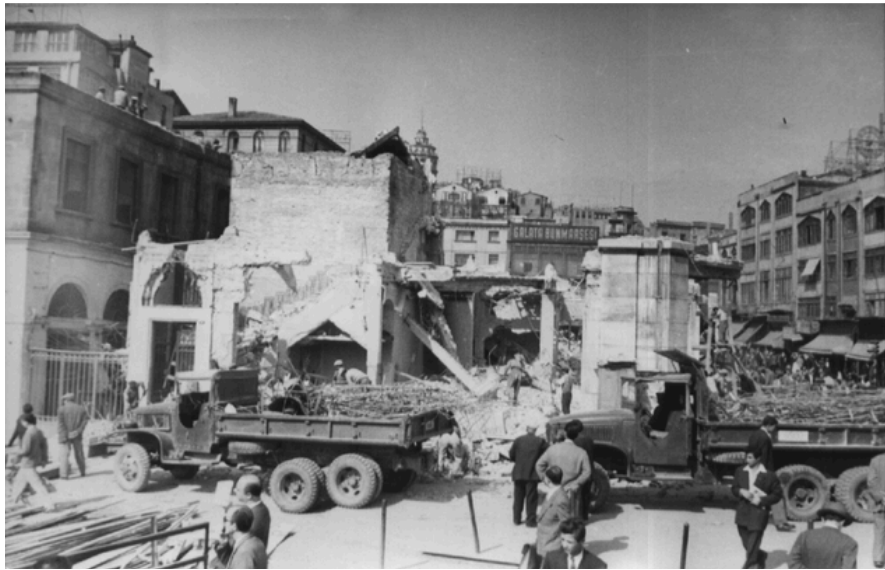
Figure 26. Demolition of the Wagon-Li Building, Cemal Işın, 1958
(<https://archives.saltresearch.org/handle/123456789/115213>, accessed 7 May 2025)

Wagon-li building's architecture had neo-classical and art nouveau styles reflecting the European influences of the period. It had elegant facade decorations, large windows and a symmetrical layout. At the same time, it was a building that symbolized the privileged position of foreign capital in Türkiye. It was demolished within the scope of Adnan Menderes' comprehensive urbanization projects. It was replaced by wider roads and square arrangements within the framework of the modernization efforts to open up the

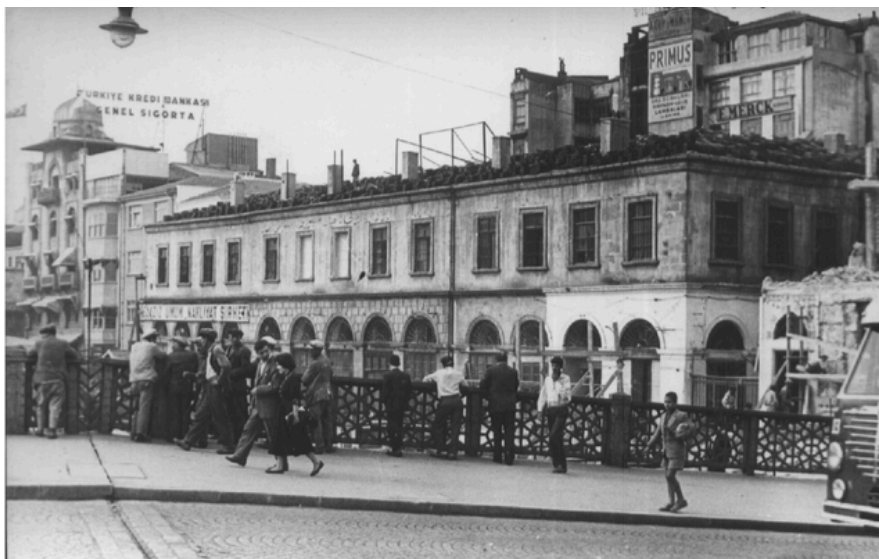
Figure 27. Mehmet Ali Pasha Inn Before Demolitions, Foto Işın, before 1958
(<https://archives.saltresearch.org/handle/123456789/109264>, accessed 7 May 2025)

Another example is the Mehmet Ali Pasha Inn next to the Wagon Li. It was a structure that had a great impact on the silhouette from the Galata Bridge. Due to its location, this inn was one of the important centers of commercial life around Karaköy Square during the Ottoman and early Republican periods. It was a frequent destination for merchants in the region. Over time, it hosted many different businesses from different communities.

Mehmet Ali Pasha Inn was built in the second half of the 19th century. It is a structure that follows the classical Ottoman inn typology. There were shops on the ground floor and commercial offices on the upper floors. However, towards the end of the 19th century, Western influence became evident in Ottoman architecture. Thus, European-style ornaments were included on the inn's facade. The entrance door and facade details have an aesthetic that is different from classical Ottoman inns. As mentioned before, the demolition of the Del Genio Brasserie part of the inn was identified by comparing the 1905 Goad map with the 1913 German Blues.

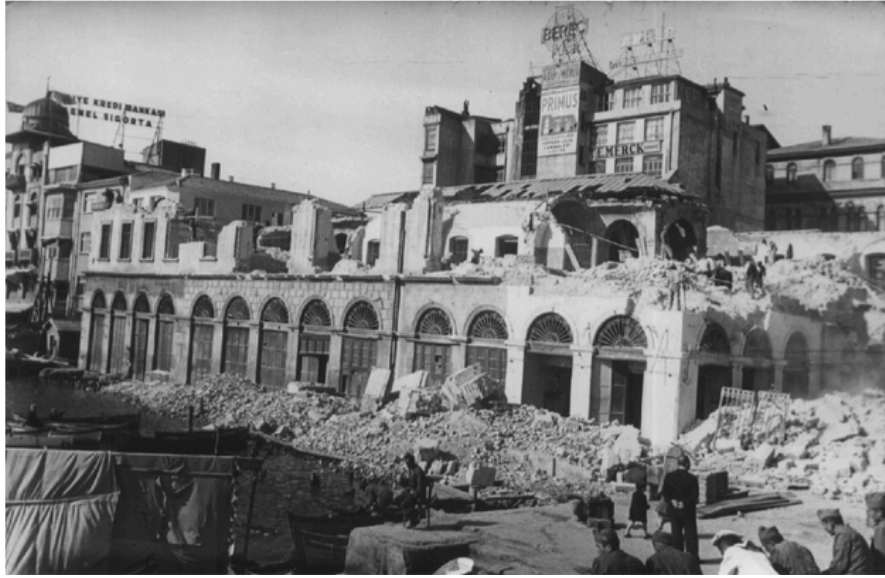
Figure 28. Mehmet Ali Pasha Inn While Demolitions, Foto Işın, 1958
(<https://archives.saltresearch.org/handle/123456789/97583>, accessed 7 May 2025)

Mehmet Ali Pasha Inn was completely demolished in order to expand Karaköy Square once again. After the demolition, the square was expanded as a whole. Karaköy's urban silhouette was reshaped with this transformation. If Mehmet Ali Pasha Inn had been preserved, it could have continued to function as a space contributing to the revitalized commercial and cultural texture of Karaköy today. However, with the rapid and unplanned modernization process, this historical heritage was completely destroyed and its square was expanded. This led to a differentiation in urban perception.

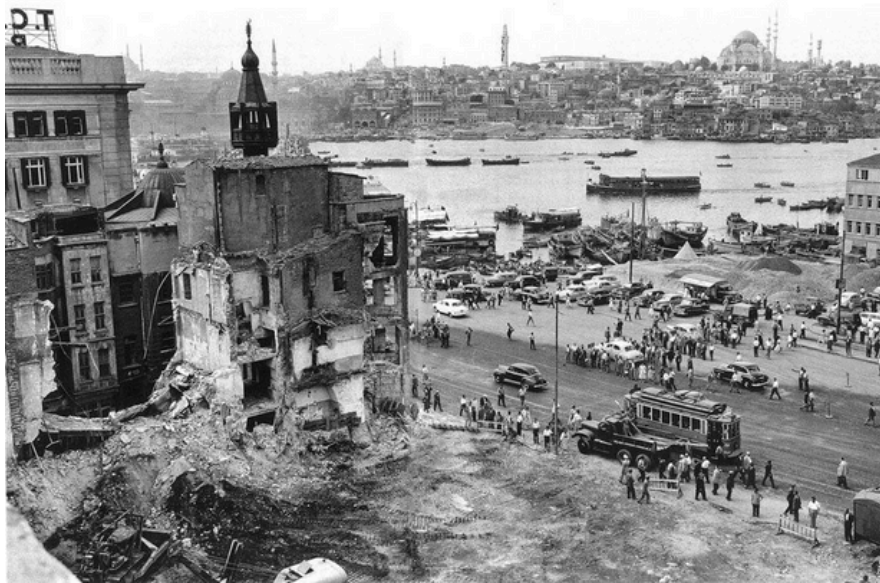
Figure 29. Demolition of Havyar Inn

The year of construction of the building is unknown, but it can be seen on Carl Stolpe's Istanbul Plan of 1882. In terms of architecture, it had the characteristic features of 19th century Ottoman commercial inns. Stone and brick were generally used as materials. It had a traditional inner courtyard plan. While the ground floor of the inn was generally used for storage areas and shops, there were rooms on the upper floors where merchants could stay.

During the Adnan Menderes period, Havyar Inn was also completely demolished as part of the expansion of Karaköy Square. After the demolition, the area where the inn was located was used for square arrangements and new transportation arteries. Thus, the traditional commercial texture of Karaköy has changed to a great extent. A commercial block that developed organically and was in contact with the city walls has disappeared.

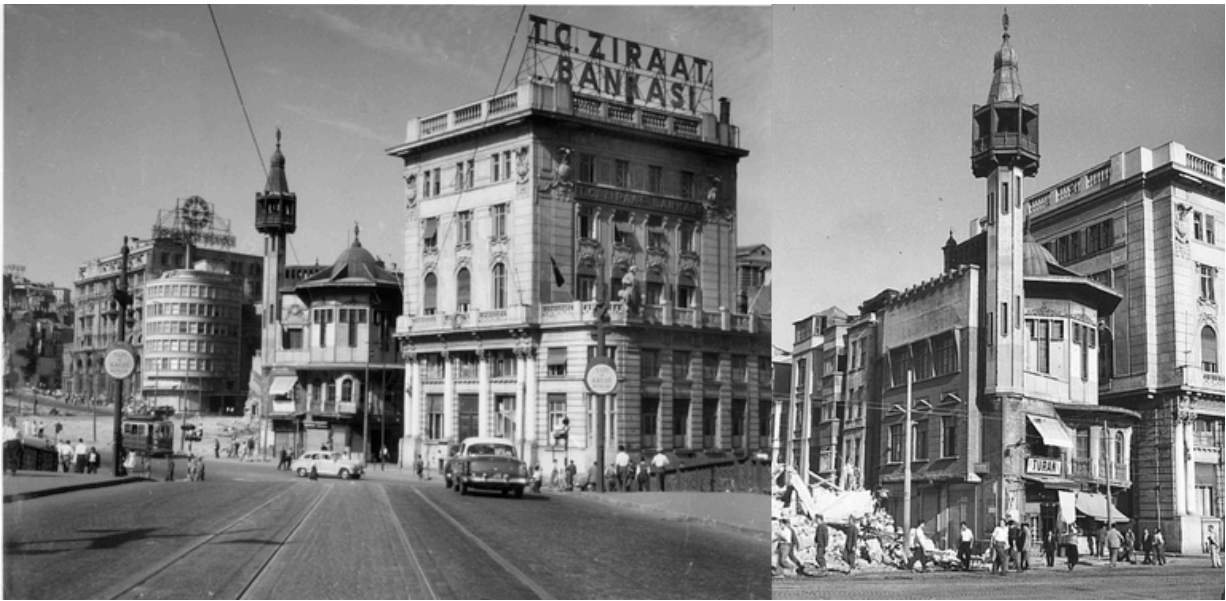
Figure 30. and 31. Demolished building block next to Merzifonlu Kara Mustafa Paşa Mosque in Karaköy, Halûk Doğanbey, 1958
(<https://archives.saltresearch.org/handle/123456789/74330>, accessed 7 May 2025)

The other major intervention to expand the square was the demolition of the Merzifonlu Kara Mustafa Pasha Mosque. As previously described, after its transformation in 1903, it had become a structure reflecting the characteristics of classical Ottoman architecture. It contributed to the religious and cultural life of the region. It was one of the most important elements determining the silhouette of the square.

While the squares were being tried to be refreshed, the historical heritage was largely ignored in this process. The Merzifonlu Kara Mustafa Pasha Mosque was also badly affected by this process. It was demolished in 1957. The authorities at that time did not want the structure to be completely destroyed before the demolition. Instead, they planned to dismantle its parts and rebuild it somewhere else. In this context, it was considered to rebuild the mosque in Kınalıada. For this purpose, the portable parts of the structure were carefully dismantled. However, this project was never implemented. The portable parts of the mosque were lost in the Sea of Marmara because the ship carrying the stones sank. This unsuccessful attempt shows that it was a period implemented with unplanned and sudden decisions. It is also a reflection of bad urban transformation policies that caused the loss of an important cultural heritage.

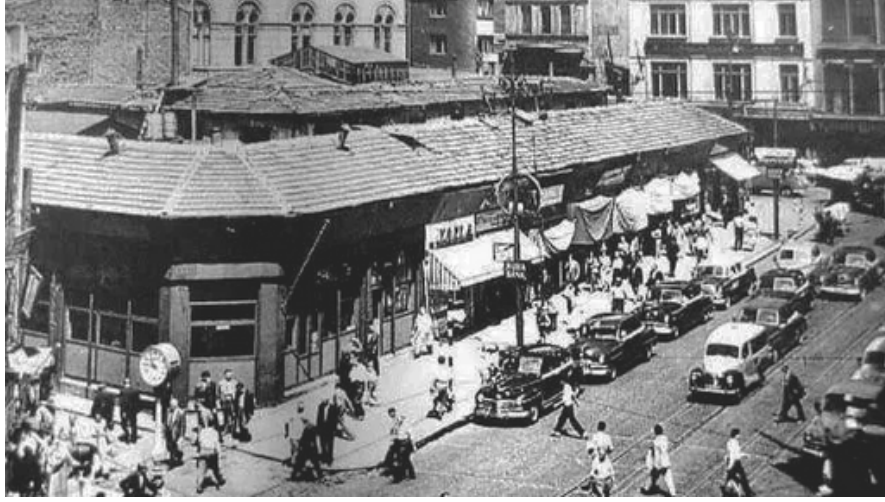
Figure 32. The Borsa Inn before it was demolished, before 1958
(<https://www.eskiistanbul.net/6411/eski-istanbul-yikilmadan-once-karakoy-deki-tek-katli-magazalar>, accessed 8 May 2025)

Another building that was demolished was Borsa Inn, or Commission and Consolidated Inn as it was called at the time. As mentioned before, it underwent its first transformation in 1912 for the passage of the electric tram line that reached Karaköy. In order to provide the necessary distance, the structure was pulled back in accordance with the urban planning strategies of the period and rebuilt as a single storey. (Kafesçioğlu, 2016, 183) The inn had a traditional form with a preserved inner courtyard. It still hosted the stock exchange and commercial activities of the period. In 1958, as part of Adnan Menderes' large-scale urban planning, Borsa Inn, like many other buildings in the square, was completely destroyed.

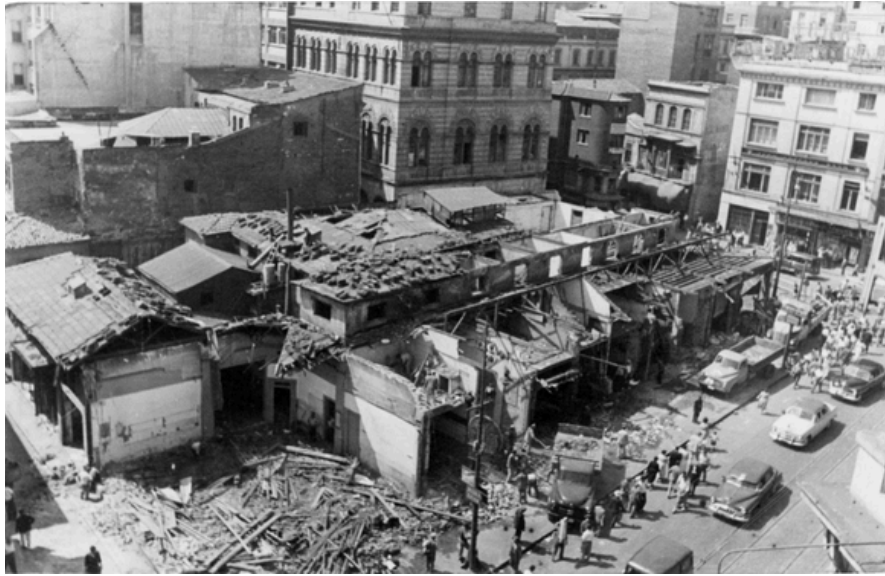
Figure 33. Demolition of Borsa Inn, Cemal Işın, 1958
(<https://archives.saltresearch.org/handle/123456789/93538>, accessed 8 May 2025)

As with many other structures, the demolition was carried out suddenly and quickly. In its place, roads and the square area were expanded. It brought a new city form. With the removal of Borsa Inn, the northeast side of the square became completely open. This made it easier to open the area to different uses in the future. With this expansion, Nordstern Inn, which was behind the Borsa Inn became visible.

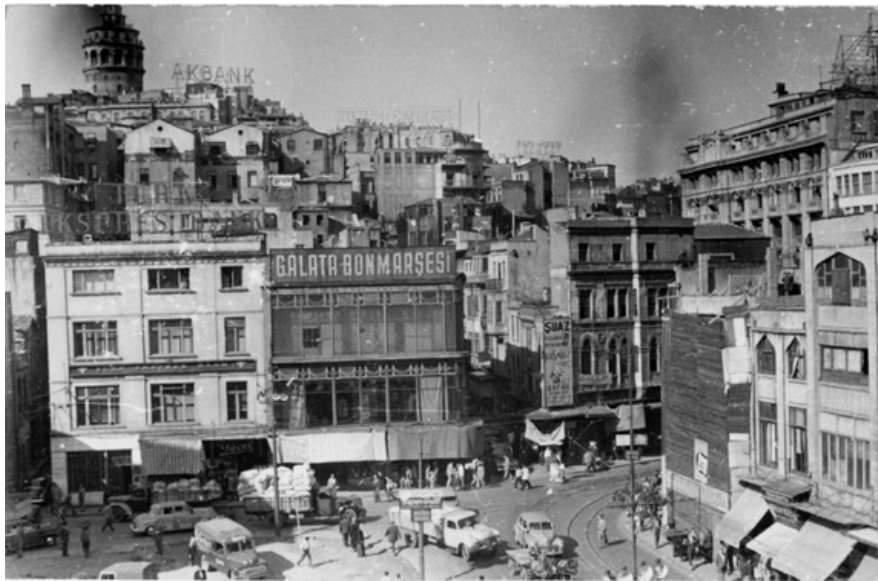
Figure 34. Before the demolition of Bon Marche, Cemal Işın, 1958
(<https://archives.saltresearch.org/handle/123456789/113289>, accessed 8 May 2025)

Another structure that was demolished was the Galata Bon Marche on the north side of the square. Galata Bon Marche was built in the late 19th century. It reflected the modern shopping concept of the period. The term "Bon Marche" comes from the French word for "good market". It was a large shopping center that aimed to serve customers with a wide range of products. Galata Bon Marche is considered one of the first modern stores in Istanbul. The building had large display windows, and the interior had high ceilings and spacious spaces. It was opened with the initiative of the French Bartoli Brothers who

settled in Istanbul after the Crimean War. The first store was opened on Istiklal Street. In 1926, the store changed hands. It was purchased by Karlmann, a Viennese Jew who had ready-made clothing stores in Galata. It became known as Karlmann Bon Marche. The stores offered a wide range of products, from clothing to household goods. Galata Bon Marche was also completely destroyed in 1958 during the Menderes transformations. After the demolition, the square was enlarged. With its demolition, a typical example of Istanbul's early shopping arcades was lost.

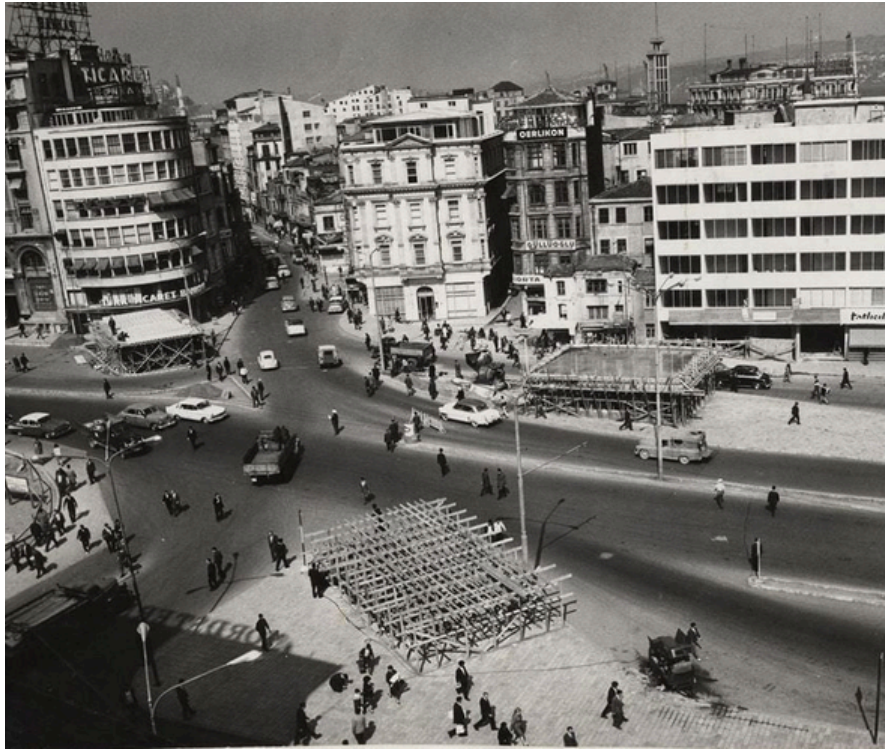
Figure 38. Underpass Construction, Kültür Envanteri, unknown (<https://kulturenvanteri.com/karakoy-meydani-ve-carsili-altgecit-insaatil/>, accessed 12 May 2025)

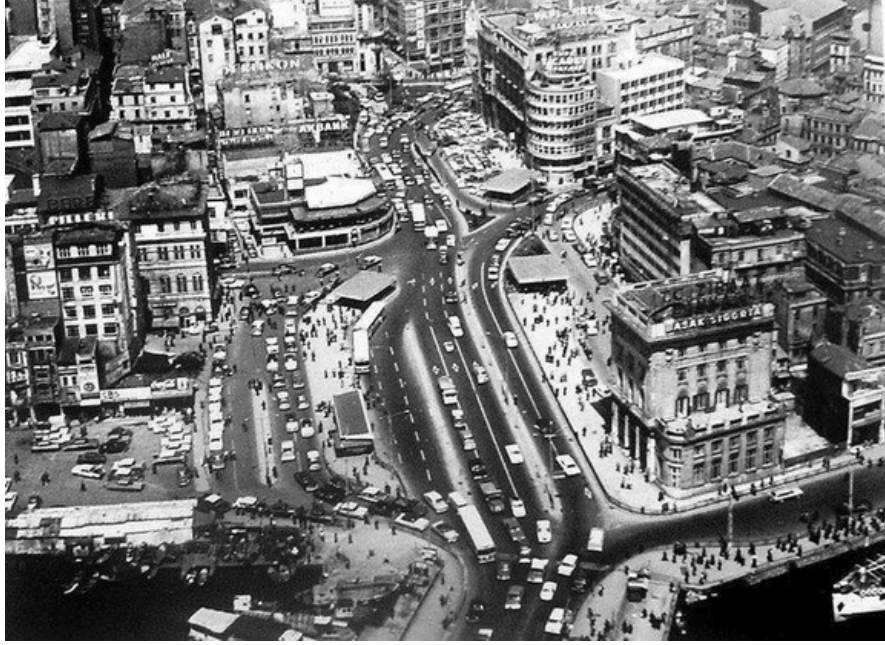
Figure 39. Karaköy After Underpasses

As a result of this transformation, Karaköy Square continued to be a 'square' physically, but it began to become a functional intersection. (Kafesçioğlu, 2016, 184) There was only the widening traffic flow and vehicle paths on top. Thus, one of the contradictions of modern urbanization became apparent here. An arrangement made for the safety and flow of pedestrians distanced them from public space. In fact, it eliminated the most fundamental element that made the square a 'square' – the pedestrian presence. The underpass was functional. However, Karaköy was diminished socially and spatially.

However, the maintenance of the structure has been neglected over time. Especially since the 1990s, there have been both infrastructure deficiencies and security problems. Some of the shops inside have closed, while others still exist with low-profile products. Despite this, the passage has always managed to exist in Karaköy's memory. The Karaköy Underpass is still in place today. The renovation work carried out in 2024 also attempted to revive the market section. However, the upper square still belongs to vehicles. Pedestrians still pass underground, and the physical emptiness of the square remains.

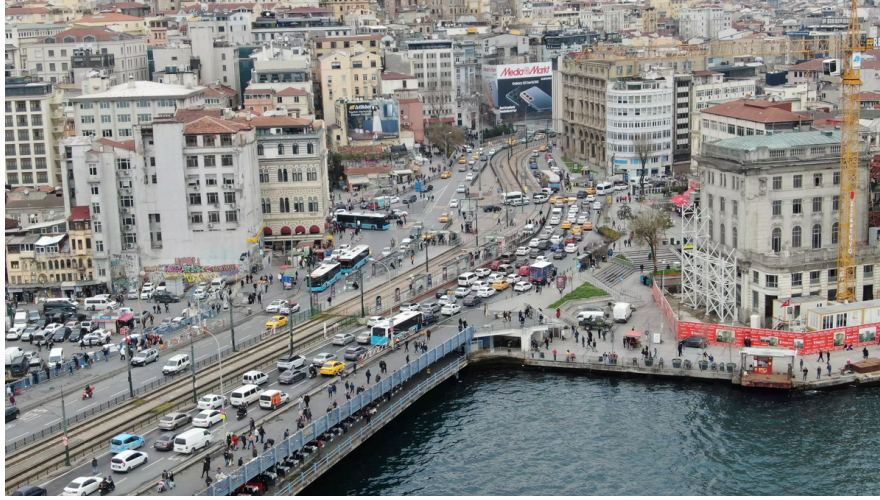
Figure 49. Aerial photo of Karaköy Square, DHA, 2021
(<https://image.dha.com.tr/i/dha/75/0x0/6182ff1845d2a01ab04c45a1.jpg>,
accessed 8 May 2025)

To understand the current character of Karaköy Square, it is not enough to look only from the pedestrian level or the facades. Karaköy is also a district of Istanbul perceived from the sea. However, unfortunately, this silhouette has deteriorated over time.

When approaching Karaköy by ferry, the observed view no longer has the meaning and aesthetic integrity of the past. In the past, the structures that rose elegantly within the silhouette of Galata were accompanied by traces of their periods in the gaps between them. Today, there is a fragmented, discontinuous, disconnected set of structures in its place. There is no harmony between the height differences, facade materials and architectural languages, but rather a conflict.

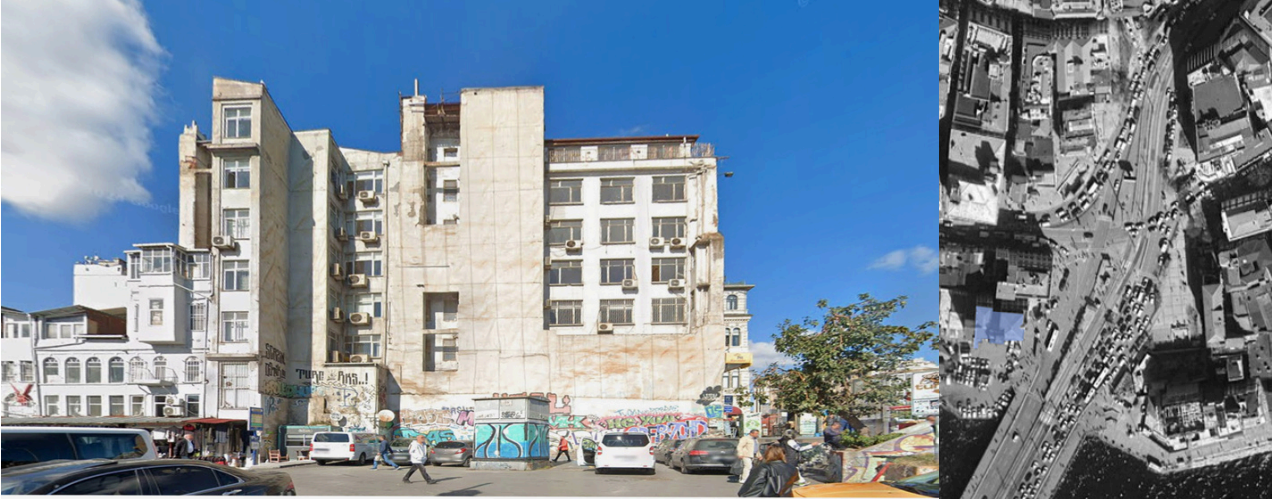
Figure 50. The void at the location of Mehmet Ali Pasha Inn and Wagon-Li Building & Building with an inactive facade, Google Street View, October 2024. (<https://maps.app.goo.gl/XRLUz7J1GRry1QwW9>, accessed 5 June 2025)

One of the most important things that draws attention when viewed from the sea is the weakness in the facade compositions of the buildings. Some buildings face the coast with their inactive facades. With the demolition of the Wagon-li building and the Mehmet Ali Paşa Inn, the dysfunctional rear facade of the building behind them has emerged. This situation is a great spatial loss for one of the symbolic centers of Istanbul, such as Karaköy. In the past, the square had an architectural continuity along the coastline. Currently, there is a gap on one of the facades where the view is most beautiful. This area has not gone beyond being defined as a parking lot. It is not a point where the users of the square can enjoy their daily lives. Some new structures, especially the commercial buildings rising on the coastline, do not contribute to the silhouette at all, on the contrary, they suppress the historical texture. These structures also fail to present a contemporary architectural language. An urban space so intertwined with the sea should have been one of the most aesthetic areas of Istanbul.

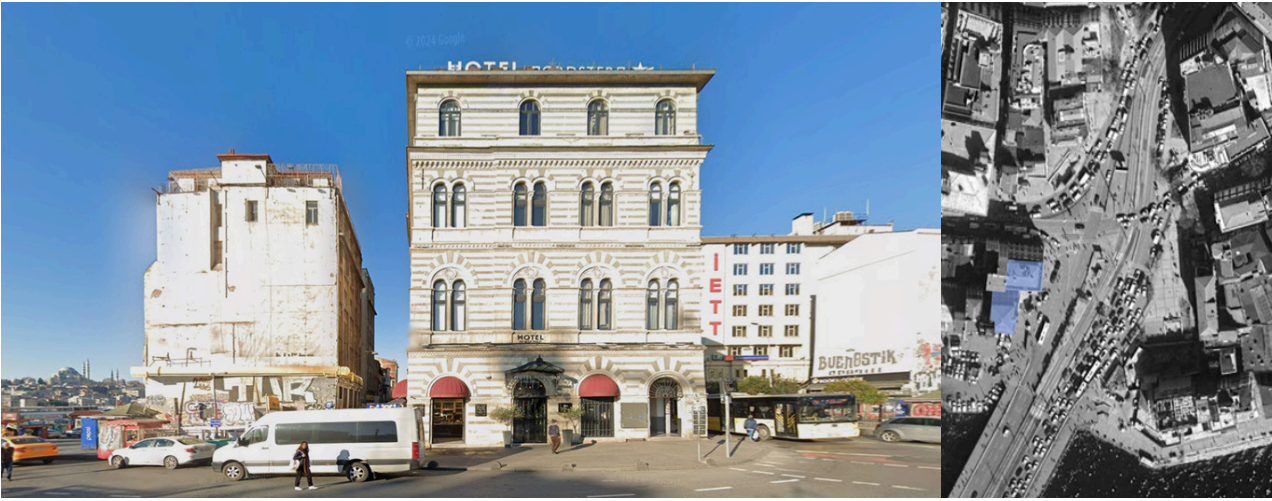
Figure 51. Building with inactive facade and Nordstern hotel, Google Street View, January 2024.

One of the elements that form the current character of Karaköy Square is the Nordstern Inn, which became visible with the demolition of Borsa Inn. It was located behind the Borsa Inn. However, it took its place in the Karaköy silhouette with the demolition of Borsa Inn. Nordstern also once had a function that was in line with the commercial texture of Karaköy. Today, it is a hotel with the transformation it has undergone. This new function has ensured both the survival of the structure and its connection with the city. However, the resulting spatial structure does not fully coincide with the commercial identity of Karaköy. Architecturally, it has proportions and a regular facade rhythm. There are symmetrical window arrangements, floor moldings and decorative details on the facade. This facade that emerges today reminds us of how layered Karaköy's architectural memory is.

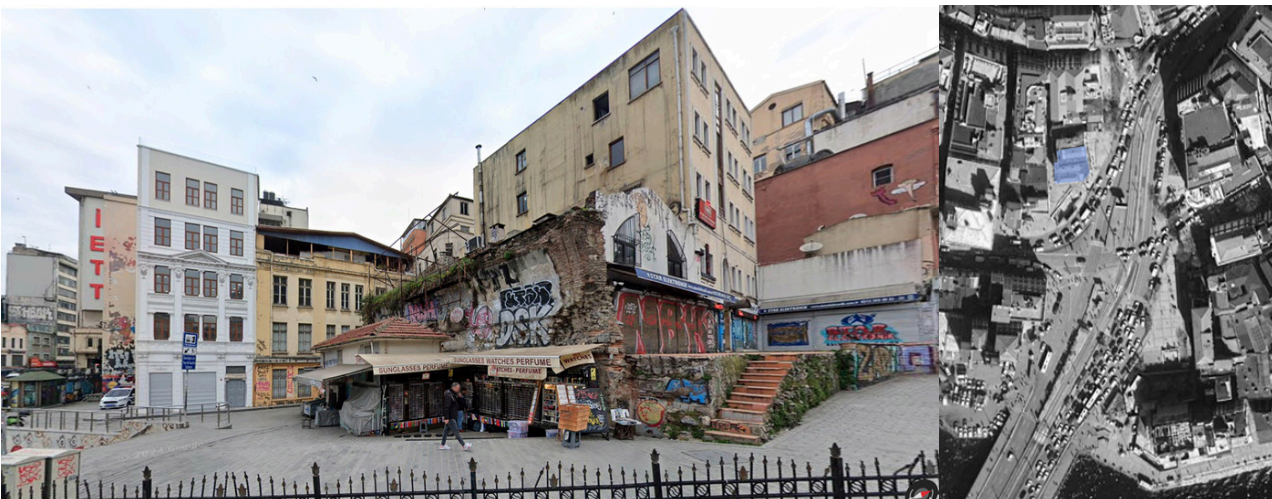
Figure 52. Galata Walls, Google Street View, February 2024. (<https://maps.app.goo.gl/6xobo3csmcNyq6EcA>, accessed 5 June 2025)

There are ruins at the northwest corner of the underpass in Karaköy Square. It is interpreted as a part of the Galata Walls. However, it has neither been taken under protection nor supported by an explanatory plaque. Although it has significant potential for the historical continuity of the square, it has remained as an abandoned piece of structure. Cultural heritage has not been made visible. This view of the walls is one of the symbols that shows the general lack of planning in Karaköy Square and how historical elements have not been integrated into urban design in this region.

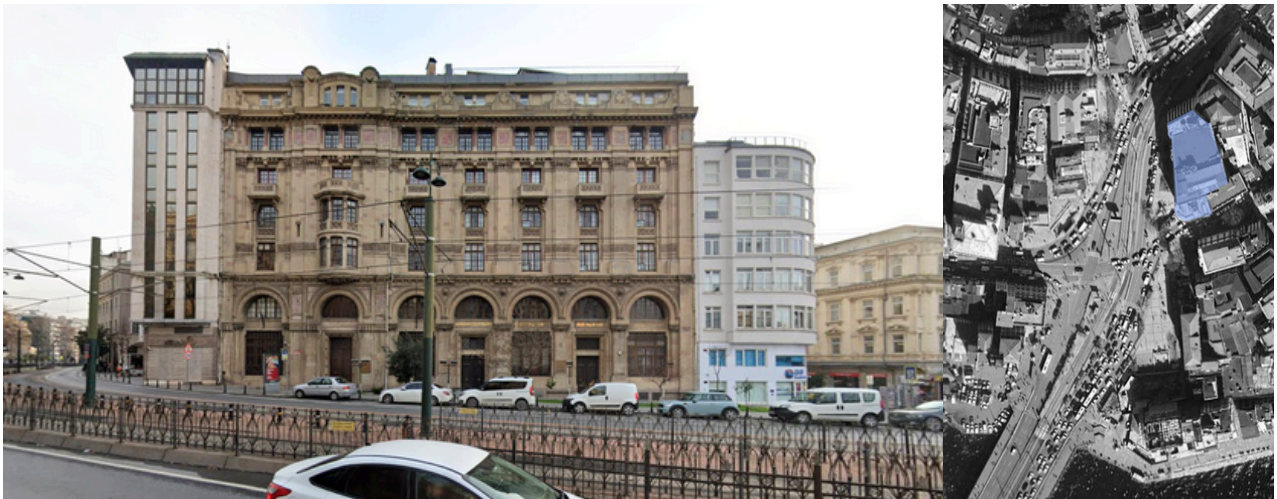
Figure 53. Karaköy Palas, Google Street View, January 2024. (<https://maps.app.goo.gl/19kpouhSgpW7DZwG9>, accessed 5 June 2025)

Karaköy Palace, with its monumental architectural details, still remains in the historical memory of Karaköy Square. The palace looks even more elegant next to the new buildings, since they don't match it at all. The new building, especially the one built to the left of the palace, is against the entire aesthetic language of the historical structure with its contemporary form. It has glass facades, reflective surfaces and disproportionate heights. Instead of completing the facade aesthetics of the Karaköy Palace, it isolates it.

A similar situation applies to the Alemdar Kardeşler Building on the right side of the palace. This building was built in the 1950s with a project determined by a competition. Although the design that participated in the competition and established a more harmonious relationship with the square and the Palace won first prize, it was not implemented. Instead, the second project, which was less costly, was implemented for economic reasons. This decision also had negative effects in the long term in terms of the urban character of the square.

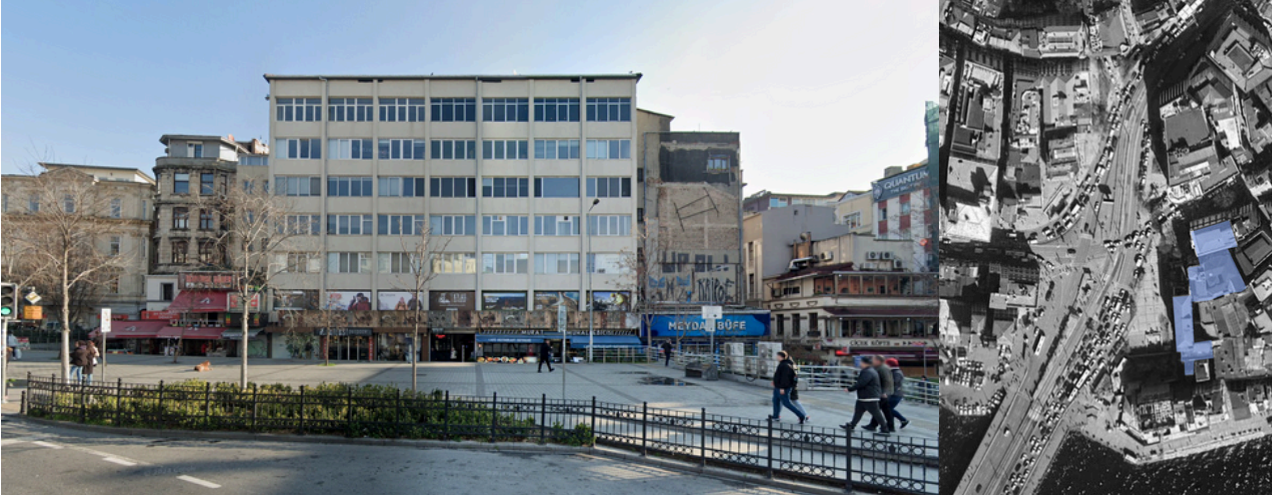
Figure 54. Eastern Facade, Google Street View, January 2024. (<https://maps.app.goo.gl/1nhbMQm8G3AMuE3D8>, accessed 5 June 2025)

There are new buildings on the eastern side of the square, facing the square after the demolition of Havyar Inn. It seems to have a temporary or complementary architectural character. It establishes a weak integrity with both the historical texture and the scale of the square. This situation reinforces the fragmented architectural appearance of the square.

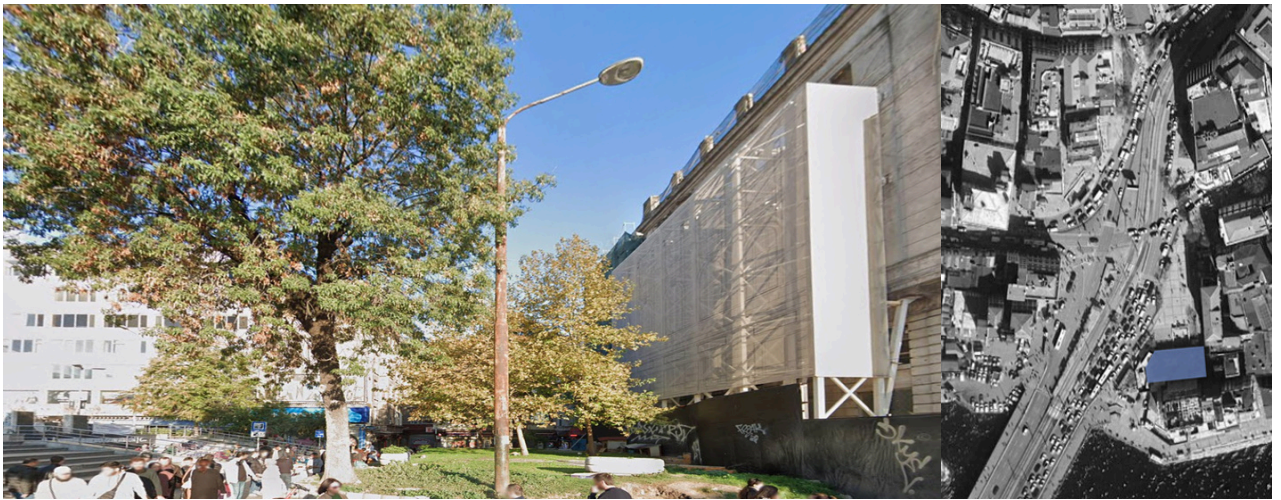
Figure 55. Location of Merzifonlu Kara Mustafa Pasha Mosque, Google Street View, January 2024.

Today, the parcel where the Merzifonlu Kara Mustafa Pasha Mosque once stood in Karaköy Square is still seen standing empty. Although it is physically empty, it also affects the integrity of the public space. It does not have any spatial function. It is an indicator of lack of planning. This creates a gap in the aesthetic, historical and social fabric of the area.
