POLITECNICO DI TORINO

**Master's Degree in
ARCHITECTURE FOR HERITAGE**
Master's Degree Thesis

**Karaköy Square Through Changes:
Urban Modernization and Heritagization in Istanbul from
1910 to 1960**

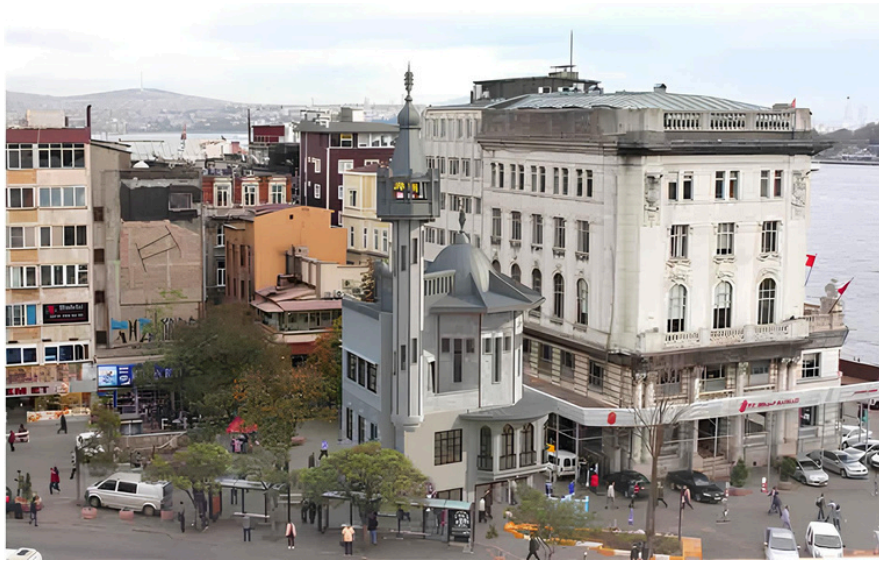
Figure 56. Reconstructed rendering of Merzifonlu Kara Mustafa Pasha Mosque, AGS Mimarlık, 2012. (<https://www.agsmimarlik.com/projelkarakoy-cami>, accessed 6 June 2025)
