Master's Degree in Building Engineering

***Developing a Risk Assessment Model for a School  
Building***

***The Case Study of Acciarini Filippo 20***

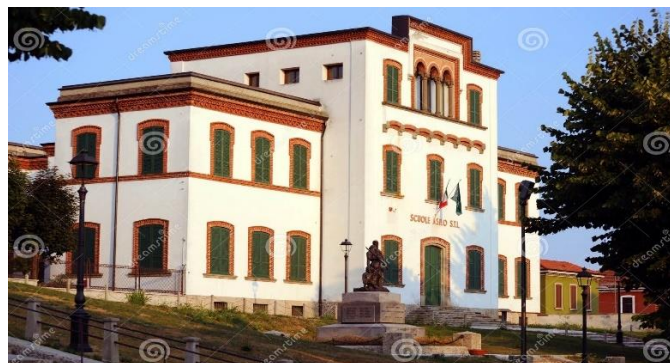
*Figure 2 –*

Example of a mid-20th century Italian school building, illustrating the common architecture and materials used in constructions now over 50 years old.

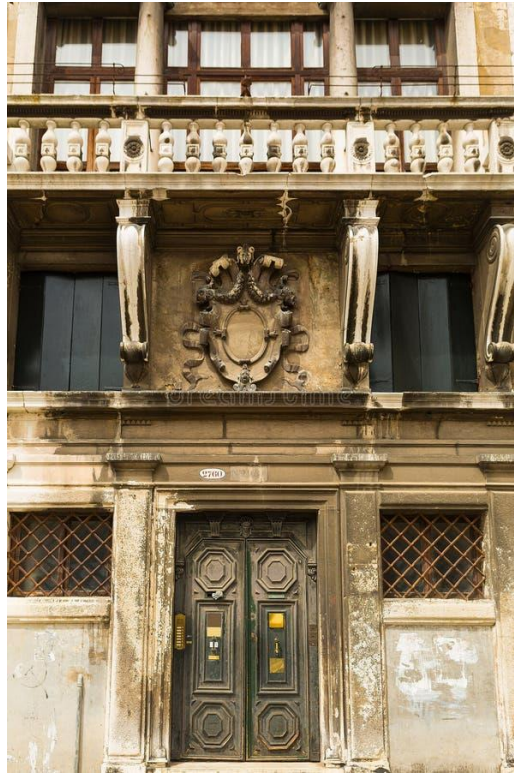
*Figure 3 –*

Example of a mid-20th century Italian school façade, illustrating common masonry and degradation in buildings now over 50 years old.

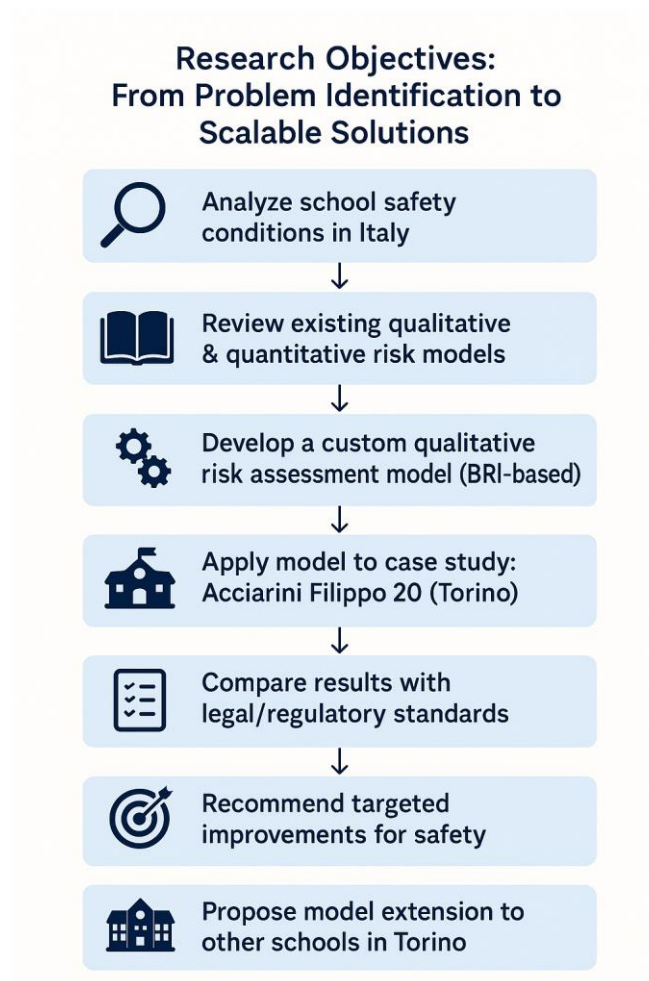
*Figure 5 – Sequential flow of research objectives.*

Figure 5 outlines the logical process from the recognition of safety issues in Italian schools to the definition and use of a risk assessment model and its wider spread application.

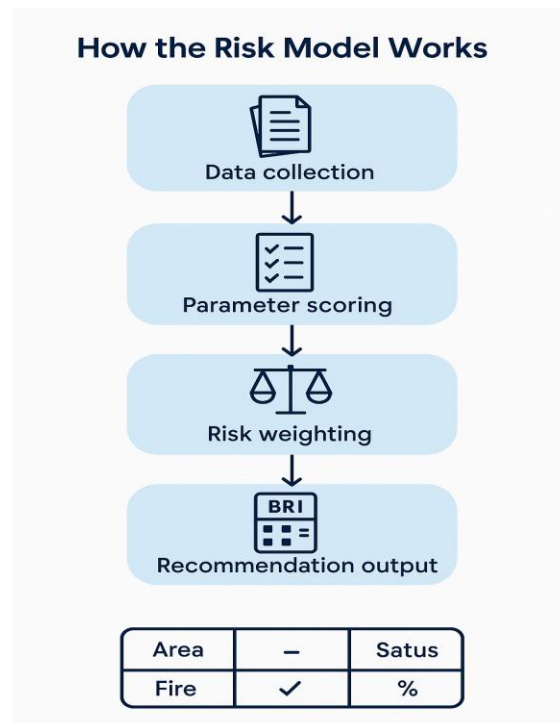
*Figure 11 – Workflow Diagram of the Qualitative Risk Assessment Model*

This diagram shows the methodology steps adopted in this thesis, which started by collecting field and regulation data, scoring parameters, risk weighting, calculating BRI, and finally outputting recommendations. The step-by-step procedure guarantees transparency, replicability, and practical usability of the developed model for local decision-makers.

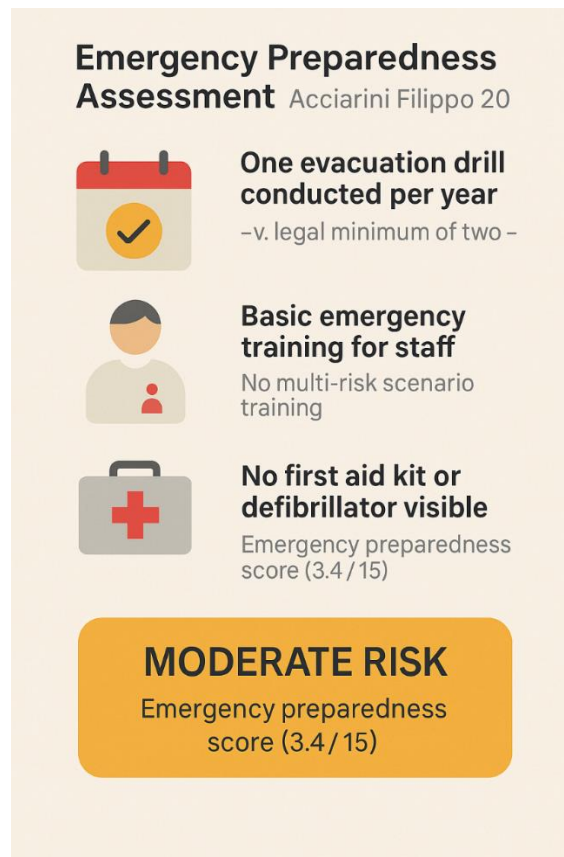
Summary of shortage of readiness protocols and emergency response capabilities in school premises, ranging from the lack of drills to the absence of visibility of basic first aid requirements and concluding with lack of advanced trained teachers' support, depicting the school at a moderate risk category.

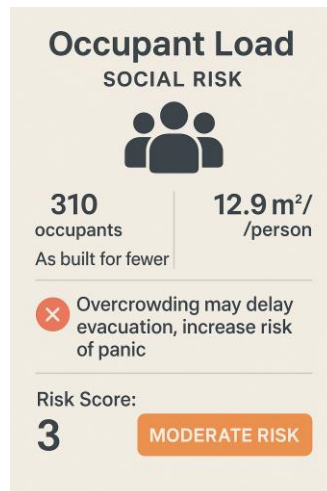
Although the space per occupant (12.9 m<sup>2</sup>/person) might be okay on the basis of space per occupant alone, it exceeds the original design of the building when occupancy load is considered. This condition could potentially delay evacuation and increase risk in emergencies, thus providing a moderate risk rating.

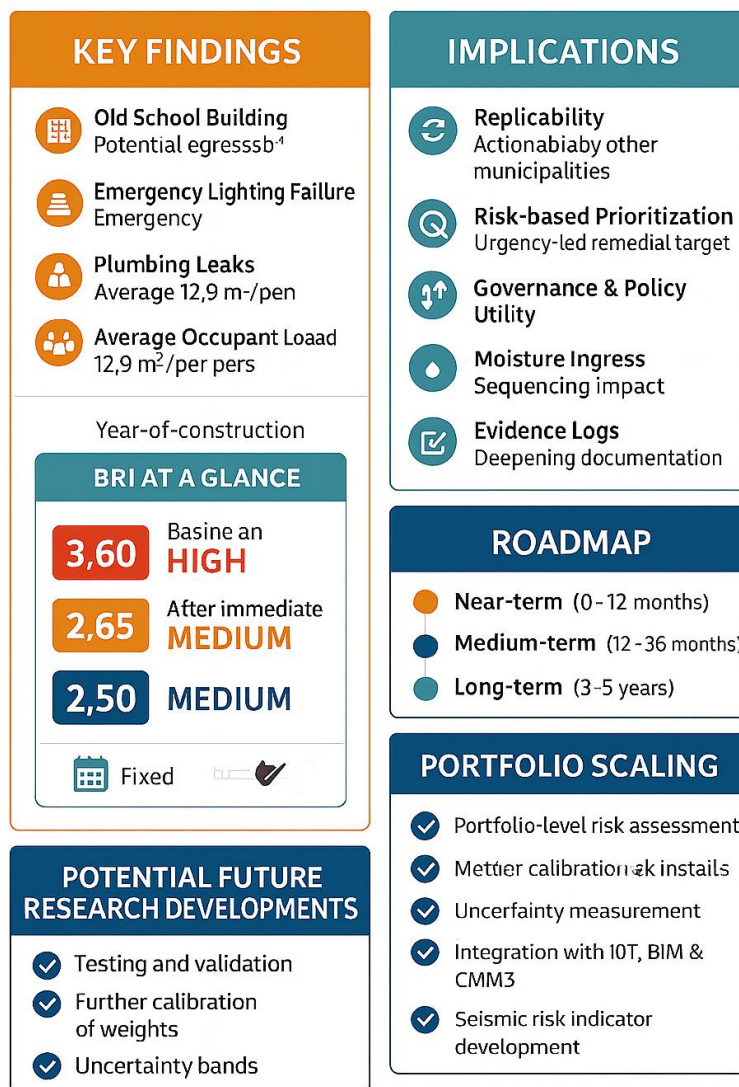
Figure 34 — Section 6 Conclusions: From Findings to Action.

*Short description:* A large end-of-chapter poster that consolidates the case-study's key findings, the BRI trajectory (3.60 High → ≈2.65 Medium, ≈2.50 if ≥13 m<sup>2</sup>/person), practical implications for school safety, a phased roadmap, portfolio-scaling notes, and a focused research agenda (validation, weight calibration, uncertainty, IoT/BIM-CMMS, seismic indicators). Designed to be readable at A3/A4 with consistent styling to earlier visuals.
