**POLITECNICO DI TORINO**

Master's Degree in Civil Engineering

**Behaviour of existing reinforced concrete slabs:  
tests vs. structural analysis**

Reinforced concrete slabs are versatile structural elements used in most types of structures. This work focuses on comparing analytical models with actual structural behaviour.

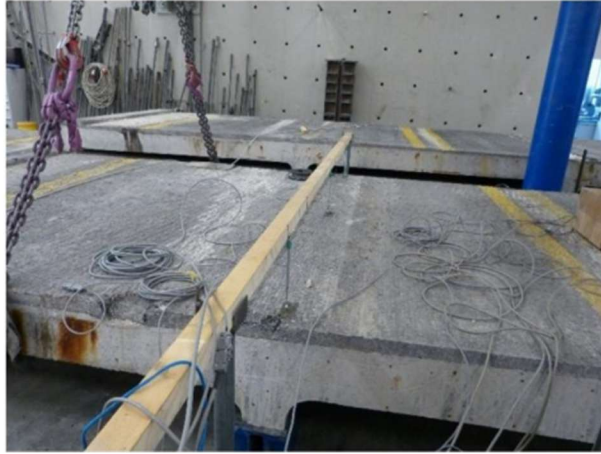
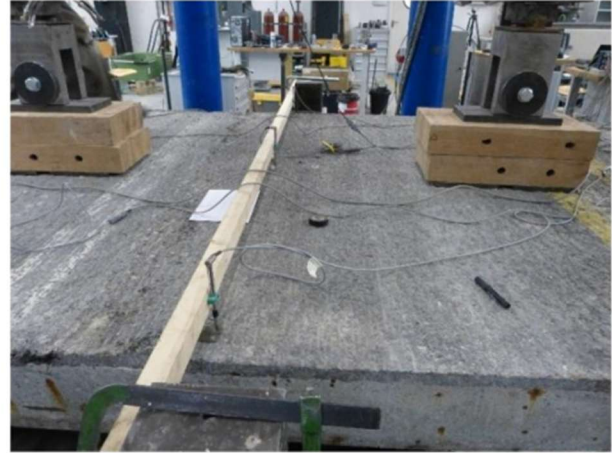
*Figure 17: Sensors positioned to monitor the failure of the internal supports*

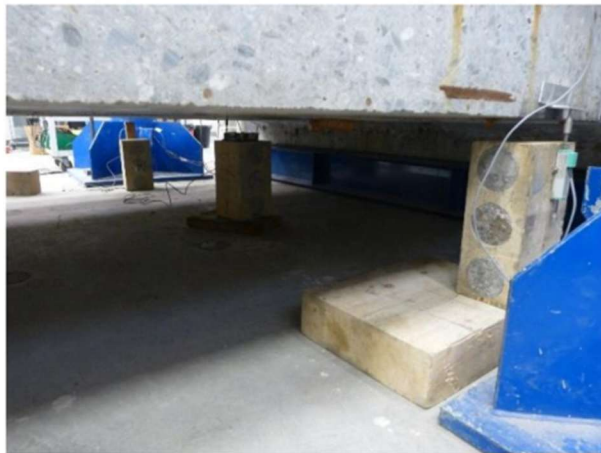
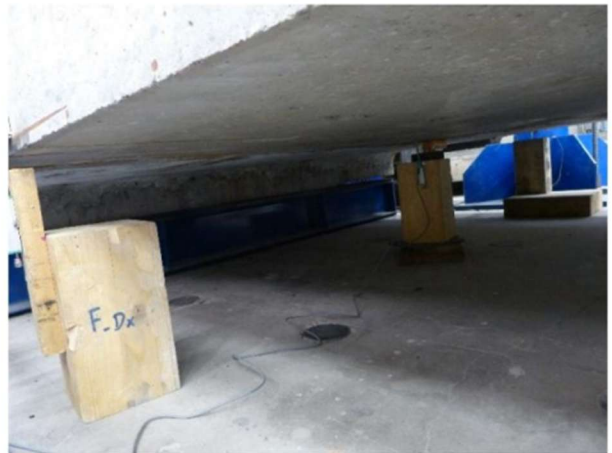
*Figure 18: Sensors positioned to monitor settlement at load application points*

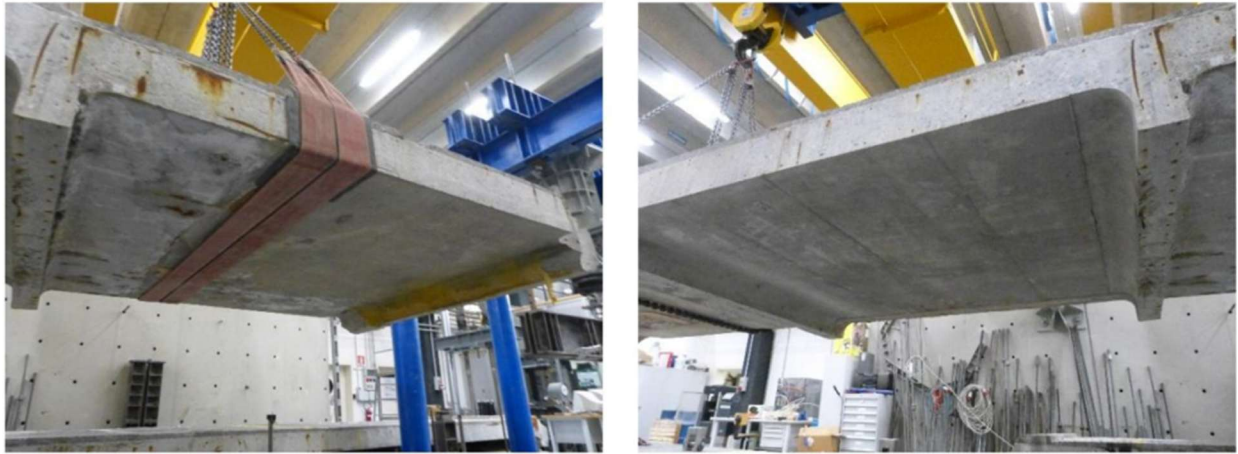
During visual inspections saline efflorescences was observed, likely caused by the humid environment. It presents a potential risk for corrosion of reinforcement. There is a crack pattern on span 1. The probable cause is transportation and handling of the sample. However, this pattern is between concrete and asphalt layers, and has minimal effect on structural layer.

*Figure 19: View of tested spans 1 and 2 respectively*

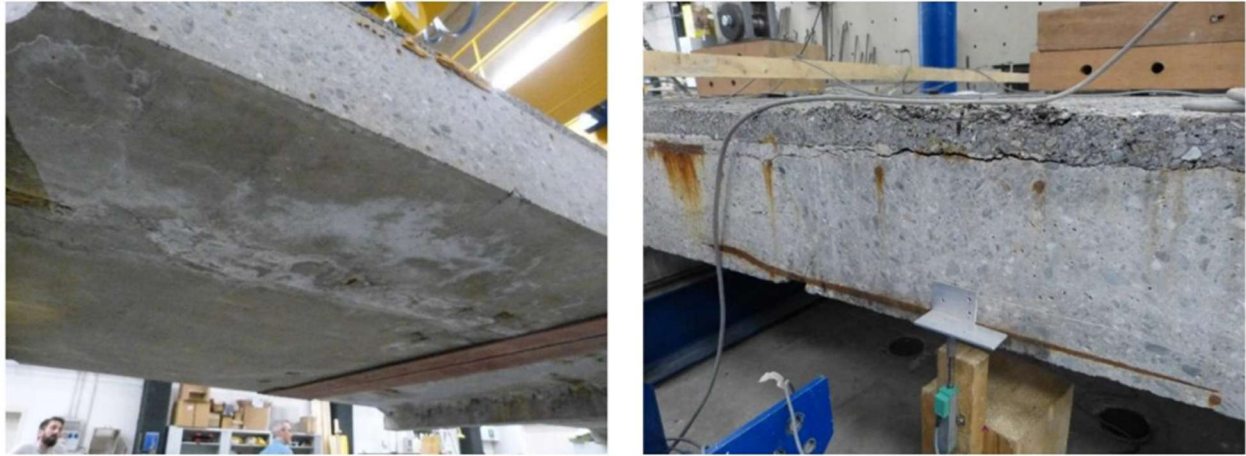
Figure 21: Left - saline efflorescences on span 1. Right: Crack pattern on span 3

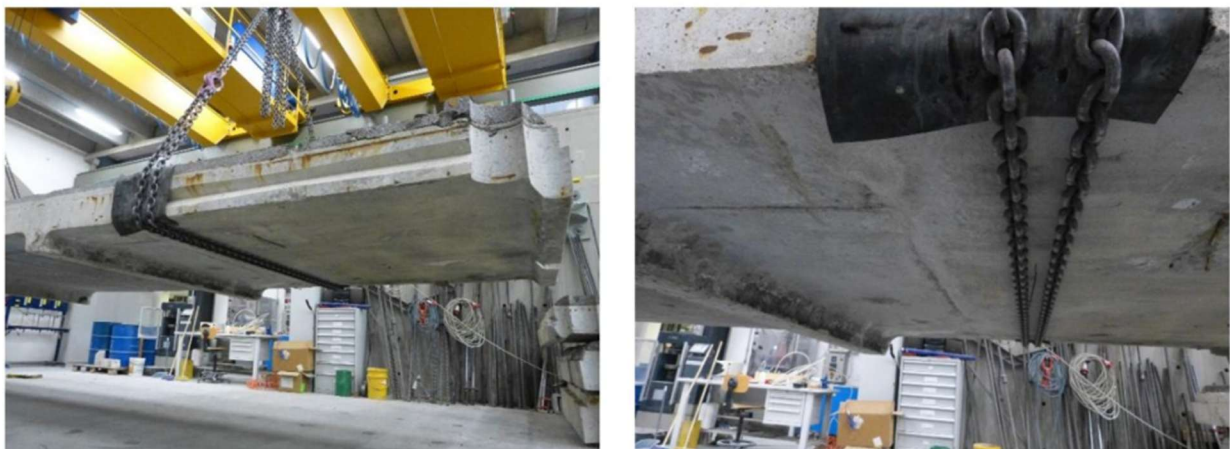
During visual inspections saline efflorescences was observed, likely caused by the humid environment. It presents a potential risk for corrosion of reinforcement. On the intrados of sample, the damage due to small demolitions is observed, probably carried out to inspect the corrosion of reinforcement.

Figure 27: Left: View of span 3. Right: Construction joint between span 2 and 3

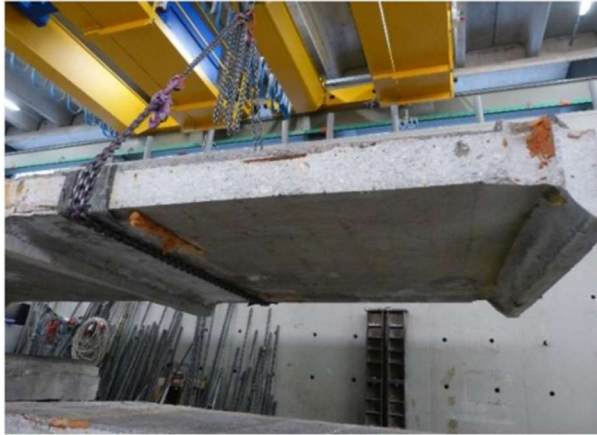
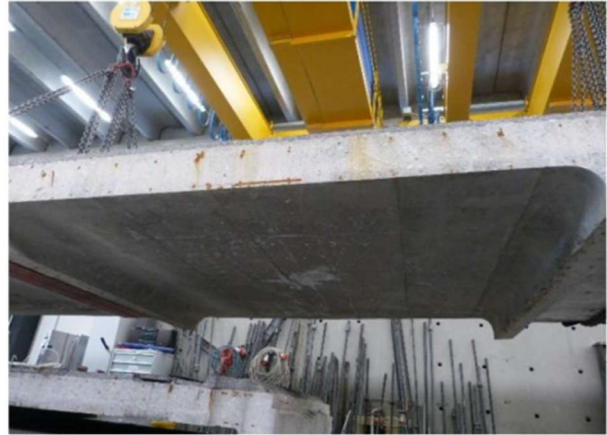
During visual inspections saline efflorescences was observed, likely caused by the humid environment. On the intrados of sample, the damage due to small demolitions is observed, probably carried out to inspect the corrosion of reinforcement. In this case it does not affect the span under test. Span 1 has areas that show restoration with cement mortar.

*Figure 36: View of span 1 and 2 respectively*

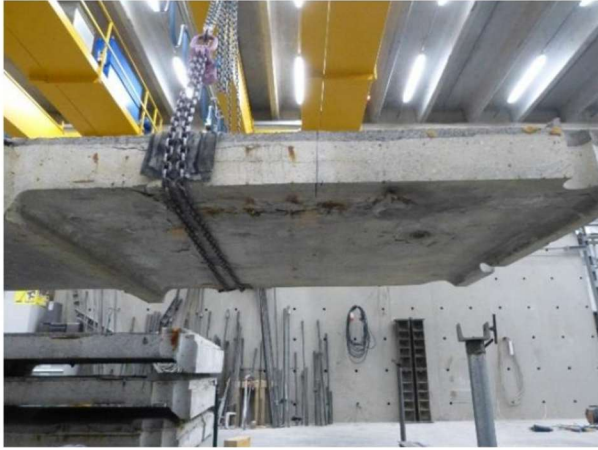
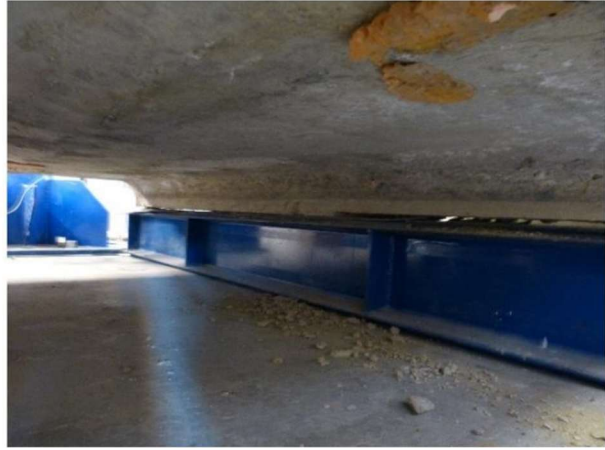
On the intrados of the tested span, damage due to small demolitions is observed, probably carried out to inspect the corrosion of reinforcement. A Significant crack is present on the front of the slab, corresponding to the cracking surface. The surfaces of the supports are discontinuous and inclined, especially support 3.

*Figure 42: Span 3 and support detail*

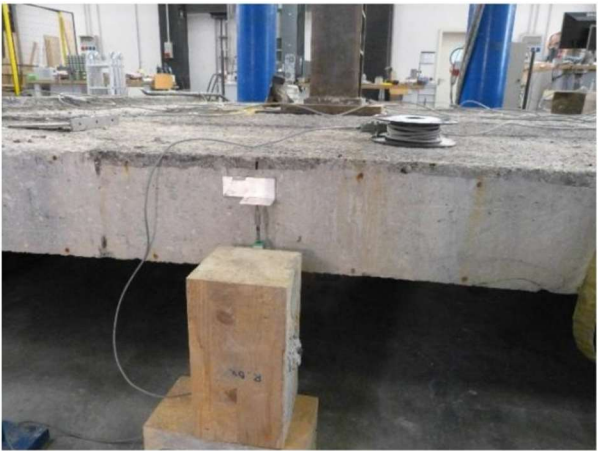
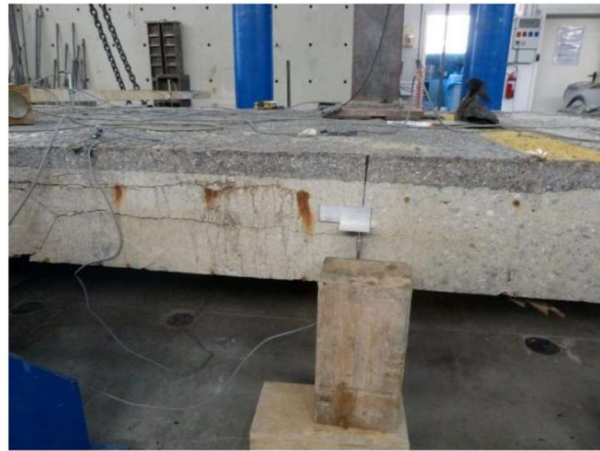
*Figure 43: Significant crack pattern on the front of the slab*

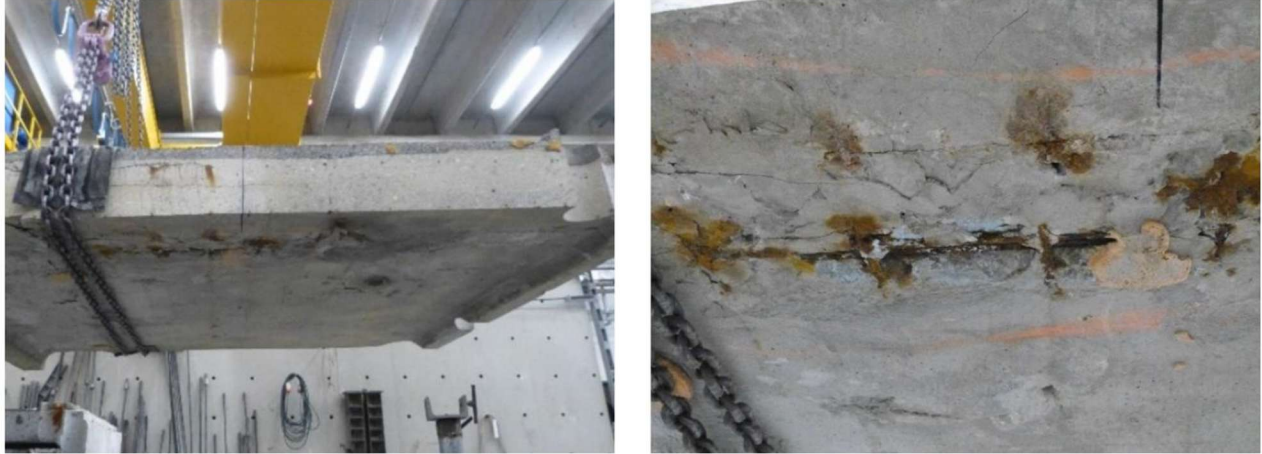
Figure 44: View of small demolition

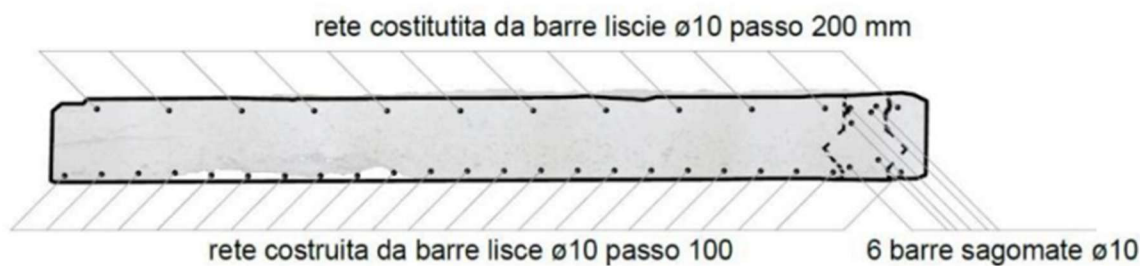
Figure 73: Reinforcement layout in lateral prefabricated segment

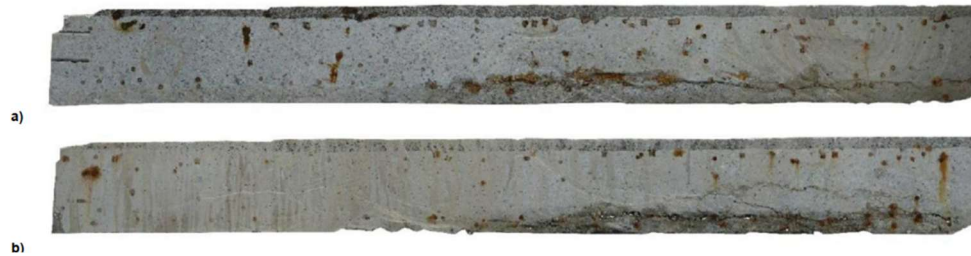
Orthophotos of the sections (Figure 74) reveal the irregularities of the top surface. It may have been damaged by asphalt milling, as some of the bars are in direct contact with asphalt.

*Figure 74: Orthophoto of section a) BB and b) CC*

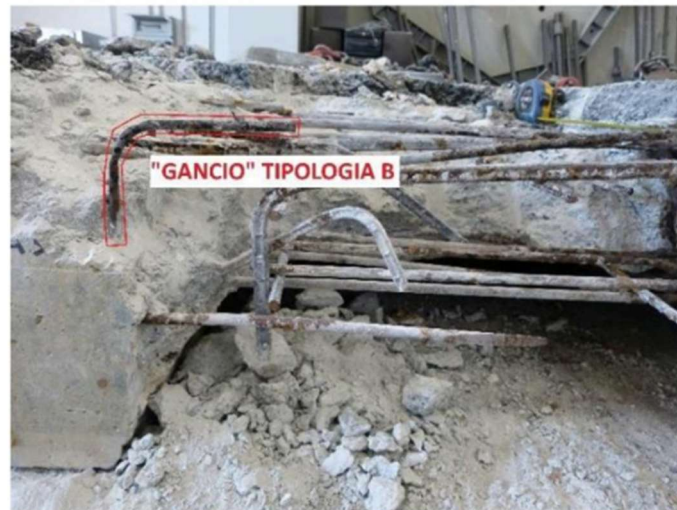
Figure 77: Detail of the hooked bar type B

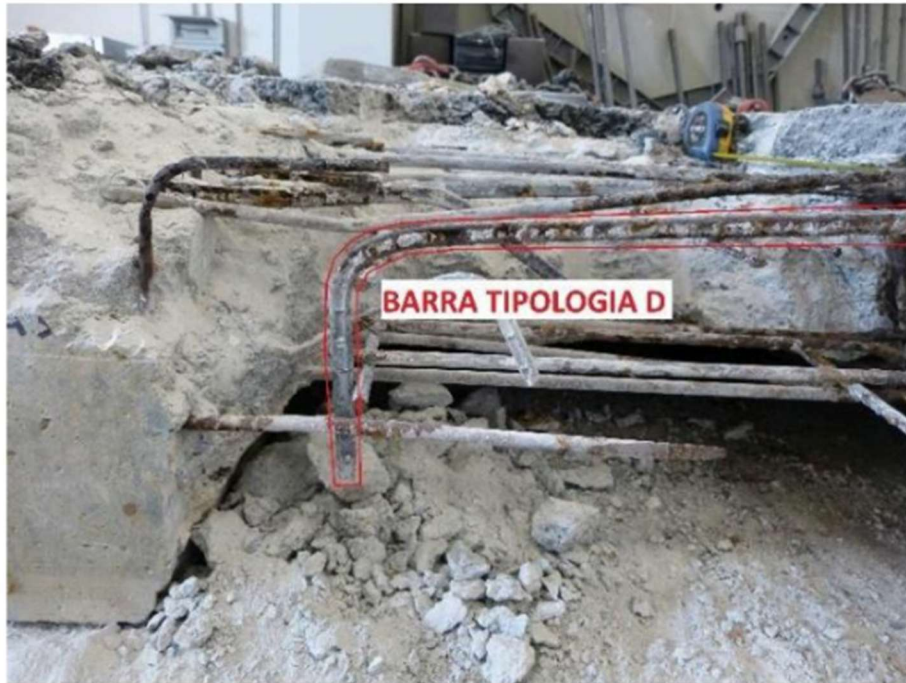
*Figure 80: Detail of the hooked bar type D*

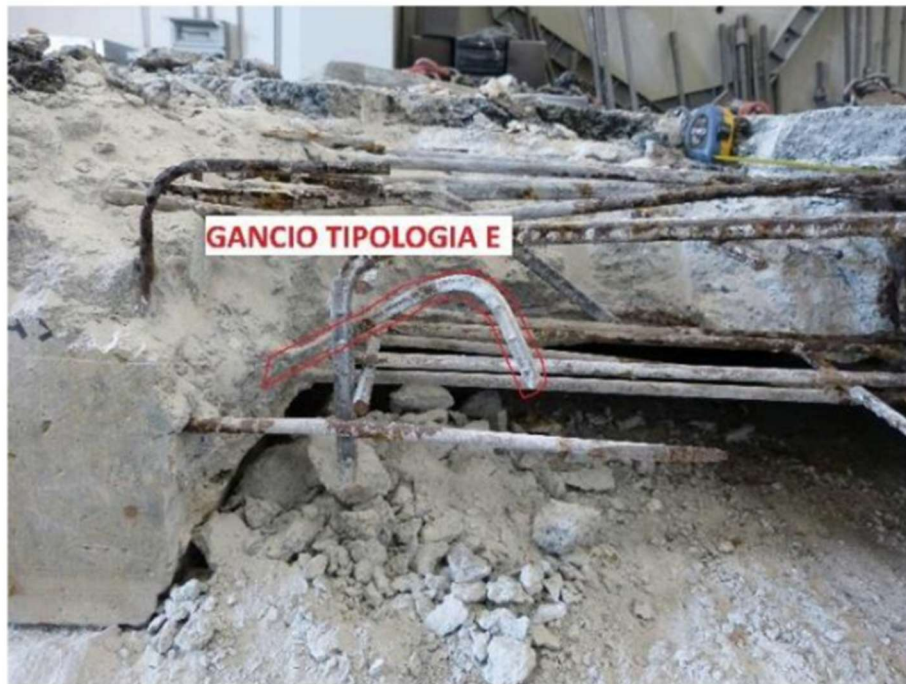
In section CC, type E bars were observed. These bars extend from the vertical partition of central prefabricated element and are bent at 90 degrees into the joint. The detail of this element is shown in Figure 81.

*Figure 81: Detail of the hooked bar type E*

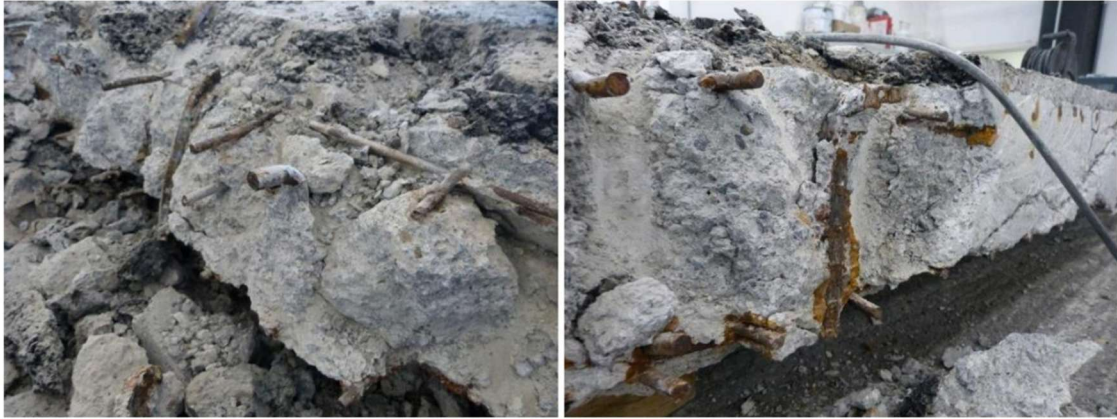
*Figure 86: Type D bars hooked inside the lateral prefabricated part*

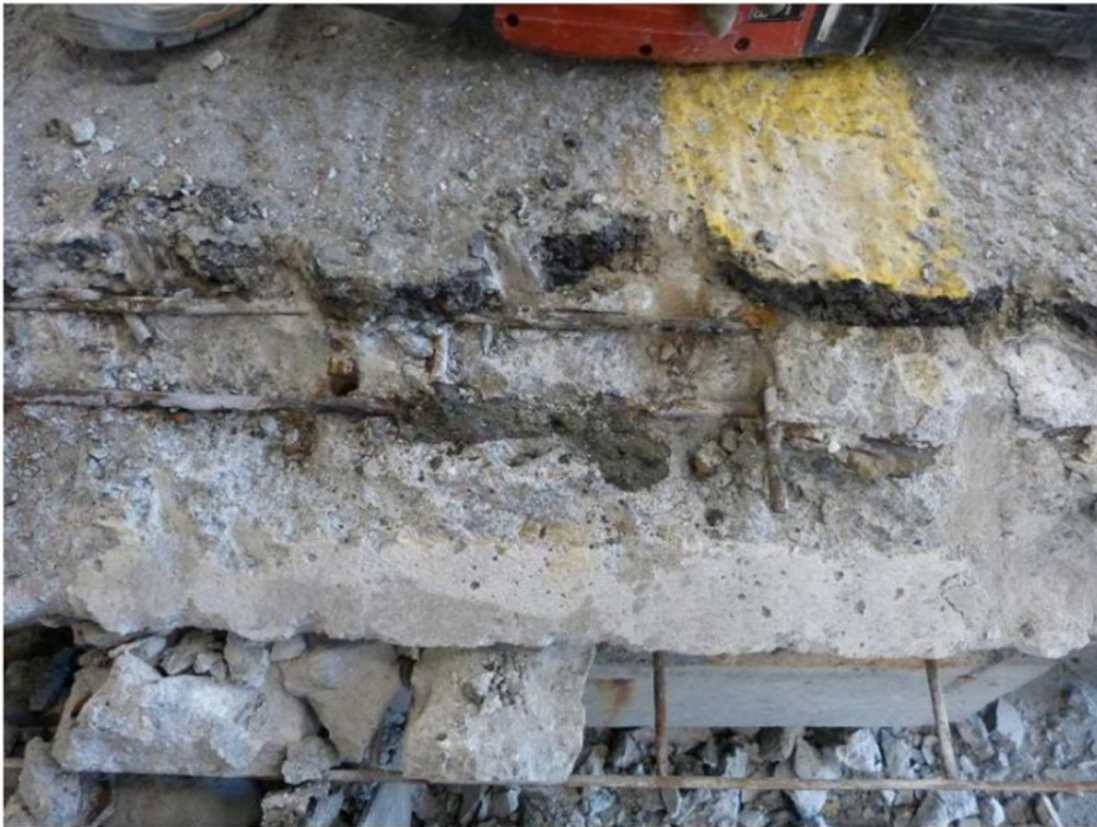
It was also observed that the reinforcement bars in the cast-in-situ joint show a high level of degradation, whereas bars in prefabricated elements are generally not heavily corroded. In some cases, corrosion has completely compromised the reinforcement section, breaking the bar into two separate elements (Figure 88).

*Figure 87: Degradation of reinforcement in cast-in-situ joint*

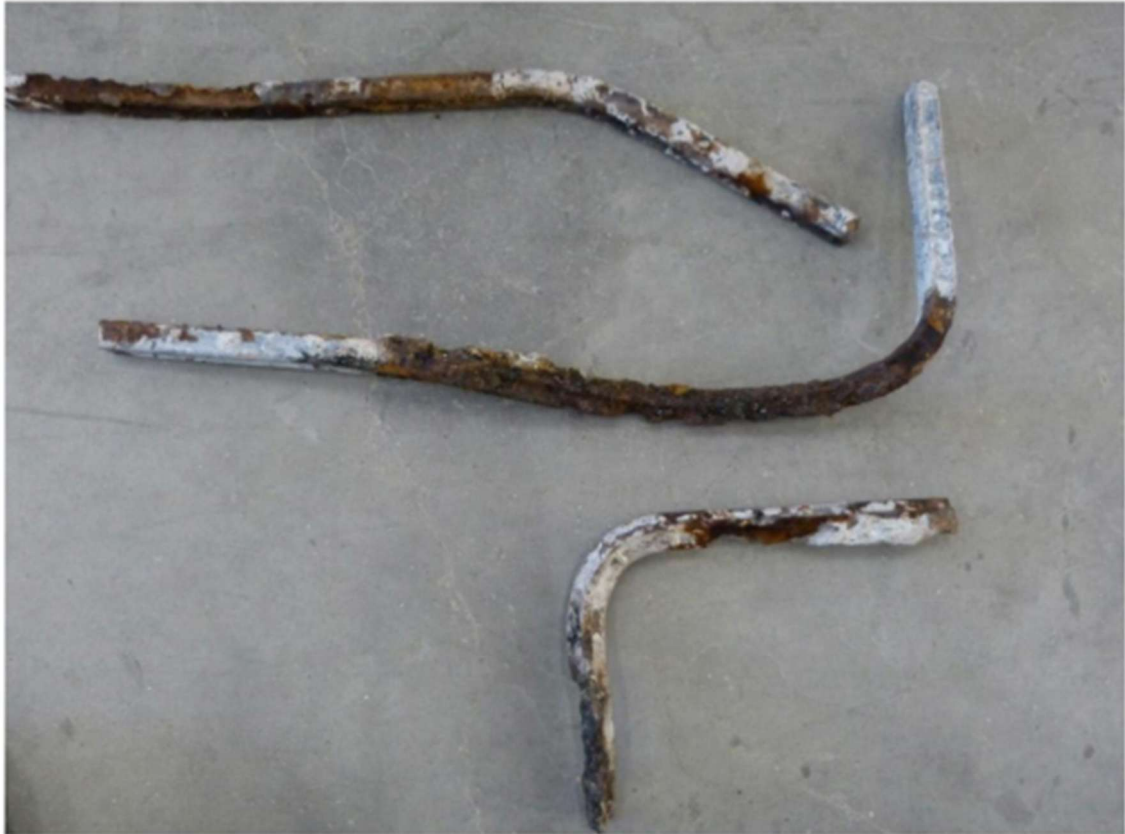
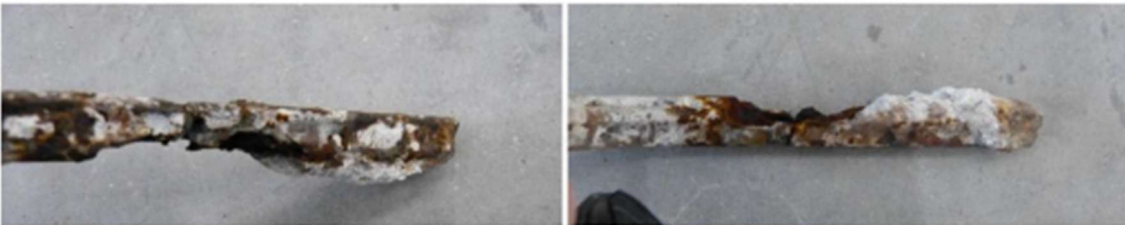
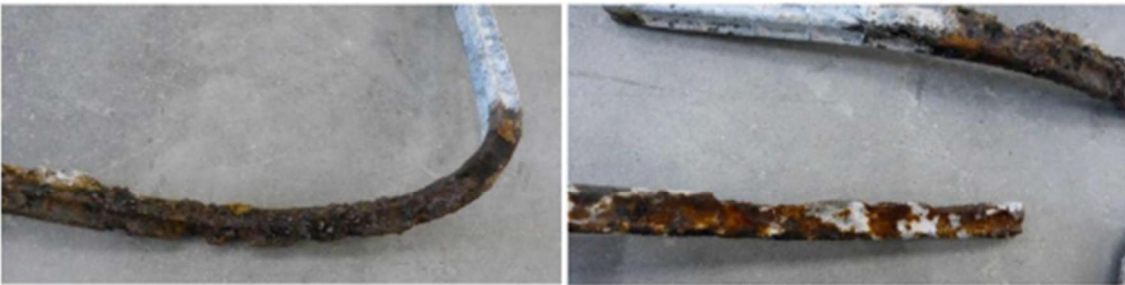
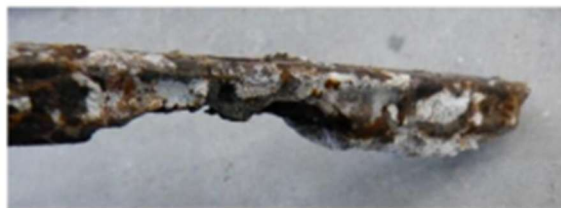
*Figure 88: View of degradation level*

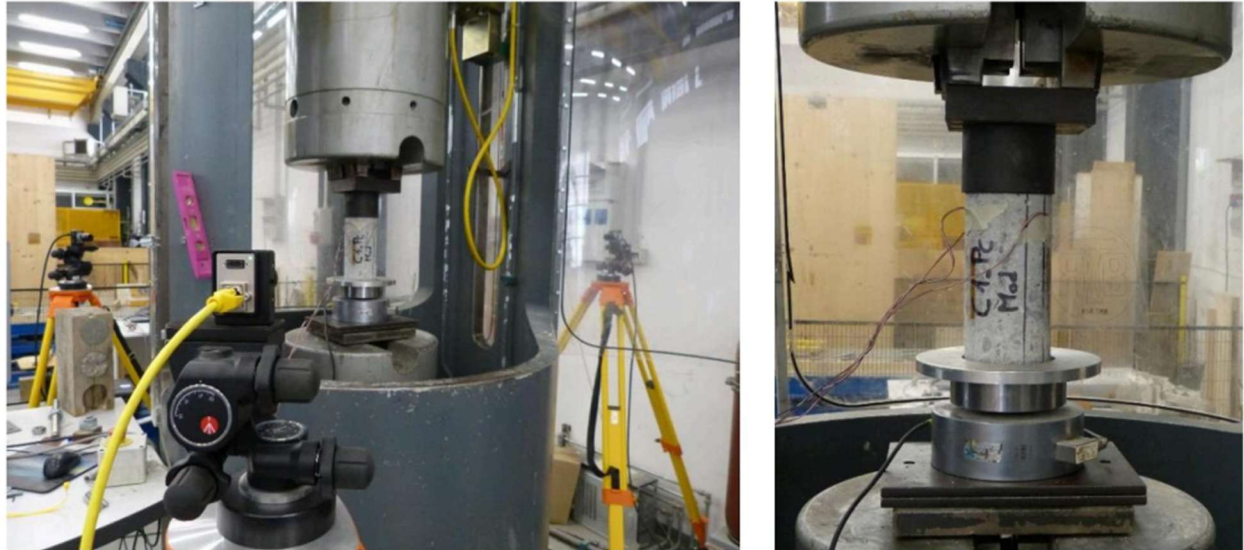
To measure deformation during the test, on the lateral face of each specimen three strain gauges spaced 120° apart were attached. These measurements were used to calibrate the non-contact measurement system (Digital Image Correlation) used to measure all the deformations until failure using three video cameras 120° apart. The complete setup is shown in Figure 109. The testing procedure followed the UNI EN 12390-13 standard and is illustrated in the Figure 110.

Figure 109: Test setup
