↑
Strategy for urban cohesion: proposal for a pedestrian and heritage circuit.

→
Urban design plan: spatial configuration of Santiago's church square.

The Mopa Mopa Cultural Center

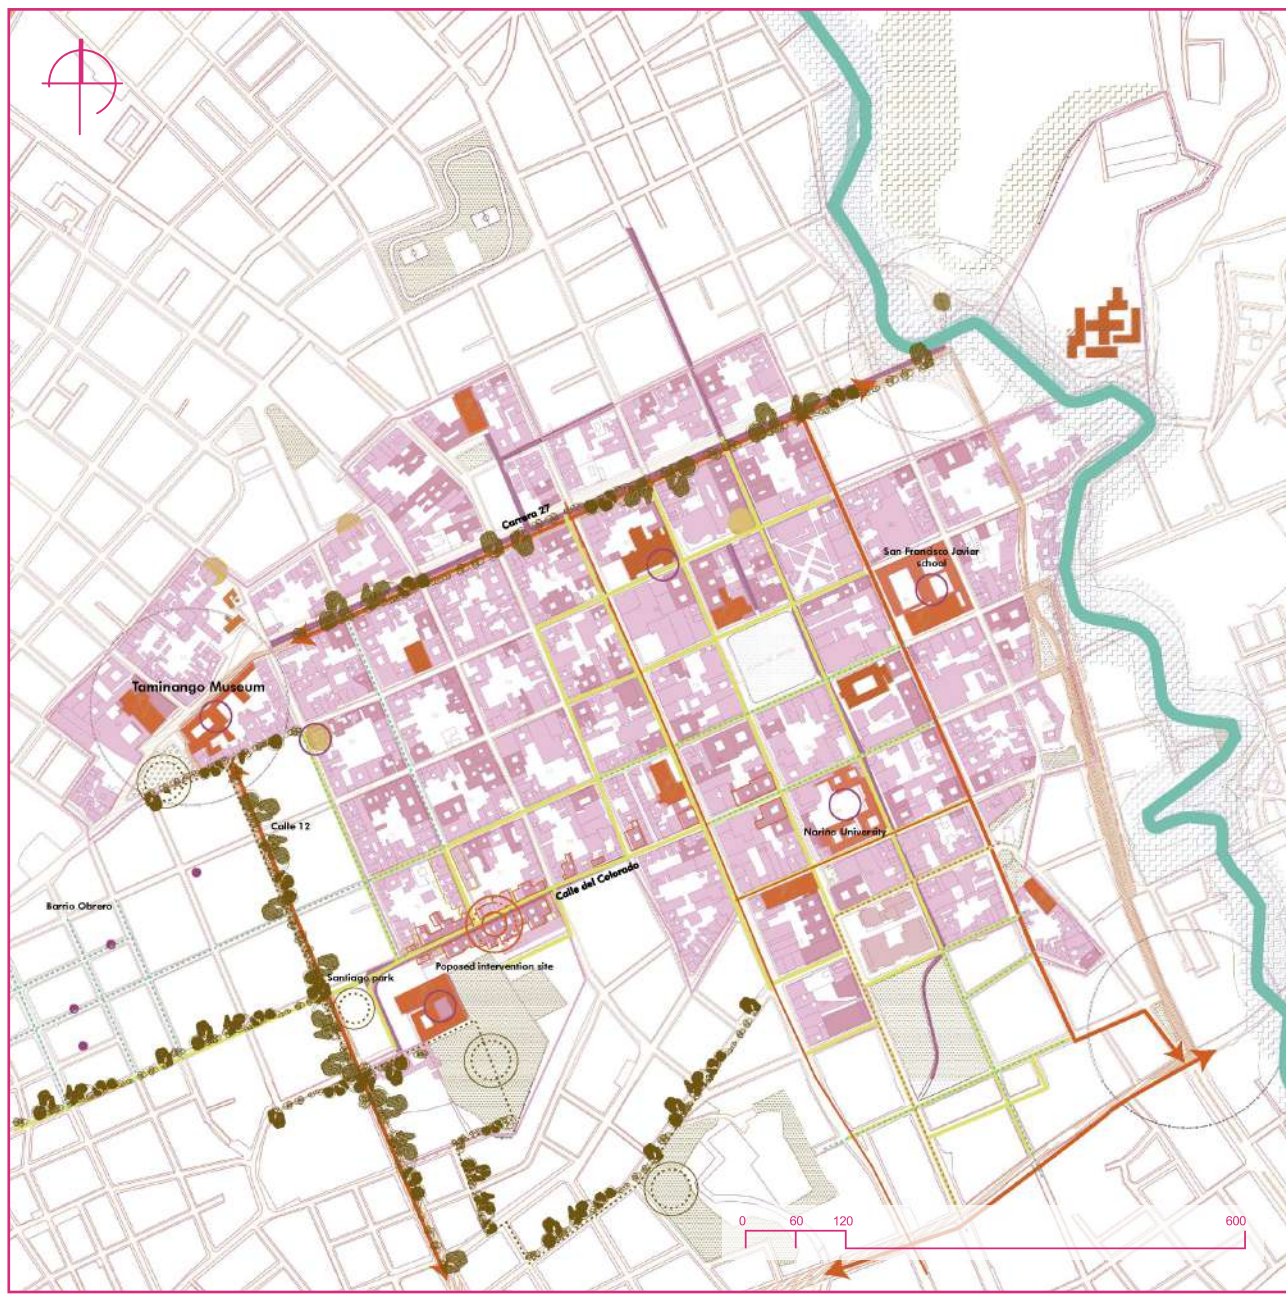
The urban proposal is articulated as a strategy for the revitalization of Pasto's historic center, with the main objective of creating a Cultural and Heritage Circuit that connects the currently fragmented heritage nodes of the city. The focus of the intervention is the articulation of the axis between the Taminango Museum and the Church of Santiago, which is key to linking the proposal with Calle del Colorado. This is achieved by reconfiguring Santiago Street into a pedestrian-priority urban corridor, aiming to unify the landscape and enhance spatial quality. Furthermore, the plan includes the full pedestrianization of Calle del Colorado (from 15th Street to Boyacá Avenue) and the semi-pedestrianization of its extension, which seeks to restore its prominence as a vital axis that stimulates local commerce, encourages pedestrian activity, and strengthens community cohesion.

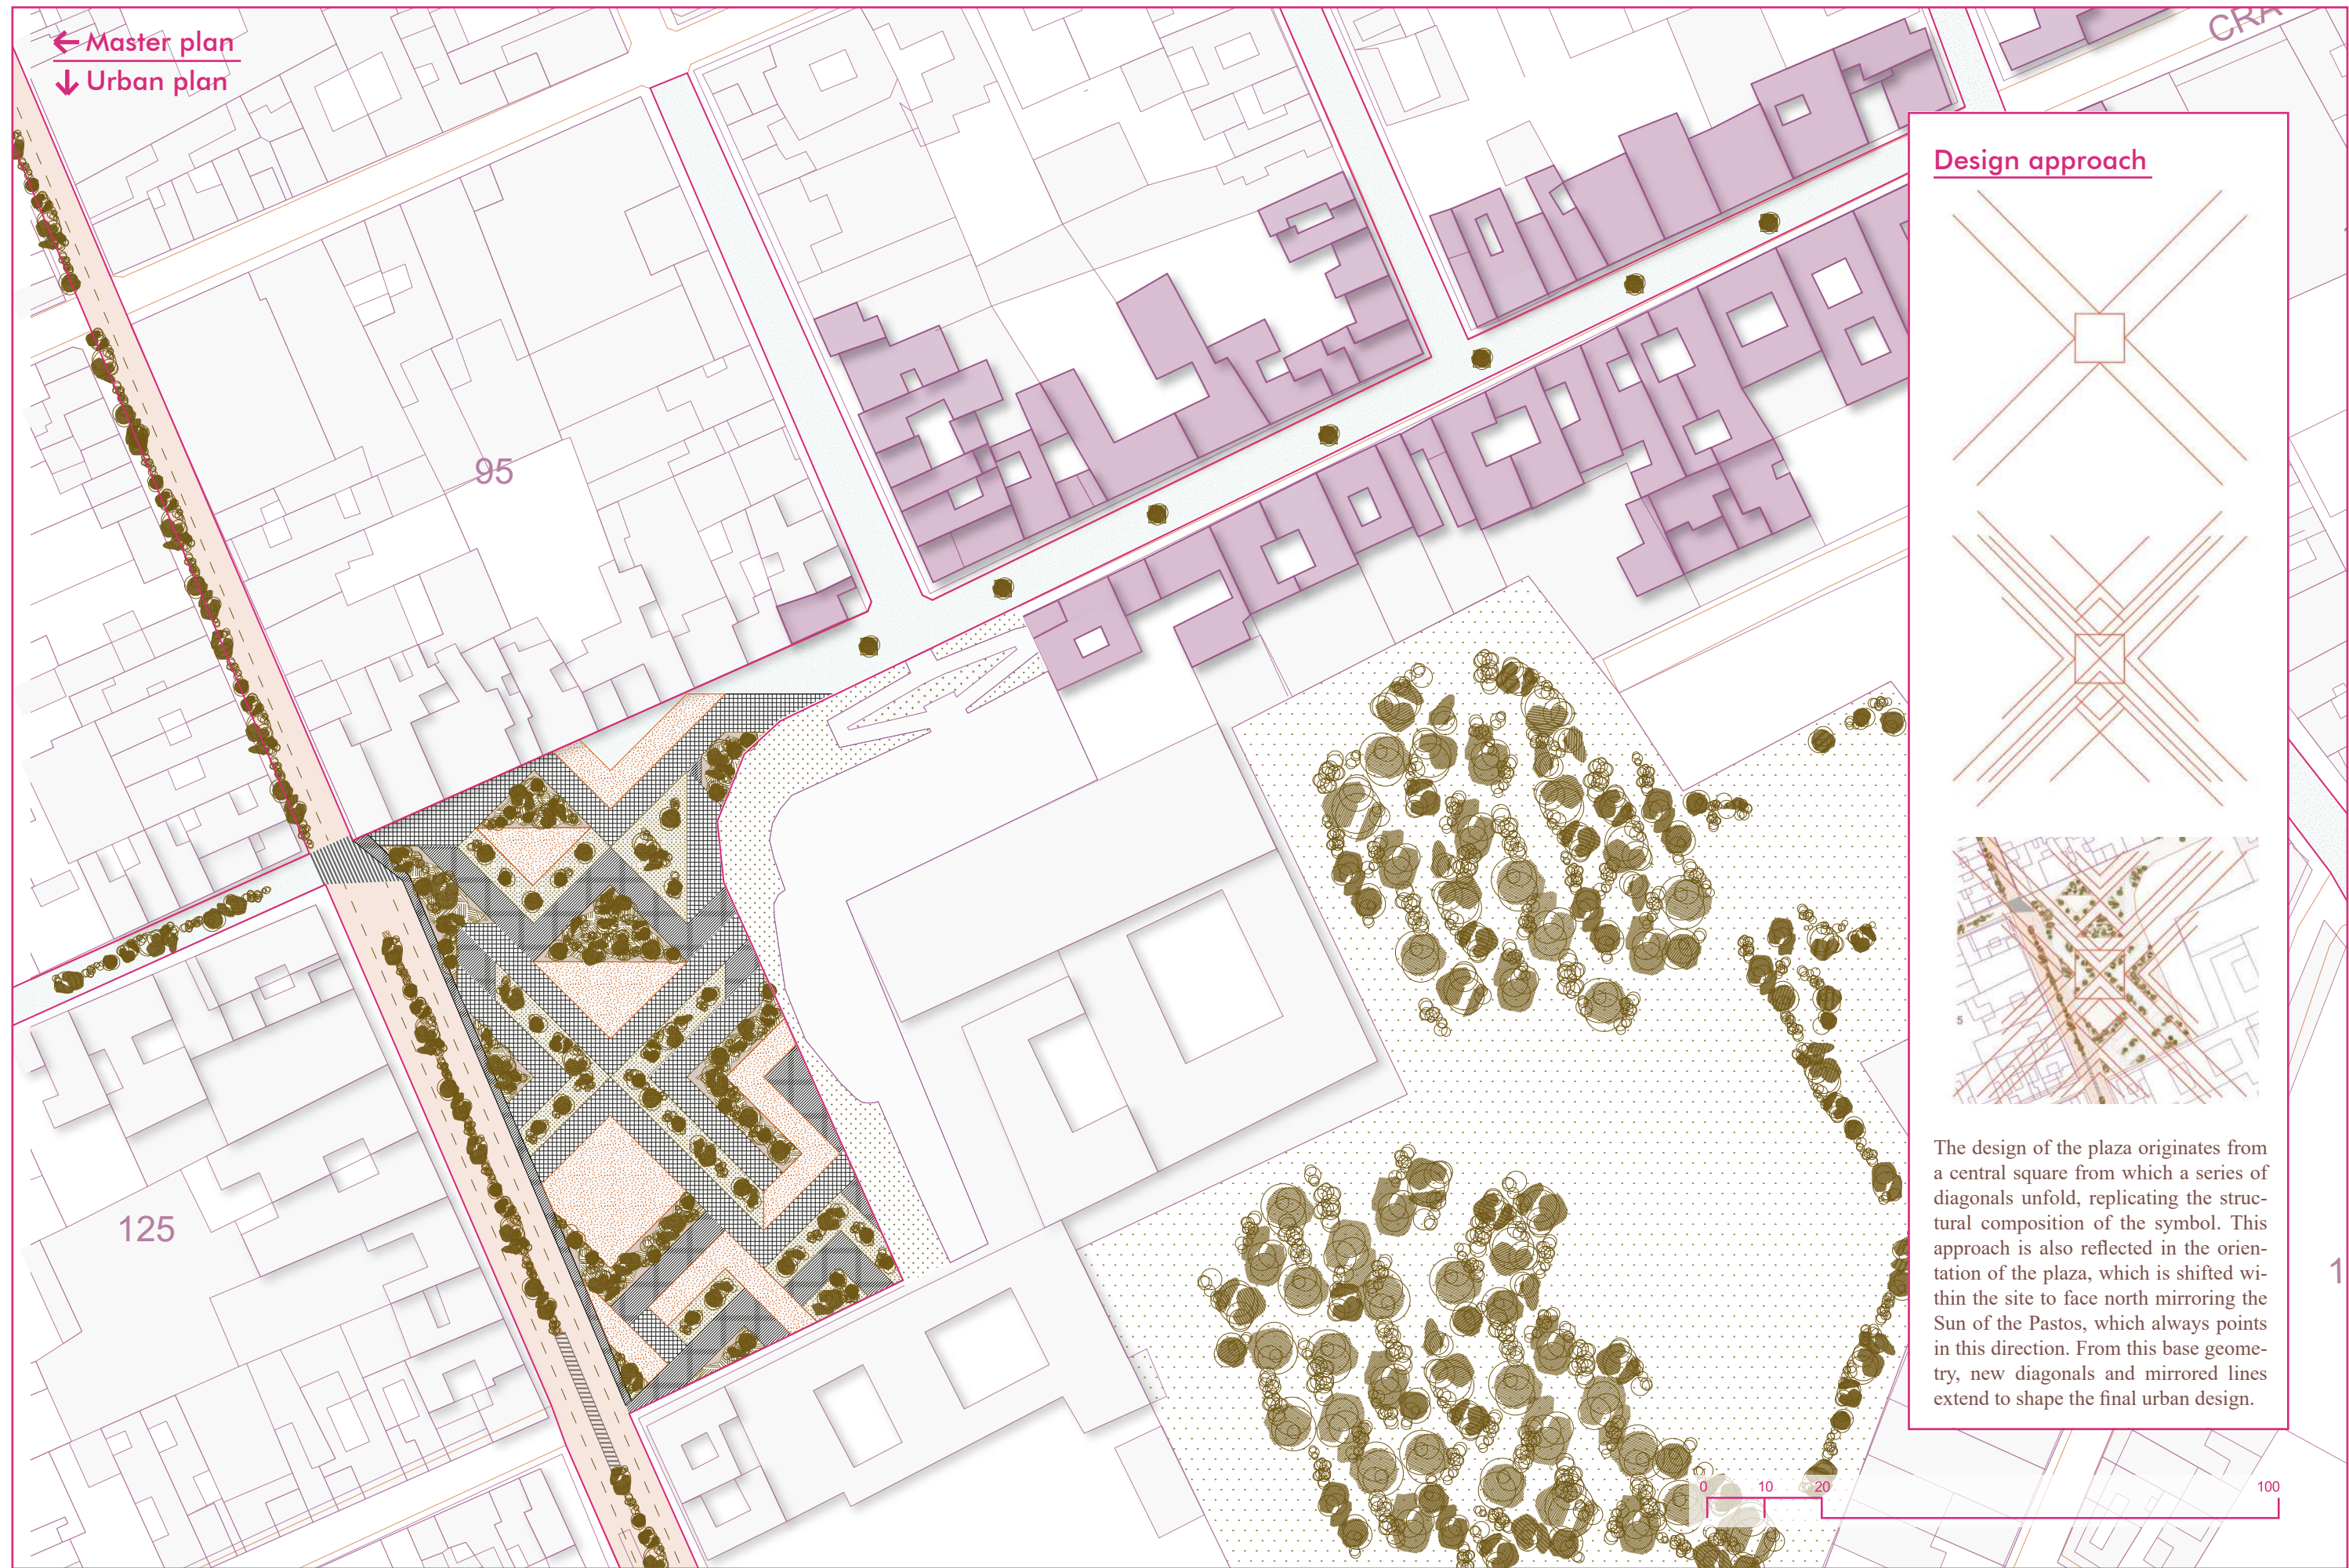
The design centers on the reconfiguration of the Santiago Church Square, using the ancestral geometry of the Sol de los Pastos as the spatial matrix. This geometric approach creates a new public space. The strategy is completed by the full pedestrianization of the Calle del Colorado and the creation of transitional green barriers to ensure safe, high-quality public space, ultimately preparing the context for the new Barniz Cultural Center.

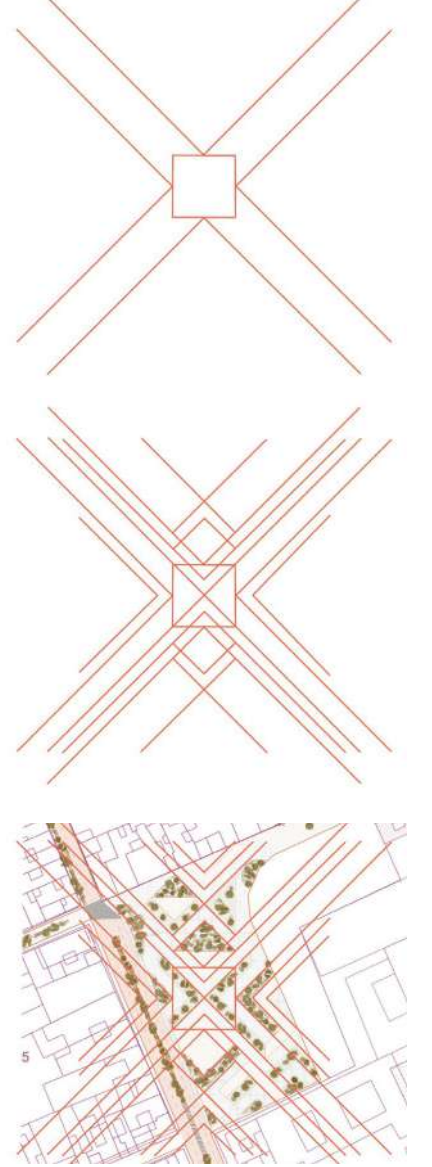
Design approach

The design of the plaza originates from a central square from which a series of diagonals unfold, replicating the structural composition of the symbol. This approach is also reflected in the orientation of the plaza, which is shifted within the site to face north mirroring the Sun of the Pastos, which always points in this direction. From this base geometry, new diagonals and mirrored lines extend to shape the final urban design.

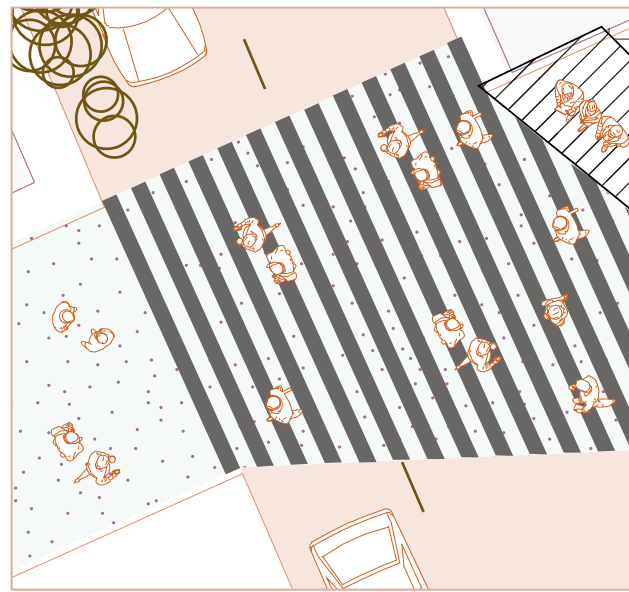
a. Detail of the pedestrian transition over 12th street towards the new Santiago Square.

The design details the critical pedestrian connection channeling flow from the Taminango Museum into Santiago Square. The intersection with vehicular traffic is managed by a distinct change in pavement texture and a wide, visible crosswalk, which clearly establishes pedestrian priority. Critically, the crosswalk's form opens seamlessly into the plaza, serving as a visual and functional guide toward the new public space.

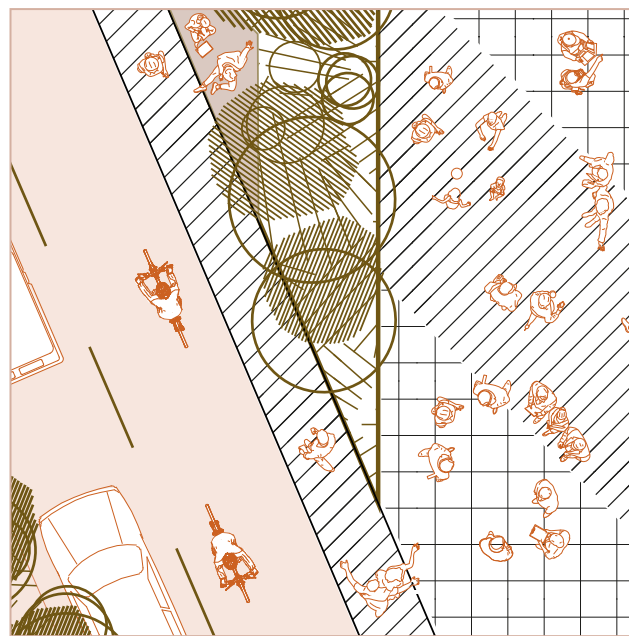
b. Detail of the Plaza – Avenida Boyacá interaction and street edge solution.

Figure b. details the design of the plaza edge adjacent to the busy Avenida Boyacá. The proposal strategically addresses this high-flow intersection by creating a visual and physical barrier aimed at protecting public spaces from traffic. This is achieved through the implementation of continuous planters that serve as a natural barrier against noise and traffic, structuring the transition. Additionally, a bike lane is positioned next to the plaza, functioning as a vital buffer between vehicular traffic and pedestrian life. Despite these boundaries, the plaza remains fully open and accessible via wide access points, ensuring its seamless integration into the urban fabric to promote social and cultural activity.

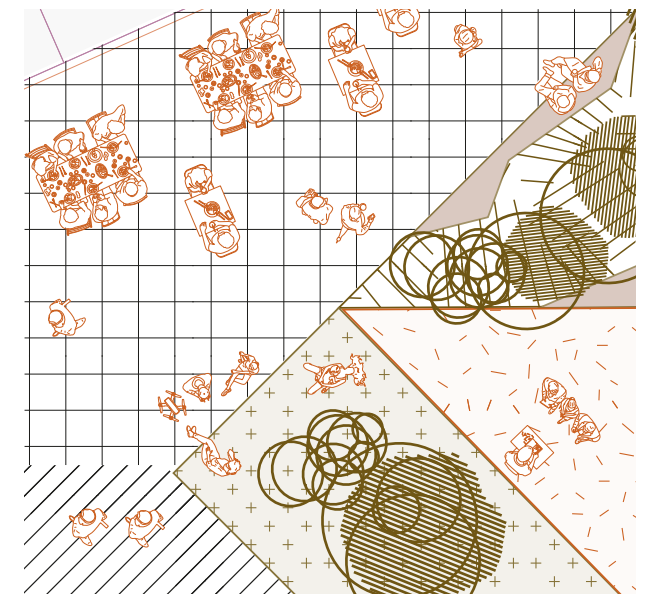
c. The relationship with the urban fabric and integration of existing uses.

The strategy for spatial integration of the square with the surrounding urban fabric, focuses on incorporating the buildings around it blurring the boundaries between what's public and what's private. In this sense the pavement is strategically designed to delimitate areas that enhance existing uses of the sector, like shops and restaurants by providing a physical space that connects them with the context. At the same time, the new geometries generate a number of spaces for gathering and interaction, with various areas dedicated to different activities.

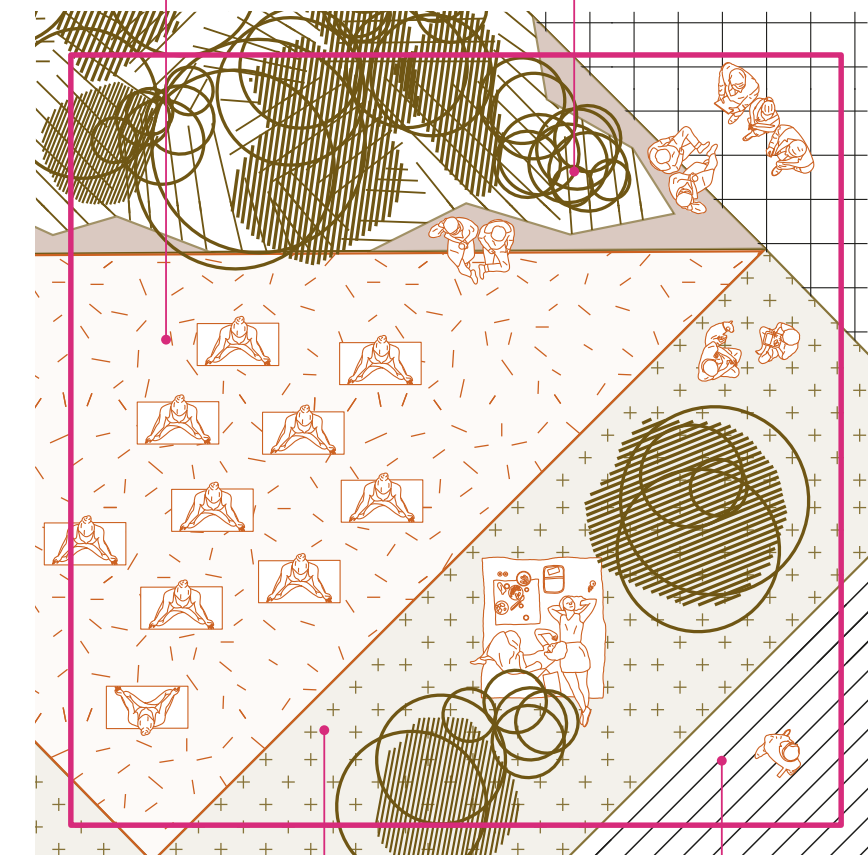
d. Materials specifications

The material for zones requiring maximum flexibility for recreational and cultural activities is EPDM safety rubber pavement. It was selected for its durability, impact-absorbing properties, and appealing appearance, which collectively create a comfortable and inviting surface that encourages continuous use and prolonged stay.

The planters are designed as elevated concrete elements that contain vegetation and incorporate wooden benches, offering comfortable seating areas. This design creates ideal spaces for social interaction within a more intimate and natural environment.

Aimed at providing thermal comfort and passive rest spaces, these areas offer shade and a natural texture to the plaza. Natural soil and grass are used to contrast with the hard surfaces, enhancing the environmental quality of the square.

These areas, designed to accommodate pedestrian flow, differentiate from the surrounding spaces by the material chosen for them: clay pavers; that offer high durability and create a visual connection with the rest of the Calle del Colorado project.

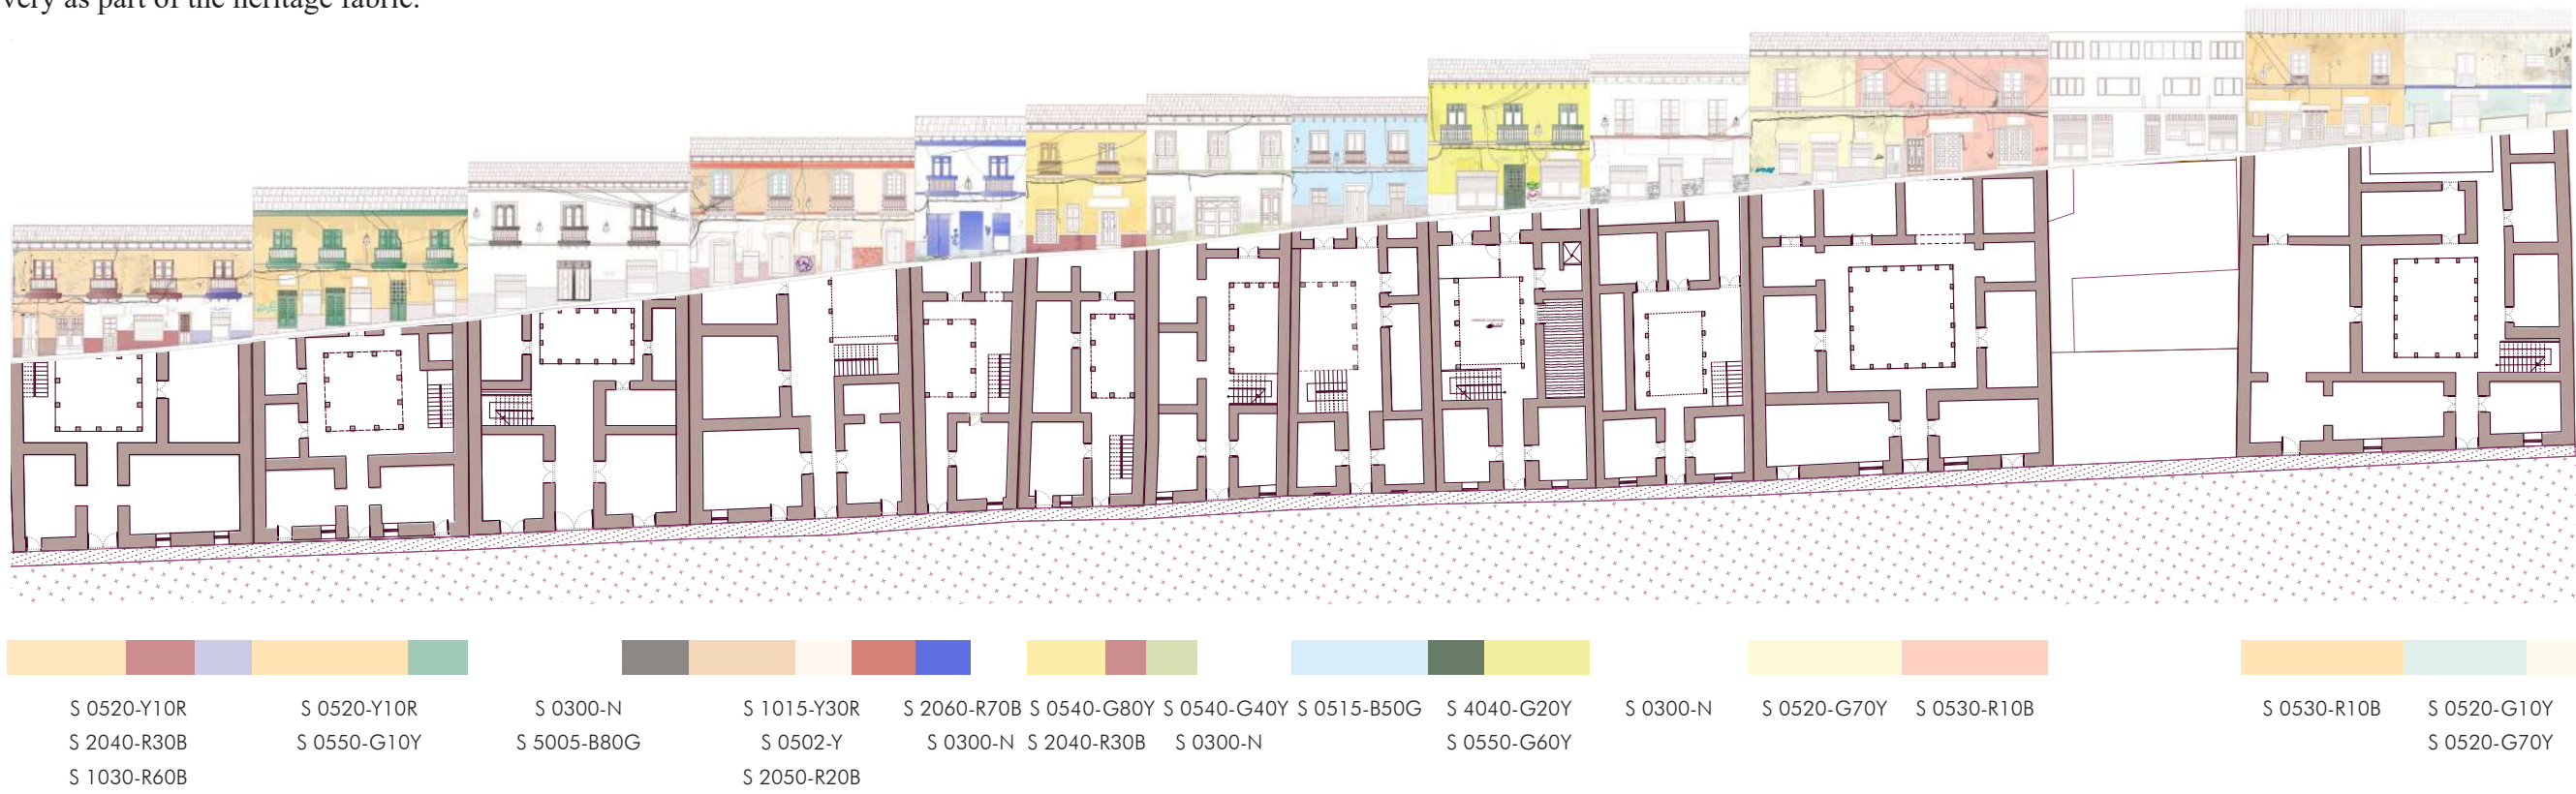
↑ South facade analysis: The colors of Calle del Colorado. Actual state. Own elaboration.

historic centers, this strategy establishes clear technical and cultural criteria for color management, ensuring visual coherence, respect for original materials, and the preservation of urban identity. Based on this methodology, a detailed analysis of Calle del Colorado was conducted to understand its chromatic heritage and richness, which is documented in the following elevation drawings.

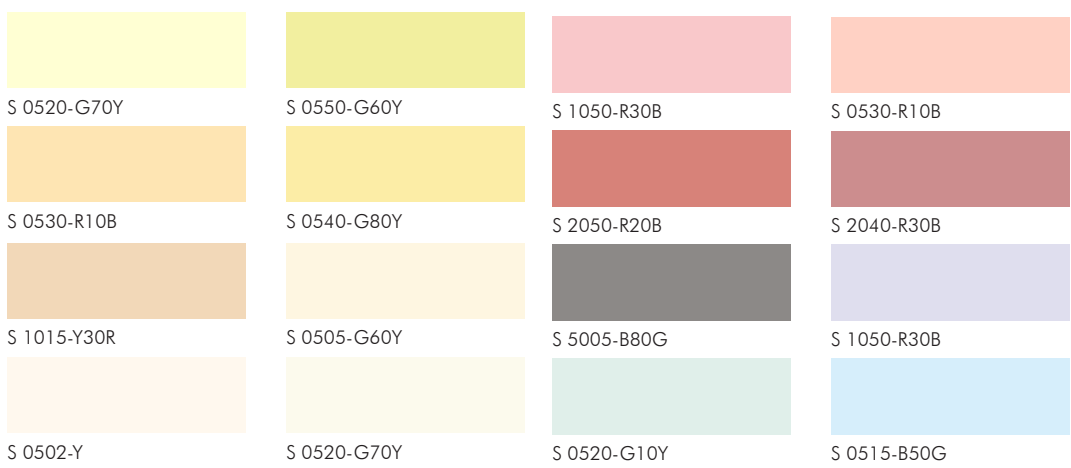
Different color palettes can be generated that allow achieving a balance, a chromatic average that considers both respect for heritage and integration with the current context. The following palette is composed of the colors obtained from the analysis of the existing facades in Calle del Colorado, as well as the hypothetical facades.

An intermediate color palette was developed that establishes a meeting point between the traditional earth tones recommended by the conservation plan and the hues observed in contemporary adaptations. The goal is to reflect the temporal continuity of the street and express harmony between old and new, preserving the expressive values and authenticity of the architecture.

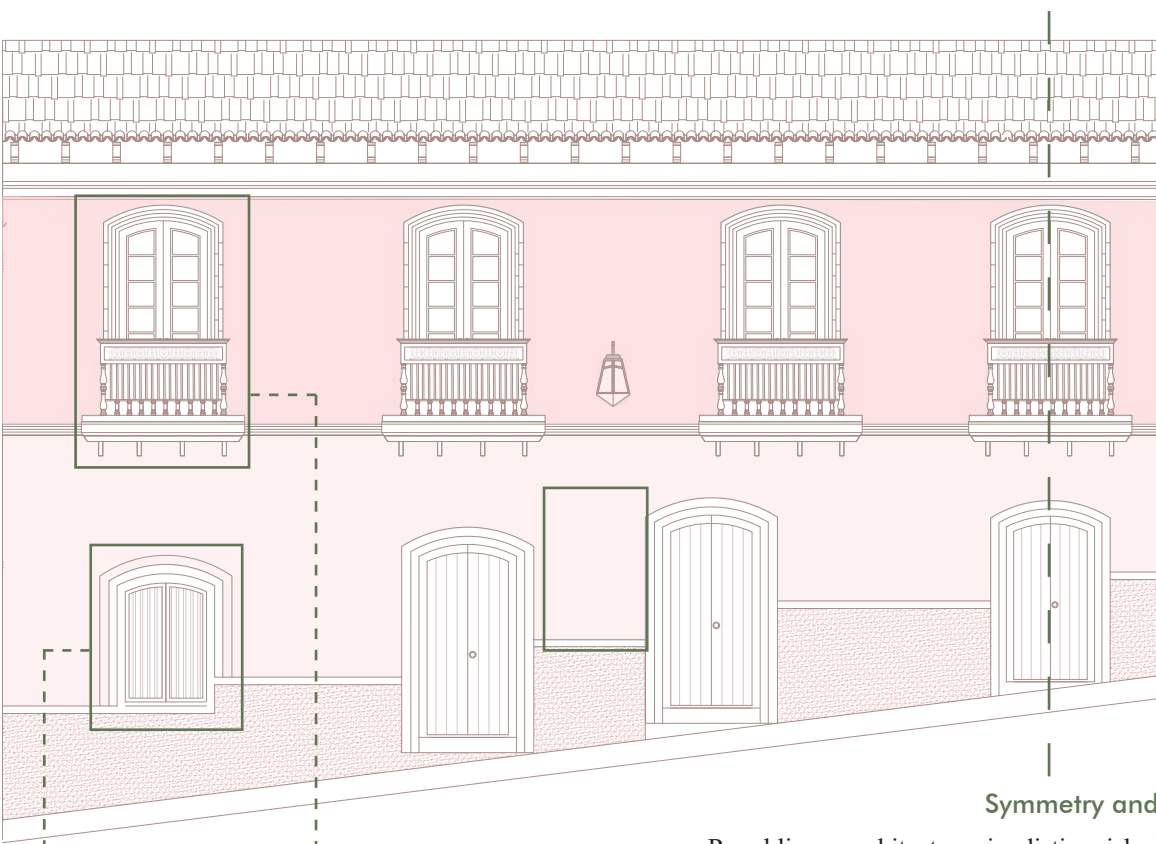
Comparative aesthetic observations between the original and current façades and visualization of significant architectural modifications.

During the Republican era, wood played a central role in façades, particularly in doors, windows, and ornamental elements like balconies. These components were not only structural but also aesthetic, contributing to the aesthetic characteristic of the period.

Republican architecture is distinguished by a strong sense of order and rhythm in its façades, achieved through the regular repetition of openings often aligned vertically and horizontally to create a balanced composition. The façades follow strict symmetry or a clear proportional logic, with well-defined axes and modular spacing between elements.

Architectural elements adapted to the constructive possibilities of their time, with proportions, materials, and detailing reflecting the available techniques and resources.

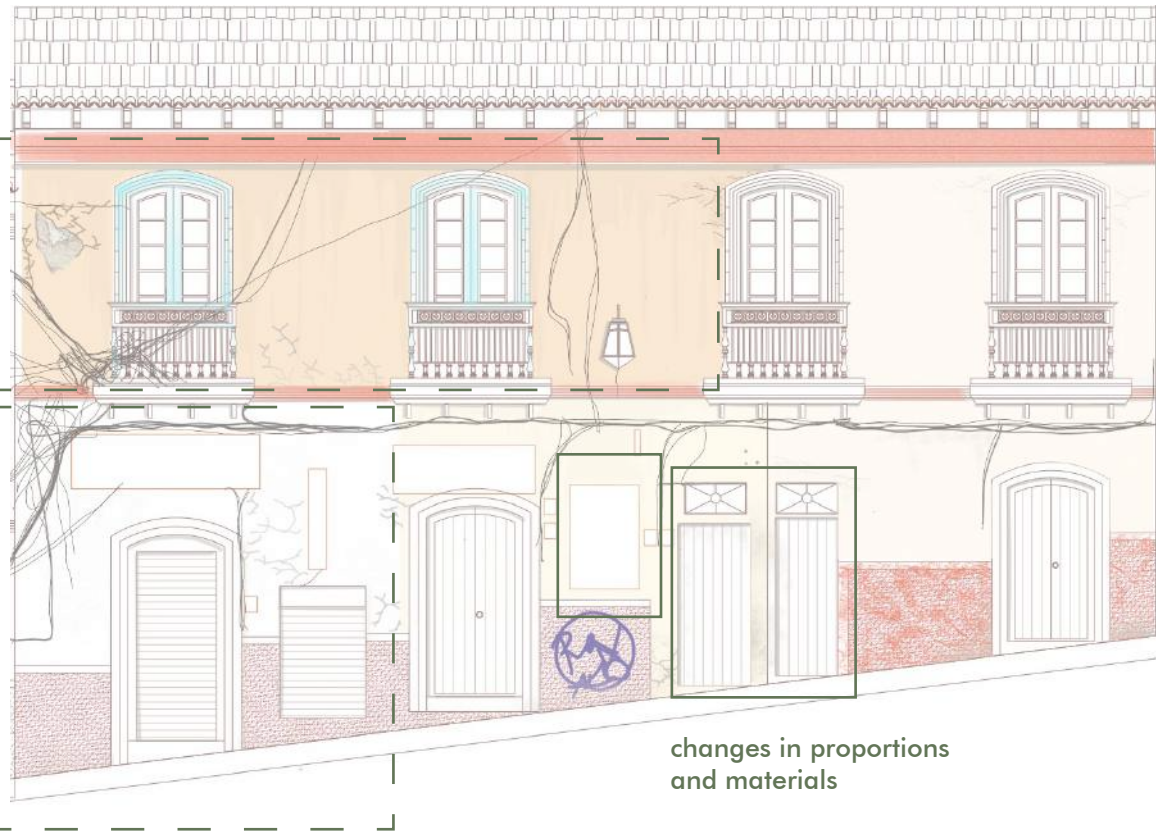
changes in proportions and materials

Significant transformation due to the progressive subdivision of the building into smaller commercial units. This fragmentation results from the partial sale or independent rental of spaces, leading to alterations in the original façade.

in adaptations original wooden elements can be removed or replaced with lower-cost, readily available materials such as aluminum, steel, or glass. These replacements prioritize durability and security over stylistic coherence, leading to a loss of historic character and material harmony.

In a comparative study between the original design for the facades and their current condition the observations reveal how architecture has reflected the evolving needs of its inhabitants during the republican period and also today. In the past, houses were designed in response to domestic life, climate, and the availability of

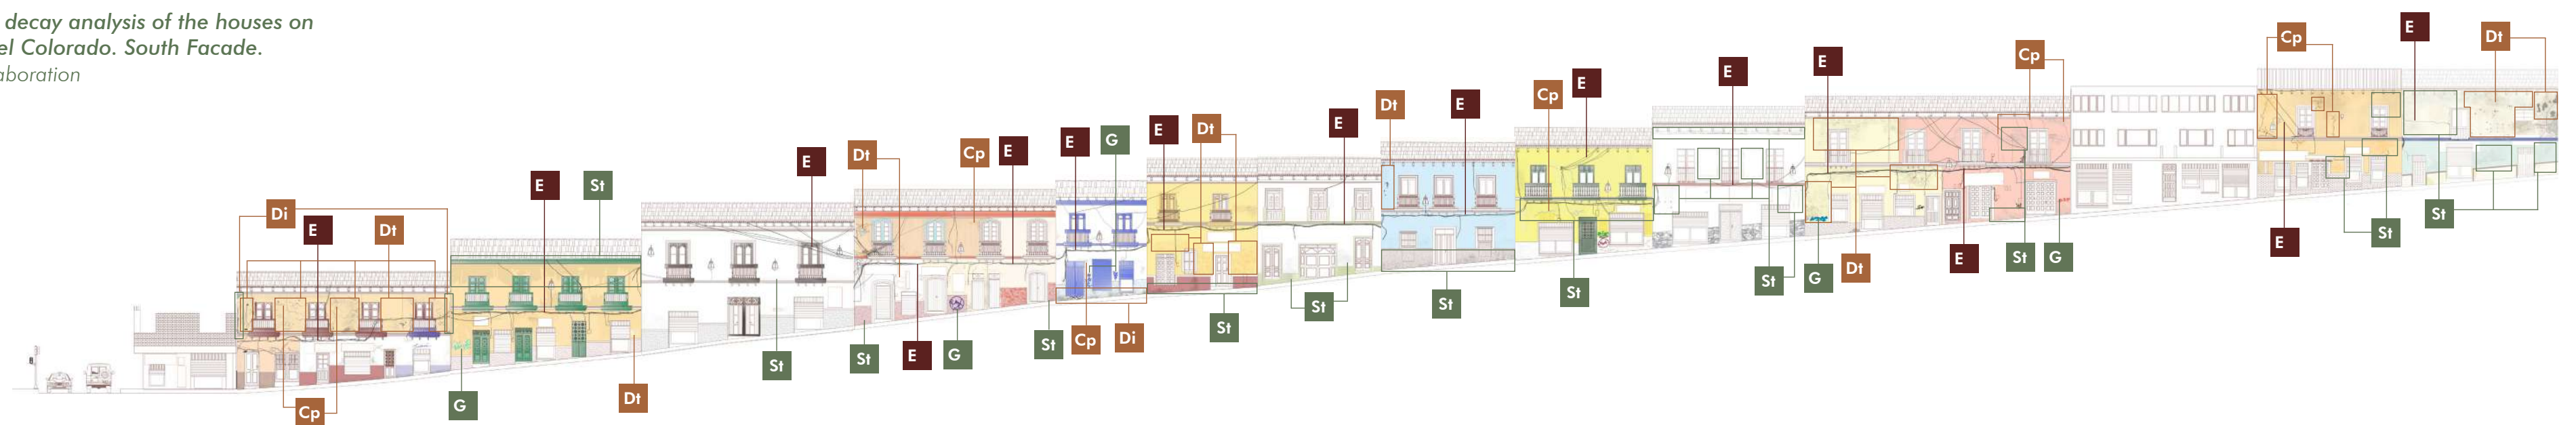
↓ **Facade decay analysis of the houses on Calle del Colorado. South Facade.**
Own elaboration

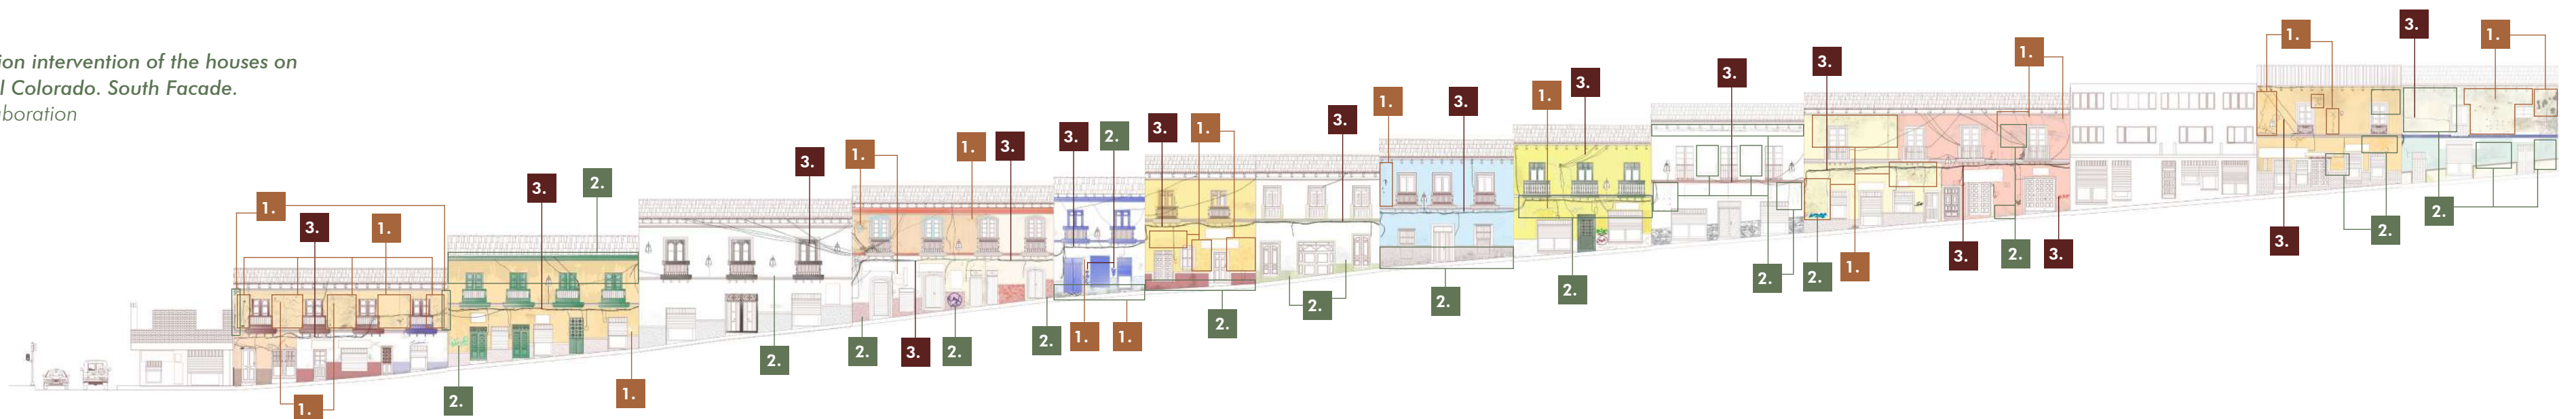
↓ Restoration intervention of the houses on Calle del Colorado. South Facade. Own elaboration

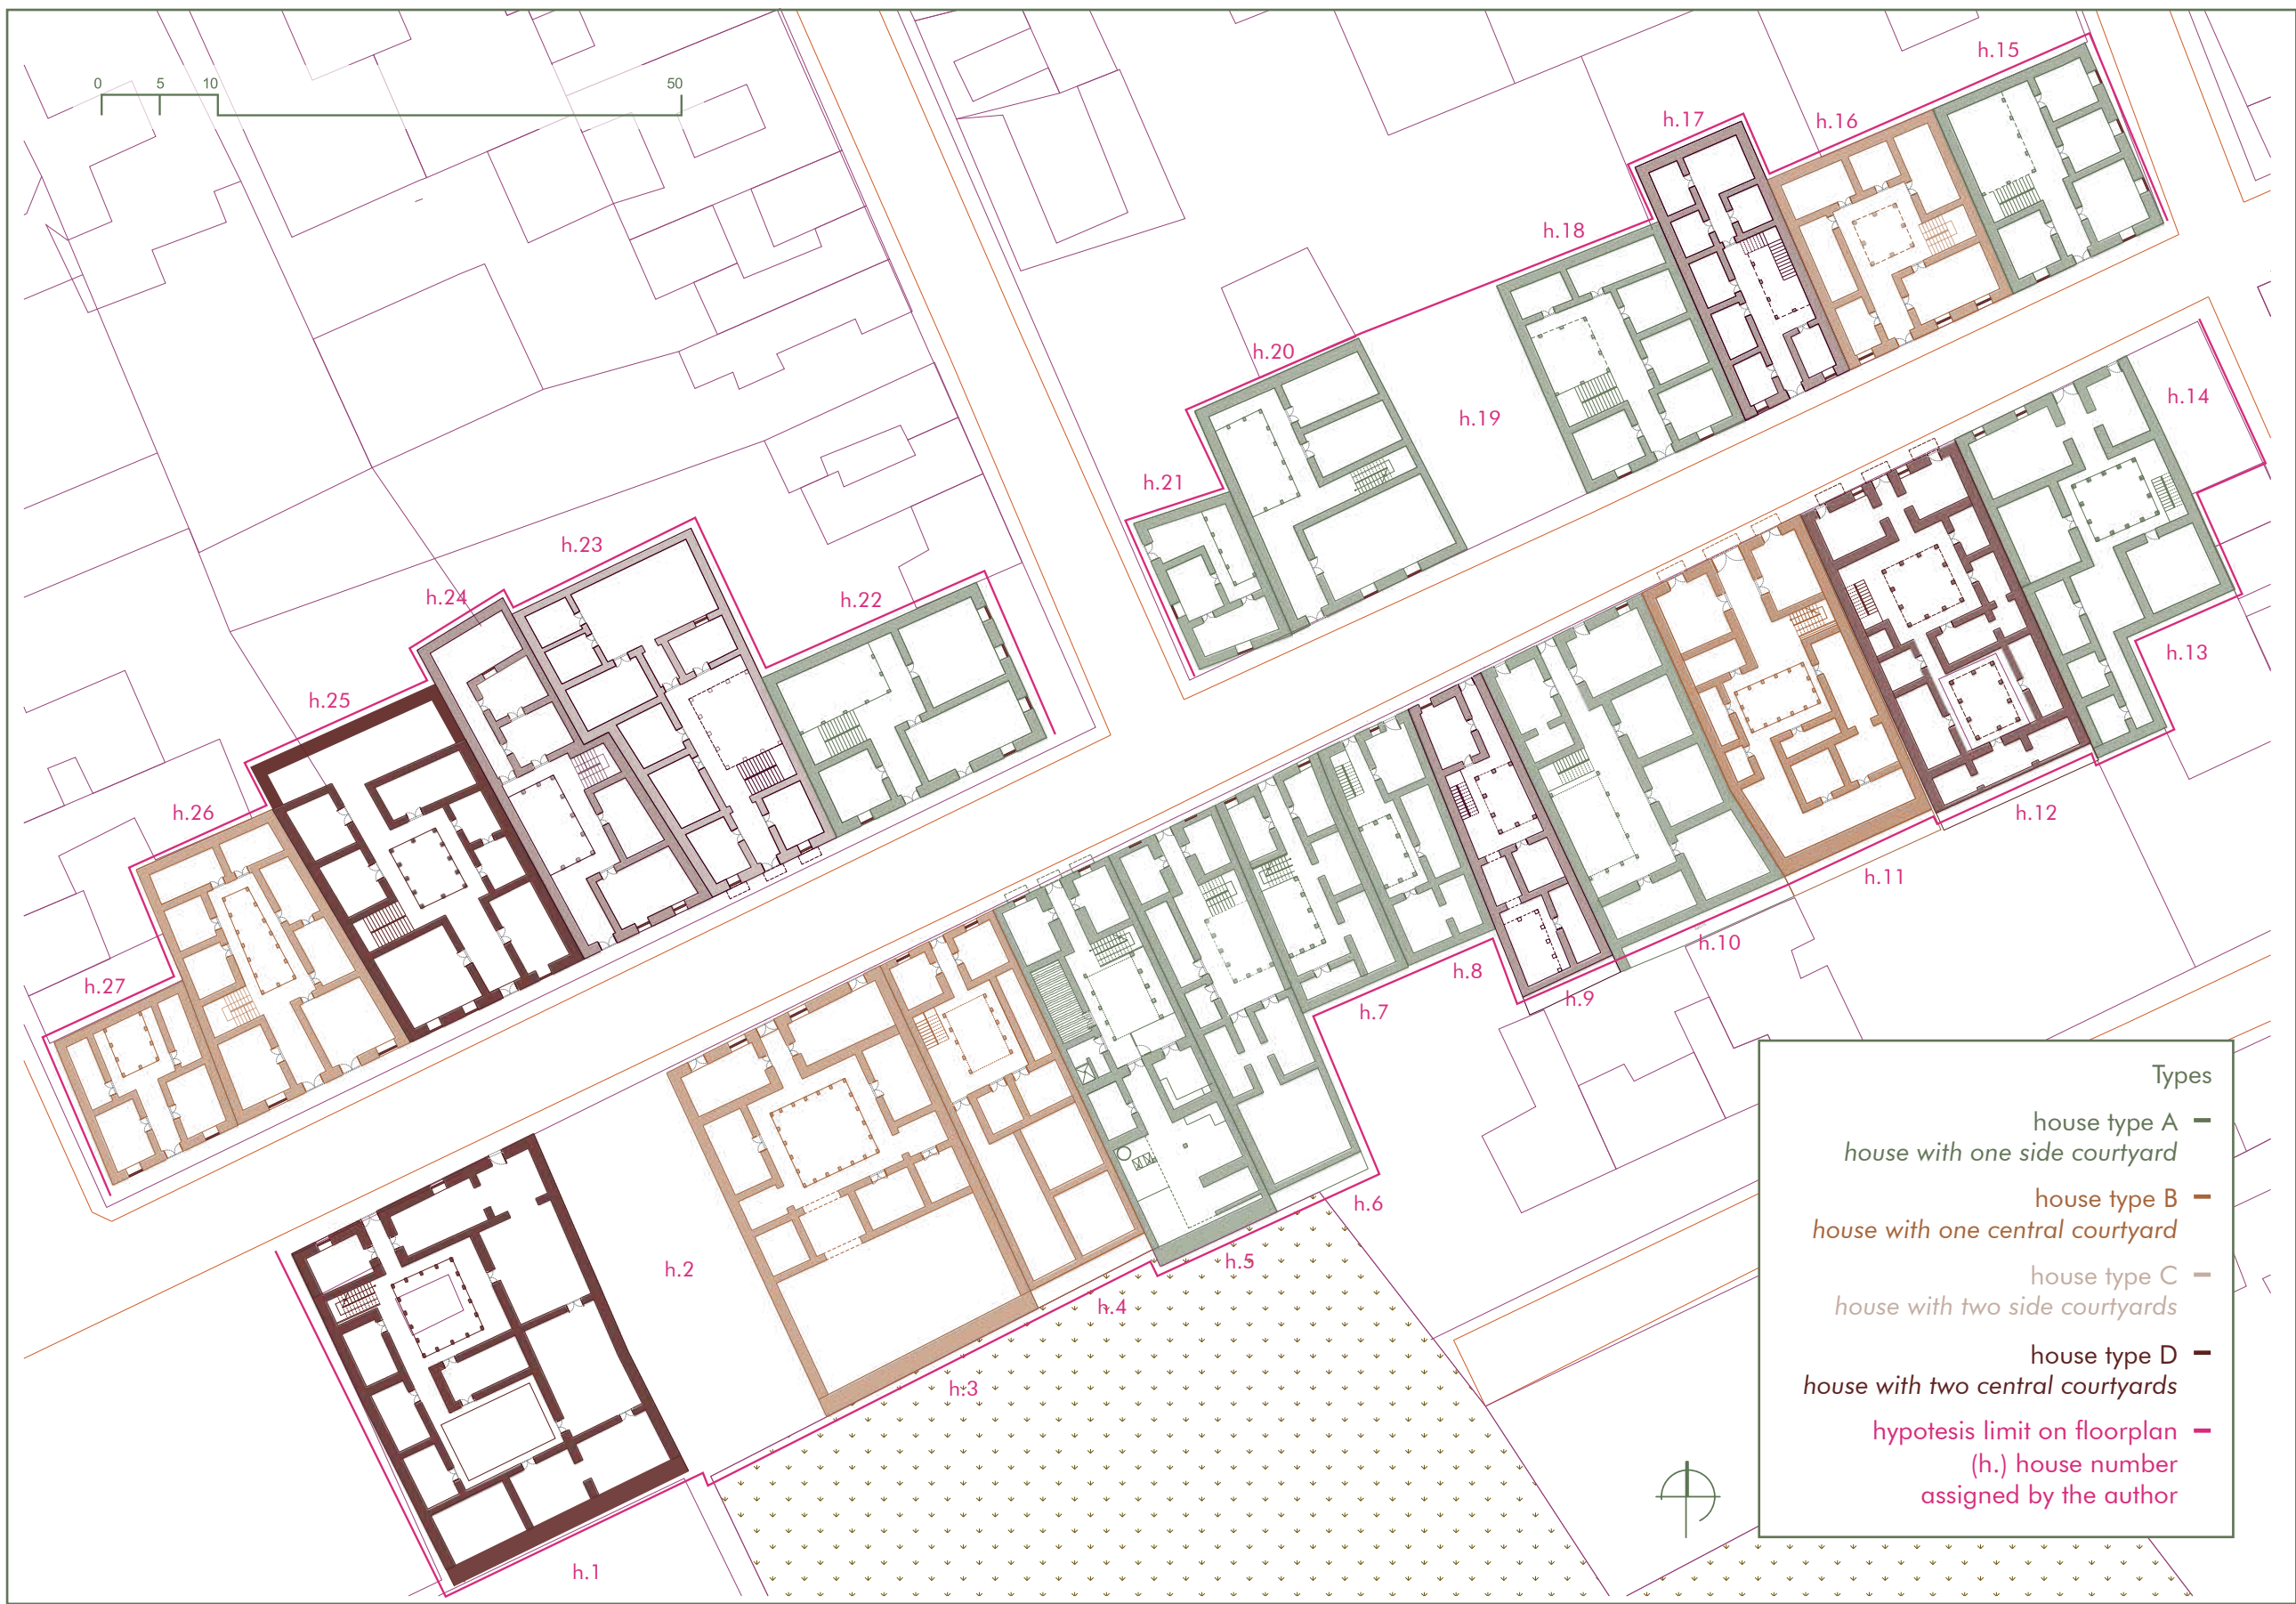
↑ Typological classification on hypotesis floorplan

To establish the core architectural values of the historic center, we conducted a thorough typological analysis, based on a hypothesis of the original Republican layouts. By categorizing the housing structures into 4 distinct typologies according to the number and location of patios (house with one side courtyard, house with one central courtyard, house with two side courtyards and house with two central courtyards), we were able to systematically decode the spatial organization, functional hierarchy, and formal values that defined the domestic life of the era. This process was fundamental for understanding the original urban and architectural rhythm, providing a crucial contextual foundation for the subsequent intervention and design stage.

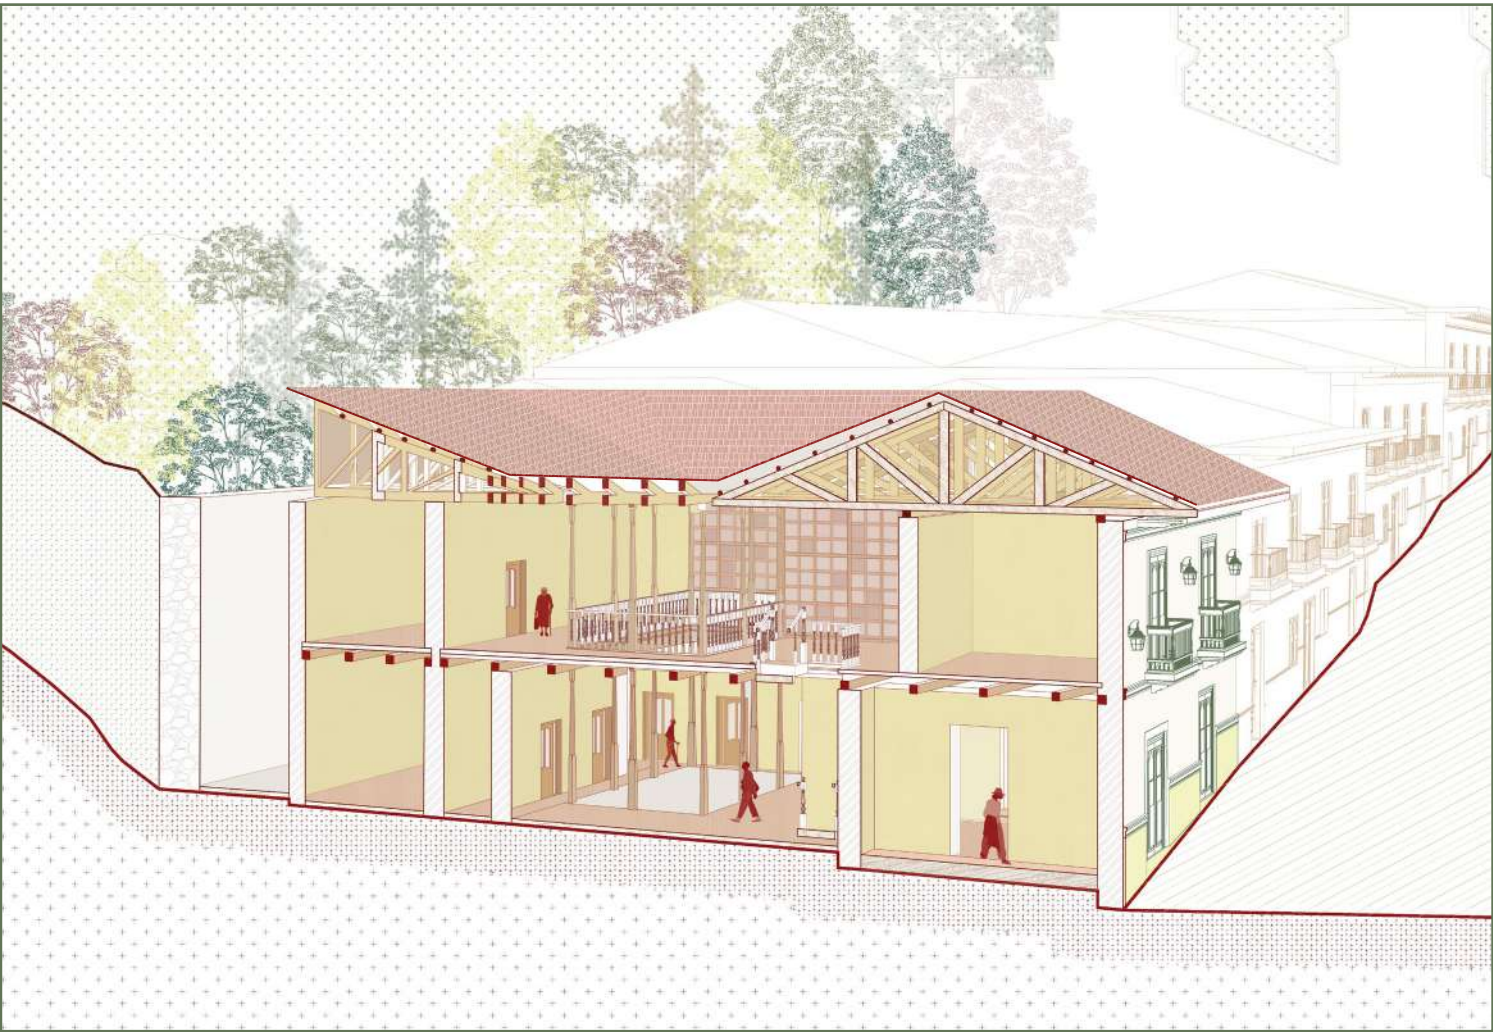
→ Axonometric perspective section, interior view of a typical republican house

This detailed axonometric perspective cut offers a clear visualization of the spatial organization and internal structure of a typical Republican house, specifically showing the house type 'B'. It effectively illustrates the relationship between the interior spaces, the circulation paths, and the way the dwelling was organized hierarchically. By showing the building in section, the diagram allows for a comprehensive understanding of the original architectural values and how the structure adapted to the sloping terrain characteristic of the area.
