↑
Strategy for urban cohesion: proposal for a pedestrian and heritage circuit.

→
Urban design plan: spatial configuration of Santiago's church square.

The Mopa Mopa Cultural Center

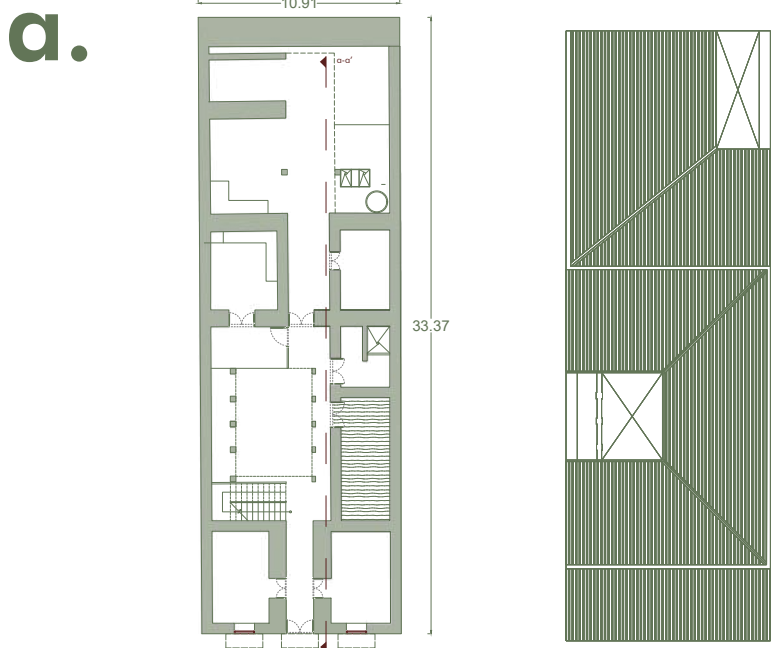
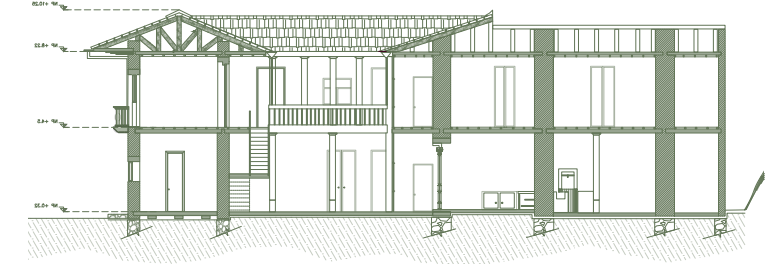
The house with a side courtyard is a typological variation that emerged during the Colombian Republican period in urban areas undergoing modernization. Unlike the traditional central courtyard house, this layout repositions the courtyard to one side, which allowed for improved cross-ventilation and natural lighting. This shift also enabled a clearer separation between public and private spaces within the dwelling. These homes represent a functional and spatial evolution from colonial models, adapting to the transformed Republican urban fabric while incorporating neoclassical decorative elements.

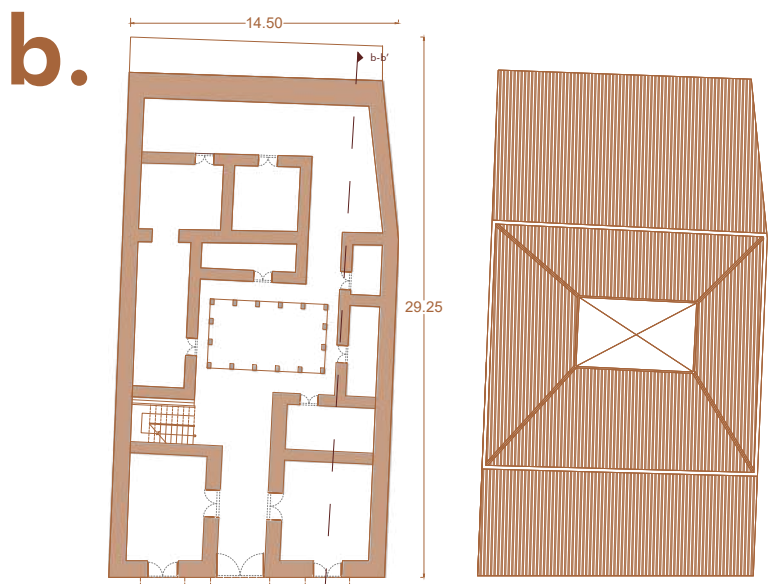
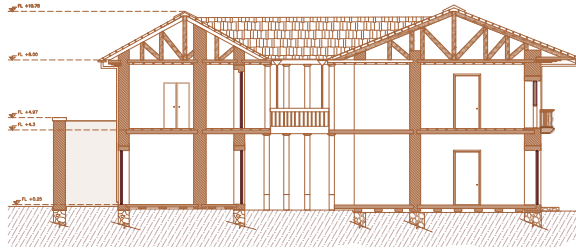
The house with a central courtyard is a classical Republican typological model that consolidated in cities where commerce and domestic life overlapped, it maintains a symmetrical layout organized around a single patio, accessed via a central zaguán. This established a clear spatial hierarchy: commercial rooms faced the street, social/private spaces surrounded the courtyard, and service areas were located toward the rear. This model reflects the adaptation of earlier types to denser urban fabrics, preserving the traditional patio organization while integrating new functional divisions and circulation patterns.

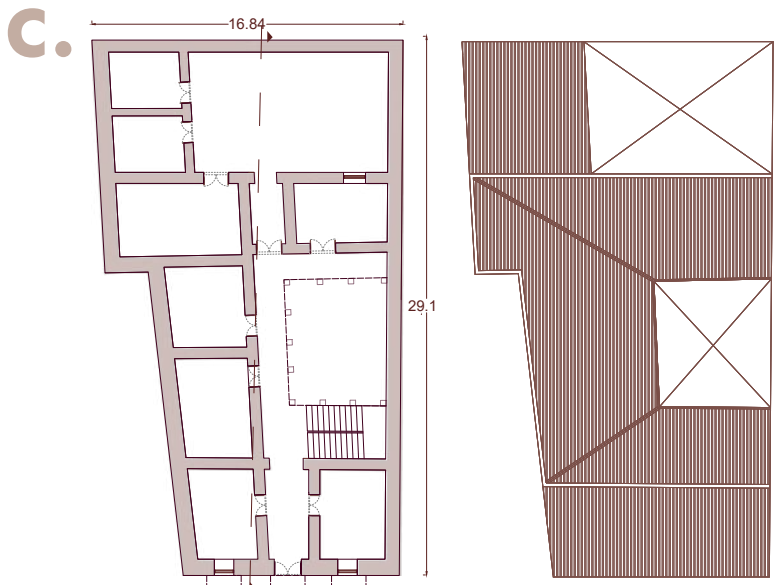
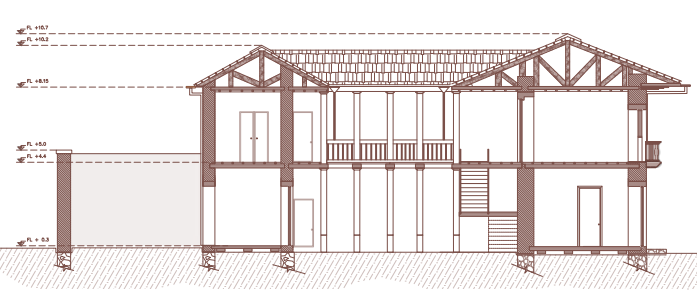
This type maintains a central axial entrance that continues as a long, uninterrupted passage toward the rear of the property. The principal courtyard remains at the heart of the house. Toward the back, a secondary service patio accommodates kitchens, storage areas, and other domestic functions, reinforcing the spatial hierarchy typical of Republican domestic architecture. This reflects an effort to preserve the symbolic and functional importance of the central patio while adjusting circulation and depth to the constraints and needs of evolving urban environments.

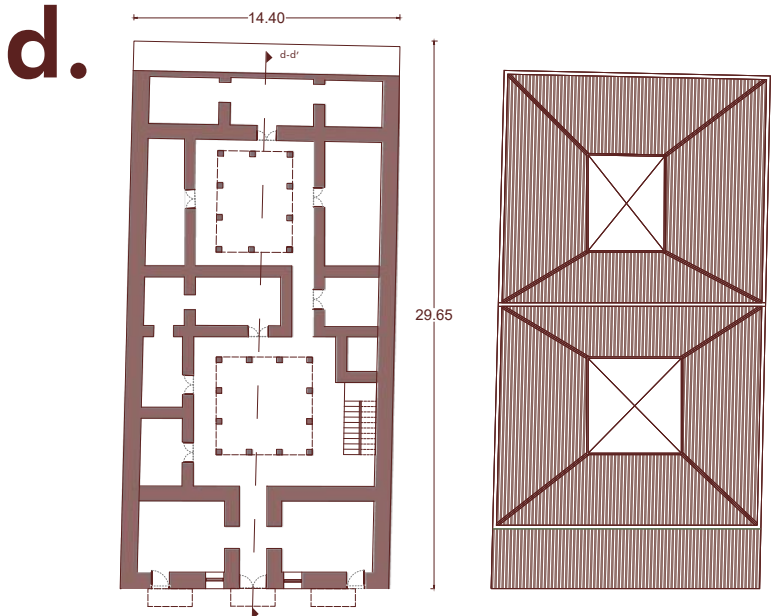
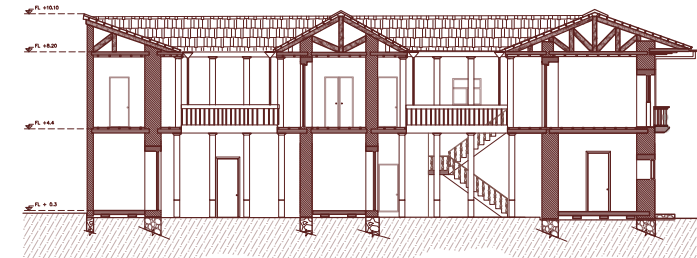
The house with two central courtyards represents the most distinguished and aristocratic typology of the Republican period. Its layout is organized around two consecutive patios, each framed by corridors supported by perimeter columns. A central zaguán leads to the first courtyard, reinforcing the ceremonial entrance. The first patio typically hosts the main staircase, while the second courtyard introduces a more private and refined domain where domestic and service functions are arranged. This dual-courtyard configuration reflects the spatial ambition and high social status associated with the era's largest and most prominent urban residences.

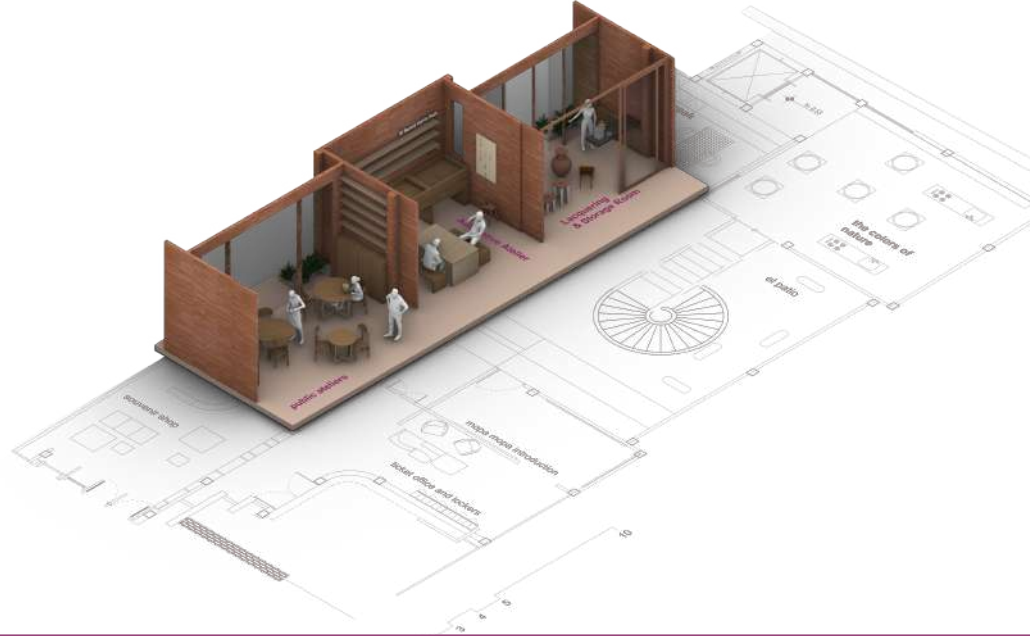
An Immersive Workshop to Reveal the Craft Process: Axonometry

More than a museum, this space functions as an immersive workshop where the craft becomes visible. The arrangement of the ateliers prioritizes transparency, allowing visitors to witness each stage of the process and understand the value of the hands that keep the tradition alive.

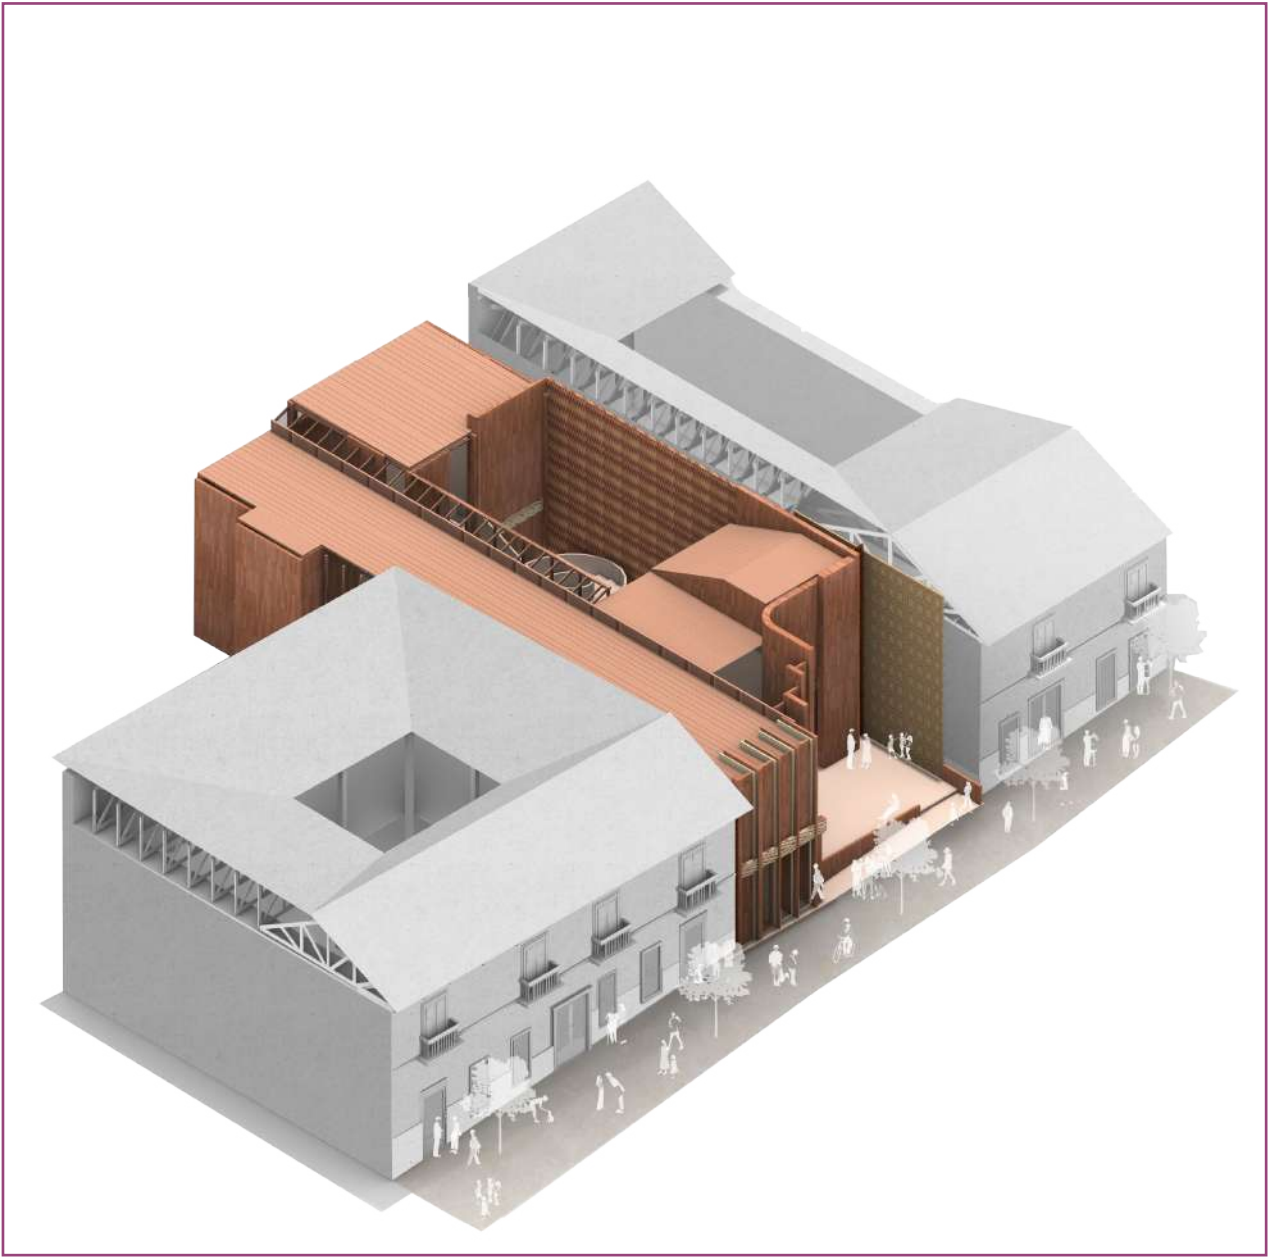
The project and its integrating elements ↓

The project incorporates the “Sol de los Pastos” carved in wood as a symbolic and spatial connector between the existing buildings and the new cultural center. Its presence highlights the value of local wood carving, an artisanal tradition deeply rooted in Pasto. In parallel, the brick latticework used on the façade and throughout the interior reinforces the idea of the building as a woven construct. Together, these elements create a continuous fabric that integrates craft, territory, and architecture into a unified expression

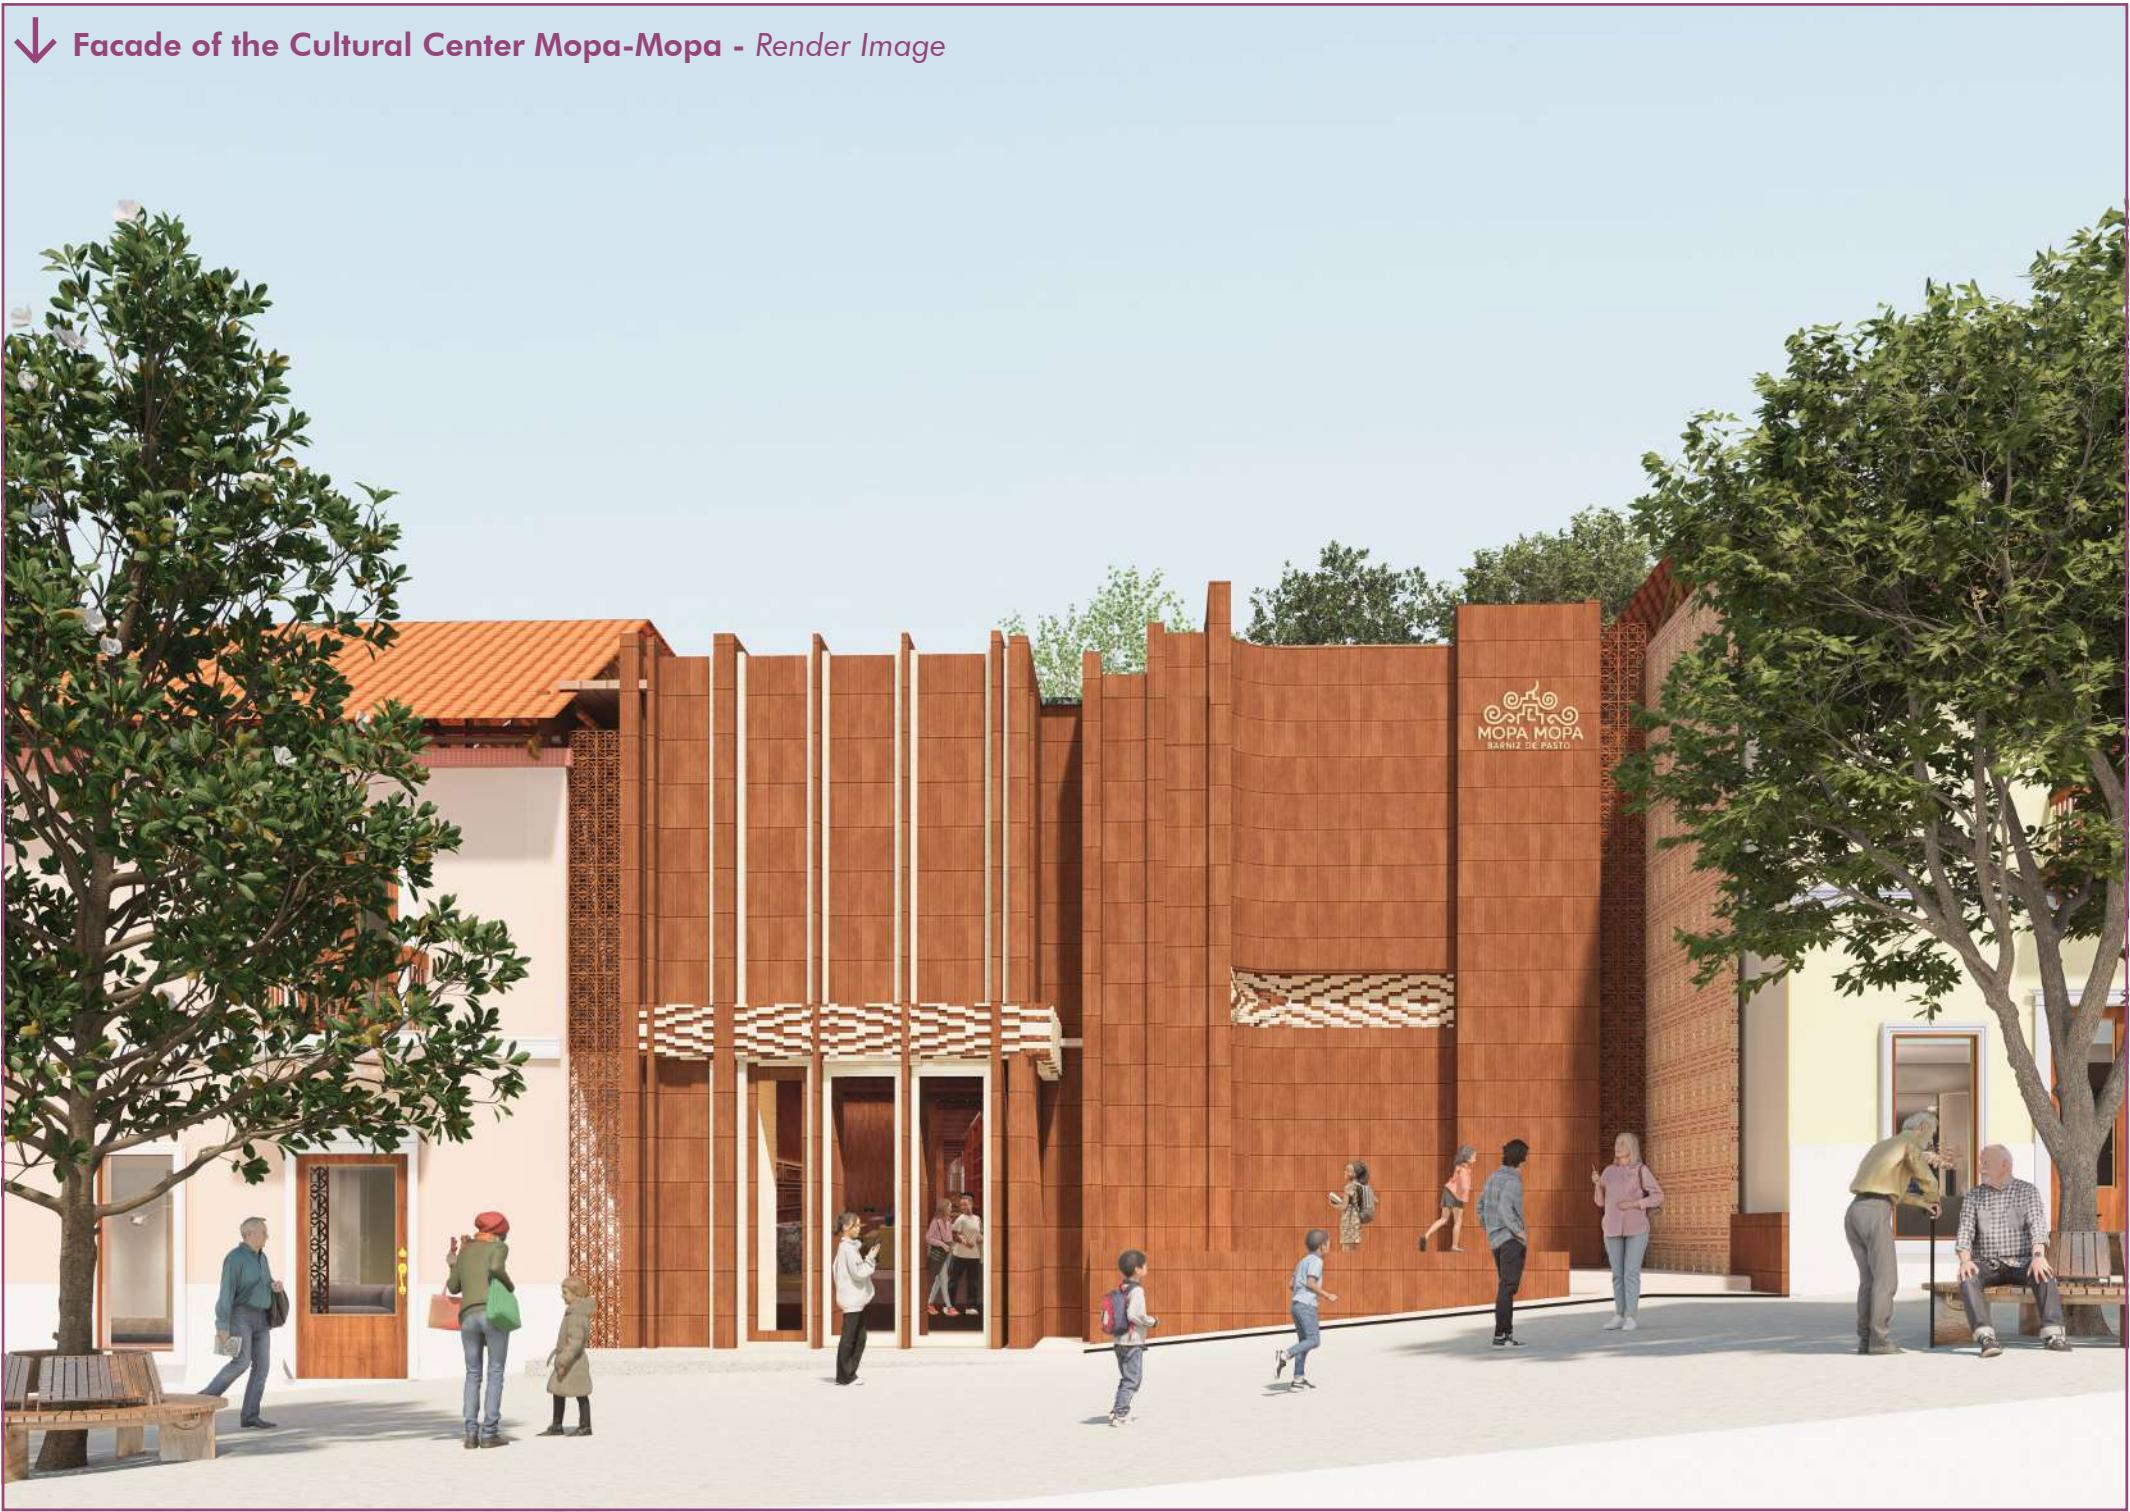
↓ Courtyard - Render Image

The design of the Mopa-Mopa C.C reinterprets the traditional typology of the republican house with a central courtyard, adapting it to create a modern flow that encourages the experiential learning of Varnish.

The articulating axis of the design is the Central Courtyard. Conceived as an open space for interaction and rest, it becomes essential by reintroducing one of the most valued architectural elements of the historical center. The courtyard not only structures the circulation but also embodies the project's material and cultural intentions: the use of brick as an artisanal, deeply Colombian material; the integration of craftsmanship into the construction itself; and the presence of a contemporary staircase that recalls the vertical connectors characteristic of the period. In this way, the project brings back the courtyard as a spatial, symbolic, and cultural anchor for the entire cultural center.
