MSc Architecture for Heritage
A.Y. 2025/2026
Graduation session December 2025

Restoration of sandwich panels in architectural heritage

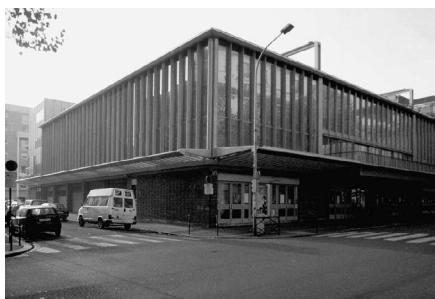
fig. 5. Façade panels of the building for the Fédération Nationale du Bâtiment (architects Raymond Gravereaux and Raymond Lopez, façade engineering Jean Prouvé, Paris, 1951). Drawing Fonds Jean Prouvé. Centre Pompidou – MNAM/CCI-Bibliothèque Kandinsky-Dist. RMN-Grand Palais.

In later works, Jean Prouvé progressed by adding windows to the ready-made panels. For the building for the Fédération Nationale du Bâtiment (architects Raymond Gravereaux and Raymond Lopez, Paris, 1951), he developed a panel with a window and insulation (fig. 5)⁵⁰. The assembly of the façade could be done by two men and a simple winch, as its mass was only 92 kg, at a speed of one storey per day. It

was the first aluminium façade on this scale in Europe⁵¹.

After the war, the Aluminium Company of America (Alcoa) commissioned new headquarters that were designed by architects Harrison and Abramovitz (1953, Pittsburgh, PA, fig. 6)⁵⁸. The structure resembles the panels Jean Prouvé designed for the Fédération Nationale du Bâtiment (see fig. 5).

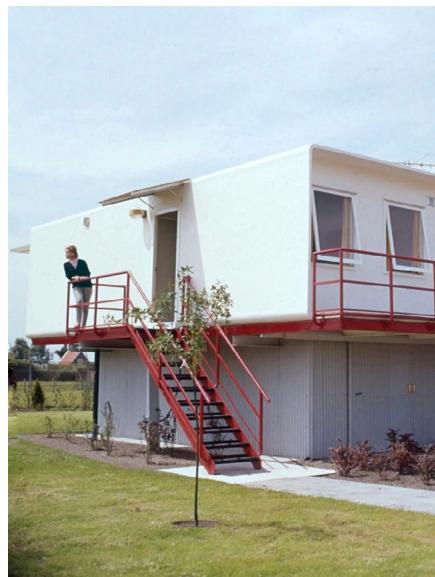
fig. 8. Fokker's Instant Home. Photo Henk Hilterman – Nationaal Archief – Collection Spaarnestad Photo.

Another experimental Dutch plastic house was developed by the airplane company Fokker in 1964. Fokker's Instant Home (fig. 8), as it was called, was designed by Egbert van Emden and used GRP panels around a PUR core⁶⁹. Fokker used the experience from the aircraft industry, using honeycomb structures and fixing techniques⁷⁰. The death of Van Emden stopped the development of the plan, which was intended as a do-it-yourself building kit⁷¹, but Fokker started producing sandwich panels

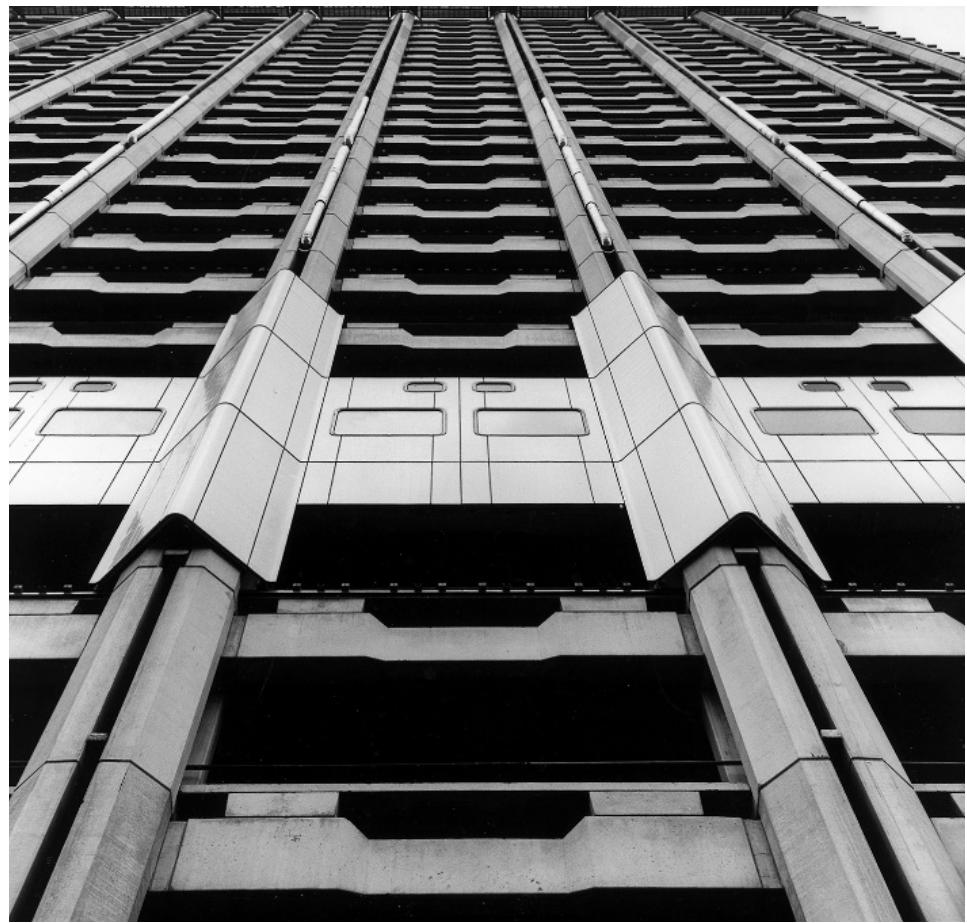
fig. 10. Facade of the medical faculty of Rotterdam. Facade engineering by Jean Prouvé. Photo Fondation Jean Prouvé. Centre Pompidou – MNAM/CCI-Bibliothèque Kandinsky-Dist. RMN-Grand Palais.

a prefabricated concrete structure⁹⁴. The façade, designed by Prouvé and his Compagnie Industrielle de Matériel de Transport (CIMT), consisted of prefabricated aluminium panels of 4 meter height (fig. 10), to match the storey height of the already existing Dijkzigt Hospital, to which the faculty was connected, and a width of 2,40 m, that matched the grid, which had a base of 1,20 m⁹⁵. The panels form a

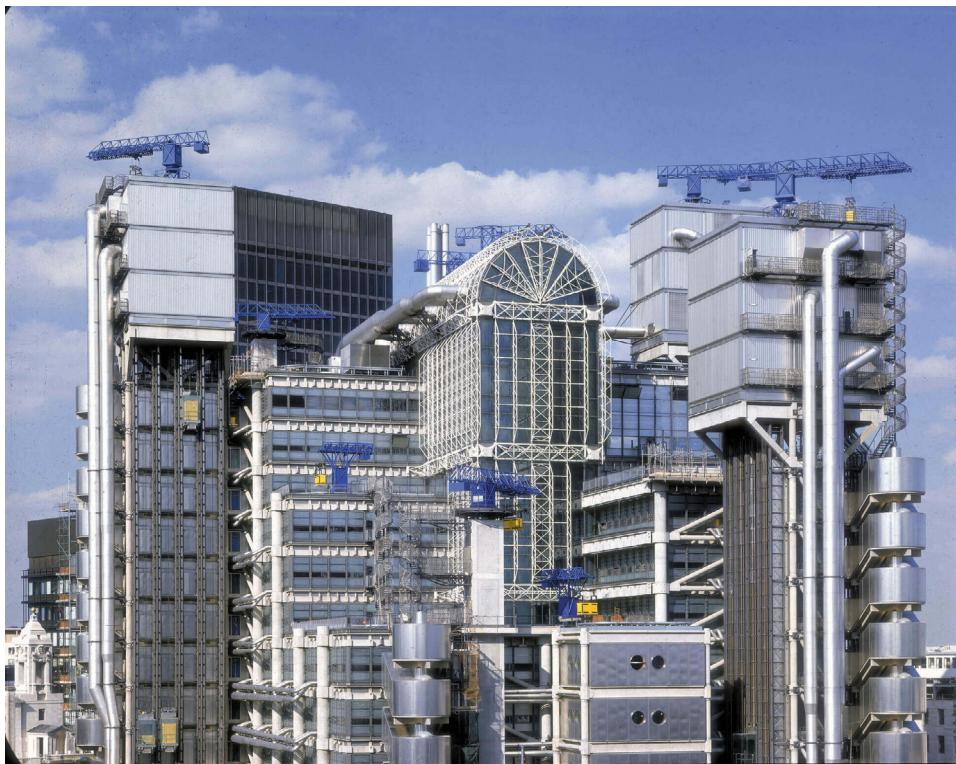
fig. 12. *Lloyd's of London* (Richard Rogers Partnership, 1986). The steel sandwich panels are used in the service towers. Photo RSHP.

An example of a building that has a façade from stainless steel sandwich panels is the Lloyd's office in London (Richard Rogers Partnership, 1986)¹²⁵. In these headquarters of the bank, elements like the structure, elevators and ducts are clearly visible from the outside (fig. 12). The building communicates a transparency,

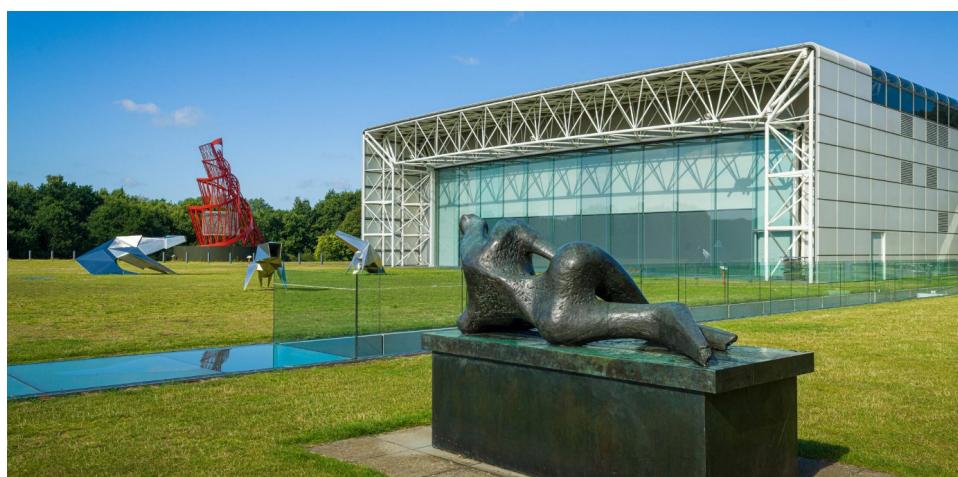
fig. 13. The Sainsbury Centre seen from the sculpture garden. The new panels are smooth instead of profiled. Photo Andy Crouch.

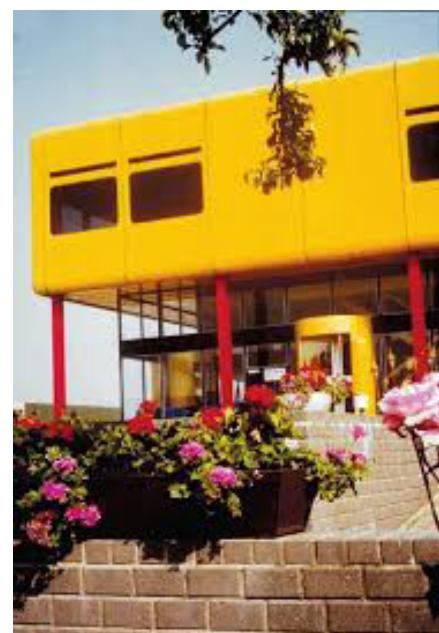
fig. 14. Sony Distribution Centre in Vianen. Photo Jan Brouwer.

(1972, fig. 14), for example, clearly indicates the two functions of the building. The ground floor, used for storage, was executed in reinforced concrete, whereas the first floor, the office space, had a façade of bright yellow GRP sandwich panels with large windows¹⁸³.

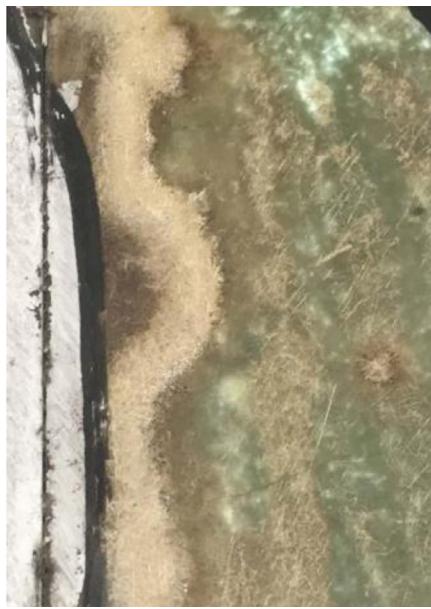
fig. 16. Exposed glass-fibres in a GRP shell, with white chalking visible. Image Pizzigati & Franzoni 2021.

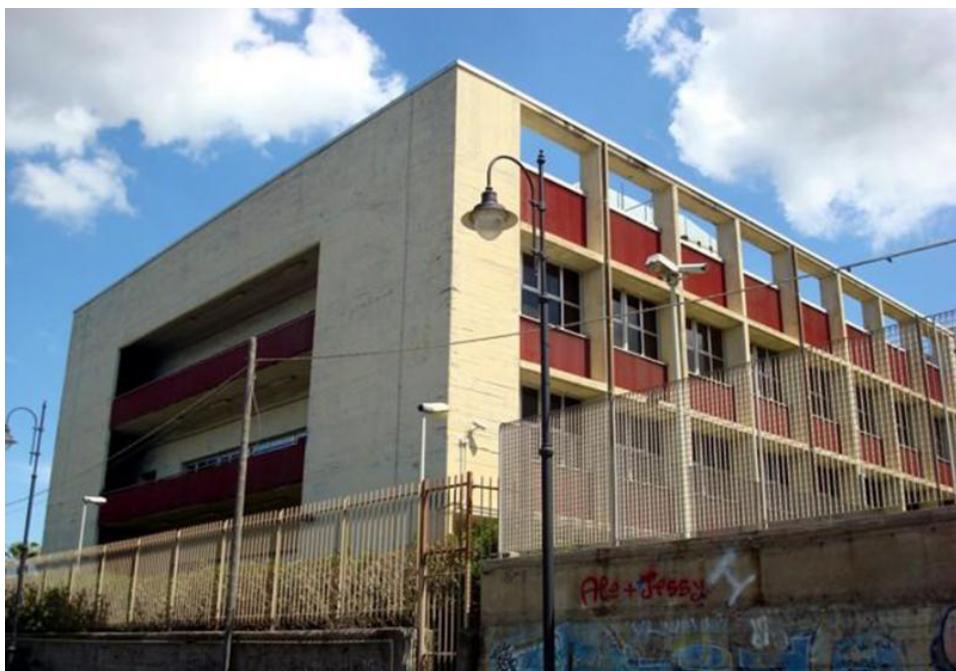
fig. 17. The research centre in Napoli. Photo Censimento delle architetture italiane dal 1945 ad oggi.

An example of a façade with PVC sandwich panels is the building of a centre for the research of the sea for the chemical company Montedison, in Napoli, by Gregotti Associati (1978, fig. 17)²¹². The choice was made for non-corrosive materials, because of the aggressive environment. Furthermore, the PVC and other polymers employed in the façade reflected the area of expertise of the company²¹³.

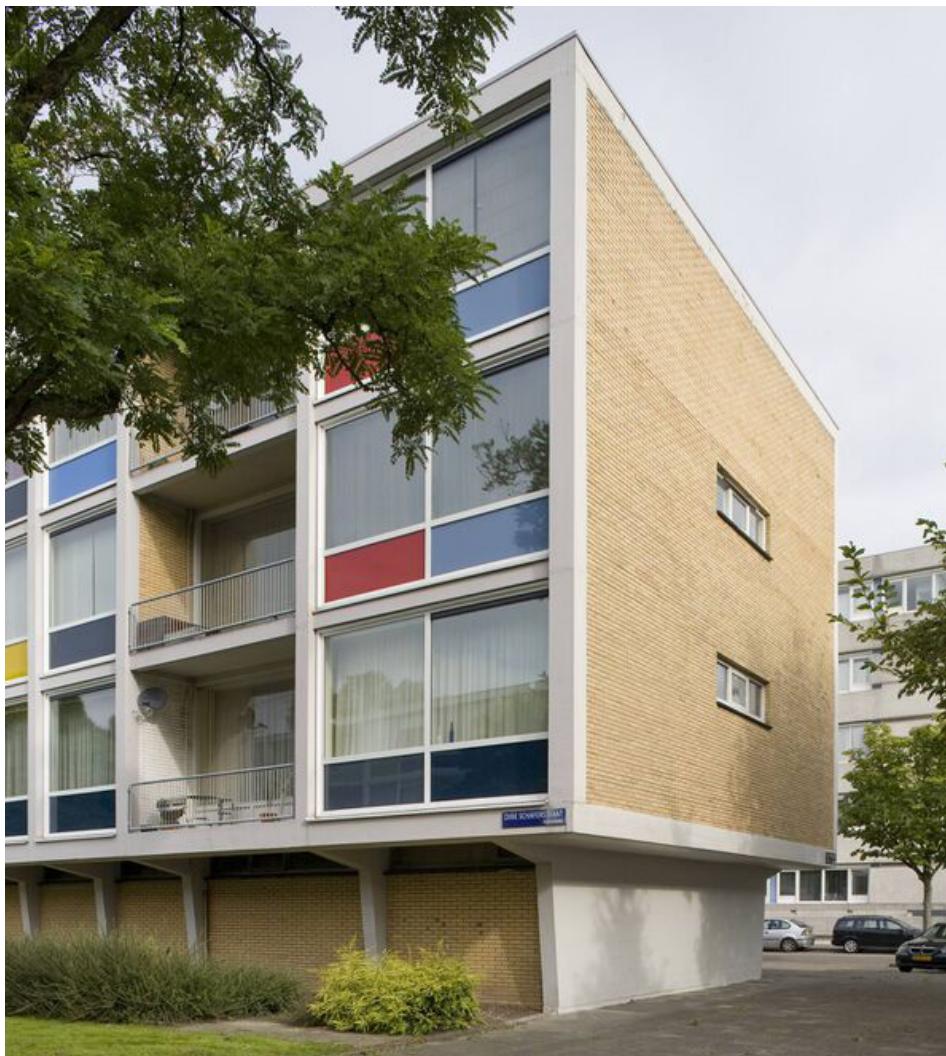
fig. 20. *Glasal façade panels in a building in Amsterdam. Photo C.S. Booms.*

In 1900, Ludwig Hatchek developed at technique to mix asbestos pulp with cement and he introduced it on the market as Eternit in 1903²³⁹. Over the course of the years, many products have been developed, like Glasal (1957, see fig. 20), which was a asbestos cement panel that was cured in an autoclave and had a vitreous enamel top coat, that was very easy to clean²⁴⁰. The great diversity of products, in terms of texture, colour and properties, made asbestos a popular material for façades.

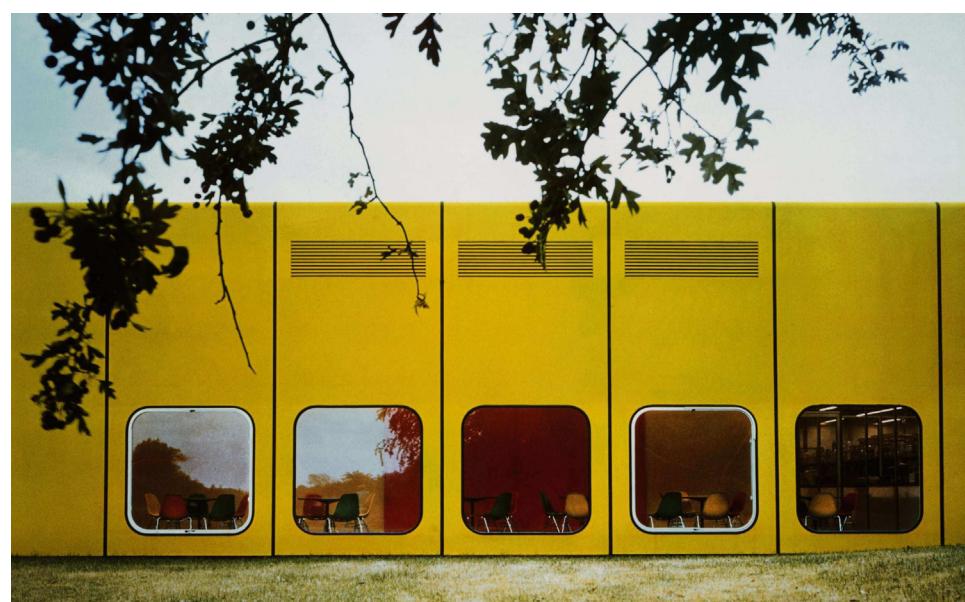
fig. 21. Bright yellow GRC sandwich panels in the façade of the UK headquarters of UOP Fragrances by Piano + Rogers. Photo RSHP.

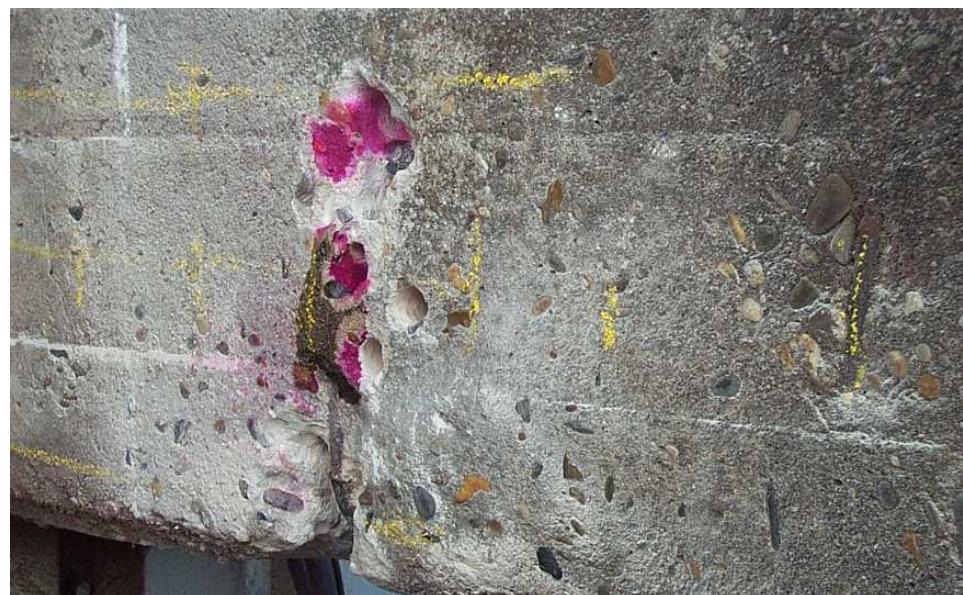
fig. 22. Testing of carbonatation depth by phenolphthalein. The purple parts are not carbonated. Photo C. van der Steen, Technoconsult Heeswijk.

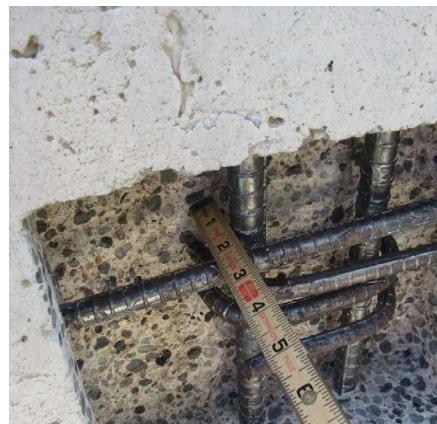
fig. 23. Removal of concrete beyond the reinforcement to allow for removal of corrosion and for proper bonding with the replacement concrete. Photo Ann Harrer and Paul Gaudette.

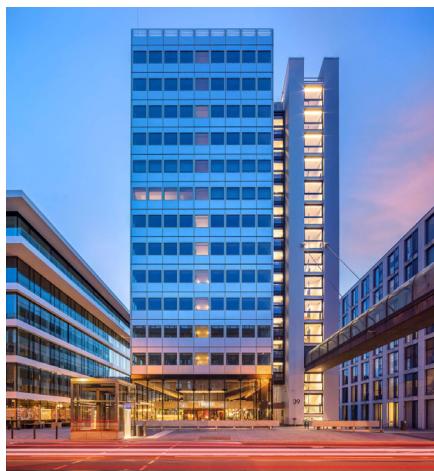
fig. 24. The aluminium sandwich panel facade of the Commerzbank in Düsseldorf. Photo Ralph Richter (HHP Architekten).

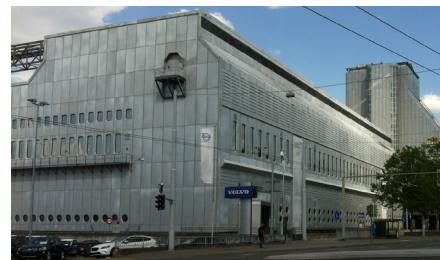
fig. 27. Briefzentrum Mülligen before the restoration (2014). Photo Kanton Zürich, Baudirektion, kantonale Denkmalpflege, no. D100662_95.

Over time, the building had deteriorated. Due to chalking and loss of gloss, the grey façade lost its original appearance³⁷⁹. It suffered from biological growth and was soiled³⁸⁰. Although the panels were structurally intact, the appearance changed over the course of the years; colour differences appeared between and within panels (fig. 27).

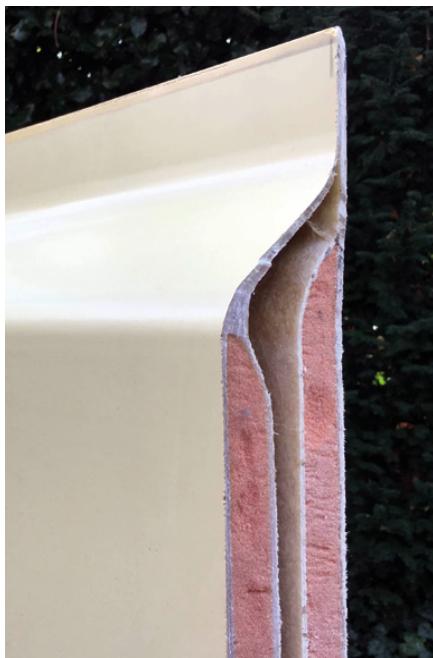
fig. 31. A section through a Herman Miller Factory facade panel, showing the two GRP sandwich panels that together form the facade. Photo R. Loader.

The original design brief – which reads almost like a manifesto – was quoted in academic publications at the time of completion of the building, for the philosophy of the building was remarkable: a factory that easily adapted to changing times and needs³⁹¹. The factory had a free floor plan that could accommodate the large machinery required for furniture production. The façade, built up from two sandwich panels of glass-fibre reinforced polyester (GRP) with cores of polyurethane (fig. 31), could be replaced by
