**Politecnico
di Torino**

Department of Architecture and design
Master's thesis in architecture for heritage
A.A. 2025/2026

**The Limitations and Reinterpretation of Authenticity in
Wooden Structural Systems:
A Comparative Study between Italy and China**

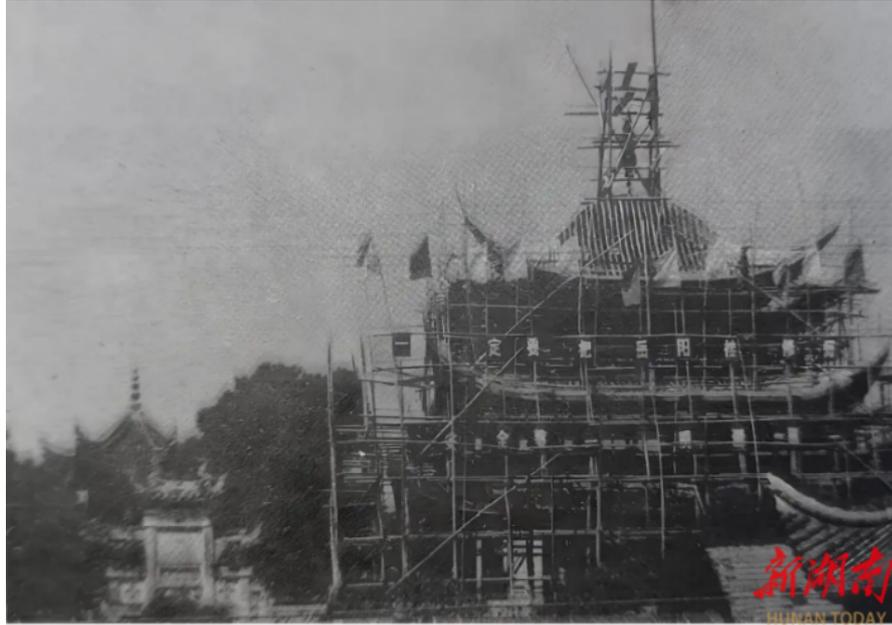
Figure 3.1: Construction scene during the 1983 dismantling restoration of Yueyang Tower. In 1983, Yueyang Tower underwent the largest and most influential overhaul in history. The overhaul was completed the following year, and Yueyang Tower was restored to its original state, reaching the first-class level of ancient building maintenance in China.

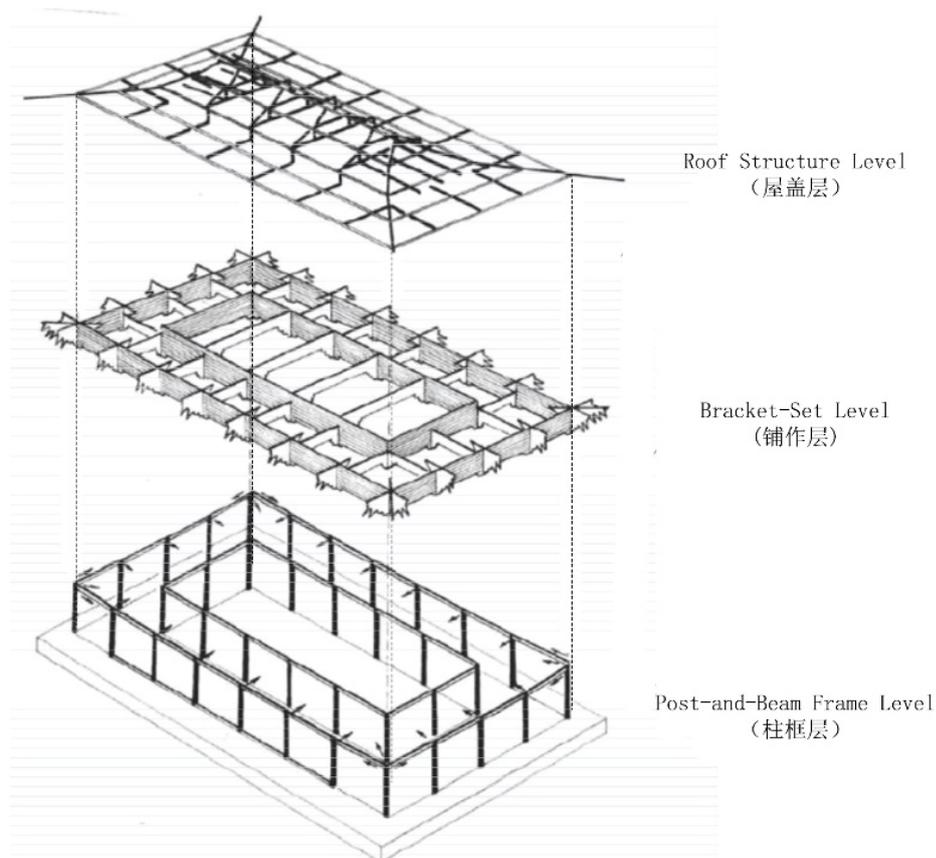
Figure 4.2: Schematic diagram of the layered wooden frame of the Main Hall of Foguang Temple,

- **Timber framework system** (Figure 4.2): This consists of two components, the column grid and the roof frame. The column grid, formed by columns and tie beams (*fang*), provides the vertical skeleton; the roof frame, composed of beams, purlins, and rafters, constitutes the structural unit supporting the roof. These two subsystems are connected through mortise-and-tenon joints, creating a stable and continuous load-bearing system.

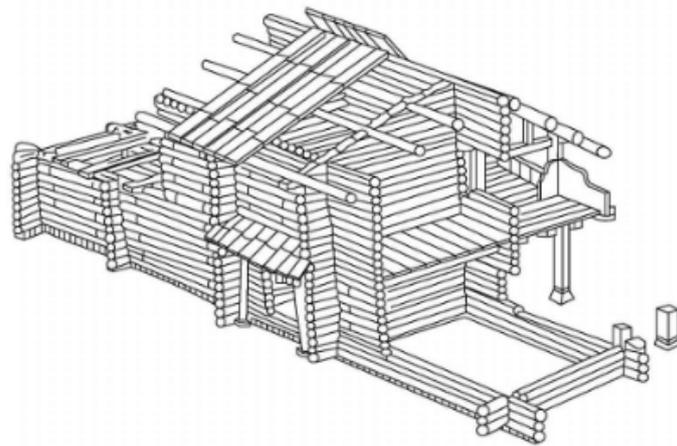
Figure 4.3: Model and structural schematic of the log-cabin wooden framework (jinggan style), traditionally used in ancient Chinese timber construction.

The Log Cabin Wooden Framework (Figure 4.3) consists of horizontal stacking of timbers to form load-bearing walls, relying primarily on the compressive strength of the wood's transverse grain.⁴⁰

From the perspective of load-bearing systems and structural logic, the Log Cabin Construction lacks an independent column-beam framework system, and its structural mechanism differs from timber-frame systems characterized by skeletal load bearing. For the purposes of analyzing structural logic, connection methods, and repair interventions in this paper, the following discussion treats the Log Cabin Construction as a distinct load-bearing timber wall type, while Post-and-lintel Wooden Framework and Column-and-tie Wooden Framework as the primary wooden framework construction under examination.

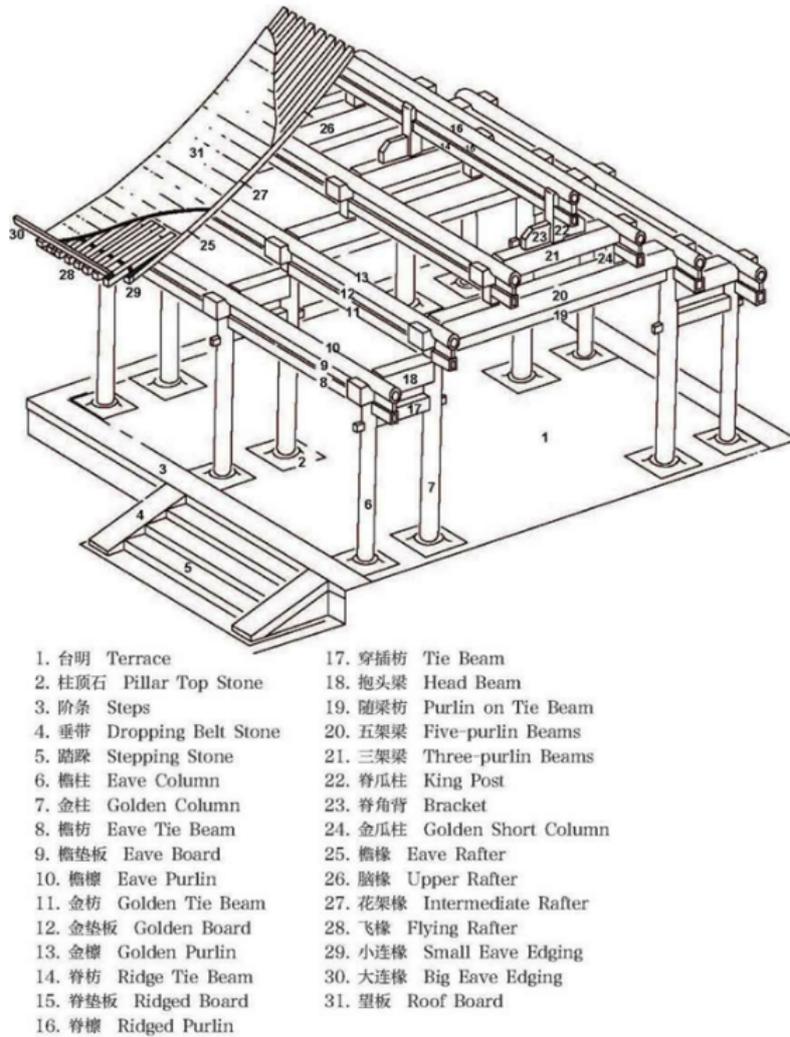
Figure 4.5: Structural system of the post-and-lintel timber framework (tailiang style), featuring ridge beams, king posts, and multiple horizontal components.

will be shorter layer by layer. Finally, there is a king post on the top, forming the entire wooden framework.⁴³

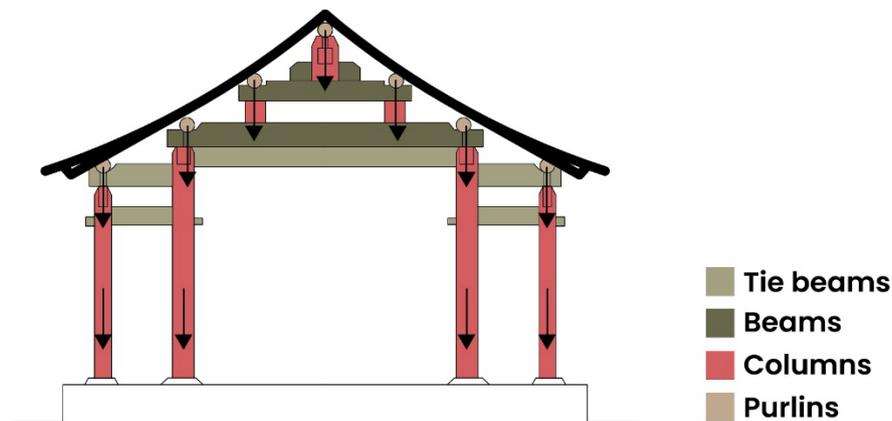
Figure 4.6: Structural system of the post-and-lintel timber framework

working primarily in bending and columns mainly in axial compression. Since bending in the beams governs the system response, the overall vertical stiffness is relatively low, and the structure is more sensitive to deflection and long-term deformation.

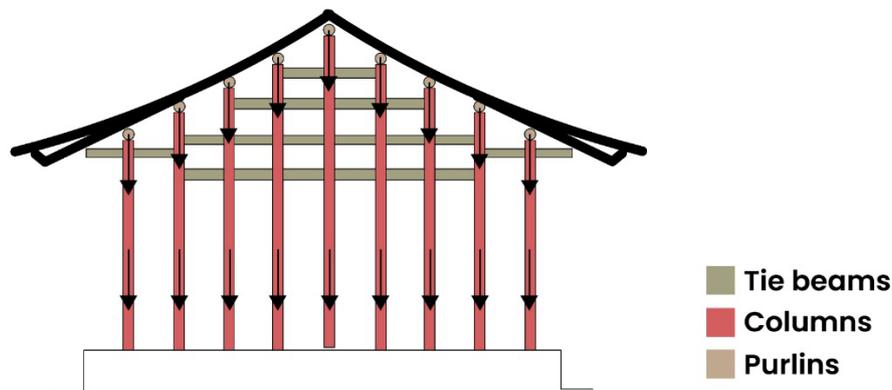
Figure 4.8: Structural system of the column-and-tie timber framework

of vertical members. After being distributed by horizontal linking elements—such as tie members and transverse beams—the loads are transferred relatively directly into the columns and then down to the foundations. Unlike the post-and-lintel system, which is governed by beam bending, the column-and-tie system exhibits a more column-dominated behavior: the principal load-bearing members work mainly in axial compression, while horizontal members play a secondary role in tying the framework together, distributing loads, and ensuring overall stability, thus forming a continuous vertical load path.

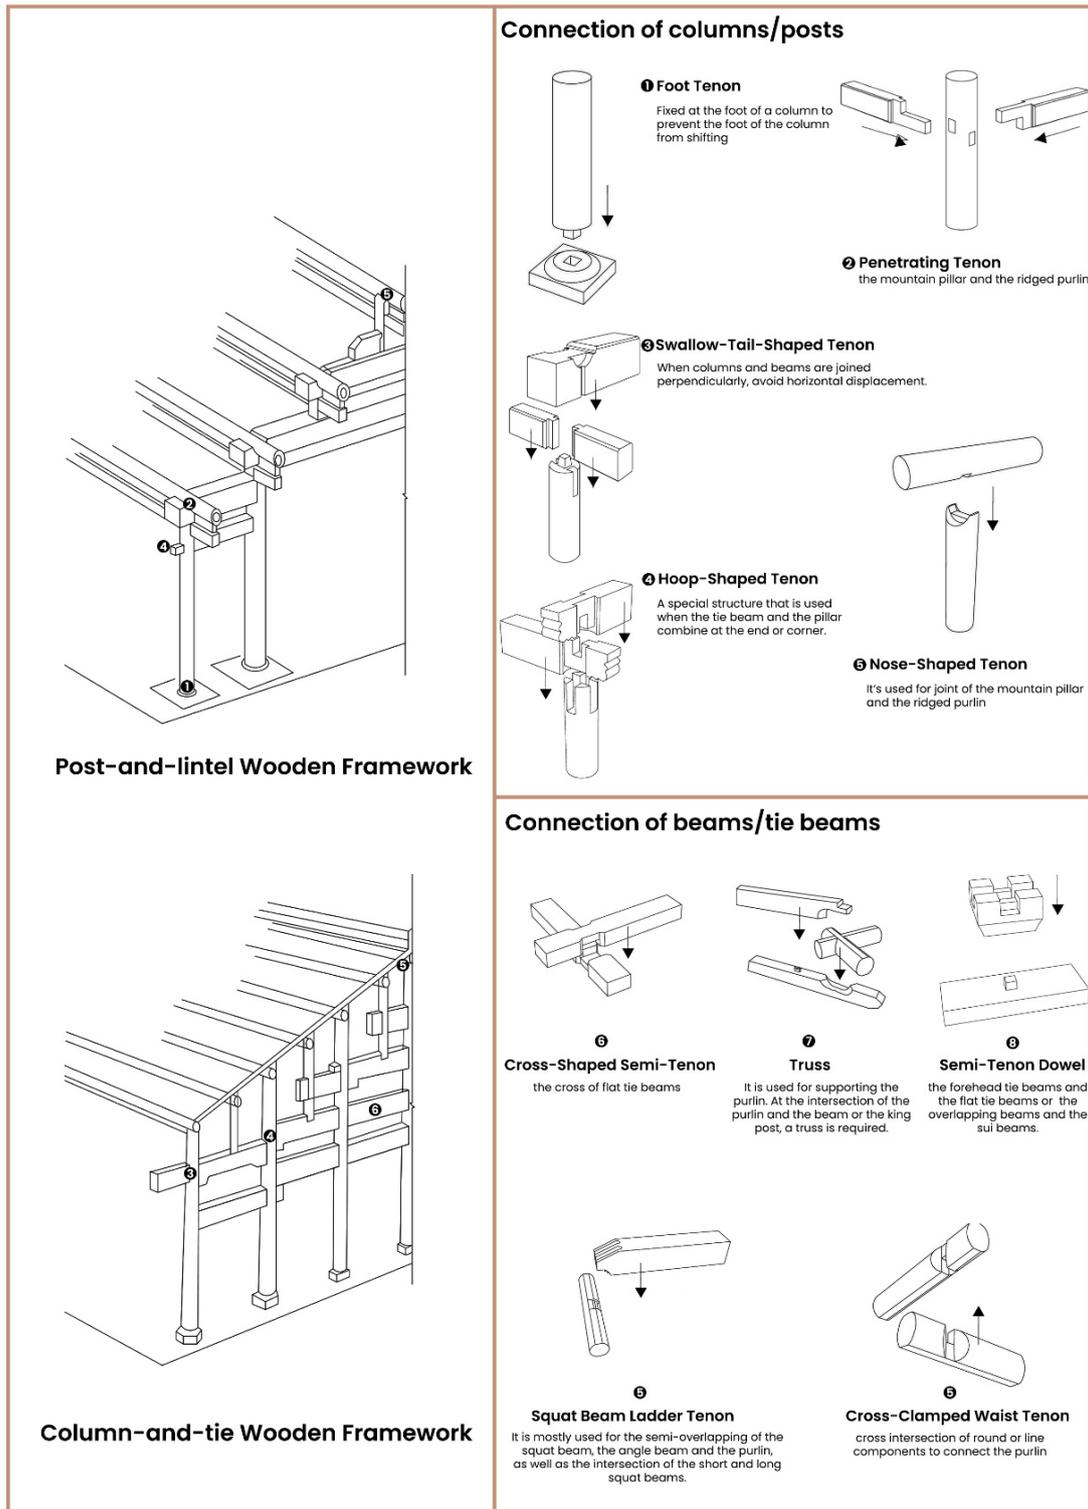
Figure 4.9: Diagram of Types and Locations of Mortise and Tenon Joints

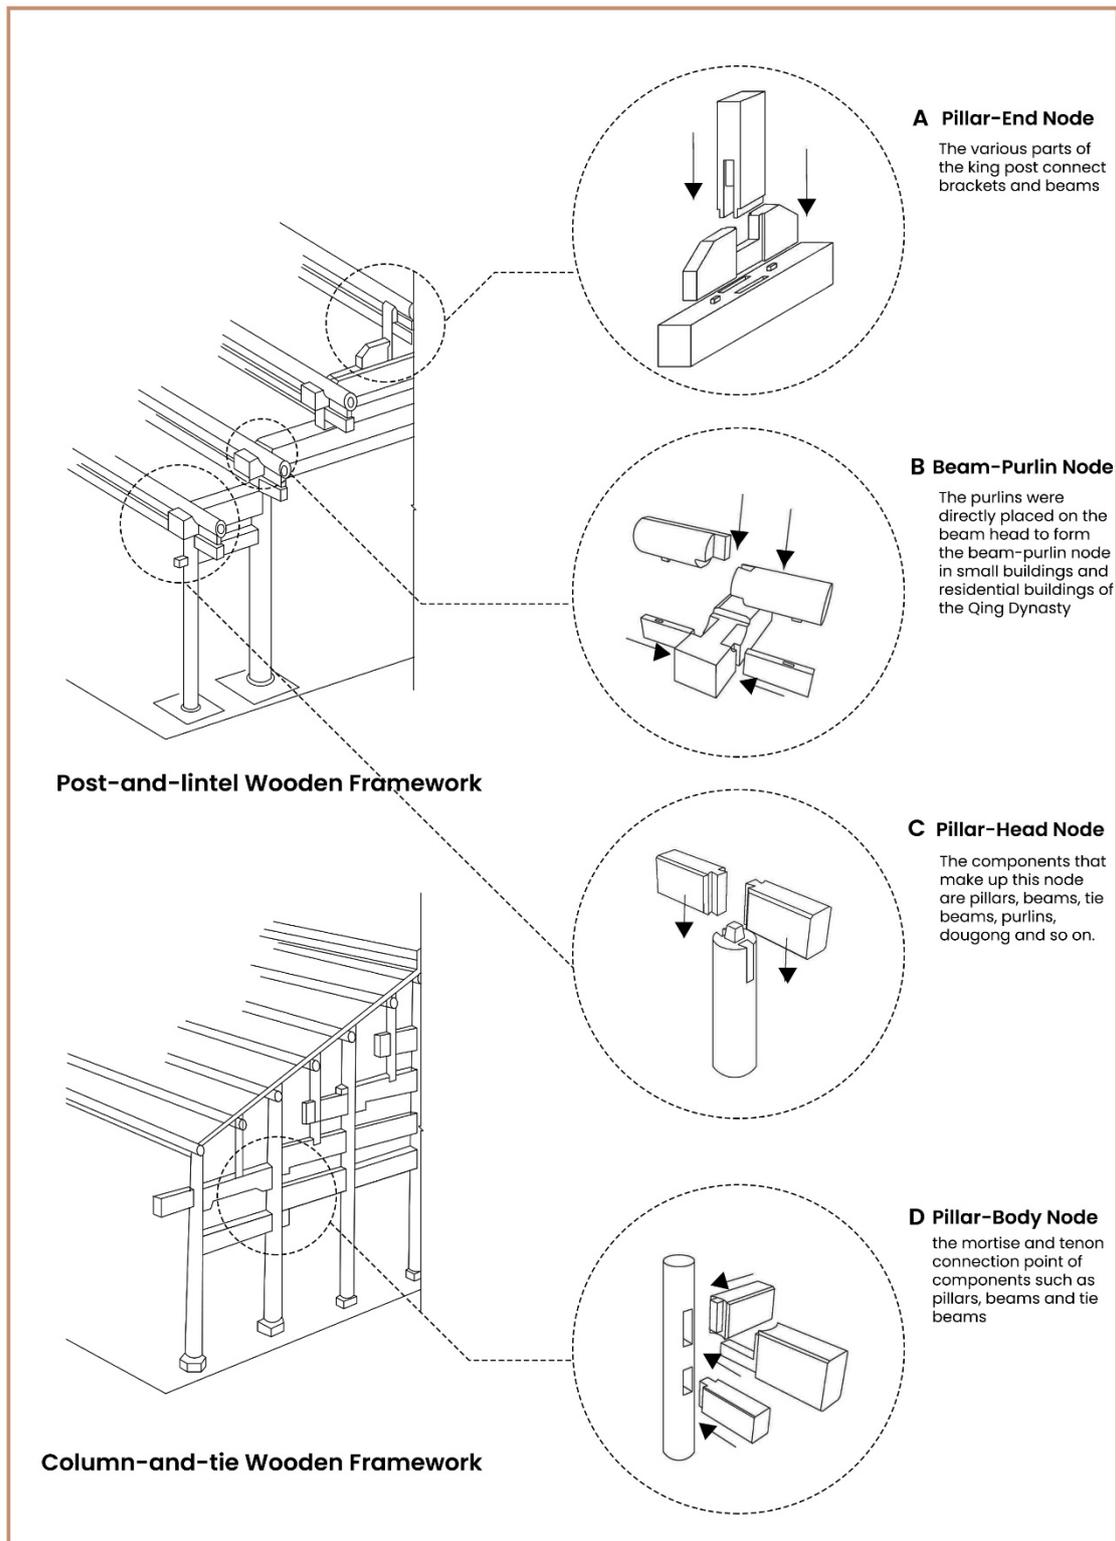
Figure 4.10: Diagram of Types and Locations of Node

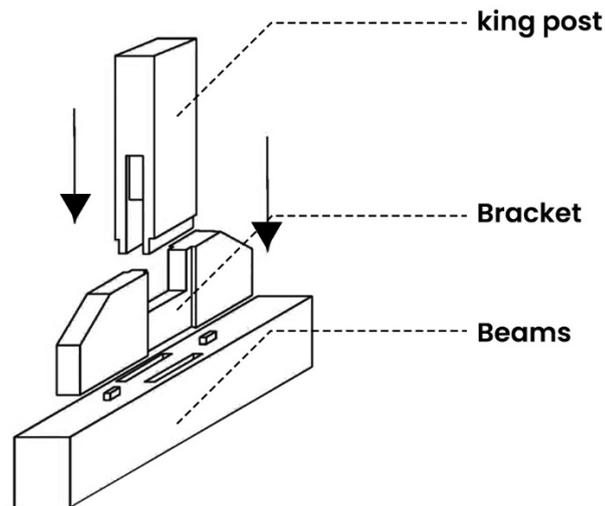
Figure 4.11: Illustration of Pillar-End Node

the column base and the foundation, but rather the joint between the king post set upon the beam and the lower load-bearing beams. Its primary function is to transmit vertical loads from the ridge or purlins to the beam framework system. This node primarily experiences compressive forces, with shear forces being secondary, and essentially bears no tensile loads.

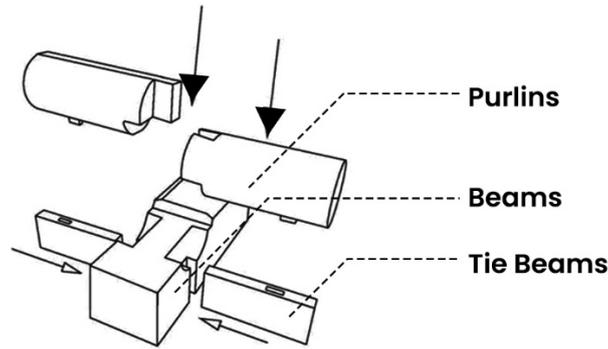
Figure 4.12: Illustration of Beam-Purlin Node

(B) The Beam-purlin node primarily bears local compressive stresses and shear force transfer between bending members, constituting one of the most susceptible locations for slippage and joint degradation within roof systems. In small buildings and residential buildings of the Qing Dynasty, the purlins were directly placed on the beam head to form the beam-purlin node.

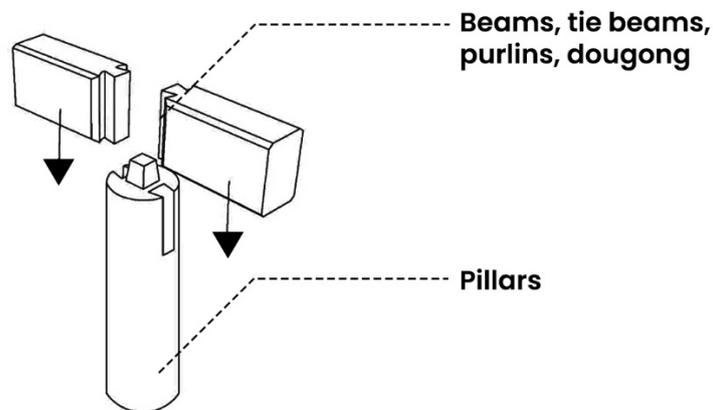
Figure 4.13: Illustration of Pillar-Head Node

(C) The pillar-head node is the most important and critical node of the architectural framework. The load in all directions is transmitted to the plinth through this node.

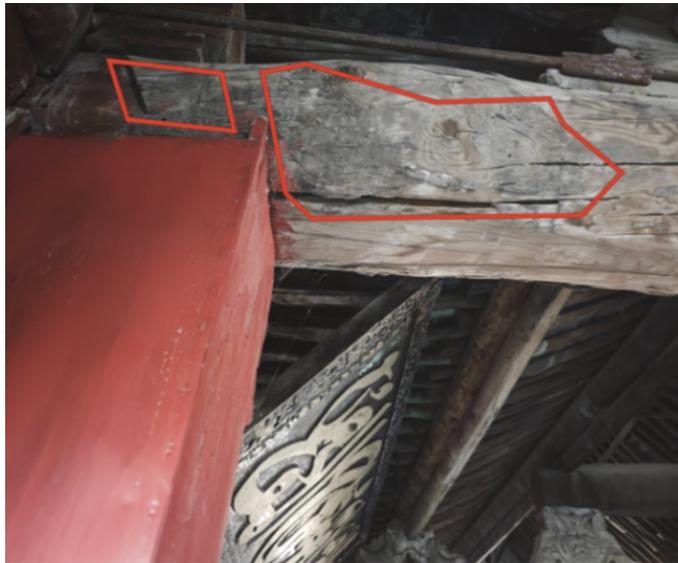
Figure 4.14: Photo of beam rotting

and joints (Figure 4.14). These areas are more prone to moisture accumulation, limited ventilation, and local stress concentration.⁴⁹

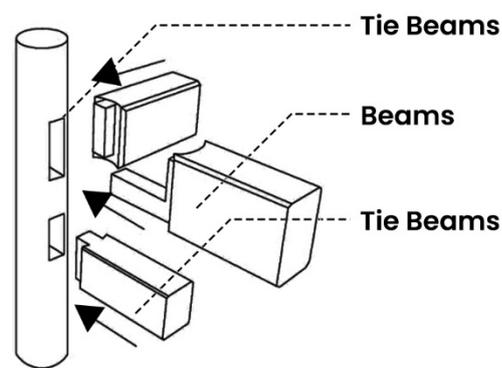
Figure 4.15: Illustration of Pillar-Body Node

(D) The pillar-body node is the mortise and tenon connection point of components such as pillars, beams and tie beams.⁵⁰ From a mechanical perspective, the pillar-body node is predominantly subjected to axial compression and plays a critical role in maintaining the continuity of the column as a load-bearing member.

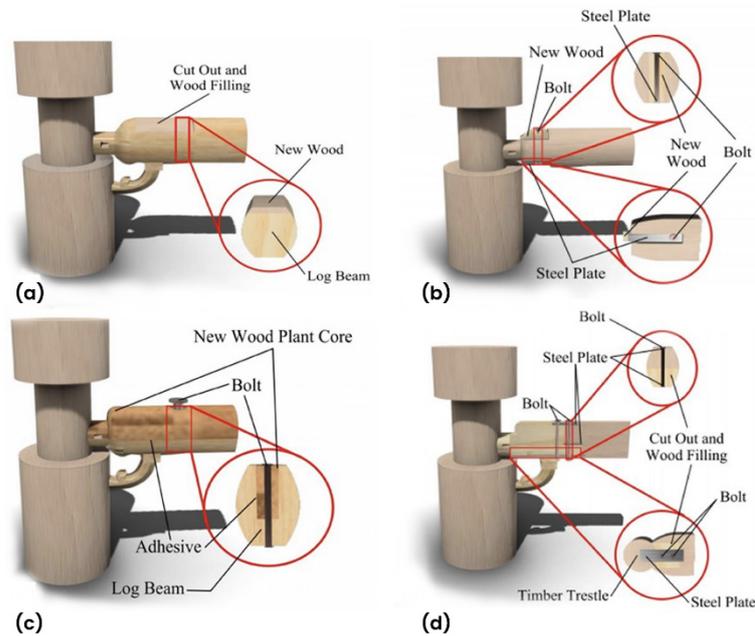
Figure 4.16: Schematic diagram of crack repair of beam and tie-beam.

compromise the visual integrity of historic buildings. In recent years, research teams have also explored novel materials as alternatives to metal reinforcement.⁵²

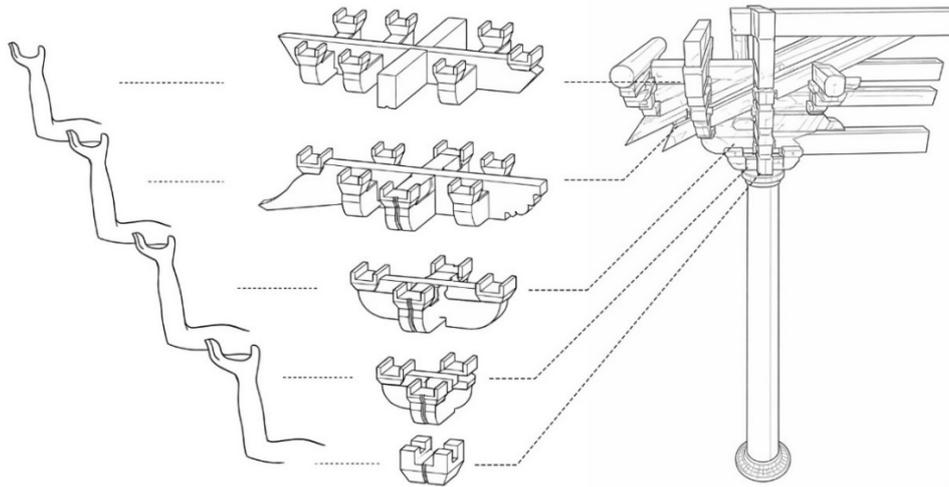
Figure 4.18: Model of Pillar-Head Dougong of the Tang Dynasty

sometimes be inferior to that of the grid-like distributed post-and-lintel system. Consequently, in official northern architecture, this deficiency was addressed by augmenting the dougong system and employing substantial wall thicknesses.

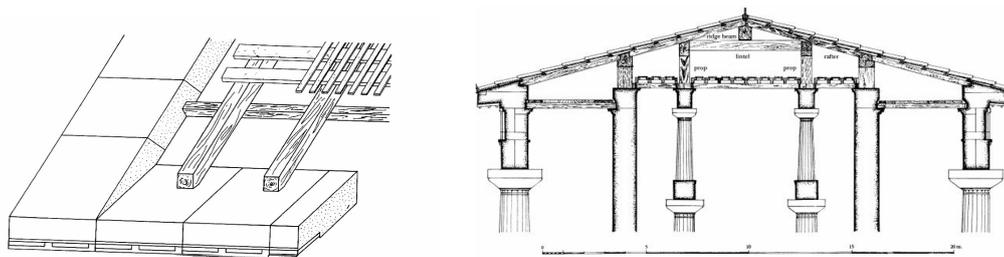
Figure 5.2: Greek roof framing (left) and post-and-lintel roof structure (right).

For instance, the span limitations of Greek-period framed roofs and the post and lintel roof (also termed the ‘prop-and-lintel’ roof or ‘trabeated system’) (Figure 5.2) spurred the development of the truss roof (‘Capriata’).

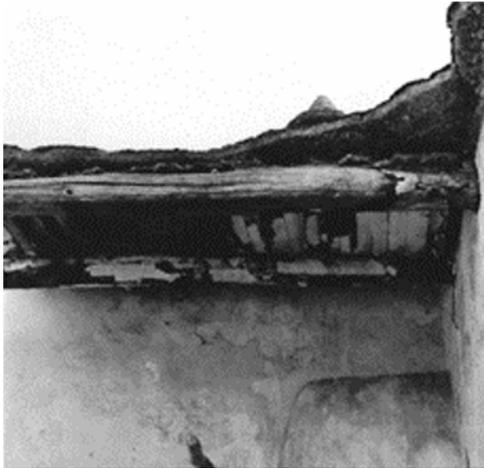
Figure 5.3: Ceiling of a ruined farm at Pompeii, showing the same structure as ancient ceilings: the beams support a parquet on which a layer of mortar is placed.

Floor and ceiling systems (Figure 5.3) are typically supported by masonry walls, with a timber beam framework forming the primary structural skeleton. Above this framework, layers of mortar and paving materials are added to create the walking surface. Correspondingly, the underside is finished with thin wooden boards, reeds, and

plaster, forming the ceiling surface, which may also perform a decorative function.

When spans increase, the system usually introduces one or more primary beams to reduce the effective span of the joists, resulting in a two-level load-bearing mechanism defined by a “primary beam–joist” structural hierarchy.⁵⁹

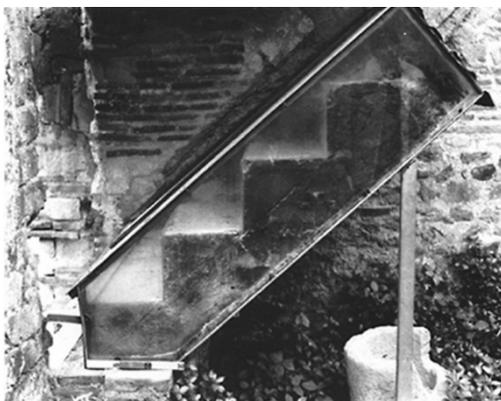
Figure 5.4: A wooden staircase is located in the plan of the shop at Herculaneum, Insula IV, no. 20., but does not belong to this shop.

In the detailing of façades and interior decoration, timber was also extensively employed for door and window frames, balcony cantilever beams, and spiral staircases. For example, staircases in the Roman period were predominantly timber-framed, though they frequently featured a short stone or brick plinth at the base (Figure 5.4).⁶⁰ These components were often embedded within stone walls, creating an interface that combined rigidity with flexibility within the main structure.

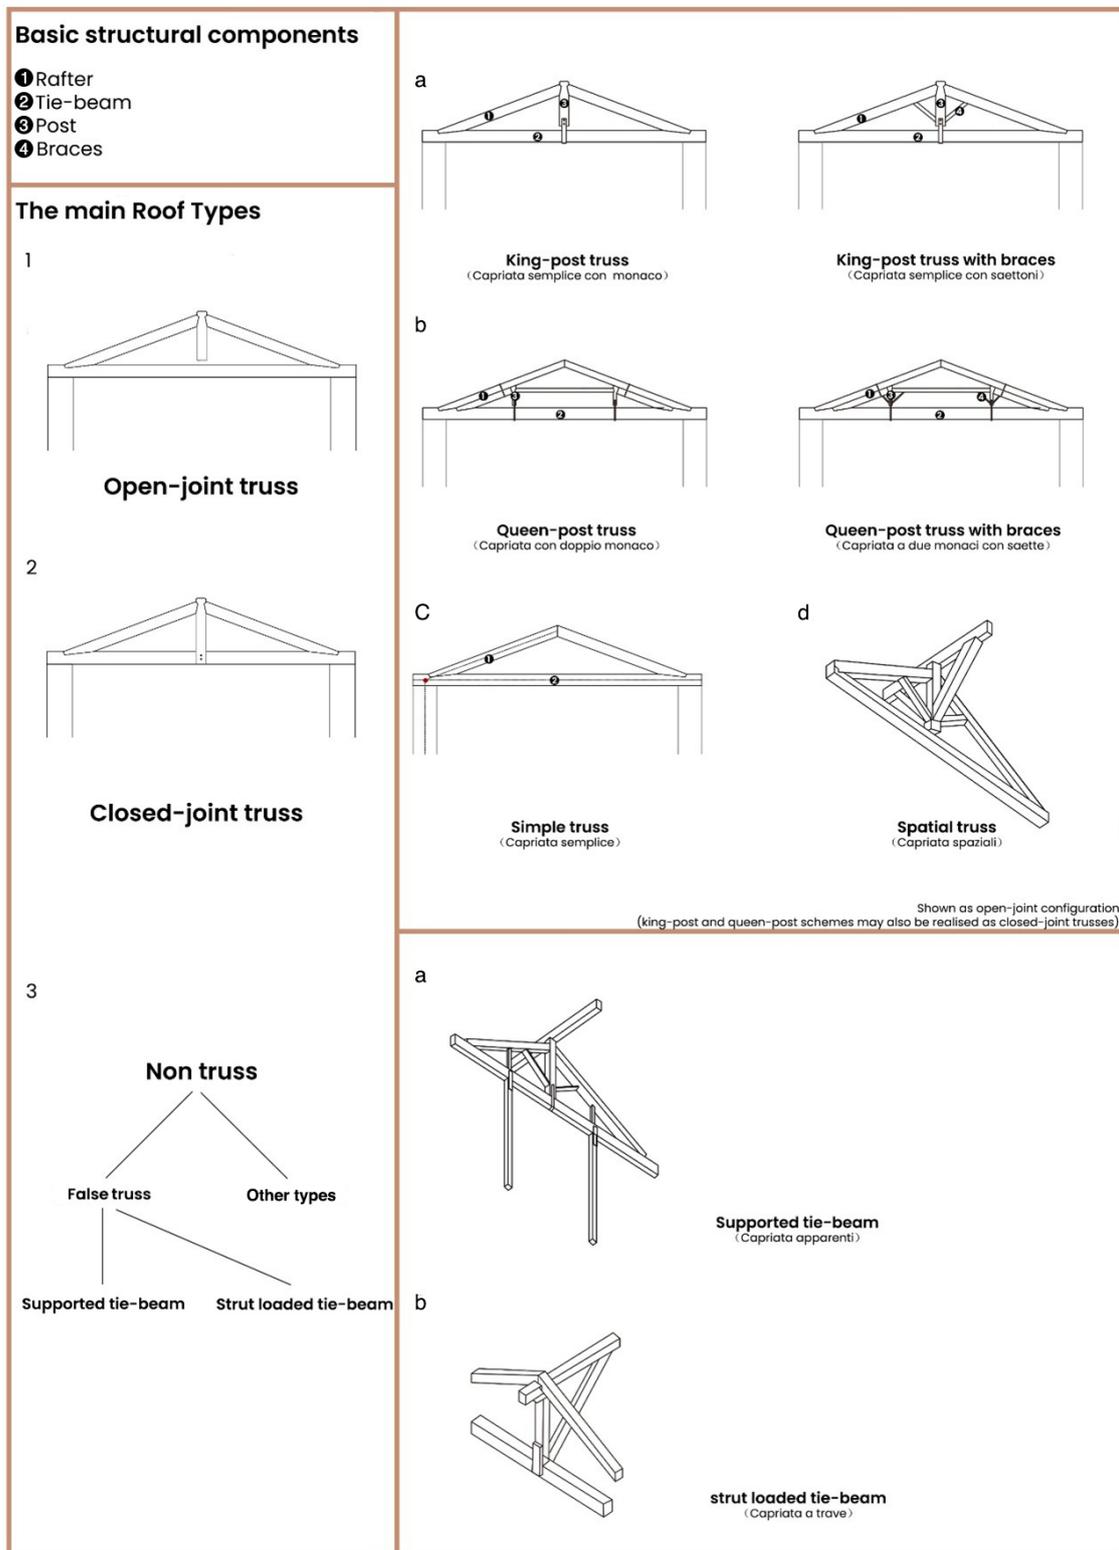
Figure 5.5: Diagram Classifying Roof Types

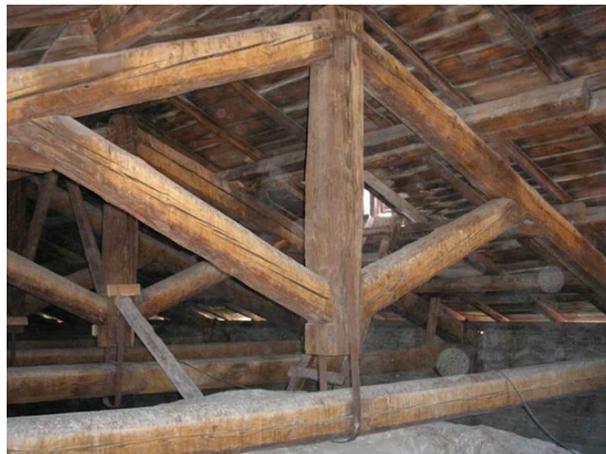
Figure 5.7: Detail of an opened joint truss of the roof of a church in Bologna

Trusses in which no rigid connection between the posts and the tie beam are commonly referred to as open-joint trusses (Figure 5.7).⁶⁴

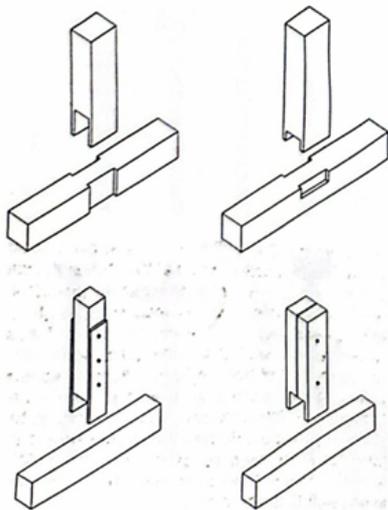
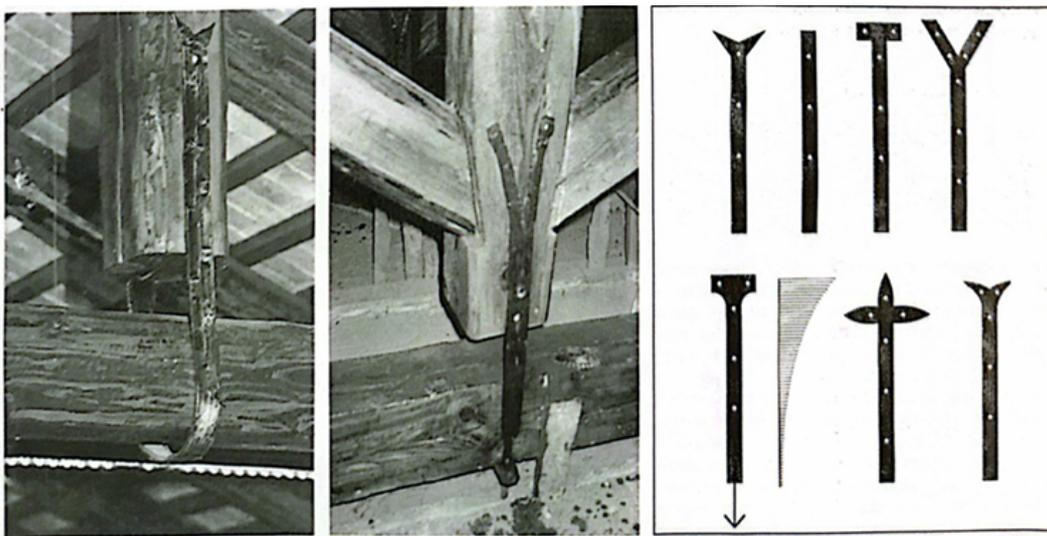
Figure 5.8

Open joint entirely realized in timber (left), characterized by a non-rigid connection between the post and the tie beam, aligned only through shallow seats or wooden pegs; and open joint reinforced by a metal clamp (Below), in which the metal component remains deliberately “loose,” engaging structurally only when the tie beam deflects under load, thereby ensuring greater flexibility and durability compared to closed joints.

Open-joint trusses are predominantly distributed across northern Italy, accounting for approximately 90% of all trusses. They were particularly employed around 1850, especially in ‘conservative’ restoration practices.⁶⁵ As the central post and tie beams lack physical connection, restraint is achieved solely through metal clamps. In practice, the tie beams do not bear loads from the posts. Only when the tie beams deflect do the clamps begin to pull against the posts bases to compensate. Furthermore, should the ridge be subjected to pressure that risks damaging the tie beams via the posts, restoration may even separate them, thereby maximizing protection for the tie beams and other structural elements.

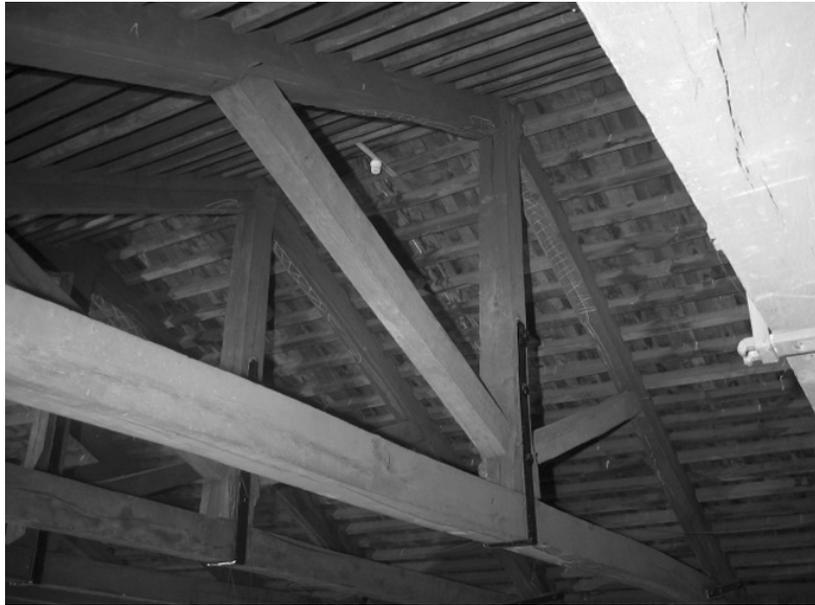
Figure 5.9 Detail of a closed-joint truss of the Basilica St Paul's Cathedral in Roma.

Trusses in which the king post (or queen post) is rigidly connected to the tie beam are commonly referred to as closed-joint trusses (Figure 5.9).⁶⁶

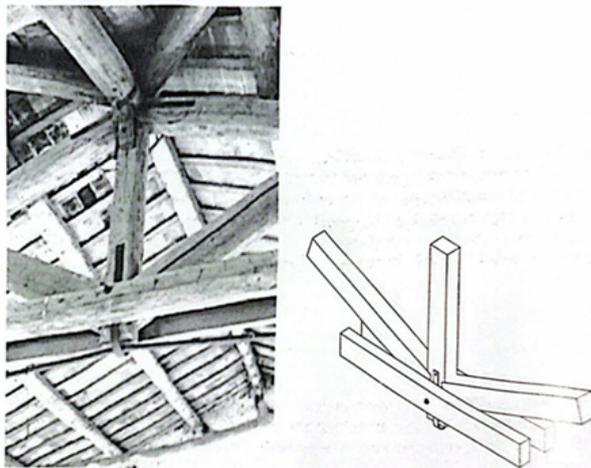
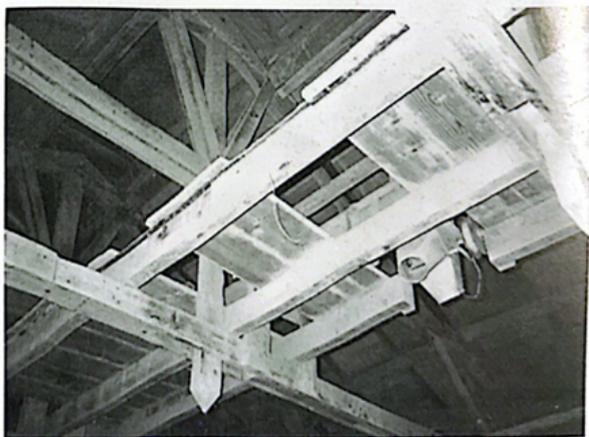
Figure 5.10 Examples of closed-joint trusses in Emilia-Romagna.

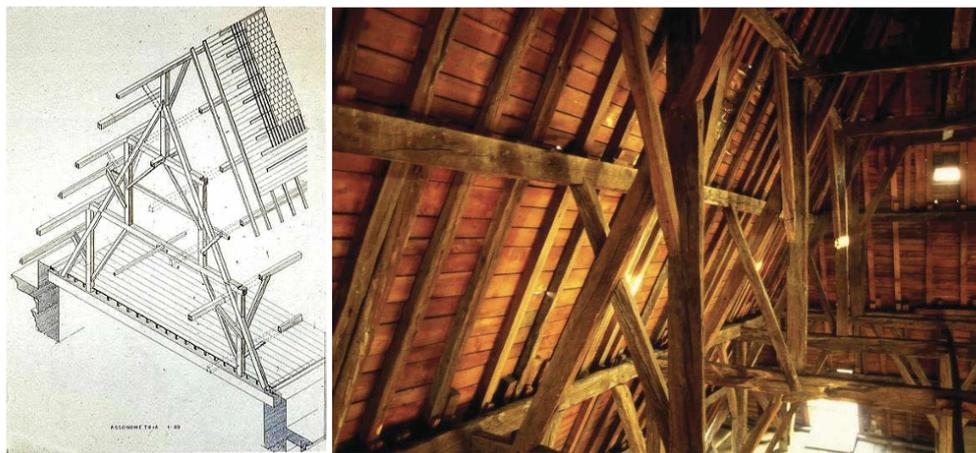
Figure 5.11. Scheme of a timber frame and its components (left), and inner view of the wooden roof structure of a tower (right).

For instance, the roof structure within the tower of Turin's Castello del Valentino is not based on a trussed system, but on a multi-layered beams-and-posts configuration organized as a spatial frame (Figure 5.11).

Structurally, the roof consists of two superimposed portal frames, with the lower frame resting on a massive beam. Structural continuity and stiffness are achieved through diagonal bracing elements extending along the full length of each roof slope and intersecting the pier–beam connections. Additional diagonal members within each frame reduce bending stress in the horizontal beams, while further elements provide direct support to the purlins.⁶⁹

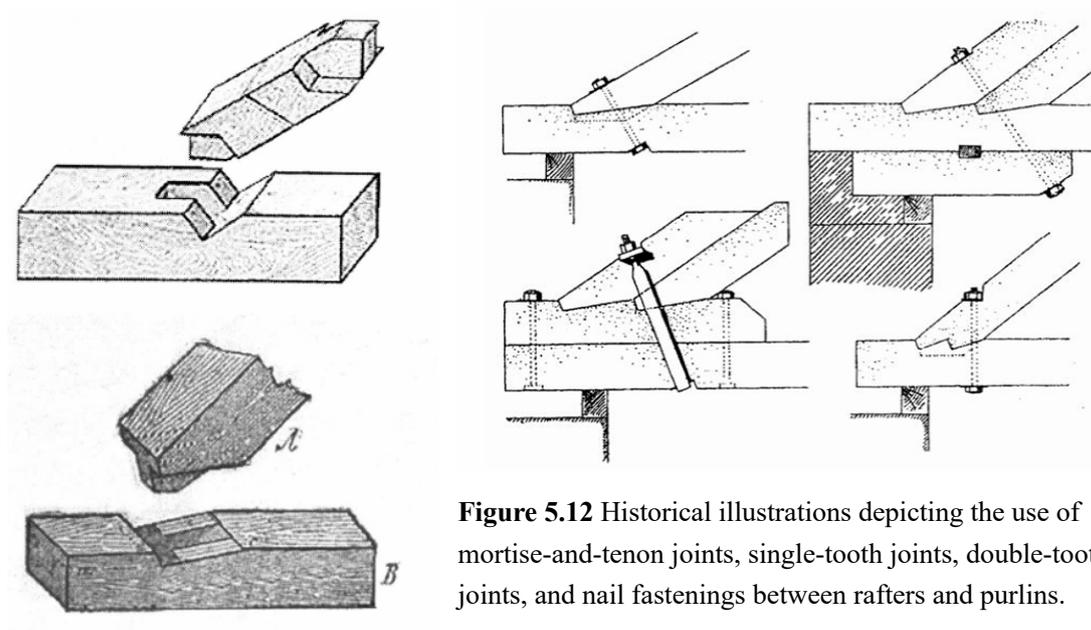
Figure 5.12 Historical illustrations depicting the use of mortise-and-tenon joints, single-tooth joints, double-tooth joints, and nail fastenings between rafters and purlins.

heavily stressed section of the entire truss.⁷⁰ In the earliest constructions employing purely timber-to-timber connections, as illustrated in (Figure 5.12), single-tooth, double-tooth, mortise-and-tenon, or hybrid joints were utilized, secured by several nails driven perpendicularly into the teeth. Later, hybrid connections were employed, with the junctions almost invariably fixed using metal U-plates and tension applied by metal wedges. (Figure 5.13)

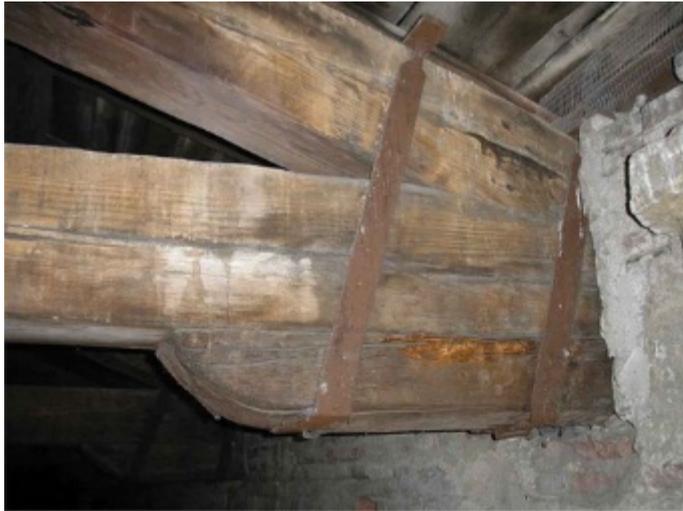
Figure 5.13 A tie-beam to rafter joint, showing one connection tooth and two metal plates to maintain in its position the joint. In this case also a short hammerbeam helps in reducing the span of the tie-beam

As shown in Figure 5.13, metal plates are frequently employed at the connection points between tie-beams and rafters to secure the assembly. Such metal components have long been employed in traditional Italian truss construction, particularly at critical joints. Metal plates or clamps effectively limit creep, elongation, and progressive loosening of timber subjected to sustained tensile forces, especially where the interlocking action of timber joints gradually diminishes over time.

From the perspective of authenticity, they enhance joint stability and local stiffness while remaining fully dismantlable and reversible, thereby allowing inspection, maintenance, and future intervention.

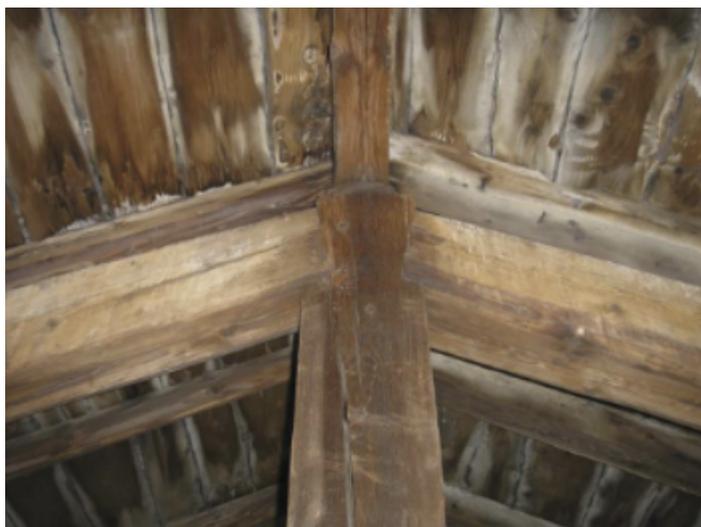
Figure 5.14: The main pillar is carefully shaped (profiled), with each joint being handcrafted to accommodate the upper ends of the rafters.

Another common connection point is where rafters meet the main uprights. This joint is often secured with nails and appears relatively simple. As shown in Figure 5.14, the head of the main member is intentionally shaped (profiled) to receive the rafters, rather than being irregular. This detail increases the bearing area and provides a more continuous contact surface.⁷¹

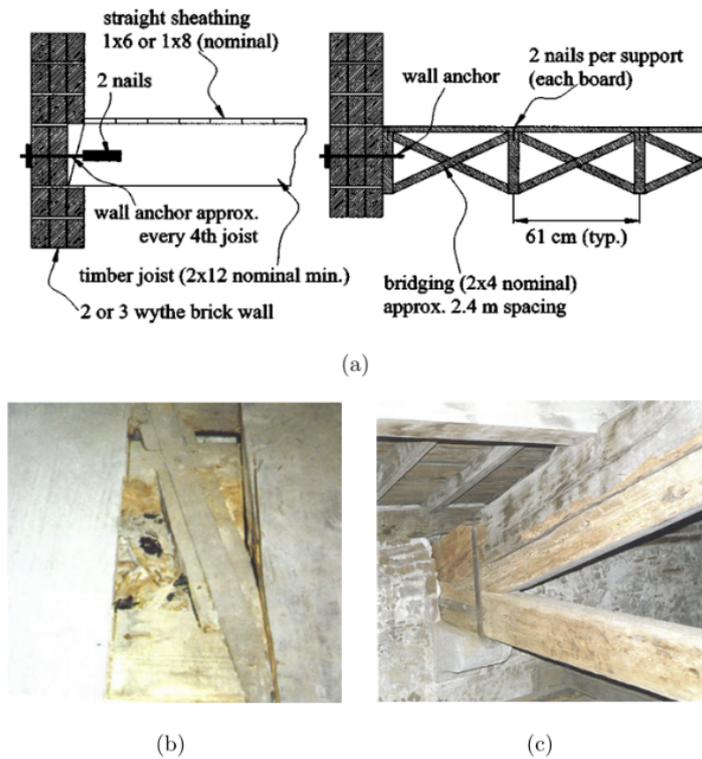
Figure 5.16: Metal anchorages between timber beams and masonry wall: (a) connections between the parallel or perpendicular joist and the wall; (b) diagonal bar embedded into the transversal joists; (c) roof-to-wall connection

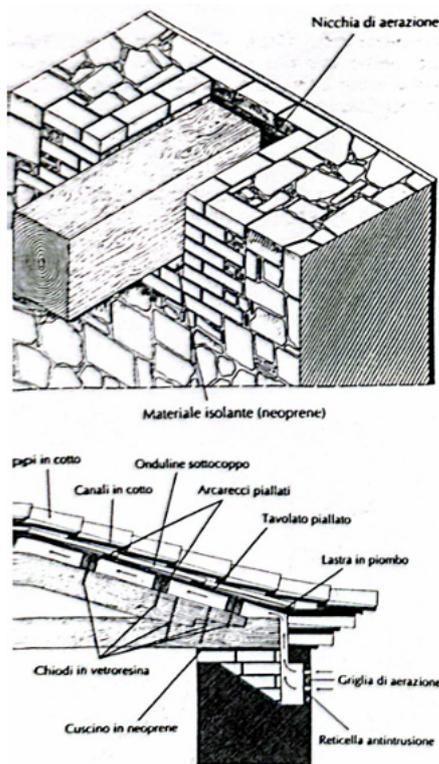
Figure 5.17 Ventilated bearing detail at the timber–masonry interface.

These practices do not compromise the wall's static continuity. Instead, by isolating the timber from moisture sources, they enhance the structure's overall durability. Modern restoration projects further incorporate corrugated bricks, damp-proof layers, and metal-assisted joints. This demonstrates Italian restoration's emphasis on structural logic and stability, employing new materials to ensure longer-term preservation. This approach to repairing new materials represents, to a degree, a building culture that balances structural rationality with material protection. While not perpetuating the original materials, the new structural joints guarantee the stability and extended service life of the entire timber structure, ultimately achieving authenticity in conservation.

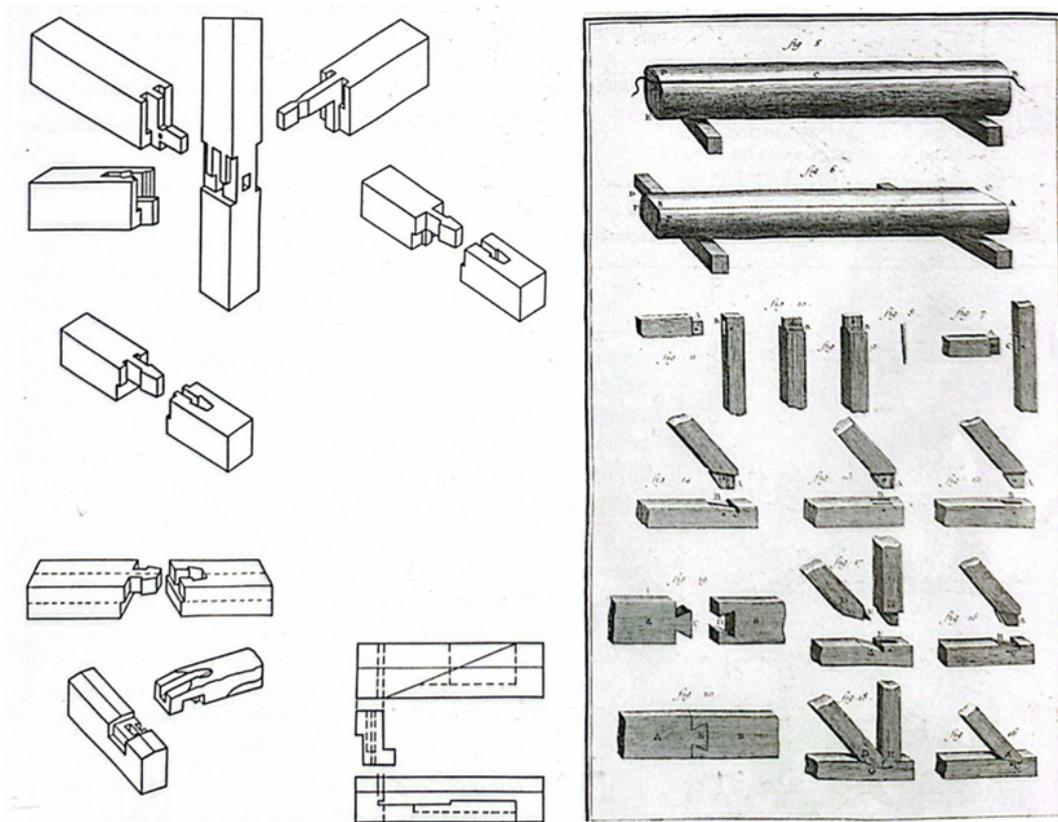
Figure 5.18: Joining and Assembly Methods for Timber Components in Western and Eastern Traditions.

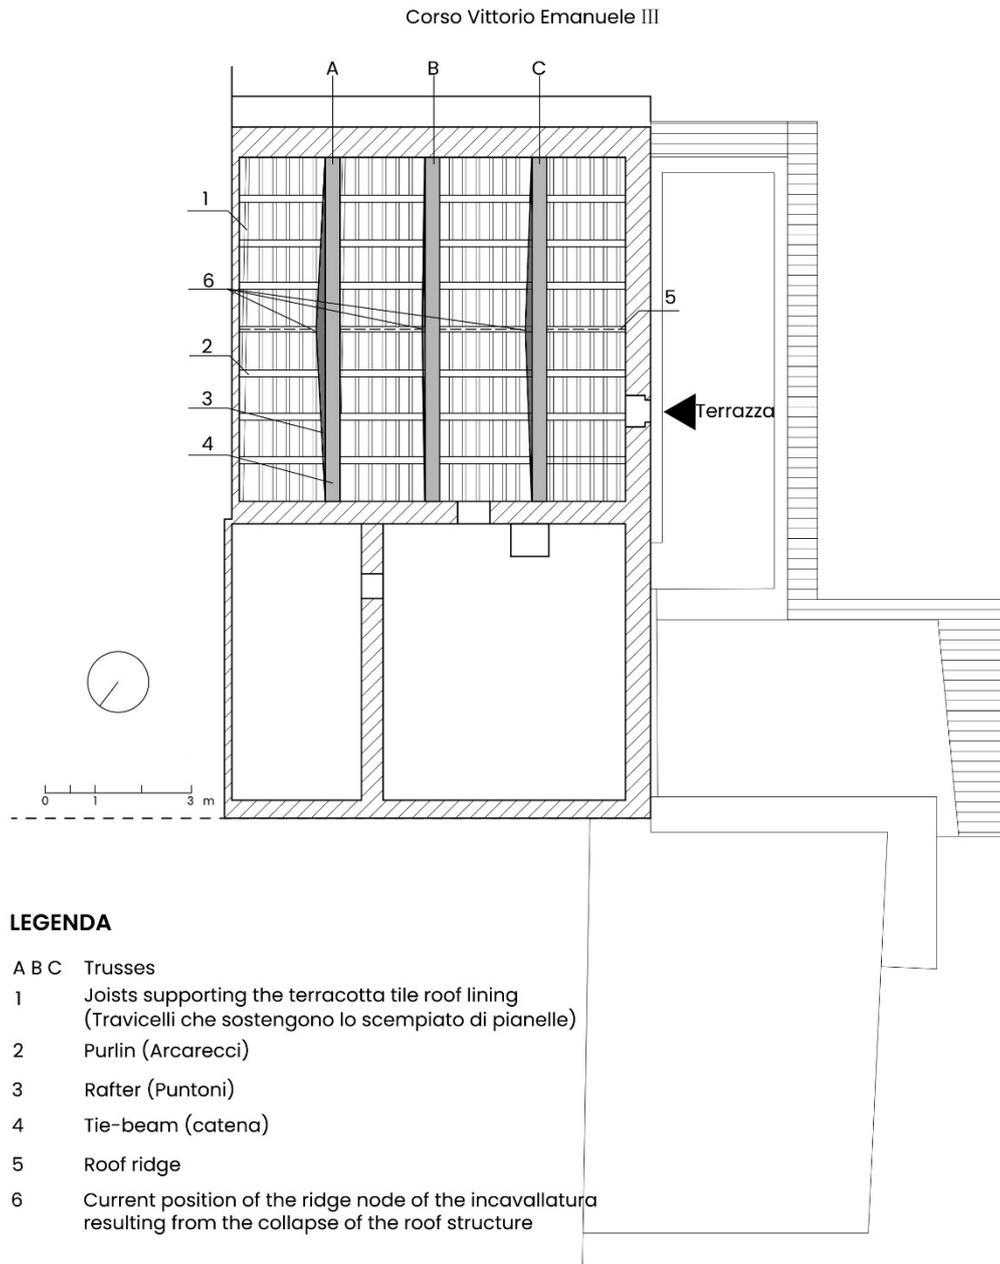
Figure 6.3: Plan of the attic level from below before restoration and indicates the location of the attic on the floor plan

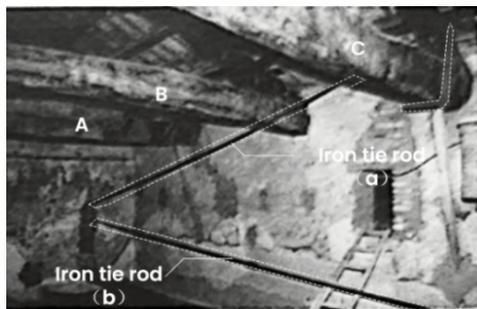
Figure 6.5 Interior of the sub-roof level, viewed from the access, the three timber roof trusses, and the two metal tie rods; note the deflection of the tie beam of truss C in the background.

For instance, truss C had undergone repeated interventions and reinforcement attempts, with numerous iron fittings installed later to ‘fortify’ the joints. Evidence of corrosion and fiber indentations between these fittings and the original timber is visible, alongside two subsequently added iron tie rods beneath to prevent wall overturning (Figure 6.5). Beneath the trusses, beams of unknown function and a wooden platform framework were found (possibly used for historical roof maintenance) (Fig. 6.6). Some purlins had been replaced multiple times, exhibiting inconsistent arrangement patterns (Fig. 6.7).⁸⁰ However, in the current condition, these interventions did not result in a coherent structural strategy and instead introduced additional discontinuities within the structural system.

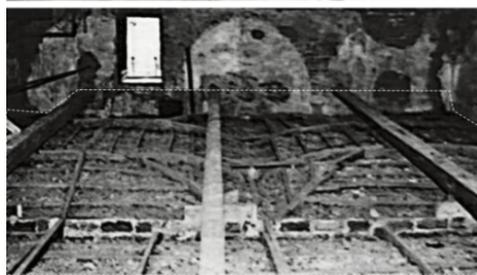
Figure 6.6 Interior of the sub-roof level, looking towards the access, showing the timber structural system supporting the *canniccato* vaults of the lower floor.

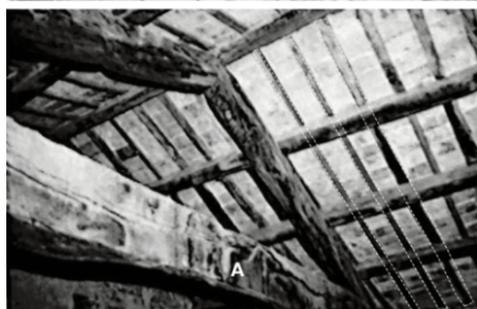
Figure 6.7 Interior of the sub-roof level, showing details of the timber roof truss system.
