**Politecnico
di Torino**

Department of Architecture and design
Master's thesis in architecture for heritage
A.A. 2025/2026

**The Limitations and Reinterpretation of Authenticity in
Wooden Structural Systems:
A Comparative Study between Italy and China**

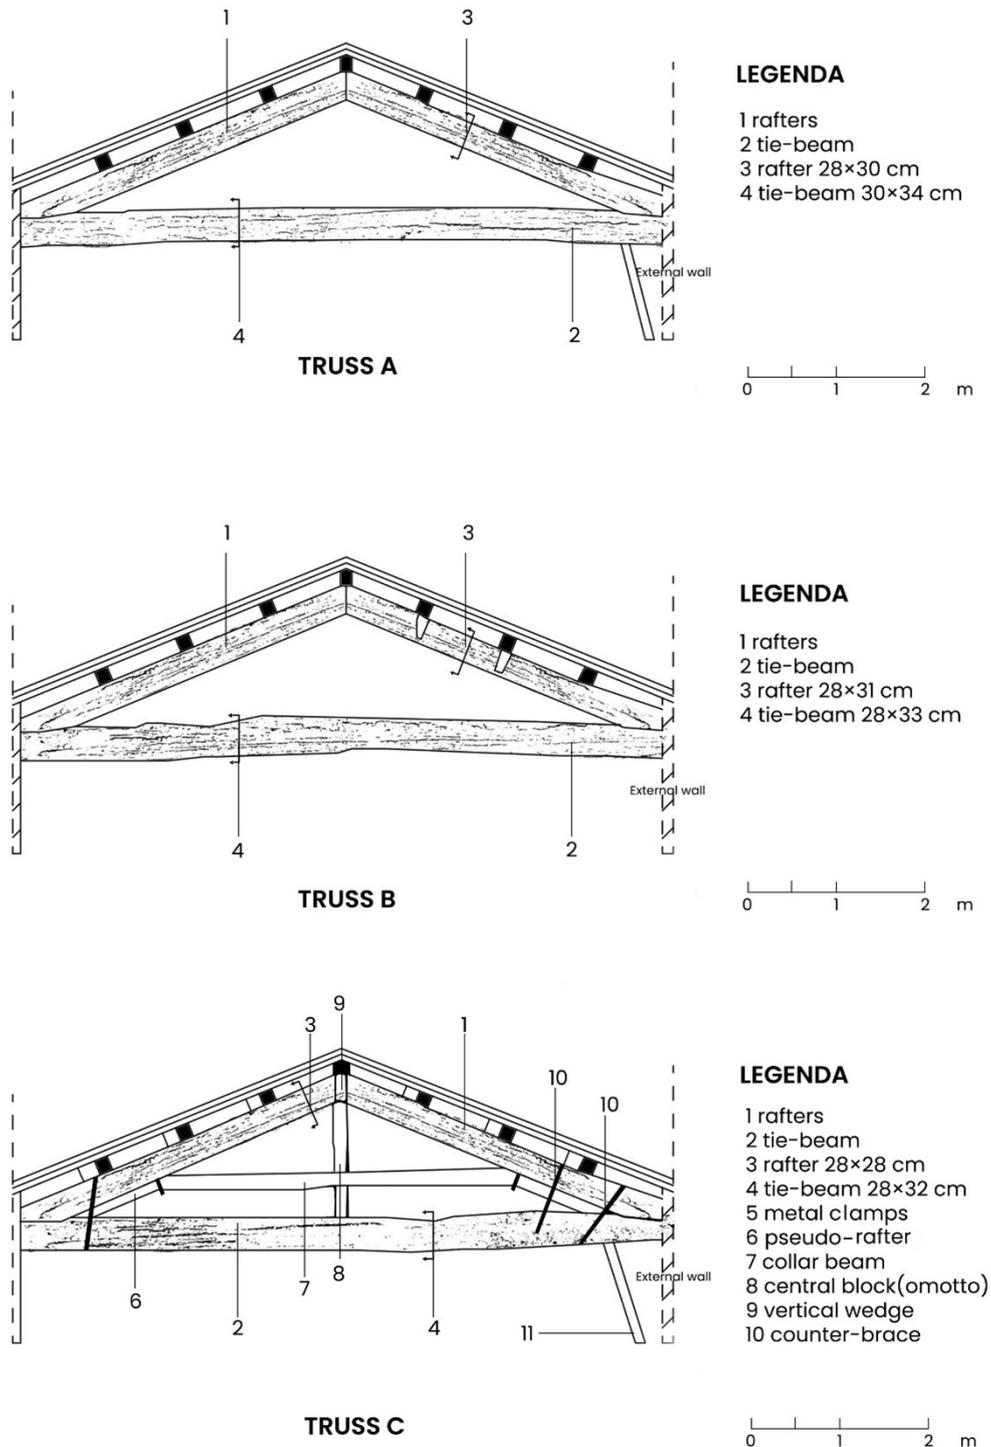
Figure 6.8: Section of the timber roof truss A、B、C

Furthermore, the section view shows that the tie-beams of Trusses A and B are slightly cambered upward, with very small curvature. By contrast, the tie-beam of Truss C shows a slight downward deflection (Figure 6.8).

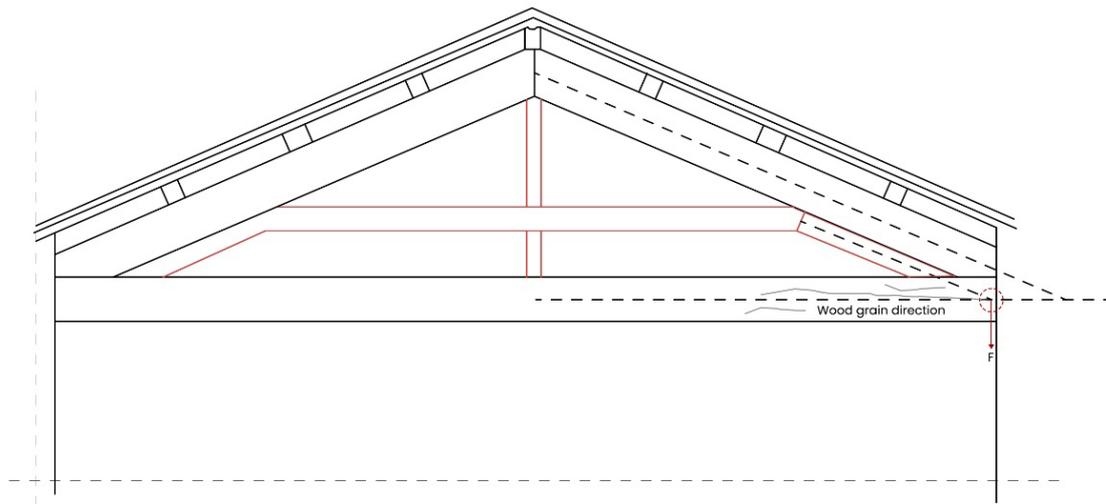
Figure 6.9: Section of the timber roof truss C

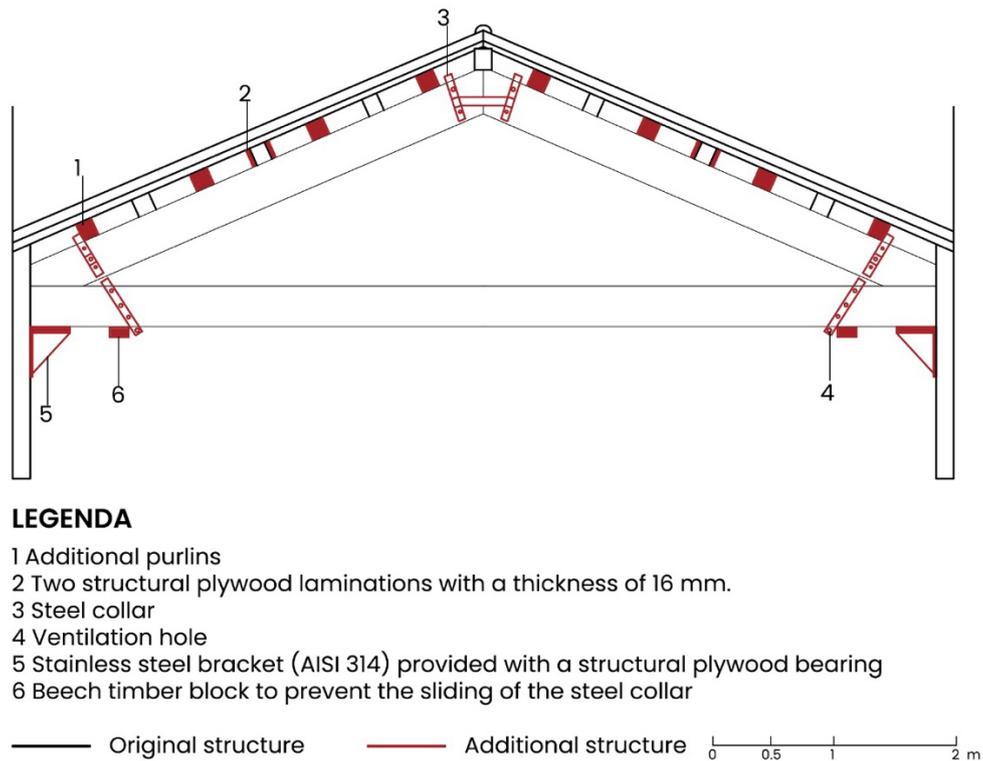
Figure 6.10: Section of the trusses A and B after restoration

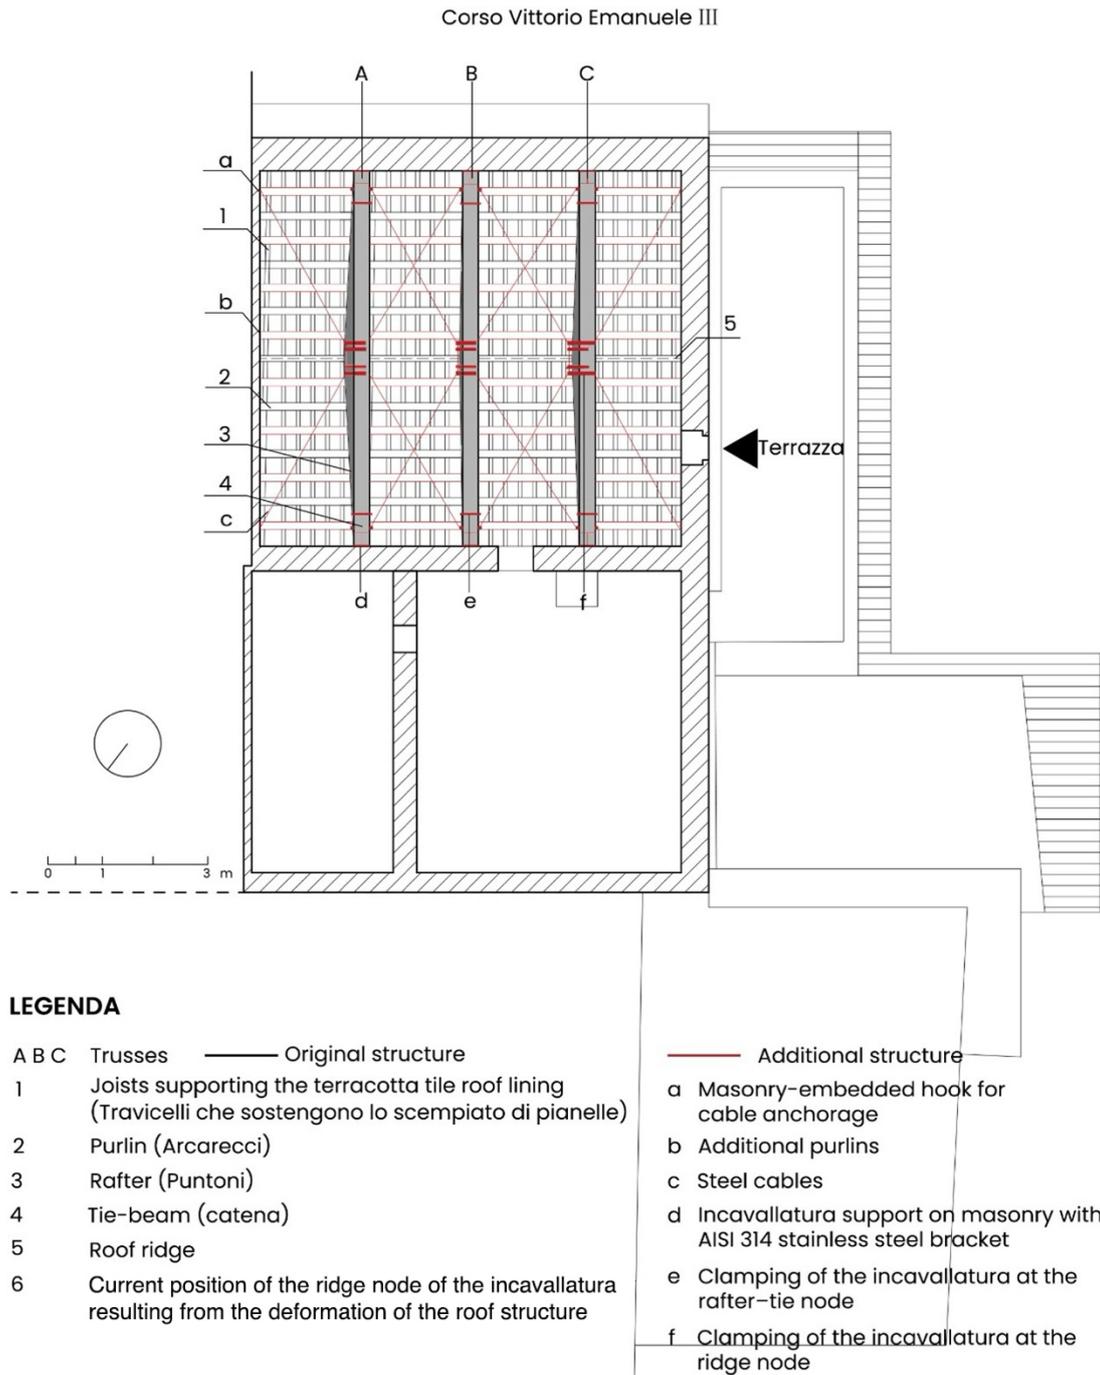
Figure 6.12: Plan of the attic level after restoration

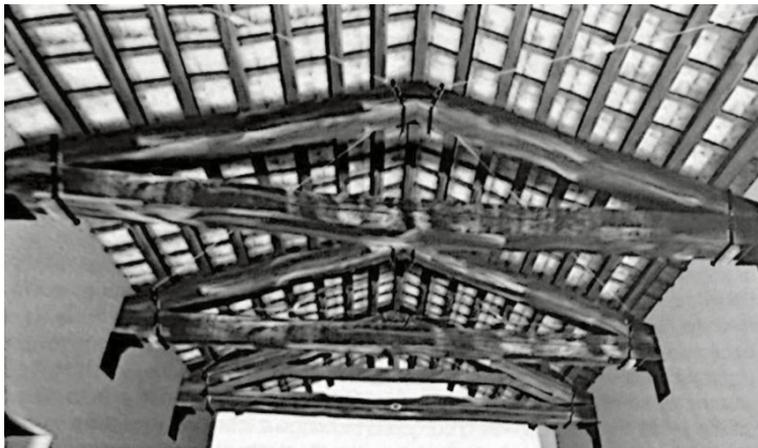
Figure 6.13: Virtual view of the trusses after the consolidation intervention

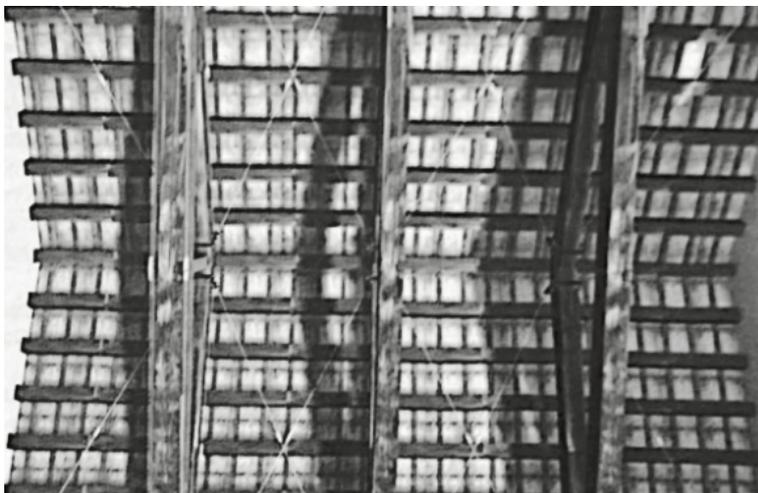
Figure 6.14: Virtual view of the trusses after the strengthening intervention

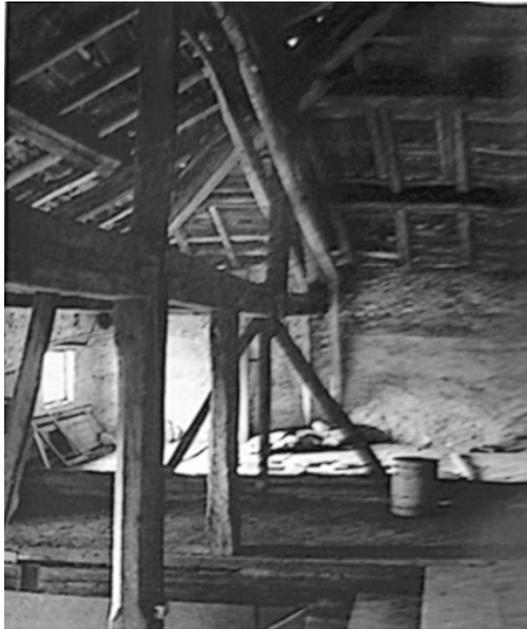
Figure 6.19: Interior view of the roof space before restoration (1986), showing the deformed timber truss system, temporary propping, and the deteriorated condition of the wall and roof boarding.

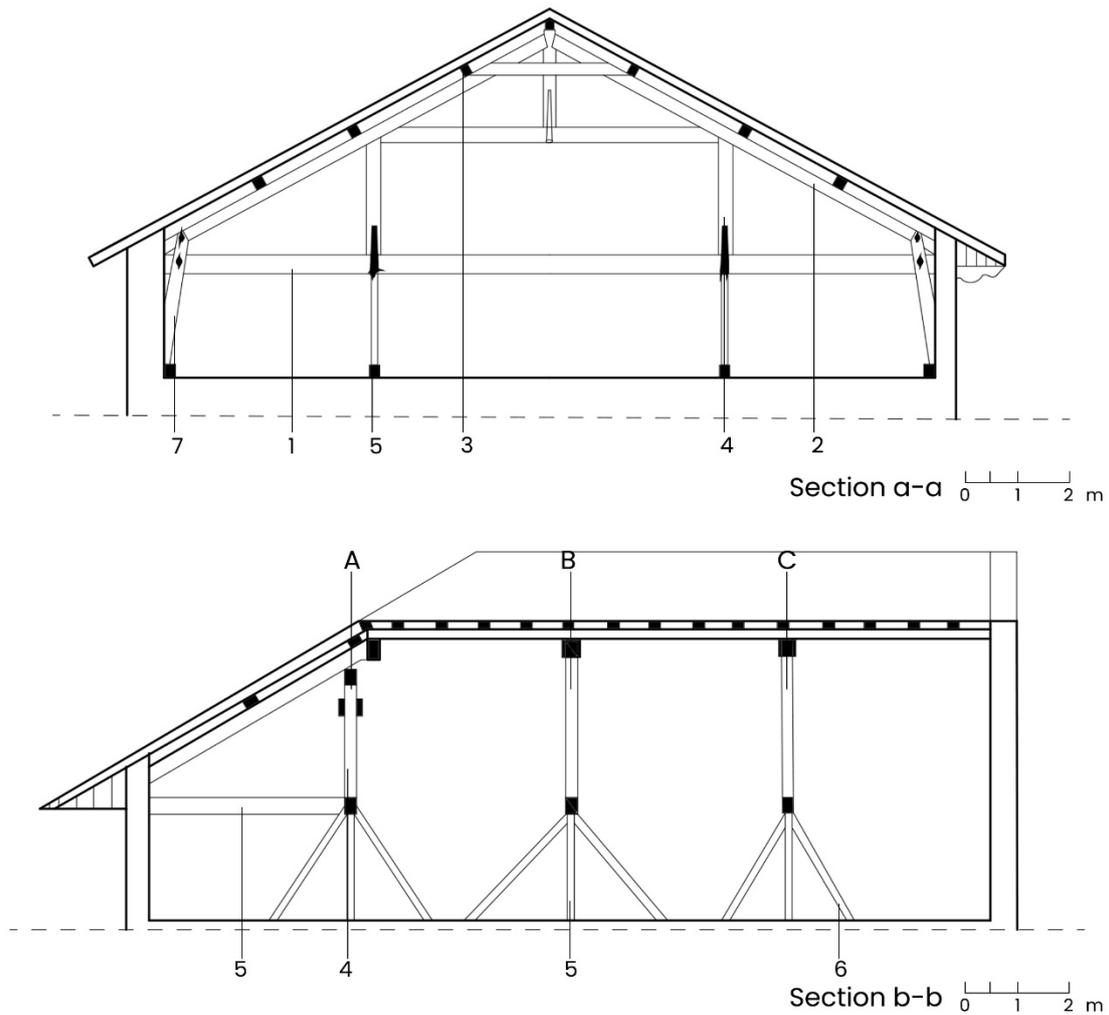
Figure 6.20: Section of the roof before restoration

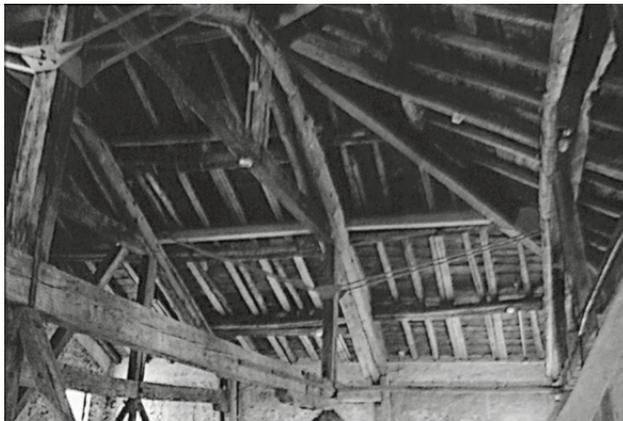
Figure 6.23: Interior view of the roof after completion of the restoration, showing the new transverse trusses.

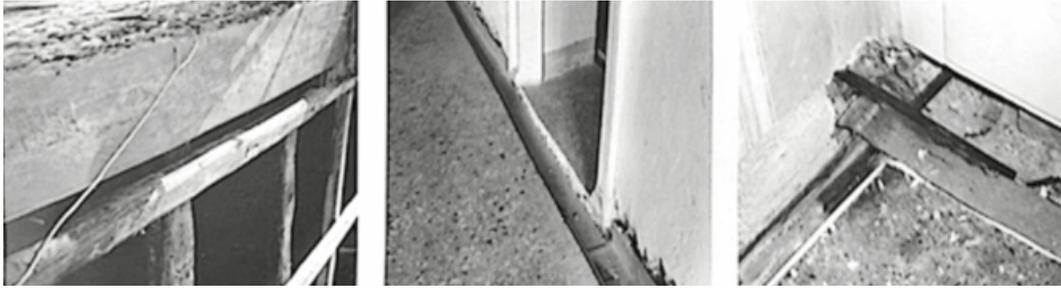
Figure 6.24: Left: Installation of the steel ring-tie at the roof level during execution. Centre: Installation of the steel ring-tie at the intermediate floor level during execution. Right: Corner connection between the floor-level ring-tie and the external anchor plate.

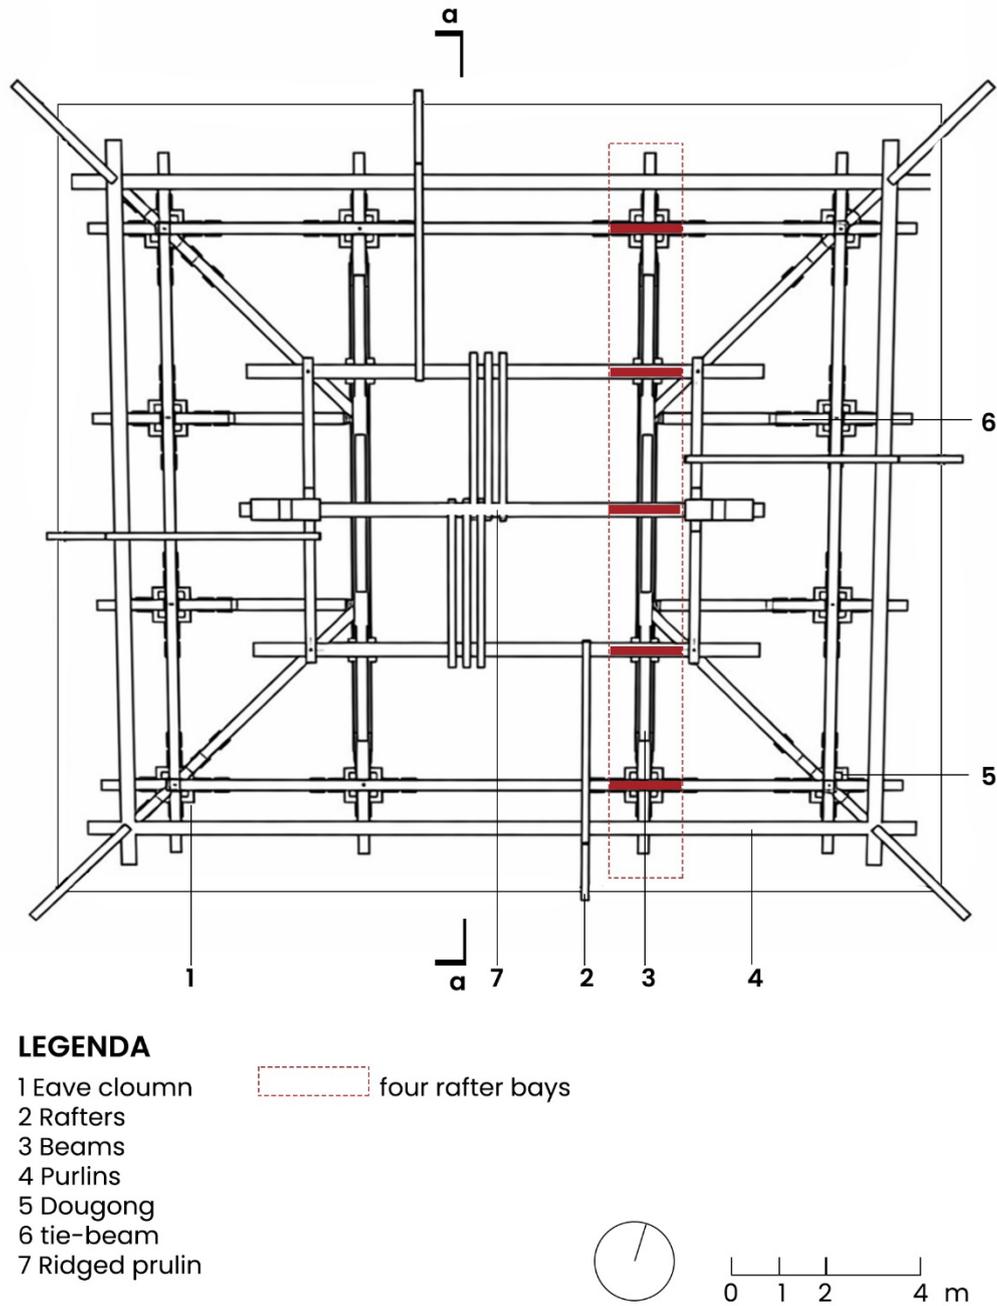
Figure 7.4: The plane of the roof structure

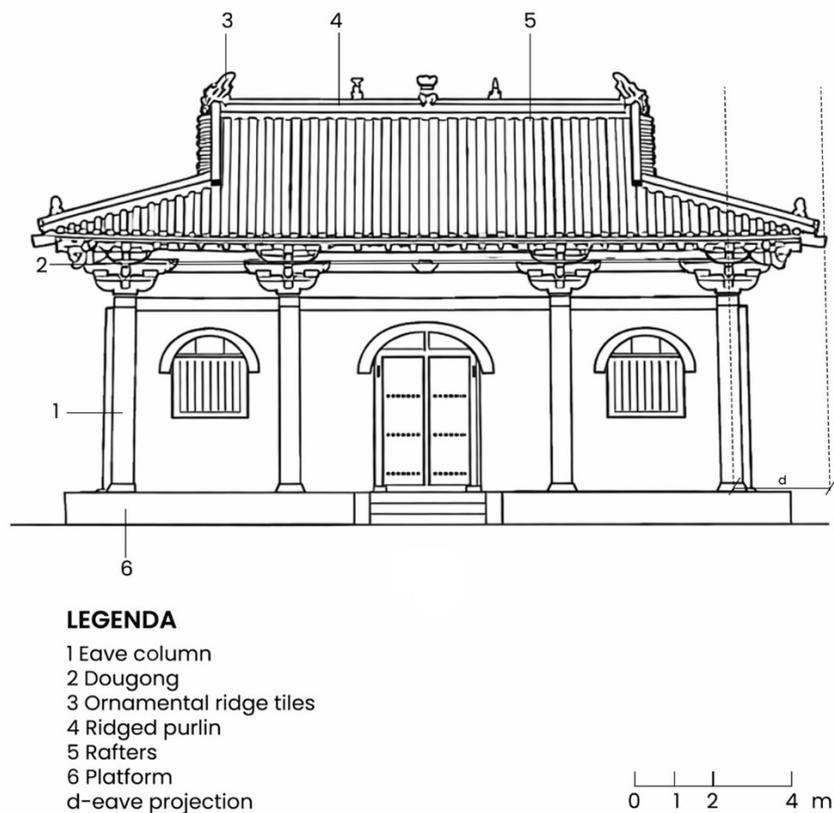
Figure 7.7: The front view of the Main Hall of Nanchan Temple before restoration

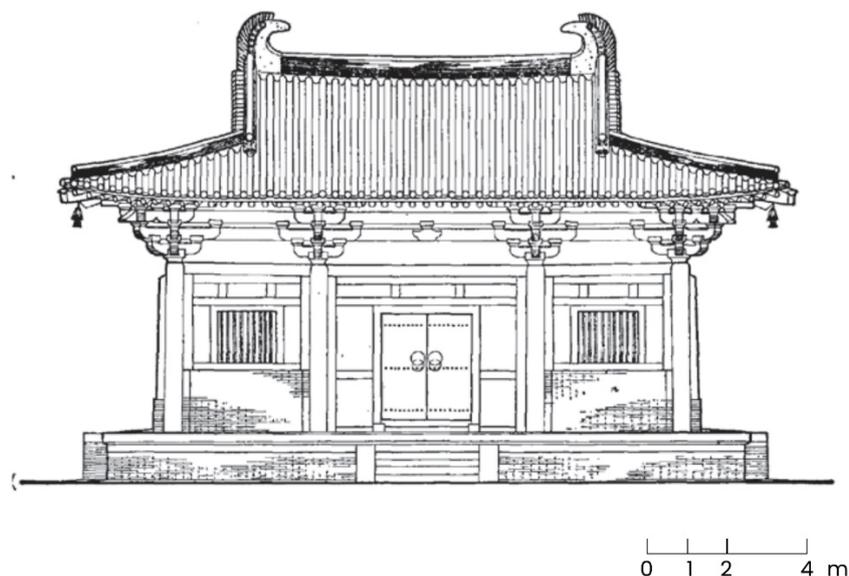
Figure 7.11: The front view of the Main Hall of Nanchan Temple after restoration

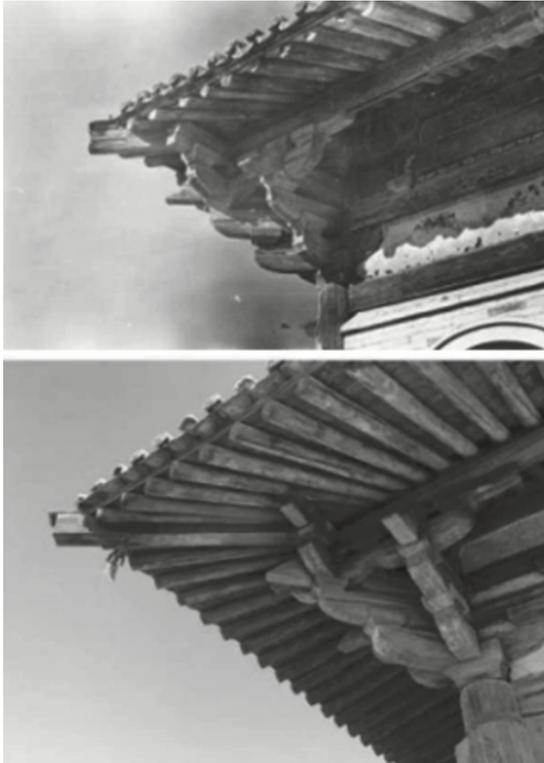
Figure 7.12: Top: The eaves of the main hall photographed in 1953; Bottom: The eaves of the main hall following restoration in 1974

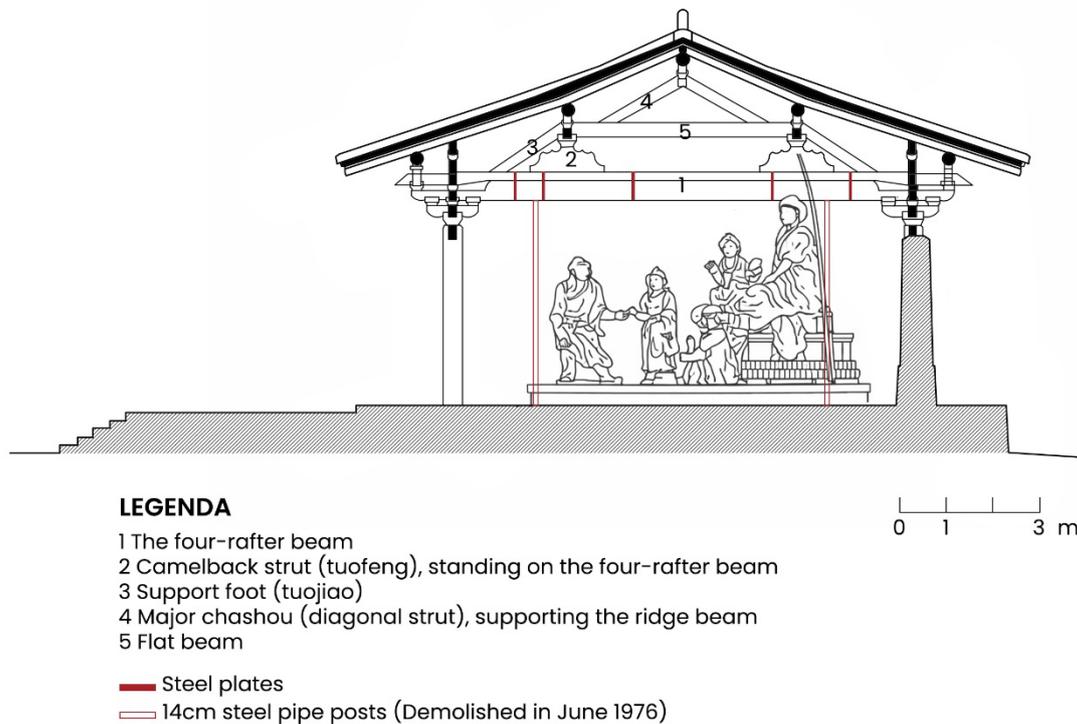
Figure 7.13: The cross-section a-a of the Main Hall of Nanchan Temple after restoration

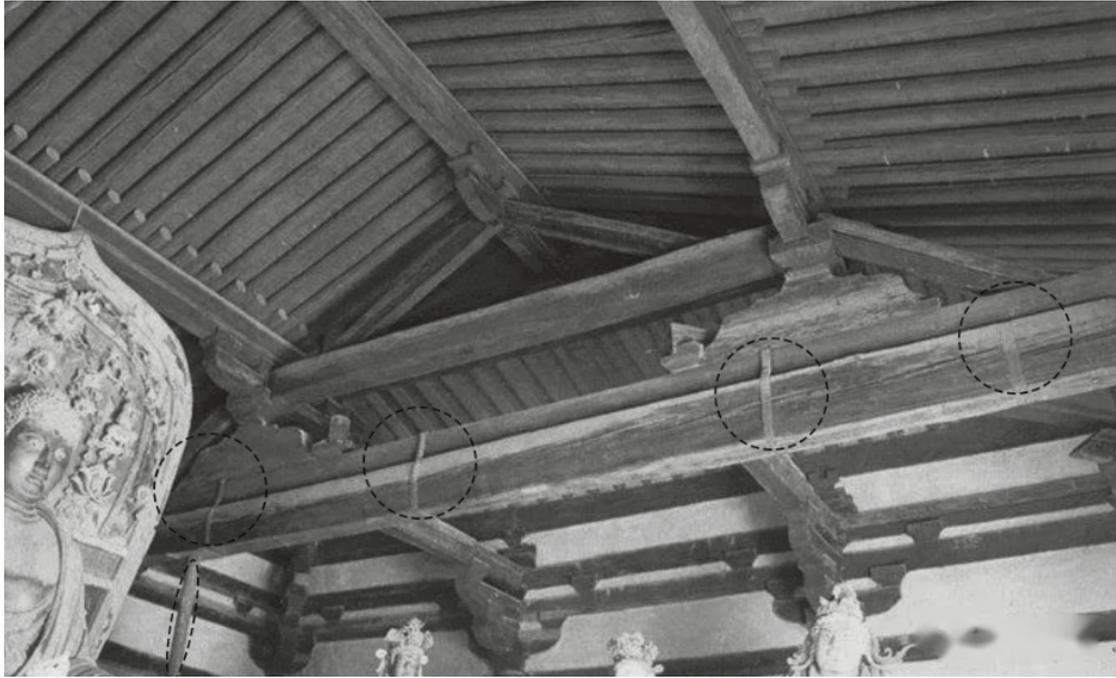
Figure 7.14: The main beam after restoration

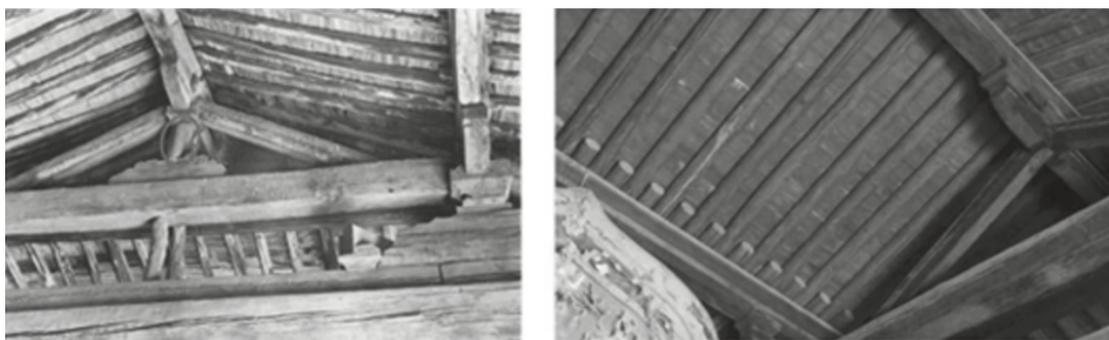
Figure 7.15: Left: Photograph of the eave pillar taken in 1953; Right: Photograph of the repaired cross-braces taken in 2014

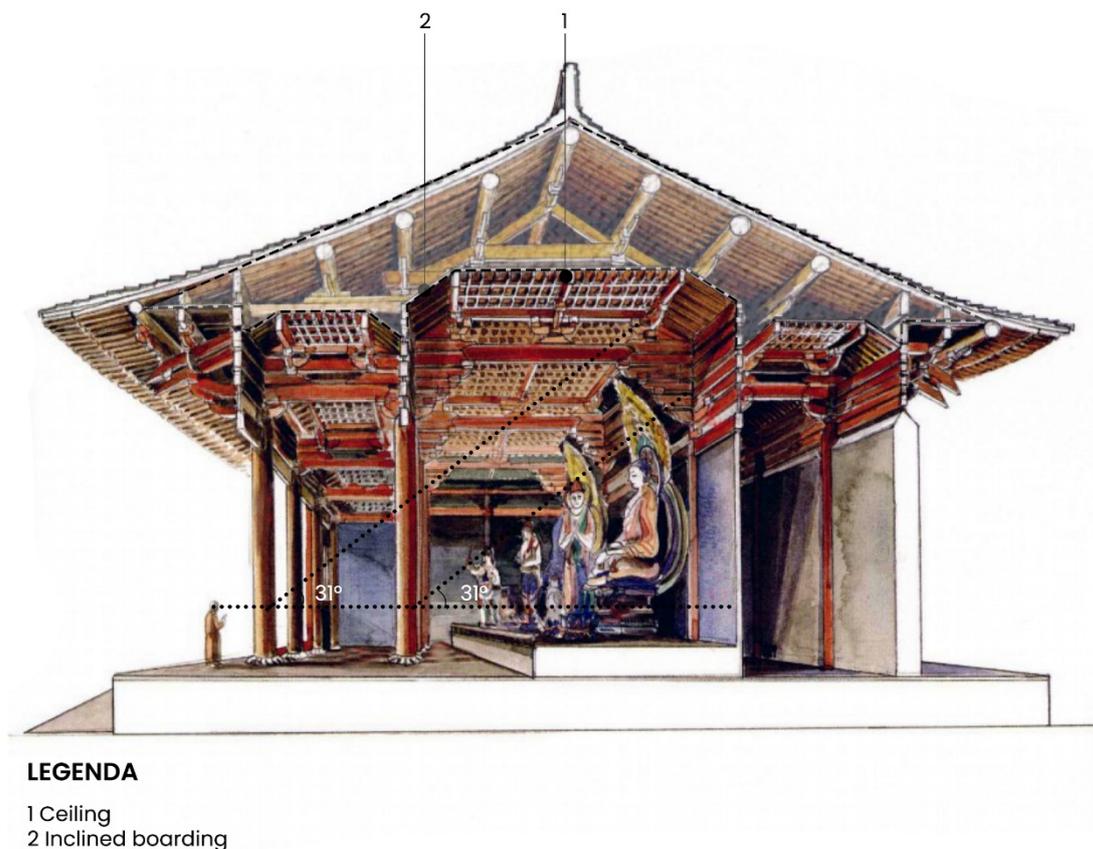
Figure 7.23: The cross-section a-a of the East Hall

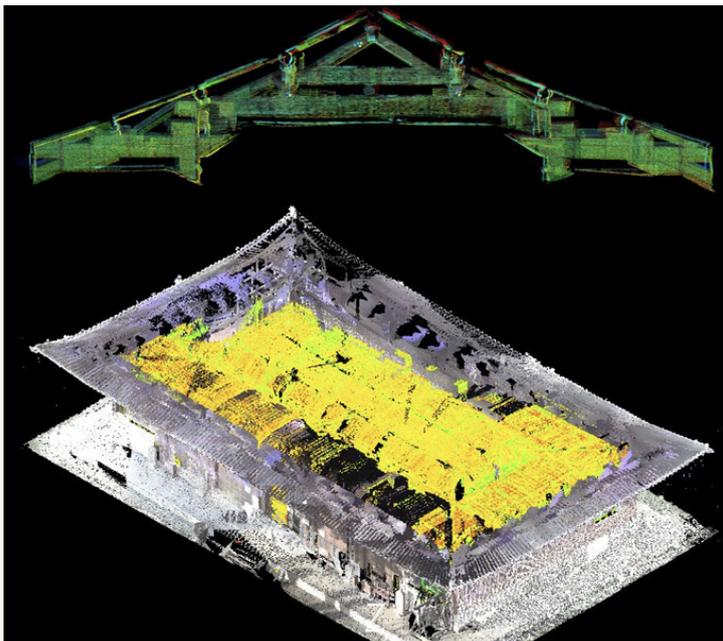
Figure 7.26: 3D laser scanning

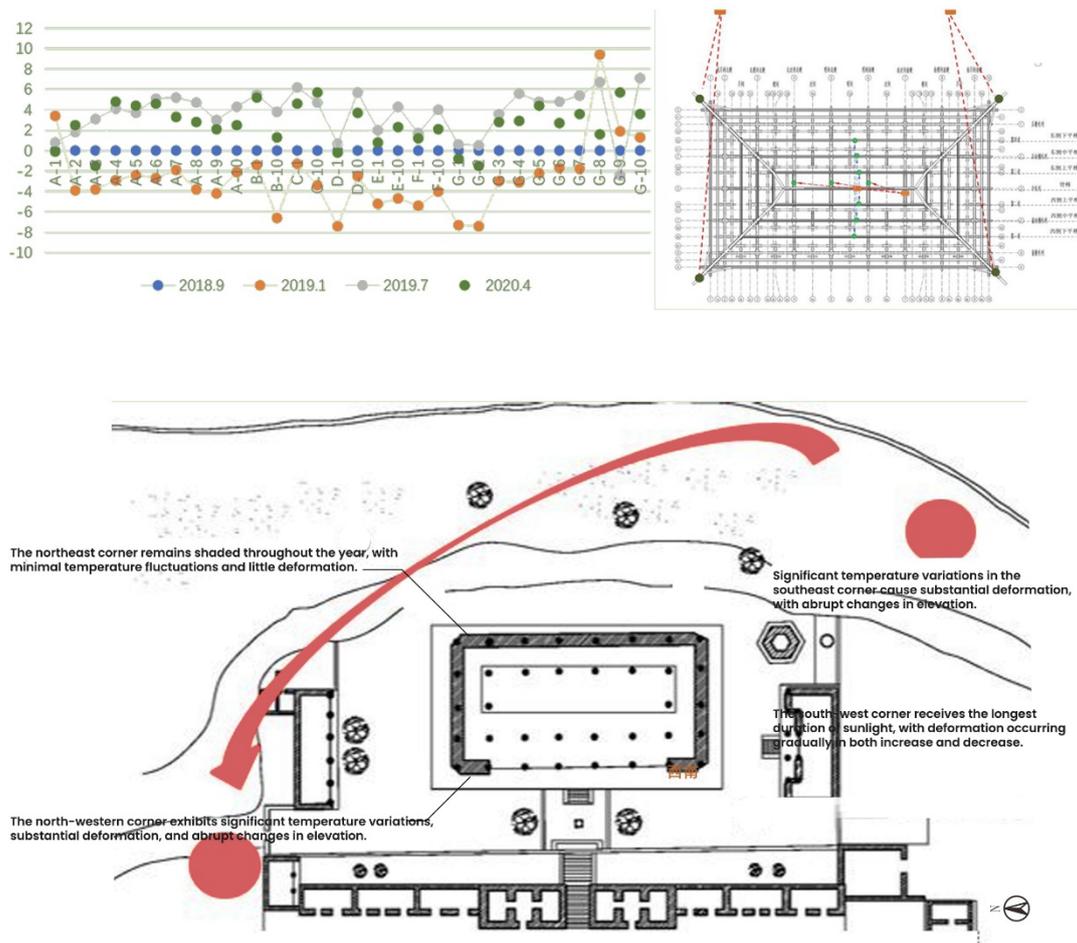
Figure 7.27: Study on Micro-Displacement of the Wooden Structure in the East Hall of Foguang Temple

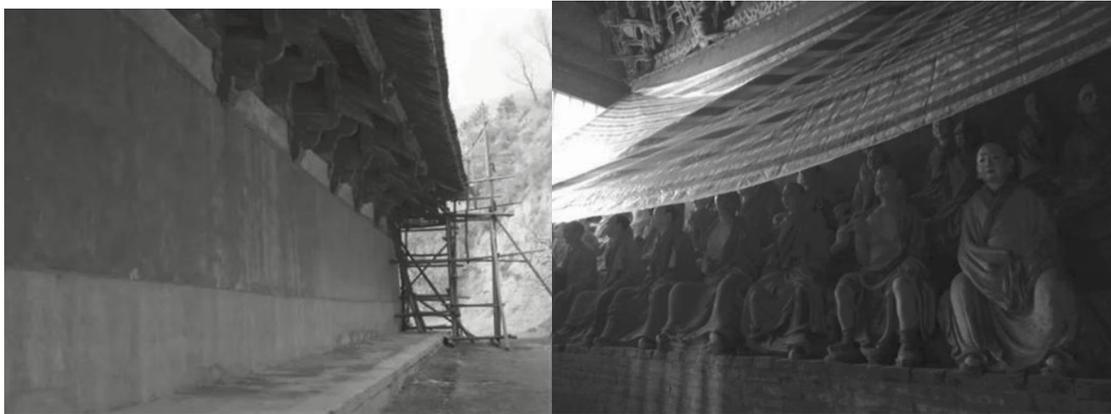
Figure 7.28: The left side shows a temporary timber support frame installed to prevent further settlement at the northeast corner of the roof. The right side shows plastic sheeting used as a temporary covering to protect the sculptures from rainwater leakage.
