Experimental evaluation of earthen plasters for the conservation of raw earth heritage in the Piemonte Region - Italy.

Master degree in Architecture for Heritage

Politecnico di Torino
Faculty of Architecture
Department of Architecture and Design

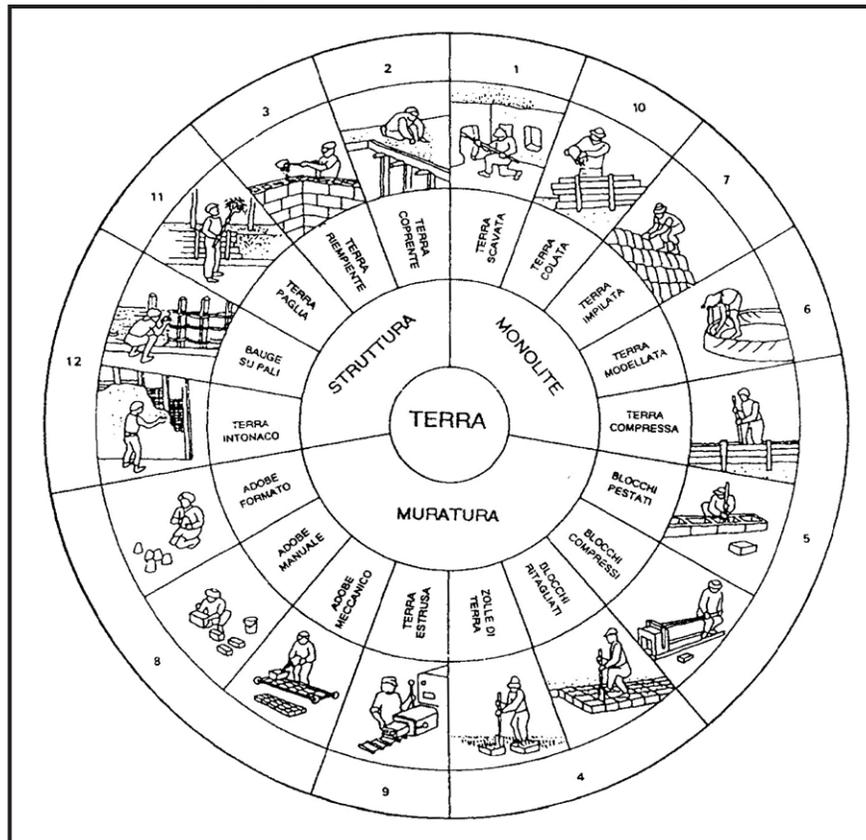
Image 13. Earth constructions techniques.

According to CRATerre fundamentally there are three main earthen construction systems: monolithic earth with a load-bearing function, masonry used as load-bearing or infill walls, and earth on a supporting structure serving as enclosure or infill. Each of these, groups different construction techniques that were adapted to the local conditions, materials and traditions.

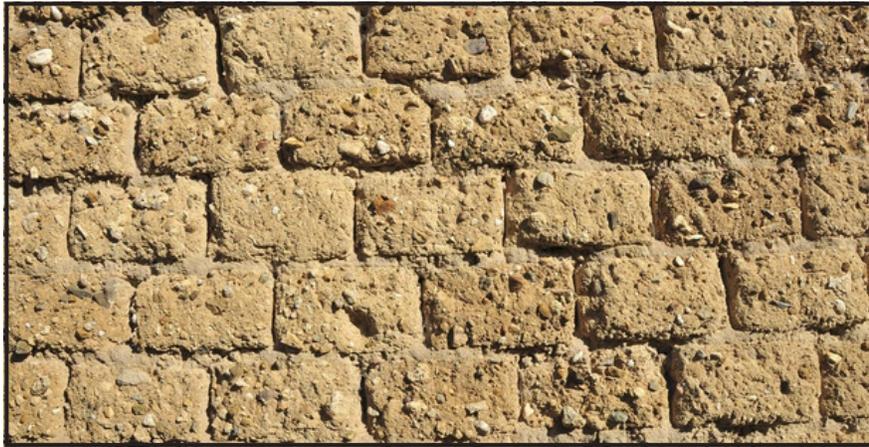
Image 22. *Ladiri*.

The rural cultures passed down many of their building traditions, its diversity in form and function reflects the local skill of the builders, from the cold and humid northern to the dry, arid climates of the south. The earthen architectural heritage is characterized primarily by the use of unfired bricks. In Italy, there are numerous examples of this technique, although it varies by region. Sardinia and the province of Alessandria have the highest concentration of earthen buildings; in the Campidano plain in southern Sardinia, many “*domu*” (traditional Irish houses) are built with unfired bricks called *ladiri* (from the Latin “*ladiri*”), which measure approximately 10 x 20 x 40 cm⁵².

The earth was normally taken from foundation excavations, then mixed with straw and placed into molds to dry. Once hardened, the bricks were used with fire bricks and on site using an earthen mortar. In Calabria’s Catanzaro province, the *casedde* were also built with raw bricks, but they change from the Sardinian ones in the type of soil used and in the addition of rice straw instead of regular straw. In Basilicata, the bricks, called *ciciule*, were used to build simple rural houses next to farmlands. In the Marche – Abruzzo area, a primitive technique called *maltone* (Marche) or *massone* (Abruzzo) developed, where a mix of earth and straw was layered using a fork⁵³.

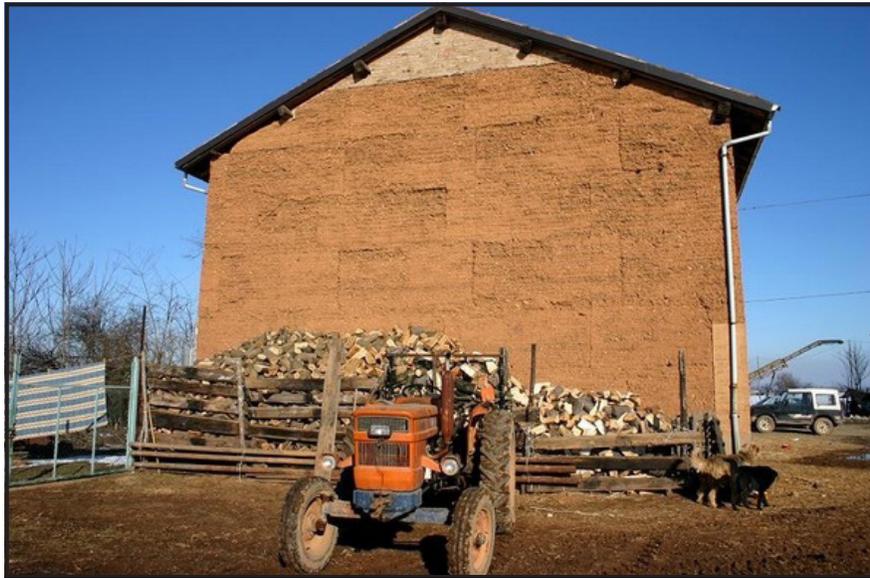
Image 25. House in pisé.

Besides the common use of unfired bricks (without straw), the constructions were also built using the rammed earth technique, known as *pisé*. The typical red soil of this region was left to “mature” over the winter under natural weather conditions. In spring, the *house rammer* began to build by compacting the earth with a wooden mallet (*pestou*) inside special molds. Once the

first block was completed, the mold was moved to create the next one. With the repetition of this process, the builder could complete the first course of outer walls and then start the second. The use of this technique was not limited to a specific building type, it was used in all kinds of structures: farm shelters, barns, churches, chapels, public and private buildings, and both rural and urban examples⁵⁵.

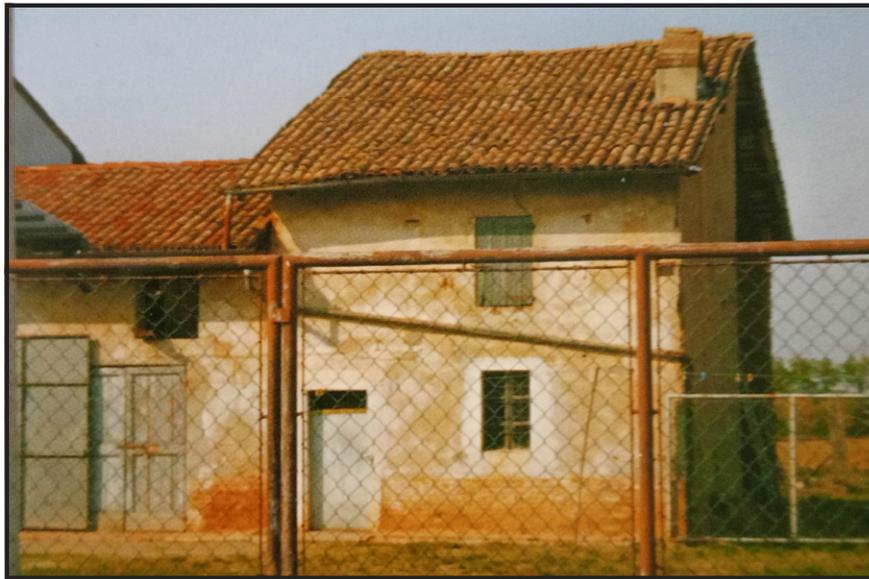
Image 27. *Trunera*.

The “*trunera*” is the simplest and most economical farmer house in the Frascchetta, possibly is the oldest typology. Its size is small and has thick walls and few openings, it offered effective protection against seasonal temperature variations. It was found in open countryside and in small settlements too, the orientations is east-west at the front of a small square plot. Its basic layout consisted of a single multifunctional space combining kitchen, living area, and bedroom, with a floor of filled earth or terracotta tiles and an originally wooden roof (later replaced by a brick vault). The heat was provided by a earth, with smoke produced through a wall channel. Due to the lacking of modern services, these needs were met via small external auxiliary structures⁶⁶.

They are completely built of rammed earth on a stone or brick base, the *Trunera* could be expanded with a “*canva*” to the north, creating doubled volumes and asymmetrical roofs. It is surrounded by a garden, well and service spaces, it eventually evolved through successive enlargements into the “*cascinotto*”, which it represents the original module⁶⁷.

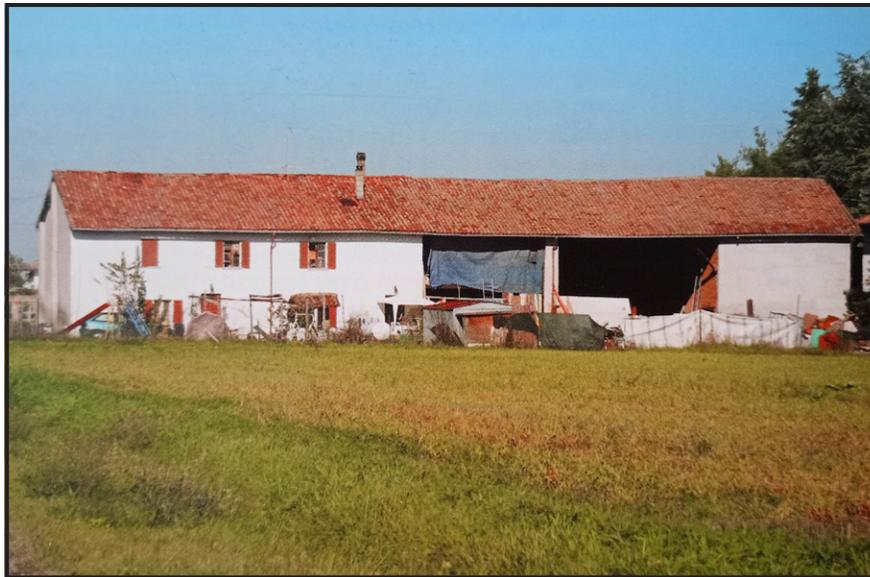
Image 28. *Cascinotto*.

The “*cascinotto*” represents the evolution of the “*trunera*”, is a single-family building combining residential and rustic spaces, sometimes with auxiliary structures such as a portico, well, oven, and “*stabbio*”. It keeps an east-west orientation and placement at the head of the lot but can be two to four times larger than the “*trunera*”. They are also mainly built in rammed earth, occasionally reinforced with bricks in pillars, lintels or arches. The ground floor has the residence and stable, while the upper floor holds the hay mow and wood storage. The openings are small, using wooden lintels or arches formed during the rammed-earth process. The kitchen communicates directly with the stable and if the building is wide, a *canva* or cellar can be added⁶⁸.

The courtyard includes a portico for storing hay or integrates the hay mow into the building, its access to the upper floor can be interior or via exterior with stairs. Depending on the household’s economy, the *Cascinotto* may feature a threshing yard, dividing walls, oven, watering trough, well, garden, chicken coop, tool shed and other sanitary facilities converting the waste into fertilizer. It is the most common rammed-earth farmhouse, it is found in open countryside and urban areas, where façades are more refined and some keep asymmetrical roofs. In urban contexts, the *Cascinotto* acquires a more formal appearance, reorganizes access, aligns buildings to protect their inner courtyards, increasing space and volume and anticipates the village “*cascina*”⁶⁹.

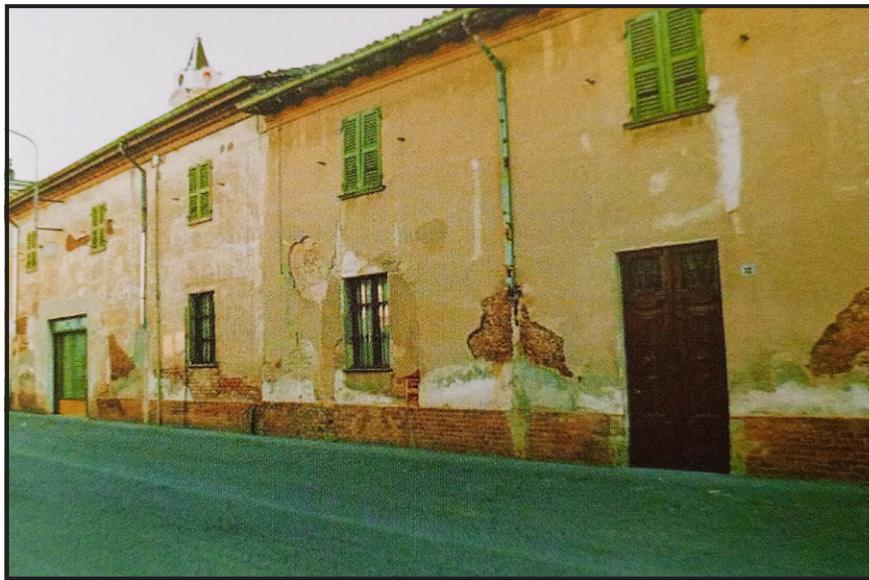
Image 29. Palazzotto urbano.

The “*palazzotto urbano*” is a residence built with rammed-earth located on the borders of the Fraschetta, recalling the brick *palazzotti* in the historic town centers. It is also constructed mainly in rammed earth, sometimes combined with brick, it is based on the *Cascinotto*’s layout and has a more formal appearance, featuring hidden eaves, pavilion roofs, brick pillars and decorative stucco finishes. In this case, the inner spaces face the streets, is composed also with balconies and larger windows. The building can have two or three floors, including mezzanines. This typology shows a technical refinement and the brick use is increased, linking the aesthetic of rural buildings with urban styles. With time, the exterior plasters normally get deteriorated and reveals the solid mass of rammed earth beneath⁷⁰.

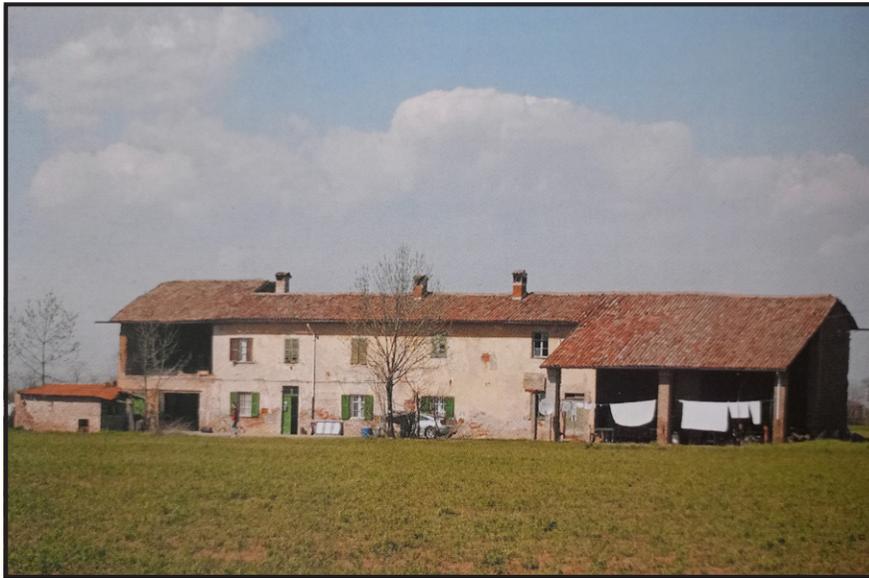
Image 30. Cascina.

The “*Cascina*” was created with increased economic resources, land ownership and agricultural machinery, creating the need for larger, more functional and representative spaces. Many of them were based on the expanded “*cascinotti*”, they are often located in isolated areas to manage crops. Through time, the “*cascine*” were improved and specialized and organized the spaces evolving in self-sufficient units. The rammed earth was mostly replaced by fired brick, showing a higher status, durability and decorative needs⁷¹.

elements. It had two floors, the ground floor had the kitchen, living room and a cellar, meanwhile the upper floor, the bedrooms and granary and was always connected to the stable next. The hay mow was above the stable and it was supported by arches or lintels, meanwhile, the porticoes sheltered sheaves, machinery and grain. The courtyard had multiple uses: the internal circulation, to storage of tools, the preparation and drying of crops. An open-field cascine held multiple families and workers, it had fenced courtyards and auxiliary structures (well, chicken coop, garden). In rural clusters, the buildings were aligned and encircled, meanwhile in the villages they were smaller and for one or two families, with contiguous buildings, large gates and rammed-earth walls the boundaries⁷².

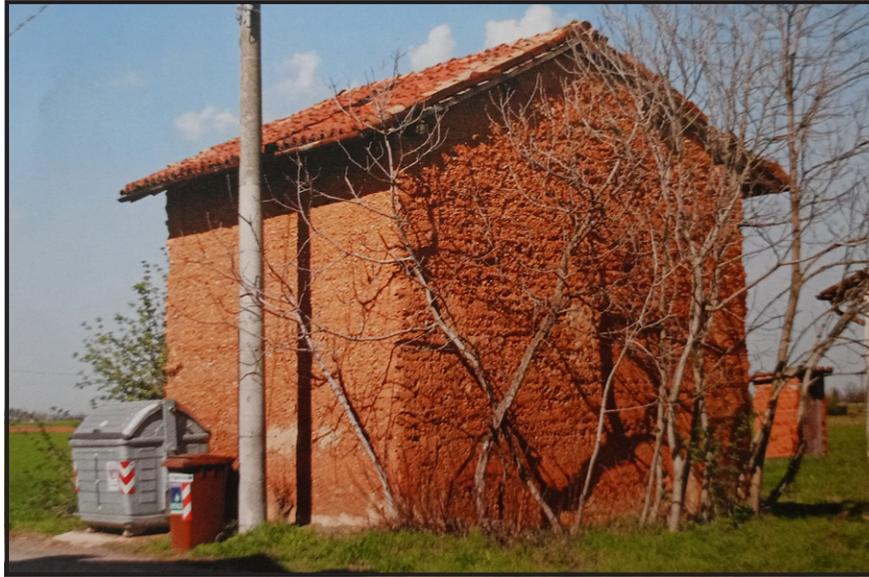
Image 31. Rimessa agricola.

In the Fraschetta, there are also open-field agricultural sheds used as porticoes or small storage buildings for tools. Although its unusual, they enhance identity to the rural landscape and there are of two main types: porticoes for storing hay or straw (similar to those in *cascinotti* and *cascine*) and tool sheds (small rammed-earth buildings) with a single door, no windows and a gabled roof, similar to the *trunera*'s volumetry on a smaller scale. Some remarkable examples include a portico near Merella, succesfully integrated into the landscape, another one along the Pollastra road, is distinguished by double openings, thin walls, and brick reinforcement at the top. Currently, an isolated portico still exists in Capannoni, near San Giuliano Vecchio. The tool sheds follow a south-north orientation and maintain the *Trunera*'s proportions, with

dimensions under 2.5 meters⁷³.

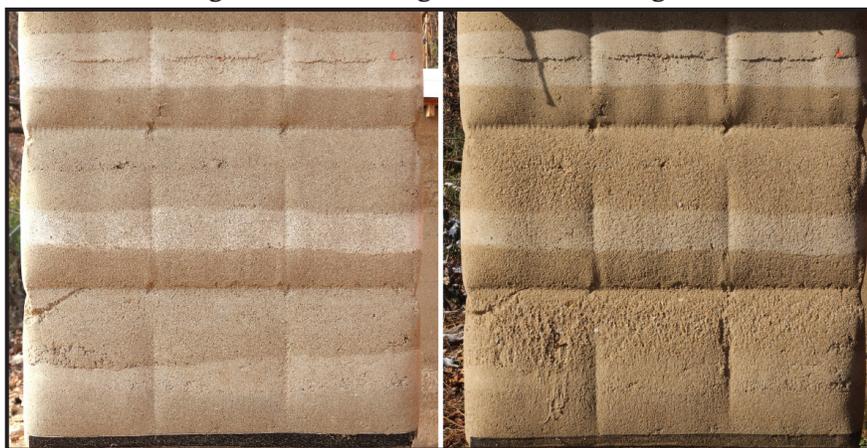
Image 37. Weathering erosion - Disintegration.

has been used since old times, Rondelet¹¹¹ says that some mud-brick walls were coated with clay and straw or with lime and gypsum in more prestigious constructions. Its low cost and simplicity of application make a balance between its limited durability and a regular maintenance. In order to guarantee its effectiveness, the plaster must be resistant to atmospheric agents, be vapor-permeable and have a proper bonding to the substrate. This can be achieved with mixtures of earth, sand, and lime, and clay can be added to improve plasticity, deformability, and adhesion to the earthen wall¹¹².

To mitigate this problem, after several experimental tests, the use (in this case, replacement of the “piece”) of lime and sand-based plasters, also with gypsum, is suggested. The characteristics of the substrate must be taken into account¹¹³.

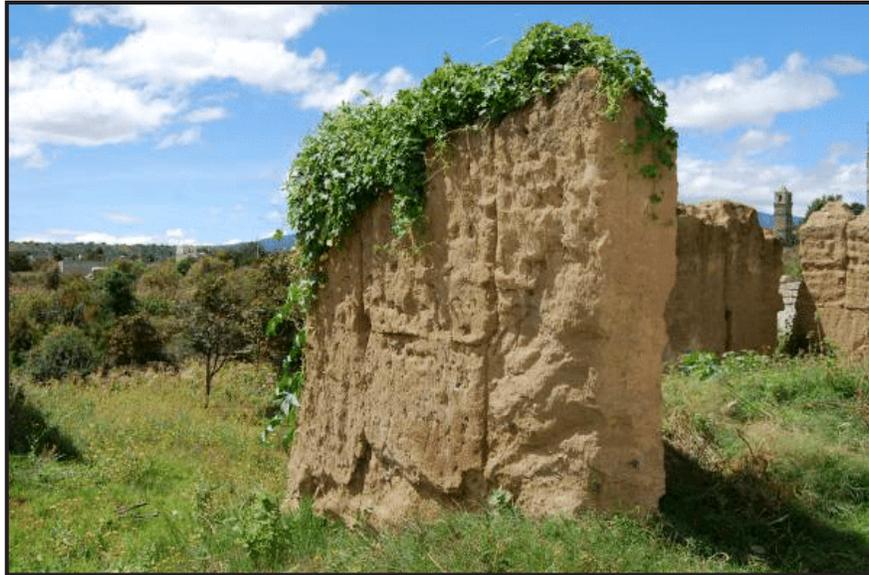
Image 40. Invasive vegetation.

It can be said that, the presence of moisture infiltration, inadequate protection and poor maintenance has the presence of vegetation and fungi on adobe walls, being a significant indicator of structural and material deterioration. Gradually, the plant roots can compromise the integrity of walls and roofing elements, while fungal growth can lead to the decay of wood elements and reduce the mechanical strength. Also, some preventive measures (proper drainage systems, roof maintenance and regular inspections) need to be carried out to reduce the intensity of these effects. In cases where damage exists, there has to be a careful removal of vegetation and affected fungal material, along with the control of moisture sources, is crucial to preserve the durability, safety, and habitability of earthen constructions.

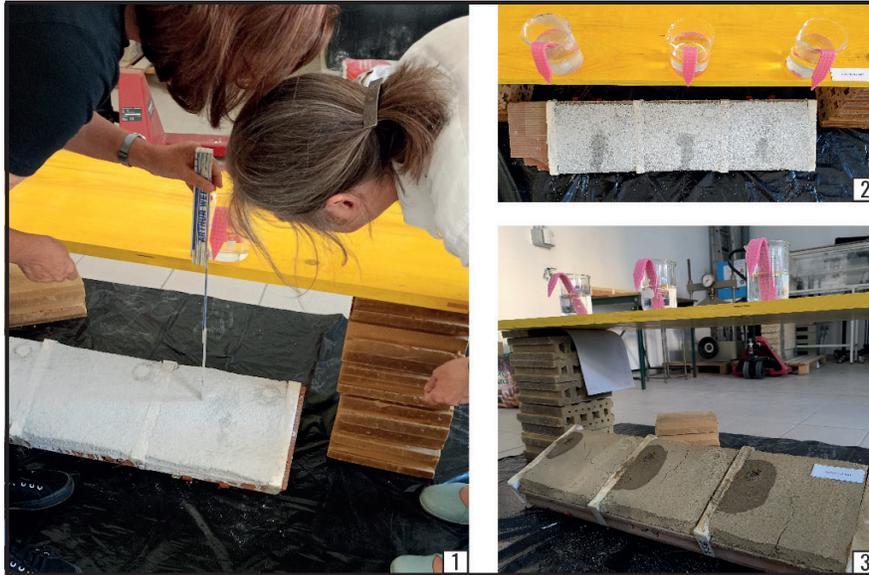
Image 50. Geelong test execution.

1. Measuring the 400 mm height.
2. Dripping strips.
3. Presence of holes.

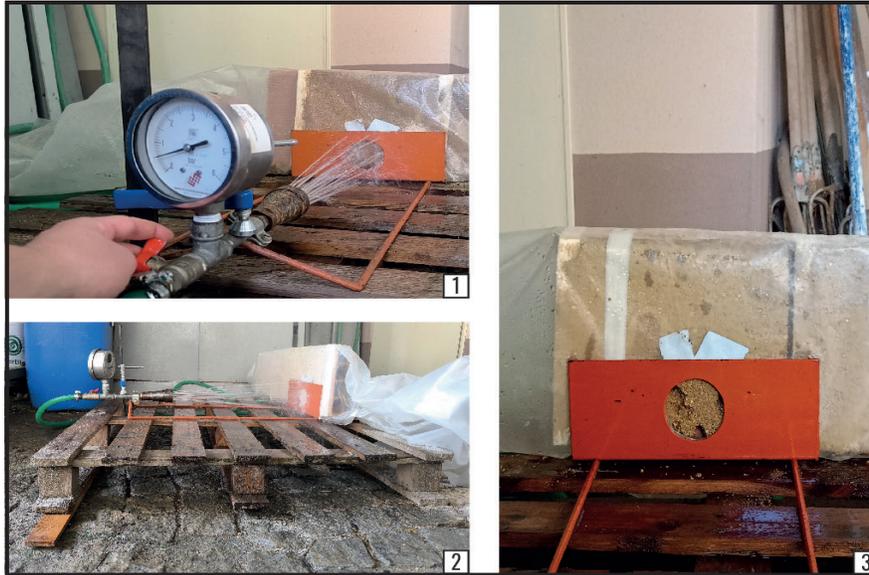
Image 52. Spray Erosion test execution.

1. Verification of water pressure and valve opening.
2. Water spraying.
3. Visual inspection for the presence of holes.

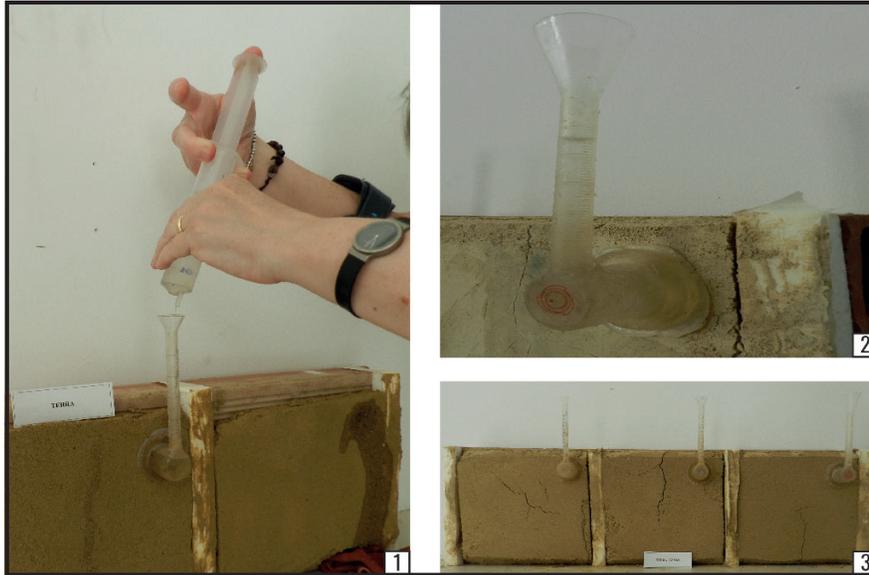
Image 52. Karsten Tube test execution.

1. Verification of silicone sealing and water filling.
2. Observation of water absorption.
3. Comparison of absorption among the samples.

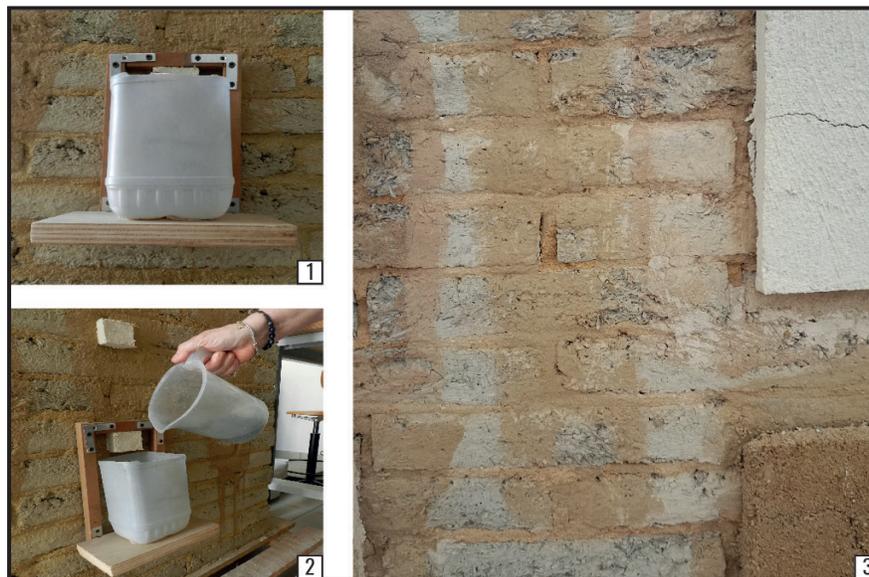
Image 54. Shear test execution.

1. VPositioning of the support device and container.
2. Progressive weights placing.
3. Failure and detachment of the samples.

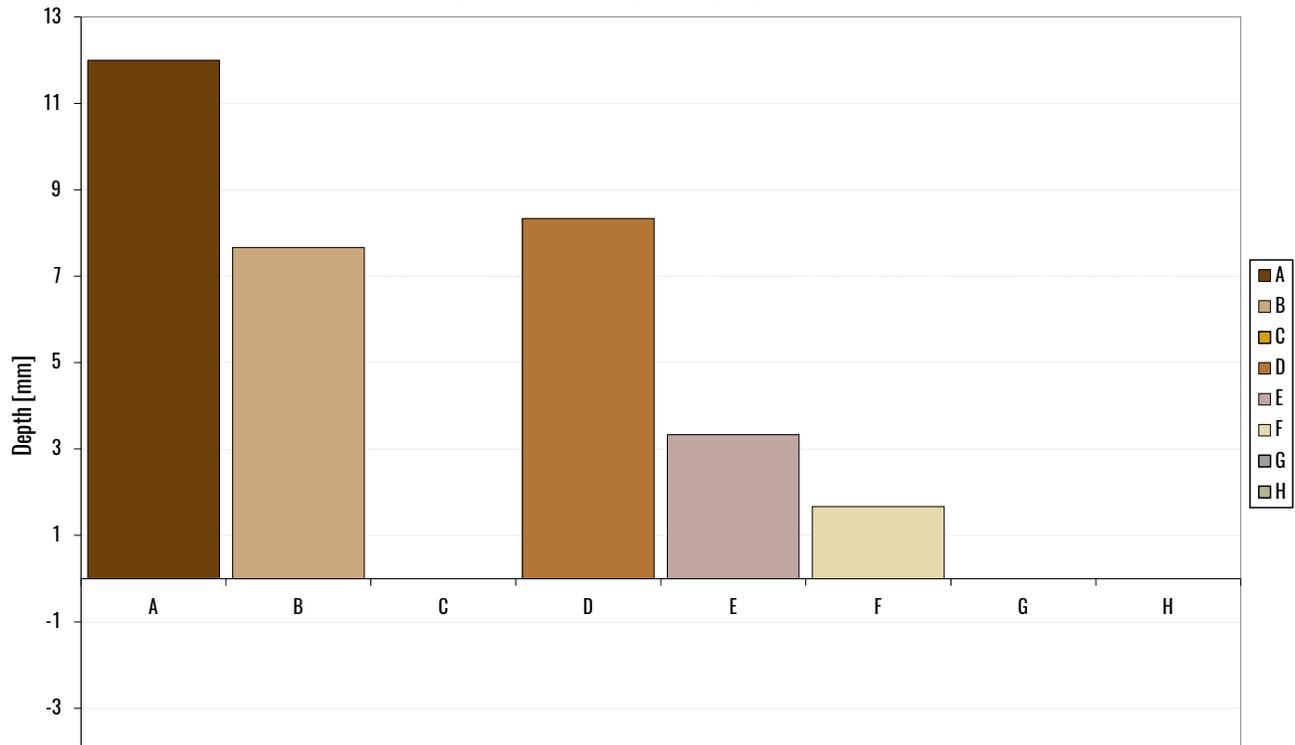
Graphic 1. Geelong test graphic result.

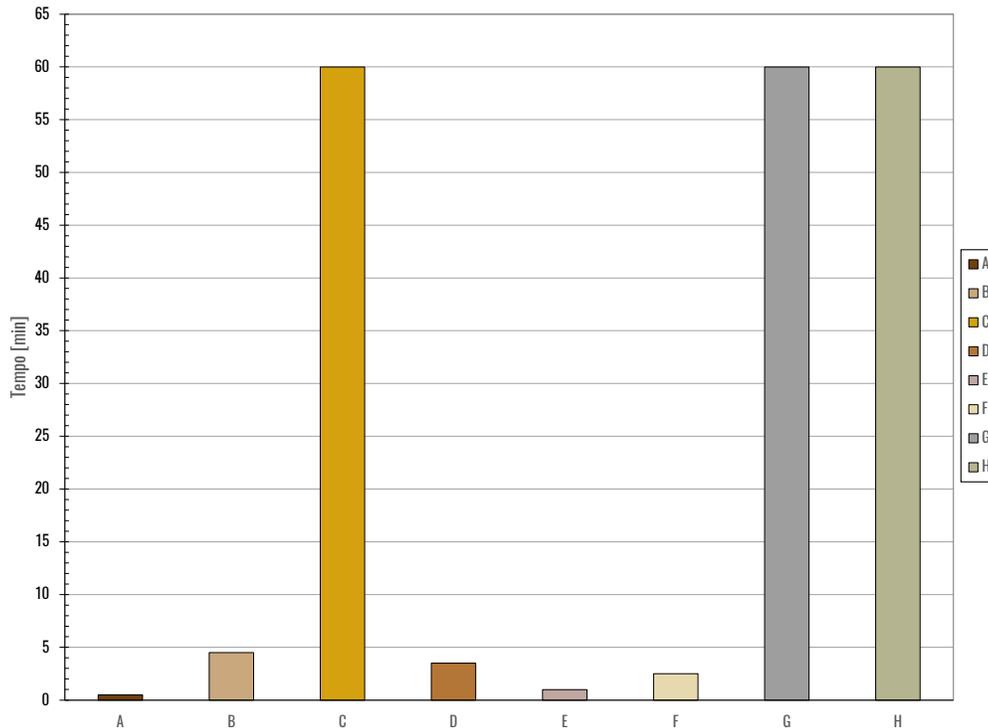
Graphic 2. Spray Erosion test graphic result.

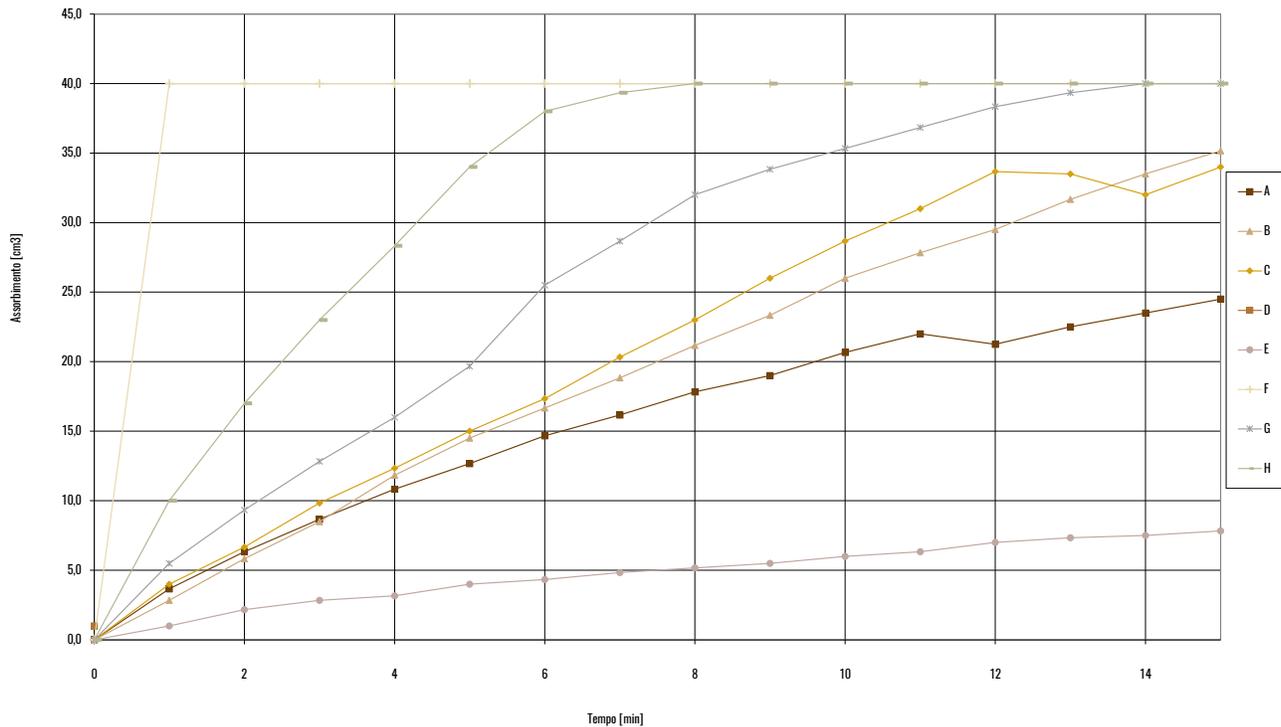
Graphic 3. Karsten Tube test graphic result.

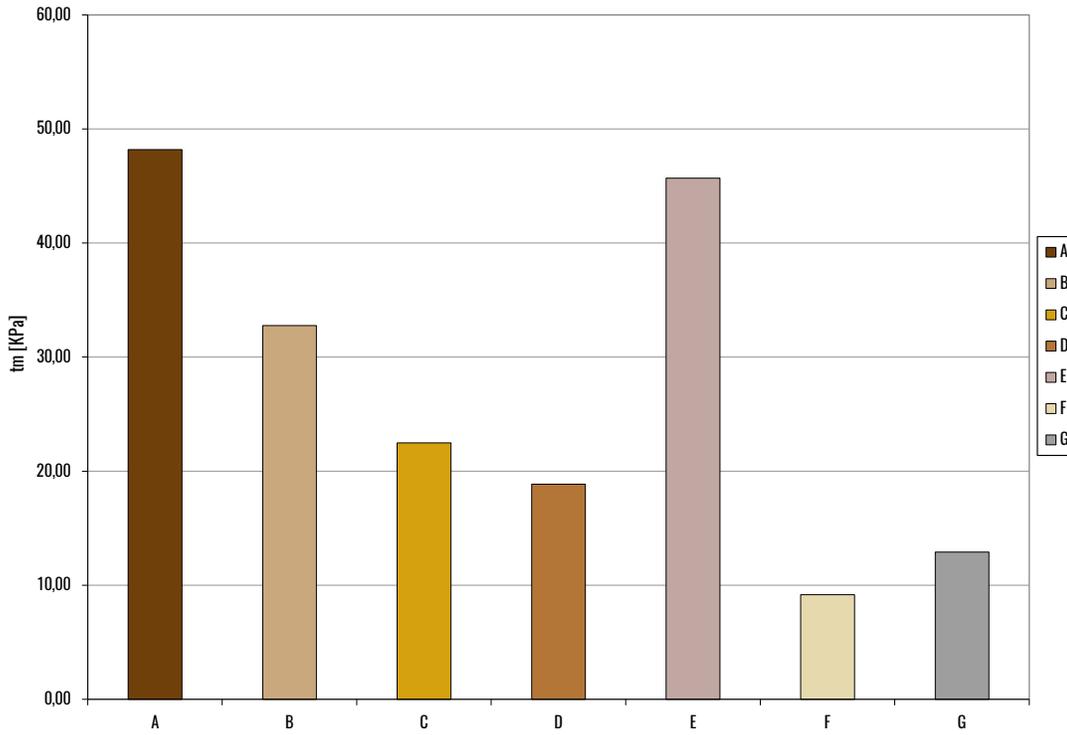
Graphic 4. Shear test graphic result.

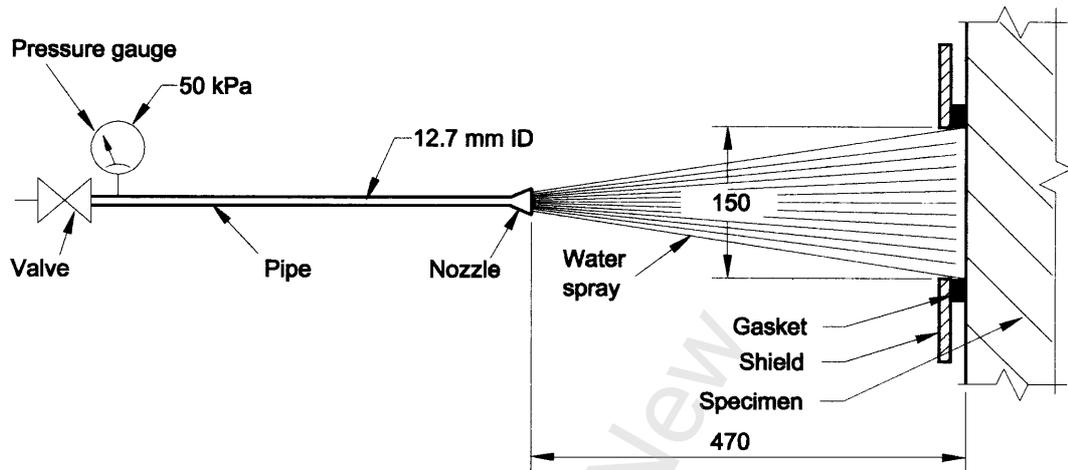
After completion of the spray test, penetration of moisture is measured by breaking the specimen across the point where erosion is deepest and inspecting the break surface if the sample is more than 120 mm thick.

Figure D1 – Pressure spray test general arrangement

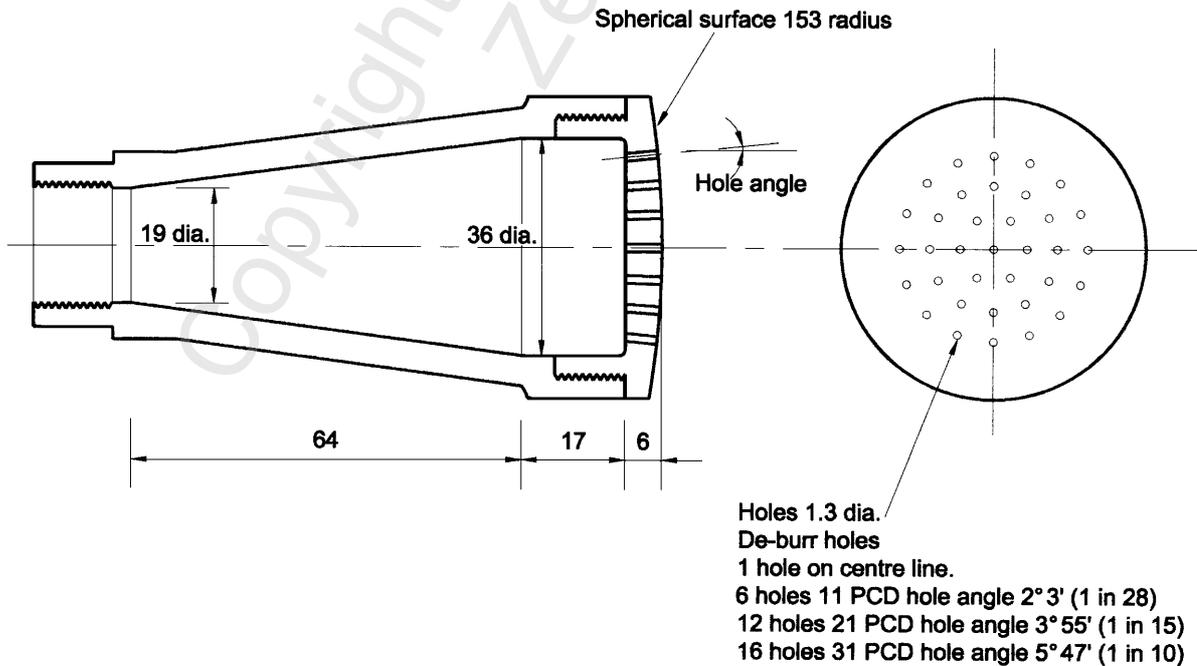
Figure D2 – Pressure spray test nozzle

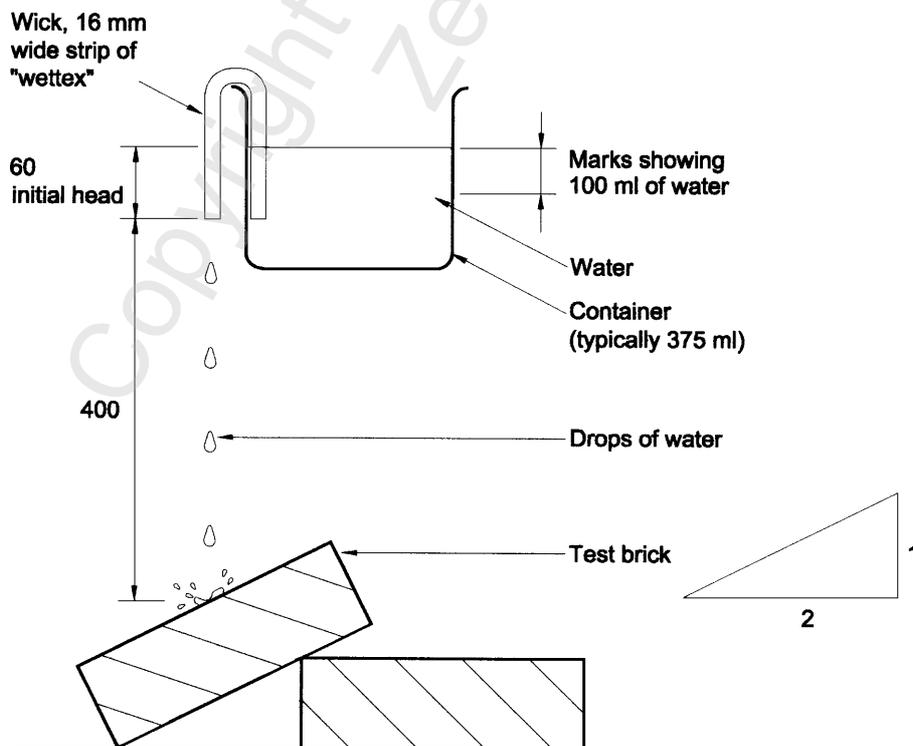
Other convenient mould or rammed earth “brick” sizes may be used if desired.

Figure E1 – Geelong method erosion test details
