A Value-based Assessment and
Intervention Framework for
Dikengyuan as Subterranean
Vernacular Heritage:
Insights from *Sassi di Matera*

Master's degree programme
Architecture for Heritage

A.A 2025/2026
Master's Thesis

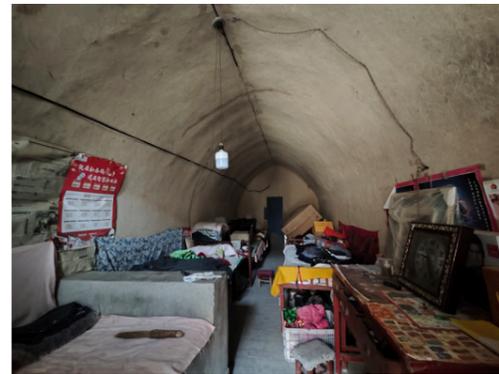
Fig. 20 *The Living Cave*. Photo by the author.

As the living space, every living cave is often equipped with the heated *Kang* bed made of adobe, which is located under the window of the entrance door. Through the heating of the stove, it will continuously provide heat for the *Kang* bed, keep the cave warm and provide a heated seat and living space in winter.

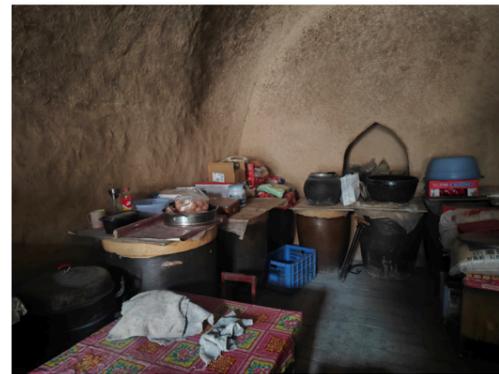
Fig. 21 *The Kitchen Cave*. Photo by the author.

The other auxiliary functional spaces such as the kitchen cave and the storage cave are usually 2.8-3 meters high, with one door and two windows, which are often set on the side of the courtyard. The livestock cave and the toilet cave are usually set on the opposite side of the main cave, and are often located at the corner of the yard.

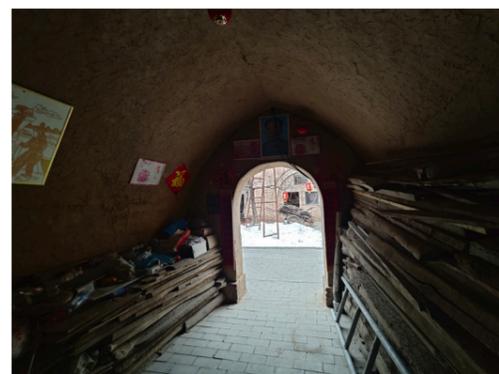
Fig. 22 *The Entrance Cave*. Photo by the author.

In terms of plan configuration, entrance caves can be classified into four main types: direct access entrance cave, passage entrance cave, ramp entrance cave, and stair entrance. The direct access entrance is primarily determined by topographic conditions. When the ground level on one side of the pit courtyard is relatively low and close to the courtyard floor level, the courtyard can be entered directly through a straight entrance without any elevation change. The passage entrance is the most common form in pit courtyards. It consists of a sloped passage provided with steps, facilitating pedestrian movement. The ramp entrance differs from the passage entrance in that it does not include stepped sections, instead, a relatively gentle ramp surface is used, which greatly facilitates the movement of transportation and animals. The stair entrance is distinct from the other three types. Rather than forming a separate cave passage, it is directly excavated along one side of the pit courtyard wall. Steps are carved following the terrain, allowing direct vertical connection between the ground surface and the underground courtyard, thereby reducing construction work (Wang, 2008).

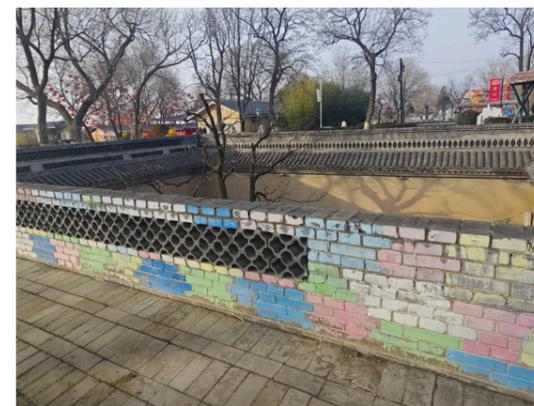
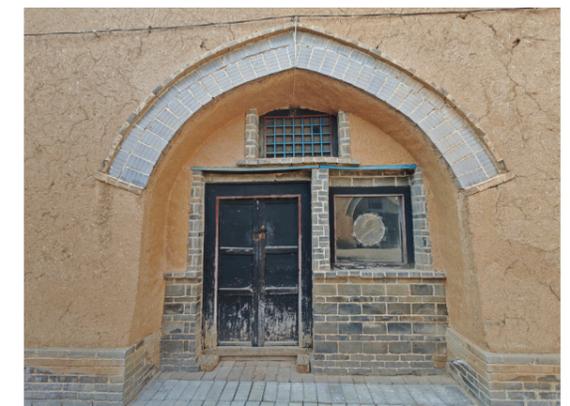
Lanmaqiang (The parapet)

Yaolian (The cave face)

Fig. 26 Photos of Facade elements. Photo by the author.

For the facades, the focus of protection shifts to the construction of a cave face protection system to prevent erosion caused by rainwater flowing along the walls. At the joint of the pit courtyard facade and the cave face, builders typically use protruding bricks or adobe to form an arch cave eave, to deflect rainwater from above away from the wall surface and protect the wooden door and window components and the straw and mud plaster layer below.

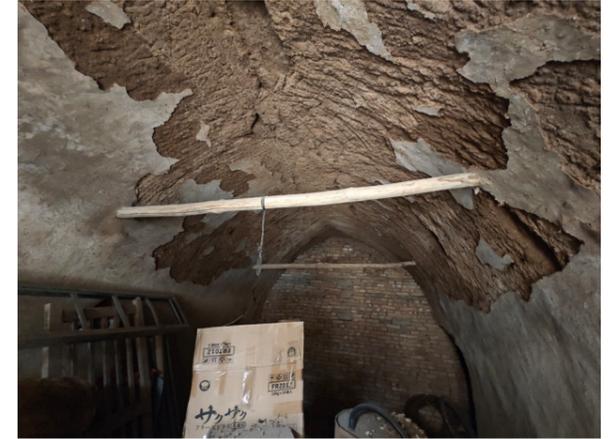
Fig. 28 The Timber Post in Cave. Photo by the author.

The spatial form of the cave is defined by an arched structural system. Structurally, the arch crown acts as the central point of force transmission, with loads distributed symmetrically to both sides, resulting in a stable center of gravity and high structural stability. To further enhance stability, some caves incorporate timber posts placed above the arch, spanning along the bay direction to support both sides of the vault and resist lateral thrust. According to the geometric characteristics of the arch crown, they can be classified into two main types, the pointed-arch cave (double-centered arches) and the round-arch cave. In the Sanmenxia region, pointed-arch caves are predominant, whereas round-arch caves are more common in the Luoyang and southern Shanxi regions.

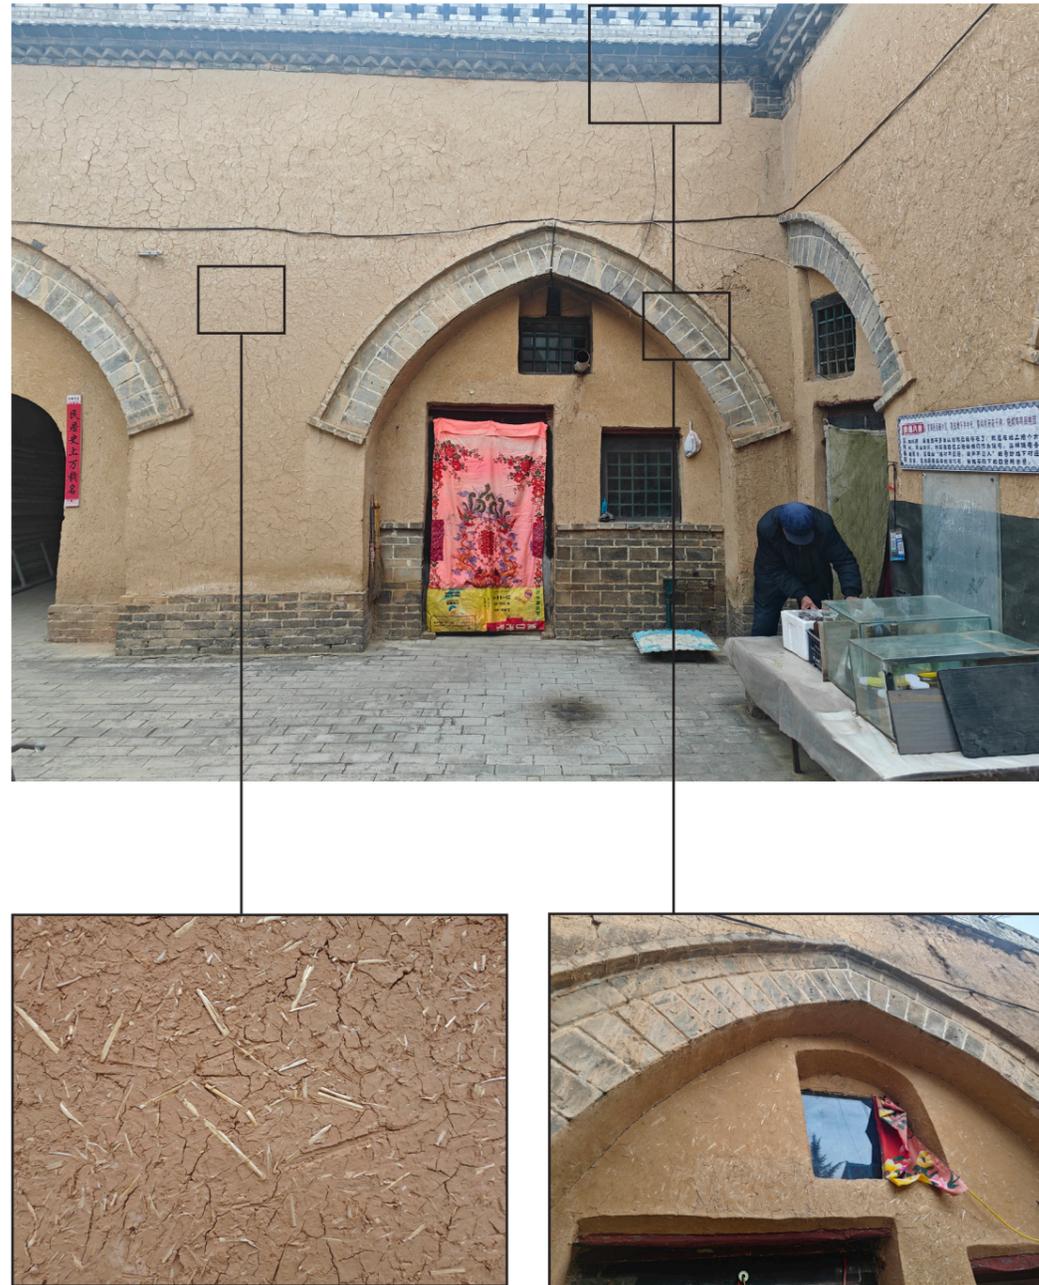
Fig. 34 The Building Materials. Photo by the author.

To overcome the drawbacks of the loess surface, such as easy peeling and dust generation, traditional artisans developed straw–mud plaster as an early form of composite surface protection for both interior and exterior walls (Knapp, 2000). Laboratory studies on earth plasters show that incorporating natural fibres such as wheat straw can reduce drying shrinkage and suppress shrinkage crack formation (Ashour & Wu, 2010). More importantly, unlike the relatively lower-permeability cement-based finishing layers that can hinder moisture transfer, porous mineral or earthen-based plasters support moisture buffering and moisture transfer across the envelope (Damle, Khatri, Rawal, 2022). This allows moisture within the wall to evaporate and contributes to maintaining a more stable indoor hygrothermal condition.

Compared to the dominant use of raw loess, woods and fired materials such as bricks and tiles were considered luxuries in pit courtyards due to their scarcity, serving only as auxiliary materials and used at key construction details. Grey bricks were mainly used at the parapet, the courtyard eaves, the cave eaves, and the plinth, to resist rain erosion or mechanical wear. Wood is used only for door and window frames and indoor furniture.

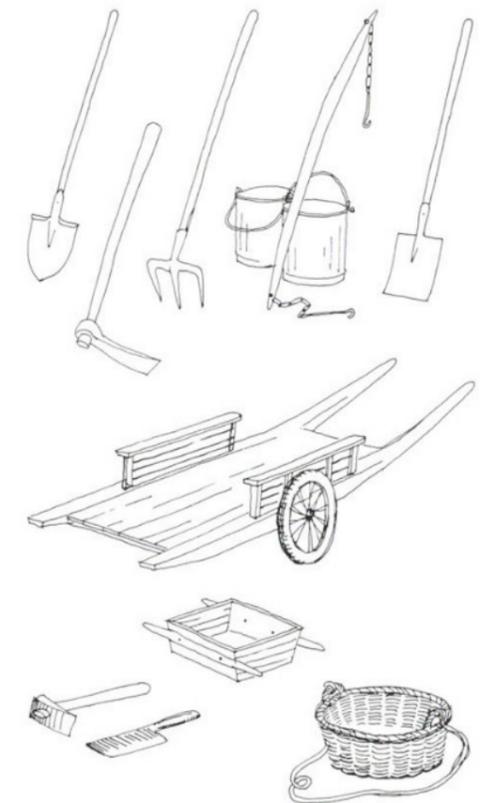
Fig. 36 Tools Used for Construction. Golany, G. (1992). *Chinese Earth-Sheltered Dwellings: Indigenous Lessons for Modern Urban Design*

These are essential for excavating the pit courtyard and the lateral caves. Tools such as *gao* (pickaxe), *juetou* (hoe), and *xian* (shovel) are used to cut and loosen the loess soil, allowing the pit and interior spaces to be shaped directly from the ground.

These are used to consolidate soil and surface layers where higher density and stability are required. Tools such as *chu* (pestle) and *hang* (rammer) help improve surface durability and structural performance (Wang et al., 2013).

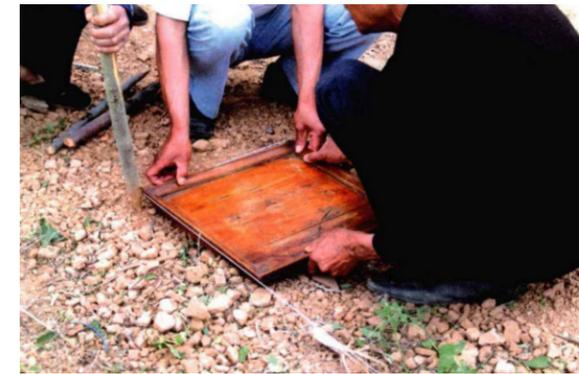
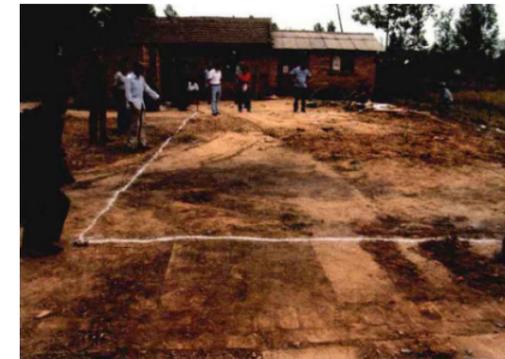
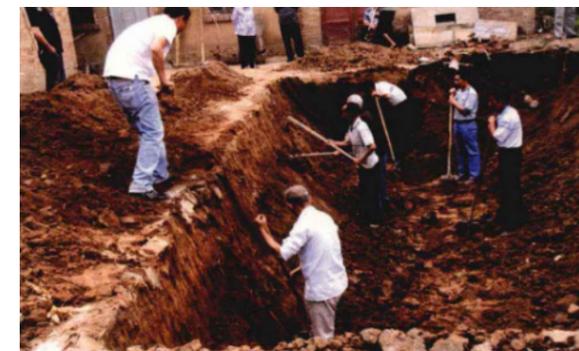
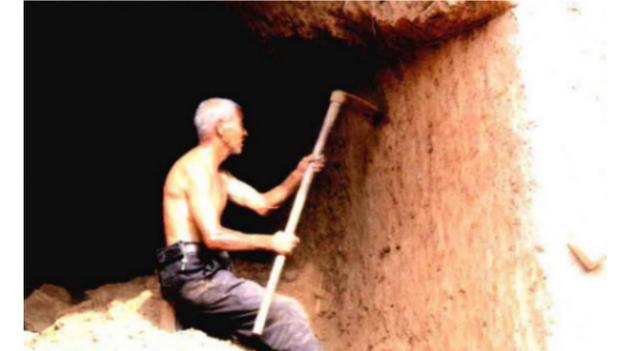
The final stage focuses on water management. Because the pit courtyard is located below ground level, drainage is essential for long-term stability. A seepage well is dug within the courtyard to collect rainwater, allowing water to infiltrate into deeper soil layers. This system helps prevent water accumulation and protects the loess walls from erosion.

The construction of traditional pit courtyards is a step-by-step process that closely responds to local topography, soil conditions, and everyday living needs. According to traditional practice, the construction follows a clear sequence, beginning from ground-level planning and gradually moving downward into the earth.

The construction begins with defining the square courtyard at ground level. Before excavation, builders select a flat area with sufficient loess depth and good drainage conditions. The orientation, size, and position of the courtyard are determined based on sunlight, prevailing winds, and local experience. Simple setting-out methods are used to mark the boundaries of the courtyard and the locations of the main cave rooms. This stage establishes the basic spatial framework of the dwelling.

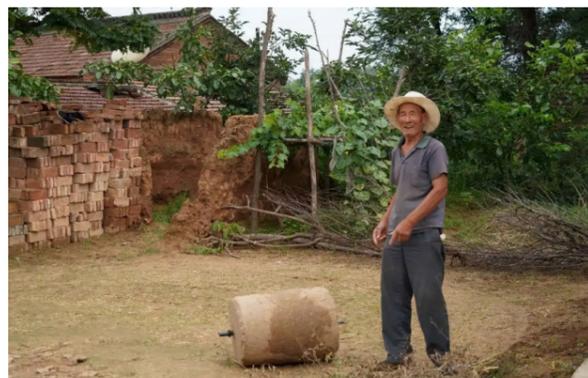
Fig. 41 A Farmer Is Compacting the Land with a Roller.
<https://baijiahao.baidu.com/s?id=1673062606814412852&wfr=spider&for=pc>

It shows that this decline is primarily a chain reaction driven by water erosion. In the traditional space utilization of pit courtyards, the flat ground at the top of the courtyard was often used as an agricultural threshing ground. During the busy harvesting season, farmers would repeatedly roll the grain on the ground with stone rollers. This seemingly purely agricultural activity actually played a crucial role in compacting and waterproofing the soil. The high-intensity rolling damaged the large-pore structure of the loess surface, forming a dense, impermeable crust that effectively blocked the vertical infiltration of rainwater (Hou, Ren, Zhou, & Li, 2018). However, with the relocation of the original inhabitants and changes in agricultural production methods, the soil layer covering the caves gradually loosened, forming micro cracks under rainwater erosion.

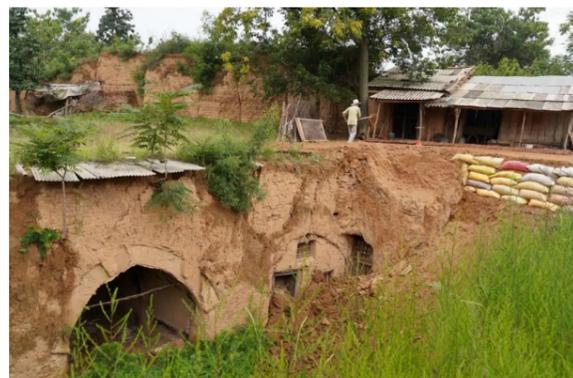
Fig. 42 A Collapsed Dikengyuan.
<https://baijiahao.baidu.com/s?id=1673062606814412852&wfr=spider&for=pc>

The damage to the drainage system of the pit courtyard, especially the parapet and the seepage well, is also catastrophic. The poorly maintained parapet quickly collapsed under wind and rain erosion, losing its water blocking function and causing surface runoff to directly flow into the courtyard, eroding the most fragile vertical cave surface. The siltation of the seepage well causing rainwater to accumulate at the bottom of the courtyard and soften the foundation, and the strength of the structure at the bottom of the cave rapidly decreases. The damage to the foundation and the leakage at the top jointly damaged the structure, leading to the overall collapse of the pit courtyard.

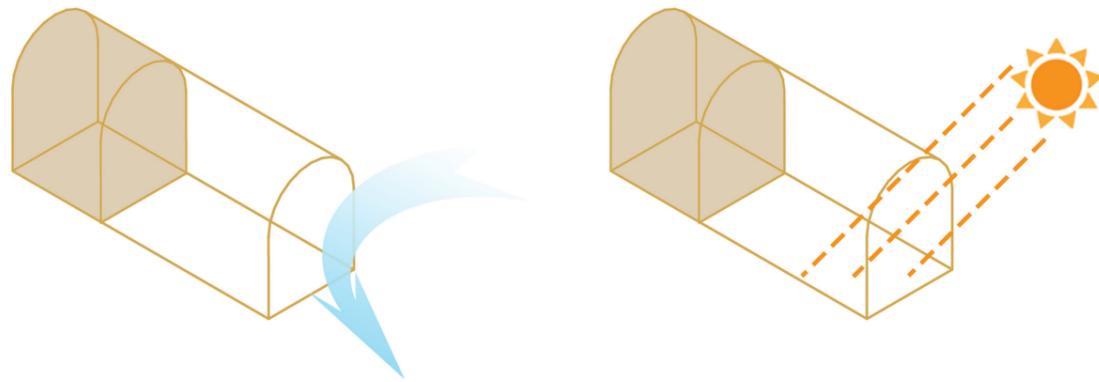
Fig. 44 *Daylighting and Ventilation of the Cave*. Drawn by the author.

Although the pit courtyard is often described as a vernacular architecture that warm in winter and cool in summer, further monitoring of the actual indoor environmental quality reveals its high humidity and weak ventilation, especially in the rainy season. In many cases, caves are ventilated mainly through the single opening facing the courtyard, which limits air exchange and makes it difficult to remove moisture effectively.

Daylighting is another structural limitation. Because natural light mainly enters from the courtyard-facing opening, illuminance drops rapidly with increasing room depth. A study on the indoor light environment of traditional pit courtyard shows that even under natural light at 12:00 noon, the indoor illuminance and daylighting coefficient of the cave dwelling are only 150.5 (lx) and 1.35% (Kong et al., 2025). That implies that the middle and rear parts of deep caves cannot meet basic daylighting needs without artificial lighting.

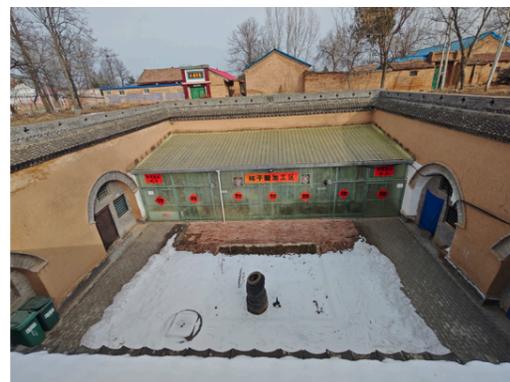
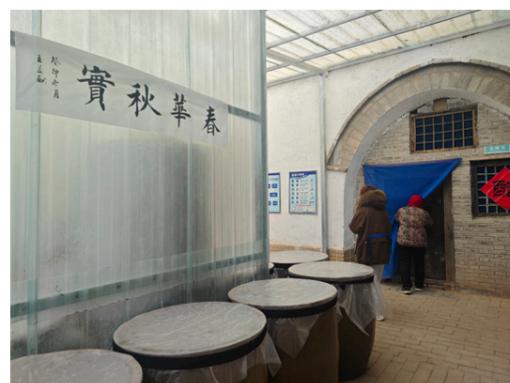
Fig. 46 *The New Built Structure in the Pit Courtyard for Local Agricultural Product Processing.* Photo by the author.

Beyond specific technical issues, some renovation work has also been a problem. On field research, it has been found that economic pressure has led some residents to introduce new structures into traditional pit courtyards. In a pit courtyard in Qu village, a household constructed a lightweight prefabricated shed within the courtyard to support the local agricultural production of persimmon vinegar processing. The new building blocks ventilation, sunlight access, and visually fragments the continuous earthen facade. Although the intervention responds to contemporary economic needs, the inserted structure occupies the central open space of the courtyard and interrupts the pit courtyard's original spatial order.

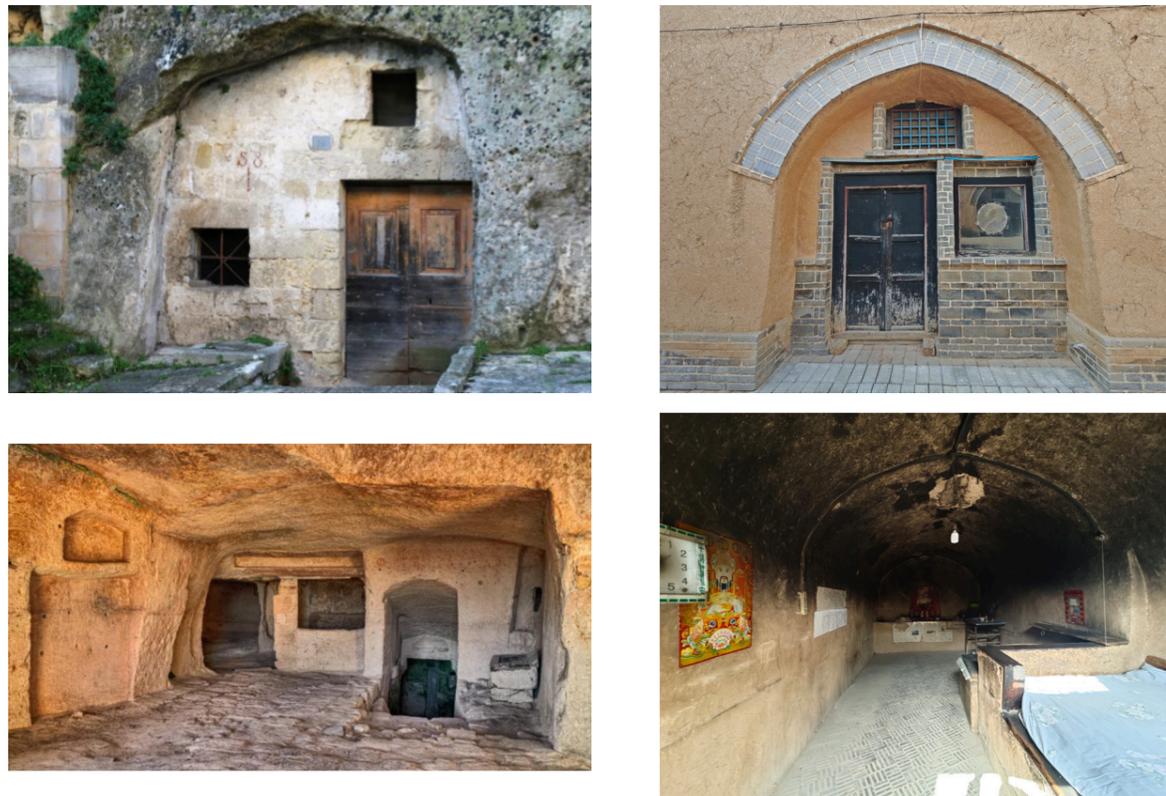
Fig. 53 The Comparison Between Cave in the Pit Courtyard and Cave in Sassi di Matera.
 Left: <https://montenegro-for.me/2019/01/matera-the-city-of-cave-dwellings/>
<https://aleteia.org/2019/02/27/matera-the-southern-italian-city-where-residents-live-in-prehistoric-caves/>
 Right: Photo by the author.

In the pit courtyards, this continuity is manifested in the integration of the courtyard with the loess soil. In Matera, it is manifested in the symbiotic relationship between the cave facade and the rock walls. This construction method, opposed to the modern main additive architecture that forms solid structures through the addition of materials, determines the deep connection between the two in terms of physical attributes and aesthetic characteristics. This fundamental consistency in construction methods provides a solid typological foundation for the cross-cultural comparative analysis in this thesis.

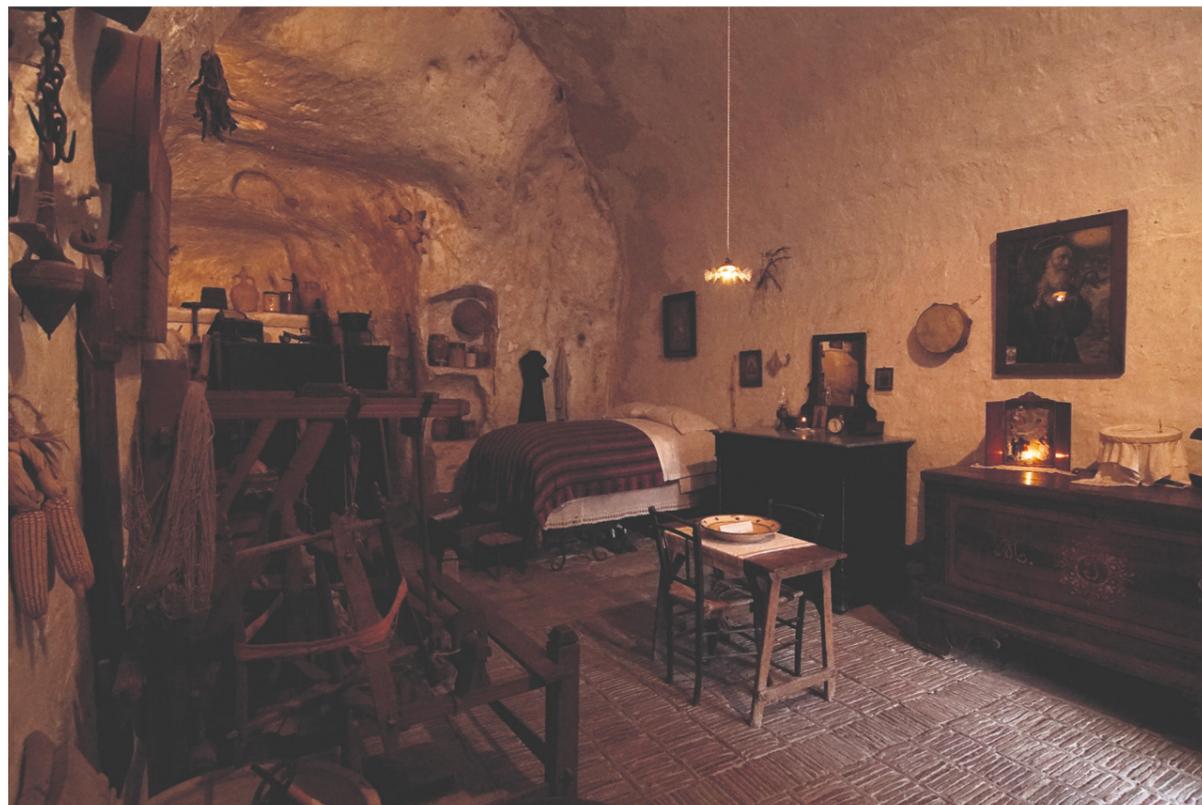
Fig. 60 *Storica Casa Grotta di Vico Solitario*.
<https://www.materawelcome.it/en/luogo/casa-grotta-di-vico-solitario/>

Architecturally, the Casa Grotta is organized as a single enclosed rock chamber hewn from the hillside, with its front closed by a masonry wall containing a simple wooden door and a single window that once provided both light and ventilation. The interior was arranged to accommodate domestic life through a linear sequence of functional zones, including a central living and sleeping area, a kitchen adjacent to the entrance, and ancillary spaces such as storage recesses and a stable for the family's mule at the rear, commonly separated by low stone partitions. Household tools, furniture, and agricultural implements were stored along the walls, while a subsurface cistern beneath the floor collected rainwater for domestic use. The one-room spatial organization typified the dual use of the cave as both living and working space, with animal husbandry integrated into the household compound (Fontana, 2018).

Casa Grotta's interior environment reflected the realities of peasant life: limited natural illumination, high humidity resulting from cooking and animal presence, and simple finishes such as lime-washed walls and stone floors (Fontana, 2018). As described in historical records, these cave houses were perceived as "cool in summer and warm in winter," but also suffered from minimal ventilation and rudimentary sanitary conditions that contributed to significant health challenges prior to mid-20th-century interventions.

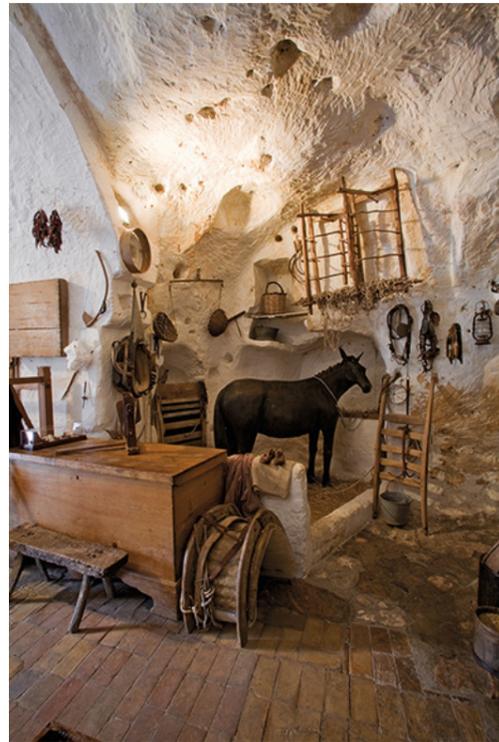
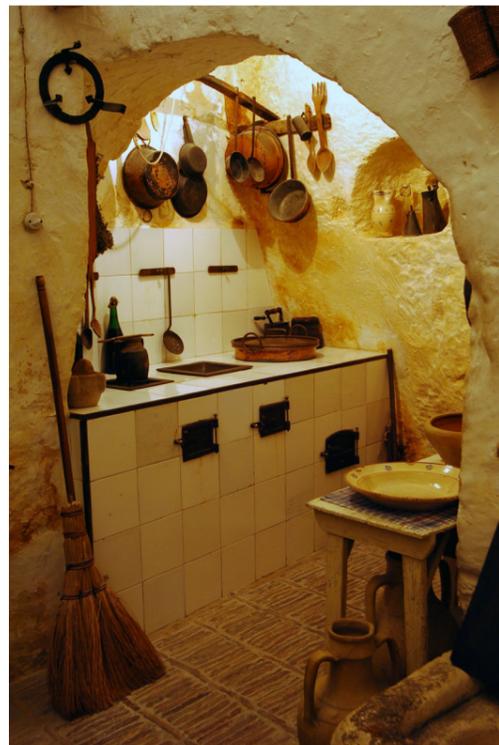
Fig. 62 Storica Casa Grotta di Vico Solitario.
<http://www.simbdea.it/index.php/musei/tutti-i-musei/1219-storica-casa-grotta-di-vico-solitario>

Today, the Casa Grotta operates as a museum of old family life in Matera, that faithfully reconstructs this domestic environment with period furnishings, authentic household objects, and interpretive material to illustrate the daily life of its former inhabitants. The interior displays include a kitchen with traditional pottery and tools, a bed with seasonal bedding, weaving implements, and other artifacts that demonstrate patterns of work and family routines typical of Matera peasant culture. The museum also provides multilingual descriptions and audiovisual material to support visitor understanding.

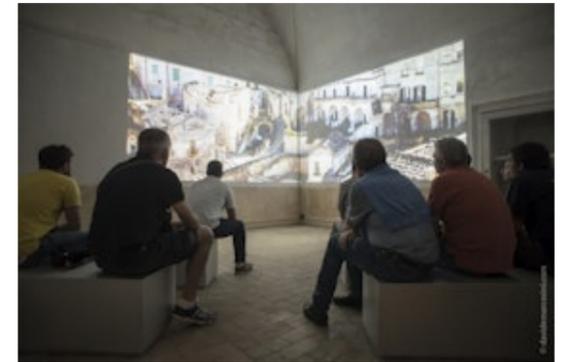
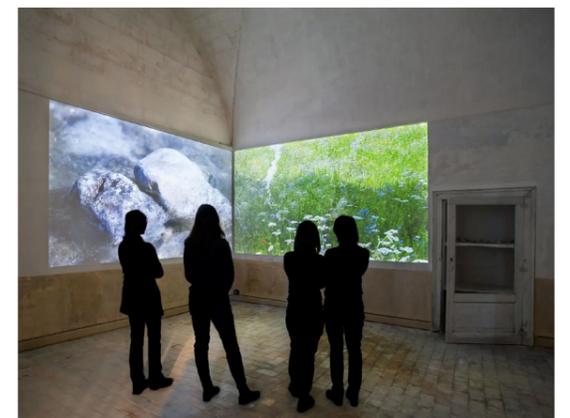
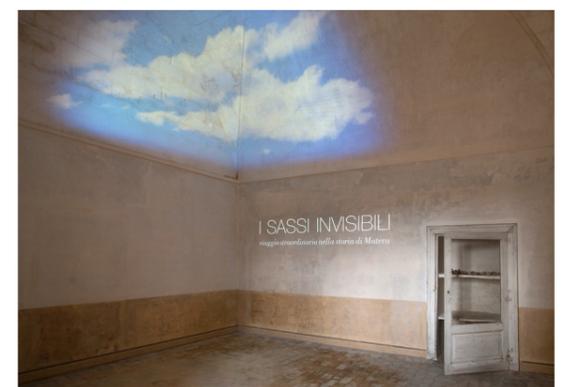
Fig. 63 The Projection in Casa Noha.
<https://www.museimatera.it/casa-noha/>
<https://www.materawelcome.it/en/luogo/casa-noha/>

Casa Noha uses multimedia video mapping technology to project images directly onto the exposed *Tufo* (tuff) walls and vaults, telling a grand historical narrative from the evolution of prehistoric settlements to the mass relocation of the 1950s (FAI, n.d.). This intervention method follows the principle of minimal intervention, using a non-material image layer projected on the material heritage layer. It effectively conveys the sociological meaning and emotional memories hidden behind the rocks without destroying the spatial form of the cave itself. This approach combined the physical objects with digital communication, ensures that Matera's core historical value is well preserved in the tide of tourism commercialization.

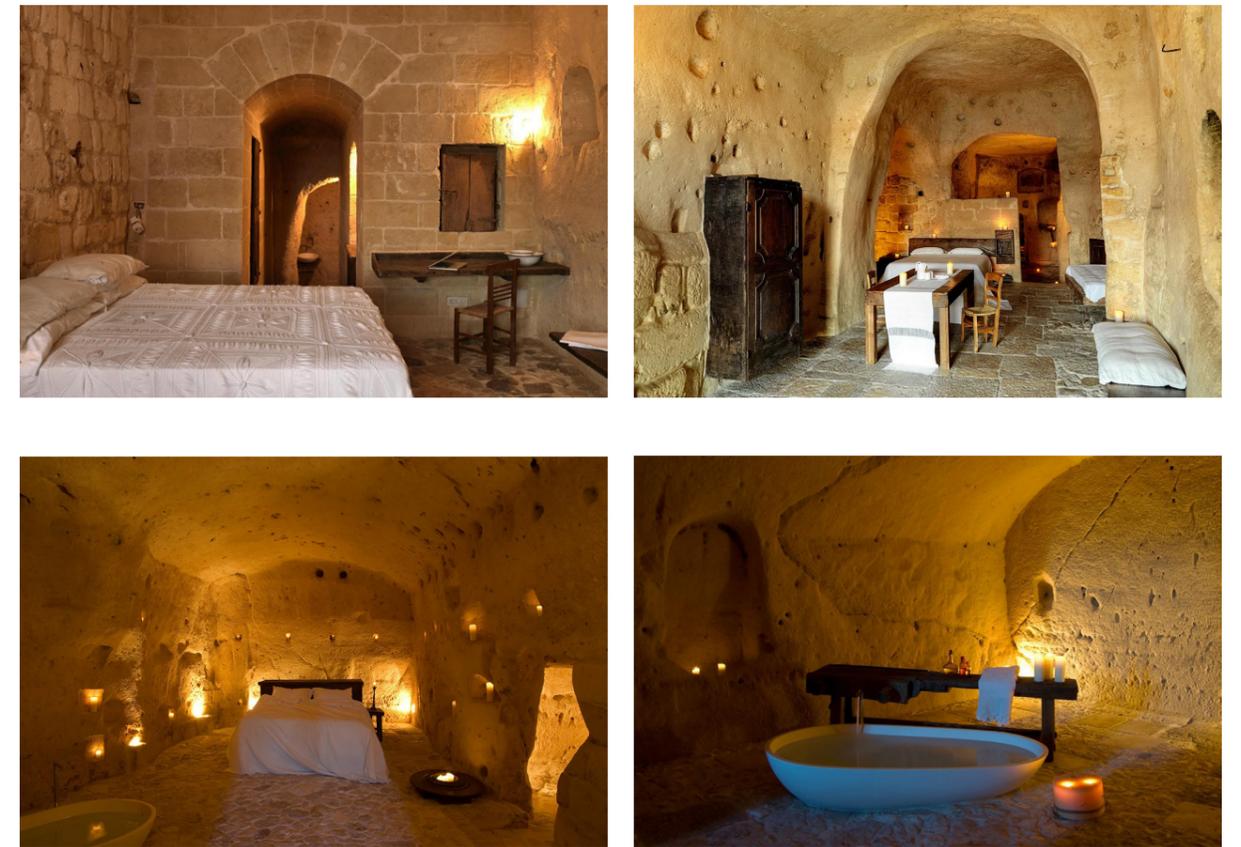
Fig. 66 *Interior Space of the Guest Room.* <https://www.sextantio.it/en/legrottedellacivita/classic-room/>

One of the main technical challenges of the adaptive reuse was the integration of modern building services required for hotel use. Heating, plumbing, electrical systems, and data connections were installed in a concealed manner to avoid visual intrusion. In particular, the project adopted underfloor radiant heating to ensure thermal comfort while keeping mechanical equipment out of sight (Archilovers, n.d.). To achieve this, existing stone floors were dismantled, numbered, and reinstalled after the heating system was placed beneath them, allowing the original appearance to be restored once construction was completed (Vanity Fair, 2019). Similar principles were applied to lighting and ventilation systems, which were hidden within recesses or secondary layers wherever possible.

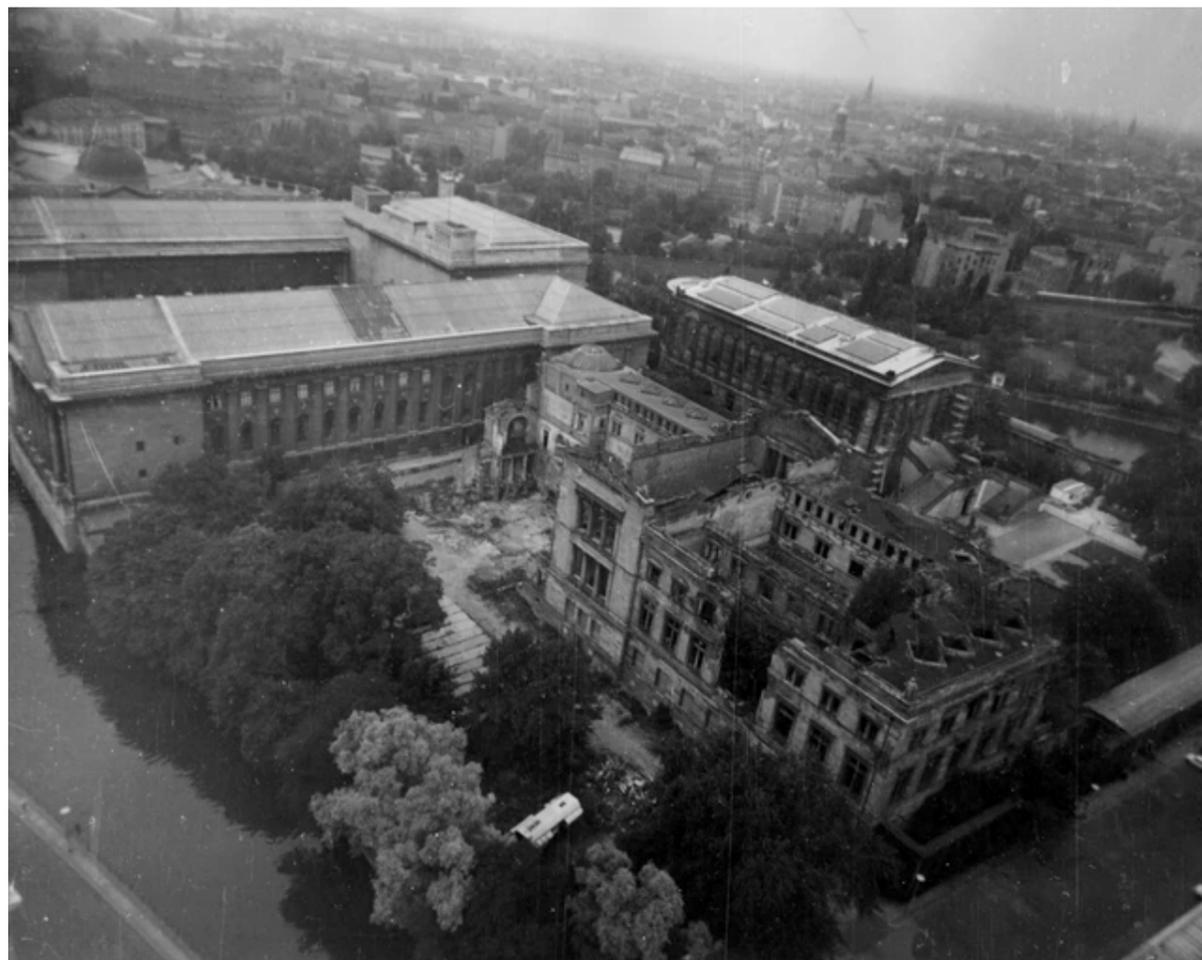
Fig. 75 Neues Museum Before Restoration. <https://davidchipperfield.com/projects/neues-museum>

The restoration project of Neues Museum (1997-2009) was completed by David Chipperfield Architects in collaboration with restoration Julian Harrap. The building was originally built in the mid-19th century and was heavily bombed during World War II, leaving it in ruins for over 60 years. Chipperfield's plan did not choose to completely restore the building, nor did it choose a thorough reconstruction that completely erased historical traces. On the contrary, they emphasize the spatial context and material characteristics of the original building, reconstructing the original volume of the remaining parts after World War II. By constructing new building units, the original room sequence has been restored and continuity has been maintained with the existing structure. And only cautiously integrate new materials into existing structures when necessary to maintain overall harmony and unity.

The sense of ruins of the original buildings and the trauma of World War II including bullet marks and burn marks have been fully preserved as part of the heritage, which not only restores the buildings but also restores the continuity of history.

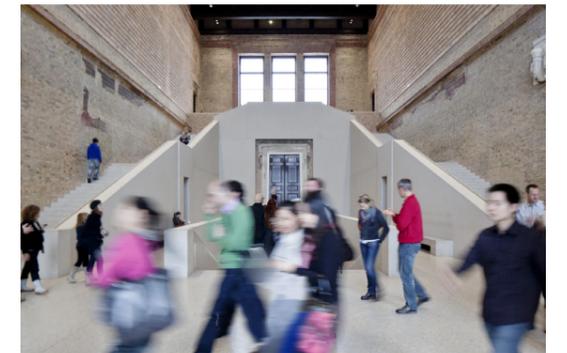
Fig. 78 Past and New Stairs. <https://davidchipperfield.com/projects/neues-museum>

The newly inserted parts, such as the central staircase and the new exhibition room, are mainly used pre-fabricated concrete elements consisting of white cement mixed with Saxonian marble chips.

And other newly built volumes are made of recycled handmade bricks, cleverly recognizing them from historical parts.

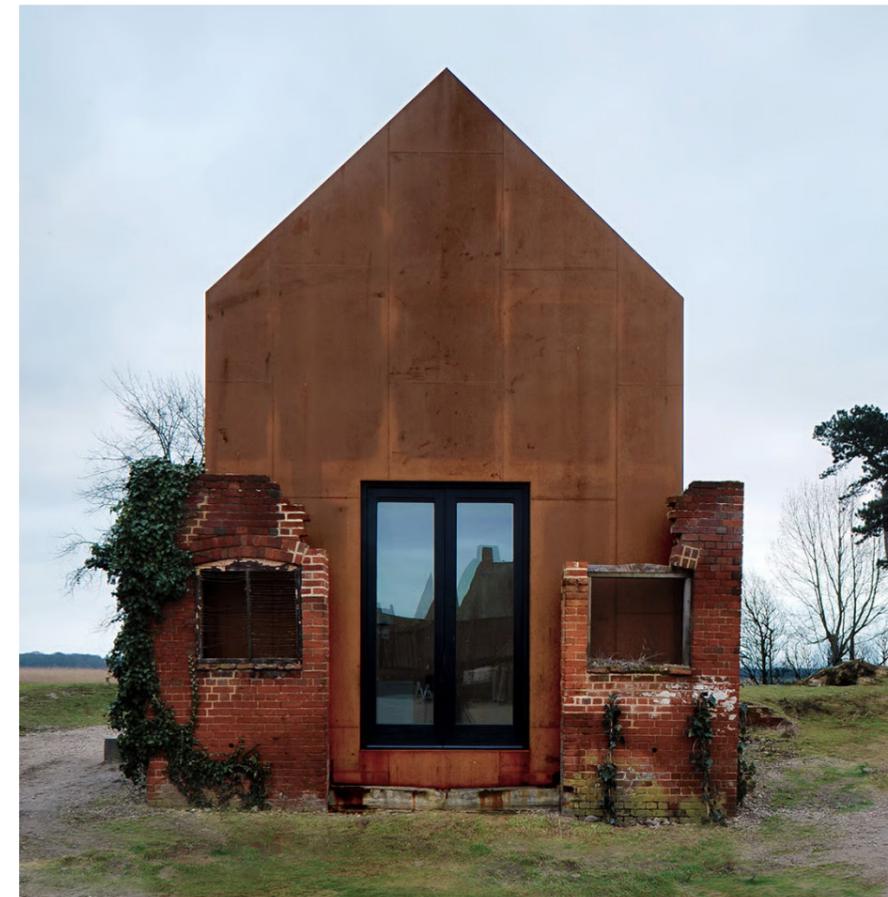
Fig. 83 *The New Dovecote Studio.*
<https://www.archdaily.com/89980/dovecote-studio-haworth-tompkins>

Located within the internationally renowned Snape Maltings music campus, the project was on the site of an abandoned Victorian dovecote, with only its crumbling red brick facade remaining. Instead of traditional reinforcement, Haworth Tompkins used a box-in-box strategy, inserting a completely freestanding, prefabricated corten steel structure directly into the old brick ruins. This newly implanted core both supports the collapsing old wall and provides a 24/7 modern art studio, achieving a symbiosis between ruin and new architecture.

The exterior uses weathering steel COR-TEN, with a rusty red color that blends with the surrounding red brick buildings. The interior walls and floors are fully lined with spruce plywood, creating a bright, warm, and sealed wooden "box" that contrasts with the rough industrial ruin outside.

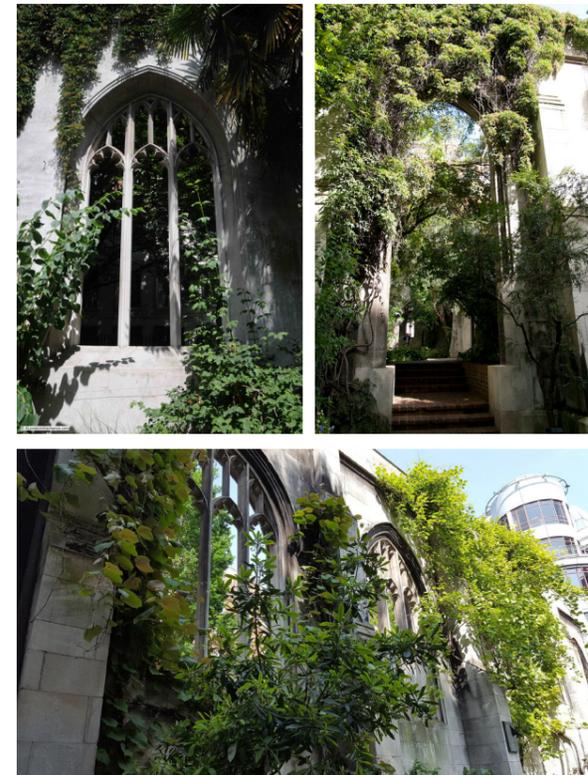
Fig. 96 *Church and Plants Coexist.*
<https://www.nationalchurchestrust.org/church/st-dunstan-east-city-london>

Vegetation was strategically introduced into the building's footprint. Lawns cover the area that was formerly the church floor, climbers grow along the remaining limestone walls, and trees are planted within the nave. The interweaving of natural vegetation with the masonry softens the severity of the ruins, utilizing the microclimate created by the high walls to establish a secluded oasis.

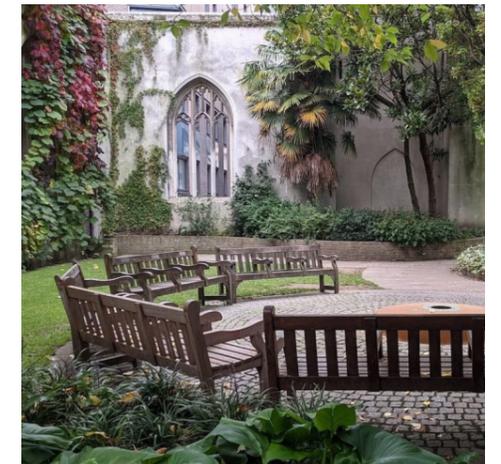
Fig. 97 *The Only Implanted Benches and Fountain.*
<https://historicengland.org.uk/listing/the-list/list-entry/1359173>

The architectural intervention was strictly limited to structural stabilization. Dangerous masonry was consolidated to ensure safety without reconstructing the missing elements. The fractured edges and weathered surfaces were retained to maintain the site's character. Apart from the addition of a fountain and necessary seating, no significant modern structures were added to the site.

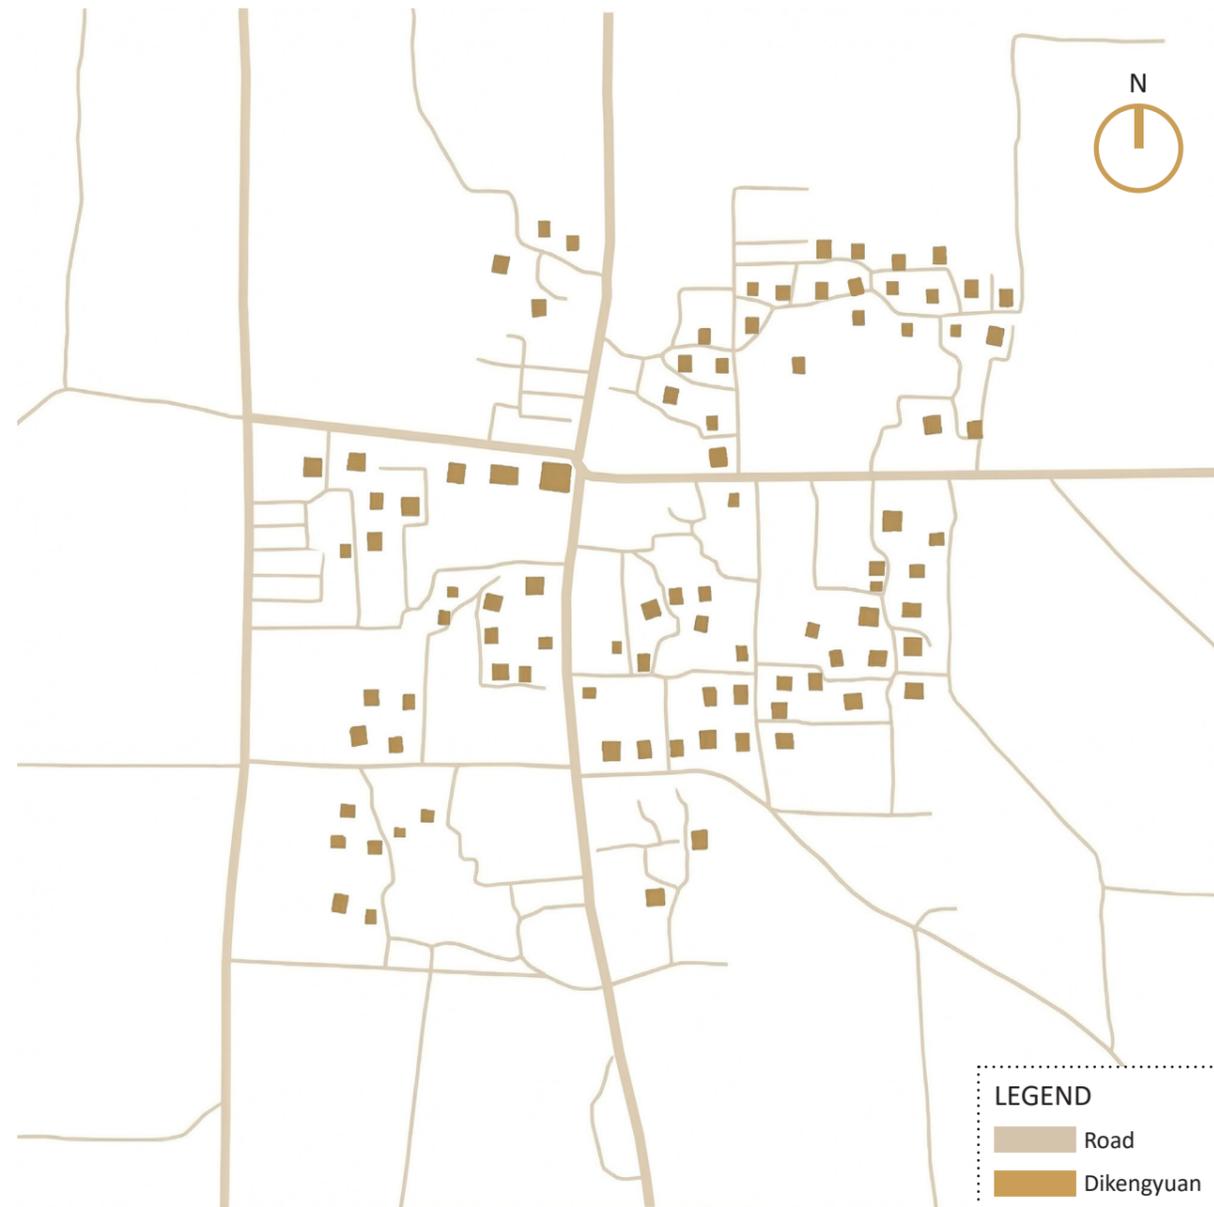
Fig. 100 Map of Qu Village. Drawn by the author.
122

Based on the principles of differentiation and typicality, this application identified three courtyards with significant characteristic differences in the Qu village as fixed empirical objects. These three sets of samples represent the typical states of Dikengyuan in three different stages of its lifecycle: traditional preservation, modern renovation, and natural abandonment.

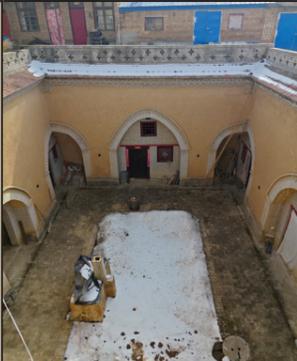
The courtyard layout is complete. All original caves are preserved and well organized. The facade elements are well preserved after renovation.	5
A3 Material and Component

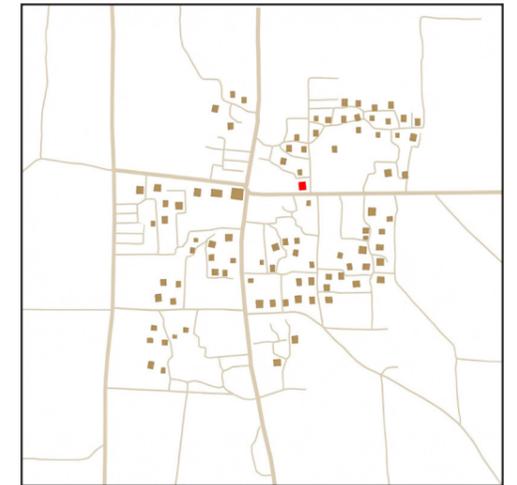
Fig. 111 Location of Starlight B&B in Qu Village. Drawn by the author.

This courtyard is a typical representative of Qu Village's rural tourism development in recent years, transformed into a family run B&B. It is located in the center of the village, adjacent to one of the main roads, and vehicles can directly reach the courtyard roof. The building has undergone a comprehensive modernization renovation, with some of the cave facades using green brick finishes, the ground hardened and paved, and independent bathroom facilities and air conditioning systems embedded inside. The doors and windows have also been replaced with modern glass windows with better air tightness.

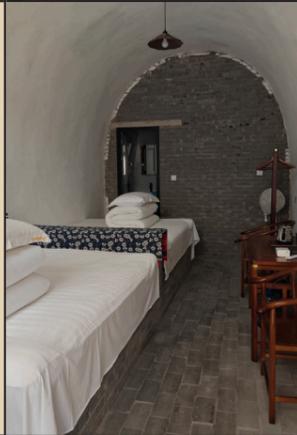
The courtyard layout is complete. But the original functions of the cave have been changed, all of which have become guest rooms. After renovation, the facade elements are well preserved.	5
A3 Material and Component

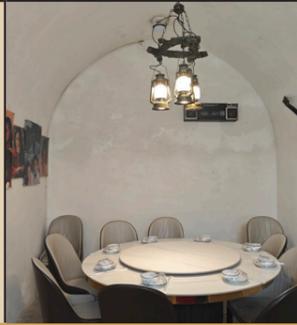
After the modern renovation of B&B, the original component materials have been completely replaced, and the facade is covered with plaster.	0

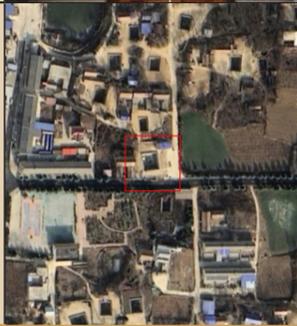
Located in the central area of the village, close to the intersection of two main village roads, adjacent to one of the main road and a secondary road.	5

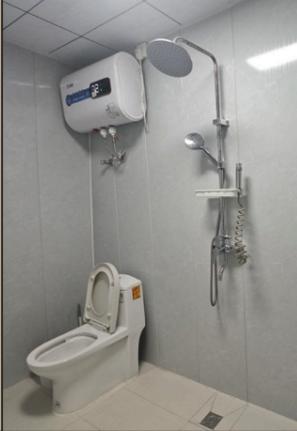
The courtyard drainage system operates efficiently, there is no water accumulation in the courtyard on rainy days. The bathroom in the guest room is equipped with a new modern drainage system.	5
C3 Thermal Environment

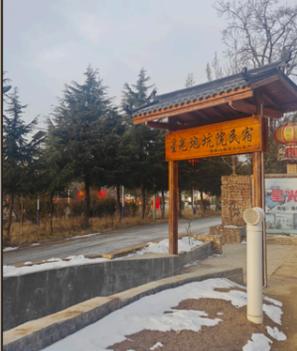
Adjacent to the village main road, vehicles can directly drive to the entrance of the courtyard. There is open space for parking on the ground around the courtyard.	5

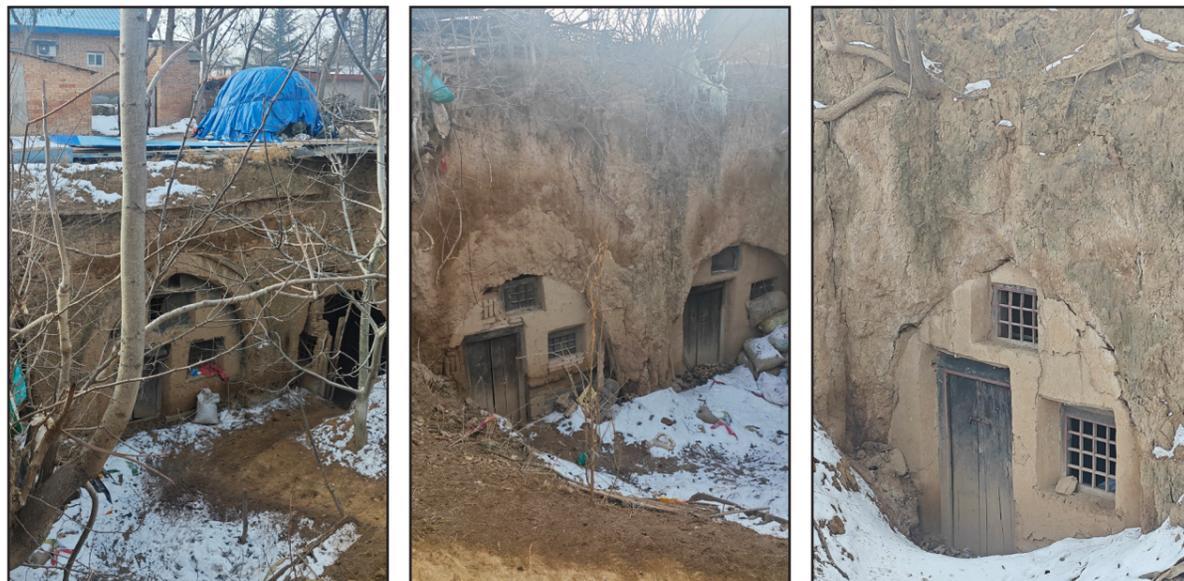
Fig. 122 The Abandoned Pit Courtyard. Photo by the author.

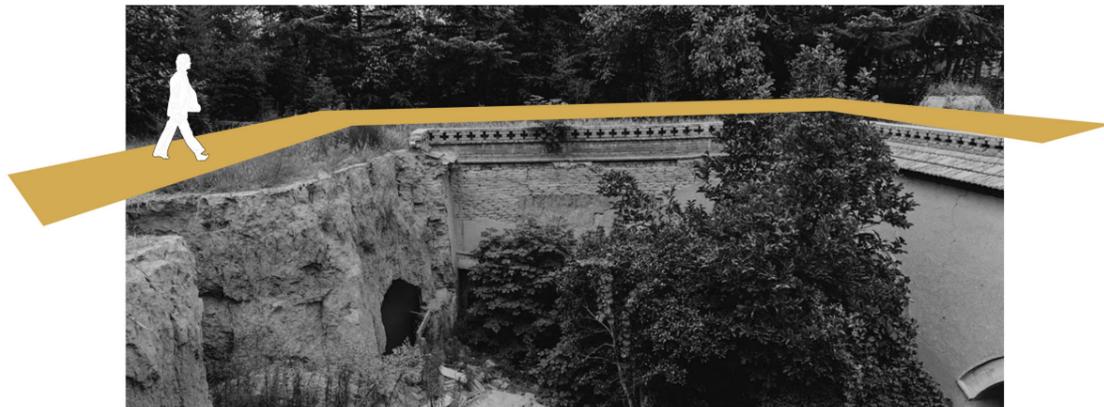
Fig. 130 Intervention Strategies for the Abandoned Pit Courtyard. Drawn by the author.
